Building and Timber Pest Inspection Report

Inspection Date: Mon, 2 Feb 2026

Property Address: 5/108 Princess St, Werrington NSW 2747,
Australia

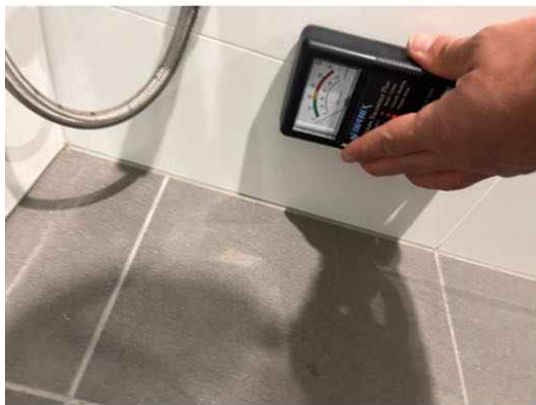
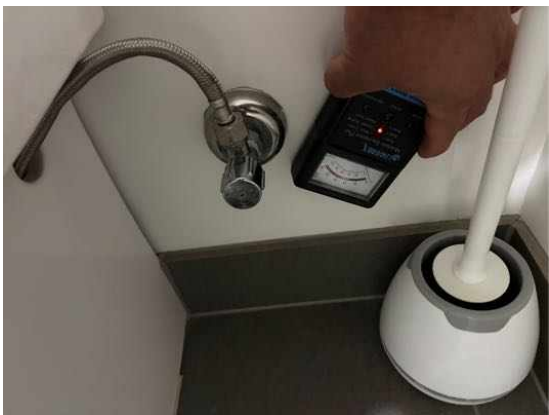
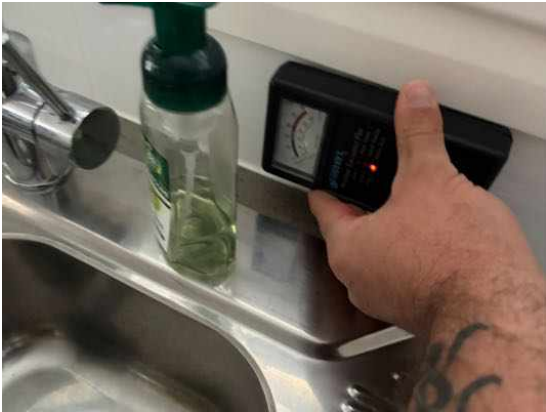
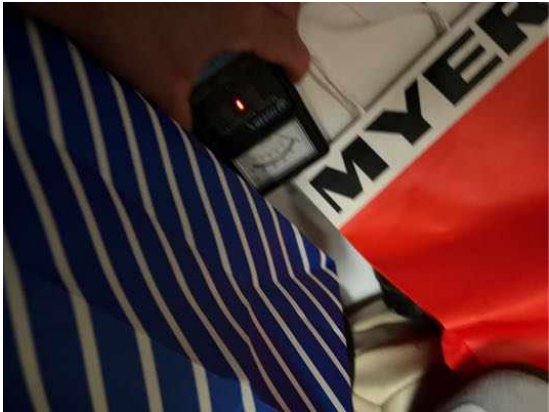
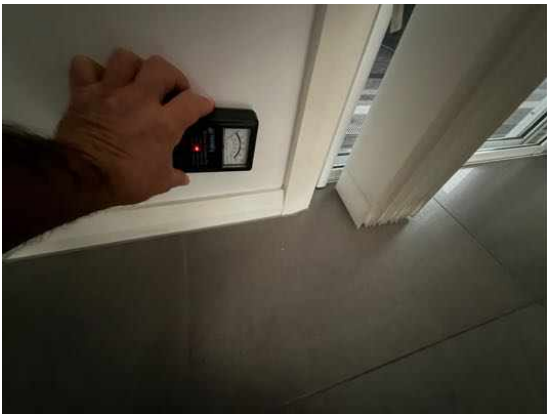
Building: Main Building
Location: All Areas
Finding: Moisture metre
Information: During the inspection the property was checked for moisture using a moisture metre.

This is for information only.

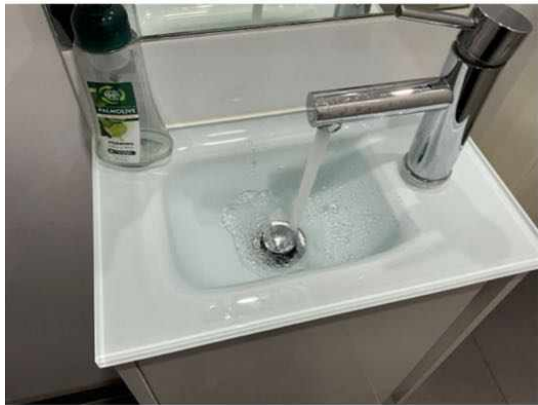
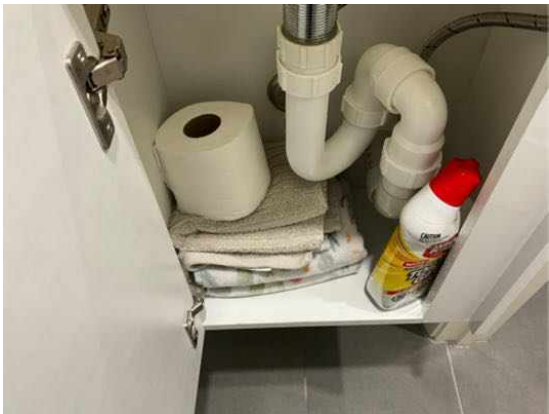
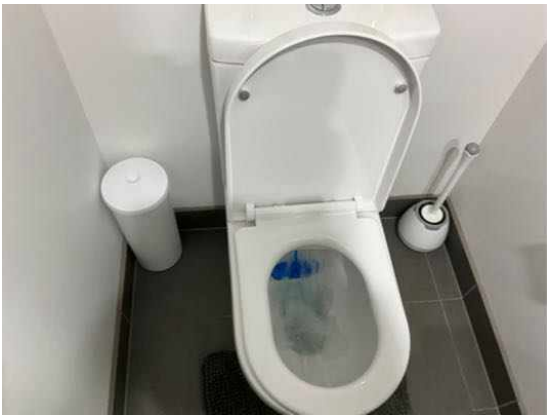
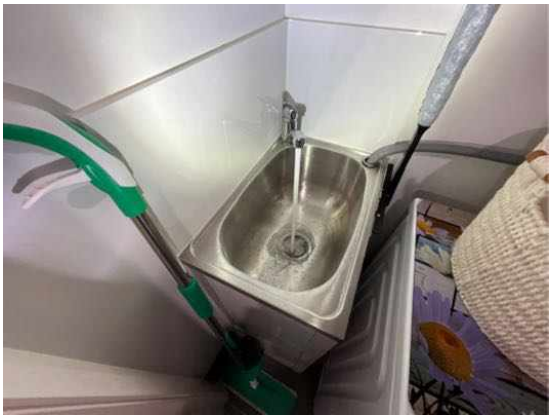
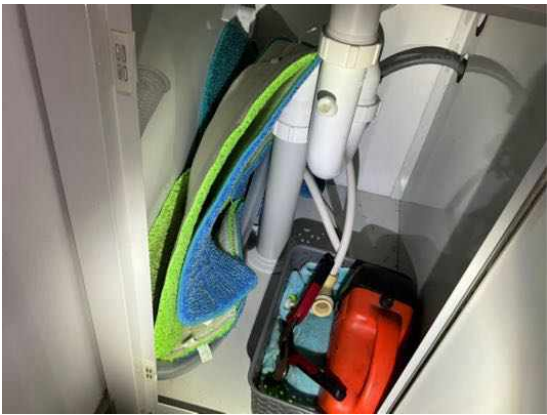
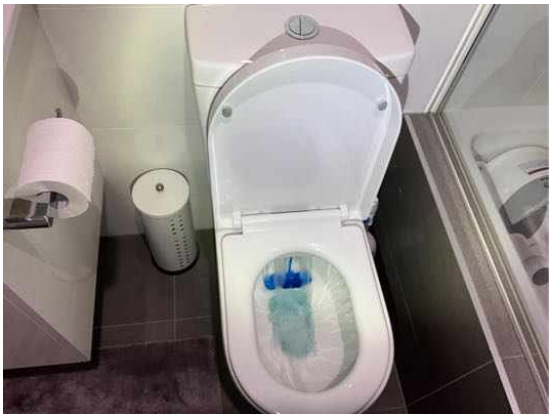
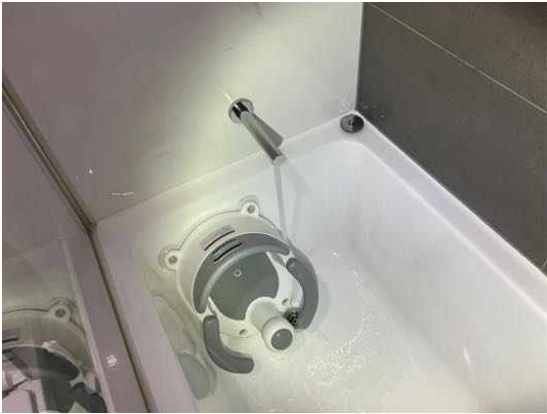
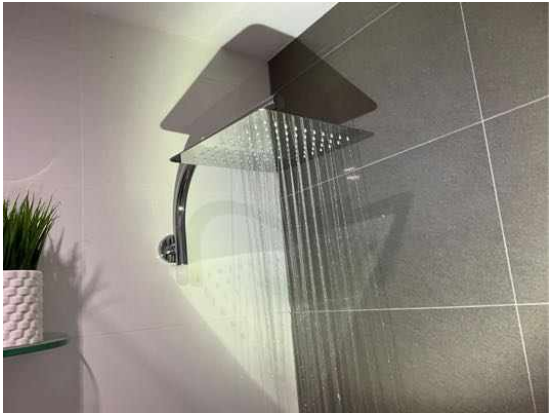
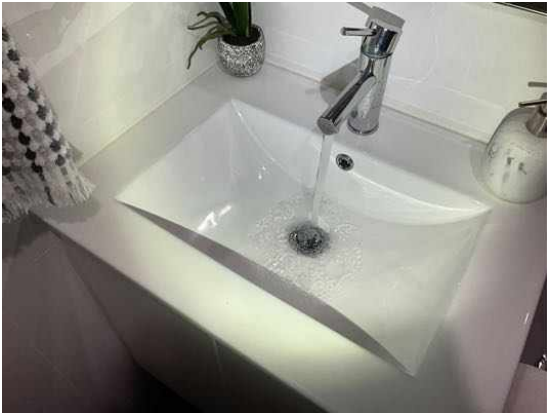
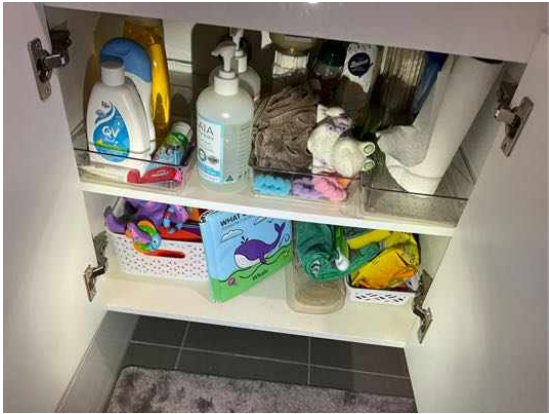
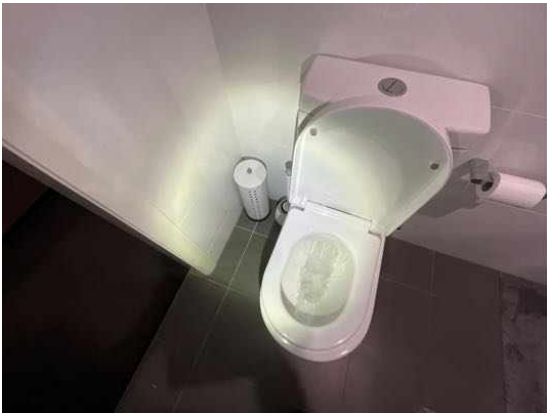
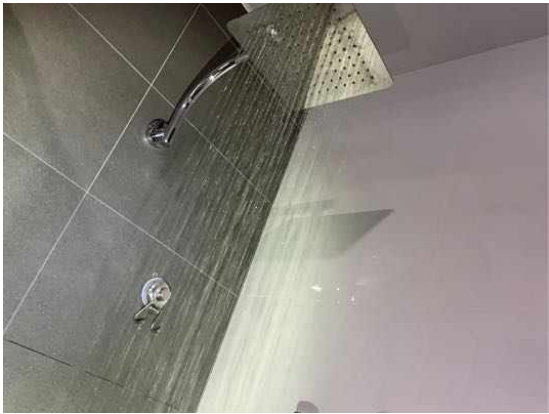
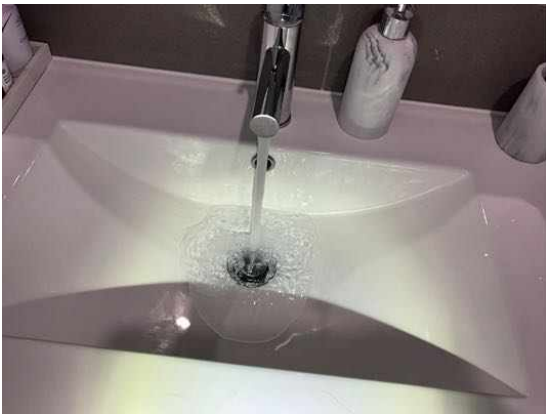
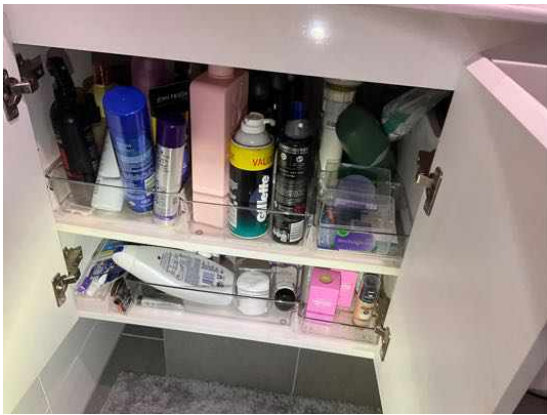
Building: Main Building
Location: All Wet Areas
Finding: Additional Photos
Information:

Additional photos are provided for your general reference.

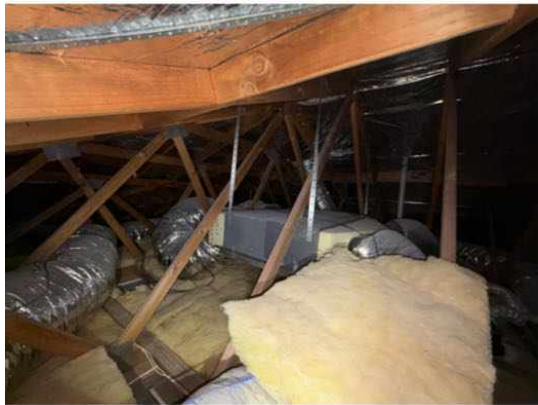
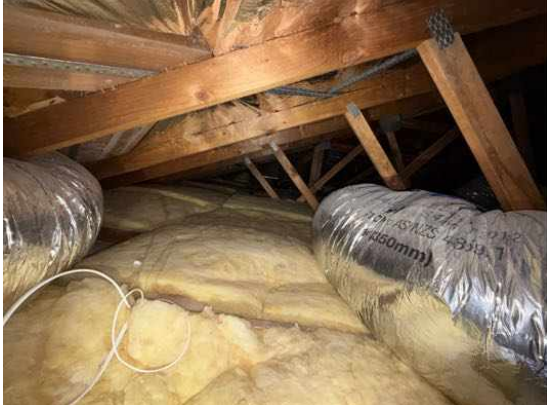
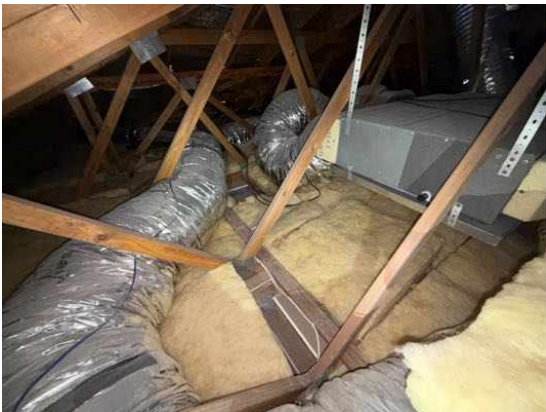
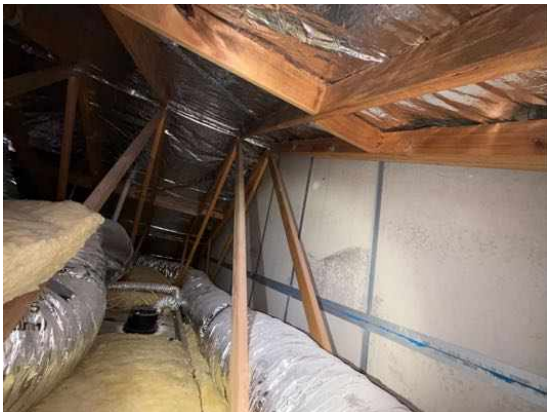
Building: Main Building
Location: Roof Void
Finding: Additional Photos
Information:

Additional photos are provided for your general reference.

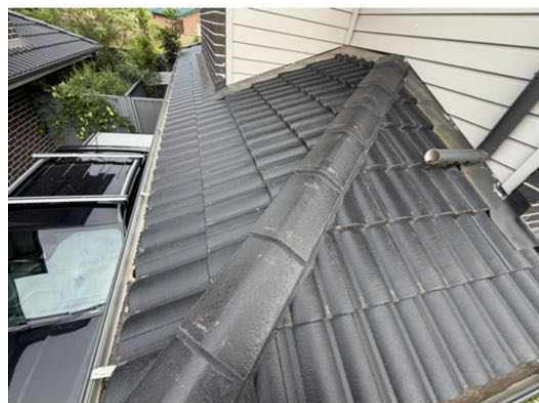
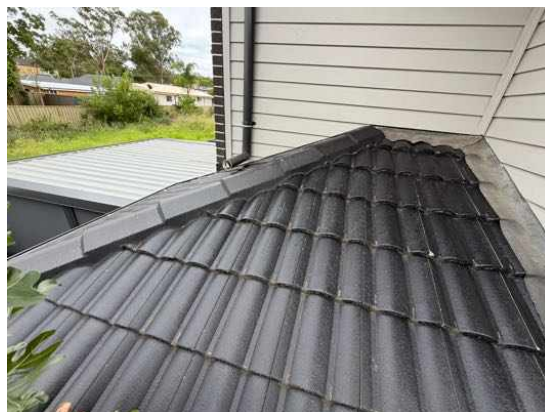
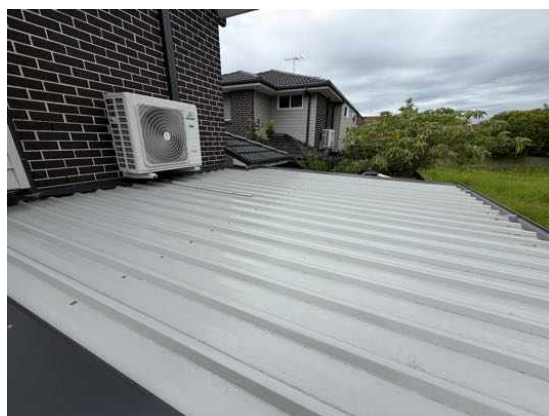
Building: Main Building
Location: Roof Exterior

Finding: Additional Photos

Information: Additional photos are provided for your general reference.

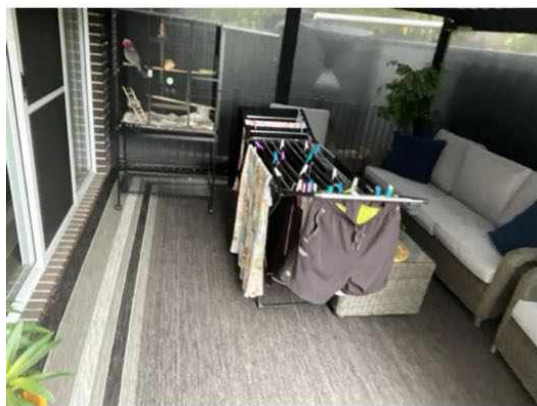
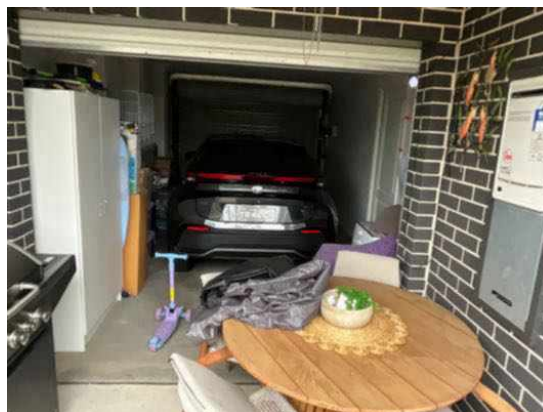
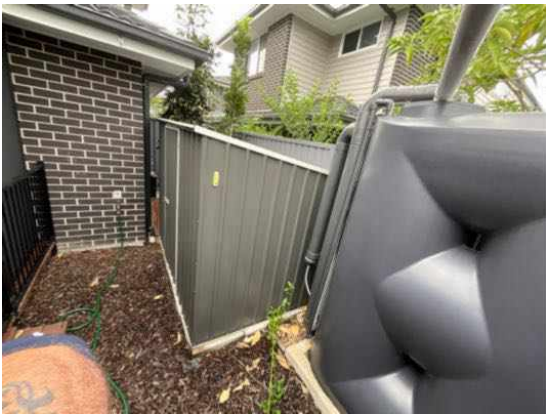
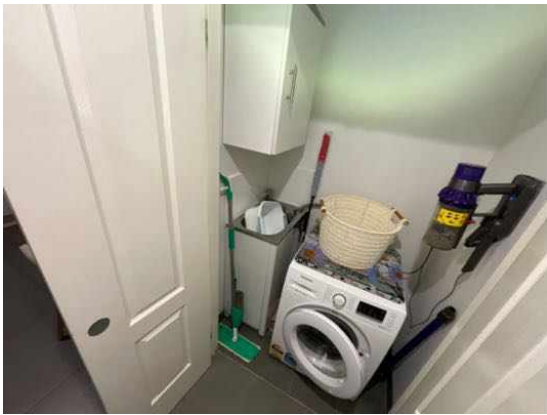
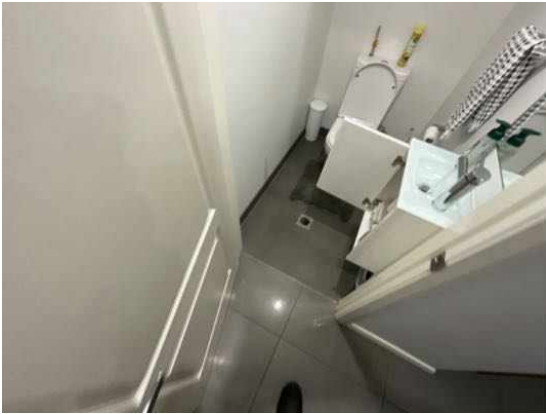
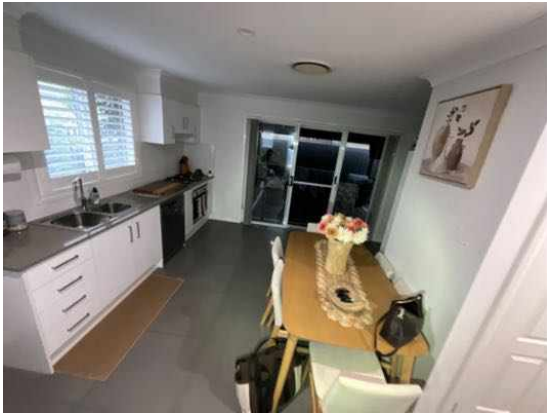
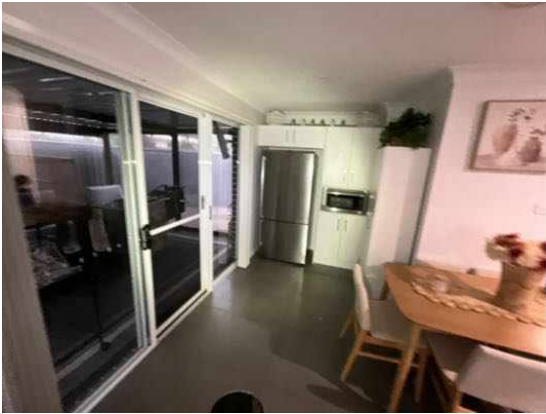
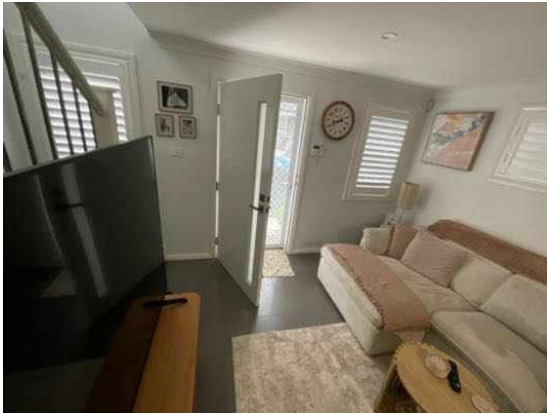
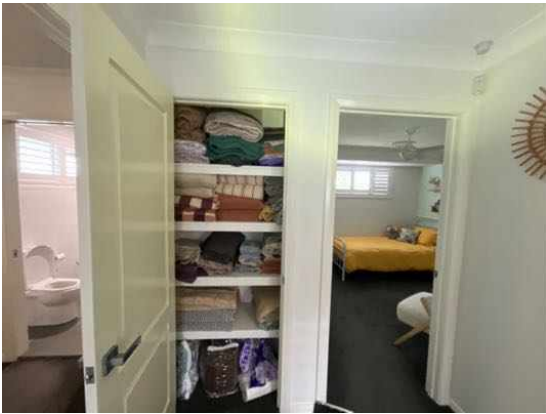
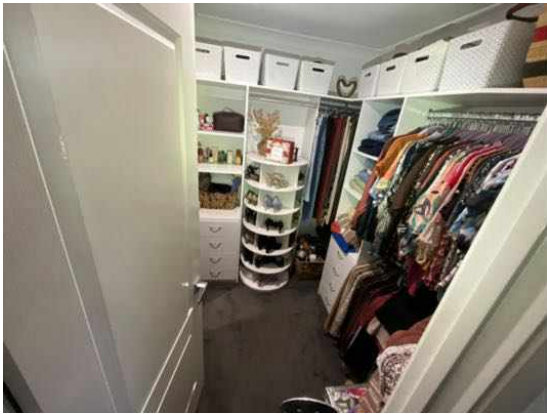
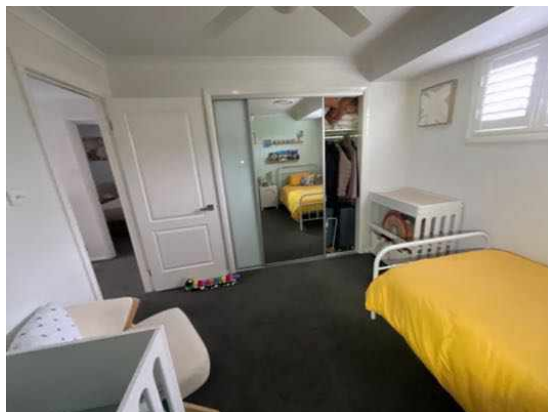
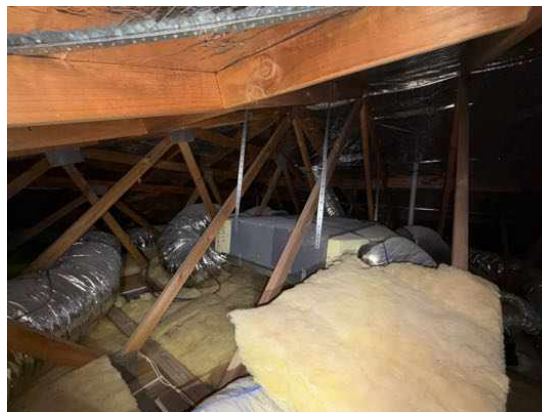
Building: Main Building
Location: All Areas
Finding: Additional Photos - Obstructions and Limitations
Information:

These photographs are an indication of the obstructions and limitations which impeded full inspection of the property at the time of inspection. These obstructions can hide an array of defects and should be removed to allow full inspection to be carried out. A re-inspection is recommended once the areas are made accessible.
