Building Inspection Report

Inspection Date: Wed, 18 Feb 2026

Property Address: 8 Aruma Ct, Burwood East VIC 3151,
Australia

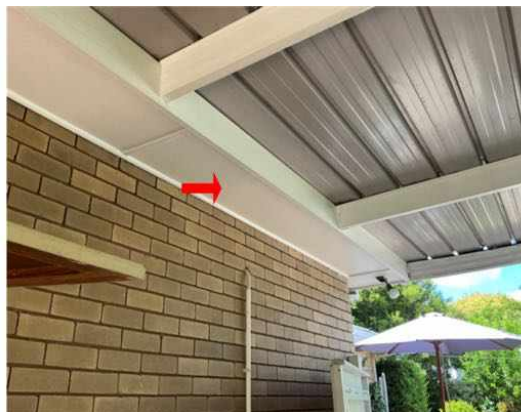
Defects 1.02

Building:	Main Building
Location:	Eaves
Finding:	Asbestos - Suspected ACM Identified on Site
Information:	Reporting on Asbestos is outside the Scope of this Report. This suspected defect is highlighted as a caution only. We suspect, based on our experience in the building industry, that there is a higher risk of the identified building element containing asbestos.

As Asbestos Reporting is outside the scope of this report, we advise that you consider a separate Asbestos Inspection and Condition Audit, which can include the taking of

samples for definitive confirmation of the presence of Asbestos.

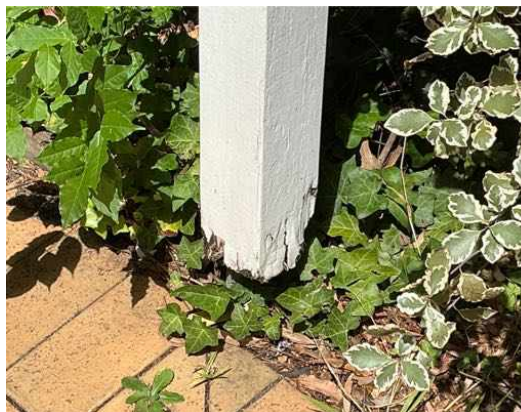
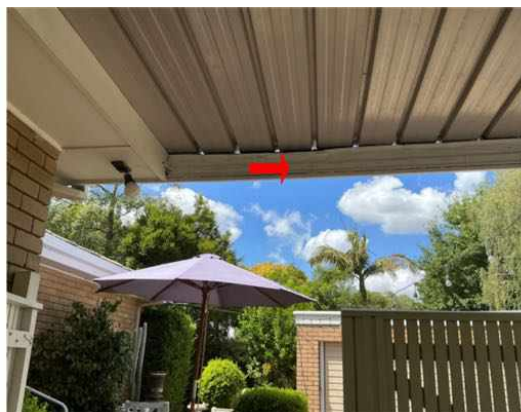
Defects 1.03

Building: Main Building

Finding: Wood rot

Information: This building element shows evidence of wood rot and may be structurally unsafe. Wood rot, also known as Fungal Decay, occurs when timbers and other cellulose building materials are exposed to damp conditions on an ongoing basis. This could be the result of exposure to weathering over a prolonged period of time, or the attraction of excessive moisture from other abutting building materials. Contributing factors also include poor air ventilation in the area.

Wood rot is often associated with general damp problems and is evidenced by a 'musty' smell or mould and mildew occurring on surfaces. If left unmanaged, damp conditions can lead to further health problems and the decay of timbers will continue.

Early intervention and regular maintenance, particularly of exterior timbers, will prolong the useful life of these building elements. Prior to any works being performed, the cause of the moisture that has created the visible wood rot should be identified and addressed in a suitable manner. Replacement of affected timbers may then be a necessary step in protecting surrounding building elements from such deterioration.

A qualified plumber may be appointed to assess the cause of excessive moisture and to provide advice on any remedial works as required. A qualified carpenter or registered builder may also be required to replace affected building materials.

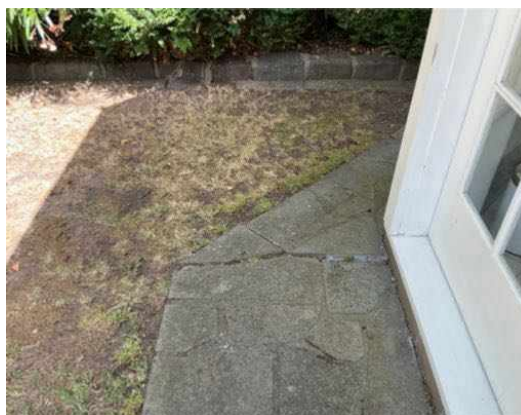
Defects 1.04

Building:	Building 2
Location:	Bungalow
Finding:	Cracking - External Concrete Paving Damage Category 4 - Gaps in Slab (4mm - 10mm +)
Information:	Gaps in the slab were identified in external concrete paving. Gaps in the slab are significant and are likely to lead to the development of safety hazards and secondary defects if left unmanaged, such as the creation of a trip hazard.

General age and expected deterioration of the paved areas is a common cause of this type of cracking. However, expansion and contraction of the slab may also have occurred due to environmental factors. Such factors include variable moisture and weather conditions, the presence of trees and their roots having a settling or lifting affect on the soil, or the effect of load bearing, e.g. heavy vehicles over a sustained period of time.

Cracking to this degree may also be due to poor original installation of the concrete. Factors such as poor compaction of the sub surface and/or inadequate reinforcing of the slab may create cracking and other secondary defects. Gaps in the concrete paving may also have a more significant structural cause, such as subsidence of soils.

Where gaps in the concrete paving are adjacent to structural elements of the building, the advice of a Structural Engineer is advisable before undertaking repairs. Significant

repair and likely replacement of the concrete paving is probable.

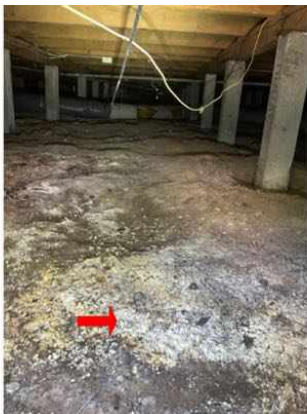
Defects 1.06

Building:	Main Building
Location:	All Areas
Finding:	Subfloor access limitations (Mill-due)
Information:	Limited access to the subfloor was present due to facts including but not limited to access hatch size or placement, for this reason access to the subfloor was minimal.

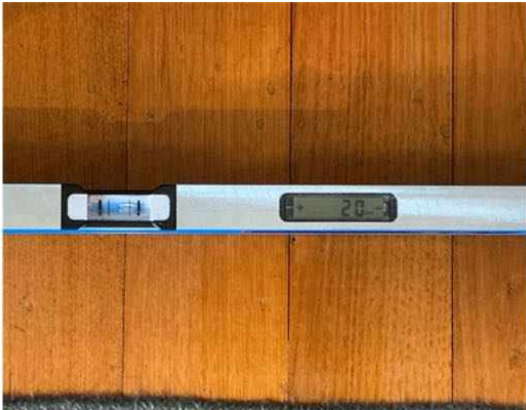
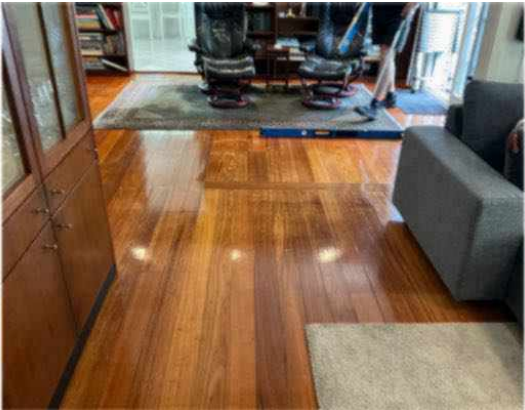
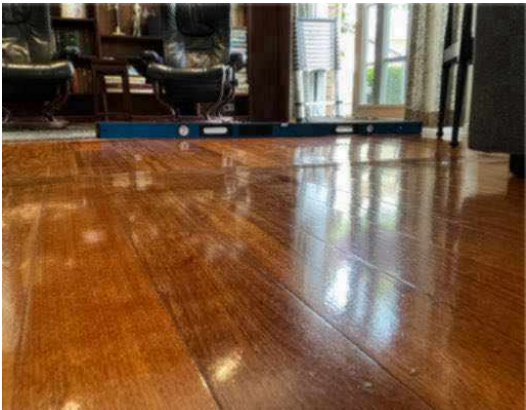
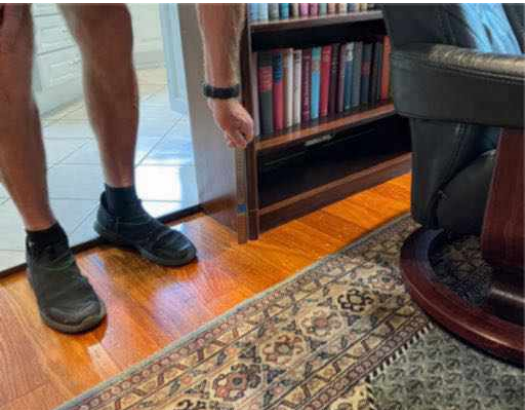
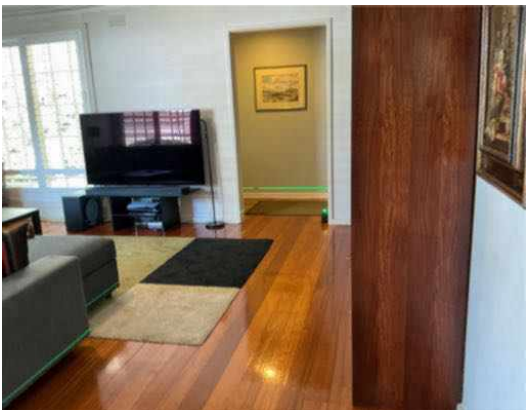
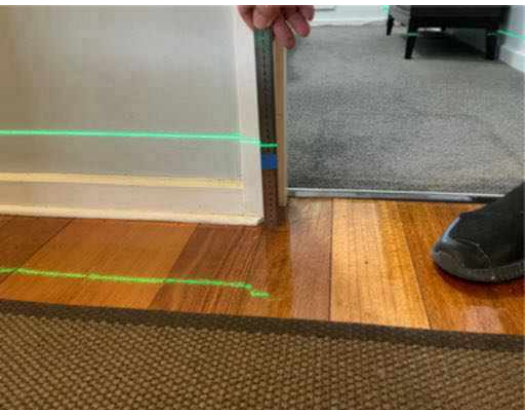
Defects 2.01

Building:	Main Building
Location:	All Areas
Finding:	Flooring - Uneven
Information:	The internal flooring in this area is out of level and uneven. Uneven flooring is likely to indicate minor defects such as expected movement of the foundations of the property, but may also indicate subsidence of the associated subfloor stumps.

It is advised that the flooring be closely monitored to identify any further movement. Where flooring remains relatively unchanged for an extended period of time (i.e. several months), it is likely that this defect has been caused by expected movement of the

foundations of the property.

However, where flooring is uneven further, potentially invasive inspection of the subfloor structures and stumps in this area is required. In this case, works to repair are likely to be required, and would be carried out by a registered builder specialising in re-stumping.

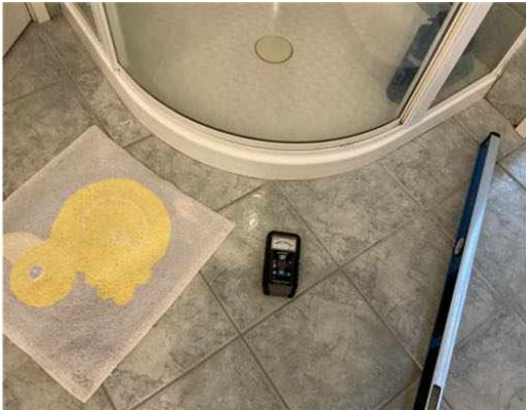
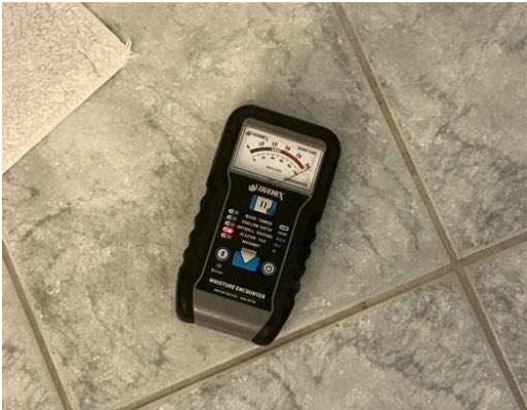
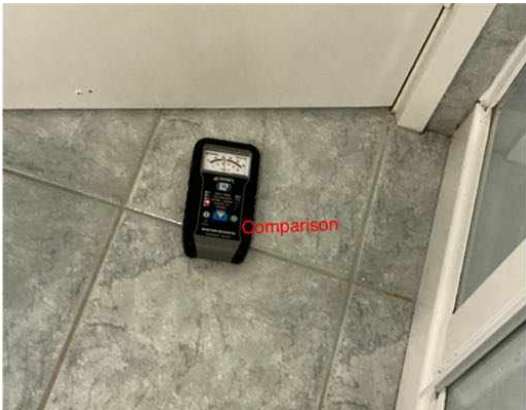
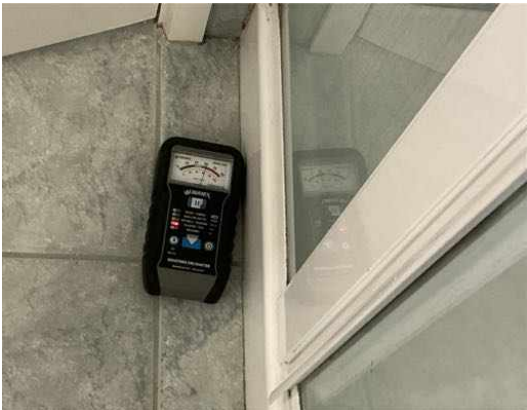
Defects 2.02

Building: Main Building
Location: Bathroom
Finding: Shower base - Leaking
Information: Leaking was evident to the shower base at the time of inspection. It is suspected that the leaking has occurred as a result of minor impact damage to the shower base or general ageing of the building elements.

Leaking from the shower base, where left unattended, is likely to lead to water damage to adjoining flooring and walls. Such damage can lead to water damage and necessitate extensive remedial works being required. Active water leaks may also create an environment that is susceptible to the formation and development of mould.

Appointment of a tiling contractor is required to repair or replace the shower base. Such works should be performed as soon as possible to ensure that no further damage occurs.

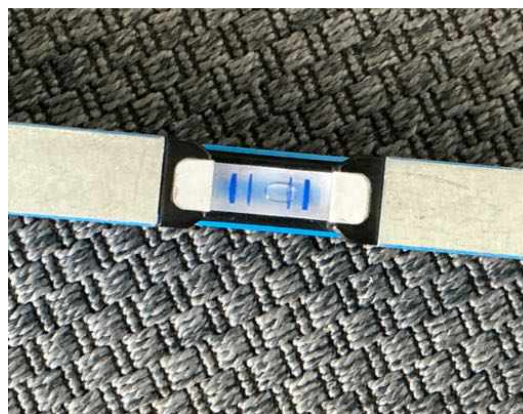
Defects 2.03

Building: Building 2
Location: Bungalow
Finding: Crack in concrete slab - Category 4
Information: A crack coded as Category 4 was identified in the slab. A Category 4 crack is described as a crack that appears as a gap in the slab, with disturbing curvature or change in level affecting the slab.

The approximate width of the crack or gap is 4mm-10mm or a change in offset of greater than 25mm when a 3m straight edge is placed over the defect.

Category 4 cracking to slabs exceeds allowable Standards and Tolerances, and are therefore considered as major defects that require rectification.

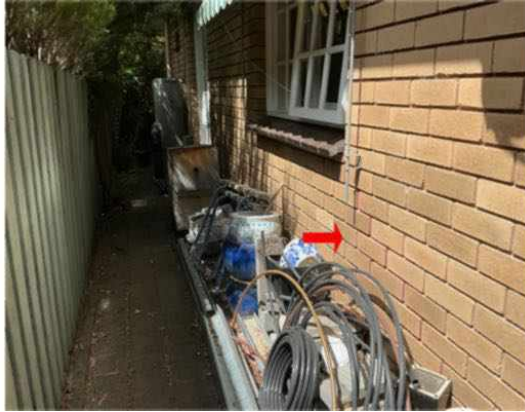
Defects 3.01

Building:	Main Building
Location:	Rear Elevation
Finding:	Brickwork - Step cracking
Information:	Step cracking was identified to the brickwork in this area at the time of inspection. Step cracking, which is similar to other forms of cracking, has a variety of possible causes. However, the most common is the subsidence of adjacent footings.

Step cracking is a relatively common defect, and is most likely to occur adjacent to windows, doors and other openings. Mortar failure in the gaps between affected bricks indicates the stresses and tensions affecting the wall.

Where step cracking is extensive or severe, the client is advised to consult a structural engineer. Minor step cracking can be used as a warning sign to address factors causing stress to the wall, which can include the effect of surrounding trees, water leaks, soil erosion, or even the presence of reactive soils in the surrounding area.

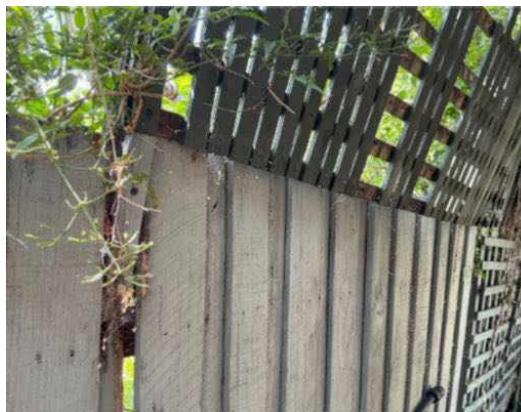
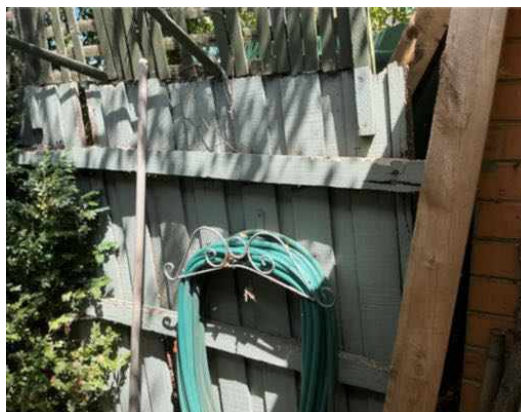
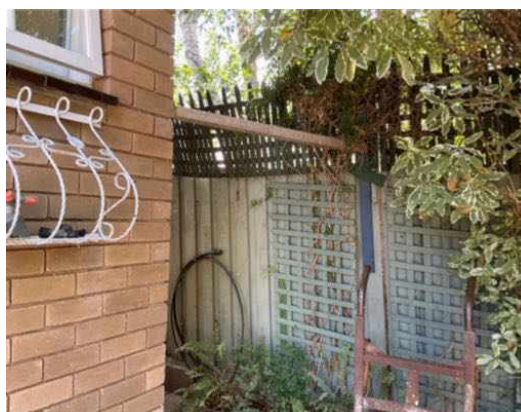
Defects 3.02

Building:	Main Building
Location:	Fencing
Finding:	Fencing - Deteriorated
Information:	It was noted at the time of inspection that sections of the fencing throughout the property have deteriorated. Typically fencing deteriorates due to age and or wear, rot and or rust which is generally expected for a structure of this age, due to prolonged exposure to weather conditions. Sometimes inadequate installation or maintenance can be to blame.

If left unattended, it is likely that further damage will occur. It is suspected that repair of several elements of the fencing may be required however replacement may be a consideration of the client also.

A licensed fencing contractor should be appointed to provide further advice and perform rectification works as necessary.

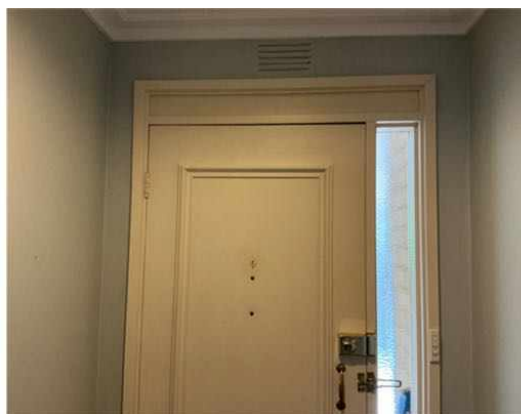
Defects 3.04

Building:	Main Building
Location:	All Areas
Finding:	Door - Gap
Information:	A significant gap was identified between the door and door frame in this area. Where large gaps to the head or foot of door frames appear, it may indicate a variety of defects, ranging from uneven framework, sagging hinges or uneven flooring.

A gap to the head of the door may also indicate movement of the foundation of the property, which is a common occurrence and does not indicate structural damage.

A qualified carpenter should be appointed to perform remedial works to restore the door to a fully operational level.

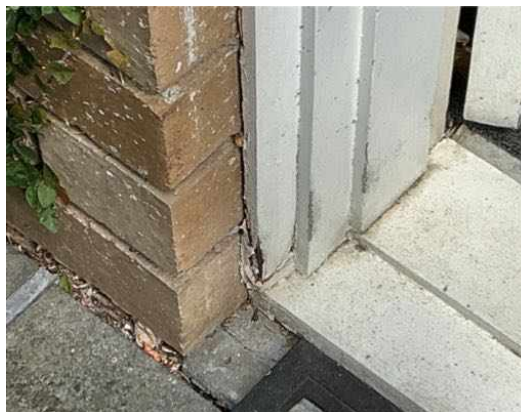
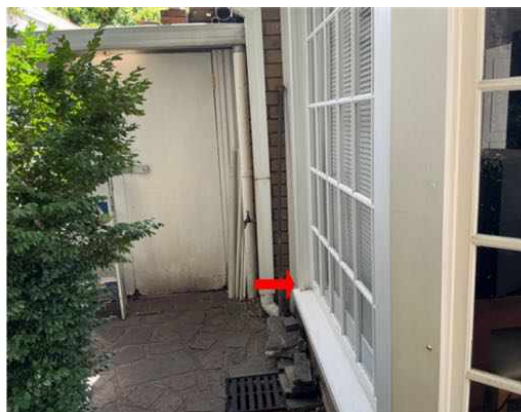
Defects 3.06

Building:	Building 2
Location:	Bungalow
Finding:	Windows and doors- Wood rot
Information:	Wood rot was found to be affecting external windows. Wood rot, also known as Fungal Decay, occurs when timbers and other cellulose building materials are exposed to damp conditions on an ongoing basis.

It is likely that this wood rot has developed as a result of frequent exposure to rain and other weather conditions. It is suspected that failure to maintain the window frames over a prolonged period has resulted in them deteriorating at an accelerated rate, increasing their susceptibility to the development of wood rot. Leaks in roof plumbing or associated pipework may have also contributed to the formation of the wood rot in this area.

Early intervention and regular maintenance will prolong the useful life of these building elements. Prior to any works being performed, any associated pipework or roof plumbing should be inspected by a licensed plumber for faults or leaks.

Repair and/or replacement of affected window frames may be a necessary step in protecting surrounding building elements from such deterioration. Remedial works should be performed by a qualified carpenter or registered builder as soon as possible to prevent any further damage.

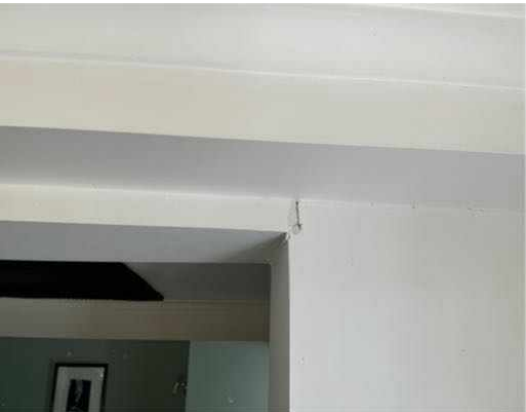
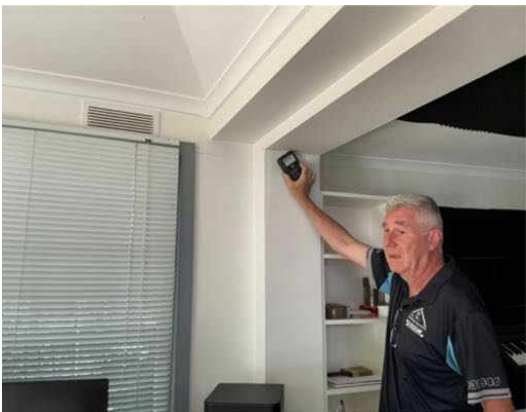
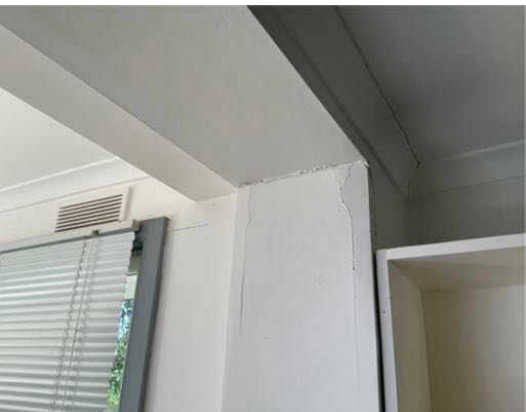
Defects 3.07

Building:	Building 2
Location:	Bungalow
Finding:	Cracking - Damage Category 3 - Repair Required (5mm-15mm or a grouping or cluster of cracks of 3mm or more)
Information:	Cracks of this type are likely to have been caused by minor, expected movement of building elements, but may also have a structural cause that is more significant. Cracking of this degree may result in doors and windows sticking or jamming, but may have more serious implications, such as fracturing service pipes. Weather tightness (the ability to resist rain and wind) is also often impaired, creating potential for the development of secondary defects.

A crack of this size may be repaired. However, these repairs may also include further works, such as easement of associated window and door frames that are jamming, as well as more extensive filling, sanding and/or repainting.

It is highly recommended to gain quotations on repair and restoration works that are required. Always contact your building inspector should cracks widen, lengthen or become more numerous.

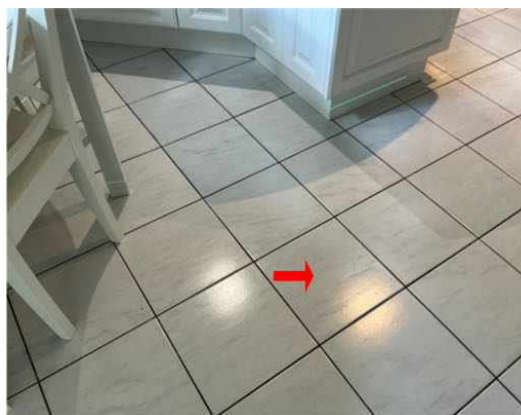
Defects 3.09

Building: Main Building
 Location: Kitchen
 Finding: Floor tiles - Cracked

Information: Cracking in the floor tiles was evident in this area at the time of inspection. It is suspected that this cracking has occurred as a result of the floor being uneven and lacking a solid or suitable foundation for the tiles to be laid on. Settlement in the floor foundations may also have caused movement and resulted in the cracking of tiles in this area.

Cracked tiles throughout the household detract from the overall appearance of the affected areas, as well as creating potential for water penetration to adjoining building elements. If left unmanaged, water damage may occur as a result of constant water penetration over a prolonged period of time.

While not considered a matter of urgency, replacement of cracked floor tiles is advised as a solution. A tiling contractor or general handyperson may be appointed to perform these works at client discretion. Where cracks become more numerous, consultation with a registered builder specialising in re-stumping may be required.

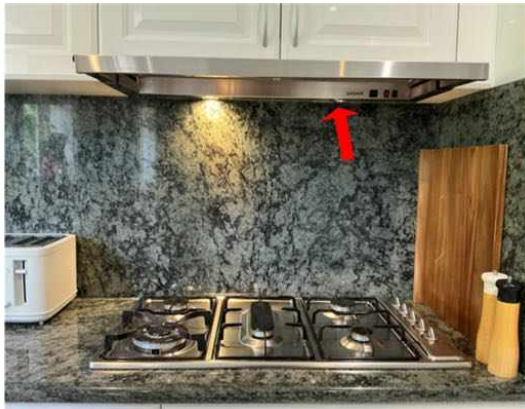
Defects 3.10

Building: Main Building
Location: Kitchen
Finding: Rangehood - Light not working
Information: While the range hood appears to be working at a satisfactory level, the light to the appliance was not working at the time of inspection.

A licensed electrician should be appointed to replace the light on the range hood to restore it to a fully operational state.

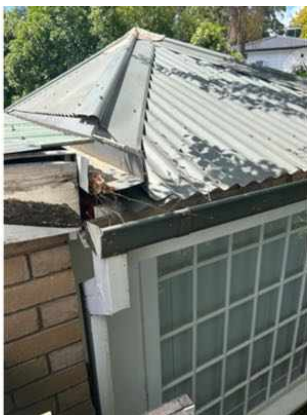
Defects 3.11

Building:	Building 2
Location:	Roof Exterior
Finding:	Roof plumbing - Flashing inadequate
Information:	Some sections of the roof are missing or have inadequate roof flashings. Flashings are metal and other materials which are applied to seals and intersections between roof coverings and building elements. They are designed to aid in weatherproofing of roof joins.

Premature ageing and secondary building defects are imminent where roof plumbing is missing or inadequately installed. Additionally, water pooling also creates an environment that is susceptible to termite and pest infestation.

A roofing plumber should be appointed as soon as possible to install relevant roof plumbing materials, ensuring that no further damage is sustained.

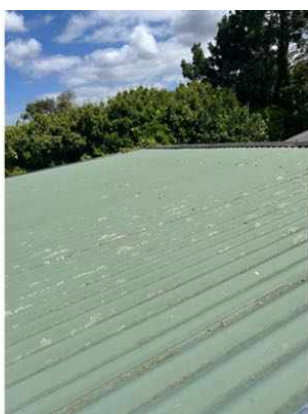
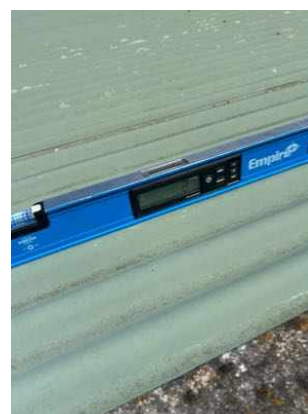
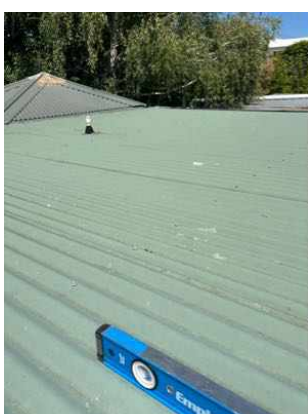
Defects 3.12

Building:	Building 2
Location:	Bungalow roof
Finding:	Roof Sheets - Insufficient fall
Information:	There is an insufficient fall in the roof sheets Corrugated , which means that the angle is inadequate to facilitate movement of rainwater affectively This is resulting in pooling of water in the area, creating the potential for water damage to associated building elements.

The manufacture recommendations are that 5 degrees minimum fall for Corrugated roofing and 1 degree fall flat roofing.

Replacement by a roofing plumber is required as soon as possible to prevent any future damage to the area.

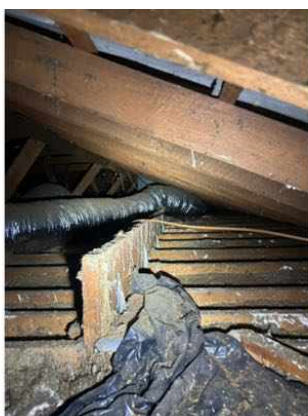
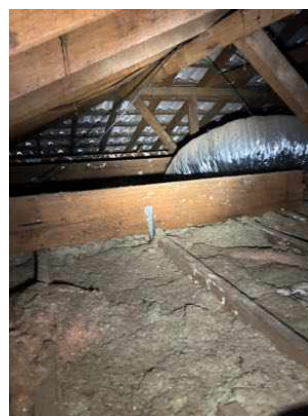
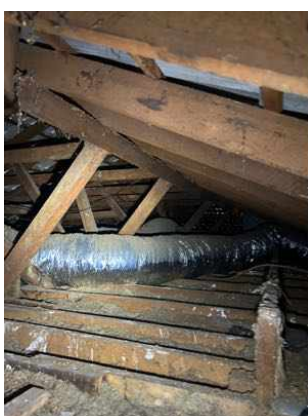
Defects 3.13

Building:	Main Building
-----------	---------------

This type of insulation is susceptible to settling and reducing in volume, detracting from its effectiveness and resulting in an overall loss of energy within the household. Additionally, the reduction in volume has led to an uneven distribution of insulation within the ceiling void, further detracting from its effectiveness.

It is highly advised that this insulation be removed and replaced with a more appropriate material. This will ensure that the property is adequately insulated and will promote an increase in energy efficiency within the property. An insulation contractor should be appointed to provide further advice on replacement options and to perform works as necessary.

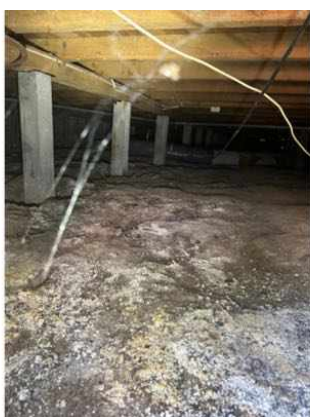
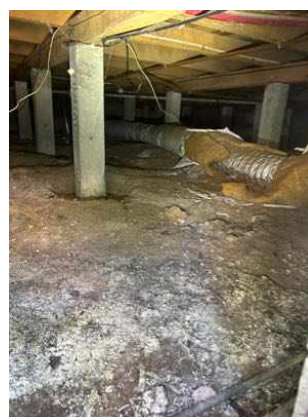
Where ventilation is substandard it is usually caused by factors such as failure to install adequate vents during construction subsequent building works or earth and vegetation covering over vents low subfloor clearance and items or debris in the subfloor restricting airflow.

Subfloor ventilation can be improved in most cases by addressing the causes such as exposing subfloor vents installing additional new vents installing mechanical (forced airflow) ventilation and removing debris from the subfloor.

A registered builder should be appointed as soon as possible to perform these works as necessary.

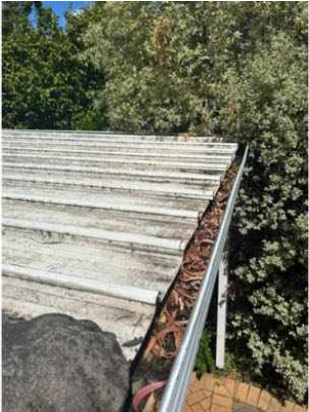
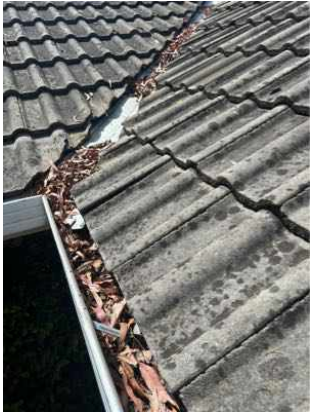
Defects 3.15

Building:	Main Building
Location:	Roof Exterior
Finding:	Gutters - Blocked
Information:	Roof plumbing structures, such as guttering and downpipes, should be free of all debris to prevent blockages. Blockages of the guttering and downpipes will lead to pooling and accumulated water overflows, which is likely to subsequently flood eaves and exterior walls.

Blocked gutters are likely to lead to high levels of moisture in the affected areas. Such moisture will not only cause rust and decay of the associated building materials, but can also provide conditions that are conducive to termite and timber pest activity. Blockages in gutters should therefore be removed immediately to ensure dry conditions are maintained.

Consult a Licensed Plumber for further specific advice on remedial works that may be required. In the interim, it is highly advised that blocked gutters be removed by the

homeowner or a general handyman as a matter of urgency.

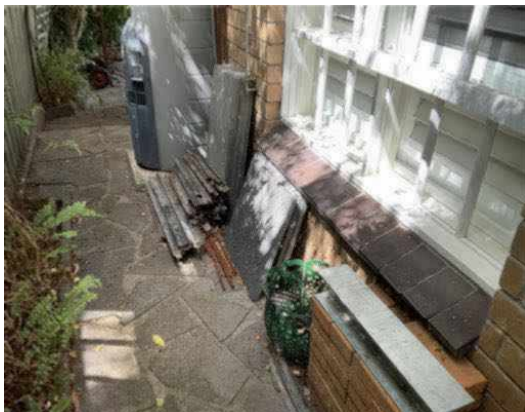
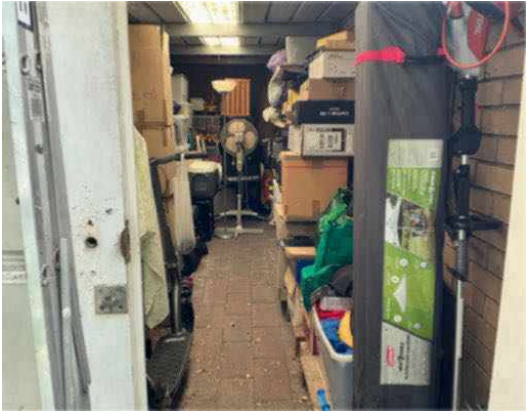
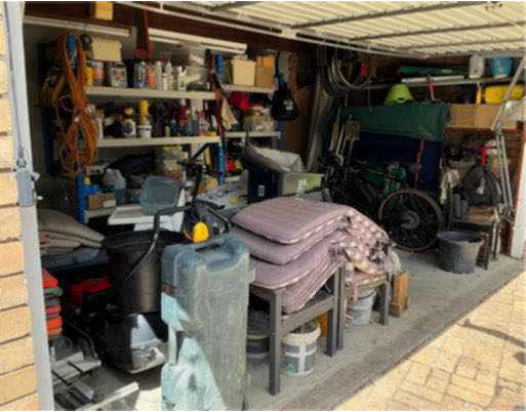
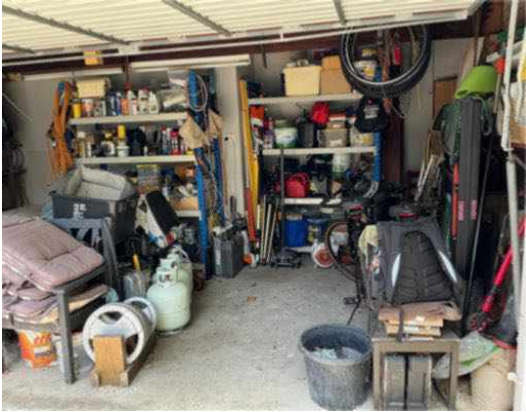
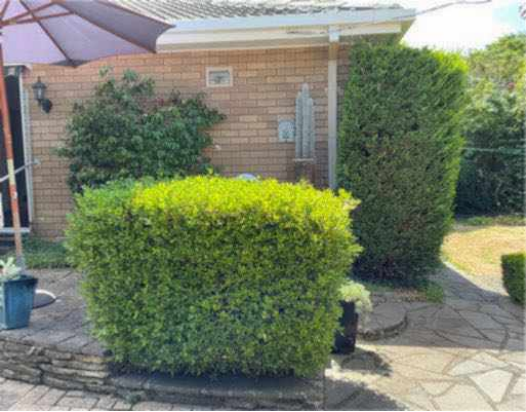
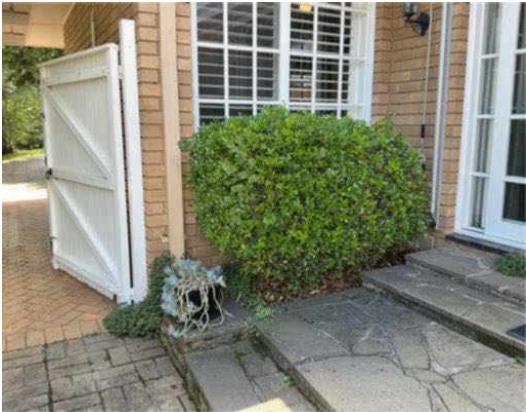
Building: Main Building
Location: All Areas
Finding: Additional Photos and Obstructions and Limitations
Information: These are additional photographs and photographs of the obstructions and limitations inside and outside (furniture, landscaping etc) which may impede full inspection of the property at the time of inspection. These obstructions can hide an array of defects and may be removed to allow full inspection to be carried out. A re-inspection may be made if clients require once the areas are made accessible.

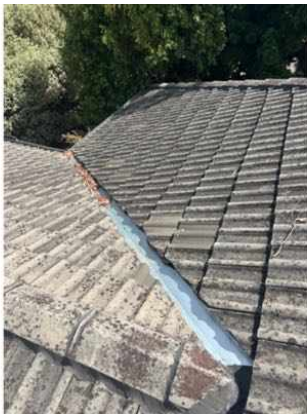
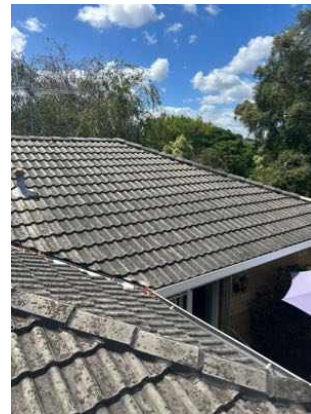
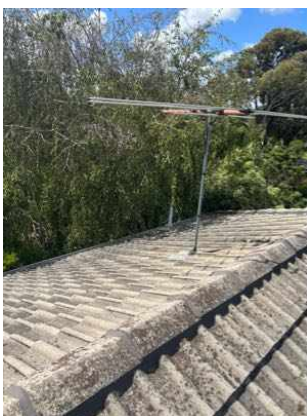
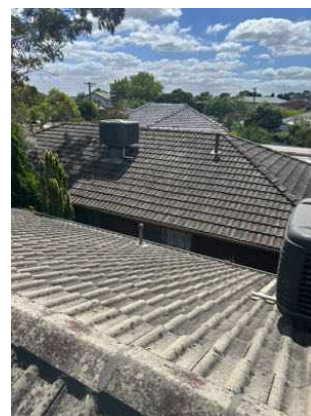
Building: Main Building
Location: Roof Exterior
Finding: Roof tiles - Weathered
Information: Upon inspection of the exterior roofing, the majority of roof tiles were considered to be in a fair condition. While weathering of the tiles is consistent with the age of the property, maintenance works are required.

Isolated areas of mortar have come loose in the valleys and minor cracking is also present. Re-pointing and re-sealing the may be considered as an interim solution by the client to help preserve and extend the life span of the tiles.

Where left unmanaged, deteriorating roof tiles are likely to lead to a number of secondary defects, including minor water leaks and weather exposure to internal roofing structures.

Consultation with a roofing contractor is highly advised to gain advice on cost of remedial works that may be required in the short to medium term. Remedial works are likely to increase the longevity of the exterior roofing structure.
