Building and Timber Pest Inspection Report

Inspection Date: Wed, 11 Feb 2026

Property Address: 6 Crane Ave, Green Valley NSW 2168,
Australia

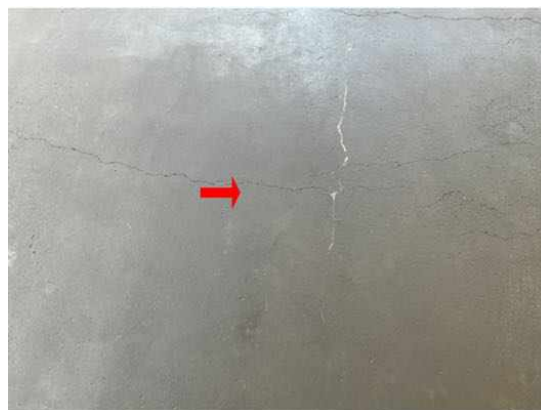
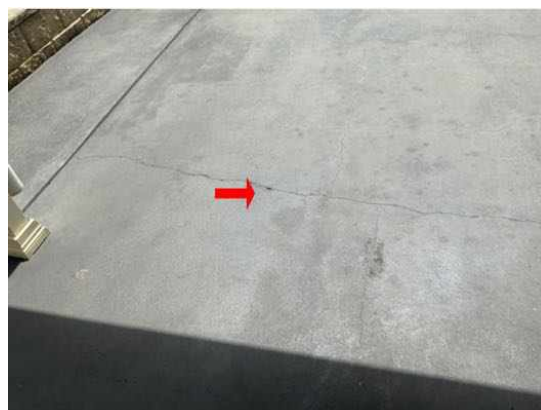
Building:	Main Building
Location:	Driveway
Finding:	Cracking - Driveway Distinct
Information:	Distinct cracks were identified in external concrete paving. Distinct cracks are generally found in older concrete paving, and may also present as a trip hazard as consequence of an uneven or curved surface.

General age and expected deterioration of the paved areas is a common cause of this type of cracking. However, expansion and contraction of the slab may also have occurred due to environmental factors. Such factors include variable moisture and weather conditions, the presence of trees and their roots having a settling or lifting affect on the soil, or the effect of load bearing, e.g. heavy vehicles over a sustained period of time.

Cracking to this degree may also be due to poor original installation of the concrete. Factors such as poor compaction of the sub surface and/or inadequate reinforcing of the slab may create cracking and other secondary defects.

Repairs are likely to be required to prevent further cracking and to reduce hazards associated with cracking, such as tripping. Monitoring of all cracking should be conducted frequently. Always contact a building inspector should cracks widen, lengthen, or become more numerous.

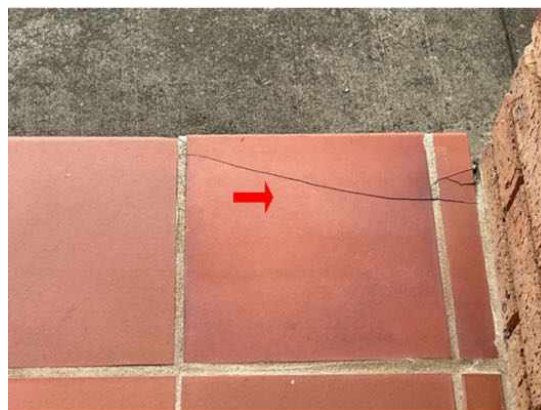
Finding 3.02

Building:	Main Building
Location:	Alfresco
Finding:	Tiles - Cracked or damaged
Information:	Cracking was evident to the tiling in this area at the time of inspection. While the cracking appears to be minor, this area is frequently exposed to water, allowing potential for water penetration into adjoining sections of of the home.

If left unmanaged, water penetration to these areas may lead to subsequent water damage, which is likely necessitate repair work to affected building elements. This can be seen in the photos.

A tiling contractor should be appointed to ensure that no further water damage occurs. The re-application of silicone and grouting throughout remaining tile work is also advised, to further protect the area against water penetration.

Where water penetration has led to water damage, appointment of a relevant tradesperson may be required to repair damaged building elements.

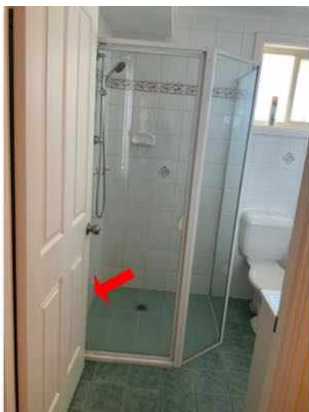
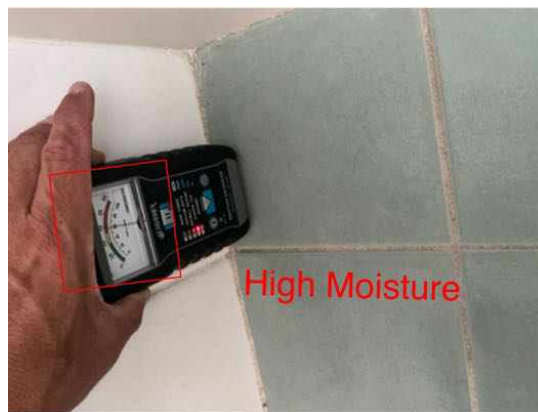
Finding 3.03

Building:	Main Building
Location:	Ensuite
Finding:	Shower damp - Monitor
Information:	Damp is evident to the lower 300mm of wall to the shower alcove. There is no high reading around the taps nor are there high readings transferring to the other side of the wall. Both sealant and grout appear in acceptable condition at present.

This defect is quite common, and is suspected to have been caused by moisture permeating or leaching through the grouting and perhaps gaps in the sealant.

Damp (or structural damp) refers to the presence of unwanted moisture in the structure of a building, either as the result of intrusion from outside, or condensation from within the structure. In the shower area, internal water leaks or other sources of excessive moisture are generally the cause of damp.

Unmanaged damp in the shower recess is likely to facilitate the formation and development of mould and fungi growth, decaying associated building materials and compromising their structural integrity. It is important to address damp conditions, as the World Health Organisation notes that excess moisture leads - on almost all indoor materials - to growth of microbes such as moulds, fungi and bacteria, which subsequently emit spores and other matter into the indoor air. Exposure to these contaminants is associated with a wide range of respiratory and other health-related problems.

Monitoring the area is advised and if any visual signs of excessive moisture appear (peeling paint, mould) then consultation with a qualified plumber or bathroom specialist would be advised to identify the cause of damp and to perform remedial works as required.

Always ensure that sealant and grout is in good condition to prevent any moisture issues occurring in the future.

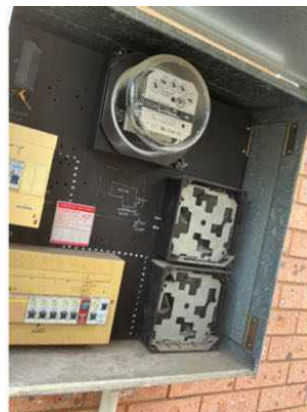
Evidence of this sticker has NOT been located in the meter box. Please see photos attached

Where a Termite Management System has not been identified you should consult a licensed pest inspector immediately to undergo further investigation in what measures would be necessary to maintain a functional pest management system. It is also recommended that a Licensed Pest Controller attend to determine the viability of the current or past treatments

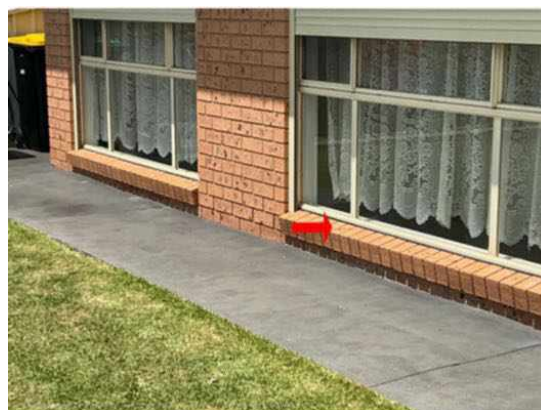
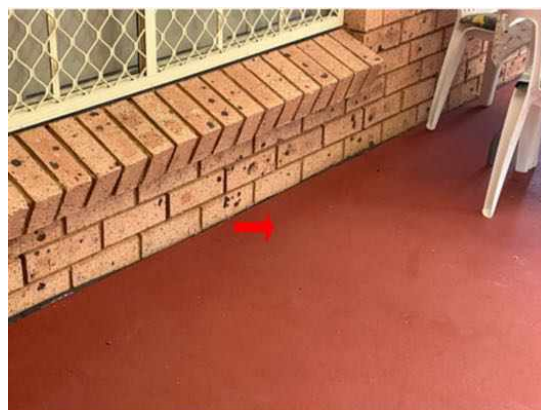
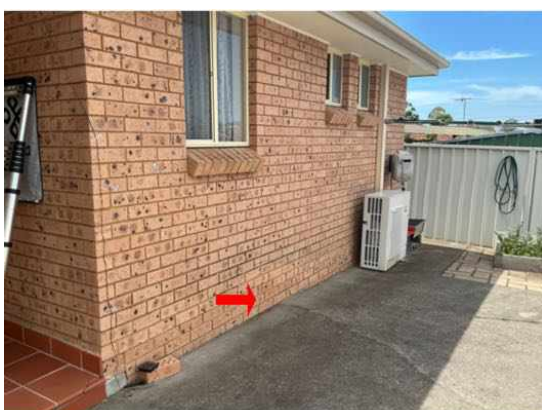
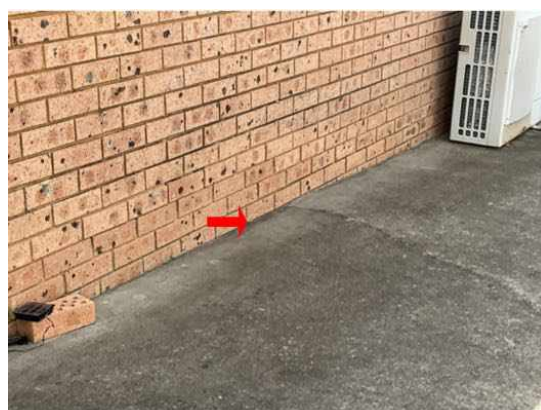
If the slab edge is not properly exposed there is a high risk of termite attack. Sometimes, in order to determine the type of slab, a suitably qualified person such as an architect or builder may be required to consult the construction plans.

Where the slab edge cannot be properly inspected, it is highly recommended that termite or timber pest inspections be carried out every 6-12 months to aid protection of the property against infestation.

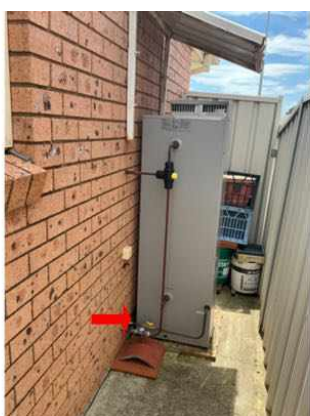
Finding 6.05

Building:	Main Building
Location:	All External Areas
Finding:	Bridging or Obstruction - Air Conditioner, Hot Water Tank
Information:	Bridging of termite barriers is a significant concern, as it occurs when termites bypass the intended protective barrier or inspection zone, often through the construction of Mud tunnels or by finding a passage that allows them to traverse the barrier undetected. This bridging comprises the effectiveness of the termite protection system and increases the risk of termite infestation entering the property in a concealed or undetectable manner, which can lead to potentially severe damage overtime.

During the inspection it was noted that certain obstructions such as an air

conditioning unit, hot water unit, storage shed, or various stored goods, impeded the clear visual inspection of the external walls and weep holes in the affected area. These obstructions create blindspots that prevent a thorough assessment of the termite barrier and the condition of the wall surfaces. The presence of such obstructions can limit the ability to detect early signs of termite activity or breaches in the protective barrier, thereby increasing the likelihood of undetected termite intrusion.

The weep holes and external walls play a critical role in maintaining the property structural integrity and ensuring that moisture and termites do not infiltrate concealed spaces. When these areas are obstructed, it becomes impossible to carry out a complete inspection, which may compromise the ability to detect termite activity or vulnerabilities in the barrier system.

To mitigate risk it is strongly recommended that all obstructions be moved away from the external walls and weep holes to allow for a comprehensive visual inspection. This step will ensure that both current and future inspections can be conducted thoroughly, enabling the detection of any termite activity, potential bridging, or breaches in the barrier. Maintaining clear access to these areas is crucial for the continued effectiveness of the termite management system and for safeguarding the property from potential damage.

It is also the responsibility of the property owner and Client to take these preventative steps and ensure that regular termite treatments are conducted to maintain the barriers effectiveness and avoid costly future repairs. Proactive measures such as keeping external walls free from obstructions conducting regular inspections, getting termite treatment done on regular basis and addressing any identified issues promptly will help maintain the integrity of the termite barrier and reduce the risk of concealed termite entry. Taking this precaution is essential for protecting the long-term safety and value of the property.

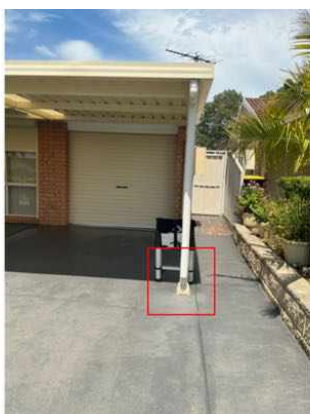
Finding 6.06

Building: Main Building
Location: Carport

Where roof plumbing doesn't drain adequately, the area at the base perimeter can become excessively damp, potentially creating an environment that is susceptible to rust and corrosion of surrounding building elements, as well as attracting termites and other pests.

It is highly recommended that a plumber be appointed to further inspect the area and to install adequate drainage equipment where necessary.

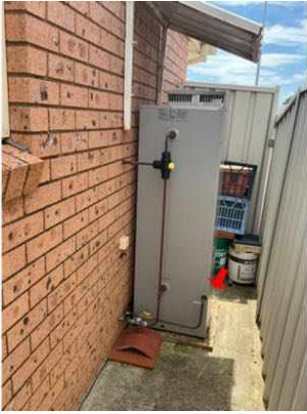
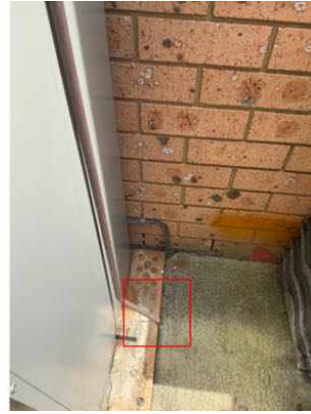
Finding 6.07

Building: Main Building

Poorly aligned materials can and will lead to further damage to nearby areas.

It is highly recommended that a licensed plumber be appointed to connect the A/C overflow in order to prevent such an environment from being created. These minor works should be carried out as soon as possible.

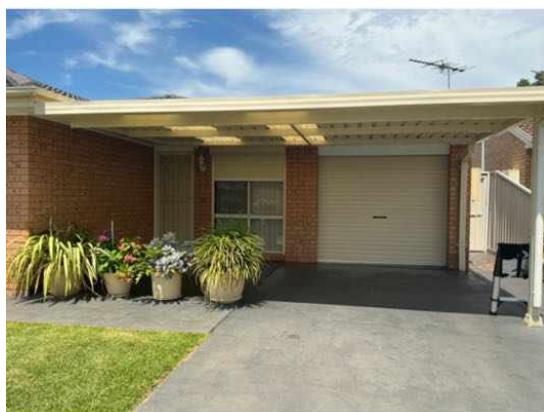
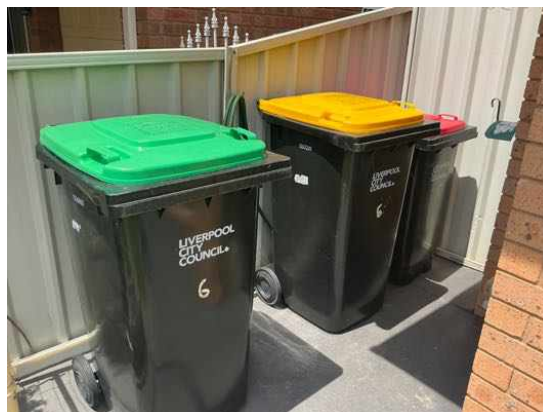
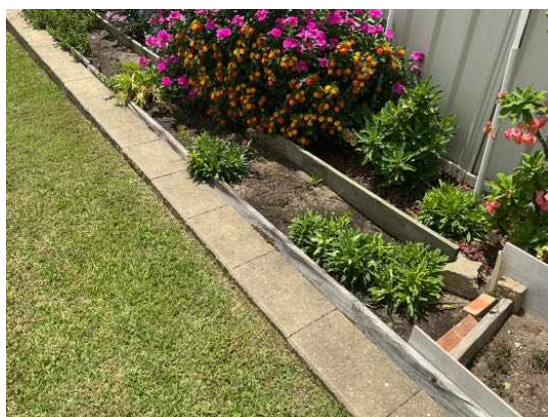
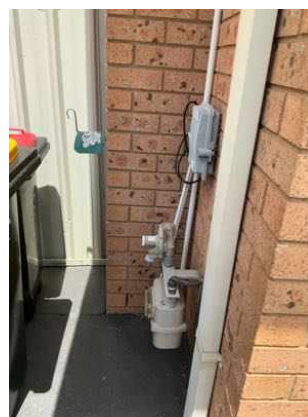
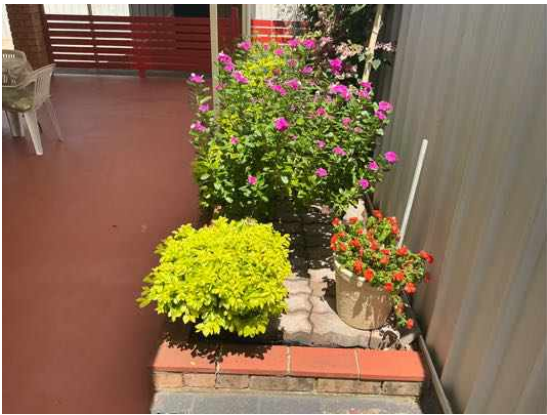
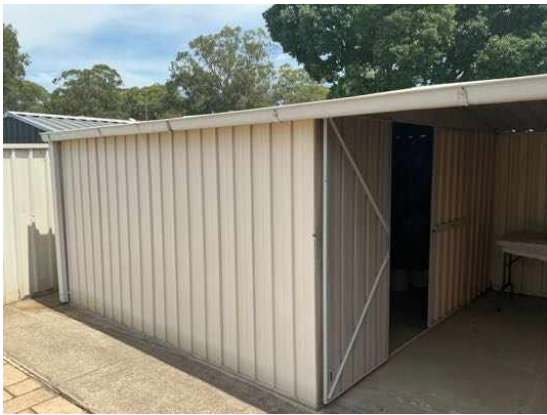
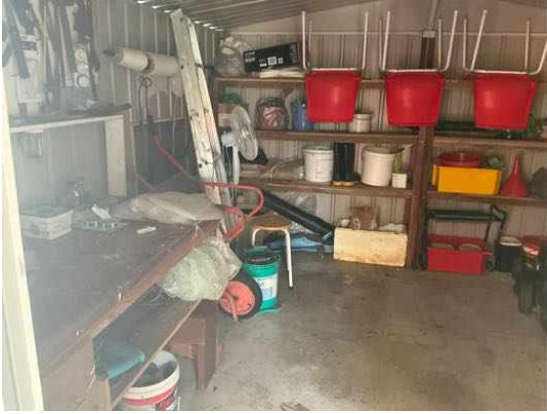
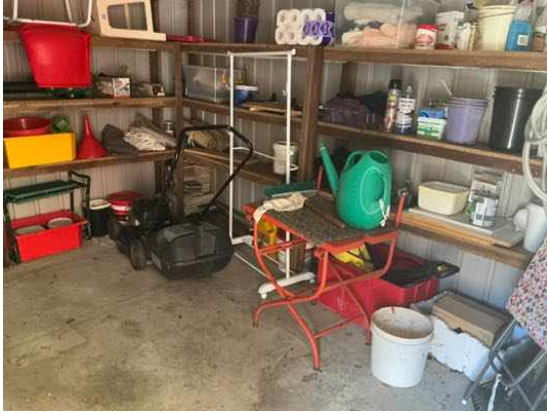
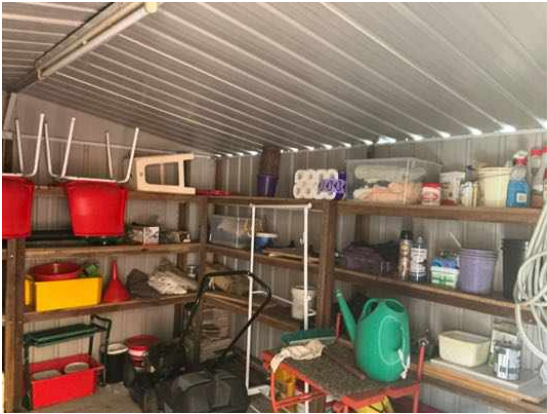
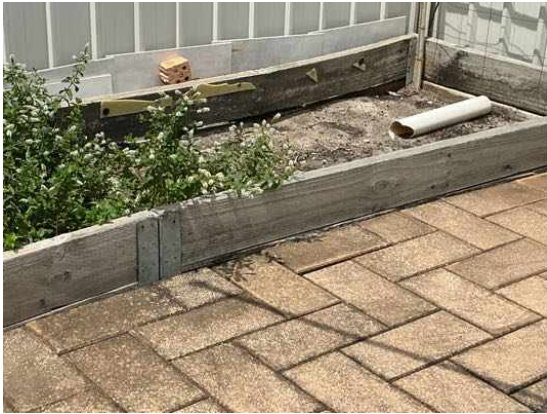
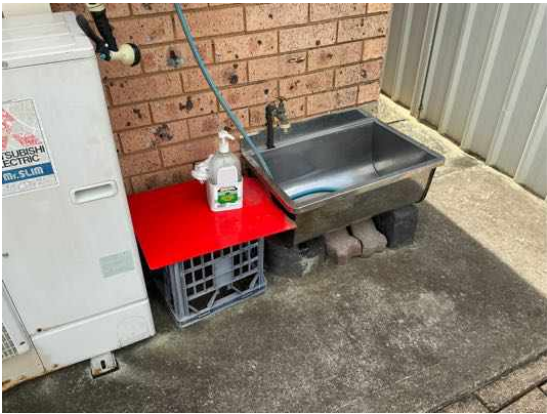
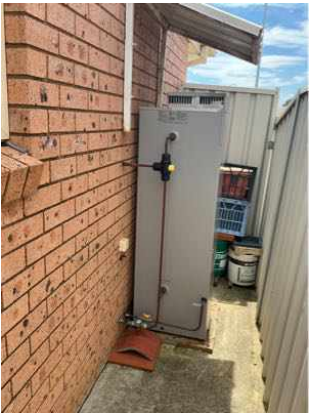
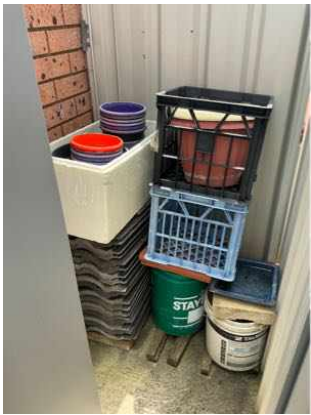
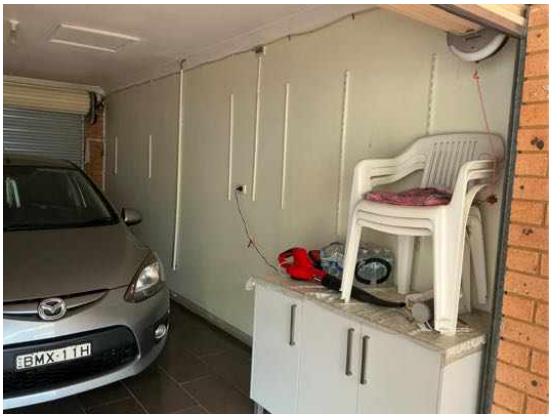
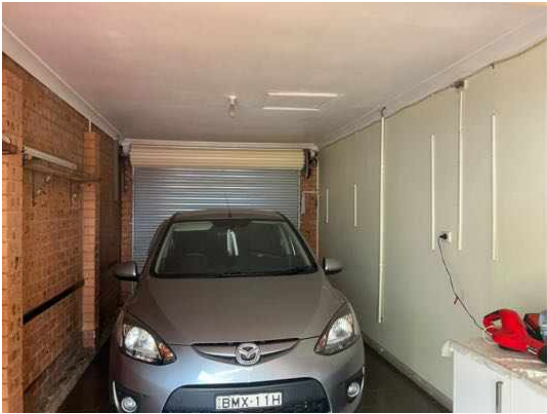
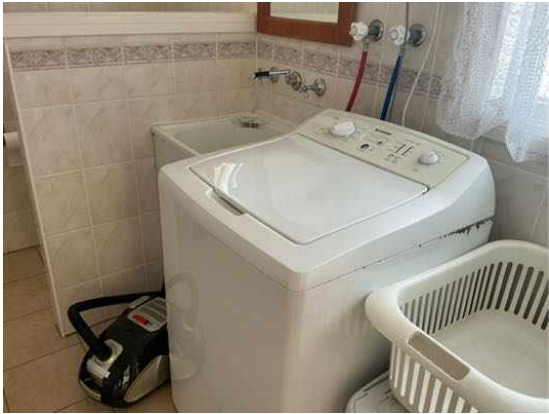
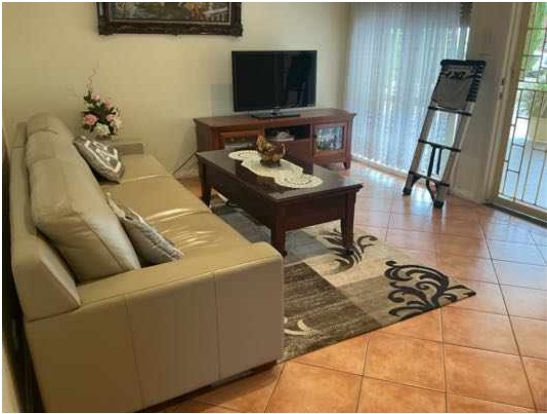
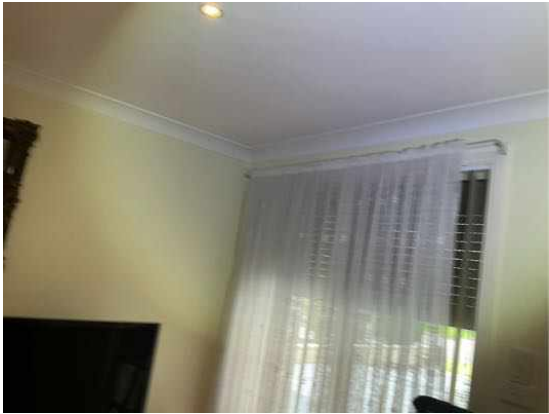
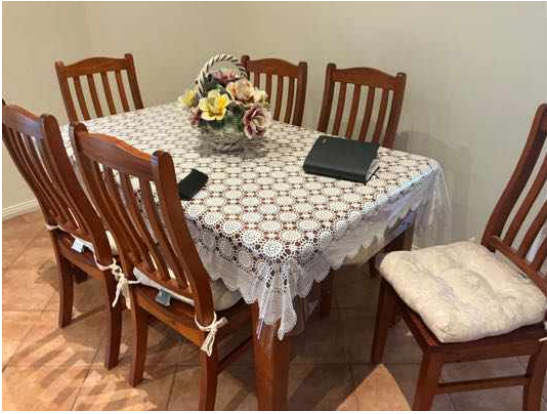
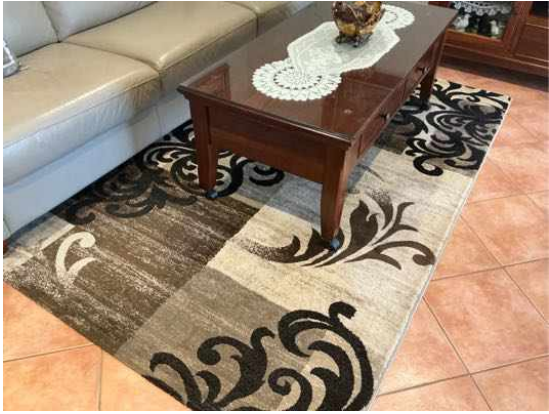
Building: Main Building
Location: All Areas
Finding: Additional Photos - Obstructions and Limitations
Information: These photographs are an indication of the obstructions and limitations which impeded full inspection of the property at the time of inspection. These obstructions can hide an array of defects and should be removed to allow full inspection to be carried out. A re-inspection is recommended once the areas are made accessible.

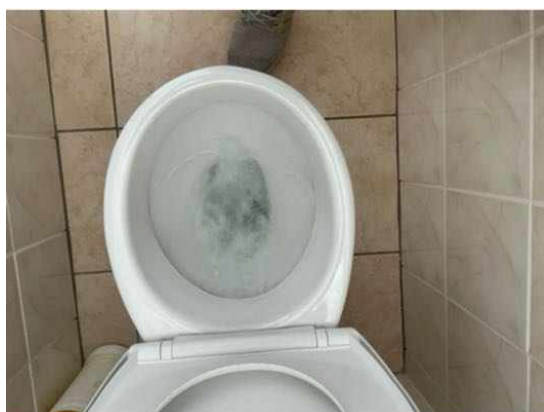
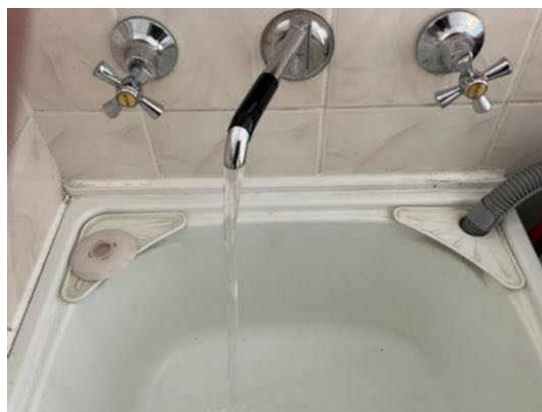
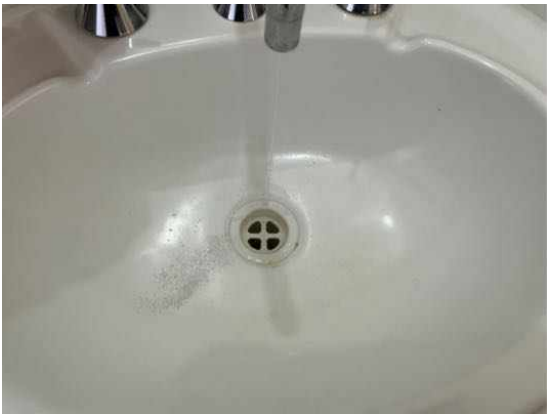
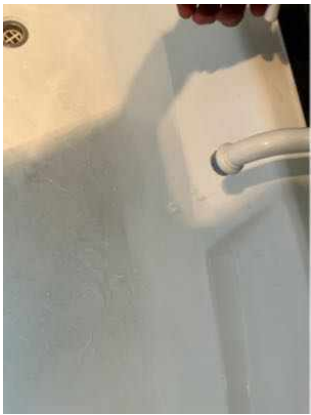
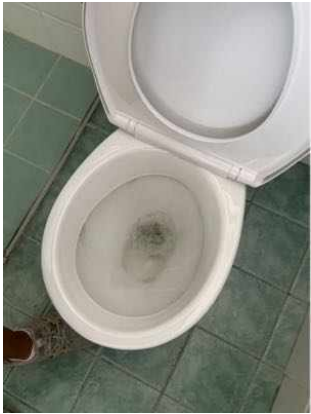
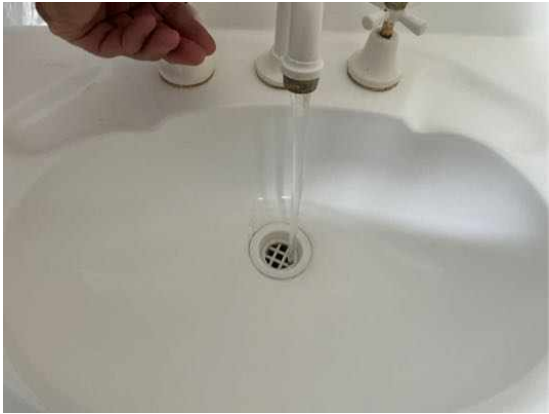
Building: Main Building
Location: All Wet Areas
Finding: Taps, Drainage and Toilets Tested
Information: During the inspection, taps, draining systems and toilets were checked for both water flow and drainage efficiency, as well as inspected for any visible signs of leakage at the time of the inspection. No issues were noted in these areas ,unless highlighted in a separate ,no immediate remedial work appears to be necessary for these items. Any relevant photo's Documenting these inspections may be found in the additional photo section for reference.

However, it is important to note that while a thorough inspection of cupboards and cabinetry was conducted the presence of instructions such as stored items or fixtures may have limited full visibility of potential water damage or hidden defects. These obstructions can conceal underlying issues that may not be immediately visible during the initial inspection. Furthermore, conditions can change after the inspection has been carried out and defects or damage could be revealed once obstructions are removed or as time progresses.

Given this, it is strongly recommended that a reinspection be conducted after all obstructions have been removed from the cupboards to allow for a full thorough assessment of these areas. This will ensure that any concealed damage or defects are identified and addressed in a timely manner. Regular maintenance and monitoring of plumbing and drainage systems are also advised to insure long-term functionality and to prevent future problems from arising.

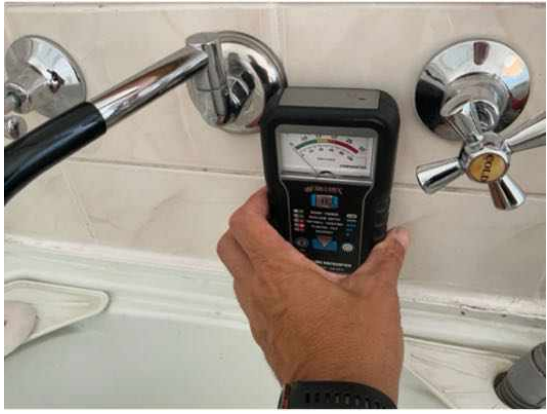
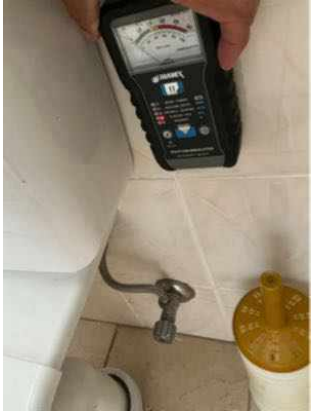
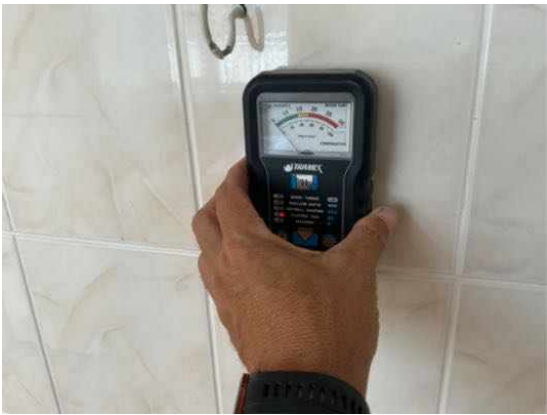
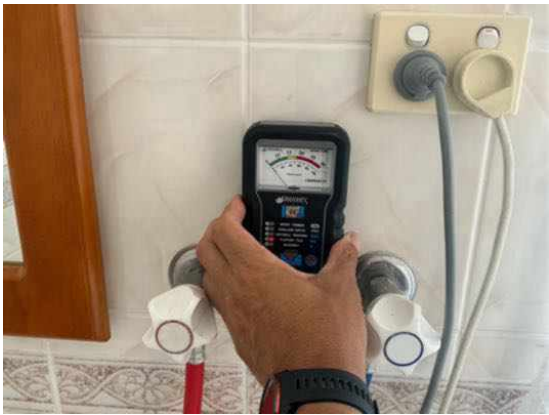
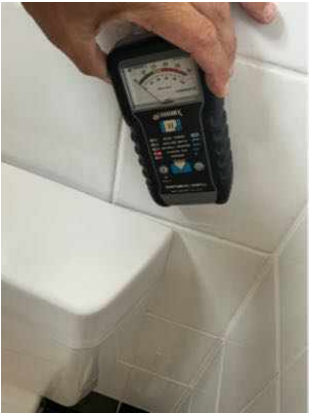
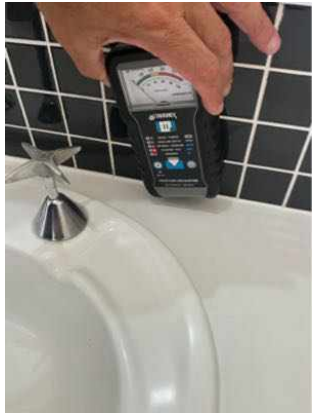
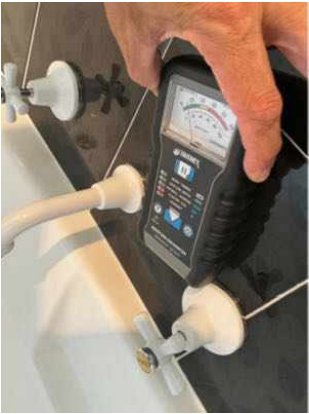
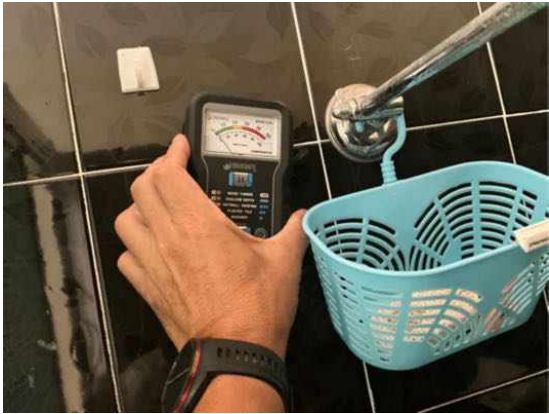
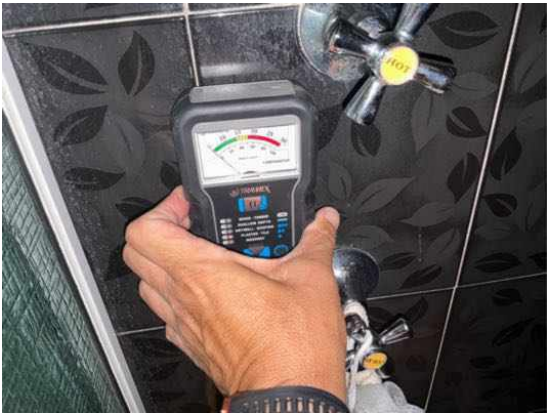
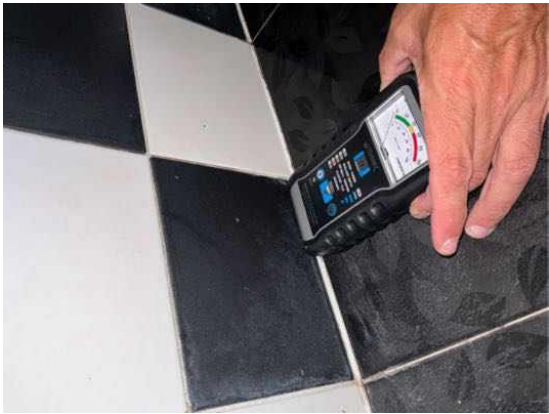
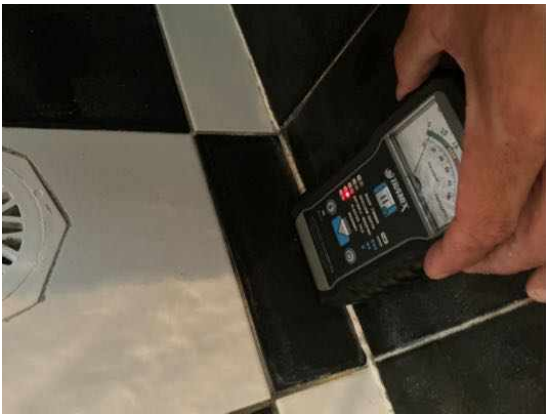
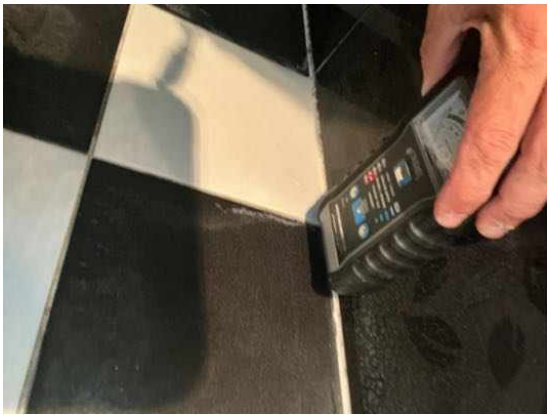
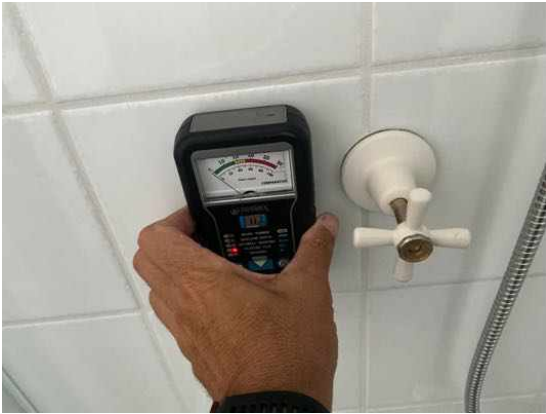
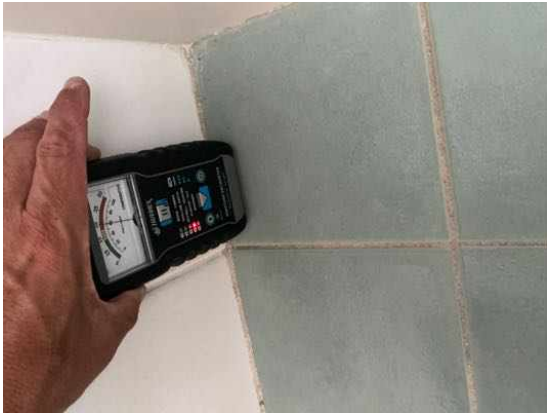
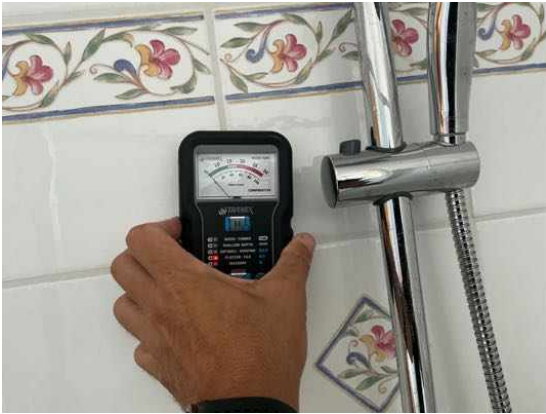
Building: Main Building
Location: All Internal Areas
Finding: Photos added Moisture Readings - Wet Areas
Information: Additional photos are provided for your general reference.

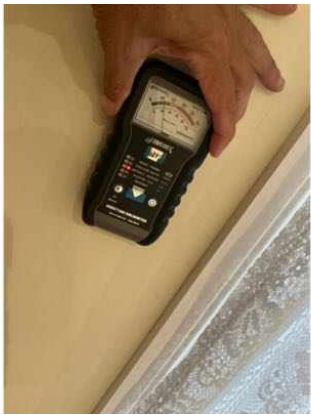
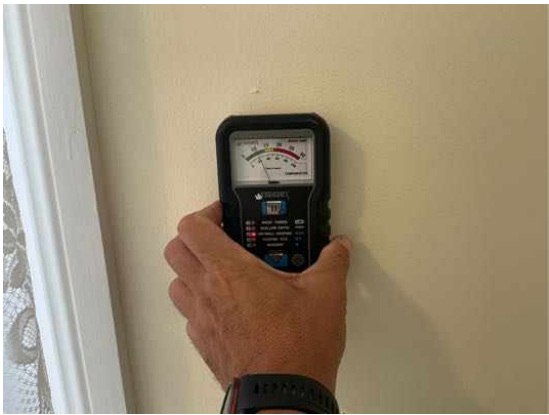
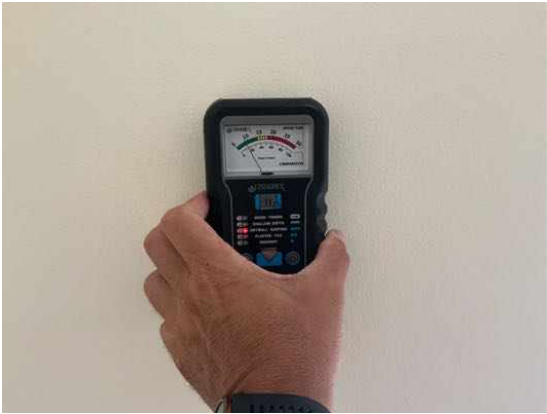
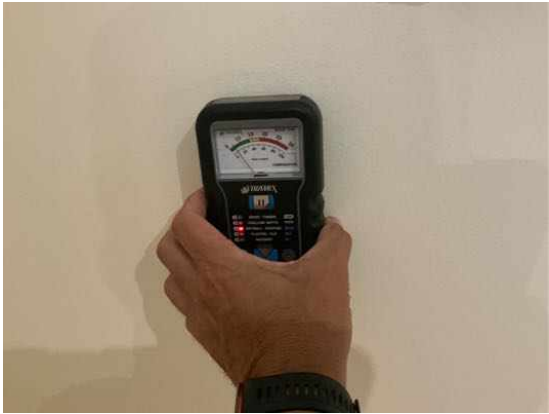
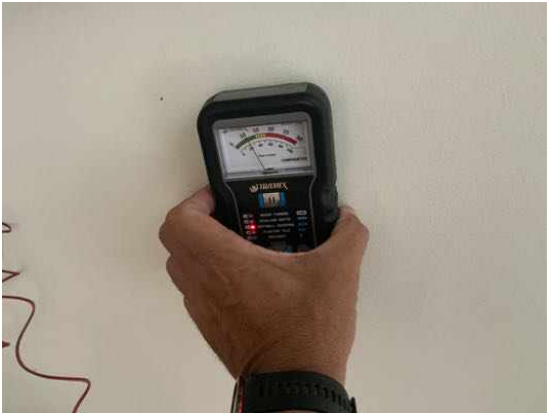
Building: Main Building
Location: All Internal Areas
Finding: Photos added Moisture Readings - Other Areas
Information: Additional photos are provided for your general reference.

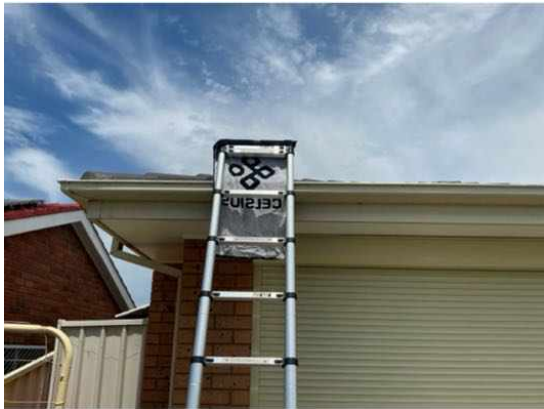
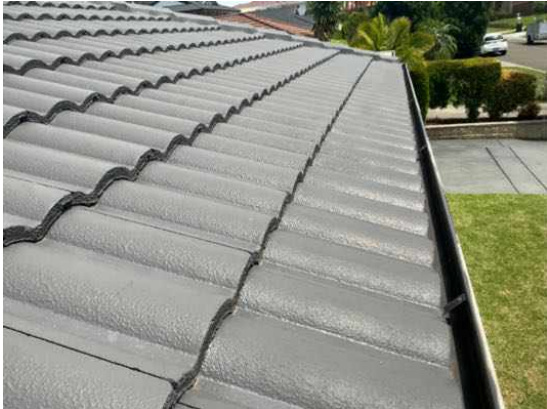
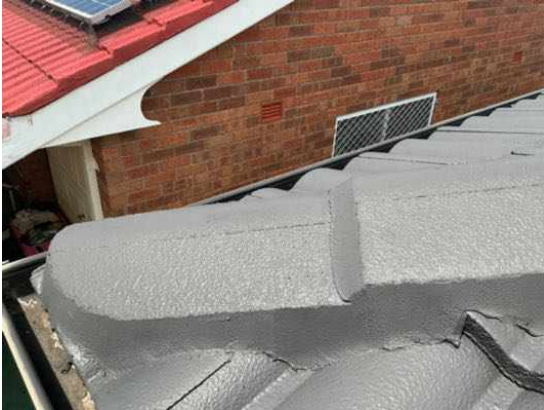
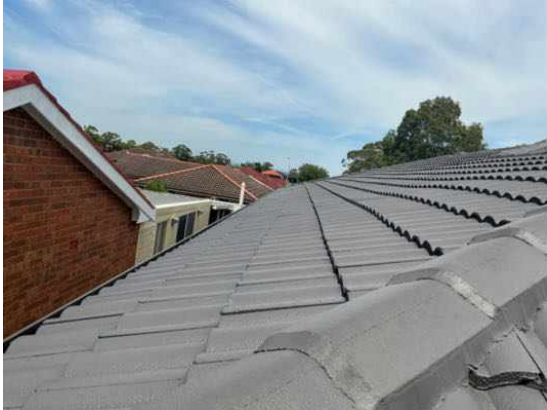
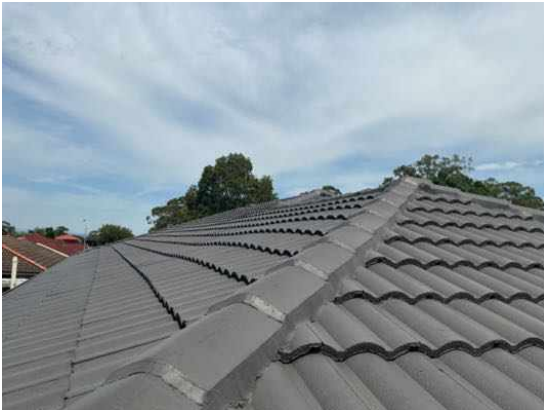
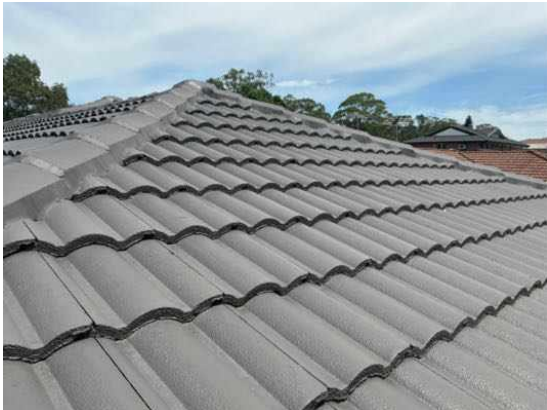
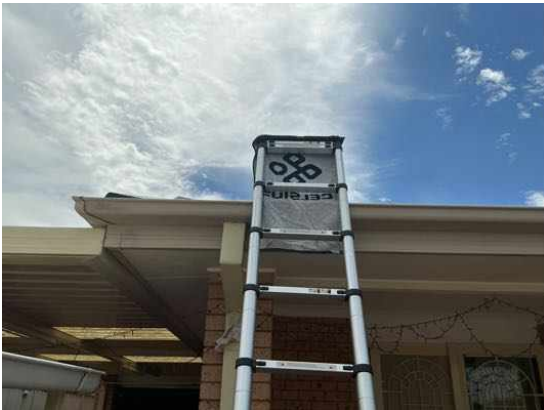
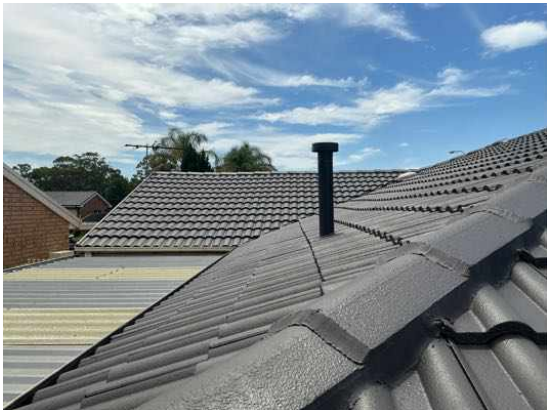
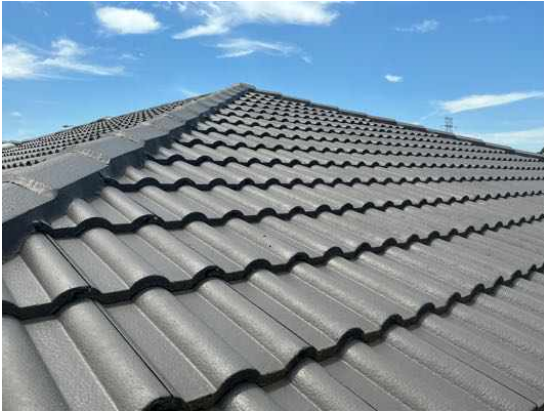
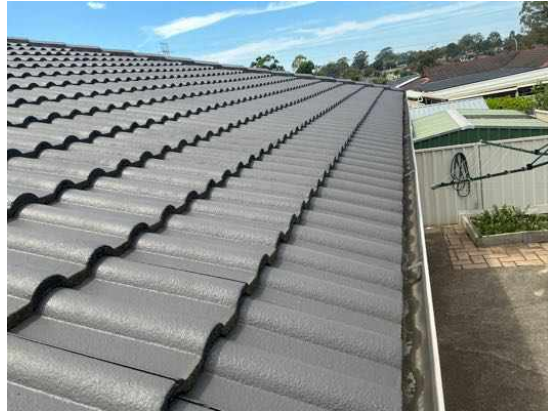
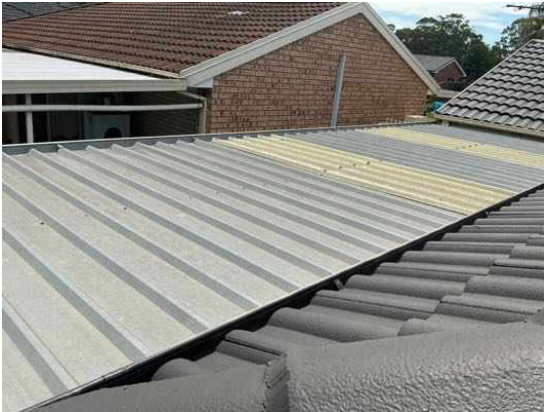
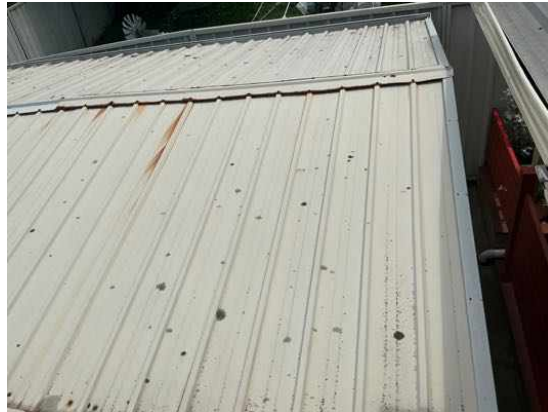
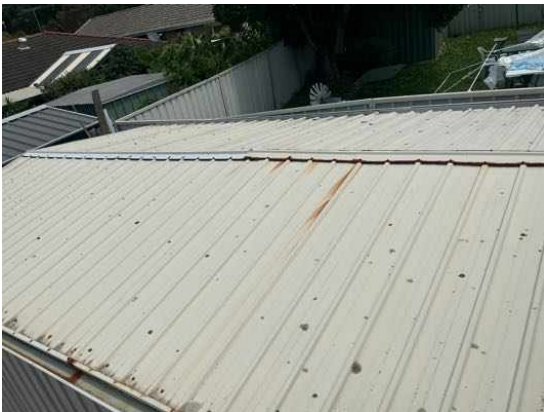
Building: Main Building
Location: Roof Exterior
Finding: Additional Photos Roof
Information: Additional photos are provided of the general roof area for your general reference at the time of inspection.

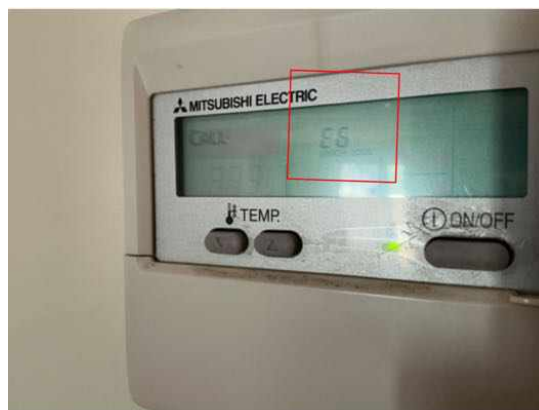
Building: Main Building
 Location: All Internal Areas
 Finding: Air Conditioner System
 Information: Inspection of Air conditioning and associated electrical equipment is not part of this inspection but it was noted that at the time of the inspection the control box showed error codes, these codes could lead to incorrect or poor performance of the associated system.

Routine inspection and servicing of the air conditioning units and condensate drainage system should be carried out by a licensed air conditioning technician.
