Building and Timber Pest Inspection Report

Inspection Date: Thu, 19 Feb 2026

Property Address: 11 Grassmere Ave, South Penrith NSW
2750, Australia

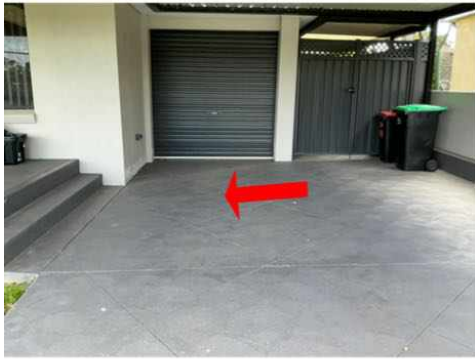
Building: Main Building
Location: Carport
Finding: Inadequate Site Drainage - Exterior Areas
Information: At the time of inspection, inadequate site drainage was observed around the perimeter of the building, which can lead to water pooling and insufficient runoff management.

This condition may result in moisture being absorbed by the foundation or lower walls, potentially leading to rising damp, cracks in brickwork, erosion of the soil around the building, or structural issues over time. Water pooling can also create ideal conditions for mould growth, contribute to the deterioration of exterior materials, and act as conducive conditions for termite activity, as termites are attracted to areas with elevated and persistent moisture levels.

It is recommended that proper site drainage be installed, such as redirecting water flow away from the building or incorporating drainage systems, to prevent further damage and ensure the long-term stability of the structure.

To address the inadequate site drainage, a qualified landscaper or drainage specialist should be engaged to design and install appropriate drainage solutions, such as grading the ground away from the building or installing French drains, surface drains, or downspout extensions. If more complex issues are present, such as damage to the foundation or moisture entering the walls, a structural engineer may need to assess the situation, and a builder may be required for repairs.

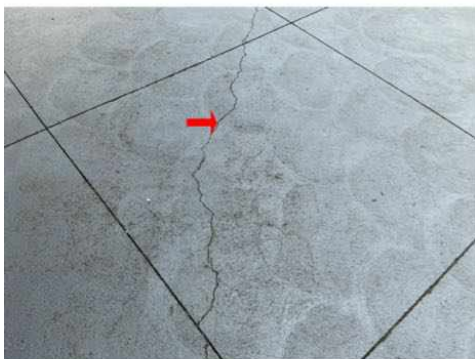
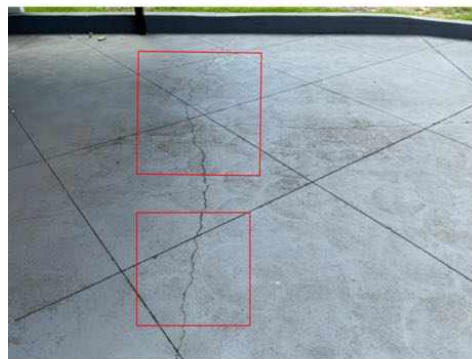
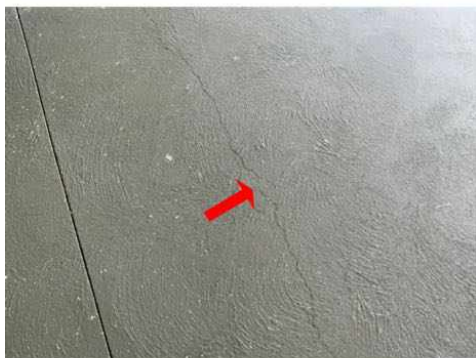
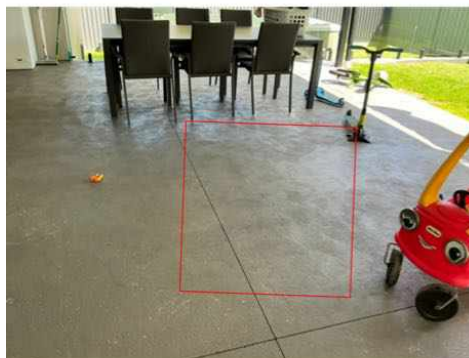
Finding 3.02

Finding: Crack in concrete slab - Category 2

Information: A crack coded as Category 2 was identified in the slab. A Category 2 crack is described as a distinct crack, with the slab being noticeably curved or changed in level.

To be considered Category 2, the approximate width of the crack is less than 2.0mm, or a change in offset of less than 15mm when a 3m straight edge is placed over the defect.

Category 2 cracks to slabs should be monitored for a period of 12 months. At the end of the monitoring period, cracks rated greater than Category 2 are considered defects that require rectification.

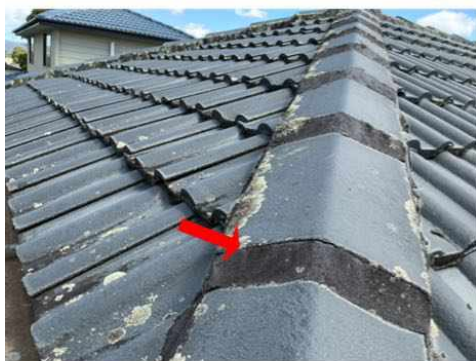
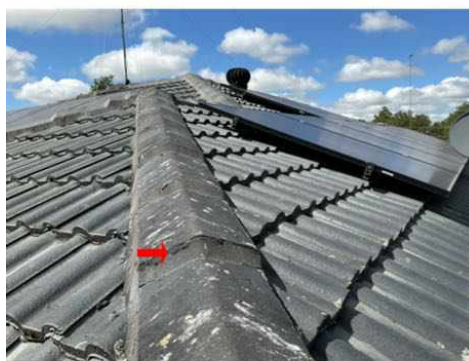
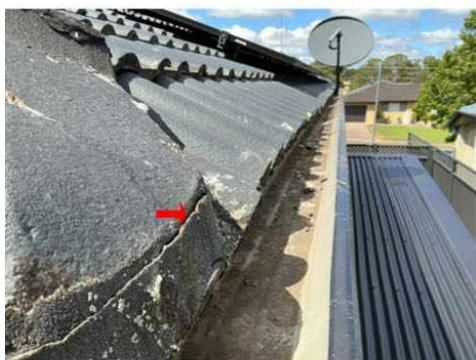
Finding 3.03

Building:	Main Building
Location:	All Areas
Finding:	Roof Mortar - Deterioration
Information:	Mortar, or `bedding`, is the material which fills joints and intersections between tiles and other building elements on the exterior roof covering, such as gable ends, hip capping and valleys.

Upon inspection of the exterior roof, it was noted that sections of the mortar show varying levels of deterioration.

Mortar generally deteriorates as a result of frequent exposure to weather conditions over a prolonged period of time. Mortar that is deteriorating may allow water ingress into the roof void, putting associated building elements and roofing structures at risk of water damage. Deteriorated mortar also detracts from the functionality of roof tiles and other roofing elements, potentially decreasing weather tightness and roof drainage.

Mortar deterioration can be attended to by a licensed roofing contractor.

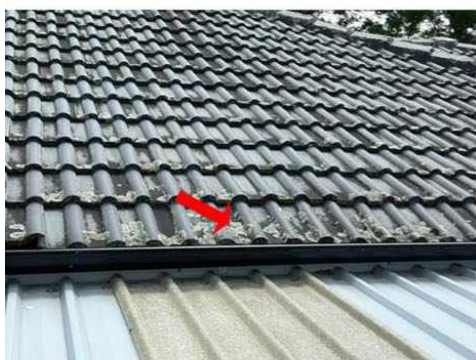
Finding 3.04

Building:	Main Building
Location:	All Areas
Finding:	Roof Tiles Weathered - Lichen Build Up
Information:	Upon inspection of the exterior roofing, the majority of roof tiles were considered to be in a fair condition. While weathering of the tiles is consistent with the age of the property, maintenance works are required.

Concrete roof tiles are typically cleaned to have the visible moss and lichen removed. Concrete tiles are made from a product which is a naturally moist material. Moss and lichen is attracted to the roof tiles surface, and if left will continue to grow and most likely restrict the flow of rain water over the tiles surface, into the roofs gutters. An application of an environmentally friendly anti-fungal solution should be applied to all moss and lichen, prior to undertaking the roof cleaning process.

A roof restoration company can be contacted for further advice at the clients discretion.

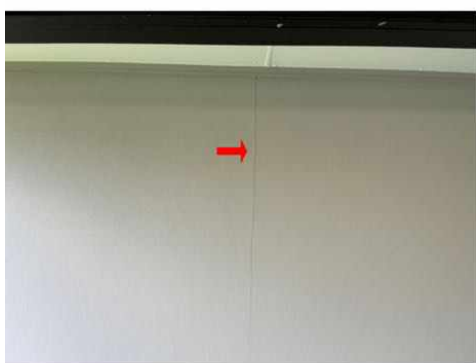
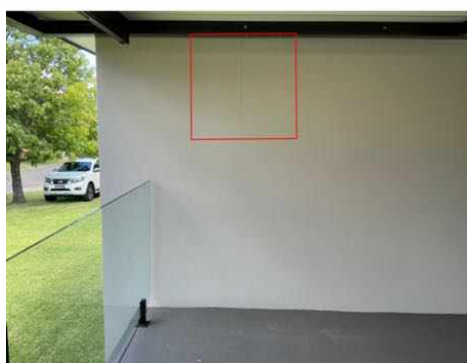
Finding 3.05

Building:	Main Building
Location:	Exterior walls - front

Finding: Cracking - Damage Category 1 - Fine (up to 1mm)
 Information: Although fine cracks are quite noticeable, they are often only considered to be an appearance defect, and usually do not indicate any structural damage. Generally, the cause of a fine crack is indicative of a separation between building materials and finishes (e.g. paint, plaster, etc.) along joints.

Cracking of this nature can generally be repaired with minor sanding, filling and/or repainting. Such works should be performed by a qualified painter or a general handyman.

Monitoring of all cracking should be conducted frequently. Always contact a building inspector should cracks widen, lengthen, or become more numerous.

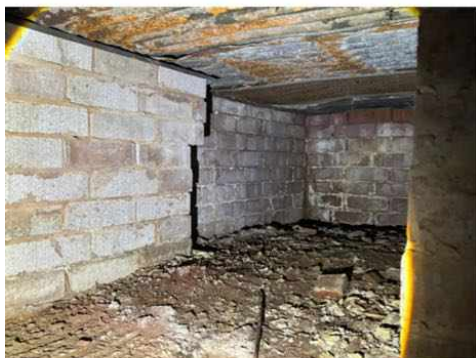
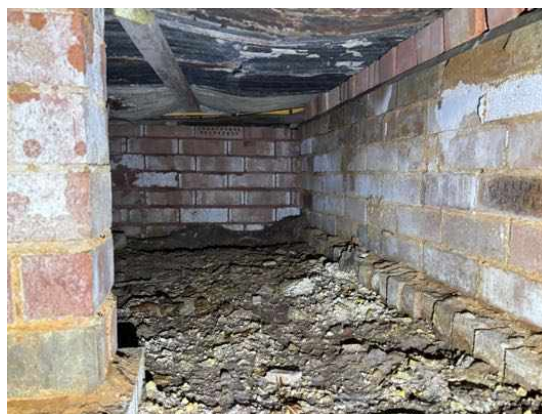
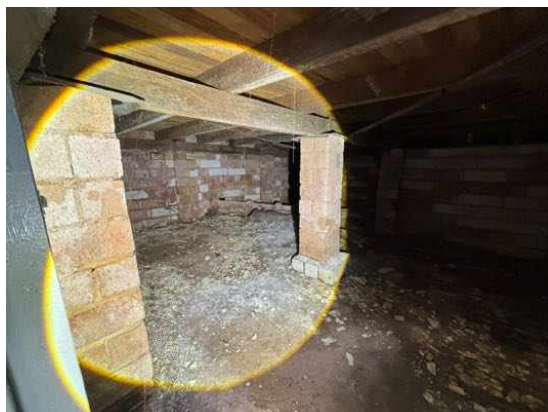
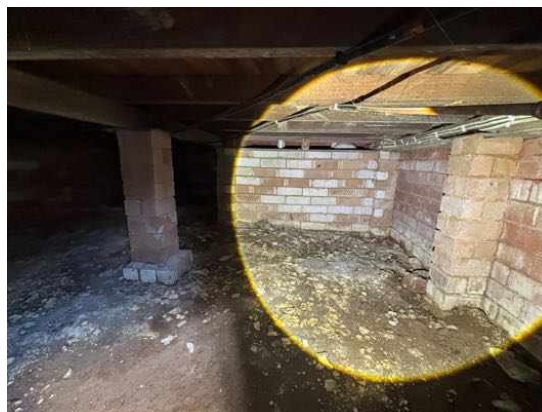
Finding 3.06

Building: Main Building
 Location: All Areas
 Finding: Subfloor Site Drainage - Inadequate
 Information: At the time of inspection, inadequate site drainage was observed under the subfloor, allowing water to accumulate and fail to drain effectively, creating a hazardous condition. This is a common defect in houses constructed on brick stumps, where poor site grading and limited subfloor ventilation can contribute to ongoing moisture retention. The resulting water pooling may lead to structural deterioration from prolonged dampness, mould and mildew growth, and create conditions conducive to termite activity. These issues can also impact indoor air quality and pose safety risks to occupants.

The client is advised to engage a licensed plumber or builder experienced in drainage and foundation work to assess and implement suitable solutions, such as improving site grading, installing appropriate drainage systems, and enhancing moisture barriers. In addition, the installation of mechanical subfloor ventilation is recommended to improve air circulation, assist with moisture control, and reduce the risk of ongoing damp-related issues.

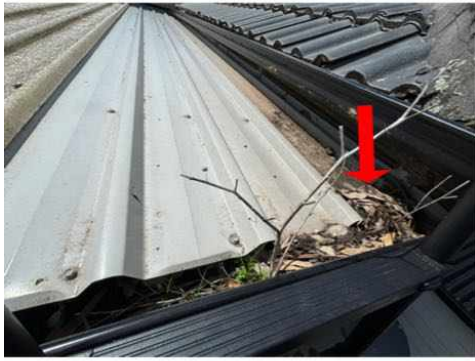
Finding 3.07

Building:	Main Building
Location:	Rear
Finding:	Debris in Gutters
Information:	Debris, including leaves and organic matter, was observed in the gutters and roof valleys at the time of inspection. This build-up can obstruct proper water flow, leading to water pooling, overflow, and potential moisture ingress into the roof structure. Prolonged moisture retention in these areas creates damp conditions that are conducive to termite activity, particularly where timber components are present nearby. It is recommended that the gutters and valleys be cleared of all debris and maintained regularly to ensure proper drainage and to reduce the risk of both water damage and termite infestation.

The client is advised to engage services of a lawn maintenance professional or a landscaper at own discretion.

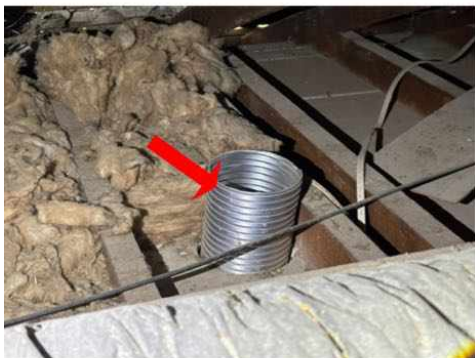
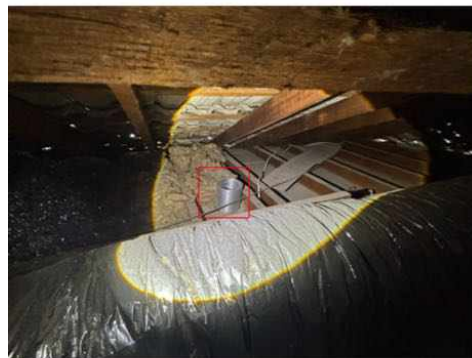
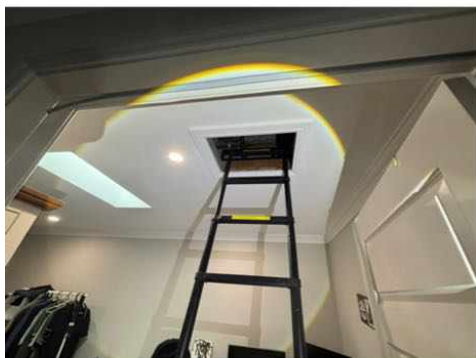
Finding 3.08

Building:	Main Building
Location:	Roof Void
Finding:	Vent - Extracted into Roof Space
Information:	During the inspection, it was noted that the exhaust vent has been improperly terminated into the roof space instead of being ducted to the exterior of the property.

This configuration is a defect as it allows moist air to accumulate within the roof cavity, increasing the risk of condensation, mould growth, and deterioration of insulation or timber framing. Proper ventilation is essential to maintain a healthy indoor environment and protect the structural integrity of the building. It is recommended that the vent be appropriately re-routed to discharge externally in compliance with relevant building standards.

A licensed mechanical ventilation contractor/electrician should be appointed as soon as possible to provide further consultation on the scope of these works and to provide quotations for any necessary works.

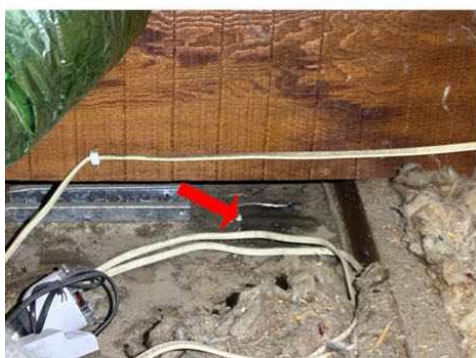
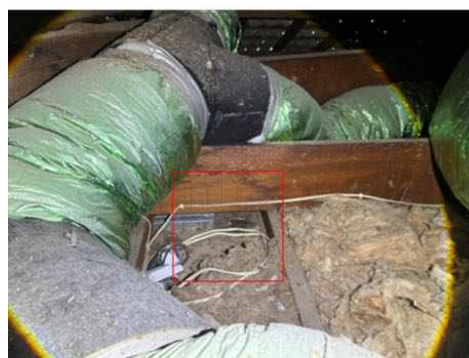
Finding 3.09

Building:	Main Building
Location:	Roof Void
Finding:	Moisture Staining Noted Beneath Air-Conditioning Duct – Roof Space
Information:	At the time of inspection, minor moisture staining was observed to insulation and adjacent roof space surfaces beneath the air-conditioning ducting. Thermal imaging indicated a localised cooler area consistent with possible condensation or minor moisture presence in this section. No active dripping was observed at the time of inspection.

It is noted that the air-conditioning system is not included as part of this building inspection. However, the staining suggests that condensation, minor duct leakage, or insulation deficiency around the ductwork may be contributing to intermittent moisture in this area.

The client is advised to make enquiries with the current owner regarding the service history and maintenance records of the air-conditioning system. Ongoing monitoring of this area is recommended. Should staining increase, insulation become saturated, or signs of active moisture develop, a licensed air-conditioning technician should be engaged to inspect the ducting and associated components and carry out rectification as required.

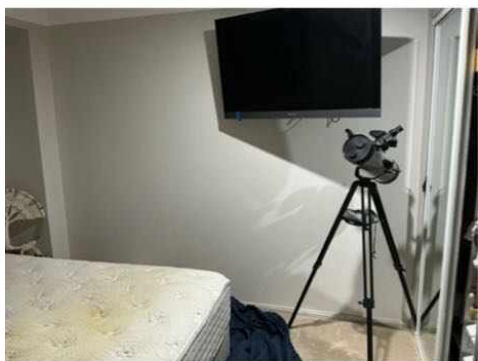
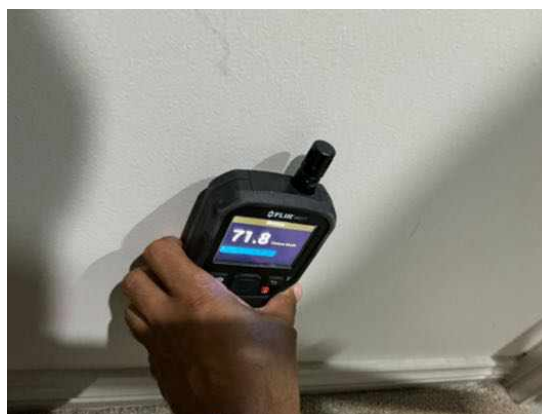
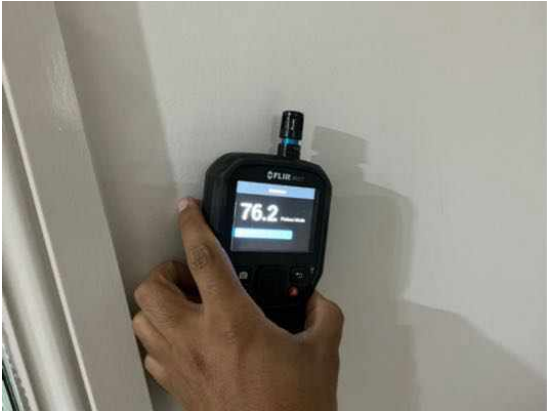
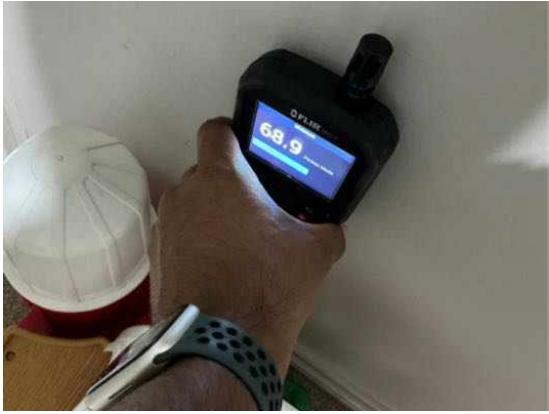
Finding 3.10

Building:	Main Building
Location:	All Bedrooms
Finding:	Rising Damp - Inadequate Subfloor Drainage
Information:	At the time of inspection, elevated moisture readings were recorded to the lower sections of internal walls, consistent with rising damp.

The moisture ingress appears consistent with rising damp originating from the subfloor area, likely influenced by inadequate site drainage and insufficient subfloor ventilation. Elevated ground moisture beneath the dwelling can allow moisture vapour to migrate upward into wall linings, resulting in dampness to internal wall surfaces. Prolonged exposure to such conditions may contribute to deterioration of wall finishes, mould growth, and potential timber decay if left unaddressed.

Installation of a mechanical subfloor ventilation system is recommended to assist in reducing subfloor humidity levels and improving airflow beneath the dwelling. A licensed electrician specialising in mechanical ventilation systems should be consulted to assess, supply, and install an appropriate system suited to the property.

In the interim, the client is advised to increase natural ventilation within the dwelling by leaving windows open for a couple of hours each day (weather permitting) to assist in reducing internal humidity levels. Ongoing monitoring of the affected wall areas is recommended following rectification works.

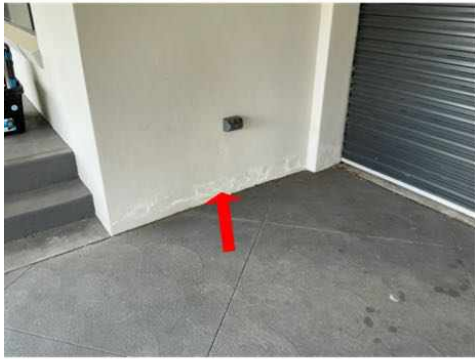
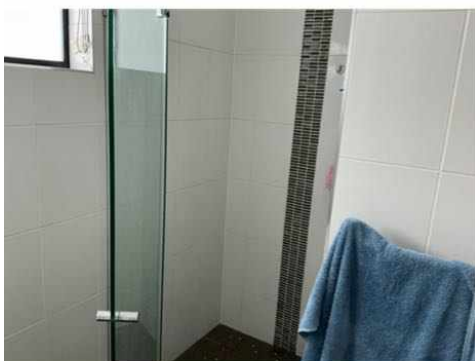
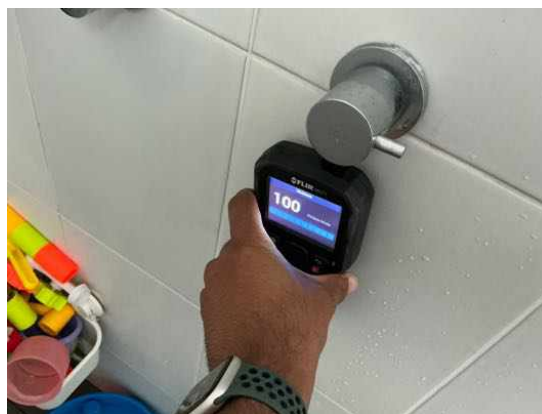
Finding 3.11

Finding: Excessive Moisture - Shower Damp

Information: At the time of inspection, excessive moisture was noted within the shower area, which is a common issue in wet areas due to the continual exposure to water. This condition is typically caused by moisture seeping through grout lines and settling behind tiles, resulting in localised high-moisture zones. Provided there is no evidence of water staining or elevated moisture readings on the opposite side of the wall, this is considered a minor defect.

However, persistently damp conditions may act as conducive conditions for termite activity, as termites are strongly attracted to moisture-rich environments. It is recommended that the client ensures regular use of the exhaust fan and maintains adequate ventilation after shower use to promote drying and reduce long-term moisture build-up, thereby also reducing the risk of attracting termites.

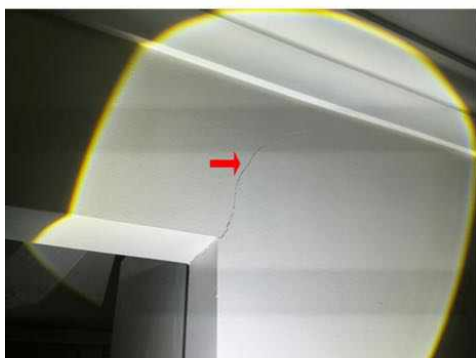
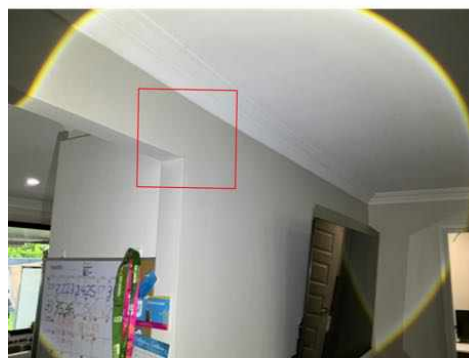
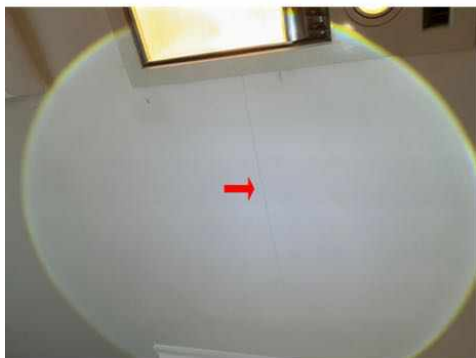
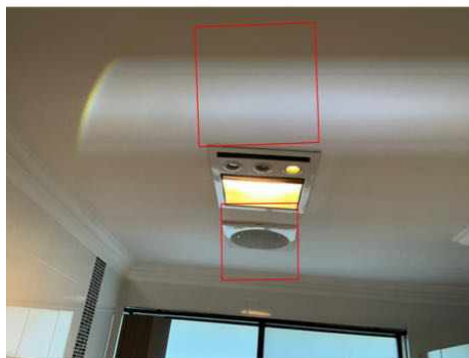
Finding 3.12

Building:	Main Building
Location:	Bathroom, Living Room
Finding:	Cracking - Damage Category 1 - Fine (up to 1mm)
Information:	Although fine cracks are quite noticeable, they are often only considered to be an appearance defect, and usually do not indicate any structural damage. Generally, the cause of a fine crack is indicative of a separation between building materials and finishes (e.g. paint, plaster, etc.) along joins.

Cracking of this nature can generally be repaired with minor sanding, filling and/or repainting. Such works should be performed by a qualified painter or a general handyman.

Monitoring of all cracking should be conducted frequently. Always contact a building inspector should cracks widen, lengthen, or become more numerous.

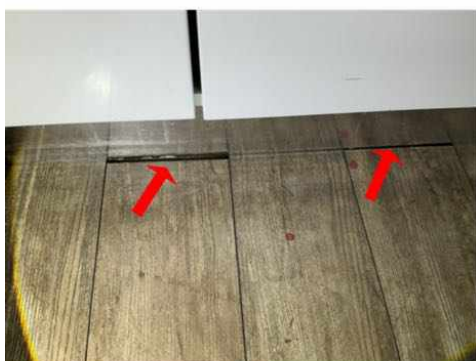
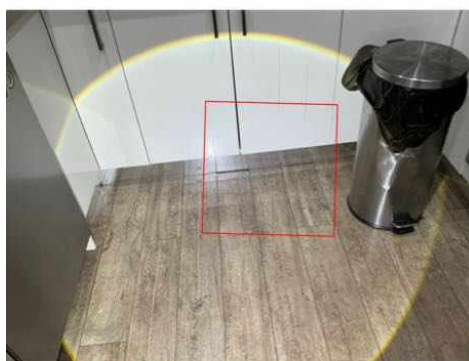
Finding 3.13

Building:	Main Building
Location:	Kitchen
Finding:	Flooring - Gaps
Information:	It was noted at the time of inspection, gaps were noted in the flooring.

These gaps could be attributed to several factors. One common reason is natural expansion and contraction of the wood due to fluctuations in temperature and humidity, which can cause the wood to shrink, leading to visible gaps. Poor installation practices, such as not leaving enough expansion space around the edges, can also contribute to this issue. Additionally, the age and wear of the flooring may lead to loosening of the boards over time. It's essential to address these gaps to prevent further movement and potential damage to the flooring structure.

Proper evaluation by a flooring professional is recommended to determine the best course of action for repair or maintenance.

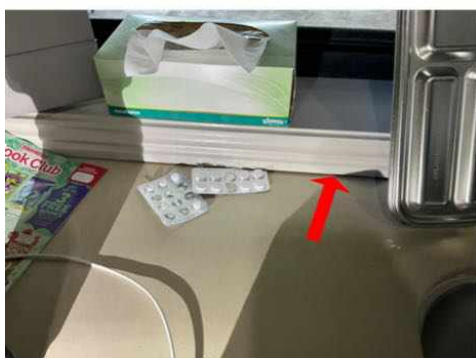
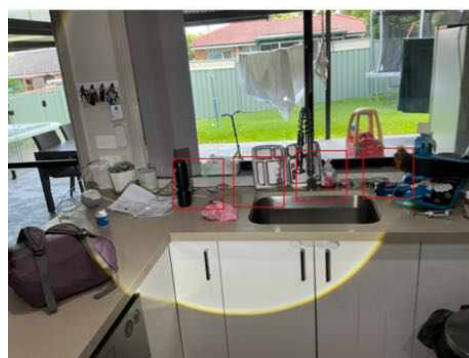
Finding 3.14

Building:	Main Building
Location:	Kitchen
Finding:	Sealant/Grouting - Missing or Damaged

Information: At the time of inspection, areas of missing and/or deteriorated sealant and grout were noted in this area. This condition can allow water to penetrate behind finishes, which may lead to moisture ingress, deterioration of waterproofing membranes, mould growth, and potential leaks into adjoining areas over time. If left unaddressed, this may result in costly repairs and hidden water damage.

It is recommended that a licensed plumber (or suitably qualified tradesperson experienced in wet area sealing) be engaged to assess the affected areas and reinstate compliant waterproof sealant and grout as required, ensuring all junctions are properly sealed to prevent further water ingress.

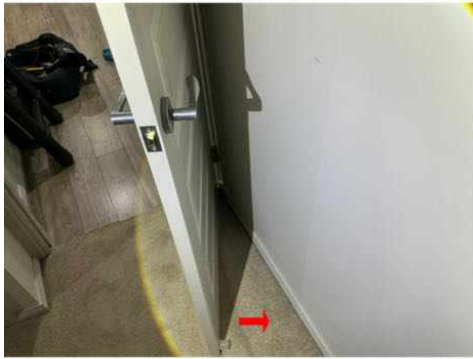
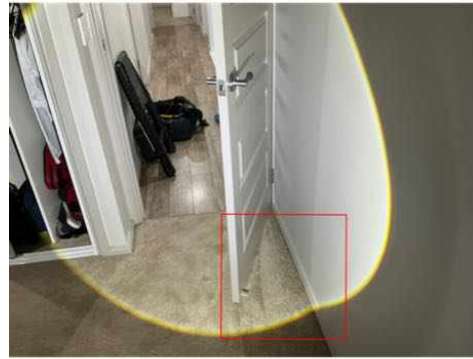
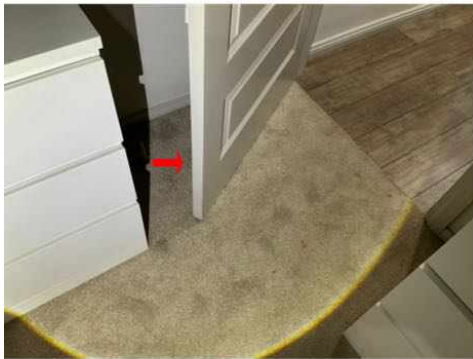
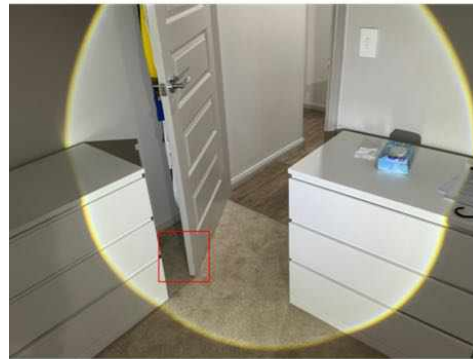
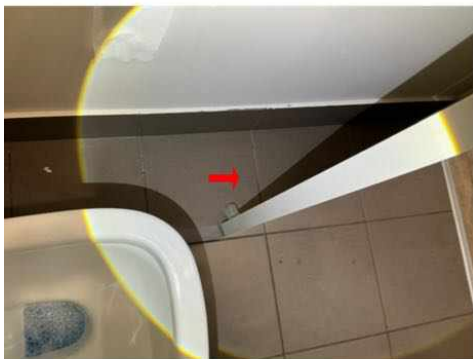
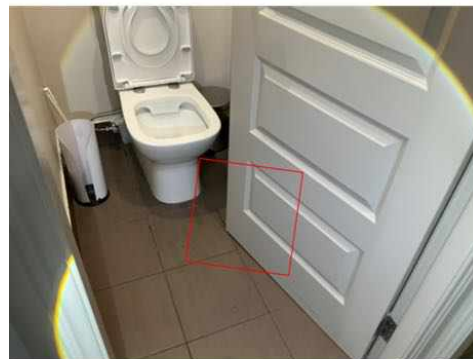
Finding: Door Stopper(s) - Missing

Information: At the time of inspection, it was noted that a door stopper was missing in this area.

The absence of a door stopper can lead to potential damage to the door, wall, or surrounding finishes, as the door may swing open too far and impact the wall or adjacent objects. Over time, this can cause dents, scuffs, or even structural damage to the wall or door. It is recommended that a door stopper be installed to prevent further damage and ensure the protection of both the door and the surrounding area.

The client is advised to engage services of a handyman to install the door stopper.

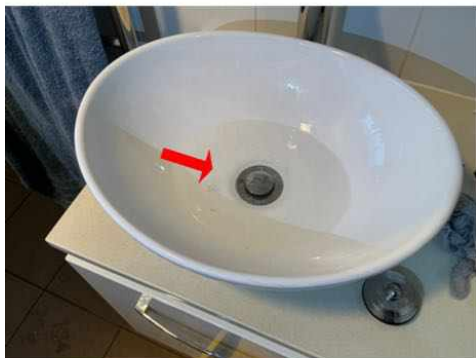
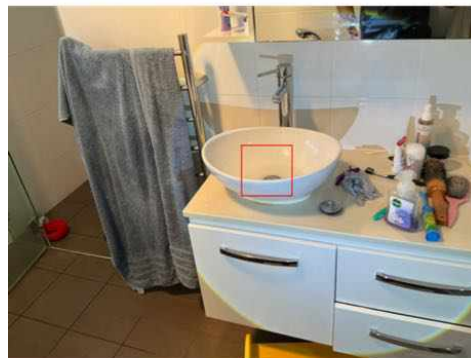
Finding 3.16

Building:	Main Building
Location:	Bathroom
Finding:	Sink - Slow Draining
Information:	The sink drain appeared to be slow draining at the time of inspection.

Blockages prevent building elements from operating as intended. If left unmanaged, a lack of general maintenance may lead to the development of more significant defects, such as water damage to surrounding building materials. It is advised that the blockage be removed as soon as possible.

If blockage remains, a licensed plumber should be appointed as soon as possible to

perform any remedial works where required.

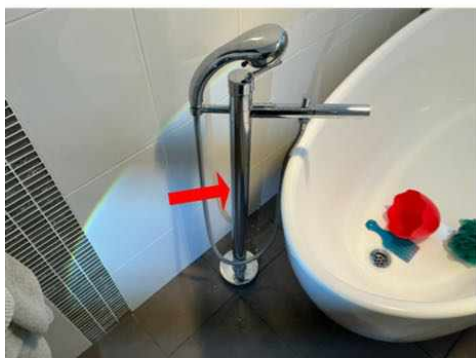
Finding 3.17

Finding: Loose Plumbing Fixtures

Information: The plumbing services were loose at the time of the inspection. Loose services limits the operation of the areas it is supplying and can result in secondary damage.

Replacement/Repair of the item should be conducted as soon as possible. A qualified plumber should be appointed to perform these works to improve the operational state of the affected area.

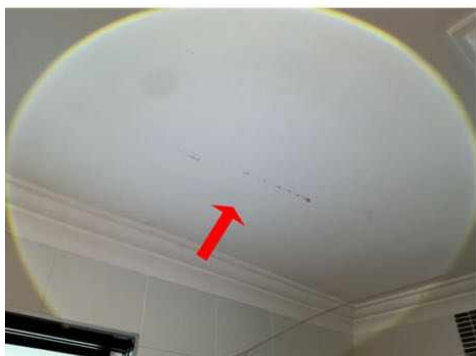
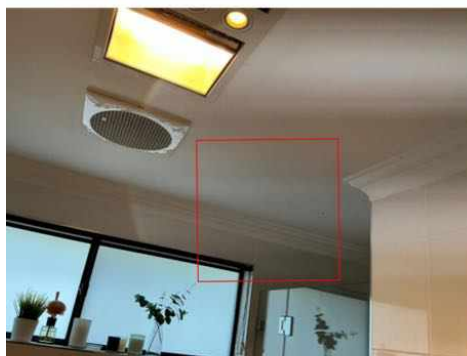
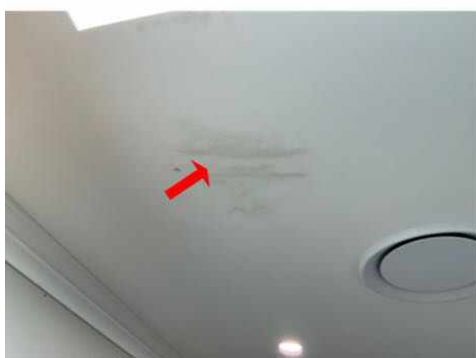
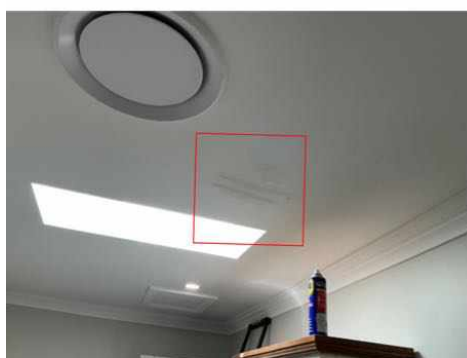
Finding 3.18

Finding: Maintenance and/or Wear and tear on building elements

Information: It was observed at the time of inspection that some building elements and areas around the property require general maintenance and/or exhibit signs of wear and tear. These typically include minor imperfections such as paint scuff marks, scratches on surfaces, small chips, nails or hooks left in walls from previous picture hanging, and

other superficial blemishes.

These are generally considered minor items that are common in established homes. While they may be noticeable on visual inspection, they do not affect the structural integrity or functionality of the property. In most cases, these issues can be easily addressed by a qualified handyman as part of routine maintenance.

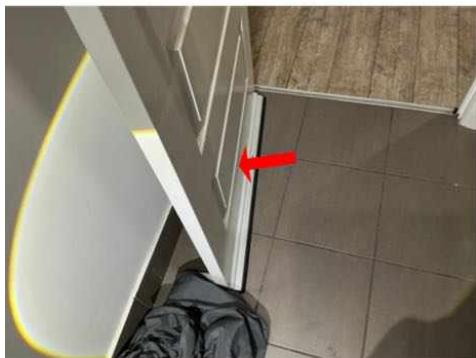
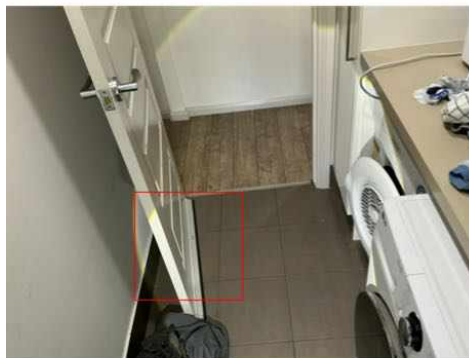
Finding 3.19

Building:	Main Building
Location:	Laundry
Finding:	Door(s) - Binding/Jamming
Information:	At the time of inspection, it was noted that the door was binding or jamming in this area.

Several factors could contribute to this issue, including swelling due to moisture, which can cause wooden doors to expand and fit tightly in the frame. Misaligned or loose hinges may also result in the door sagging or becoming misaligned, making it difficult to close. Over time, wooden doors may warp due to fluctuations in temperature or humidity, leading to improper closure.

It is recommended that a qualified carpenter or handyman be engaged to carry out the necessary repairs to ensure proper door operation.

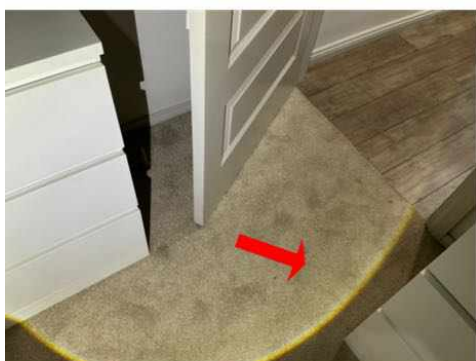
Finding 3.20

Finding: Carpet - Stained

Information: At the time of inspection, staining was observed on the carpet in these areas of the property.

Carpet stains can result from a range of sources, including food and drink spills, pet accidents, water intrusion, or general wear and tear from foot traffic. If left untreated, these stains may become permanent, cause unpleasant odours, and contribute to the growth of mould or bacteria, particularly in high-moisture environments.

The client is advised to engage services of a carpet cleaning company at own discretion.

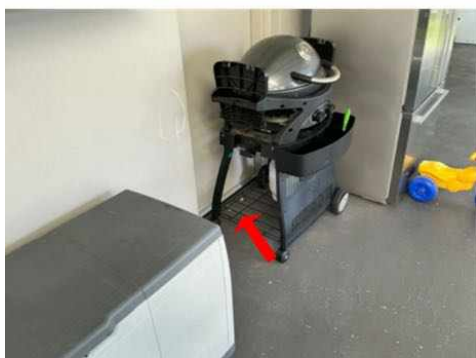
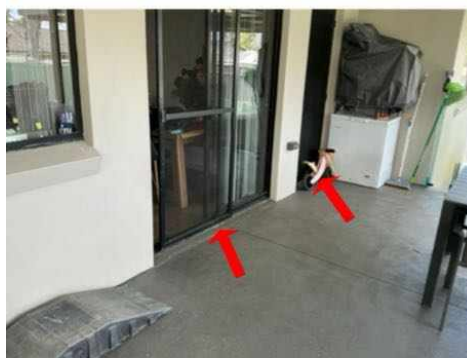
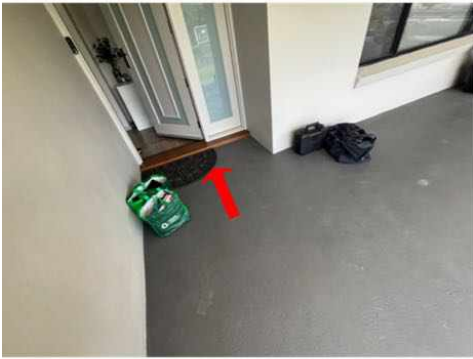
It is important for internal flooring to be raised above adjacent external ground levels. Where external ground levels are above or same level as internal flooring, water pooling and subsequent internal flooding is likely to occur which may attract termite activity to the internal area.

It is highly advised that a landscaper or relevant tradesperson be appointed to lower external grounds that are raised above or same as adjacent internal flooring. Alternatively if external grounds and internal flooring is level installation of a raised door sill may be appropriate in preventing any water pooling in the area. If the client wishes not to make any changes, then a qualified pest controller is recommended for termite treatment around the perimeter of the house and subfloor (if any) as soon as possible.

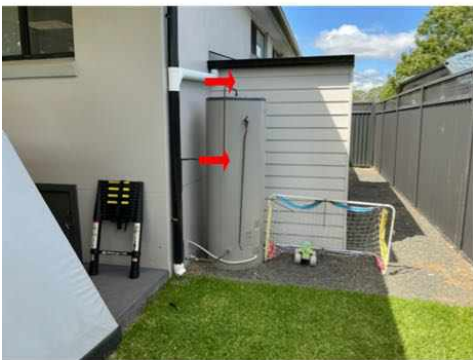
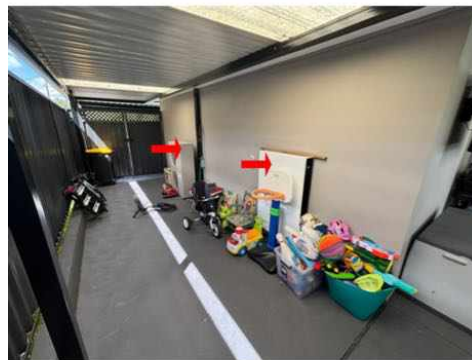
Finding 6.02

Building:	Main Building
Location:	All Areas
Finding:	Bridging Appliances - Attachment to Buildings
Information:	Bridging occurs when items against a building provide a concealed entry point for termites into the building or by passing around a termite management system.

Where any part of an attachment to a building is not isolated and is not provided with a clear gap of not less than 25mm from the building, bridging occurs. Attachments to buildings such as hot water services, downpipes, verandahs, decks, steps, fences, service conduits and the like provide the opportunity for concealed entry.

Building attachments of this nature need to be frequently inspected for termite activity by a qualified inspector.

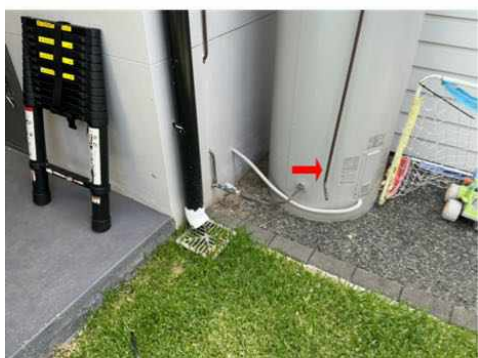
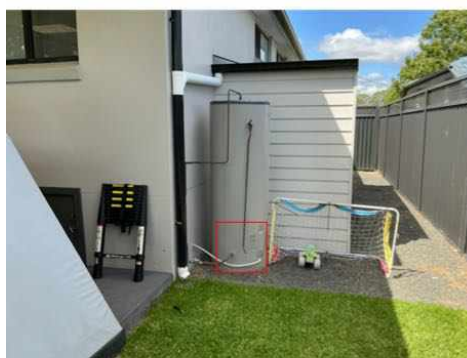
Finding 6.03

Building:	Main Building
Location:	Yard - Back
Finding:	Overflow Disconnected - HWS/AC/Gas - Conducive Conditions to Termites
Information:	The overflow to this service was found to be disconnected from stormwater drainage and is creating excessive moisture in the surrounding area.

Such leaking creates an environment that is conducive to an array of defects, including water damage to associated building elements and the attraction of termite or timber pest infestation. These damp conditions can lead to secondary defects such as rot, rust, or corrosion of associated building elements, the formation of fungal decay, or even the creation of potential slip hazards. When coupled with poor site drainage, pooling of water may also attract termite activity to this area.

It is highly recommended that a licensed plumber be appointed to connect the overflow in order to prevent such an environment from being created. These minor works should be carried out as soon as possible.

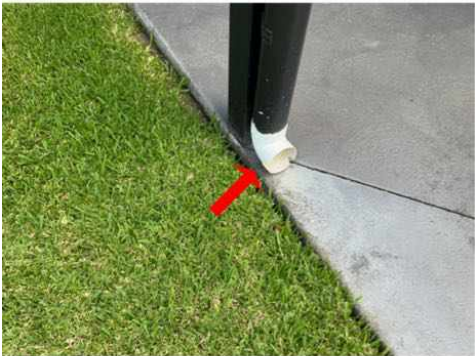
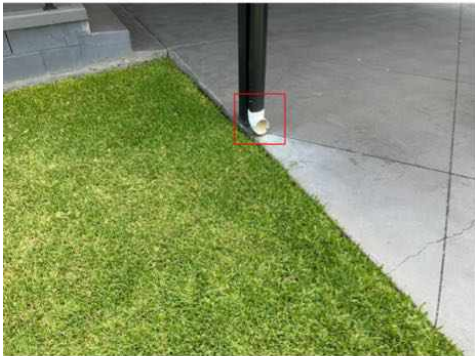
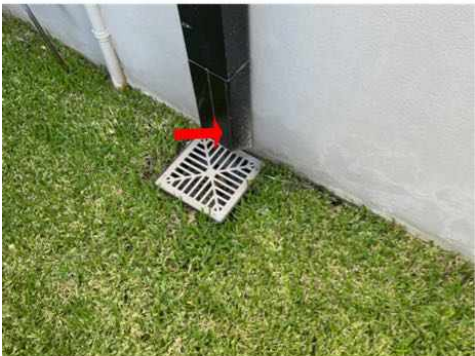
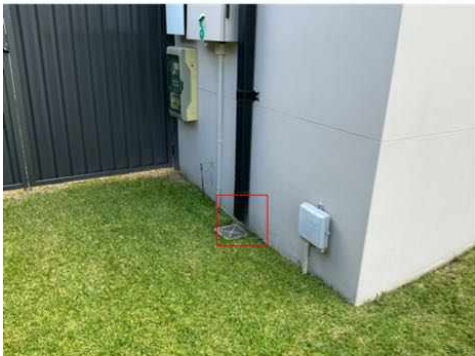
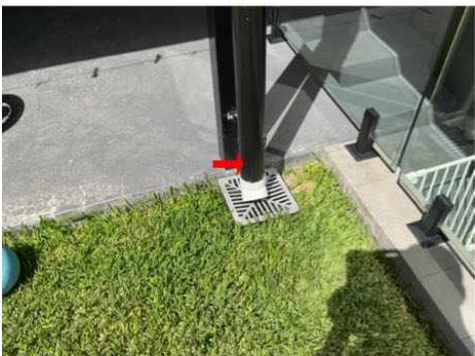
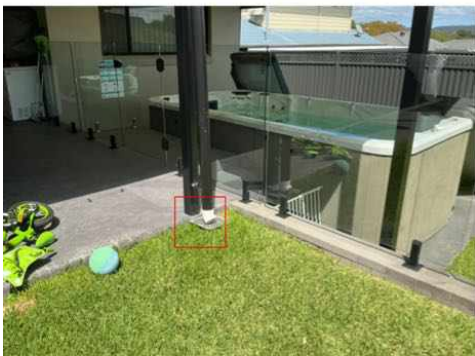
Finding 6.04

Building:	Main Building
Location:	All Areas
Finding:	Stormwater Drain - Not Connected (Roof Plumbing)
Information:	The inspection revealed that the roof plumbing system is not adequately connected to the site's stormwater drainage, reducing its functional efficiency. This disconnection can lead to water pooling around the base of the property, increasing the risk of rust and corrosion to building elements, structural damage, and attracting termites due to the persistent dampness.

Improper drainage can also contribute to mould and mildew growth, affecting indoor air quality and health, and may lead to ground movement, causing cracks in walls and other structural issues.

It is strongly recommended that a licensed roof plumber be engaged to assess the system and ensure appropriate connections to stormwater outlets are installed to effectively redirect water away from the structure.

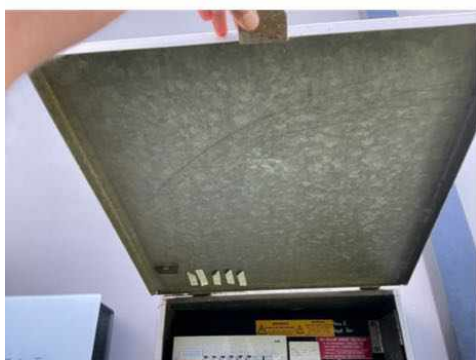
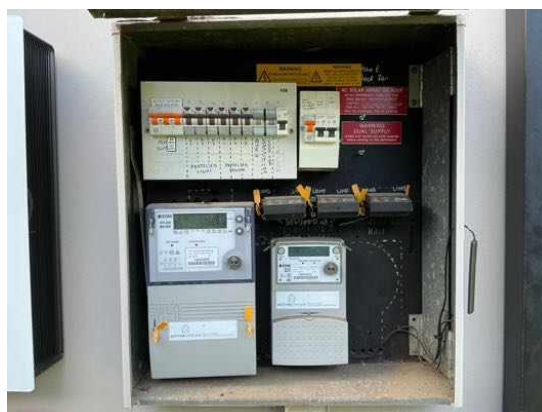
Finding 6.05

Building:	Main Building
Location:	Meter Box
Finding:	Termite Management System - No Evidence of Installation
Information:	The application of a post-construction chemical termite barrier is strongly recommended for all properties, especially if there has been any history of live termite activity on-site. These barriers are highly effective in protecting timber building elements throughout the property by preventing termite attacks. It is also advisable to install a durable notice within the switchboard unit, indicating the presence of any termite barriers for future reference.

During the inspection, there was no indication that a termite management system had been installed, nor was there any evidence to suggest that preventative measures had previously been undertaken. The client is encouraged to seek further advice from a licensed pest controller regarding the costs and procedures involved in the application of a termite barrier. Prioritizing this step in the short term is strongly advised to ensure long-term protection.

Additionally, the client may want to consult with the vendor to determine whether regular Timber Pest inspections, as per AS4349.3 or AS 3660.2, have been conducted in the past. This will provide further insights into any past termite management practices and help inform the appropriate course of action.

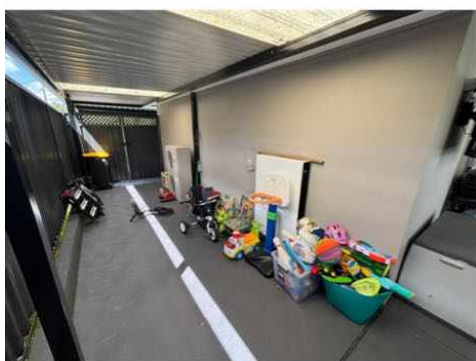
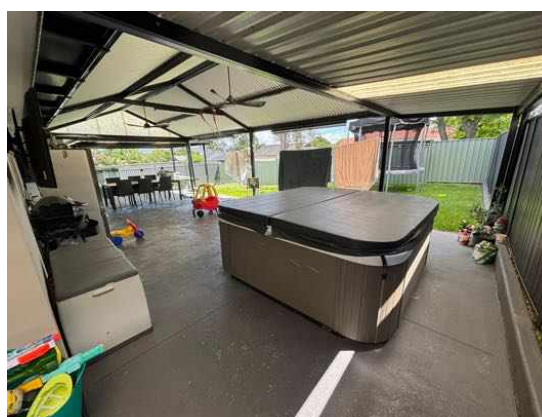
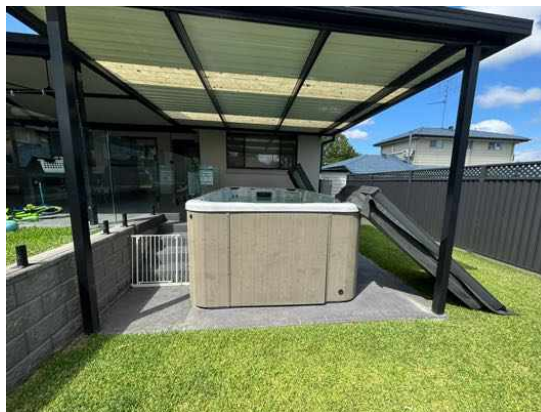
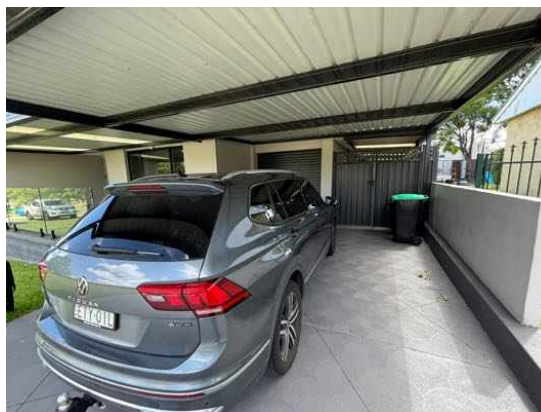
Building: Main Building
Location: All External Areas
Finding: Obstructions and Limitations - External Areas
Information: The attached photographs provide a visual representation of the obstructions and limitations that impeded a full inspection of the external areas of the property at the time of assessment. These obstructions, which may include vegetation, stored items, debris, or other physical barriers, can obscure potential defects and prevent a thorough evaluation of the property's condition. Obstructions of this nature can conceal a wide range of issues, such as structural damage, water ingress, pest infestations, or deteriorating building materials, which may not be visible during the initial inspection.

It is essential that these obstructions be cleared to allow for a comprehensive inspection of the external areas. Removing these barriers will enable a more accurate assessment of the property's condition and allow any hidden defects to be identified and addressed promptly. Failure to do so could result in undetected issues worsening over time, potentially leading to more costly repairs in the future.

Therefore, it is strongly recommended that the obstructions be removed and a re-inspection be scheduled once the affected areas are made fully accessible. This will ensure a complete evaluation of the property's exterior and provide the client with a clear understanding of any potential issues that may have been concealed during the initial inspection.

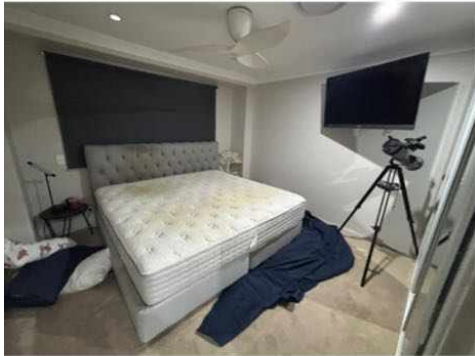
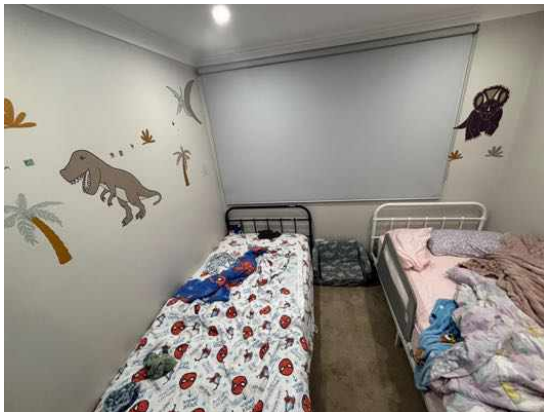
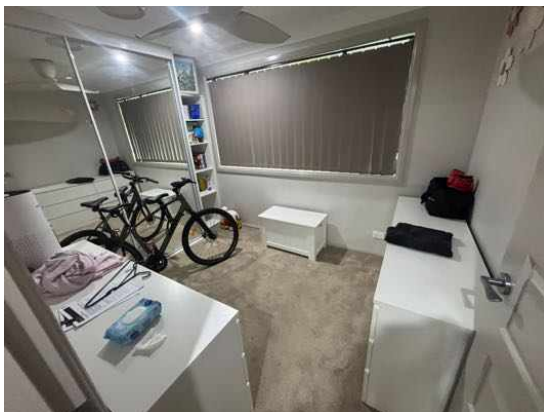
Information: The accompanying photographs provide clear evidence of the obstructions and limitations that restricted a comprehensive inspection of the internal areas of the property at the time of assessment. These obstructions, which may include furniture, personal belongings, stored items, or structural elements such as wall coverings and built-ins, significantly hindered the ability to thoroughly evaluate these areas. It is important to note that such obstructions can potentially conceal a wide array of defects, ranging from hidden structural damage, water leaks, pest infestations, or electrical issues, to deteriorating materials that may not be visible during the initial inspection.

The presence of these impediments means that critical areas of the property were not accessible, and therefore, any underlying defects that may affect the integrity and safety of the property could remain undetected. These hidden defects, if left unaddressed, could worsen over time and may result in costly repairs or pose potential safety hazards to the occupants.

It is highly recommended that all obstructions be cleared to facilitate a complete and thorough inspection of the internal areas. Once the obstructions have been removed and full access is available, a re-inspection should be carried out to ensure that any

previously concealed issues can be properly identified and rectified. This follow-up inspection will provide a more accurate assessment of the property's internal condition and help the client make informed decisions about any necessary repairs or maintenance.

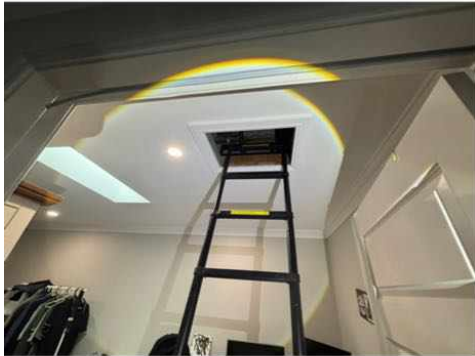
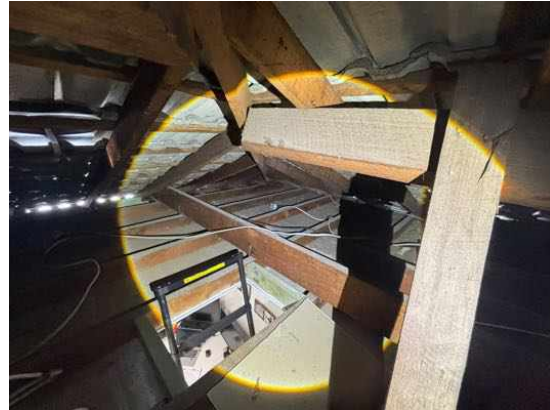
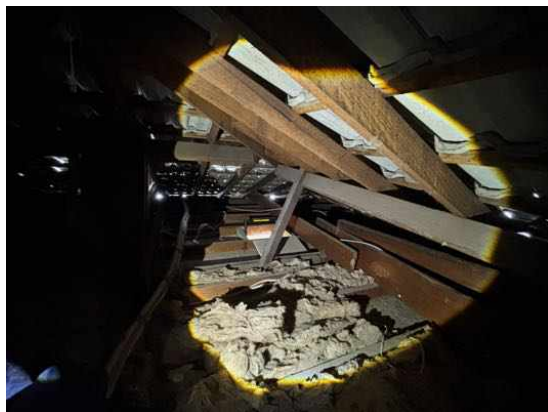
Finding: Obstructions, Limitations, and General Roof Space Condition

Information: The photographs provided document both the general condition and the obstructions and limitations that were present in the roof cavity of the main building at the time of inspection. These obstructions—such as insulation materials, stored items, structural elements, or electrical wiring—restricted safe and adequate access to key areas within the roof space. As a result, a comprehensive inspection of all components could not be completed.

Obstructions of this nature may conceal a variety of potential defects, including

damaged framing, compromised insulation, evidence of moisture ingress, pest activity, or electrical hazards. While no major issues were observed in the visible areas, the presence of these limitations means that some defects may remain undetected.

It is recommended that these barriers be removed or repositioned to facilitate full and safe access to the roof space. Once clear, a follow-up inspection should be conducted to allow for a thorough assessment of all concealed areas. This will help ensure that the condition of the roof cavity is accurately evaluated and any hidden issues are appropriately identified and addressed.
