Building and Timber Pest Inspection Report

Inspection Date: Thu, 19 Feb 2026

Property Address: 11 Grassmere Ave, South Penrith NSW
2750, Australia

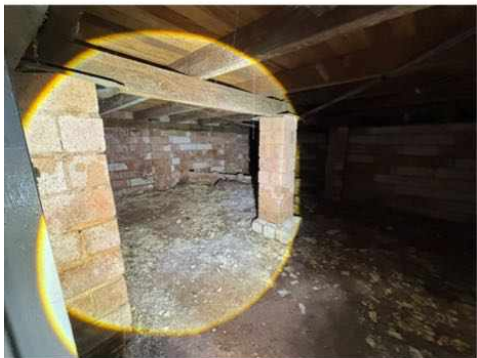
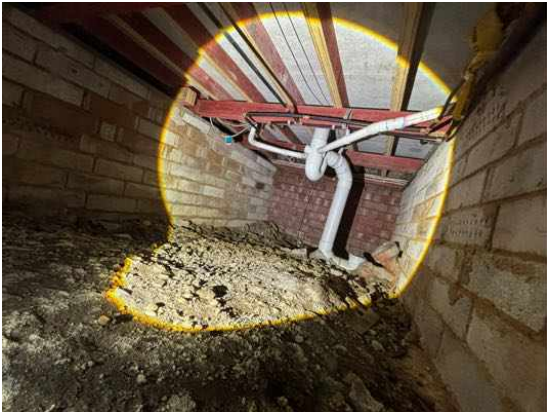
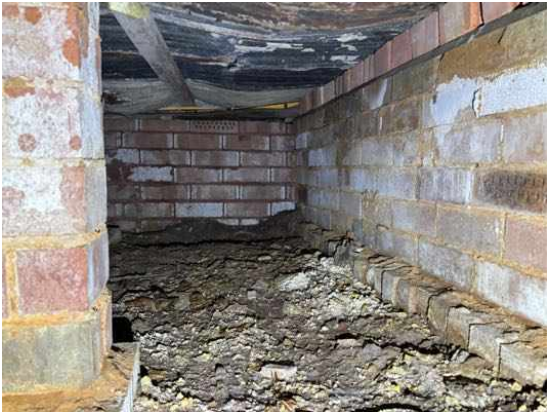
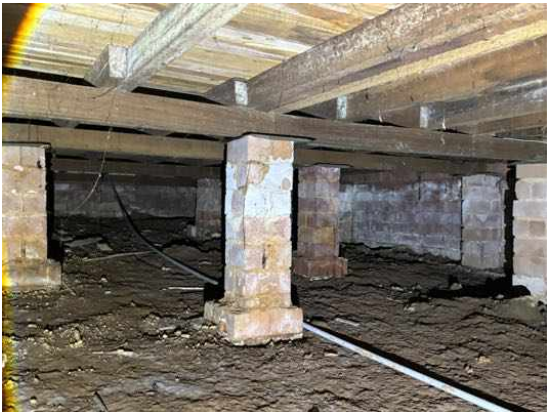
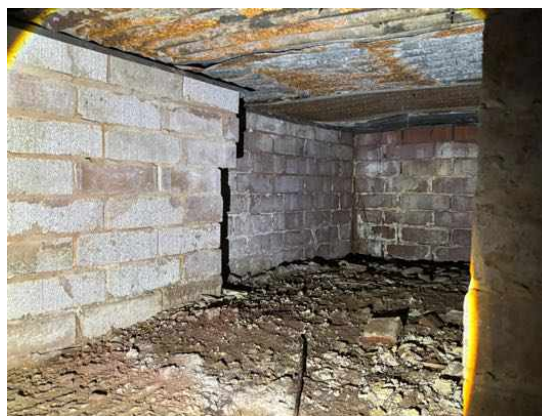
Finding: Obstructions, Limitations, and General Subfloor Condition

Restricted access and confined spaces can significantly hinder the ability to evaluate important elements such as floor joists, bearers, stumps, drainage, subfloor ventilation, and signs of moisture or pest activity. These obstructions may also conceal defects such as timber decay, water ingress, termite damage, inadequate support, or ventilation issues that are not immediately visible during a limited inspection.

While no major concerns were identified in the accessible areas, a full and unobstructed inspection is necessary to properly assess the overall condition of the subfloor. It is recommended that obstructions be removed and access improved where possible. Once adequate clearance is provided, a re-inspection should be arranged to ensure that any concealed defects can be identified and addressed accordingly. This will assist in providing a more comprehensive understanding of the subfloor's condition and reduce the risk of unforeseen issues.

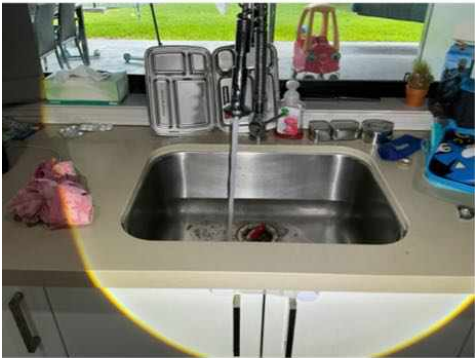
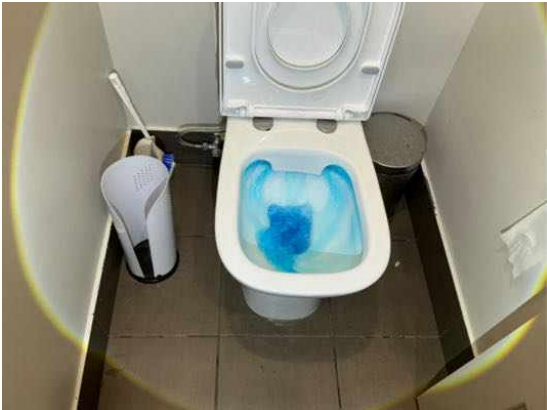
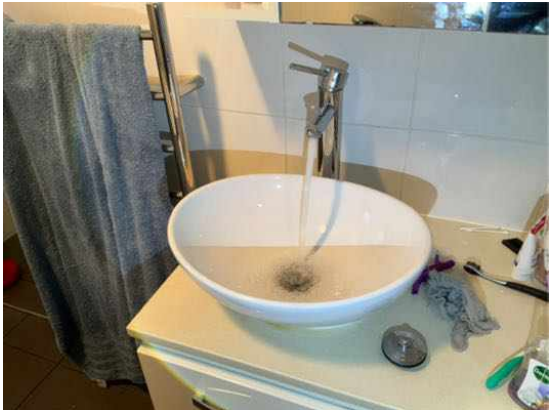
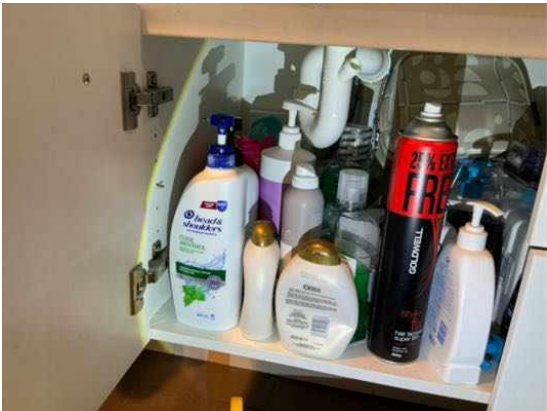
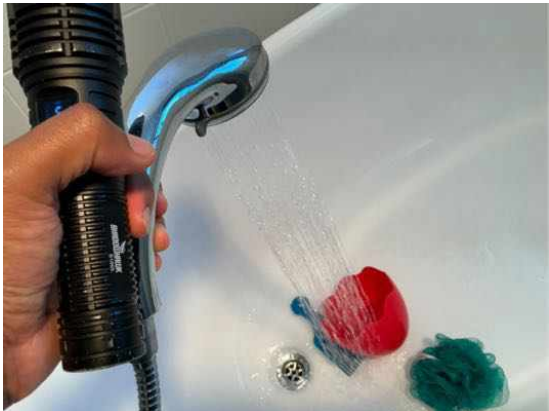
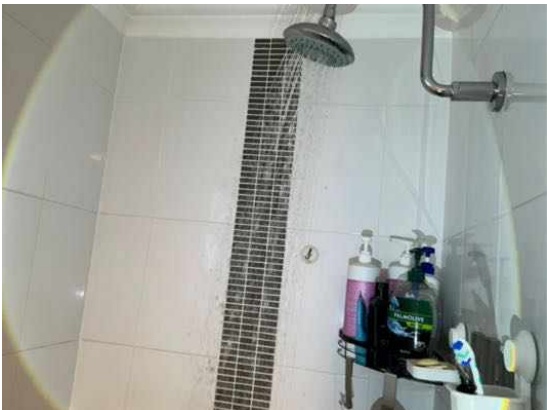
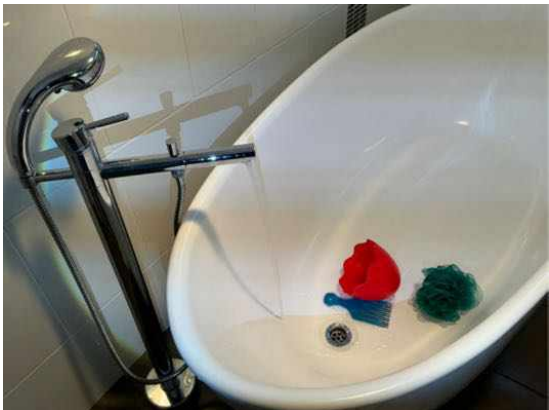
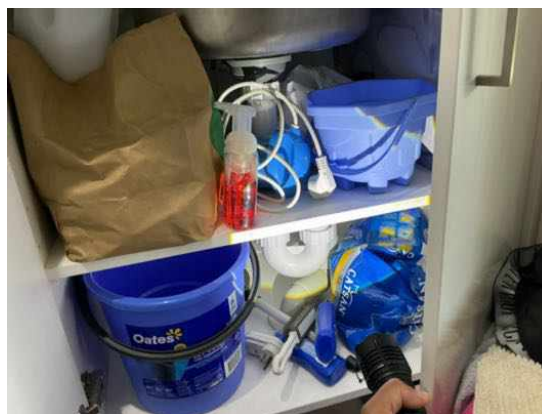
Building:	Main Building
Location:	All Areas
Finding:	FYI - Taps, Drainage & Toilets Tested and Cabinetry Obstructions
Information:	During the inspection, all accessible taps, drainage systems, and toilets were tested for water flow and drainage efficiency, and checked for any visible signs of leakage. At the time of the inspection, no issues were noted in these areas. Unless highlighted in a separate defect statement, no immediate remedial work appears necessary. Supporting images may be found in the additional photos section for reference.

It is important to note that while a visual inspection of cupboards and cabinetry beneath sinks and vanities was undertaken, stored personal items and fixtures presented obstructions that limited full visibility of the internal areas. As per standard inspection practices, inspectors are not permitted to move or disturb personal belongings during the inspection process. Therefore, only visible and accessible sections were inspected, and concealed water damage or plumbing defects may not have been detected.

Given this, a re-inspection is recommended after all obstructions have been cleared to allow for a comprehensive assessment of these areas. Regular maintenance and monitoring of plumbing and drainage systems is also advised to ensure ongoing functionality and early detection of potential issues.

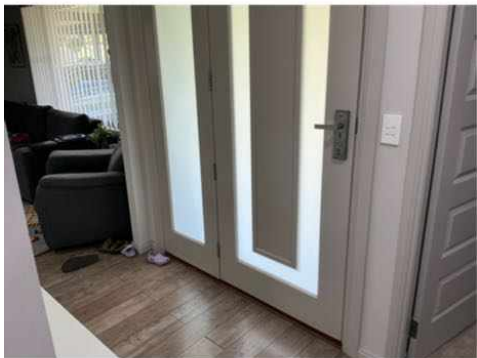
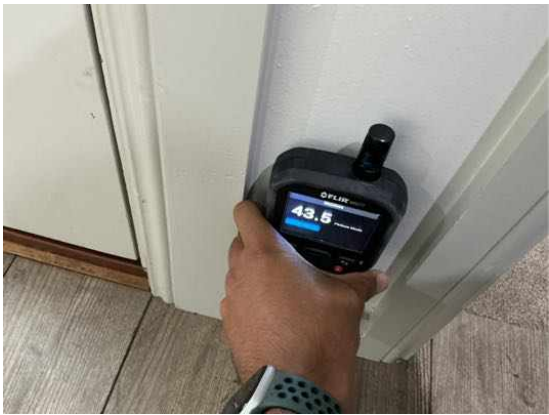
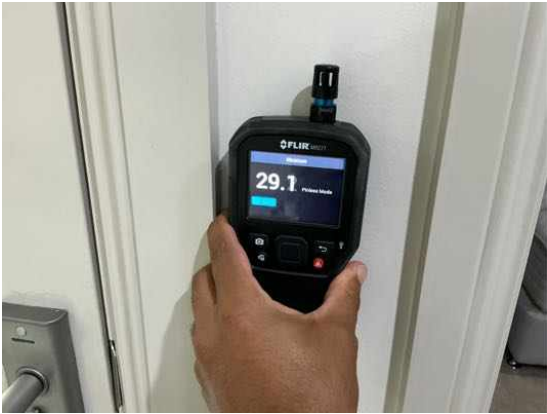
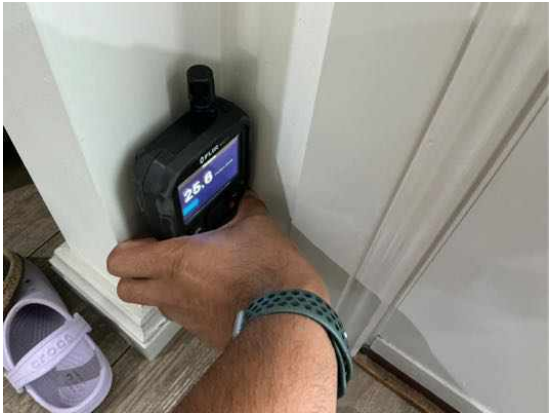
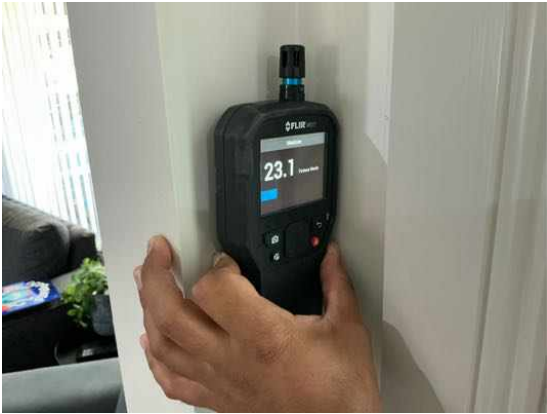
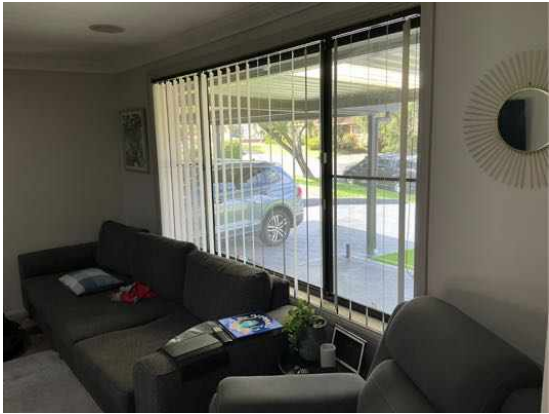
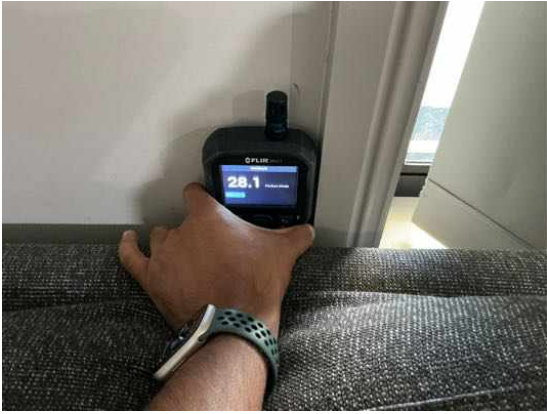
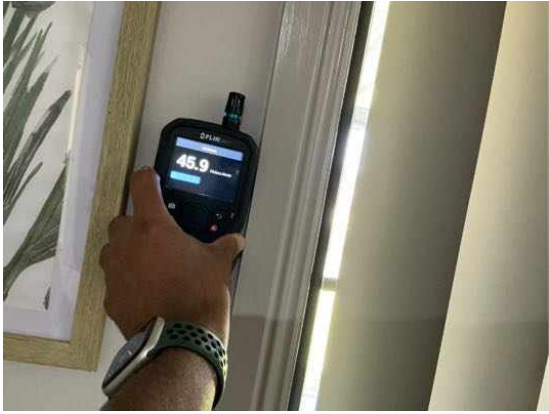
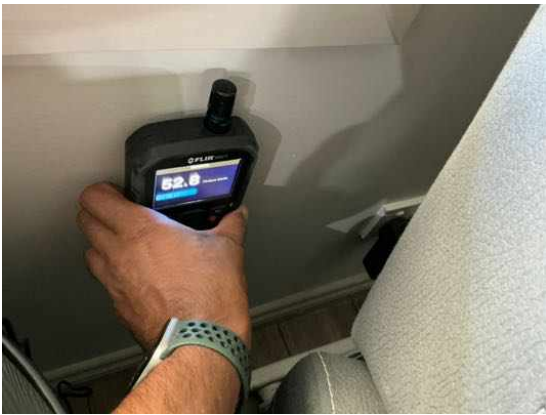
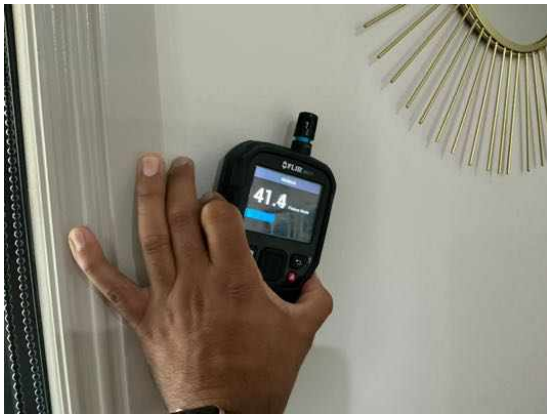
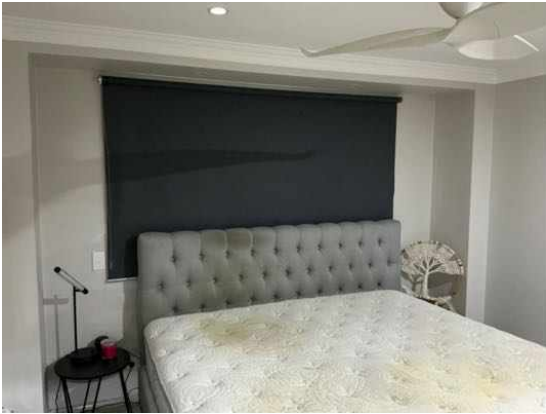
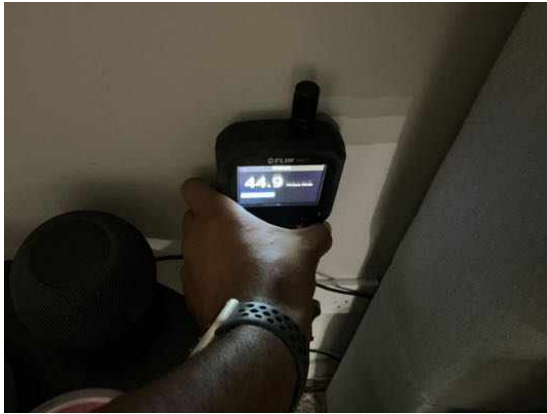
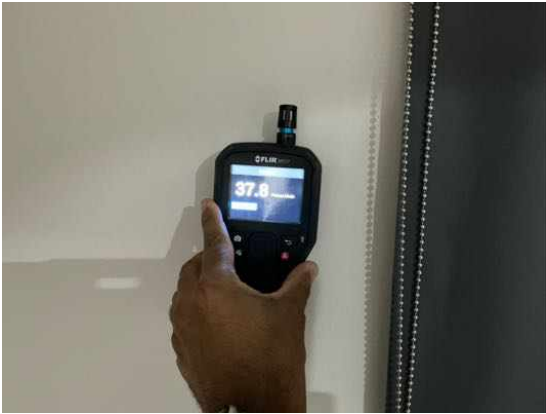
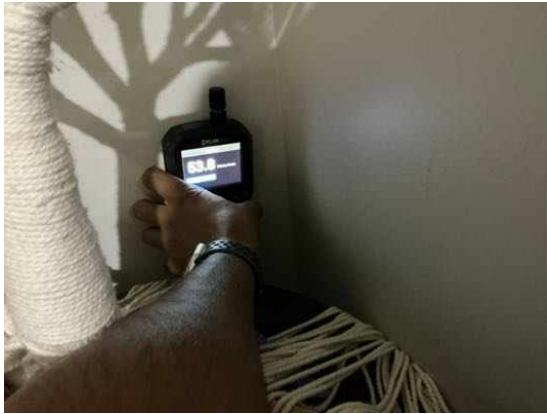
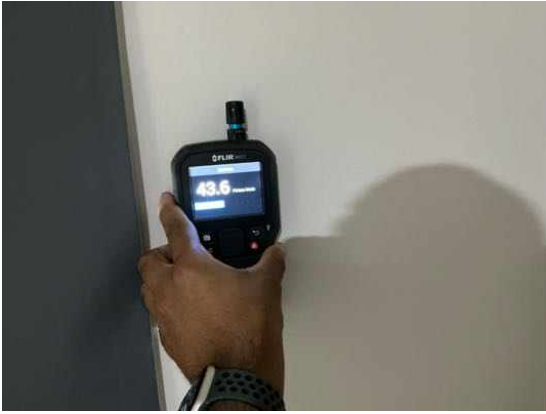
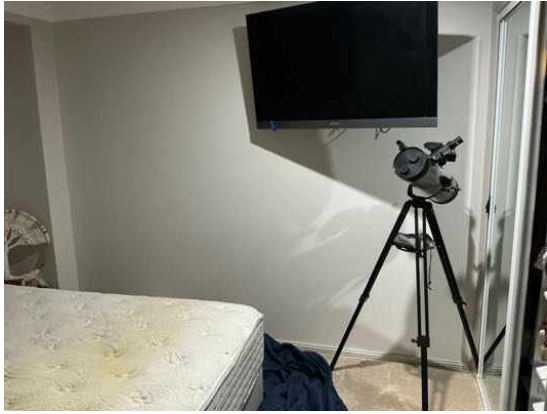
Finding: Additional Photos - Moisture Meter Readings

Information: Additional moisture meter reading photos have been provided for the property to offer further clarity on areas tested during the inspection. These photos are intended to give a visual reference for the specific locations where moisture levels were measured. These readings were taken at the time of the inspection to assess any potential moisture-related issues within the property. Any defects related to moisture that were identified during the inspection have been separately mentioned in the defect statements within the report.

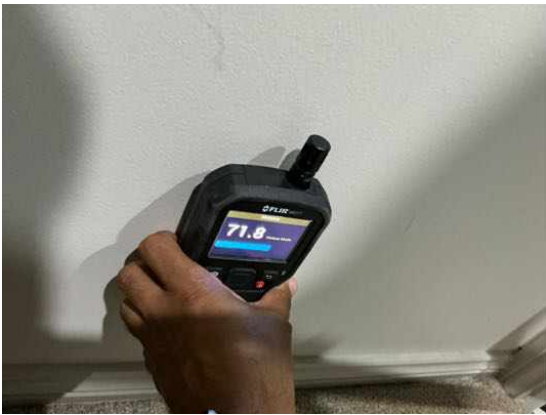
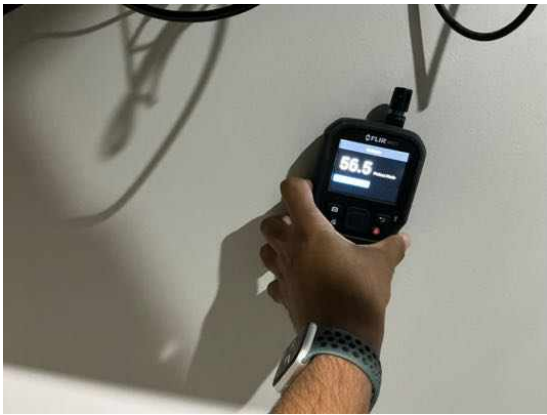
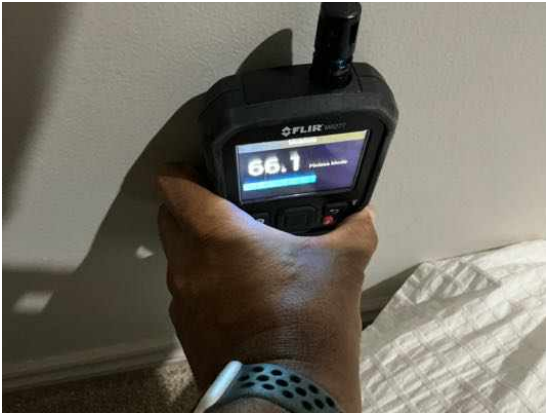
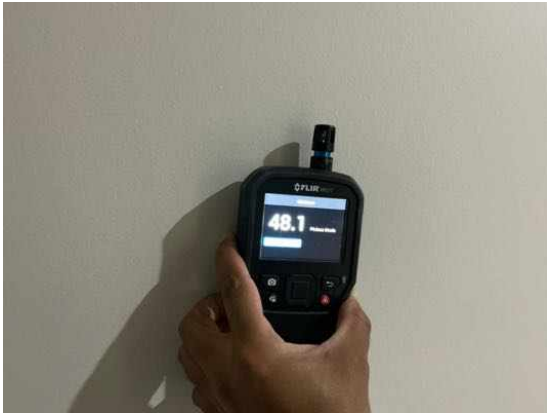
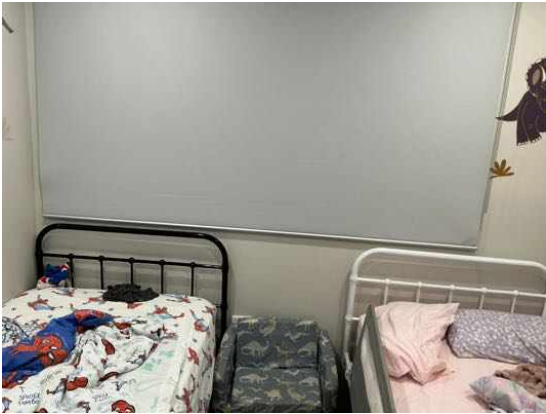
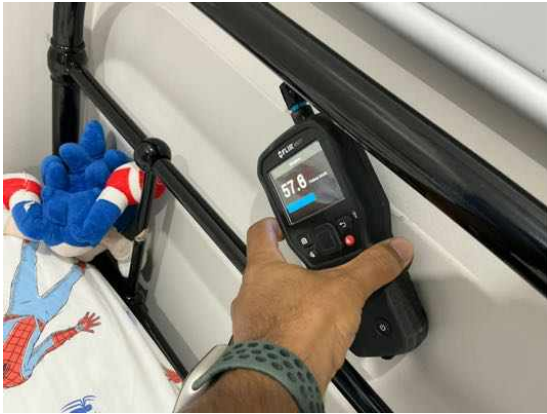
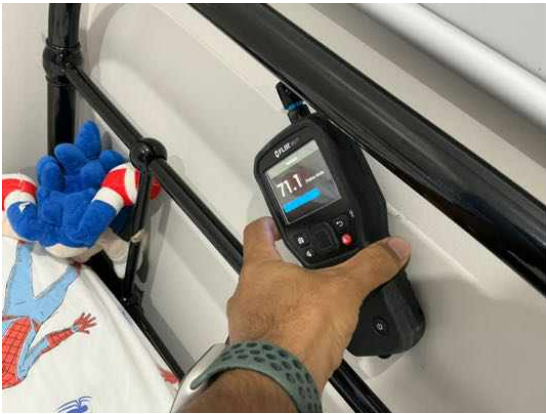
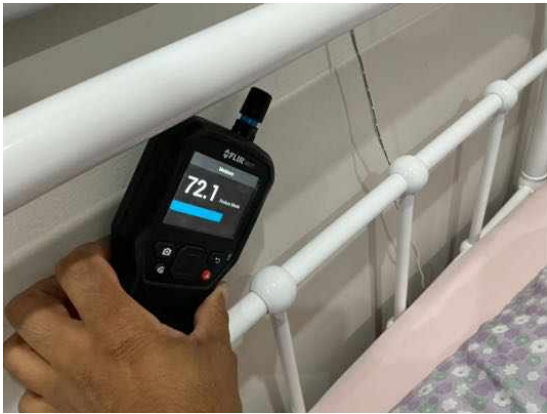
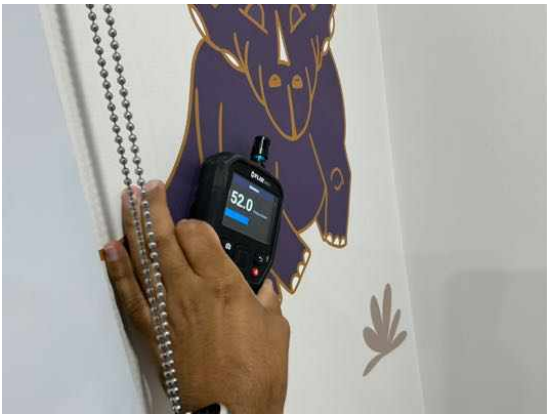
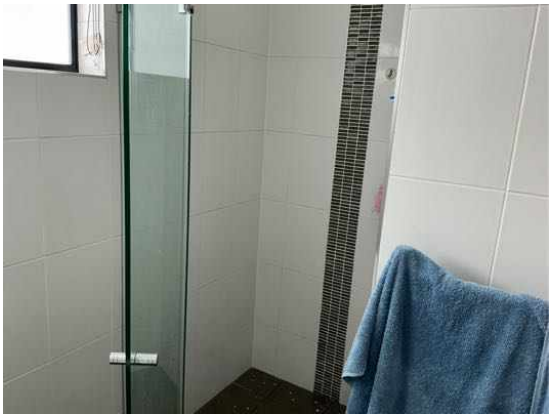
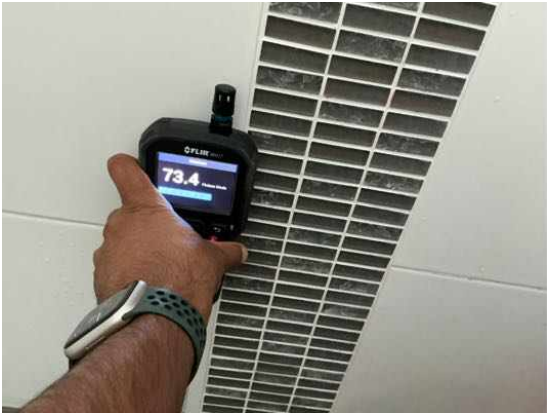
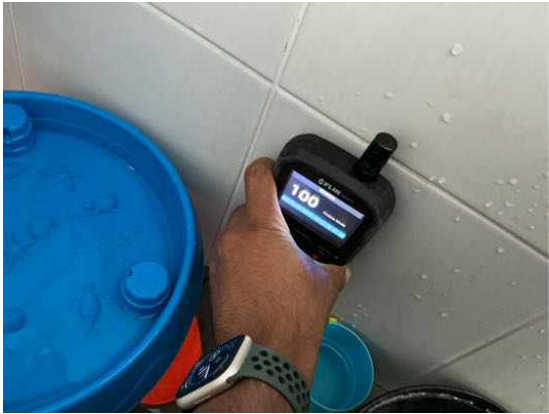
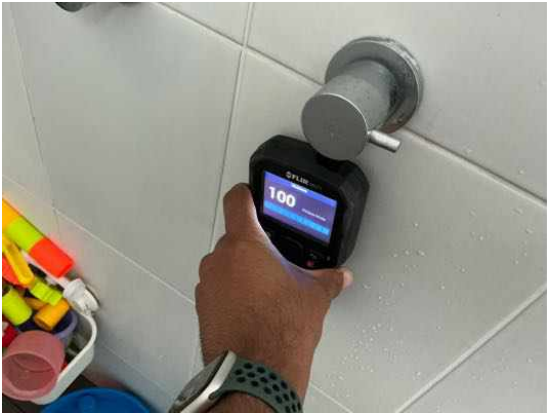
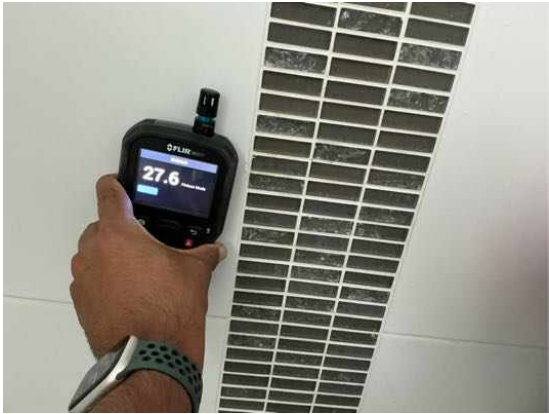
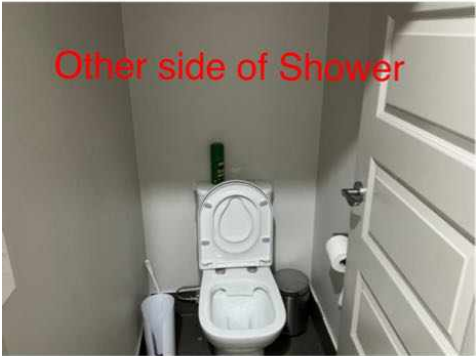
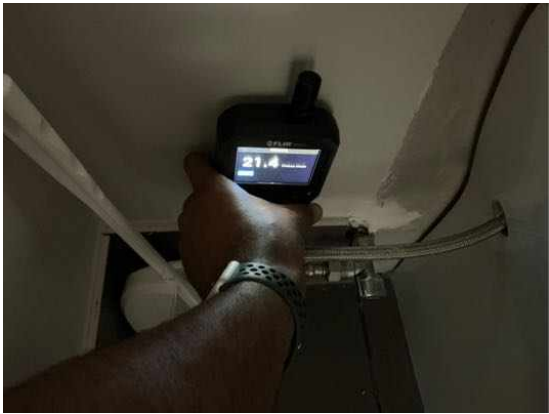
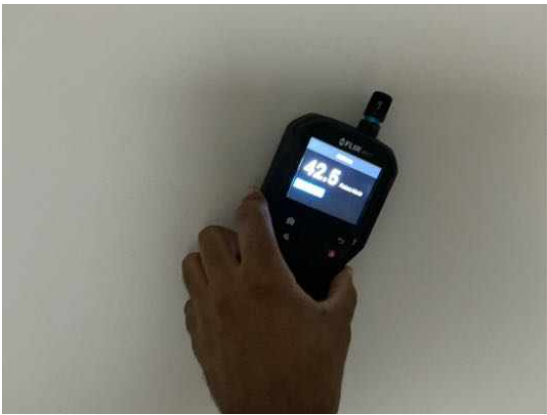
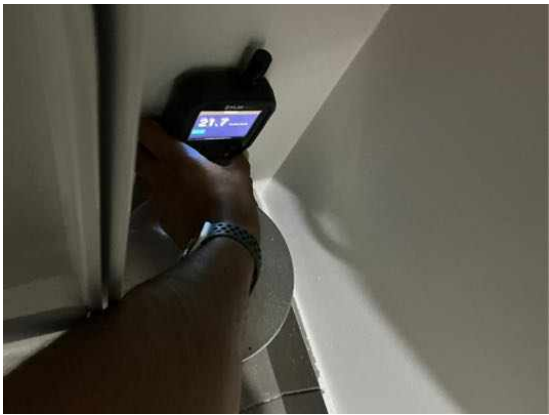
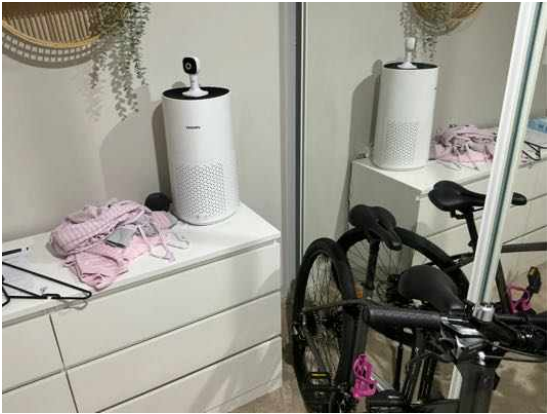
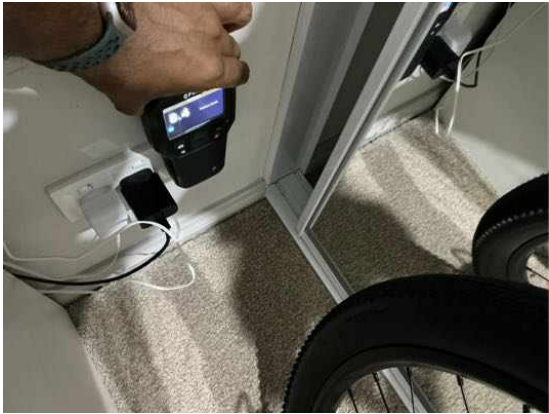
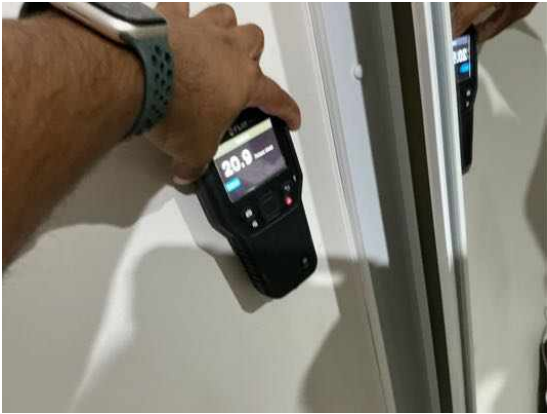
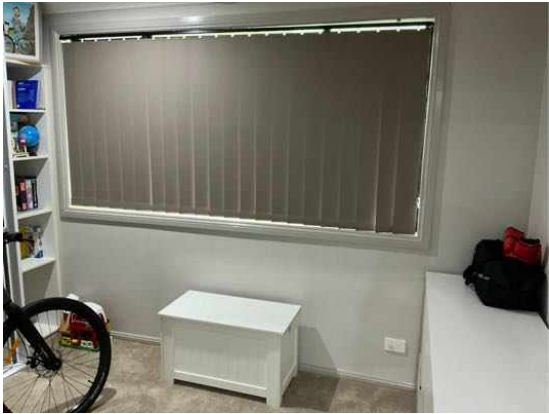
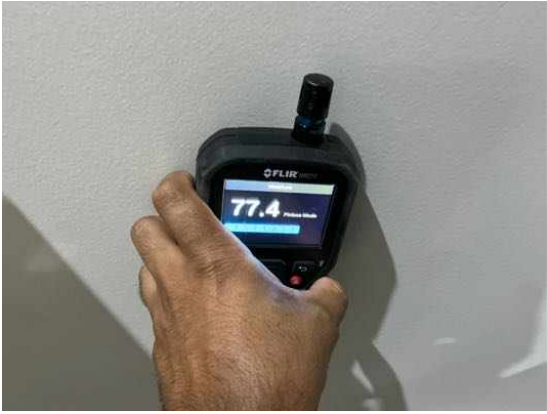
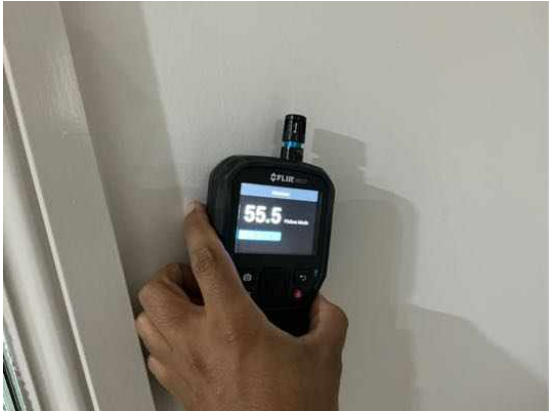
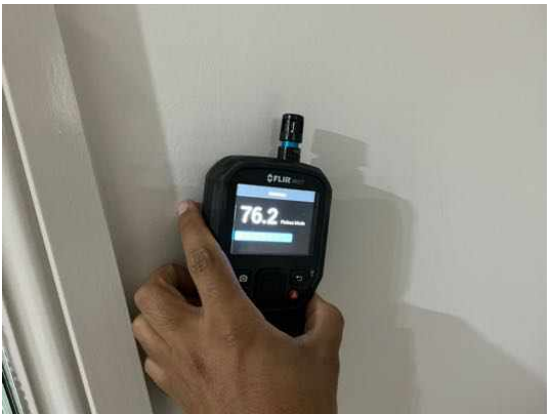
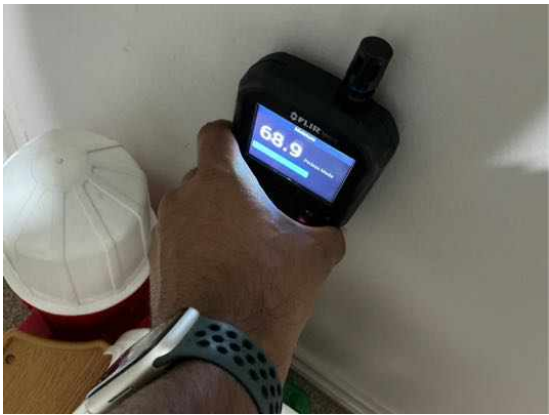
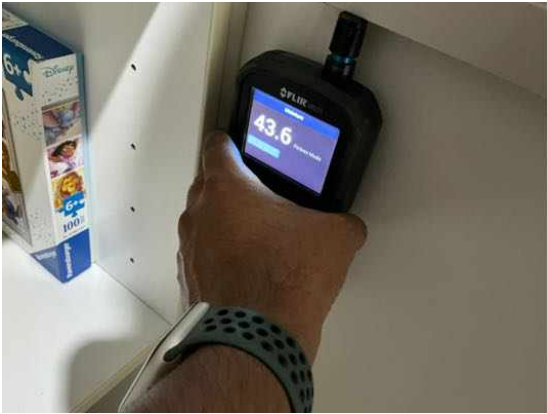
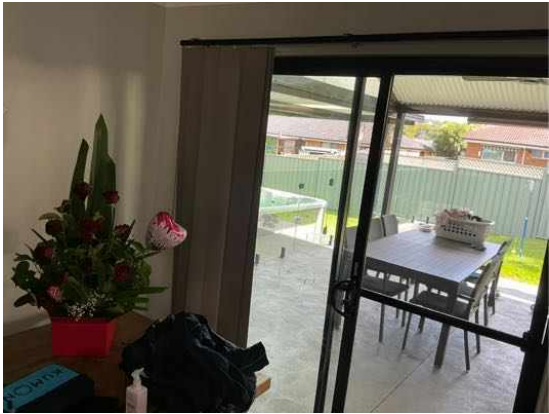
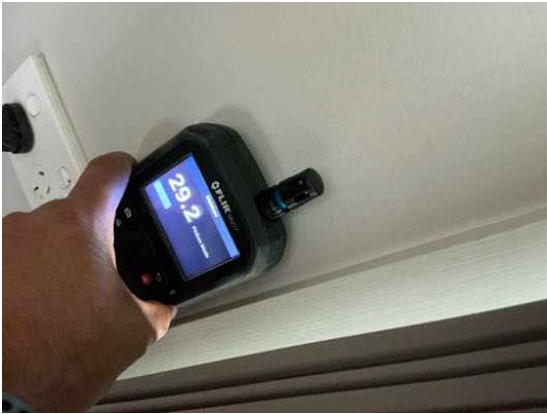
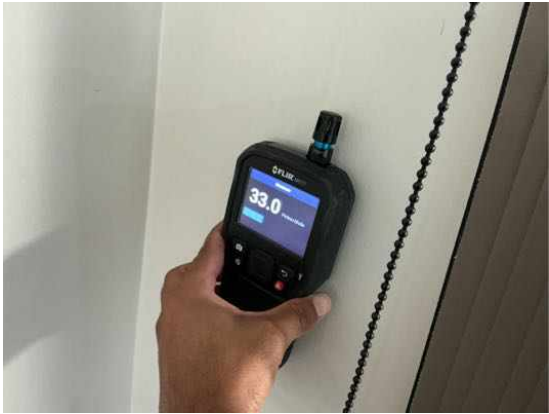
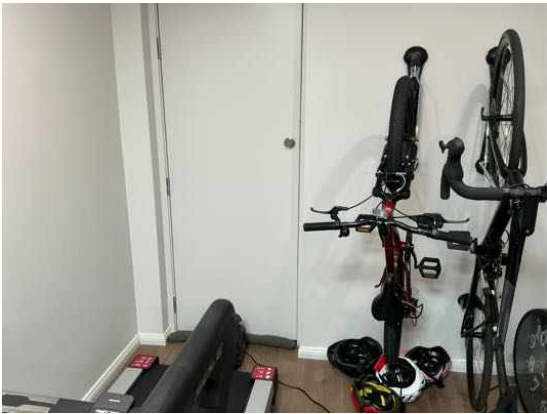
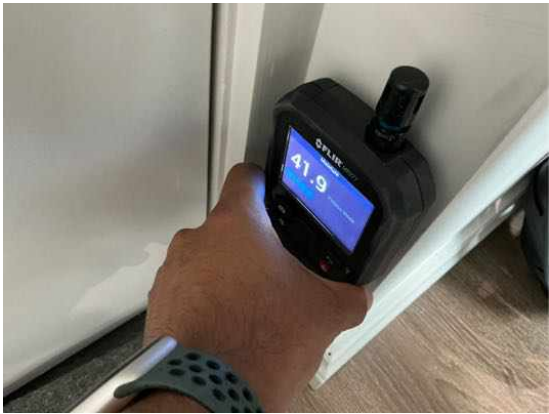
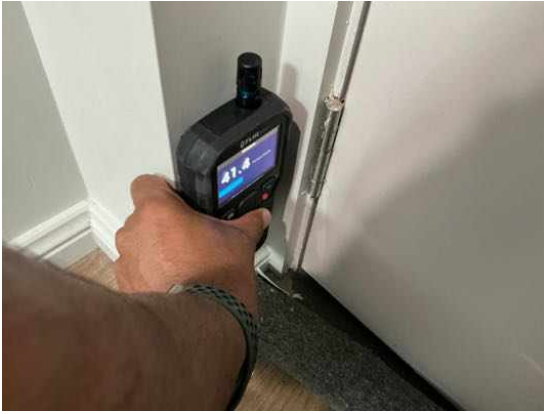
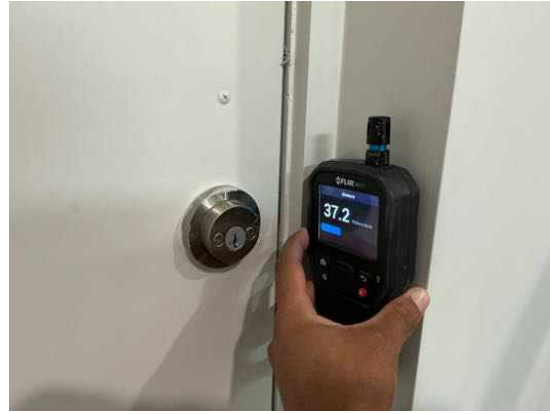
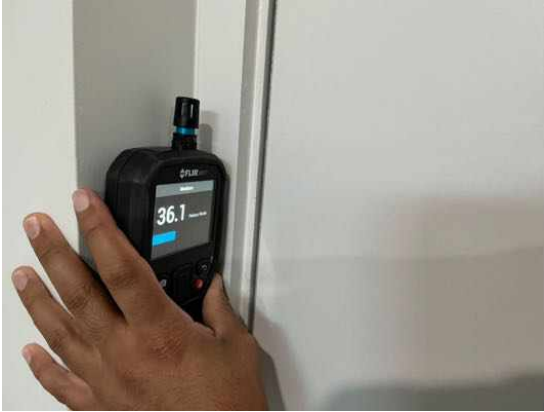
It is important for the client to understand that moisture levels can fluctuate over time due to various factors, including changes in weather, humidity, and environmental conditions. While the readings reflect the property's moisture levels during the inspection, they may not represent future conditions, and increased moisture could lead to issues such as dampness, mould growth, or deterioration of building materials if left unmonitored.

For further clarification or additional information regarding the moisture readings, the client is encouraged to contact the building inspector directly. Regular monitoring of moisture-prone areas is recommended to ensure any emerging concerns are addressed promptly, particularly during wetter seasons or in high-humidity conditions.

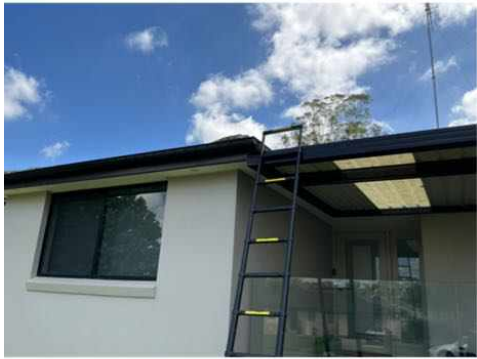
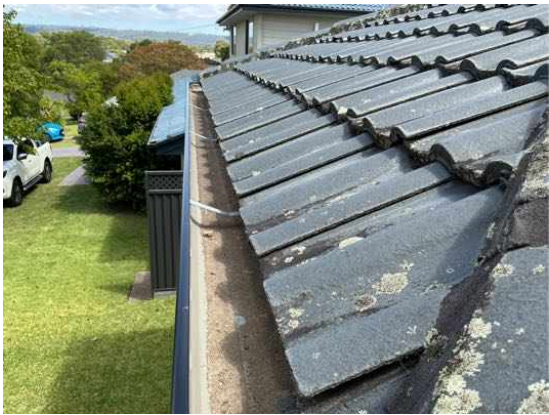
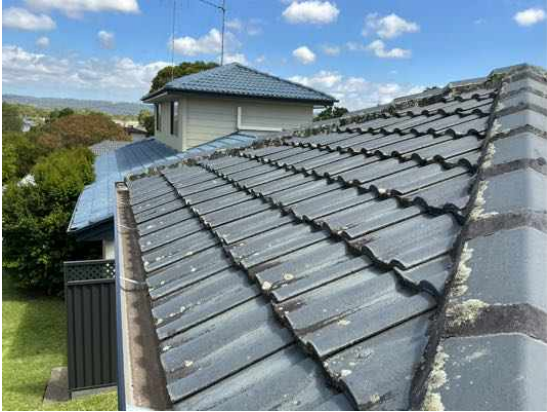
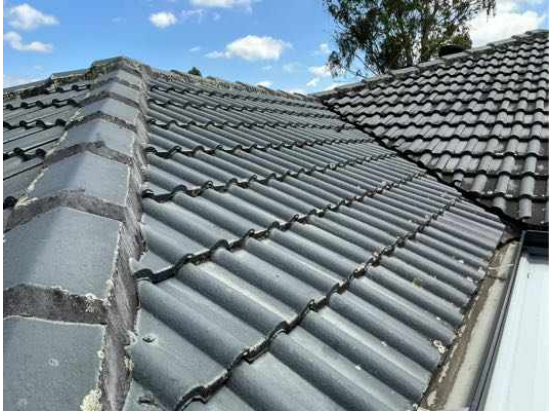
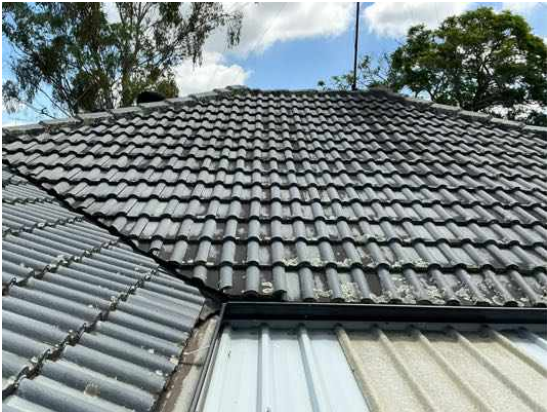
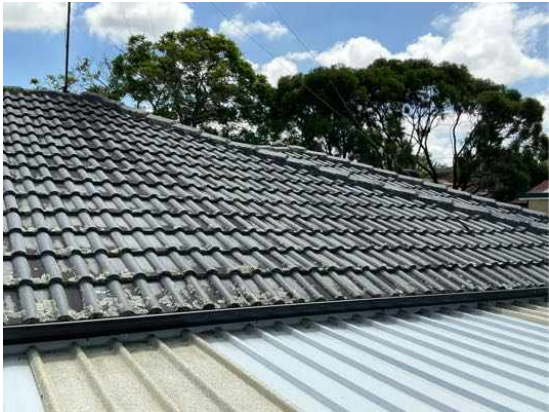
Building:	Main Building
Location:	Roof Exterior
Finding:	Additional Roof Photos
Information:	As part of the information provided, please note that the attached roof photos represent the condition of the roof at the time of inspection. These photos are for visual reference only and do not constitute a detailed roofing assessment. Any defects or issues identified with the roof are mentioned separately in the defect statements. It is strongly recommended that the client engage a qualified roofer to conduct a thorough inspection of the roof, ensuring that any potential issues, such as leaks, structural integrity, or wear and tear, are properly identified and addressed.

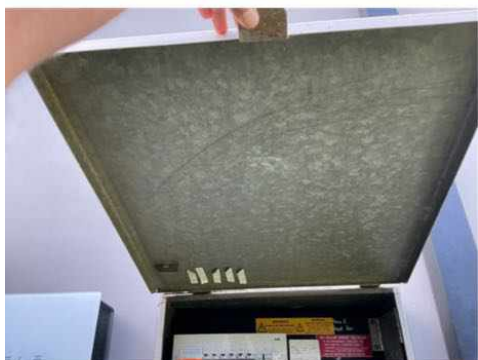
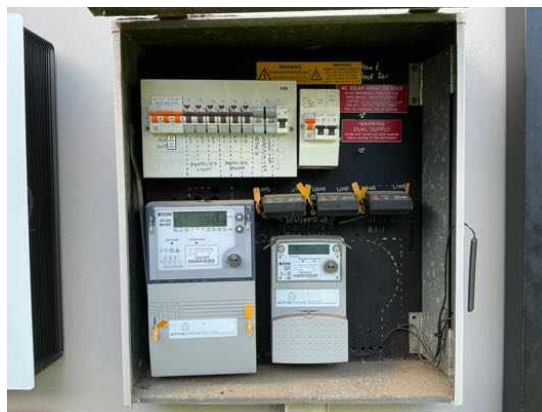
Finding: Termite Management Recommendation – No Evidence of Chemical Installation

In accordance with standard requirements, a durable notice should be located within the electrical switchboard to detail any termite protection systems applied, including chemical treatments. No such notice was observed during the inspection.

It is recommended that the client engage a licensed pest controller to assess the suitability of installing a chemical barrier, and to provide advice on associated costs and procedures. This should be considered a short-term priority, particularly if the property has any history of termite activity or is located in a high-risk area.

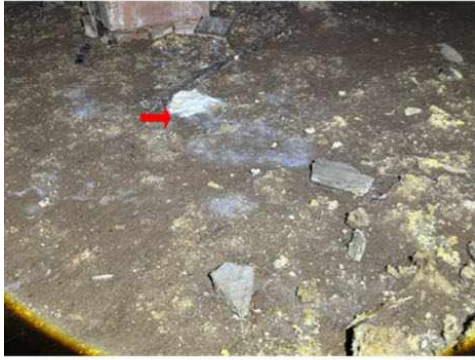
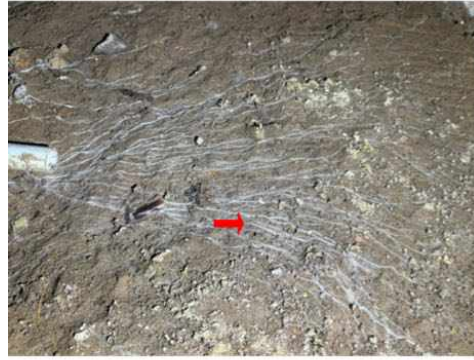
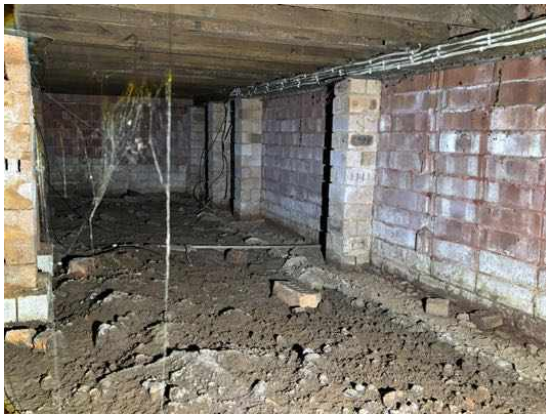
Building:	Main Building
Location:	All Areas
Finding:	Suspected Mould - Present
Information:	Where evidence of suspected mould growth was identified during the inspection, there may be associated environmental, biological, or health concerns. In cases where the suspected mould is extensive or where questions regarding air quality, spores, or other related issues arise, it is recommended to engage a suitably qualified mould inspector. The inspector can take samples of the suspected mould, send them to a laboratory for analysis, and confirm whether it is mould and its type, allowing for a more accurate assessment and appropriate remediation.

To prevent further mould growth, the client is advised to maintain a dry and well-ventilated environment by addressing moisture and humidity levels within the property. Any suspected mould observed during the inspection should be cleaned promptly by the homeowner or a professional cleaning contractor, depending on the extent of the growth.

For building elements severely affected by suspected mould and beyond repair, replacement by a registered builder or qualified carpenter may be required to ensure the structural integrity of the property. Timely action is essential to mitigate potential health risks and prevent further deterioration.

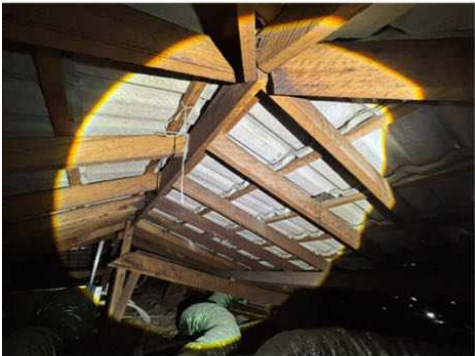
Building:	Main Building
Location:	All Areas
Finding:	Sarking - Missing
Information:	Sarking is missing under the roof sheeting. Sarking acts as an insulator that helps with noise reduction and protects against water penetration. Sarking plays a key role in the operation and function of the overall roofing structure and its performance.

Although not a requirement at the time of construction, replacement of any missing building element is advisable (although this can be quite expensive to do after the time of construction). Where sarking is missing, regular inspections of the roof tiles for cracking and potential moisture penetration is required.

Sarking may be retrospectively fitted by a registered builder at the discretion of the client.
