Building and Timber Pest Inspection Report

Inspection Date: Wed, 4 Feb 2026

Property Address: 2/55 Durham St, Eaglemont VIC 3084,
Australia

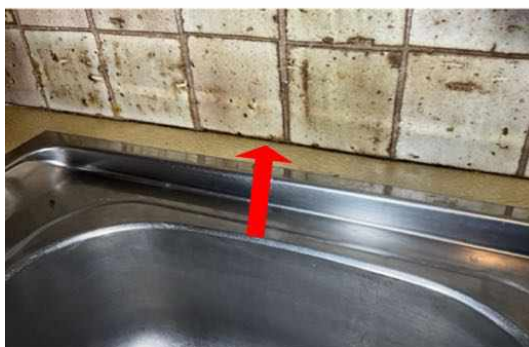
Finding: Sealant - Damaged or Missing

Information: Sealant is damaged in this area. Sealant is used to protect gaps and crevices in building materials to ensure that they are water-tight and prevent water penetration to the associated structures.

Failure to do so may lead to further deterioration of the sealant which in turn can lead to water damage to the surrounding area.

Where sealant is missing or damaged , a competent handyman may be appointed to scrape out and re-apply any silicone where necessary.

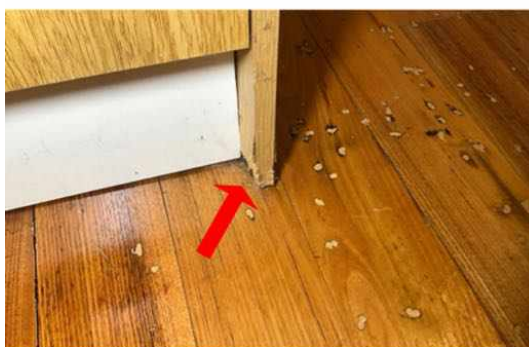
Finding: Slight damage to the kitchen cupboards

Information: Evidence of damage was identified to the kitchen cabinetry at the time of inspection .

It is suspected that this has occurred as a result of either excess moisture from internal spills or impact damage to the area.

A licenced carpenter or competent handyman should be engaged to inspect the damaged areas and repair or replace any items where necessary.

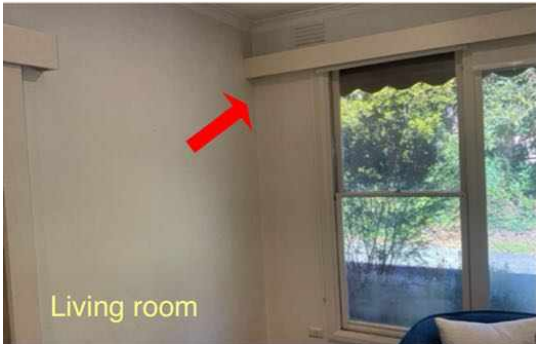
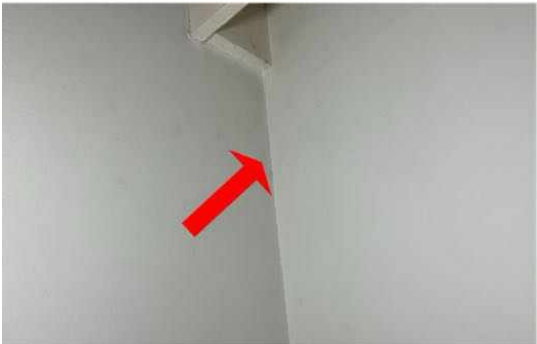
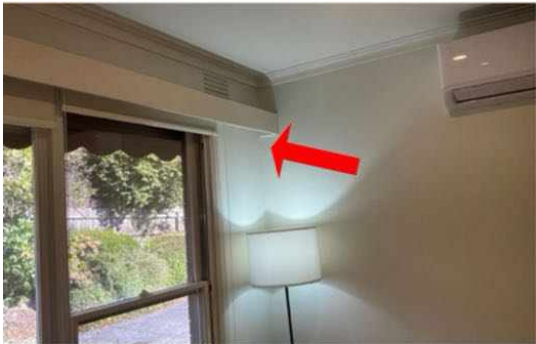
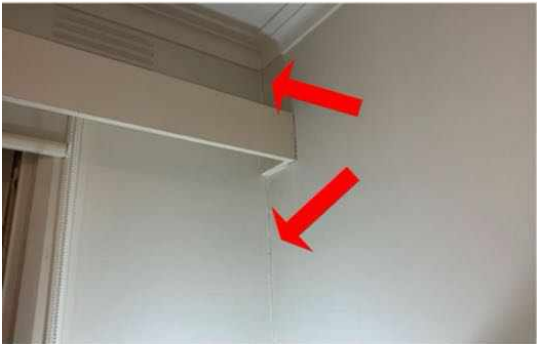
Finding 3.04

Building:	
Location:	All Areas
Finding:	Cracking - fine
Information:	Some fine cracking was noted throughout the property.

Although fine cracks are quite noticeable, they are often only considered to be an appearance defect, and usually do not indicate any structural damage. Generally, the cause of a fine crack is indicative of a separation between building materials and finishes (e.g. paint, plaster, etc.) along joints.

Note: photos included are indicative of fine cracking noted at the the time of

inspection. Other fine cracks may be present but not recorded here.

Cracking of this nature can generally be repaired with minor sanding, filling and/or repainting. Such works should be performed by a qualified painter or a general handyman.

Monitoring of all cracking should be conducted frequently. Always contact a building inspector should cracks widen, lengthen, or become more numerous.

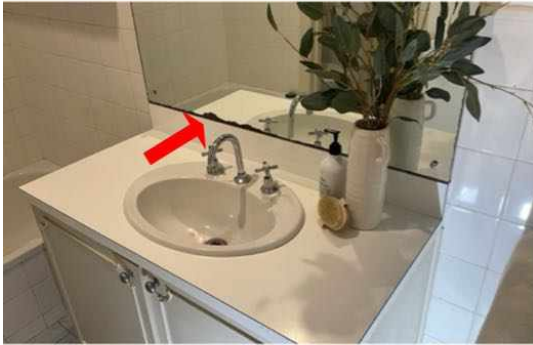
This usually happens when the reflective silver (or aluminium) backing starts to deteriorate, often from moisture, cleaning chemicals, or age.

This defect is more of a cosmetic defect.

The mirror should be monitored for any further deterioration and should that occur, the homeowner may replace the mirror at their discretion.

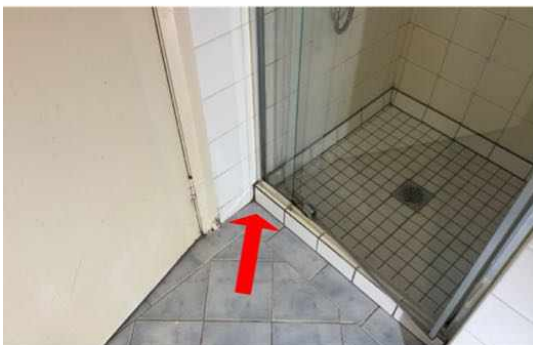
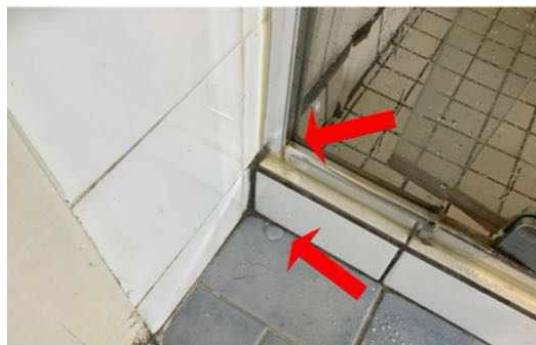
Finding: Shower screen seal - Leaking

Information: Leaking was evident to the shower screen at the time of inspection. It is suspected that the leaking has occurred as a result of the screen not being sealed correctly in this area.

Leaking from the shower, where left unattended, is likely to lead to water damage to adjoining flooring and walls. Such damage can lead to water damage and necessitate extensive remedial works being required. Active water leaks may also create an environment that is susceptible to the formation and development of mould.

Appointment of a tiling contractor or competent handyman is required to repair / replace the sealant. Such works should be performed immediately to ensure that no further damage occurs.

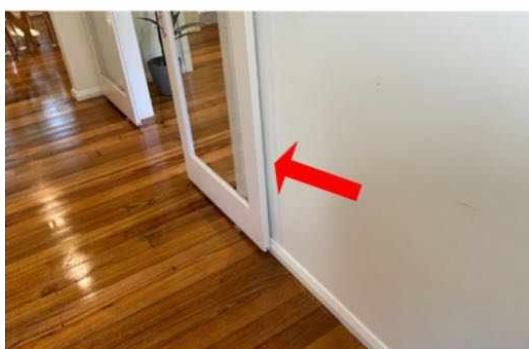
Information: The door in this area was stiff and difficult to slide along the associated tracks at the time of the inspection. The door also appeared to be slightly loose within the frame.

Restricted function of the affected door may pose as a potential safety hazard if required for emergency egress from the building.

Generally, factors such as age of the building element and a lack of maintenance are the usual causes for this type of defect.

Cleaning of the tracks may improve the operation of the door. Replacement of door hardware or tracks may be required should the cleaning not be effective.

A door specialist or competent handyman may be engaged to perform this task.

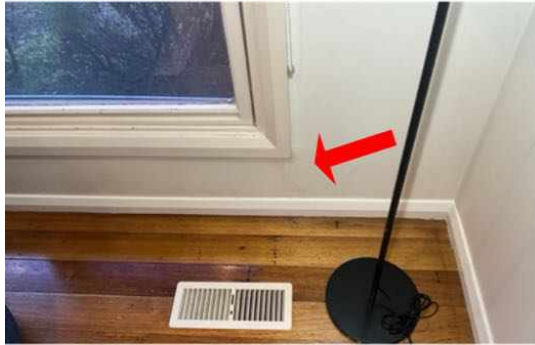
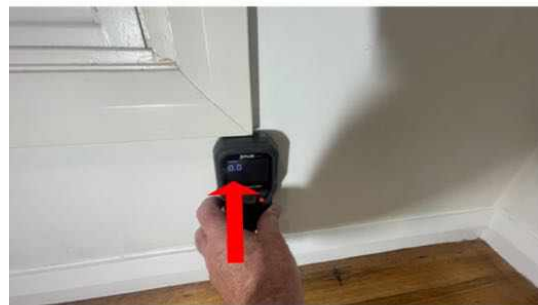
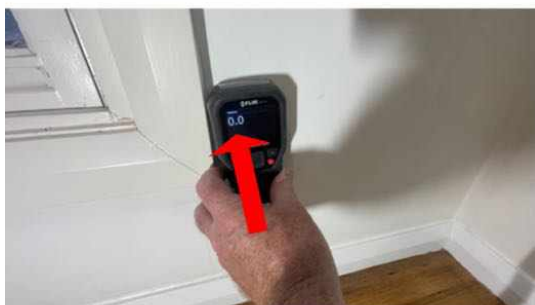
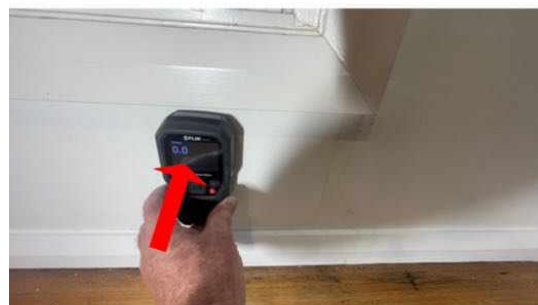
Finding: Wall stained - no current moisture noted

Information: At the time of inspection, there appeared to be some suspected moisture staining to the wall in this area. It is suspected the staining may be the result of moisture coming in around the window or window frame in this area. No current moisture was noted to the wall when tested with a moisture meter.

It is recommended that the area be monitored for any changes or increase in staining. Should this occur, consultation with a registered builder should be undertaken to determine the source of the leak and make necessary repairs.

Should no changes occur, the area may be repainted at the discretion of the homeowner.

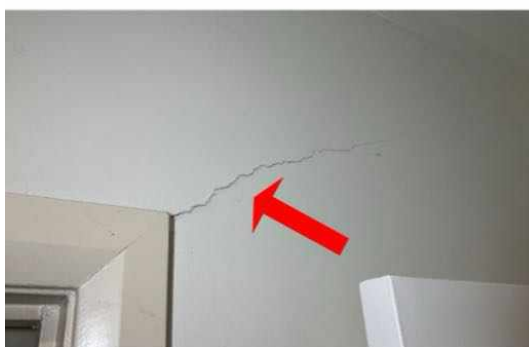
Finding 3.16

Building:
 Location: Laundry
 Finding: Cracking - Noticeable
 Information: Cracking was noted within the plasterboard wall in the laundry.

Monitoring of all cracking should be conducted frequently. Always contact a building inspector should cracks widen, lengthen, or become more numerous. Additionally, your building inspector should also be contacted if associated building elements such as doors and windows become more difficult to operate over time.

Relevant tradespeople, such as carpenters, painters and plasterers, should be appointed to perform remedial works, as deemed necessary.

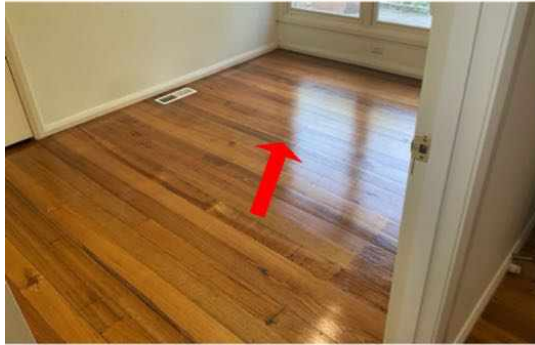
Finding 3.17

Building:	
Location:	All Areas
Finding:	Floor - creaking slightly
Information:	The internal flooring in this area was creaking slightly when walked upon at the time of inspection.

Creaking floors generally indicate that the fixings for the flooring may be coming loose slightly.

The area should be monitored for any changes or unevenness. Should this occur, consultation with a registered builder should be undertaken to determine the cause. The potential resolution may involve regluing and screwing the floor down through to replacement of subfloor support structures.

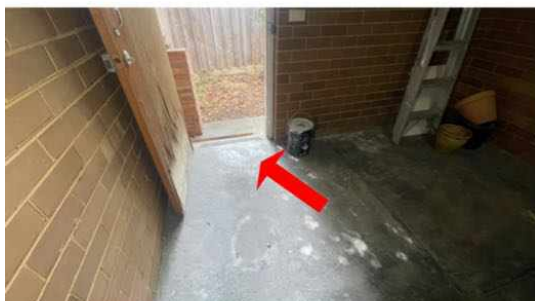
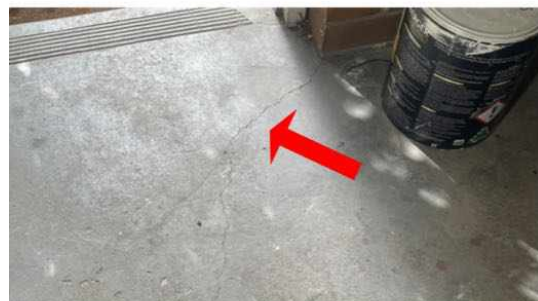
Fine cracks may also be due to poor original installation of the concrete. Factors such as poor compaction of the sub surface and/or inadequate reinforcing of the slab may create cracking and other secondary defects.

Monitoring of all cracking should be conducted frequently. Always contact a building inspector should cracks widen, lengthen, or become more numerous.

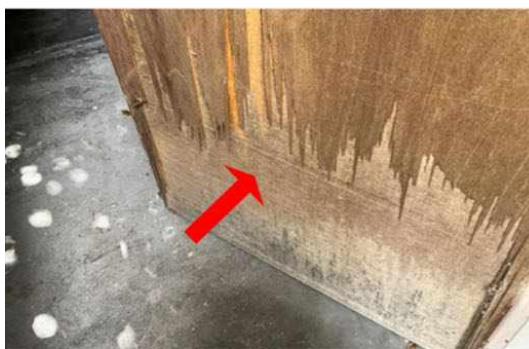
Building:	
Location:	Garage
Finding:	Door showing signs of damage to the base
Information:	At the time of inspection the rear garage door showed evidence of moisture damage. It is suspected this has occurred due to a lack of upkeep on the external door.

Doors should be sealed on all faces including top and bottom to prevent moisture seeping into the door structure and potentially causing secondary damage.

A suitably qualified handyman or painter should be engaged to remove door, repair any damage, paint the door including top and bottom and rehang them.

If the door cannot be repaired, a new door may be required.

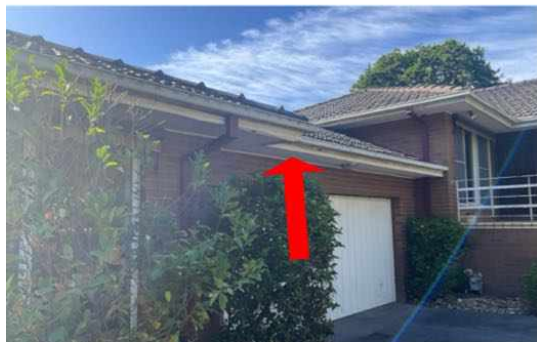
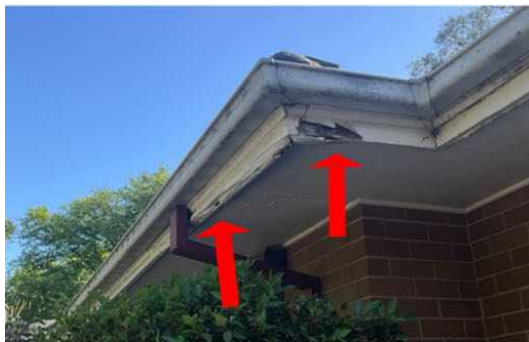
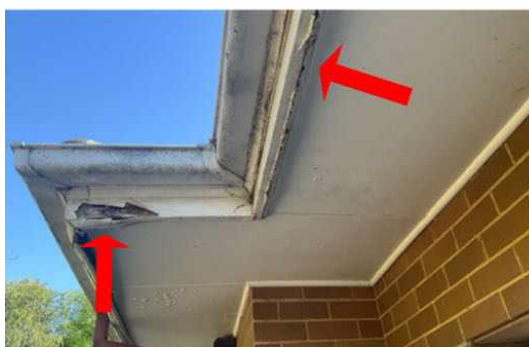
Finding 3.21

Finding: Fascia - Wood rot noted

Information: Wood rot was found to be affecting the fascia in this area. Wood rot, also known as Fungal Decay, occurs when timbers and other cellulose building materials are exposed to damp conditions on an ongoing basis.

It is likely that this wood rot has developed as a result of faults in the roof cover or plumbing, creating excessive moisture in this areas. Frequent exposure to rain and other weather conditions also make fascias and barges susceptible to accelerated deterioration.

Early intervention and regular maintenance will prolong the useful life of these building elements. Prior to any works being performed, the cause of the moisture that has created the visible wood rot should be identified and addressed in a suitable manner.

It is advised that a roof plumber be appointed to inspect all roof plumbing and subsequently identify the cause of the wood rot. Replacement of affected fascias and barges may then be a necessary step in protecting surrounding building elements from such deterioration.

A qualified carpenter or registered builder will then be required to replace affected building materials.

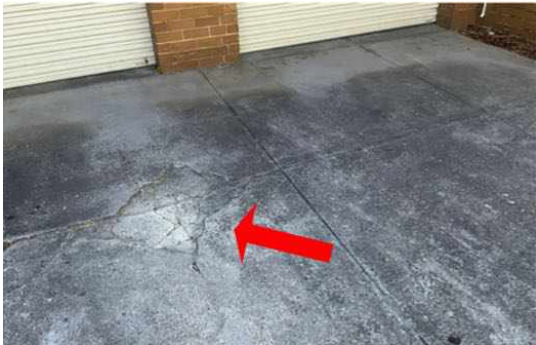
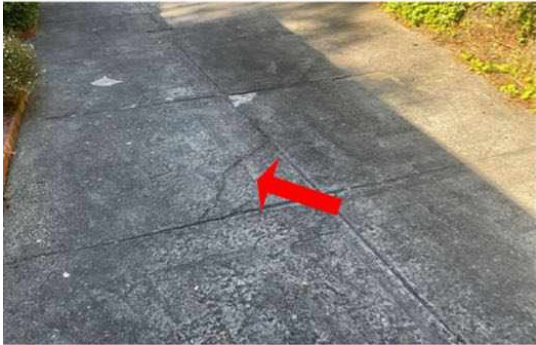
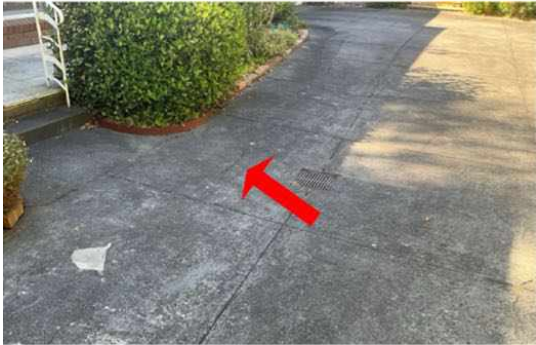
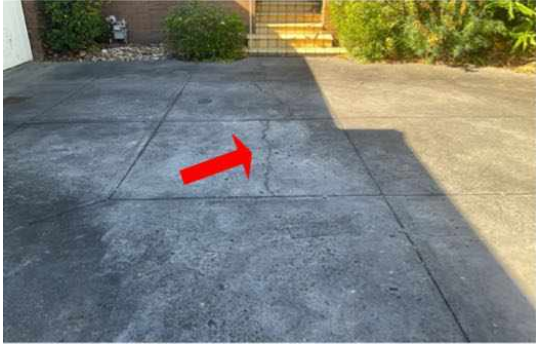
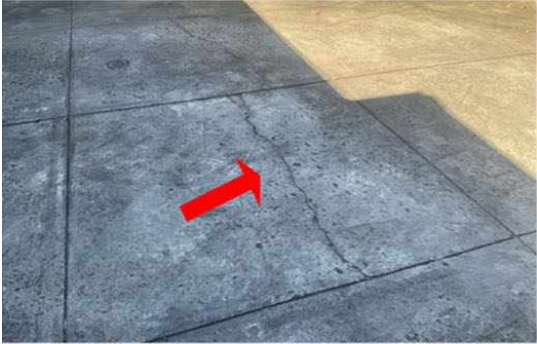
Finding 3.22

Building:	
Location:	Driveway
Finding:	Noticeable Cracking - Concrete driveway (suspected owners corporation responsibility)
Information:	Noticeable cracks were identified in the concrete driveway.

General age and expected deterioration of the concreted areas is a common cause of this type of cracking. However, expansion and contraction of the driveway may also have occurred due to environmental factors. Such factors include variable moisture and weather conditions, the presence of trees and their roots having a settling or lifting affect on the soil, or the effect of load bearing, e.g. heavy vehicles over a sustained period of time.

Cracking to this degree may also be due to poor original installation of the driveway. Factors such as poor compaction of the sub surface and/or inadequate reinforcing of the slab may create cracking and other secondary defects. Noticeable cracks may also be due to subsidence of soils.

The area should be monitored for any changes that may occur and potentially cause tripping hazards. Should this occur, repair and likely replacement of the concrete section may be necessary.

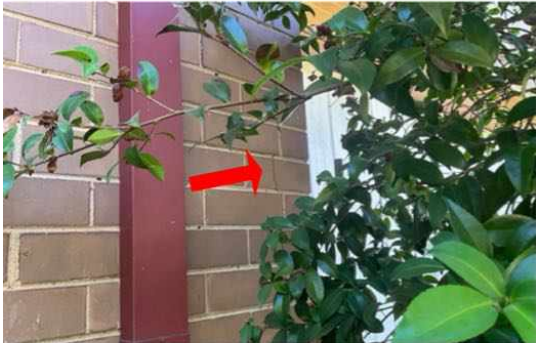
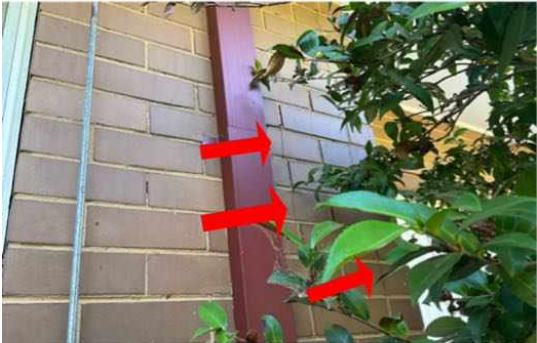
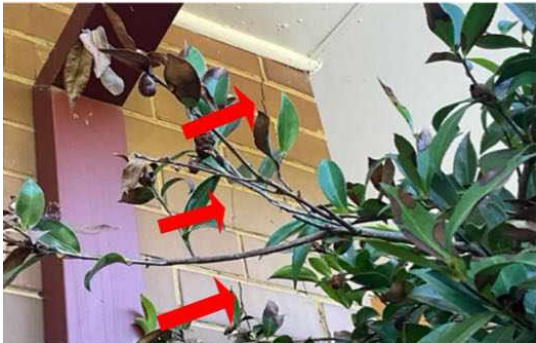
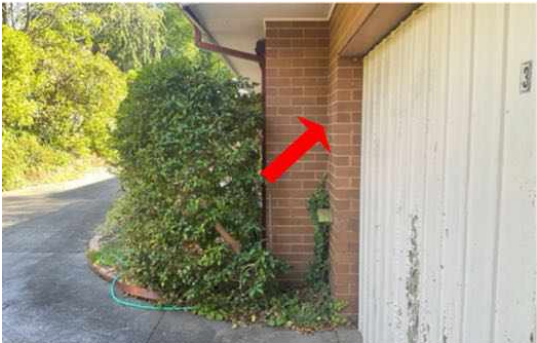
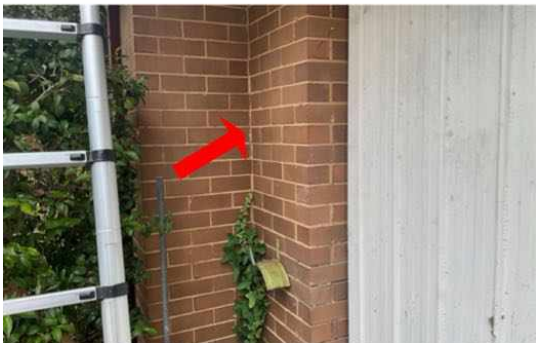
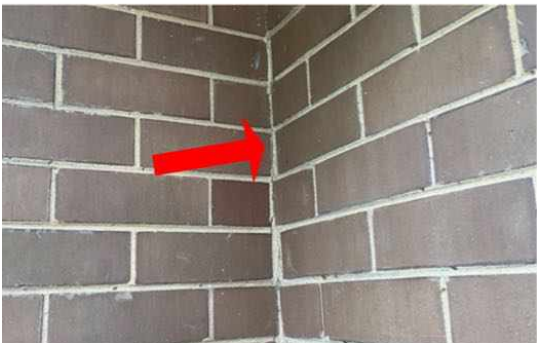
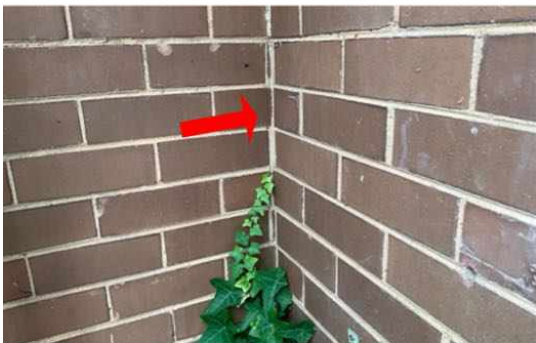
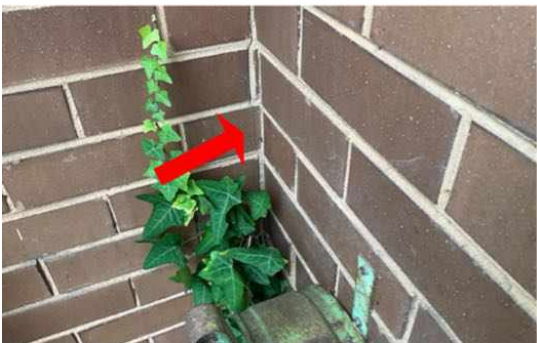
Finding 3.23

Building:
Location: Exterior walls - front
Finding: Brickwork - noticeable cracking
Information: Noticeable cracking to the brickwork at the front of the property was observed at the time of inspection.

Noticeable cracks are a common occurrence in external brickwork and are a likely result of age, expected movement, general expansion, and/or contraction of building materials in different weather conditions. Noticeable cracks in brickwork may develop if left unattended, with potential for necessitating major remedial works or replacement of the brickwork.

It is highly advised that monitoring of these cracks be carried out to ensure no further cracking occurs in the area. Should no further movement occur, the brickwork may be patched by a competent bricklayer.

Always contact a building inspector should cracks widen, lengthen, or become more numerous.

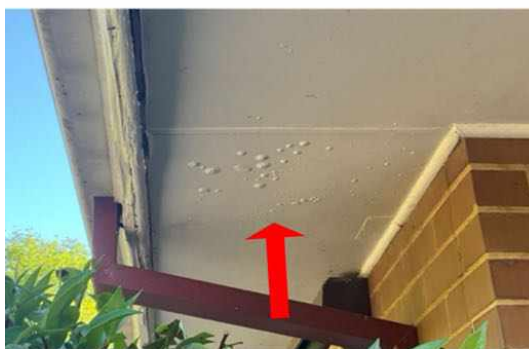
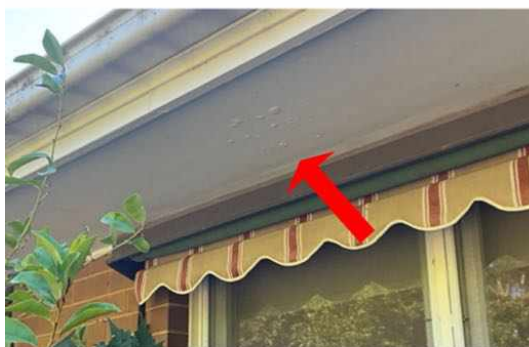
Finding 3.24

Building:
Location: Eaves
Finding: Eaves - bubbling to painted surfaces
Information: At the time of inspection, bubbling of the painted surface was noted to the eaves in various areas of the property. It is suspected that the bubbling has been caused by a failure in the guttering or roofing system above, creating excessive moisture within the area.

Please note: given the age of the property there is a high chance that the eave sheets may contain asbestos material. It is recommended that prior to any works being carried out on the eaves, an asbestos inspection and sampling be carried out to determine whether this is the case. Your Jim's building consultant can help you with this.

Please note: As the eaves form part of the exterior structure of the building, this defect may be covered by the owners corporation. Your own enquiries should be made to determine whether this is the case.

Where bubbling is evident, the primary requirement is to identify and rectify the source of the leaking. Where the damage is still active a roofing plumber should be appointed immediately to identify the leak and perform rectification works as necessary, ensuring the moisture damage is restricted.

Once the leak is repaired, consultation with relevant tradespeople, including painters is advised. Rectification works may include replacement of eave lining or minor repainting, depending on the extent of the damage.

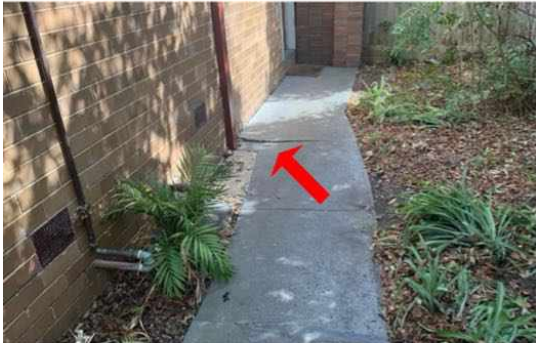
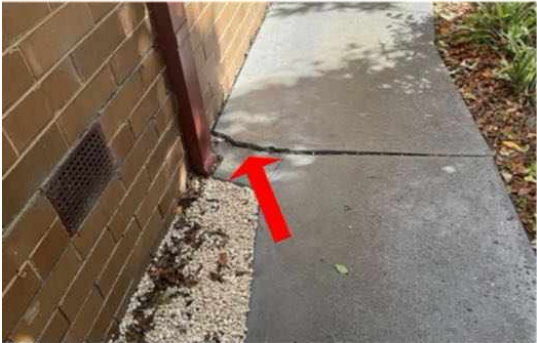
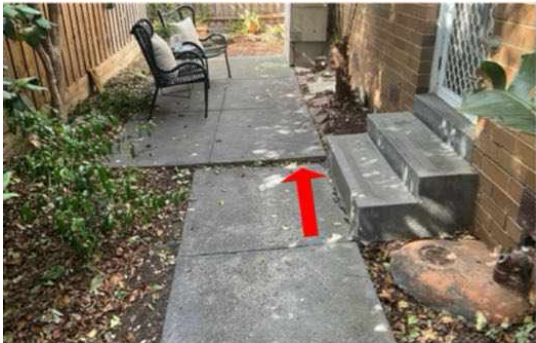
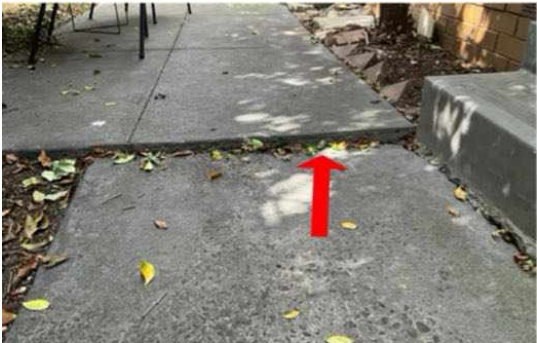
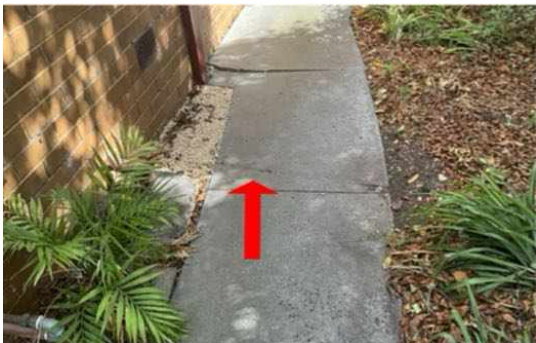
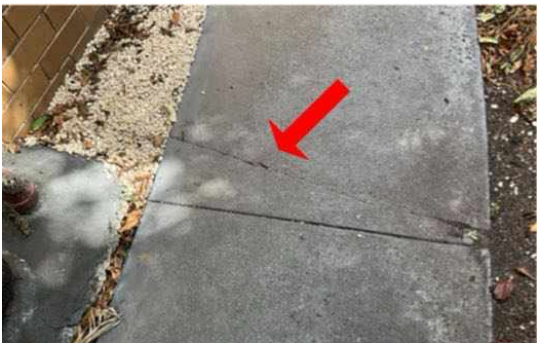
Finding 3.25

Finding: Distinct Cracking and subsidence to concrete paving

Information: Distinct cracking and some subsidence was identified to the concrete paving in this area.

Distinct cracks and subsidence are generally found in older paving, and may also present as a trip hazard as consequence of an uneven or curved surface.

General age and expected deterioration of the paved areas is a common cause of this type of defect. However, damage may also have occurred due to environmental factors. Such factors include variable moisture and weather conditions, the presence of trees and their roots having a settling or lifting affect on the soil, or the effect of load bearing over a sustained period of time.

Damage to this degree may also be due to poor original installation of the pavers . Factors such as poor compaction of the sub surface may create cracking, subsidence and other secondary defects.

Repairs and/or replacement will be to be required to prevent further damage and to reduce hazards associated, such as tripping. A landscaper should be engaged to inspect the pavers and repair / rectify the subsided and cracked pavers.

Monitoring of the area should be conducted frequently.

Always contact a building inspector should cracks widen, lengthen, or become more numerous.

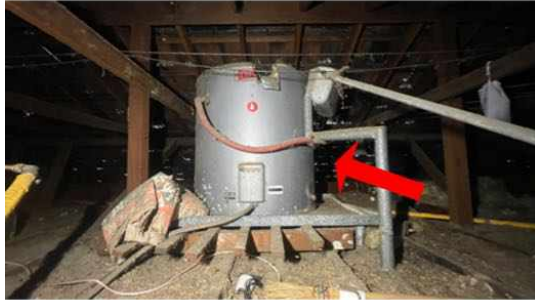
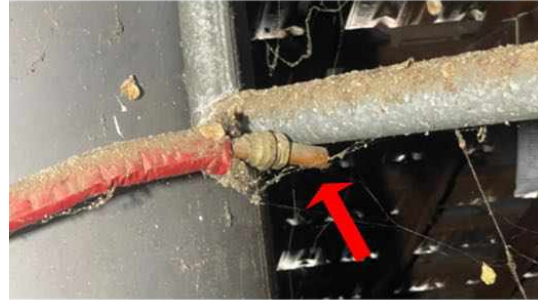
Finding 3.26

Building: Roof Void
Location: Gravity-Fed HWS - Disconnected
Finding: It was noted at the time of inspection that a disconnected gravity-fed hot water system (HWS) remains in this area.
Information:

Despite this plumbing structure being unused, it is likely to be storing residual water, and is therefore susceptible to rust and corrosion. If allowed to continue, rust and corrosion is likely to lead to damage to adjoining building elements, and may also make the area susceptible to termite or timber pest activity.

While it is a costly exercise to remove the disused gravity-fed HWS, it is advisable in the short-term future to prevent any possible damage to the area.

Further consultation with a licensed plumber is required to gain further advice on removal of the structure.

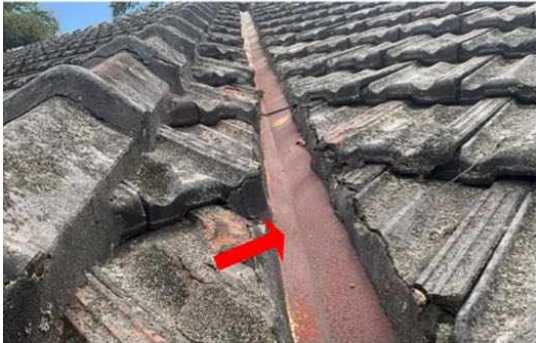
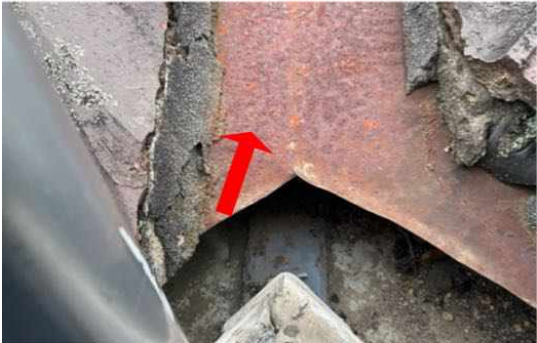
Finding 3.27

Finding: Roof valley - Rusted

Information: At the time of inspection it was noted that the valleys between the tiled roof structures have a coverage of surface rust.

If left unmanaged, this can lead to holes developing and potential water ingress to the internal roofing structures - leading to secondary damage of building elements. Accelerated deterioration of the valley channels and any associated building elements is also likely to occur.

A roofing contractor should be appointed to assess the damage and to perform remedial works as necessary. Works may include replacement of severely affected areas or minor works such as the application of rust-retardant surface protectors.

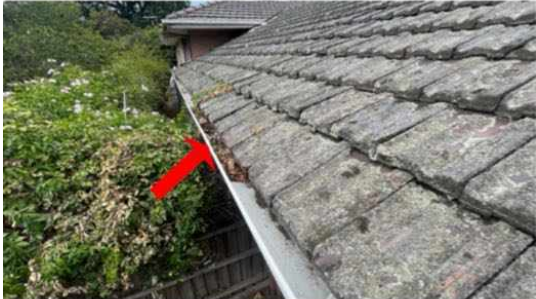
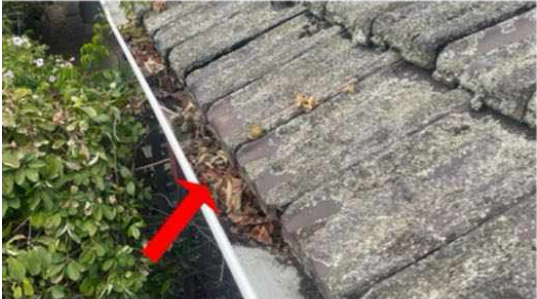
Finding 3.28

Building: Roof Exterior
Location: Gutters - require cleaning
Finding: At the time of inspection it was noted that the gutter in this area was full of leaves .

Blocked gutters are likely to lead to high levels of moisture in the affected areas. Such moisture will not only cause rust and decay of the associated building materials, but can also provide conditions that are conducive to termite and timber pest activity. Blockages in gutters should therefore be removed immediately to ensure dry conditions are maintained.

It is highly advised that blocked gutters be cleared by the homeowner or a general handyperson as a matter of urgency. Failure to do so may result in moisture entering the property causing more significant damage.

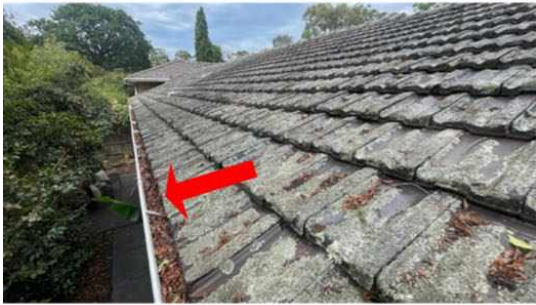
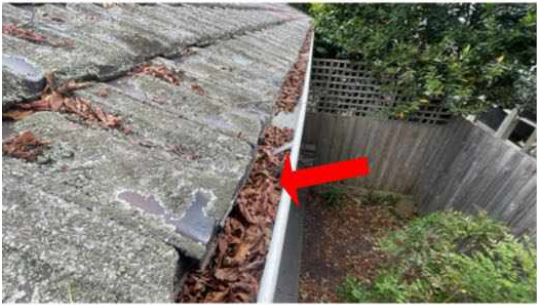
Finding 3.29

Finding: Weathered Roof tiles - fair condition but with some minor maintenance required

Information: Upon inspection of the exterior roofing, the majority of roof tiles were considered to be in a fair condition. While weathering of the tiles is consistent with the age of the property, some minor maintenance works are required.

Cracking of the mortar around the ridge and hip capping was noted. Tiles had shifted from their original positions allowing gaps underneath the tiles.

Repairs to the roof is required.

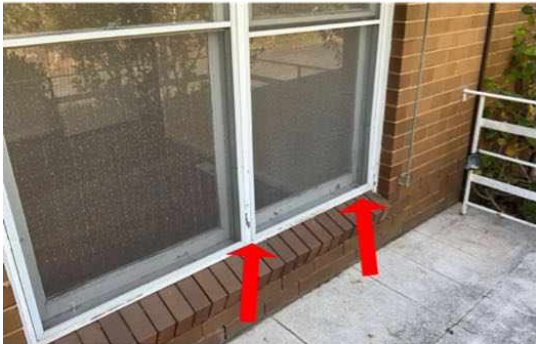
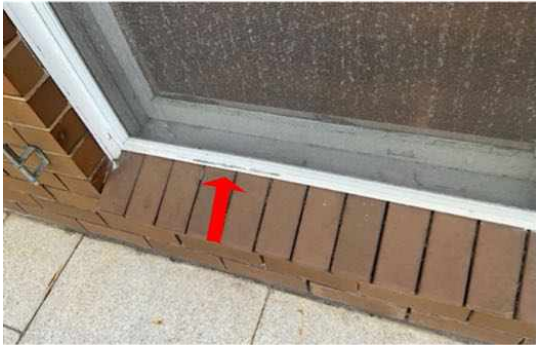
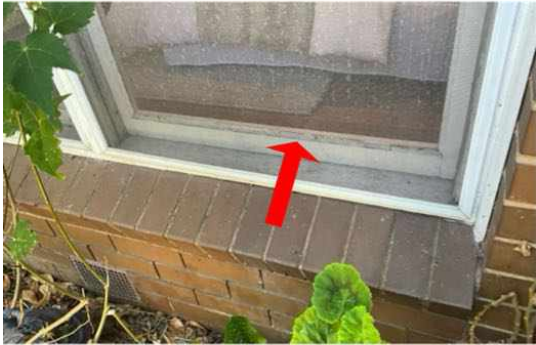
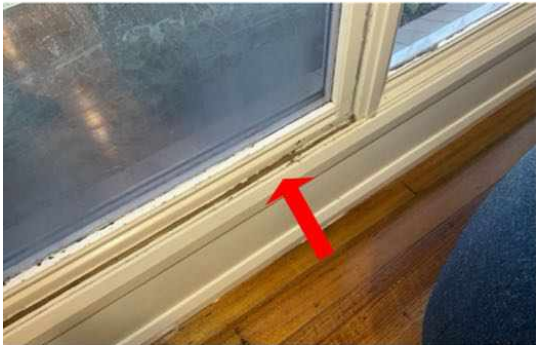
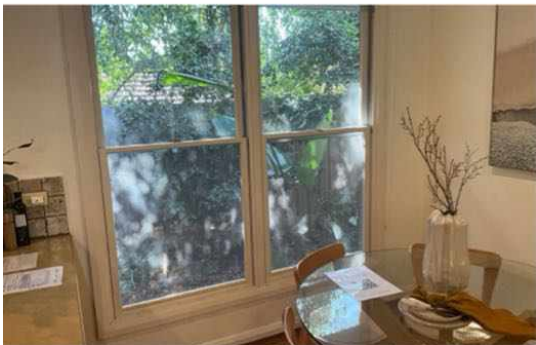
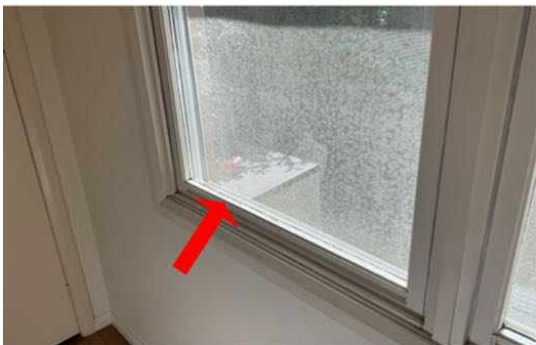
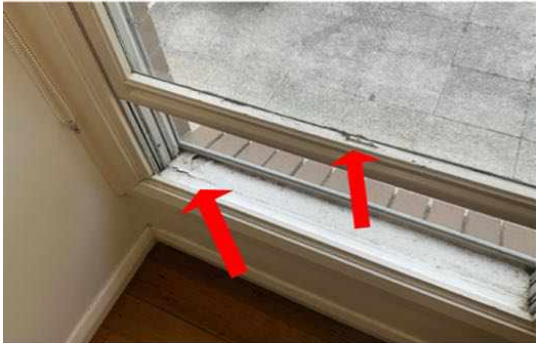
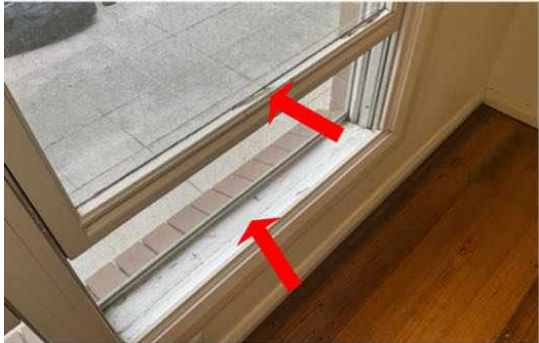
Finding 3.30

Building:
Location: All Areas
Finding: Timber - exposed to weather
Information: At the time of inspection, it was noted that several timbers around the property were weathered and require treatment .

Timbers that are frequently exposed to harsh weather conditions require adequate protection in order to maintain their condition. Where timbers have not been painted or treated adequately, general deterioration is likely to occur at an accelerated rate.

If left unattended, replacement of these timbers is likely to be necessary in the short-term future. Adequate treatment of these timbers is required as soon as possible by a painting contractor or general handyman.

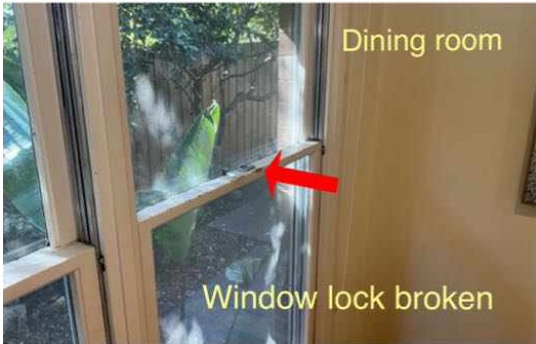
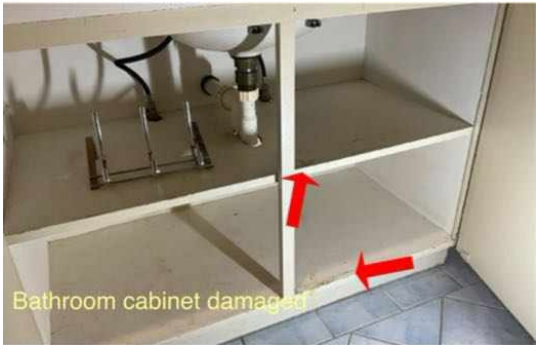
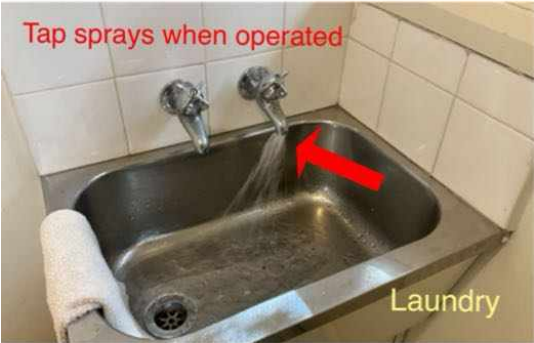
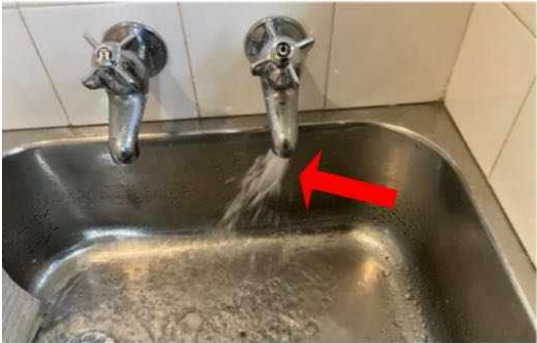
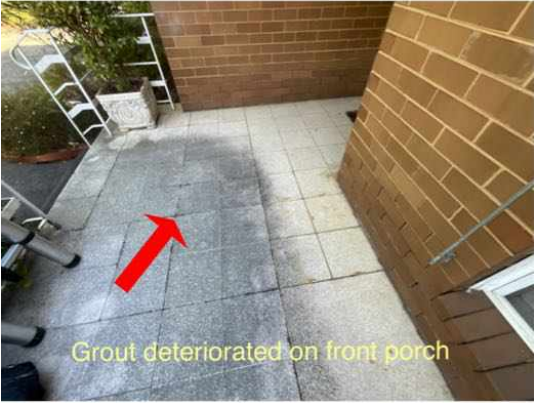
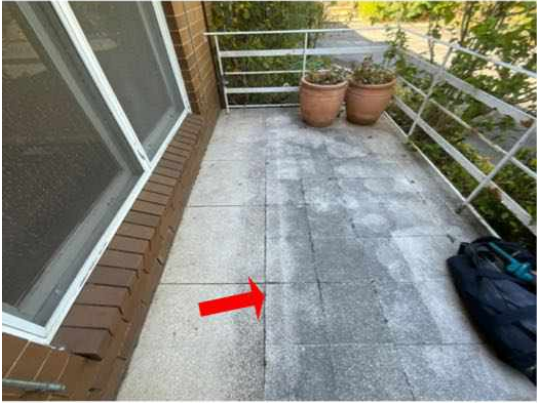
Finding 3.31

Building:
Location: All Areas
Finding: Additional Photos - minor defects
Information: Additional photos are provided for your general reference. Arrows have been included where necessary to highlight areas of importance.

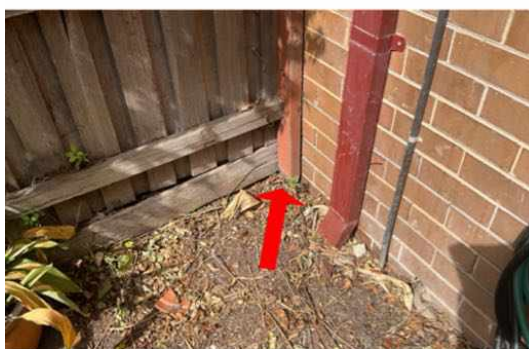
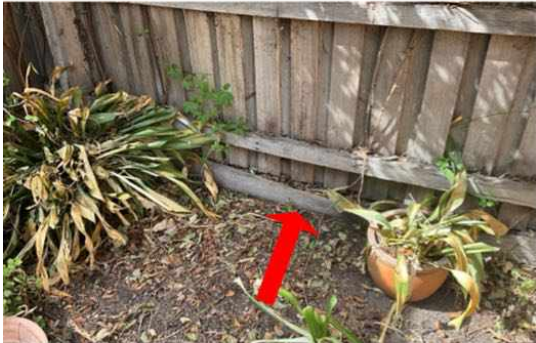
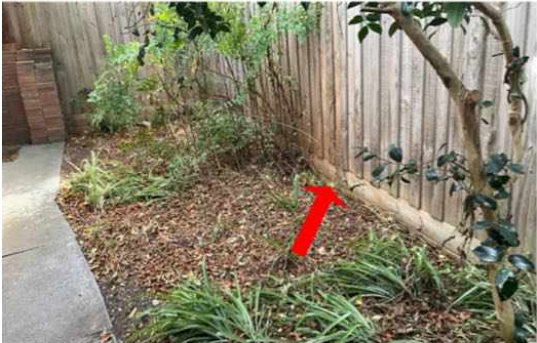
Information: Where timber elements are in direct contact with the ground and consequently moisture or dampness, they become conducive to termite activity. Whether timber is used as a building element, part of a fencing structure or stored as an unused item, they can provide an environment that is attractive to termite infestation.

When met with excessive moisture, timber begins to decay and develop wood rot. Any timbers that are in direct contact with external grounds especially if left untreated or non-durable also provide ingress for subterranean termites into that particular element.

Where possible, the removal of any such materials that may be conducive to termite activity should be carried out as soon as possible to minimise the risk of termite attack. Where not possible or practical, regular monitoring of timber elements is recommended. Replacement of any damaged materials should be carried out where necessary.

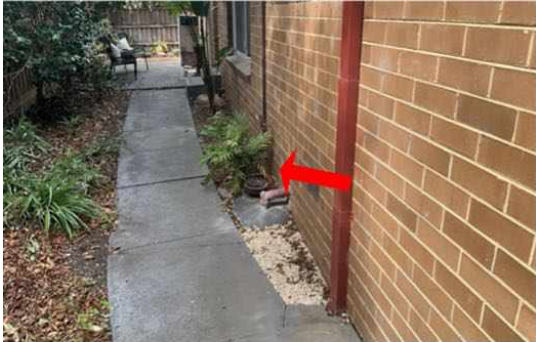
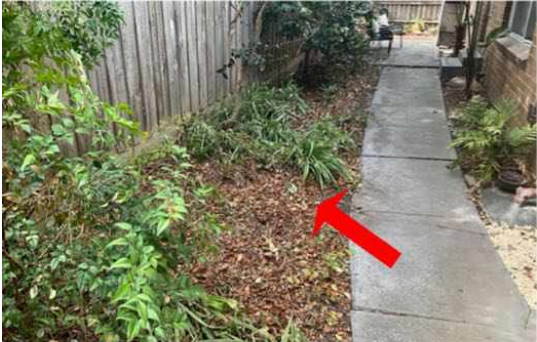
Finding 6.02

Building: All External Areas
Location: Garden Beds - Conditions Conducive to Termites
Finding: Garden beds were found to be evident around and against the property. These garden beds can include untreated timber, and with a combination of moisture from rainfall and hosing, can make conditions conducive to termite activity and termite ingress.
Information:

The removal and replanting of species that do not provide "cover" or cutting back of existing vegetation will assist greatly in preventing this from occurring.

The removal of any such materials that may be conducive to termite activity should be carried out as soon as possible to minimize the risk of potential termite attack.

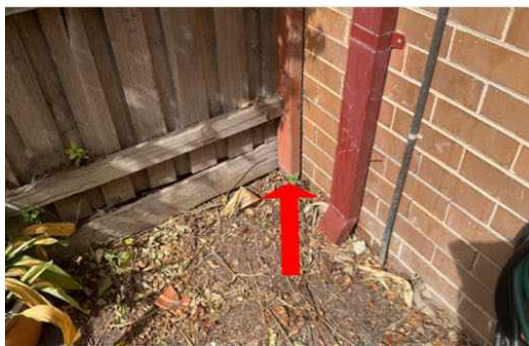
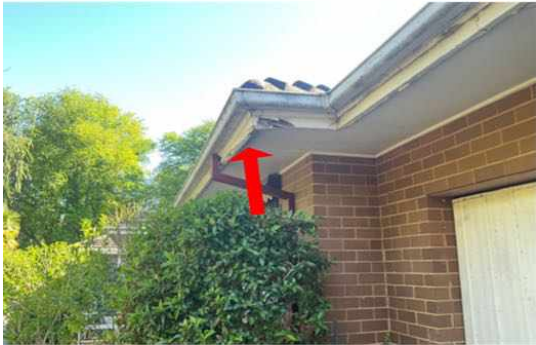
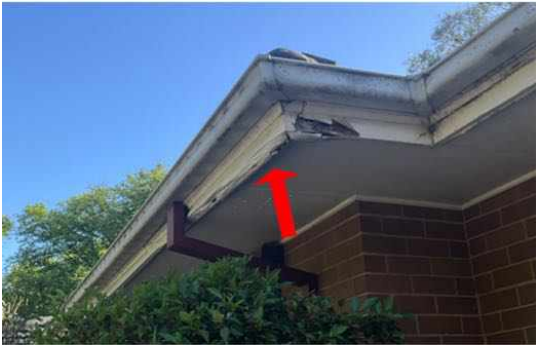
Finding 7.01

Finding: Fungal decay - conditions conducive to timber pest attack

Information: Fungal decay also known as wood decay or wood rot generally refers to the deterioration of timber elements when in contact with excessive levels of moisture for a prolonged period of time.

Generally fungal decay develops on timber elements that are in use in an external environment which are exposed to rain penetration.

There was some wood rot (fungal decay) noted to the fascia boards at the front of the property. It is suspected this has occurred due to failure of either the guttering or roof tiles. There was some cracking noted to the mortar around the ridge capping above this area. The damaged fascia boards will need to be replaced along with repairs to the roof tiles and capping.

Decaying timbers can create an environment conducive to timber pest attack. It is recommended that the decaying timbers be repaired / replaced to lessen the risk of timber pests.

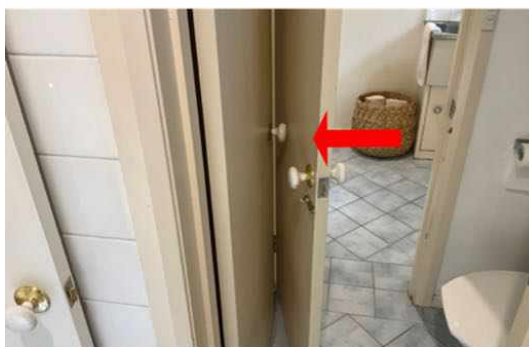
Building:
 Location: All Areas
 Finding: Additional Photos for your information - toilet and bathroom door hit each other
 Information: At the time of inspection, it was noted that the toilet and the bathroom door hit each other when they were both opened.

This item is more of a design feature issue and is listed for your information only.

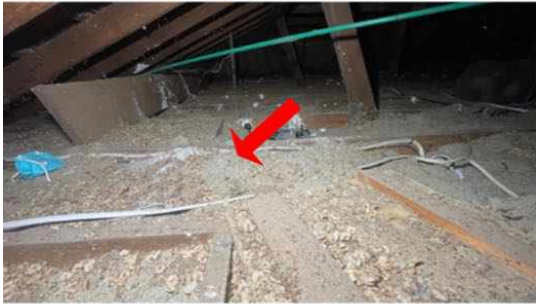
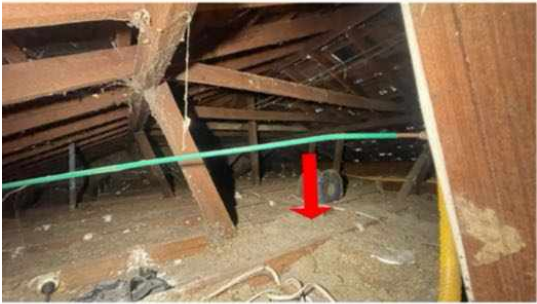
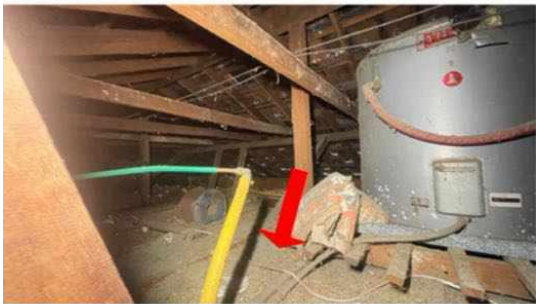
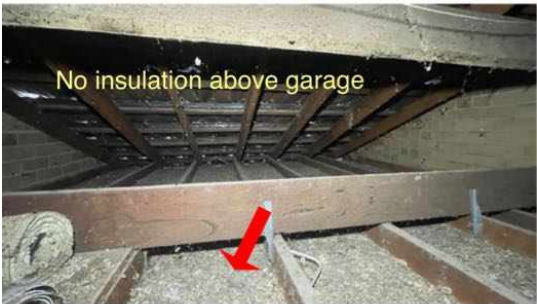
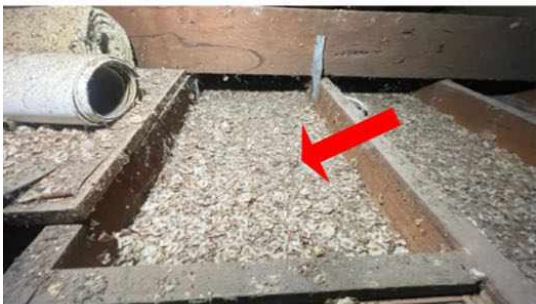
Building:
 Location: Roof Void
 Finding: Insulation - older style insulation
 Information: At the time of inspection, it was noted that the insulation within the roof void was the older insulation. Whilst there appeared to be a fairly decent coverage, this insulation has a tendency to settle and reduce in volume over time. This settling can reduce the effectiveness of the insulation.

Please note: the space above the garage does not have any insulation. This is very common and in fact garages are not required to have insulation installed.

It is recommended that the comfort levels within the property be monitored for any changes. New insulation may be required to improve the thermal efficiency of the house should the current insulation be shown to be an adequate.

An insulation contractor should be engaged to perform this task at the discretion of the homeowner.
