Building and Timber Pest Inspection Report

Inspection Date: Sat, 31 Jan 2026

Property Address: 11/9-11 Troy Street, Emu Plains NSW 2750

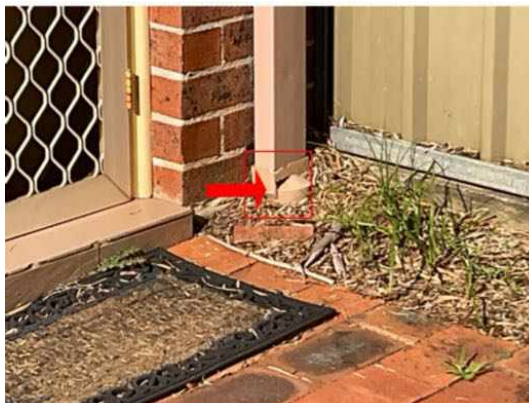
Building: Main Building
Location: Exterior walls - rear/left
Finding: Downpipe - Damaged connection
Information:

- The roof plumbing (downpipe connection) in this location has been damaged and is not fully sealed.

- Poorly sealed downpipes can result in:
 - Water pooling around the base of the building
 - Excessively damp conditions at the foundation or subfloor level
 - Increased risk of foundation movement, moisture ingress, or wood rot
- Water runoff may also be diverted to a neighbouring property, which is non-compliant with building codes and may create legal or council-related issues.

Recommendation:

- Rectification is strongly advised.
- A licensed plumber should be appointed to:
 - Inspect the area thoroughly
 - Assess the condition of the stormwater system
 - Repair, replace or properly connect all downpipes to ensure compliant and effective drainage

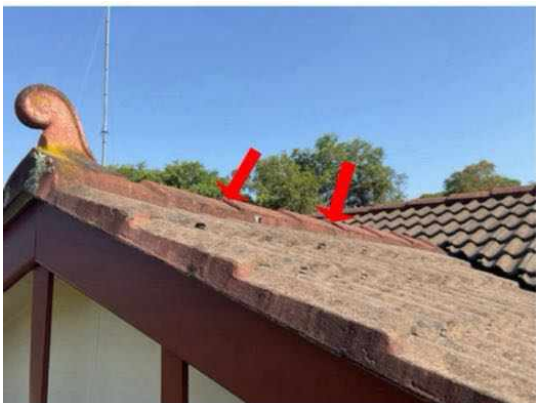
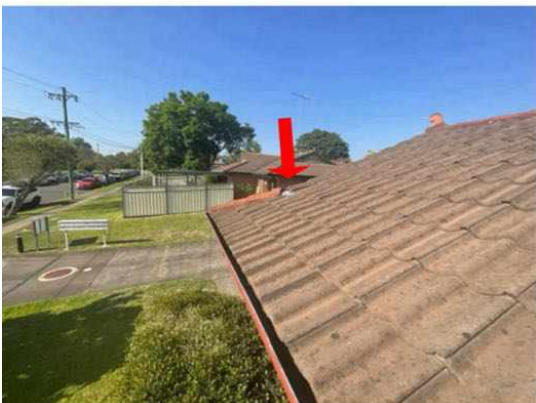
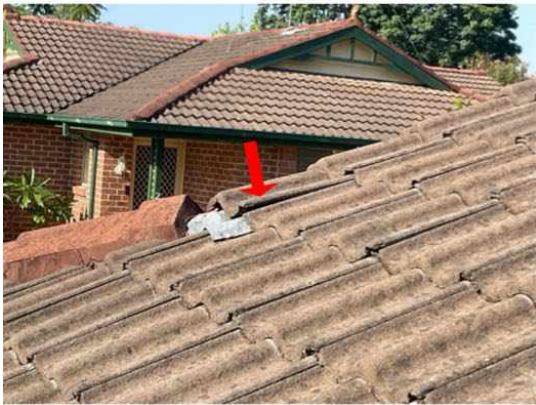
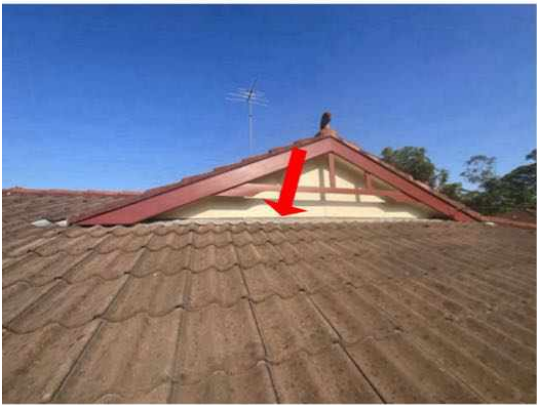
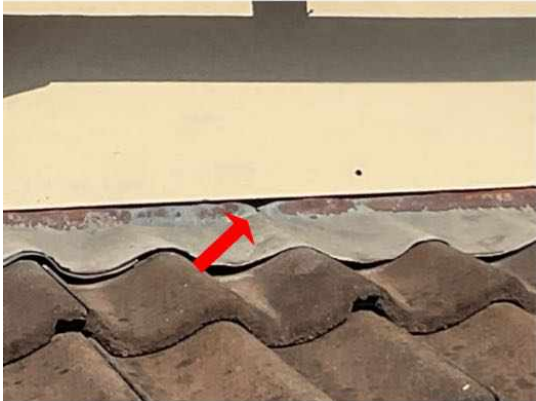
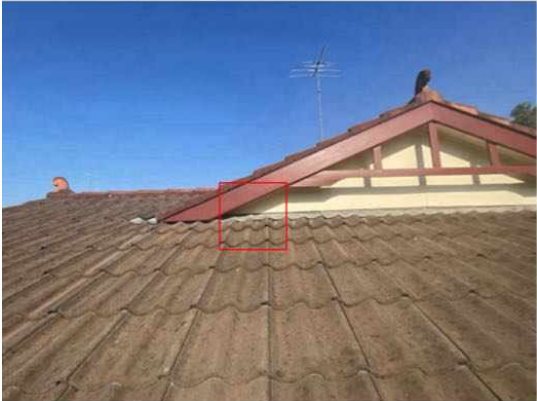
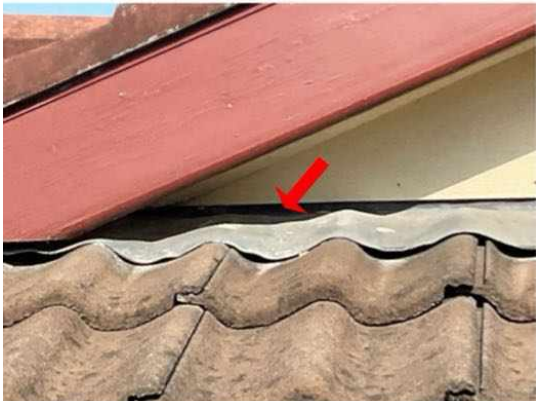
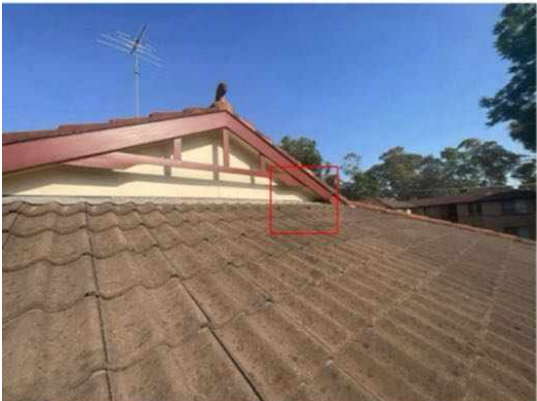
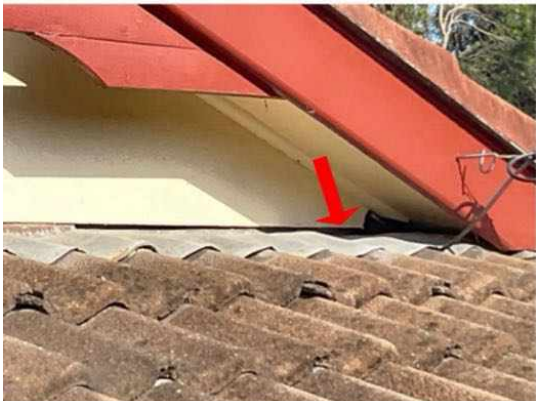
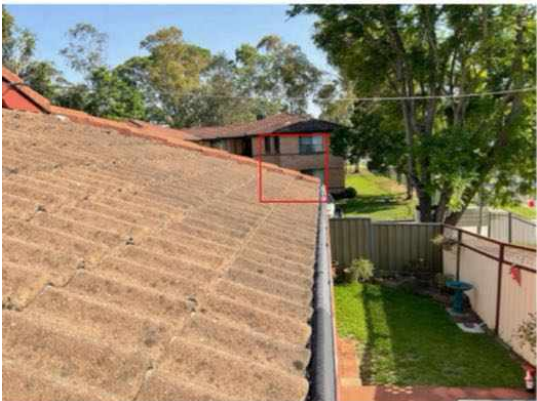
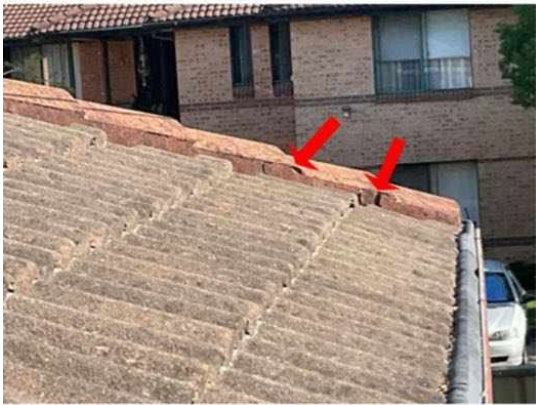
Finding 3.02

Building:	Main Building
Location:	Roof Exterior
Finding:	Roof Tile Inspection Summary & Recommendations
Information:	Access & Limitations

At the time of inspection, the tiled roof covering appeared to be in a generally sound condition. No cracked or broken tiles were observed in accessible areas. Some tiles were noted to be uneven in isolated locations, particularly adjacent to flashings. These conditions are considered consistent with age, weather exposure, and minor movement over time. While not currently presenting as a failure, uneven tile alignment may increase the risk of water ingress if left unmanaged.

The ridge and hip cappings were observed to be generally intact. Minor deterioration of mortar bedding and pointing was noted in isolated areas. This level of deterioration is common for roofs of this age and does not currently constitute a major defect. However, periodic maintenance, including re-pointing, is recommended to maintain weatherproofing and prevent future water penetration.

Lead roof flashings were observed to be in average condition overall. Localised sagging and cracking were noted. Sagging flashings may provide inadequate fall for effective water run-off, and cracked flashings can allow moisture entry, particularly if deterioration progresses. Maintenance or re-sealing by a licensed roofing contractor is recommended to reduce the risk of future water ingress.

Roof valleys and drainage channels were generally clear and appeared functional at the time of inspection. Some tiles within the valley areas were noted to have become loose and will require reinstatement to ensure proper water flow. Regular cleaning and maintenance of valleys is recommended to prevent debris build-up, blockages, and potential water overflow beneath roof tiles.

No visible evidence of active roof leaks was identified at the time of inspection. Internally, some unevenness to ceilings was noted, particularly within the garage area. While no direct correlation to roof leakage was confirmed during the inspection, conditions may vary following heavy rainfall. Ongoing monitoring is recommended, and further assessment should be considered if signs of moisture staining or water ingress become evident.

Roof sarking or underlay was not observed. Sarking was not a mandatory requirement at the time of original construction. It is noted that the absence of sarking can reduce protection against wind-driven rain, dust ingress, and condensation. This is a design limitation rather than a defect but should be considered in future roof upgrade works.

The tiled roof covering was observed to be in generally sound condition at the time of inspection, with no active leaks identified in accessible areas. Minor maintenance is recommended to ridge cappings, flashings, and valley tiles to ensure continued weather resistance. Due to access limitations associated with roof pitch and non-trafficable framing, the inspection was restricted to safely accessible areas only. Improved access, including the installation of an additional manhole, would allow for a more thorough inspection in the future.

Regular roof maintenance, including cleaning of valleys and gutters and periodic re-pointing of ridge tiles, is recommended to preserve the roof's performance and extend its overall service life.

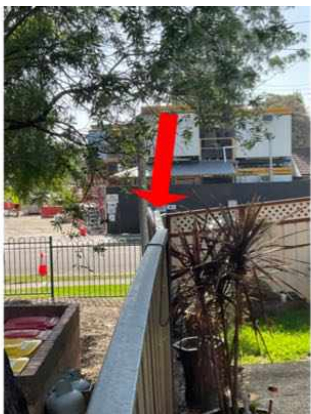
Finding 3.03

Building: Yard
Location: Fencing
Finding: Leaning Boundary Fence.
Information: Observation:

Rectification is at the discretion of the client. A licensed fencing contractor or qualified handyman should be engaged to assess the extent of deterioration and carry out repairs or replacement as required.

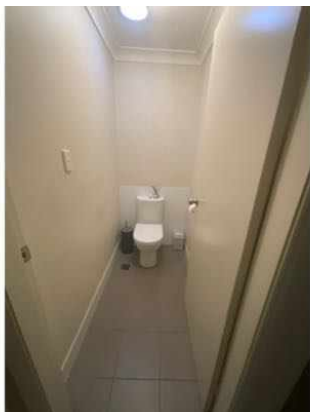
Finding 3.04

Building:	Main Building
Location:	Toilet (WC)
Finding:	Defect – Inadequate Ventilation (No Exhaust Fan Installed)
Information:	Observation:

Recommendation:

- An electrician and/or ventilation specialist should be engaged immediately to:
- Assess the area
- Install a compliant exhaust fan or alternative ventilation system
- Rectification is recommended prior to occupancy to ensure compliance and reduce the risk of long-term moisture-related issues.

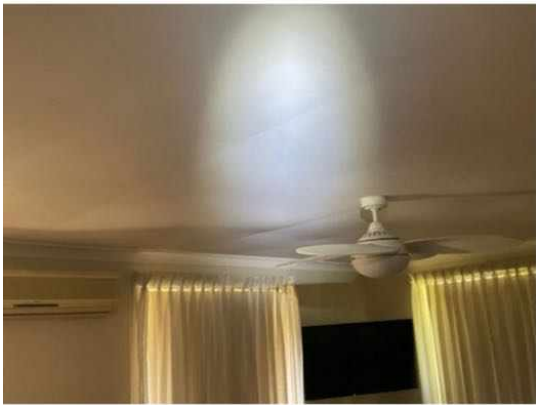
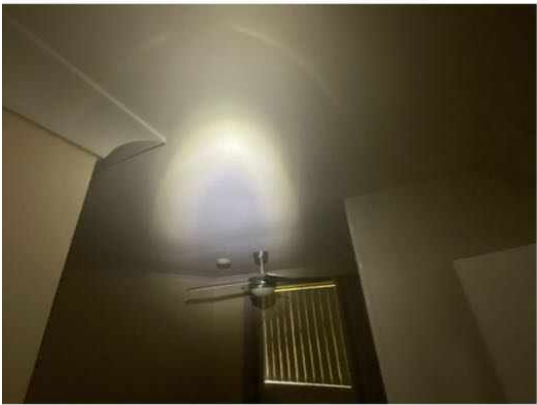
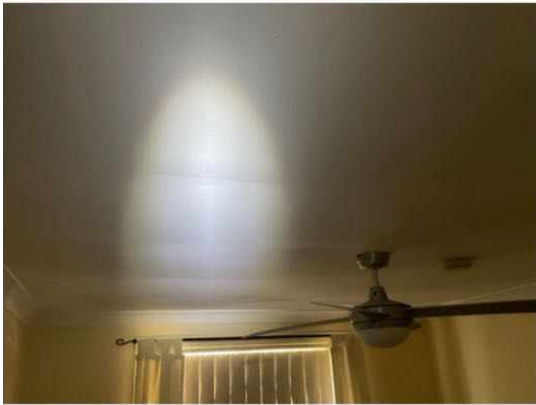
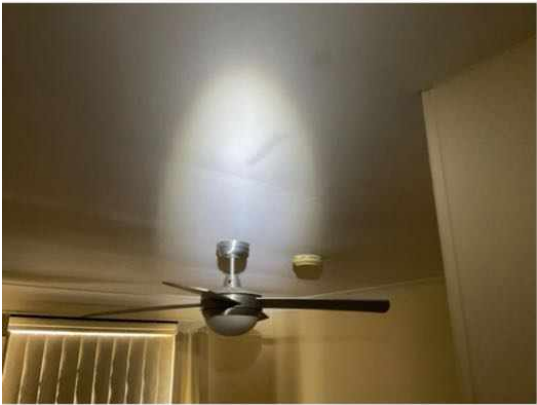
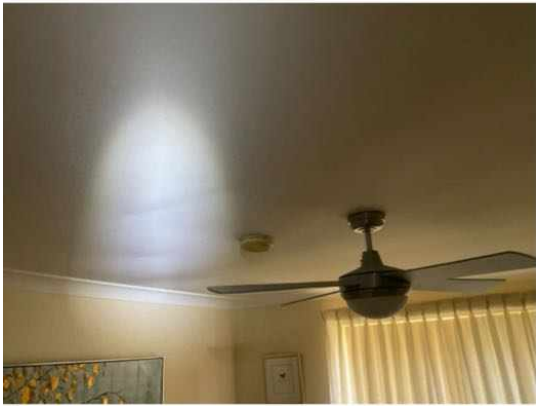
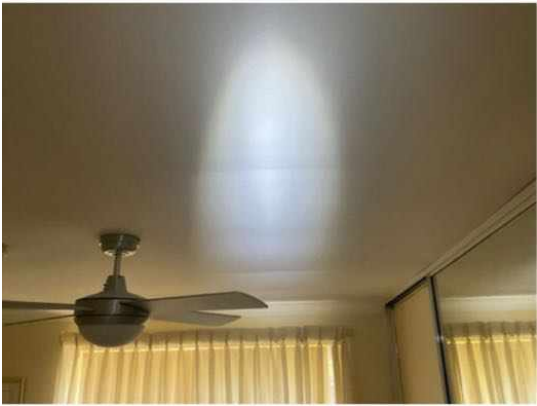
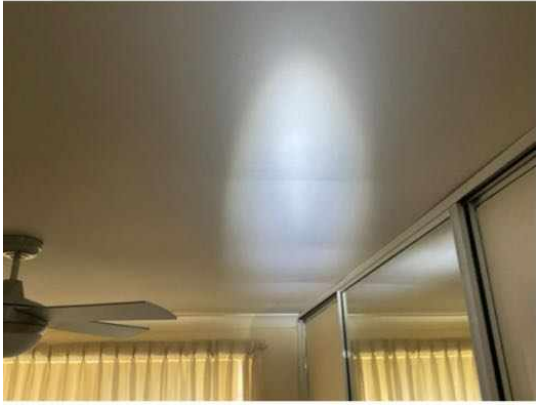
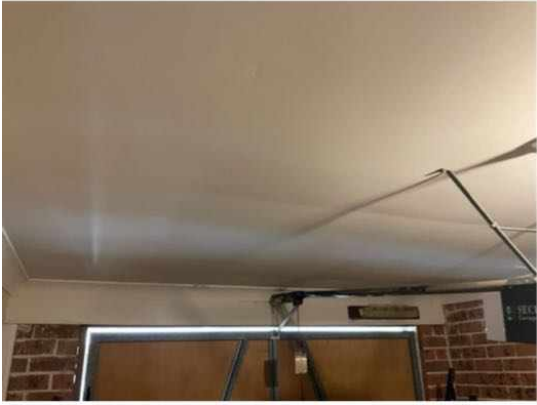
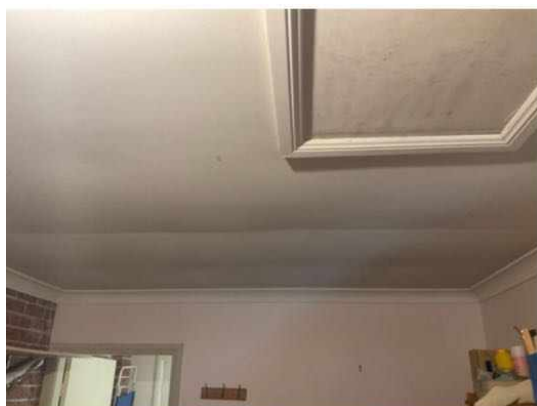
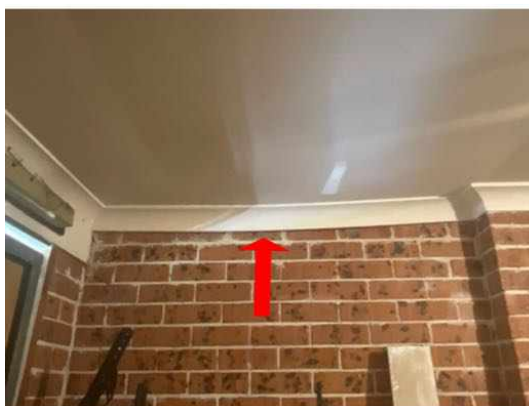
Finding 3.05

Building:	Main Building
Location:	All Areas
Finding:	Ceiling Linings – Uneven or Sagging Surfaces.
Information:	Observation:

- Re-securing sheets using appropriate modern fixings
- These works can be carried out by a qualified plasterer or painter,
- Ongoing monitoring is advised to detect any worsening of the condition or further movement over time.

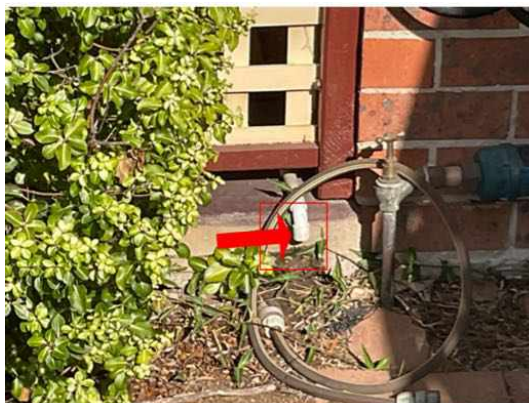
Finding 6.02

Building:	Main Building
Location:	All External Areas
Finding:	Overflow Management – Risk of Termite Activity..
Information:	Observation: Water Pooling from HWS and Air Conditioning Overflows

redirected away from the building, preferably via fixed drainage or extension piping, to prevent water accumulation near the structure.

These minor corrective works should be undertaken promptly to minimise the risk of both termite ingress and potential structural damage due to ongoing moisture exposure.

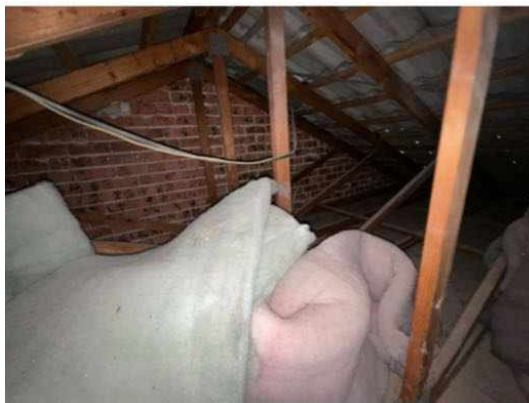
Building:	Main Building
Location:	All Areas
Finding:	Termite Management System (strata)..

Recommendation:

Installation of an additional manhole is recommended to facilitate a re-inspection and enable a more thorough assessment of the roof void in the future. This will help ensure that all structural elements and concealed areas are properly evaluated.

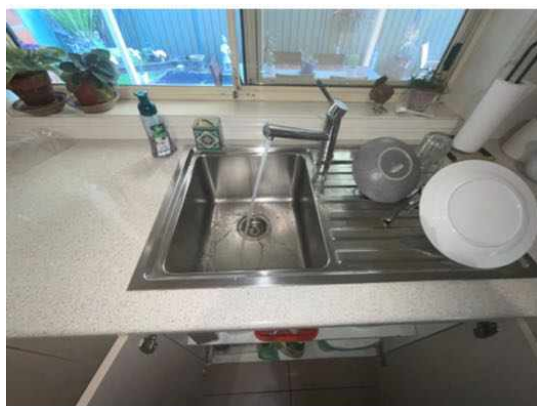
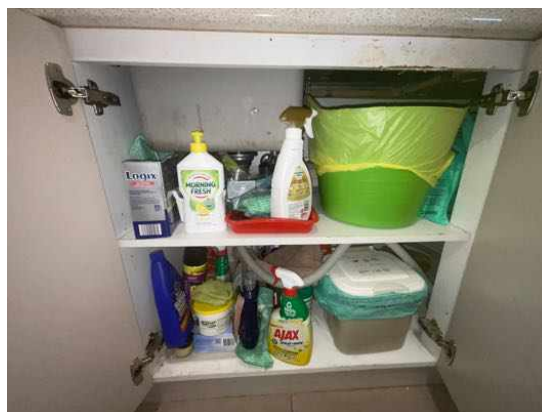
Noted Item

Building: Main Building
 Location: Kitchen
 Finding: Kitchen Sink – Overall Condition & Recommendations.
 Information: Observations:

Recommendations:

- Further monitoring and testing are recommended once the tap(s) are in constant use, to identify any drainage issues or signs of slow leaks not evident during the limited inspection.
- For long-term property care, it is advised that sealant and grouting in water-exposed areas be regularly inspected and maintained.
- It is recommended that the stored items beneath the sink be removed to allow for a full re-inspection of the plumbing and cabinetry, ensuring no concealed defects are present.

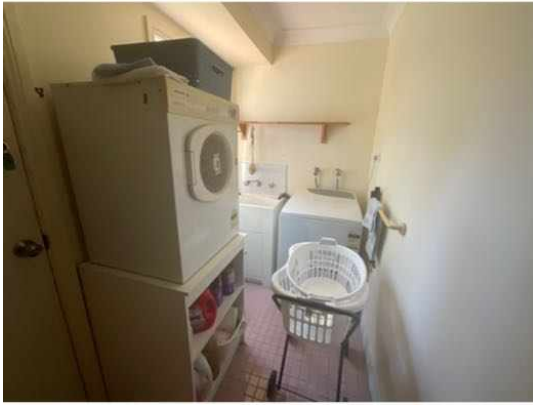
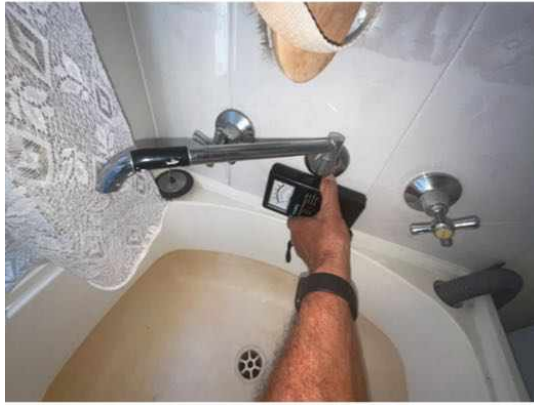
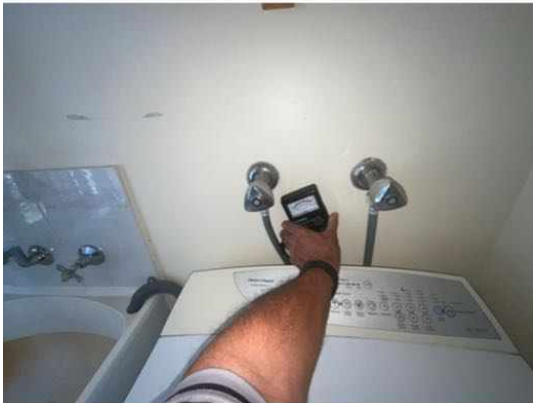
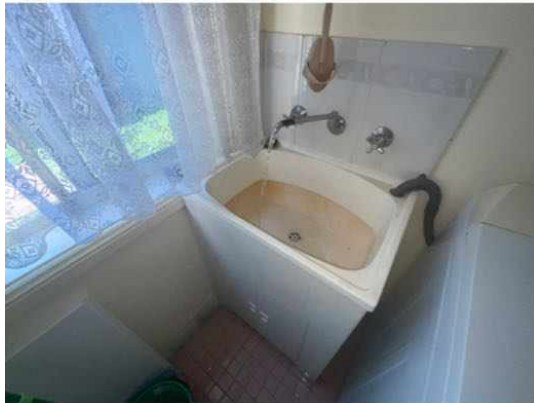
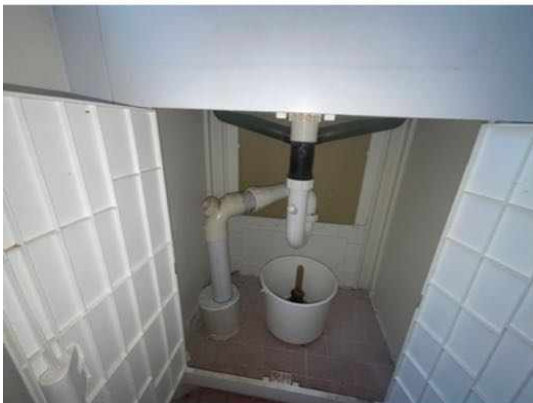
Noted Item

Building: Main Building
 Location: Laundry
 Finding: Laundry - Taps/Plumbing/Drainage.
 Information: Observation: Laundry Tub – Taps, Plumbing, and Cabinetry

Recommendations:

- Further monitoring or testing is recommended once the taps are placed into regular use, to ensure no leaks develop over time and that the drainage system continues to perform adequately.
- Flexible and mould-resistant sealant should be applied to junctions between the basin and the wall to prevent water ingress that may lead to damage.
- Regular maintenance and prompt replacement of missing or deteriorated sealant is highly recommended, as this is a common wear-and-tear issue.
- Sealant and grouting in wet areas should be maintained as part of the long-term care and upkeep of the property.
- Where required, a sealant specialist or qualified tiling contractor should be appointed to carry out remedial sealing works.

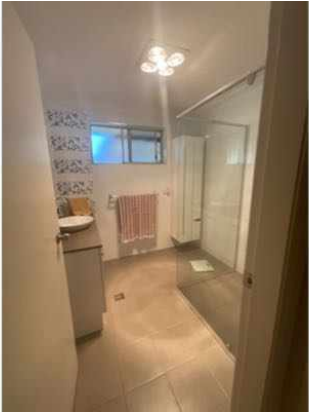
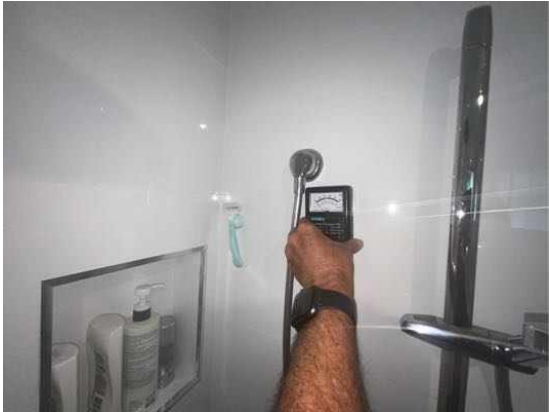
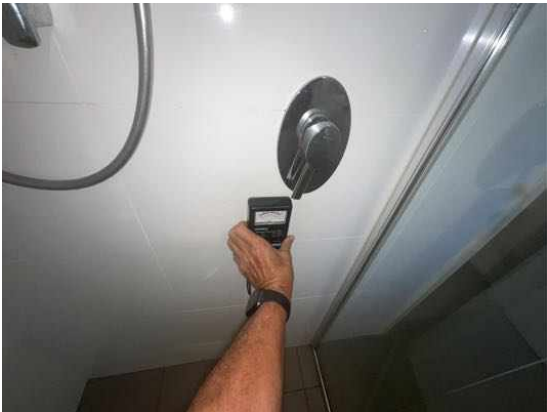
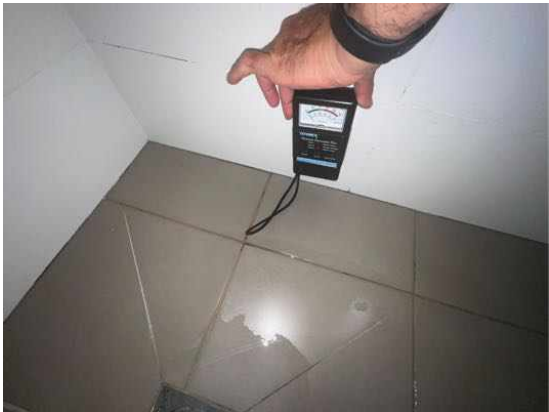
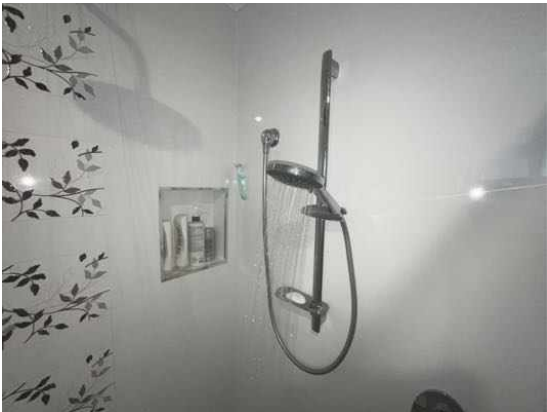
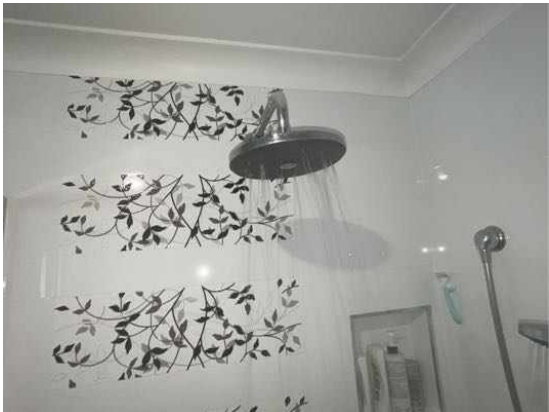
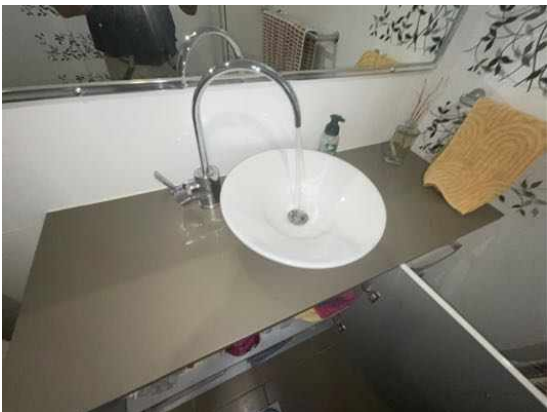
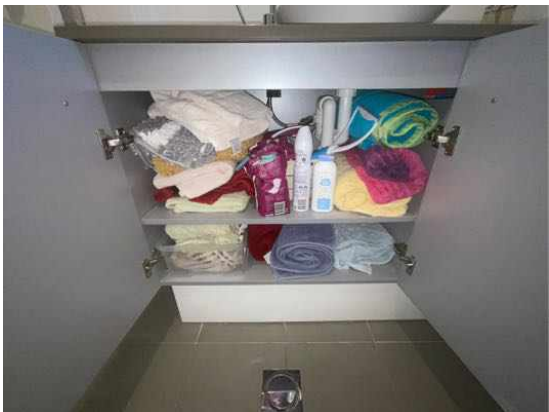
- Flood testing of the shower recess is recommended. This may reveal inadequacies in the waterproofing or shower screens, which could lead to water damage in surrounding areas.
- Floor waste was found to be clear and free of blockages at the time of inspection. Further monitoring is advised after consistent use to identify any drainage issues or buildup requiring cleaning.
- No elevated moisture readings were detected around the tap fittings or behind the shower walls (as viewed from adjacent rooms), suggesting no active plumbing leaks at the time of inspection.
- Sealing of grout and tiles is recommended to prevent moisture buildup and mould growth in damp areas such as showers.
- The condition of grout and sealant appeared to be Good
- The exhaust fan appeared to be operational, which supports moisture control in the bathroom.

- Basin(s) were water tested and inspected, with no leaks or blockages identified in the plumbing or drainage system at the time of inspection.
- Further monitoring is recommended after the basin(s) are placed under regular use to confirm ongoing performance and cleanliness.
- No visible water damage was observed to the vanity cabinetry at the time of inspection.
- Stored items inside the vanity obstructed full visibility during the inspection. It is advised that the area be re-inspected once all obstructions are removed.

It is not possible under the visual inspection criteria of a standard pre-purchase report to categorically determine if leaks are present. If a more detailed or accurate assessment is required, a special-purpose inspection should be undertaken.

Alternatively, the assumption should be made that leakage may occur, particularly where historical or environmental conditions are conducive. The visual nature of this inspection cannot detect issues concealed behind wall/floor linings or cabinetry, and invasive investigation may be necessary to confirm the true condition of adjacent or

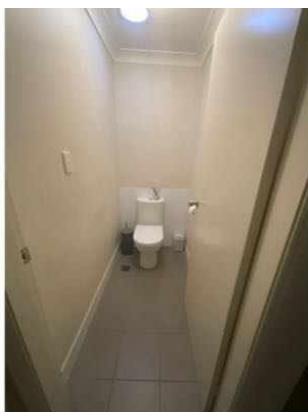
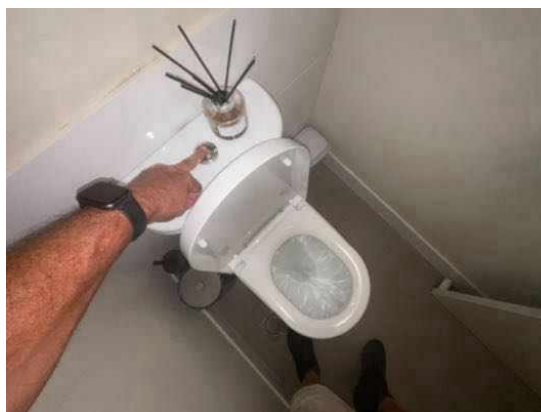
Building: Main Building
 Location: Toilet (WC)
 Finding: Overall Condition: Toilet.
 Information: TOILET ASSESSMENT

- No leaks were observed during the flushing process.
- The toilet operated normally with no signs of malfunction or abnormal water flow.
- The toilet pan was securely fixed to the floor at the time of inspection.

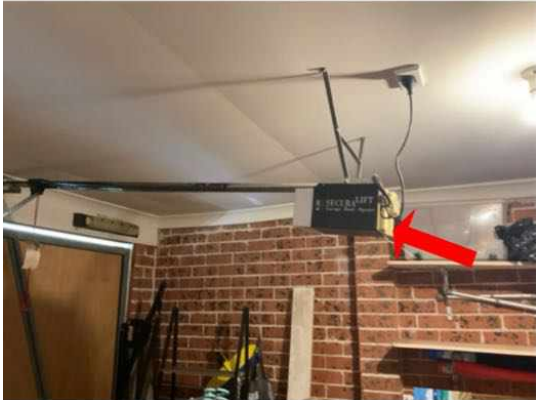
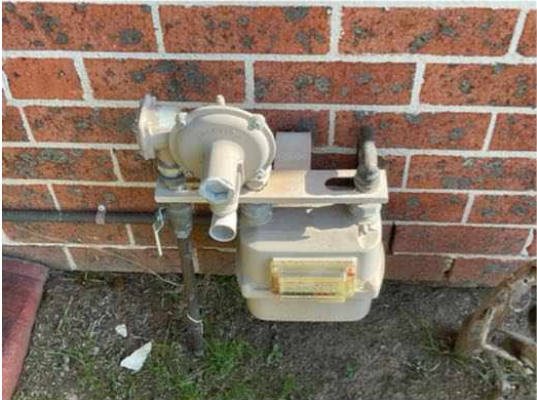
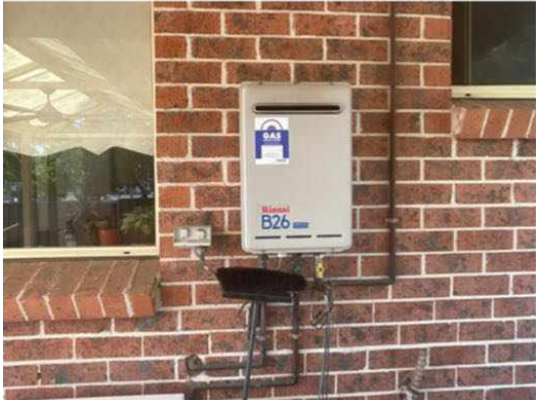
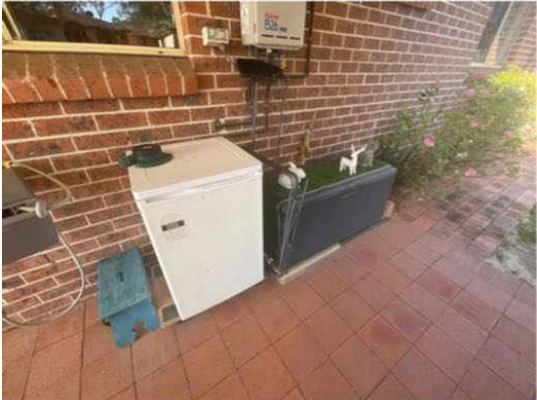
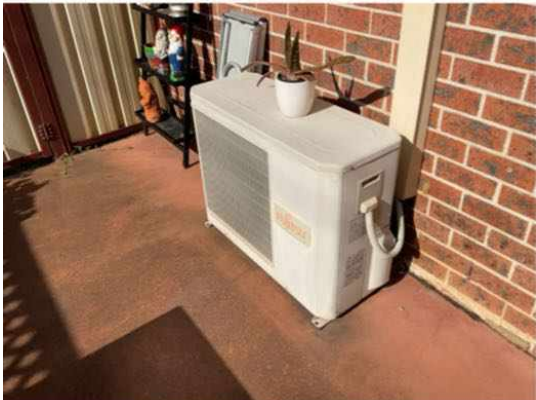
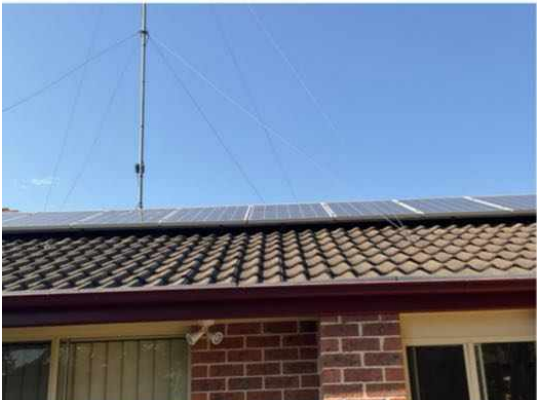
Building: Main Building
 Location: All Areas
 Finding: Plumbing, Electrical & Gas Installations – Scope and Recommendations.
 Information: The garage door motor did not appear to be functional and recommend further assessment.

- Any gas appliances (if applicable) must be inspected by a licensed gas plumber to confirm they are operating safely and efficiently.
- We also recommend that all other plumbing and electrical installations be thoroughly checked by qualified professionals to ensure they are functioning correctly and meet current safety and compliance standards.
