# Building and Timber Pest Inspection Report

Inspection Date: Sat, 7 Feb 2026

Property Address: 376 Abell Rd, Melonba NSW 2765, Australia

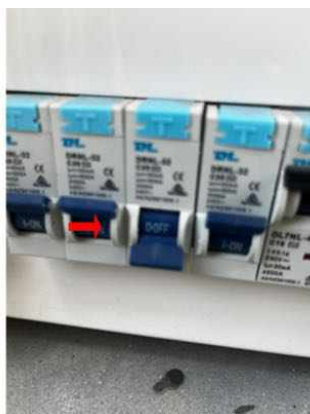
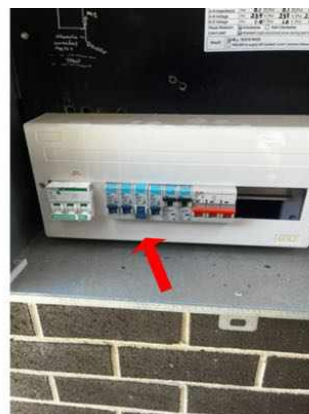
In addition, each State and Territory has legislation in place with different requirements that make it mandatory under certain circumstances to have a safety switch installed. These are triggered by the age of the building, its intended use (e.g. as a rental) and sometimes by the sale of the property itself. You should refer to the State-based regulator for electrical safety in your State to determine the requirements and obligations for the upgrade to the electrical switchboard.

It is advised that a qualified electrician be contacted immediately to install a safety switch and provide any further advice on additional works that may be required in this State.

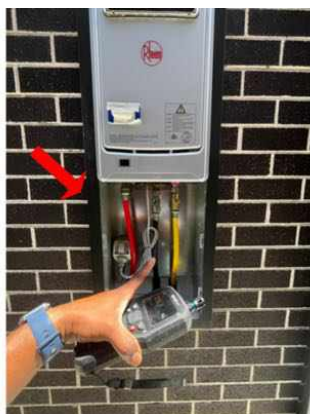
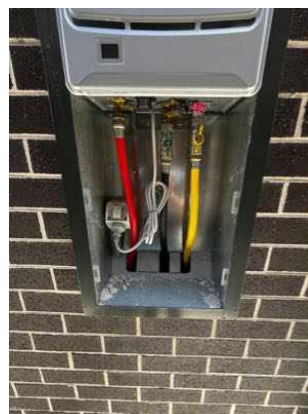
### Finding 3.01

Information: The HWS appeared to be in good condition at the time of inspection.

The Hot water unit was missing the lid cover at the time of inspection.

Water pressure appears to be normal, however, this is not an opinion of a licensed plumber. No water hammer was noted when taps are turned off fast.

It is advised that the cover may be replaced to prevent any safety hazard.

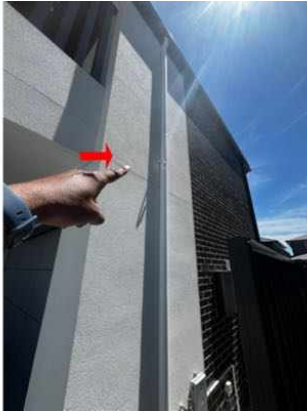
### Finding 3.02

Building:	Main Building
Location:	Front RHS
Finding:	Down Pipes clamp not connected.
Information:	The Roof plumbing is not adequately connected to stormwater drainage on the site as the clamp holding the down pipe is loose and has to be fixed in order to any building element coming loose of the building and creating any further defects.

Where roof plumbing doesn't drain adequately, the area at the base perimeter can become excessively damp, potentially creating an environment that is susceptible to rust and corrosion of surroundings building elements, as well as attracting termites and other pests.

It is highly recommended that a plumber be appointed to further inspect the area and to install adequate drainage equipment where necessary.

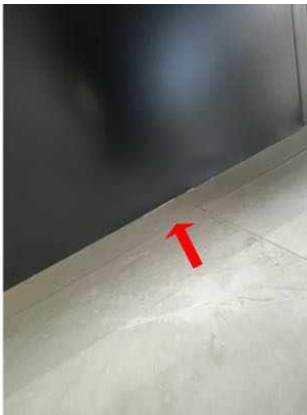
### Finding 3.03

Information: Though comments on Kitchen joinery is not part of the report, Still we would like to bring to your note few photos where the Joinery has been damaged due to Wear and tear/ daily Usage or low quality of materials used in the product.

The Buyer may consider renovation costs involved by requesting quotes from Joinery manufacturers etc if relevant.

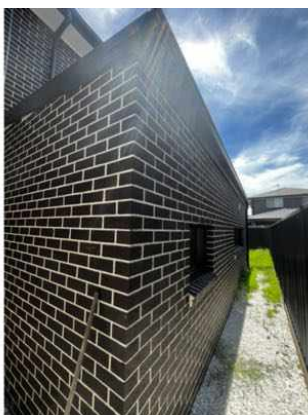
### Finding 6.01

Building: Main Building  
Location: All Areas  
Finding: Additional Photos - Obstructions and Limitations  
Information: These photographs are an indication of the obstructions and limitations which impeded full inspection of the property at the time of inspection. These obstructions can hide an array of defects and should be removed to allow full inspection to be carried out. A re-inspection is recommended once the areas are made accessible.

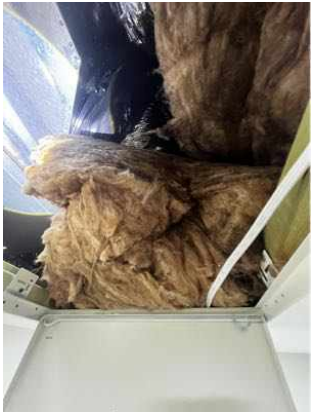
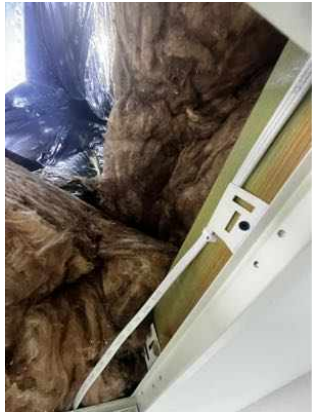
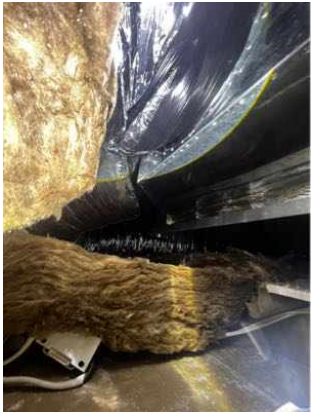
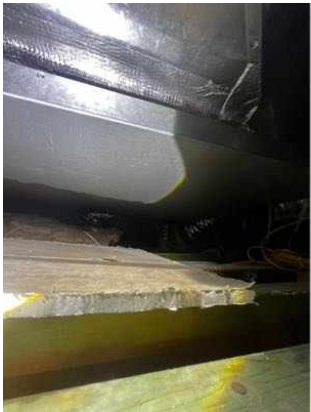
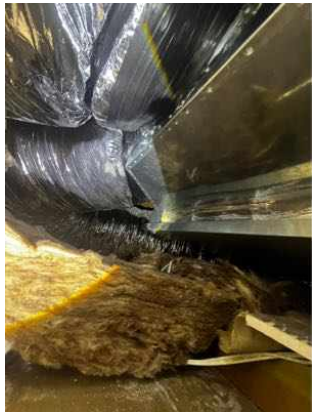
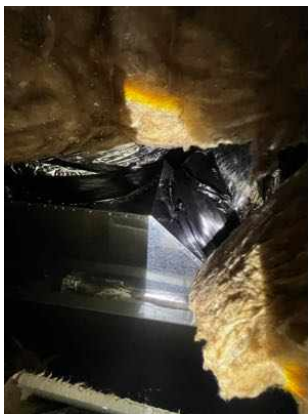
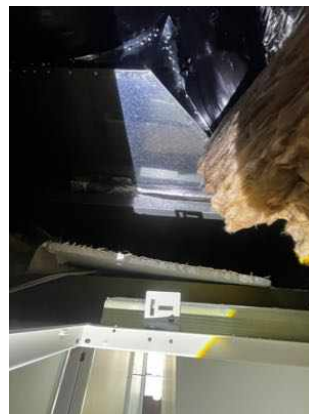
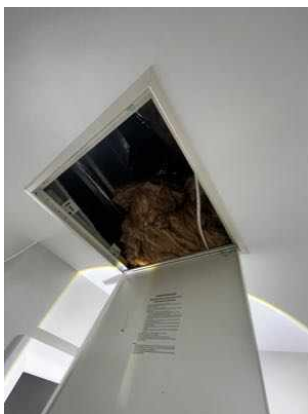
### Finding 6.02

Building:	Main Building
Location:	Roof Void
Finding:	Obstructions and Limitations - Roof space
Information:	Upon Inspection of the Roof void below mentioned photos have been attached as to the point been reachable to inspect the roof upon safe condition.

These photographs are an indication of the obstructions and limitations which impeded inspection of the Roof Space/Void at the time of inspection such as Stored items, Ducting, Aircon ducting, Skylight tubes, Electrical wires , insulation and cross beams, rafters, low clearance as of the pitch in the roof. These obstructions can hide an array of defects and should be removed to allow full inspection to be carried out.

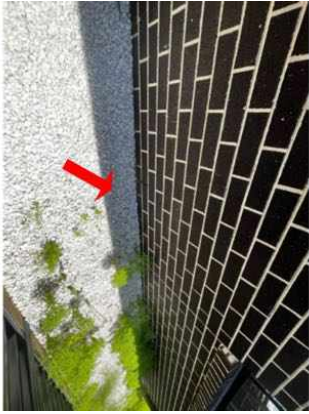
### Finding 6.03

Building:	Main Building
Location:	All External Areas
Finding:	Slab Edge - Exposure
Information:	An inspection zone of at least 75mm in relation to the exposed slab edge, between the bottom brick and the perimeter pavement, is required. This inspection zone should be maintained in order to force termites into the open where they can be detected more readily during regular inspections. The slab edge should not be concealed by anything that may prevent inspection of the area, including render, landscaping, soil, turf, paving, concrete cladding or other structures.

If the slab edge is not properly exposed there is a high risk of termite attack. Sometimes, in order to determine the type of slab, a suitably qualified person such as an architect or builder may be required to consult the construction plans.

Where the slab edge cannot be properly inspected, it is highly recommended that termite or timber pest inspections be carried out every 6-12 months to aid protection of the property against infestation.

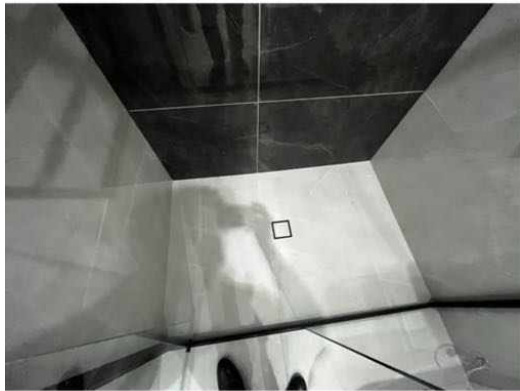
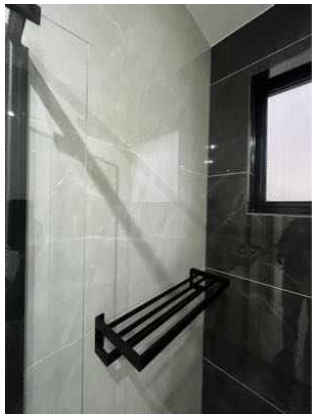
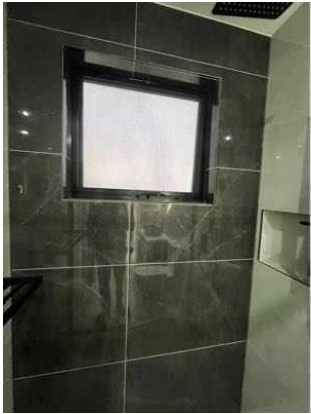
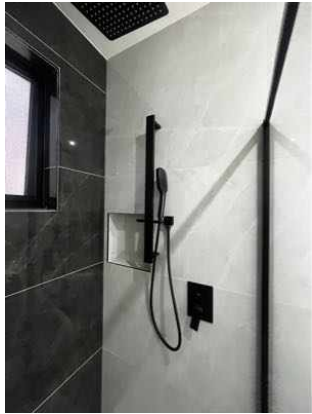
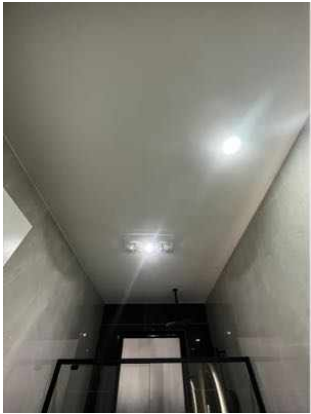
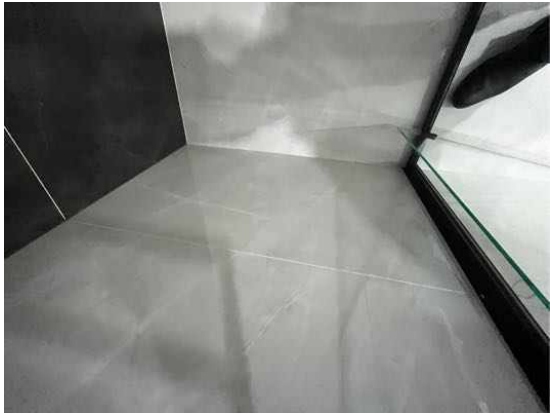
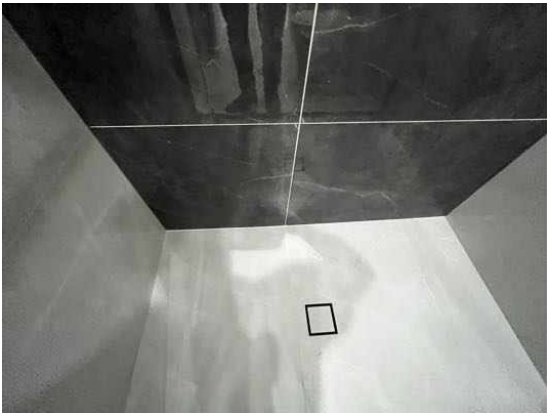
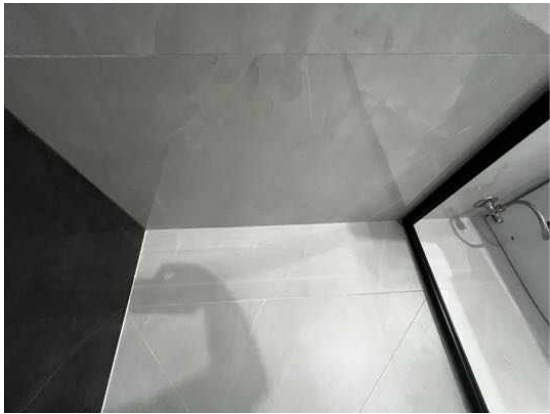
Building: Main Building  
Location: Ground Floor Bathroom >  
Finding: For information only  
Information: No remedial works are required at the current time.

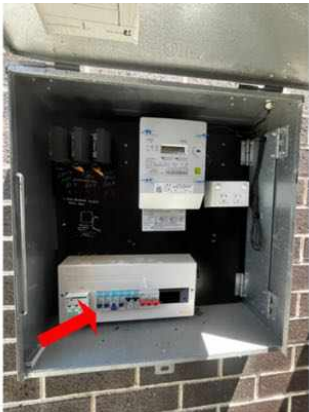
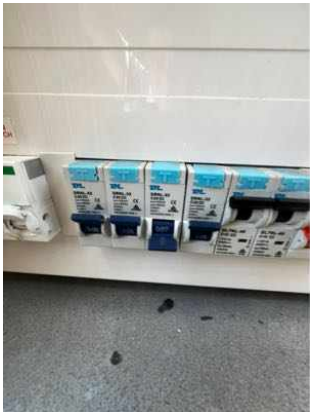
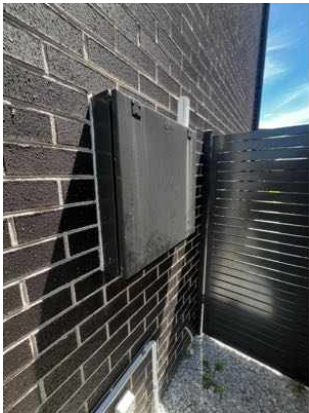
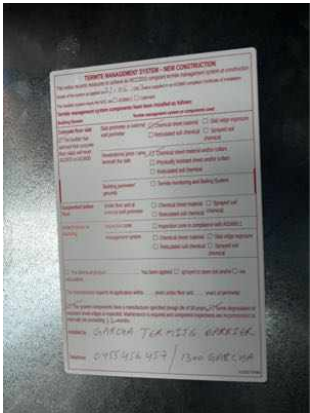
Building: Main Building  
 Location: Electrical Meter Box  
 Finding: Evidence of a previous termite management system was identified  
 Information: Upon Inspection There was a Durable Notice of Termite treatment identified but the date and the information in the notice was not readable/ identifiable - So It is highly recommended to have a termite treatment organised and to follow a termite treatment proposal and keep note of the system every 12 months in duration.

Where a Termite Management System has been identified you should refer to the type of barrier date of installation warranty conditions and any documentation provided by a builder or past owner. Consult the company who installed the barrier to confirm whether the system is still under warranty.

Most chemical termite management systems expire and require replenishment and all physical systems are primarily designed to prevent concealed entry.

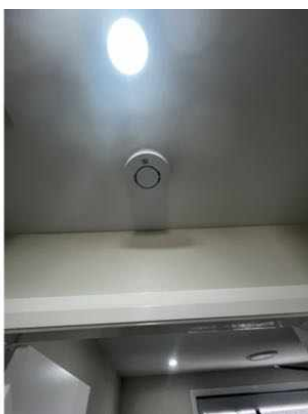
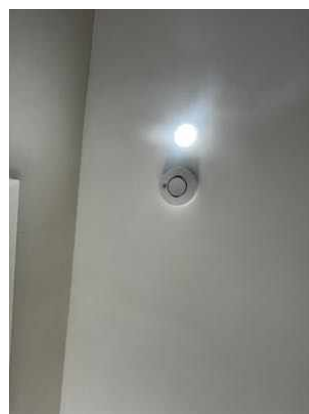
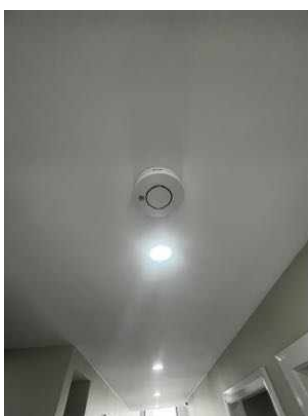
Building: Main Building  
 Location: All Internal Areas  
 Finding: Smoke Detector and Alarms  
 Information: Reporting on Smoke Detectors or Alarms, including hard wired smoke detection systems and their legislative requirements, is outside the Scope of this Report.

Additionally, it is advised that all smoke detectors be tested by the homeowner on a monthly basis.

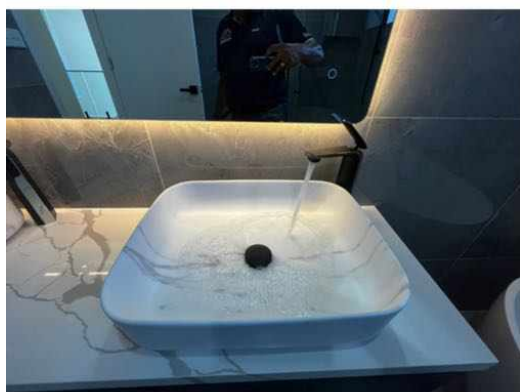
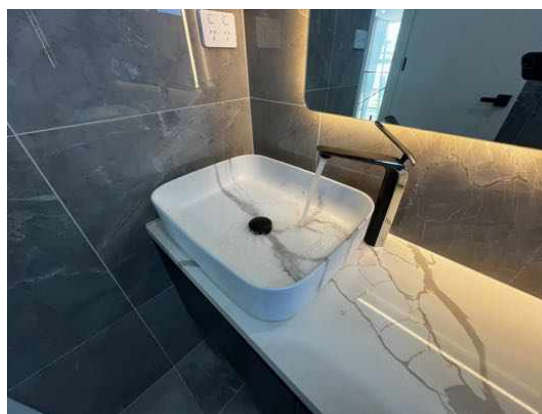
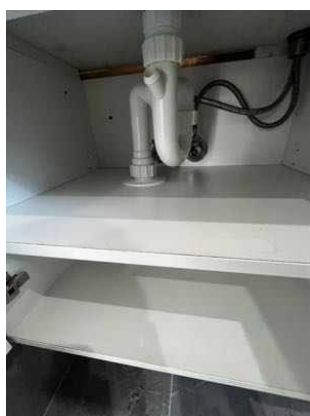
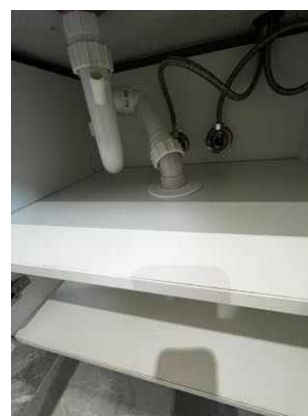
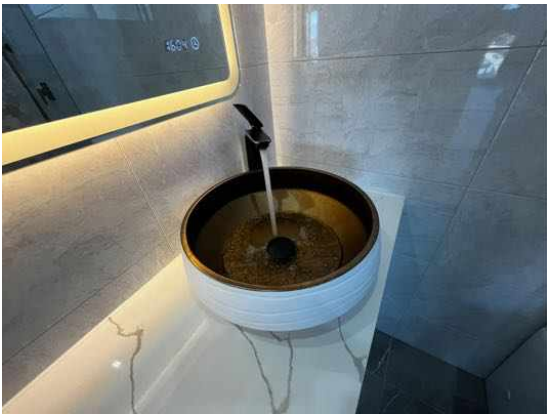
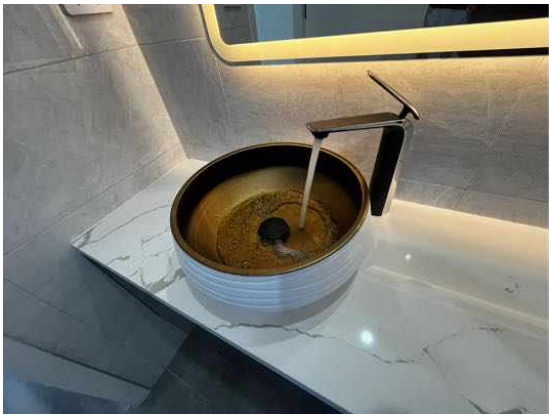
Building: Main Building  
 Location: Kitchen/ Laundry/ Ensuite/ Bathroom

All cupboards where sinks and basins with drainage plumbing were inspected and no evidence of leaks were present at the time of inspection.

For your information only no remedial works are required at the time of inspection.

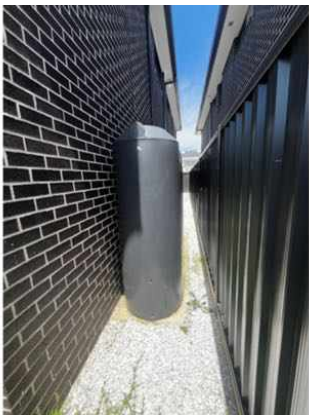
Building: Main Building  
Location: Yard - Side  
Finding: Storm Water Tank  
Information: Storm Water Tank photos taken at the time of inspection.

Please consult a licensed Plumber to check the Connections/ pressure/ pumps/ flow of water and functionality accordingly.

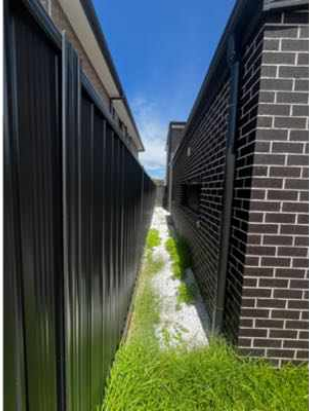
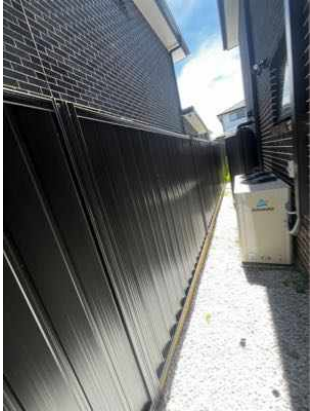
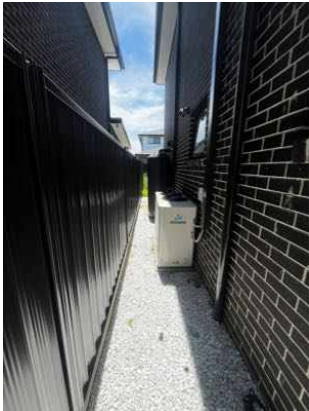
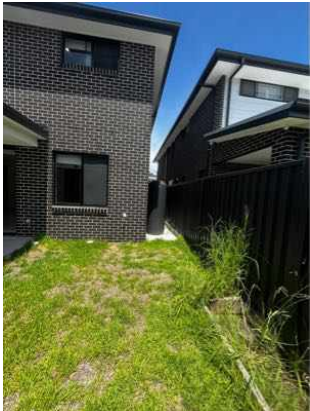
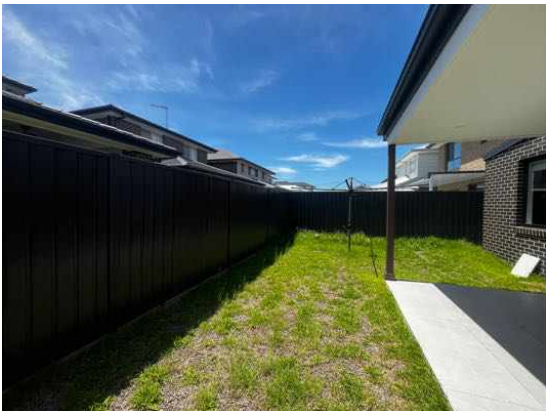
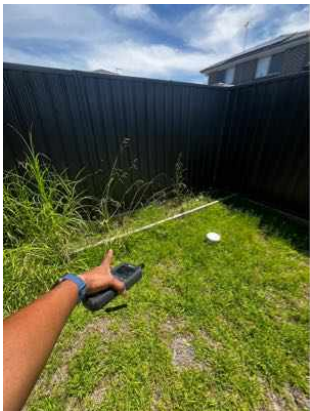
Building: Main Building  
Location: Yard  
Finding: Perimeter Fencing -  
Information: For your information photos taken at the time of inspection.

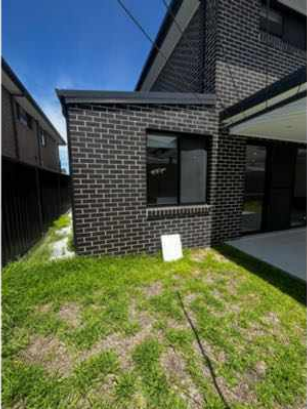
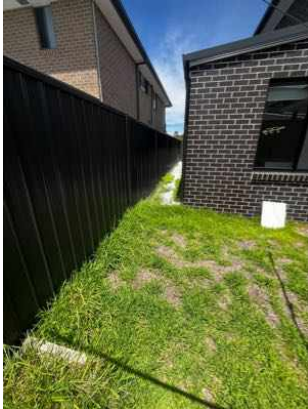
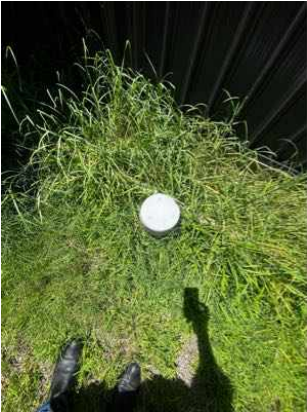
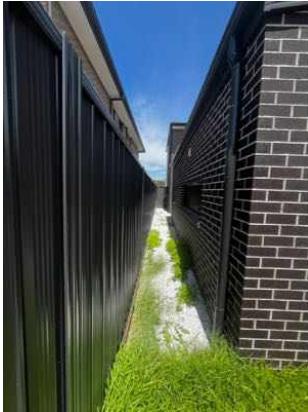
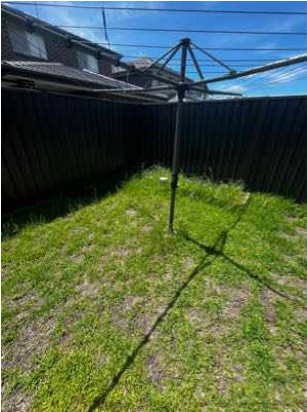
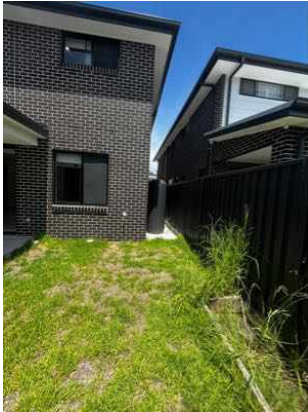
Building: Main Building  
 Location: All External Areas  
 Finding: Site drainage - For your Information  
 Information: Upon Inspection The site drainage was inspected, however, the site/ Yard should be monitored during heavy rain to determine whether the existing drains cope. If it appears that they cannot cope, then additional drains may be required.

Any comments made in the section are relevant only in light of the conditions present at the time of inspection. It is recommended that a smoke test be obtained to determine any illegal connections, blocked or broken drains.

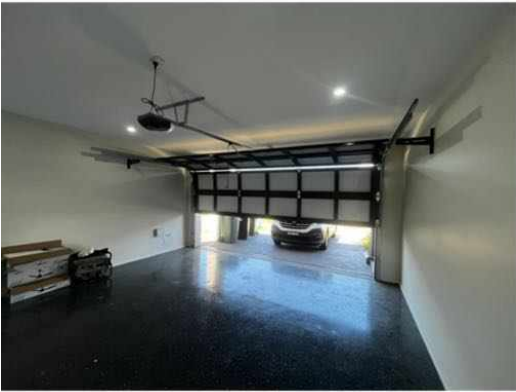
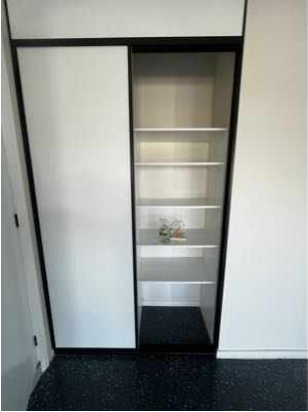
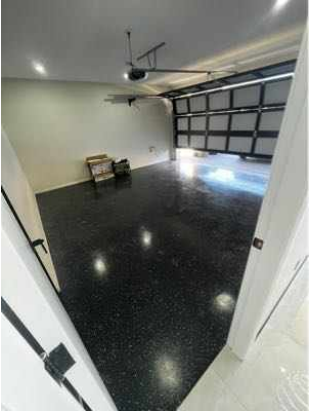
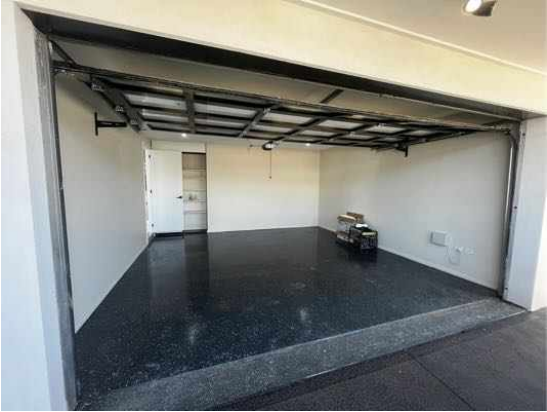
Building: Main Building  
Location: Garage  
Finding: For information only  
Information: A Cluster of Photos taken at the time of inspection.

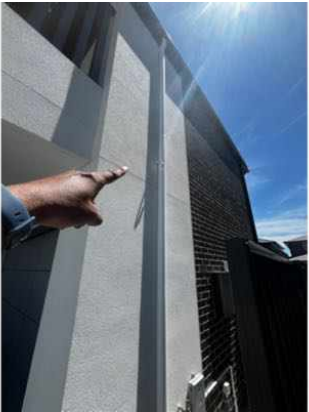
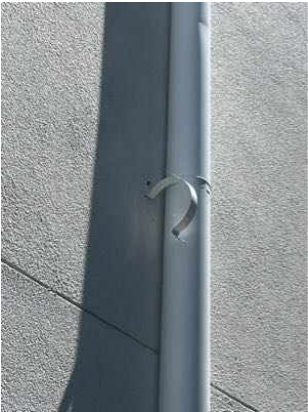
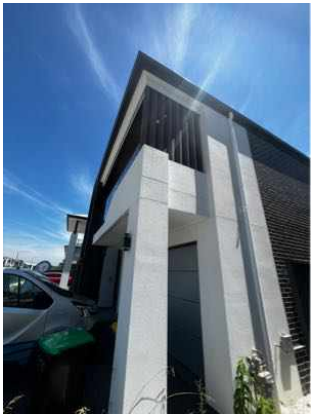
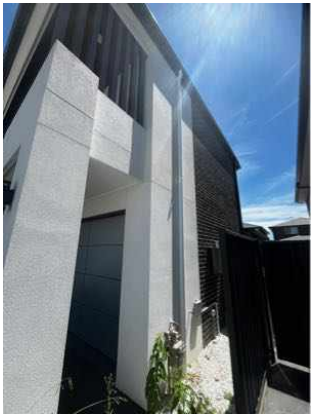
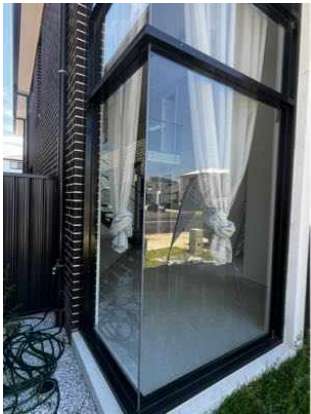
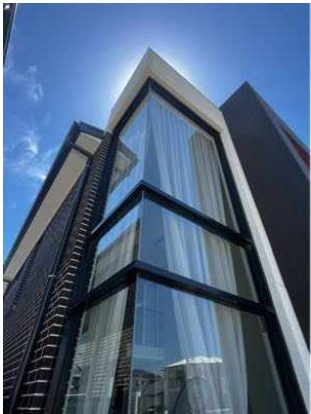
Building: Main Building  
Location: All External Areas  
Finding: For information only  
Information: A Cluster of Photos taken at the time of inspection.

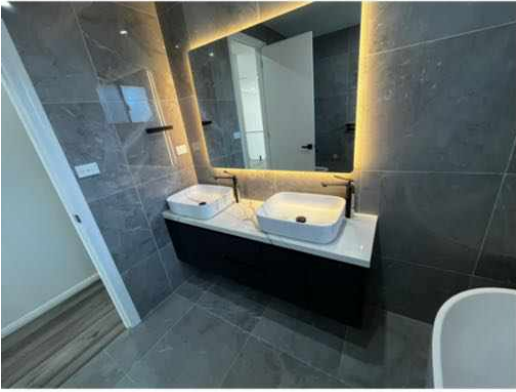
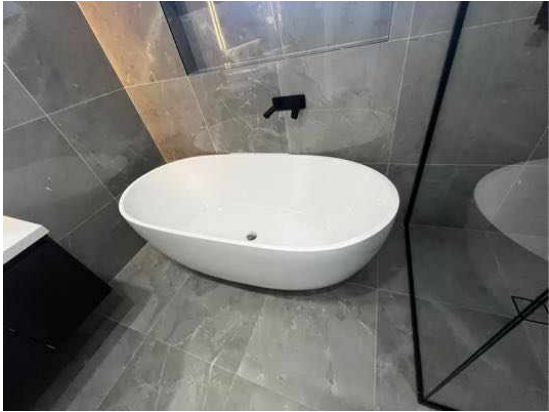
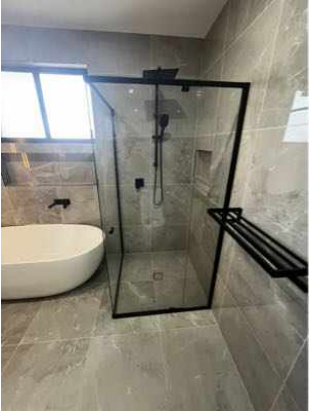
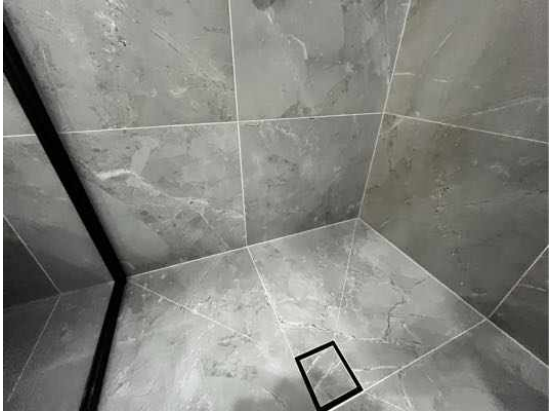
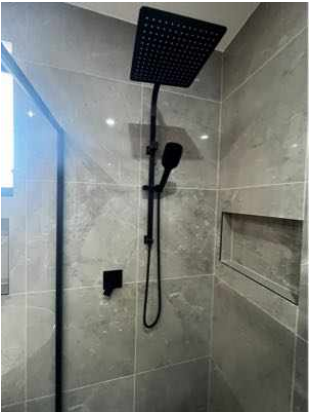
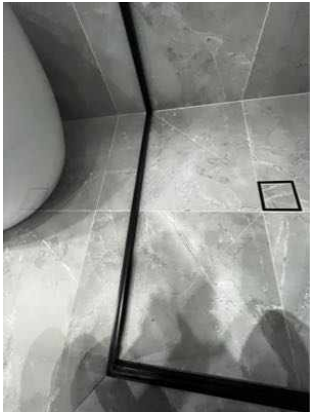
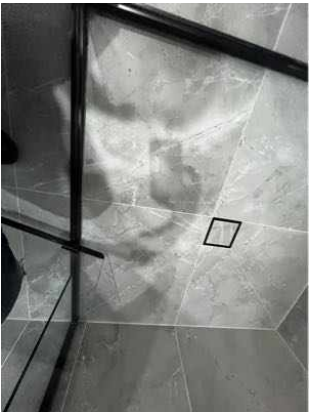
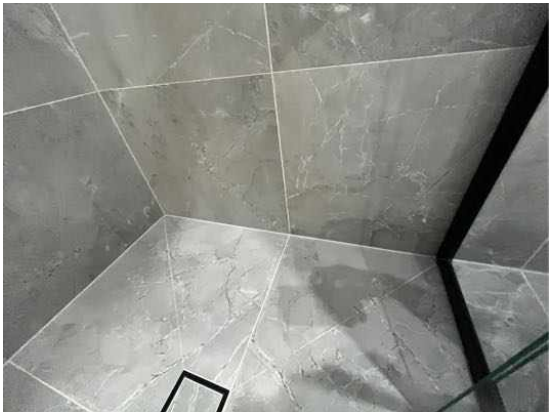
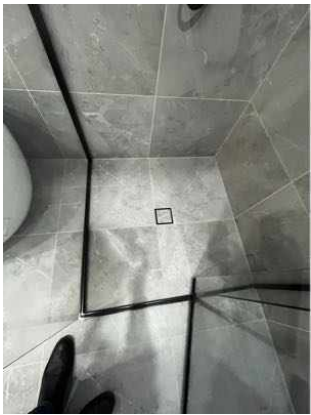
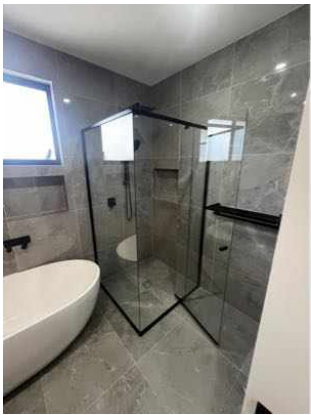
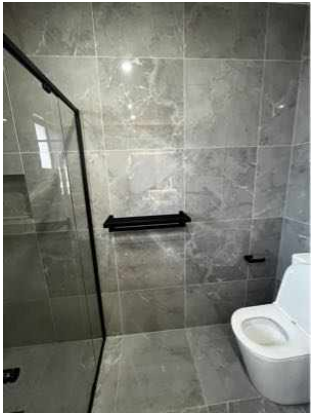
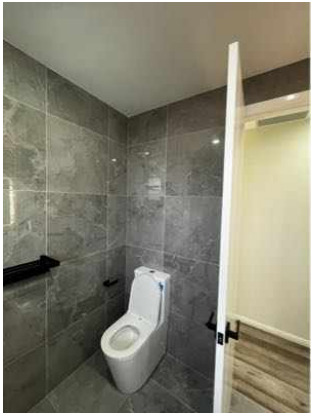
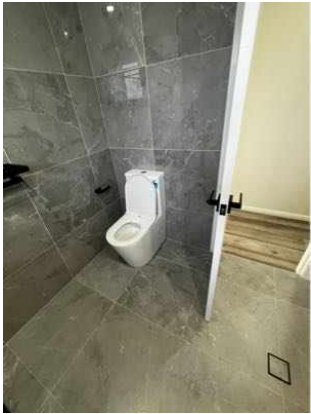
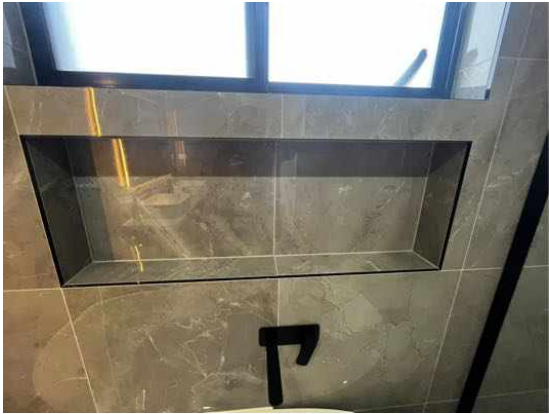
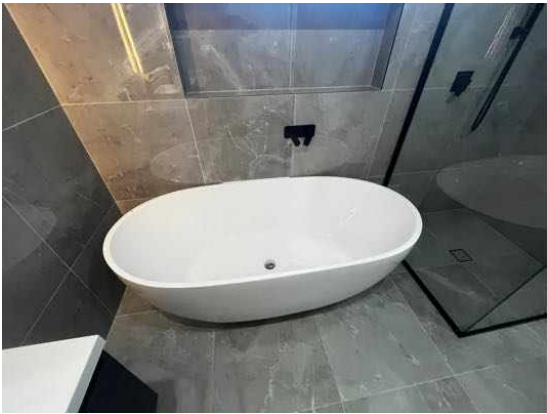
Building: Main Building  
Location: Main Bathroom  
Finding: For information only  
Information: A Cluster of Photos taken at the time of inspection.

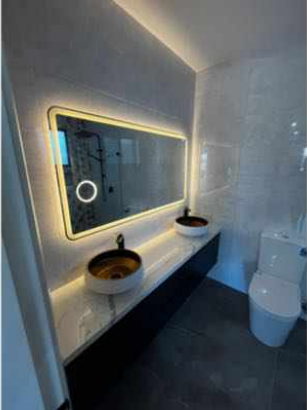
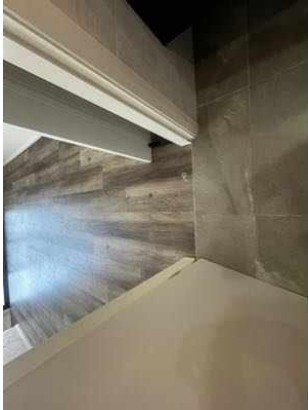
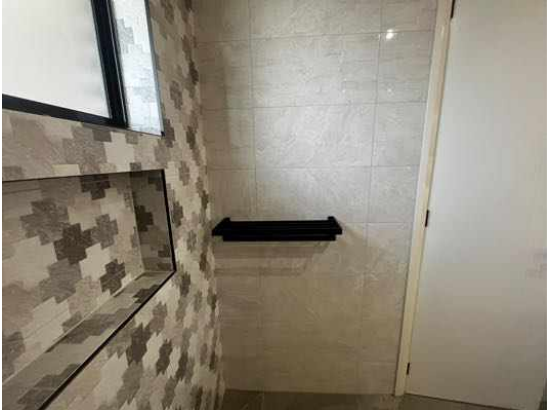
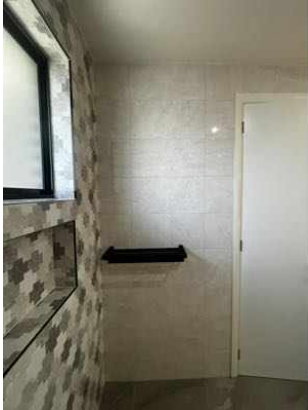
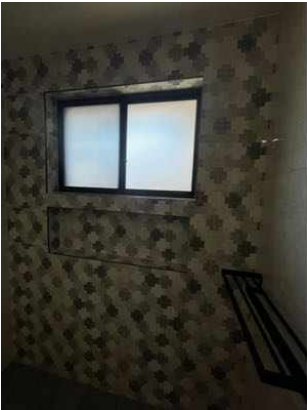
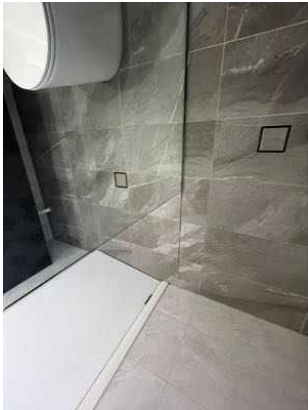
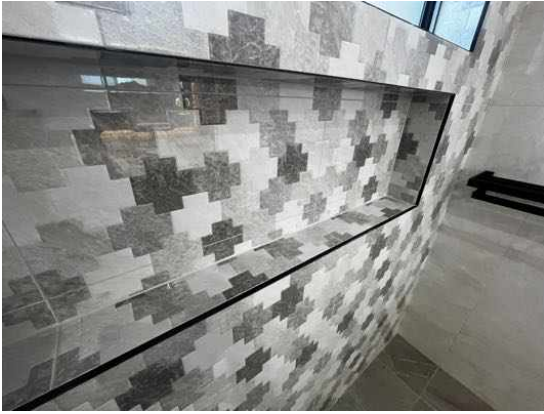
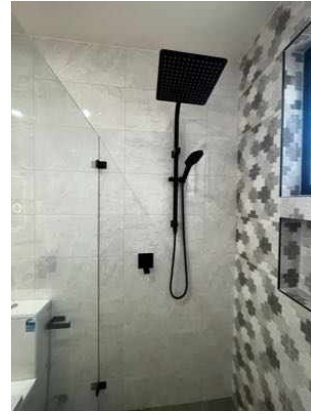
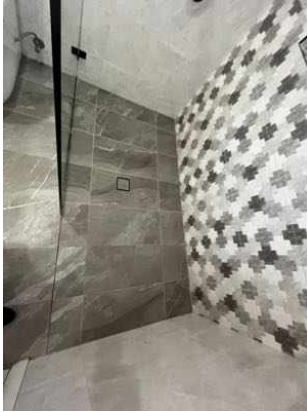
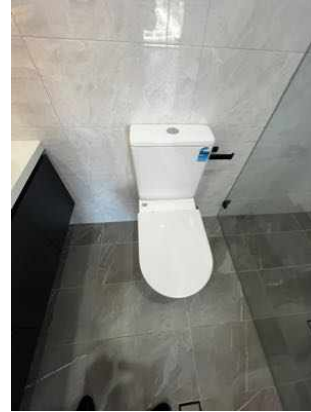
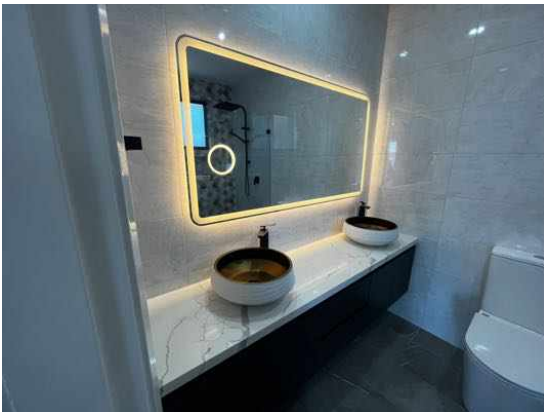
Building: Main Building  
Location: Ensuite  
Finding: For information only  
Information: No remedial works are required at the current time.

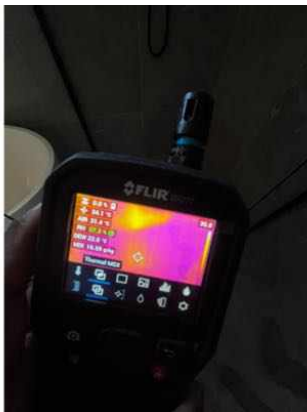
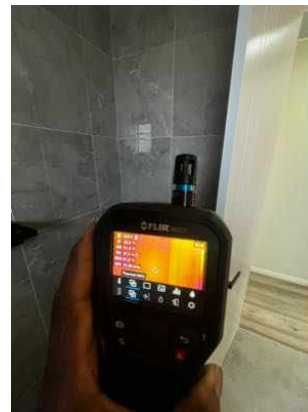
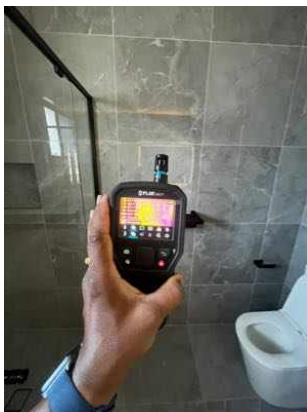
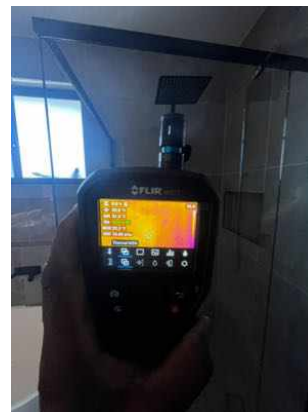
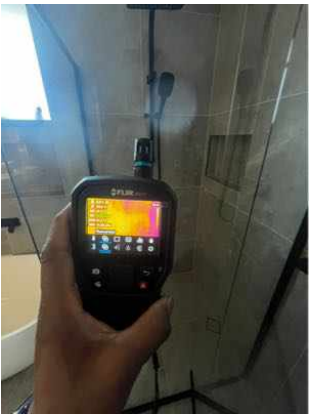
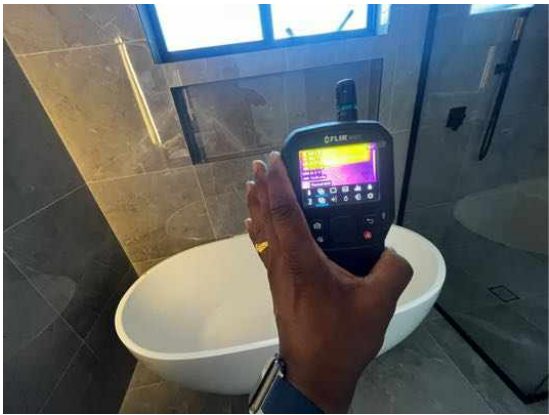
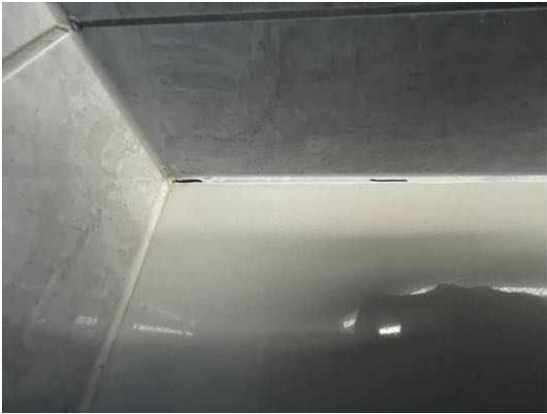
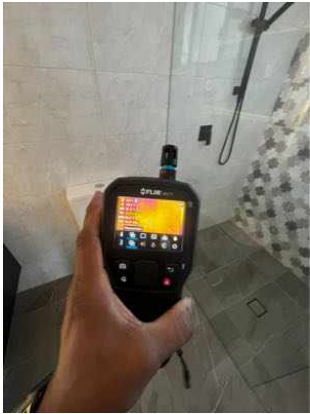
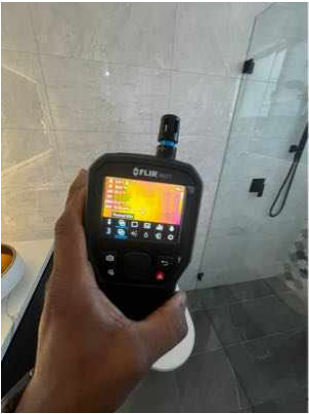
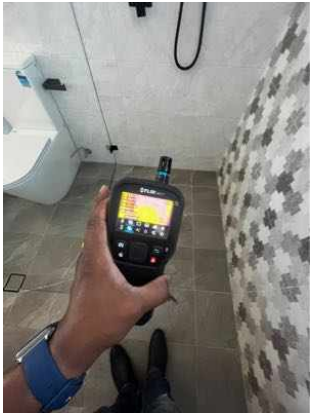
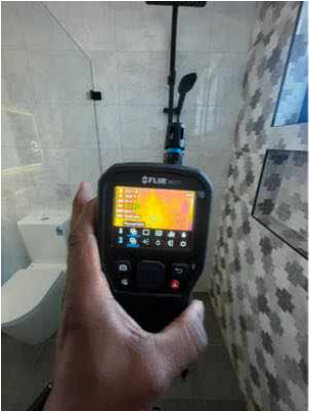
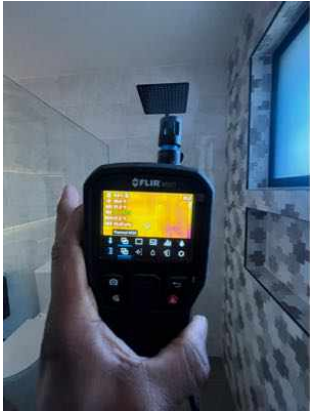
Building: Main Building  
Location: All Internal Areas  
Finding: Thermal Camera  
Information: All areas of the dwelling are checked with particular attention paid to wet areas which were closely assessed to check for excessive levels of moisture and temperature anomalies.

No evidence of termite activity was found inside the house at the time of the inspection.

NO readings of High Moisture was found at the time of inspection.

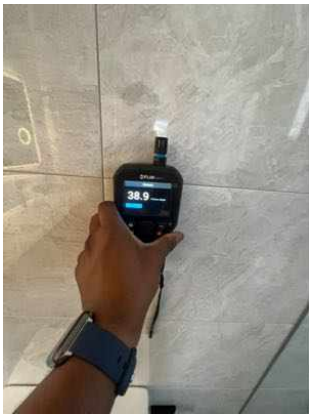
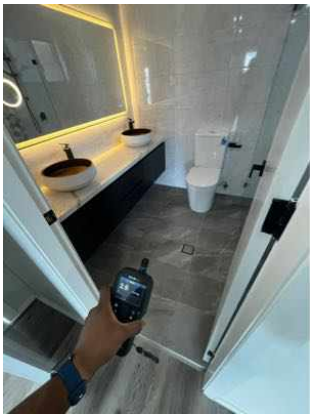
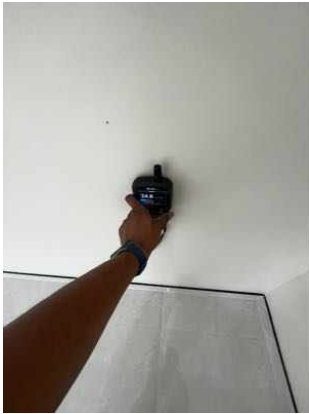
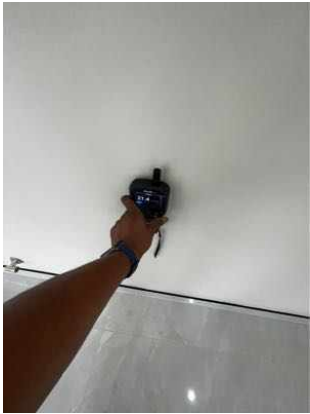
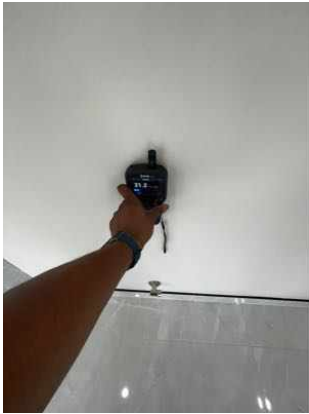
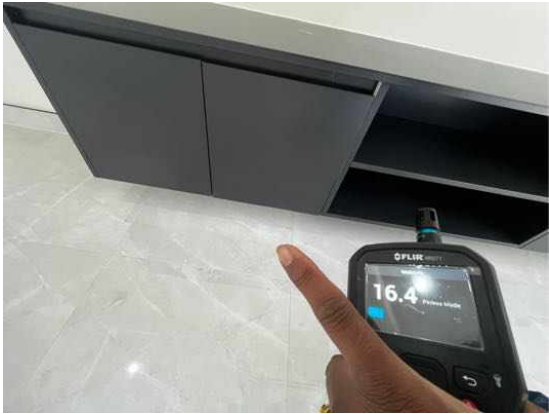
### Noted Item

Termite activity generates high temperatures and moisture and if this irregularity is found it can be grounds for further investigation.
