# Building and Timber Pest Inspection Report

Inspection Date: Thu, 26 Mar 2026

Property Address: 2/72 Page Ave, North Nowra NSW 2541, Australia

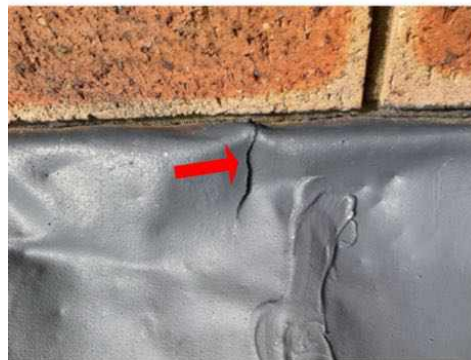
Building: Building 1  
Location: Roof Exterior/ Roof Void  
Finding: Flashing cracked and large gaps in cladding found  
Information: Cracks were evident to the pictured roof flashing and gaps in the timber cladding were found at the time of inspection.

Regardless of the location, if left unmanaged, even minor leaks can lead to serious damage of associated building elements, potentially resulting in the need for replacement of building materials. Damage to ceilings and wood rot has already occurred as these defects have largely been left unmanaged.

A roofing contractor should be engaged to replace this damaged flashing and cladding as soon as possible (see also wood rot and sealant damaged defects).

Replacing the timber cladding with colorbond will be relatively maintenance free for many years.

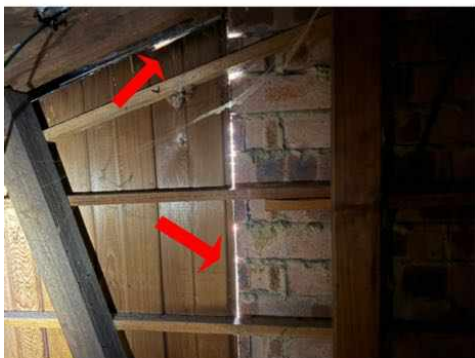
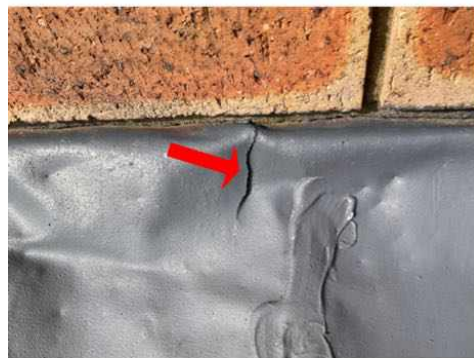
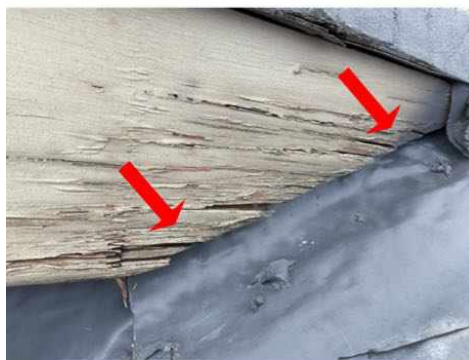
Building:	Building 1
Location:	Roof Exterior
Finding:	Roofing areas - Weathered
Information:	Upon inspection of the exterior roofing, the majority of the roof areas were considered to be in a fair condition. While weathering of these pictured areas is consistent with the age of the property, maintenance works are required.

Re-sealing and replacing small areas of gaps, damage, wood rot and rust must be considered as an interim solution by the client to help preserve and extend the life span of these roofing areas. Where left unmanaged, deteriorating roofing materials are likely to lead to a number of secondary defects, including minor water leaks and weather exposure to internal roofing structures.

Consultation with a roofing contractor is highly advised to gain advice on cost of remedial works that are immediately required.

Remedial works are likely to increase the longevity of the exterior roofing structure.

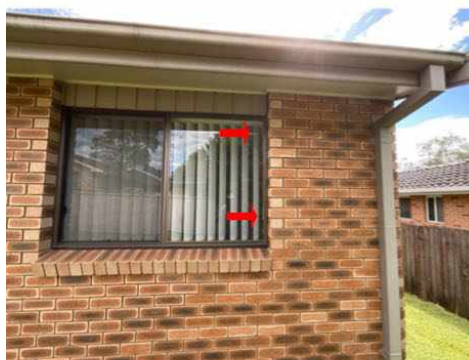
### Finding 3.02

Building:	Building 1
Location:	Rear window
Finding:	Sealant (external) - Missing.
Information:	It was noted on inspection that areas of external sealant was missing to small areas of the external rear window.

Flexible sealants should be applied to these affected areas to prevent any subsequent water damage that is likely to occur.

A sealant specialist or skilled handy person should be appointed to complete these works as soon as possible

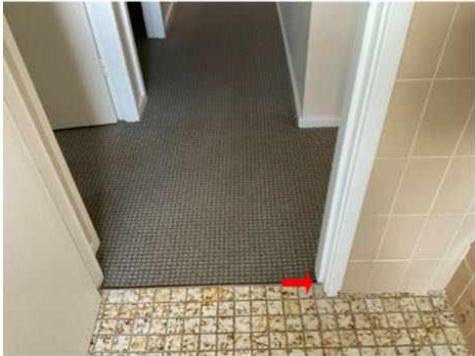
### Finding 3.03

Building:	Building 1
Location:	Pictured areas
Finding:	Wood rot
Information:	The building shows evidence of wood rot to roof barges, roof cladding and the bathroom door frame. Wood rot, also known as Fungal Decay, occurs when timbers and other cellulose building materials are exposed to damp conditions on an ongoing basis. This could be the result of exposure to weathering over a prolonged period of time, or the attraction of excessive moisture from other abutting building materials.

Early intervention and regular maintenance, particularly of exterior timbers, will prolong the useful life of these building elements. Replacement of affected roof timbers is a necessary step in protecting surrounding building elements from such deterioration.

A qualified carpenter or registered builder may also be required to replace affected building materials.

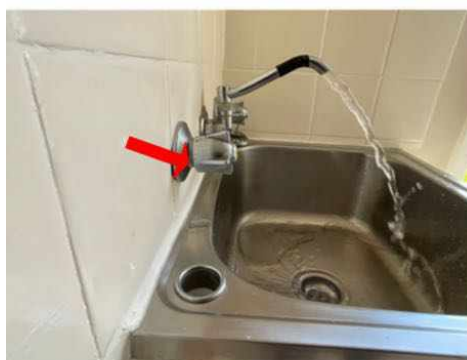
### Finding 3.04

Building:	Building 1
Location:	Pictured areas
Finding:	Building elements - Damaged
Information:	Evidence of minor damaged areas was identified at the time of the inspection. These include -

1. The loungeroom sliding door frame and south east bedroom sliding window frame (holding the glass) are slightly loose and require additional fixings to the wall and sliding window frames respectively.

2. The laundry tap shows a consistent slow leak into the tub when on, requiring a minor plumbing repair.

A carpenter and plumber would be the trade responsible for rectification of these areas when convenient.

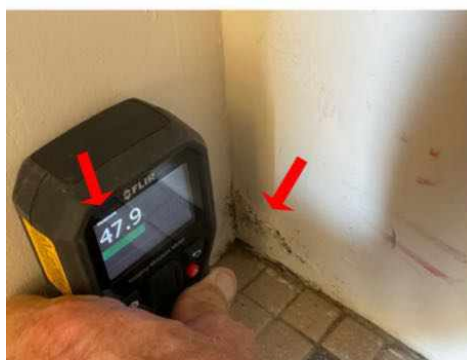
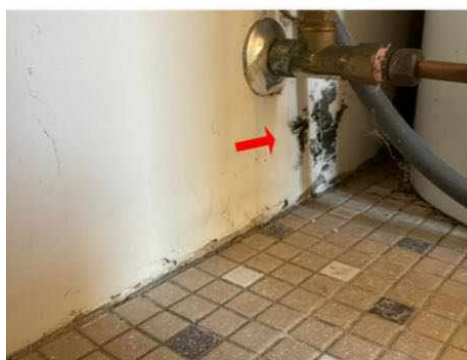
### Finding 3.05

Building:	Building 1
Location:	Laundry cupboard
Finding:	Evidence of excessive moisture and mould was present at the time of inspection
Information:	Excessive moisture and mould was found in the laundry cupboard. A medium

moisture reading of 47.9 was recorded. All nearby areas and all other rooms had zero readings out of 24 readings taken. This moisture can attract termites and produce conditions that promote termite attack fungal growth and wood decay.

Excessive moisture is generally caused by deteriorated, inadequate or missing drainage, leaking plumbing pipes or fixtures poorly plumbed HWS overflows or condenser units and poor site drainage.

It is highly recommended that all plumbing and drainage fixtures and fittings be maintained regularly in order to prevent excessive moisture being present in the internal property. This wall needs to be opened to find the source.

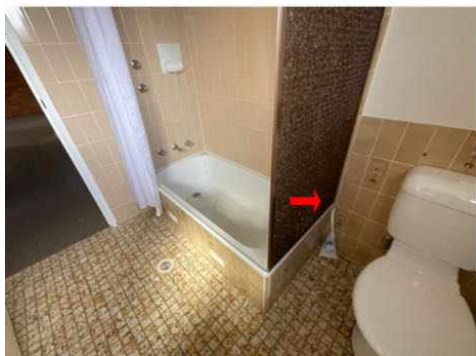
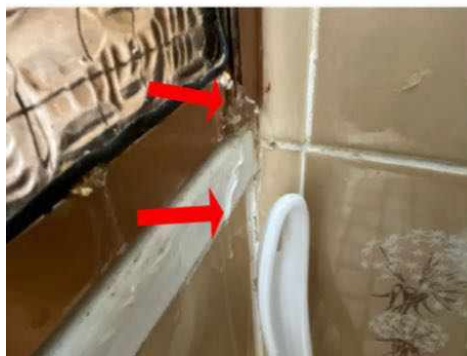
### Finding 3.06

Building:	Building 1
Location:	Bathroom
Finding:	Shower screen - Leaking
Information:	Leaking was evident to the shower screening at the time of inspection. It is suspected that the leaking has occurred as a result missing sealant. Leaking from the shower , where left unattended, is likely to lead to water damage to adjoining flooring and walls. Such damage can lead to water damage and necessitate extensive remedial works being required. Active water leaks may also create an environment that is susceptible to the formation and development of mould.

Appointment of a sealant expert is required to repair or replace this missing sealant. Such works should be performed as soon as possible to ensure that no further damage occurs.

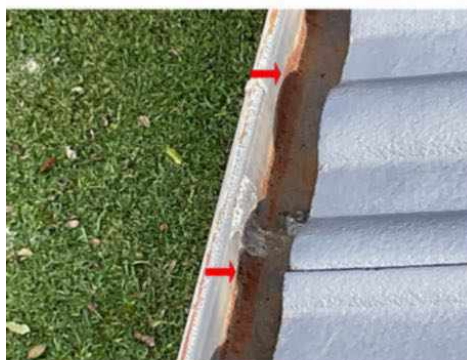
Building:	Building 1
Location:	Roof Exterior & bath
Finding:	Roof areas and bath with minor rusted
Information:	These areas shows evidence of minor rusting and corrosion, which is likely to have developed as a result of excessive exposure to moisture and or inadequate coatings.

As surface rust provides no protection to the underlying iron, the deteriorating condition is likely to worsen if not addressed in the short-term future.

Where possible, the use of galvanized (treated) metals or aluminium coated metals aid in rust prevention, as does regular general maintenance. Rust formation can be controlled with coatings, such as paint, that isolate the iron from the environment.

Rusting and corrosion should be managed by ideally removing or limiting the affected surface from exposure to moisture. A registered builder may be appointed to replace any building elements that have been severely affected by rust or water damage.

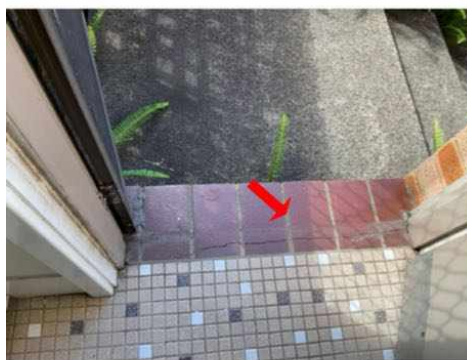
Building:	Building 1
Location:	Bathroom, laundry
Finding:	Tiles cracked
Information:	Cracked tiles were evident in these pictured areas at the time of inspection. It is suspected that this cracking has occurred as a result of minor settlement or impact damage.

Cracked tiles throughout the household detract from the overall appearance of the affected areas. In wet areas of kitchens and bathrooms, it can lead to water damage of adjoining walls and floors.

Replacement of cracked tiles is recommended as soon as possible. A tiling contractor

may be appointed to perform these works. Where cracks become more numerous, contact a licensed building inspector for further investigation.

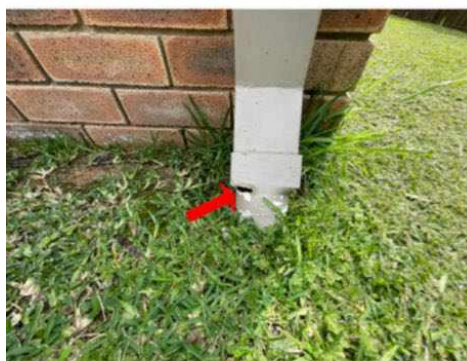
### Finding 3.12

Building:	Building 1
Location:	Walls
Finding:	Site drainage - Inadequate
Information:	The site drainage in this area was found to be inadequate at the time of inspection, creating potential for subsequent water damage to associated building elements.

No rear drainage is evident. One rear downpipe boot has cracked. The hot water system overflow run against the house walls.

Where site drainage is inadequate, installation of an Agricultural (Aggie) Drain may be required. A qualified plumber should be appointed to further inspect the property and perform any remedial works as necessary. Secondary defects are likely to occur if left

unmanaged.

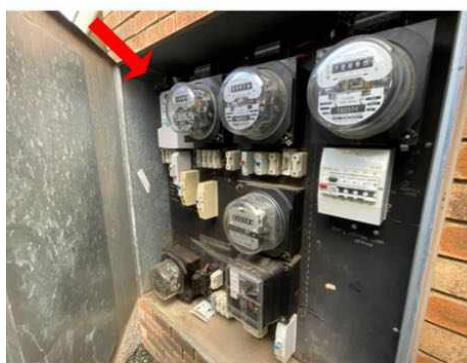
Information: The application of a post-construction chemical termite barrier is highly recommended for all properties. Such barriers are highly effective in preventing termite attack on any timber building elements throughout the property.

A durable notice should be placed in the switchboard unit to indicate current termite barriers. At the time of inspection, no durable notice was evident and it appeared as though no chemical termite management system has been installed, with no evidence to suggest preventative works taking place since the property was built.

The client may consider gaining further advice from a pest controller as to the costs and procedures involved with a 'chemical' application. It is recommended that obtaining such advice be a short-term priority.

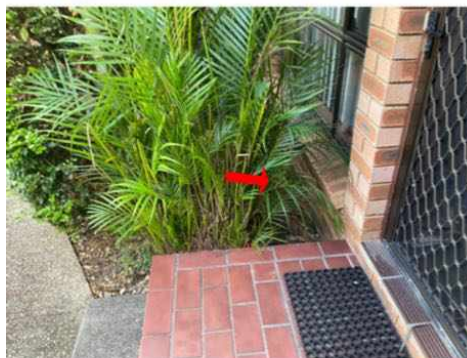
### Finding 6.03

Building: Building 1  
 Location: Exterior walls  
 Finding: Slab Edge - Exposure  
 Information: An inspection zone of at least 75mm in relation to the exposed slab edge, between the bottom brick and the perimeter pavement, is required. This inspection zone should be maintained in order to force termites into the open where they can be detected more readily during regular inspections. The slab edge should not be concealed by anything that may prevent inspection of the area, including render, landscaping, soil, turf, paving, concrete cladding or other structures.

If the slab edge is not properly exposed there is a high risk of termite attack. Sometimes, in order to determine the type of slab, a suitably qualified person such as an architect or builder may be required to consult the construction plans.

Where the slab edge cannot be properly inspected, it is highly recommended that termite or timber pest inspections be carried out every 6-12 months to aid protection of the property against infestation.

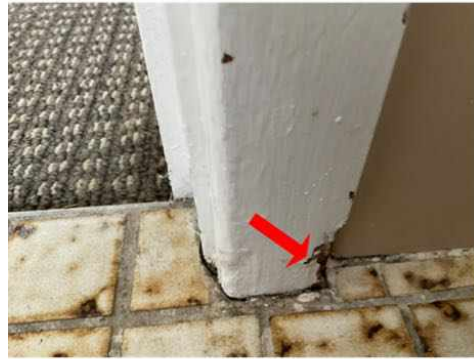
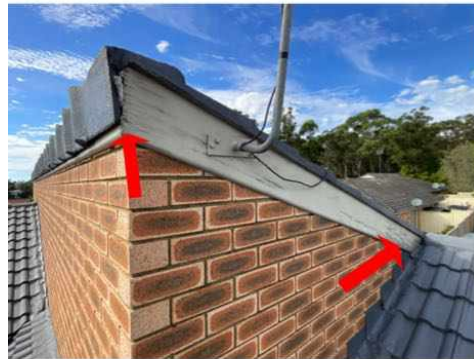
### Finding 7.01

Building:	Building 1
Location:	Verandah
Finding:	Fungal decay - present (localised)
Information:	Fungal decay also known as wood decay or wood rot generally refers to the deterioration of timber elements when in contact with excessive levels of moisture for a prolonged period of time.

The development of fungal decay is accelerated by temperatures from 5degreeC to 40degreeC as well as the presence of oxygen. Generally fungal decay develops on timber elements that are in use in an external environment which are exposed to rain penetration.

Note - See ALL wood rot photos, all these show fungal decay.

In this case, the affected timber element is in a decaying state and will need replacement by a carpenter or licensed builder.

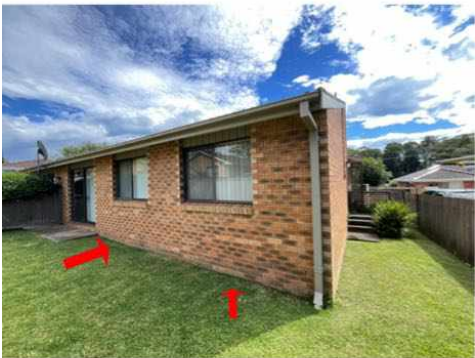
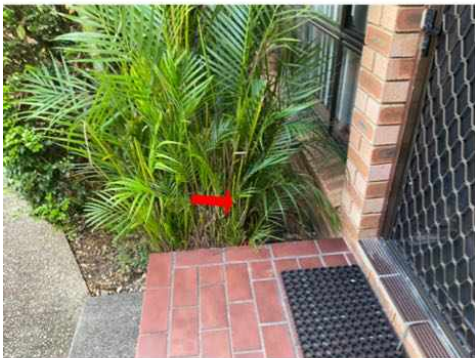
#### Noted Item

Building: Building 1  
 Location: All External Areas  
 Finding: Additional Photos - Obstructions and Limitations of EXTERNAL AREAS  
 Information: These photographs are an indication of the obstructions and limitations which impeded full inspection of external areas at the time of inspection. These obstructions can hide an array of defects and should be removed to allow full inspection to be carried out. A re-inspection is recommended once the areas are made accessible.

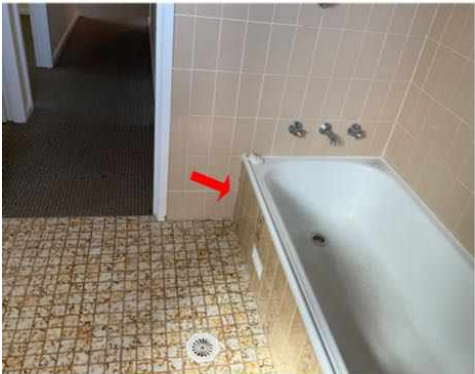
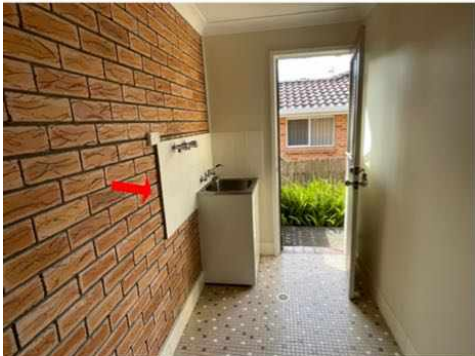
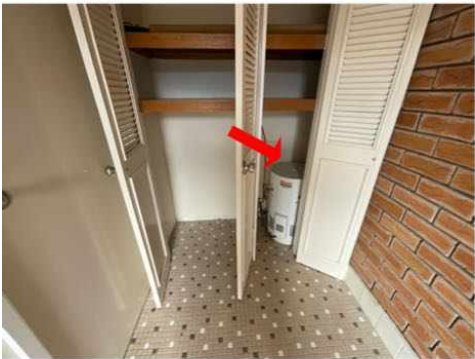
**Noted Item**

Building: Building 1  
Location: All Internal Areas  
Finding: Additional Photos - Obstructions and Limitations of INTERNAL AREAS  
Information: These photographs are an indication of the obstructions and limitations which impeded full inspection of Internal areas at the time of inspection. These obstructions can hide an array of defects and should be removed to allow full inspection to be carried out. A re-inspection is recommended once the areas are made accessible.

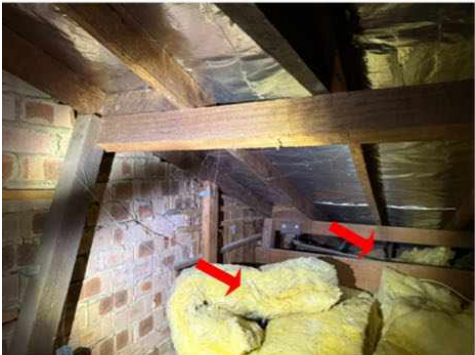
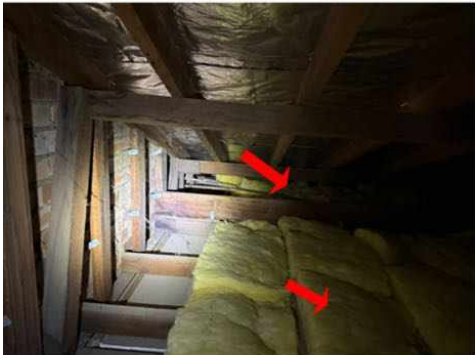
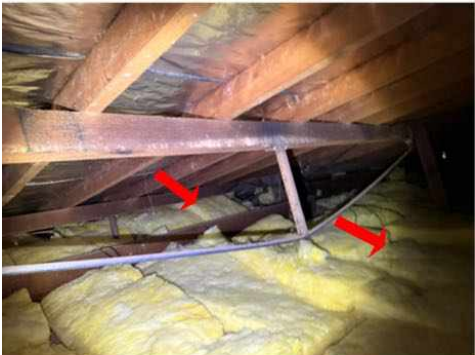
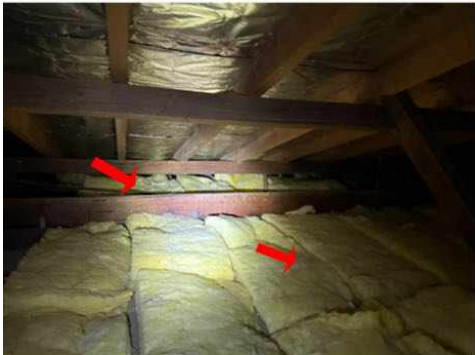
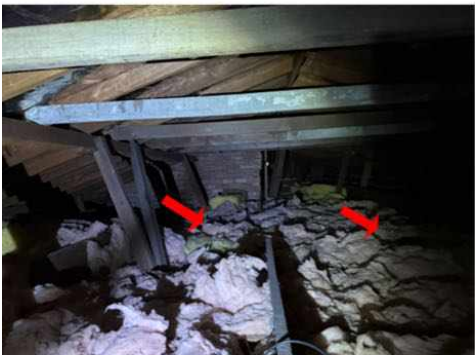
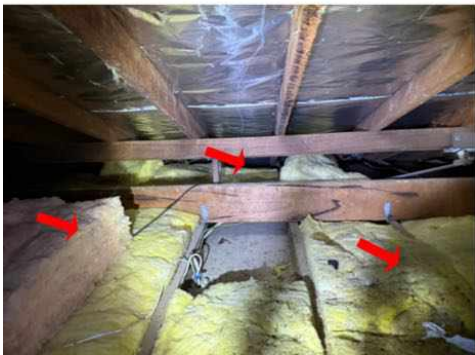
**Noted Item**

Building: Building 1  
Location: All Roof cavity areas  
Finding: Additional Photos - Obstructions and Limitations of the ROOF CAVITY  
Information: These photographs are an indication of the obstructions and limitations which impeded full inspection of roof cavity areas at the time of inspection. These obstructions can hide an array of defects and should be removed to allow full inspection to be carried out if applicable. A re-inspection is recommended once the areas are made accessible.

The inspection was also limited to areas with an allowable crawl space of 600mm x 600mm, in particular towards the external walls where the roof line diminishes, these areas were not accessible.

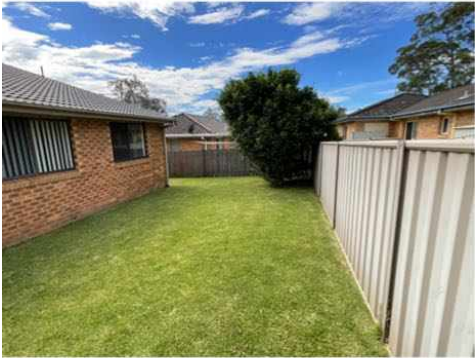
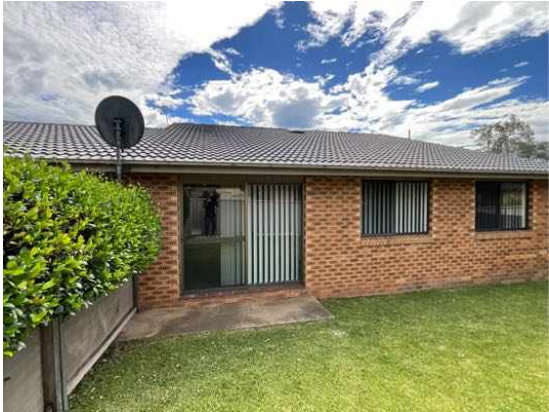
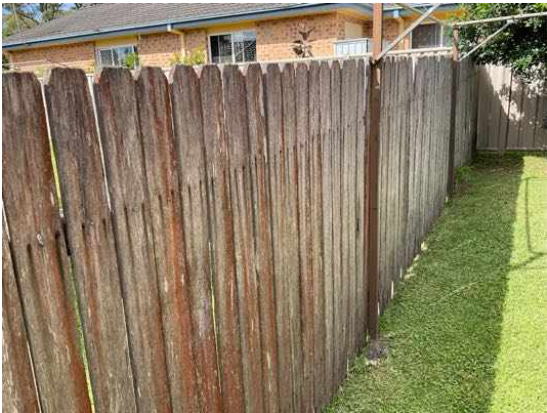
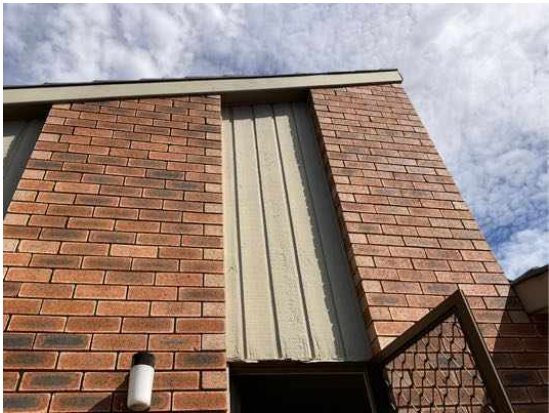
Building: Building 1  
Location: All External Areas

Finding: Additional Photos  
Information: Additional photos are provided for your general reference

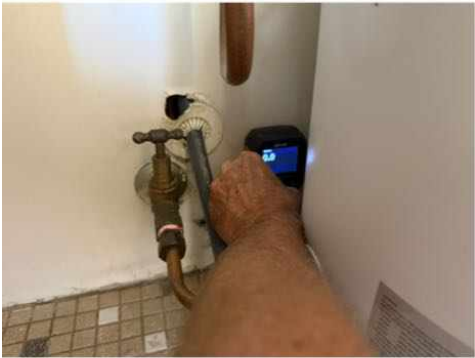
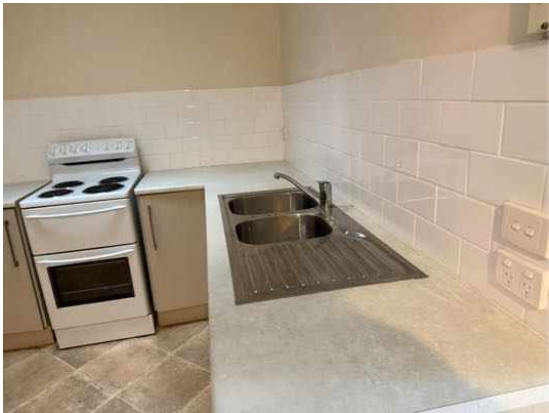
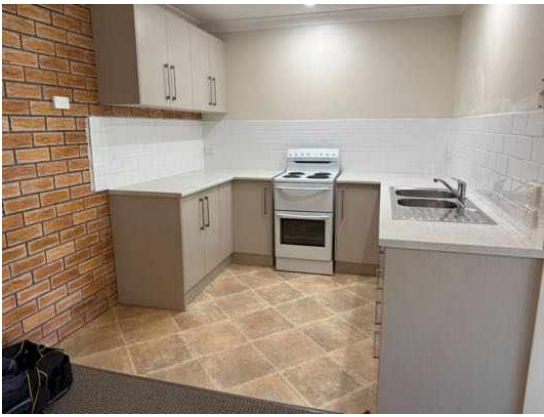
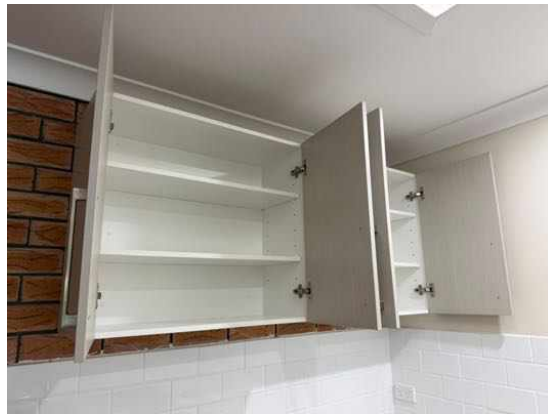
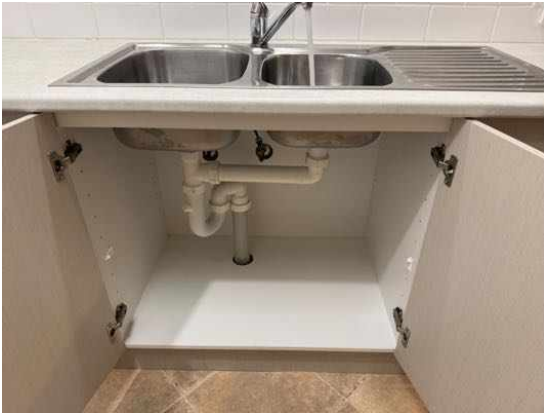
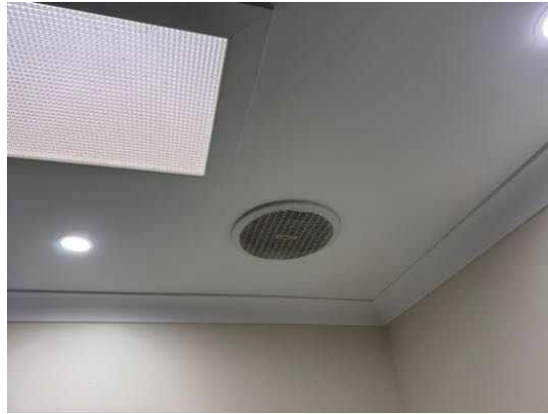
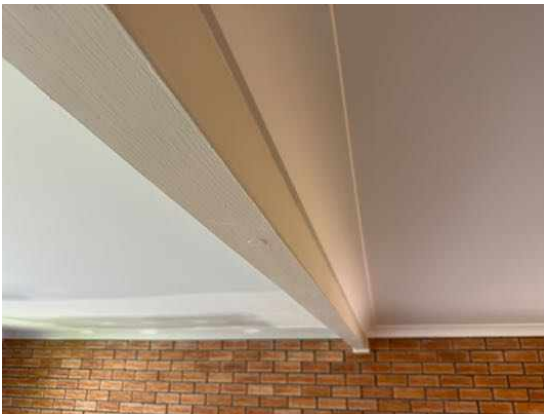
Building: Building 1  
Location: All Internal Areas  
Finding: Additional Photos  
Information: Additional photos are provided for your general reference

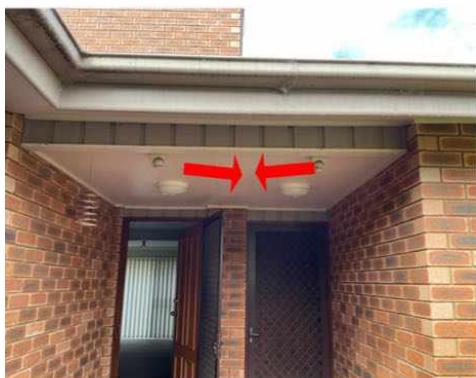
Finding: Firewall missing

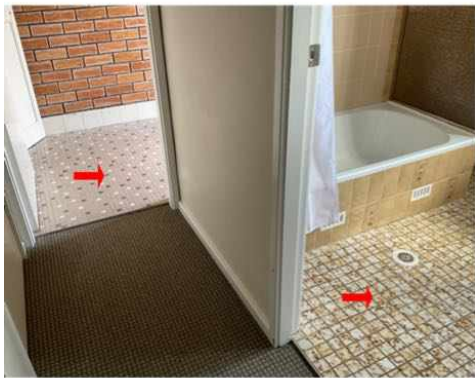
Building:	Building 1
Location:	Bathrooms and laundry
Finding:	Waterproofing membranes - Information Only
Information:	Internal Water Proofing Membranes, are crucial in preventing water ingress into the property is important to know that the Membrane System used is to Australian Standards and has been installed correctly.

With older property's where this information is unavailable all wet areas should be monitored. If any leaks, water staining, peeling or bubbling of the paint become evident to any adjacent walls or ceilings below a licensed builder or waterproofing specialist is recommended to investigate further.
