Building and Timber Pest Inspection Report

Inspection Date: Tue, 17 Mar 2026

Property Address: 2 Bradford Ave, Prospect Vale TAS 7250,
Australia

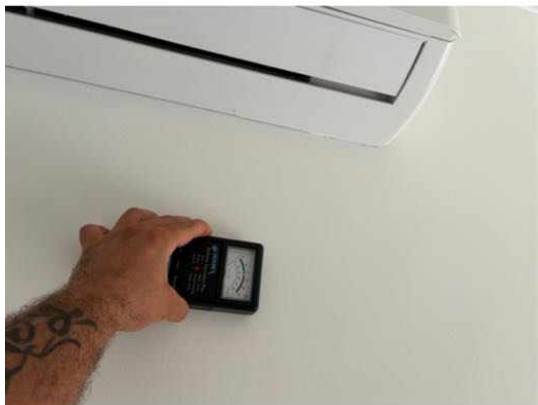
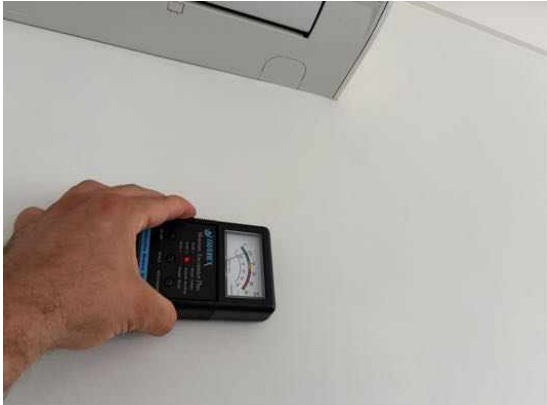
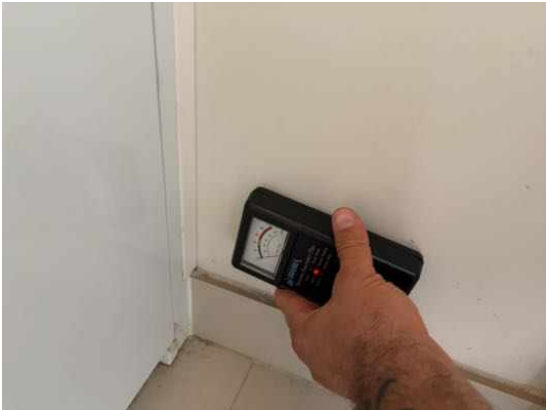
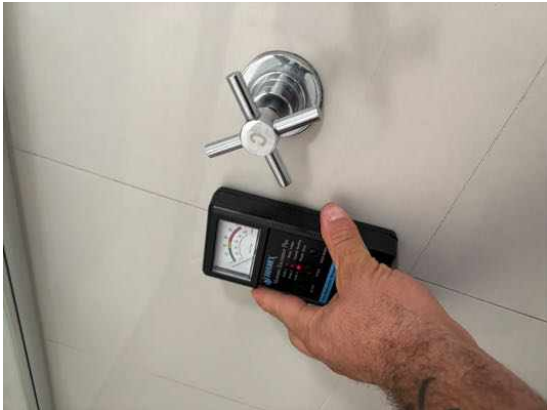
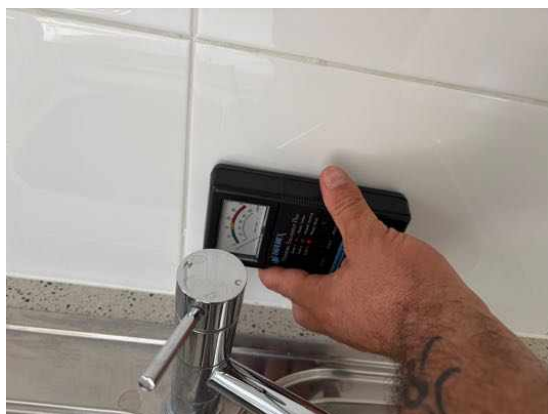
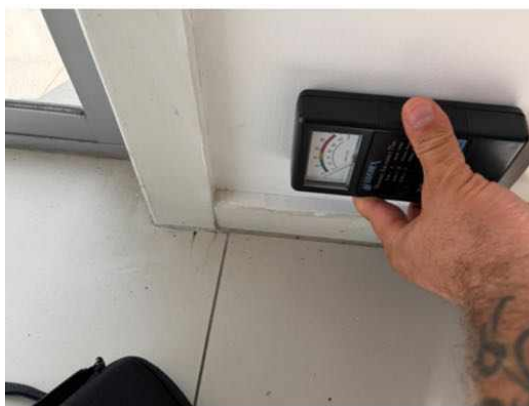
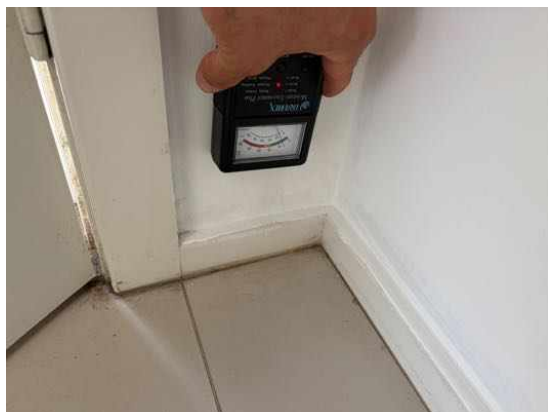
Building: Main Building
Location: All Areas
Finding: Moisture metre
Information: During the inspection the property was checked for moisture using a moisture metre.

This is for information only.

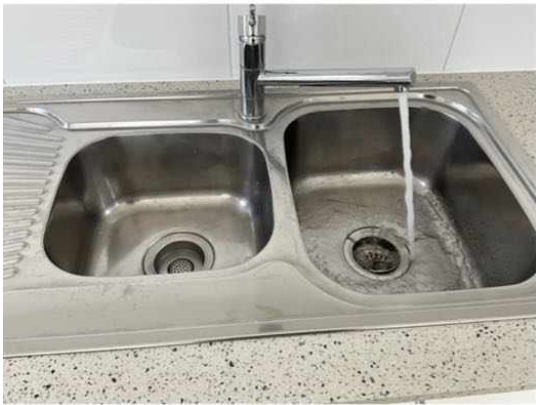
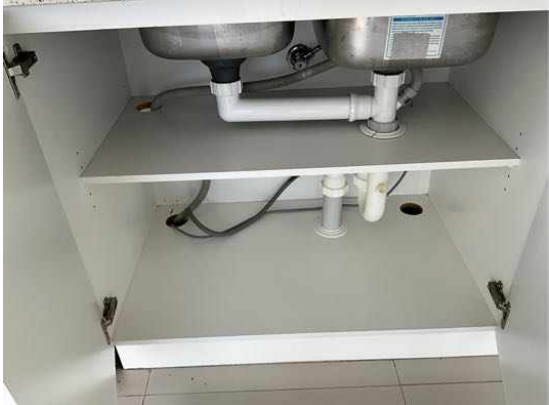
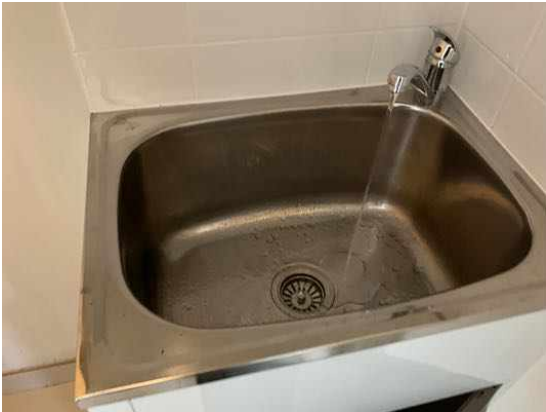
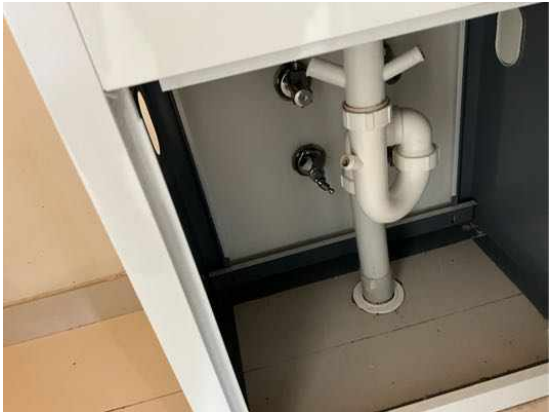
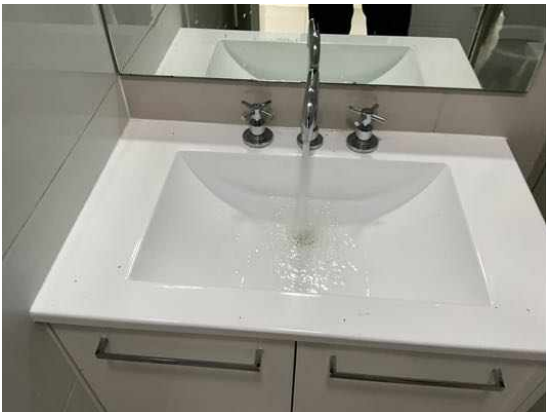
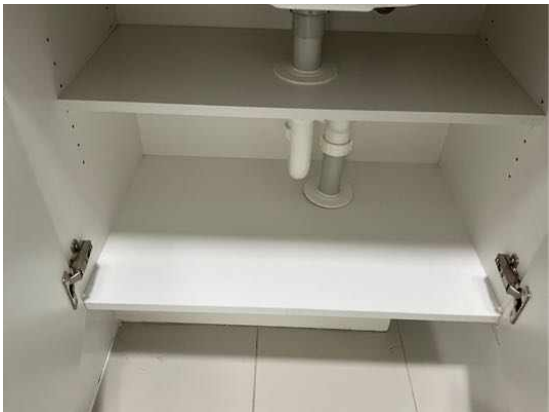
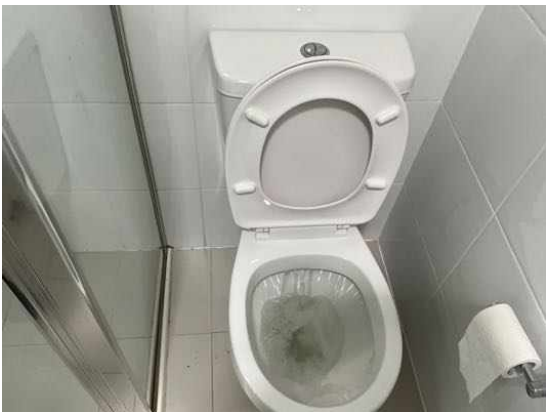
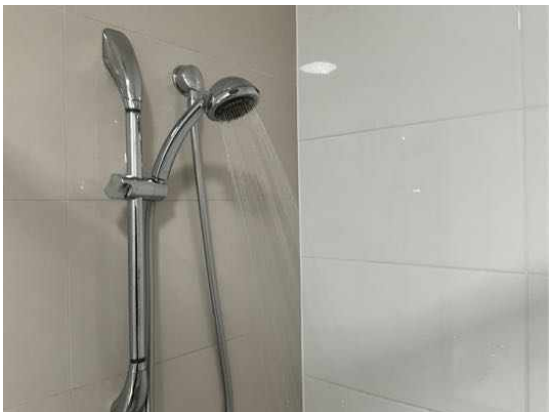
Building: Main Building
 Location: All Wet Areas
 Finding: Waterproofing
 Information:

All taps, mixers and toilets were tested for operation, except for those obstructed. The waterproofing to the shower recess was assessed by checking the walls in and around the shower recess for varying moisture content. There were no significant variations across the tested areas. No sign of recent water damage was evident upon a visual inspection of the surrounding walls, where the visual nature of the inspection was possible.

Consequently, there is no conclusive evidence of any current shower recess leakage other than those which may have already been mentioned earlier in this report. It is reasonable to assume the shower waterproofing is sound. Note that if the shower is not used, or has not been used for some time, moisture readings would not vary significantly and this can lead to erroneous results. It is not possible under the visual inspection criteria (under which a prepurchase inspection is carried out) to categorically determine if there are leaks. If a more accurate assessment is required, a special purpose inspection should be requested. Alternatively, the assumption should be made that the shower may leak.

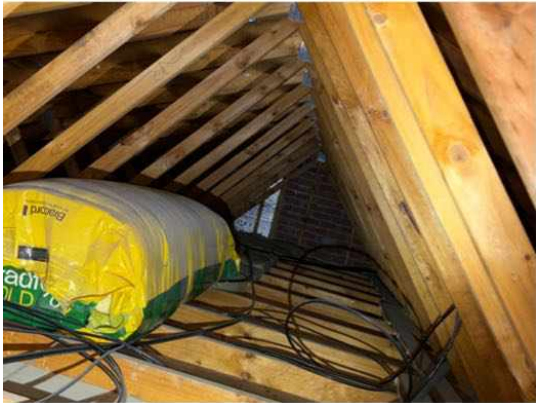
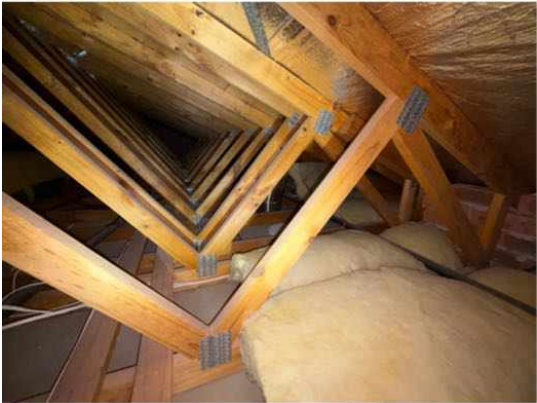
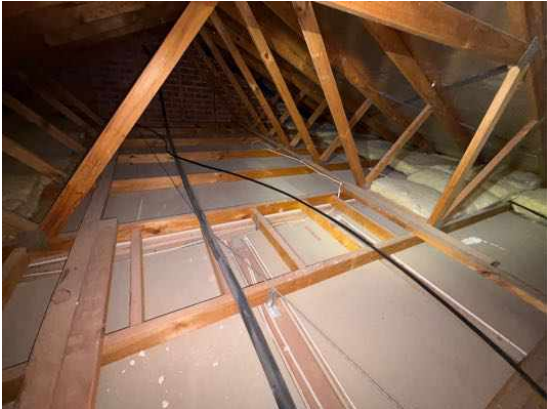
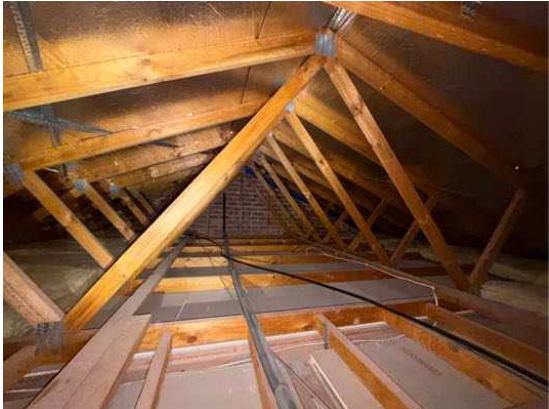
Building: Main Building
Location: Roof Void
Finding: Additional Photos
Information:

Additional photos are provided for your general reference.

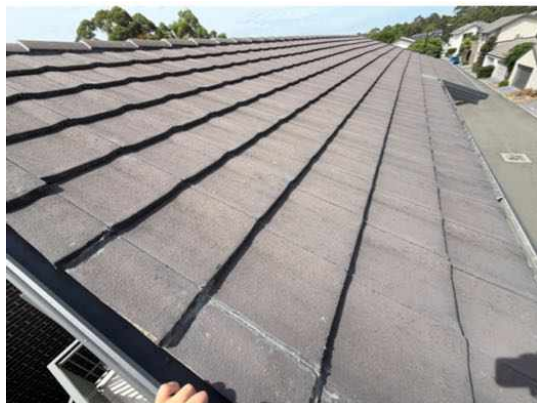
Building: Main Building
Location: Roof Exterior
Finding: Additional Photos
Information:

Additional photos are provided for your general reference.

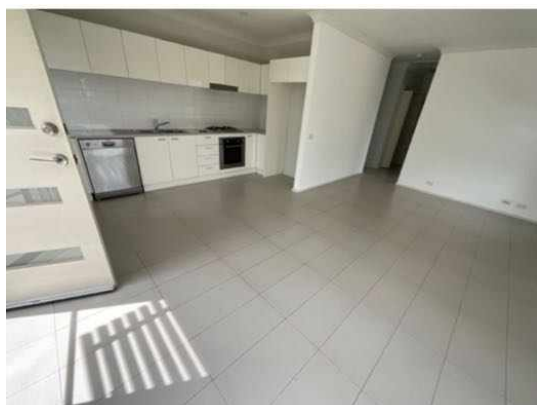
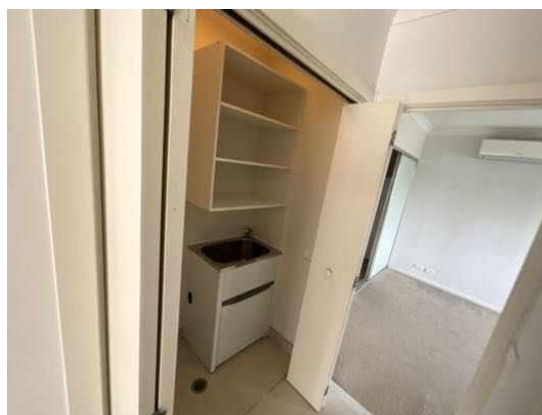
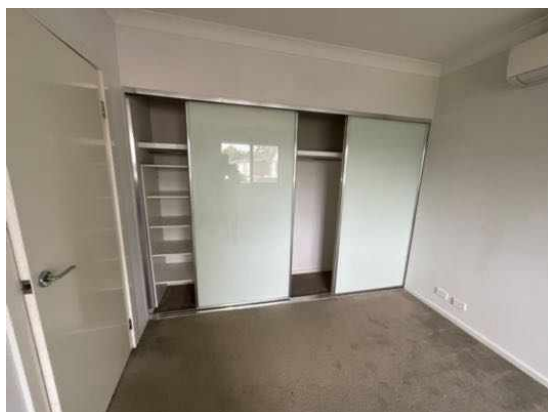
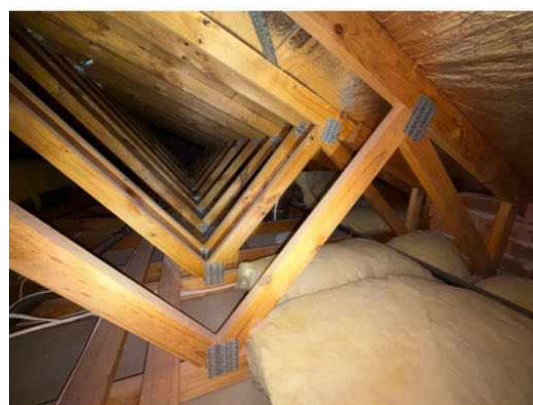
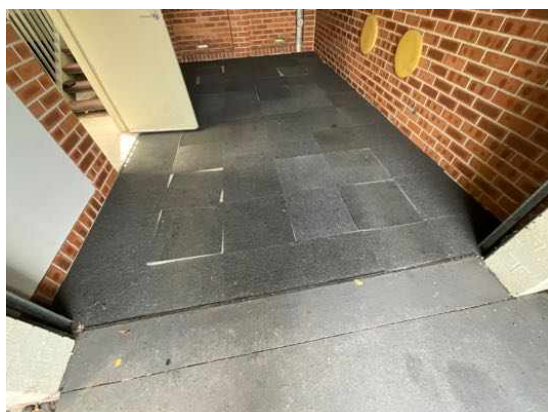
Building: Main Building
Location: All Areas
Finding: Additional Photos - Obstructions and Limitations
Information:

These photographs are an indication of the obstructions and limitations which impeded full inspection of the property at the time of inspection. These obstructions can hide an array of defects and should be removed to allow full inspection to be carried out. A re-inspection is recommended once the areas are made accessible.

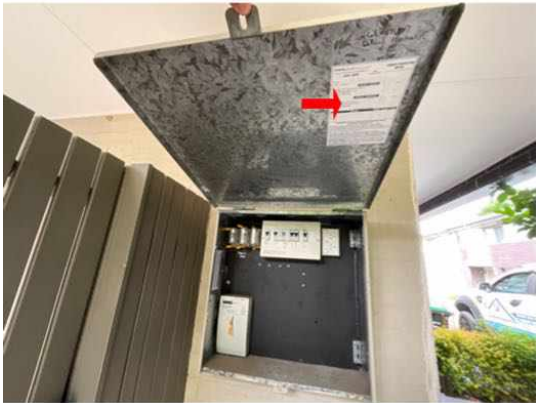
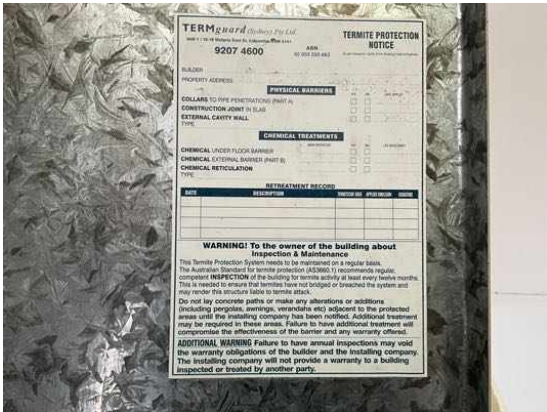
The following items were noted as - Evidence of a previous termite management program

Where a Termite Management System has been identified you should refer to the type of barrier date of installation warranty conditions and any documentation provided by a builder or past owner. Consult the company who installed the barrier to confirm whether the system is still under warranty.

Most chemical termite management systems expire and require replenishment and all physical systems are primarily designed to prevent concealed entry.
