Building and Timber Pest Inspection Report

Inspection Date: Wed, 11 Feb 2026

Property Address: 510 Milro Ave, East Albury NSW 2640,
Australia

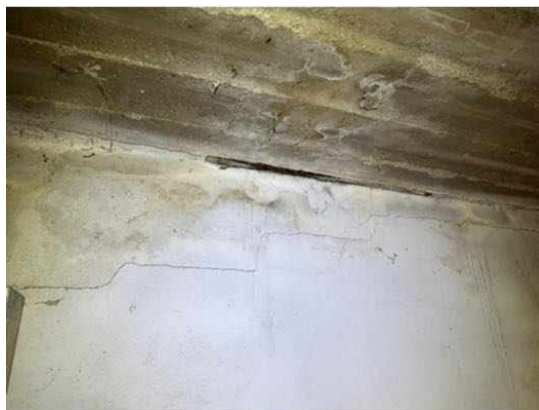
Building: Main Building
Location: Balcony Slab, Brickwork
Finding: Brickwork & Balcony Slab - Cracking & Rising Damp
Information: Cracking was identified to some areas of the brickwork and the balcony slab at the time of inspection. Cracking, has a variety of possible causes. However, the most common is general movement of adjacent footings. Rising damp (moisture in the brickwork) was also identified to the garage walls.

Step cracking is a relatively common defect, and is most likely to occur adjacent to windows, doors and other openings.

The client should monitor the cracking. Should the cracking lengthen, widen or become more numerous, a structural engineer should be engaged promptly, to provide further advice. Should the rising damp develop, a damp-proofing specialist should be engaged to provide further advice.

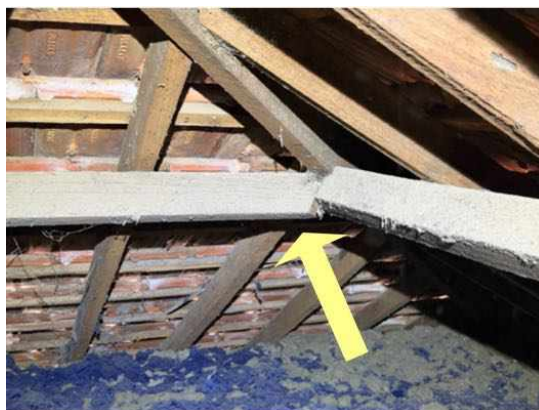
Finding 3.02

Building: Main Building
Location: Roof Void
Finding: Roof Framing - Additional Fixings / Support Recommended
Information: It appears some areas of the under-purlins in the roof void, are slightly sagging and require additional fixings and/or support. Although it appears this has been present for an extended period of time, additional fixings / support are recommended to avoid further potential movement and sagging.

Recommend engaging a registered builder in the short term, to provide further advice & remedial works where necessary.

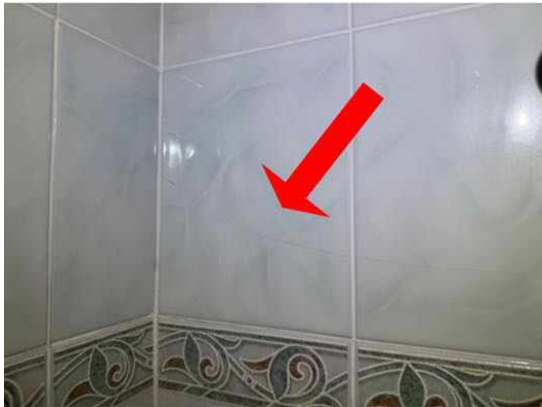
Finding 3.03

Finding: Sealant / grouting - deteriorated or missing & Cracked Tiles

Information: It appears that the sealant and grout has deteriorated in some tiled areas, a common defect in buildings of a similar age. Areas of cracked tiles were also noted, which can allow for moisture ingress behind the tiles, if neglected.

Sealant and grouting in areas that come into regular contact with water should be maintained for the long term care of your property.

Recommend engaging a licensed tiling contractor in the short term, to provide maintenance works where necessary.

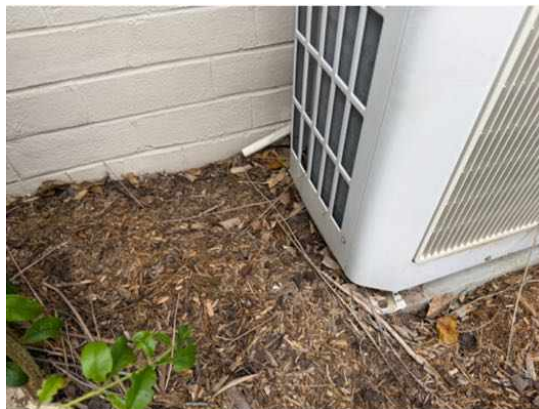
beds against the house are present, water pooling is likely to occur, and can create areas conducive to timber pests and potential damage to the subfloor structure overtime, if neglected.

Recommend consulting with a licensed plumber in the short term to further assess and provide remedial advice.

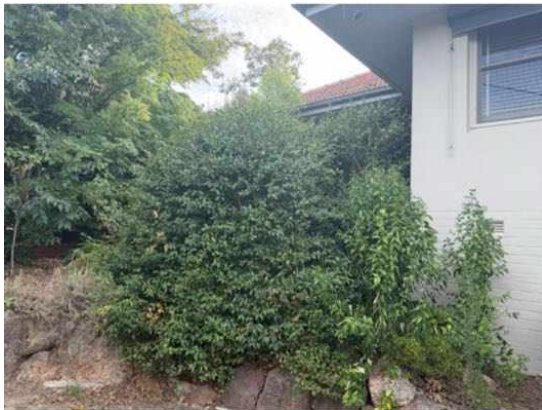
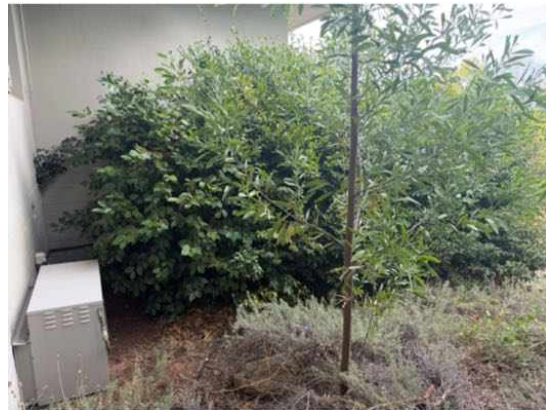
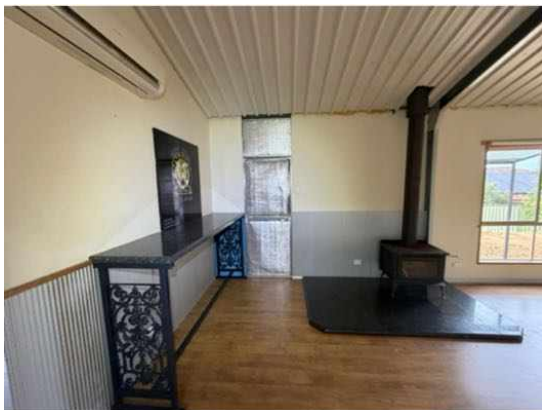
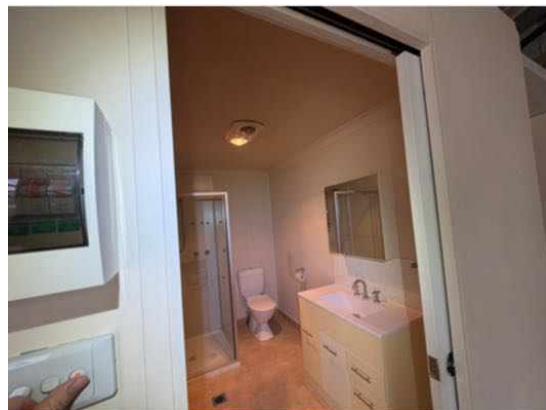
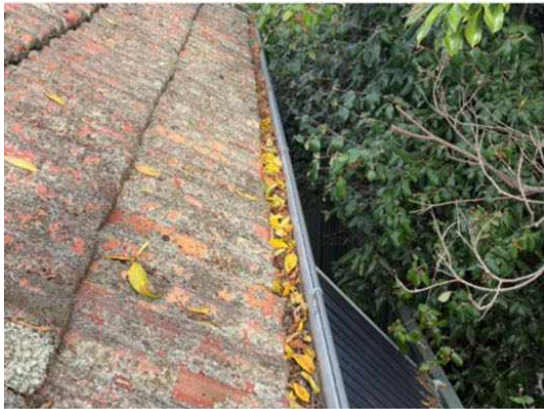
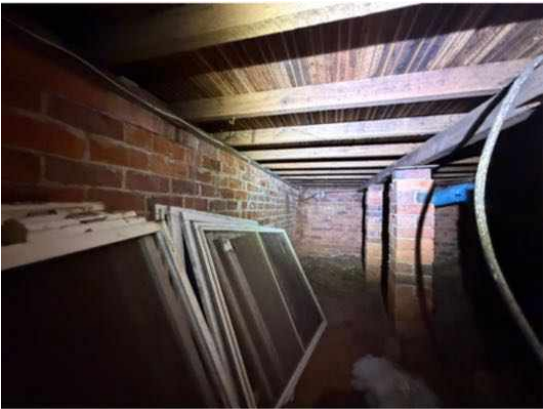
Noted Item

Building: Main Building
Location: All Areas
Finding: Additional Photos - Obstructions and Limitations
Information: These photographs are an indication of the obstructions and limitations which impeded full inspection of the property at the time of inspection. These obstructions can hide an array of defects and should be removed to allow full inspection to be carried out. A re-inspection is recommended once the areas are made accessible.

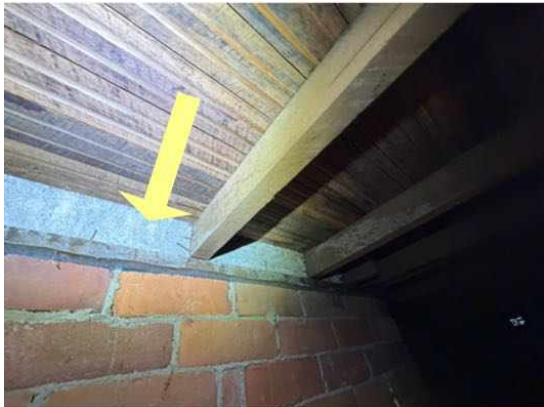
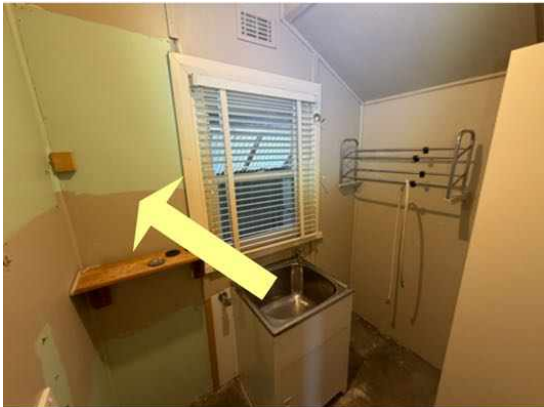
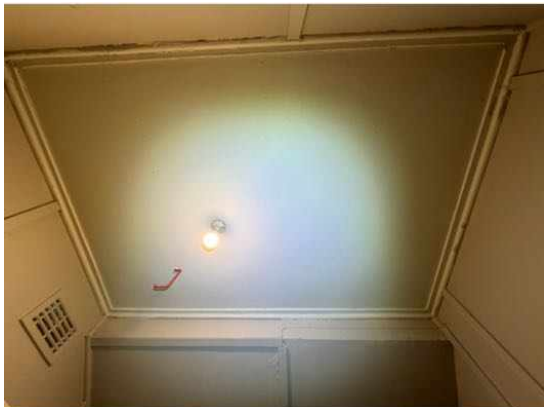
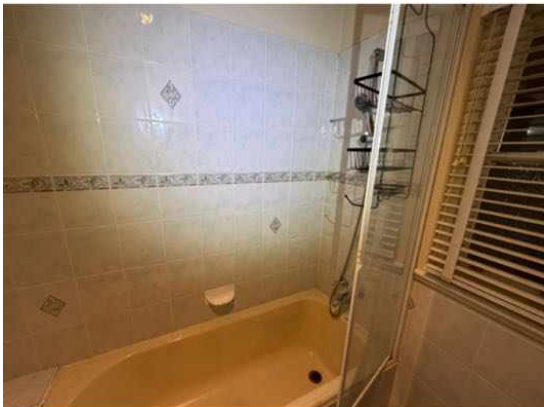
Noted Item

Building: Main Building
 Location: Eaves, Bathroom, Toilet, Laundry, Switchboard
 Finding: Asbestos - Suspected ACM Identified on Site
 Information: This suspected defect is highlighted as a caution only as reporting on asbestos is outside the scope of this report. It is suspected that the materials including but not limited to the eave sheets, switchboard, bathroom, toilet & laundry wall linings may be ACM (Asbestos containing materials)

It is advised that the client consider a separate Asbestos Inspection and Condition Audit, which can include the taking of samples for definitive confirmation of the presence of Asbestos, carried out by a licensed Asbestos Inspector.

In the interim, no works should be conducted to these areas without further specialist advice.
