Building Inspection Report

Inspection Date: Thu, 12 Mar 2026

Property Address: 907/311 Hume Hwy, Liverpool NSW 2170,
Australia

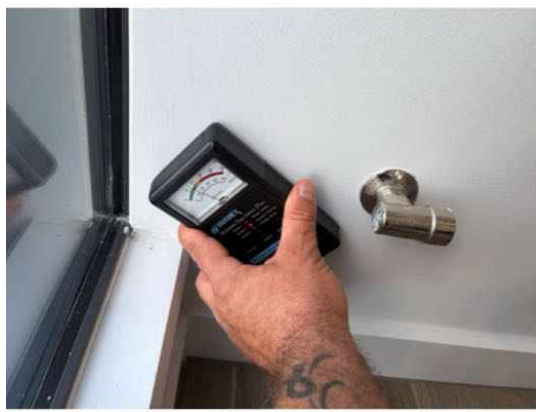
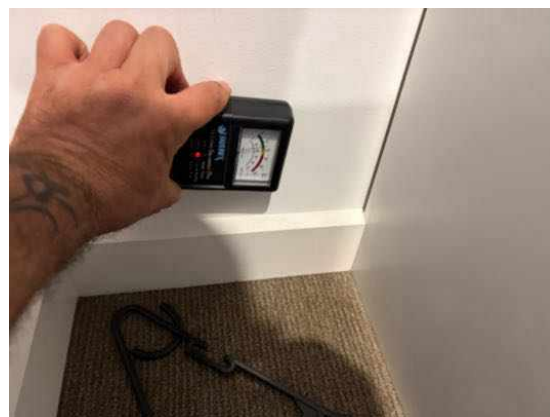
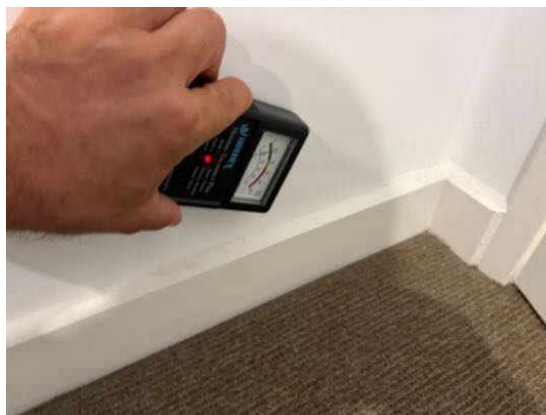
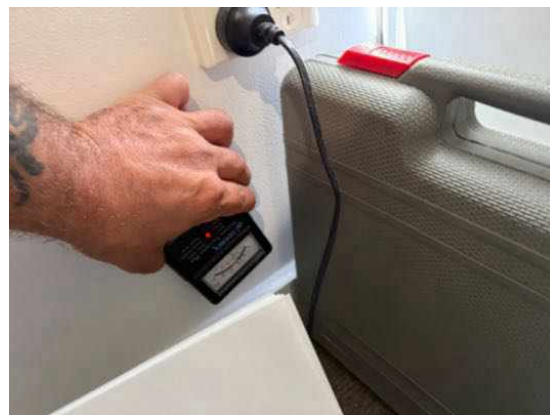
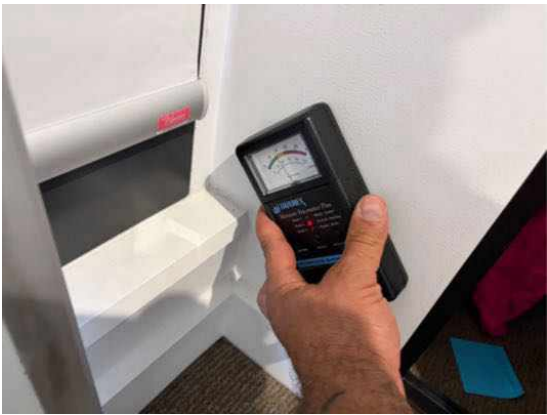
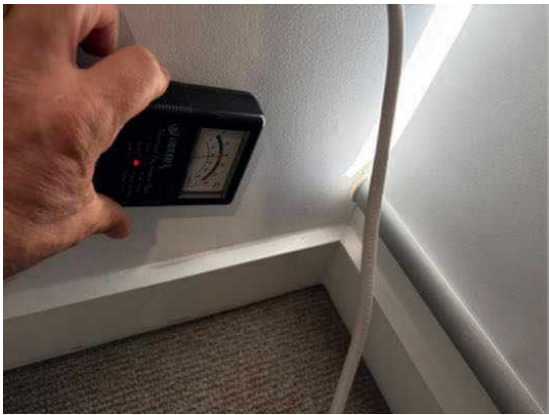
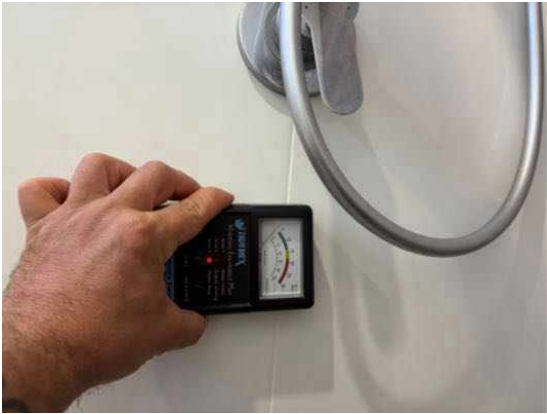
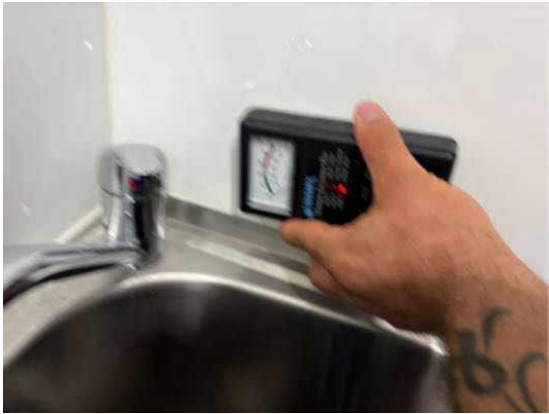
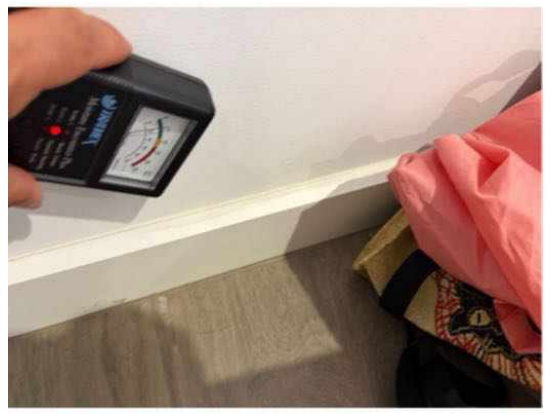
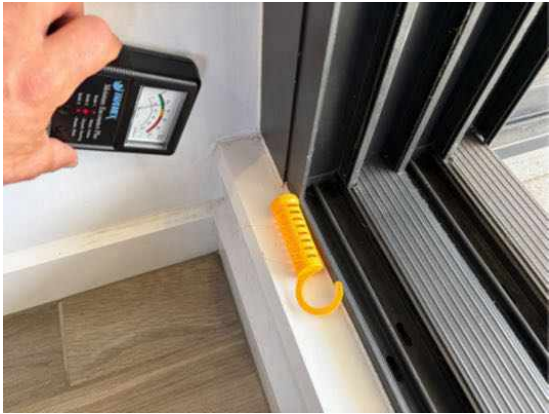
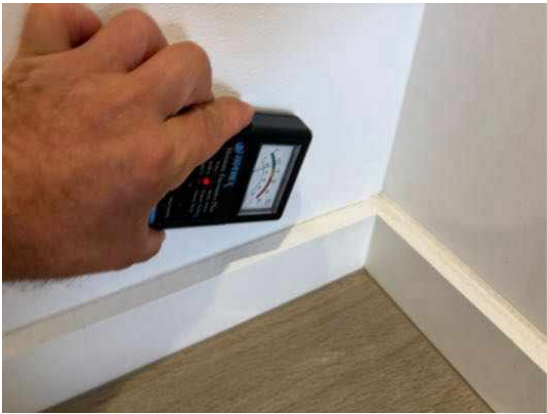
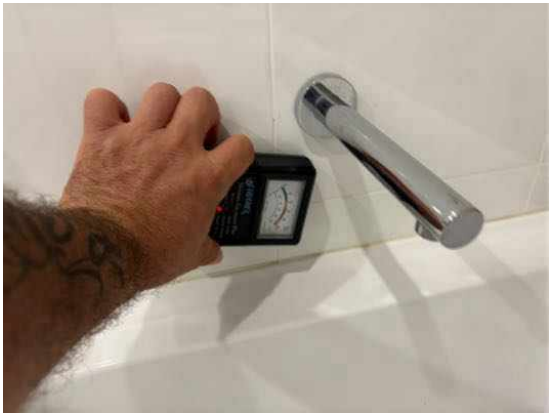
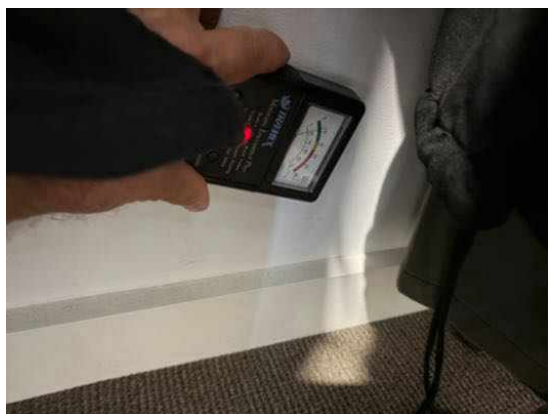
Building: Main Building
Location: All Areas
Finding: Moisture metre
Information: During the inspection the property was checked for moisture using a moisture metre.

This is for information only.

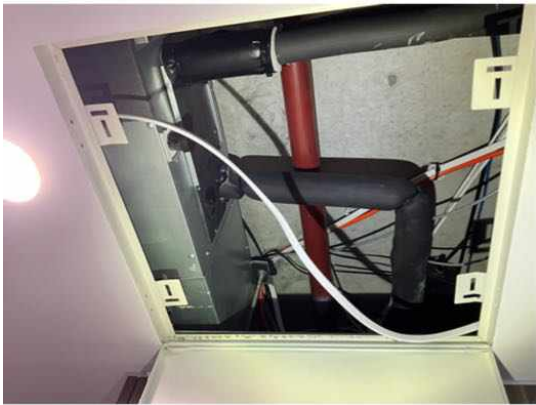
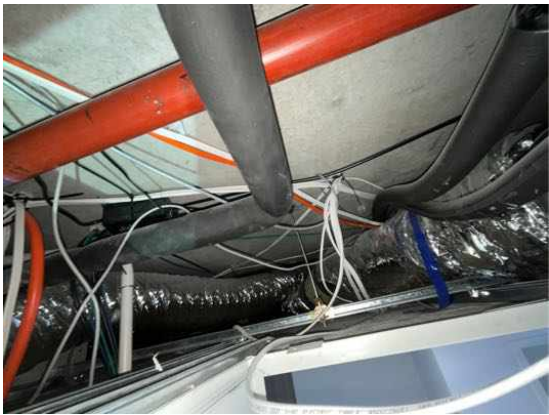
Building:	Main Building
Location:	Ceiling cavity
Finding:	Additional Photos- ceiling cavity
Information:	Additional photos are provided for your general reference. Arrows may have been included to highlight areas of importance. Please discuss these photos with your building consultant for clarification.

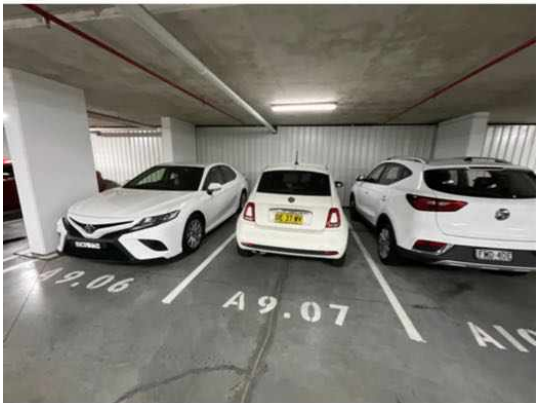
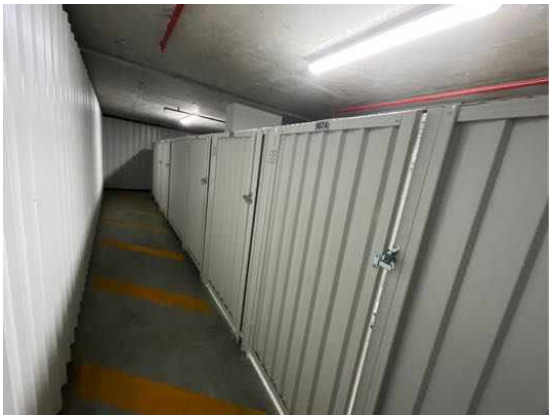
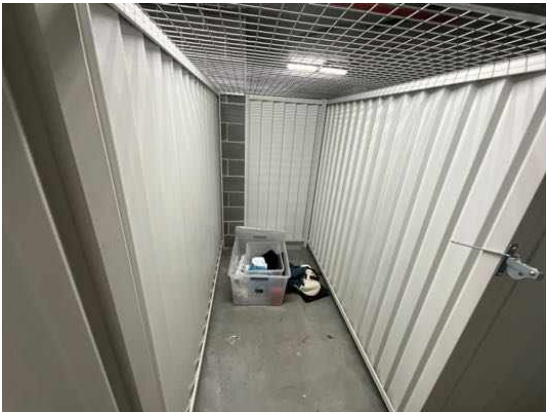
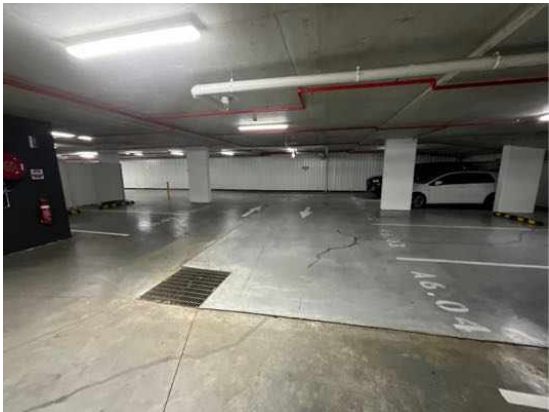
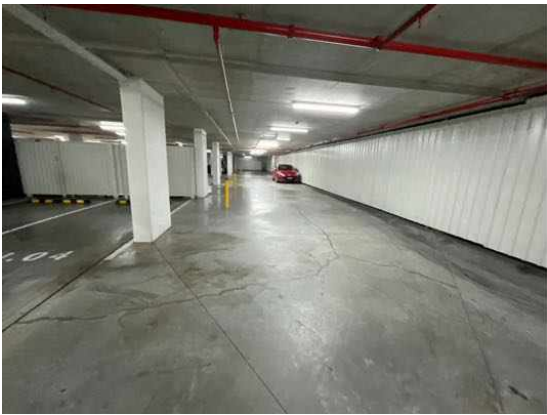
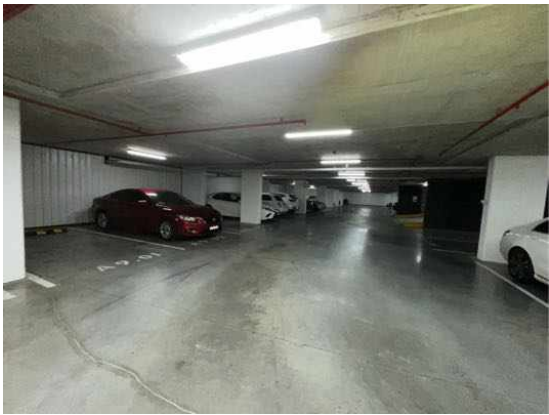
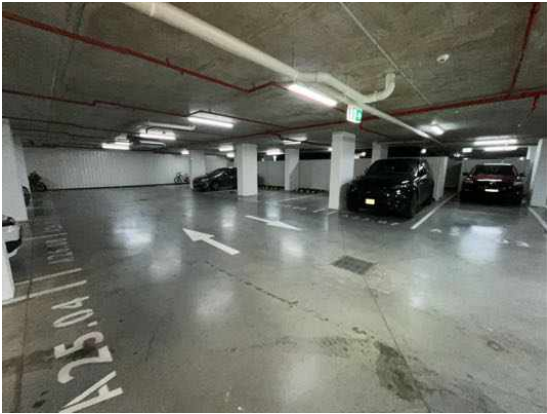
Building: Main Building
 Location: Garage
 Finding: Additional Photos- Garage
 Information: Additional photos are provided for your general reference. Arrows may have been included to highlight areas of importance. Please discuss these photos with your building consultant for clarification.

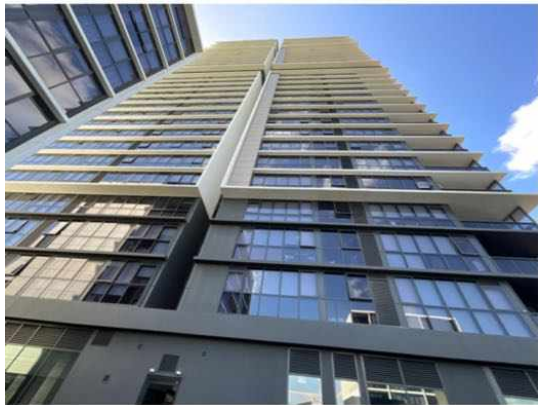
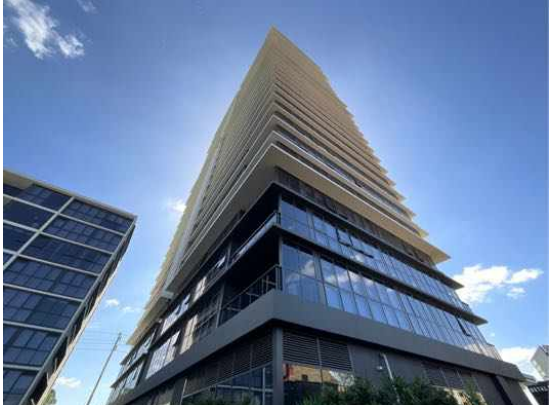
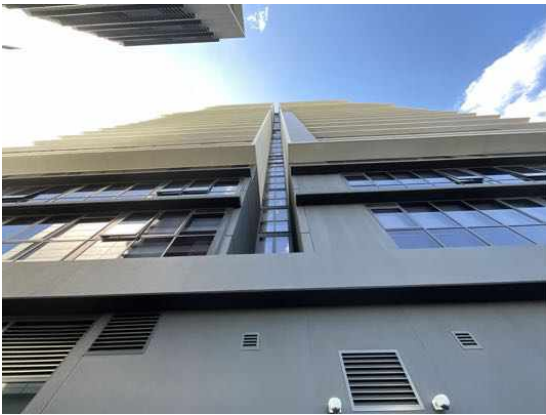
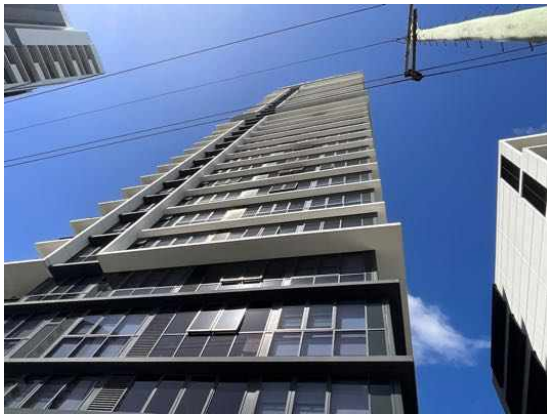
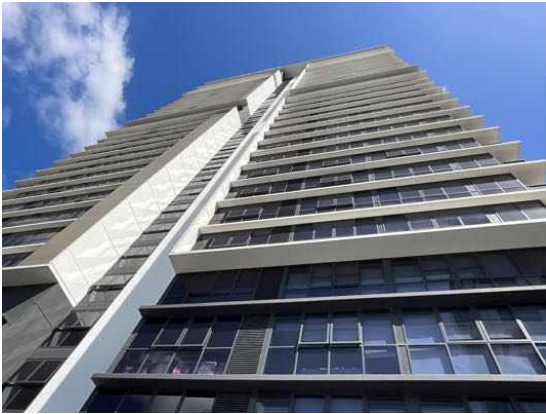
Building: Main Building
Location: Exterior
Finding: Additional Photos
Information:

Additional photos are provided for your general reference.

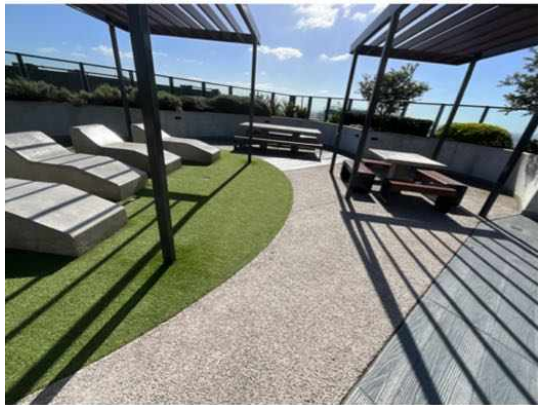
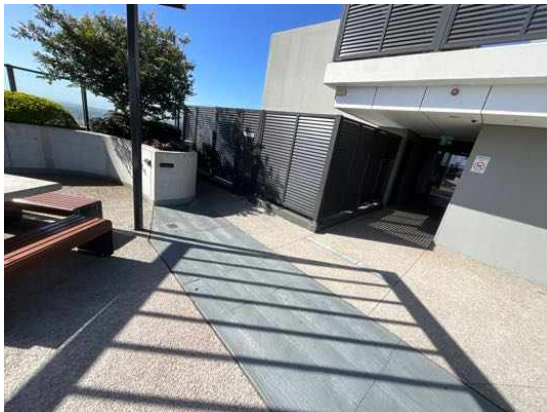
Building: Main Building
Location: Rooftop
Finding: Additional Photos
Information:

Additional photos are provided for your general reference.

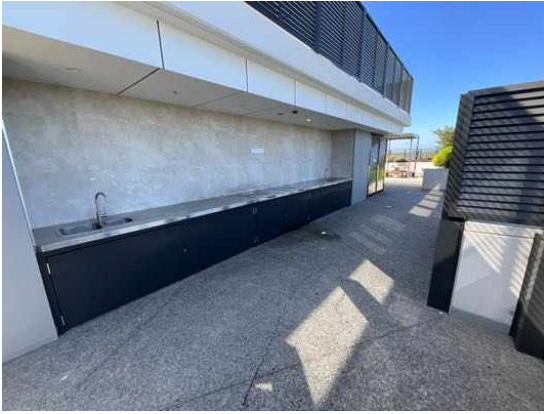
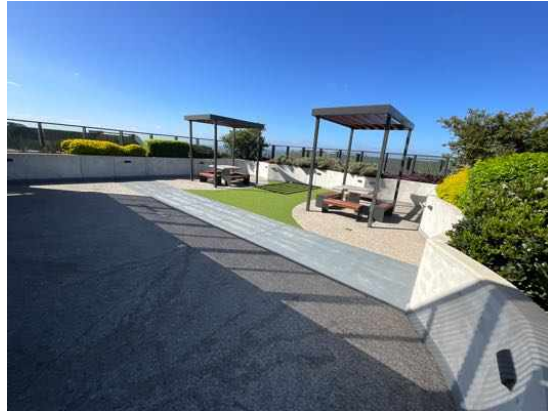
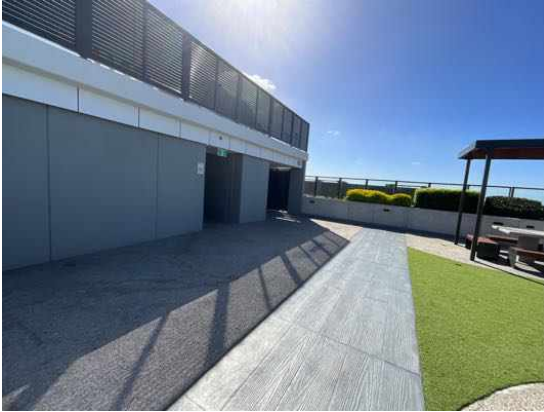
Building: Main Building
 Location: All Areas
 Finding: Additional Photos - Obstructions and Limitations
 Information:

These photographs are an indication of the obstructions and limitations which impeded full inspection of the property at the time of inspection. These obstructions can hide an array of defects and should be removed to allow full inspection to be carried out. A re-inspection is recommended once the areas are made accessible.
