Building and Timber Pest Inspection Report

Inspection Date: Thu, 26 Mar 2026

Property Address: 131 Mywee Rd, Strathmerton VIC 3641,
Australia

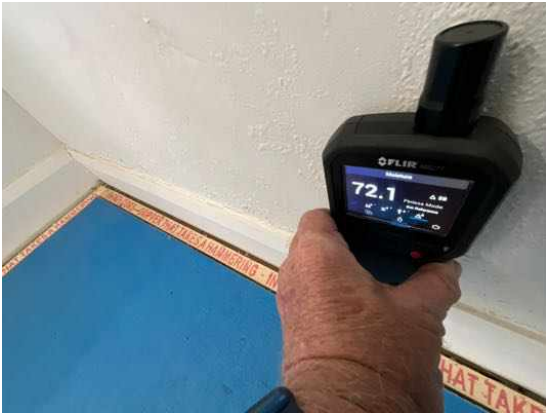
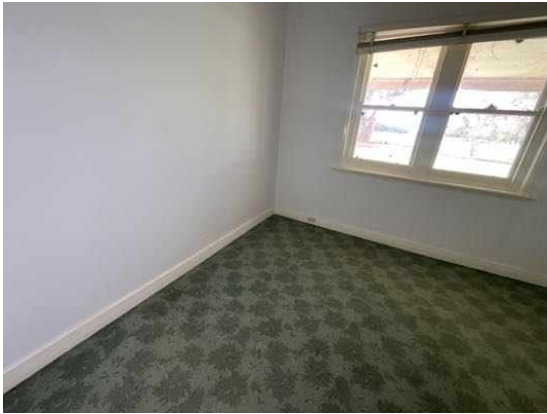
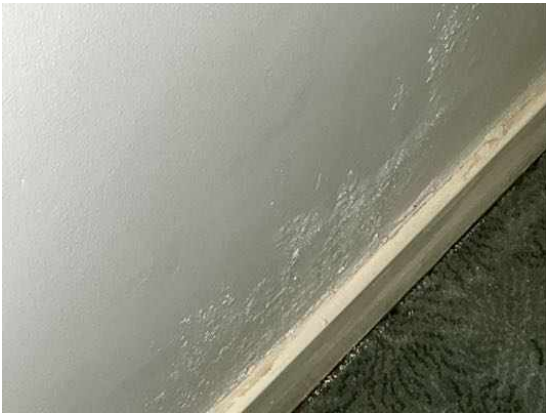
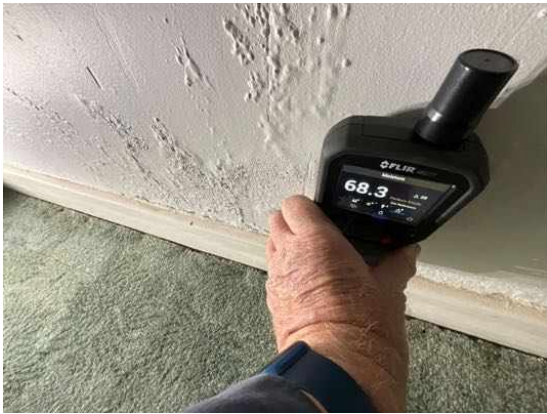
Finding 2.03

Building: Building 1
 Location: Brick work to external walls
 Finding: Damp - Rising
 Information: Rising damp describes the upward movement of water in low sections of building elements (e.g. walls) by capillary action - the movement of water through porous materials such as bricks, sandstone or mortar.

Rising damp is generally managed by the installation of a damp proof course during construction. A Damp Proof Course (DPC) is an impermeable barrier at the base of the wall above ground level. However, many 19th Century buildings have no damp course installed, or the materials have failed. The DPC may have been omitted as a

consequence of poor workmanship, or it may have been bridged where materials built up against the side of the house allow moisture ingress above the DPC level.

The first step in addressing rising damp is to diagnose the cause. The identified cause should be addressed first before addressing the appearance and other defects which have resulted from the rising damp. If the original cause is not resolved, further cases of damp are likely to ensue, resulting in secondary defects.

Consultation with a qualified plumber is advised immediately to identify the cause of the damp and perform remedial works as required.

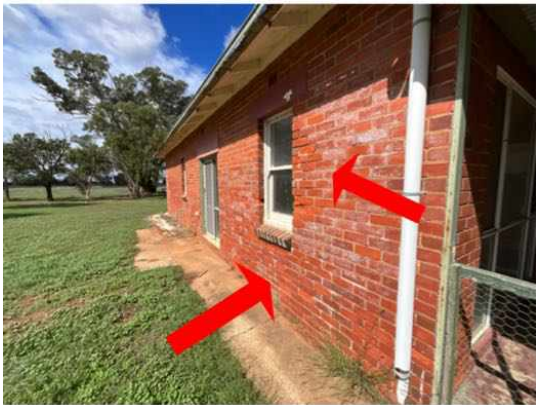
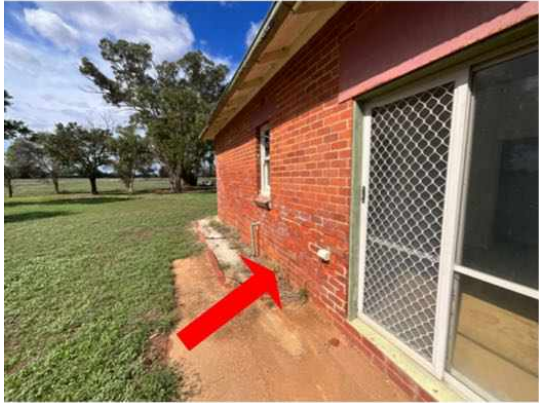
Finding 2.04

Building: Building 1
Location: External brickwork
Finding: Brickwork - Deterioration
Information: Deterioration was evident to sections of the brickwork in this area at the time of inspection. Commonly referred to as brick corrosion or erosion, the bricks are aged and likely to have been affected by a variety of factors, including weather exposure, damage, salt-based deterioration, and more.

Overtime, these factors can affect the bricks, causing them to become brittle and appear corroded or eroded. The mortar in the brickwork may also become powdery, further detracting from the structural integrity of the brickwork. If left unmanaged, potential implications include further deterioration of the building materials, the development of secondary defects, and potential development of structural instability of the wall.

Where this degree of damage has already occurred, you should consult a Building Surveyor or Engineer to seek advice regarding the structural stability and load bearing capabilities of the wall. Such consultation is always required prior to performing any remedial works on the affected brickwork.

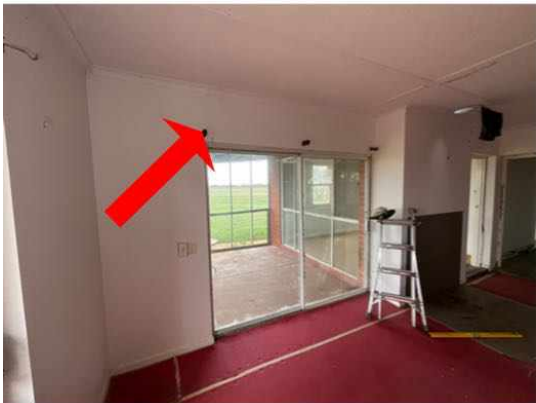
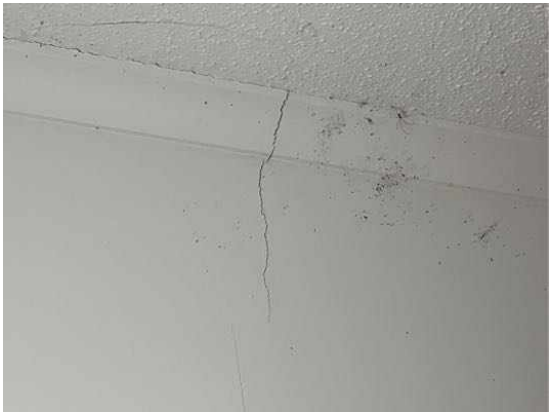
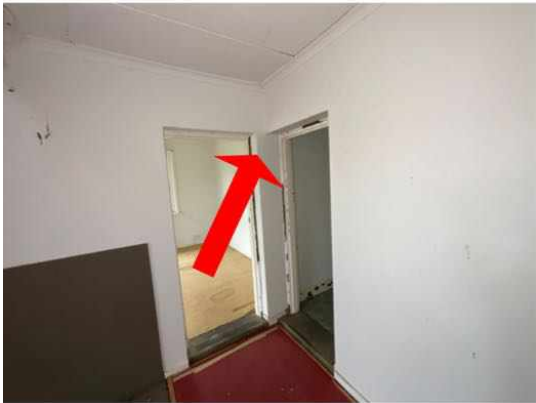
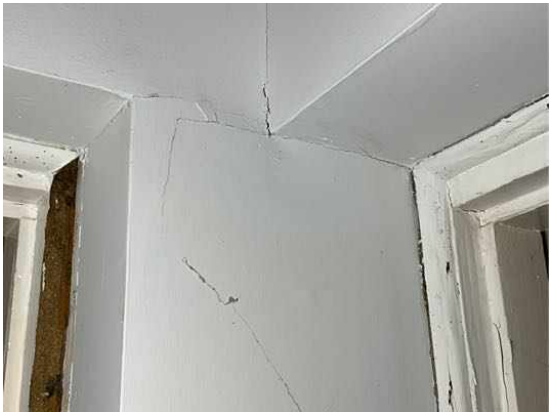
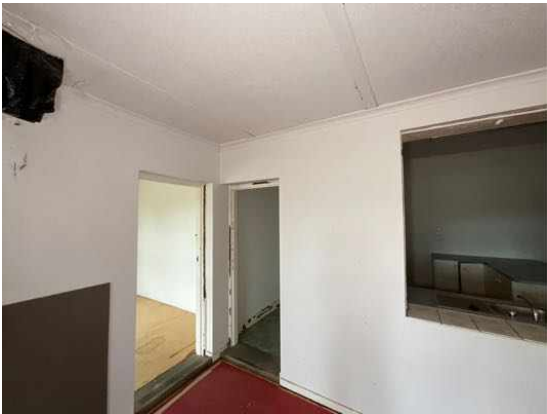
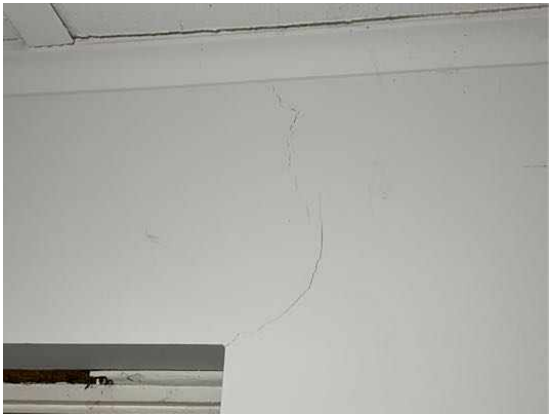
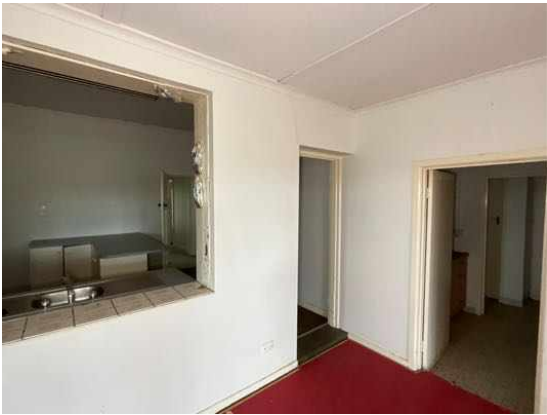
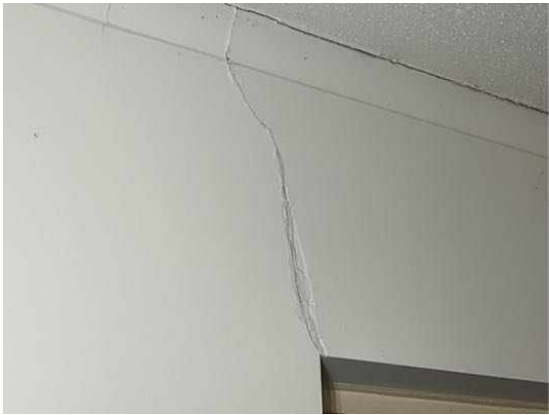
Finding 3.01

Building:	Building 1
Location:	Family Room
Finding:	Cracking - Damage Category 2 - Noticeable (up to 5mm)
Information:	Noticeable cracks are a common occurrence as a result of many primary defects. Such causes may include age, general wear and tear, expected building movement, general expansion/contraction of building materials in different weather conditions, and/or minor failings in the installation or application of building materials.

Noticeable cracks may result in minor sticking or jamming of associated doors and windows, which require easement. However, noticeable cracks are easily filled and repaired. A plasterer can be consulted to install an expansion joint at this point to allow for this movement during different weather conditions.

Monitoring of all cracking should be conducted frequently. Always contact a building inspector should cracks widen, lengthen, or become more numerous. Additionally, your building inspector should also be contacted if associated building elements such as doors and windows become more difficult to operate over time.

Relevant tradespeople, such as carpenters, painters and plasterers, should be

appointed to perform remedial works, as deemed necessary.

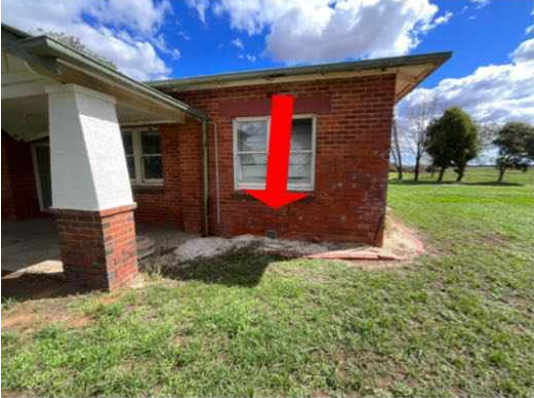
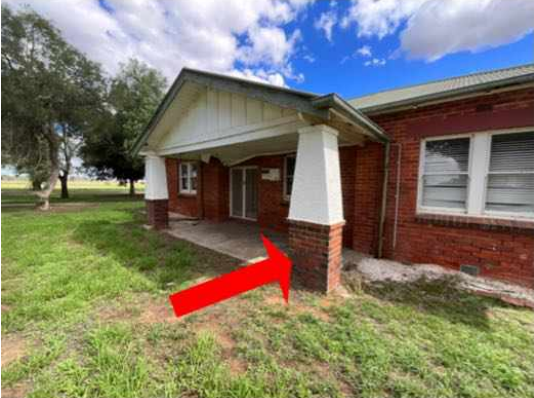
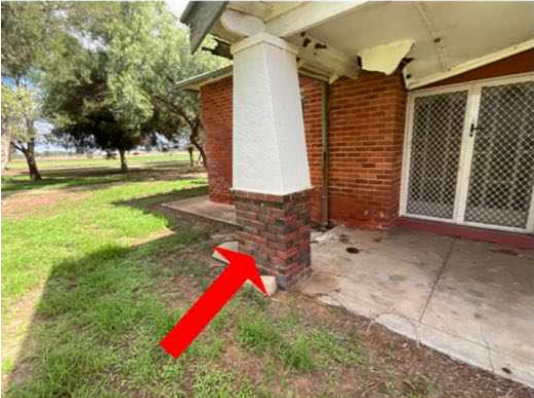
Finding 3.02

Building:	Building 1
Location:	Brickwork
Finding:	Brickwork - Deteriorated mortar
Information:	Mortar, or 'bedding', is the material which fills joints and intersections between bricks in masonry walls and structures. Sections of mortar in this brickwork were identified as having deteriorated, which is generally expected for a property of this age and condition.

Mortar may deteriorate as a result of age of building materials, minor movement of bricks, or frequent exposure to weathering. Mortar should be replaced to ensure that

bricks remain in their intended location and to prevent gaps, which would allow water or moisture ingress and secondary damage as a result.

Mortar deterioration can be addressed by a bricklayer where areas of deterioration are localised and easily accessible. Alternatively, appointment of a registered builder is advised, to repoint large areas of decaying mortar. Where secondary structural defects have become evident, consultation with a structural engineer may be required.

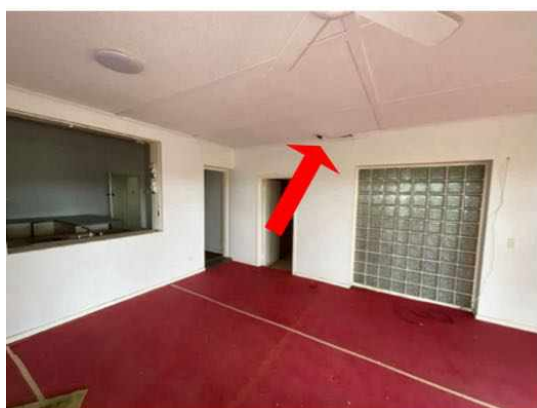
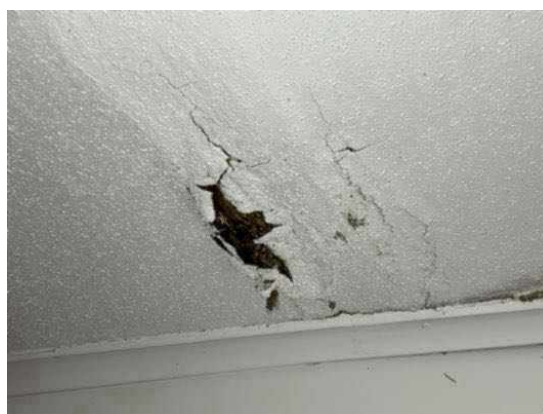
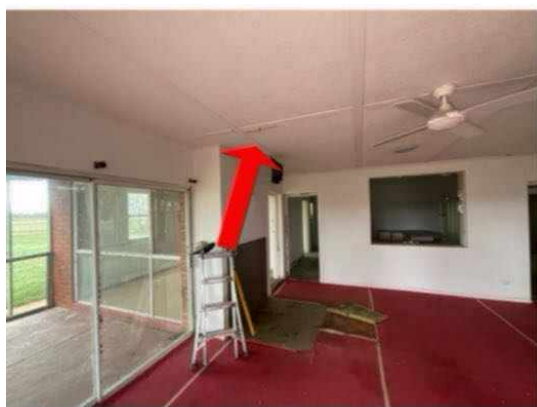
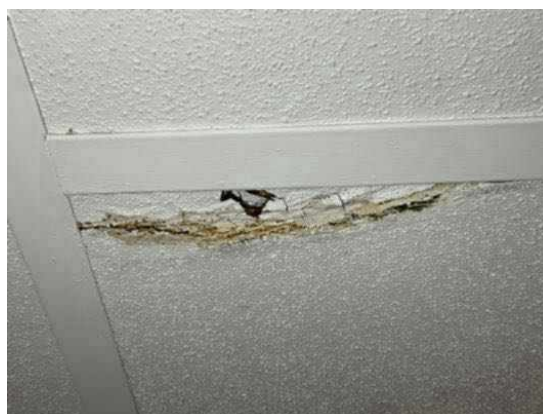
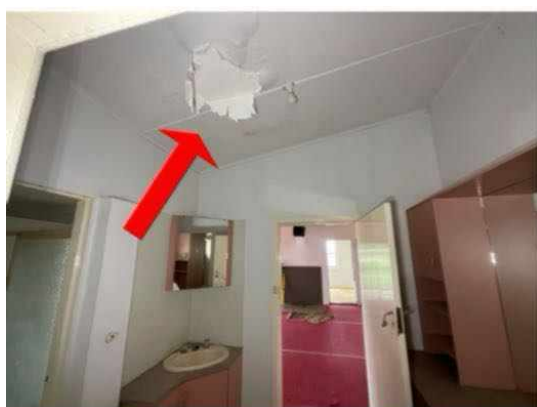
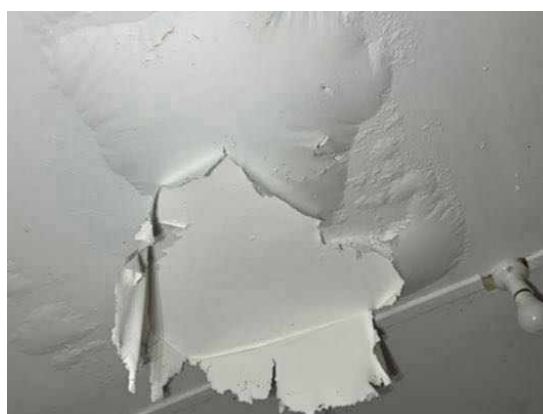
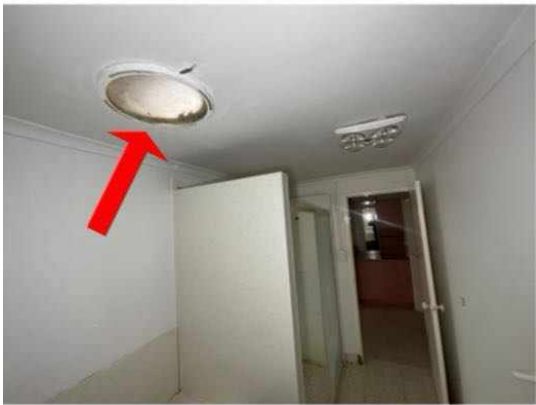
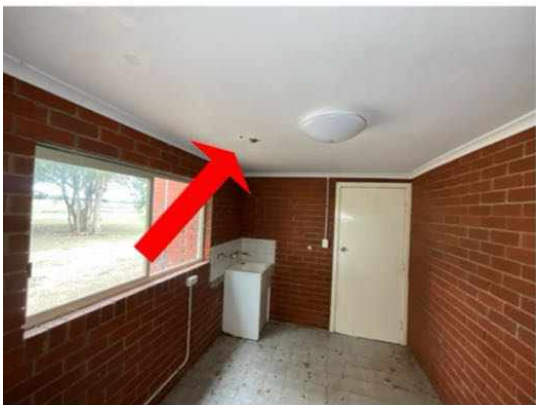
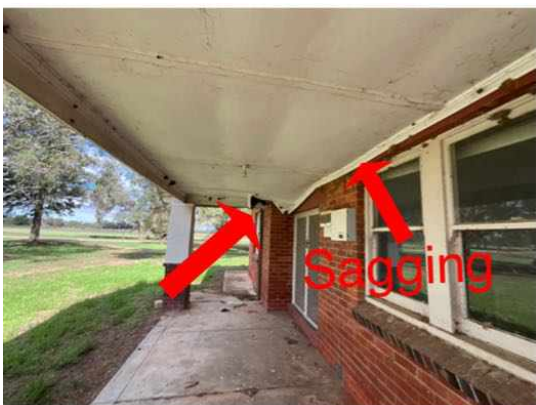
Finding 3.03

Building: Building 1
Location: Family Room, bathroom, laundry, entry

Finding: Ceiling - Water damaged

Information: Water damage to the ceiling lining is generally an indication of excessive moisture being present in the roof void, usually via a leak to the roof covering.

Where water damage is evident to the ceiling, the primary requirement is to identify and rectify the source of the leak. A roofing plumber should be appointed as soon as possible to identify the leak and perform rectification works as necessary, ensuring the water damage is restricted.

Once the leak is repaired, consultation with relevant tradespeople, including plasterers and painters, is advised. Rectification works may include replacement of ceiling lining or minor repainting, depending on the extent of the damage.

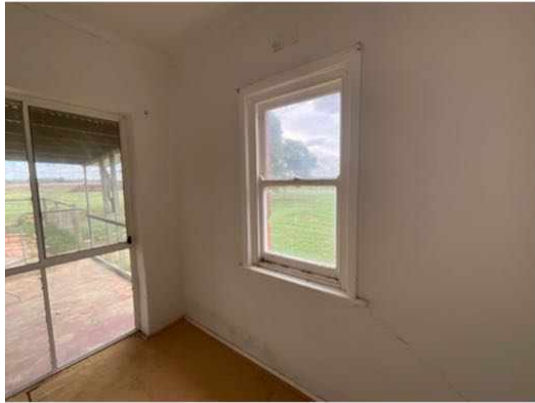
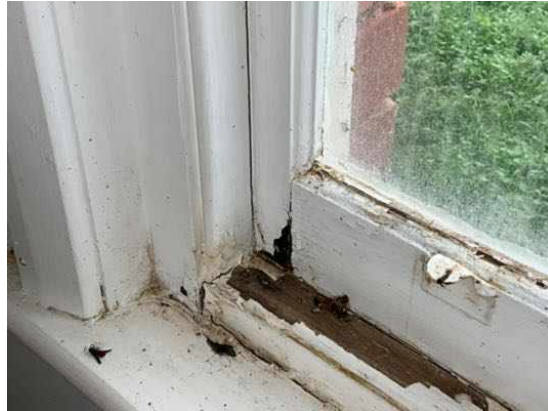
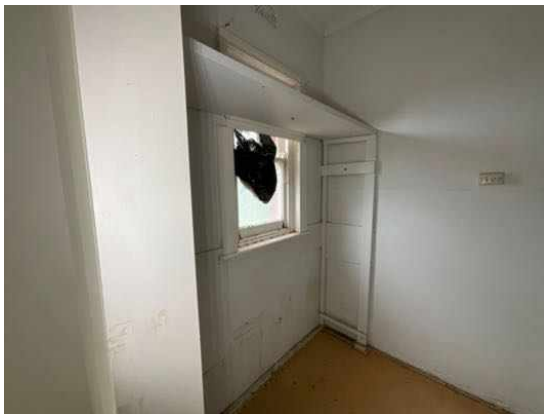
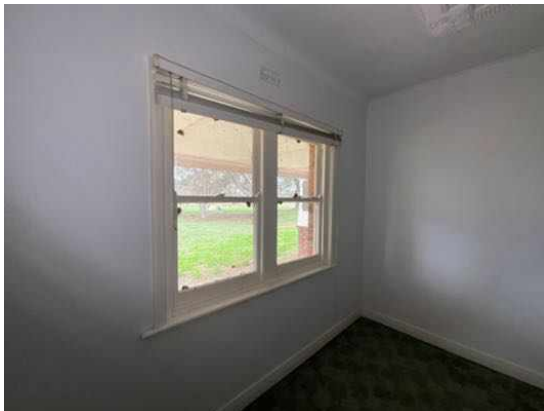
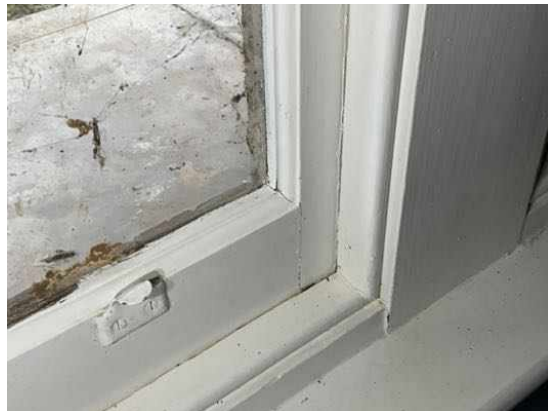
Finding 3.04

Building: Building 1
 Location: Most timber windows
 Finding: Window - Binding/jamming
 Information: Binding and/or jamming of this window is evident during standard operation. This defect inhibits the functionality of the affected window as well as creating potential for secondary defects to associated building elements, such as damage to the frame.

A window that binds to the associated frame may have several causes, ranging from minor defects, such as poor installation or deteriorated hinges, through to major structural issues, such as damage to framing structures.

Where binding/jamming appears to indicate major structural issues, a registered builder specialising in re-stumping should be appointed to provide an estimate on the cost of rectification.

For minor causes, a qualified carpenter, general handy person or window specialist should be appointed to perform minor rectification works at client discretion.

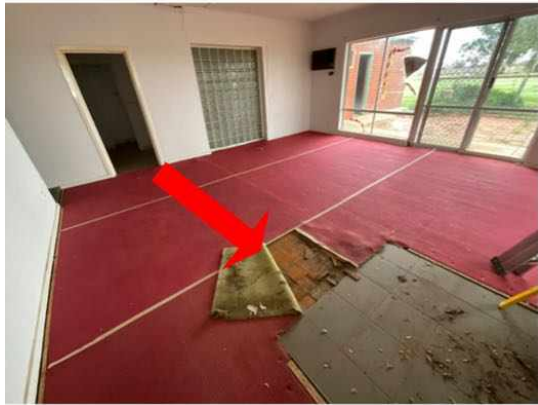
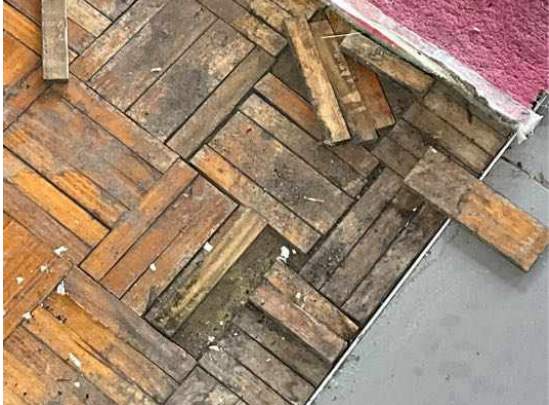
Finding 3.05

Building: Building 1
 Location: Family Room
 Finding: Timber flooring- deterioration
 Information: The flooring in this area shows signs of deterioration. Movement and separation of the parquet is evident. This damage appears to be from excessive heat.

A Flooring specialist should be contacted soon to restore the area and prevent further deterioration.

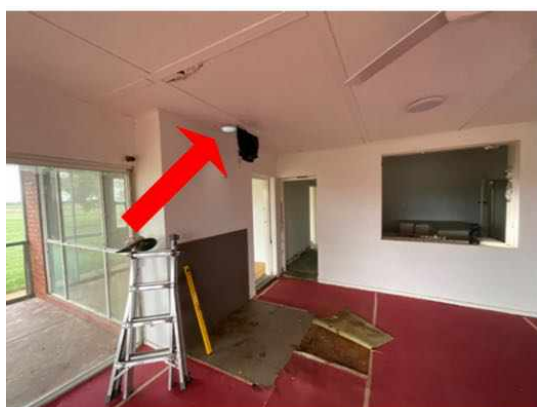
Finding 3.06

Building:	Building 1
Location:	Family Room
Finding:	Installation - substandard or incomplete
Information:	The installation of this building element appears to have been completed to a substandard level of workmanship or is incomplete. Generally substandard repairs or installation are related to poor workmanship, the use of inappropriate materials, or a failure to complete installation to a suitable standard.

Where installation is substandard and/or incomplete, the client should contact the responsible trade to undertake rectification. Unfinished and substandard building works are likely to degrade more quickly and may create potential for secondary defects to associated building elements.

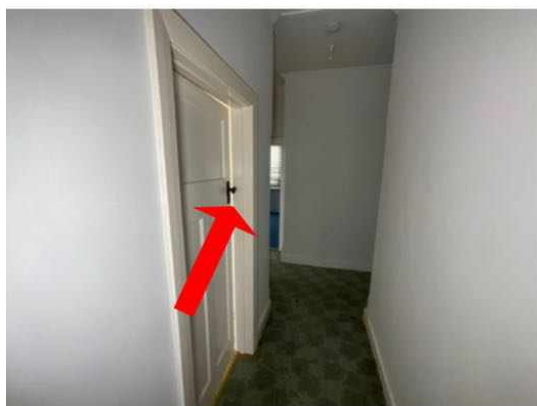
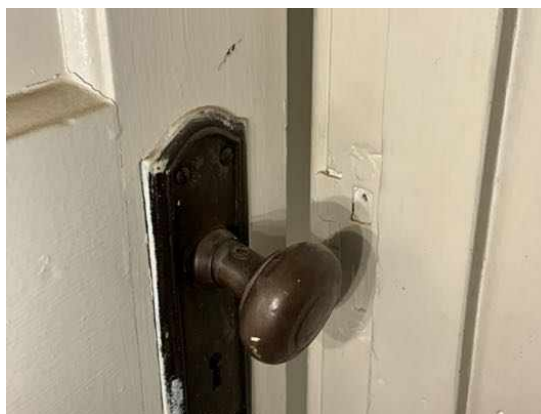
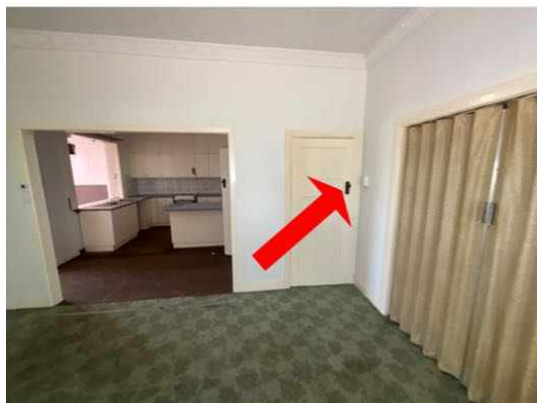
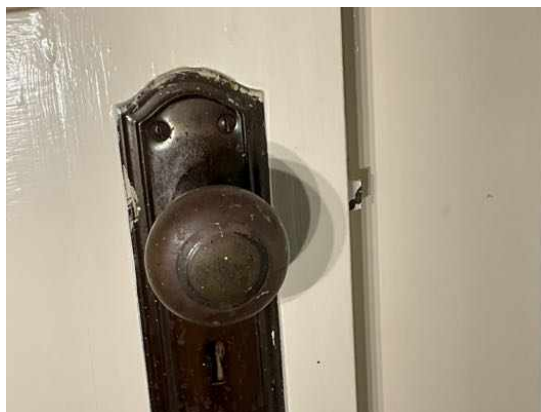
This is a common defect and is expected in a property of this age, whether being due to substandard installation or general deterioration of the door hardware.

Readjustment of the striker plate is recommended at client discretion. Works such as these can be completed by a general handyman or qualified carpenter.

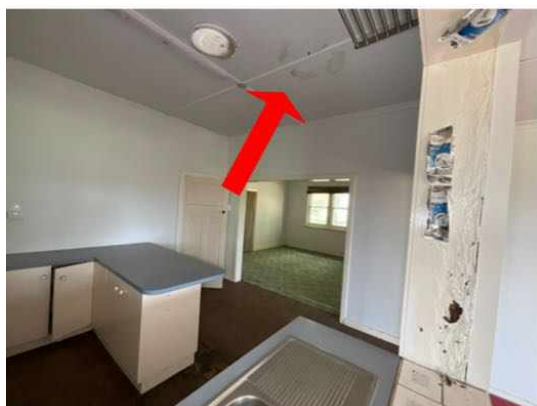
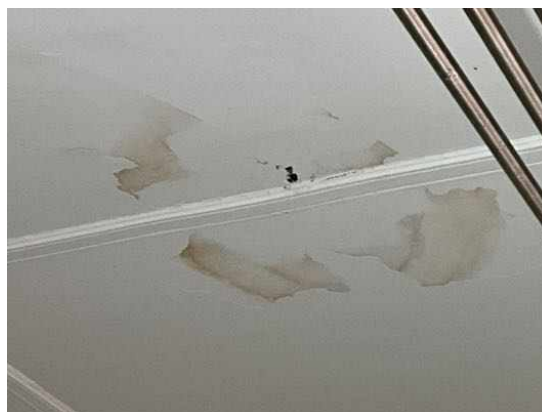
Finding 3.08

Building:	Building 1
Location:	Kitchen
Finding:	Ceiling - Water stained
Information:	Water staining to ceiling linings in this area was evident at the time of inspection. Water staining indicates that surfaces have been exposed to excessive moisture over time. The minerals and other elements in the water lead to staining, which may graduate to corrosion and deterioration if left unmanaged.

While mostly an appearance defect, water staining can be indicative of more serious defects, which may be currently concealed by interior ceilings.

Where water staining is active, a licensed plumber must be consulted to identify the cause of the staining and to provide advice on any reparation works that may be required. Replacement of any damaged structures is advised.

Conversely, where water staining is old and inactive, affected building materials may be repaired or replaced at client discretion.

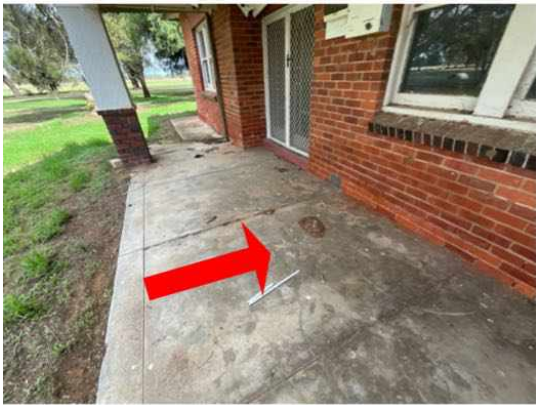
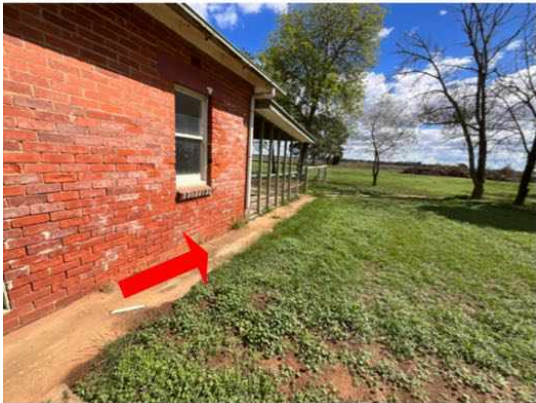
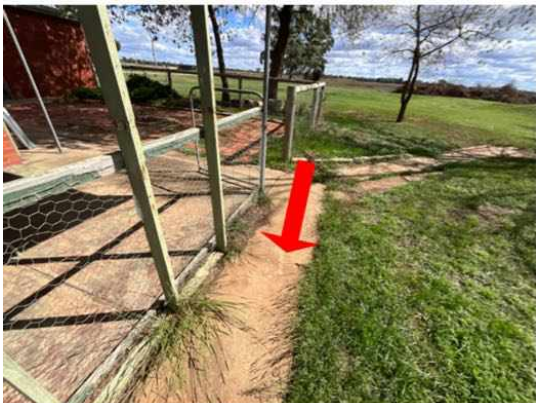
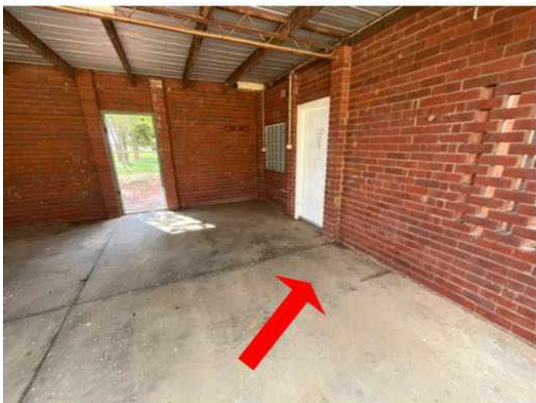
Finding 3.09

Building:	Building 1
Location:	All External Areas
Finding:	Cracking - External Concrete Paving Damage Category 2 - Distinct (less than 3mm)
Information:	Distinct cracks were identified in external concrete paving. Distinct cracks are generally found in older concrete paving, and may also present as a trip hazard as consequence of an uneven or curved surface.

General age and expected deterioration of the paved areas is a common cause of this type of cracking. However, expansion and contraction of the slab may also have occurred due to environmental factors. Such factors include variable moisture and weather conditions, the presence of trees and their roots having a settling or lifting affect on the soil, or the effect of load bearing, e.g. heavy vehicles over a sustained period of time.

Cracking to this degree may also be due to poor original installation of the concrete. Factors such as poor compaction of the sub surface and/or inadequate reinforcing of the slab may create cracking and other secondary defects.

Repairs are likely to be required to prevent further cracking and to reduce hazards associated with cracking, such as tripping. Monitoring of all cracking should be conducted frequently. Always contact a building inspector should cracks widen, lengthen, or become more numerous.

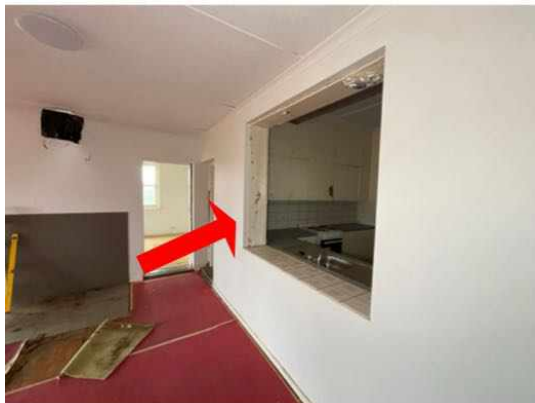
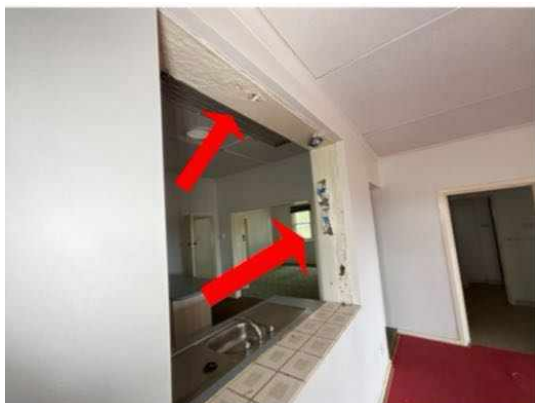
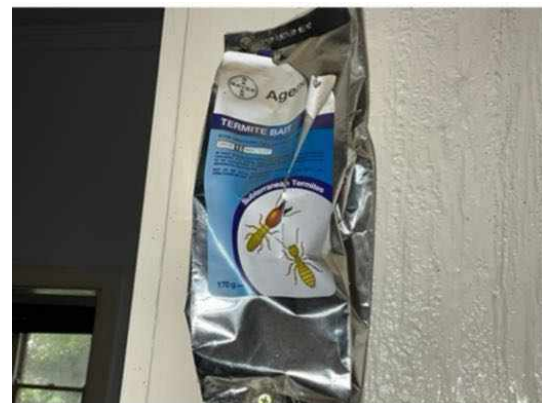
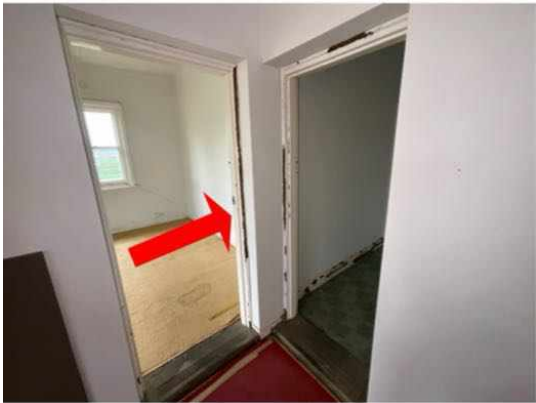
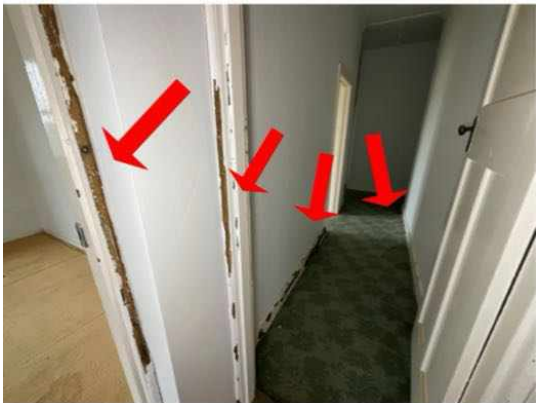
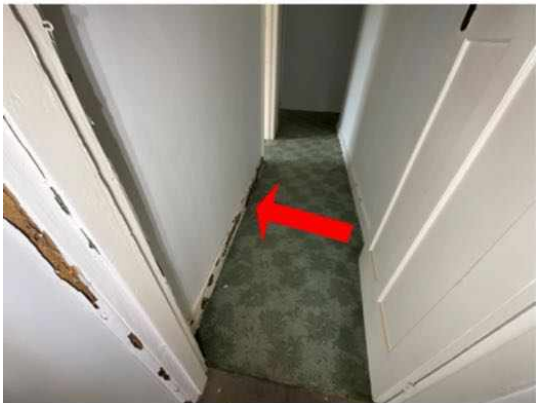
Building:	Building 1
Location:	Most internal areas
Finding:	Evidence of termite damage - structural
Information:	Despite no live termite or timber pest activity being identified, previous termite damage was found in this area. This damage is considered to be structural in nature. Such damage creates a potential safety hazard, and is likely to worsen and cause further damage to adjoining building materials.

If left unattended, this damage creates an unsafe environment and is likely to lead to the need for major structural works.

A building contractor should be appointed immediately to advise on options to prevent further damage and repair all affected building materials. Until such time, caution should be taken by all people coming into contact with these building elements and this area.

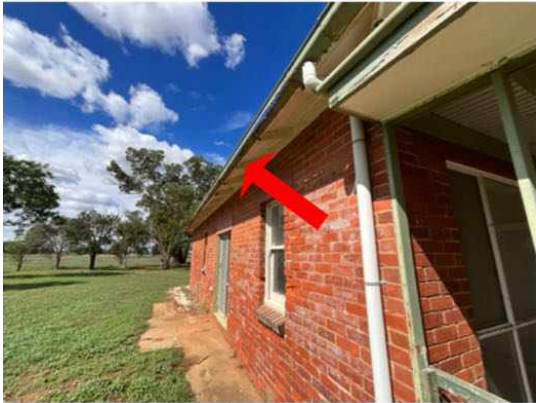
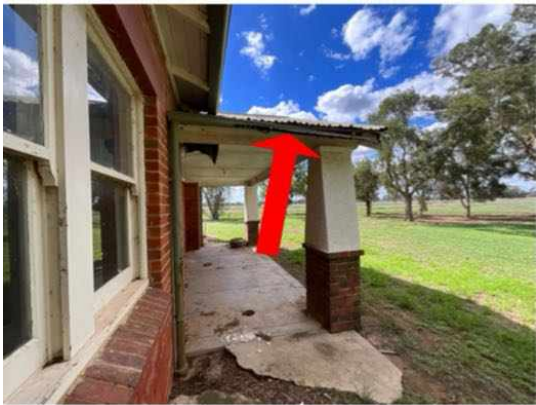
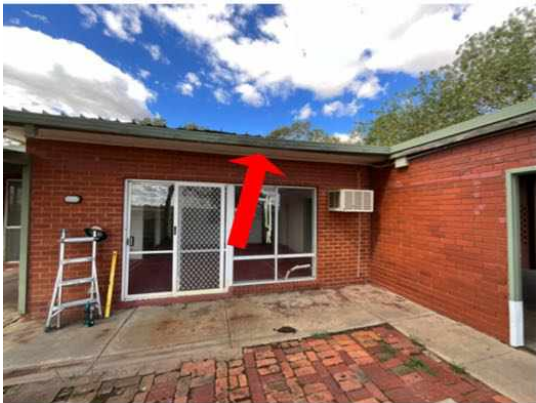
Finding 6.01

Building: Building 1
Location: Eaves
Finding: Gutters- Deteriorated
Information: The guttering and some downpipes have deteriorated.

Although not a major problem now, they will deteriorate further if left for an extended period.

Sagging can be seen in the gutter.

A Licensed Plumber should be engaged as soon as possible to advise on any repairs or maintenance that may be required.

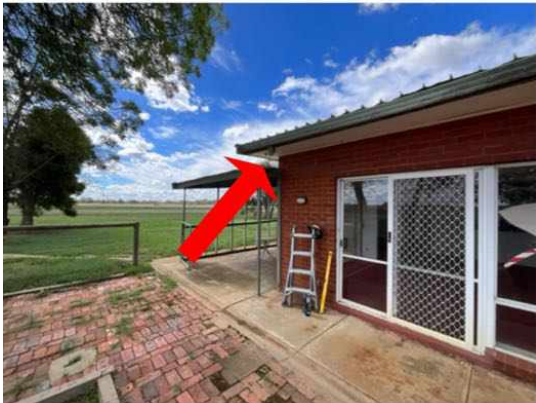
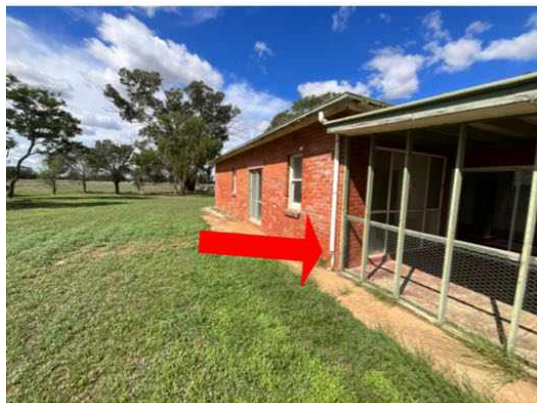
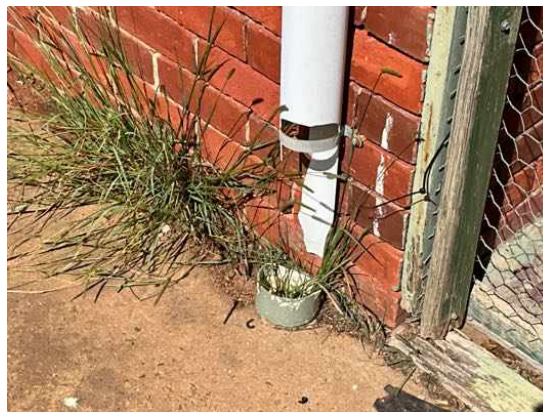
Finding 6.02

Building: Building 1
Location: Yard - Back, side
Finding: Stormwater drain - Not connected
Information: The roof plumbing is not adequately connected to stormwater drainage on the site. This disconnection negatively impacts the functional capacity of the roof plumbing.

Where roof plumbing doesn't drain adequately, the area at the base perimeter can become excessively damp, potentially creating an environment that is susceptible to rust and corrosion of surrounding building elements, as well as attracting termites and other pests.

It is highly recommended that a plumber be appointed to further inspect the area and to install adequate drainage equipment where necessary.

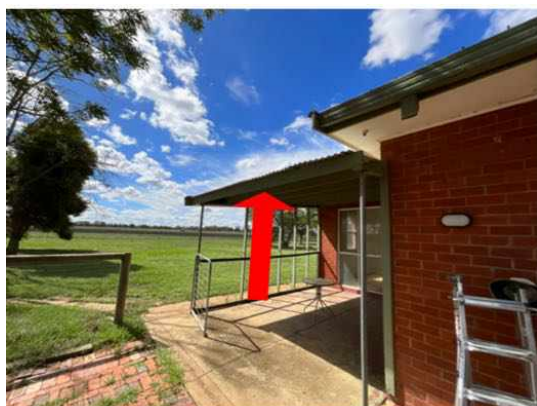
Finding 6.03

Building: Building 1
 Location: Alfresco
 Finding: Guttering Missing
 Information: The Guttering in this area was missing at the time of inspection. Guttering, Downpipes and Stormwater drainage are vital to protect the integrity of the structure and to prevent an environment conducive to Timber Pest attack.

A Plumber should be contacted as soon as possible to replace and connect to drainage the missing Guttering.

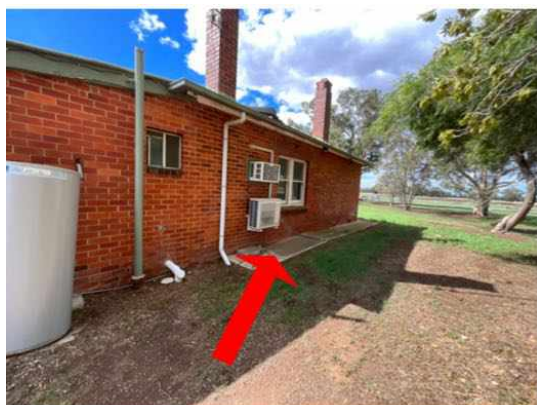
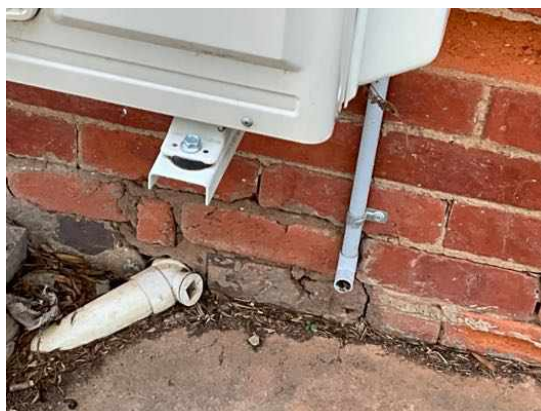
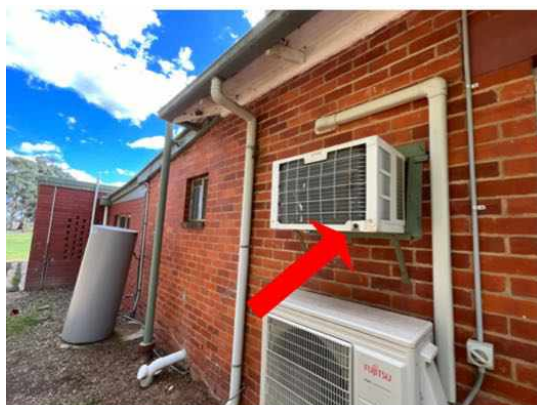
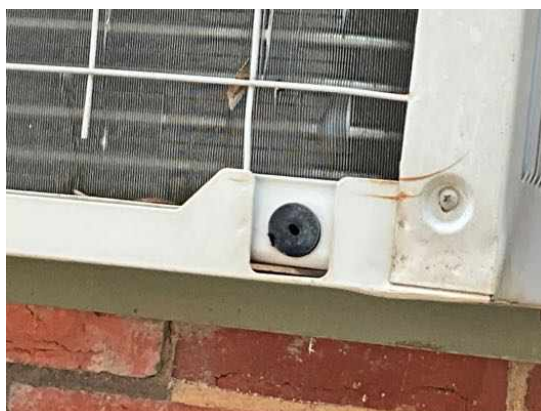
Finding 6.04

Building: Building 1
 Location: Driveway side
 Finding: Air conditioner - Disconnected overflow
 Information: The Air Conditioner (A/C) overflow was found to be disconnected from storm water drainage and is creating excessive moisture in the surrounding area.

Such leaking creates an environment which is conducive to an array of defects, including water damage to associated building elements and the attraction of termite or timber pest infestation.

It is highly recommended that a licensed plumber be appointed to connect the A/C overflow in order to prevent such an environment from being created. These minor works should be carried out as soon as possible.

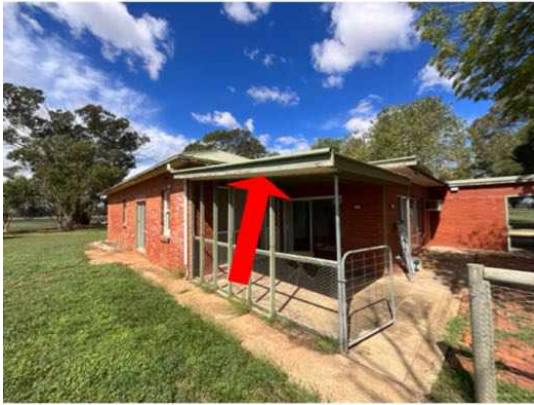
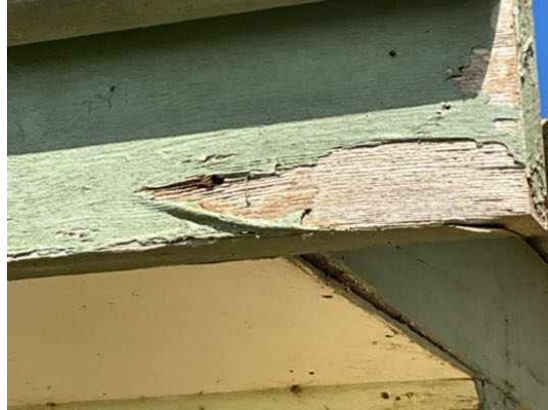
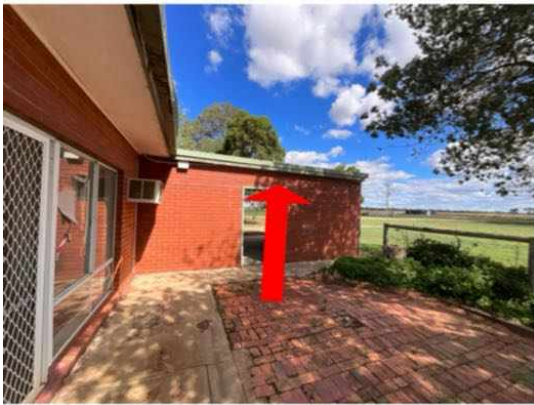
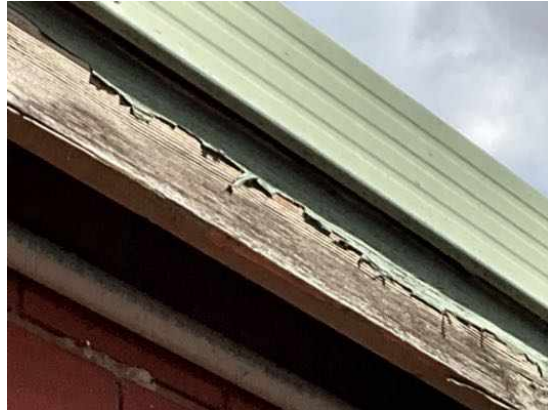
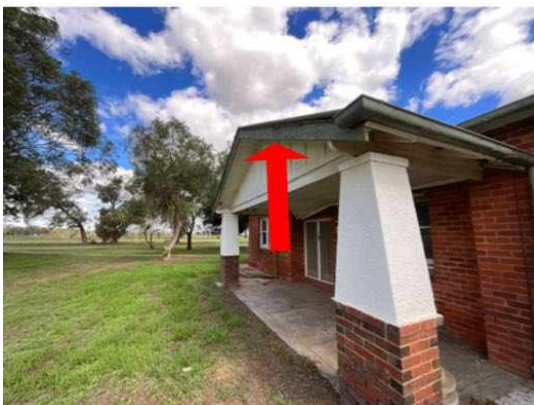
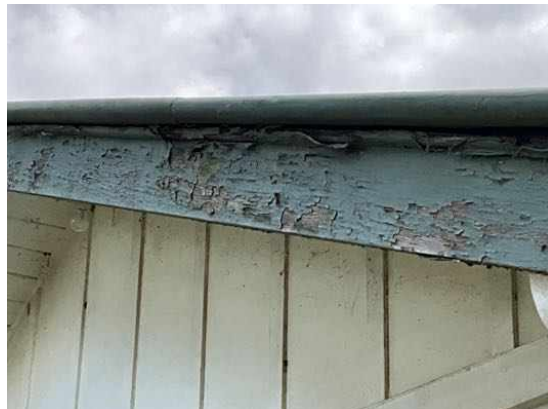
Building:	Building 1
Location:	All External Areas
Finding:	External painting deteriorated
Information:	Much of the external paintwork including but not limited to windows, fascias, guttering, veranda and other external fitments have been neglected and require attention to prepare and re-paint.

Whilst incomplete or missing paint finish is generally an appearance defect, it can also lead to the development of secondary building defects over time. Incomplete areas of paint finish expose the area to moisture, potentially accelerating the deterioration of underlying building materials.

Degraded paint finishes should be sanded back, filled, leveled and painted, as applicable. Where inadequate or missing paint protection has led to the deterioration of the associated building element, repair and/or replacement of this building element may be required.

A painting contractor should be appointed as soon as possible to perform necessary works to aid the appearance of the affected area and to ensure the area is protected against further deterioration. Alternatively, the homeowner following manufacturer instructions may perform these works.

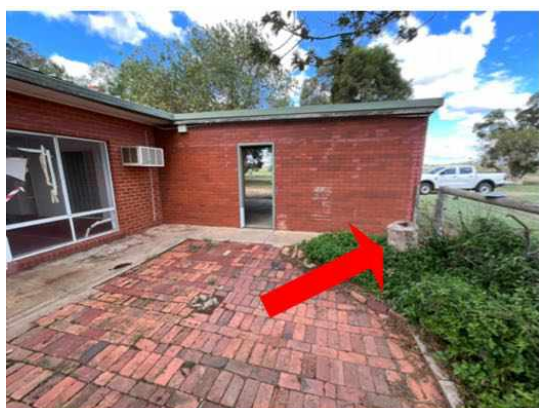
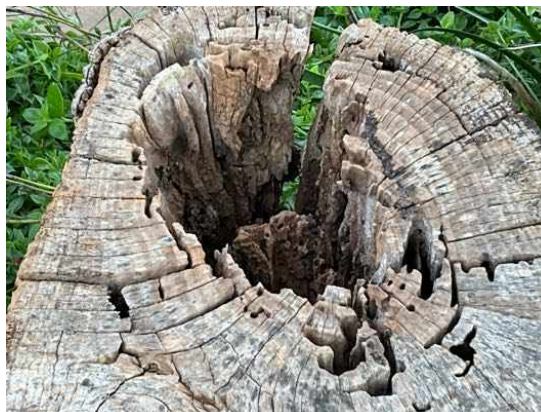
Finding 6.06

Building:	Building 1
Location:	Yard - Back
Finding:	Tree Stump in Ground
Information:	Any tree stumps in the yard not removed during the tree removal process provides the opportunity for Termite infestation and is likely to be subject to decay from damp

conditions against the stump.

All tree stumps should be removed by professional tree removal services where possible. Meanwhile regular inspections are advised to identify any termite activity in the areas identified.

Services for tree stump removal should be contacted as soon as possible to reduce the risk of timber pest attack.

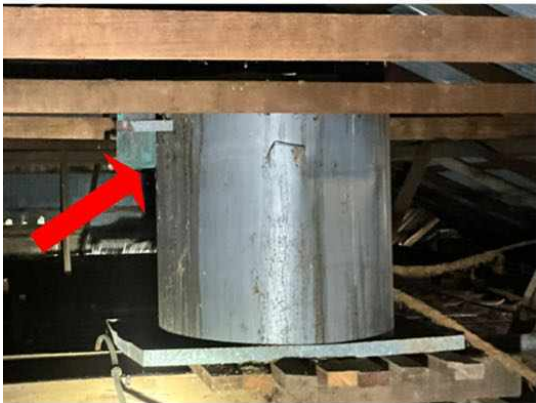
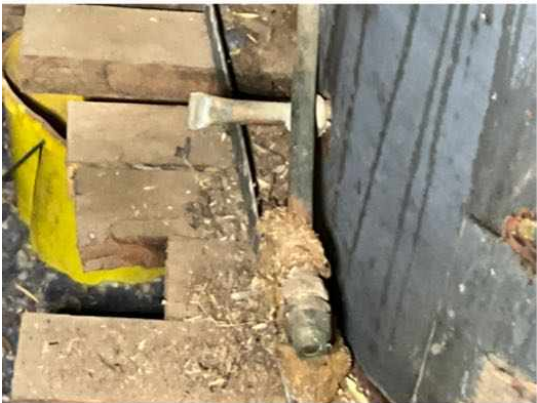
Finding 6.07

Building:	Building 1
Location:	Roof Void
Finding:	Gravity-Fed HWS - Disconnected
Information:	It was noted at the time of inspection that a disconnected gravity-fed hot water system (HWS) remains in this area.

Despite this plumbing structure being unused, it is likely to be storing residual water, and is therefore susceptible to rust and corrosion. If allowed to continue, rust and corrosion is likely to lead to damage to adjoining building elements, and may also make the area susceptible to termite or timber pest activity.

While it is a costly exercise to remove the disused gravity-fed HWS, it is advisable in the short-term future to prevent any further damage to the area. Further consultation with a licensed plumber is required to gain further advice on removal of the structure.

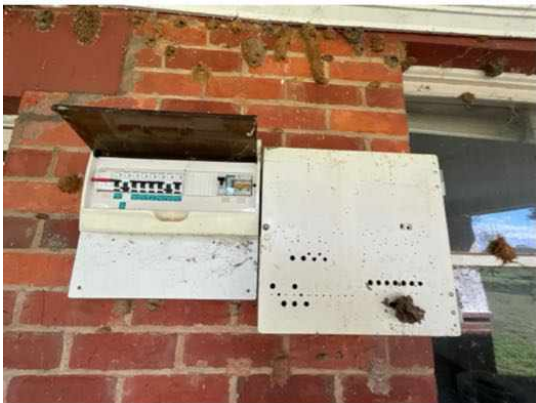
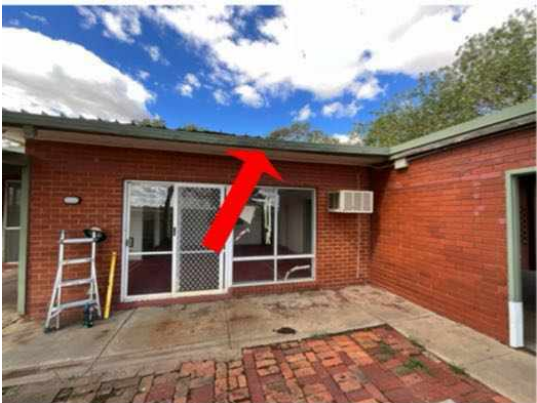
Finding 6.08

Building: Building 1
 Location: All External Areas
 Finding: Termite Management System - no evidence of a chemical installation
 Information: The application of a post-construction chemical termite barrier is highly recommended for all properties, particularly if live termite activity has been found on the site previously. Such barriers are highly effective in preventing termite attack on any timber building elements throughout the property.

A durable notice should be placed in the switchboard unit to indicate current termite barriers. At the time of inspection, it appeared as though no termite management system has been installed, with no evidence to suggest preventative works taking place.

The client may consider gaining further advice from a pest controller as to the costs and procedures involved with this application. It is recommended that obtaining such advice be a short-term priority.

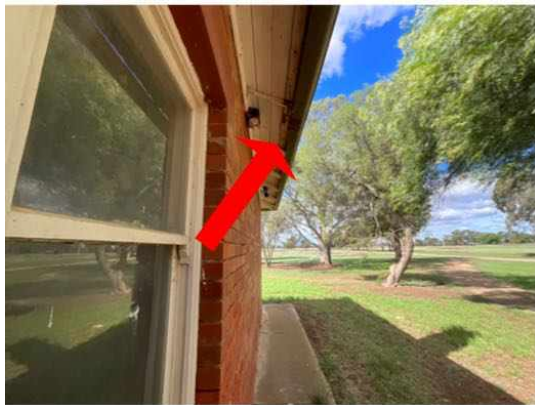
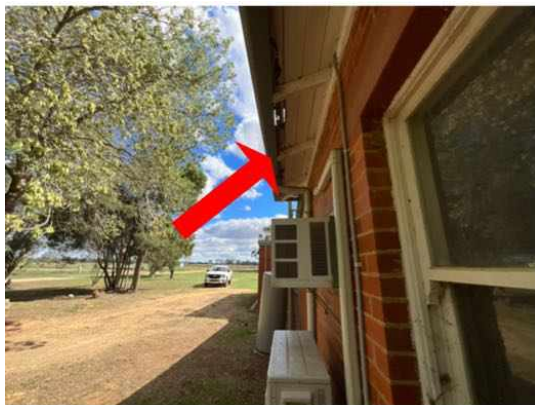
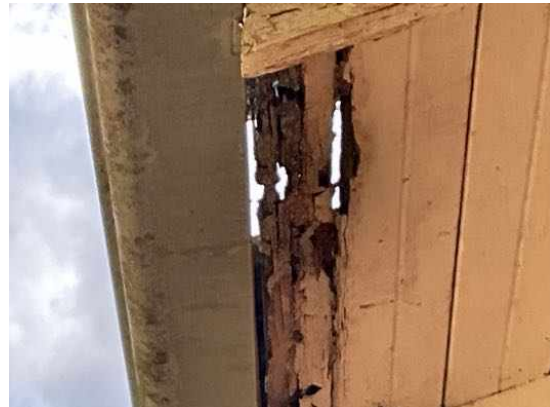
Finding 7.01

Building:	Building 1
Location:	Eaves
Finding:	Fungal decay - present (localised)
Information:	Fungal decay also known as wood decay or wood rot generally refers to the deterioration of timber elements when in contact with excessive levels of moisture for a prolonged period of time.

The development of fungal decay is accelerated by temperatures in the range of 5degreeC to 40degreeC as well as the presence of oxygen. Generally fungal decay develops on timber elements that are in use in an external environment which are exposed to rain penetration.

In this case although the affected timber element is in a decaying state the extent of any visible damage appears to be localised to a specific area and is yet to spread to other parts of the building element or affect adjoining structures. The fungal decay is therefore likely to be of a relatively superficial nature with minimal impact on the structural integrity or tensile strength of the timber element.
