Building and Timber Pest Inspection Report

Inspection Date: Thu, 26 Mar 2026

Property Address: 131 Mywee Rd, Strathmerton VIC 3641,
Australia

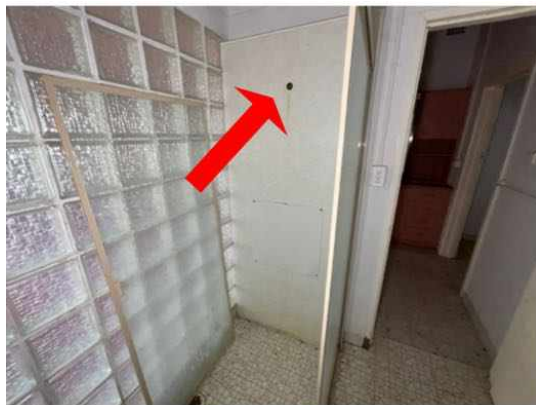
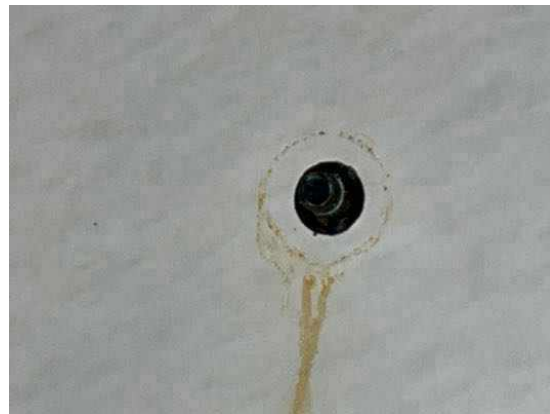
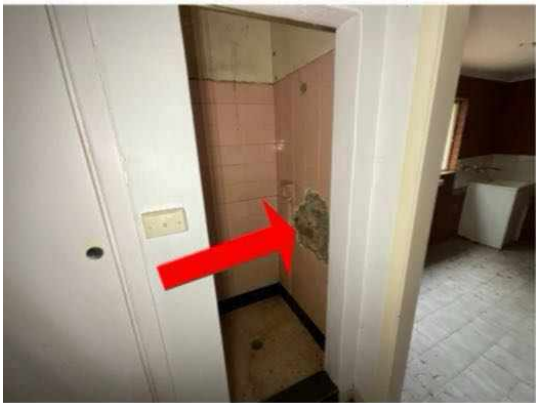
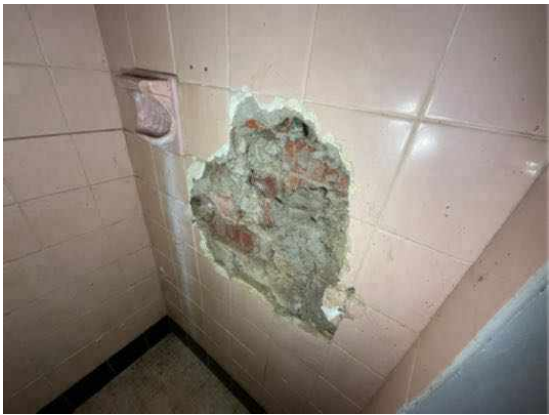
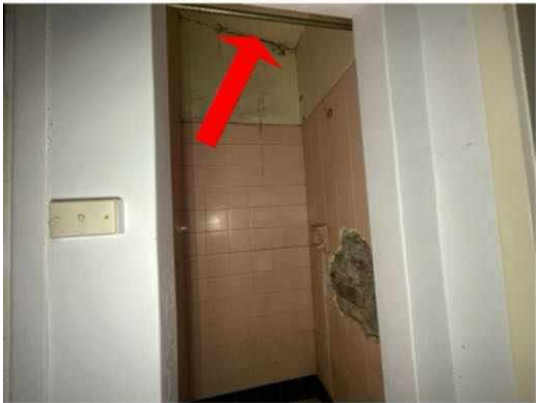
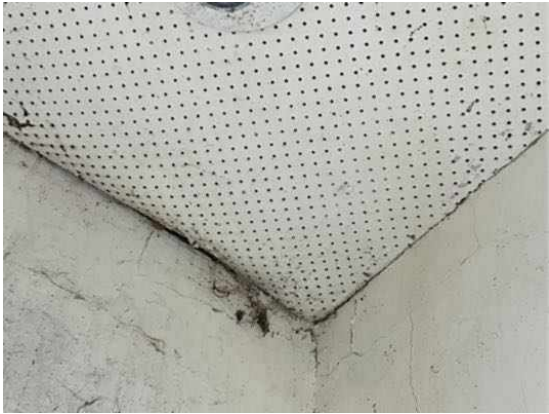
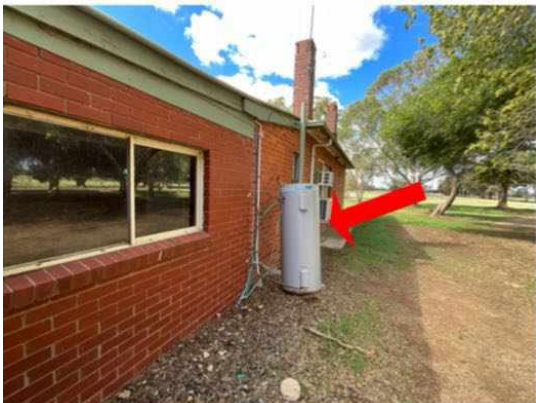
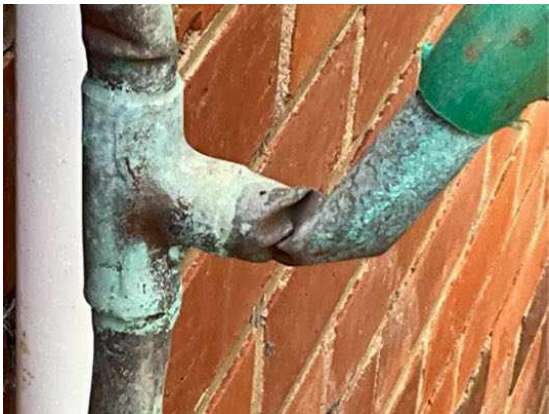
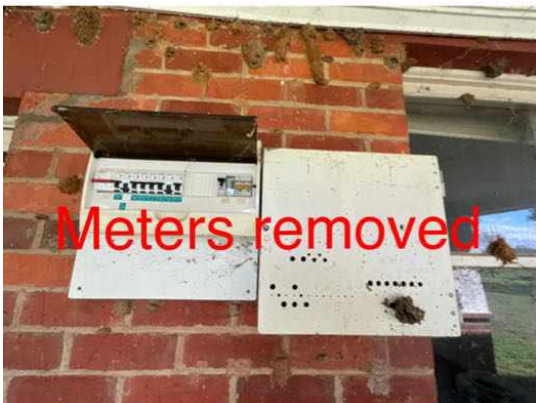
Building: Building 1
Location: All Areas
Finding: Plumbing and Electrical
Information: Some installations appear of poor quality. A plumber should be contacted at client discretion, to improve the installation and prevent further deterioration.

It is highly recommended that the client makes immediate arranges to have the gas appliances checked by a licensed gas plumber to ensure that the appliances are working safely and efficiently.

We recommend all other installations be checked also.

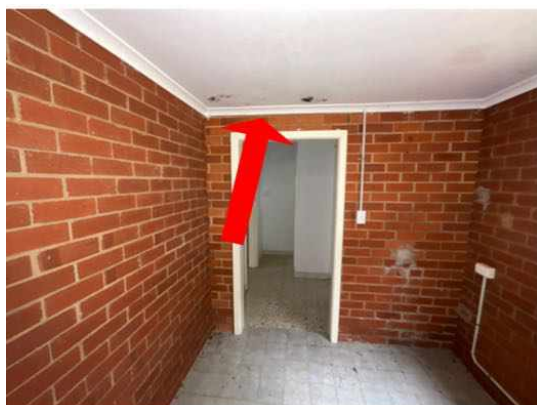
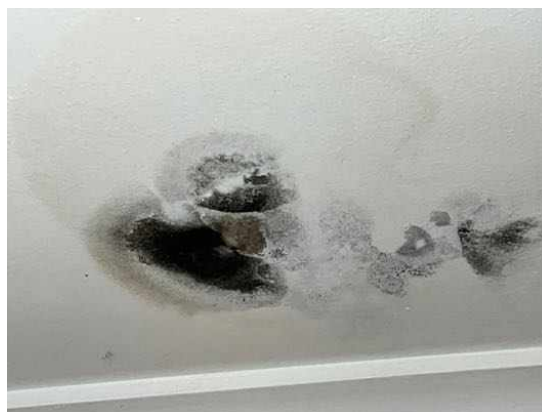
Building: Building 1
Location: Laundry
Finding: Mould - Present
Information: Where evidence of mould growth was noted, there may be environmental, biological or health issues associated with the report. A specialist inspection by a suitably qualified environmental health inspector is warranted, where mould is extensive or where any queries regarding air quality spores or other related issues apply.

Generally, the client is advised to ensure that the general environment is free of moisture and humidity to aid in the prevention of mould formation and development. Any mould found during the inspection should be cleaned immediately by a cleaning contractor or the homeowner as applicable.

Please note that severely affected building elements may require replacement by a registered builder or qualified carpenter.

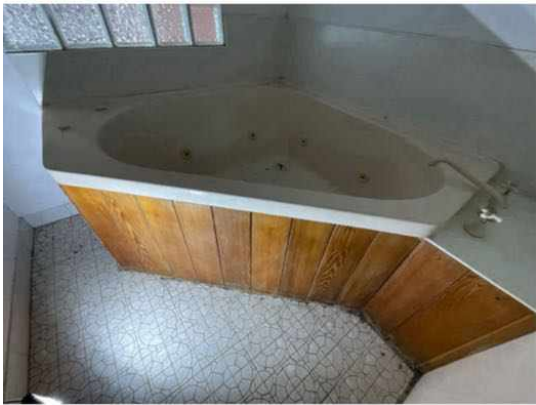
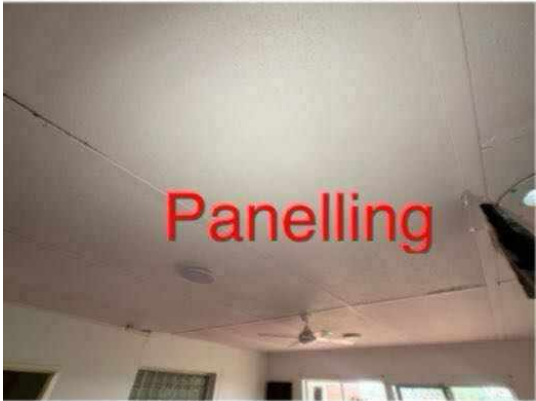
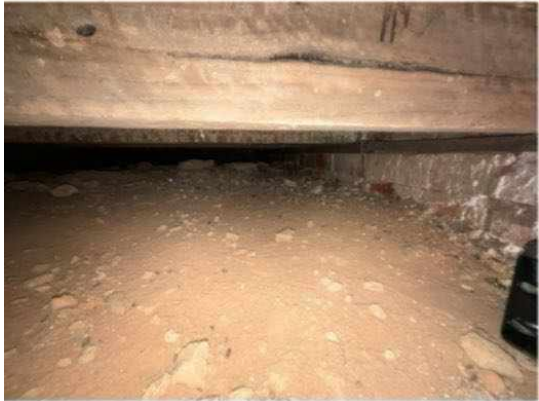
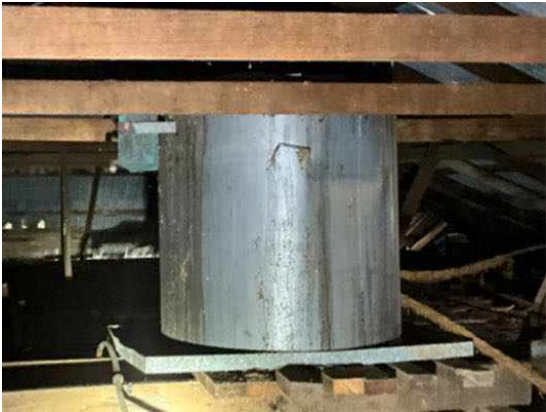
Building: Building 1
Location: All Areas
Finding: Additional Photos - Obstructions and Limitations
Information: These photographs are an indication of the obstructions and limitations which impeded full inspection of the property at the time of inspection. These obstructions can hide an array of defects and should be removed to allow full inspection to be carried out. A re-inspection is recommended once the areas are made accessible.
