## Building Inspection Report

Inspection Date: Wed, 4 Feb 2026

Property Address: 26 Dowling St, COLAC, VIC, 3250, Australia

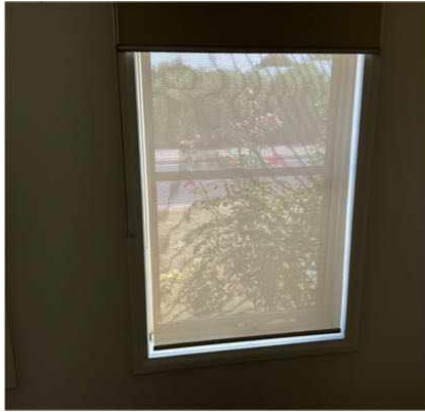
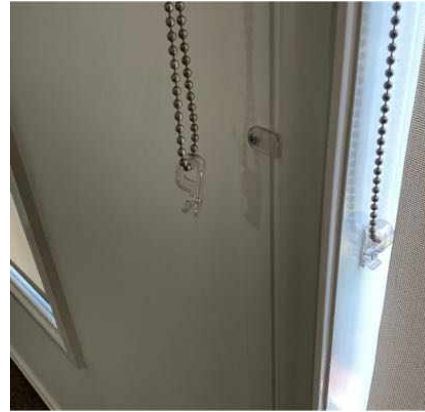
#### Defects 1.01

Building:	Main Building
Location:	Bedroom
Finding:	Unsecured Blind Cords – Safety Hazard
Information:	During the inspection, several window coverings were found to have unsecured blind cords that were not fastened to the window frame or wall. This condition presents a significant safety risk, particularly to young children, as unsecured cords and loops have been linked to strangulation incidents.

- Increased risk of injury or fatality due to entanglement hazards, particularly in homes with children.
- Non-compliance with the Mandatory Safety Standards for Corded Window Coverings (ACCC) may result in legal penalties.
- Liability risks for landlords or property owners if not rectified, particularly in rental or tenanted properties.

The unsecured blind cords present a serious but preventable safety hazard. Immediate corrective action is advised to ensure compliance and occupant safety.

- Secure all blind cords using compliant cleats, cord tensioners, or guides installed at a minimum height of 1600mm from the floor, as per ACCC safety regulations.
- Replace any non-compliant blind mechanisms or convert to cordless alternatives where possible.
- Conduct a full check of all window coverings throughout the property to ensure compliance with applicable safety requirements.
- Property owners and landlords should ensure all corded window furnishings meet the current safety standards prior to occupancy or leasing.

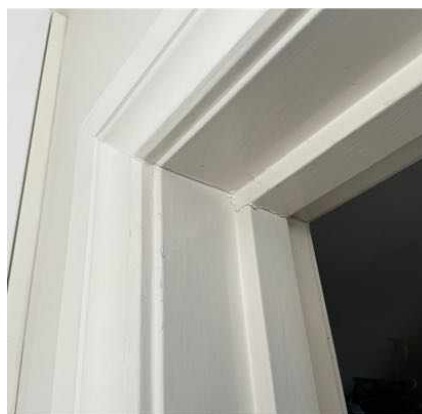
### Defects 3.01

Building:	Main Building
Location:	All Internal Areas
Finding:	Cracking to Painted Architraves and Skirting Boards
Information:	Cracks were observed opening up in various sections of the painted architraves and skirting boards. These cracks may be associated with minor building movement, timber shrinkage, or inadequate surface preparation prior to painting.

- Aesthetic presentation is compromised by visible cracking.
- Potential ongoing movement may lead to further deterioration or require repeated maintenance.
- May indicate underlying workmanship or preparation issues.

This condition is not uncommon following recent painting, particularly in timber joinery, and is typically considered a maintenance item unless associated with significant structural movement.

- Engage a qualified painter or builder to assess the extent of cracking and undertake necessary repairs, which may include filling, sanding, and repainting affected areas.
- Monitor for any signs of worsening or recurring movement over time.

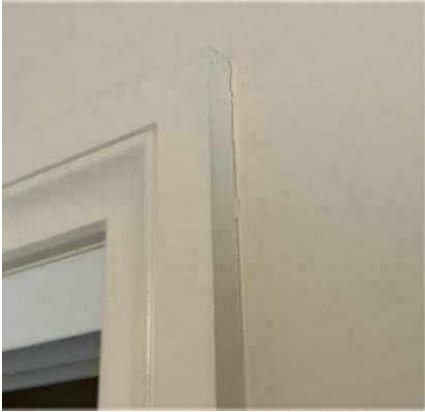
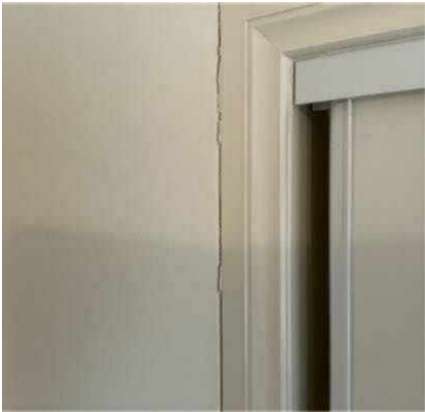
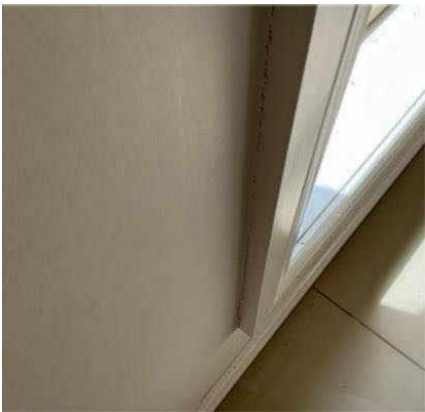
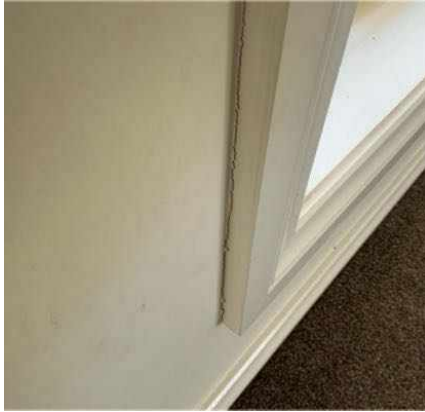
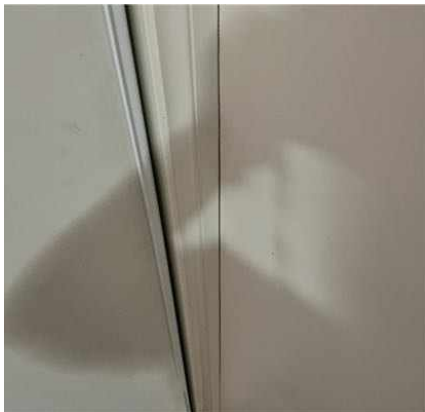
### Defects 3.02

Building:	Main Building
Location:	All Internal Areas
Finding:	Cracking Between Architrave and Wall Junction
Information:	During the inspection, cracking and separation were observed between the architrave and the adjoining wall surface. This condition is commonly caused by normal building movement, minor frame shrinkage, or seasonal expansion and contraction of materials. In some cases, movement may also be influenced by additional loads from attached fittings such as blinds or curtain brackets.

- Cracking detracts from the appearance of internal finishes.
- Minor separation may continue with seasonal changes or building movement.
- Unsealed gaps can collect dust or allow minor moisture staining over time.

The condition appears cosmetic and is typical of normal building movement. It can be readily repaired through routine maintenance and repainting.

- Ensure that any attached fittings are adequately supported to reduce future stress on trim components.

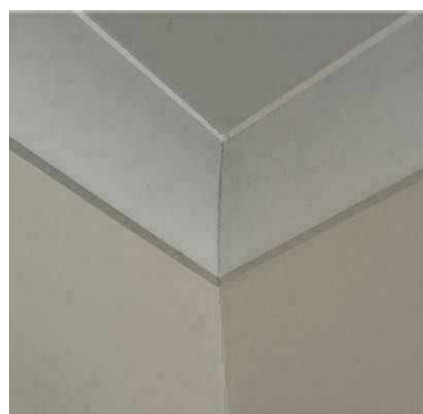
### Defects 3.03

Finding: Cracking to Internal Wall Linings

Information: Cracking was observed to internal wall linings during the inspection. These types of cracks are generally considered common and are typically the result of natural building movement, age-related wear, thermal expansion and contraction, or minor installation-related issues in plasterboard or supporting framing members.

The cracking noted is typical of minor building movement and does not currently present as structural. Regular monitoring and cosmetic repair will assist in preserving the internal presentation and allow early intervention if future issues arise.

- Engage a qualified plasterer to repair cracks and consider installing expansion joints if necessary to accommodate ongoing building movement.
- Arrange for repainting by a qualified painter following any plaster repairs.
- Monitor cracks over time for signs of progression (e.g. widening, lengthening, or new cracks forming).
- If deterioration continues or operational issues with doors/windows arise, seek further assessment from a building inspector or structural engineer.

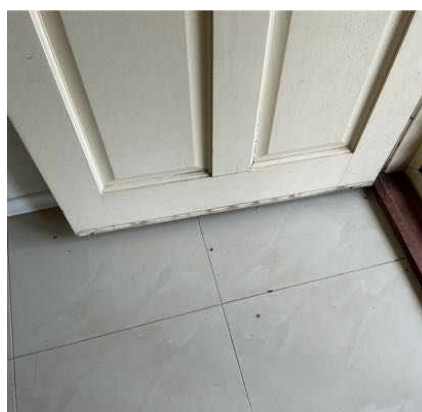
Defects 3.04

Building: Main Building  
 Location: Entry  
 Finding: Missing Bottom Door Seal to External Door  
 Information: During the inspection, it was noted that a bottom door seal had not been installed to one or more external perimeter doors. These seals—such as Raven or similar weather seals—are commonly used in conjunction with perimeter seals to improve the weather-tightness and energy efficiency of the dwelling.

- Gaps at the base of external doors can allow drafts, moisture, dust, insects, and noise to enter the home.
- The absence of door seals can reduce the thermal efficiency of the property and negatively impact the overall energy rating.
- Poorly sealed doors may lead to higher heating and cooling costs due to loss of conditioned air.

Installing appropriate bottom and perimeter door seals will assist in weatherproofing the property, enhancing thermal comfort, and supporting energy efficiency.

- After settlement, engage a competent handyman or carpenter to install bottom and perimeter door seals where missing.
- Select door seals that are compliant with energy efficiency requirements and appropriate for the type of door and threshold.
- Ensure proper installation to maximise effectiveness and longevity.

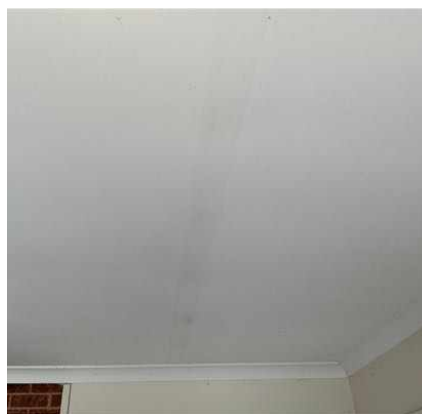
### Defects 3.15

Building:	Garage
Location:	Garage
Finding:	Garage Ceiling – Linear Discolouration / Marking
Information:	During the inspection, linear discolouration was observed across the garage ceiling, following the alignment of the ceiling framing members above. The marks appear as long vertical lines and are consistent in spacing and pattern. No visible ceiling sagging,

Based on the inspection at the time, the observed markings appear consistent with thermal and environmental effects rather than a structural or moisture-related failure.

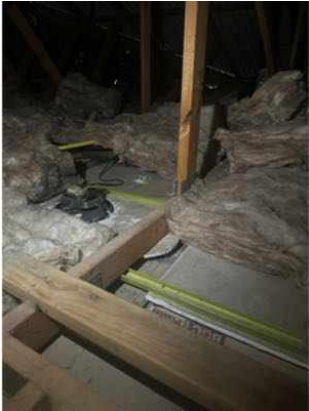
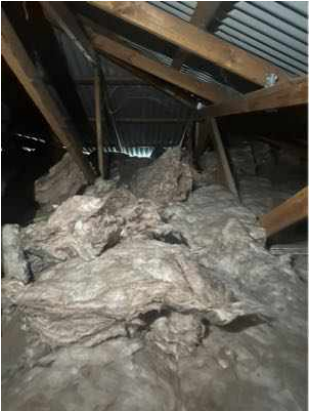
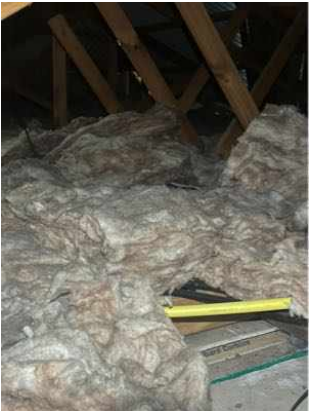
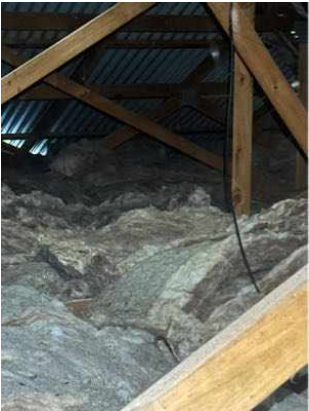
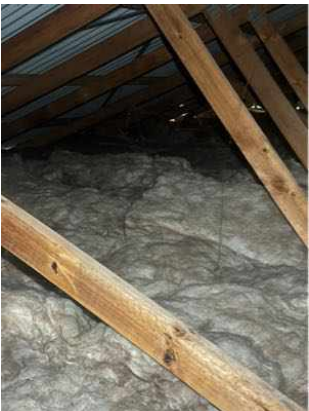
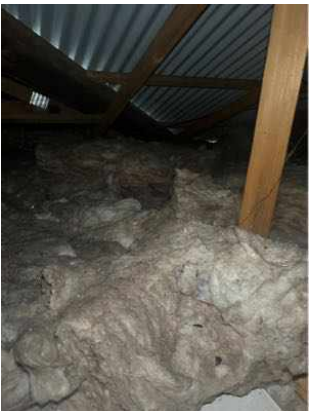
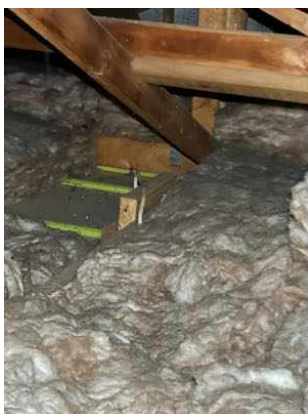
### Defects 3.16

Building:	Main Building
Location:	Roof Void
Finding:	Poorly Installed Ceiling Insulation
Information:	During the inspection, it was observed that the ceiling insulation has been inadequately installed, with numerous areas showing misalignment, gaps, and inconsistent coverage. Proper insulation is critical to achieving thermal comfort, reducing energy usage, and ensuring compliance with minimum energy efficiency expectations. Even minor gaps can drastically reduce insulation effectiveness—industry studies indicate that as little as 5% missing coverage can compromise performance by up to 50%.

The current condition of the insulation reflects substandard workmanship and requires attention to restore the property’s thermal efficiency, comfort, and energy performance.

- Reinspect insulation after any roof or ceiling works to ensure it remains correctly positioned and undisturbed.

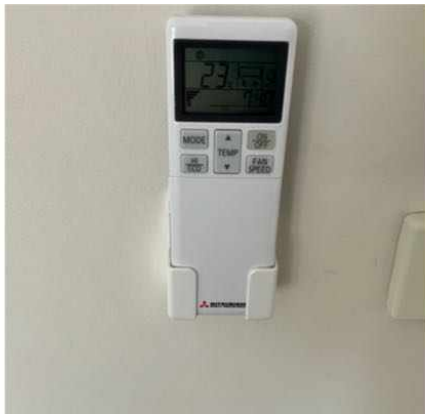
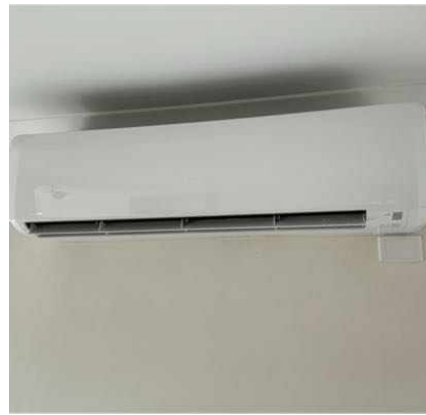
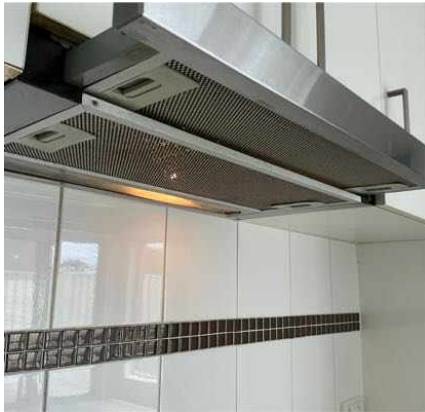
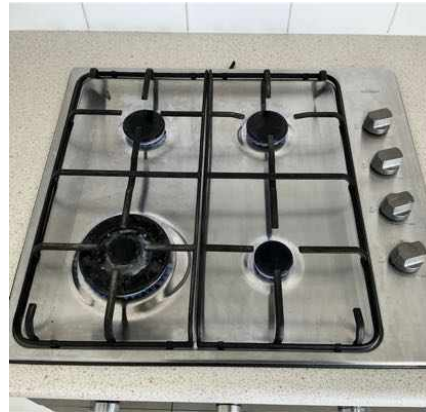
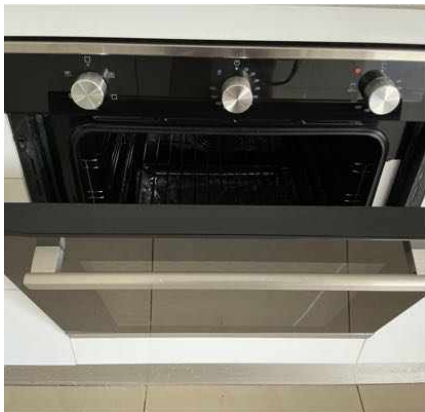
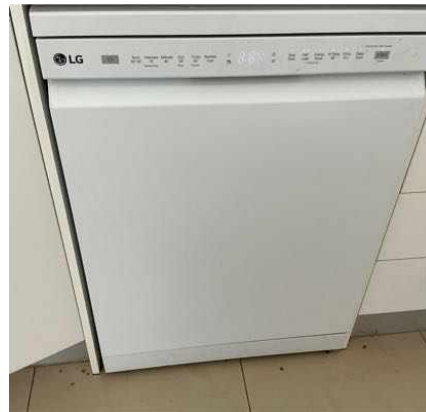
While the appliances and reverse cycle air conditioner were operational during the inspection, it should be noted that a full performance test was not conducted, and future performance or safety compliance cannot be guaranteed.

- Confirm inclusions with the sales contract to ensure all appliances and the reverse cycle air conditioner are covered.
- Retain user manuals and warranty information where available.
- Re-test all appliances and the air conditioning system upon settlement and prior to first use, as function may vary with time, load, or power supply conditions.
- Engage a licensed electrician or suitably qualified appliance or air conditioning technician to conduct a safety and performance check, particularly if installation dates, service history, or compliance documentation are unknown.

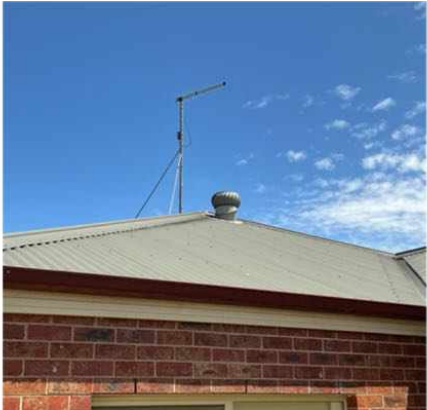
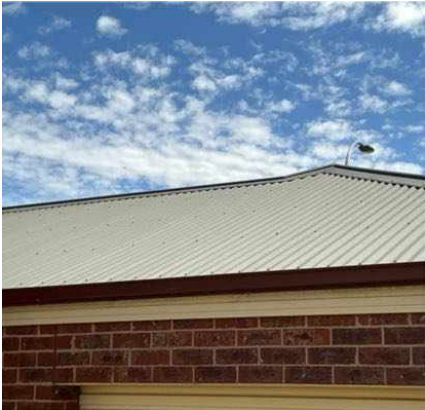
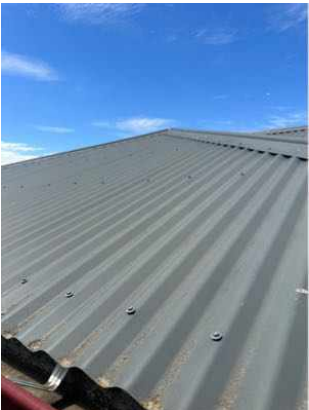
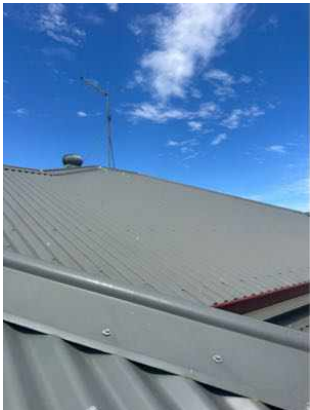
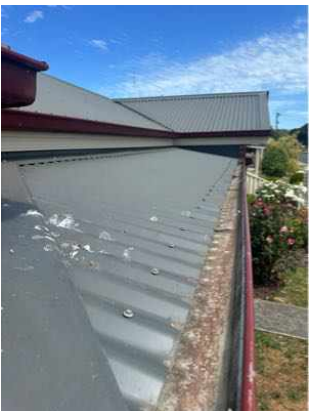
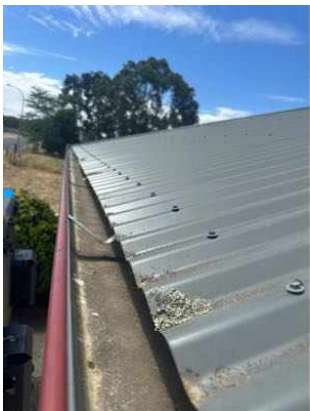
At the time of inspection, the roofing system appeared sound and well-maintained. Continued upkeep will help preserve its function and longevity.

- Maintain routine roof inspections every 1–2 years, particularly before and after storm seasons.
- Monitor for signs of fastener loosening, rust development, or flashing wear.
- Keep gutters and valleys free of debris to ensure efficient drainage and prolong material life.
