## Building Inspection Report

Inspection Date: Fri, 6 Mar 2026

Property Address: 1 Walsh St, West Melbourne VIC 3003,  
Australia

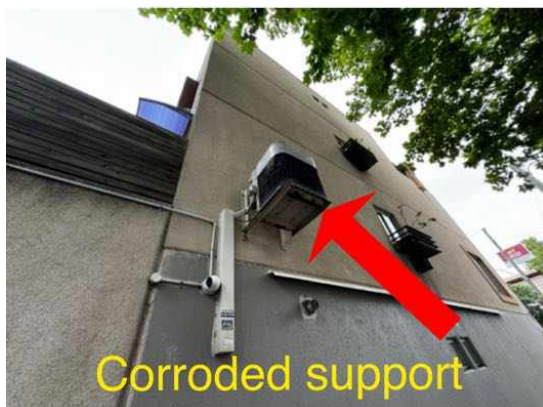
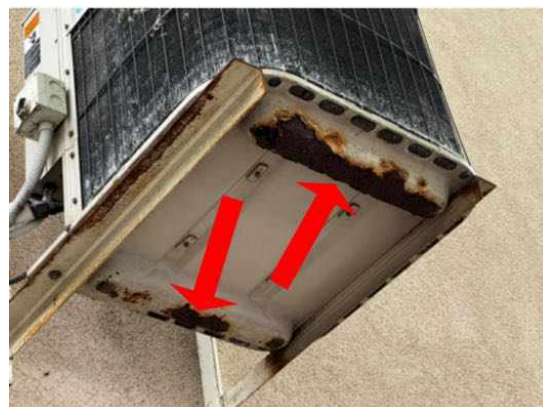
#### Defects 1.01

Building:	Main Building
Location:	Walls > Centre Left
Finding:	Corroded Air Conditioning Bracket Over Public Footpath (Safety Hazard)
Information:	A suspected air conditioning condenser unit mounted to the external east wall of the building was observed to be supported by a metal wall bracket that was heavily corroded. The unit is positioned such that it overhangs a public footpath, increasing the risk to pedestrians should the bracket fail.

Advanced corrosion to structural metal brackets can significantly reduce the load-bearing capacity of the support system. Given the weight of typical air conditioning condenser units, deterioration of the bracket may lead to structural failure of the mounting system, potentially allowing the unit to detach from the wall. Due to the location above a public access area, this condition presents a serious safety hazard to occupants and members of the public.

Immediate, as failure of the corroded bracket could result in the unit falling from height and causing injury or damage.

It is recommended that the air conditioning mounting system be inspected immediately by a qualified HVAC technician or structural contractor. The corroded bracket should be replaced with a suitably rated corrosion-resistant mounting system, and all fixings should be checked to ensure the unit is securely anchored to the structure.

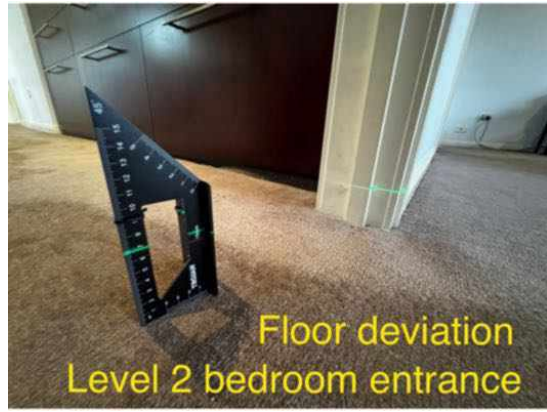
Floor deviation  
Level 2 bedroom entrance

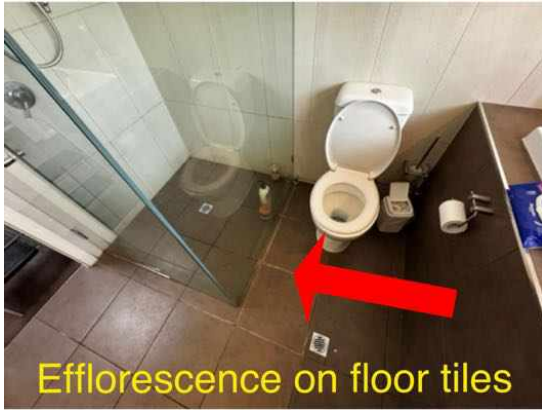
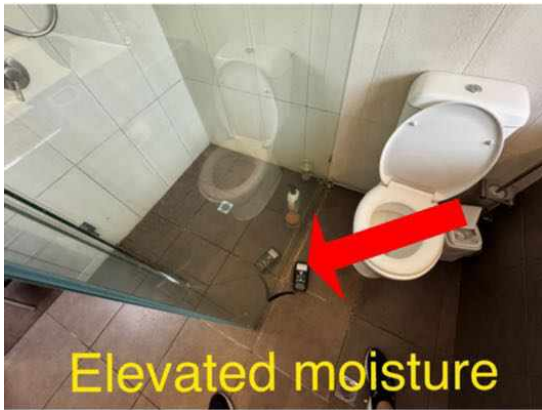
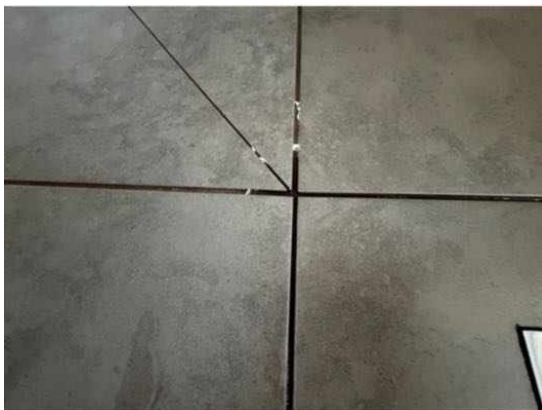
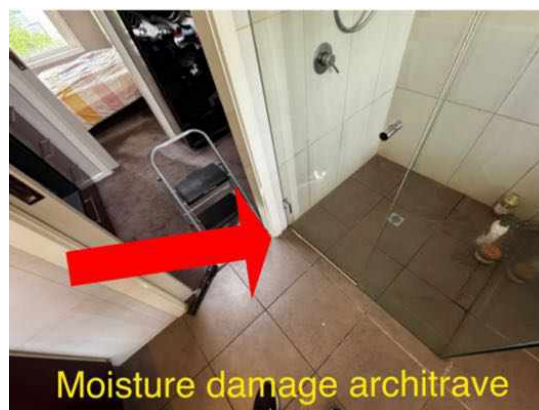
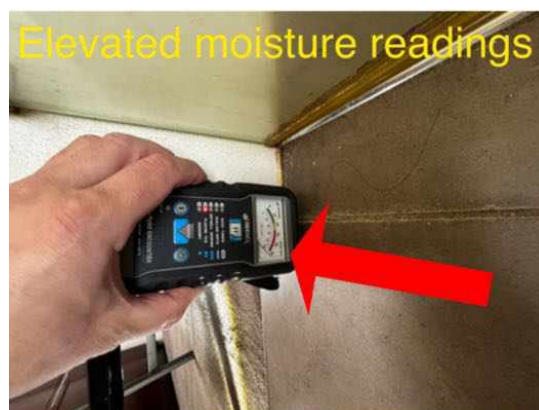
Defects 2.02

Building: Main Building  
Location: Ensuite - Master > Level 3  
Finding: Wet Area Moisture Ingress – Level 3 Ensuite Shower Area  
Information: Elevated moisture levels were detected to the floor tiles in the Level 3 ensuite bathroom, particularly around the external perimeter of the shower screen. Moisture readings were obtained using a moisture meter and were concentrated mainly in areas outside the shower enclosure.

Visible efflorescence was observed on the floor tiles adjacent to the shower screen, indicating prolonged moisture migration through the tile or grout system. Additionally, the architrave to the door jamb directly adjacent to the shower screen showed visible signs of moisture damage, including swelling and early deterioration of the timber element.

The condition of the grout and sealant within the shower enclosure was poor, with heavily deteriorated joints noted during inspection. Deterioration of grout and sealant can allow water to bypass the tiled surface and migrate into surrounding building elements.

It was also noted that no visible water stop could be identified beneath the shower screen threshold during the inspection. Without a visible water stop, water can escape the wet area and migrate into adjoining floor areas. The compliance of the waterproofing system within this bathroom could not be verified, as the waterproofing membrane is concealed beneath the tiled surface.

Given the presence of elevated moisture readings, efflorescence, deterioration of timber joinery, and degraded grout and sealant conditions, this defect is considered a Major Defect under the principles of AS 4349.1–2007, as it indicates ongoing moisture ingress that may lead to concealed damage to floor substrates, framing and surrounding building elements.

It is recommended that a licensed plumber or waterproofing specialist undertake further investigation to determine the source of the moisture ingress. This may require invasive inspection of the shower base and waterproofing system. Rectification works may include repair or replacement of grout and sealants, installation of a compliant water stop if missing, and potential remediation of the waterproofing system if found to be defective. Damaged architraves and adjacent building elements should be repaired once the moisture issue has been resolved.

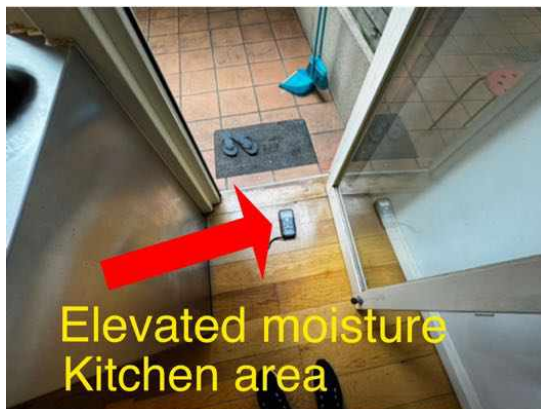
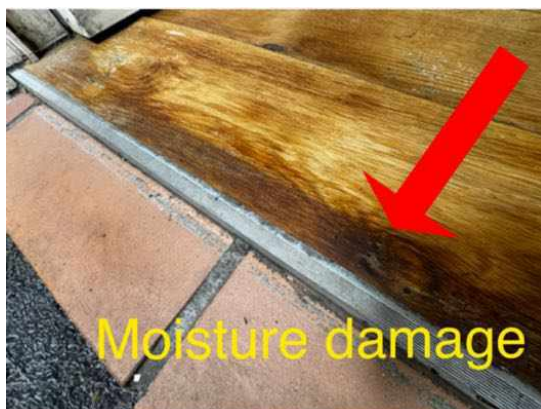
## Defects 2.03

Building:	Main Building
Location:	Kitchen > Level 1
Finding:	Timber Floor Moisture Damage – Kitchen Courtyard Door
Information:	Elevated moisture levels were detected to the timber floorboards in the kitchen area directly in front of the door leading to the external courtyard. Moisture testing was conducted using a moisture meter, which returned high readings to the timber flooring immediately behind the door threshold.

Visible signs of moisture damage were also observed to a small section of the timber flooring in this location, including deterioration and discolouration of the floorboards. The pattern and location of the moisture damage suggest that water may be entering beneath the door during rainfall events. However, other possible causes such as inadequate door sealing, drainage issues at the external threshold, or other moisture ingress sources cannot be ruled out at this stage.

Timber flooring exposed to ongoing moisture can deteriorate over time, leading to swelling, warping and potential damage to the underlying subfloor or surrounding building elements.

It is recommended that the courtyard door threshold and external drainage conditions

be assessed to determine whether rainwater is entering beneath the door. Improvements may include installing or replacing door seals, adjusting the door threshold, or improving external drainage away from the doorway. Damaged timber flooring should be repaired or replaced once the moisture source has been identified and rectified.

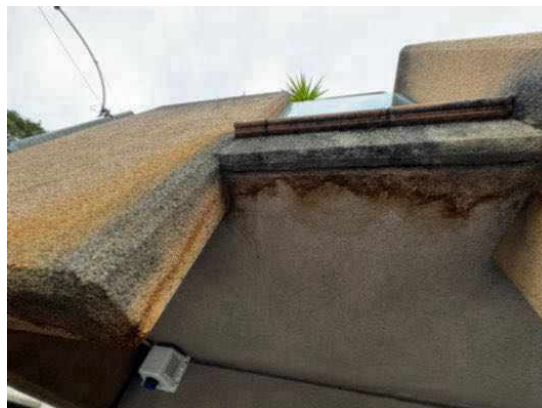
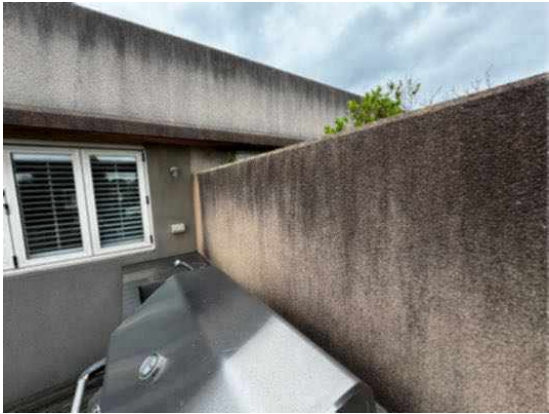
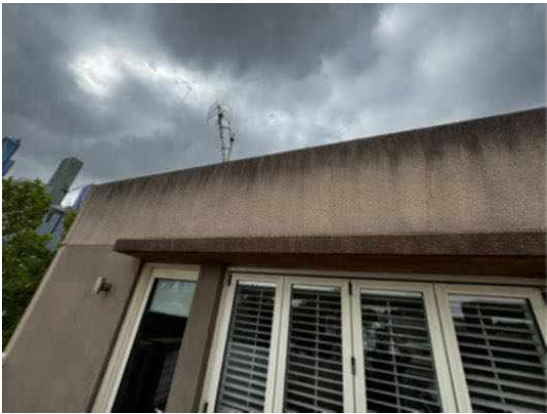
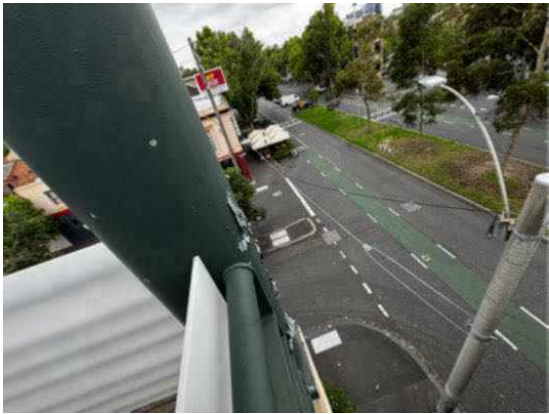
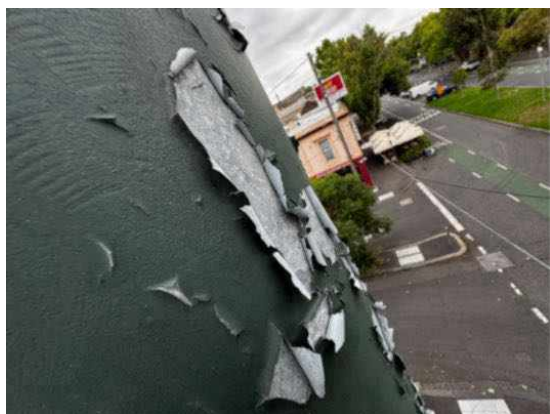
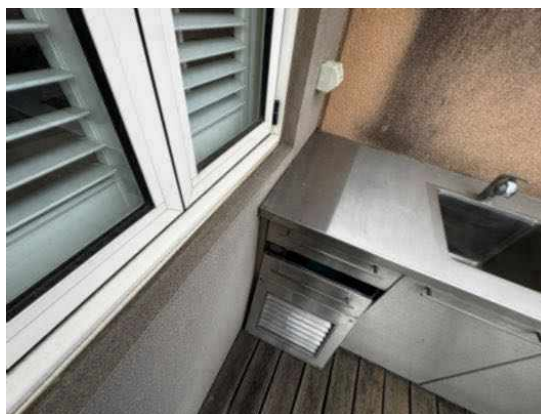
### Defects 3.01

Building: Main Building  
 Location: All Areas > All Areas  
 Finding: External Defects – Concrete Walls, Steel Columns and Terrace Kitchen Junctions  
 Information: The following external defects were observed during the inspection:

Accumulation of dirt, grime, mould and moisture staining was observed to the external

concrete panel walls, including areas around balconies and terrace spaces. The staining appears consistent with prolonged exposure to weather conditions combined with a lack of routine maintenance and cleaning.

Peeling paint was observed to the steel columns supporting the top floor terrace. Deterioration of protective paint coatings can expose steel elements to moisture, potentially leading to corrosion over time if not maintained.

The outdoor kitchen located on the top floor terrace was observed to have gaps at junction points where the kitchen structure meets the surrounding walls. These junctions require sealing with an appropriate flexible sealant to prevent moisture ingress.

Additionally, pipe penetrations beneath the outdoor kitchen bench were observed to have visible gaps, with sections of the wall cavity clearly visible. Although located beneath the bench, these penetrations should be sealed to prevent potential moisture ingress and to reduce the risk of pest entry into the building envelope.

It is recommended that the external concrete surfaces be professionally cleaned to remove mould and grime. Steel columns should be prepared and repainted with an appropriate protective coating to prevent corrosion. Junctions around the outdoor kitchen and pipe penetrations should be sealed with suitable exterior-grade sealant to close gaps and protect the building envelope.

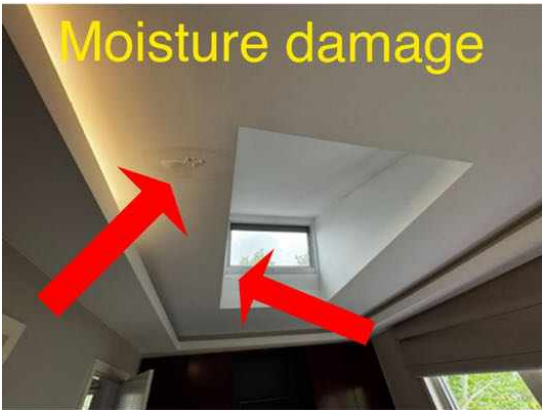
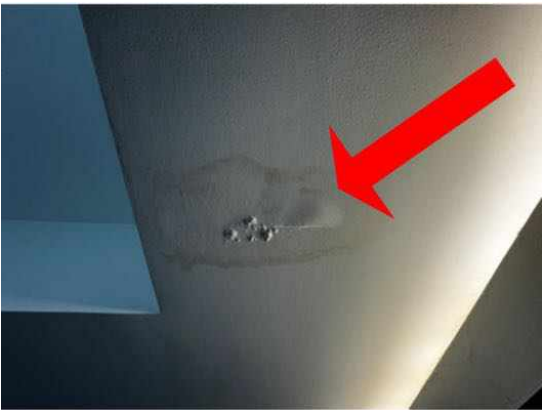
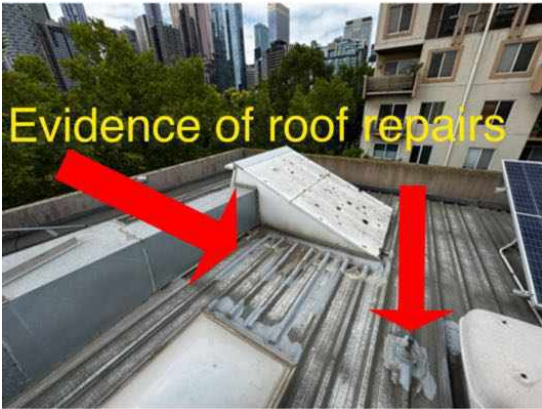
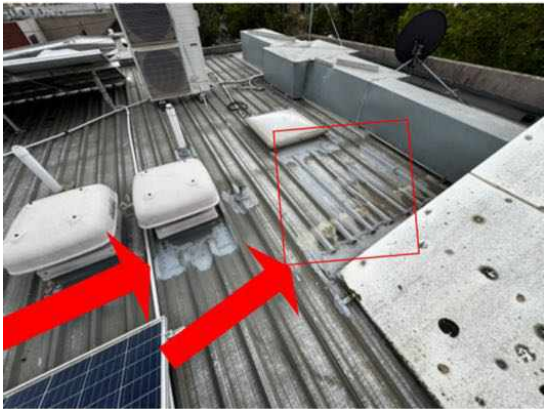
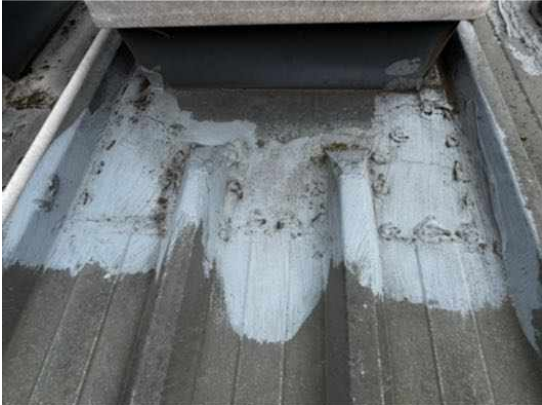
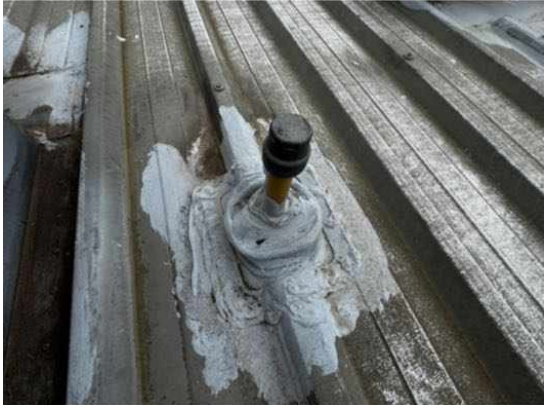
### Defects 3.02

Building:	Main Building
Location:	Bedroom - Master > Level 3
Finding:	Roof Leak – Reported Historical Moisture Damage to Level 3 Bedroom Ceiling
Information:	Evidence of moisture damage was observed to the ceiling of the bedroom on Level 3 on the south side of the building. The damage consisted of visible staining and deterioration to sections of the plaster ceiling lining.

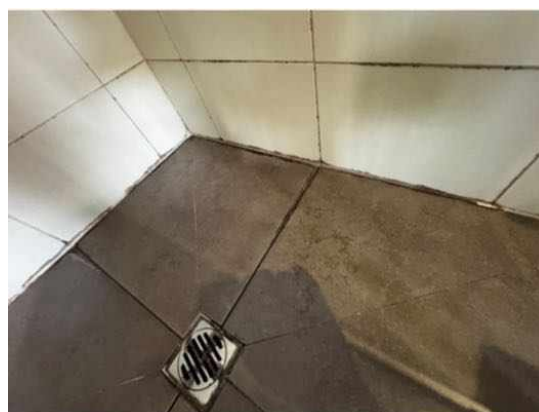
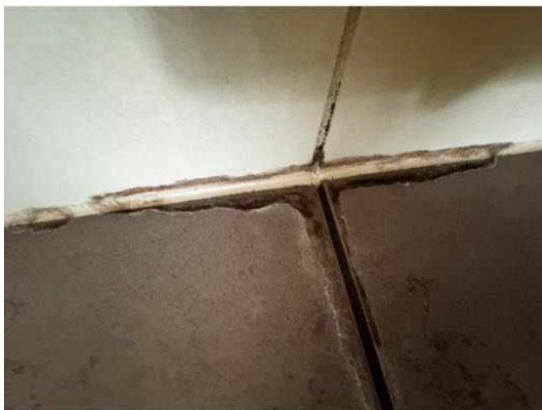
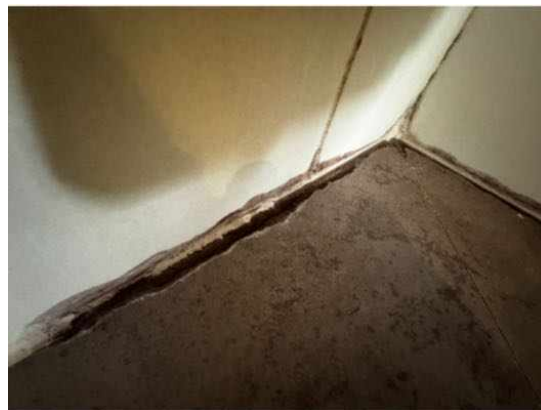
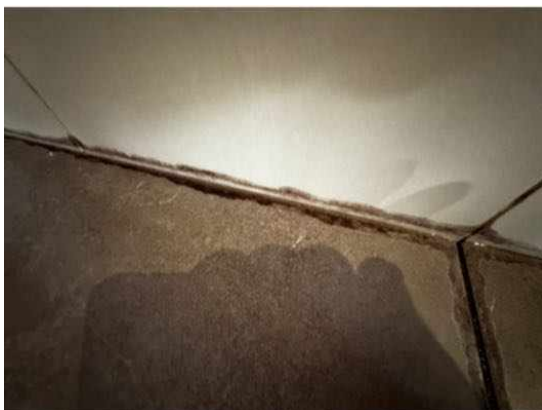
Defects 3.03

Building: Main Building  
Location: Ensuite - Other > Level 2  
Finding: Ensuite Shower – Mould Build-Up to Floor Tiles  
Information: Mould build-up was observed on the floor tiles within the ensuite shower on Level 2. The mould appears consistent with a lack of regular cleaning and maintenance within the shower enclosure.

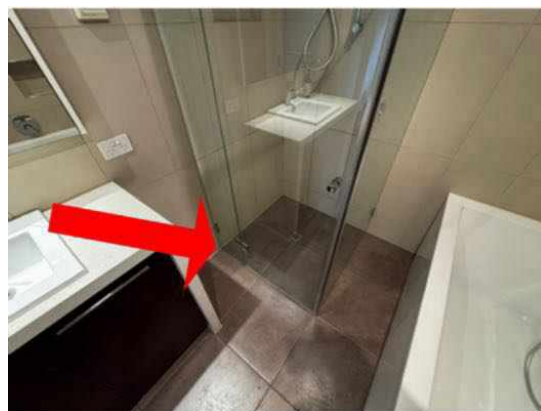
### Defects 3.04

Building: Main Building  
 Location: Bathroom > Level 2  
 Finding: Shower Screen Leakage – Level 2 Main Bathroom  
 Information: A minor leak was identified to the shower screen in the Level 2 main bathroom during testing. A water test was conducted using the shower rose, and when water was directed toward the wall and shower screen junction, a small amount of water was observed leaking from the corner of the shower screen onto the bathroom floor tiles.

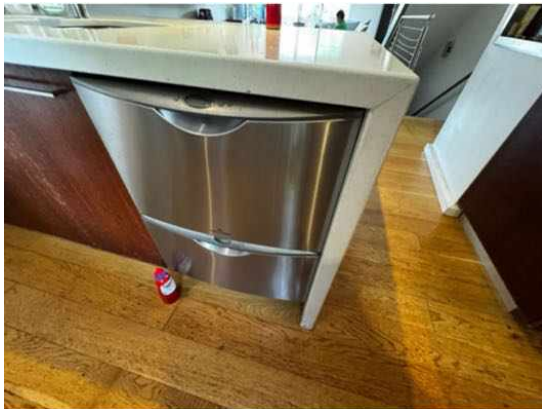
### Defects 3.06

Building: Main Building  
 Location: Kitchen > Level 1  
 Finding: Dishwasher – Reported Non-Operational  
 Information: The dishwasher located in the kitchen was reported by the tenant to be non-operational and faulty at the time of inspection. No functional testing of the appliance was undertaken during the inspection, and the defect was noted based on the tenant’s report.

Household appliances such as dishwashers are generally considered non-structural components of the building and fall outside the core structural elements of the property. However, faulty appliances may require repair or replacement to restore

It is recommended that the dishwasher be inspected by a qualified appliance technician to determine the cause of the fault and whether repair or replacement is required.

Maintenance recommended in the short term to restore normal operation of the appliance.

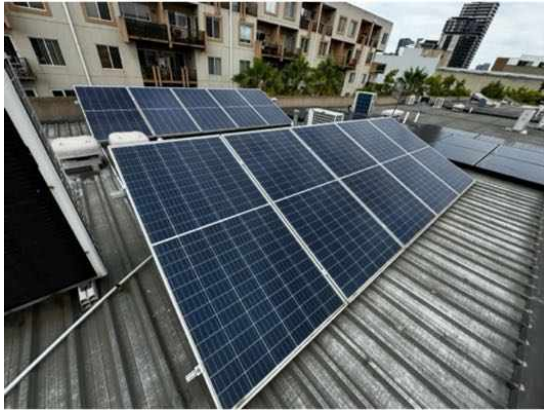
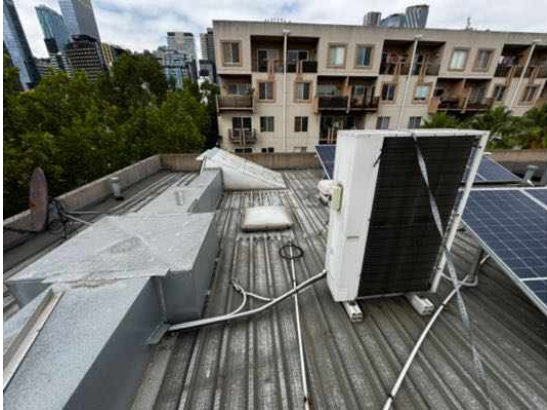
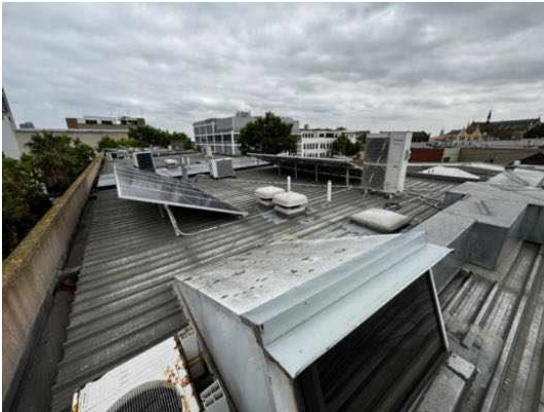
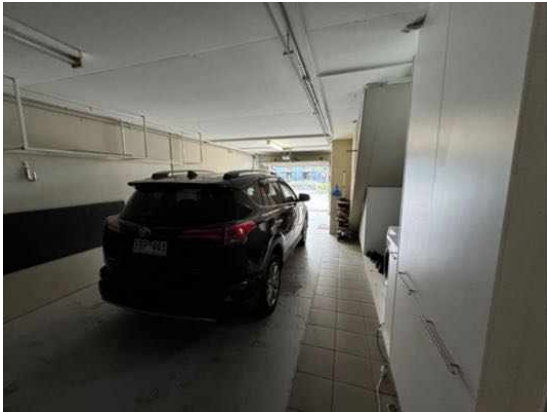
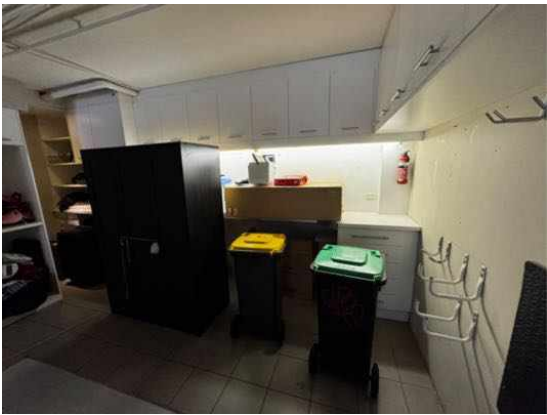
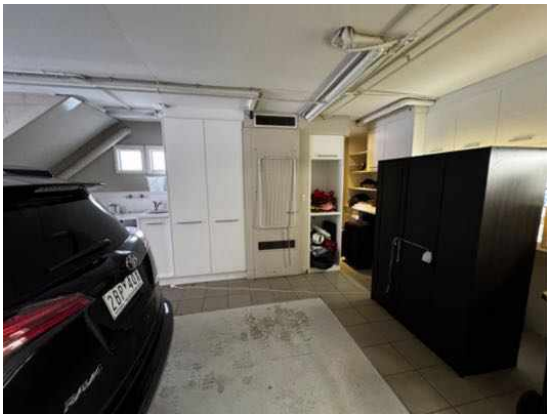
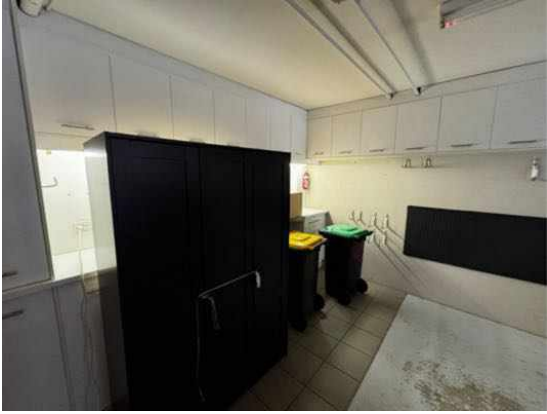
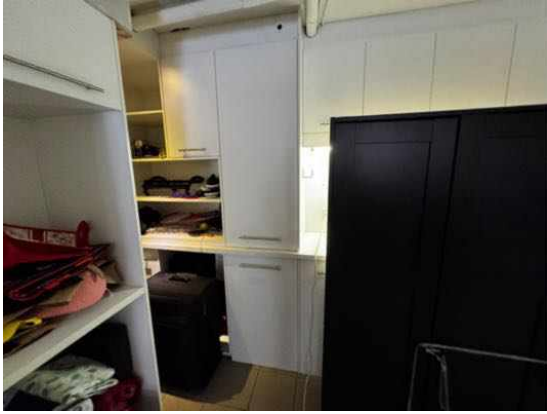
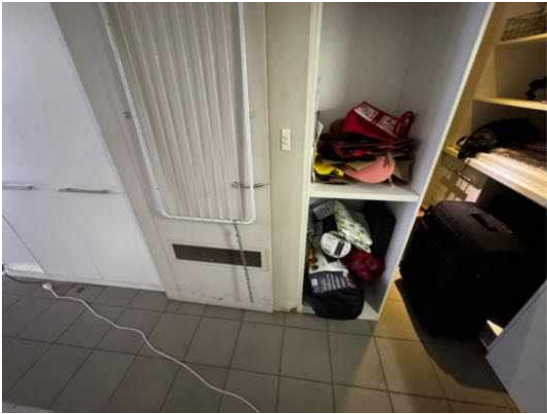
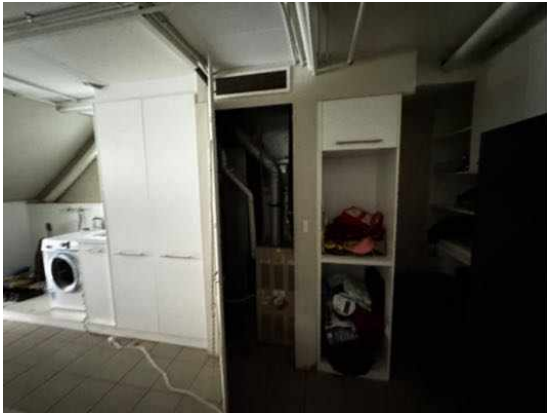
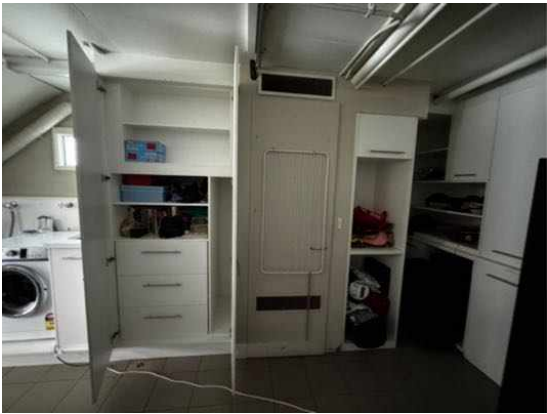
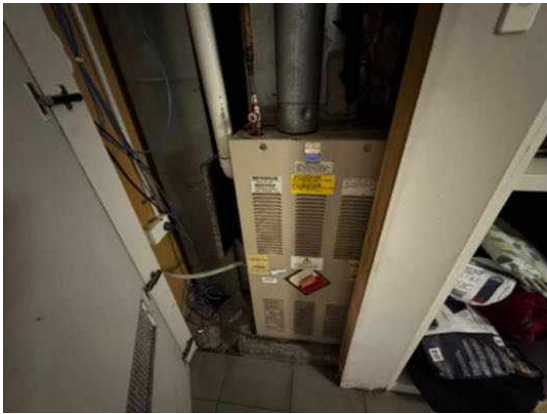
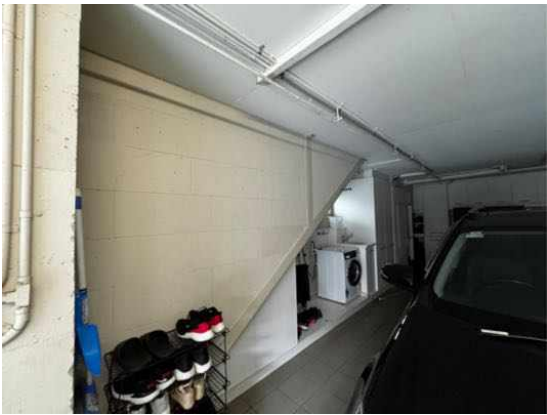
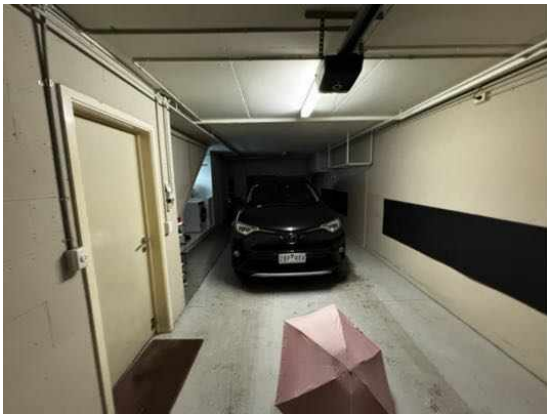
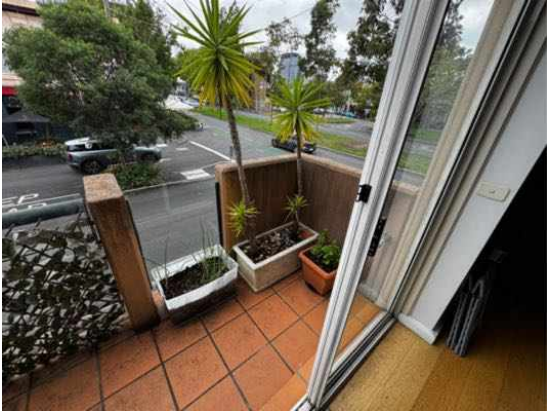
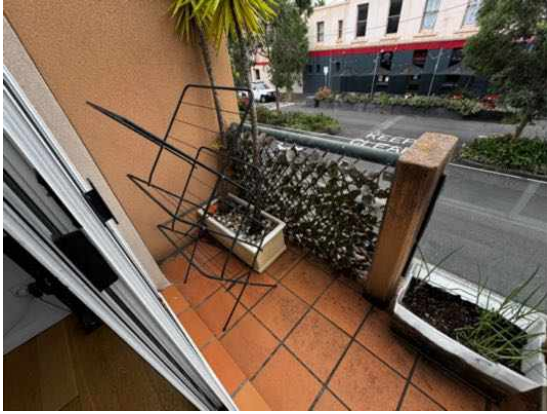
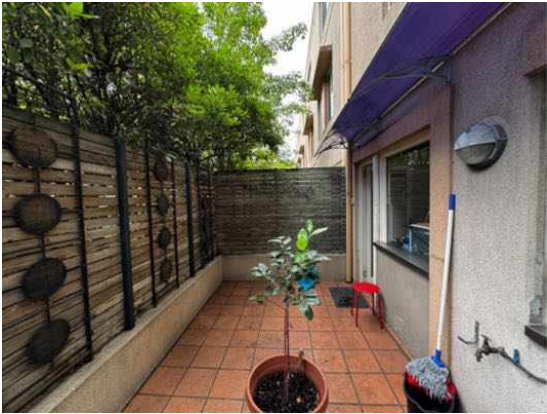
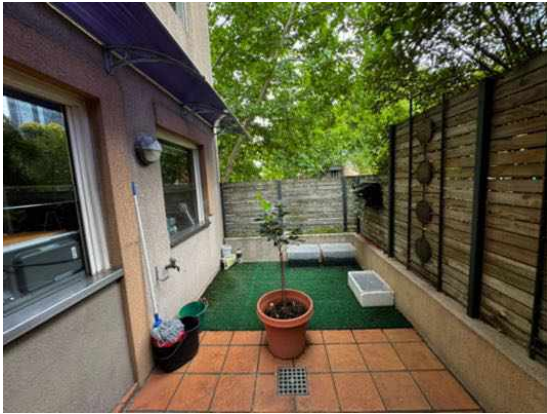
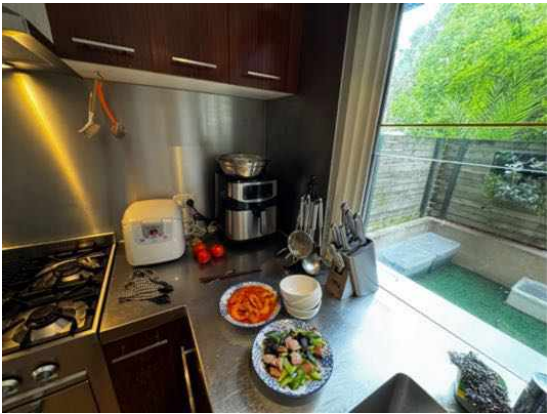
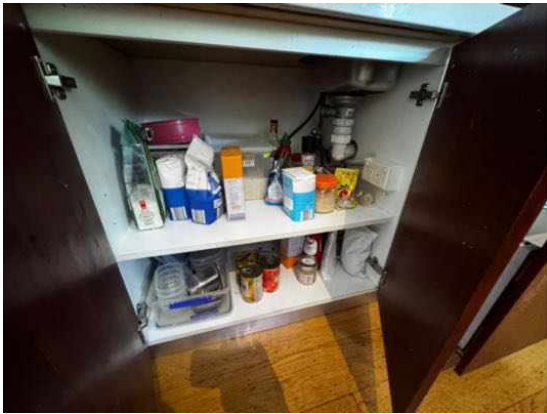
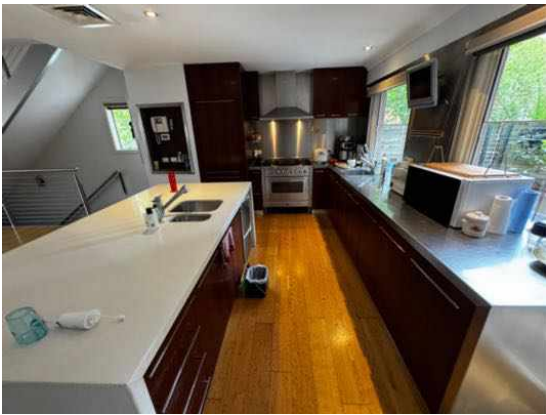
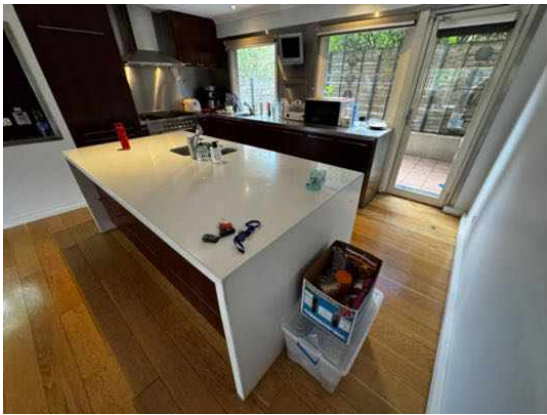
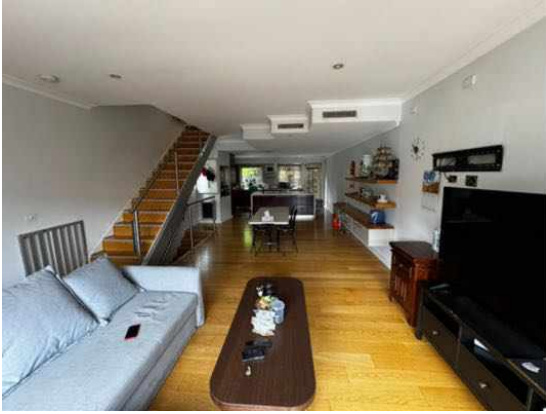
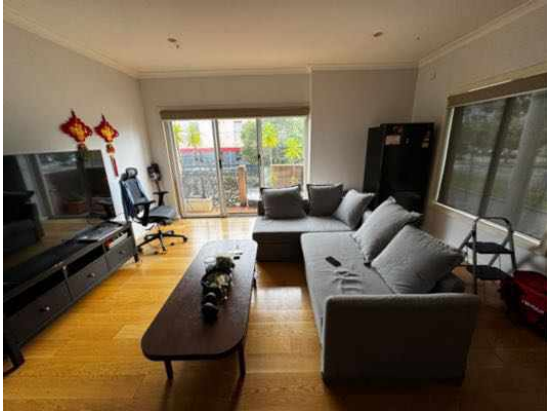
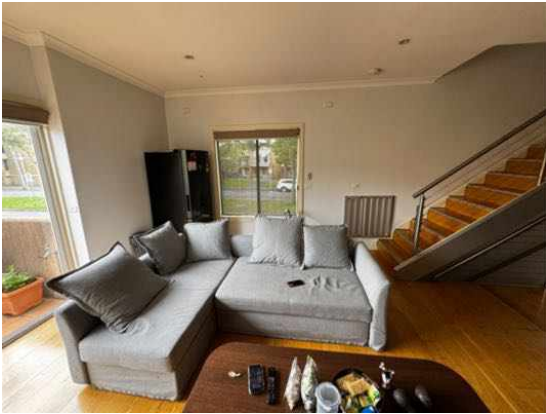
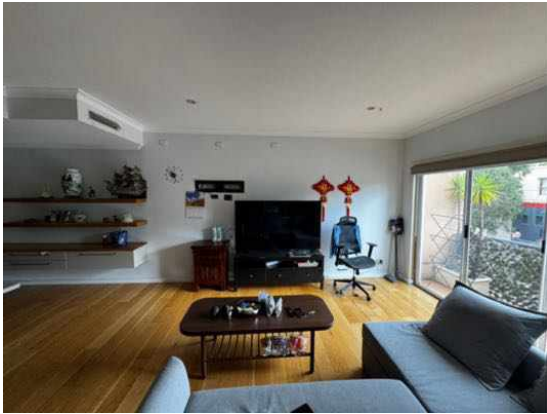
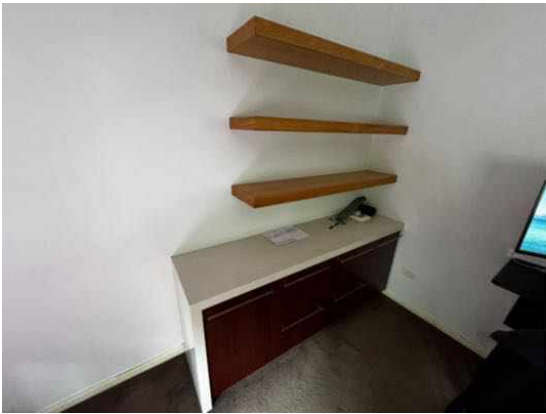
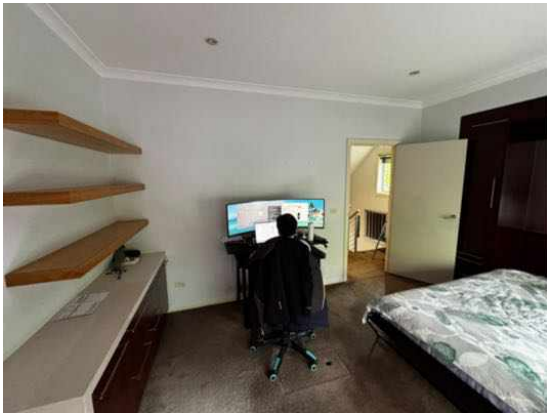
Building: Main Building  
Location: All Areas > All Areas  
Finding: Additional Photos - Obstructions and Limitations  
Information: These photographs are an indication of the obstructions and limitations which impeded full inspection of the property at the time of inspection. These obstructions can hide an array of defects and should be removed to allow full inspection to be carried out. A re-inspection is recommended once the areas are made accessible.
