## Building Inspection Report

Inspection Date: Fri, 6 Mar 2026

Property Address: 1 Walsh St, West Melbourne VIC 3003,  
Australia

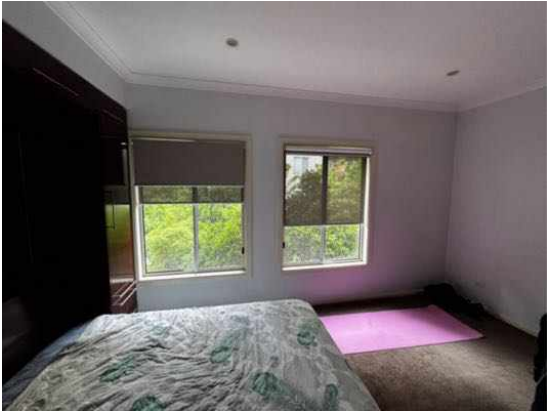
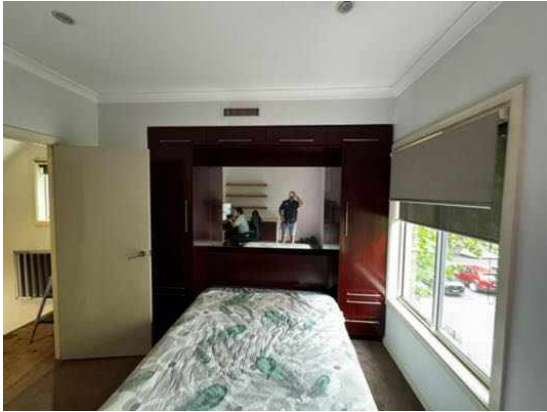
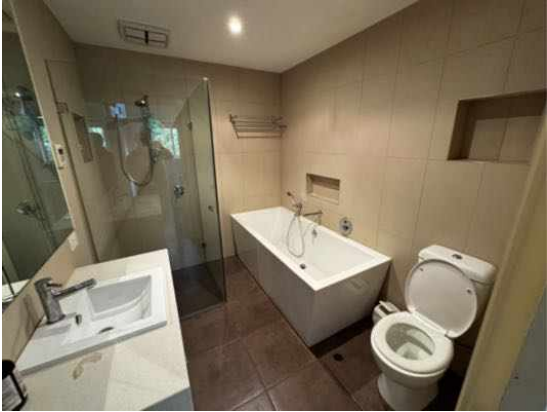
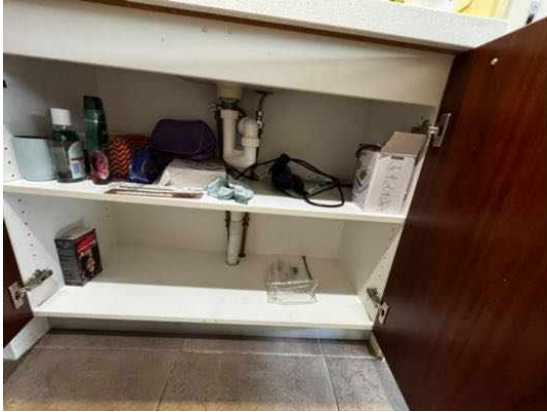
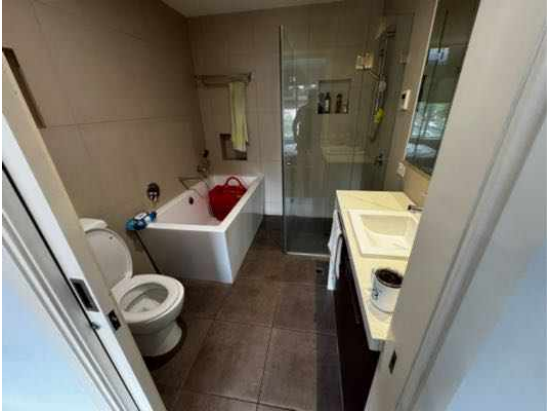
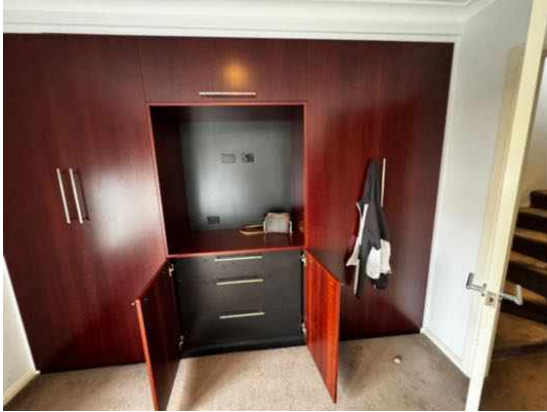
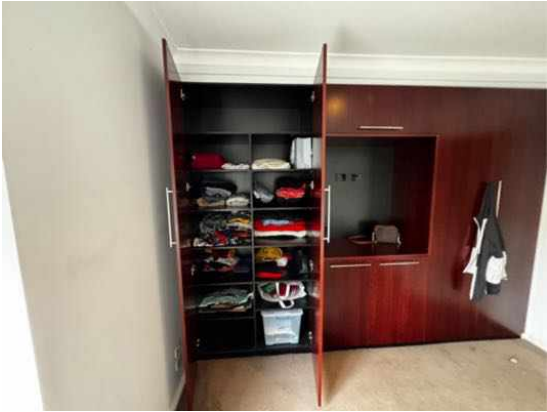
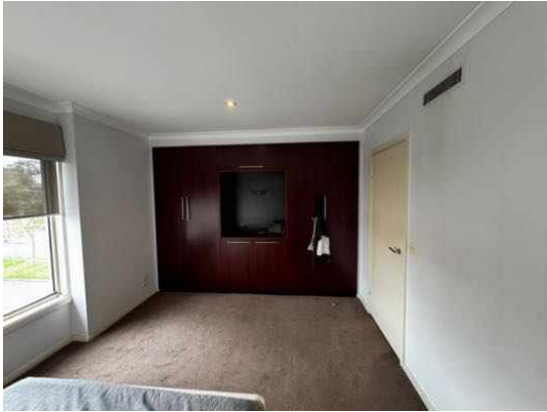
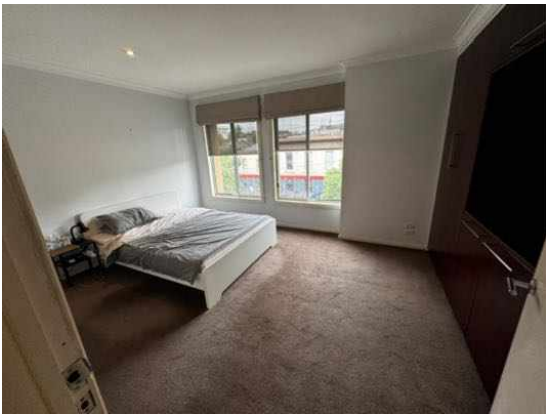
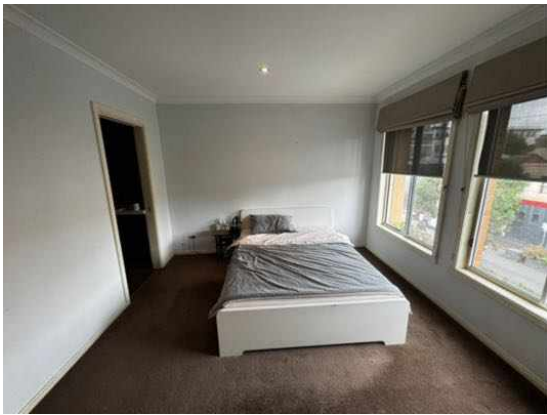
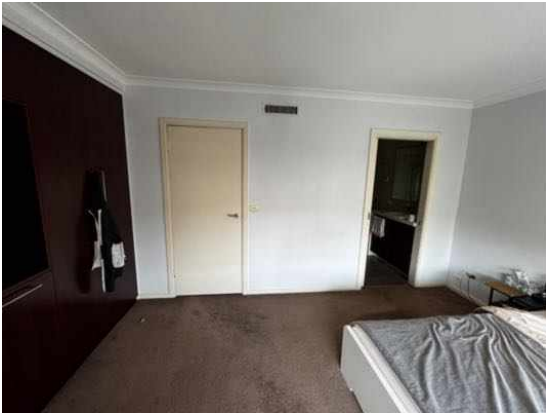
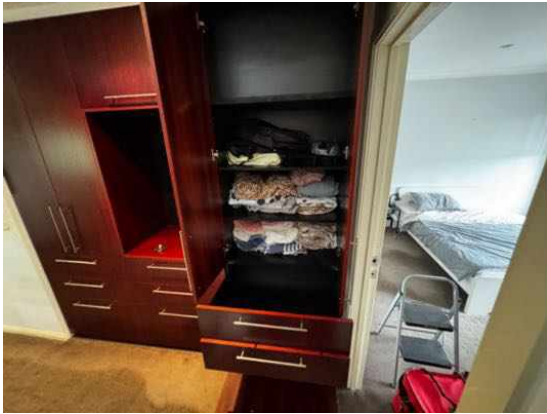
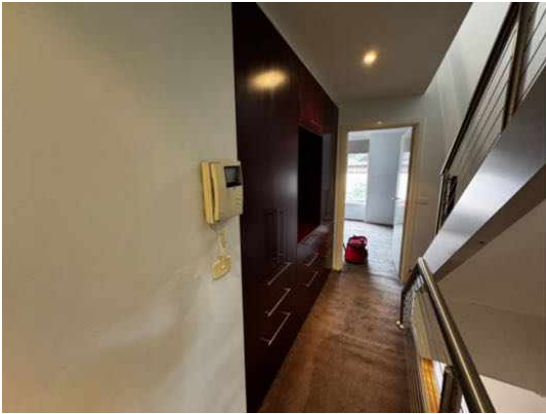
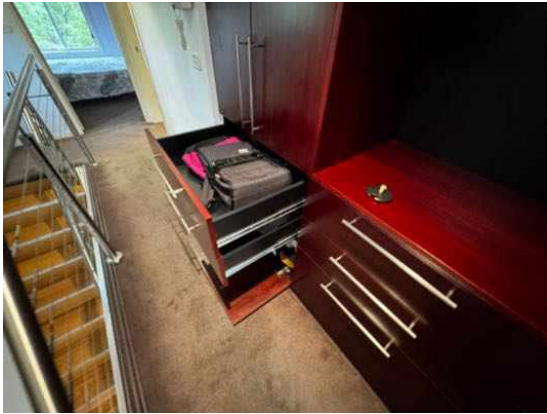
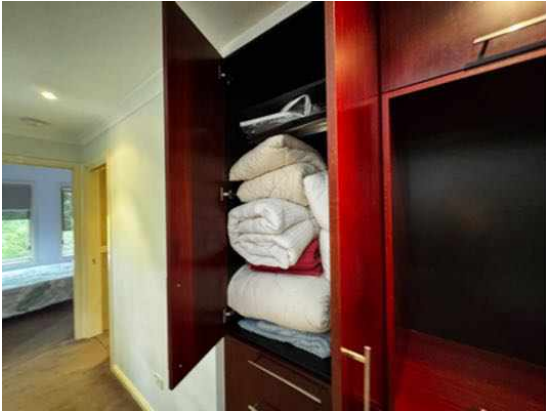
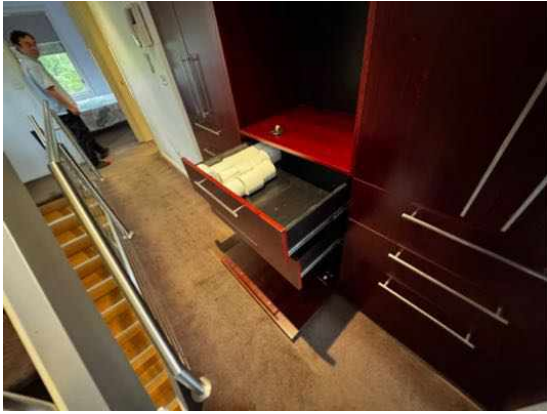
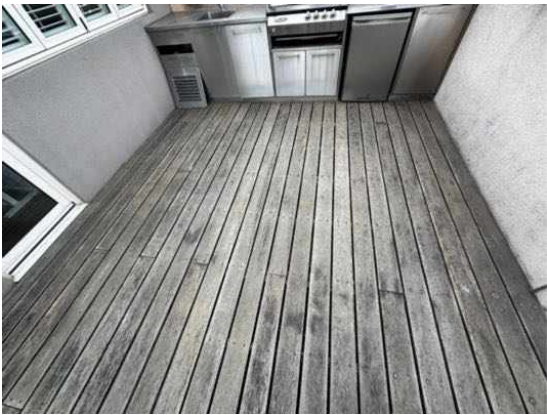
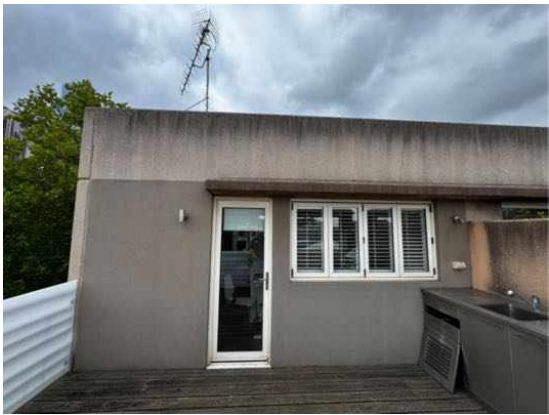
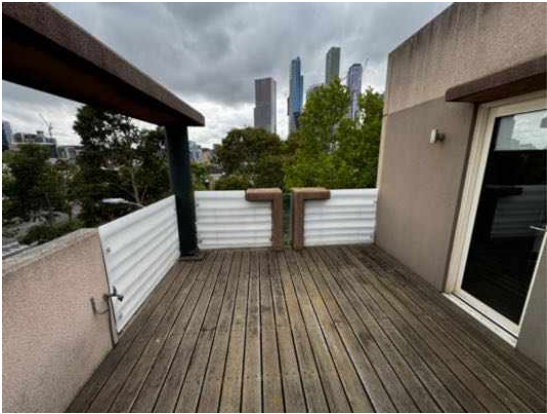
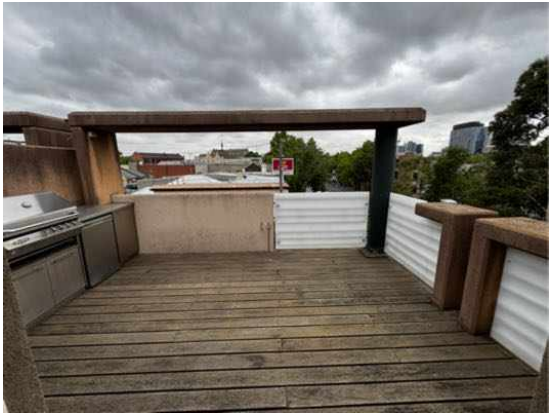
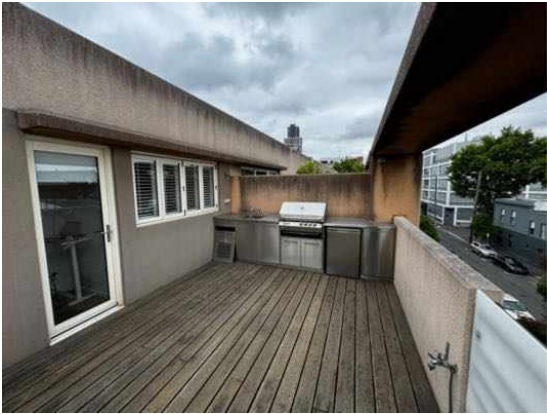
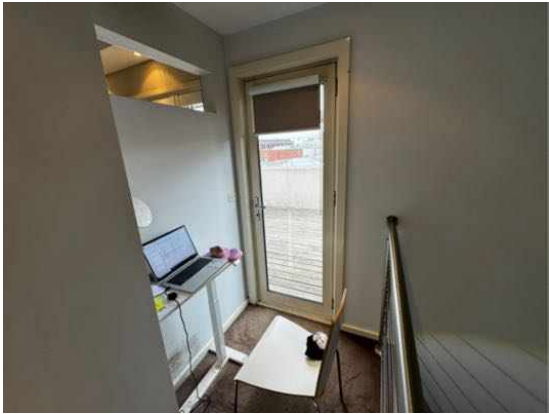
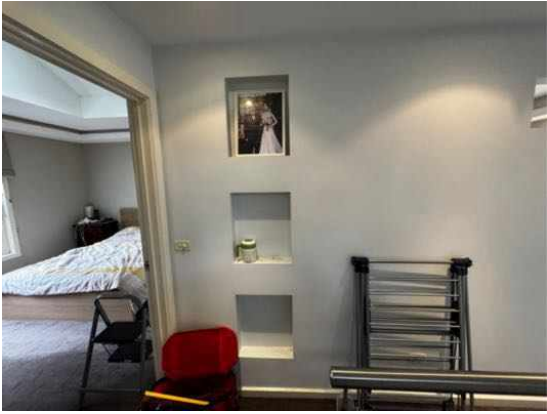
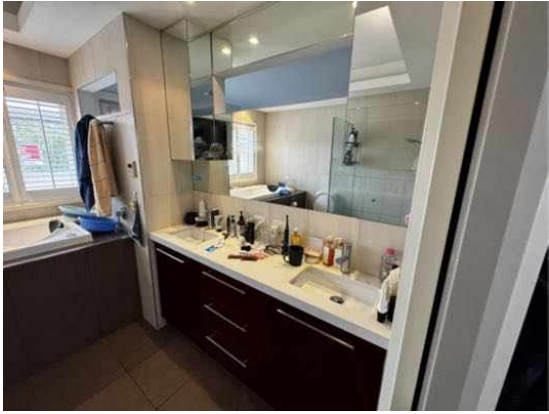
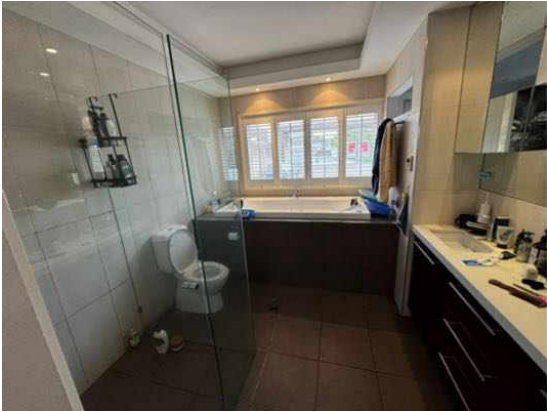
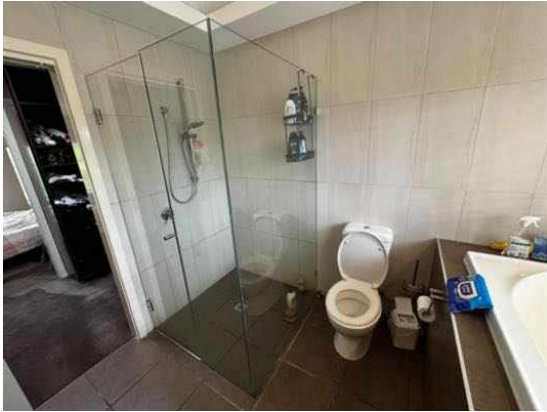
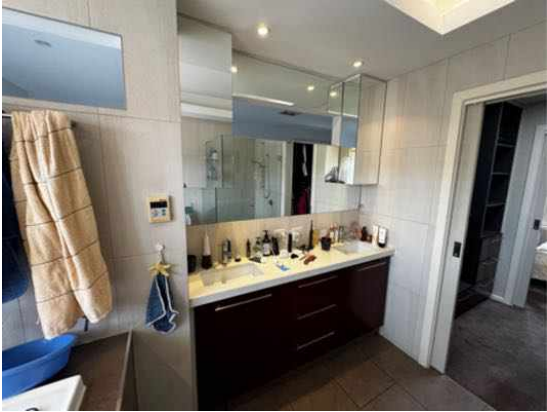
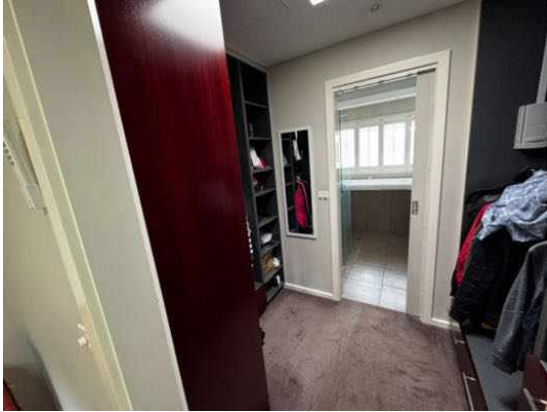
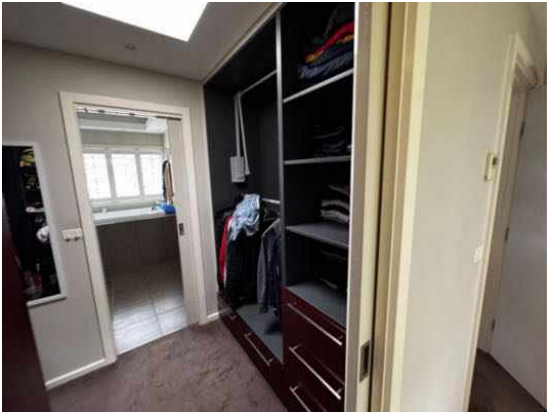
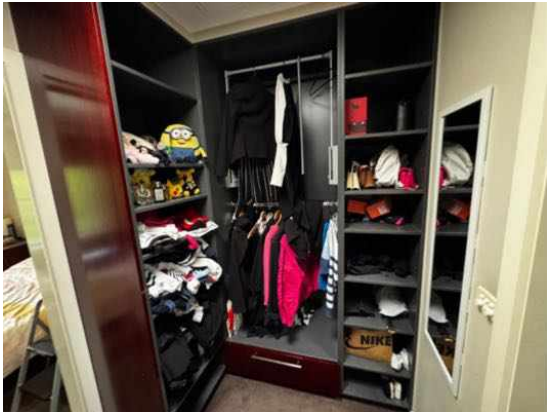
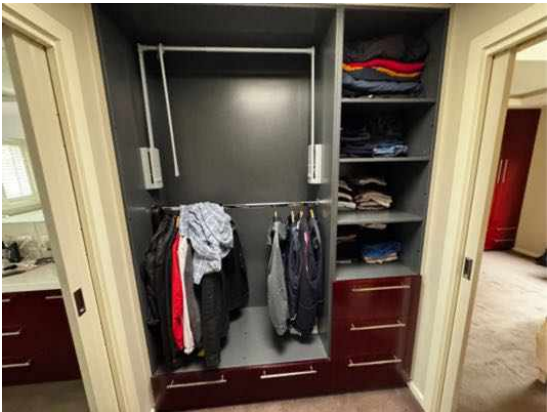
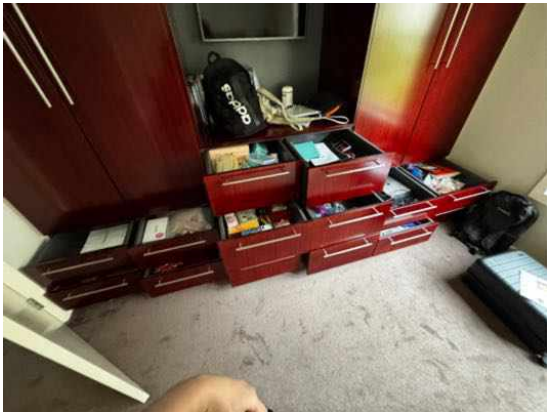
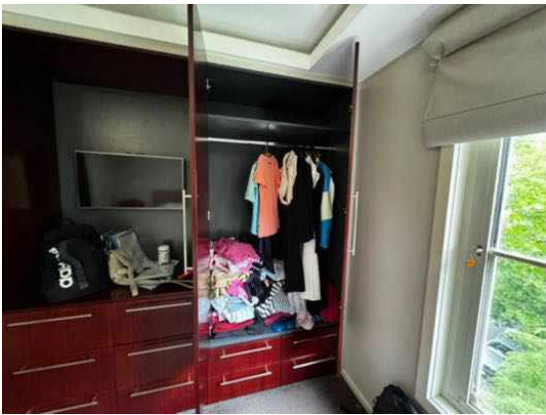
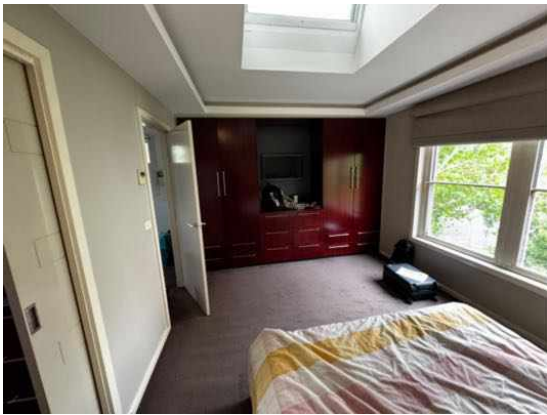
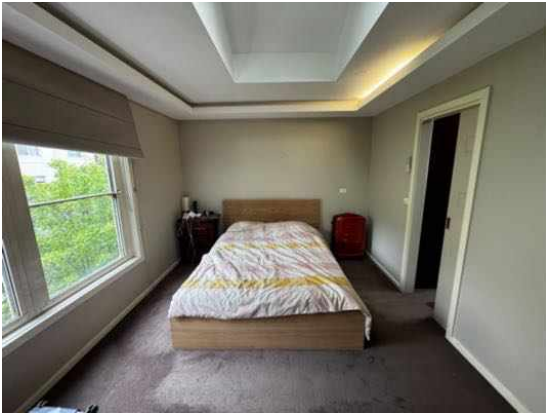
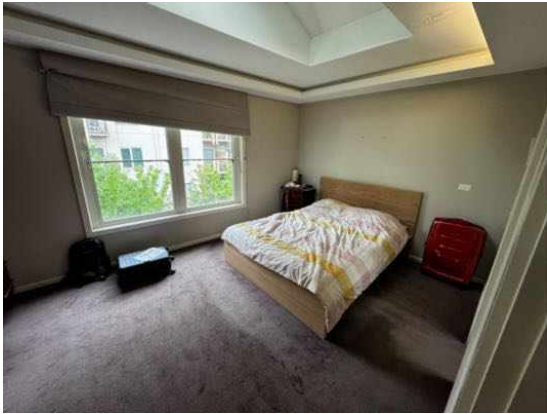
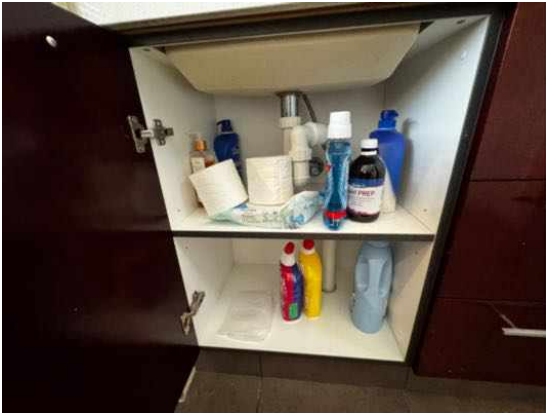
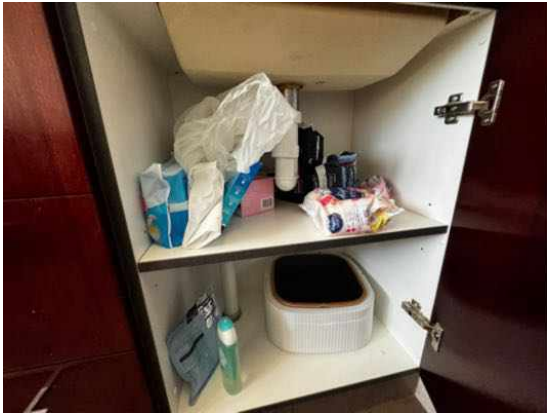
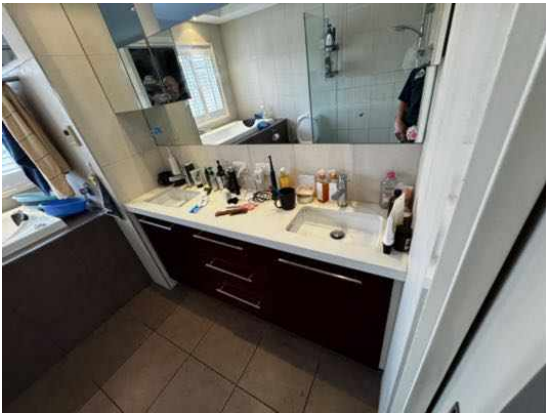
Building: Main Building  
Location: All Areas > All Areas  
Finding: Additional Photos  
Information: Additional photos are provided for your general reference

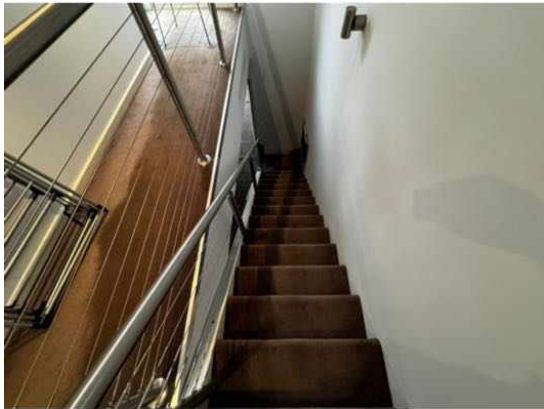
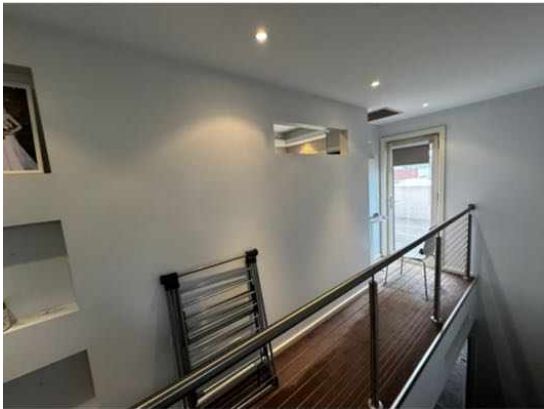
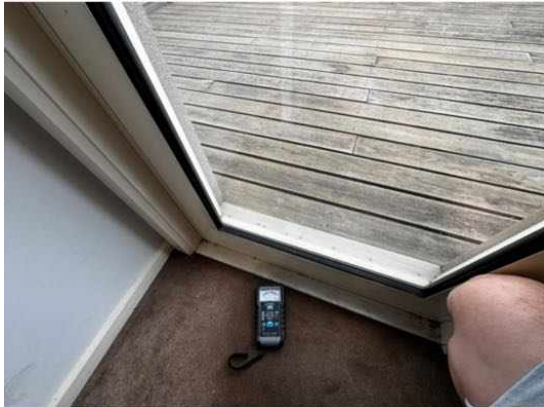
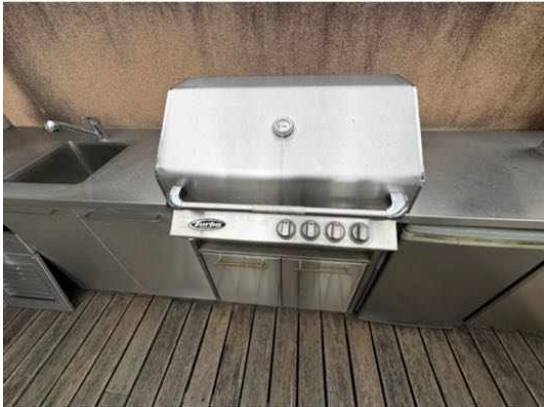
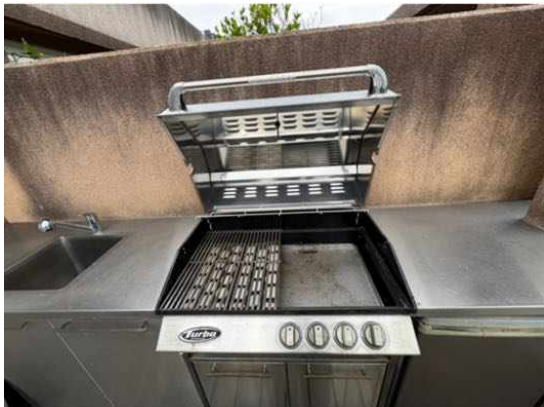
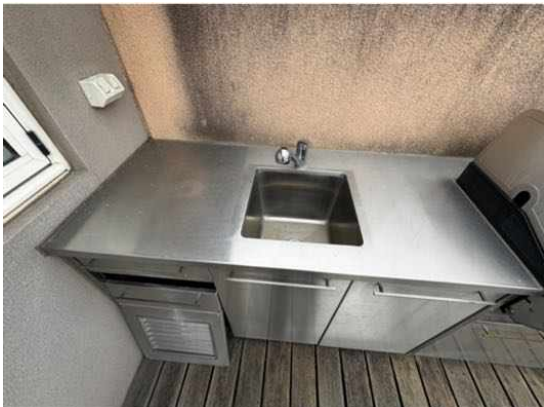
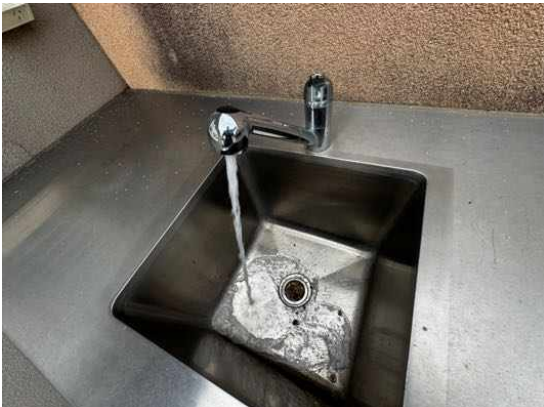
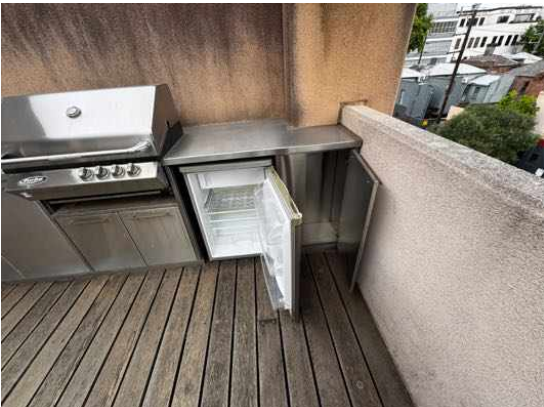
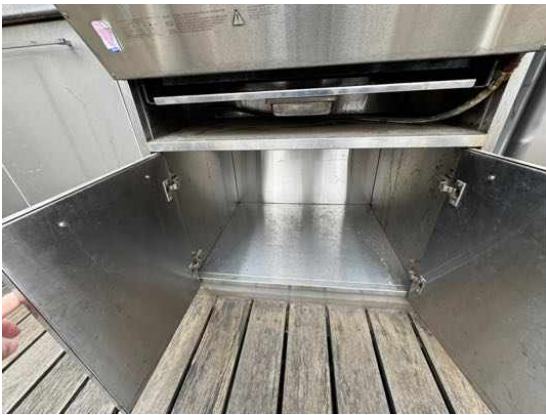
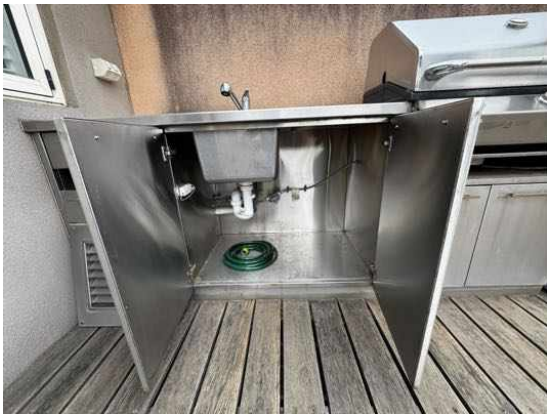
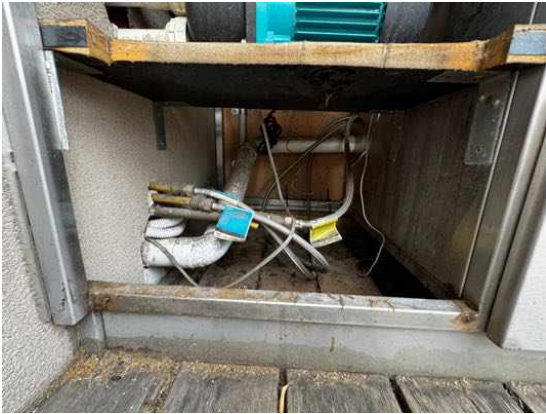
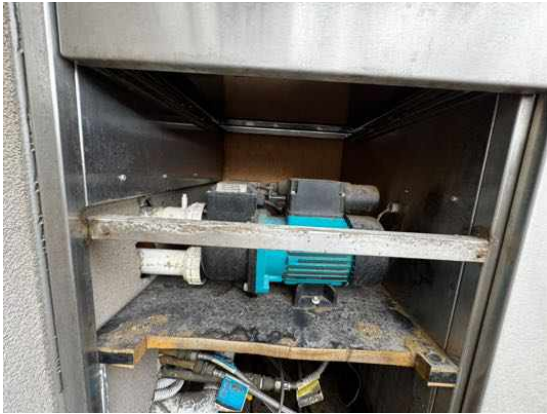
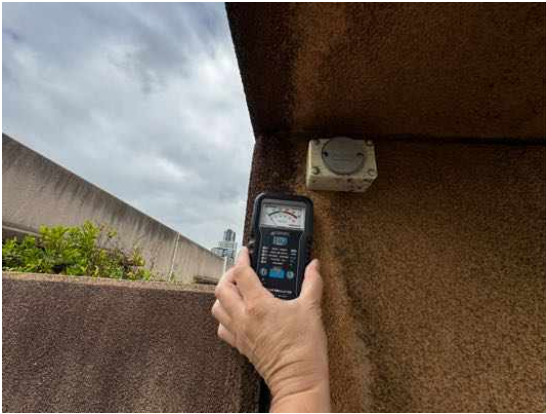
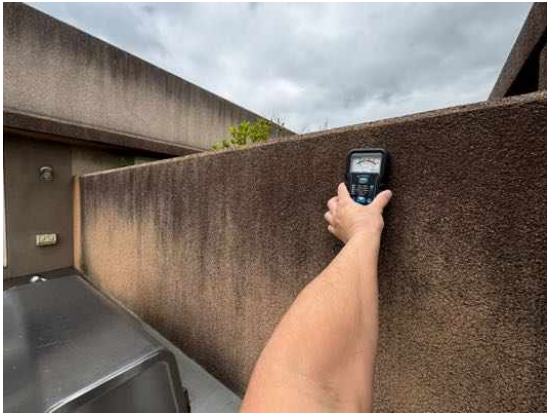
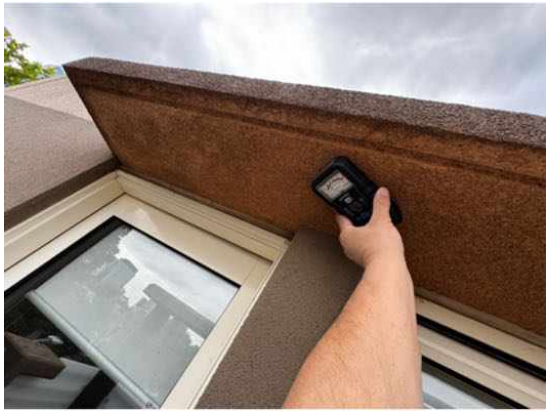
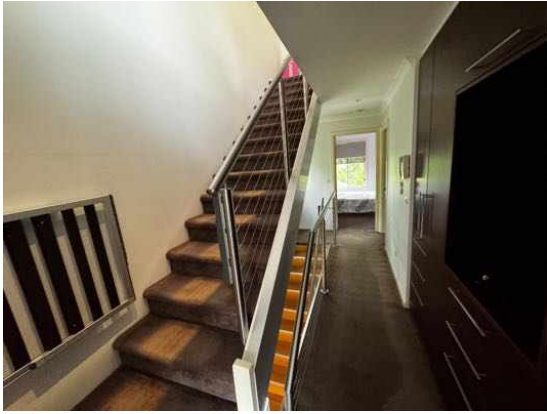
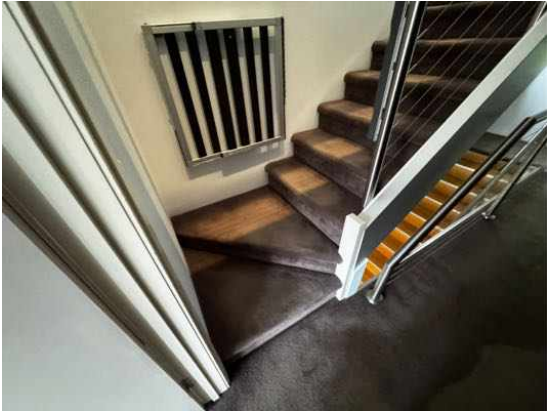
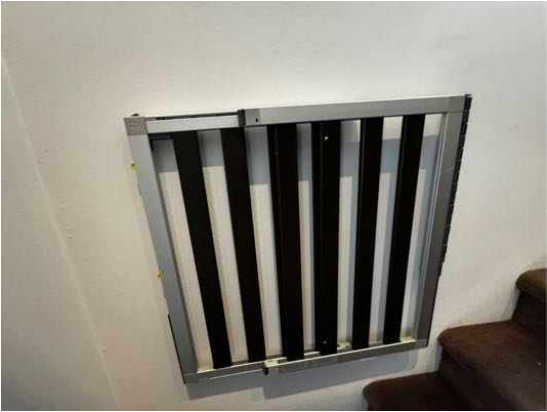
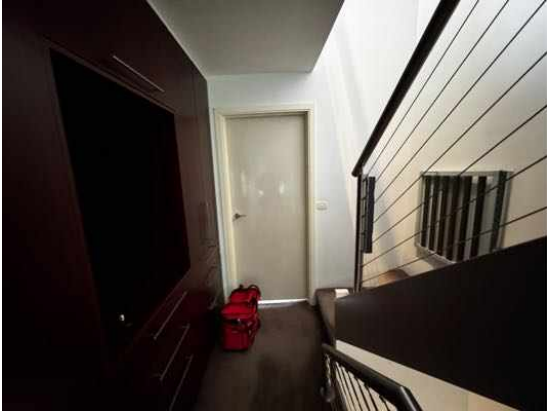
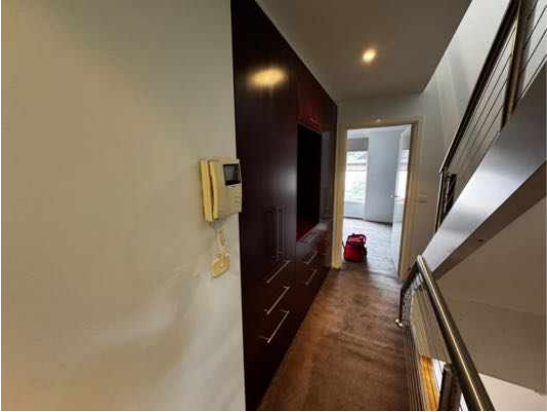
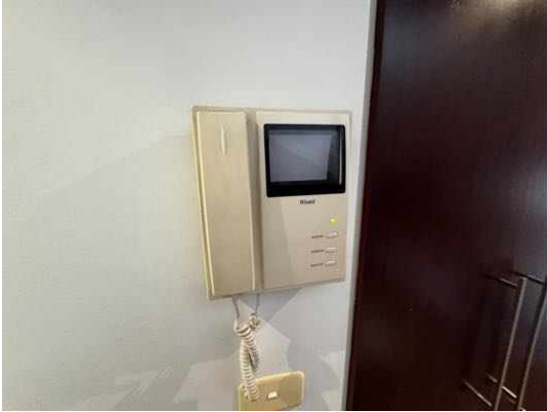
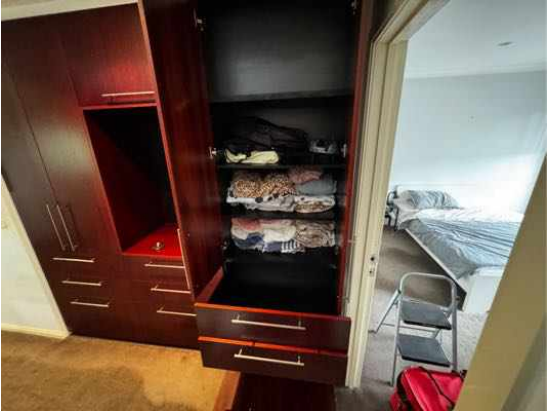
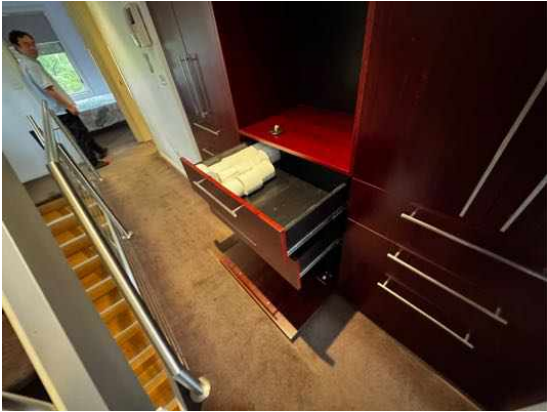
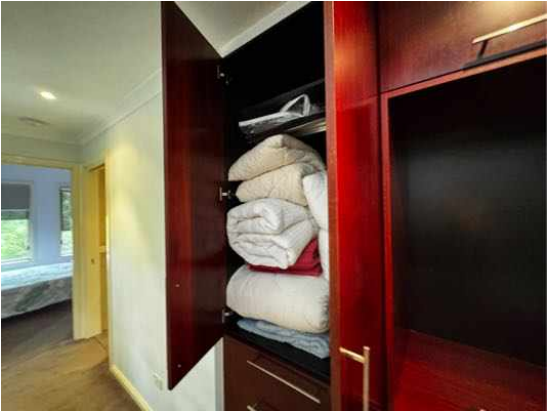
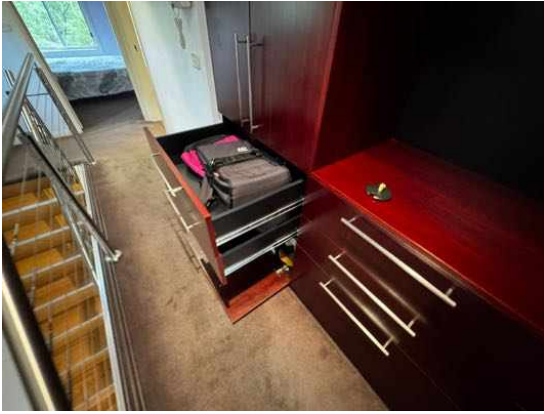
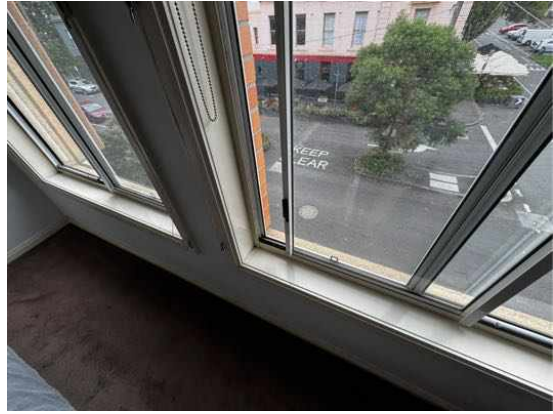
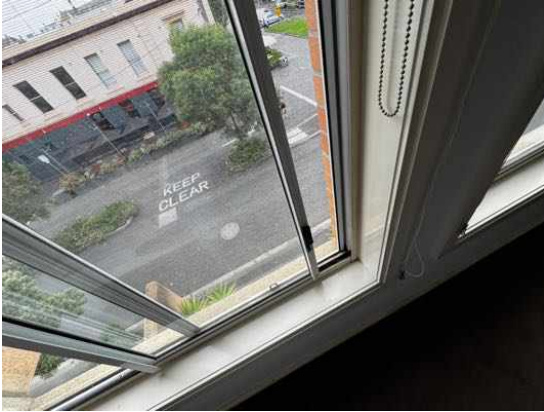
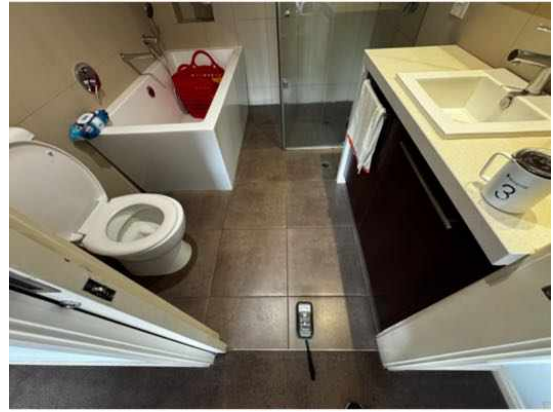
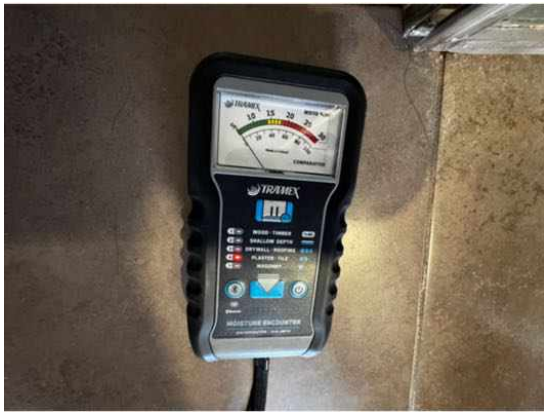
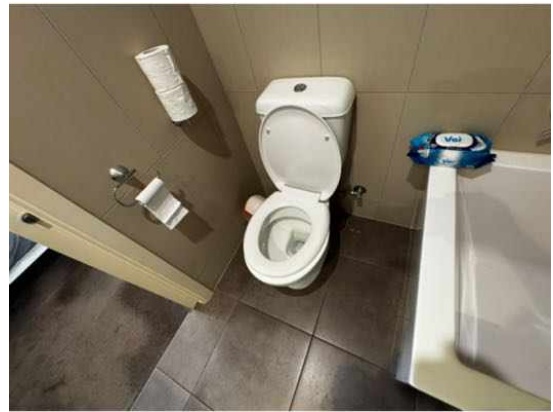
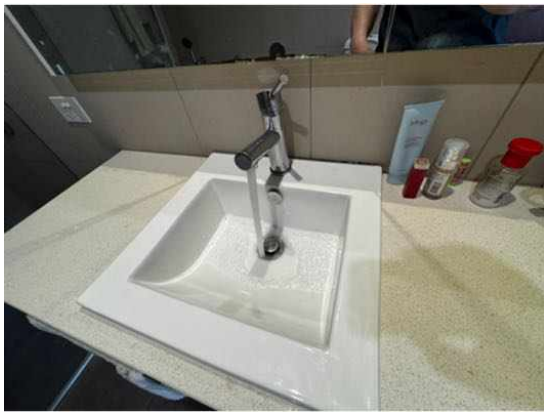
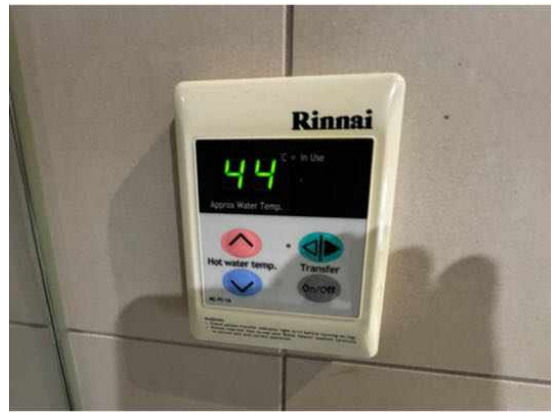
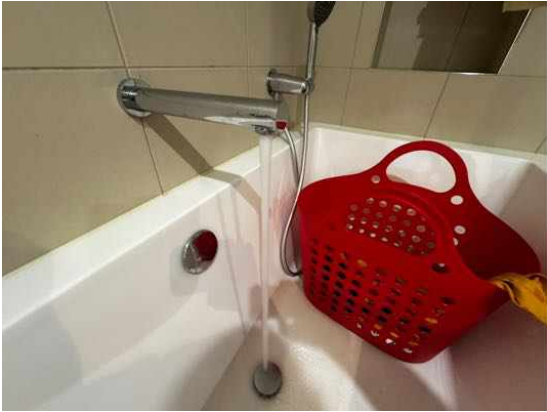
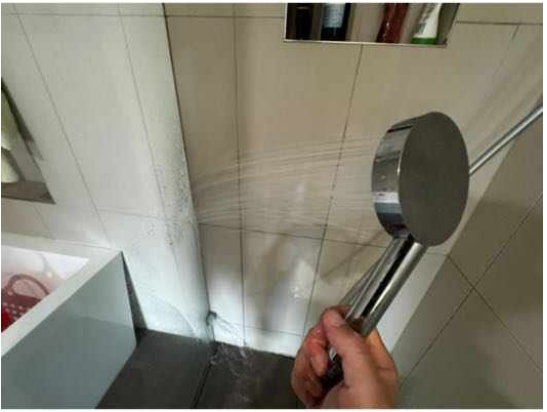
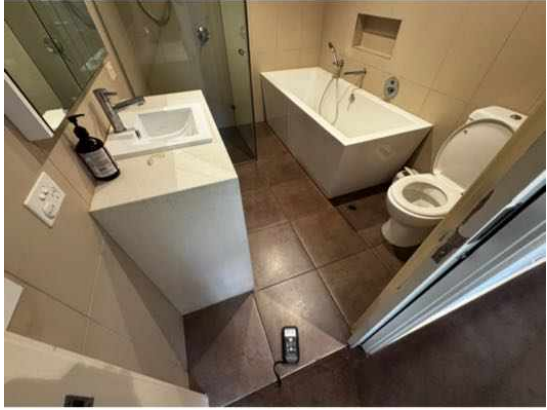
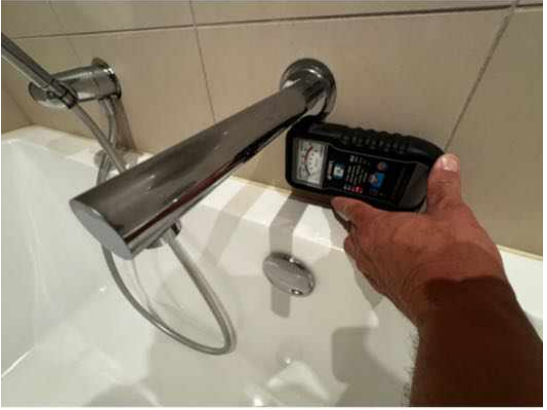
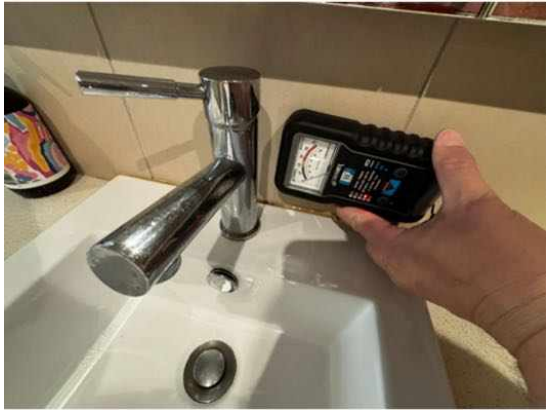
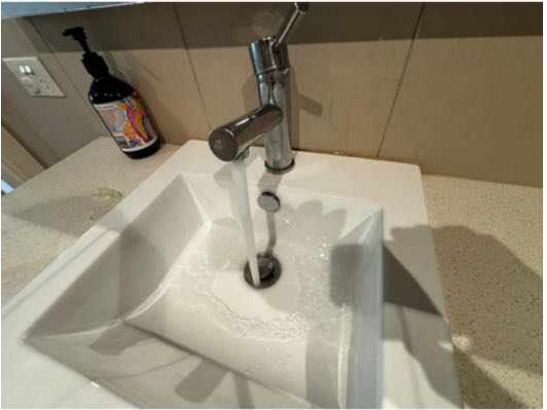
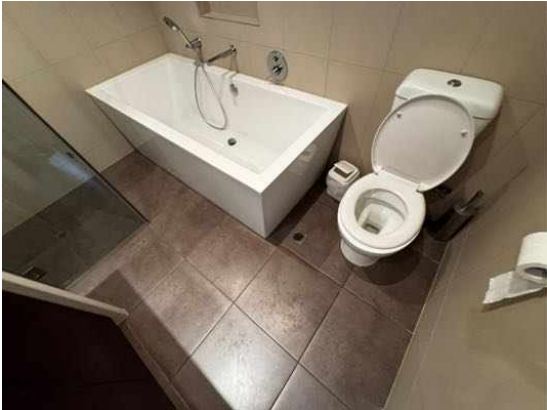
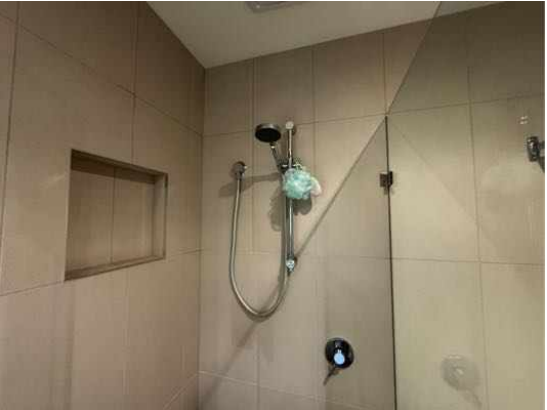
Building: Main Building  
Location: All Areas > All Areas  
Finding: Additional Photos - Obstructions and Limitations  
Information: These photographs are an indication of the obstructions and limitations which impeded full inspection of the property at the time of inspection. These obstructions can hide an array of defects and should be removed to allow full inspection to be carried out. A re-inspection is recommended once the areas are made accessible.
