## Building Inspection Report

Inspection Date: Fri, 6 Mar 2026

Property Address: 1 Walsh St, West Melbourne VIC 3003,  
Australia

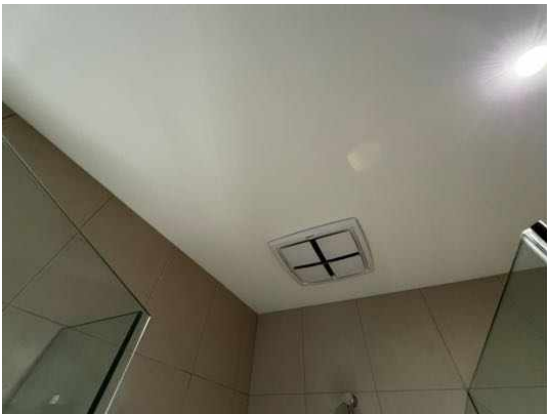
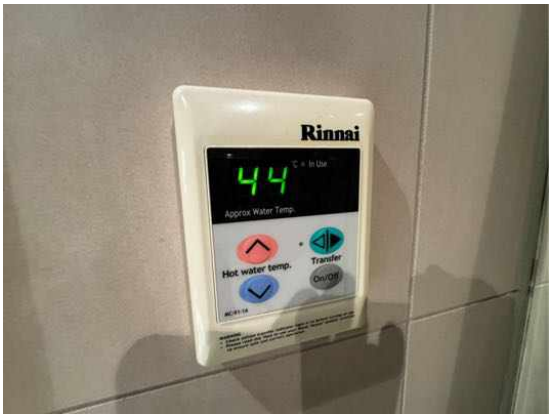
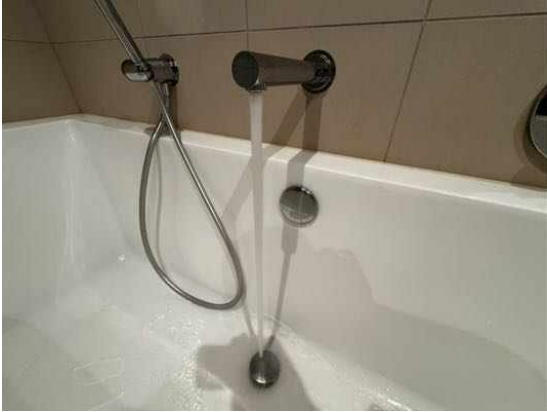
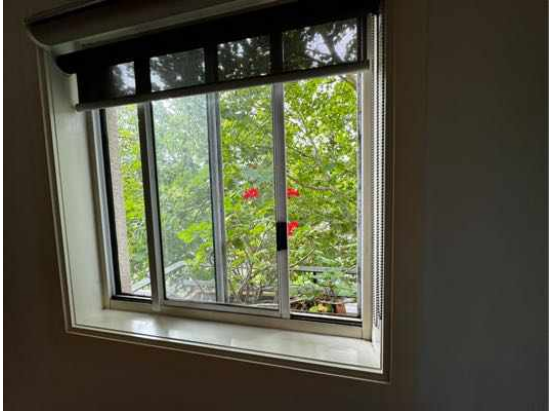
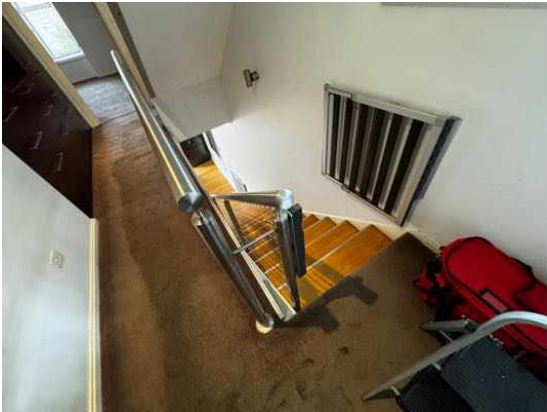
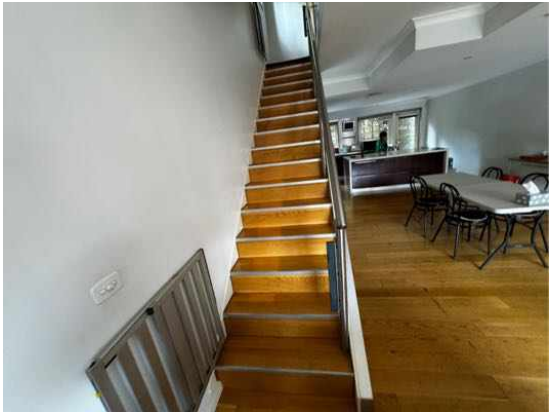
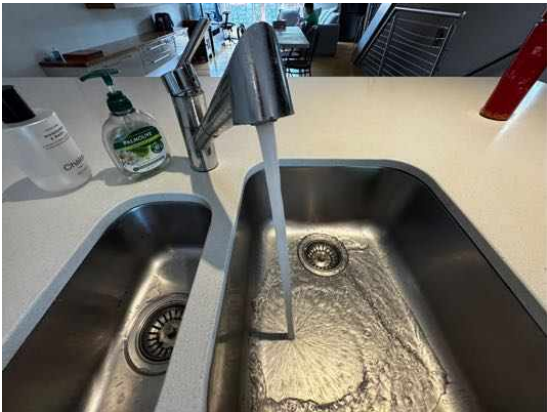
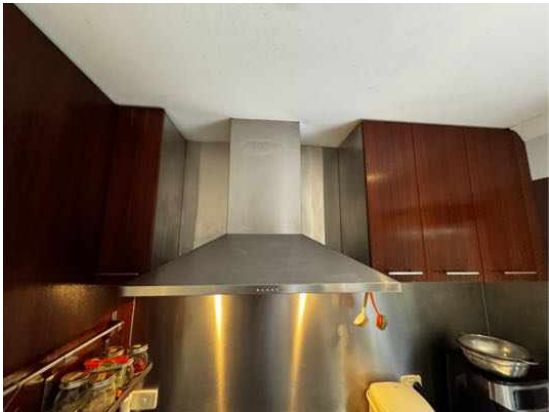
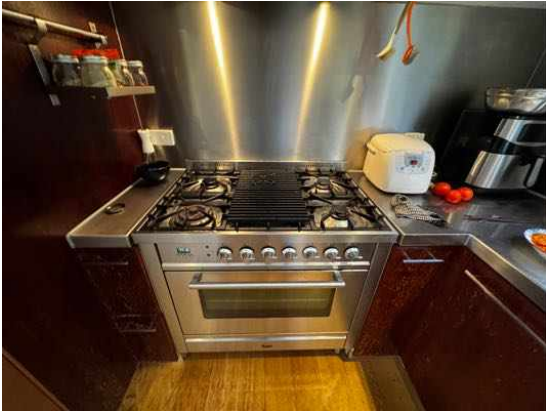
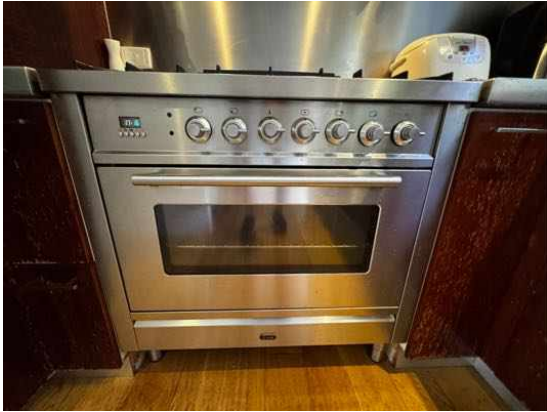
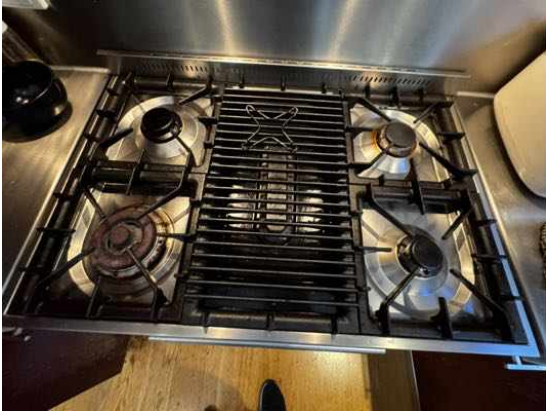
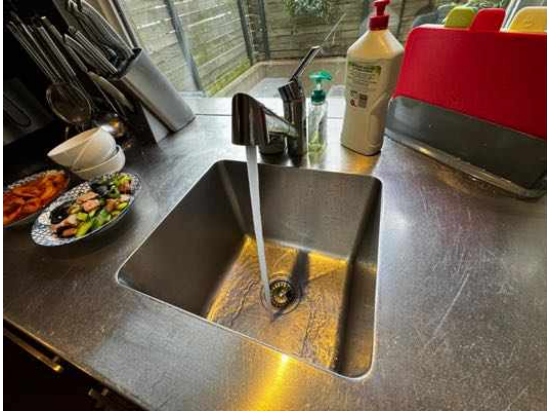
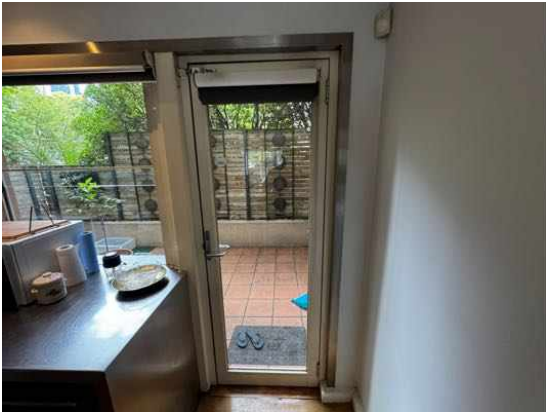
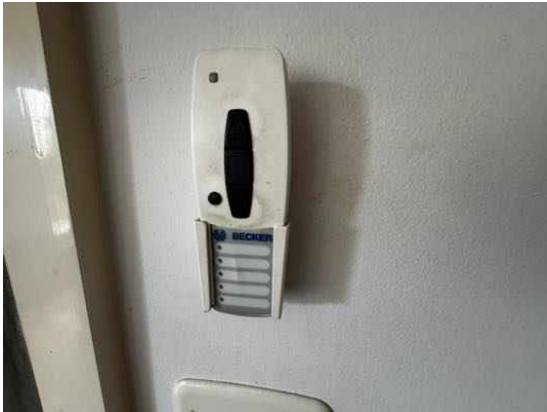
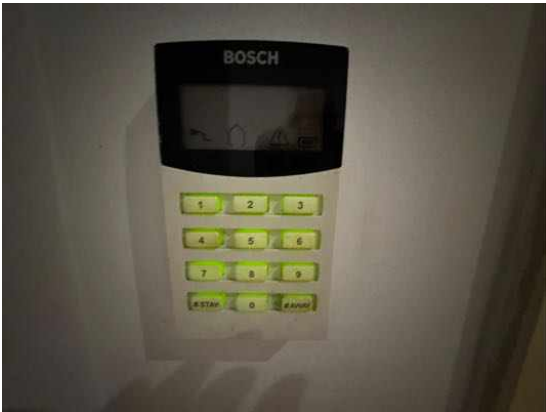
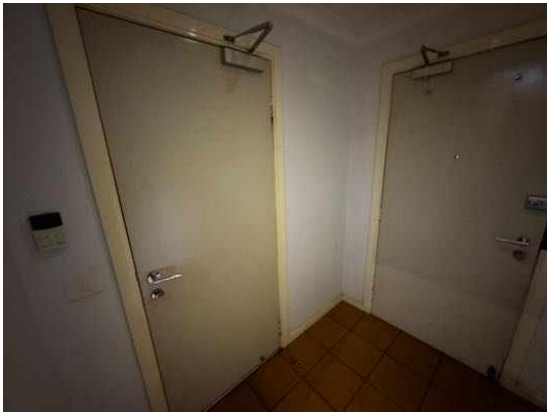
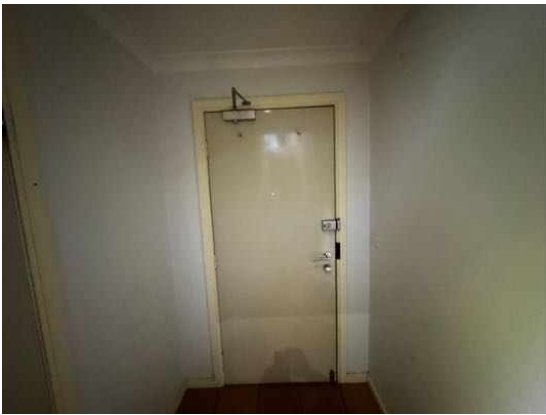
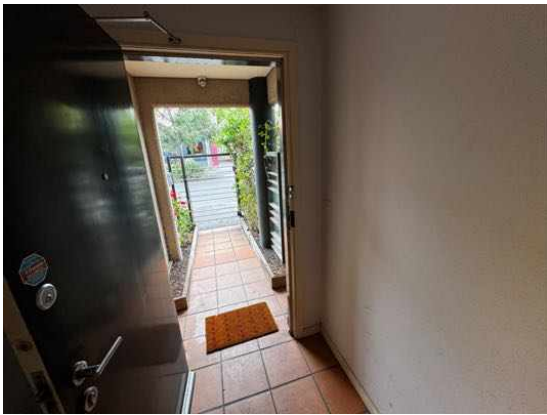
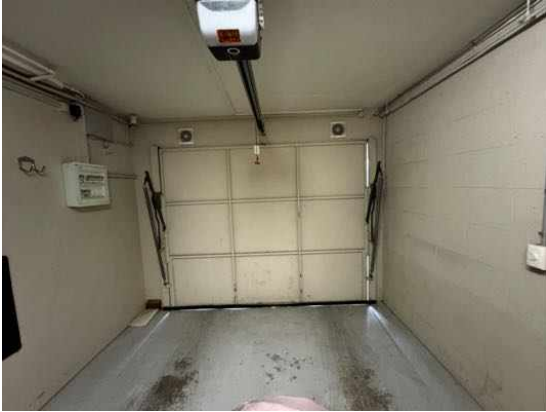
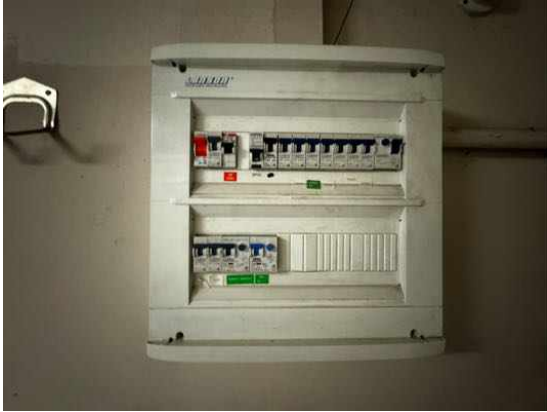
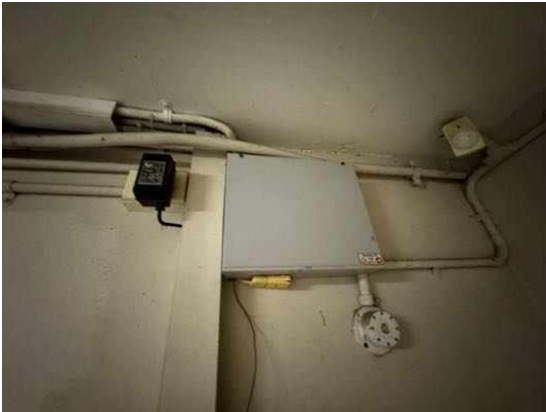
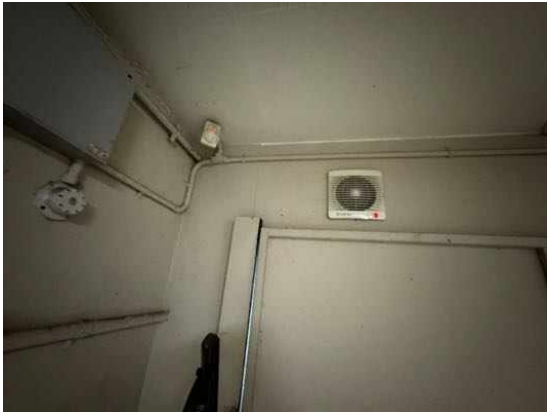
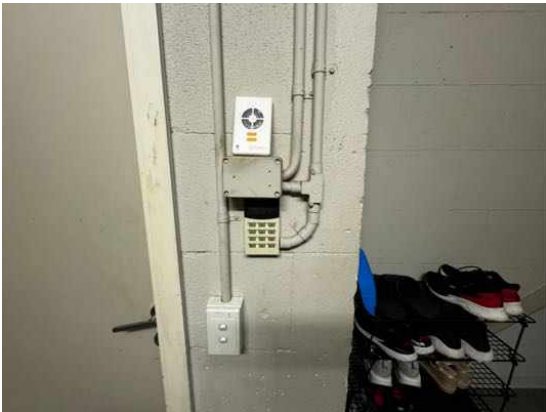
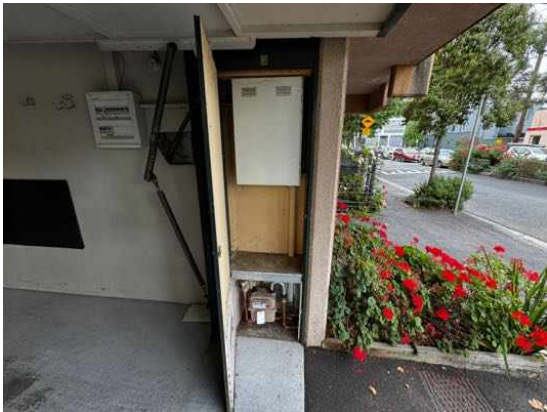
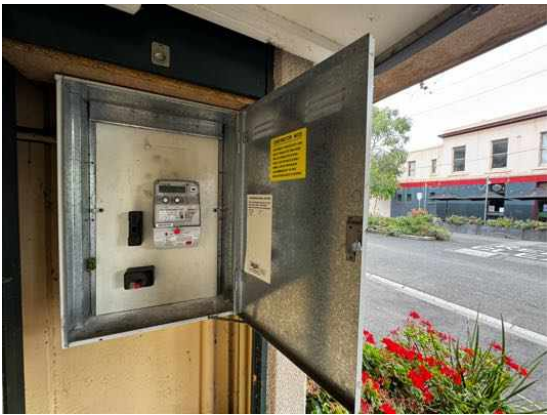
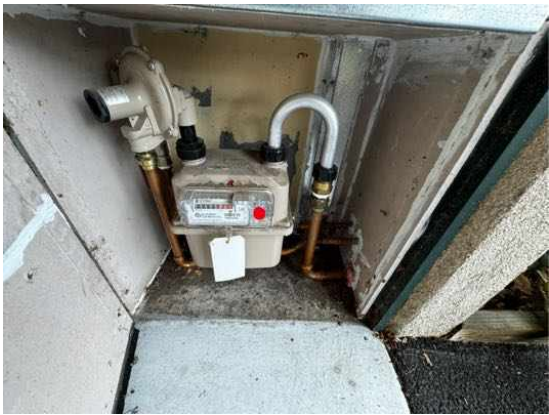
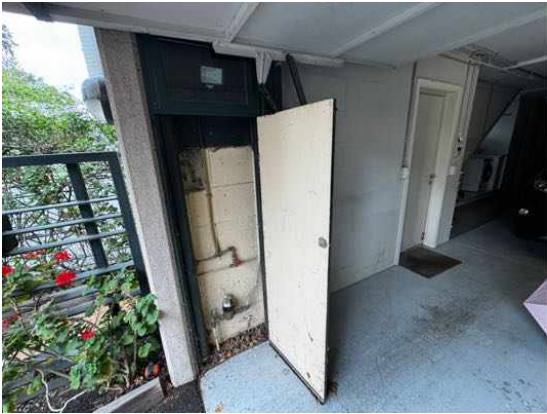
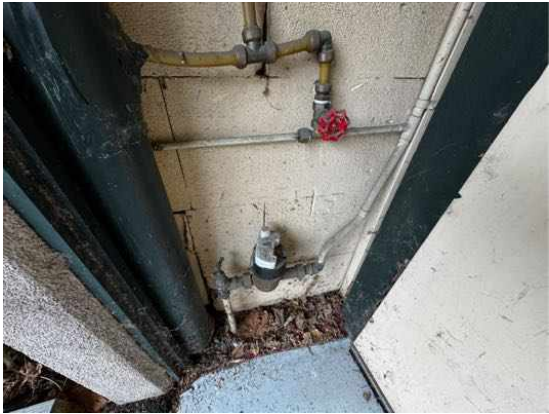
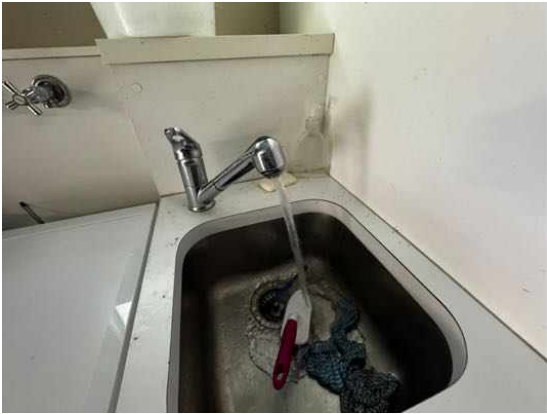
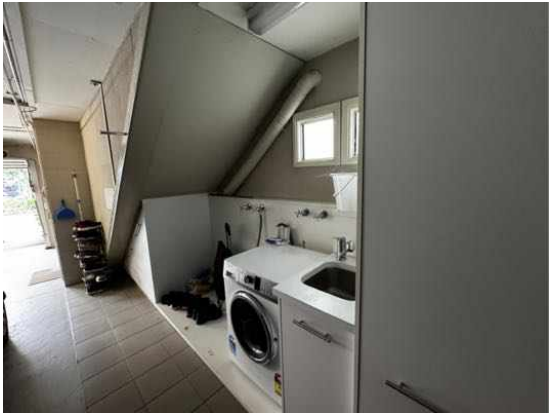
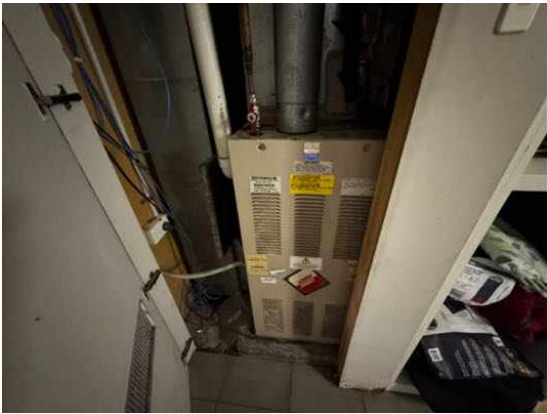
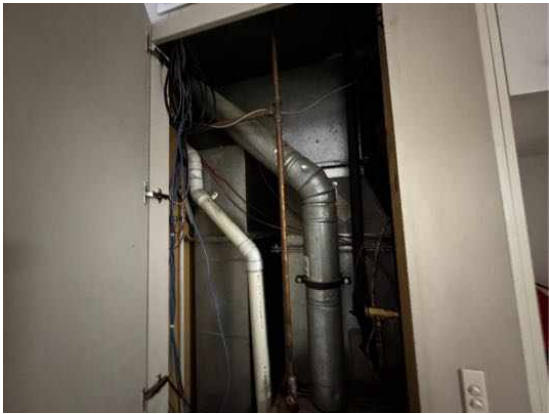
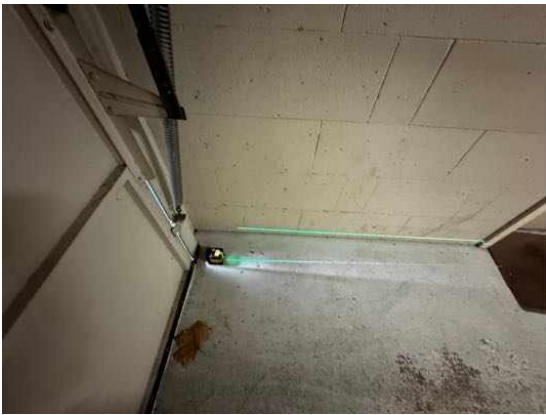
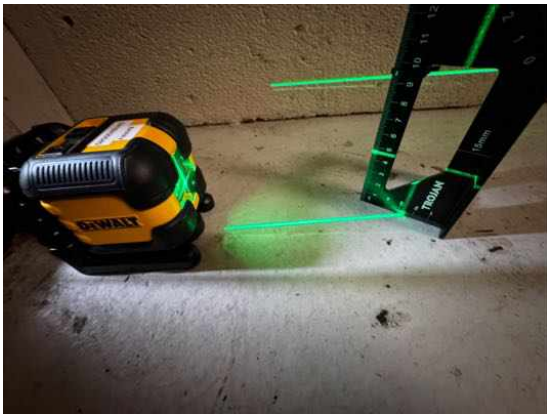
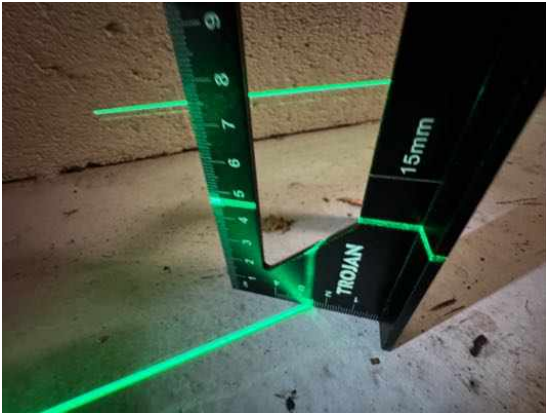
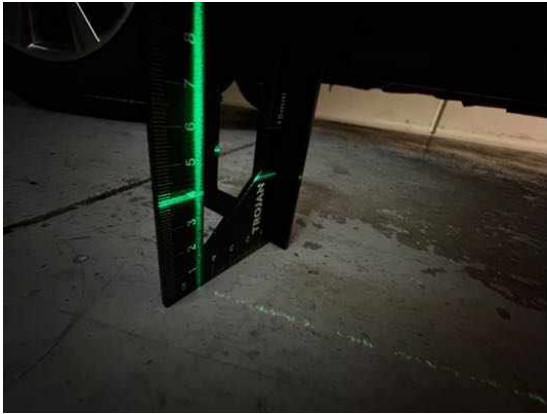
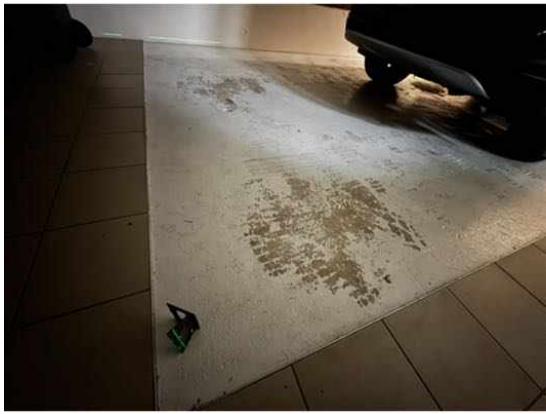
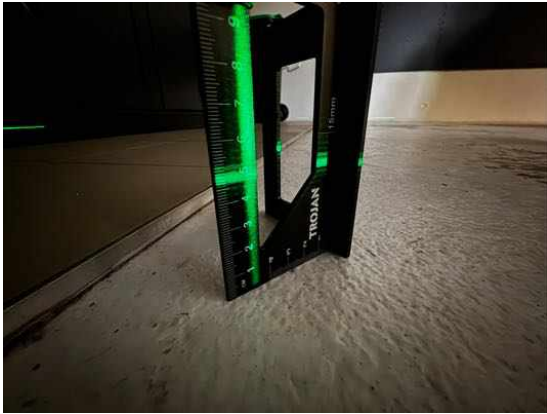
Building: Main Building  
Location: All Areas > All Areas  
Finding: Additional Photos - Obstructions and Limitations  
Information: These photographs are an indication of the obstructions and limitations which impeded full inspection of the property at the time of inspection. These obstructions can hide an array of defects and should be removed to allow full inspection to be carried out. A re-inspection is recommended once the areas are made accessible.
