Building and Timber Pest Inspection Report

Inspection Date: Fri, 13 Mar 2026

Property Address: 169 Wallarah Rd, Gorokan NSW 2263, Australia

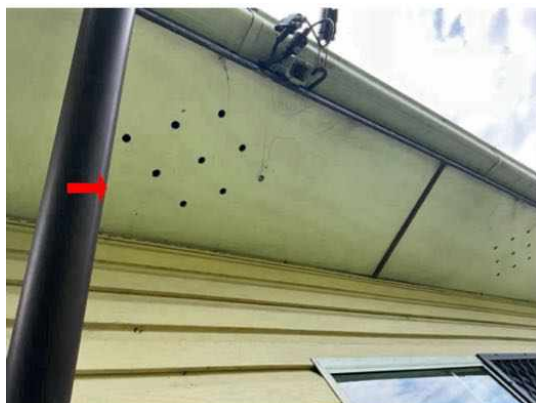
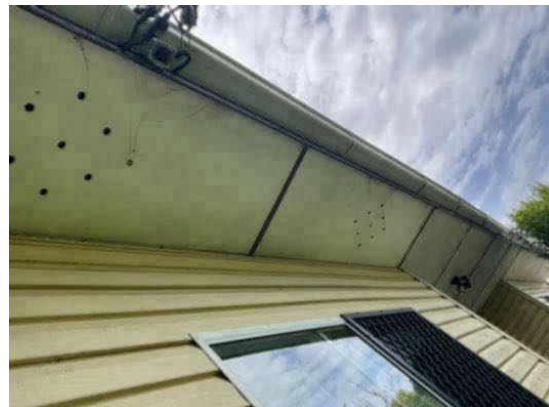
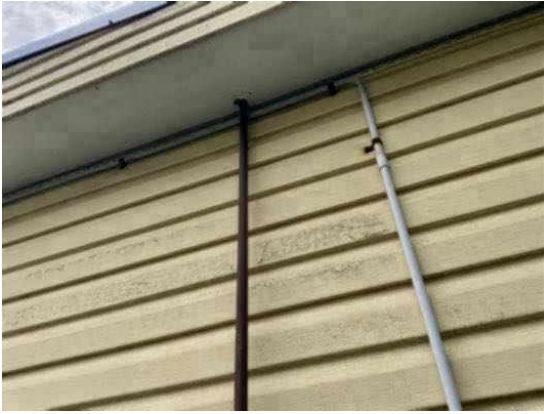
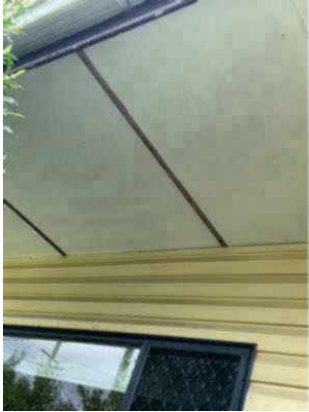
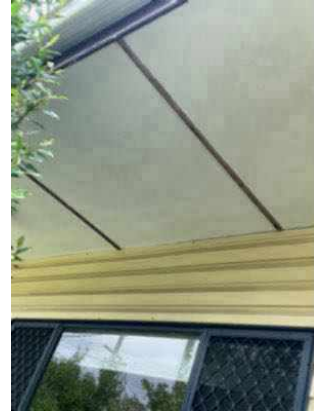
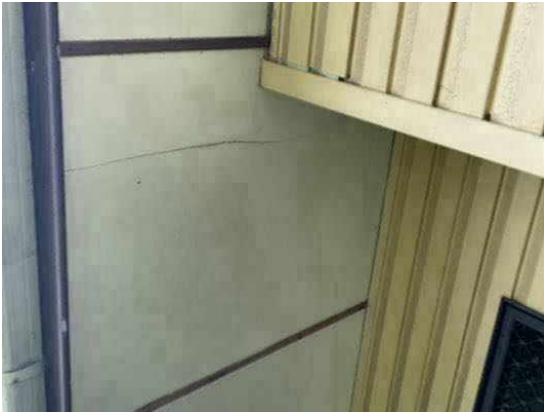
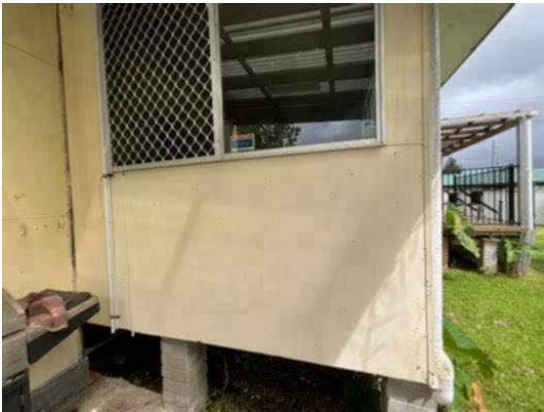
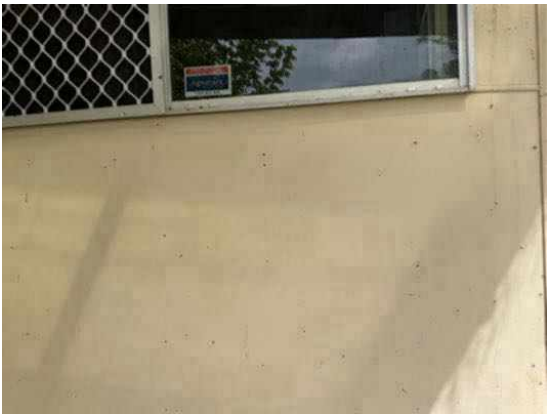
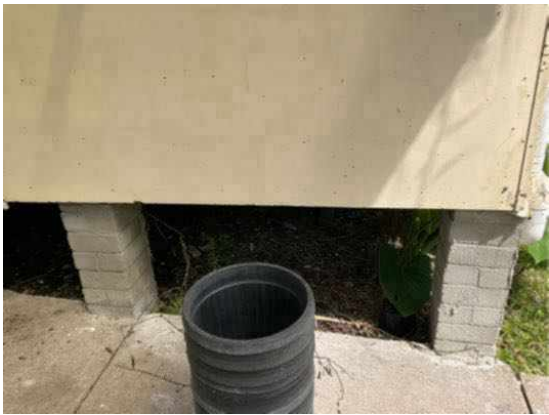
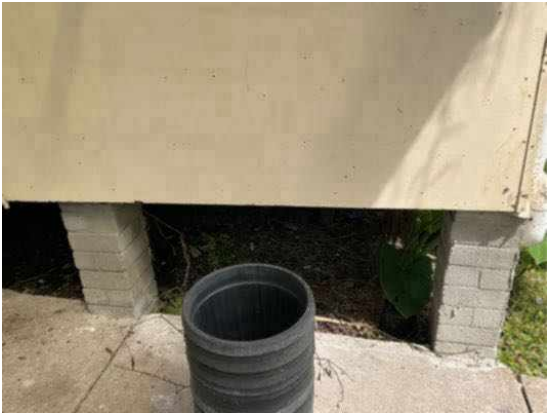
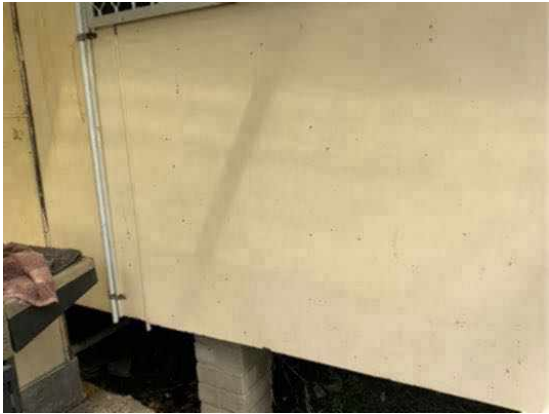
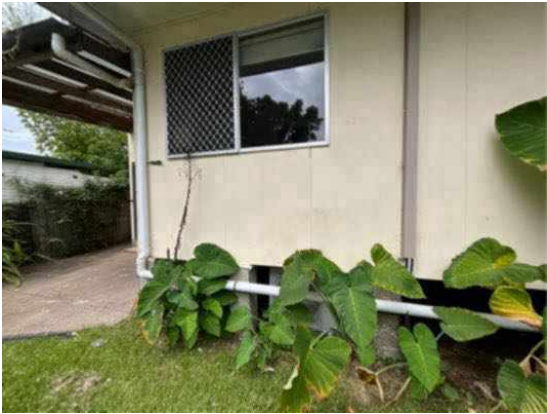
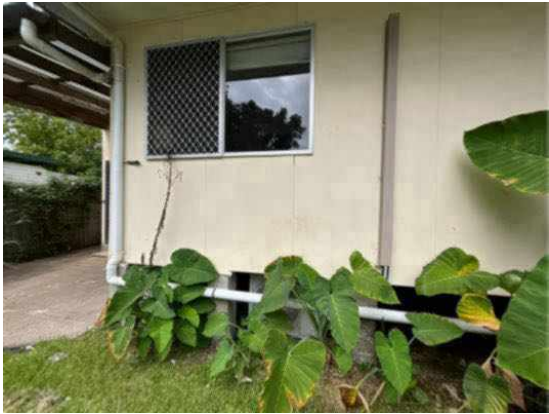
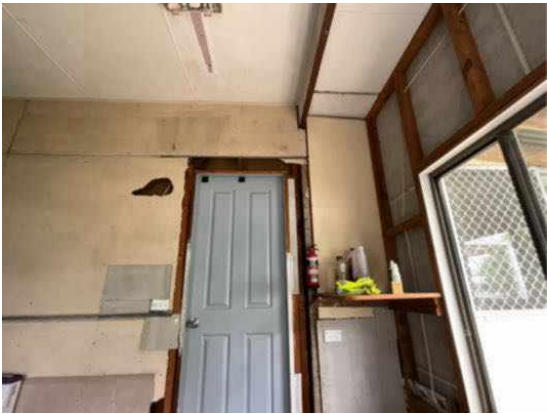
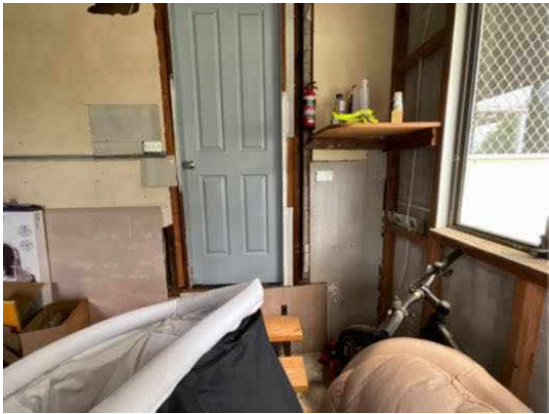
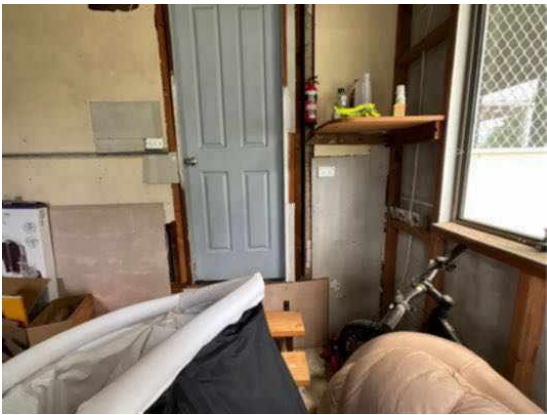
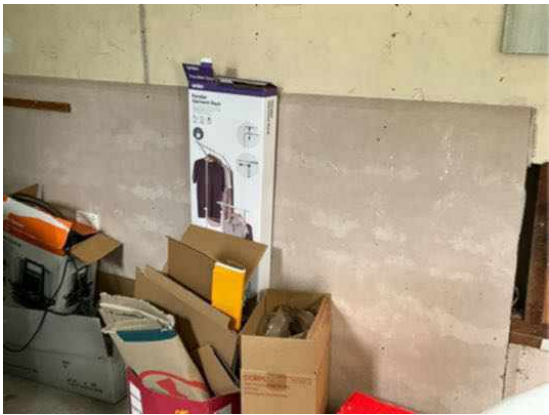
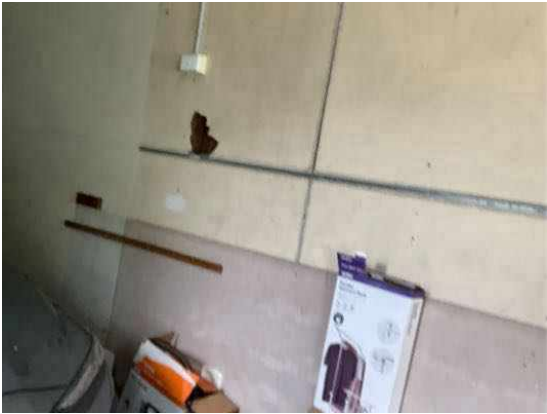
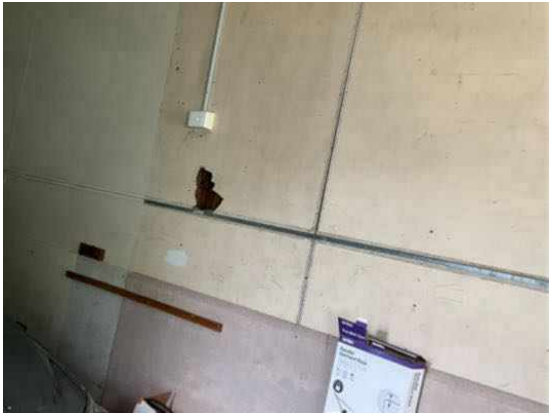
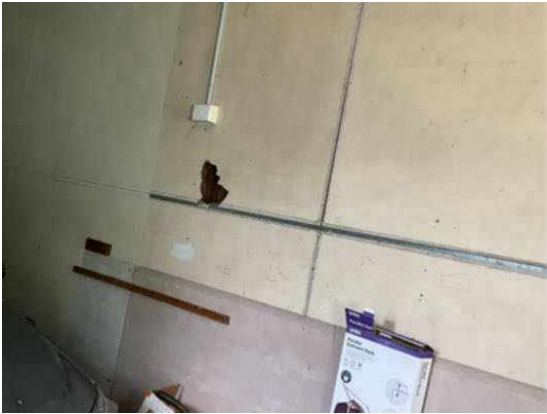
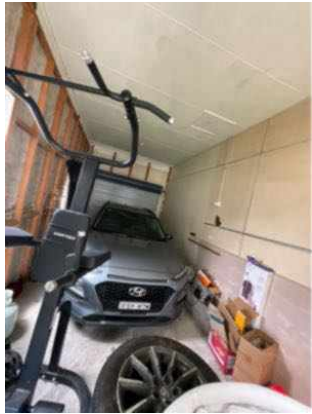
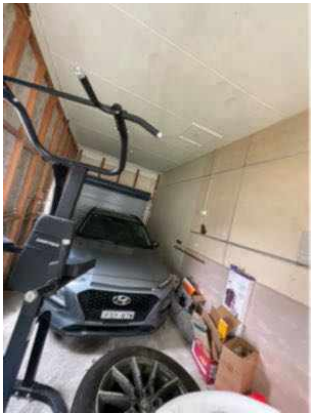
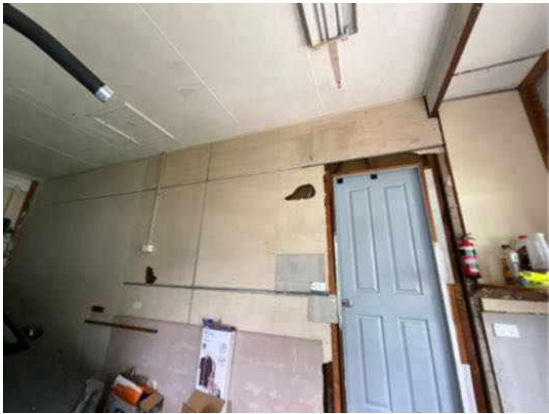
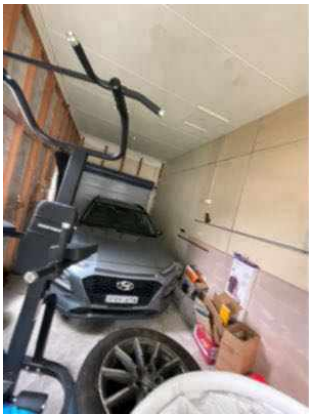
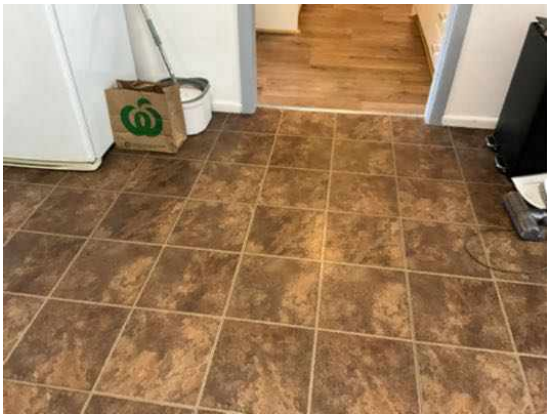
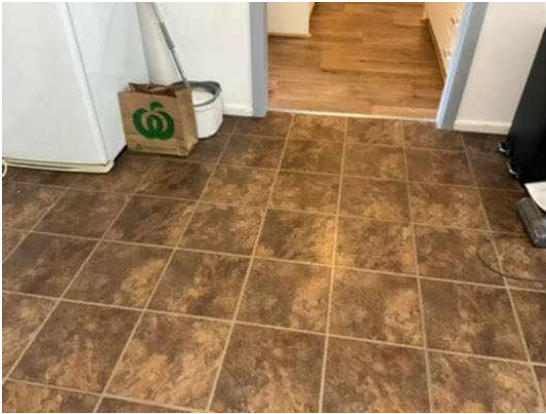
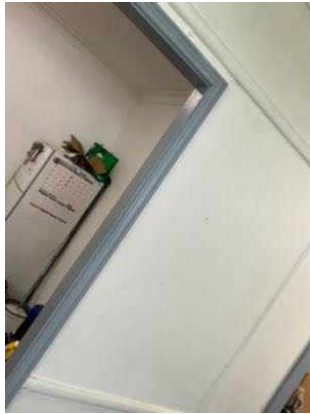
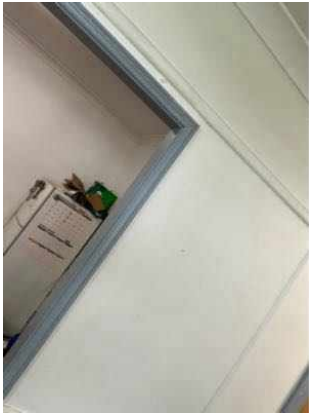
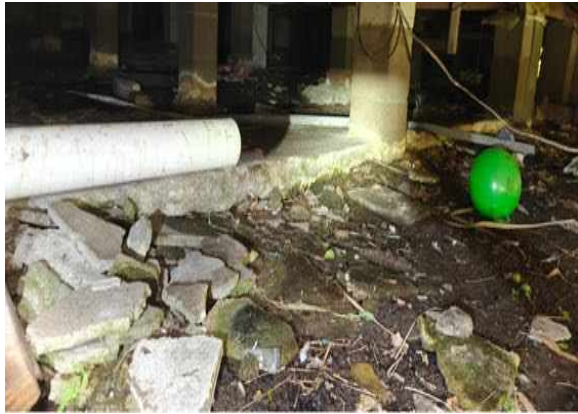
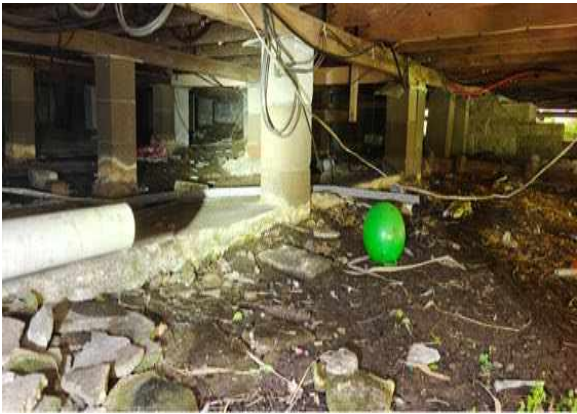
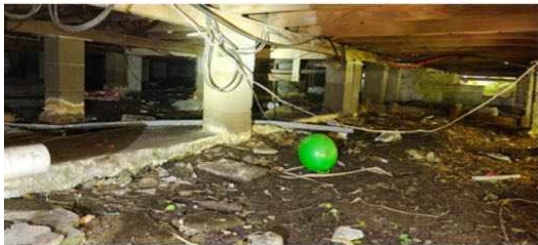
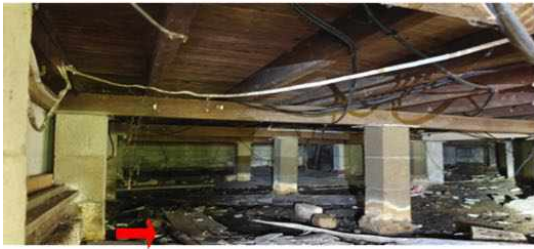
Building: Main Building
Location: All Areas
Finding: Asbestos - Suspected ACM Identified on Site
Information: Reporting on Asbestos is outside the Scope of this Report. This suspected defect is highlighted as a caution only. We suspect, based on our experience in the building industry, that there is a higher risk of the identified building element containing asbestos.

As Asbestos Reporting is outside the scope of this report, we advise that you consider a separate Asbestos Inspection and Condition Audit, which can include the taking of samples for definitive confirmation of the presence of Asbestos.

In the interim, the client is advised to act with caution, especially when considering any damage to building materials general wear and tear renovations extensions demolition and general maintenance activities due to the suspected presence of Asbestos.

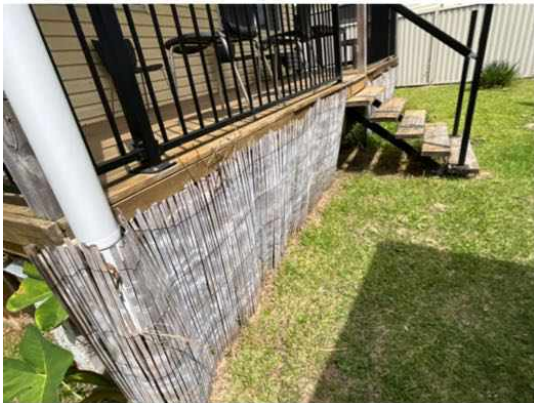
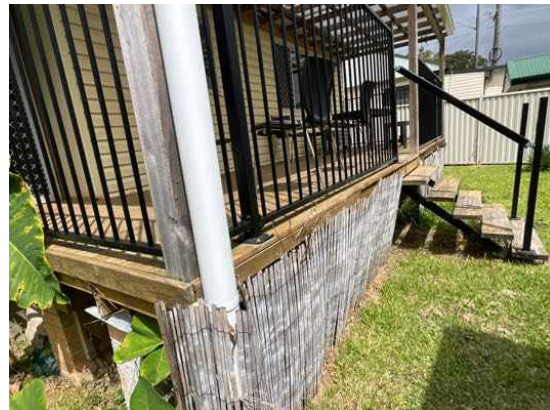
Finding 1.02

Building:	Main Building
Location:	Deck
Finding:	External timber balcony or deck-structural stability
Information:	The load capacity of the external balcony or deck could not be verified during the inspection.

External timber structures are also constantly exposed to weather deteriorates in an exhilarate manner, ongoing assessments are required.

It is highly recommended that a structural engineer further, assess the external timber balcony or a deck to inform the client of its load capacity.

Regular maintenance inspections by competent practitioners is needed.

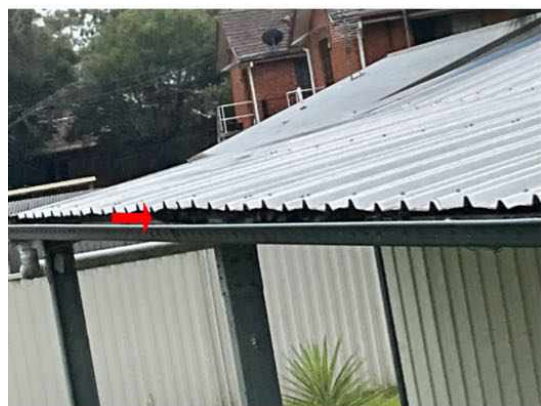
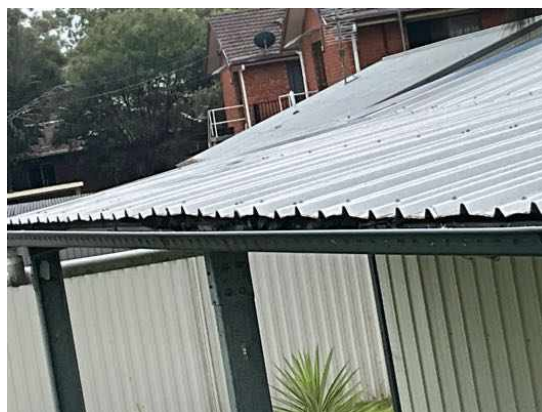
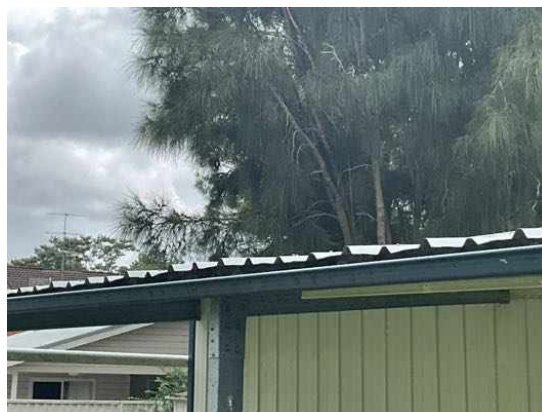
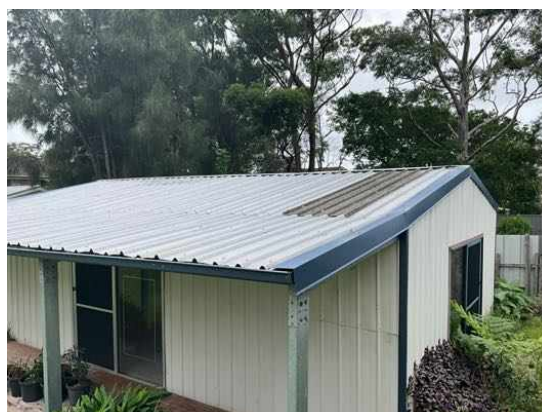
Finding 2.02

Building:	Main Building
Location:	Shed
Finding:	Roof Weathered - metal roof sheeting
Information:	The roof sheeting shows visible weathering, surface oxidation, and deterioration of fastener washers. Some sheet overlaps appear uneven and may not provide adequate weatherproofing at joints near the dormer. The sealant and flashing junctions also show signs of age and deterioration.

Prolonged weather exposure and rusting can lead to corrosion, potential roof leaks, and reduced lifespan of the sheeting. Deteriorated fasteners may allow water ingress, particularly around joints and penetrations.

Engage a licensed roofing contractor to inspect and maintain the affected areas. Replace rusted screws and washers, resecure loose or uneven sheets, and apply protective roof coating or repainting as required. Check flashings and sealants to ensure watertightness.

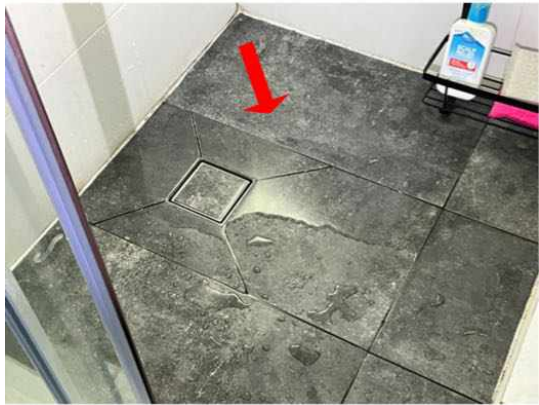
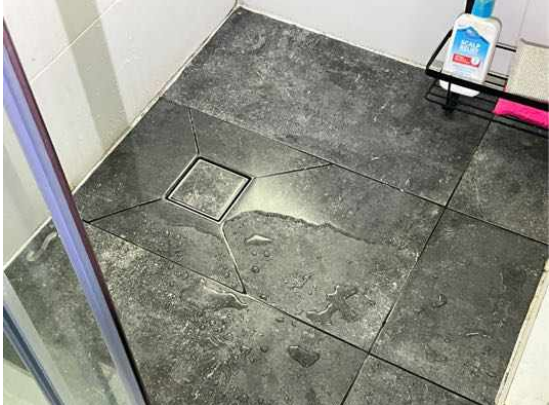
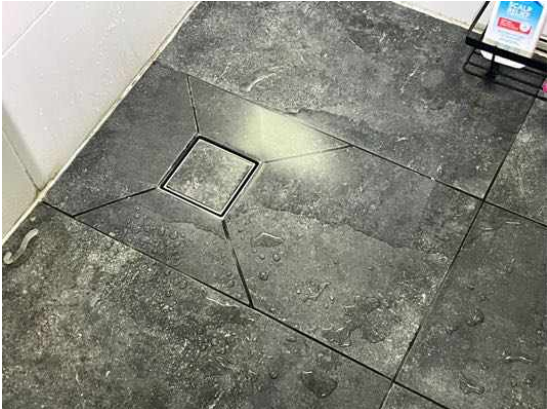
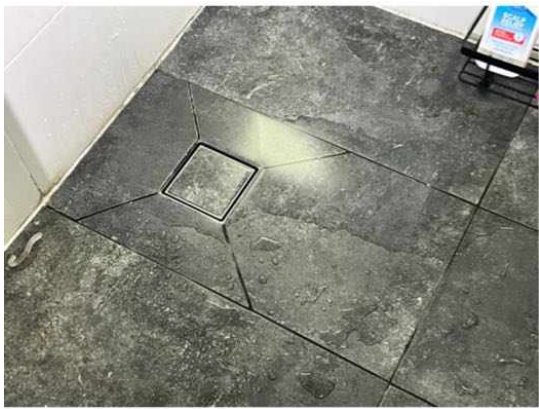
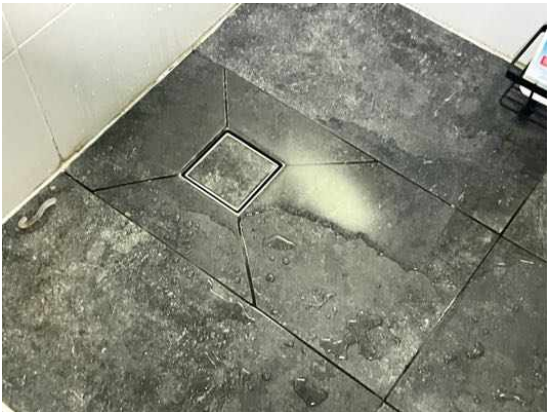
Finding 2.03

Building:	Main Building
Location:	Bathroom
Finding:	Shower base - Water pooling
Information:	Evidence of water pooling around the floor waste in the shower recess was noticed at the time of inspection. It is suspected that this excessive moisture is attributed to insufficient fall in the shower floor tiles.

This pooling is Major & considered unsatisfactory, as standard tiling practices would not permit this situation to occur. Pooling water around floor wastes can create a slip hazard in extreme cases and create conditions that are conducive to mould growth over time. Where left unmanaged, the degradation of sealant and grouting is also likely

to occur, possibly necessitating further repair works.

Remedial works may involve some sections of tiling and flooring repair and replacement. A tiling contractor or bathroom specialist should be appointed to provide further advice on reparation options and to perform works as necessary.

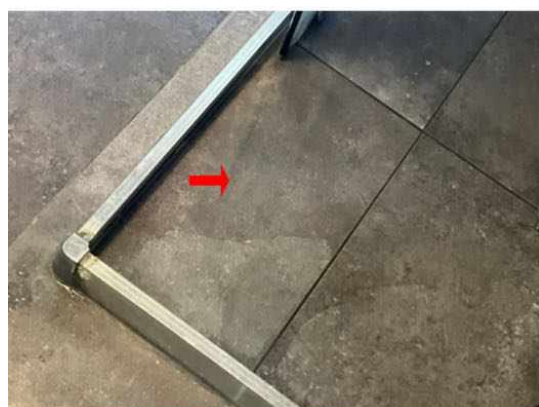
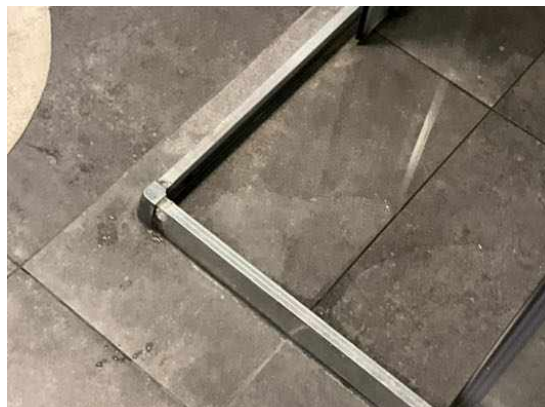
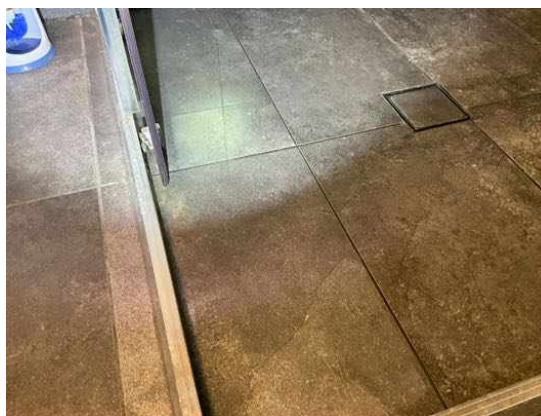
Finding 2.04

Building: Main Building
Location: Bathroom / Laundry
Finding: Shower base - Water pooling
Information: Evidence of water pooling around the floor waste in the shower recess was noticed at

the time of inspection. It is suspected that this excessive moisture is attributed to insufficient fall in the shower floor tiles.

This pooling is Major & considered unsatisfactory, as standard tiling practices would not permit this situation to occur. Pooling water around floor wastes can create a slip hazard in extreme cases and create conditions that are conducive to mould growth over time. Where left unmanaged, the degradation of sealant and grouting is also likely to occur, possibly necessitating further repair works.

Remedial works may involve some sections of tiling and flooring repair and replacement. A tiling contractor or bathroom specialist should be appointed to provide further advice on reparation options and to perform works as necessary.

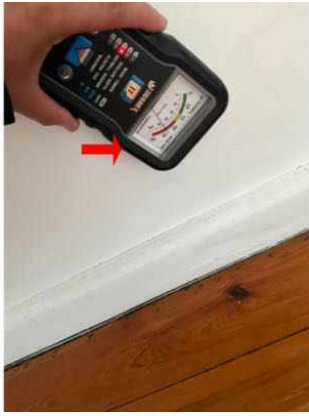
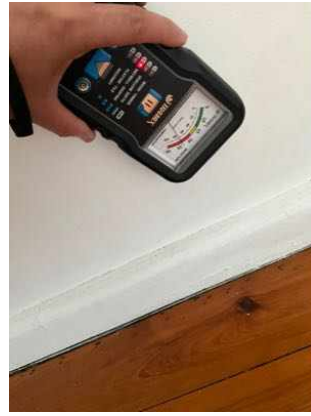
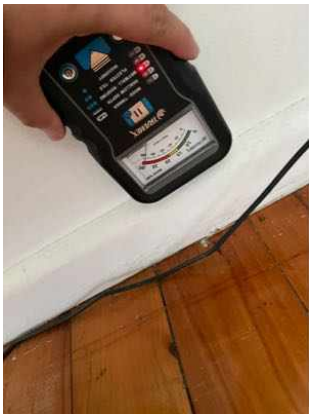
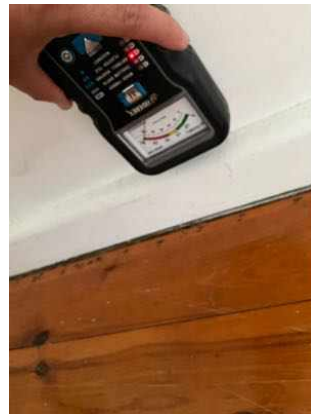
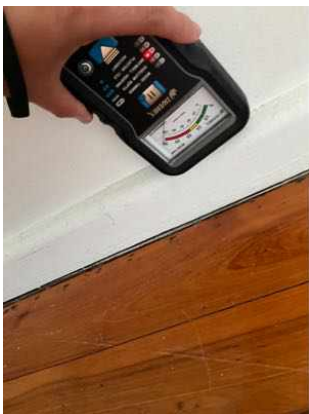
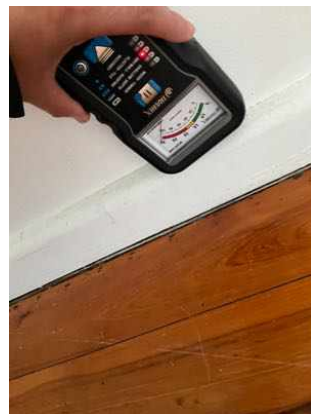
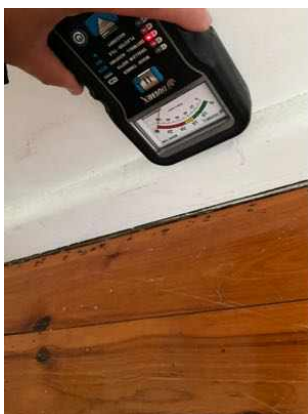
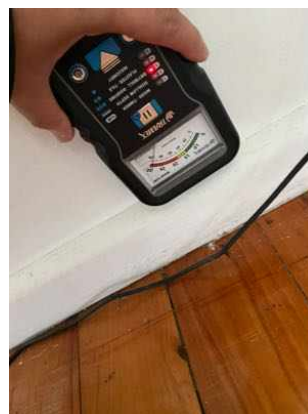
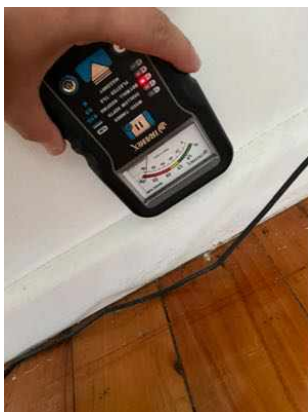
Finding 2.05

Building:	Main Building
Location:	All Areas
Finding:	Damp - Rising
Information:	Rising damp describes the upward movement of water in low sections of building elements (e.g. walls) by capillary action - the movement of water through porous materials such as bricks, sandstone or mortar.

Rising damp is generally managed by the installation of a damp proof course during construction. A Damp Proof Course (DPC) is an impermeable barrier at the base of the wall above ground level. However, many 19th Century buildings have no damp course installed, or the materials have failed. The DPC may have been omitted as a consequence of poor workmanship, or it may have been bridged where materials built up against the side of the house allow moisture ingress above the DPC level.

The first step in addressing rising damp is to diagnose the cause. The identified cause should be addressed first before addressing the appearance and other defects which have resulted from the rising damp. If the original cause is not resolved, further cases

of damp are likely to ensue, resulting in secondary defects.

Consultation with a qualified plumber is advised immediately to identify the cause of the damp and perform remedial works as required.

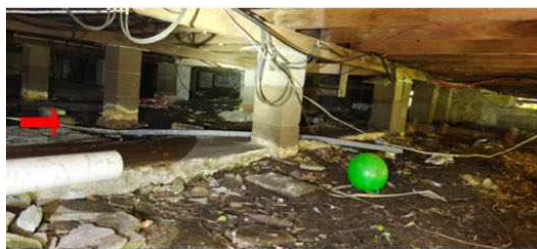
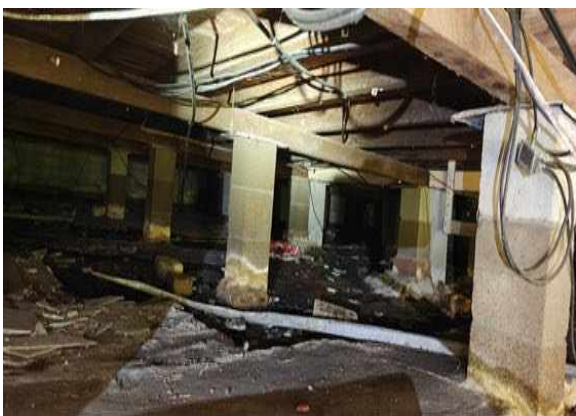
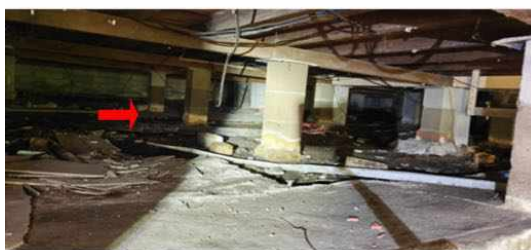
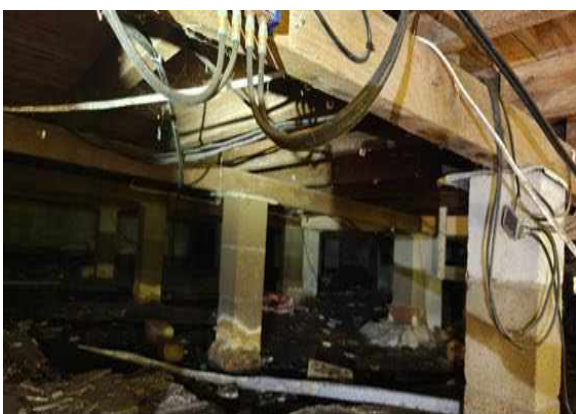
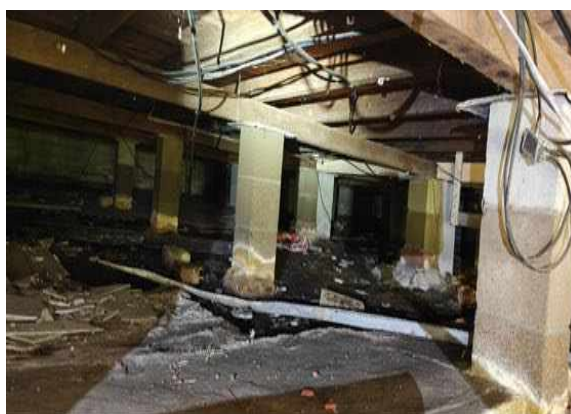
Finding 2.06

Building:	Main Building
Location:	Subfloor
Finding:	Rising Damp - Subfloor
Information:	Rising damp has been identified in the subfloor area. This condition is characterized by moisture seeping upward through the foundation and into the subfloor structures. The presence of dampness has been confirmed by visible signs such as discoloration, efflorescence, and potential mold growth on the lower sections of walls and subfloor timbers.

1. Structural Damage: Prolonged exposure to moisture can weaken the structural integrity of timber and masonry, potentially leading to rot, decay, and compromised load-bearing capacity.
2. Health Hazards: Damp conditions can foster the growth of mold and mildew, which can cause respiratory issues, allergies, and other health problems for the occupants.
3. Decreased Property Value: Rising damp can significantly reduce the property's value and appeal to potential buyers.
4. Increased Energy Costs: Damp conditions can make it more challenging to heat or

1. Identify and Address the Source: A thorough inspection should be conducted to identify the source of the rising damp. This could involve checking for inadequate drainage, poor waterproofing, or damage to the damp-proof course (DPC).

2. Improve Drainage: Ensure that the property has adequate drainage systems in place to divert water away from the foundation. This may involve installing or repairing gutters, downpipes, and surface drains.

3. Damp-Proofing: Implement appropriate damp-proofing measures such as the installation or repair of a damp-proof course or damp-proof membrane. In some cases, chemical damp-proofing injections may be necessary.

4. Ventilation: Improve subfloor ventilation to reduce moisture buildup. This could involve installing additional vents or fans to promote air circulation.

5. Repair Damaged Areas: Replace or repair any timber or masonry that has been damaged by rising damp.

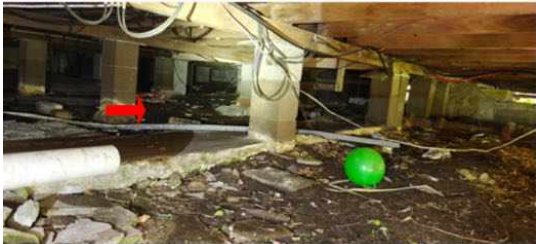
Finding 2.07

Finding: Subfloor - Site drainage - Inadequate

Information: The site exhibits poor drainage under the subfloor, leading to several critical issues. Water accumulates and does not properly drain away from the subfloor area, creating a hazardous condition.

1. Frequent water pooling and stagnation under the subfloor.
2. Risk of subfloor structural damage due to prolonged moisture exposure.
3. Potential for mold and mildew growth, compromising indoor air quality and a potential of Termite attack.
4. Safety hazard for occupants due to slippery surfaces and potential electrical hazards.

The poor site drainage under the subfloor poses a significant safety risk to the occupants, as it can lead to structural damage and health hazards.

This issue requires immediate attention and rectification. A licensed and experienced plumber or licensed builder specialising in drainage and foundation work should be engaged to assess the problem and implement necessary drainage solutions, such as improved grading, installation of drainage systems, and moisture barrier enhancements. Regular maintenance and inspections should also be scheduled to prevent future occurrences. Water damage and secondary defects are likely to occur if left unmanaged.

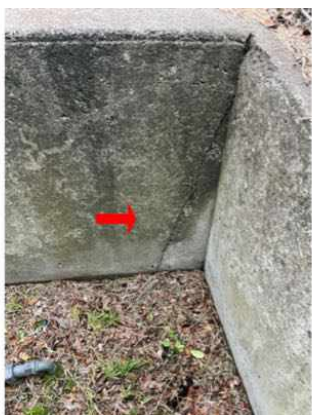
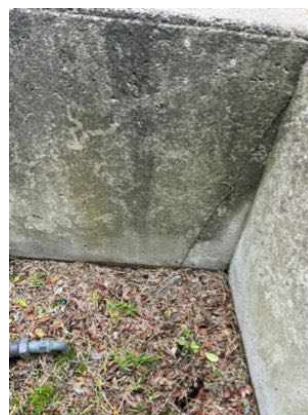
Building:	Main Building
Location:	Yard - Front
Finding:	Cracking - Damage Category 2 - Noticeable (up to 5mm)
Information:	Noticeable cracks are a common occurrence as a result of many primary defects. Such causes may include age, general wear and tear, expected building movement, general expansion/contraction of building materials in different weather conditions, and/or minor failings in the installation or application of building materials.

Noticeable cracks may result in minor sticking or jamming of associated doors and windows, which require easement. However, noticeable cracks are easily filled and repaired. A plasterer can be consulted to install an expansion joint at this point to allow for this movement during different weather conditions.

Monitoring of all cracking should be conducted frequently. Always contact a building inspector should cracks widen, lengthen, or become more numerous. Additionally, your building inspector should also be contacted if associated building elements such as doors and windows become more difficult to operate over time.

Relevant tradespeople, such as carpenters, painters and plasterers, should be

appointed to perform remedial works, as deemed necessary.

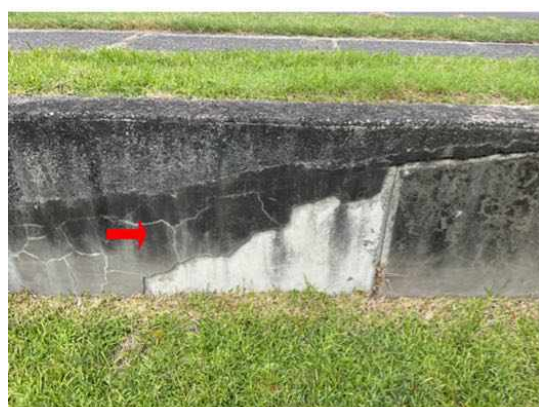
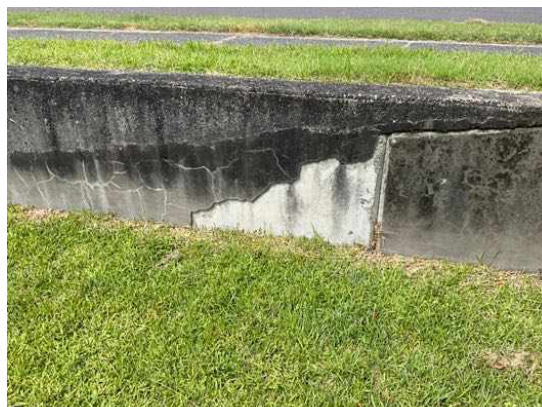
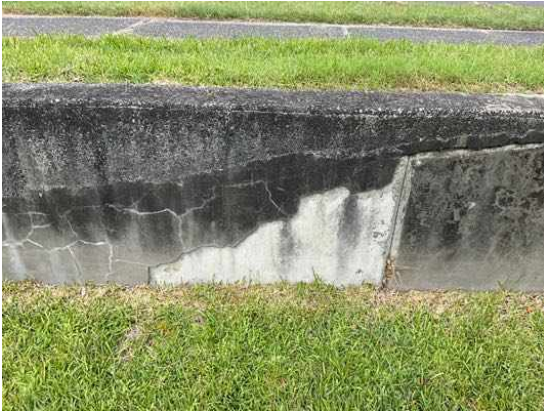
Finding 3.02

Finding: Cracking - rendered surface

Information: Cracking observed along the vertical and diagonal plane of the rendered surface. The cracks appear as fine to moderate-width cracks, indicating potential shrinkage or movement within the substrate.

According to AS 4349.1-2007 Inspection of Buildings and the Guide to Standards and Tolerances 2017 cracks up to 1mm wide are considered an acceptable tolerable limit for plaster and render finishes in the absence of other symptoms (such as displacement or water ingress). Cracks between 1mm and 5mm wide may require repair depending on their cause and severity.

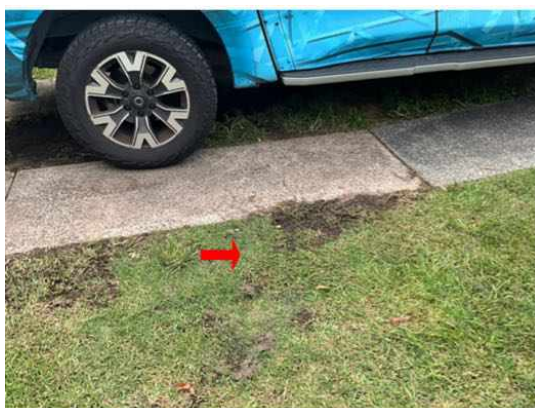
Finding 3.03

Building:	Main Building
Location:	Yard - Front
Finding:	Water pooling - poor surface drainage
Information:	Surface drainage

Surface water drainage is defective if it is not in accordance with the requirements of the Building Code of Australia.

Such water pooling also increases the risk of termite activity and the development of fungal decay in the area.

Consult a Licensed Plumber regarding the cost of potential site drainage rectification works.

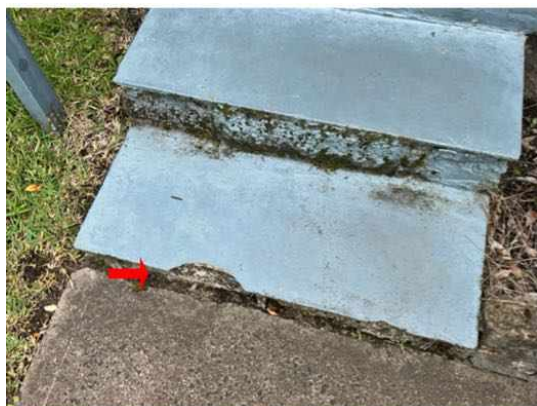
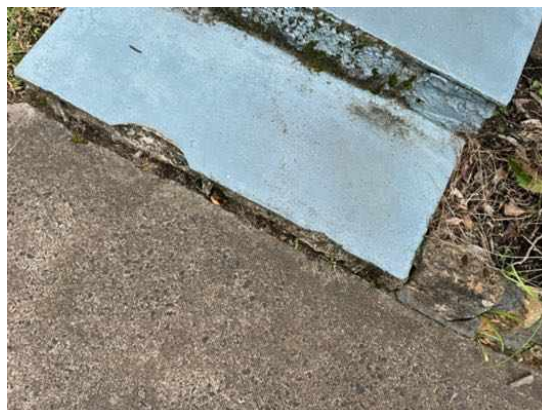
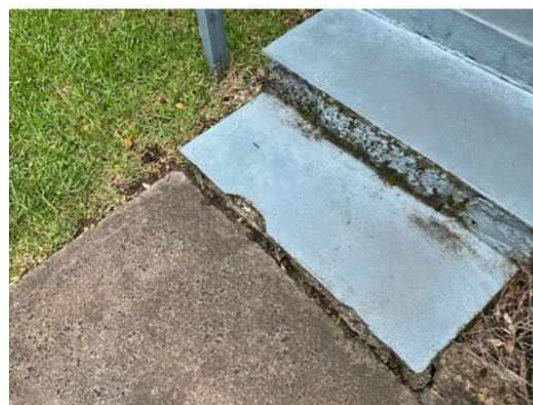
Finding 3.04

Finding: Step crack

Information: A defect has been identified in the front elevation of the property, specifically involving a crack in the step. The step crack poses a safety concern and diminishes the aesthetic appeal of the property.

The cracked step poses a significant safety risk for occupants and visitors, increasing the likelihood of accidents or injuries. Additionally, the visual impact on the property's front elevation can lead to a negative perception and potential decrease in property value.

A licensed contractor or construction professional specializing in structural repairs should be engaged to assess and fix the broken step. The property owner or manager should take immediate action to address the safety and aesthetic concerns.

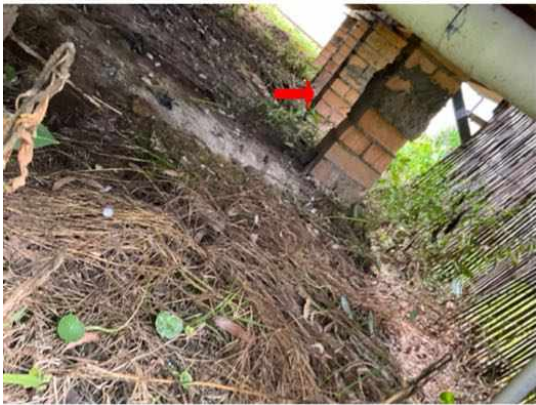
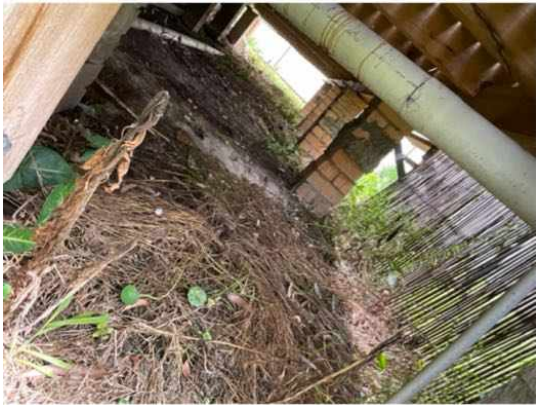
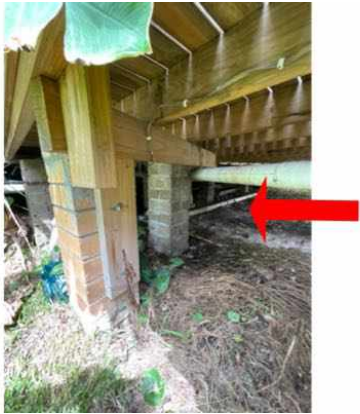
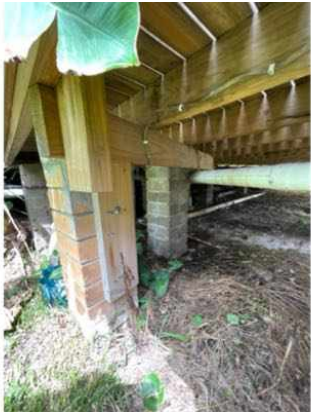
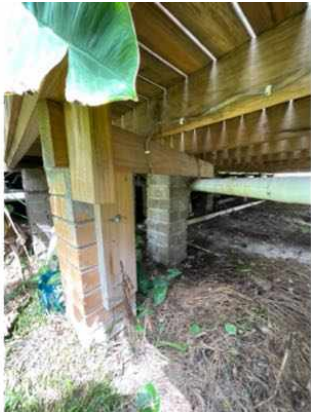
Finding 3.05

Building:	Main Building
Location:	Deck
Finding:	Poor workmanship
Information:	The structure exhibits signs of poor workmanship, evident in various aspects of construction and finishing.

Risk: Poor workmanship poses a range of risks, including compromised structural integrity, potential safety hazards, and a decreased lifespan of the structure. It may also lead to aesthetic and functional issues.

Resolution: A qualified contractor or construction professional should be consulted to assess and address the poor workmanship. They can implement corrective measures to ensure structural soundness, safety, and overall quality of the construction.

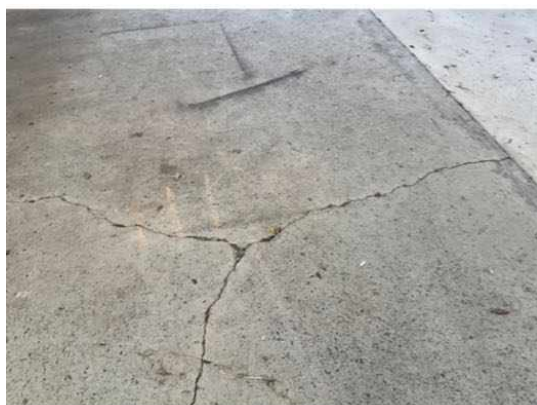
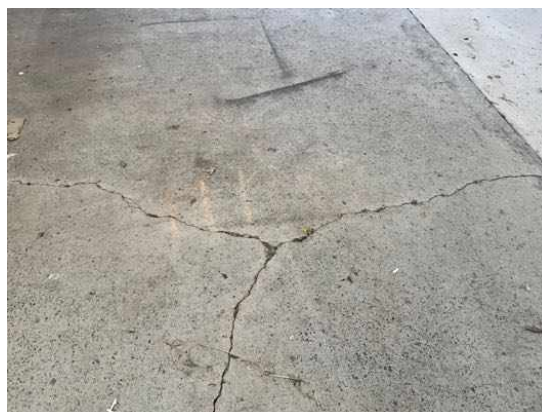
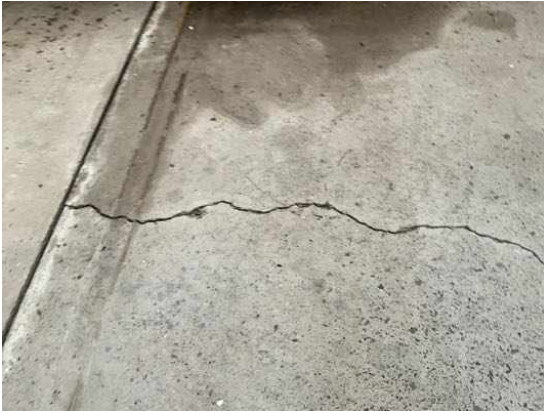
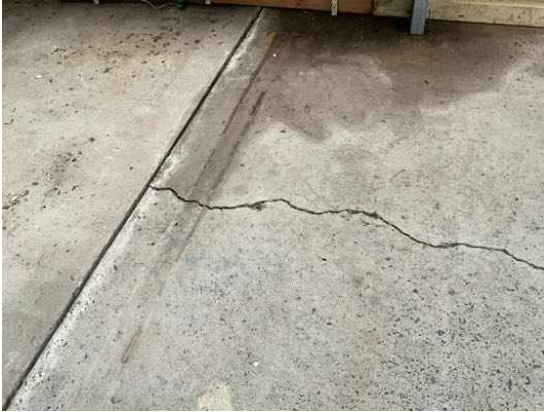
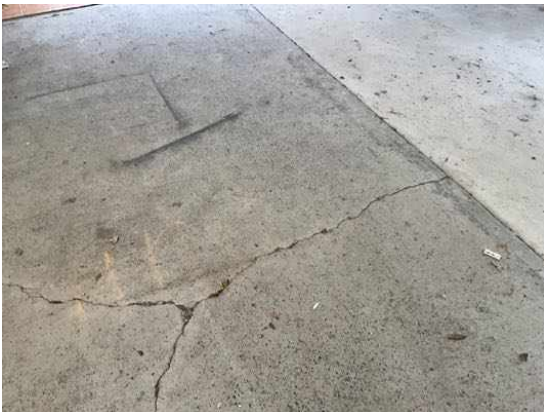
Finding 3.06

Building: Main Building
Location: All Areas
Finding: Noticeable Cracking in Concrete Slab
Information: Noticeable cracking has been observed in the concrete slab, failing to meet the required construction and quality standards.

- Cracks are visible on the surface and may extend through the depth of the slab.

- Evidence of improper curing or inadequate reinforcement leading to cracking.

- Compromised structural integrity of the slab, potentially leading to failure under load.
- Water ingress through cracks, causing corrosion of reinforcement and further weakening the structure.
- Potential trip hazards and aesthetic issues, reducing the overall value and safety of the property.
- Increased maintenance and repair costs due to ongoing deterioration.

- A structural engineer should be engaged to assess the extent of the cracking and recommend appropriate repair methods.
- A licensed contractor or concrete repair specialist should carry out the recommended repairs under the guidance of the structural engineer.

A detailed inspection should be conducted post-repair to confirm compliance with the required standards and to ensure that the structural integrity of the concrete slab has been restored.

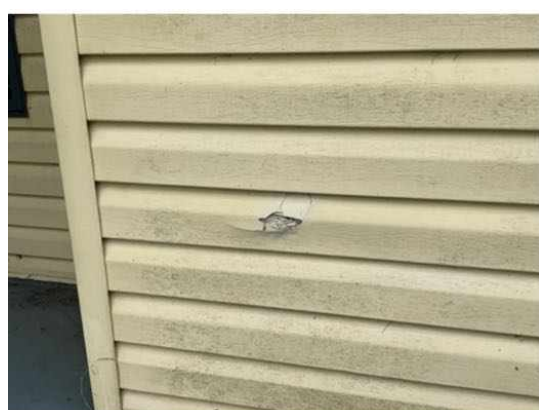
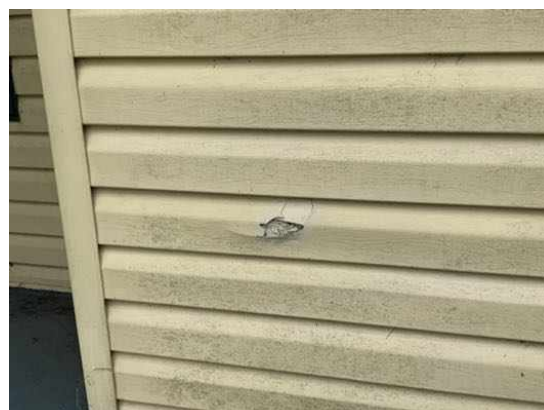
Finding 3.07

Building: Main Building
 Location: All Areas
 Finding: Damaged Cladding
 Information: The cladding is damaged, displaying cracks, peeling, and disintegration, compromising its structural integrity and aesthetic appeal.

1. Structural instability: The damaged cladding can weaken the structure, leading to potential collapse or safety hazards.

2. Water ingress: Gaps in the cladding allow water to penetrate, leading to moisture damage, mold growth, and potential deterioration of the underlying structure.

3. Aesthetic degradation: Damaged cladding diminishes the visual appeal of the building, affecting its market value and reputation.

A qualified construction contractor specializing in cladding repair and replacement can fix the damaged cladding. Additionally, an architect or structural engineer may be required to assess the extent of the damage and recommend appropriate repair methods.

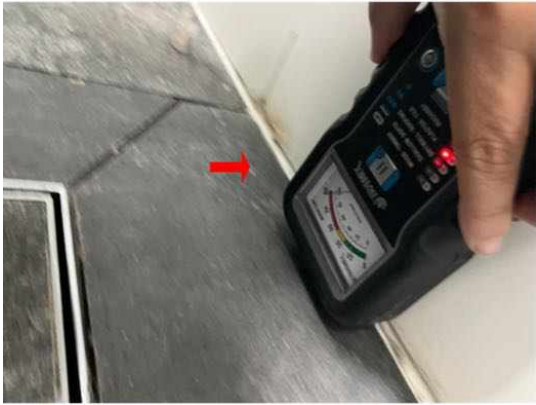
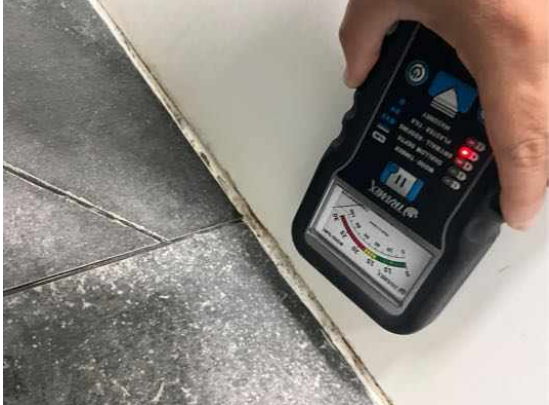
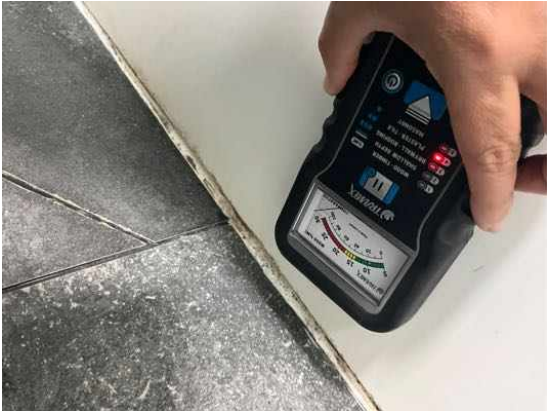
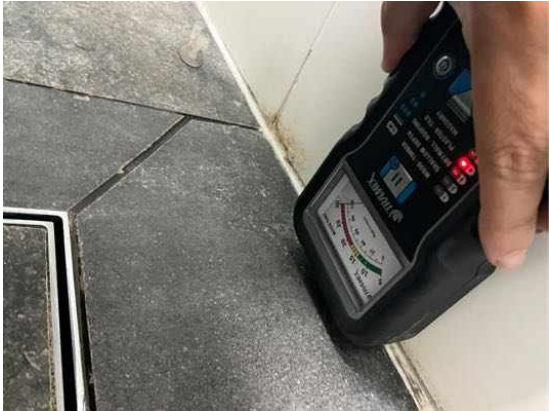
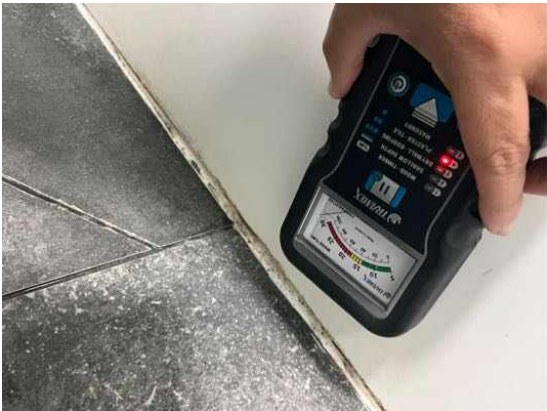
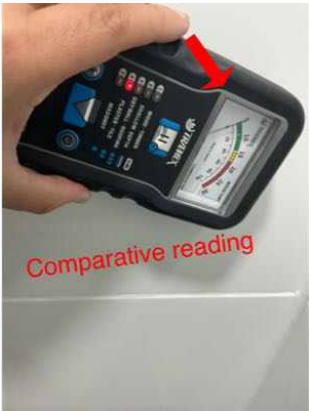
Finding 3.08

Building:	Main Building
Location:	Bathroom
Finding:	Shower - Damp
Information:	Damp is evident to the lower 300mm of wall to the shower alcove. This defect is quite common, and is suspected to have been caused by moisture permeating through the grouting in this area, which shows evidence of deterioration. Leaking pipes within the adjoining wall is also a possible cause.

Unmanaged damp in the shower recess is likely to facilitate the formation and development of mould and fungi growth, decaying associated building materials and compromising their structural integrity. It is important to address damp conditions, as the World Health Organisation notes that excess moisture leads - on almost all indoor materials - to growth of microbes such as moulds, fungi and bacteria, which subsequently emit spores and other matter into the indoor air. Exposure to these contaminants is associated with a wide range of respiratory and other health-related

Consultation with a qualified plumber or bathroom specialist is advised immediately to identify the cause of damp and to perform remedial works as required. Where excessive mould growth is present, further inspection by a specialist environmental health inspector should also be considered.

Always ensure that sealant and grout is in good condition to prevent any moisture issues occurring in the future.

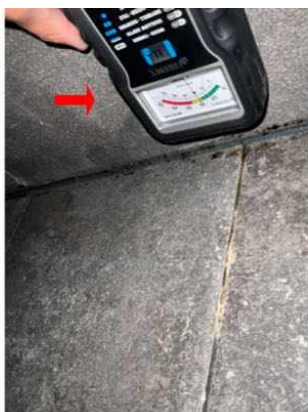
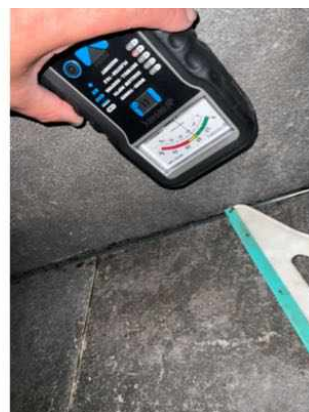
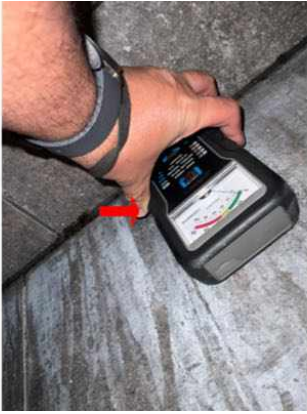
Finding 3.09

Location: Bathroom / Laundry
Finding: Shower - Damp
Information: Damp is evident to the lower 300mm of wall to the shower alcove. This defect is quite common, and is suspected to have been caused by moisture permeating through the grouting in this area, which shows evidence of deterioration. Leaking pipes within the adjoining wall is also a possible cause.

Unmanaged damp in the shower recess is likely to facilitate the formation and development of mould and fungi growth, decaying associated building materials and compromising their structural integrity. It is important to address damp conditions, as the World Health Organisation notes that excess moisture leads - on almost all indoor materials - to growth of microbes such as moulds, fungi and bacteria, which subsequently emit spores and other matter into the indoor air. Exposure to these contaminants is associated with a wide range of respiratory and other health-related problems.

Consultation with a qualified plumber or bathroom specialist is advised immediately to identify the cause of damp and to perform remedial works as required. Where excessive mould growth is present, further inspection by a specialist environmental health inspector should also be considered.

Always ensure that sealant and grout is in good condition to prevent any moisture issues occurring in the future.
