Building and Timber Pest Inspection Report

Inspection Date: Fri, 13 Mar 2026

Property Address: 169 Wallarah Rd, Gorokan NSW 2263, Australia

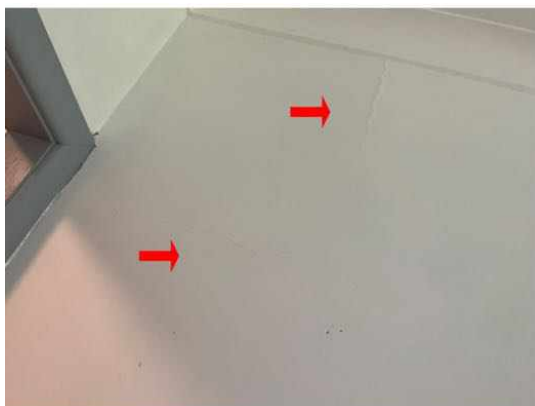
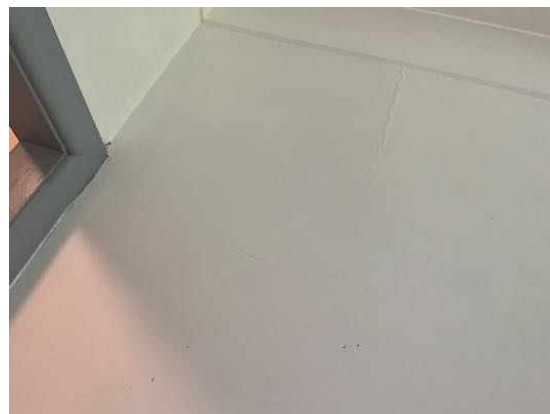
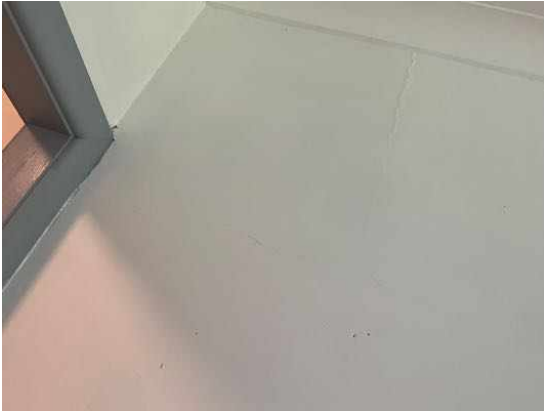
Finding 3.10

Building: Main Building
 Location: Living Room
 Finding: Gyprock - Fine Cracking
 Information: Fine cracks were observed in the plasterboard wall. These cracks are likely due to minor building movement or settlement and are generally considered cosmetic in nature.

- A licensed plasterer or painter can fill the cracks with a flexible compound and repaint the affected area.

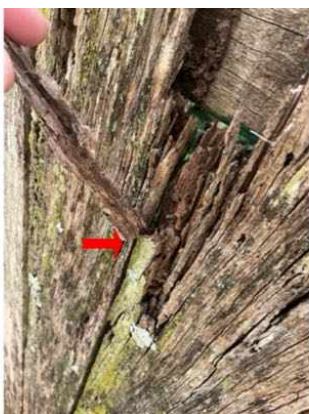
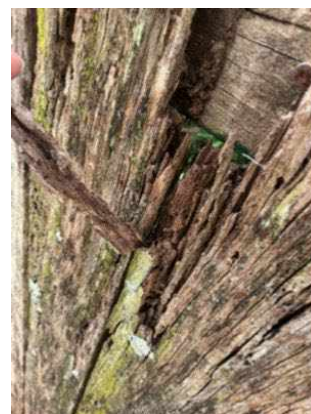
Building:	Main Building
Location:	All Areas
Finding:	Suspected - Timber pest damage
Information:	Despite no live termite or timber pest activity being indicated, suspected previous timber pest damage was found to have affected this area. This damage is considered to be inactive at the time of inspection.

It is advised that the area be visually inspected frequently to ensure that the condition of affected building materials does not worsen.

A licensed pest controller must be appointed to provide a further invasive inspection.

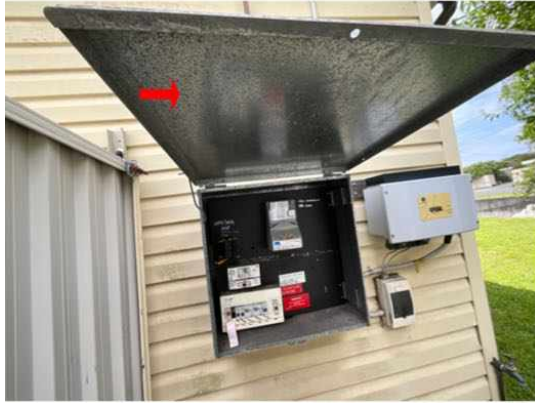
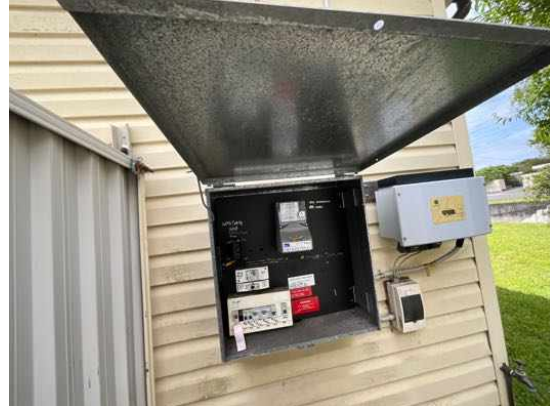
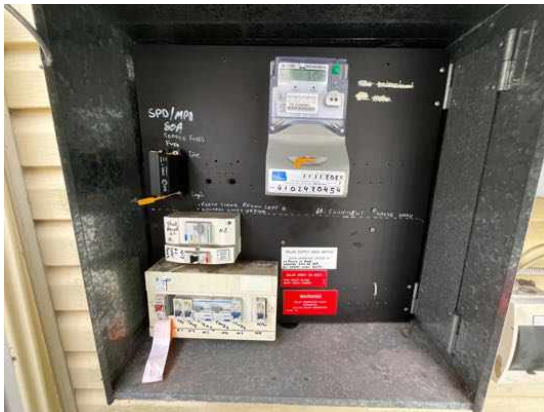
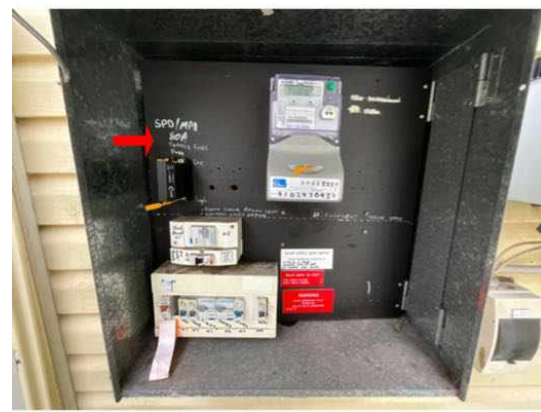
Finding 6.01

Building:	Main Building
Location:	Exterior walls - left side
Finding:	No Evidence of Termite Management System - Durable notice / Legible Sticker
Information:	The application of a pre & post-construction chemical termite barrier is highly recommended for all properties. Such barriers are highly effective in preventing termite attack on any timber building elements throughout the property.

A durable notice was not placed in the switchboard unit to indicate current termite barriers is legible at the time of inspection.

Client must seek further information from the vendor or real estate agent if the conditions of termite management systems were maintained.

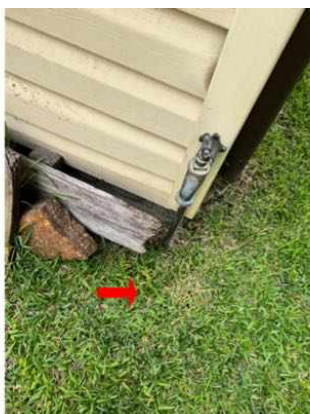
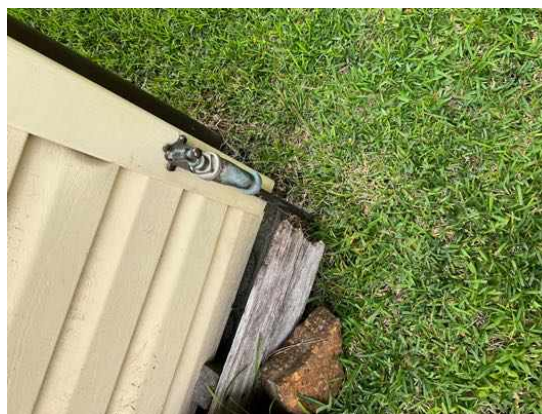
Finding 6.02

Building: Main Building
 Location: All Areas
 Finding: No Drain under tap
 Information: There is no drain installed under the tap, leading to water accumulation and creating conducive conditions for timber pests. This defect needs immediate attention to prevent potential damage and pest infestation.

1. Water Accumulation: Without proper drainage, water can accumulate around the base of the tap, leading to persistent dampness in the surrounding area.
2. Timber Pest Infestation: The damp environment created by standing water is highly conducive to timber pests, such as termites and wood borers, which thrive in moist conditions and can cause significant damage to wooden structures.

3. Structural Damage: Prolonged exposure to moisture can lead to wood rot and deterioration of structural timber, compromising the integrity of the building.

A licensed plumber or a qualified building contractor can address this defect by:

3. Repair and Prevention: Inspecting and repairing any existing water damage and implementing measures to prevent future water accumulation and pest infestations.

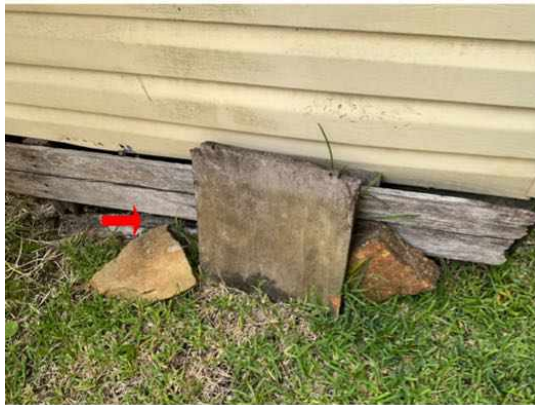
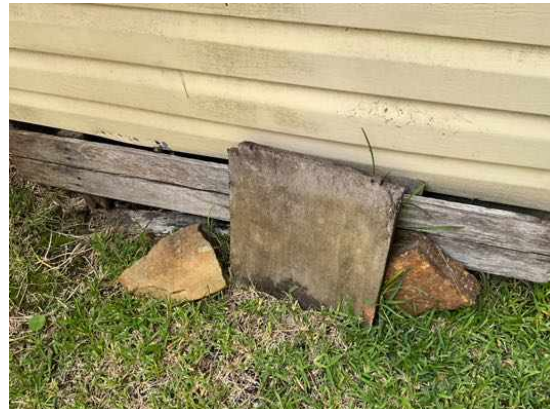
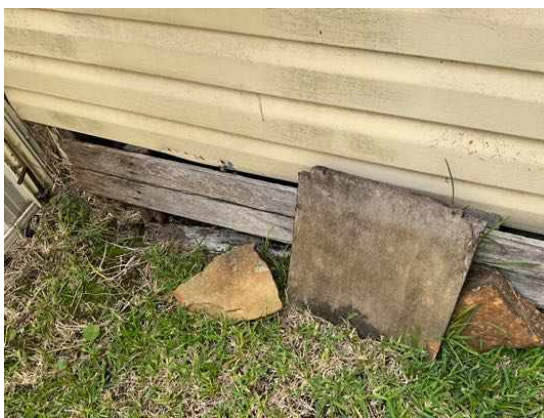
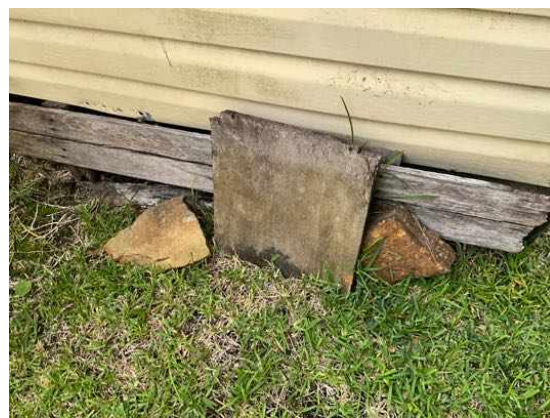
Finding 6.03

Building:	Main Building
Location:	All Areas
Finding:	Timber on ground / conducive conditions to termite damage
Information:	Timber on the ground is indeed conducive to termite damage. Termites are known to thrive in moist environments, and wood in contact with soil or moisture is more susceptible to infestation.

To prevent this, it's important to keep timber elevated and away from direct ground

contact. Regular inspections and proper termite control measures are also essential to protect your wooden structures from termite damage.

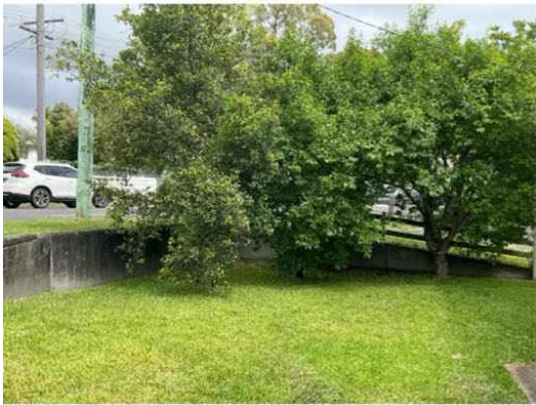
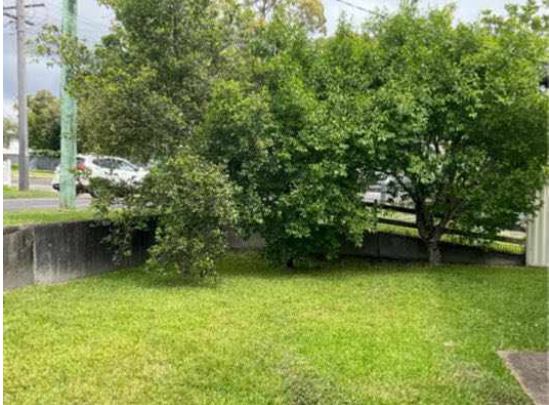
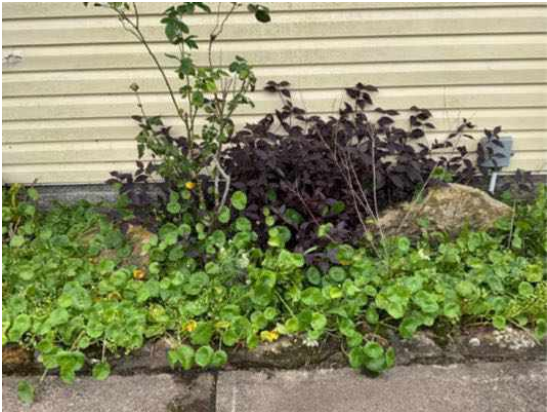
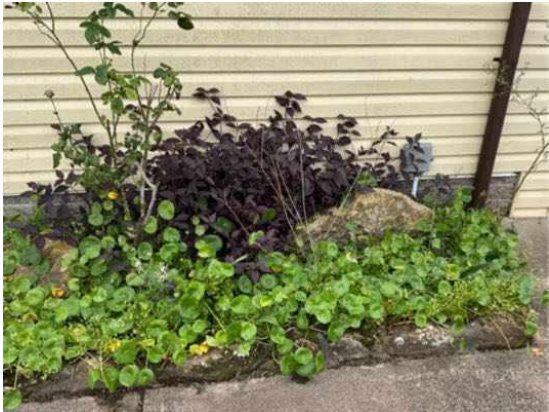
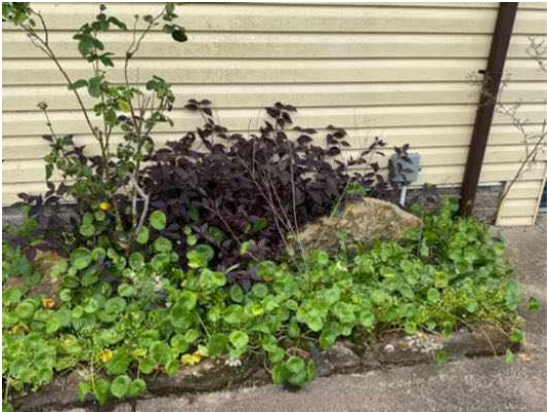
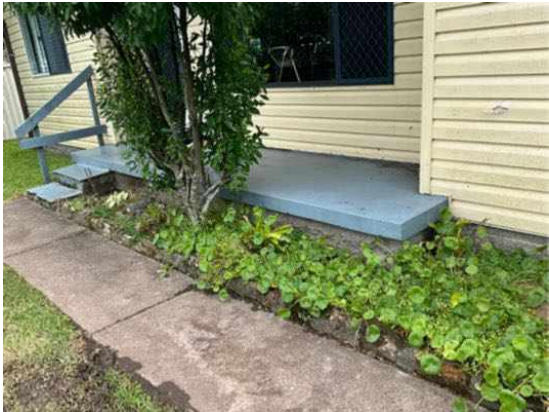
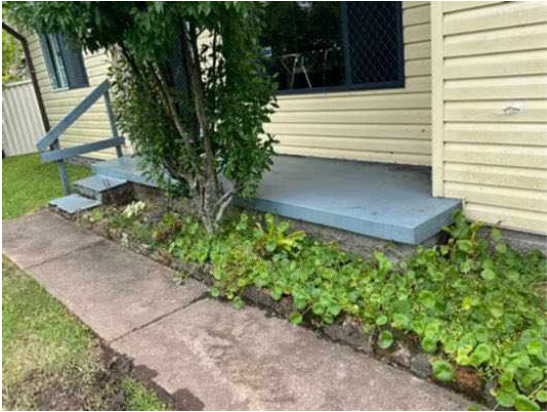
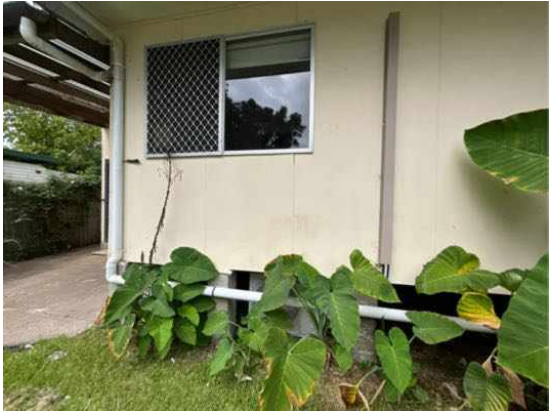
Finding 6.04

Building:	Main Building
Location:	All Areas
Finding:	Dense vegetation around a property can increase the risk of termite infestation
Information:	The presence of dense vegetation around a property can increase the risk of termite infestation, as it provides a conducive environment for them. To address this, consider maintaining a clear space between the vegetation and your home. If you suspect a termite issue, it's advisable to consult with a licensed pest control professional for inspection and treatment.

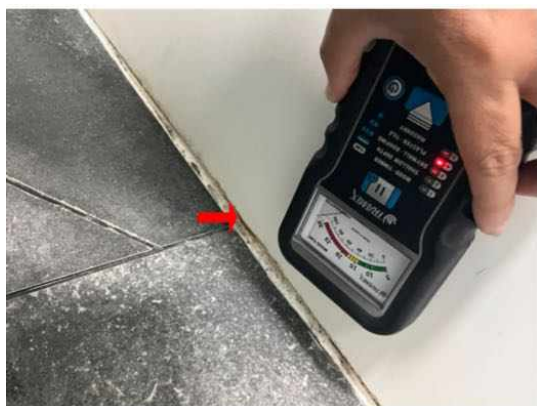
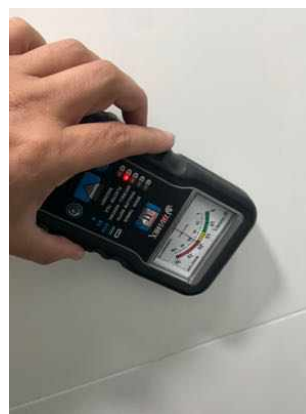
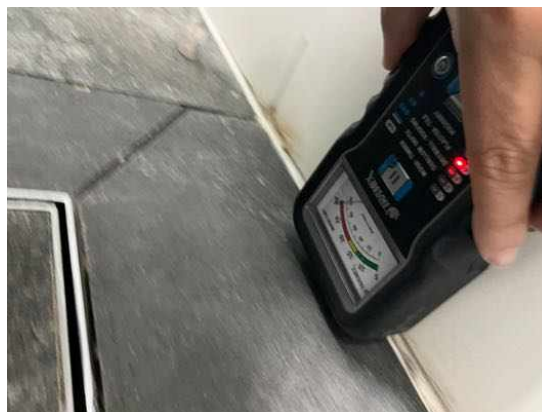
Finding 6.05

Building:	Main Building
Location:	Bathroom
Finding:	Excessive moisture - Conducive to Timber pest
Information:	Excessive moisture can attract termites and produce conditions that promote fungal growth and wood decay.

Excessive moisture is generally caused by deteriorated inadequate or missing roof drainage leaking plumbing pipes or fixtures poorly plumbed HWS overflows or condenser units and poor site drainage.

If mould growth has been found there may be environmental biological or health issues involved. In these cases an appropriately qualified inspector should also be contacted.

Prior to any remedial works being performed a qualified plumber should be appointed to further inspect the property and to identify the cause of the excessive moisture. Works to remove affected building elements may then be necessary and should be performed by an appropriate tradesperson.

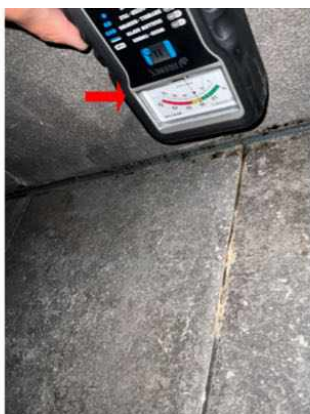
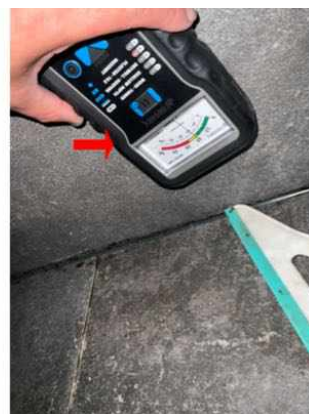
Finding 6.06

Building:	Main Building
Location:	Bathroom / Laundry
Finding:	Excessive moisture - Conducive to Timber pest
Information:	Excessive moisture can attract termites and produce conditions that promote fungal growth and wood decay.

Excessive moisture is generally caused by deteriorated inadequate or missing roof drainage leaking plumbing pipes or fixtures poorly plumbed HWS overflows or condenser units and poor site drainage.

If mould growth has been found there may be environmental biological or health issues involved. In these cases an appropriately qualified inspector should also be contacted.

Prior to any remedial works being performed a qualified plumber should be appointed to further inspect the property and to identify the cause of the excessive moisture. Works to remove affected building elements may then be necessary and should be performed by an appropriate tradesperson.

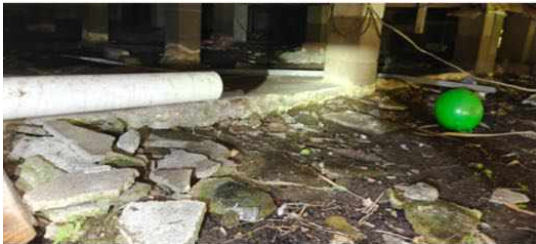
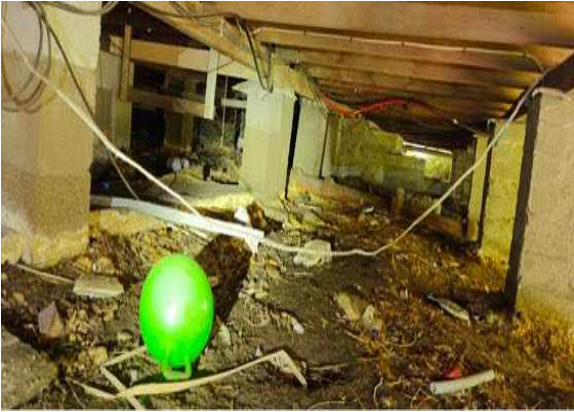
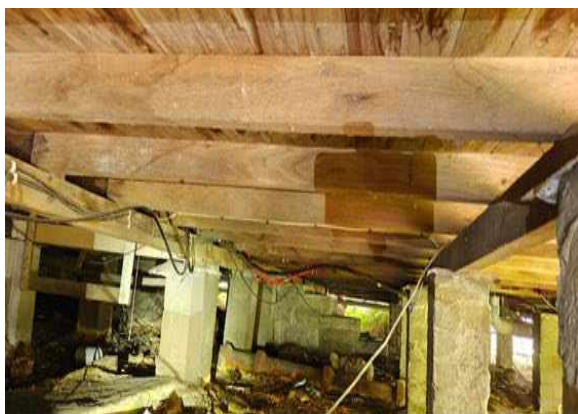
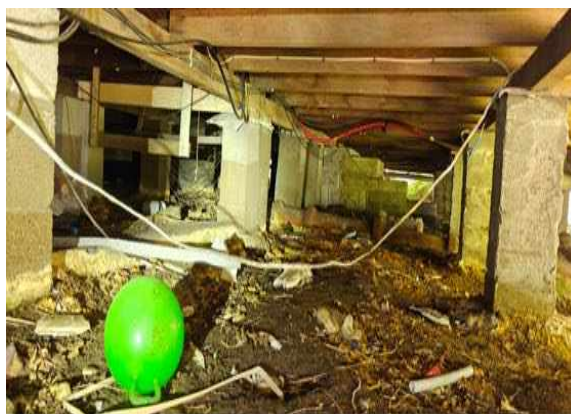
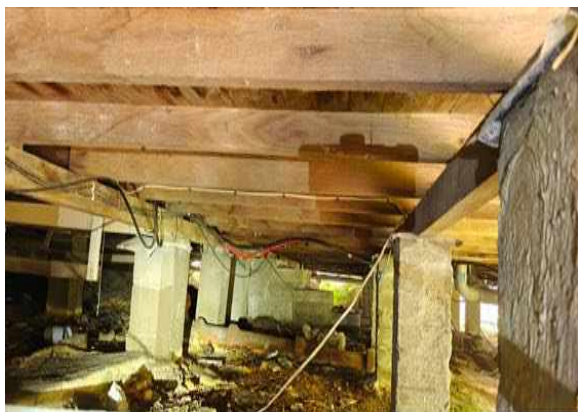
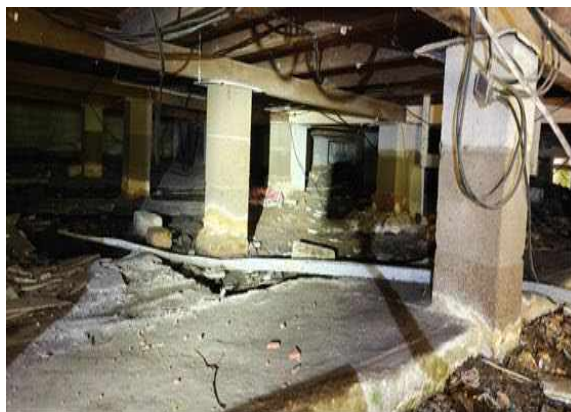
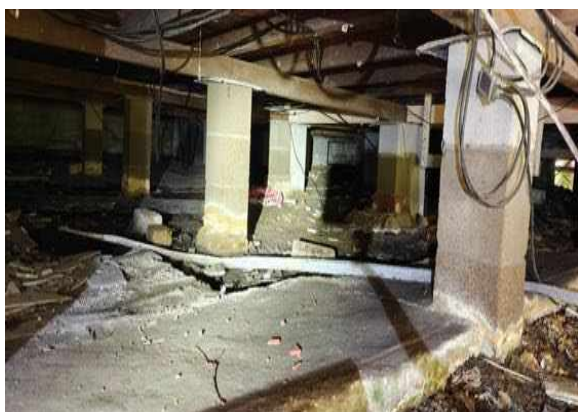
Finding 6.07

Building:	Main Building
Location:	Subfloor
Finding:	Subfloor - poor ventilation, inadequate site drainage, water stains
Information:	The subfloor lacks adequate ventilation, suffers from inadequate site drainage, exhibits water stains, creating conducive conditions for timber pests such as termites.

Risk: The combination of poor ventilation, inadequate drainage, water stains significantly increases the risk of timber pest infestations. Termites are attracted to moist environments and can thrive in subfloors with high humidity levels and water damage. The lack of proper ventilation and drainage exacerbates moisture retention, providing an ideal habitat for timber pests to establish colonies and cause extensive damage to the subfloor structure. Additionally, water stains indicate previous or ongoing moisture issues, which further attract timber pests and contribute to the deterioration of timber materials.

A licensed pest control professional specializing in timber pest management should be consulted to assess the extent of the infestation and develop a comprehensive treatment plan. They can implement strategies to eliminate existing timber pests, such as termites and prevent future infestations by addressing underlying moisture issues. Additionally, a qualified plumber or builder may be needed to improve subfloor ventilation, enhance site drainage, repair water-damaged areas. Regular inspections and maintenance are essential to ensure ongoing protection against timber pests and maintain the structural integrity of the subfloor.

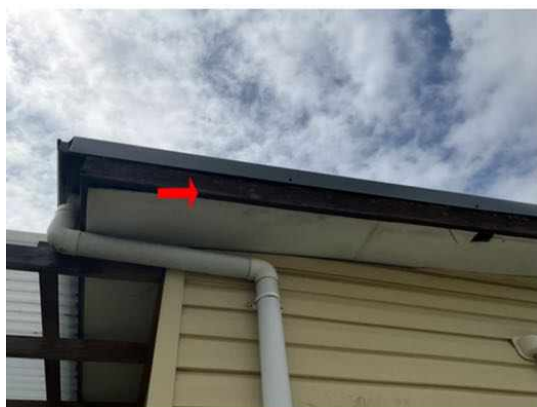
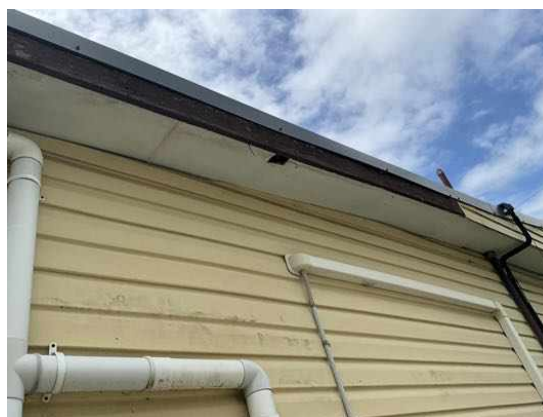
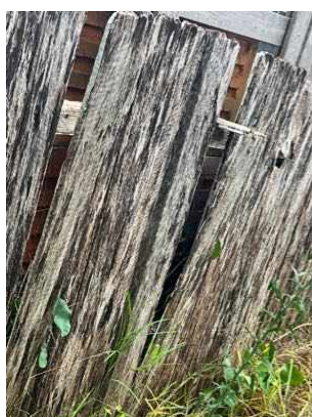
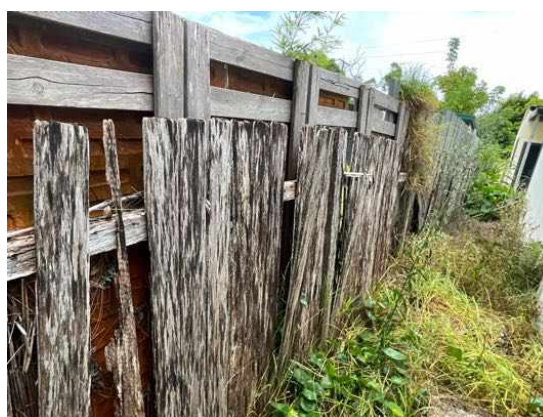
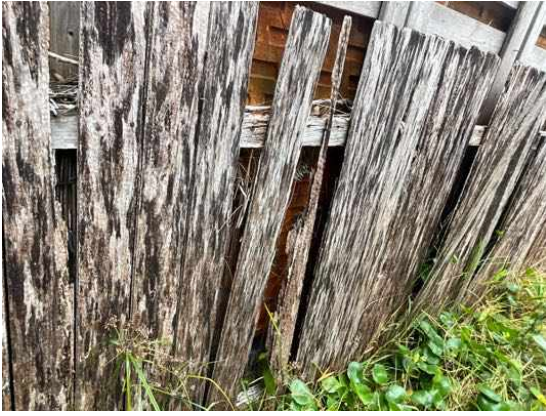
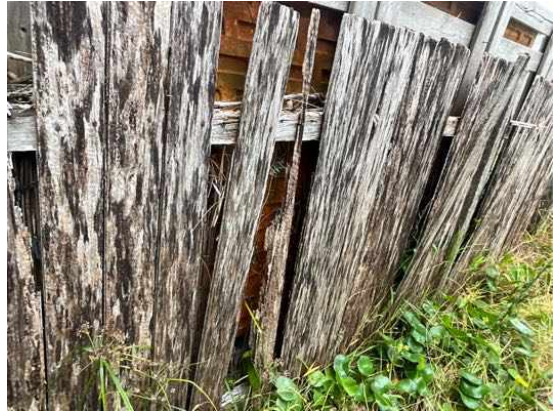
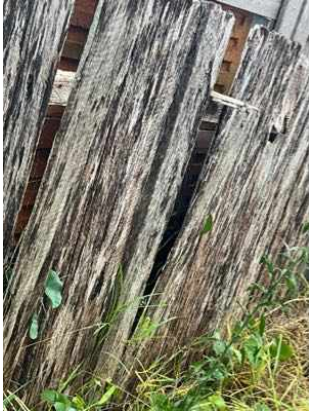
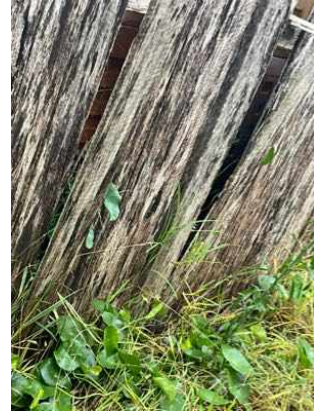
Finding 7.01

Building:	Main Building
Location:	All Areas
Finding:	Wood rot
Information:	This building element shows evidence of wood rot. Wood rot, also known as Fungal Decay, occurs when timbers and other cellulose building materials are exposed to damp conditions on an ongoing basis. This could be the result of exposure to weathering over a prolonged period of time, or the attraction of excessive moisture

Wood rot is often associated with general damp problems and is evidenced by a 'musty' smell or mould and mildew occurring on surfaces. If left unmanaged, damp conditions can lead to further health problems and the decay of timbers will continue.

Early intervention and regular maintenance, particularly of exterior timbers, will prolong the useful life of these building elements. Prior to any works being performed, the cause of the moisture that has created the visible wood rot should be identified and addressed in a suitable manner. Replacement of affected timbers may then be a necessary step in protecting surrounding building elements from such deterioration.

A qualified plumber may be appointed to assess the cause of excessive moisture and to provide advice on any remedial works as required. A qualified carpenter or registered builder may also be required to replace affected building materials.

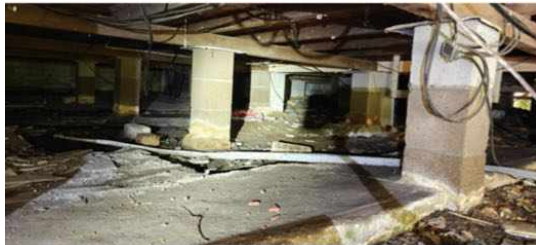
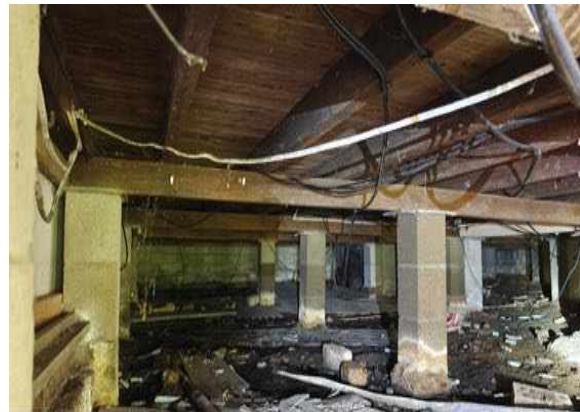
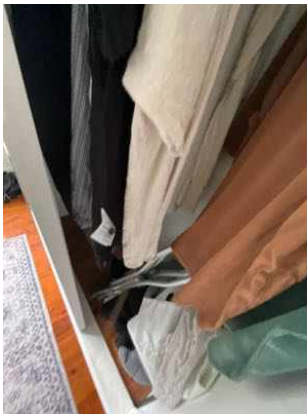
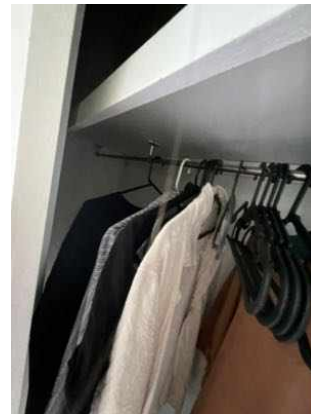
Noted Item

Building: Main Building
Location: All Areas
Finding: Additional Photos - Obstructions and Limitations
Information: These photographs are an indication of the obstructions and limitations which impeded full inspection of the property at the time of inspection. These obstructions can hide an array of defects and should be removed to allow full inspection to be carried out. A re-inspection is recommended once the areas are made accessible.

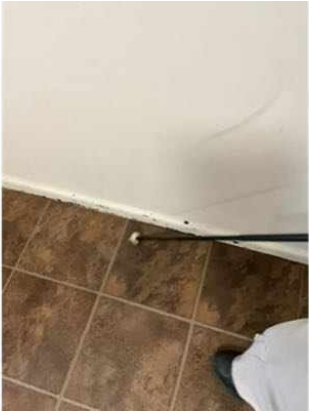
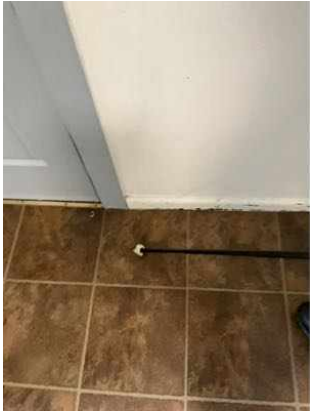
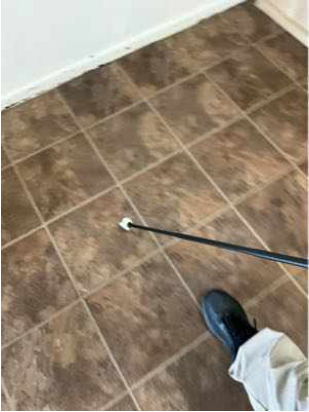
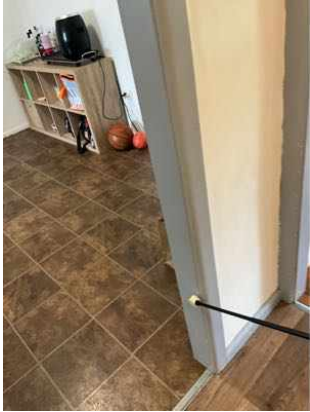
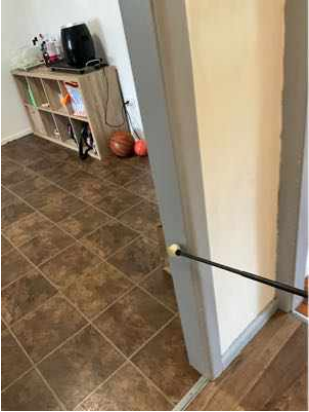
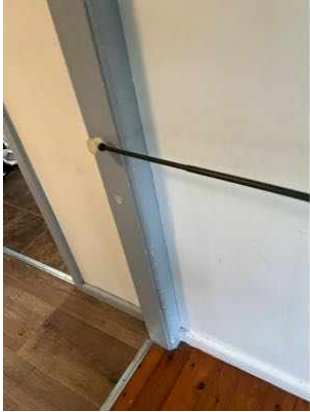
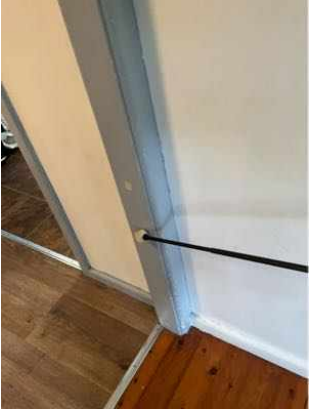
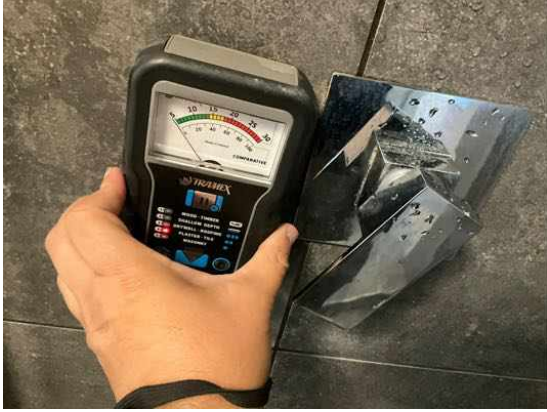
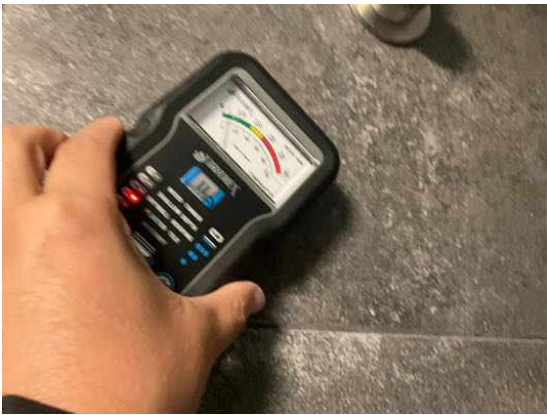
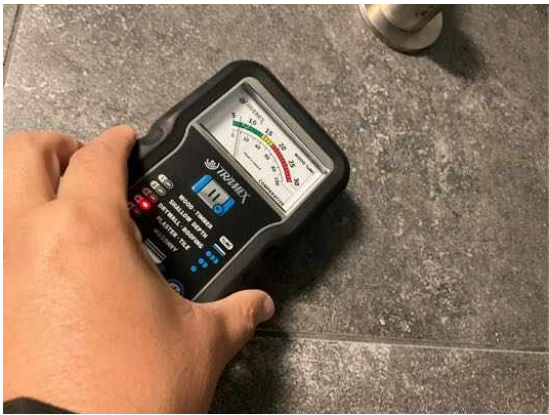
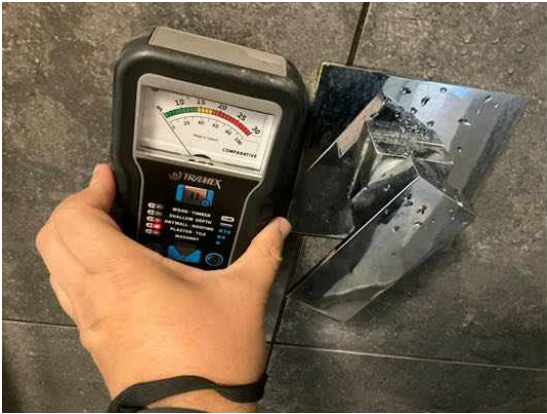
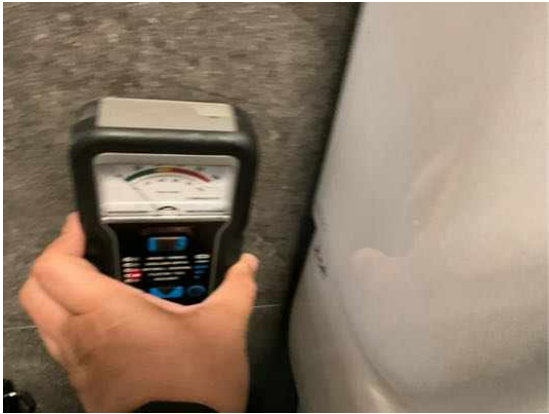
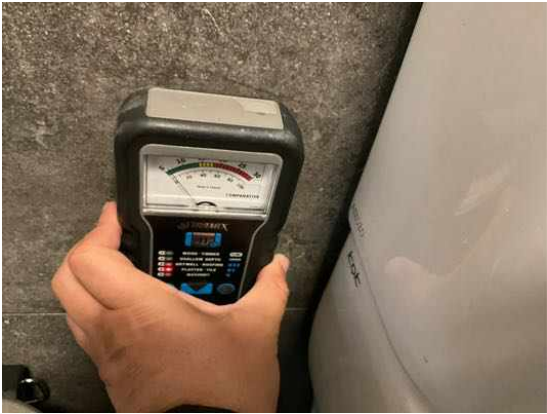
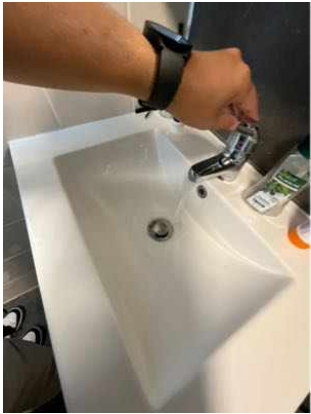
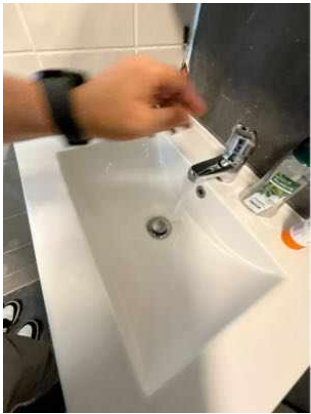
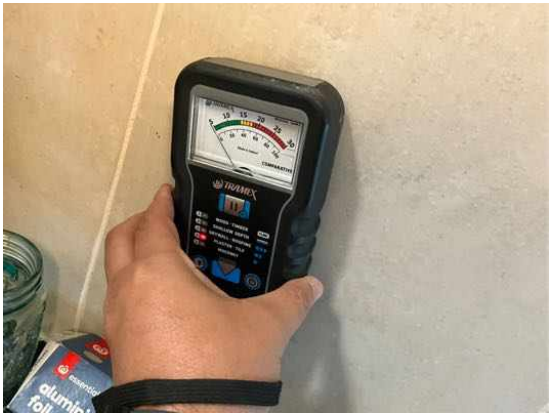
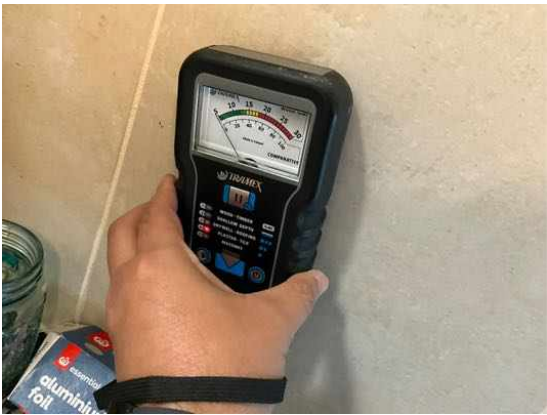
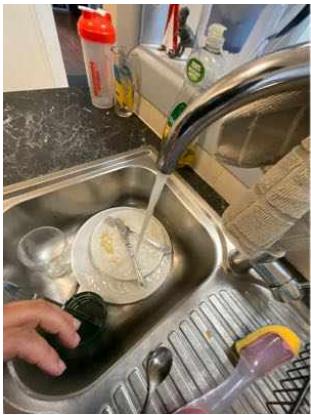
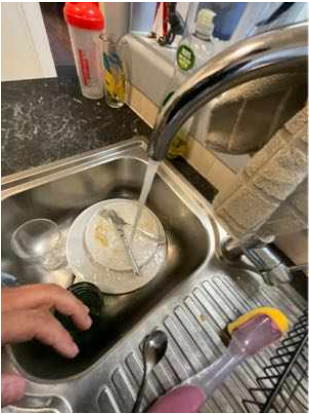
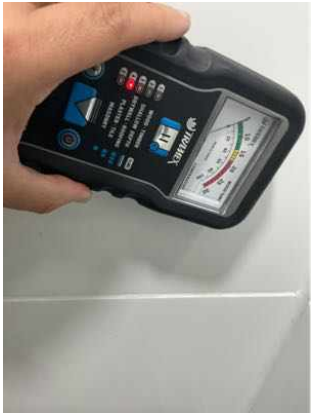
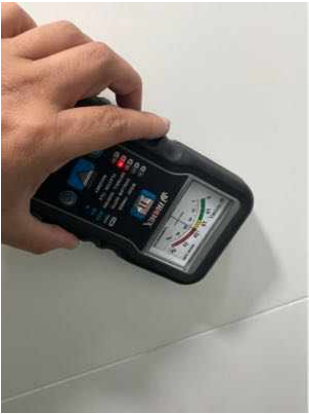
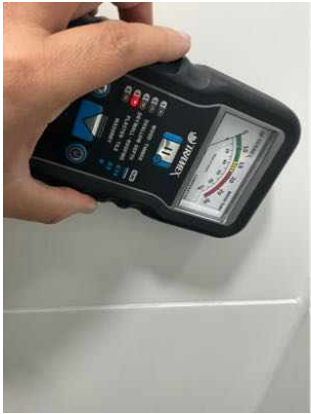
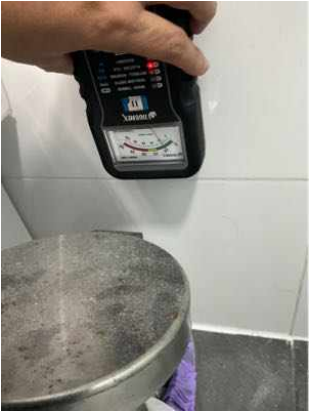
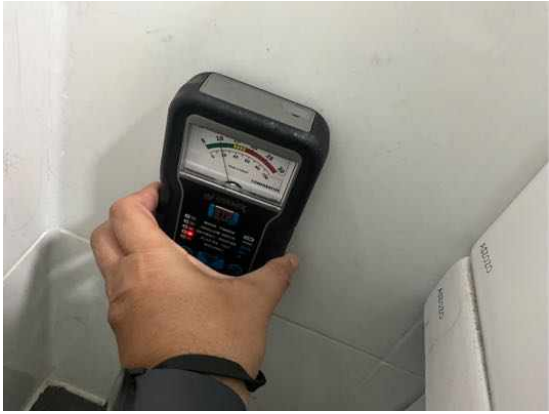
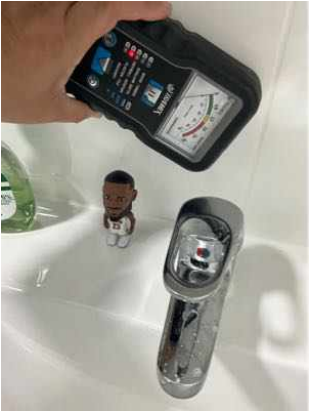
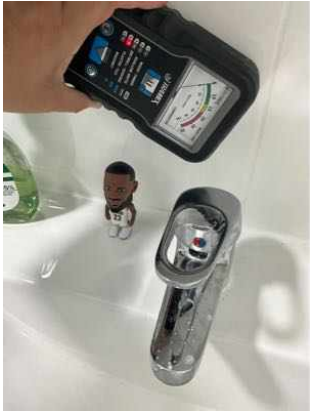
Building: Main Building
Location: All Areas
Finding: Additional Photos
Information: Additional photos are provided for your general reference
