# Building and Timber Pest Inspection Report

Inspection Date: Tue, 13 Jan 2026

Property Address: 3/42 Gilchrist St, Shepparton VIC 3630,  
Australia

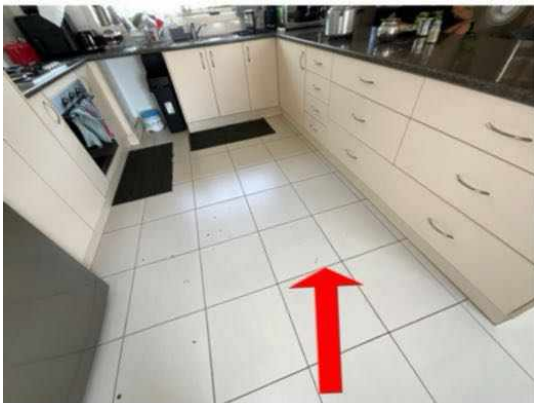
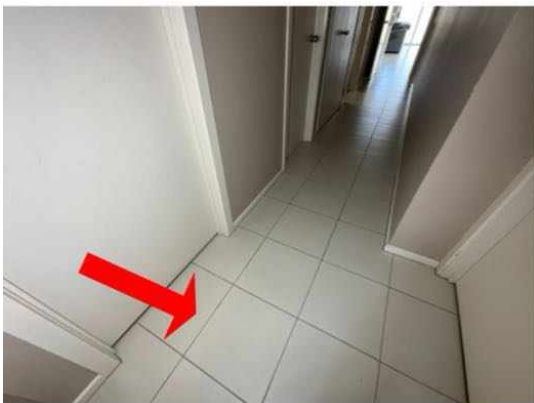
Building:	Building 1
Location:	Kitchen, hall, living
Finding:	Cracked floor tiles
Information:	Cracking in the floor tiles was evident in this area at the time of inspection. It is suspected that this cracking has occurred as a result of minor settlement or impact damage.

Cracked tiles throughout the household detract from the overall appearance of the affected areas however it is unlikely to create or lead to any secondary defects.

While not considered a matter of urgency, replacement of cracked floor tiles is recommended at the clients discretion. A tiling contractor may be appointed to perform these works. Where cracks become more numerous, contact a licensed building inspector for further investigation.

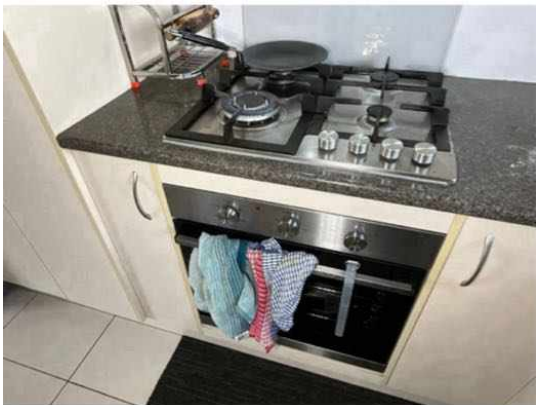
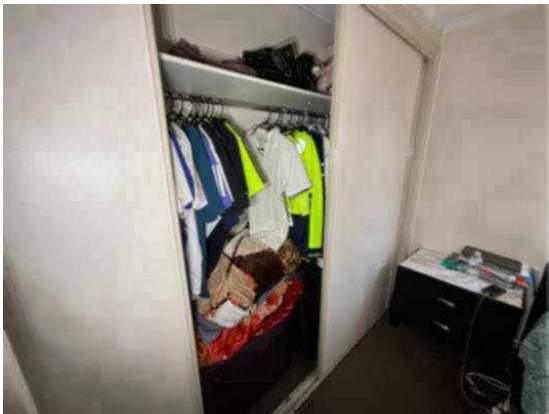
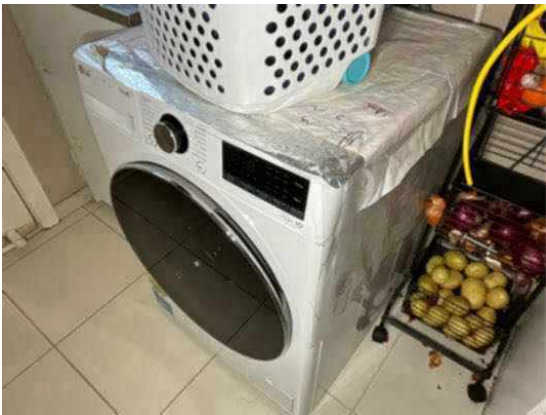
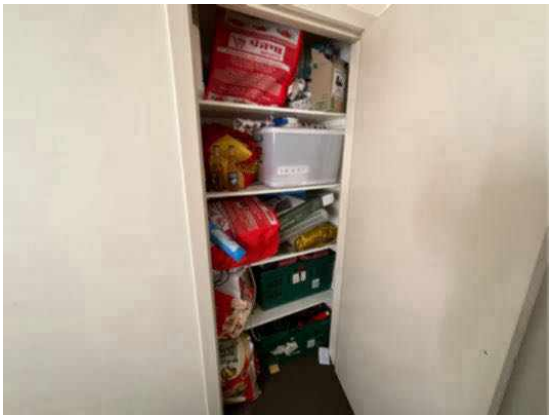
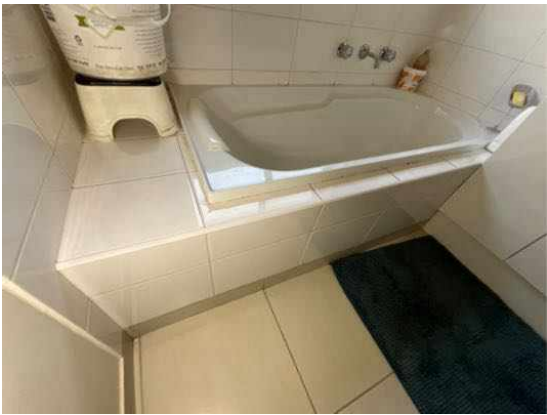
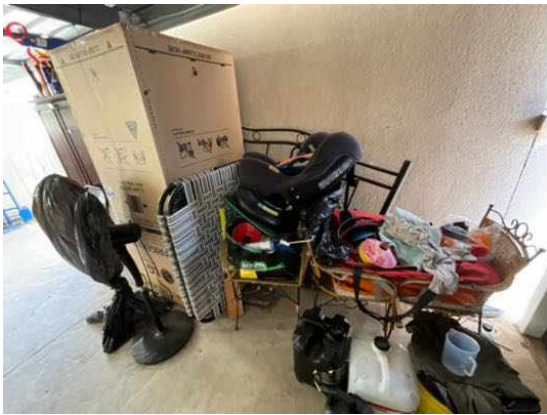
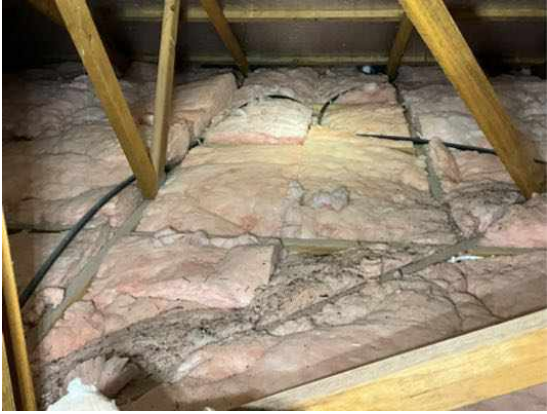
**Noted Item**

Building: Building 1  
Location: All Areas  
Finding: Additional Photos - Obstructions and Limitations  
Information: These photographs are an indication of the obstructions and limitations which impeded full inspection of the property at the time of inspection. These obstructions can hide an array of defects and should be removed to allow full inspection to be carried out. A re-inspection is recommended once the areas are made accessible.
