# Building and Timber Pest Inspection Report

Inspection Date: Thu, 29 Jan 2026

Property Address: 211 Woods Rd, Yagoona NSW 2199,  
Australia

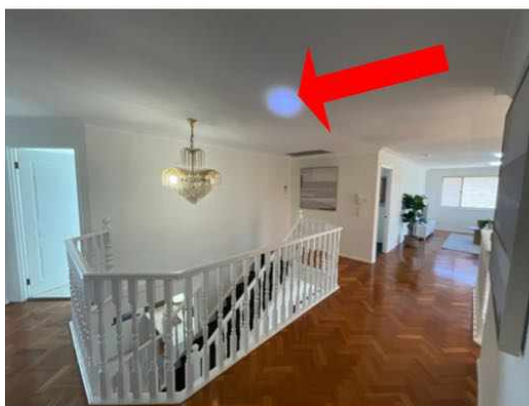
Finding: Ceiling - Water stained

Information: Water staining to ceiling linings in this area was evident at the time of inspection. Water staining indicates that surfaces have been exposed to excessive moisture over time. The minerals and other elements in the water lead to staining, which may graduate to corrosion and deterioration if left unmanaged.

While mostly an appearance defect, water staining can be indicative of more serious defects, which may be currently concealed by interior ceilings.

Where water staining is active, a licensed plumber must be consulted to identify the cause of the staining and to provide advice on any reparation works that may be required. Replacement of any damaged structures is advised.

Conversely, where water staining is old and inactive, affected building materials may be repaired or replaced at client discretion.

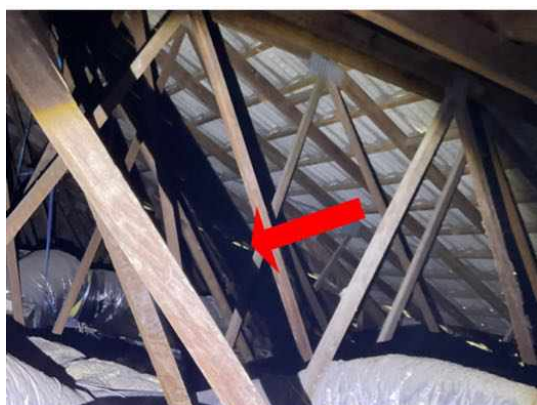
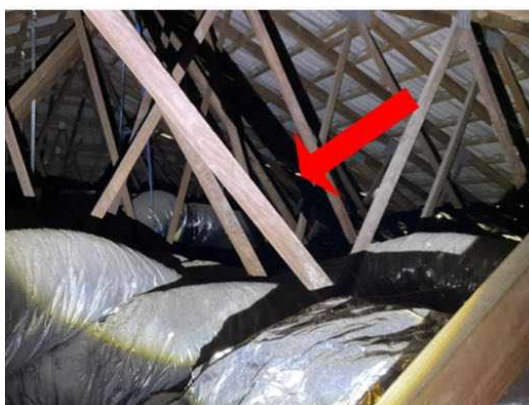
### Finding 2.02

Building:	Main Building
Location:	Roof Void
Finding:	Exterior roof - Leaking
Information:	Active roof leaks were evident at the time of inspection. Roof leaks can have a number of causes, including damage to roof coverings, deterioration of roof fixtures and fittings, or loosely associated materials (fascias etc.).

Where water leaks are active, rain penetration is likely to cause water damage to associated structures and building elements in this area, which can have a range of implications. If left unmanaged, the development of major structural damage to the roofing and associated structures may occur.

A roof plumber should be appointed as soon as possible to primarily identify the cause of the leak, and to provide subsequent repair works as necessary. Depending on the extent of the damage, replacement of sections of the roof covering and/or roofing structures may be required, and may be performed by a registered builder or qualified carpenter.

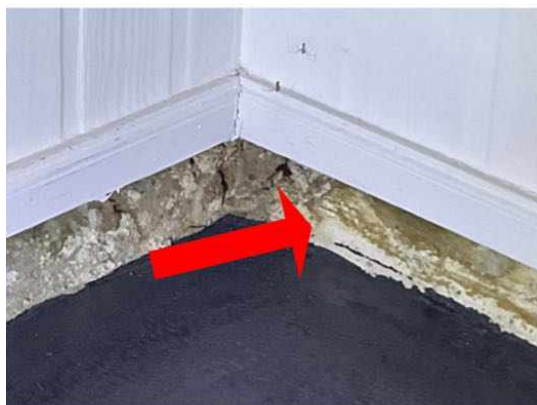
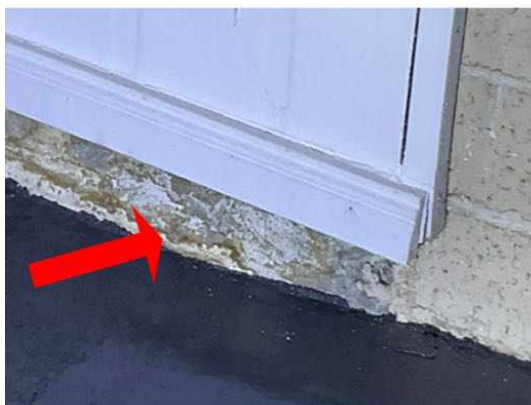
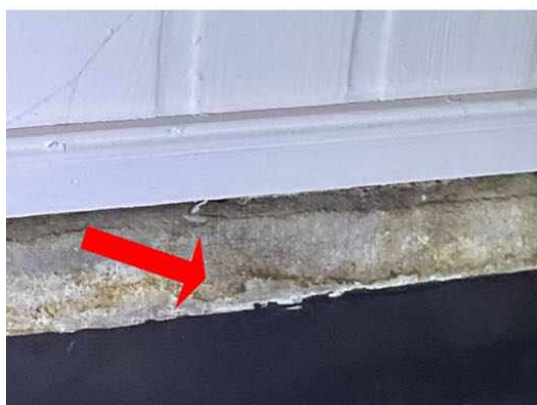
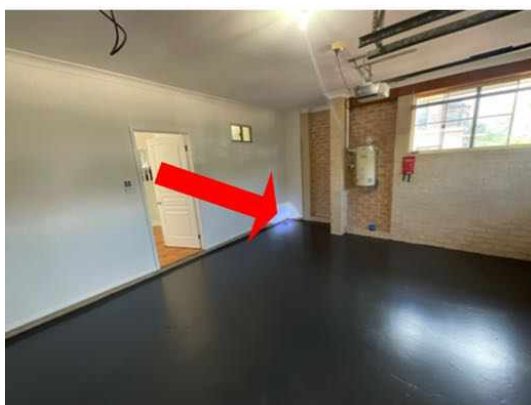
### Finding 2.03

Building:	Main Building
Location:	Garage

Rising damp is generally managed by the installation of a damp proof course during construction. A Damp Proof Course (DPC) is an impermeable barrier at the base of the wall above ground level. However, many 19th Century buildings have no damp course installed, or the materials have failed. The DPC may have been omitted as a consequence of poor workmanship, or it may have been bridged where materials built up against the side of the house allow moisture ingress above the DPC level.

The first step in addressing rising damp is to diagnose the cause. The identified cause should be addressed first before addressing the appearance and other defects which have resulted from the rising damp. If the original cause is not resolved, further cases of damp are likely to ensue, resulting in secondary defects.

Consultation with a qualified plumber is advised immediately to identify the cause of the damp and perform remedial works as required.

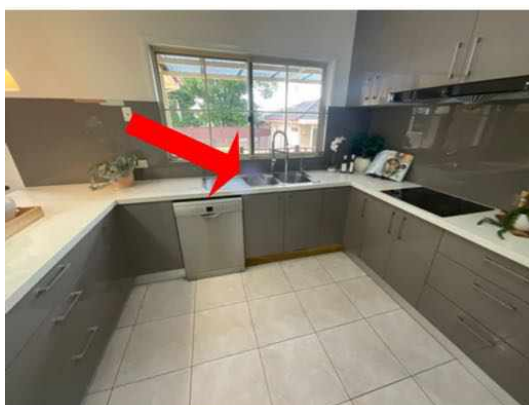
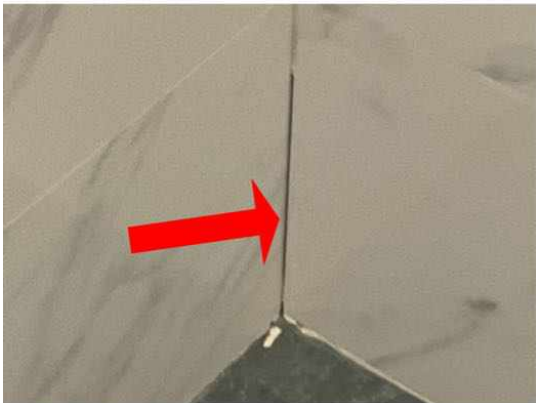
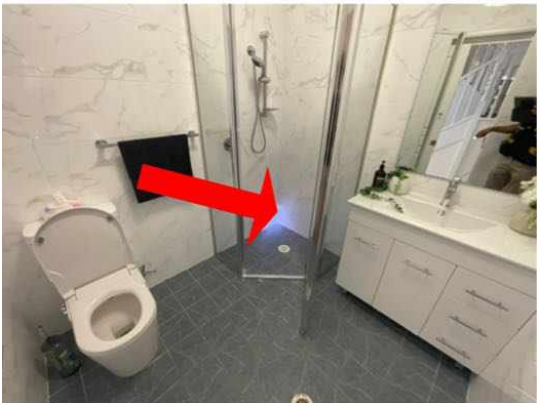
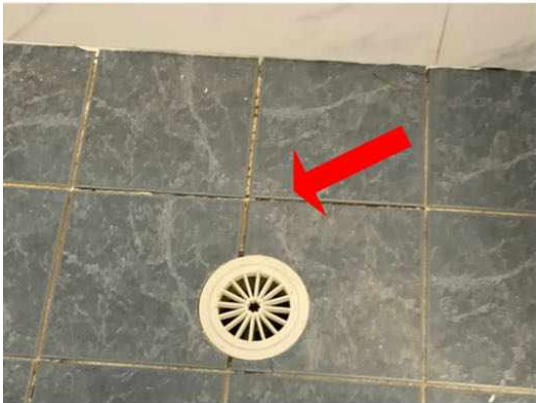
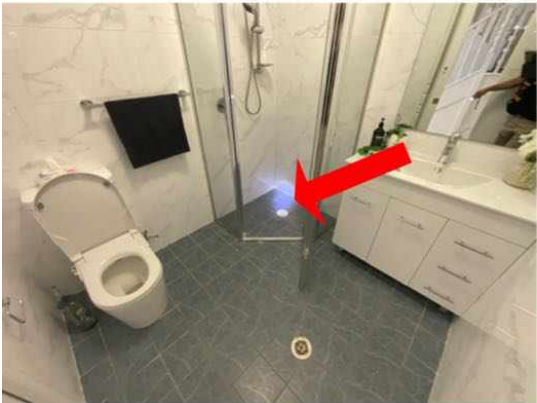
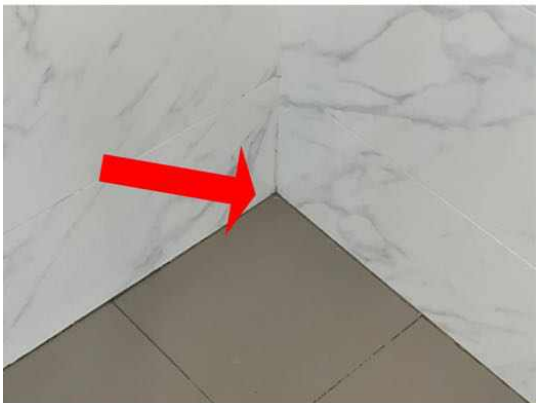
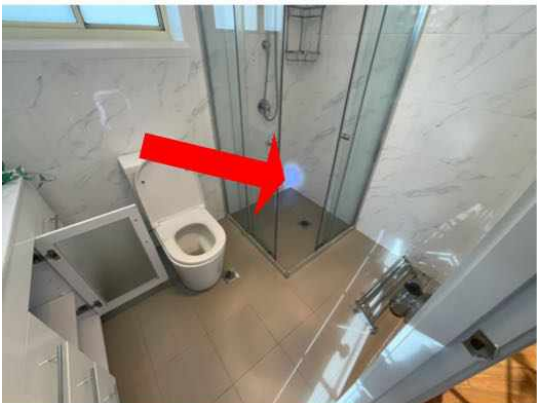
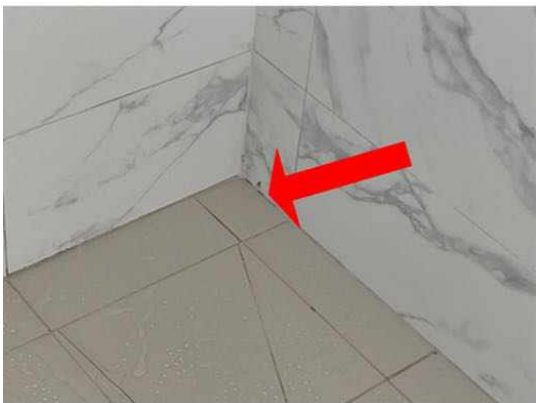
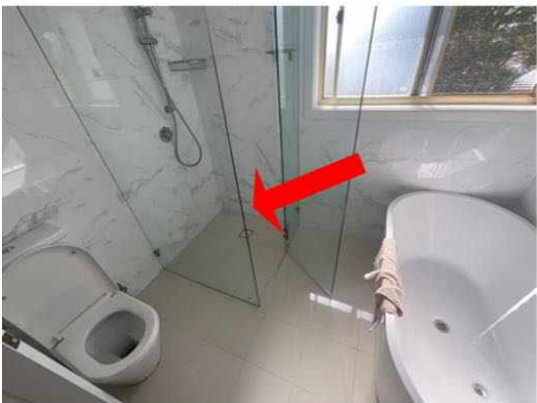
### Finding 3.01

Building:	Main Building
Location:	Kitchen
Finding:	Sealant and grouting - Missing or damaged
Information:	It was noted on inspection that sealant or grout is degraded to the tiled shower alcove and or other areas of the bathroom.

Different materials and floor areas move at different rates, generally causing cracking to grout or sealant at this point. A flexible sealant is required to allow for expected expansion and contraction, while keeping the joint water tight and protective of all associated building materials.

There appears to be excessive mould to the sealant and grout which will likely require scraping out and replacement.

Flexible and mould resistant materials should be applied to affected areas to prevent any subsequent water damage that is likely to occur. Regular maintenance and replacement of damage or missing or damaged sealant and grout is highly recommended to the wet areas, as this is a regular wear and tear defect. Sealant and grouting in areas that come into regular contact with water should be maintained for the long term care of your property.

A sealant specialist or tiling contractor should be appointed to complete these works as soon as possible

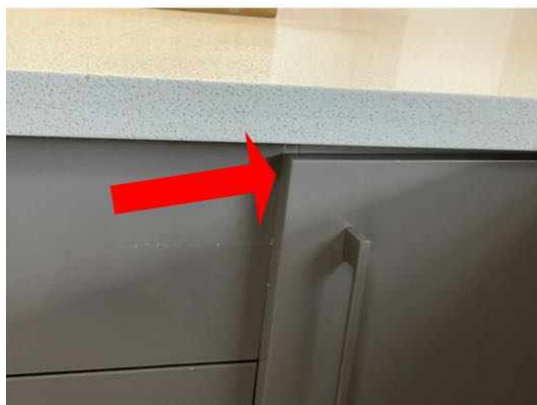
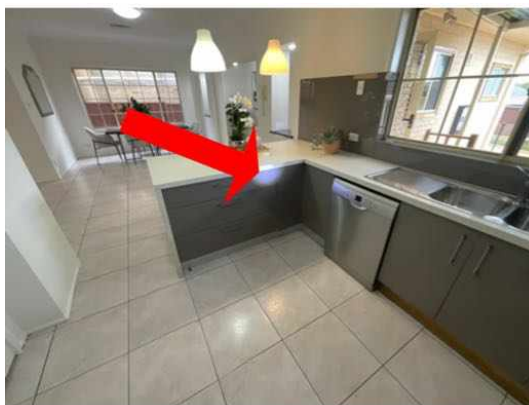
Finding 3.02

Building:	Main Building
Location:	Kitchen
Finding:	Cabinet doors - misaligned
Information:	It is observed that some of the cabinet doors are not aligned and / or have inconsistent gaps between the doors.

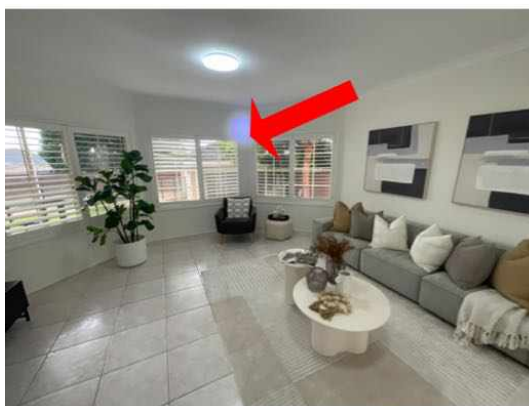
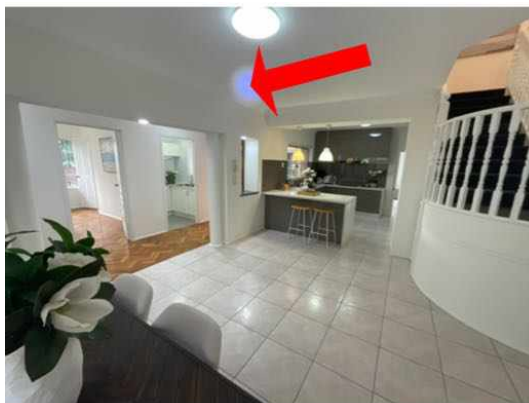
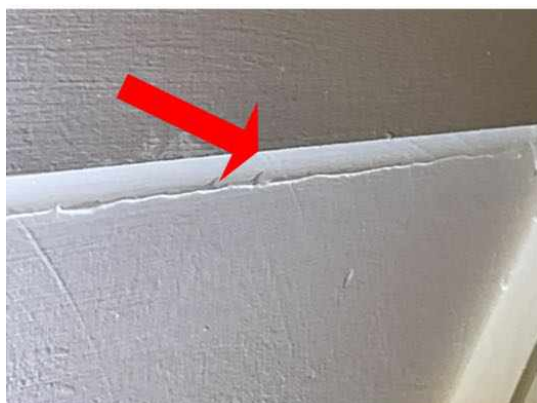
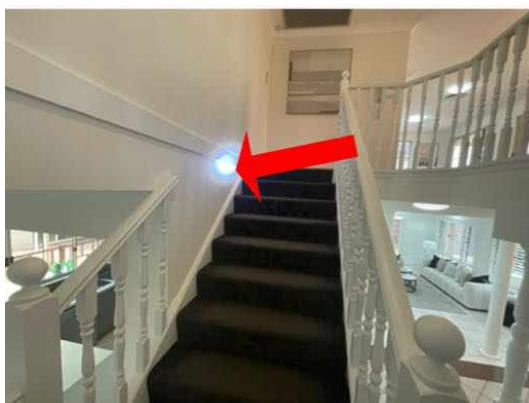
### Finding 3.03

Building:	Main Building
Location:	All Internal Areas
Finding:	Paint finish - Substandard
Information:	The paint finish in this area was found to have been completed to a substandard level. Substandard painting is generally classified as an appearance defect. However, the substandard appearance may also be indicative of poor surface preparation and substandard workmanship.

If this applies, further areas of poor and incomplete finishes could develop over time. Furthermore, substandard paint finishes in areas exposed to moisture, e.g. external areas or wet areas, could lead to deterioration of underlying building materials.

Substandard paint finishes should be sanded back, filled, leveled and repainted, as applicable. Where inadequate paint protection has led to the deterioration of the associated building element, repair and/or replacement of this building element may be required.

A painting contractor should be appointed as soon as possible to perform necessary works to aid the appearance of the affected area and to ensure that the area is protected against further deterioration. Alternatively, the homeowner following manufacturer instructions may be able to provide this service.

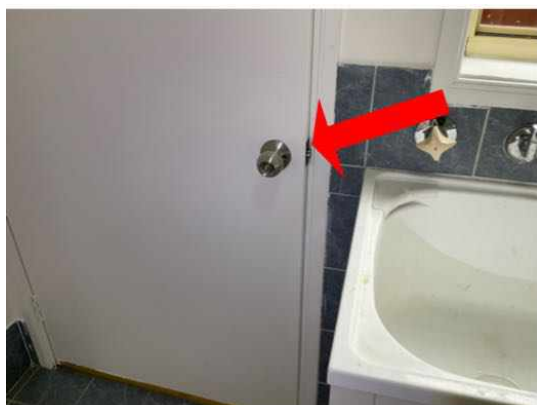
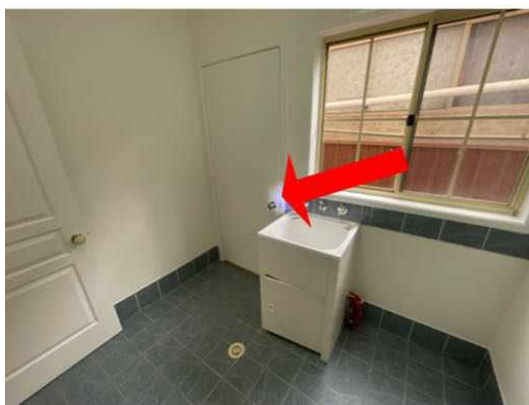
### Finding 3.04

Building:	Main Building
Location:	Laundry
Finding:	Door - Jamming or Binding
Information:	Binding and/or jamming of this door is evident during standard operation. This defect inhibits the functionality of the affected door as well as creating potential for secondary defects to associated building elements, such as damage to the floor covering. A door that binds to flooring or to the associated door frame may have several causes, ranging from minor defects, such as poor installation of the door or deteriorated hinges, through to major structural issues, such as damage to subfloor structures. Where door binding/jamming appears to indicate major structural issues, a registered

builder specialising in re-stumping should be appointed to provide an estimate on the cost of rectification. For minor causes, a qualified carpenter or general handyperson should be appointed to perform minor rectification works at client discretion.

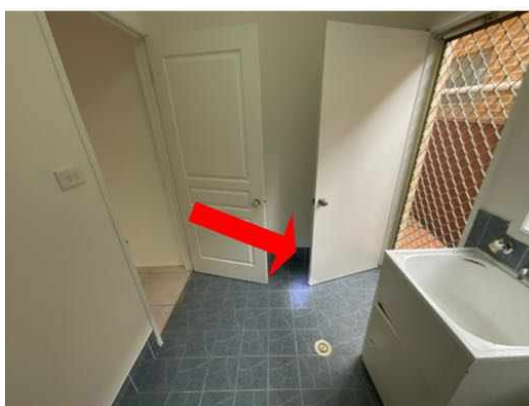
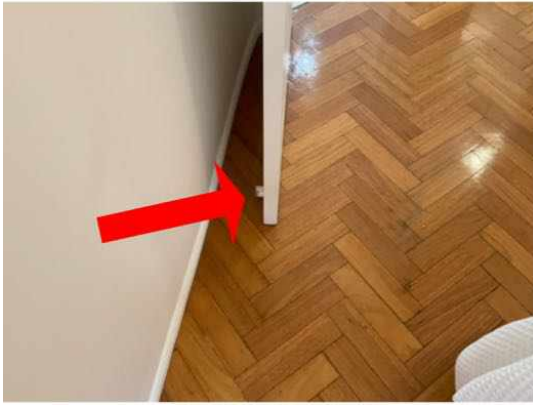
### Finding 3.05

Building:	Main Building
Location:	All Internal Areas
Finding:	Door stop - Missing
Information:	The door stop is missing or is inadequate to stop the door handle from damaging the wall. Although some building elements may seem irrelevant or unnecessary, all building elements play a key role in the operation and function of the overall structure and its performance.

Re-installation or replacement of the door stop is advised as soon as possible to prevent any subsequent damage to the door or associated structures. A general handyman may be appointed to perform these works at client discretion.

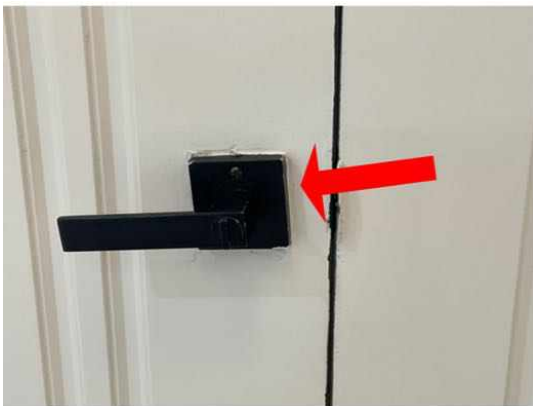
### Finding 3.06

Building:	Main Building
Location:	Entry
Finding:	Fitting (door handle) - Loose
Information:	The fitting in this area is loose and requires adjustment to tighten.

If left unmanaged, the fitting may further deteriorate, causing potential for the development of other minor secondary defects.

A relevant tradesperson should be appointed to perform these rectification works at discretion of the client.

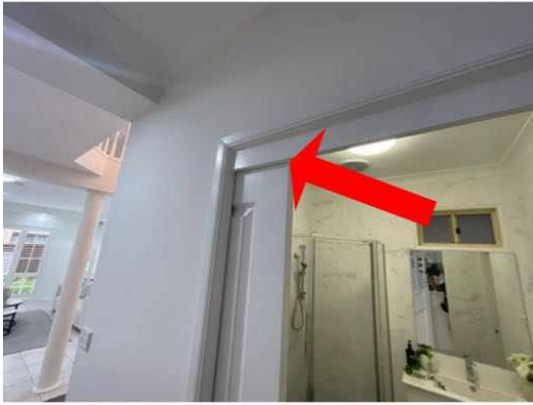
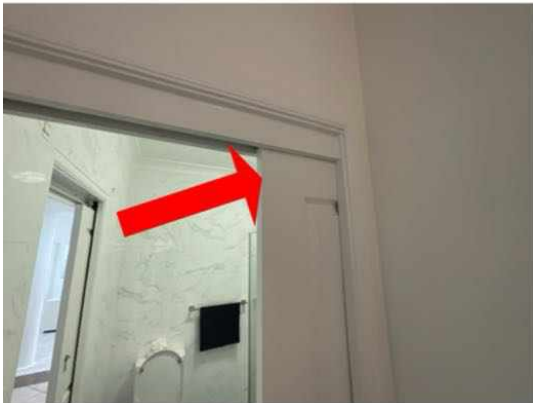
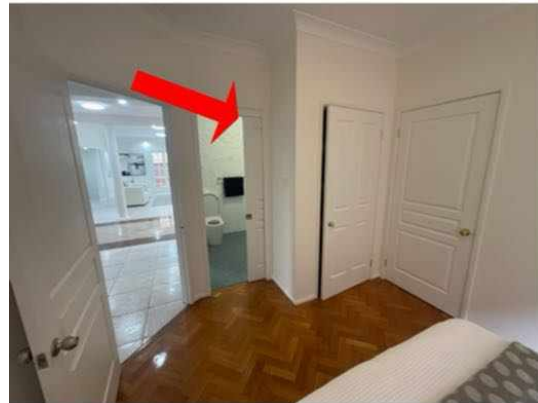
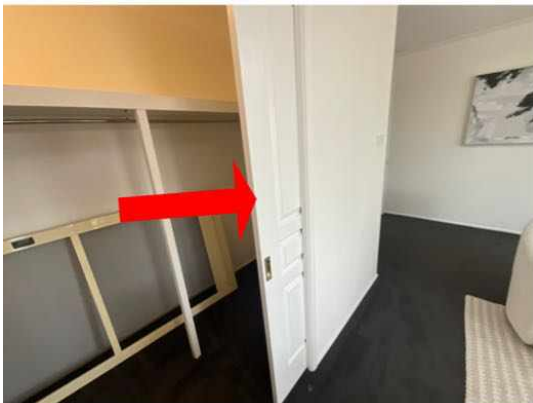
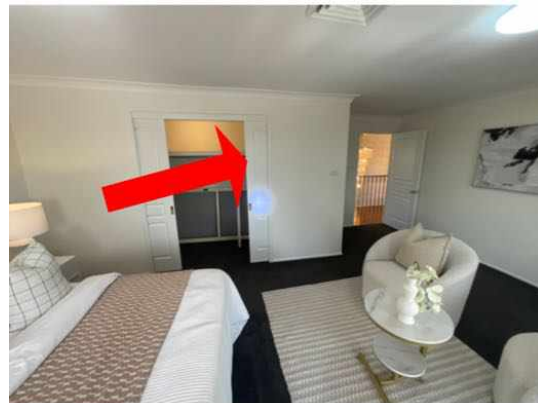
### Finding 3.07

Building:	Main Building
Location:	Bathroom > Ground Level
Finding:	Cavity Sliding door - defect
Information:	Most of cavity sliding doors may have a ball bearing type system that runs along the track and this system may get the defects by installation and some other impacts.

The qualified carpenter should be nominated to repair the matter.

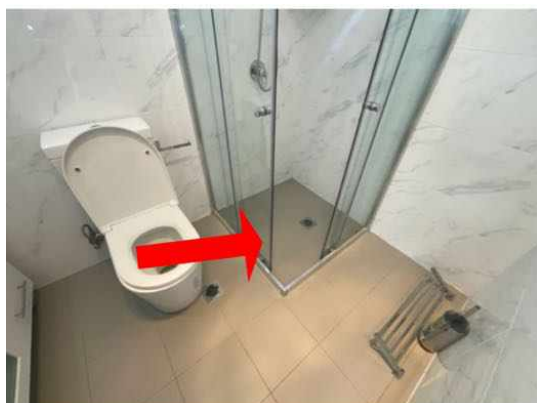
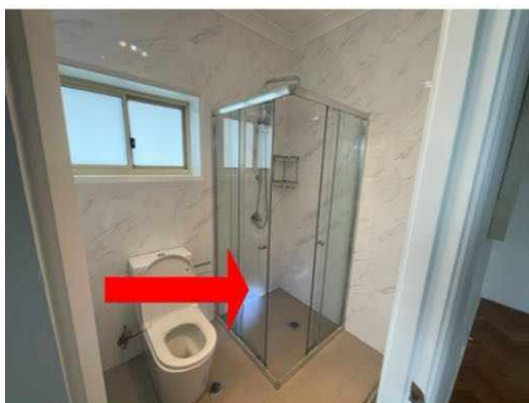
### Finding 3.08

Building: Main Building  
Location: Bathroom / Ensuites >  
Finding: Shower Screen Door Jamming at Head  
Information: The shower screen door was found to be jamming at the top edge during operation. The door does not swing freely and is scraping against the frame, indicating poor installation or misalignment.  
Location:  
Ground floor bathroom shower enclosure.

- Risk of damage to glass panels, which may result in shattering if stress points develop.
- Increased wear and tear on hinges and fittings.
- Safety hazard for occupants due to difficulty in operating the door.

The builder is to adjust or reinstall the shower screen door to ensure it swings smoothly without obstruction, in accordance with AS 1288 requirements. All fittings and clearances should be checked and rectified to prevent recurrence.

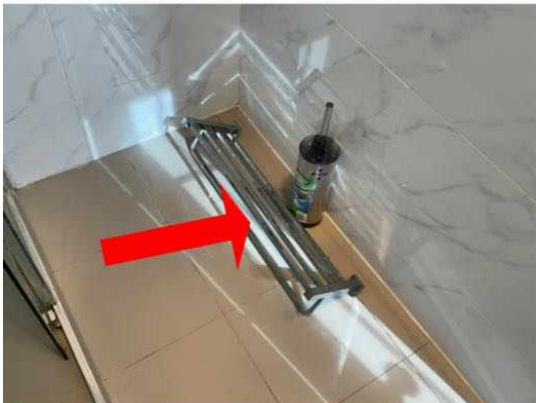
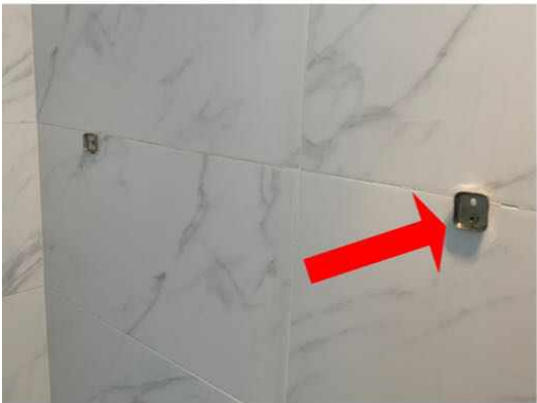
**Finding 3.09**

Building: Main Building  
Location: Ensuite > Ground Level  
Finding: Bathroom holders - Loose  
Information:

The bathroom holder was found to be loose at the time of inspection. While not a major operational defect, function can deteriorate if the problem is left unmanaged.

It is advised that the homeowner performs remedial works to re-attach the bathroom holder to its original fixing. A general handyperson may be required to perform these works.

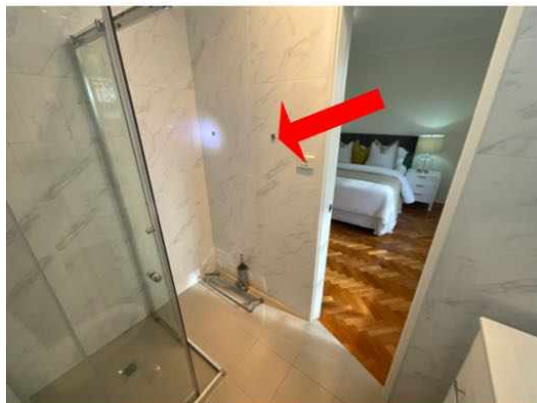
### Finding 3.10

Building:	Main Building
Location:	Ensuite > Ground Level
Finding:	Internal drains (vanity) - Blockages
Information:	Vanity drains throughout the property have blocked at the time of the inspection. Vanity drains are vital in removing the water in the vanity bowl and should be fully functional. Minor blockages create potential for the development of moisture damage over time.

All vanity drains should be assessed by the building contractor and cleared or replaced where applicable.

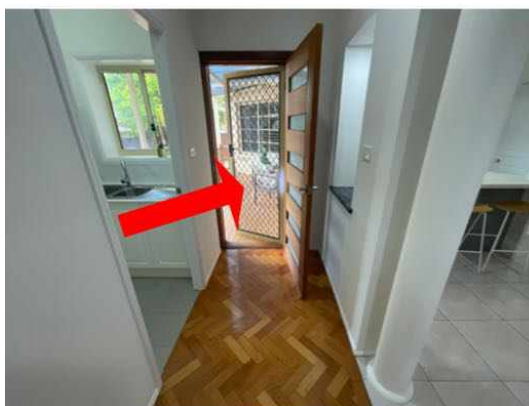
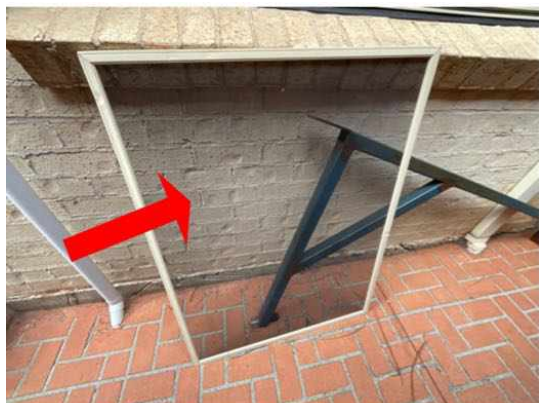
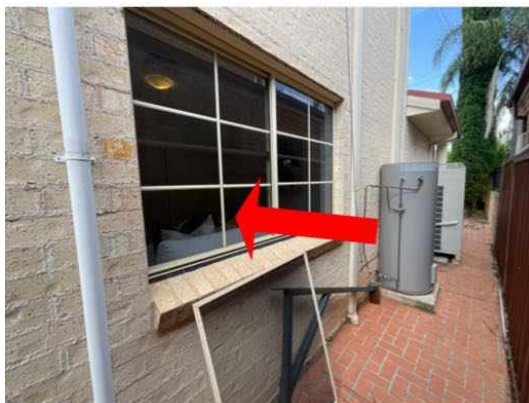
Finding: Flyscreens - Damaged

Information: Flyscreens were found to be damaged to the windows in this area at the time of inspection. This damaged building element detracts from the operational state of the window. Where not replaced, damaged flyscreens allow pest and insect ingress into the adjoining room/s. It is advised that all damaged building elements be replaced in order to ensure the full function of all building structures. A general handyperson may be appointed to replace flyscreens at the discretion of the client.

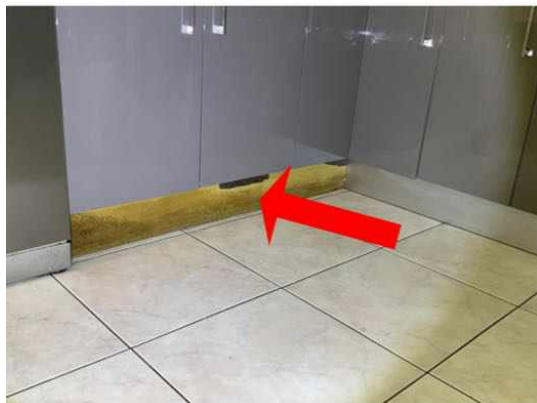
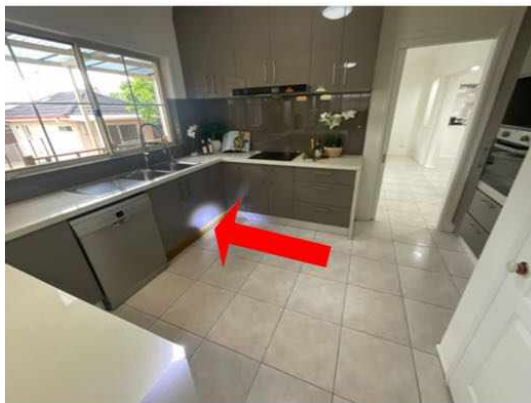
### Finding 3.14

Building:	Main Building
Location:	Kitchen
Finding:	Delamination of timbers
Information:	Delamination is one means by which composite materials (e.g. layered timber composites) may fail over time. In laminated materials, repeated cyclic stresses may lead to the formation of mini-structures of separate layers, with significant loss of mechanical toughness. Water penetration or the presence of excessive moisture also generally contributes to delamination.

Where building materials have become delaminated, they lose their structural strength, and are likely to have a variety of appearance and serviceability defects as a result.

Delamination of timbers may be repaired where the area affected is minor and/or easily accessible, by gluing and screwing layers back together. However, this is an interim repair, and where delamination has occurred, the client should plan for the replacement of affected timbers sooner than would otherwise be expected.

All timber structures affected by delamination should be replaced as soon as possible to avoid any further damage. Repair and replacement estimates should be sought from a registered builder or qualified carpenter.

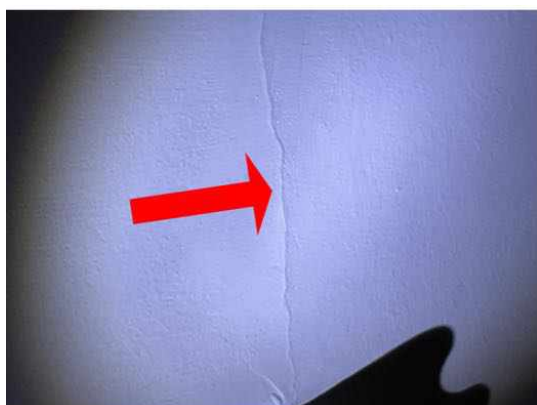
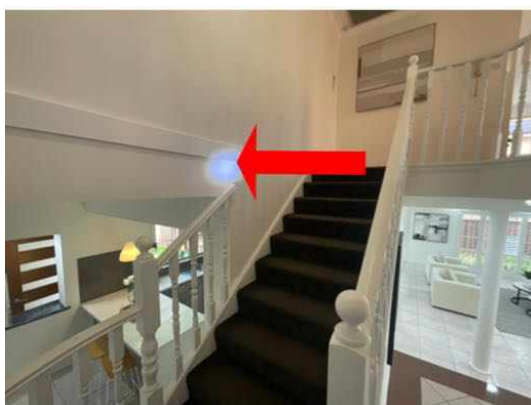
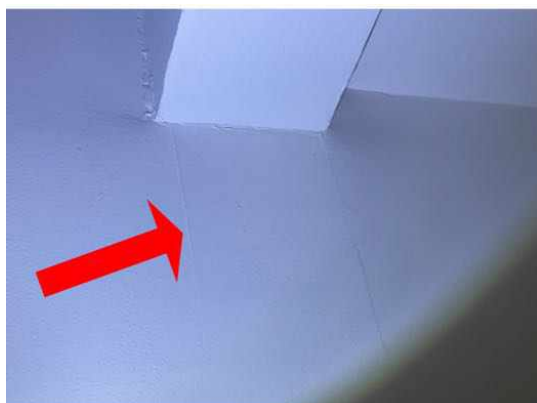
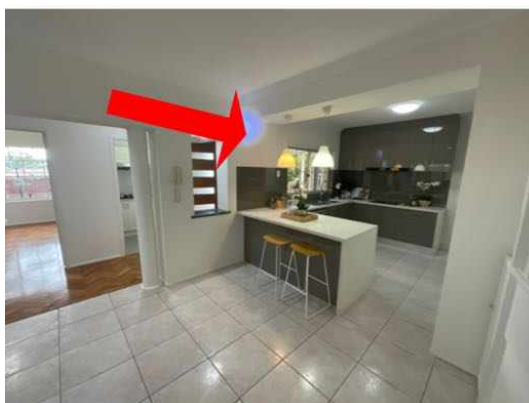
### Finding 3.15

Building:	Main Building
Location:	All Internal Areas
Finding:	Cracking - Damage Category 1 - Fine (up to 1mm)
Information:	Although fine cracks are quite noticeable, they are often only considered to be an appearance defect, and usually do not indicate any structural damage. Generally, the cause of a fine crack is indicative of a separation between building materials and finishes (e.g. paint, plaster, etc.) along joins.

Cracking of this nature can generally be repaired with minor sanding, filling and/or repainting. Such works should be performed by a qualified painter or a general handyman.

Monitoring of all cracking should be conducted frequently. Always contact a building inspector should cracks widen, lengthen, or become more numerous.

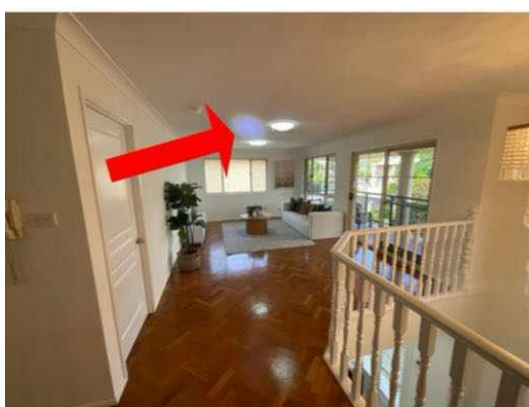
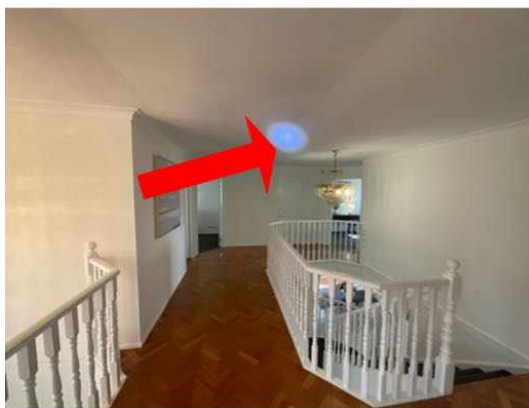
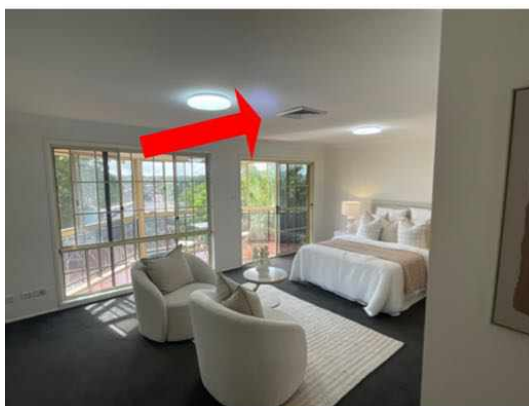
### Finding 3.16

Information: Sections of the ceiling were found to be sagging at the time of inspection. Sagging to the fixed ceiling structure generally indicates that the building materials have swollen, due to contact with water, or that fixings (e.g. nails or glue) have become loose and require reattachment.

In some cases, sagging ceiling linings may also indicate that there are structural issues, causing surfaces to warp, twist or sag. Where sagging appears to be major, appointment of a structural engineer is advised to further inspect the property and identify the source and rectification works required.

Where minor sagging is evident, comparatively minor works, such as re-gluing of ceiling sheets, may be required. Such works may be performed by relevant tradespeople, such as plasterers and painters. Where excessive moisture has caused the roofing structure to swell and sag, the source of the water leak should primarily be identified prior to any remedial works being performed.

The appropriate action should be taken by the client as soon as possible to ensure that any potential further damage is limited.

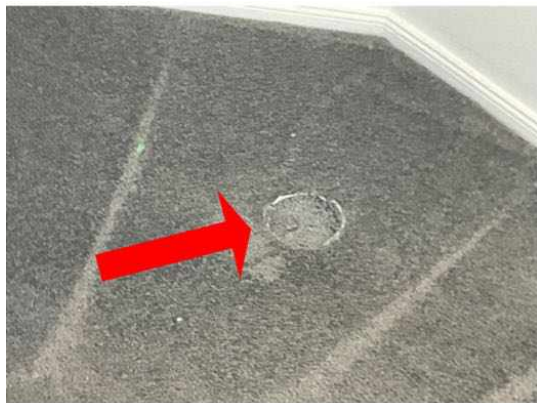
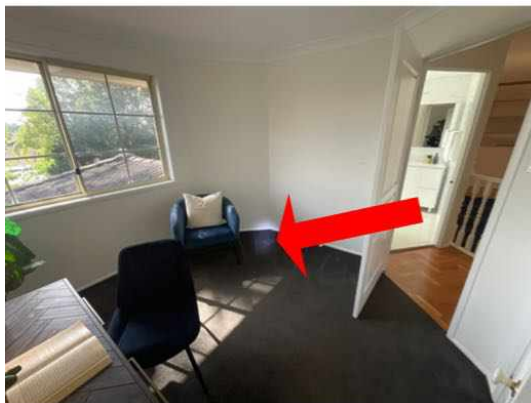
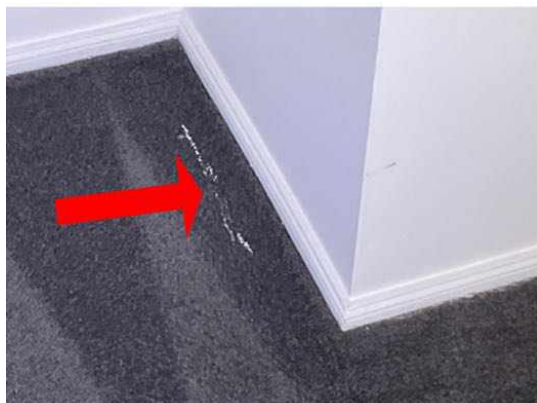
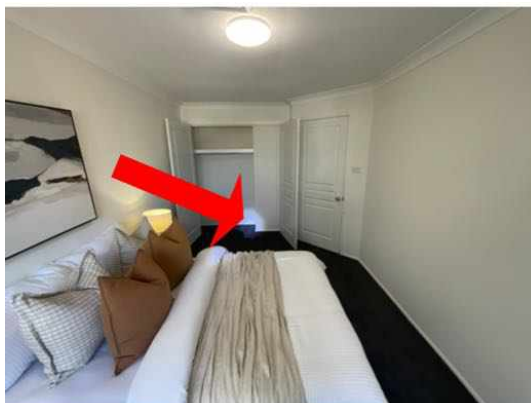
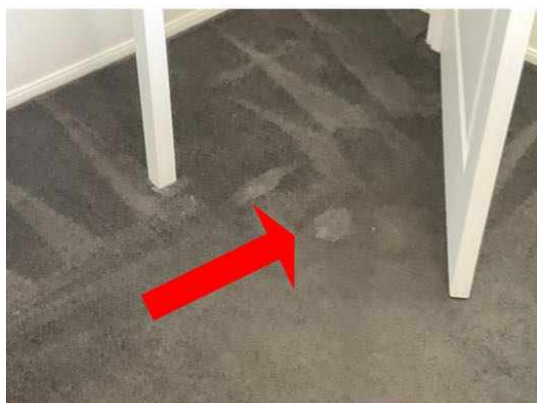
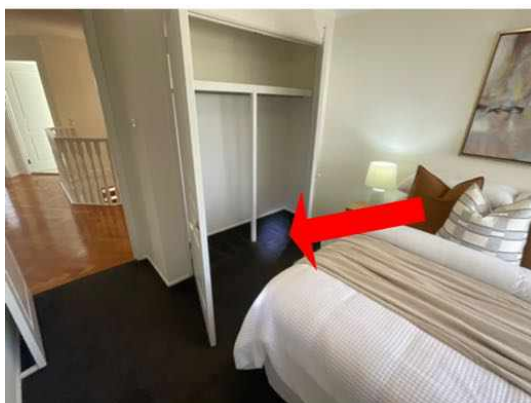
### Finding 3.17

Building:	Main Building
Location:	All Internal Areas > Upstairs
Finding:	Carpet - Deteriorated
Information:	Sections of the carpet floor covering in this area appeared to be mouldy. It is suspected that the presence of excessive moisture, possibly due to an internal water leak, has created an environment conducive to mould/fungi growth.

Mould presents as a health hazard and may create potential for respiratory difficulties.

Prior to any remedial works being completed, it is essential that a licensed plumber further inspect the area and identify the cause of the excessive moisture, as well as identifying any underlying issues that may be associated.

Replacement of the affected carpet is required as a matter of urgency to ensure the safety of the area. Where required, remedial works should be undertaken to any associated walls and flooring showing evidence of mould.

Where mould is excessive, further inspection by an Environmental Health inspector is advisable.

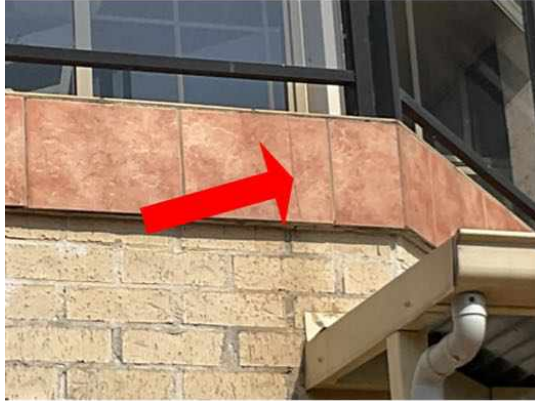
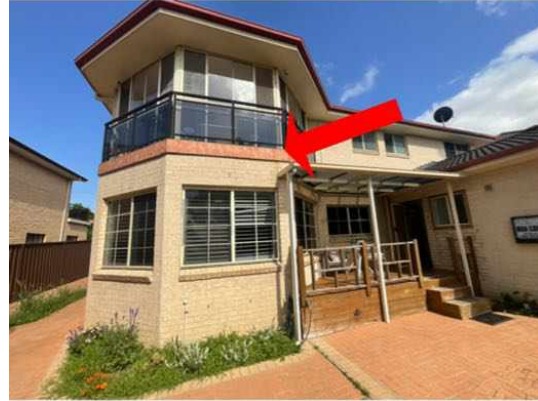
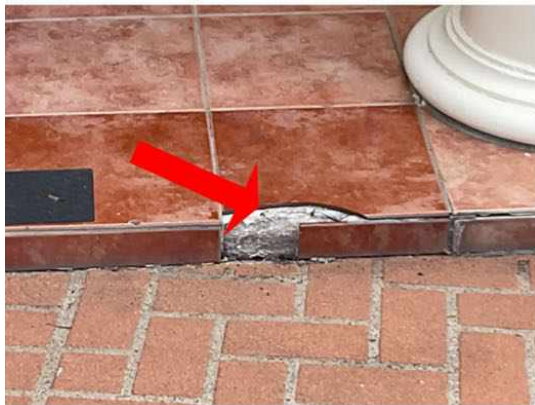
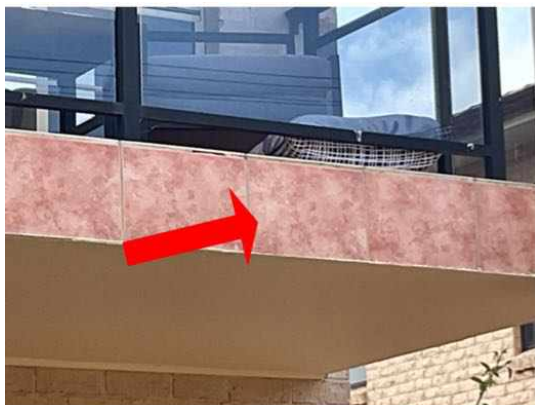
### Finding 3.18

Building:	Main Building
Location:	All External Areas
Finding:	Tiles - Cracked or damaged
Information:	Cracking was evident to the tiling in this area at the time of inspection. While the cracking appears to be minor, this area is frequently exposed to water, allowing potential for water penetration into adjoining sections of walls or flooring.

If left unmanaged, water penetration to these areas may lead to subsequent water damage, which is likely necessitate repair work to affected building elements.

A tiling contractor should be appointed to ensure that no further water damage

occurs. The re-application of silicone and grouting throughout remaining tile work is also advised, to further protect the area against water penetration.

Where water penetration has led to water damage, appointment of a relevant tradesperson may be required to repair damaged building elements.

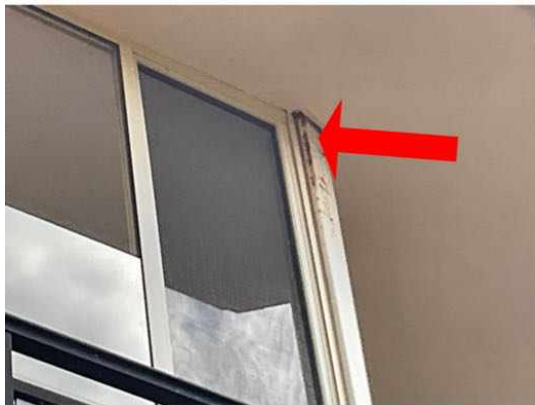
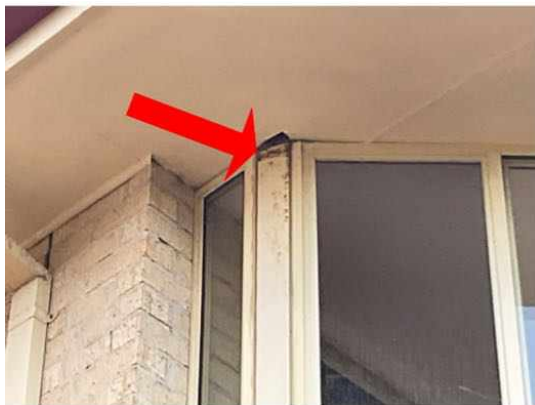
### Finding 3.19

Building:	Main Building
Location:	All External Areas
Finding:	Building element - Rusted or corroded
Information:	This building element shows evidence of rusting and corrosion, which is likely to have

developed as a result of excessive exposure to moisture and or inadequate coatings.

As surface rust provides no protection to the underlying iron, the deteriorating condition is likely to worsen if not addressed in the short-term future.

Where possible, the use of galvanized (treated) metals or aluminium coated metals aid in rust prevention, as does regular general maintenance. Rust formation can be controlled with coatings, such as paint, that isolate the iron from the environment.

Rusting and corrosion should be managed by ideally removing or limiting the affected surface from exposure to moisture. A registered builder may be appointed to replace any building elements that have been severely affected by rust or water damage.

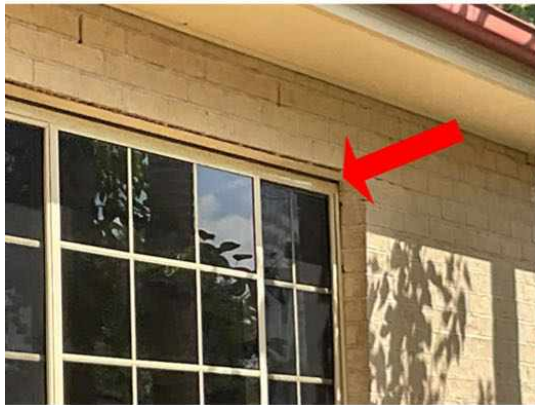
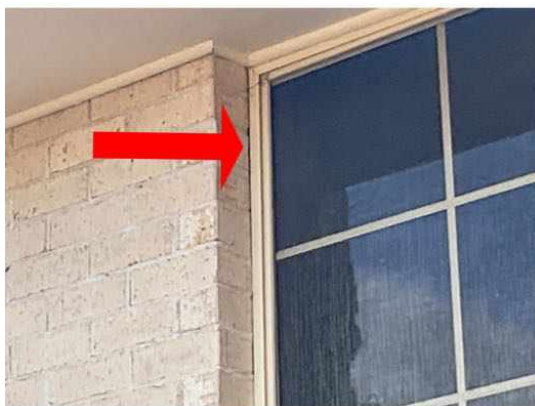
### Finding 3.20

Building:	Main Building
Location:	All External Areas
Finding:	Window - Gap
Information:	A significant gap was identified between the brick and window frame in this area. Where large gaps to the head appear, it may indicative of a variety of defects, ranging from uneven framework, sagging hinges or uneven flooring.

A gap to the head of the window may also indicate movement of the foundation of the property, which is a common occurrence and does not indicate structural damage.

A qualified tradesmen should be appointed to perform remedial works to restore the window to a fully operational level.

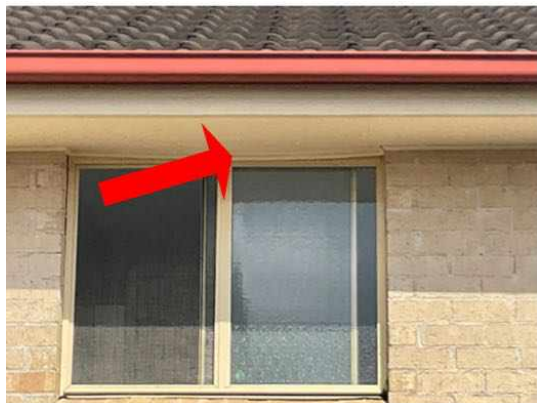
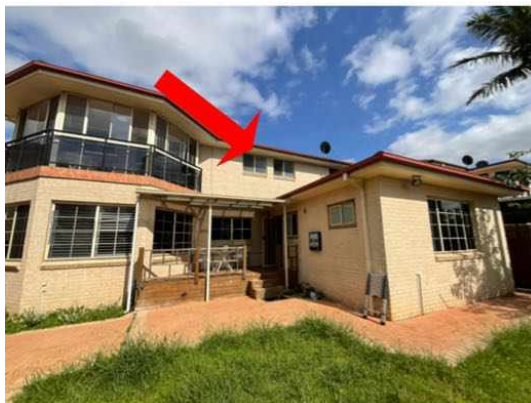
### Finding 3.21

Building:	Main Building
Location:	All External Areas
Finding:	Beads - damage
Information:	Where beading (also known as 'quad') are damaged from the eaves It was noted at the time of inspection that beading in this area has deteriorated. Beading is important in weatherproofing the surrounding building elements and preventing termite or pest ingress. Furthermore, beading works to protect the joints of building materials, which are more susceptible to deterioration and decay. Repair or replacement of the beading is advised to ensure the protection and longevity of any associated building elements. Such works may be performed by a general handyperson or qualified carpenter.

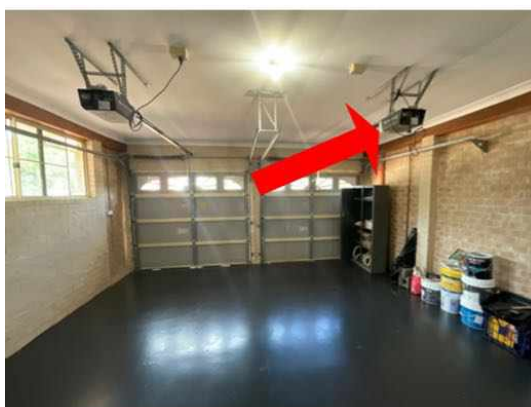
### Finding 3.22

Building:	Main Building
Location:	Garage
Finding:	Garage Door - Motor is not working
Information:	The garage roller door has a number of marks and dents likely to have resulted from impact damage be it accidental or deliberate impact at sometime.

Garage roller doors can fail when the building materials have aged but may be indicative of impact damage (accidental or deliberate). While superficial markings detract from the aesthetics of the building element, the functionality has not been hindered in any way.

Repair and/or replacement of the two garage doors would improve the condition of the garage but certainly not an urgent item

A qualified roller door installer or supplier should be engaged to check out the operation and overall condition of the doors to determine if repair is an option otherwise replacement may need to be considered.

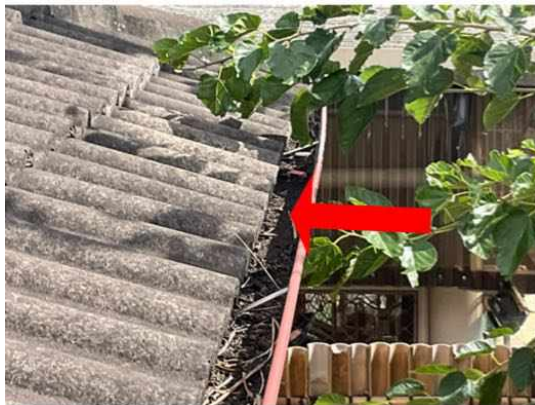
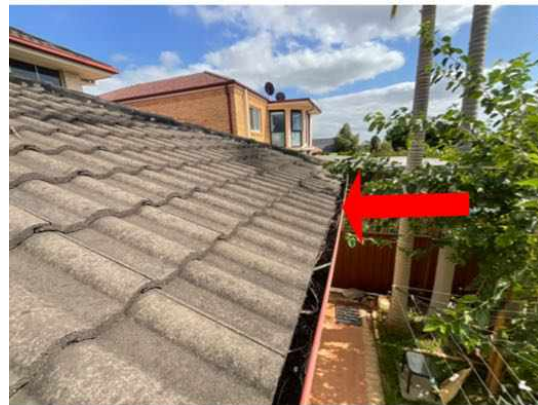
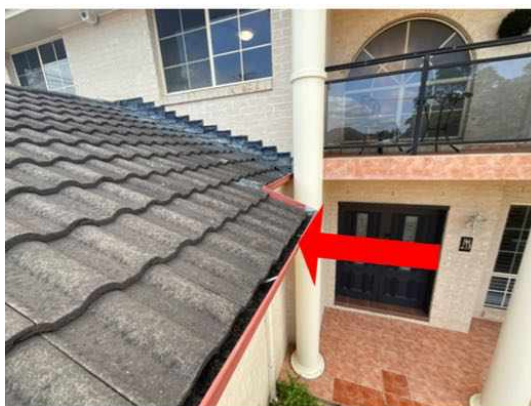
Blocked gutters are likely to lead to high levels of moisture in the affected areas. Such moisture will not only cause rust and decay of the associated building materials, but can also provide conditions that are conducive to termite and timber pest activity. Blockages in gutters should therefore be removed immediately to ensure dry conditions are maintained.

Consult a Licensed Plumber for further specific advice on remedial works that may be required. In the interim, it is highly advised that blocked gutters be removed by the homeowner or a general handyperson as a matter of urgency.

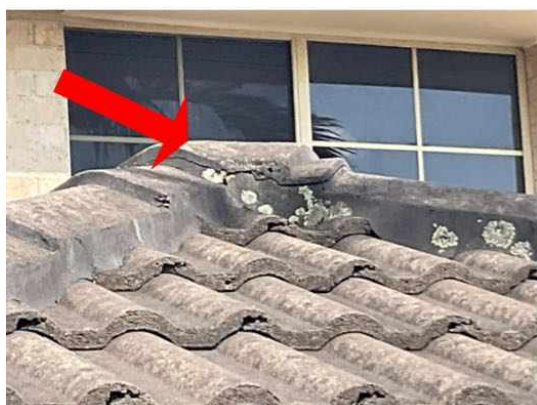
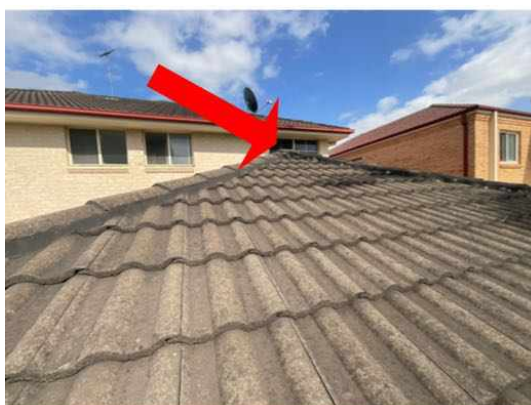
**Finding 3.24**

Building: Main Building  
 Location: Roof Exterior  
 Finding: Mortar - Deterioration  
 Information: Mortar, or 'bedding', is the material which fills joints and intersections between tiles and other building elements on the exterior roof covering, such as gable ends, hip capping and valleys. Upon inspection of the exterior roof, it was noted that sections of the mortar show varying levels of deterioration.

Mortar generally deteriorates as a result of frequent exposure to weather conditions over a prolonged period of time. Mortar that is deteriorating may allow water ingress into the roof void, putting associated building elements and roofing structures at risk of water damage. Deteriorated mortar also detracts from the functionality of roof tiles and other roofing elements, potentially decreasing weather tightness and roof drainage.

Mortar deterioration can be attended to by a handyperson where areas of deterioration are localised and easily accessible. Otherwise, consultation with a roofing contractor is advised where greater works are required.

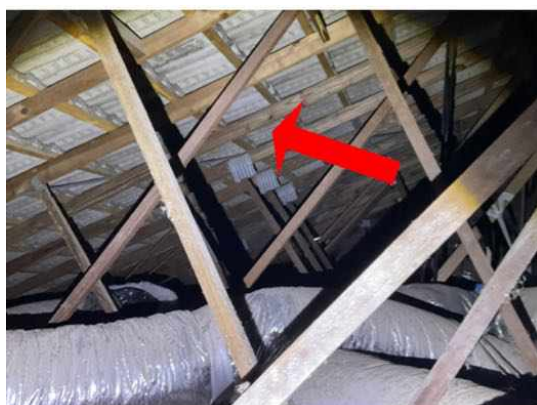
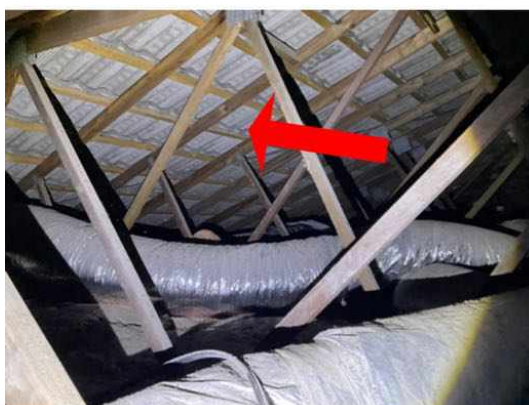
**Finding 3.25**

Building: Main Building  
 Location: Roof Void

Finding: Sarking - Missing  
 Information: Sarking is missing under the roof sheeting. Sarking acts as an insulator that helps with noise reduction and protects against water penetration. Sarking plays a key role in the operation and function of the overall roofing structure and its performance.

Although not a requirement at the time of construction, replacement of any missing building element is advisable (although this can be quite expensive to do after the time of construction). Where sarking is missing, regular inspections of the roof tiles for cracking and potential moisture penetration is required.

Sarking may be retrospectively fitted by a registered builder at the discretion of the client.

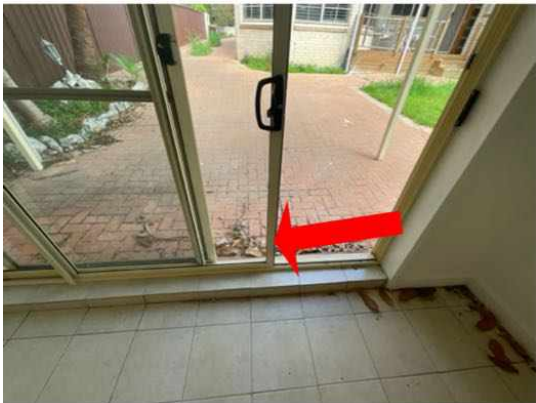
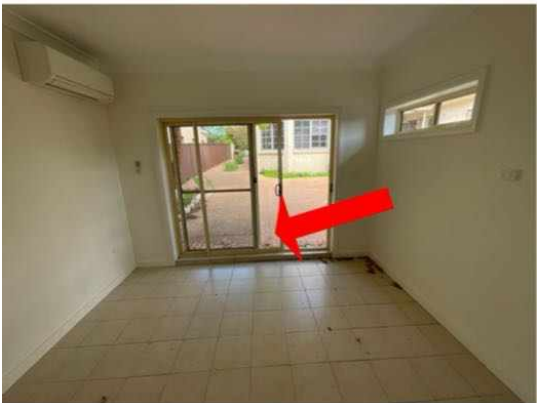
### Finding 3.26

Building: Out Building  
 Location: All External Areas  
 Finding: Door - Stiff to slide  
 Information: The door in this area was jammed and difficult to slide along the associated tracks at the time of the inspection. Restricted function of the affected door may pose as a potential safety hazard if required for emergency egress from the building.

Generally, factors such as general age of the building element and a lack of maintenance are the usual causes for this type of defect.

Replacement of door hardware or tracks may be required, as well as minor repairs and cleaning. A registered builder or general handy person will be required to repair the affected doors.
