# Building and Timber Pest Inspection Report

Inspection Date: Thu, 29 Jan 2026

Property Address: 211 Woods Rd, Yagoona NSW 2199,  
Australia

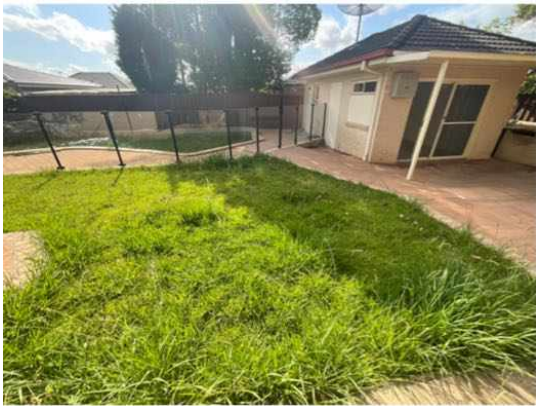
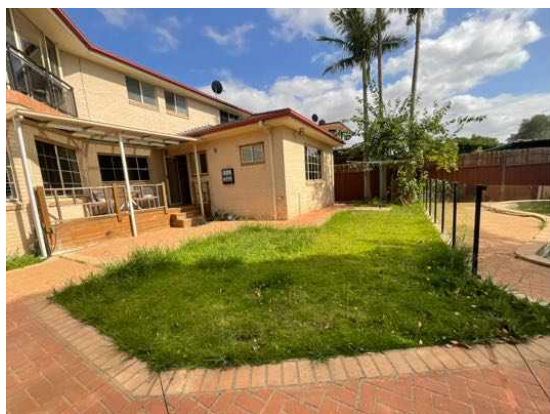
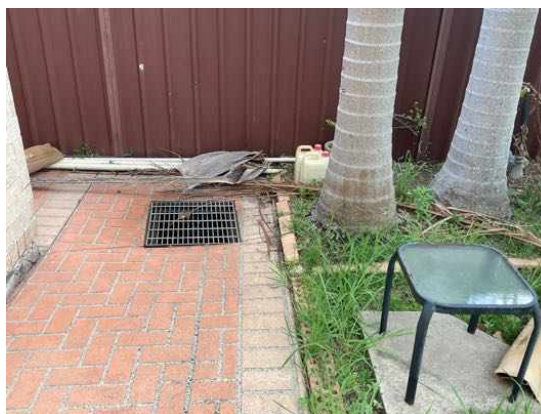
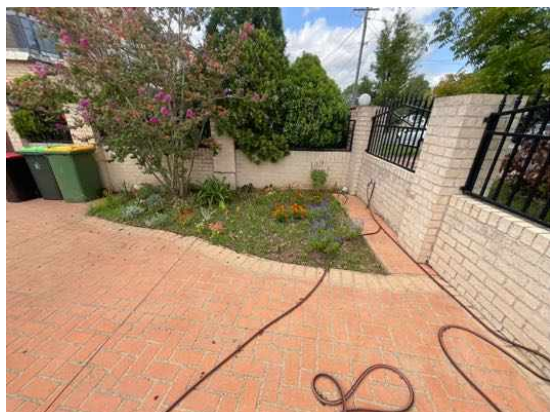
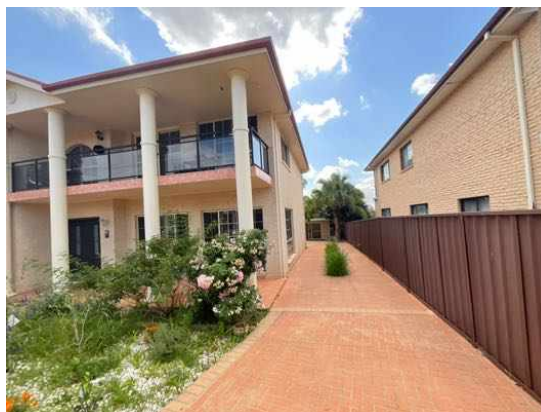
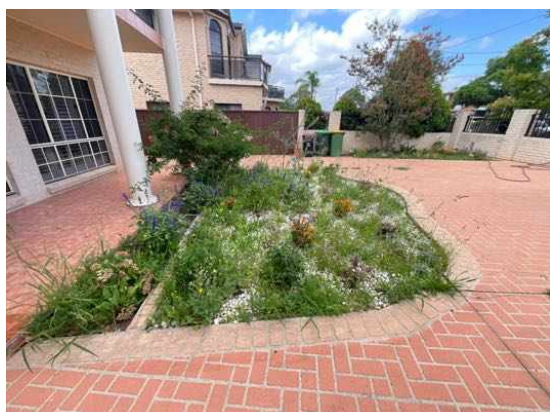
**Finding 6.01**

Building: Main Building  
 Location: All Areas  
 Finding: Garden Beds - Conditions Conducive to Termites  
 Information: Garden beds were found to be evident in the garden area. These garden beds can include untreated timber, and with a combination of moisture from watering hosing can make conditions conducive to termite activity and termite ingress.

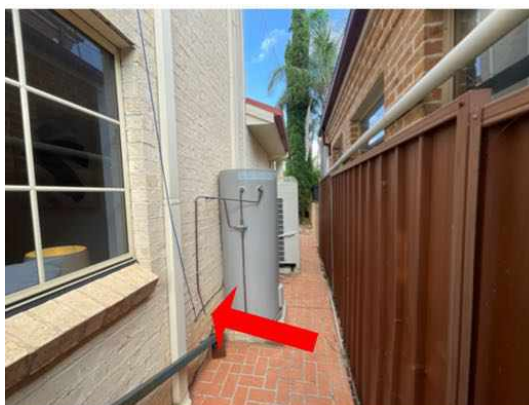
## Finding 6.02

Building:	Main Building
Location:	All Areas
Finding:	HWS Overflow - Not Connected
Information:	The Hot Water System (HWS) overflow was found to be disconnected from storm water drainage and is creating excessive moisture in the surrounding area.

These damp conditions can lead to secondary defects such as rot, rust or corrosion of associated building elements, the formation of fungal decay, or even the creation of potential slip hazards. When coupled with poor site drainage, pooling of water may also attract termite activity to this area.

It is highly recommended that a licensed plumber be appointed to connect the HWS overflow in order to prevent such an environment from being created. These minor works should be carried out as soon as possible.

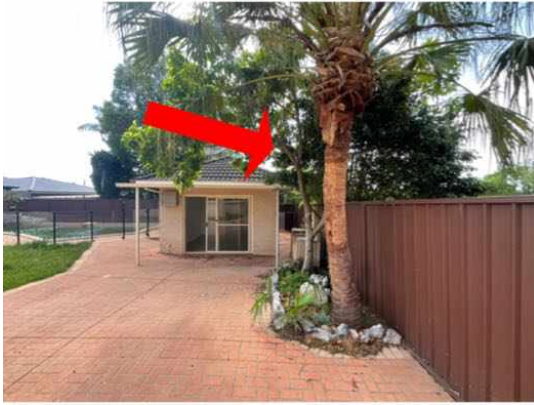
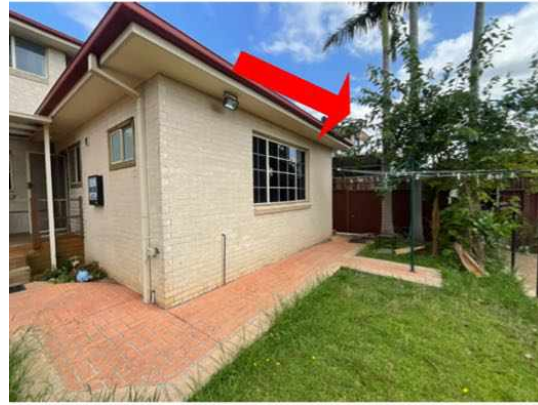
### Finding 6.03

Building:	Main Building
Location:	All Areas
Finding:	Trees - Overhanging and filling gutters
Information:	Overhanging trees often result in excessive amounts of leaf debris accumulating in gutters.

Gutters are a critical part of the building's management of storm water and rain. It is therefore important that they be kept clear to prevent secondary damage to associated building elements, including exterior and interior walls, ceiling linings and any adjoining building elements. Where gutters are blocked, pooling of rainwater is likely to occur, fast-tracking rust and corrosion of the roof plumbing elements.

It is highly advised that all overhanging tree branches be removed as soon as possible to prevent any further damage. Repair and/or replacement of sections of damaged guttering may also be required where the extent of the damage necessitates.

Such works should be performed by the homeowner; however, appointment of a landscape contractor or an arborist may be required. Consultation with a licensed roof plumber is required where guttering has been damaged.

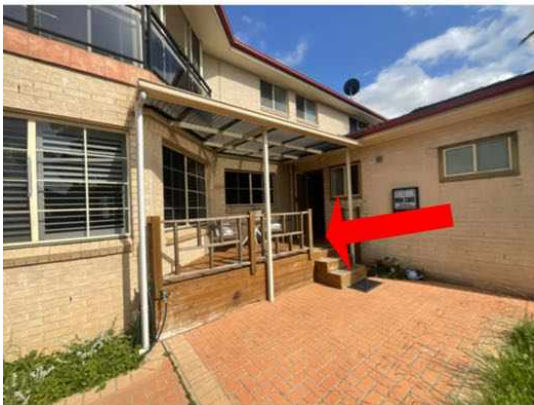
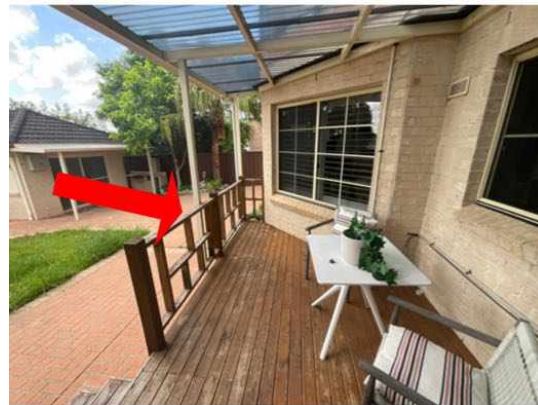
### Finding 6.04

Building:	Main Building
Location:	All Areas
Finding:	Timber - exposed to weather
Information:	External timbers that are frequently exposed to harsh weather conditions require adequate protection in order to maintain their condition. Where timbers have not been painted or treated adequately, general deterioration is likely to occur at an accelerated rate.

If left unattended, replacement of these timbers is likely to be necessary in the short-term future. Adequate treatment of these timbers is required as soon as possible by a painting contractor or general handyman.

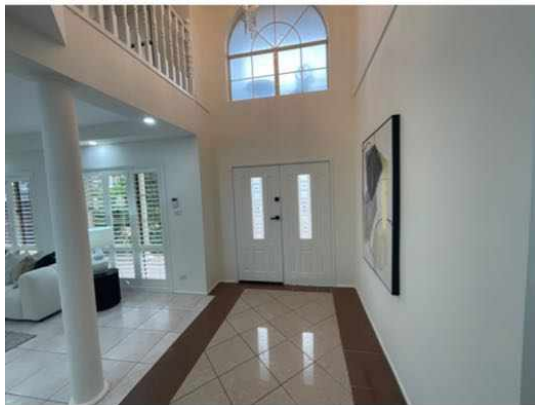
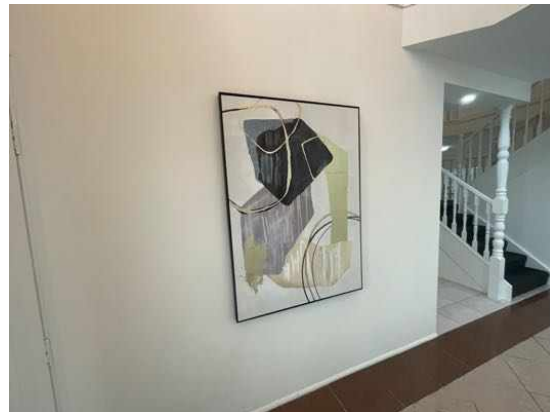
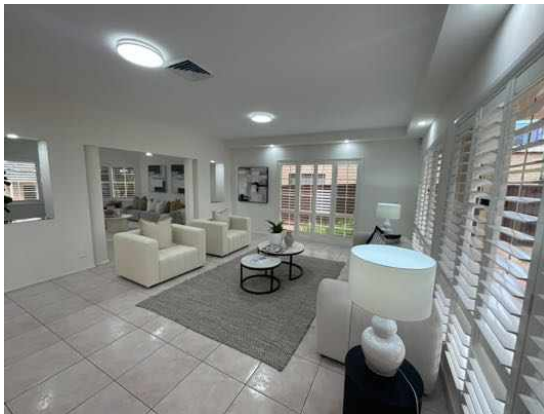
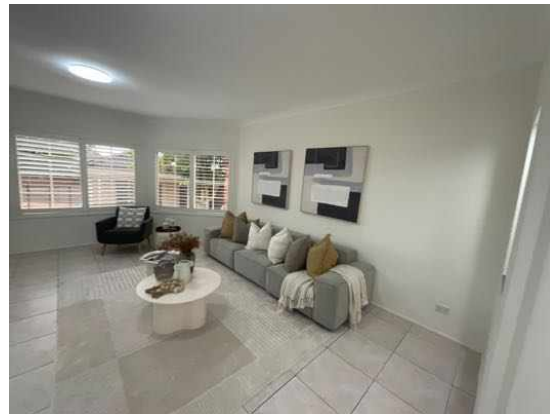
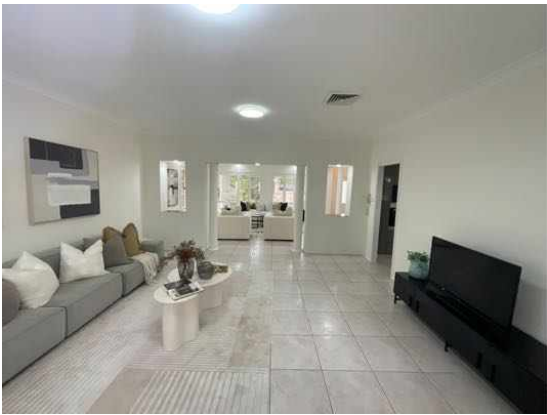
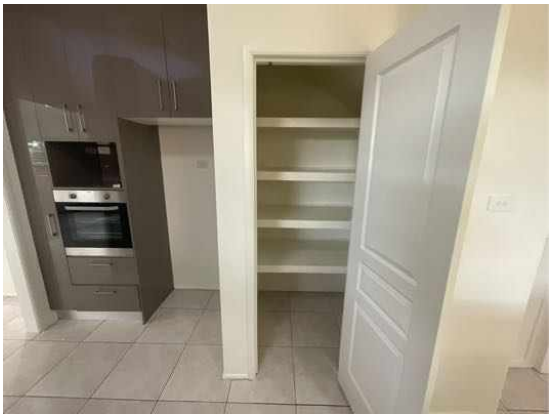
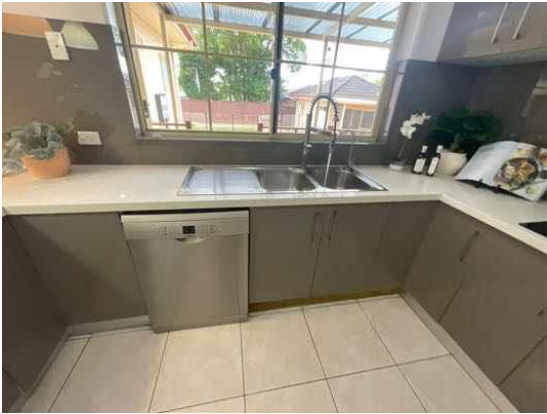
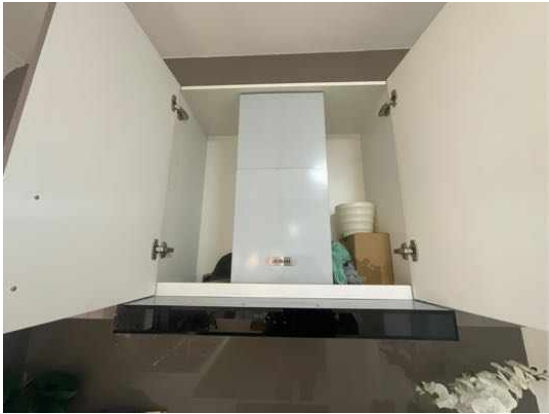
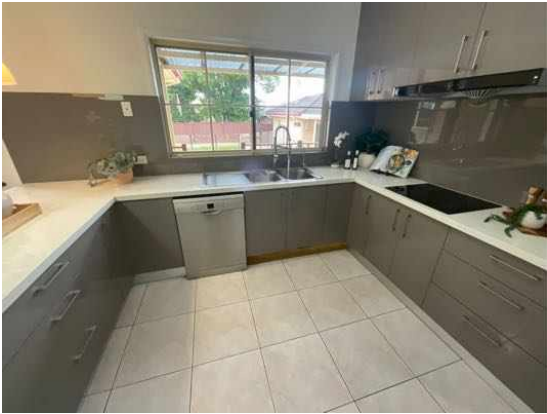
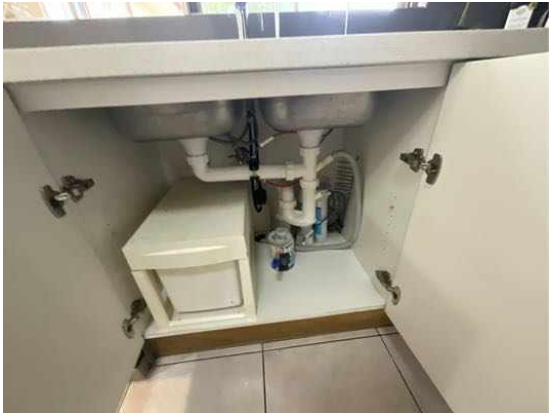
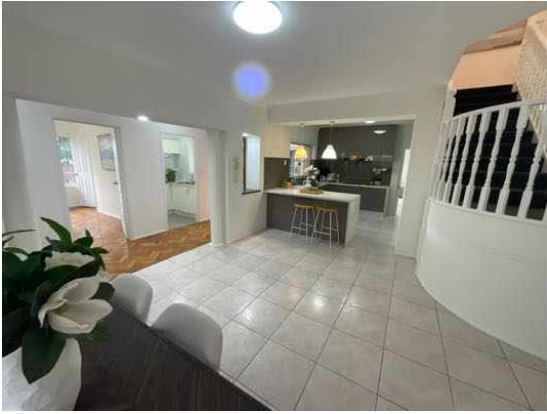
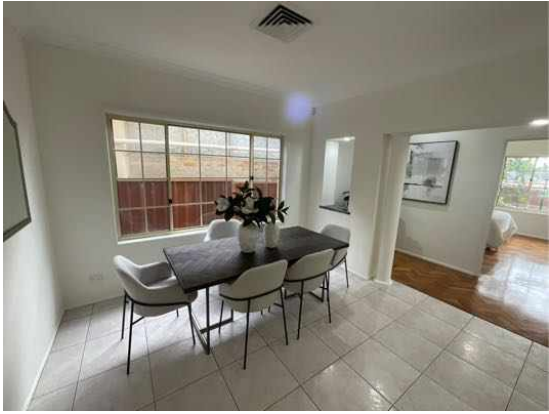
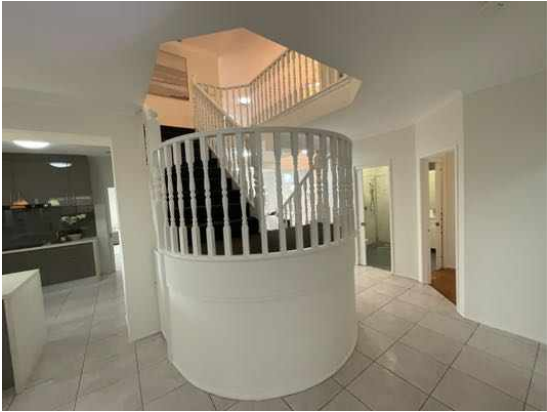
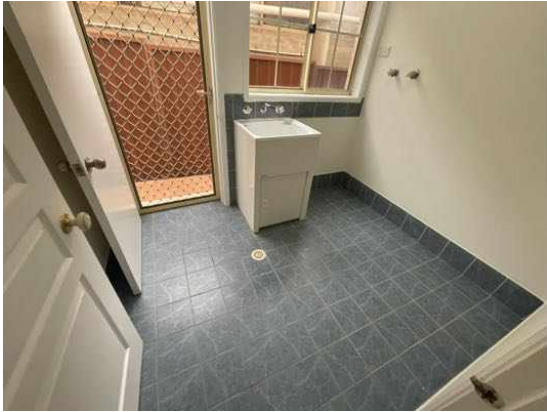
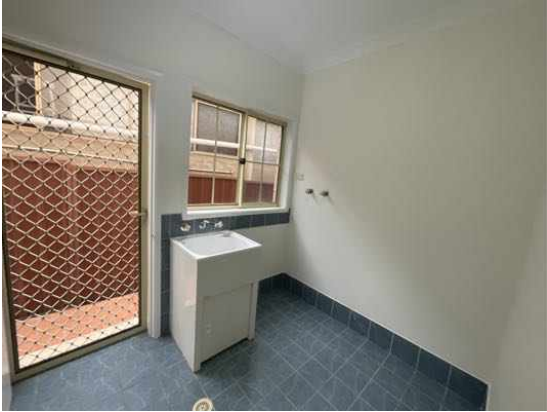
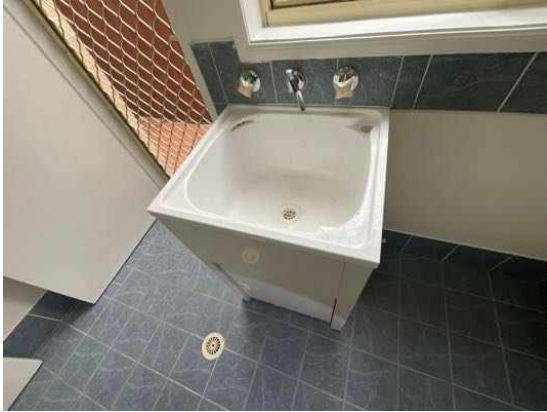
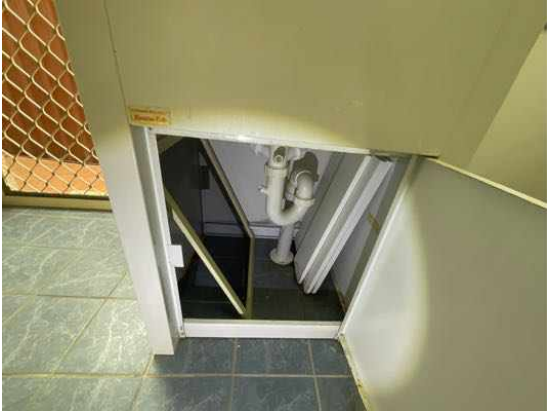
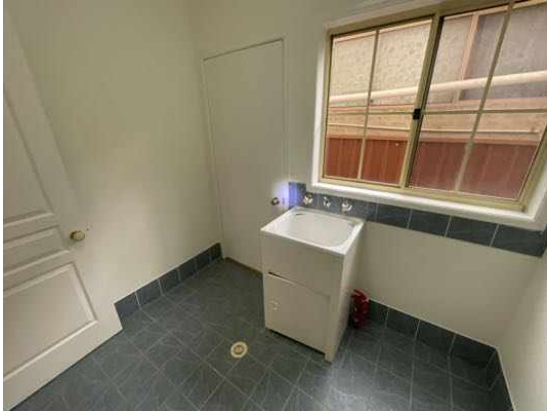
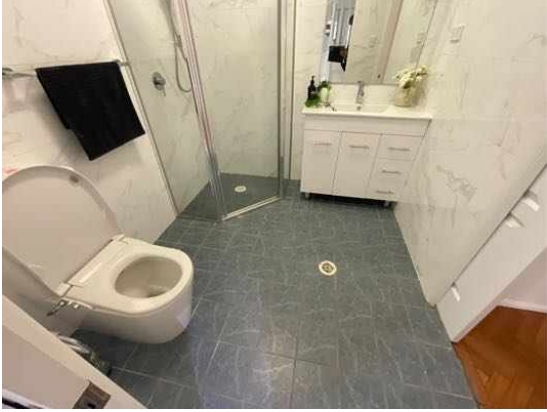
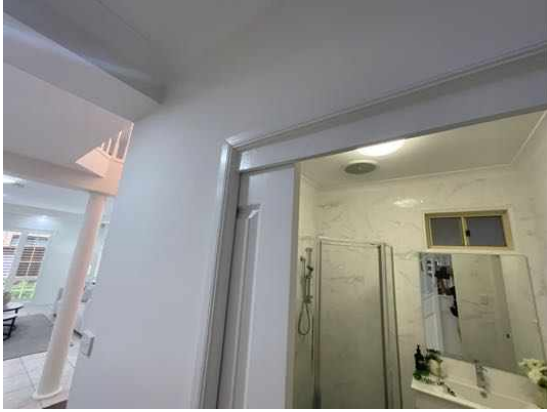
### Noted Item

Building: Main Building  
Location: All Areas  
Finding: Additional Photos - Obstructions and Limitations  
Information: These photographs are an indication of the obstructions and limitations which impeded full inspection of the property at the time of inspection. These obstructions can hide an array of defects and should be removed to allow full inspection to be carried out. A re-inspection is recommended once the areas are made accessible.

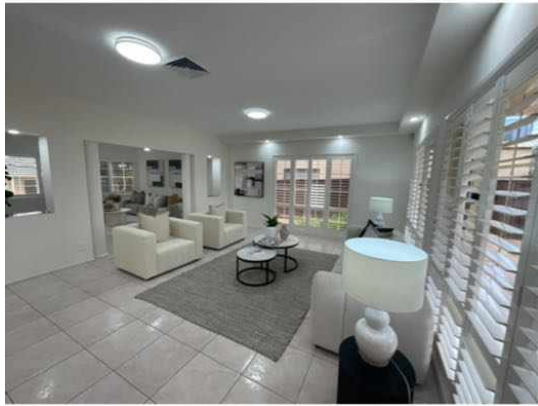
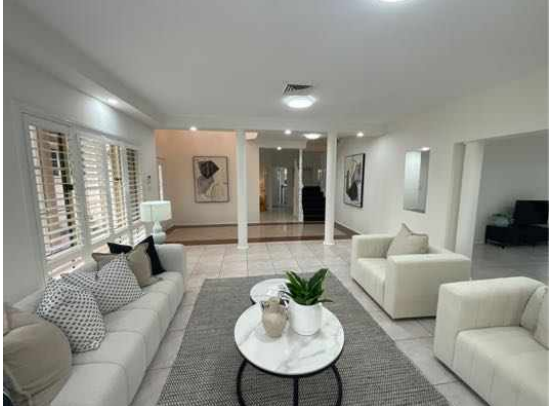
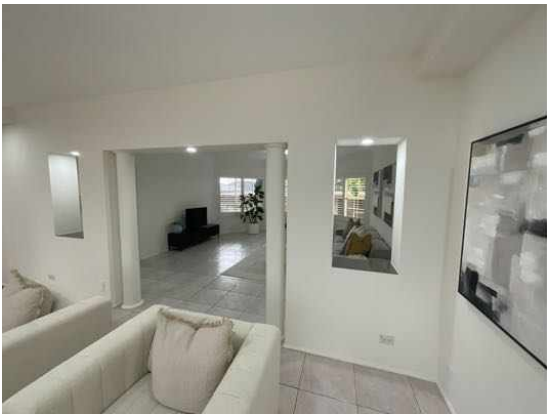
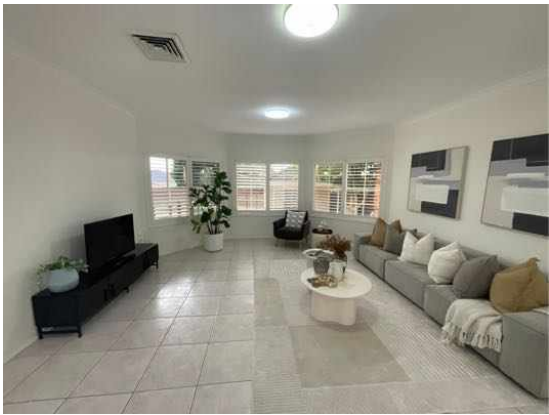
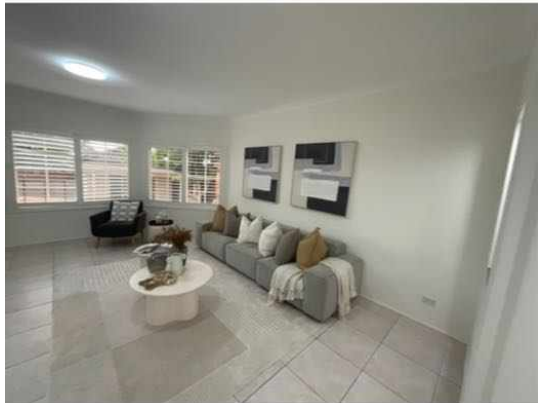
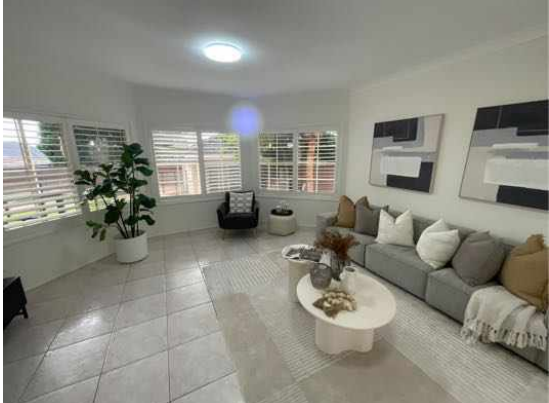
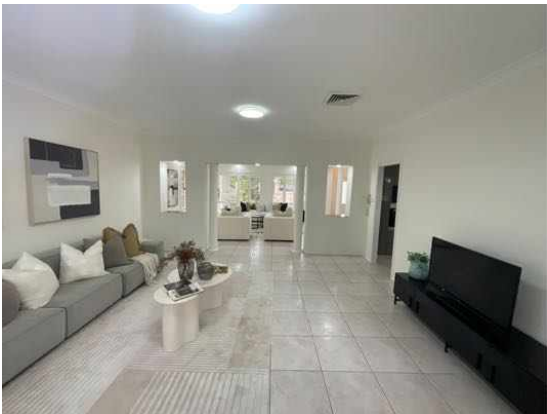
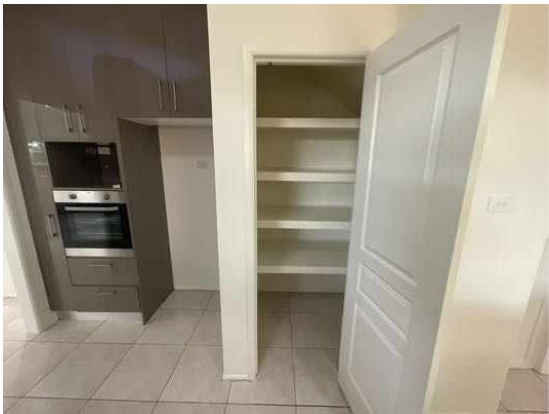
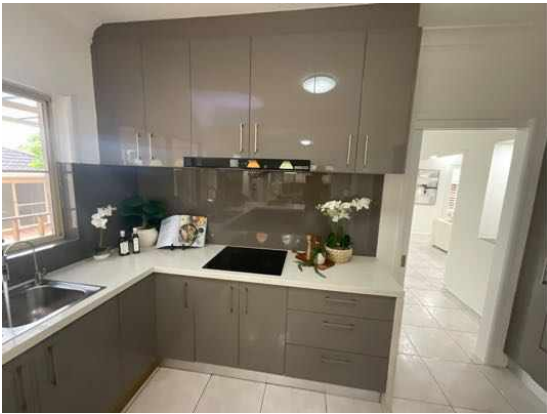
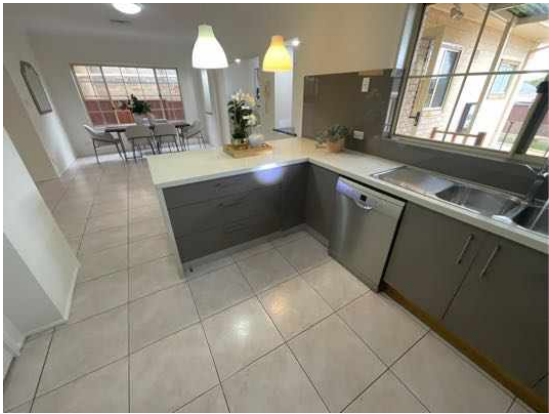
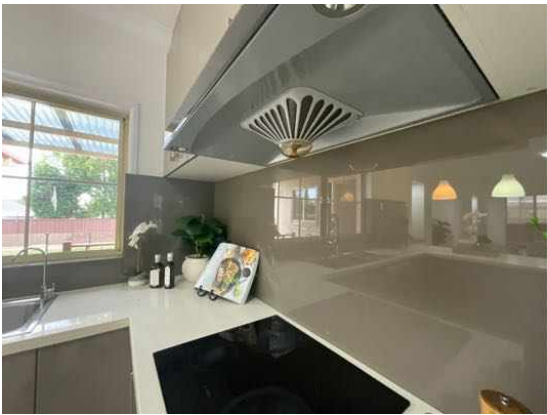
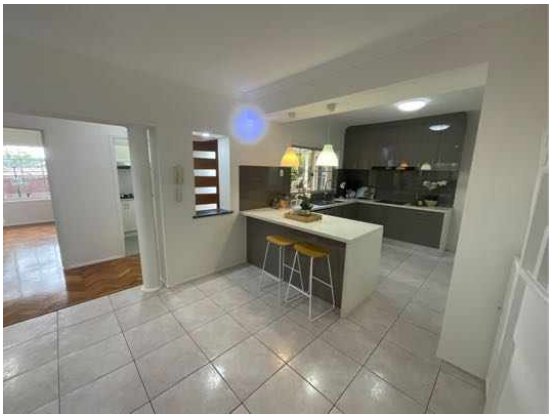
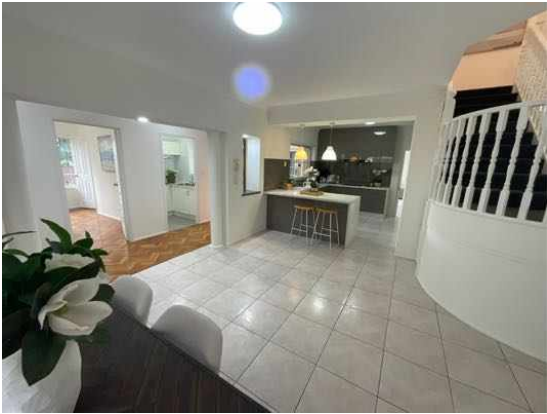
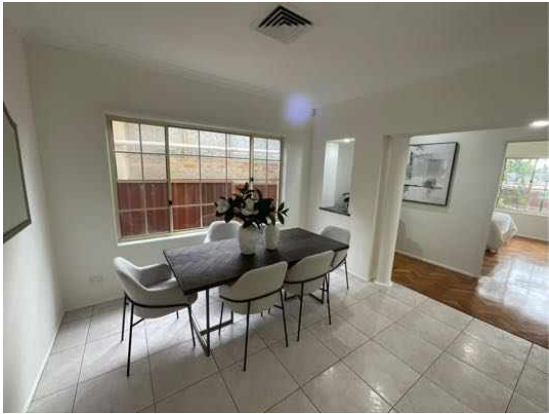
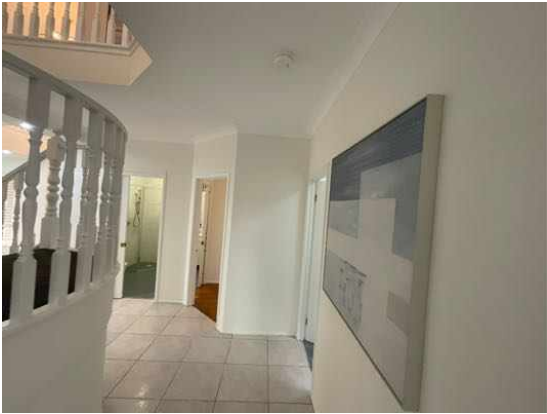
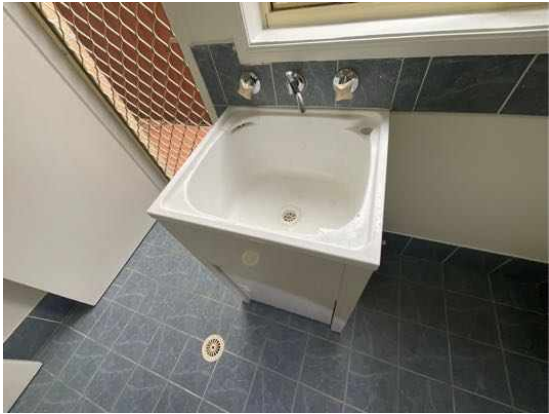
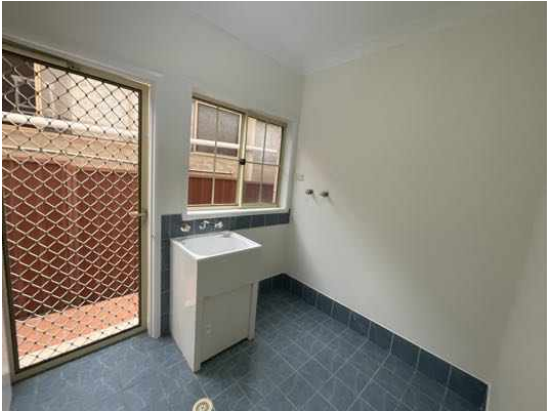
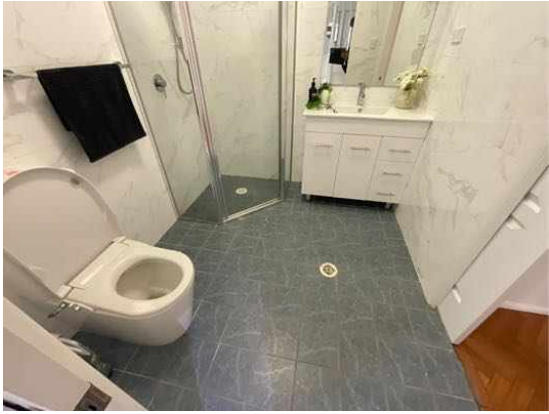
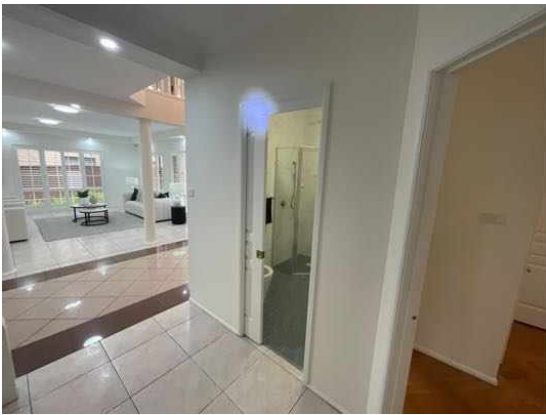
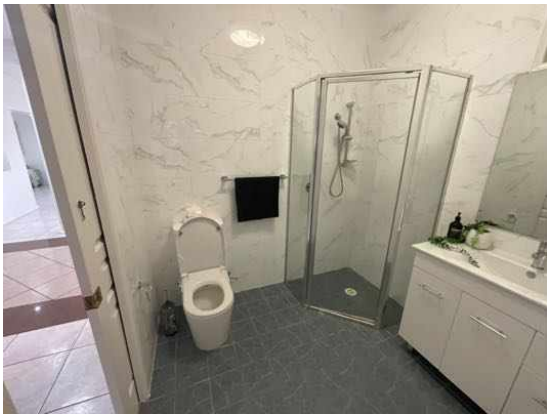
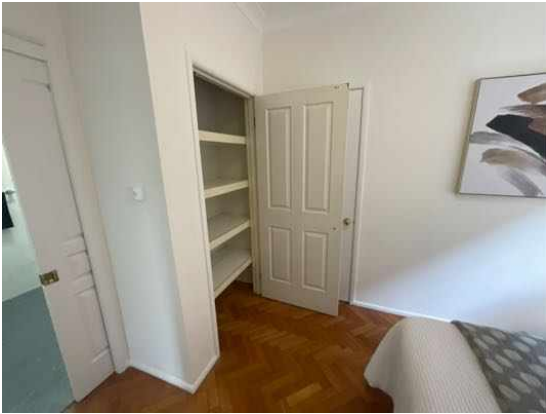
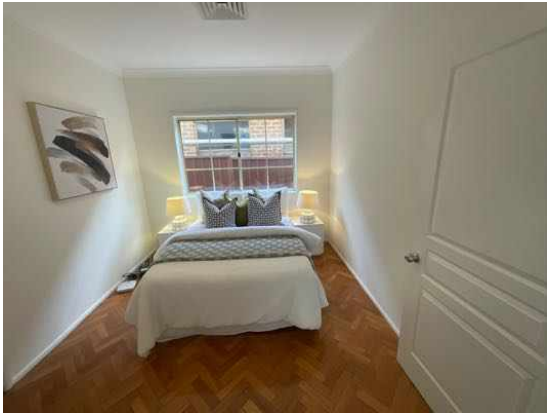
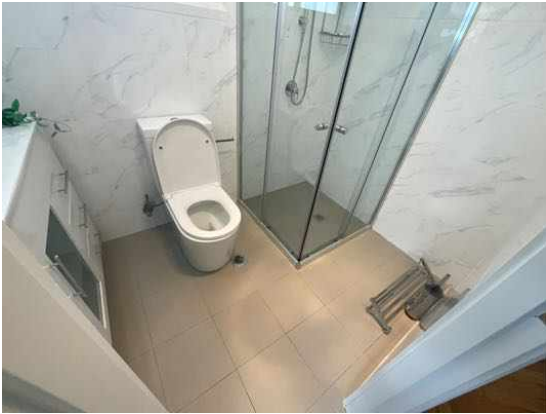
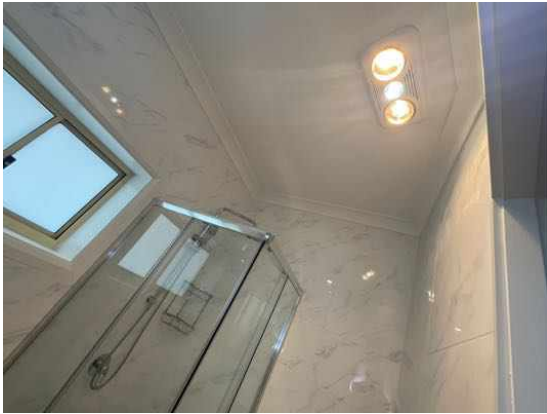
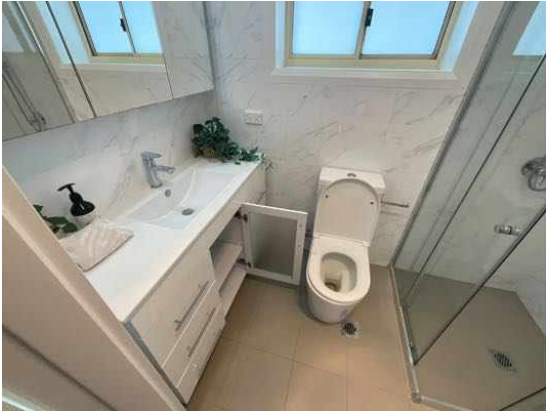
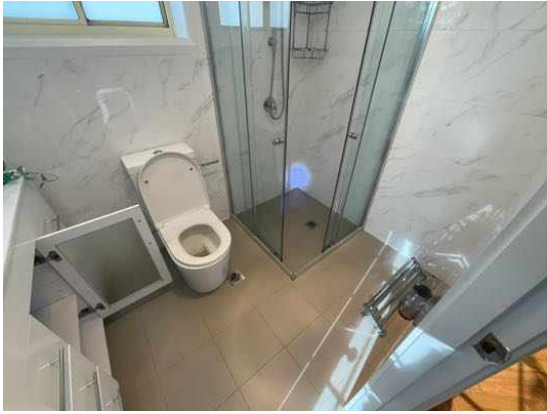
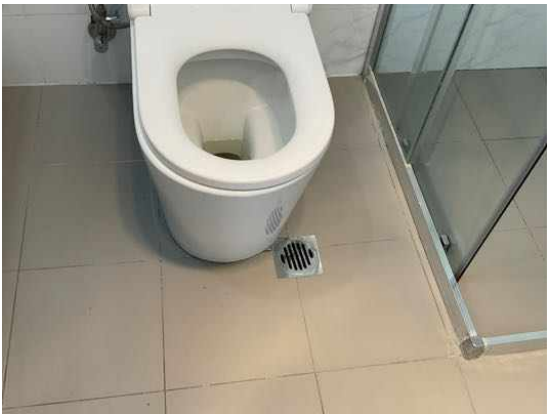
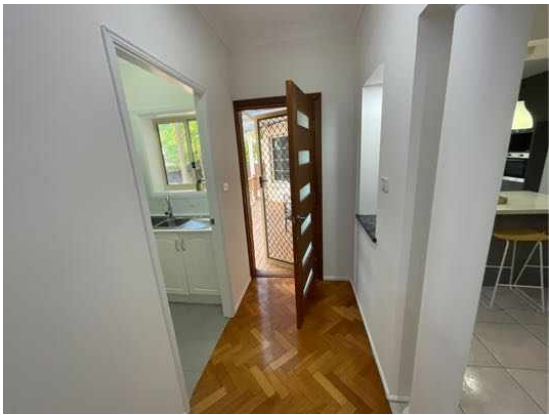
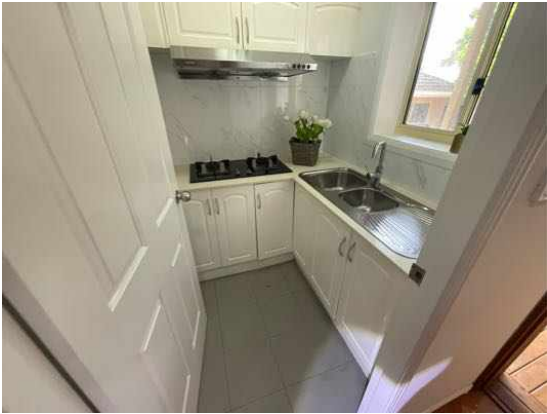
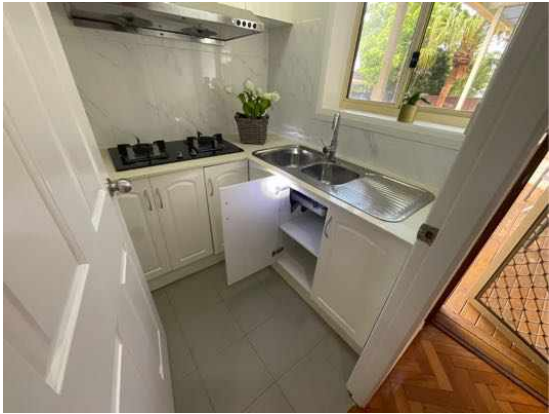
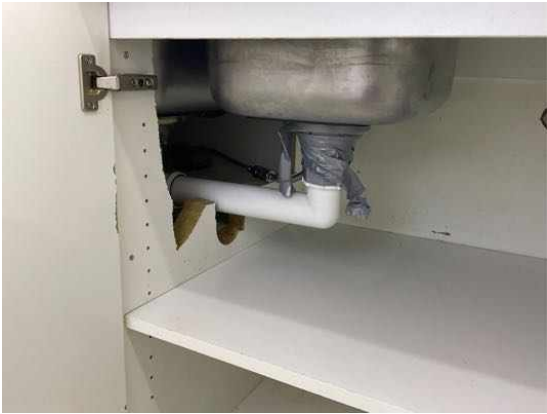
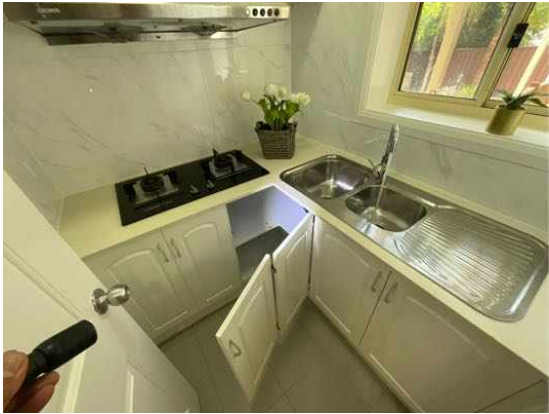
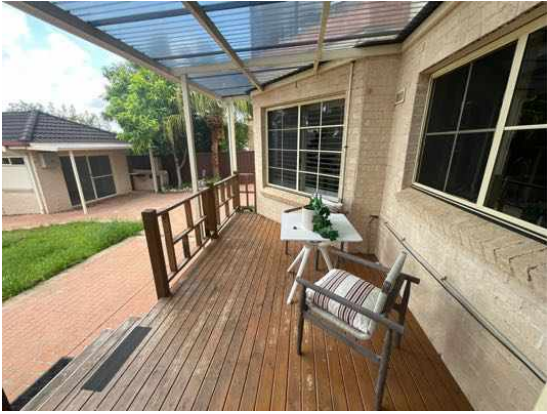
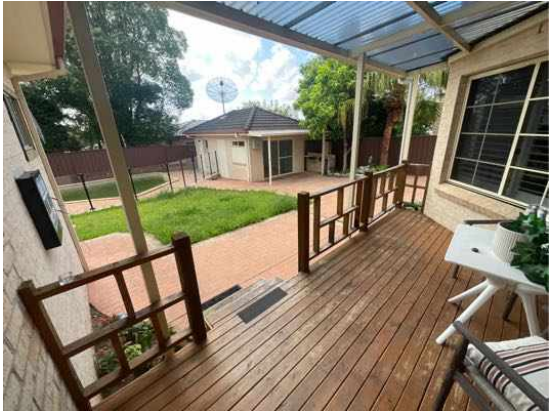
Building: Main Building  
Location: All Areas  
Finding: Additional Photos  
Information: Additional photos are provided for your general reference
