# Building and Timber Pest Inspection Report

Inspection Date: Thu, 29 Jan 2026

Property Address: 211 Woods Rd, Yagoona NSW 2199,  
Australia

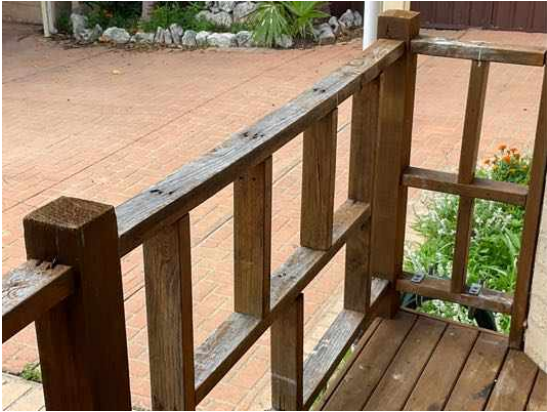
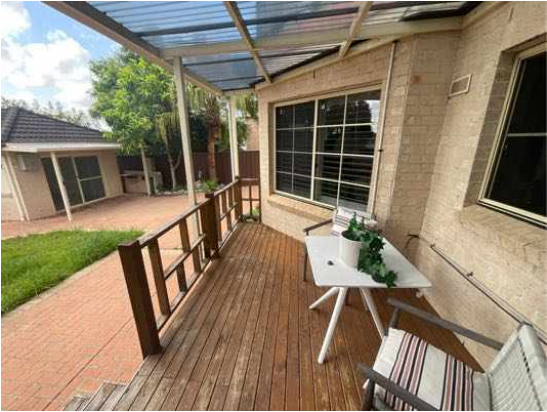
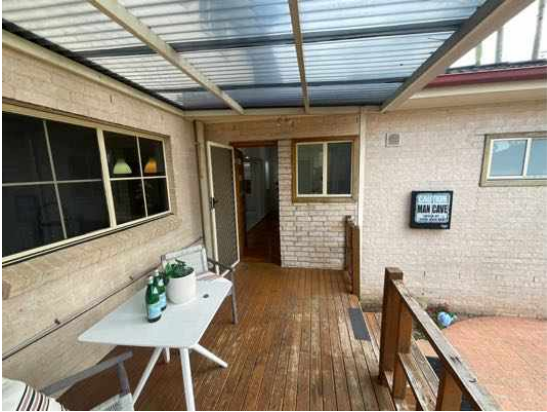
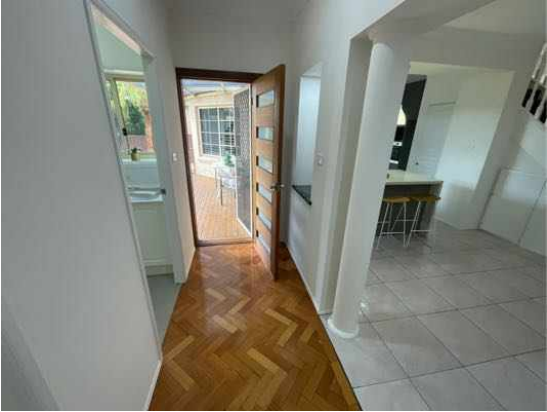
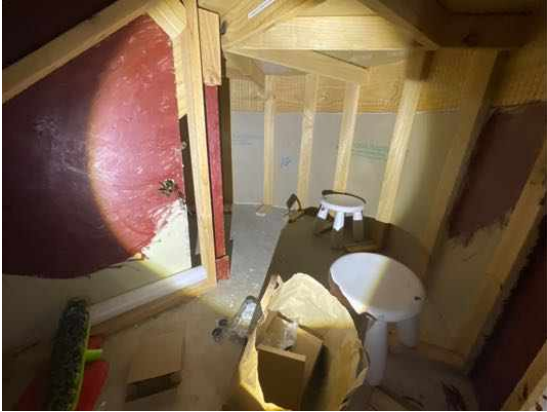
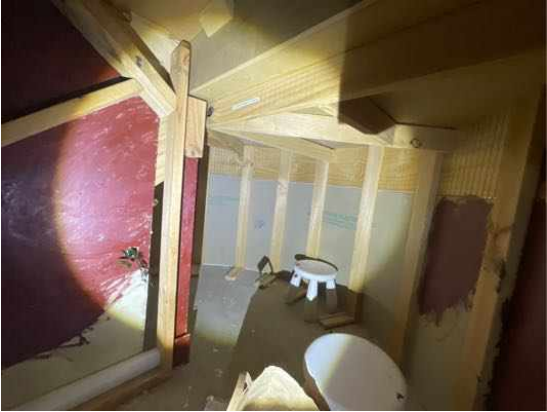
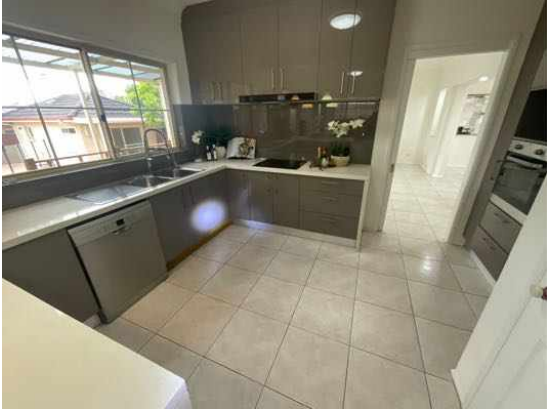
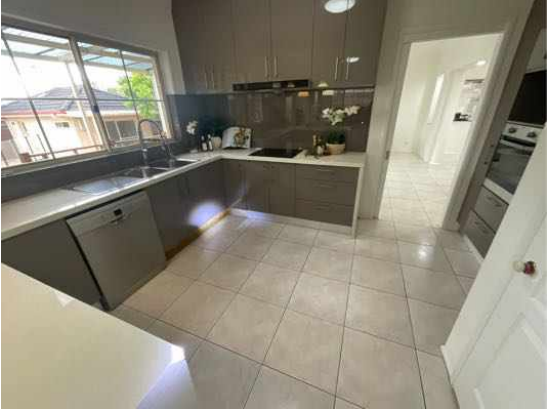
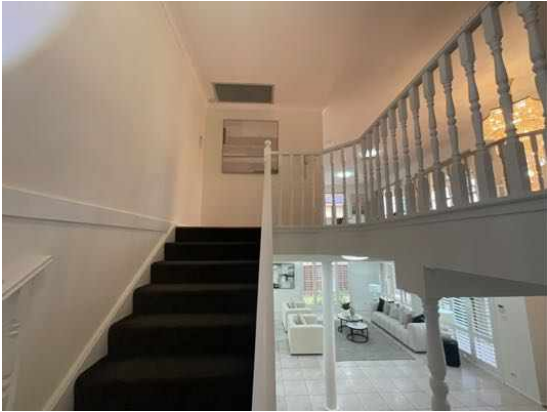
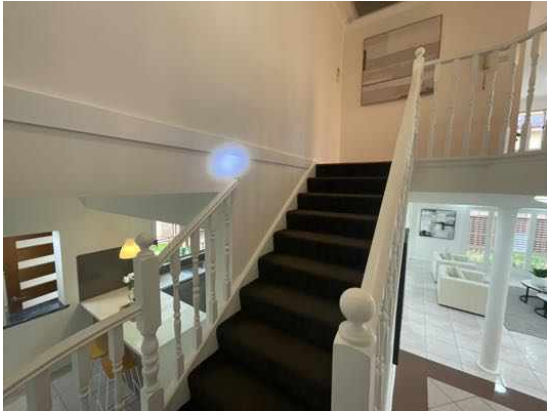
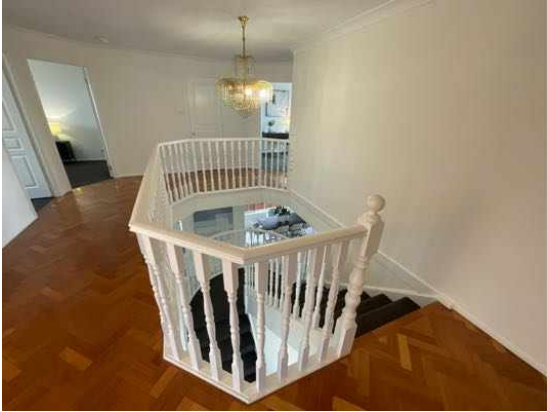
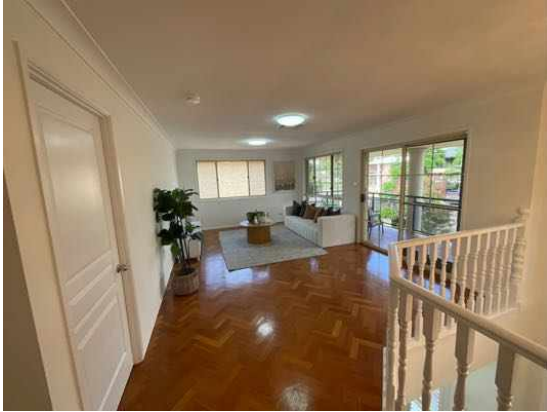
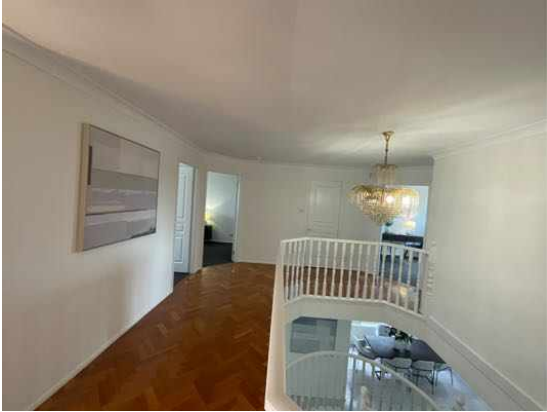
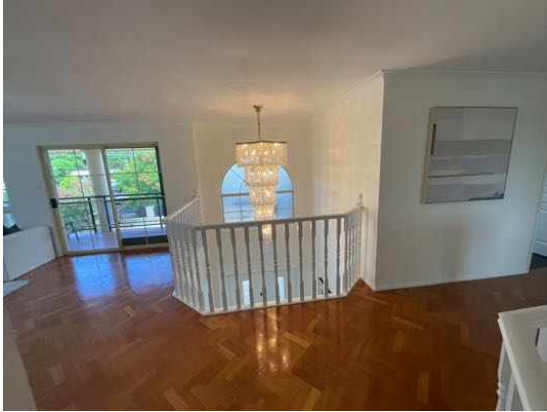
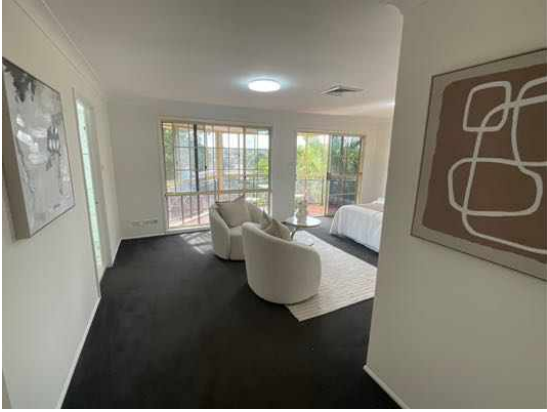
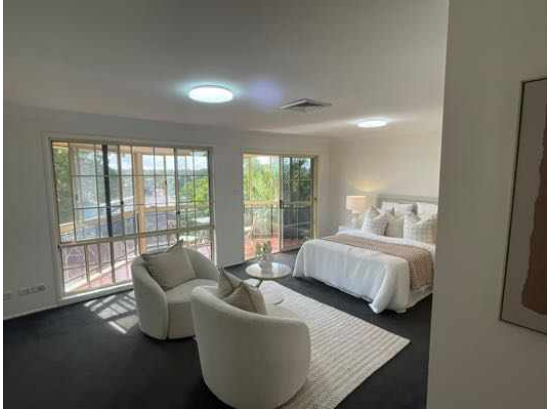
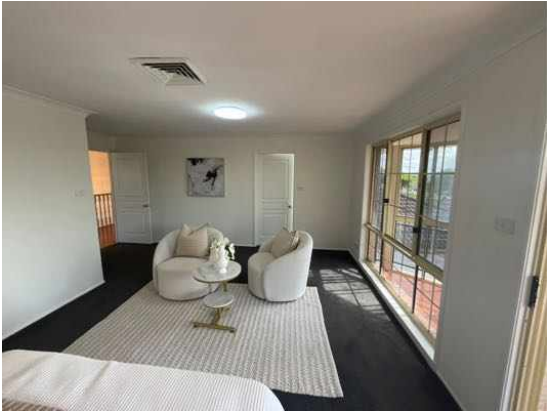
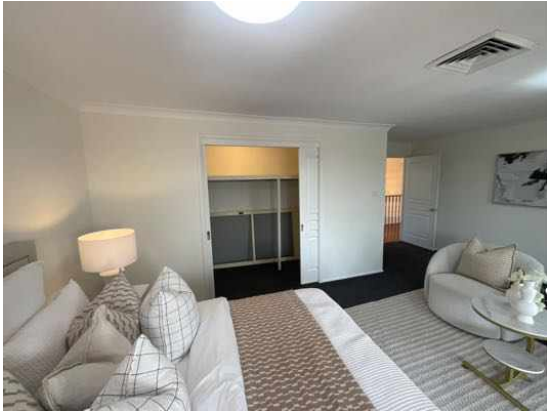
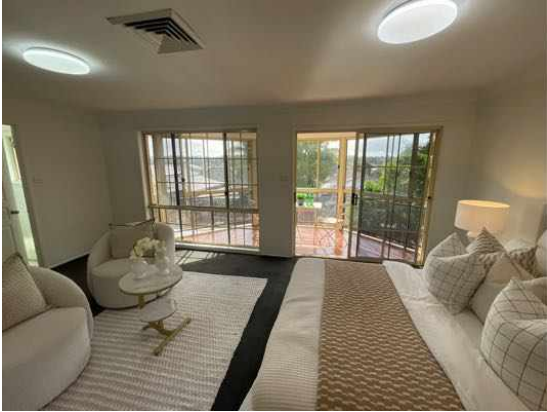
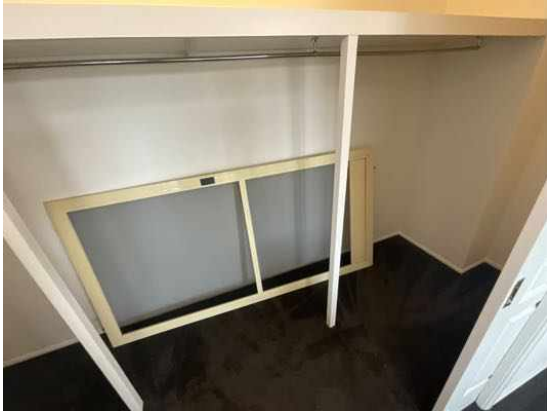
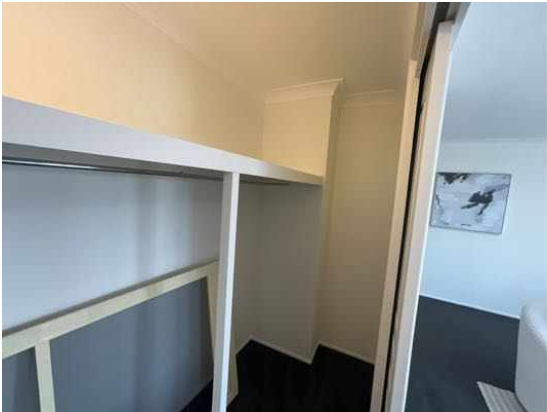
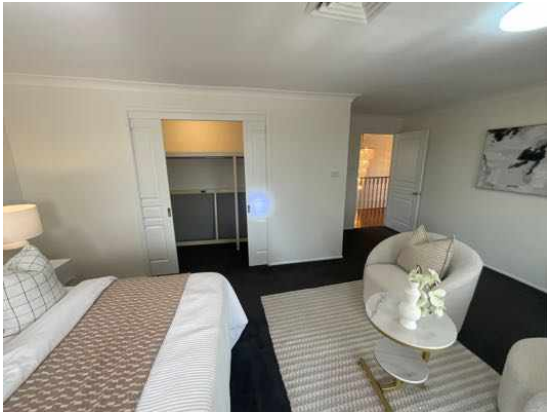
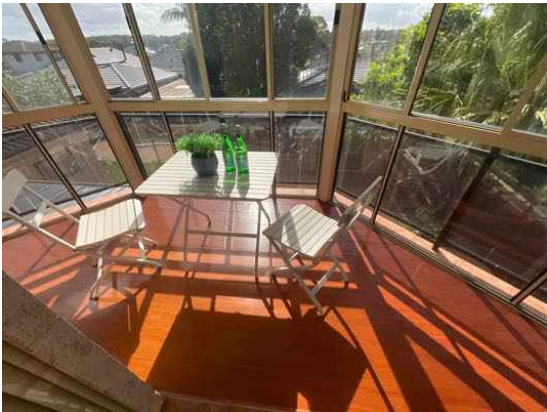
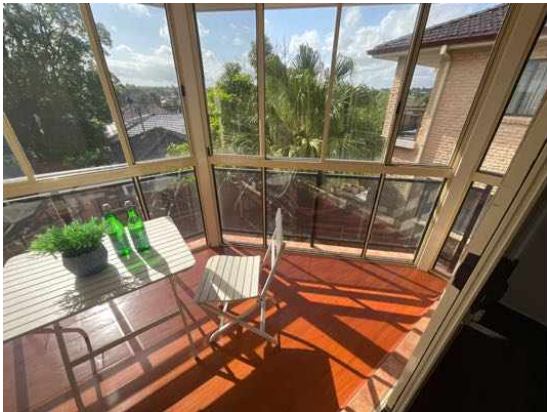
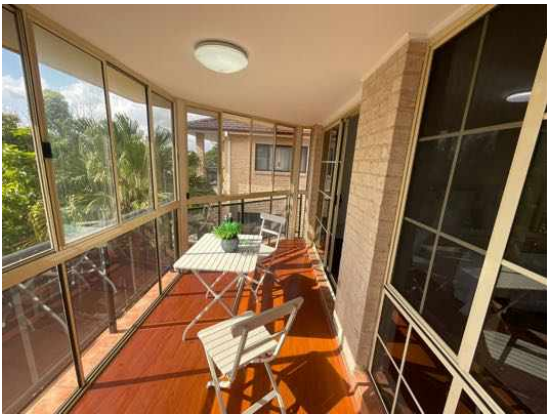
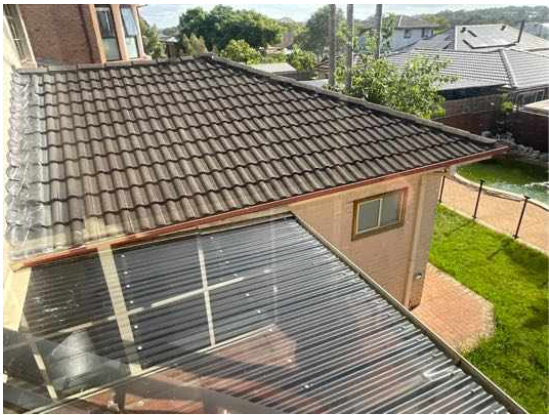
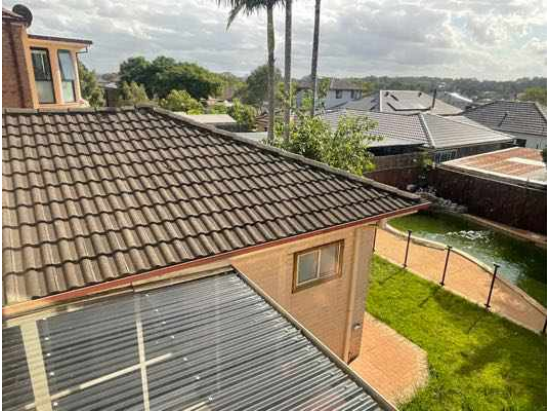
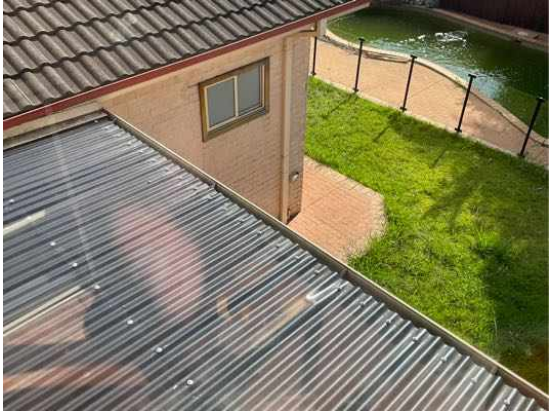
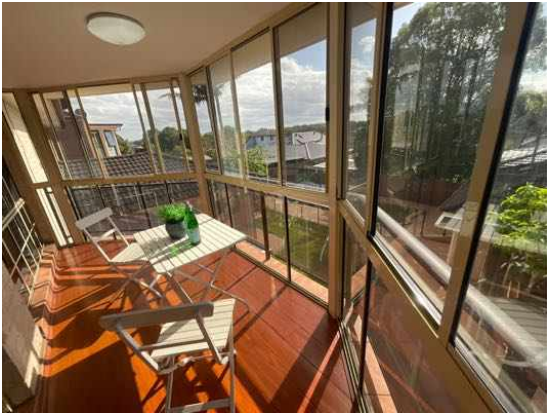
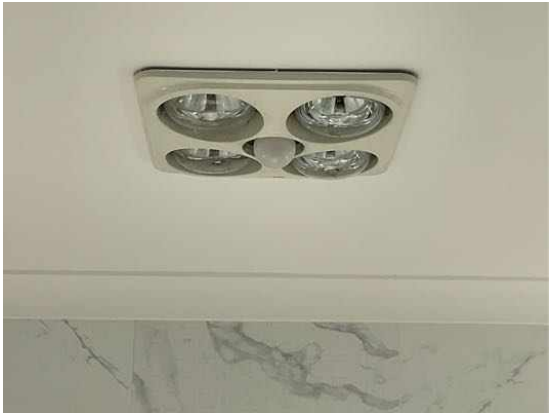
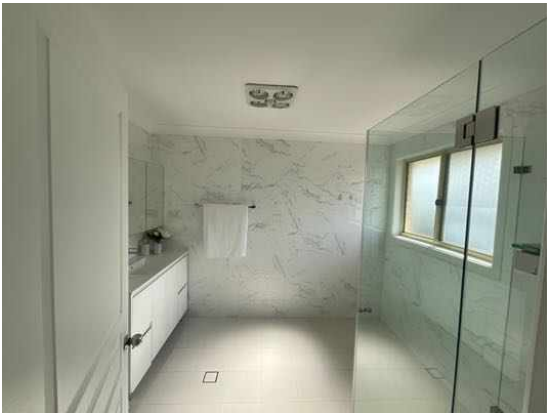
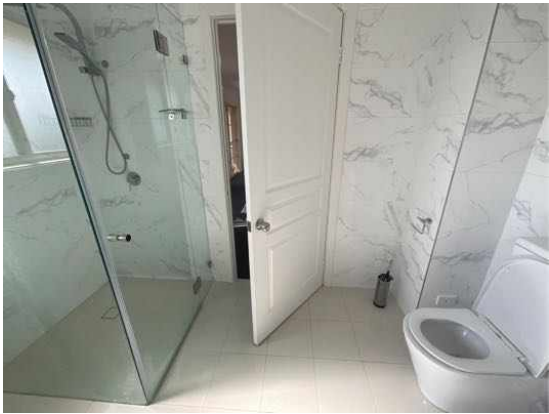
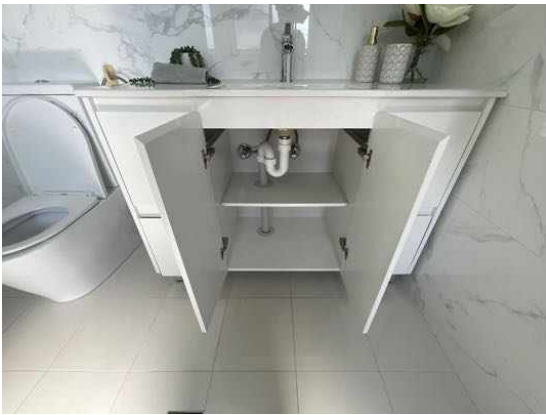
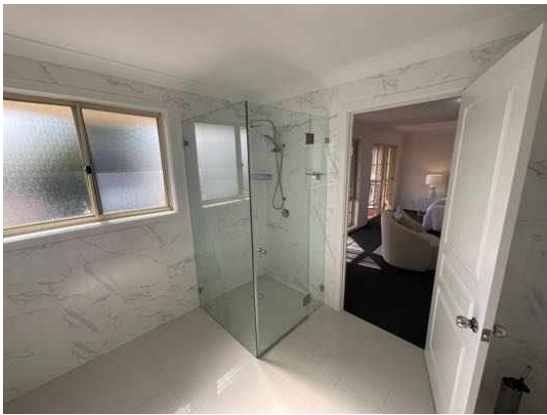
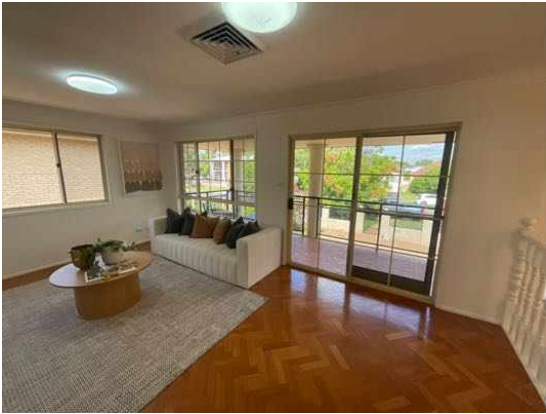
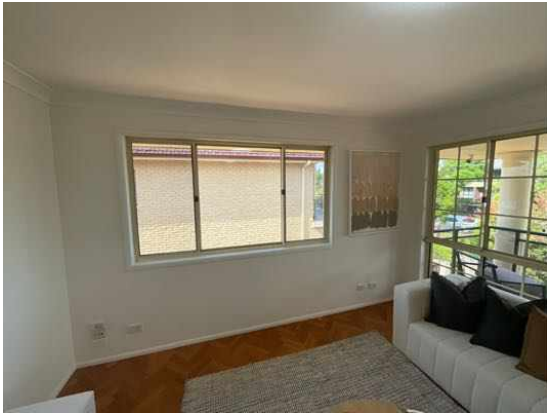
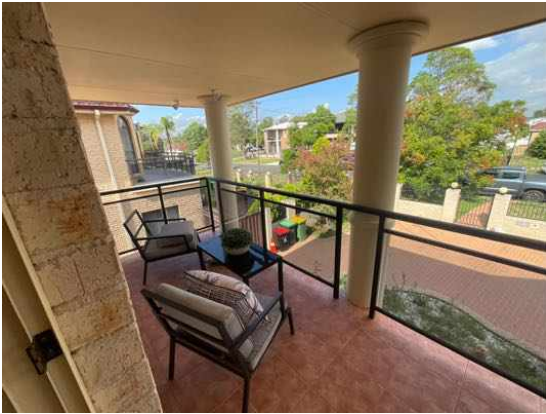
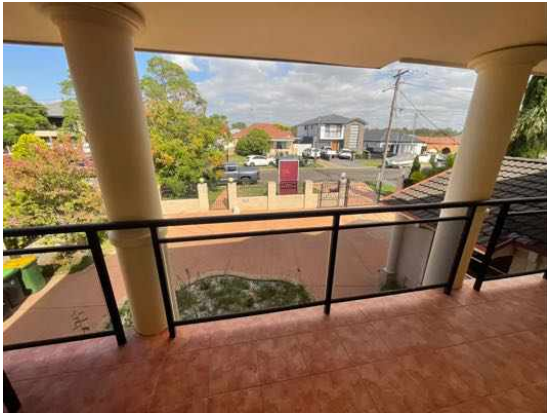
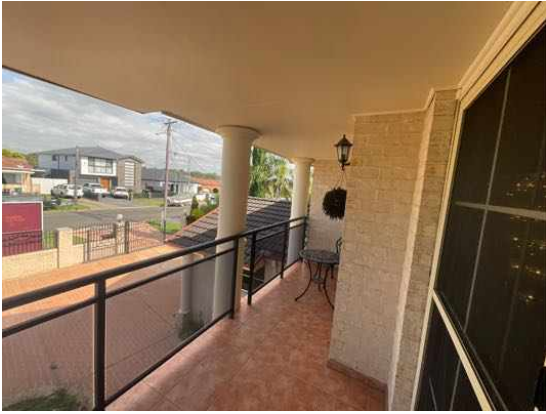
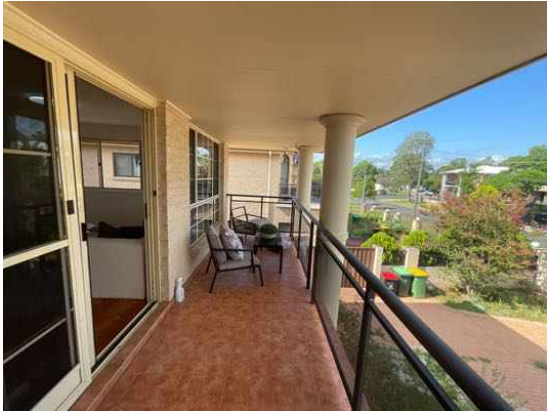
Building: Main Building  
Location: All Areas  
Finding: Additional Photos - Obstructions and Limitations  
Information: These photographs are an indication of the obstructions and limitations which impeded full inspection of the property at the time of inspection. These obstructions can hide an array of defects and should be removed to allow full inspection to be carried out. A re-inspection is recommended once the areas are made accessible.

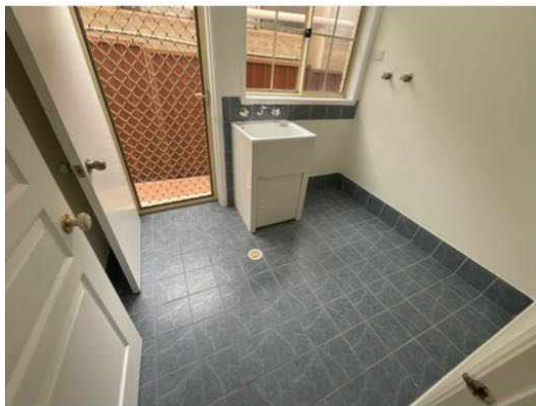
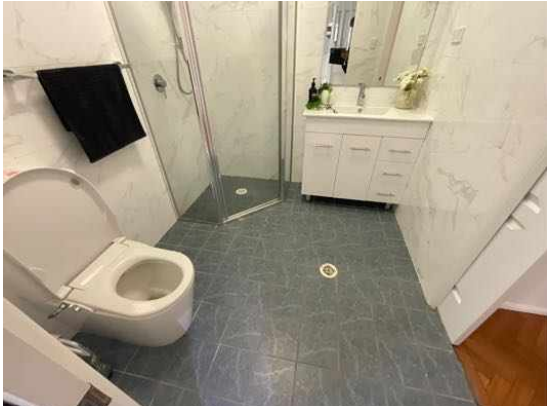
Building: Main Building  
Location: All Areas  
Finding: Water Proofing Membranes - Information Only  
Information: Internal Water Proofing Membranes, are crucial in preventing water ingress into the property is important to know that the Membrane System used is to Australian Standards and has been installed correctly. Please refer to the original Building Documents or Maintenance Schedule for the relevant information including; - Membrane used and Manufacturers Specifications. - The Installer and Installation Certification. Especially with older property's where this information is unavailable, all wet areas should be monitored. Generally new waterproofing with a certificate may only have a guarantee of 8yrs. If any leaks, water staining, peeling or bubbling of the paint become evident to any adjacent walls or ceilings below a licensed builder or waterproofing specialist is recommended to investigate further.

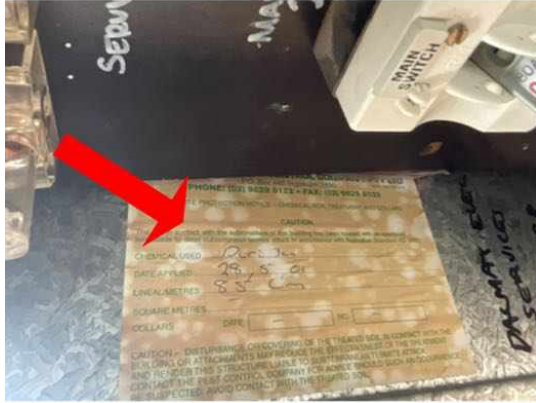
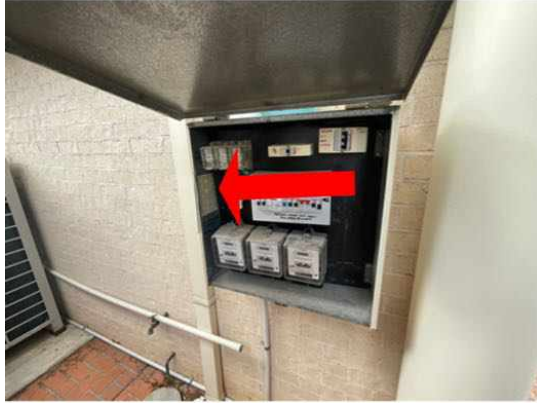
Building:	Main Building
Location:	All Areas
Finding:	Evidence of a previous termite management system was identified
Information:	There are a number of factors which indicate the presence of a previously installed or applied termite barrier. The most common are a durable notice (to the inside of your meter box) observable physical barriers installed to building perimeter and in ground reticulation systems.

Where a Termite Management System has been identified you should refer to the type of barrier date of installation warranty conditions and any documentation provided by a builder or past owner. Consult the company who installed the barrier to confirm

whether the system is still under warranty.

Most chemical termite management systems expire and require replenishment and all physical systems are primarily designed to prevent concealed entry.
