Building Inspection Report

Inspection Date: Wed, 1 Apr 2026

Property Address: Unit 3 1 Carlyle st, Croydon VIC 3138,
Australia

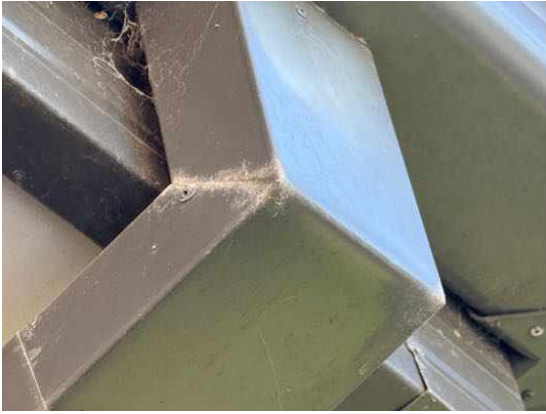
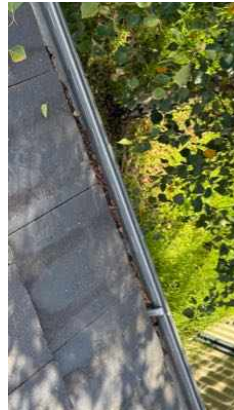
Defects 3.01

Blocked gutters are likely to lead to high levels of moisture in the affected areas. Such moisture will not only cause rust and decay of the associated building materials, but can also provide conditions that are conducive to termite and timber pest activity. Blockages in gutters should therefore be removed immediately to ensure dry conditions are maintained.

It is recommended that blocked gutters be cleaned and leaf matter and debris be removed by a relevant tradespersons as a priority.

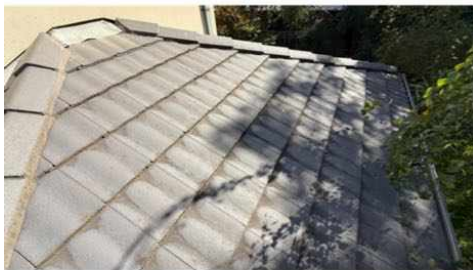
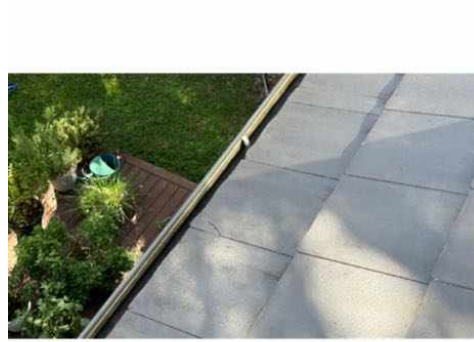
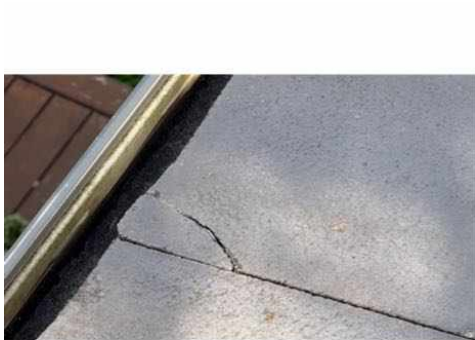
Defects 3.02

Building: Building 1
Location: All Areas > All Areas
Finding: Roof tiles - some broken edges or chipped
Information: Upon inspection of the exterior roof covering, a few of the roof tiles showed some small broken off or chipped roofing tiles were observed. Broken and friable roof tiles are generally the result of getting a bit brittle overtime, plus normal weathering of what is essentially a concrete porous material.

Over time the roof tiles can get brittle, will further deteriorate and are likely to lead to water penetration via the roof into the ceiling space, causing secondary damage to ceiling linings, insulation and roof structures. Where broken or chipped roof tiles are left unmanaged they are also likely to lead the roof not being watertight, creating the potential for secondary damage. Replacement of any broken or chipped roof tiles is required and should be performed by a roofing contractor as soon as possible. This can be carried out by a roof tiling company or a qualified roof tiler.

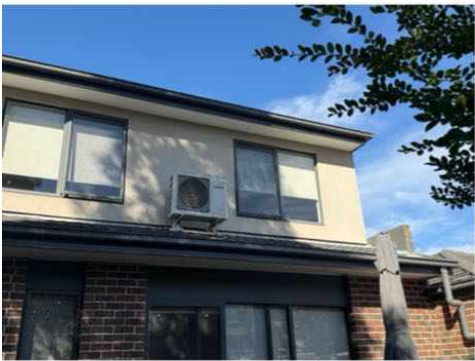
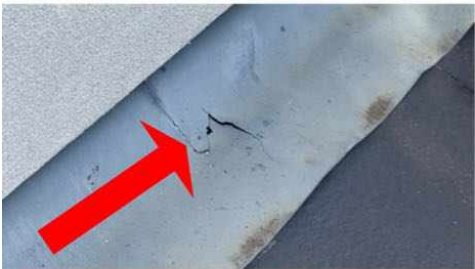
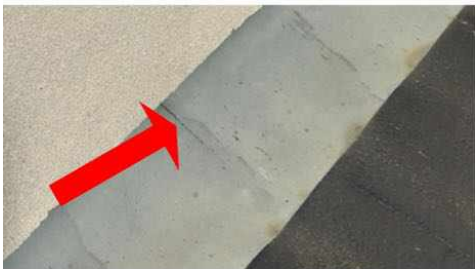
Defects 3.03

| Information: | The roof flashing above the rear lining room were observed to be showed cracks in the wall to roof flashings, these are not currently sealed adequately. The flashing in this section of the roofing appears to be good expect for these cracks, these are suspected to have been caused at the time of installation and construction of the unit. This roof flashing needs to be sealed immediately or rectified as soon as possible in the short term future to ensure it is weather proof and water tightness remains in this area. |

Metal and other material flashings are applied to seals and intersections between roof coverings and building elements. They are designed to aid in weatherproofing of roof joins. Left unmanaged moisture damage in this area may be eminent, failure to perform these works may result in water damage and accelerated deterioration of other associated roof and building elements. A roofing plumber should be appointed immediately or as soon as possible to restore these flashings to a fully operational state.

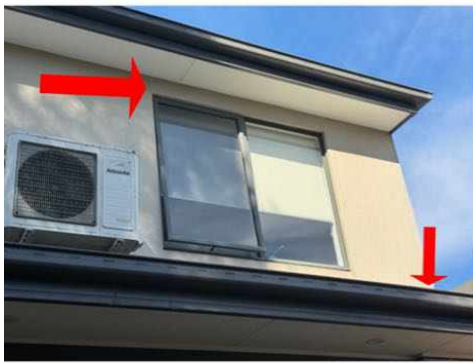
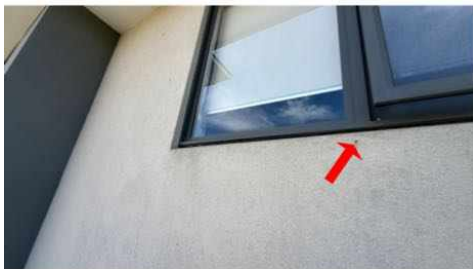
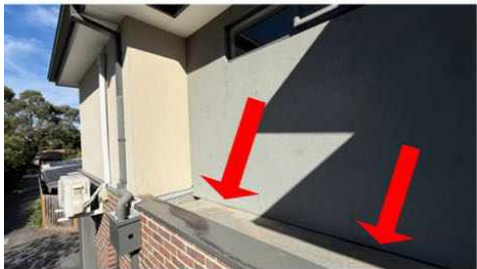
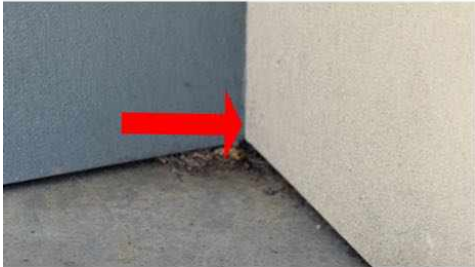
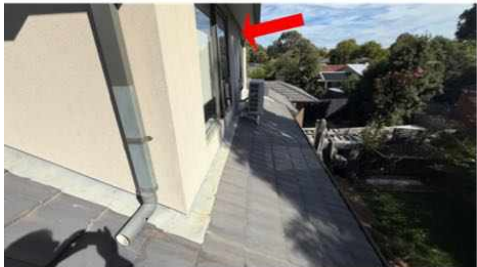
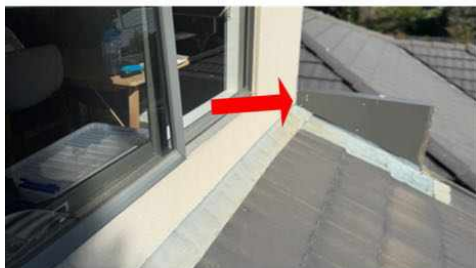
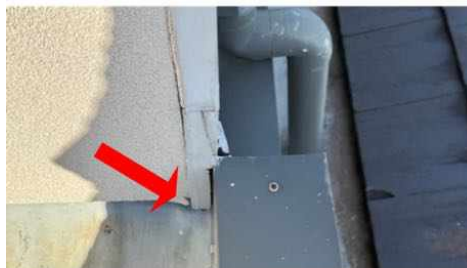
Defects 3.04

Finding: Cracks to exterior rendered surfaces

Information: It has been observed that numerous cracks to the rendered surfaces has occurred throughout the external areas. The degree of damage is described as numerous minor cracks which are generally less than 1- 3mm in width. In the future the client may consider some repair and remedial works to seal these areas to ensure water and moisture cannot enter into the internal areas behind the rendered surfaces.

This type of cracking is considered to be from normal movement from expansion and contraction at the many stress points throughout the exterior of the home. However they will still required the client to monitor to ensure they do not become larger and deteriorate, if these cracks and or defects were to further deteriorate, it is considered a defect that requires rectification in the short term future. Always contact your relevant building or tradesperson should cracks widen, lengthen, or become more numerous.

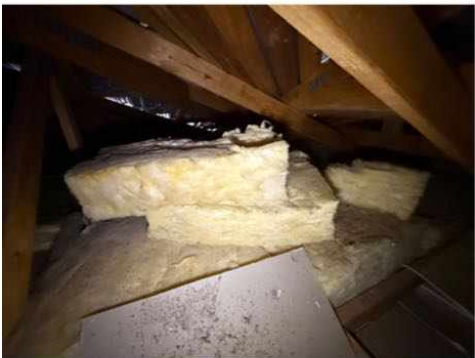
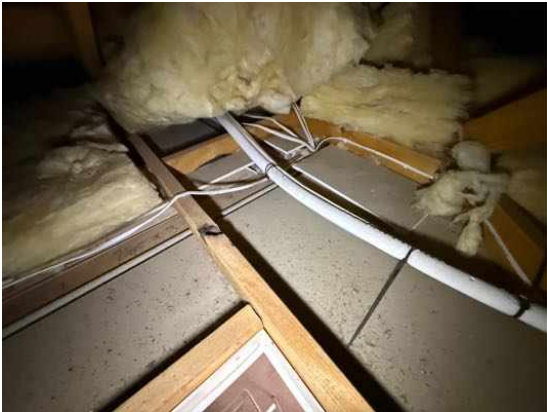
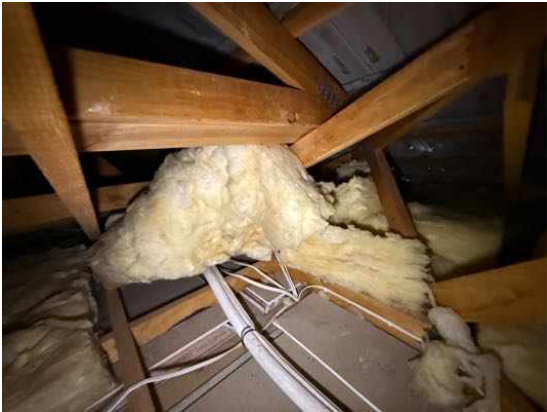
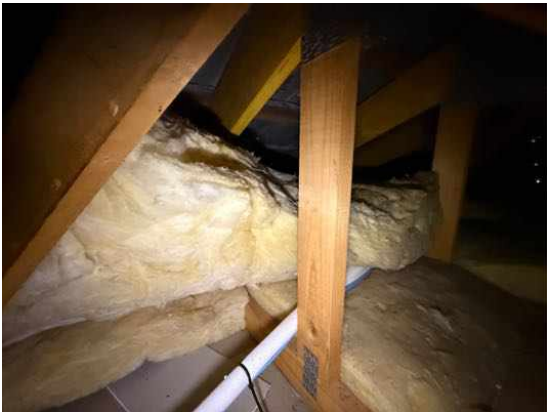
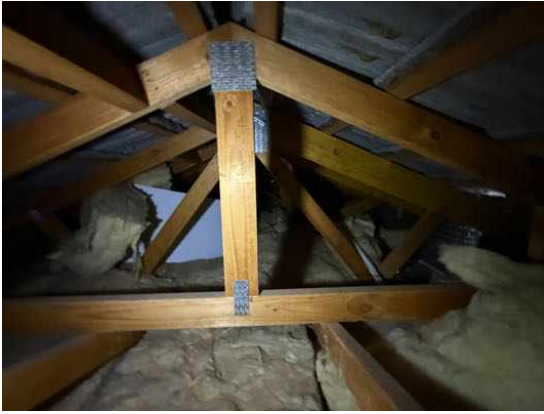
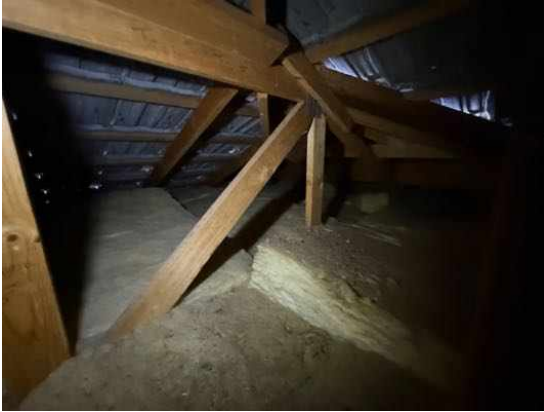
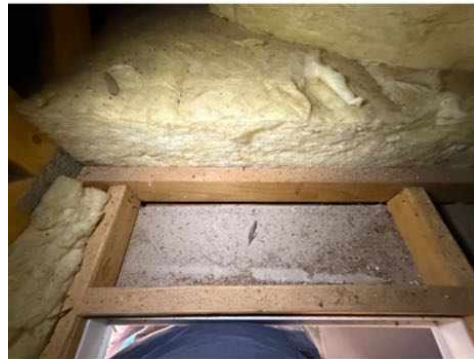
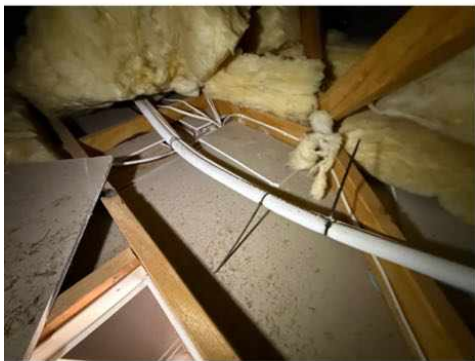
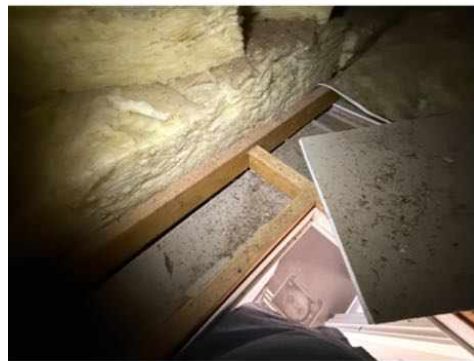
Defects 3.05

| Finding: | Insulation - poorly installed - missing or moved |
| Information: | Some areas of the roof insulation in the roof space is suspected to have been poorly installed, missing or have been moved from their original position. Insufficient insulation will result in a comparatively higher cost to heat and cool a property as there is a lack of Insulation (or uneven coverage of insulation) which works as a barrier to heat transfer. This helps to keep out unwanted heat in summer and preserves warmth inside your home in winter. It can also help soundproof your home from unwanted airborne noise transfer. |

Example - Where there is a gap in coverage totaling 5% there is a potential for up to 50% of the energy efficiency to escape. Caution should always be exercised when accessing the roof void. Do not attempt to stand on the framework and especially be aware that there is a potential for electric shock if contact is made with exposed or faulty electrical wiring.

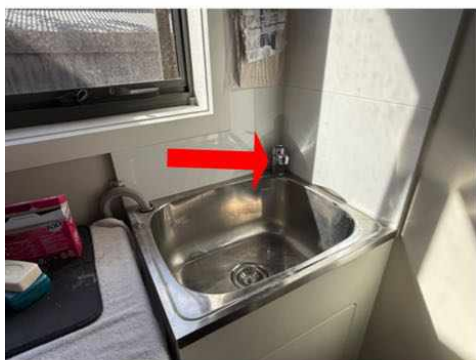
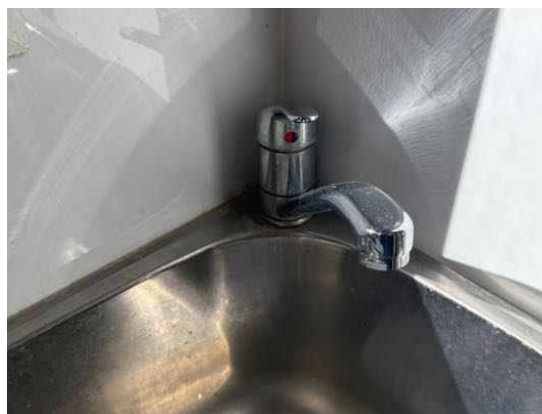
Defects 3.06

| Finding: | Laundry trough flick-mixer tap is loose |
| Information: | The laundry trough flick-mixer tap was observed not to be loose at the time of inspection. It appeared to be operating correctly, however it is recommended that the client appoint a licensed plumber to perform remedial works on the affected tap. Such works should be performed prior to the development of secondary defects to ensure adequate functionality of all associated building elements. |

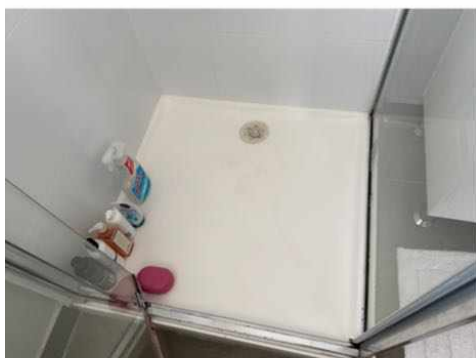
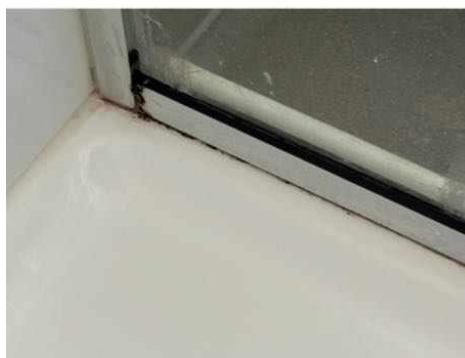
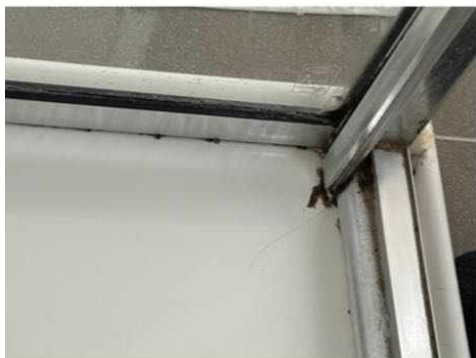
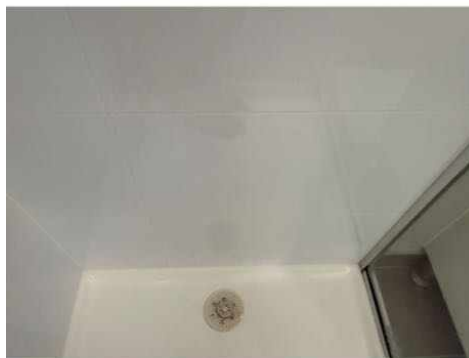
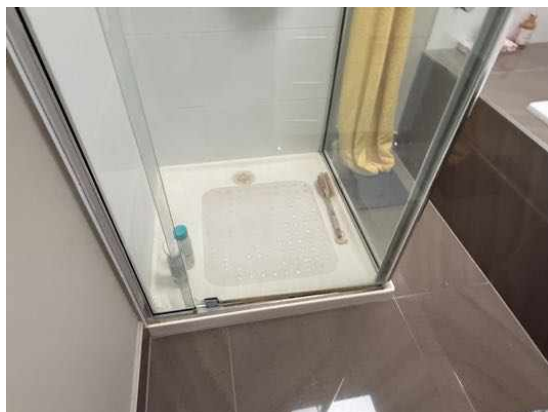
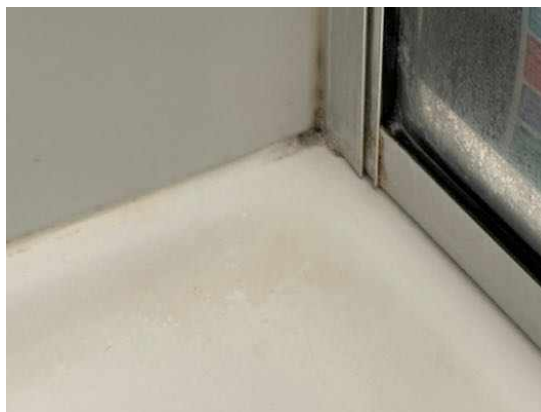
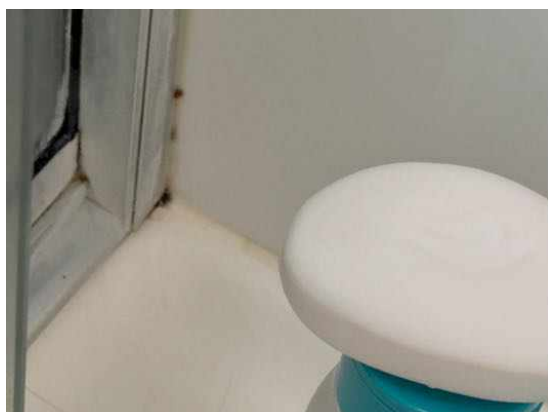
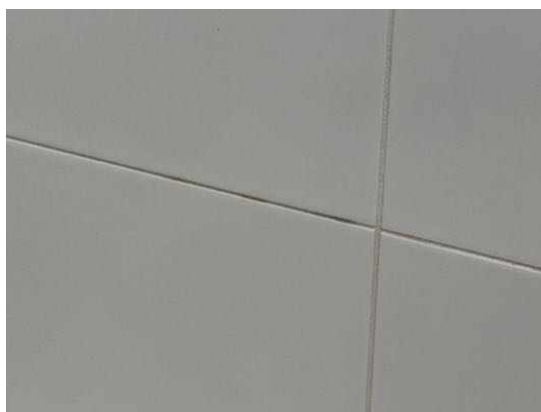
Defects 3.07

| Information: | It was observed on inspection that shower cubicles showed some mould in the sealant or grout in the en-suite or bathrooms. There appears to be some mould to the sealant and or grout which will likely require scraping out and replacement. |

Different materials on the walls and floor areas move at different rates, generally causing cracking to grout or sealant at this point. A flexible sealant is required to allow for expected expansion and contraction, while keeping the joint water tight and protective of all associated building materials. Flexible and mould resistant materials should be applied to affected areas to prevent any subsequent water damage that is likely to occur.

Regular maintenance and replacement of any missing or damaged sealant and grout is highly recommended to the wet areas, as this is a regular wear and tear defect. Sealant and grouting in areas that come into regular contact with water should be maintained for the long term care of your property. A sealant specialist or tiling contractor should be appointed to complete these works as soon as possible.

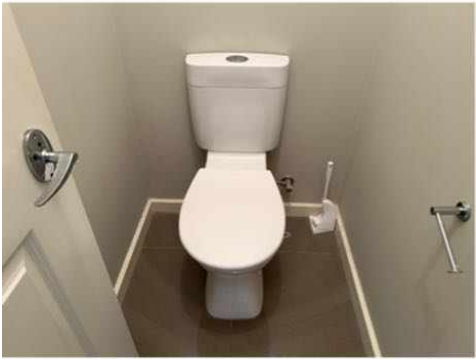
Defects 3.08

| Finding: | Toilet roll holders - Loose |
| Information: | The toilet roll holders and towel rail were found to be loose at the time of inspection. While not a major operational defect, function can deteriorate if the problem is left unmanaged. It is recommended that some remedial works to rectify the loose toilet roll holders and towel rails to its original fixing. If these cannot be be rectified to function as intended, client is recommended to renew. A qualified carpenter may be required to perform these works. |

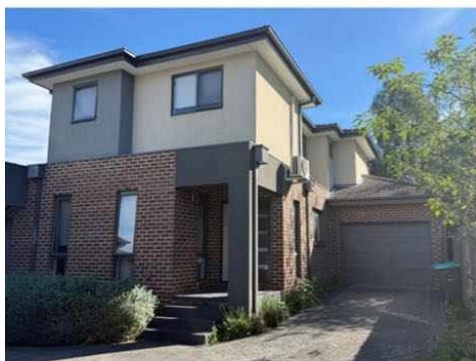
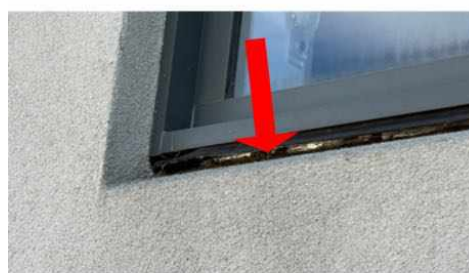
Defects 3.09

| Finding: | Gaps between the bottom of the aluminium window frames and sills |
| Information: | <p>At the time of the inspection some aluminium windows were showing gaps to the bottom of the windows between aluminium window frames and sills. All windows with gaps to the exterior perimeter should be filled with a good quality sealant, aluminium angle or flat. It is recommended that for the large gaps, firstly you may need a backing rod (Cylindrical foam) in the gap to take up the bulk of the space, this should prevent the sealant from falling through any gaps. If a colour matched colourbond aluminium angle is used, the tradesperson must ensure that this will match the exterior window colour as close as possible, then apply a sealant to ensure a good, wind and weather tight seal and rivet to the window frame. The installer or tradespersons must be capable and competent to ensure a good quality sealant finish. A good quality sealant, should be used, for the small gaps. The installer must ensure that the sealant used is mildew and mould resistant and fit for purpose.</p> |

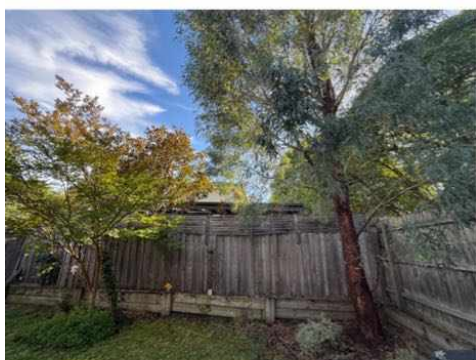
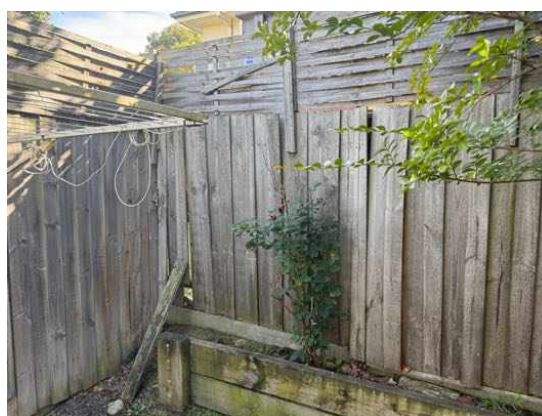
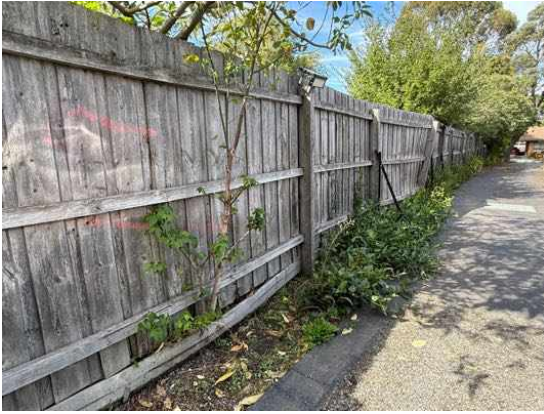
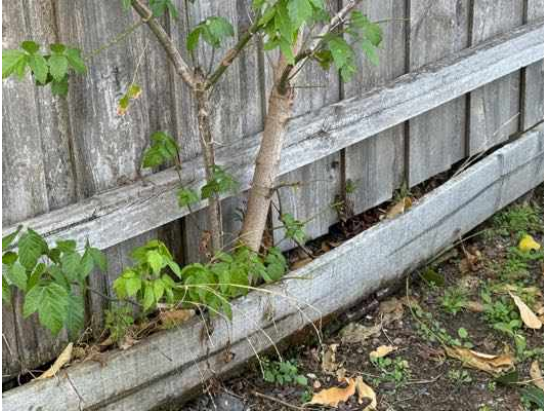
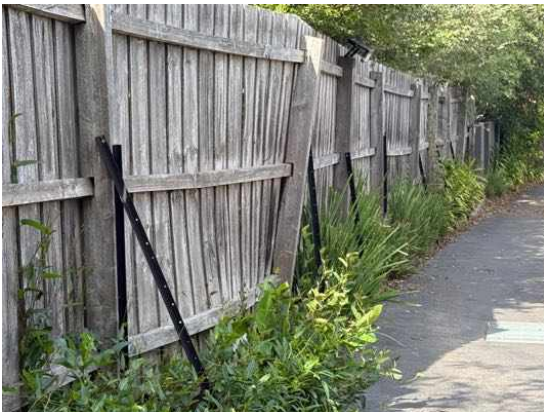
Defects 3.10

| Information: | Post and rail fences showed damage and deterioration at the time of the inspection. This deterioration is suspected to have developed over a prolonged period of time due to frequent weather exposure, which is expected in a property of this age and condition. |

Left unmanaged, further deterioration is likely to develop further, necessitating in extensive repair or replacement areas of the timber fences, this will depend on the age and deterioration and or wood rot, further damage is suspected of occur.

To maintain the condition of the external timber building elements, any affected areas should be substituted as soon as possible with pre-treated replacements. A qualified fencing contractor should be appointed to repair and replace post and rail fencing where deemed to be necessary.

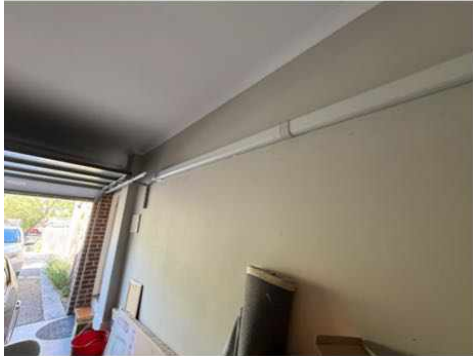
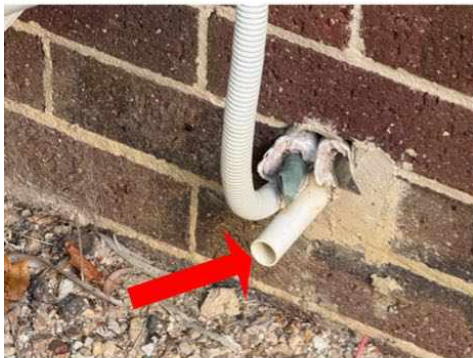
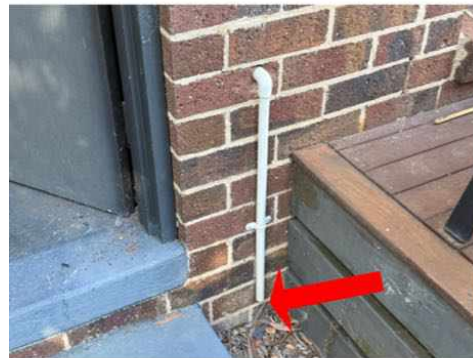
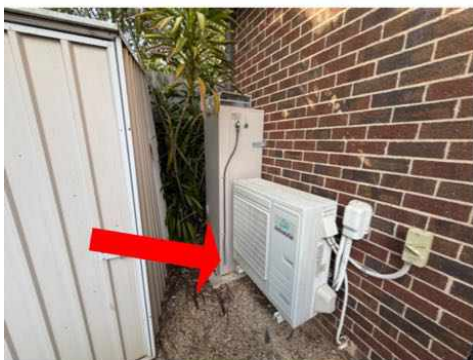
Defects 3.11

| Finding: | HWS and air-conditioning overflows not connected |
| Information: | The Hot Water System (HWS) and external air-conditioning units showed that the overflow pipes not to be connected to any form of storm water drainage system and may in the future create excessive moisture in the surrounding area, as these units as they get aged, deteriorated and particularly during their use. These damp conditions can lead to secondary defects such as rot, rust or corrosion of associated and adjoining building elements, as well as the formation of fungal decay and even the creation of potential slip hazards for occupants. When coupled with poor site |

drainage, pooling of water may also attract termite activity to these areas. It is highly recommended that a licensed plumber be appointed to connect the HWS and air-conditioning overflows in order to prevent such an environment from being created. These remedial works should be carried out as soon as possible.

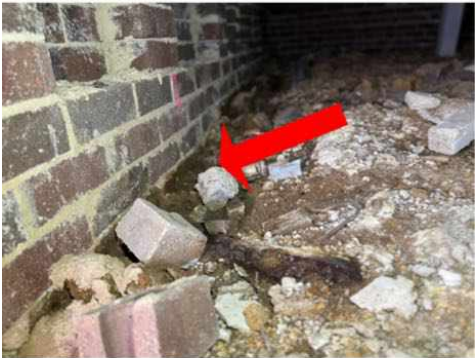
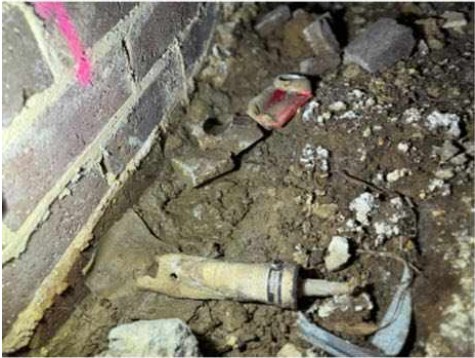
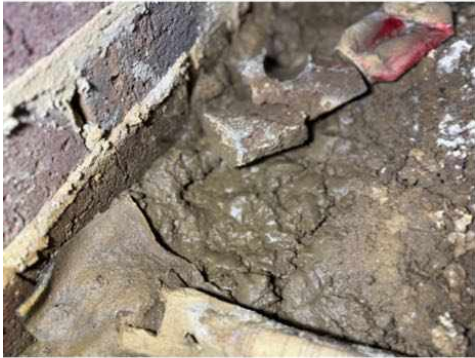
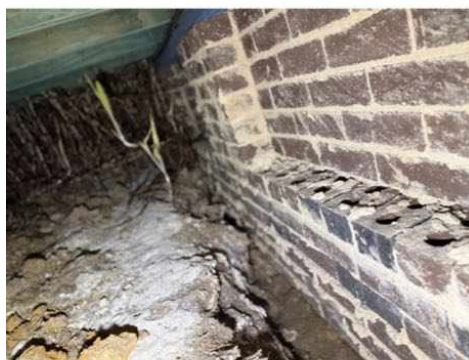
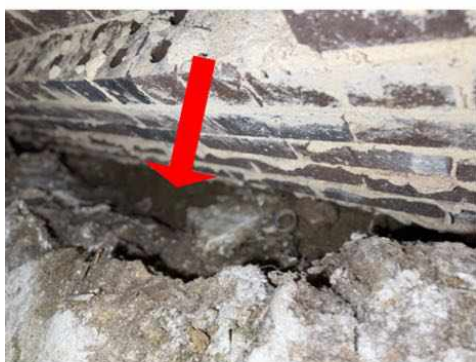
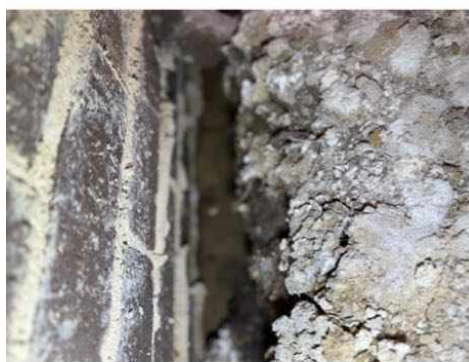
Defects 3.12

Building: Building 1
 Location: All Areas > All Areas
 Finding: Subfloor moisture travelling around the subfloor foundations
 Information: At the time of the inspection to the subfloor areas, moisture was observed to be travelling around the subfloor foundations in some of the rear areas in the subfloor. It is

Where roof plumbing doesn't drain adequately, the exterior areas at the base perimeter can become excessively moist and damp, moving through and under the home creating an environment that is making the foundations susceptible to heaving and other building elements and materials to moisture damage, wood rot, rust and corrosion, as well as attracting termites and other pests to these areas. It is highly recommended that a plumber be appointed to further inspect the exterior and subfloor areas and to install adequate drainage and equipment where deemed to be necessary.

recommended that the client appoint a Registered drainage plumber to provide adequate drainage to alleviate as much moisture from entering the subfloor as possible. A plumbing contractor should be instructed to add the necessary site drainage such as agriculture drainage and rectify any drainage not adequately working or connected to stormwater drainage on the site. Any disconnection or drainage problems can negatively impact the functional capacity of the site drainage system.

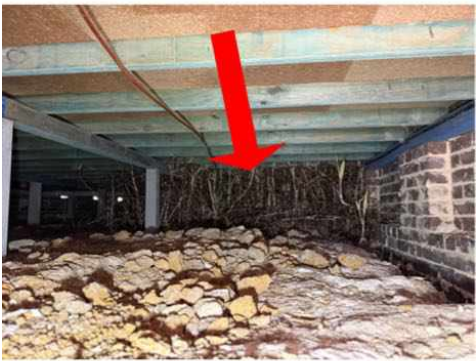
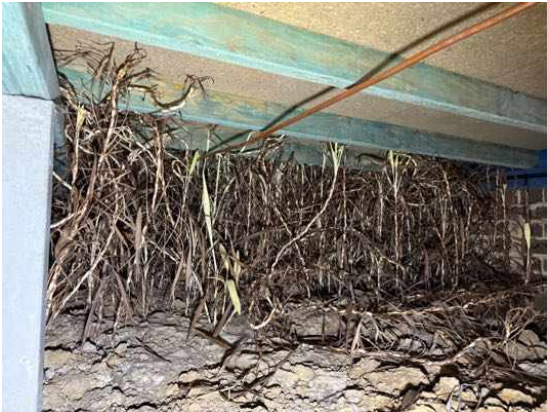
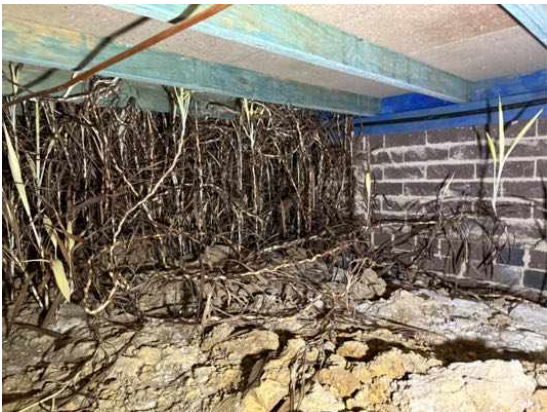
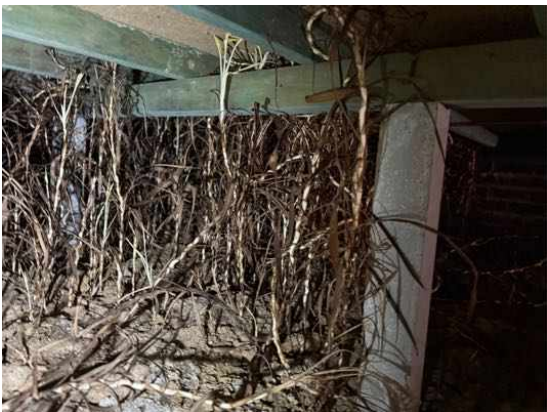
Defects 3.13

| Information: | An excessive amount of long grass was found in the subfloor area at the time of inspection. The grass in this area creates potential for concealed pest entry and may also make the area susceptible to termite activity. A clear and empty subfloor will be better ventilated and easier to maintain in a dry condition. The removal of this grass is considered important in minimising the risk of unwanted insect and pest activity. |

This grass is recommended to be removed and killed off as soon as possible. Depending on the location and amount, the homeowner may elect to undertake this task. Alternatively there are a large number of subcontractors that could undertake these works.

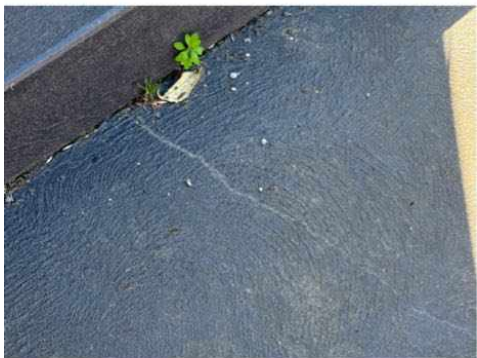
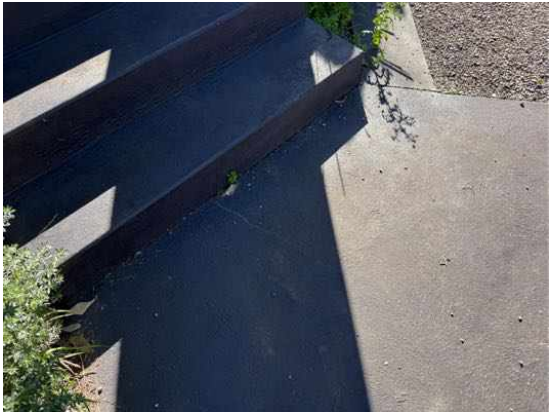
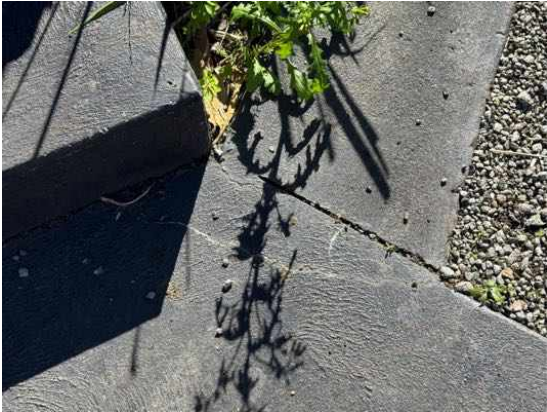
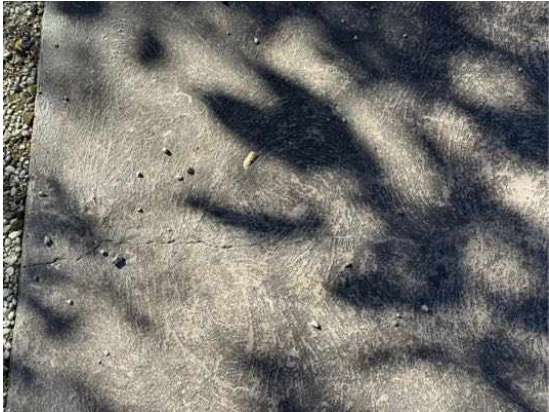
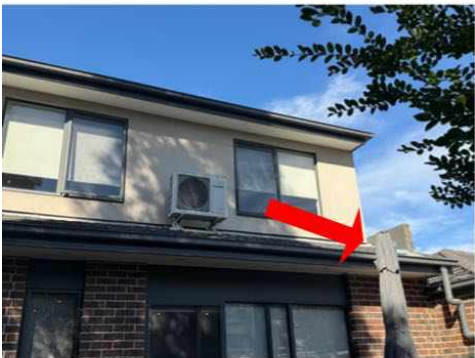
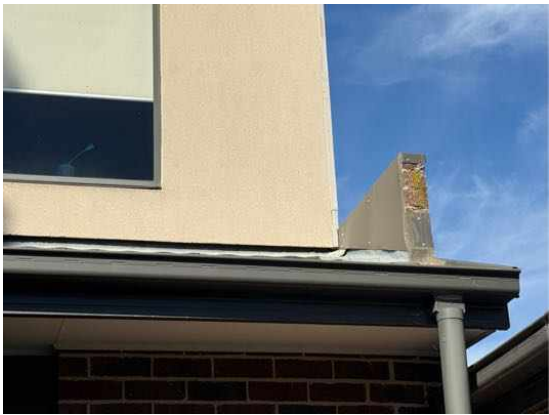
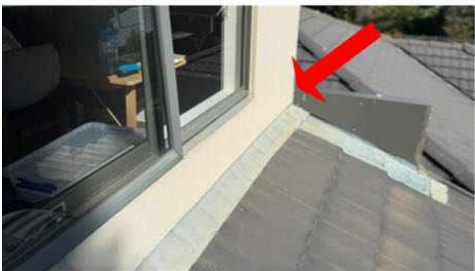
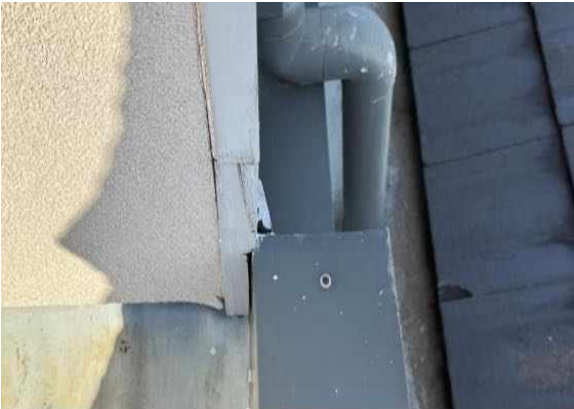
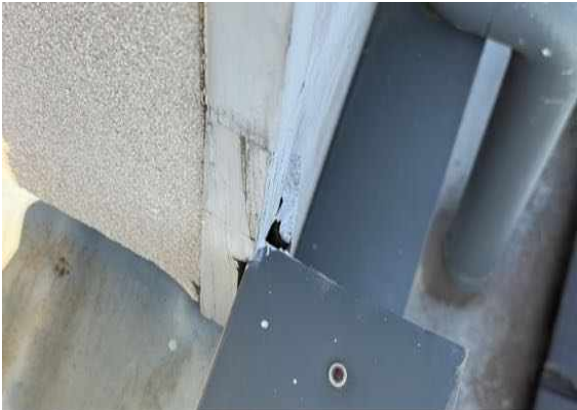
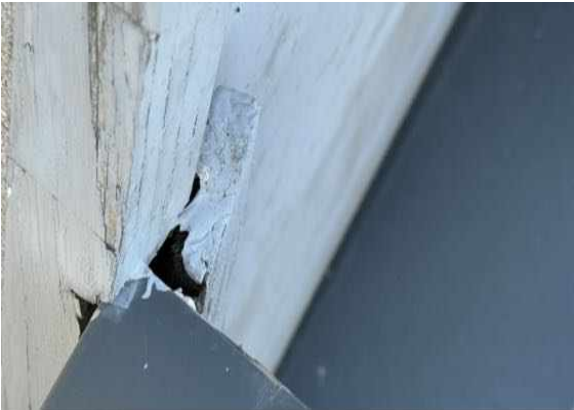
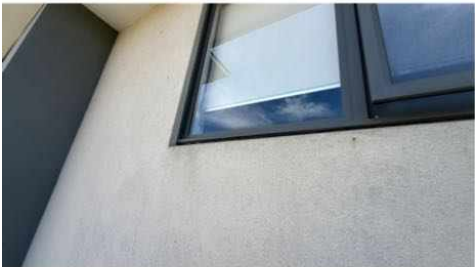
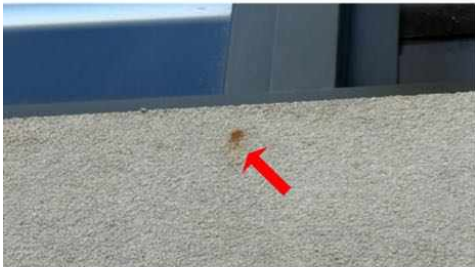
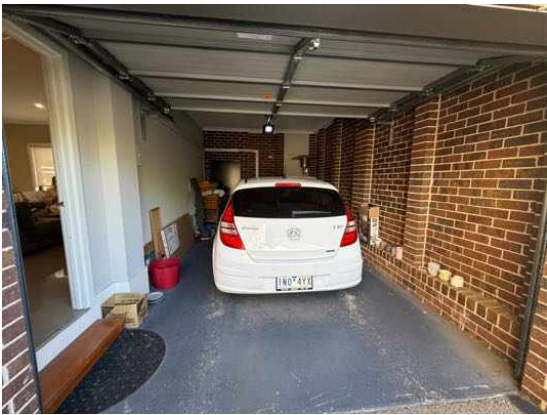
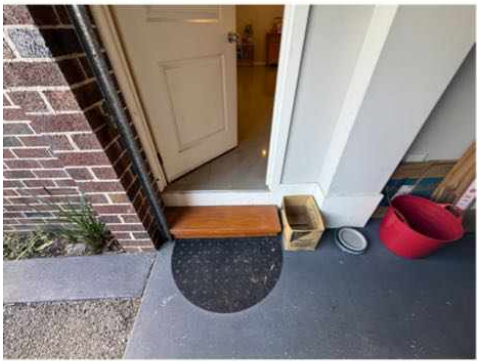
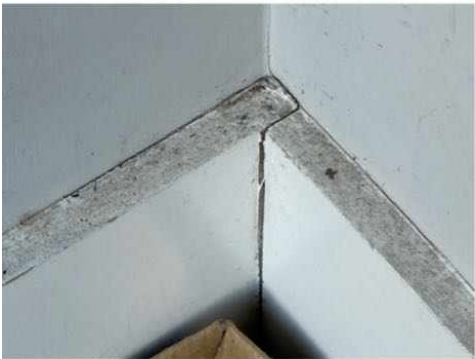
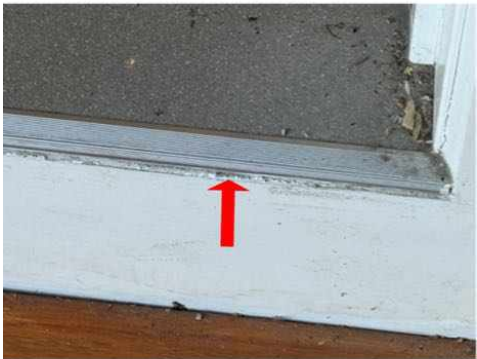
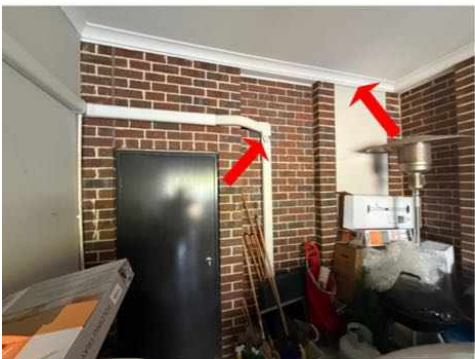
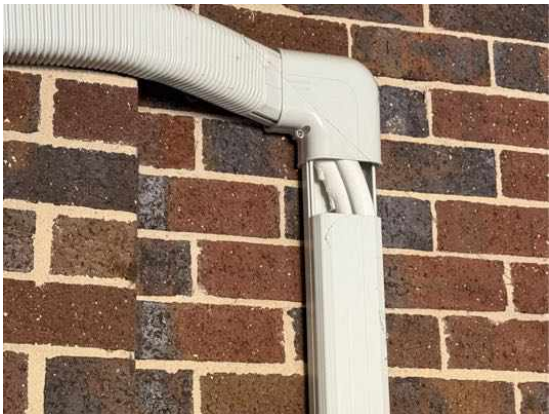
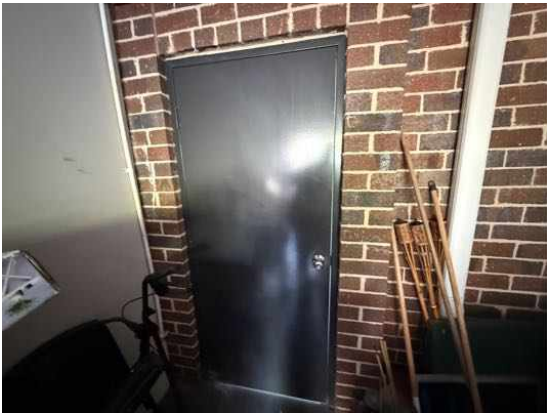
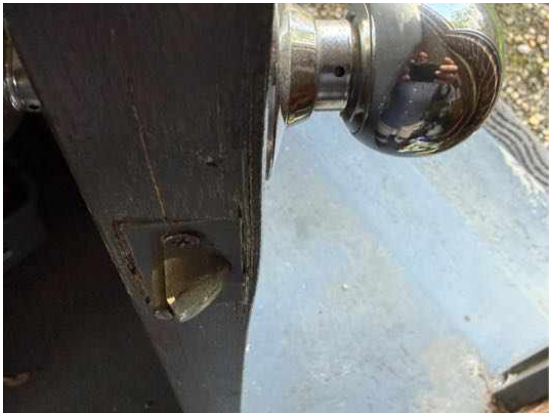
Building: Building 1
Location: All Areas > All Areas
Finding: Additional Photos
Information: Additional photos are provided for either future maintenance items for clients attention and or general reference. Arrows may have been included to highlight areas of importance. Please discuss these photos with your building consultant for clarification.

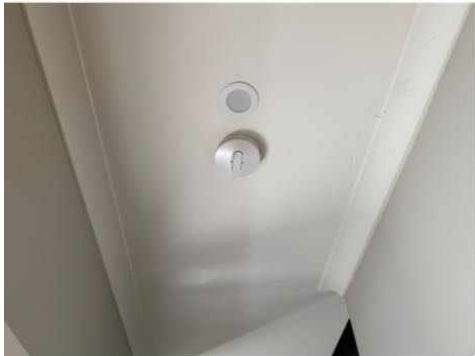
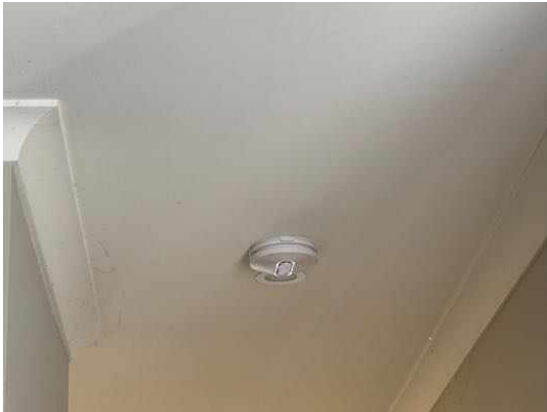
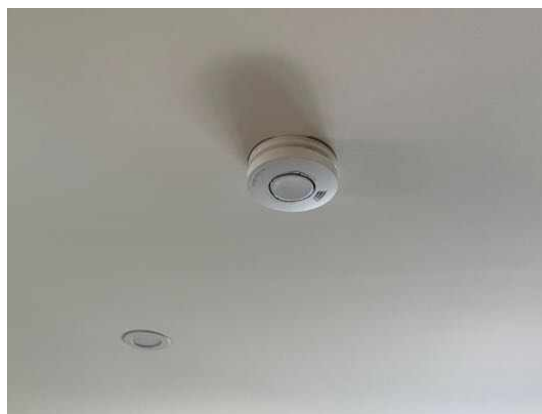
Building: Building 1
Location: All Areas > All Areas
Finding: Smoke detectors and alarms
Information: Reporting on Smoke Detectors or Alarms, including hard wired smoke detection systems and their legislative requirements, is outside the Scope of this Report. Please note that this defect is highlighted as a caution only. We suspect, based on our experience in the building industry, that smoke detectors are sometimes get overlooked, or they may be in a poor condition, so we recommend that they always should be addressed prior to occupation to improve occupant safety.

Always ensure sufficient working and suitable smoke detectors are installed prior and during to occupying any building. Additionally, it is advised that all smoke detectors be tested by the homeowner on a monthly basis.

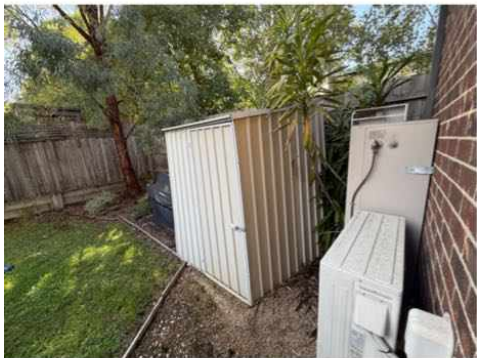
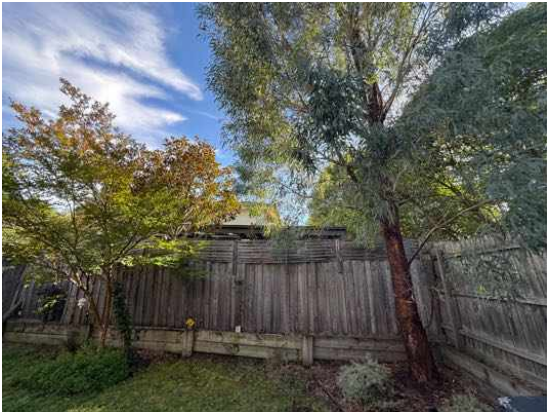
Building: Building 1
 Location: All Areas > All Areas
 Finding: Trees - close trees
 Information: Overhanging trees often result in excessive amounts of leaf matter and debris accumulating in gutters. Blockages of the guttering and downpipes will lead to pooling and accumulated water overflows, which is likely to subsequently flood eaves and exterior walls. Blocked gutters are likely to lead to high levels of water and moisture sitting in the gutters, which can cause rust and decay of the associated building materials, but can also provide conditions that are conducive to termite and timber pest activity. Blockages in gutters should be clean and kept clean at all times to ensure dry conditions are maintained.

Gutters are a critical part of the building's management of storm water and rain. It is therefore important that they be kept clear to prevent secondary damage to associated building elements, including exterior and interior walls, ceiling linings and any adjoining building elements. Where gutters are blocked, pooling of rainwater is likely to occur, fast-tracking rust and corrosion of the roof plumbing elements. A gutter guard can be beneficial in these situations to reduce the regular maintenance that will be required. But the client will still have to periodically provide maintenance and cleaning of gutter guard of any debris which may rest on top of the filter or the finer material through the top.

It is therefore highly recommended that any overhanging trees and branches be removed as soon as possible to prevent any future damage. Such works should be performed by the homeowner; however, appointment of a landscape contractor or an arborist may be required and highly recommended.

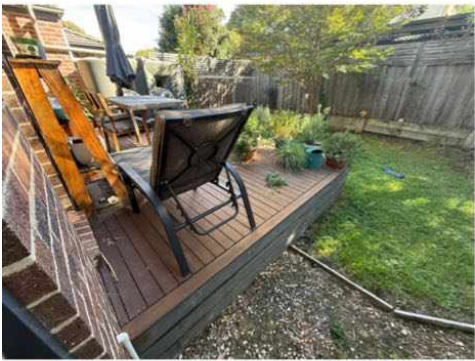
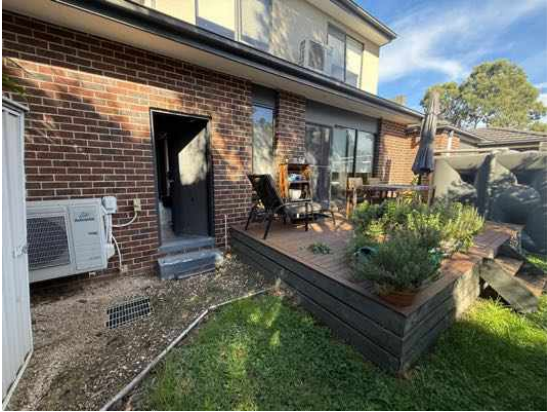
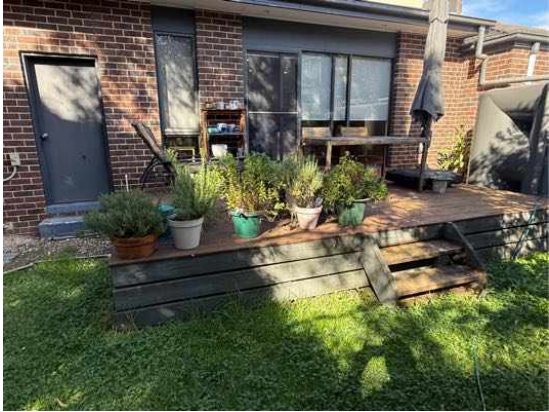
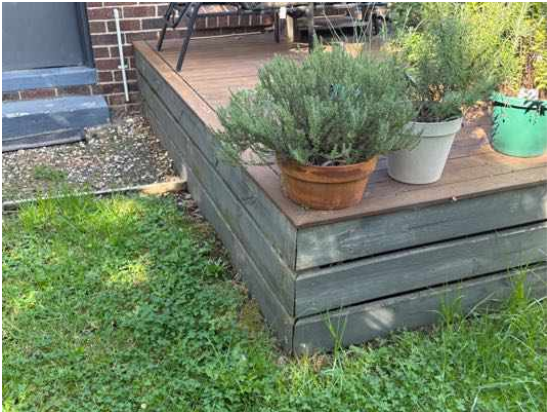
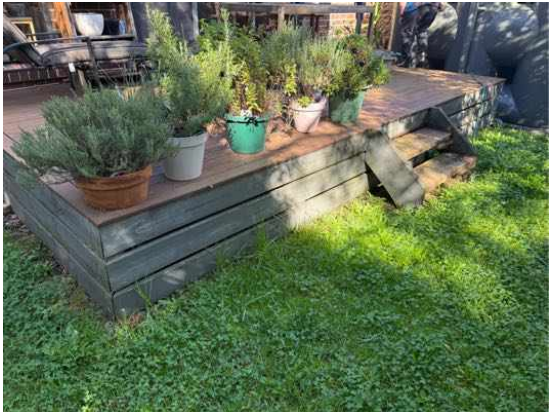
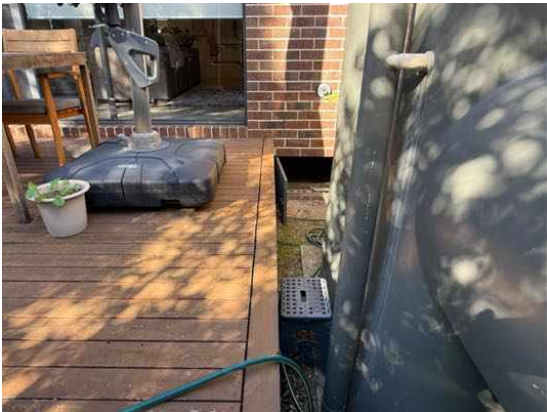
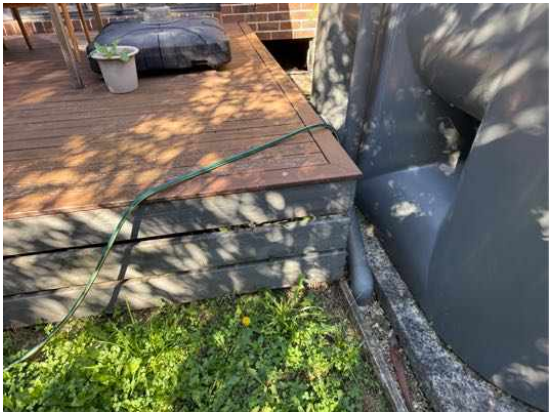
Building: Building 1
Location: All Areas > All Areas
Finding: Rear timber exposed to harsh weather conditions
Information: Rear external deck timbers that are frequently exposed to harsh weather conditions require adequate protection in order to maintain their condition and protection. Where timbers have not been painted or treated adequately, general deterioration is likely to occur at an accelerated rate. If left unattended, replacement of these timbers is likely to be necessary in the future. Adequate treatment of these timbers is a must and required if these deck timbers are to remain in a good condition. In the future client may elect to appoint a painting contractor to ensure deck are remains in a good condition.

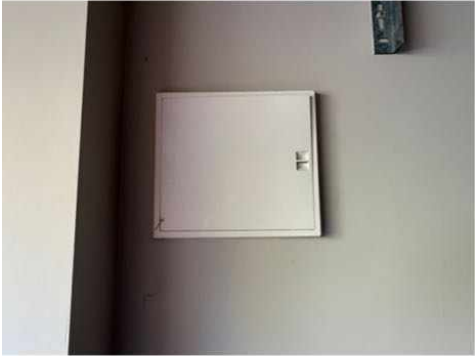
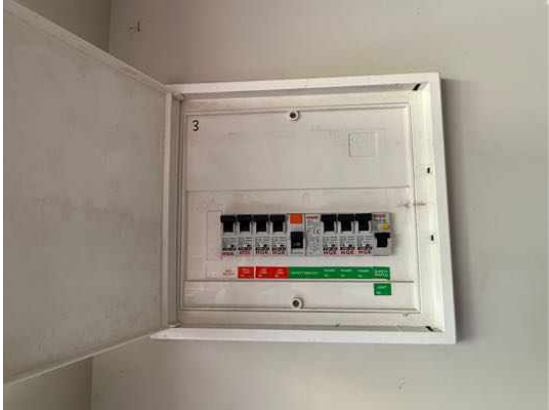
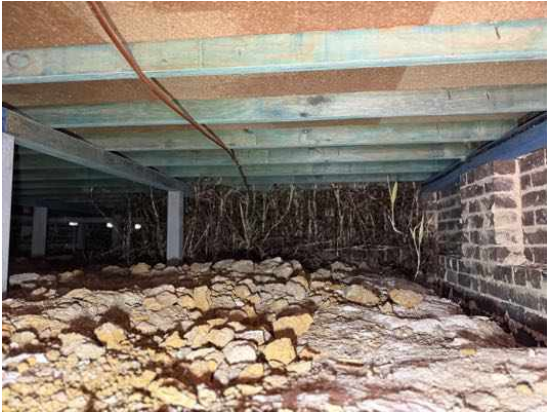
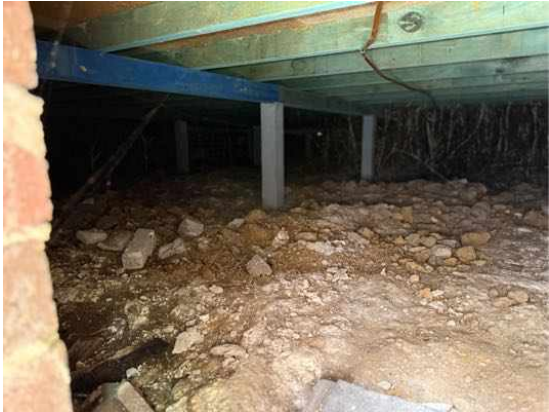
Building: Building 1
Location: All Areas > All Areas
Finding: Termite Management System - no evidence of a chemical installation or durable notice
Information: At the time of the inspection no application of a chemical termite barrier or durable notice was observed. Such barriers are highly effective and highly recommended for all properties in preventing termite attack on any timber building elements throughout the property.

A durable notice should be placed in the switchboard unit or in the another accessible area to indicate current termite barriers. At the time of inspection, no evidence to suggest preventative works taking place. The client may consider gaining further advice from builders or a pest controller and as to the costs and procedures involved with this application. It is recommended that obtaining such advice be a short-term priority.
