# Building Inspection Report

Inspection Date: Fri, 23 Jan 2026

Property Address: 26 Murdoch Ct, Sunbury VIC 3429,  
Australia

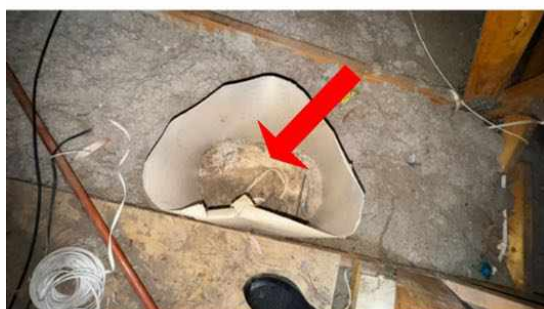
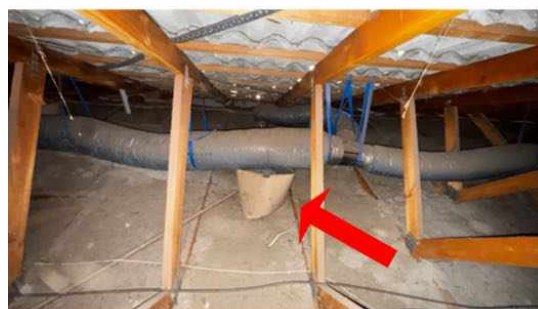
#### Defects 1.01

Building:	Main Building
Location:	Roof Void >
Finding:	Roof Void - Electrical - Downlight Fittings Wrapped With Debris
Information:	Downlight fittings within the roof space were observed to be covered with debris. This is an unsafe condition, as combustible materials in close proximity to light fittings can increase the risk of overheating and fire.

This condition may have resulted from insulation contact.

A licensed electrician should be engaged immediately to remove the debris and assess the downlight installation. The fitting should be made safe, which may include installing an appropriate fire-rated downlight cover or replacing the fitting to ensure safe operation and reduce fire risk.

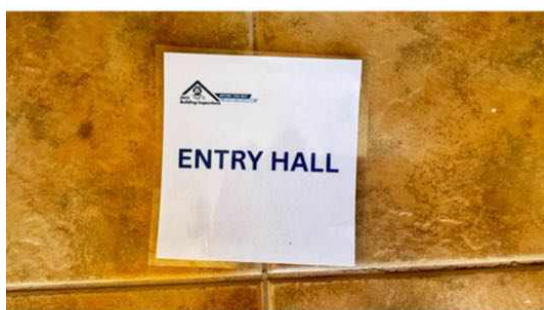
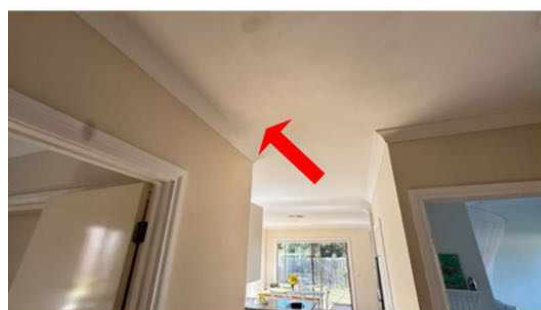
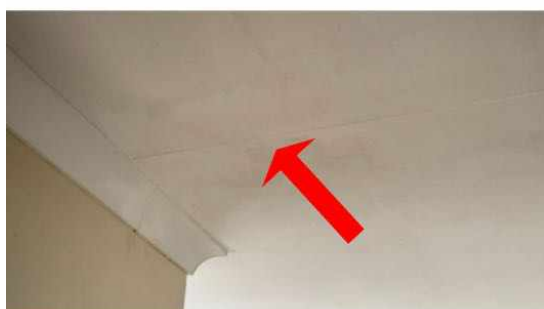
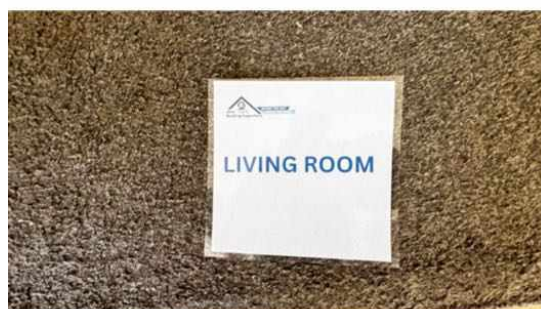
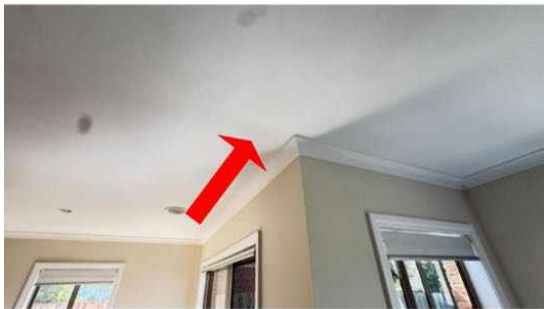
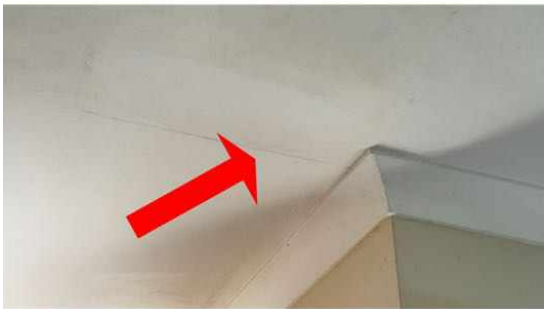
#### Defects 3.01

Building:	Main Building
Location:	All Areas
Finding:	Ceilings - Plaster Cracking
Information:	The ceilings were inspected and cracking in the plaster was observed in this area. Cracks can affect the appearance of the ceilings and may worsen over time if left

When practical, a qualified plastering contractor should be engaged to assess and repair the cracked plaster. Prompt action will improve the appearance of the ceilings and help prevent further deterioration.

Cracking should be monitored over time to determine whether movement is ongoing. Where cracks are purely cosmetic, patching and repainting by a qualified plasterer may be undertaken as part of routine maintenance. If cracks widen, reappear after repairs, or are accompanied by other structural signs, further investigation by a registered builder or structural engineer is recommended immediately.

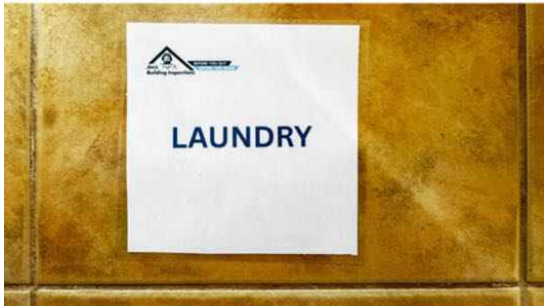
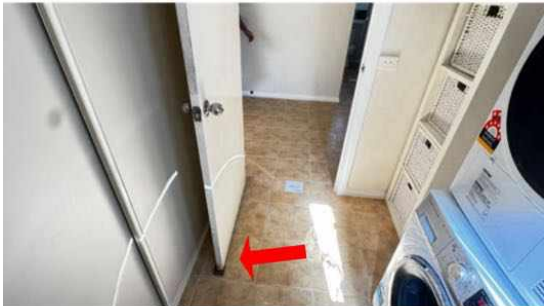
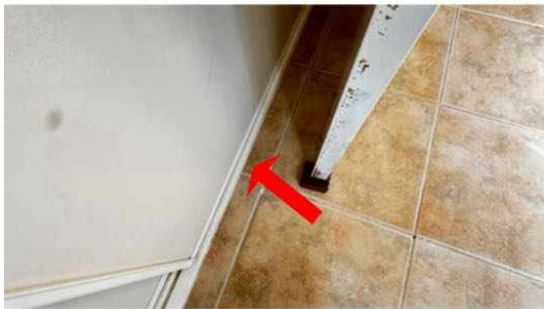
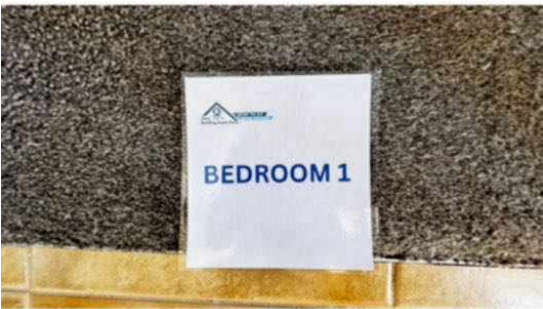
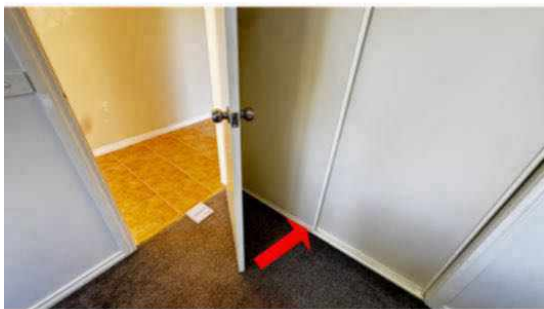
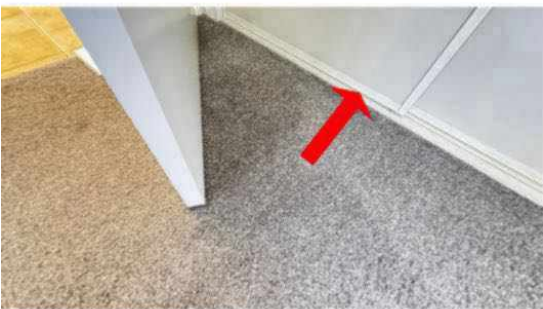
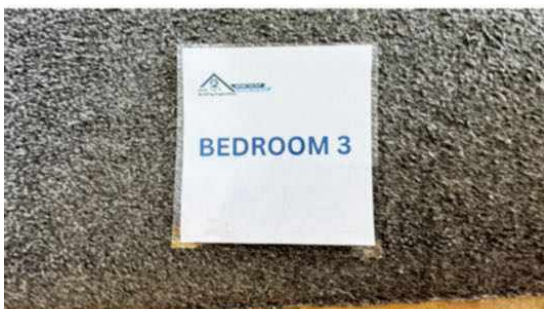
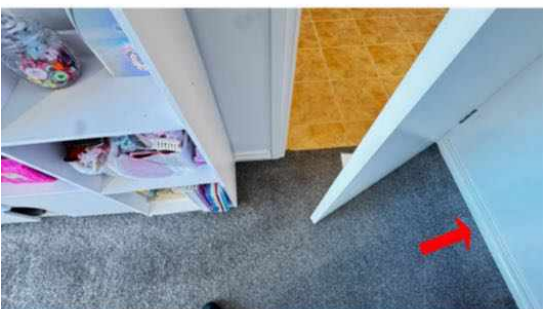
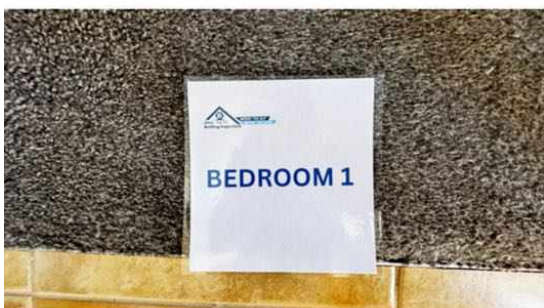
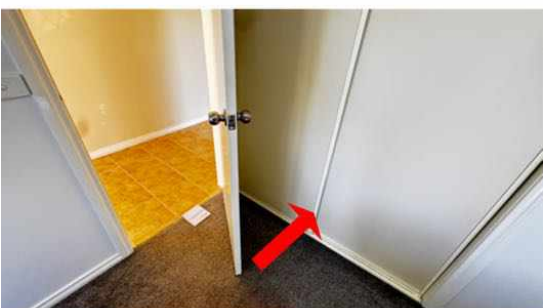
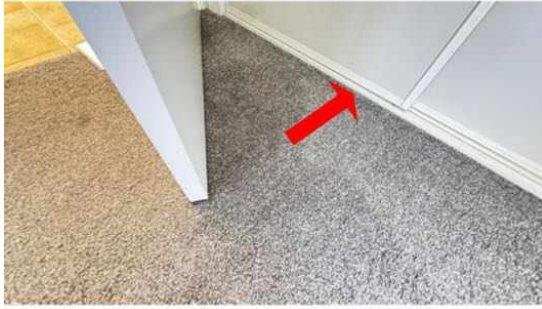
**Defects 3.02**

Building: Main Building  
Location: All Areas >  
Finding: Doors - Missing Door Stops  
Information: The inspection identified missing door stops in this area. Missing door stops can lead to damage to walls or doors and may impair the proper operation of the doors.

The absence of door stops may be due to them not being installed during construction or having been removed after installation.

It is recommended that a qualified carpenter or competent handyman be engaged promptly to install the missing door stops. Correct installation will protect doors and walls and ensure proper door functionality.

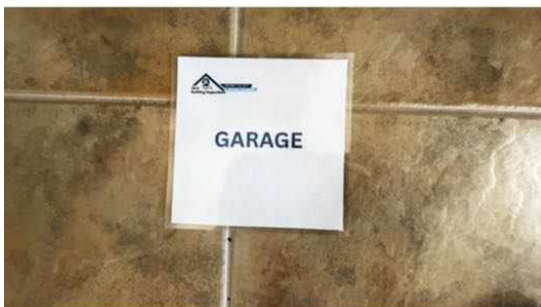
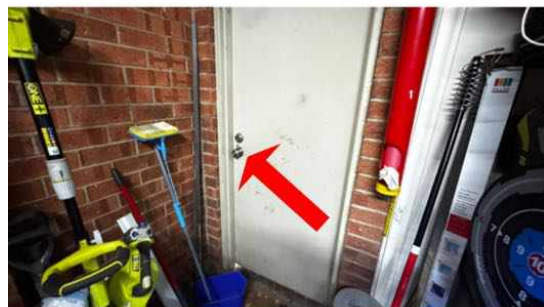
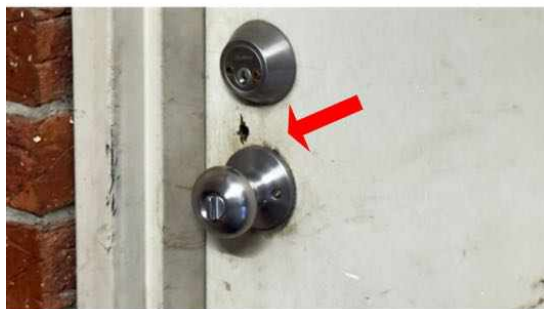
### Defects 3.03

Finding: Doors - Damaged Doors

Information: The inspection identified doors with visible damage, including cracks, dents and splits. The damaged doors may affect operation, convenience, security, weatherproofing, and appearance.

The damage appears to be caused by age-related wear, poor maintenance such as inadequate painting or sealing, and minor structural movement affecting door alignment.

When practical, a qualified carpenter or door specialist should be engaged to repair, replace, or refinish the damaged doors. Prompt rectification will ensure safe operation, maintain security, and protect weatherproofing.

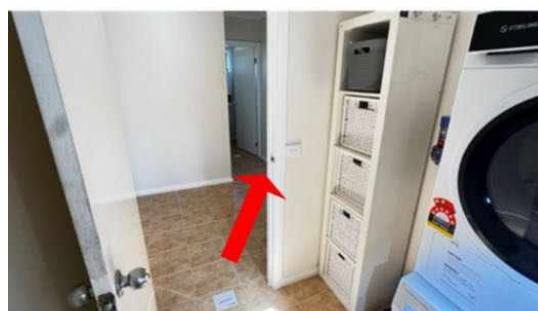
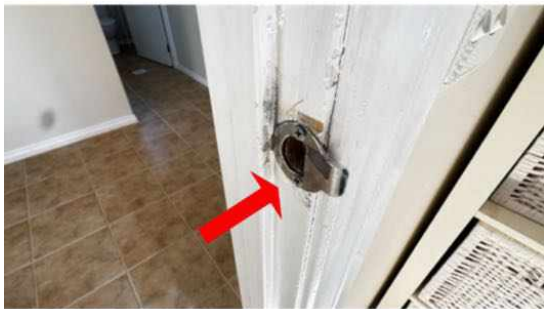
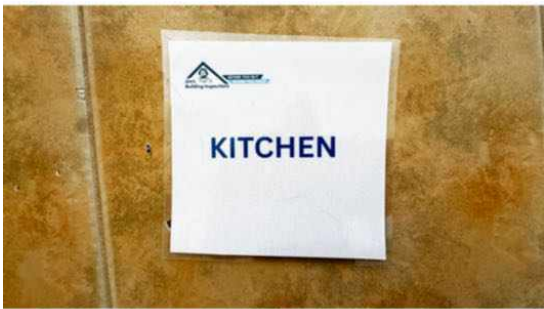
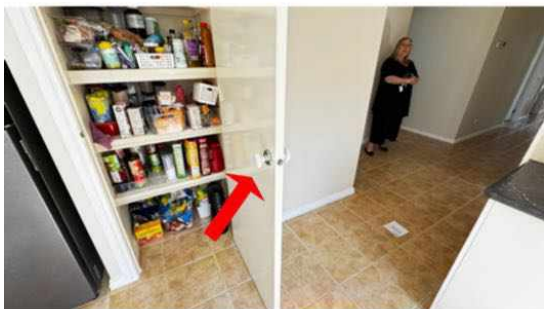
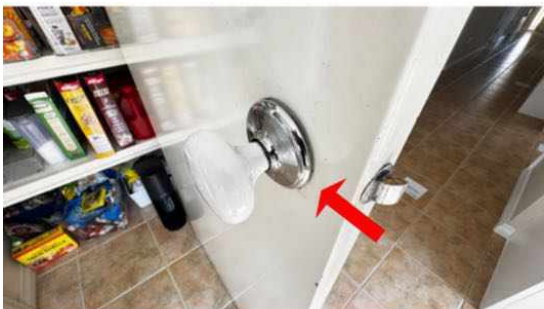
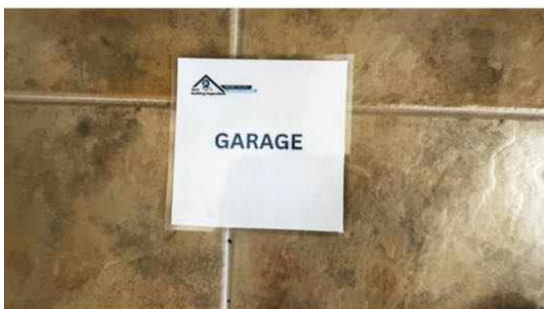
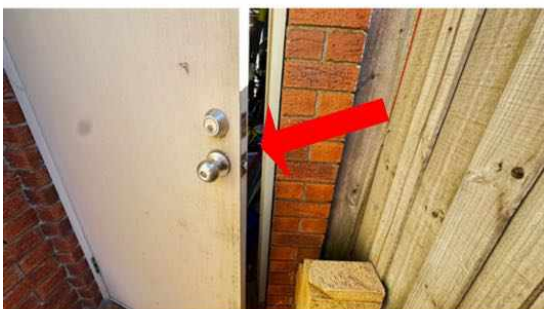
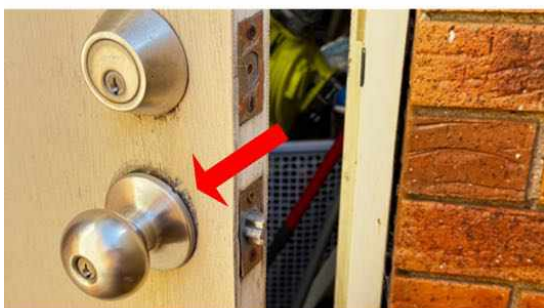
### Defects 3.04

Building:	Main Building
Location:	All Areas >
Finding:	Fittings - Loose
Information:	Fittings were observed to be loose and inadequately secured to walls in this area, moving when light pressure was applied. This reduces usability and may cause further damage if not addressed.

Common causes include incorrect or inadequate fixings, use of anchors unsuitable for the wall type, movement of the wall or timber substrate, wear from repeated use, or improper installation.

If left unresolved, loose fittings may detach, damage wall finishes, or cause progressive deterioration of both fittings and surrounding surfaces.

When practical, a qualified carpenter or experienced handyman should be engaged to securely refix or replace all loose fittings using appropriate fixings and methods for the wall type. The fittings should be monitored over time to ensure they remain secure.

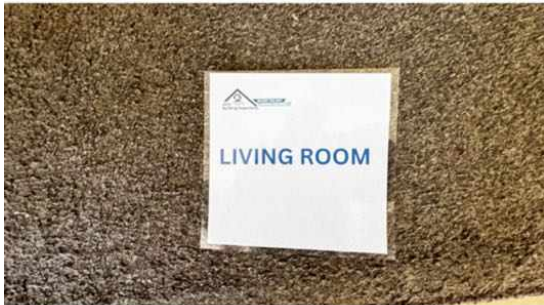
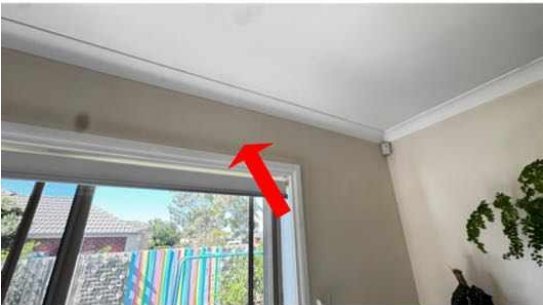
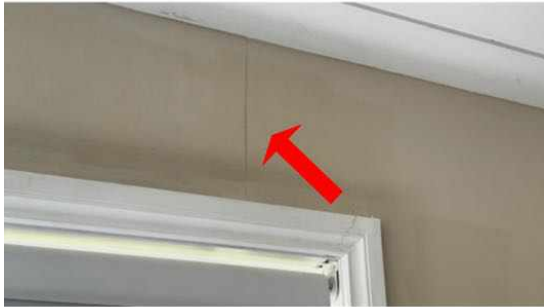
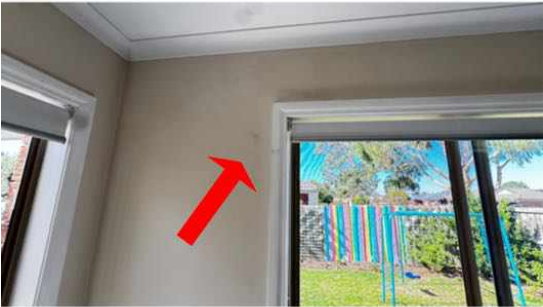
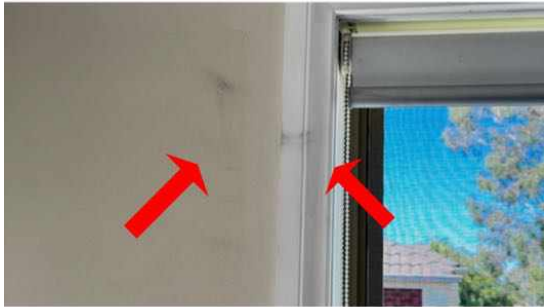
Defects 3.05

Building: Main Building  
Location: All Areas  
Finding: Walls - Paint Finishes Discolouration  
Information: The walls were inspected for paint condition, and discolouration was observed in this area.

While primarily a cosmetic issue, the affected paint may indicate age-related wear, poor surface preparation, or previous repairs.

When practical, a qualified painter should be engaged to prepare and repaint the affected areas. Addressing paint deterioration will improve the appearance of the ceilings and help protect the surfaces from further wear.

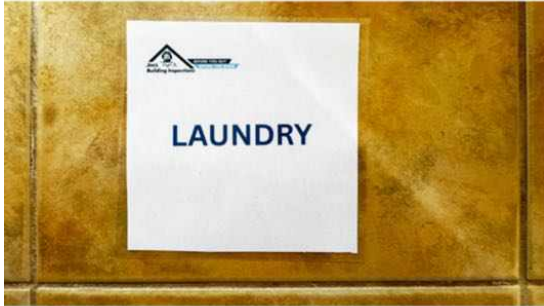
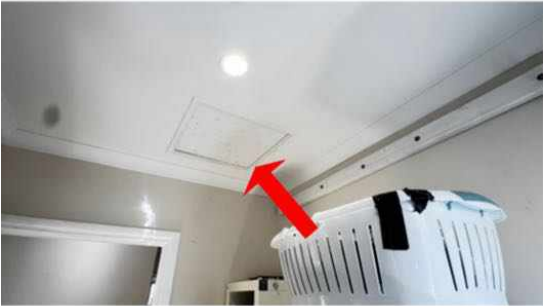
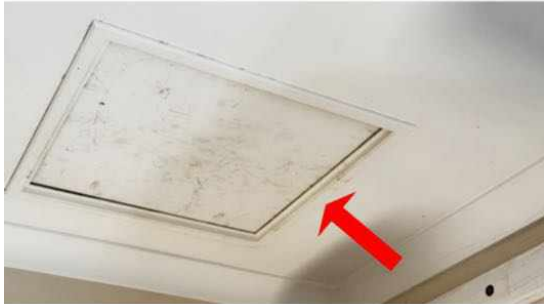
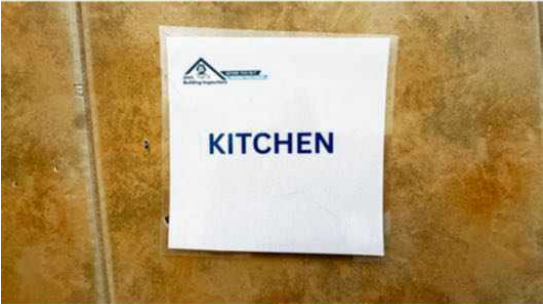
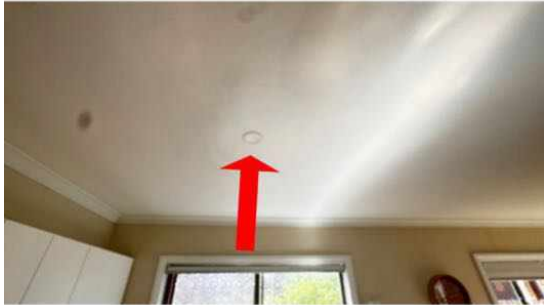
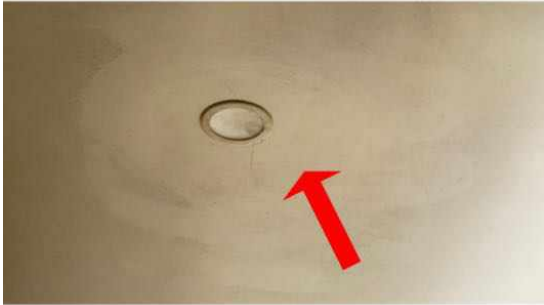
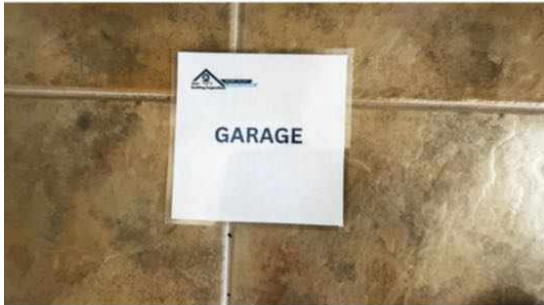
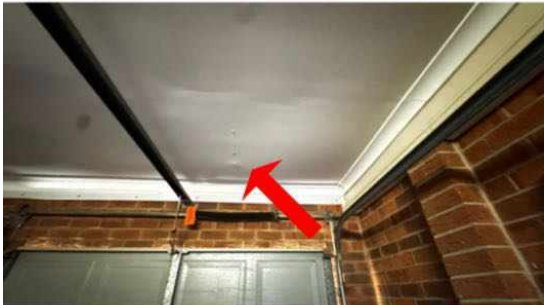
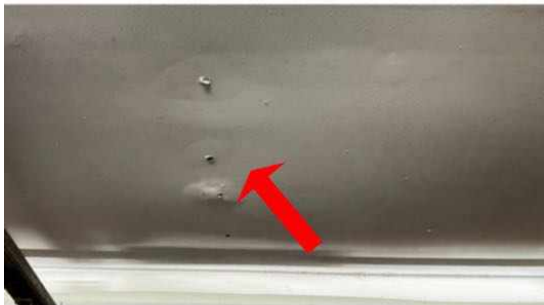
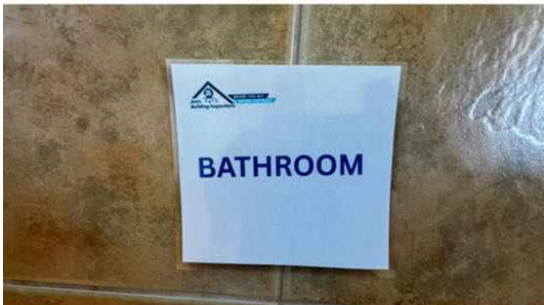
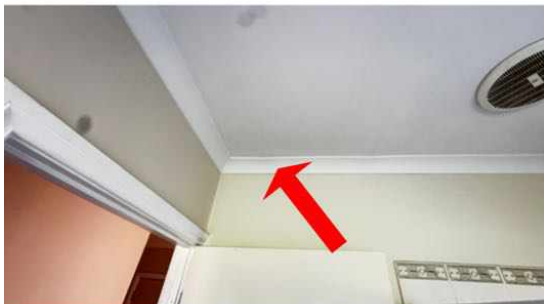
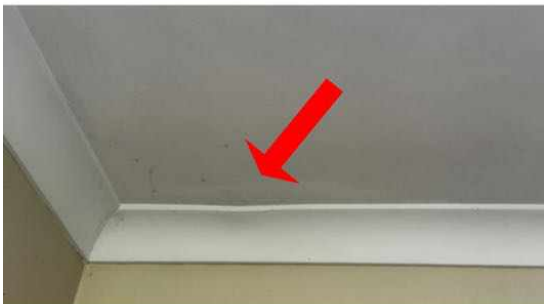
**Defects 3.06**

Building: Main Building  
Location: All Areas >  
Finding: Ceilings - Paint Finishes Discolouration  
Information: The ceilings were inspected for paint condition, and discolouration and uneven finishes were observed in this area. While primarily a cosmetic issue, the affected paint may indicate age-related wear, poor surface preparation, or previous repairs.

This may be due to age-related degradation of paint layers, poor application or surface preparation, or previous patching with incompatible paint.

When practical, a qualified painter should be engaged to prepare and repaint the affected areas. Addressing paint deterioration will improve the appearance of the ceilings and help protect the surfaces from further wear.

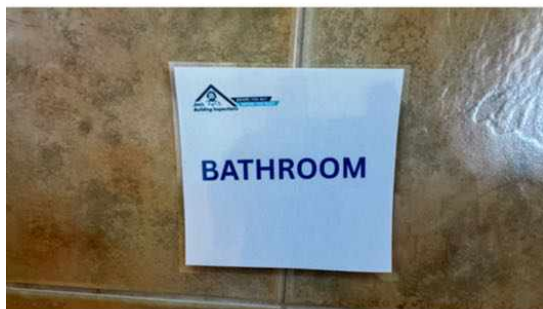
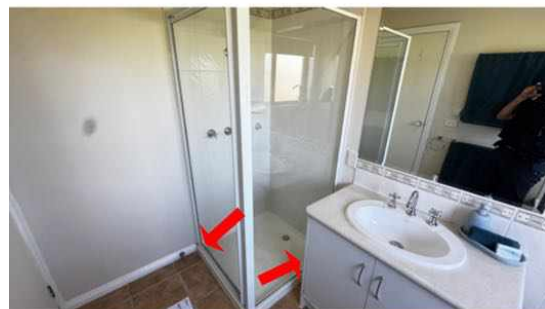
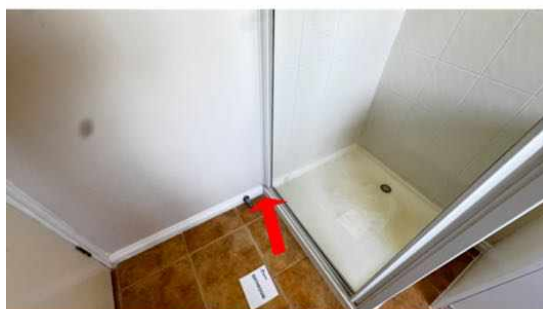
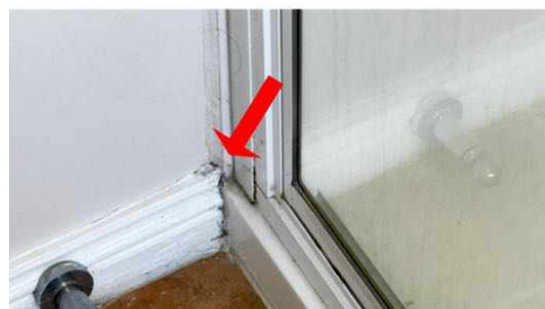
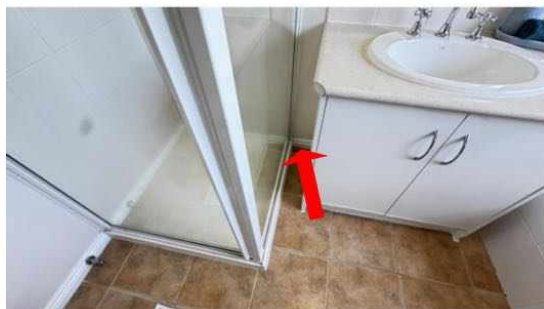
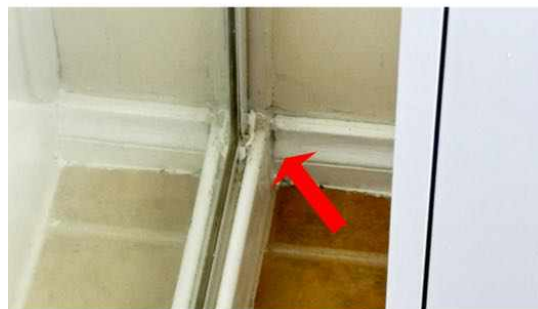
Defects 3.07

Finding: Shower Screen - Leaking - Inadequate Sealant

Information: The shower screen in this area was inspected, and water leakage was observed, which appears to be caused by inadequate or deteriorated sealant at joints and connections.

Defective sealant can allow water to escape the shower enclosure, leading to damage of surrounding floor finishes, wall linings, and potentially underlying structures. Prolonged leakage may also promote mould growth and compromise hygiene.

This condition may result from poor original installation, age-related deterioration of the sealant, or lack of maintenance.

A licensed plumber, qualified tiler, or bathroom specialist should be engaged immediately to remove any deteriorated sealant and reapply a compliant, waterproof seal. Prompt rectification will prevent water damage, maintain hygiene, and ensure the shower functions as intended.

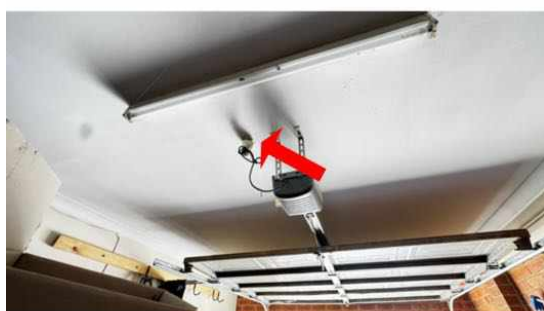
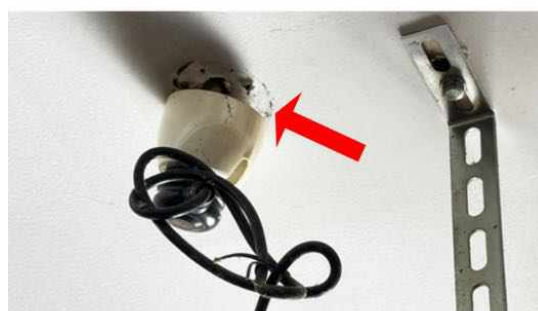
### Defects 3.08

Building: Main Building  
 Location: Garage  
 Finding: Electrical - Loose GPO  
 Information: A general power outlet (GPO) was observed to be loose in this area. Loose outlets can affect the safe operation of electrical devices and may pose a risk of electric shock or arcing if not addressed.

The looseness may be caused by wear and tear, improper installation, or movement of the outlet or wall cavity over time.

A licensed electrician should be engaged immediately to secure or replace the affected GPO. Prompt rectification will ensure safe operation and reduce the risk of electrical hazards.

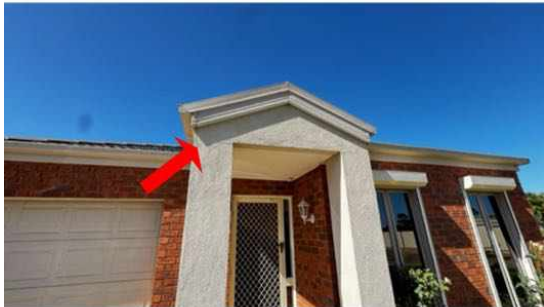
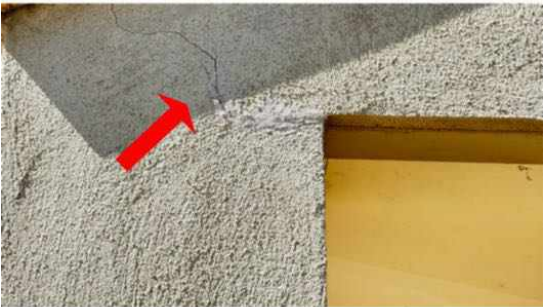
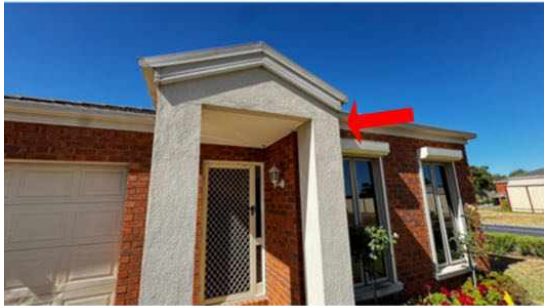
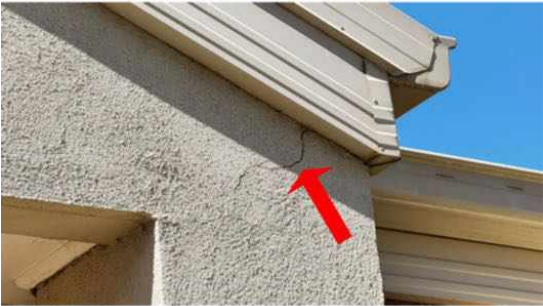
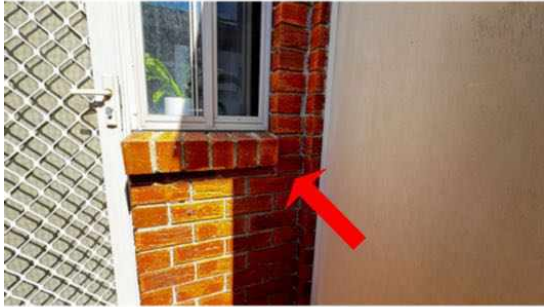
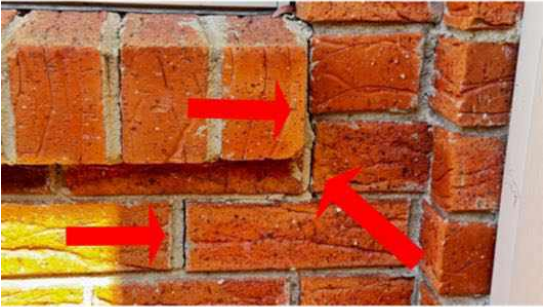
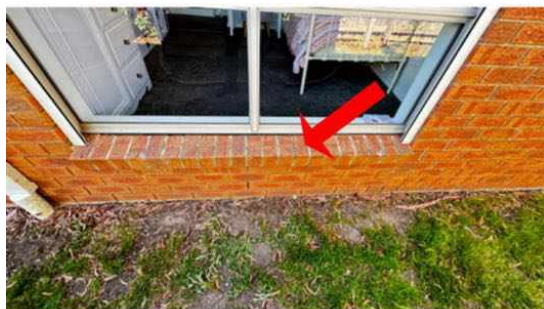
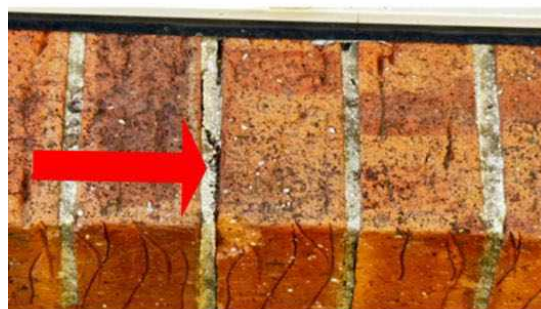
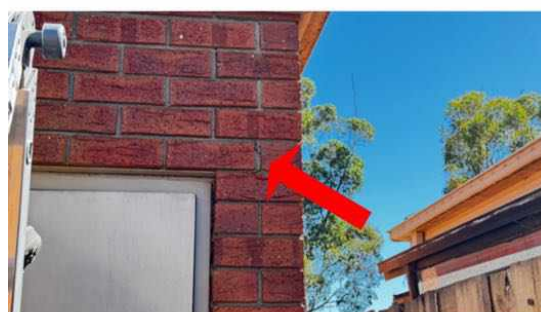
### Defects 3.10

Building:	Main Building
Location:	All External Areas >
Finding:	External Walls - Minor Cracking To Wall Claddings
Information:	Minor cracking was observed to the external walls in this area. The cracking appeared superficial and did not indicate significant structural movement; however, such cracking can allow moisture ingress if left unaddressed.

The cracking is likely due to building movement or minor settlement.

When practical, a registered builder should assess and repair the cracking, which may include sealing and repainting. The area should be monitored, and any increase in

cracking or signs of movement should be further investigated immediately by a Structural Engineer.

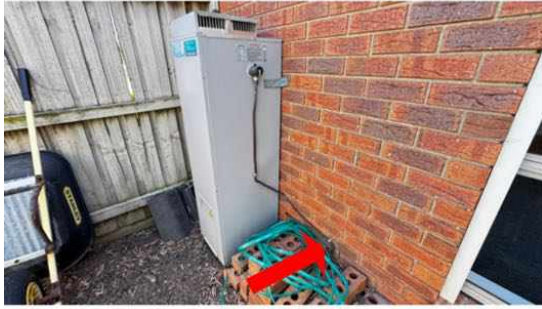
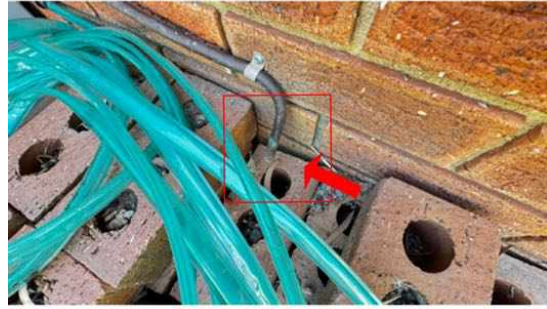
### Defects 3.11

Building:	Main Building
Location:	All External Areas >
Finding:	HWS - (T&P) Valve Not Connected To Storm Water
Information:	The Hot Water System (HWS) Temperature & Pressure Relief (T&P) valve discharge pipe was observed to be disconnected from stormwater drainage.

When not properly connected, discharged water can create damp conditions around the HWS, potentially leading to secondary defects such as timber rot, corrosion of nearby metal components, mould growth, or slip hazards. Prolonged exposure to moisture in this area may also attract termite activity and contribute to long-term deterioration of surrounding building elements.

A licensed plumber should be engaged immediately to connect the T&P discharge pipe to a suitable stormwater outlet or floor waste. Prompt rectification will ensure safe operation of the HWS, protect surrounding structures, and reduce potential health and safety risks.

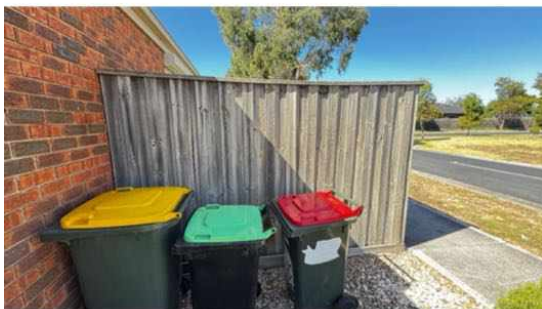
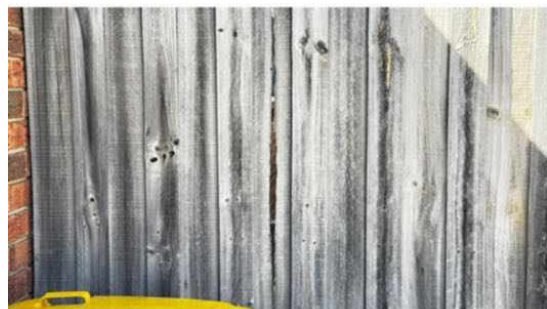
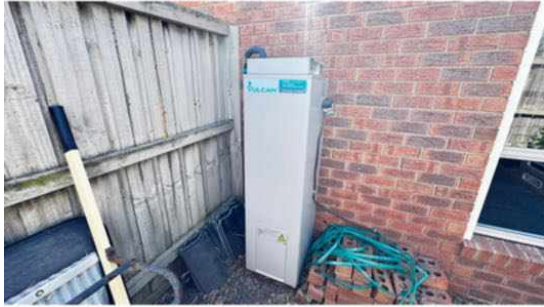
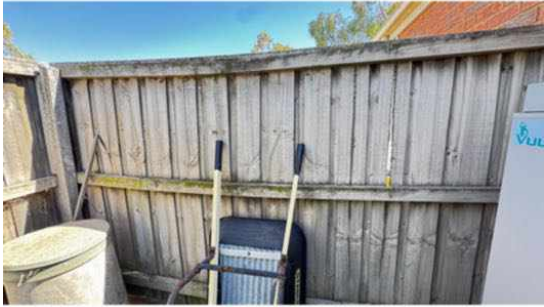
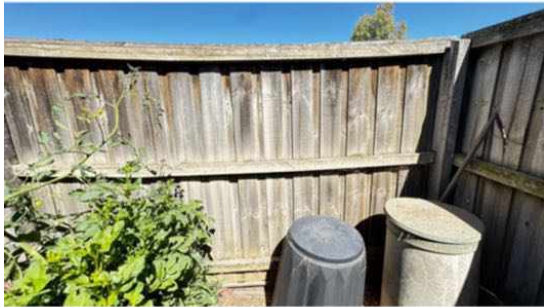
## Defects 3.12

Information: Timber fencing was inspected and deterioration was observed in this area. Deteriorated fencing can compromise structural stability, reduce privacy, and may allow pest ingress or accelerated decay if left unaddressed.

Possible causes include age-related timber decay, prolonged exposure to moisture or sunlight, poor maintenance, or impact damage.

When practical, a qualified carpenter or fencing specialist should be engaged to repair or replace affected sections, and a qualified painter should be engaged to restore protective finishes. Prompt rectification will maintain structural performance, improve appearance, and extend the lifespan of the fencing.

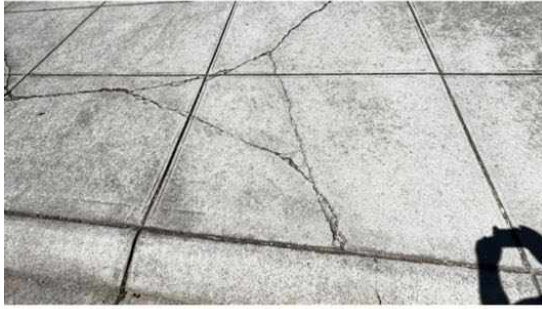
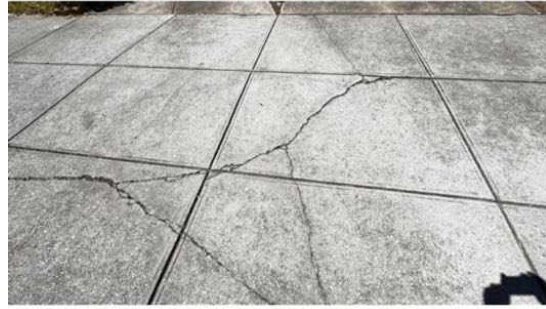
**Defects 3.14**

Building: Main Building  
Location: Driveway >  
Finding: Driveway - Minor Cracking & Surface Imperfections  
Information: The external driveway was visually inspected. Minor cracking, surface settlement, and minor unevenness was observed in this area. While these defects do not currently compromise structural safety, they may affect long-term durability, appearance, and vehicle access.

These issues may be caused by age-related wear, soil movement or settlement beneath the driveway, possible tree root intrusion, or inadequate original construction or reinforcement.

A qualified concreter should be engaged when practical to repair or resurface affected areas. Prompt rectification will restore a smooth surface, improve appearance, and prevent further deterioration.

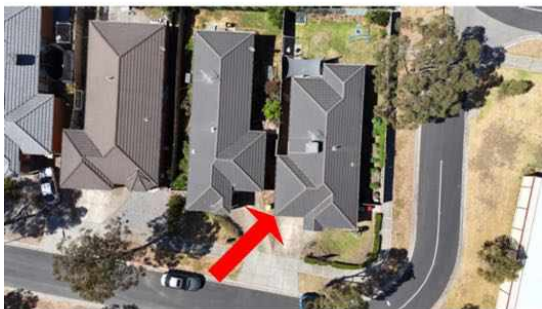
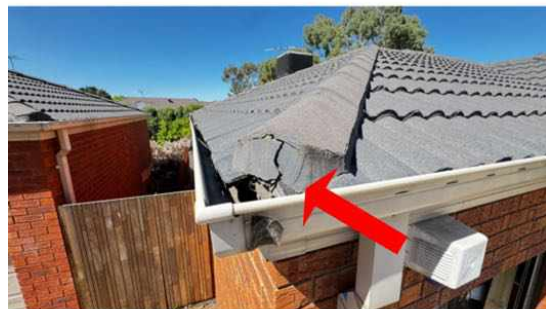
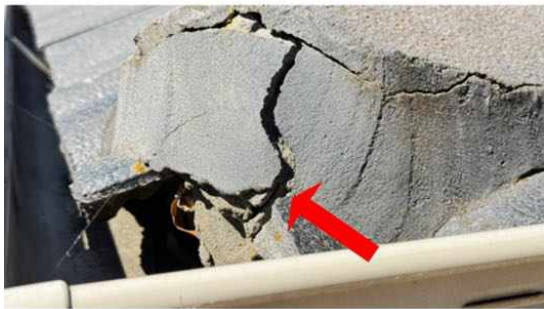
### Defects 3.15

Building: Main Building  
 Location: Roof Exterior  
 Finding: Roof Plumbing - Roof Tiles Mortar Cracked  
 Information: Cracking was observed to the mortar bedding and/or pointing to roof tiles in this area. Cracked mortar can allow water penetration, reduce the stability of ridge or hip tiles, and increase the risk of tile displacement during high winds.

The condition is commonly caused by age-related deterioration, thermal movement, and shrinkage of traditional sand and cement mortar.

A qualified roof tiler should be engaged as soon as possible to repair or re-bed and re-point the affected roof tiles using appropriate materials. Rectification will reduce the risk of water ingress, tile movement, and further deterioration of the roofing system.

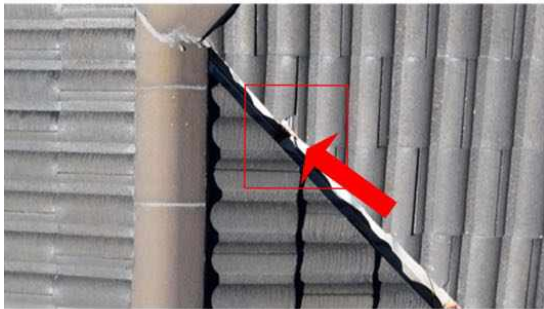
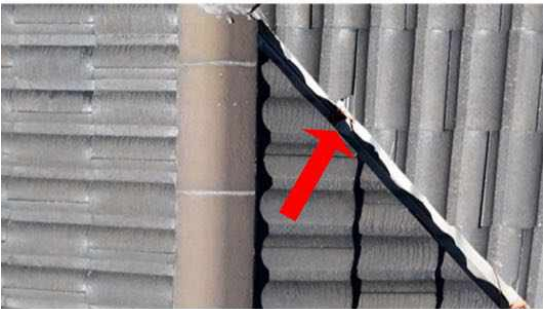
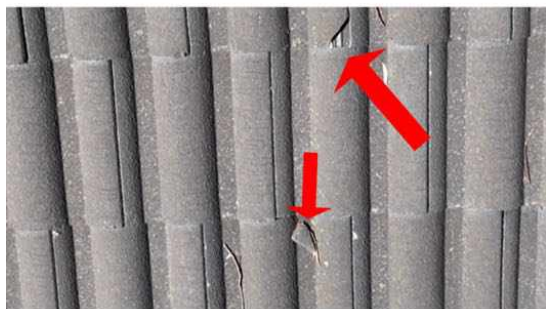
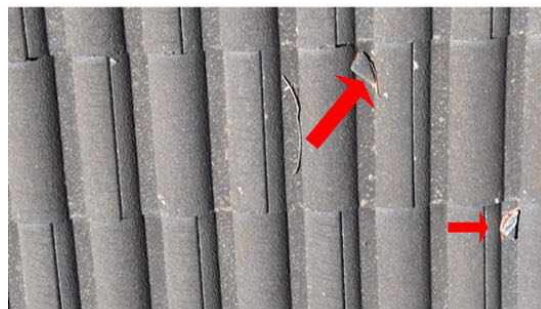
**Defects 3.16**

Building: Main Building  
Location: Roof Exterior  
Finding: Roof Plumbing - Roof Tiles Cracked  
Information: Roof tiles in this area are cracked and may no longer provide full protection. The issue is observed across the roof surface where damaged tiles are present.

This has likely occurred due to impact, weathering, or poor installation. Cracked tiles may allow water to penetrate, causing leaks, water damage to internal structures, or deterioration of surrounding tiles.

A licensed roof plumber is required to inspect and repair or replace the cracked tiles in this area. This should be rectified immediately to prevent water ingress and further damage.

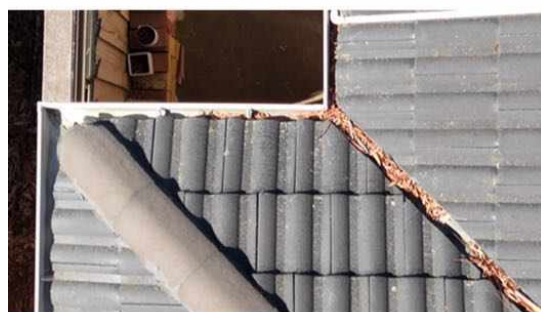
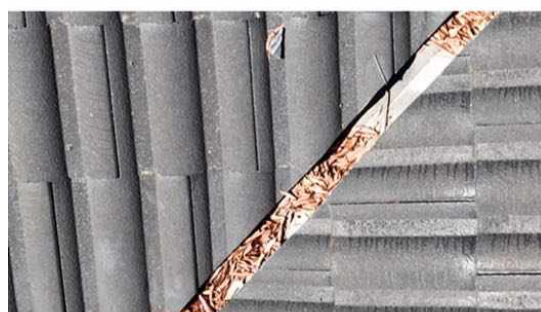
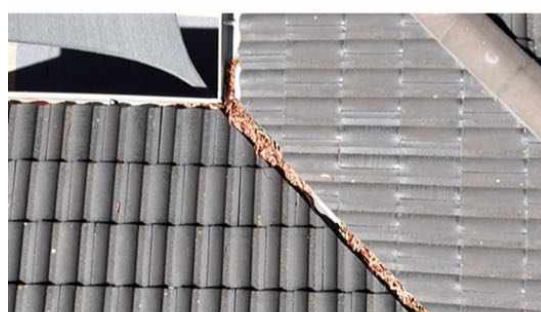
### Defects 3.17

Building:	Main Building
Location:	Roof Exterior
Finding:	Roof Plumbing - Gutters Blocked
Information:	Gutters in this area are blocked and not allowing water to flow freely. The issue is observed along the gutter runs where leaves, debris, or other obstructions have accumulated.

This has likely occurred due to lack of maintenance or build-up of debris over time. Blocked gutters may cause water to overflow, damage the roof, walls, or foundations, and increase the risk of erosion or water ingress.

A licensed roof plumber or competent handy man is required to inspect and clear the blocked gutters in this area. This should be rectified immediately to ensure water drains correctly and to prevent potential damage to the building.

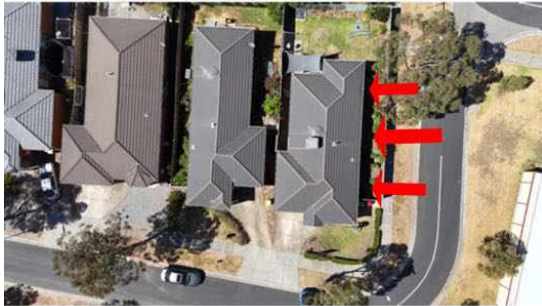
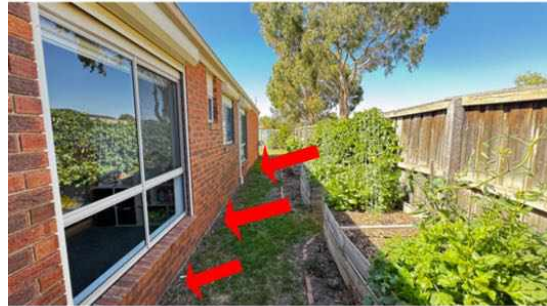
### Defects 3.18

Finding: Site Drainage - Inadequate

Information: The overall site drainage was observed to be inadequate at the time of inspection. Poor drainage can cause water to pond near external walls, increasing the risk of rising damp, foundation movement, timber decay, and deterioration of associated building elements.

directed away from the property through adequately sized and maintained drains. Where ground levels are too high and cover the damp-proof course (DPC), lowering the levels may be necessary to expose the DPC and allow effective drainage.

A licensed plumber should be engaged promptly to investigate and recommend suitable remedial works, which may include the installation of an agricultural (aggie) drain or other site drainage improvements. Immediate action is strongly recommended, as inadequate drainage can lead to progressive water damage and secondary building defects over time.

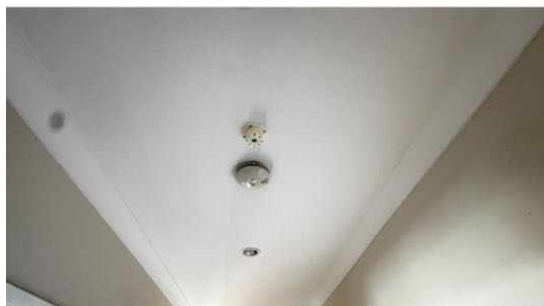
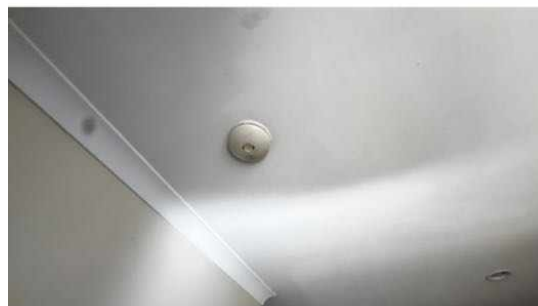
Building: Main Building  
 Location: All Internal Areas  
 Finding: Smoke Detectors - Advisory  
 Information: During the inspection, smoke detectors were noted for advisory purposes only. The operation, age, type, and compliance of smoke detectors could not be fully verified as part of this inspection.

Smoke detectors are critical life-safety devices, and non-compliant, outdated, or non-operational units may not provide adequate warning in the event of a fire.

It is recommended that a licensed electrician be engaged immediately to test, service, and upgrade smoke detectors as required to ensure correct operation and compliance with current safety requirements.

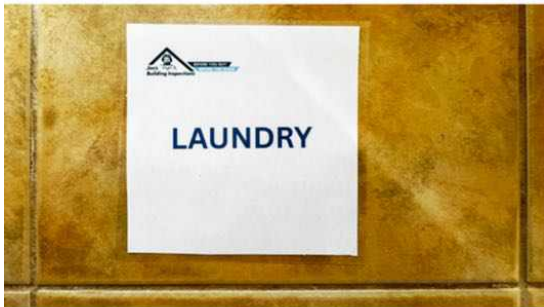
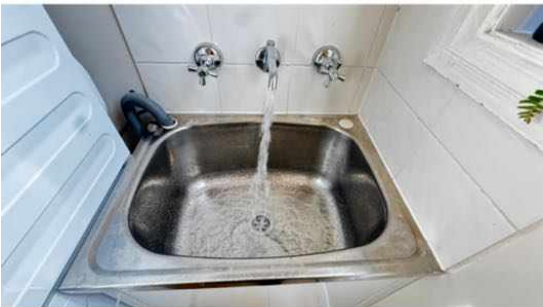
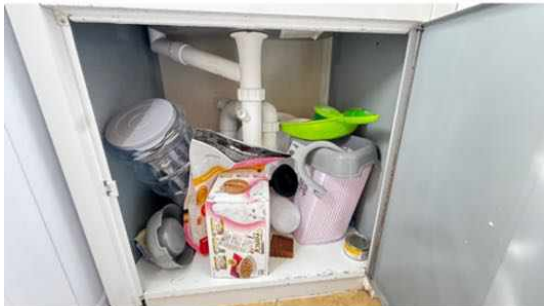
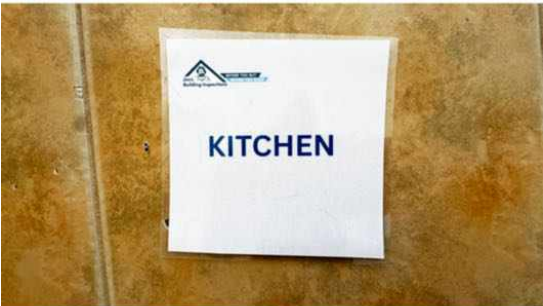
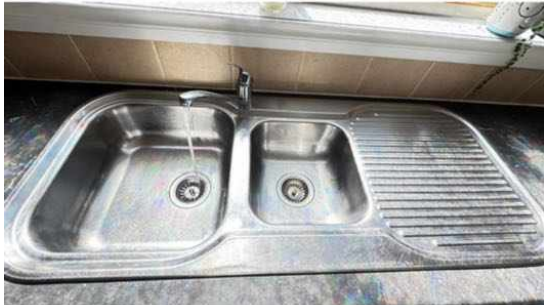
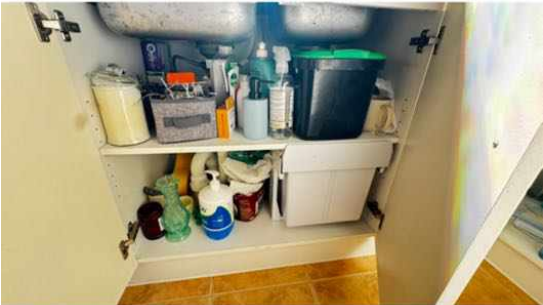
Building: Main Building  
 Location: All Internal Areas  
 Finding: Water Supply & Drainage - Shower, Basins, Toilets, & Plumbing Fixtures  
 Information: The shower recess was tested, and no visible water penetration to surrounding areas was observed at the time of inspection, except where noted as a separate defect elsewhere in this report. Water appeared to flow freely toward the floor waste. Moisture detected to the shower walls is documented separately in the report. The shower floor waste appeared clear during inspection.

Flushing the toilet revealed no visible leaks, and the fixture appeared to operate normally unless otherwise noted as a separate defect. No water damage was observed to the vanity unit unless specifically stated elsewhere in the report. Basins,

bathtubs, laundry tubs, vanities, and sinks were tested and inspected with no evidence of leaks, blockages, or drainage issues at the time of inspection unless otherwise noted. All internal taps and shower heads were tested with no leaks observed, unless documented as a separate defect.

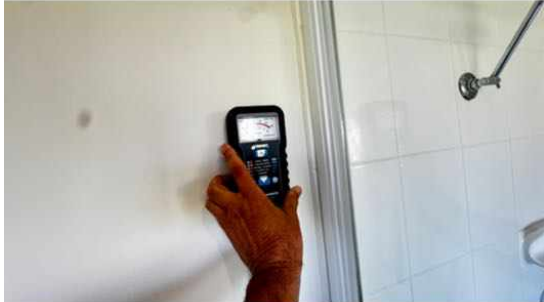
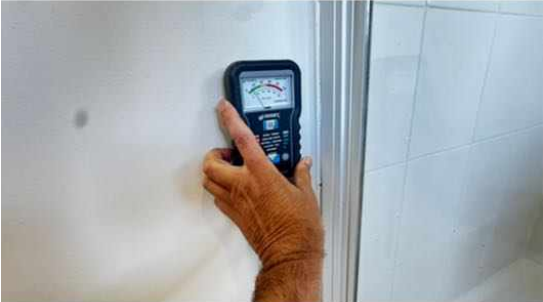
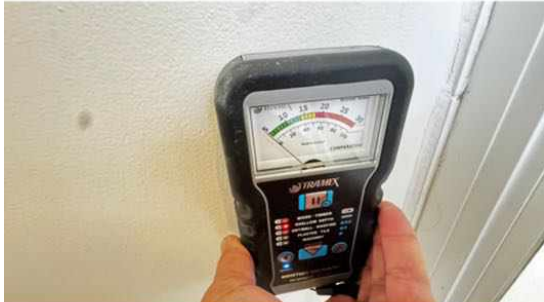
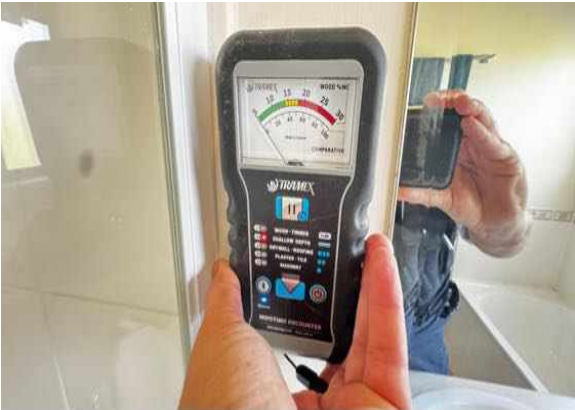
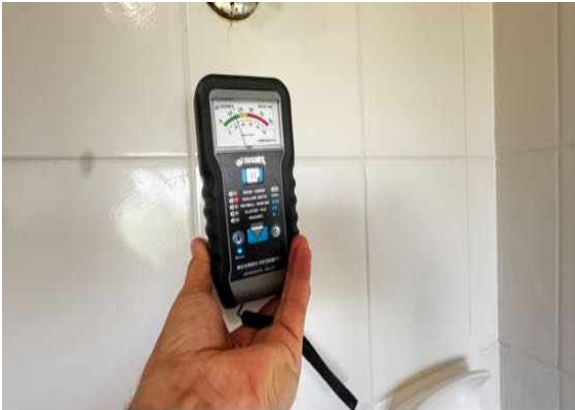
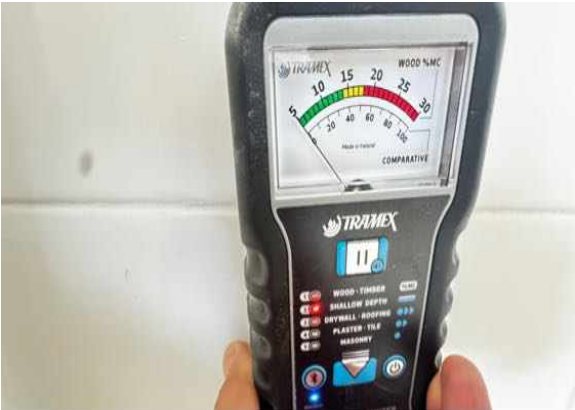
Building: Main Building  
 Location: All Areas Interior & Exterior  
 Finding: Moisture Levels - Advisory - No Elevated Moisture Levels Present  
 Information: At the time of inspection, no elevated moisture levels were detected in these areas. Moisture readings were taken (using a Tramex Moisture Meter) and non-invasive testing methods and reflect conditions present at the time of inspection only. This item is noted for advisory purposes and should not be relied upon as a guarantee that moisture issues are not present elsewhere or may not occur in the future.

Ongoing monitoring of the property is recommended, and further investigation by a qualified tradesperson should be considered if signs of water ingress, dampness, staining, mould growth, or material deterioration become apparent.
