# Building Inspection Report

Inspection Date: Fri, 23 Jan 2026

Property Address: 26 Murdoch Ct, Sunbury VIC 3429,  
Australia

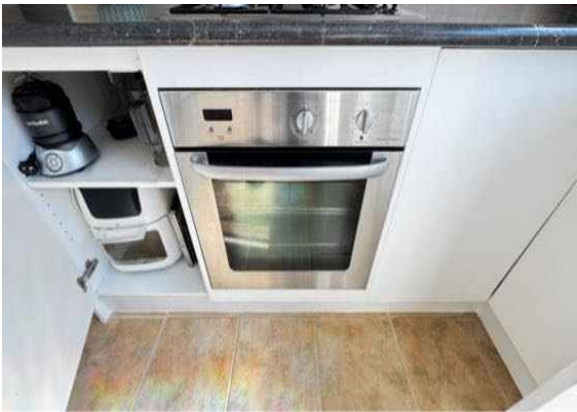
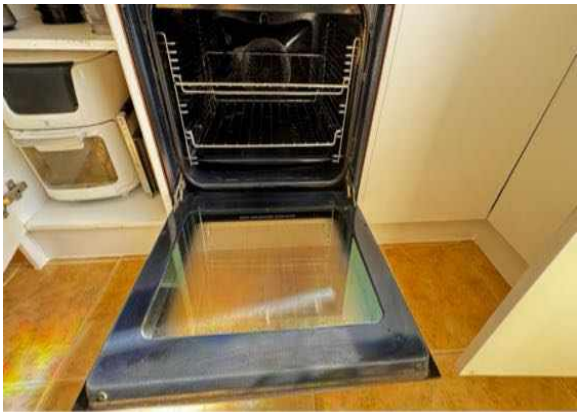
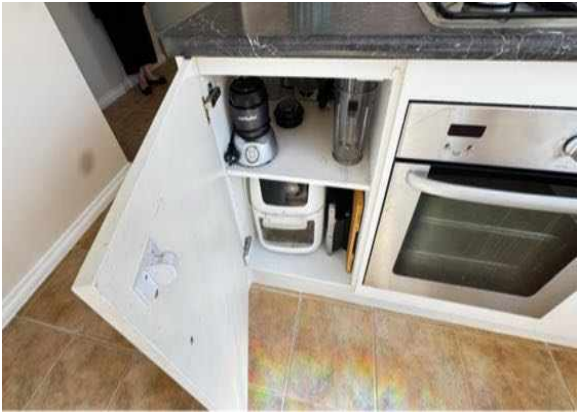
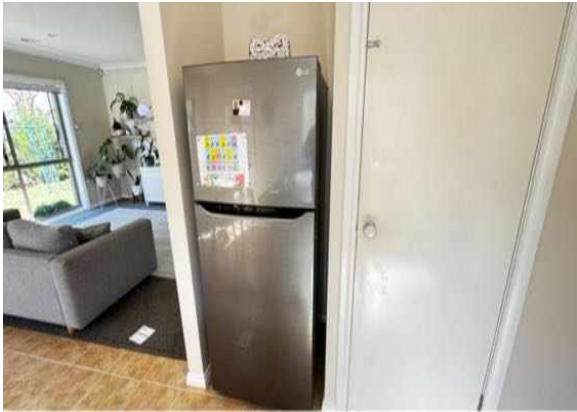
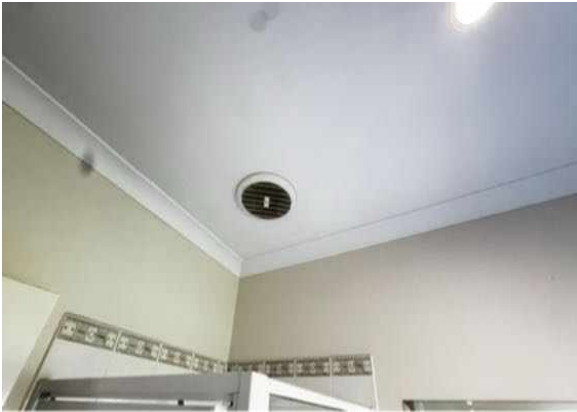
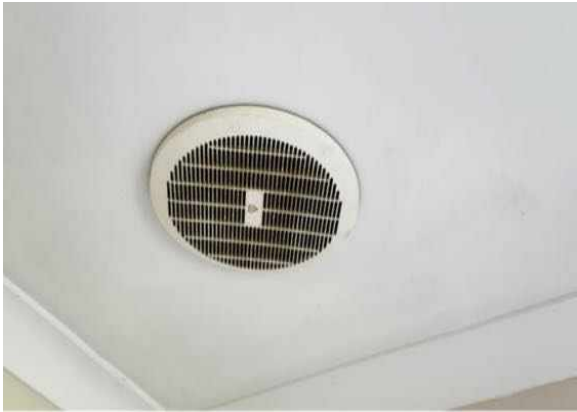
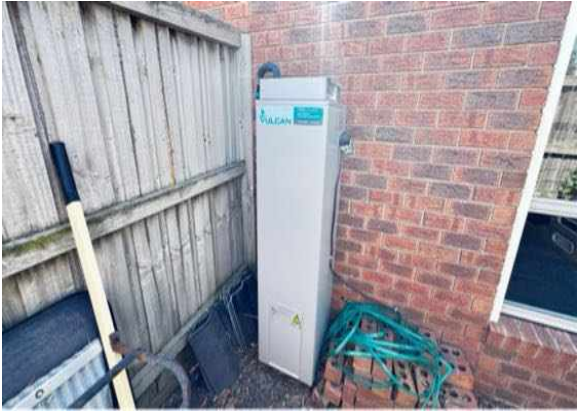
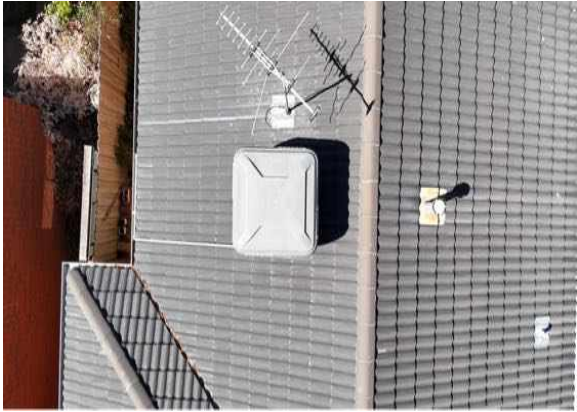
Building:	Main Building
Location:	All Areas, Interior & Exterior
Finding:	Appliances, Heating & Cooling Systems, Mechanical Systems, Plumbing, Electrical, Fireplaces - Advisory
Information:	The inspection did not include testing, operation, safety, or assessment of any installed or portable appliances or mechanical systems. This includes, but is not limited to, ovens, cooktops, microwaves, rangehoods, dishwashers, ducted vacuum systems, air-conditioning units, heating systems, hot water services, ceiling fans, exhaust fans, intercoms, security systems, fireplaces, and solid fuel heaters.

Appliances may be worn, damaged, or malfunctioning. Electrical or gas appliances can pose serious safety hazards if incorrectly installed or maintained.

Observations and images of appliances are for informational purposes only and do not form part of the formal building inspection.

Service, repair, or replace equipment as necessary, particularly where service history or warranty coverage is unknown.

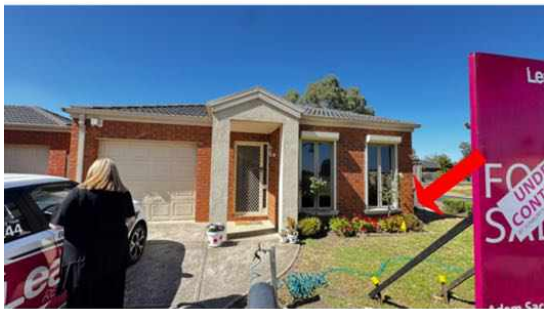
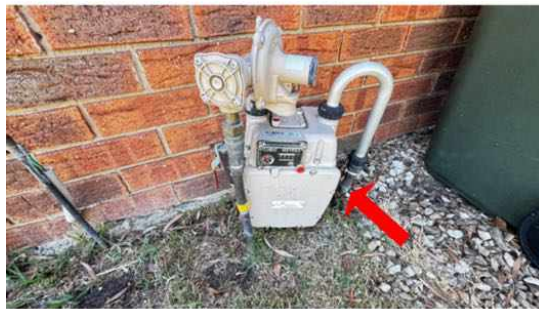
Gas meters can be affected over time by age, environmental exposure, or accidental impact, which may lead to corrosion, physical damage, leakage, or non-compliance with current regulations. Regular checks are recommended to ensure ongoing safe operation.

(AS 4349.1–2007: Gas meter images are for your information only, as functional testing is outside the scope of a standard pre-purchase building inspection.)

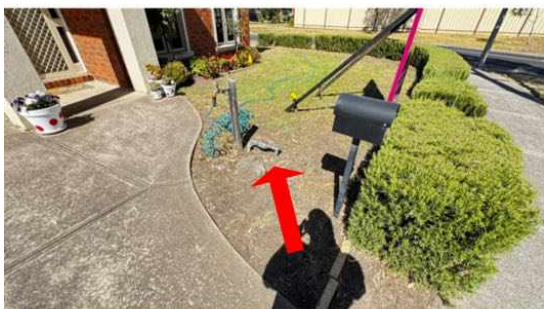
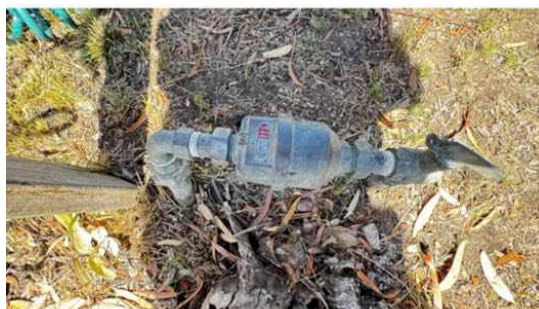
Building:	Main Building
Location:	All External Areas
Finding:	Water Meter - Location For Your Information Only
Information:	The water meter was photographed at the time of the inspection. The meter is included for reference & location purposes only.

Water meters can be affected over time by age, environmental exposure, accidental impact, or poor maintenance. Potential issues could include leaks, corrosion, or malfunction that may impact water supply or cause water damage.

It is recommended that a licensed plumber carry out routine inspections and maintenance to ensure continued safe and compliant operation. Observations are for informational purposes only and do not form part of a full safety or compliance inspection.

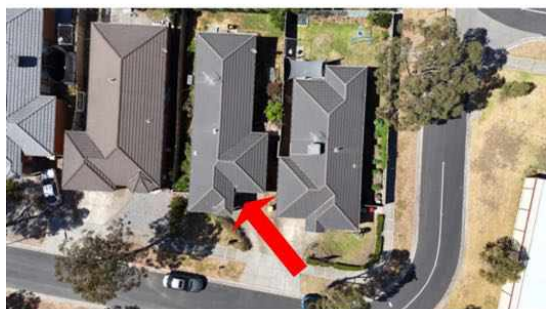
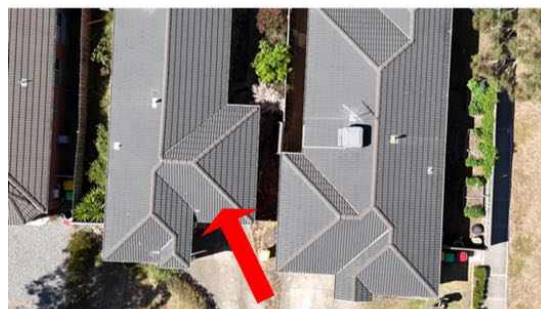
(AS 4349.1-2007: inspection of neighbouring properties is not included in standard pre-purchase building inspections; this statement is for your information only.)

Recommendation: For concerns regarding noise, encroachments, or structural issues affecting neighbouring properties, it is recommended to engage relevant specialists (e.g., acoustic consultant, building surveyor, or a registered builder) and/or contact the local council.

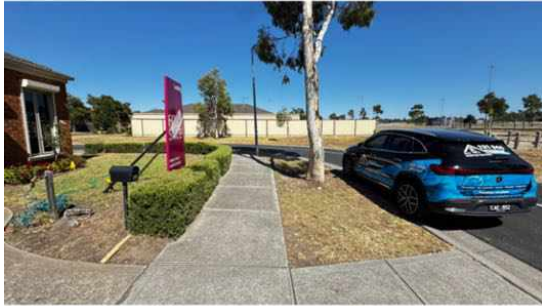
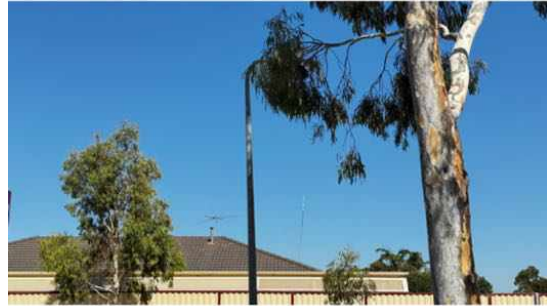
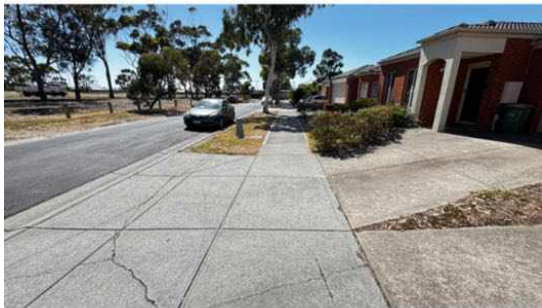
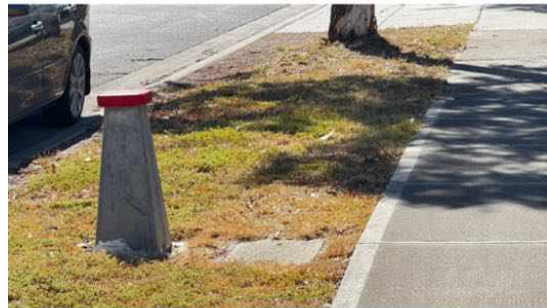
During the inspection, minor cracking, surface wear, or uneven sections were observed on footpaths or crossovers. Some accessible metal components, such as street signage or grates, showed signs of rust or deterioration. Debris accumulation and vegetation encroachment were also noted around council infrastructure. Access or visibility was limited to certain council-owned assets.

immediately. Regular monitoring of adjacent council assets is recommended to ensure ongoing safety and proper maintenance.

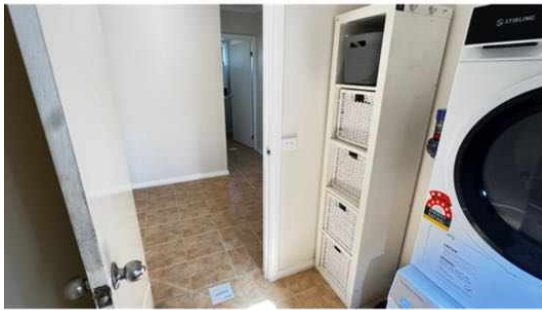
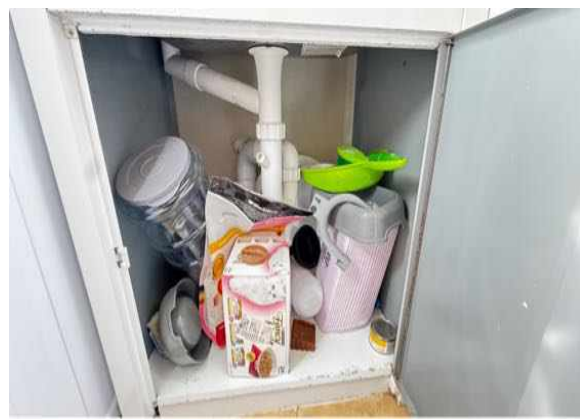
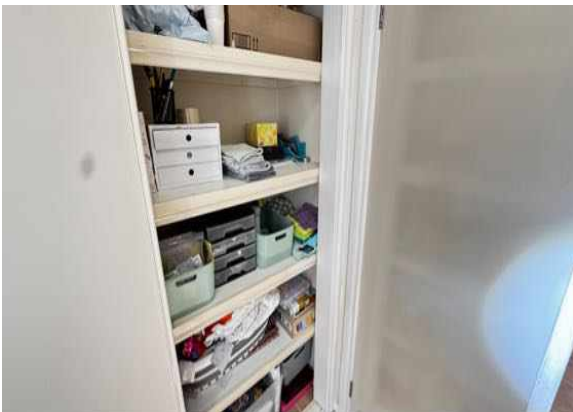
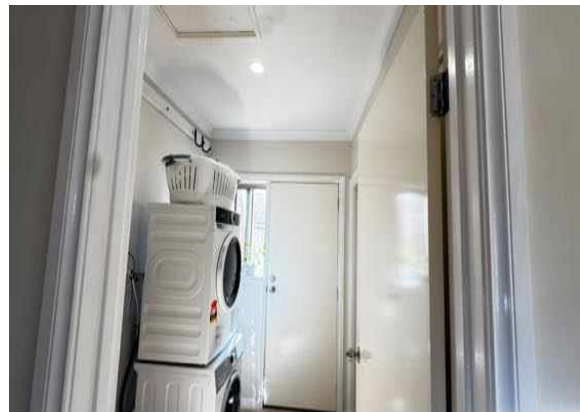
It is important to note that these restrictions can conceal a wide range of building defects, including but not limited to:

Because these areas could not be visually assessed, no comment can be made on their condition within this report.

It is strongly recommended that obstructions be removed and concealed areas made fully accessible immediately. A re-inspection should then be carried out to allow a complete assessment of the property's condition. This is particularly important prior to purchase, as defects in concealed areas can carry significant rectification costs.
