Building Inspection Report

Inspection Date: Thu, 12 Mar 2026

Property Address: 1901/311 Hume Hwy, Liverpool NSW 2170,
Australia

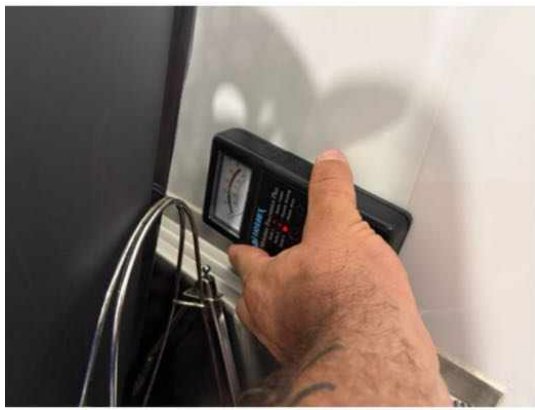
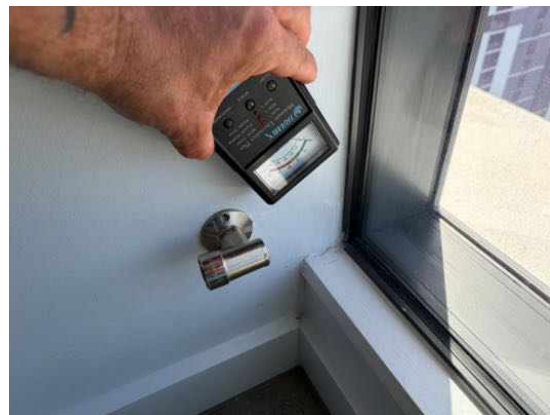
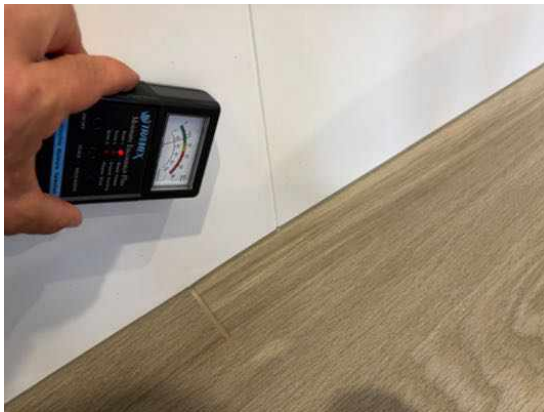
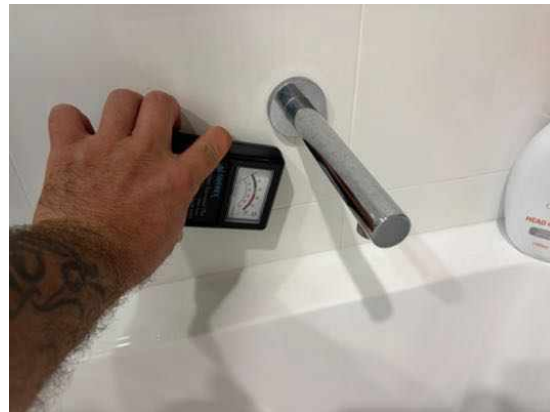
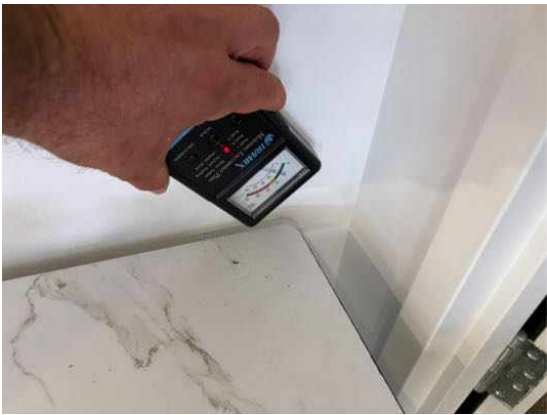
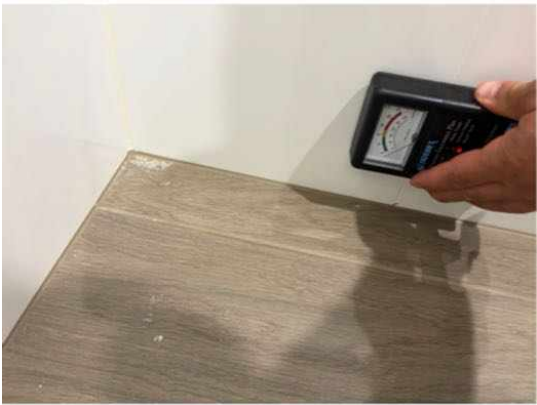
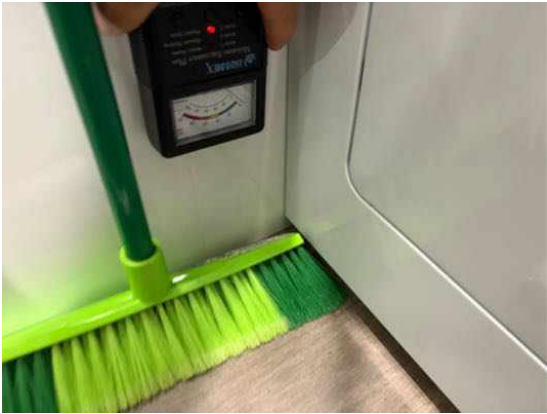
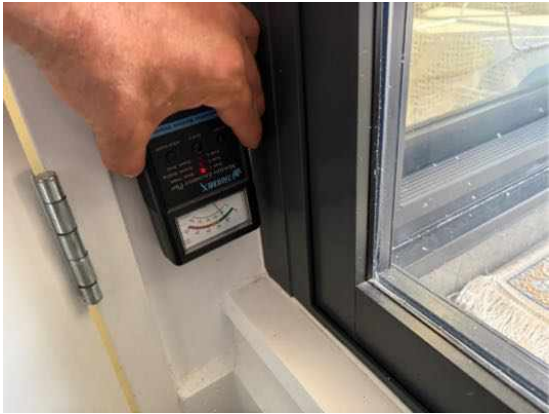
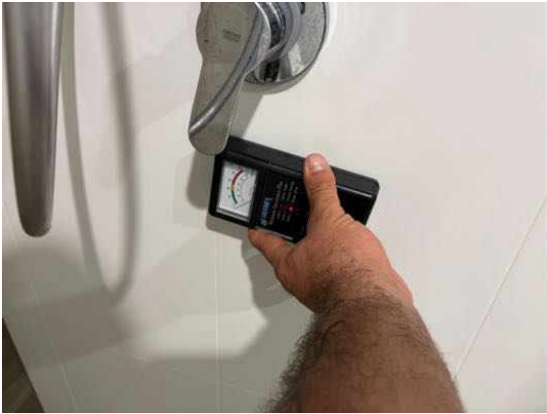
Building: Main Building
Location: All Areas
Finding: Moisture metre
Information: During the inspection the property was checked for moisture using a moisture metre.

This is for information only.

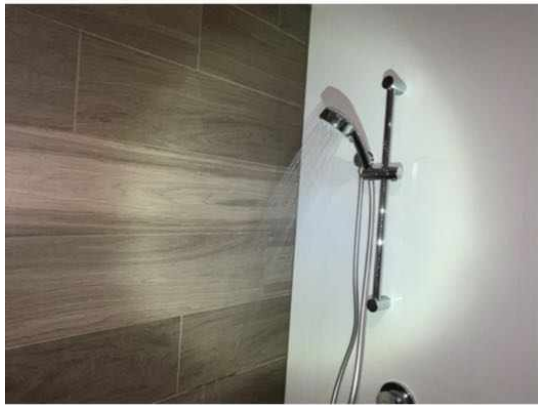
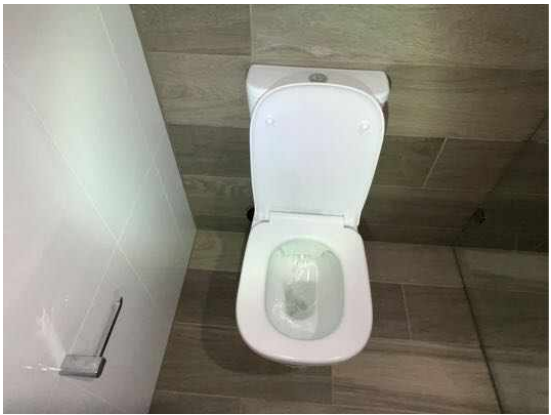
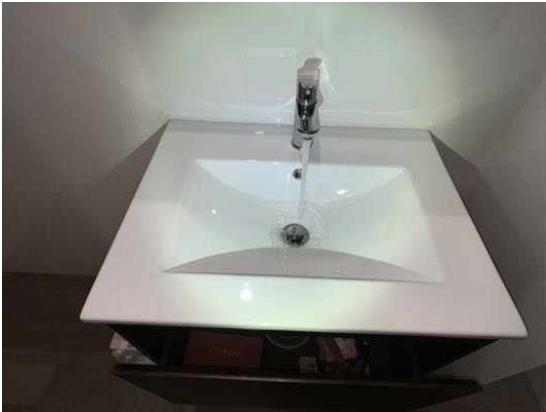
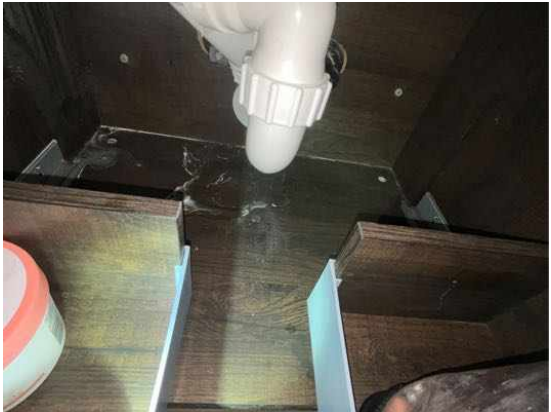
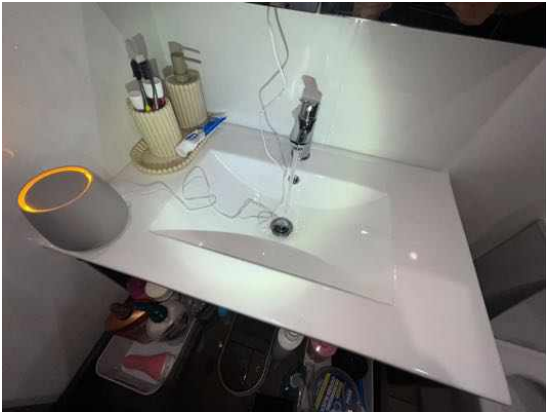
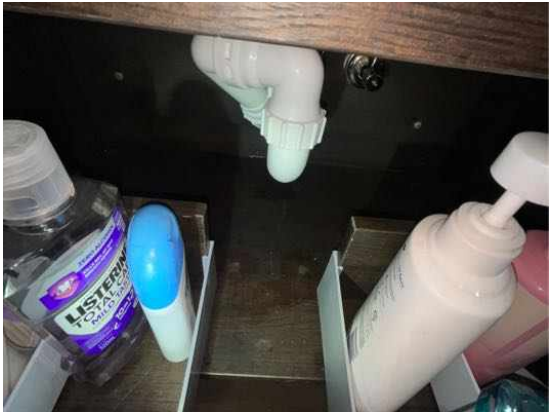
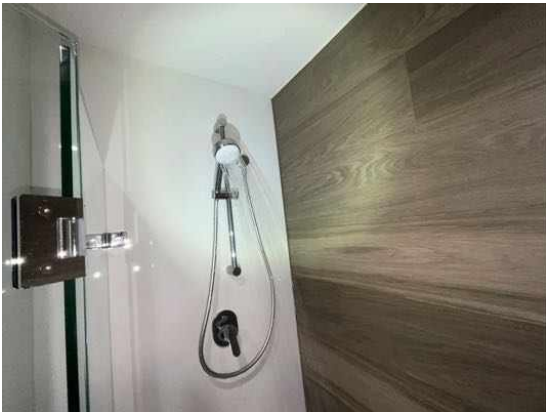
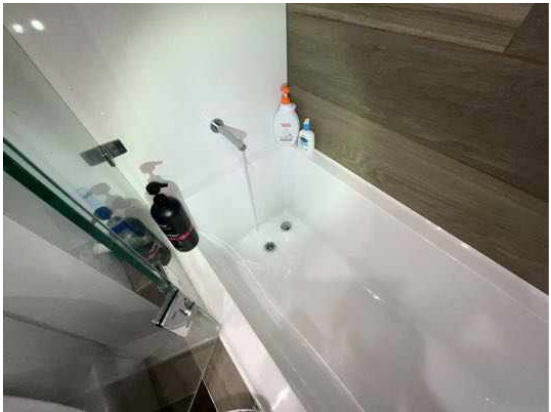
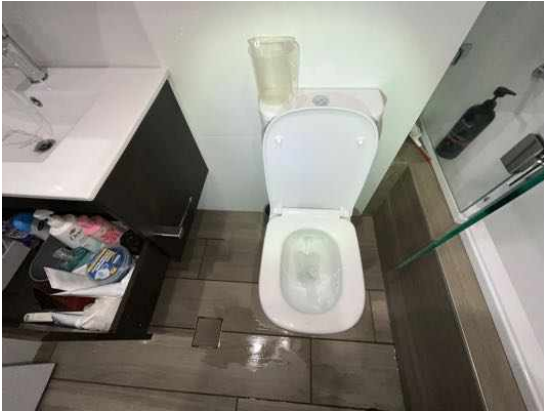
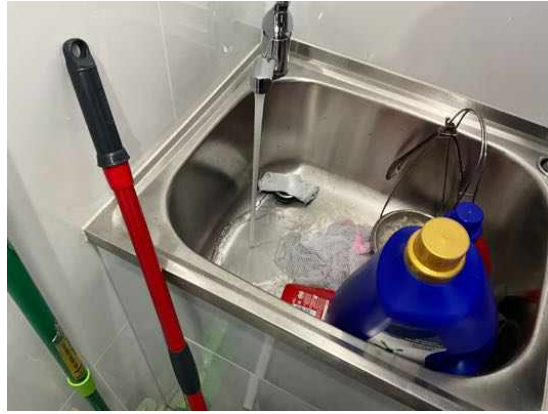
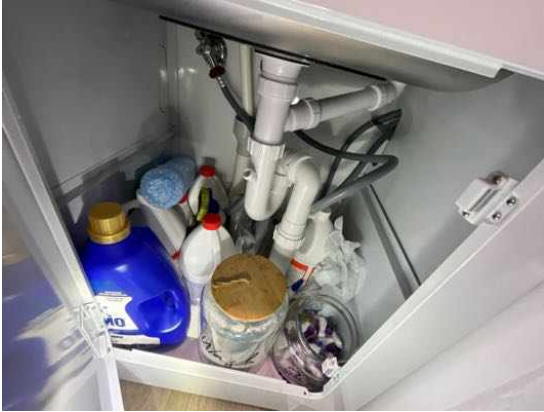
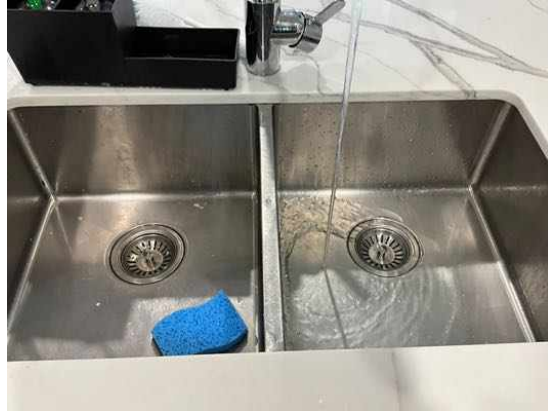
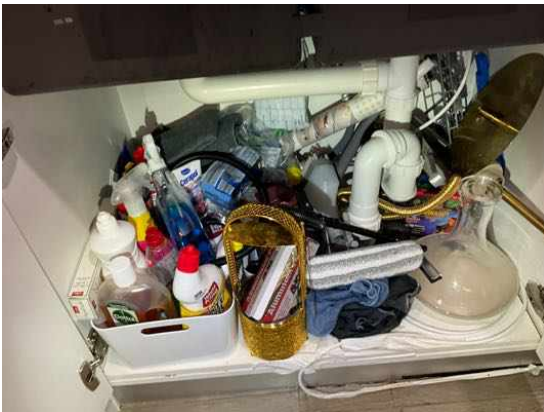
Building: Main Building
Location: All Wet Areas
Finding: Additional Photos
Information:

Additional photos are provided for your general reference.

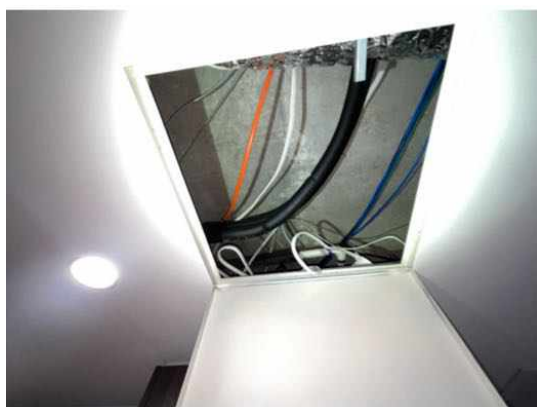
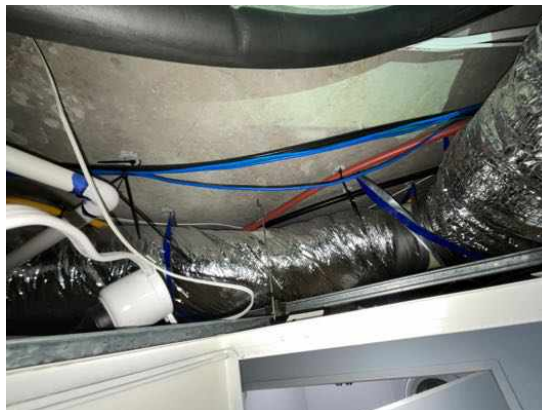
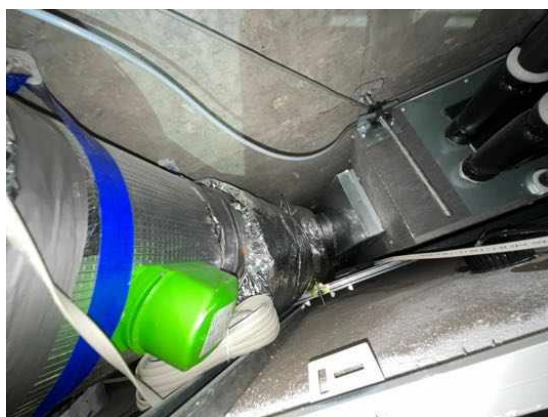
Building: Main Building
 Location: Ceiling cavity
 Finding: Additional Photos- ceiling cavity
 Information: Additional photos are provided for your general reference. Arrows may have been included to highlight areas of importance. Please discuss these photos with your building consultant for clarification.

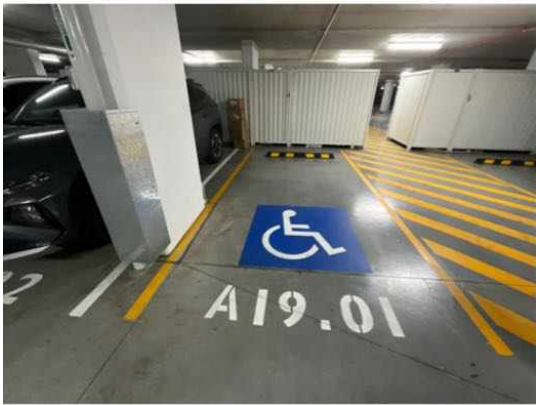
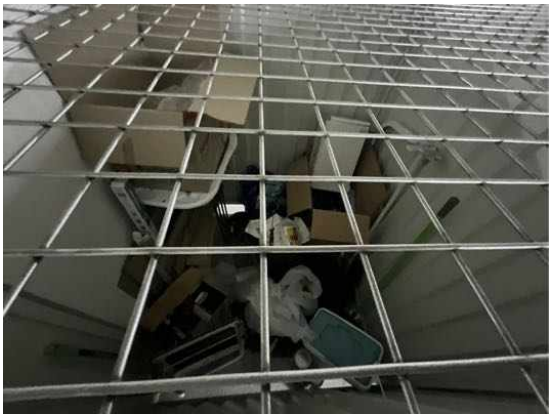
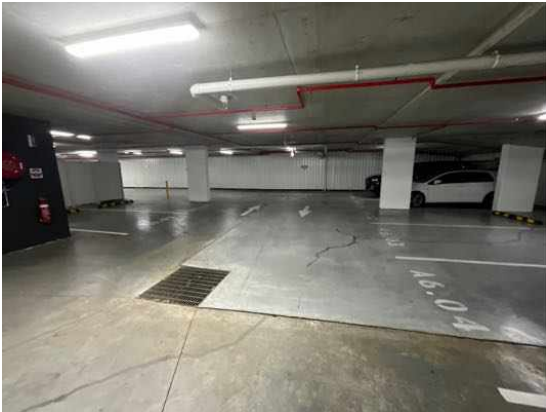
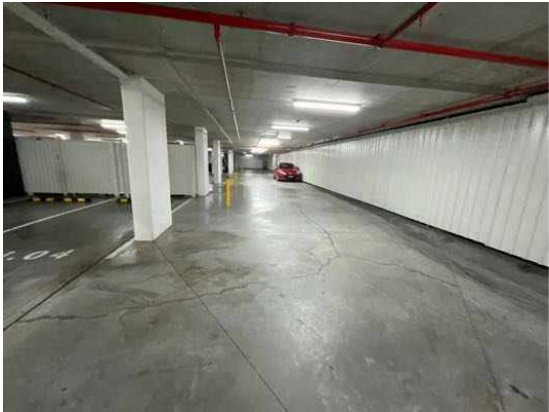
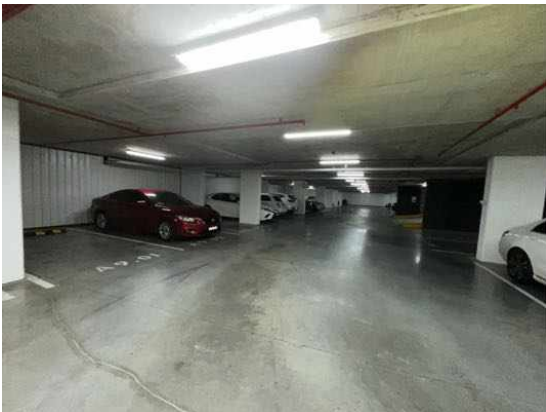
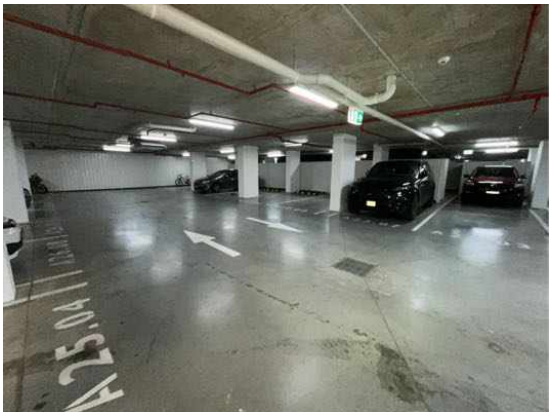
Building: Main Building
 Location: Garage
 Finding: Additional Photos- Garage
 Information: Additional photos are provided for your general reference. Arrows may have been included to highlight areas of importance. Please discuss these photos with your building consultant for clarification.

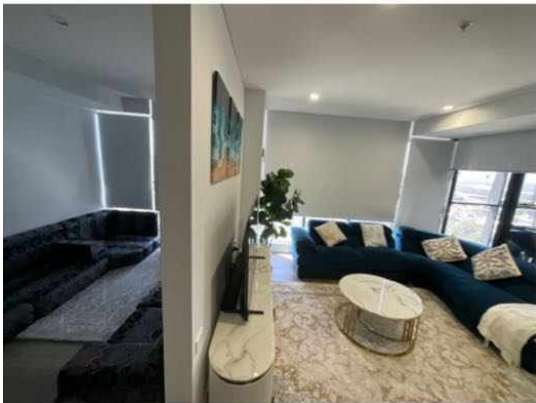
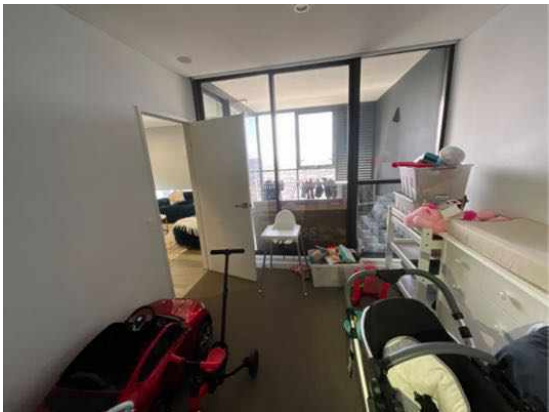
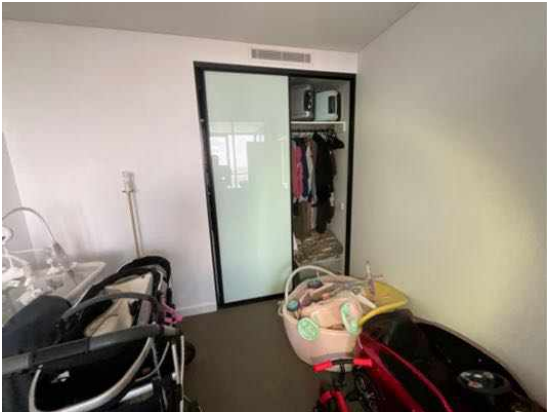
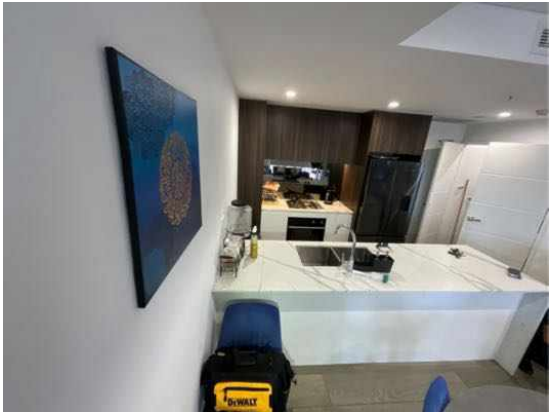
Building: Main Building
 Location: All Areas
 Finding: Additional Photos - Obstructions and Limitations
 Information:

These photographs are an indication of the obstructions and limitations which impeded full inspection of the property at the time of inspection. These obstructions can hide an array of defects and should be removed to allow full inspection to be carried out. A re-inspection is recommended once the areas are made accessible.
