Building and Timber Pest Inspection Report

Inspection Date: Tue, 27 Jan 2026

Property Address: 10 Cowdroy Ave, Cammeray NSW 2062, Australia

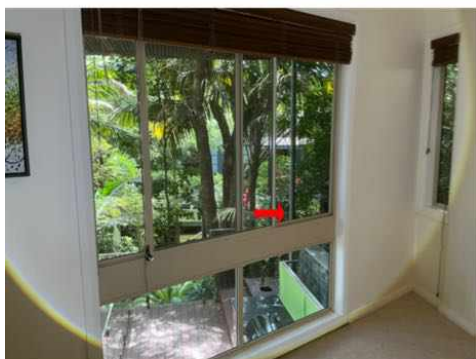
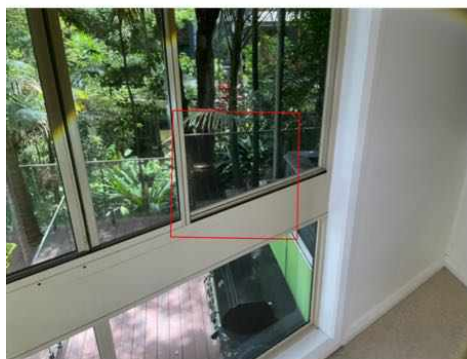
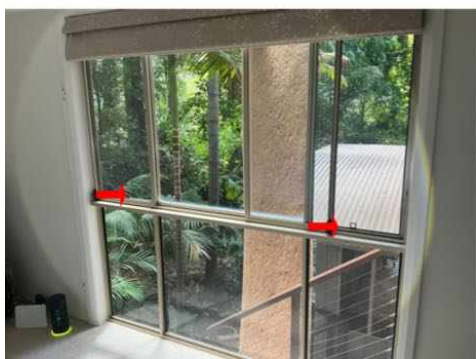
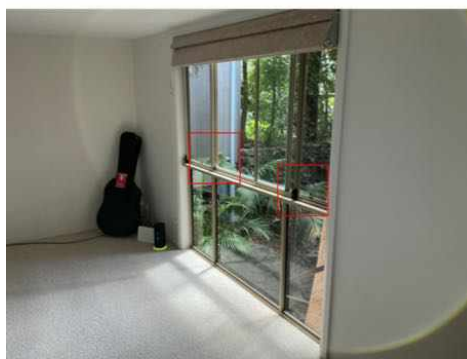
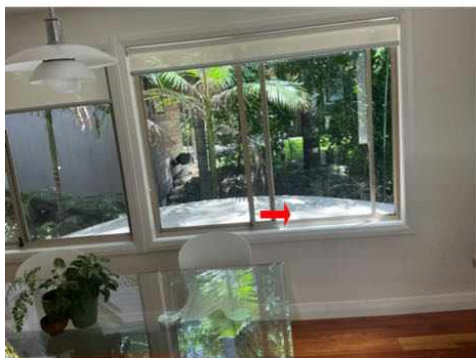
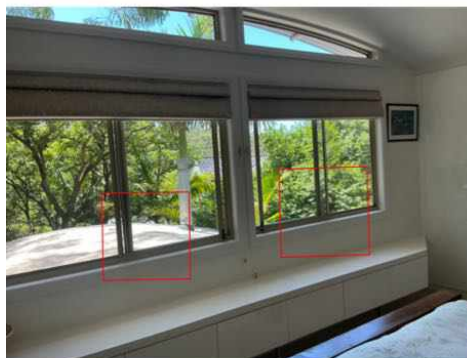
Building: Main Building
Location: All Areas
Finding: Window Restrictors - Recommended
Information: Upstairs windows did not have window restrictors installed. Although not a requirement at the time of construction, it is advisable to install window opening restrictors on all second storey windows with sill heights below 1.7 meter and potential fall of 2 meters or more.

If you live in a strata scheme, window safety devices must be installed on all applicable windows by 13 March 2018. Residents with safety devices installed can still fully open their windows but it's recommended that devices be engaged whenever children are present, to prevent falls.

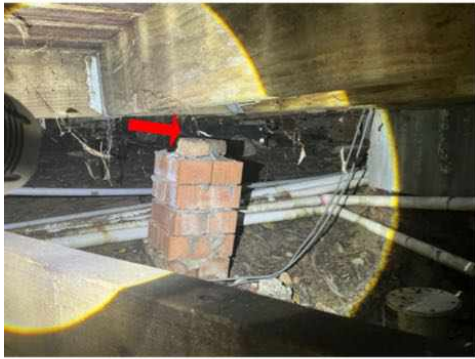
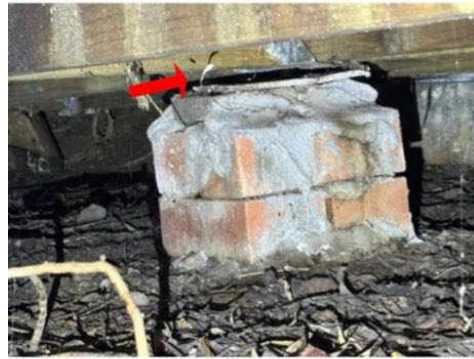
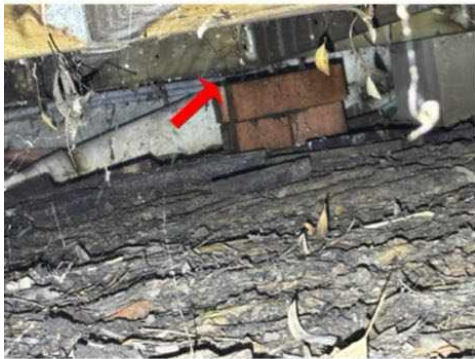
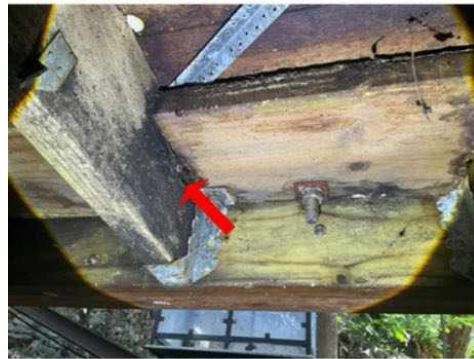
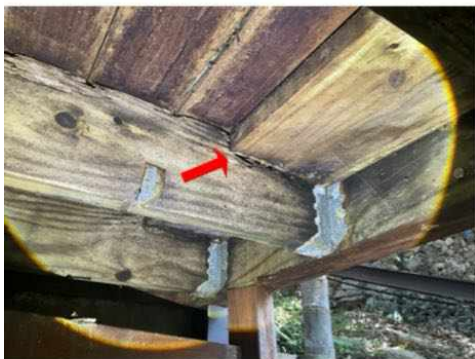
Finding 2.01

Finding: Wood Rot / Fungal Decay and Subsided Deck Piers

Information: At the time of inspection, timber elements beneath the deck were observed to be affected by wood rot and fungal decay. This deterioration is consistent with prolonged moisture exposure and inadequate ventilation beneath the deck structure. In addition, several brick piers supporting the deck were noted to be subsided and are no longer providing adequate structural support to the deck framing.

The presence of decayed timber and inadequately supported piers compromises the structural integrity and load-bearing capacity of the deck. If left unaddressed, this condition may worsen over time, increasing the risk of further structural movement, progressive timber deterioration, and potential safety hazards. The ongoing moisture exposure also creates conditions conducive to termite activity.

It is recommended that a suitably qualified deck specialist or structural contractor be engaged to further assess the extent of timber decay and pier subsidence. Remedial works may include replacement of affected timber members, rectification or rebuilding of subsided piers, and improvements to subfloor drainage and ventilation to reduce future moisture-related deterioration.

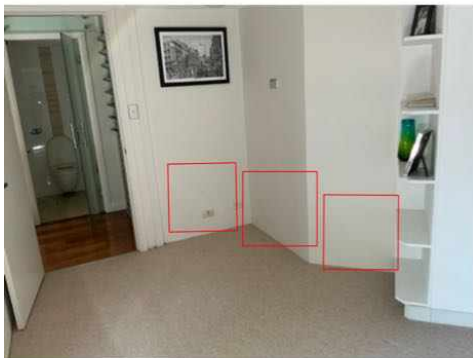
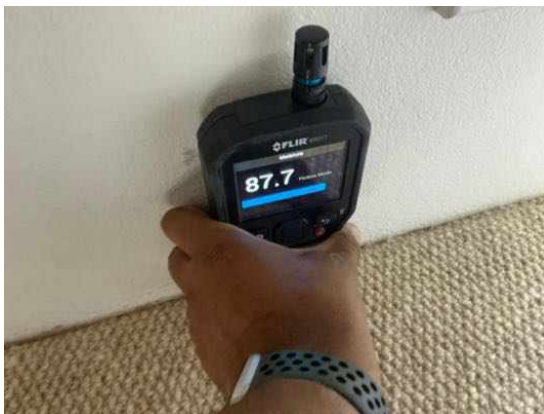
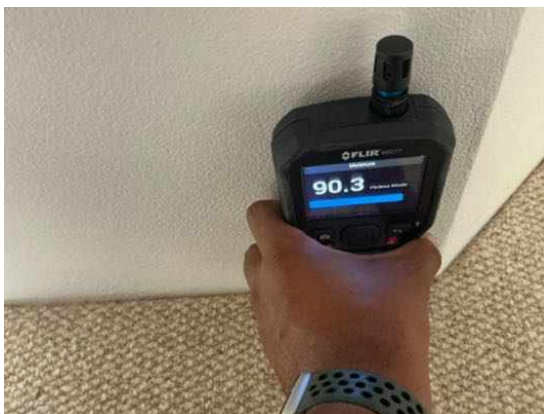
Finding 2.02

Building:	Main Building
Location:	Bedroom 4, Rumpus
Finding:	Rising Damp / Excessive Moisture to Internal Walls
Information:	At the time of inspection, excessive moisture readings were recorded to internal wall surfaces, particularly at low-level areas, with a subfloor space located on the opposite side of the affected walls. Moisture meter readings were significantly elevated, indicating active moisture ingress consistent with rising damp.

This condition is typically caused by the upward movement of ground moisture through porous building materials such as masonry and mortar via capillary action. Contributing factors may include the absence, deterioration, or bridging of the damp-

proof course (DPC), as well as elevated external ground levels, inadequate subfloor ventilation, or poor site drainage adjacent to the affected walls.

If left unrectified, rising damp can lead to progressive deterioration of wall linings, plaster, paint finishes, and internal timbers, and may also create conditions favourable for mould growth. Prolonged damp conditions are also considered conducive to termite activity, increasing the overall risk to the structure.

It is strongly recommended that the client engage a qualified waterproofing to carry out appropriate remedial works.

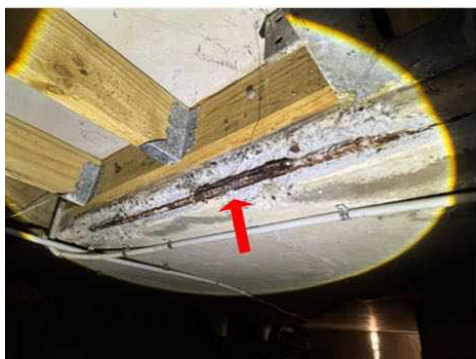
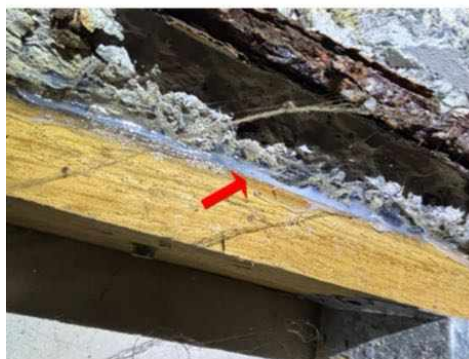
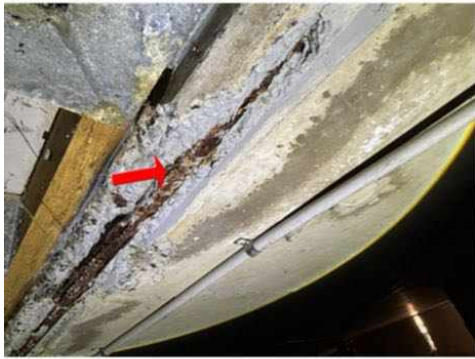
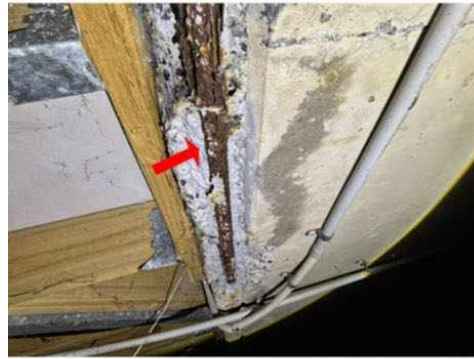
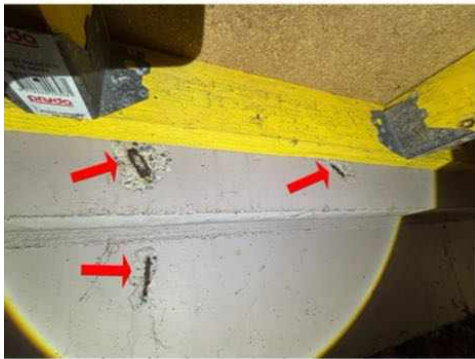
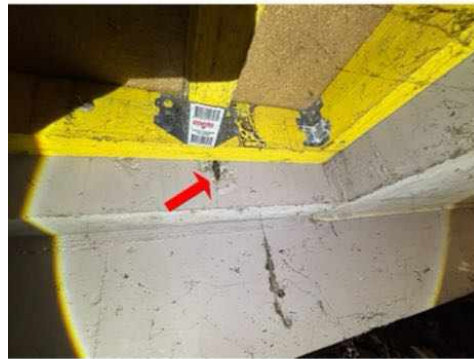
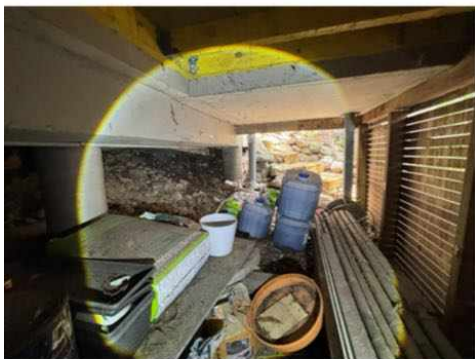
Finding 2.03

Building: Main Building
Location: Under Garage/Entry Area
Finding: Concrete - Cancer
Information: Concrete cancer is the common term used to describe a number of factors which cause concrete construction to deteriorate. Generally, water penetration causes the concrete reinforcement to rust and expand, creating stresses on the surrounding concrete and in turn causing it to spall (or break away). Alternatively, if the cement component is too alkaline, reactions with the general atmosphere occurs and star-shaped cracks appear which allow rainwater to penetrate. Concrete cancer may also originate from poor original water proofing.

In some instances, repairs are possible; however, repair works will generally involve extensive works, including removal of affected concrete and the treatment or replacement of any exposed steel. Some injection of resins or special mortars may also be possible, however this depends on the size and extent of consequent damage.

Treatment of concrete cancer can be expensive and, if left unmanaged, the problem is likely to worsen over time, potentially leading to the development of major structural defects or safety hazards.

The client is advised to exercise caution and to prepare for the potential cost of remedial and / or replacement works. A concrete specialist should be appointed to provide estimates on the required works.

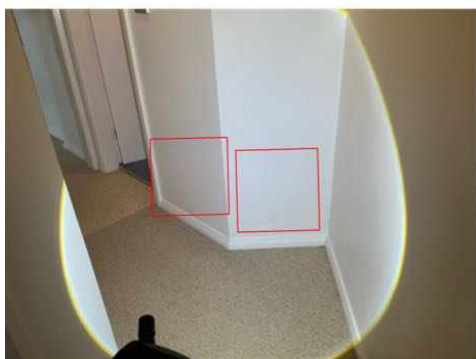
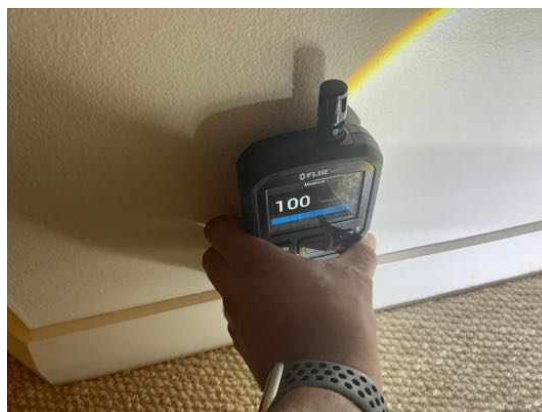
Finding 2.04

Building:	Main Building
Location:	Level 2 Bathroom
Finding:	Shower Damp - Adjacent Bathroom
Information:	At the time of inspection, shower damp was observed on the wall adjacent to the shower in the bathroom.

This issue, likely caused by deteriorated grout, failed waterproofing, or leaking pipes within or behind the wall, allows moisture to penetrate and accumulate, compromising the wall's integrity. The presence of dampness creates an environment conducive to mould growth, timber decay, and potential structural deterioration if left unaddressed, posing health risks to occupants, such as respiratory problems, allergies, and skin

irritation. Additionally, prolonged moisture exposure could lead to further damage to surrounding building materials, including paint, plaster, and any timber elements, increasing repair costs over time.

It is strongly recommended that the client engage a qualified plumber or waterproofing specialist to which may involve resealing the shower area, replacing damaged grout, or repairing any leaks. To prevent future issues, maintaining sealants and grout in good condition and operating the bathroom exhaust fan during and after showering for at least 20-30 minutes to remove excess humidity is advised.

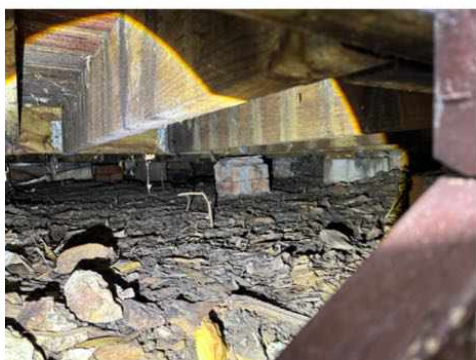
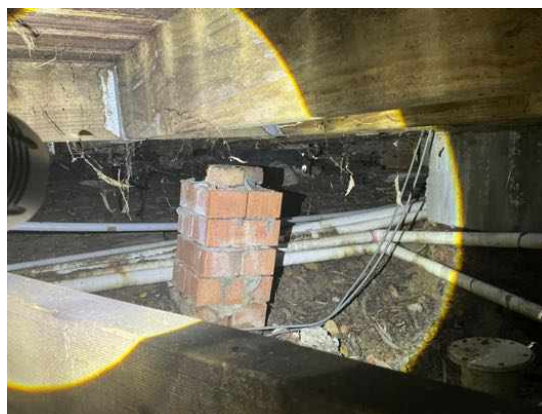
Finding 3.01

Building:	Main Building
Location:	Under Deck
Finding:	Subfloor Site Drainage - Inadequate
Information:	At the time of inspection, inadequate site drainage was observed under the subfloor, allowing water to accumulate and fail to drain effectively, creating a hazardous condition. This is a common defect in houses constructed on brick stumps, where poor site grading and limited subfloor ventilation can contribute to ongoing moisture retention. The resulting water pooling may lead to structural deterioration from

prolonged dampness, mould and mildew growth, and create conditions conducive to termite activity. These issues can also impact indoor air quality and pose safety risks to occupants.

The client is advised to engage a licensed plumber or builder experienced in drainage and foundation work to assess and implement suitable solutions, such as improving site grading, installing appropriate drainage systems, and enhancing moisture barriers. In addition, the installation of mechanical subfloor ventilation is recommended to improve air circulation, assist with moisture control, and reduce the risk of ongoing damp-related issues.

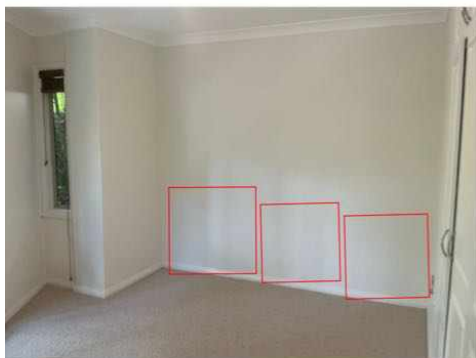
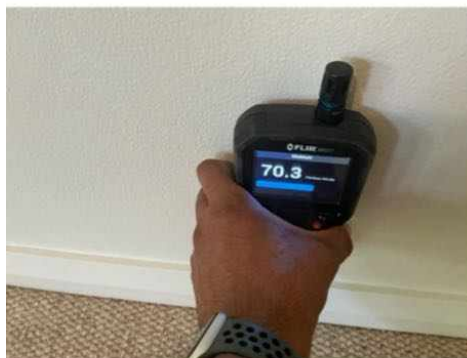
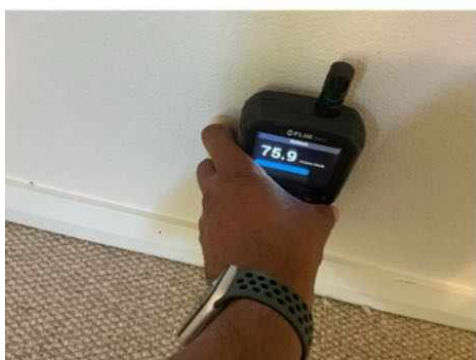
Finding 3.02

Building:	Main Building
Location:	Bedroom 3
Finding:	Excessive Moisture / Lateral Damp
Information:	At the time of inspection, excessive moisture readings were recorded to internal walls. Moisture testing indicated elevated levels consistent with moisture ingress. It was noted that water tanks are located on the opposite side of these walls, which may be contributing to excessive moisture due to restricted drainage, overflow, leakage, or prolonged saturation of the surrounding ground.

The presence of water tanks in close proximity to the building, combined with limited separation and drainage, may allow moisture to migrate laterally through the wall system (lateral damp). If left unaddressed, this condition may result in deterioration of wall linings, paint failure, mould growth, and long-term damage to building materials. Prolonged damp conditions may also create conducive conditions for termite activity.

It is strongly recommended that a suitably qualified waterproofing specialist be engaged to rectify the issue

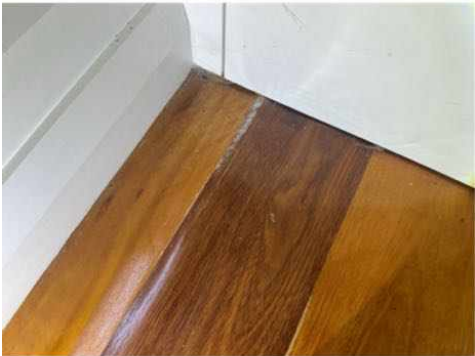
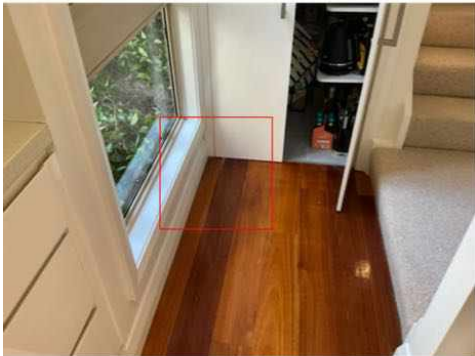
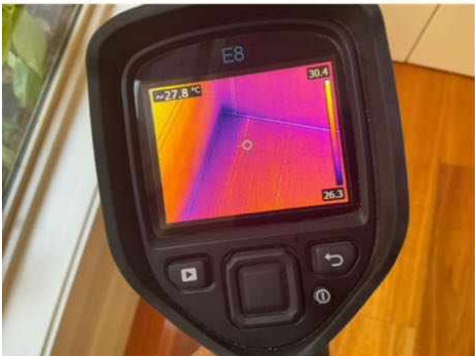
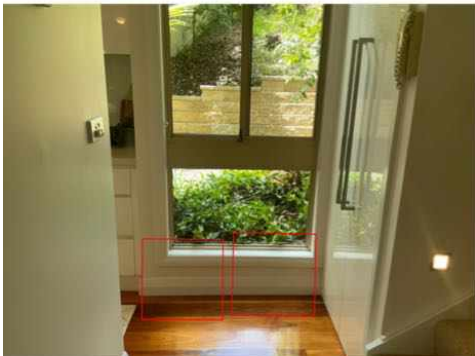
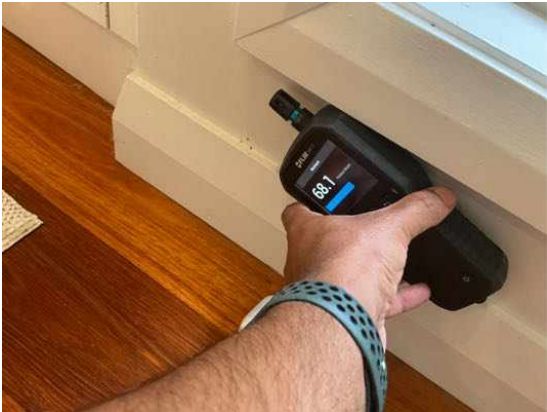
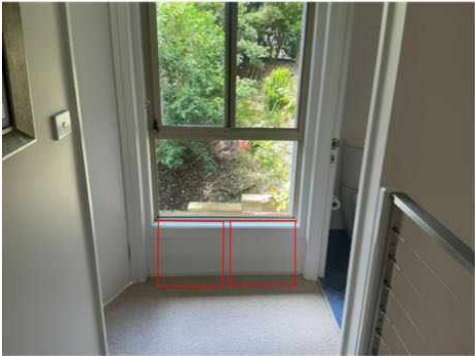
Finding 3.03

Building:	Main Building
Location:	Kitchen
Finding:	Moisture Readings to Internal Walls and Minor Flooring Damage
Information:	At the time of inspection, minor elevated moisture readings were recorded to sections of internal walls, particularly around window areas. No visible signs of active water ingress, staining, mould growth, or deterioration to wall linings were observed at the time of inspection. The moisture readings may be attributable to minor gaps or inadequate sealing around window frames, allowing limited moisture ingress during wet weather conditions.

In addition, minor damage was noted to sections of the kitchen flooring. This damage appears localised and consistent with minor moisture exposure or general wear and tear. No structural concerns were identified in relation to this issue at the time of inspection.

It is advised that these areas be monitored over a 12-month period. Should signs of moisture recurrence occur in the future—such as bubbling, staining, softening of wall linings, or further deterioration to flooring—further investigation by a suitably qualified trade may be required. At the time of inspection, no immediate remedial action is considered necessary.

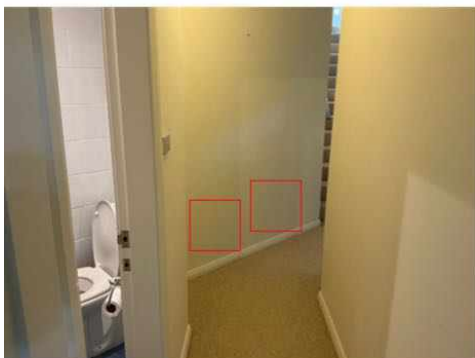
Finding 3.04

Finding: Excessive Moisture - Walls

Information: At the time of inspection, elevated moisture readings were recorded to sections of internal walls, with a subfloor area located on the opposite side. These readings are consistent with early signs of rising damp, where moisture travels upward through porous building materials. Contributing factors may include subfloor moisture conditions or the condition of the damp-proof course (DPC).

No significant visible damage was observed at the time of inspection. The area should be monitored, and if moisture levels increase or visible signs such as staining or bubbling paint develop, assessment by a suitably qualified waterproofing specialist is recommended.

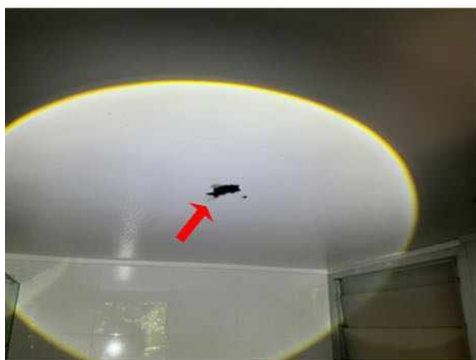
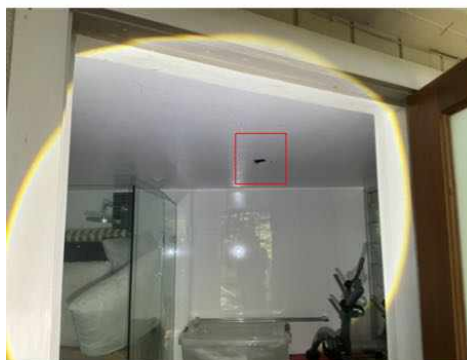
Finding 3.05

Building:	Main Building
Location:	Pool Level Bathroom
Finding:	Plasterboard - Damaged
Information:	During the inspection of the property, significant damage to the plasterboard was observed in the specified areas.

The plasterboard shows minor damage due to physical damage.

The client is advised to hire plasterer or relevant contractor to replace or fix the damaged areas of the plasterboard as soon as possible.

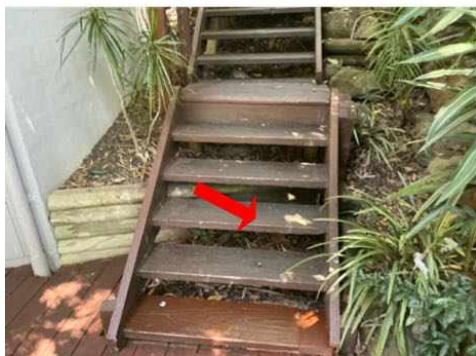
Finding 3.06

Building:	Main Building
Location:	Stairs Left Side
Finding:	Subsidence to External Timber Stairs
Information:	At the time of inspection, minor subsidence was observed to the external timber stairs. The stairs appear to have settled unevenly, likely due to ground movement, inadequate footings, or deterioration of supporting elements over time. While the stairs were functional at the time of inspection, continued movement may lead to misalignment, instability, or accelerated wear of the stair structure.

It is recommended that a qualified carpenter assess the stairs, including the supporting structure and footings, and carry out any necessary levelling, re-supporting, or repairs to ensure long-term stability and safe use.

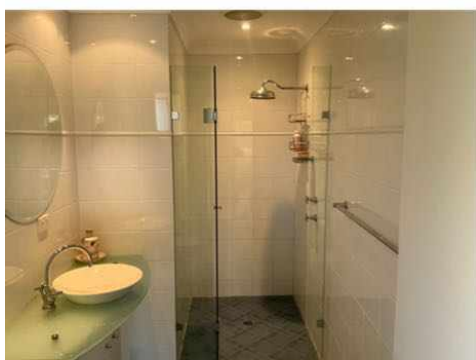
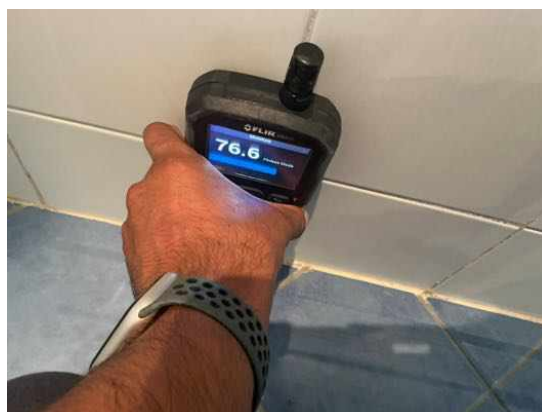
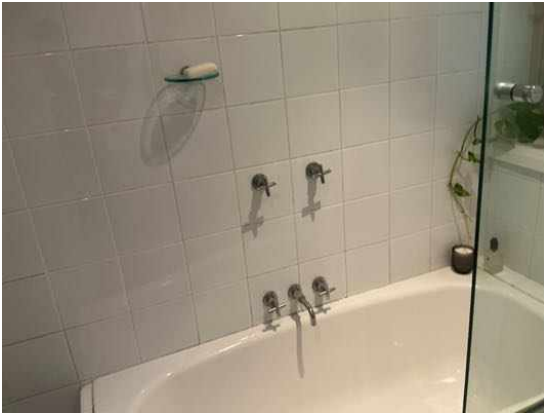
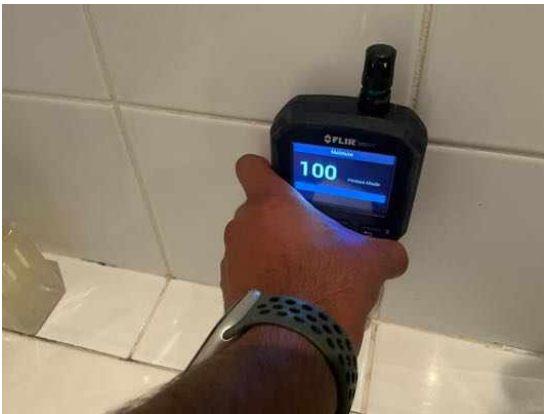
Finding: Excessive Moisture - Shower Damp

Information: At the time of inspection, excessive moisture was noted within the shower area, which is a common issue in wet areas due to the continual exposure to water. This condition is typically caused by moisture seeping through grout lines and settling behind tiles, resulting in localised high-moisture zones. Provided there is no evidence of water staining or elevated moisture readings on the opposite side of the wall, this is considered a minor defect.

However, persistently damp conditions may act as conducive conditions for termite activity, as termites are strongly attracted to moisture-rich environments. It is recommended that the client ensures regular use of the exhaust fan and maintains adequate ventilation after shower use to promote drying and reduce long-term moisture build-up, thereby also reducing the risk of attracting termites.

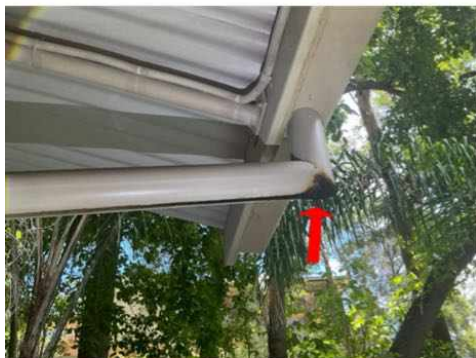
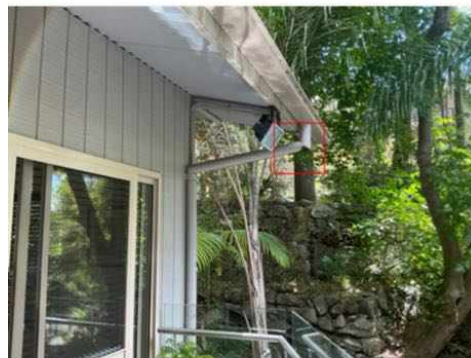
Finding 3.08

Building: Main Building
 Location: Yard - Back
 Finding: Downpipe - Corroded
 Information: At the time of inspection, sections of the downpipe were observed to be damaged and showing signs of corrosion. This deterioration is likely due to prolonged exposure to moisture, standing water within the pipe, or insufficient drainage maintenance.

It is recommended that a licensed roof plumber be engaged to replace the rusted or corroded sections and ensure the downpipe is securely fitted and functioning correctly.

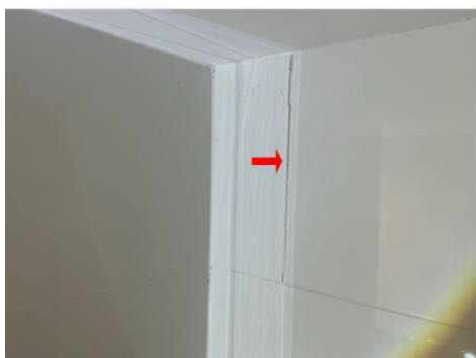
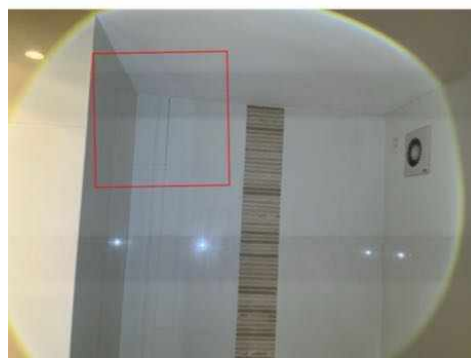
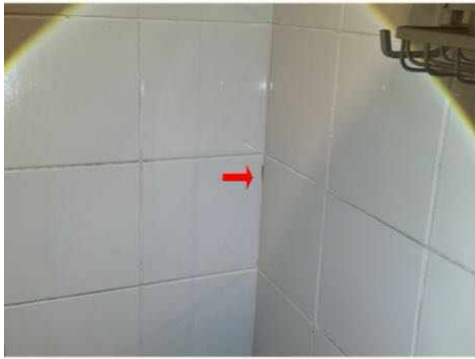
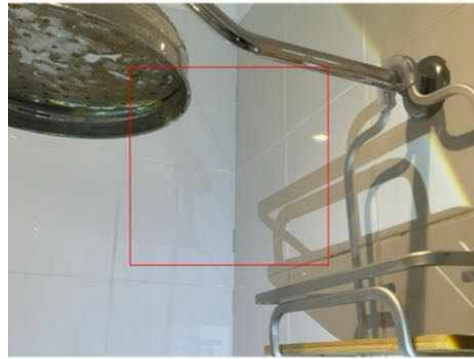
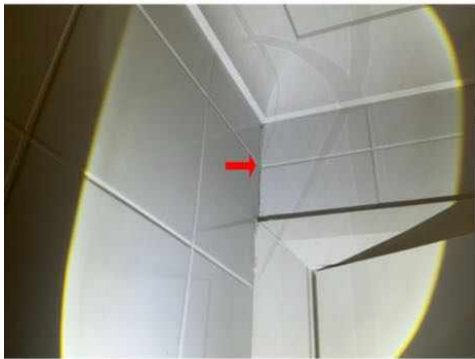
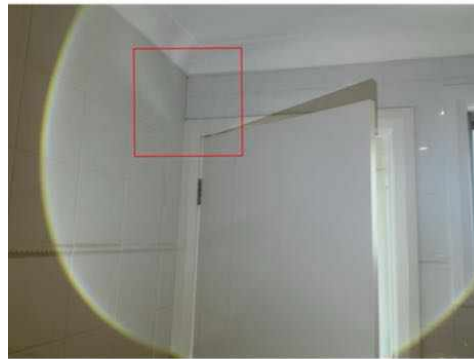
Finding 3.09

Building:	Main Building
Location:	Both Bathrooms
Finding:	Sealant and Grouting - Missing or Damaged
Information:	It was noted on inspection that sealant or grout is degraded/missing to these areas.

Different materials and floor areas move at different rates, generally causing cracking to grout or sealant at this point. A flexible sealant is required to allow for expected expansion and contraction, while keeping the joint water tight and protective of all associated building materials.

Flexible and mould resistant materials should be applied to affected areas to prevent any subsequent water damage that is likely to occur. Regular maintenance and replacement of damage or missing or damaged sealant and grout is highly recommended to the wet areas, as this is a regular wear and tear defect. Sealant and grouting in areas that come into regular contact with water should be maintained for the long term care of your property.

A sealant specialist or tiling contractor should be appointed to complete these works as soon as possible

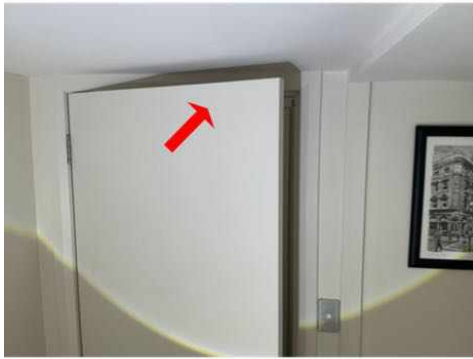
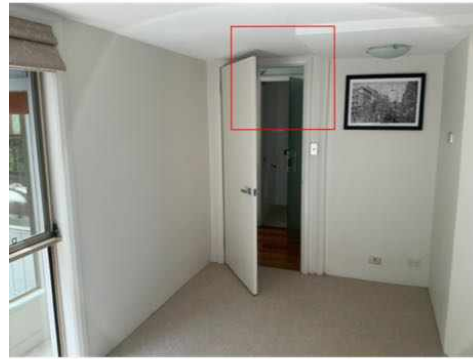
Finding 3.10

Building:	Main Building
Location:	Bedroom 4
Finding:	Door(s) - Binding/Jamming
Information:	At the time of inspection, it was noted that the door was binding or jamming in this area.

Several factors could contribute to this issue, including swelling due to moisture, which can cause wooden doors to expand and fit tightly in the frame. Misaligned or loose hinges may also result in the door sagging or becoming misaligned, making it difficult to close. Over time, wooden doors may warp due to fluctuations in temperature or humidity, leading to improper closure.

It is recommended that a qualified carpenter or handyman be engaged to carry out the necessary repairs to ensure proper door operation.

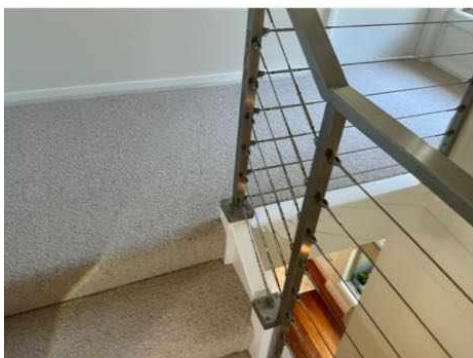
Finding 3.11

Information: A bouncy floor was noted at this area during the inspection. Several factors could be contributing to this issue. One potential cause is insufficient structural support, such as undersized or improperly spaced floor joists, which may result in excessive flexing when weight is applied. Over time, this can lead to a bouncy or springy sensation underfoot. Another possibility is that the subfloor may not be securely fastened to the joists, causing movement between the layers of the floor system. Additionally, wear and tear on the structural components, such as floorboards or beams, could cause degradation or warping, further contributing to the issue. If the floor structure is compromised, it may also indicate settlement or movement in the building itself, which can affect the alignment and stability of the stairs and floors.

It is recommended that a flooring specialist or qualified building professional assess the condition of the floor and stairs. They may recommend reinforcing the joists, securing the subfloor, or addressing any structural shifts to ensure the safety and stability of the floor and staircase.

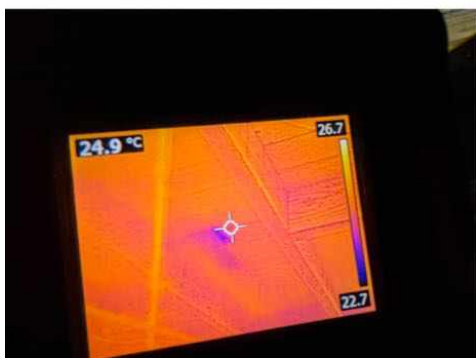
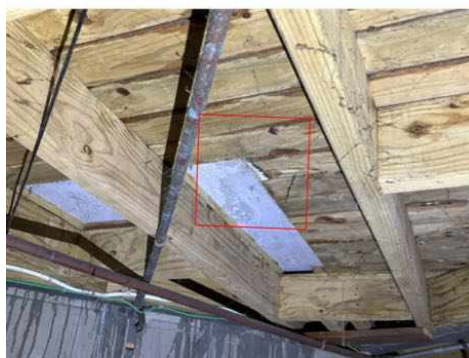
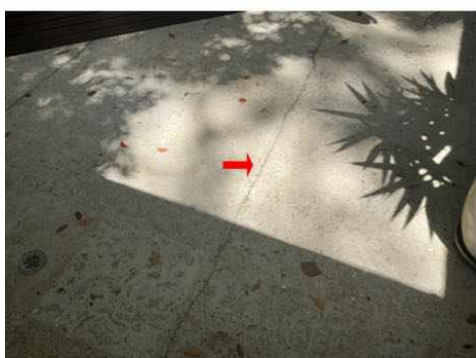
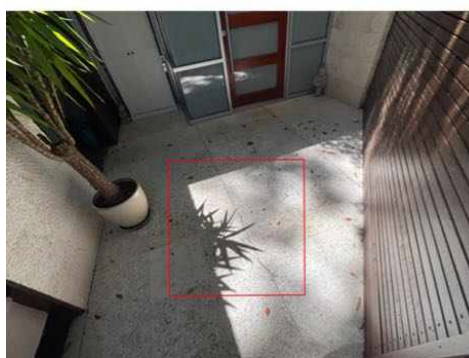
Finding 3.12

Building: Main Building
 Location: Subfloor
 Finding: Minor Water Leak Identified to Subfloor Area
 Information: At the time of inspection, evidence of a minor water leak was observed within the subfloor area. Thermal imaging and visual inspection indicate this is likely associated with cracked or damaged tiles located in the area above. Deterioration to tiled surfaces and grout joints can allow moisture to bypass the waterproofing system and migrate into the subfloor space.

While the leak appeared minor at the time of inspection, ongoing moisture exposure may lead to deterioration of subfloor elements if left unaddressed. It is recommended that a qualified tiler assess the tiled area above, reseal or replace any cracked or damaged tiles, and confirm that the waterproofing membrane remains intact and effective.

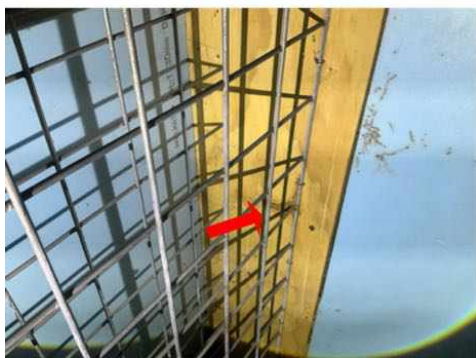
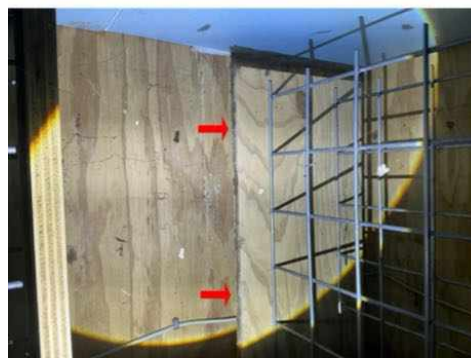
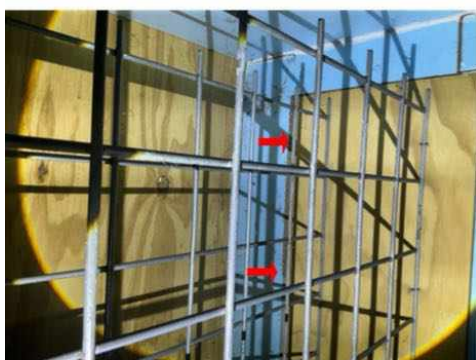
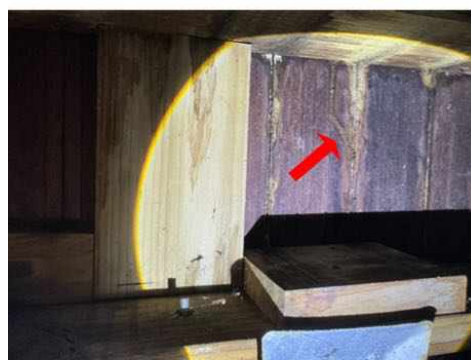
Building:	Main Building
Location:	Deck, Wine Cellar
Finding:	Termite Damage
Information:	At the time of inspection, termite damage was identified within the wine cellar room, with additional minor damage noted beneath the deck. The visible damage indicates past or possible ongoing termite activity; however, the full extent of damage cannot be determined without further invasive investigation.

It is recommended that selected building elements within the wine cellar room be carefully removed by a suitably qualified contractor to allow inspection of concealed areas and to determine the full extent of the damage behind wall linings and finishes.

It is strongly recommended that a licensed pest control professional be engaged as soon as possible to carry out a comprehensive termite inspection and implement an appropriate termite treatment and ongoing management plan to prevent further damage.

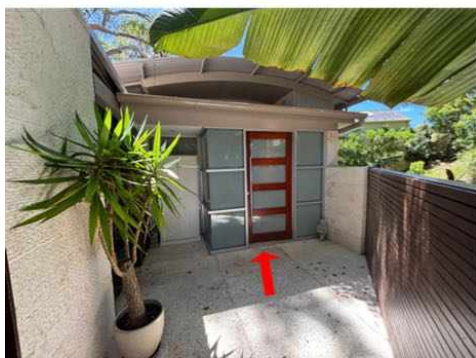
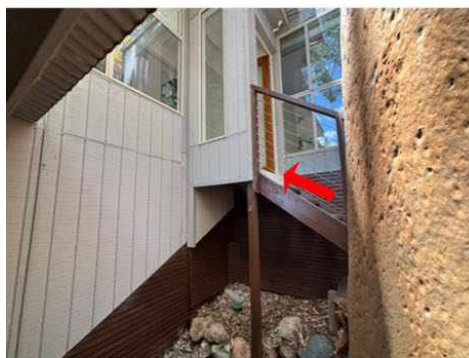
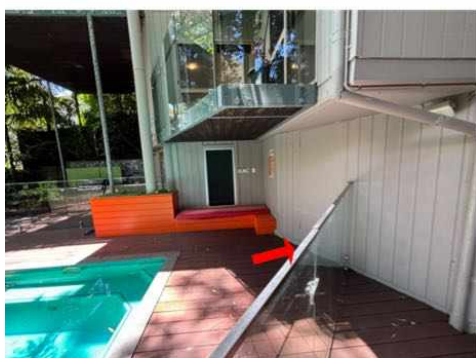
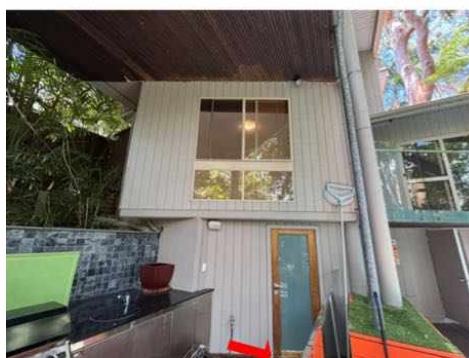
Finding 6.01

It is important for internal flooring to be raised above adjacent external ground levels. Where external ground levels are above or same level as internal flooring, water pooling and subsequent internal flooding is likely to occur which may attract termite activity to the internal area.

It is highly advised that a landscaper or relevant tradesperson be appointed to lower external grounds that are raised above or same as adjacent internal flooring. Alternatively if external grounds and internal flooring is level installation of a raised door sill may be appropriate in preventing any water pooling in the area. If the client wishes not to make any changes, then a qualified pest controller is recommended for termite treatment around the perimeter of the house and subfloor (if any) as soon as possible.

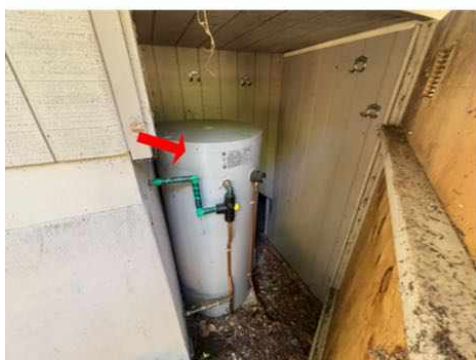
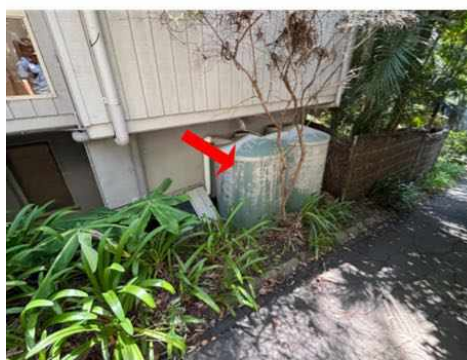
Finding 6.02

Building:	Main Building
Location:	All Areas
Finding:	Bridging - Attachment to Buildings
Information:	Bridging occurs when items against a building provide a concealed entry point for termites into the building or by passing around a termite management system.

Where any part of an attachment to a building is not isolated and is not provided with a clear gap of not less than 25mm from the building, bridging occurs. Attachments to buildings such as hot water services, downpipes, verandahs, decks, steps, fences, service conduits and the like provide the opportunity for concealed entry.

Building attachments of this nature need to be frequently inspected for termite activity by a qualified inspector.

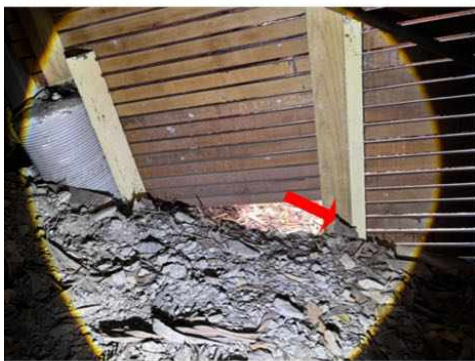
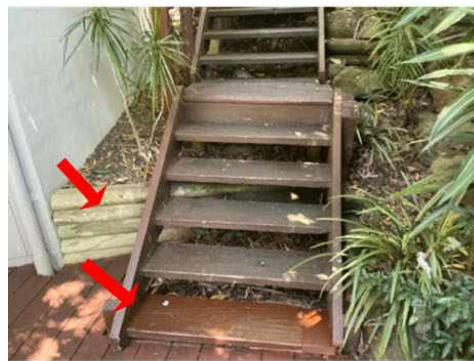
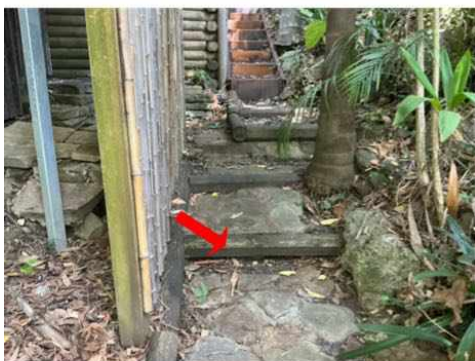
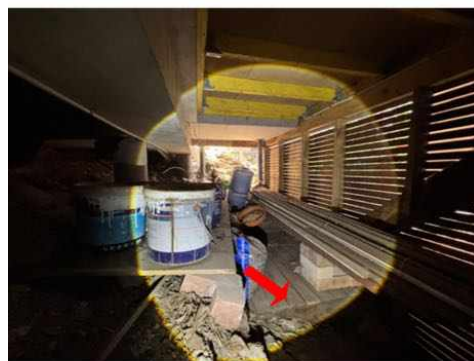
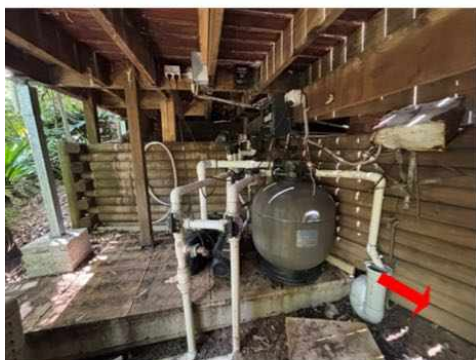
Finding 6.03

Building:	Yard
Location:	All Areas
Finding:	Building Materials in Direct Ground Contact - Conducive to Termites
Information:	Timber elements that are in direct contact with the ground and exposed to moisture or damp conditions are highly conducive to termite activity. This susceptibility arises because timber, when in contact with soil and dampness, creates an environment that is particularly attractive to termites, encouraging infestation and potential structural compromise. Whether the timber is used as a part of the building's construction or incorporated into fencing, its presence near or on the ground can become a pathway for termites to access and damage the property.

When exposed to excessive moisture, timber begins to deteriorate, developing conditions such as wood decay and rot. These compromised areas of timber are even more appealing to termites, as they are easier to infest and consume. This is especially true for untreated or non-durable timber, which lacks the protective treatments that can deter or withstand termite attacks. Termites can use these weakened, moisture-laden elements as a bridge into other parts of the structure, creating an entry point for potential infestations that can spread and cause extensive

damage if left unchecked.

For any timber in direct contact with the external ground, special attention is required. The combination of moisture, untreated wood, and direct ground contact not only accelerates the decay process but also provides subterranean termites with a straightforward means of ingress into the structure. This entry can lead to termites moving undetected into other vulnerable areas, resulting in potentially significant structural issues and costly repairs.

To mitigate the risk of termite activity, it is imperative that any such materials or timber elements be appropriately treated or removed as soon as possible. Timbers that are necessary for use should be made durable through appropriate treatments and maintained to ensure they do not create conditions conducive to termites. Additionally, the client is advised to schedule regular termite treatments to maintain an effective barrier against infestations and ensure ongoing protection.

The client is strongly advised to assess the property for any timber elements that may be in direct contact with the ground and ensure prompt action is taken to remove or treat them effectively. Regular inspections, proactive maintenance, and consistent termite treatment are essential steps in minimising the risk of termite attack and protecting the structural integrity of the property. Taking these preventive measures is crucial for maintaining a termite-free environment and avoiding potentially costly damage and future repairs.

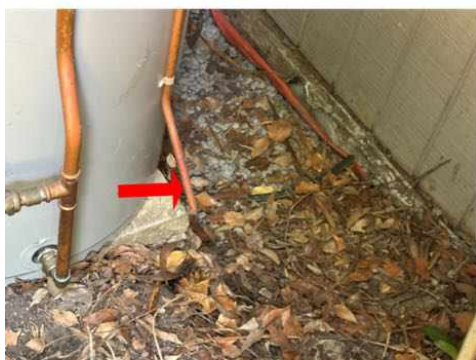
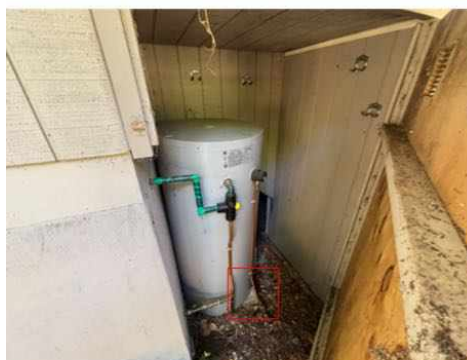
Finding 6.04

Building:	Main Building
Location:	Exterior walls - right side
Finding:	Overflow Disconnected - HWS/AC/Gas - Conducive Conditions to Termites
Information:	The overflow to this service was found to be disconnected from stormwater drainage and is creating excessive moisture in the surrounding area.

Such leaking creates an environment that is conducive to an array of defects, including water damage to associated building elements and the attraction of termite or timber pest infestation. These damp conditions can lead to secondary defects such as rot, rust, or corrosion of associated building elements, the formation of fungal decay, or even the creation of potential slip hazards. When coupled with poor site drainage, pooling of water may also attract termite activity to this area.

It is highly recommended that a licensed plumber be appointed to connect the overflow in order to prevent such an environment from being created. These minor works should be carried out as soon as possible.

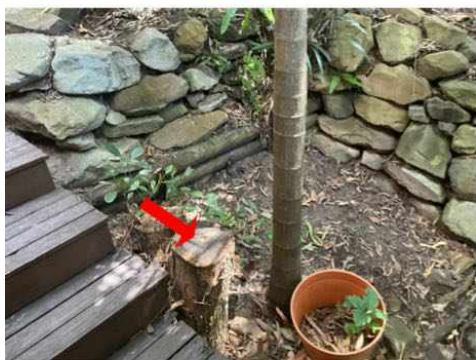
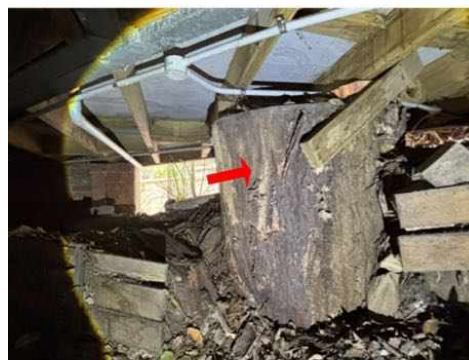
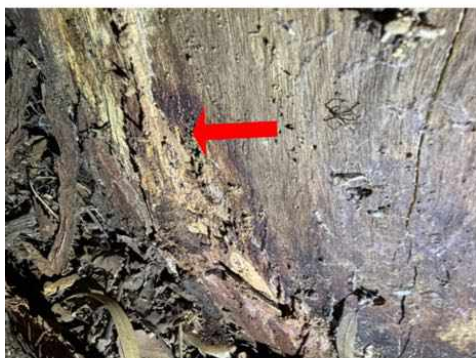
Finding 6.05

Building:	Yard
Location:	Yard - Back, Subfloor

Finding: Tree Stumps - Remove
 Information: Old tree stumps were found in the property at the time of inspection with termite damage.

Any tree stumps in ground contact provide opportunity for concealed termite infestation and are likely to be subject to decay as the soil retains moisture or damp conditions against the tree stump.

All tree stumps should be removed where possible or alternatively be test drilled and treated. Frequent pest inspections are advised to readily identify any termite activity in these areas.

Timber pest management plan should be implemented and 6-12 monthly Timber Pest inspections carried out in accordance with AS4349.3 or AS 3660.2.

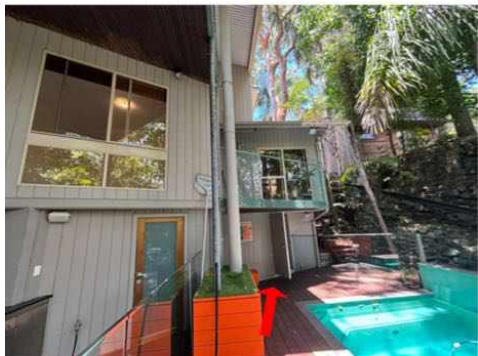
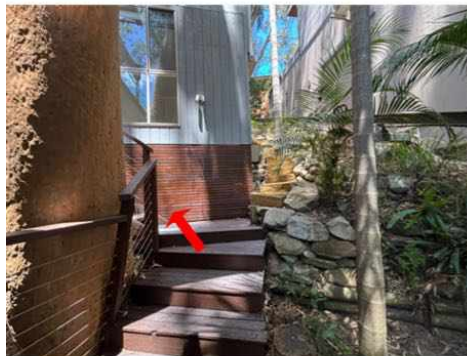
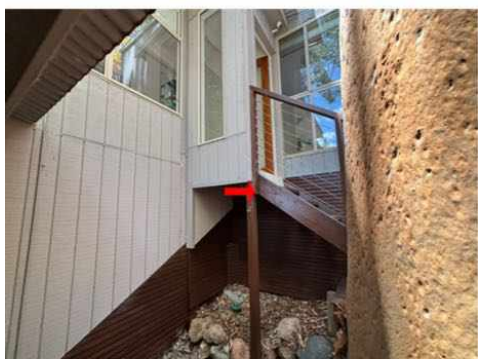
Building: Main Building
 Location: All Areas
 Finding: Timber Directly Attached to Building
 Information: At the time of inspection, timber materials were noted to be directly attached to the external wall of the dwelling. This practice is considered a conducive condition for termite activity, as it provides both a potential food source and concealed entry point

for termites into the structure.

It is recommended that the timber be removed, isolated, or appropriately treated to reduce the risk of termite infestation. A licensed pest management specialist should be consulted for further assessment and advice in line with AS 3660.2 (Termite Management).

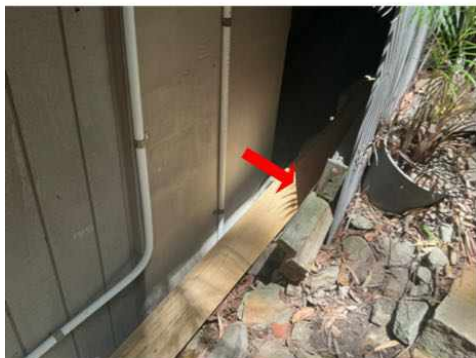
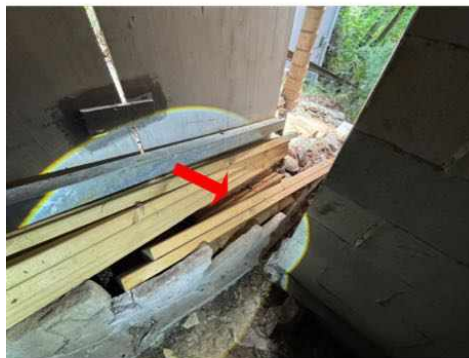
Finding 6.07

Building:	Main Building
Location:	Subfloor
Finding:	Stored Timbers - On Site
Information:	The storage of timber around external areas or within subfloor spaces poses a significant risk of attracting termite activity. Timber left exposed to moisture can develop wood rot, creating an ideal environment for termites and other timber pests. When placed directly on the ground or in damp, concealed subfloor areas, this timber can act as a bridge for termites to enter the structure, potentially causing serious and costly damage.

In addition to termites, stored timber can promote mould, mildew, and fungal growth, which may affect both the structure and the health of occupants.

To reduce these risks, it is strongly advised that any stored timber be removed.

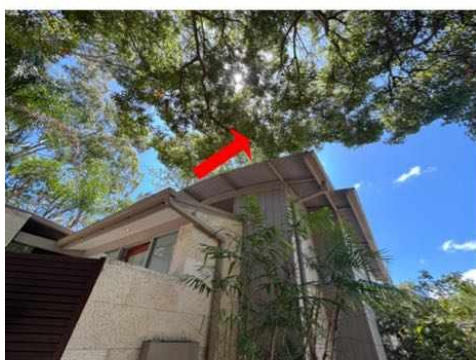
Finding 6.08

Building:	Main Building
Location:	All Areas
Finding:	Overhanging Trees/Branches/Roots
Information:	Overhanging trees and exposed roots were noted near the property, which pose potential risks to the structure and surrounding areas.

The overhanging branches can cause damage to the roof, gutters, or walls, particularly during storms or high winds. Additionally, the roots may pose a threat to the foundation by causing ground movement, leading to cracks or uneven settling over time. The accumulation of leaves and debris in gutters and drainage systems can also lead to blockages, contributing to water overflow and potential water damage.

It is recommended that a qualified arborist be engaged to prune back the overhanging branches and assess any potential risks posed by the tree roots to prevent further damage to the property. It is advised to get this fixed as soon as possible. Regular maintenance should be carried out to ensure the trees are managed effectively and the property remains safe.
