Building and Timber Pest Inspection Report

Inspection Date: Tue, 27 Jan 2026

Property Address: 10 Cowdroy Ave, Cammeray NSW 2062, Australia

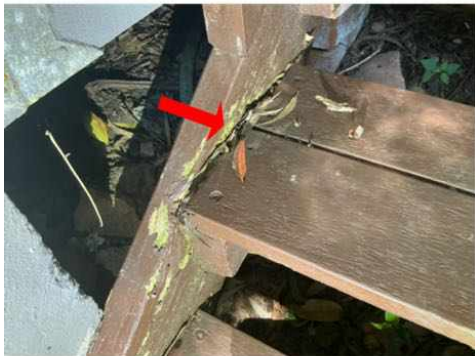
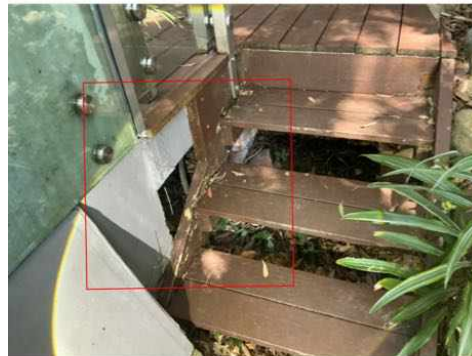
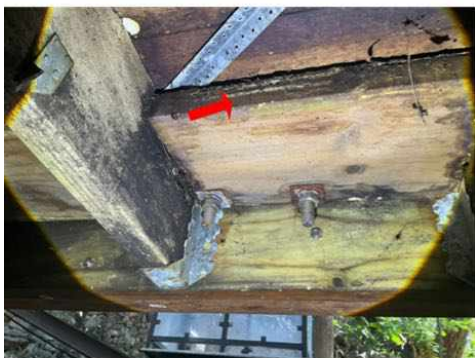
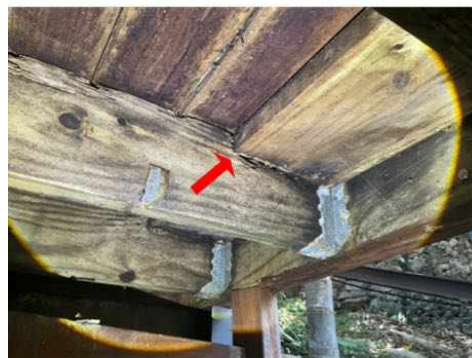
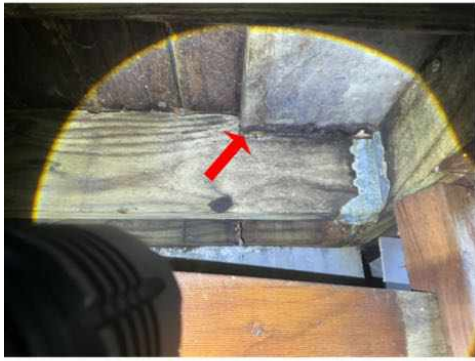
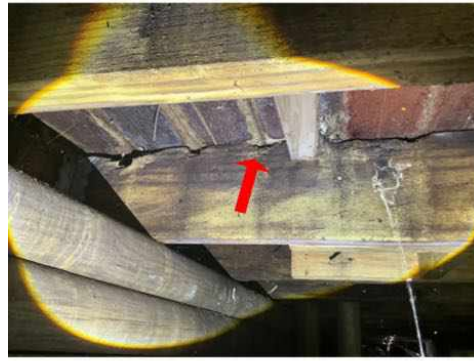
Finding 7.01

Building:	Main Building
Location:	Deck, External Stairs
Finding:	Fungal Decay - Present (Localised)
Information:	Fungal decay, also referred to as wood decay or wood rot, typically occurs when timber elements are exposed to excessive moisture for extended periods. This deterioration process is accelerated by temperatures ranging between 5°C and 40°C, as well as the presence of oxygen. Fungal decay is commonly found in timber components used in external environments, particularly when they are exposed to rain or moisture penetration.

In this instance, although the timber element shows signs of decay, the visible damage appears to be localized to a specific area and has not yet spread to adjoining structures or other parts of the building element. As a result, the fungal decay is likely to be relatively superficial, with minimal impact on the structural integrity or tensile strength of the timber. However, it is advisable to monitor the affected area to prevent further deterioration and address the underlying moisture issue to mitigate future risk.

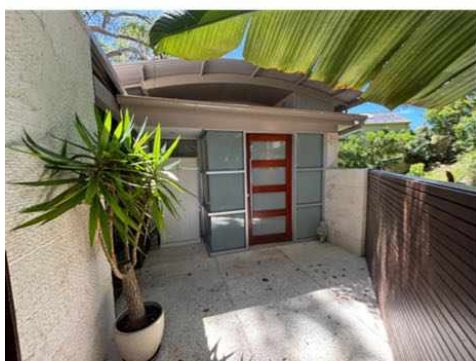
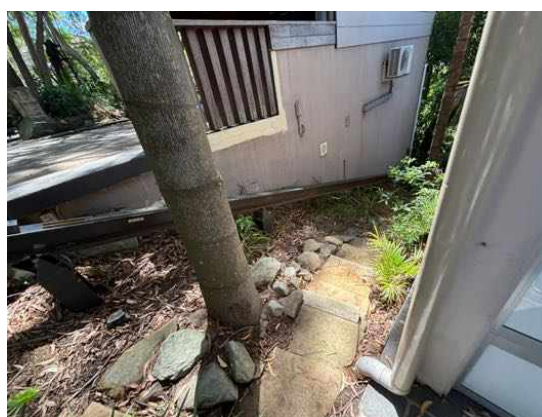
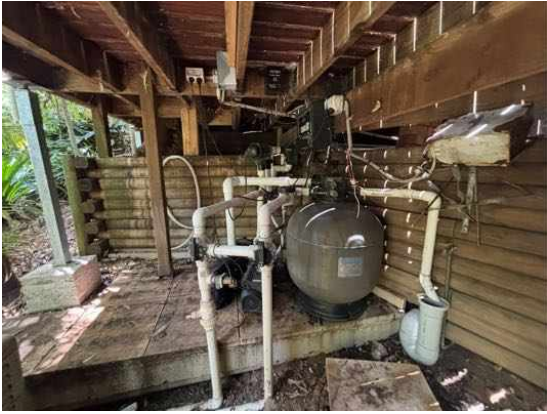
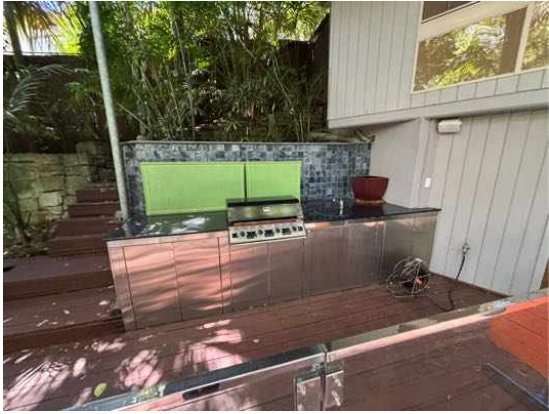
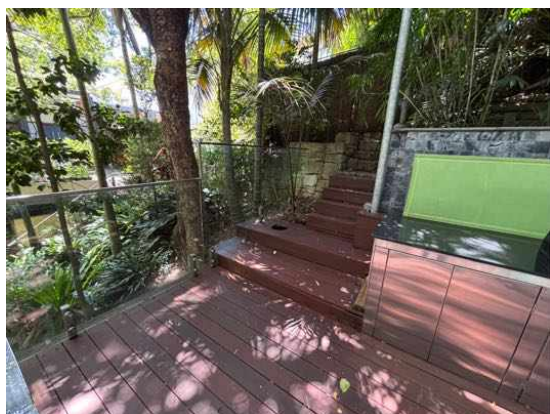
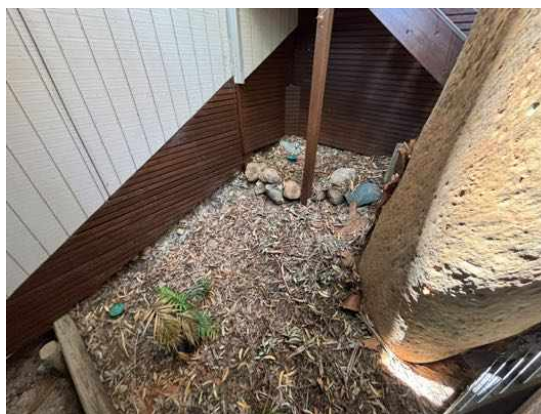
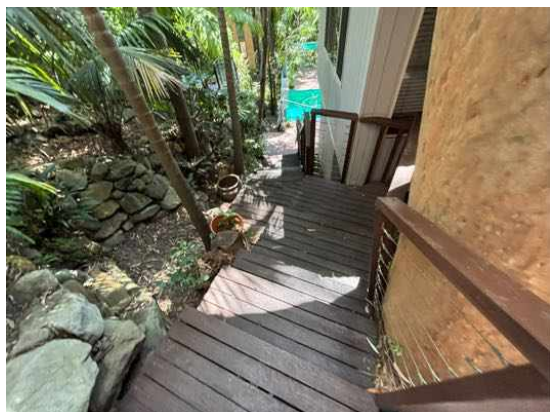
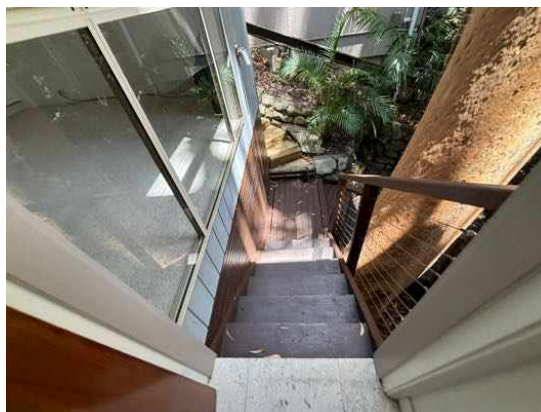
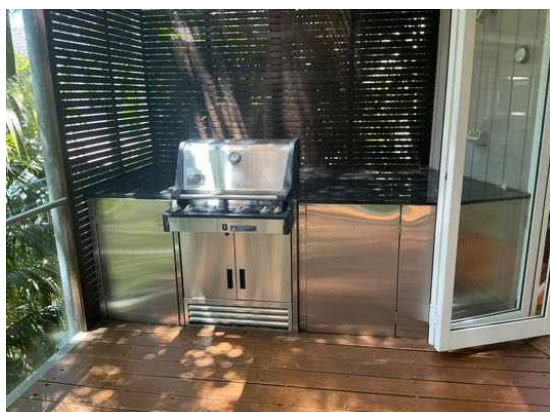
Building: Main Building
Location: All External Areas
Finding: Obstructions and Limitations - External Areas
Information: The attached photographs provide a visual representation of the obstructions and limitations that impeded a full inspection of the external areas of the property at the time of assessment. These obstructions, which may include vegetation, stored items, debris, or other physical barriers, can obscure potential defects and prevent a thorough evaluation of the property's condition. Obstructions of this nature can conceal a wide range of issues, such as structural damage, water ingress, pest infestations, or deteriorating building materials, which may not be visible during the initial inspection.

It is essential that these obstructions be cleared to allow for a comprehensive inspection of the external areas. Removing these barriers will enable a more accurate assessment of the property's condition and allow any hidden defects to be identified and addressed promptly. Failure to do so could result in undetected issues worsening over time, potentially leading to more costly repairs in the future.

Therefore, it is strongly recommended that the obstructions be removed and a re-inspection be scheduled once the affected areas are made fully accessible. This will ensure a complete evaluation of the property's exterior and provide the client with a clear understanding of any potential issues that may have been concealed during the initial inspection.

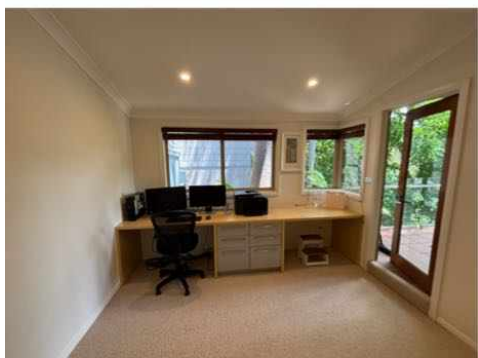
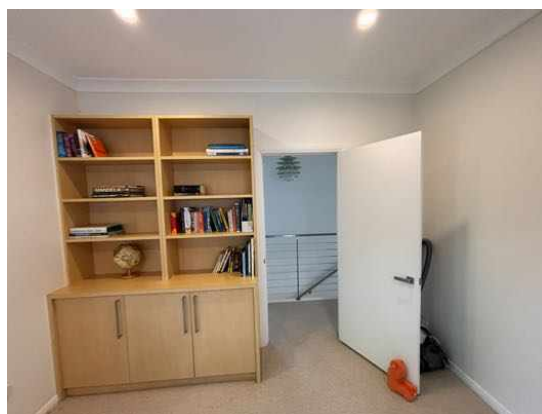
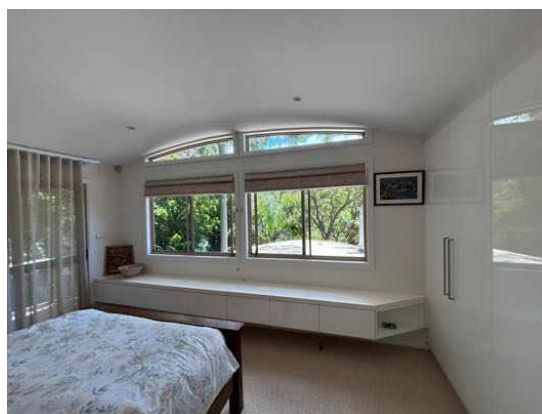
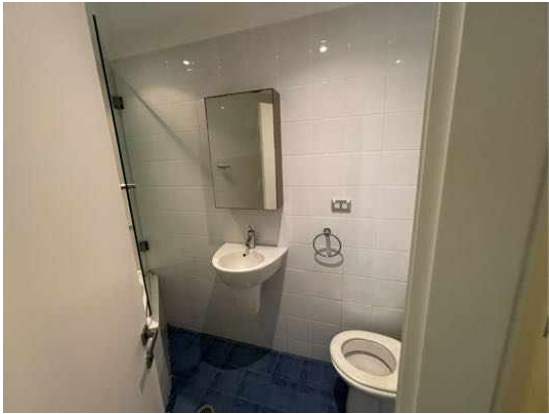
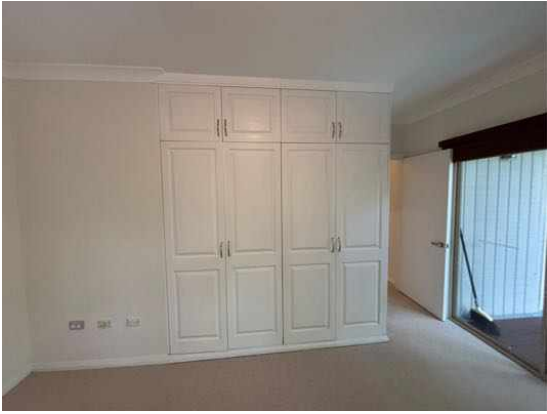
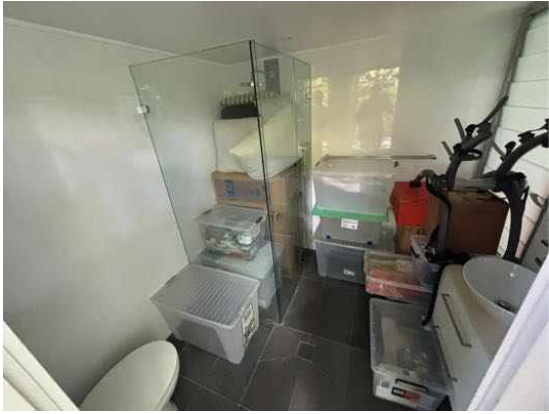
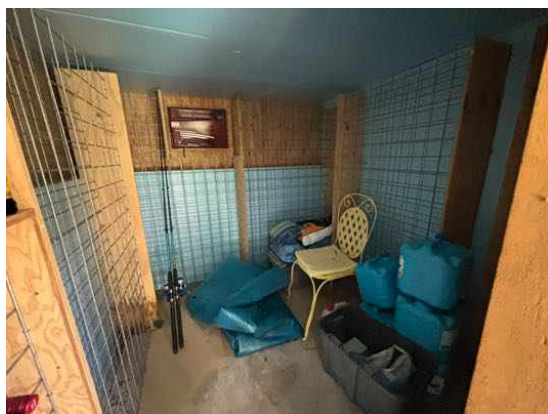
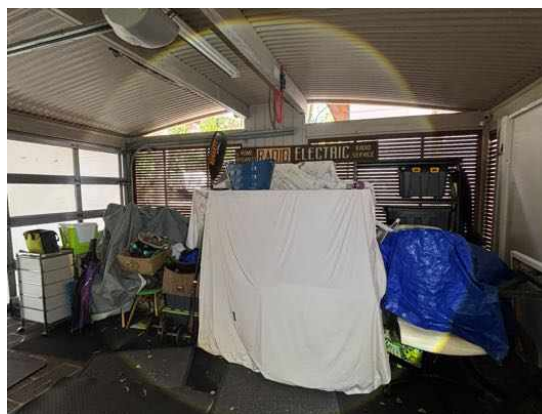
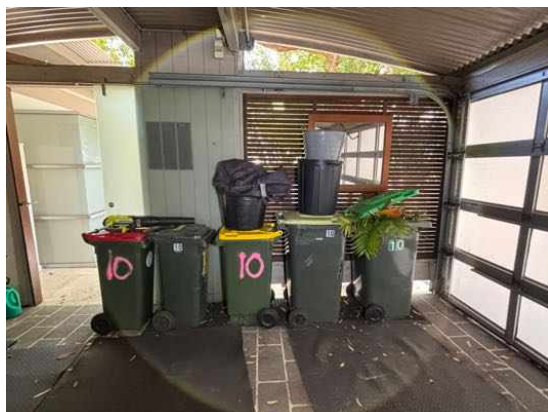
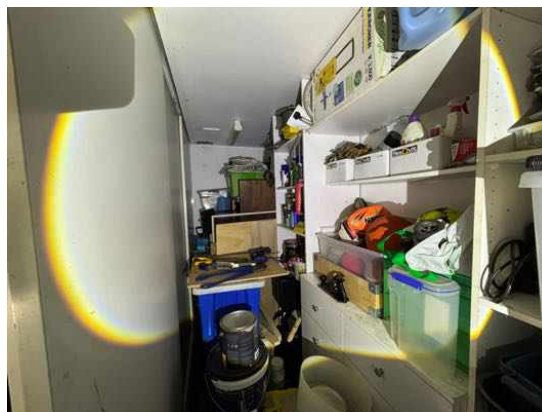
Building:	Main Building
Location:	All Internal Areas
Finding:	Obstructions and Limitations - Internal Areas
Information:	The accompanying photographs provide clear evidence of the obstructions and limitations that restricted a comprehensive inspection of the internal areas of the property at the time of assessment. These obstructions, which may include furniture, personal belongings, stored items, or structural elements such as wall coverings and built-ins, significantly hindered the ability to thoroughly evaluate these areas. It is important to note that such obstructions can potentially conceal a wide array of defects, ranging from hidden structural damage, water leaks, pest infestations, or

electrical issues, to deteriorating materials that may not be visible during the initial inspection.

The presence of these impediments means that critical areas of the property were not accessible, and therefore, any underlying defects that may affect the integrity and safety of the property could remain undetected. These hidden defects, if left unaddressed, could worsen over time and may result in costly repairs or pose potential safety hazards to the occupants.

It is highly recommended that all obstructions be cleared to facilitate a complete and thorough inspection of the internal areas. Once the obstructions have been removed and full access is available, a re-inspection should be carried out to ensure that any previously concealed issues can be properly identified and rectified. This follow-up inspection will provide a more accurate assessment of the property's internal condition and help the client make informed decisions about any necessary repairs or maintenance.

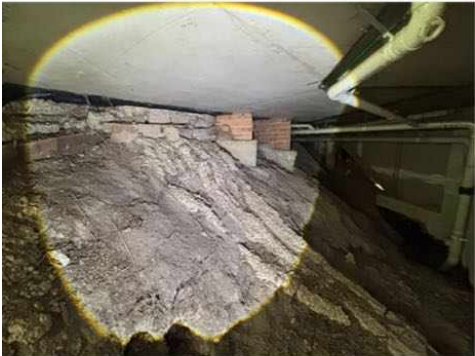
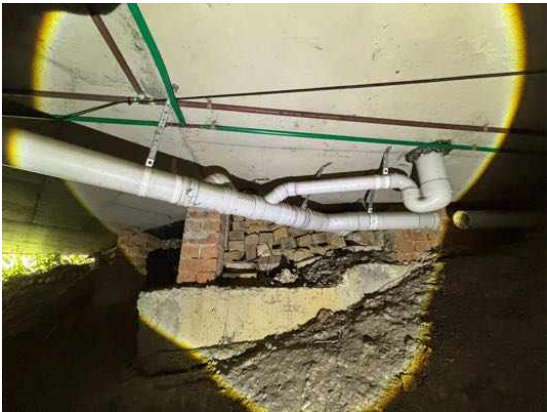
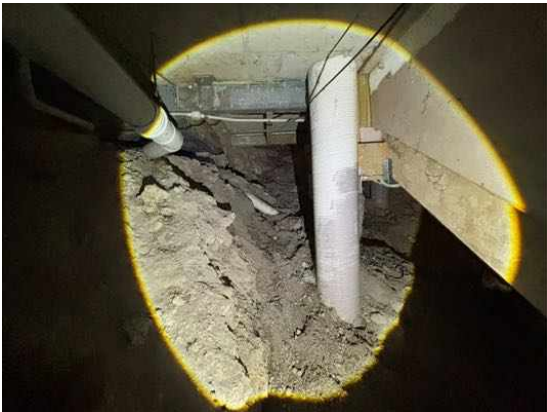
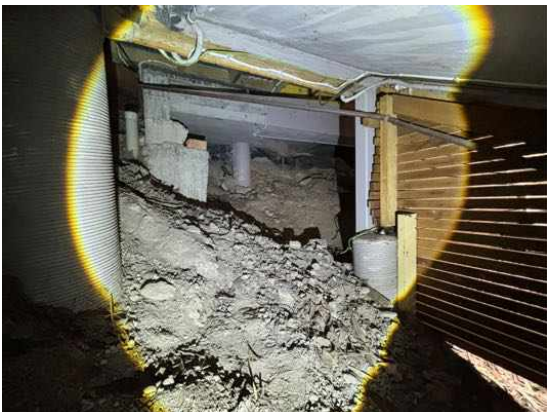
Building: Main Building
 Location: Subfloor
 Finding: Obstructions, Limitations, and General Subfloor Condition
 Information: The attached photographs illustrate the obstructions and access limitations that restricted a full inspection of the subfloor area of the main property at the time of assessment. Items such as stored materials, construction debris, low-hanging services, and insulation impeded movement and visibility within key sections of the subfloor. In addition, the limited crawl height further restricted safe access to inspect critical structural components.

Restricted access and confined spaces can significantly hinder the ability to evaluate important elements such as floor joists, bearers, stumps, drainage, subfloor ventilation, and signs of moisture or pest activity. These obstructions may also conceal defects such as timber decay, water ingress, termite damage, inadequate support, or ventilation issues that are not immediately visible during a limited inspection.

While no major concerns were identified in the accessible areas, a full and unobstructed inspection is necessary to properly assess the overall condition of the subfloor. It is recommended that obstructions be removed and access improved where possible. Once adequate clearance is provided, a re-inspection should be arranged to ensure that any concealed defects can be identified and addressed accordingly. This will assist in providing a more comprehensive understanding of the

subfloor's condition and reduce the risk of unforeseen issues.

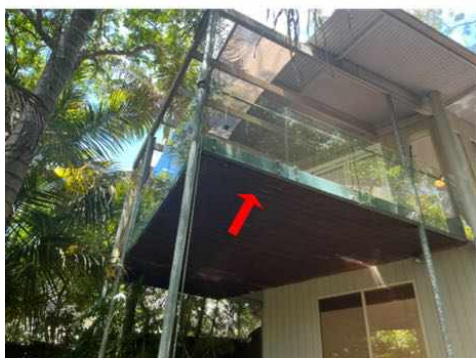
You should also arrange annual inspections of the structure by an engineer or other suitably qualified person to ensure any maintenance, that may become necessary, is identified. Care must be taken not to overload the structure.

Nothing contained in this report should be taken as an indicator that an assessment has been made, on any elevated structure, as suitable for any specific number of people or purpose. This can only be done by a qualified engineer. For the purpose of this report, the Structure includes elevated decks, verandah, pergolas, balconies, handrails, stairs and children's play areas.

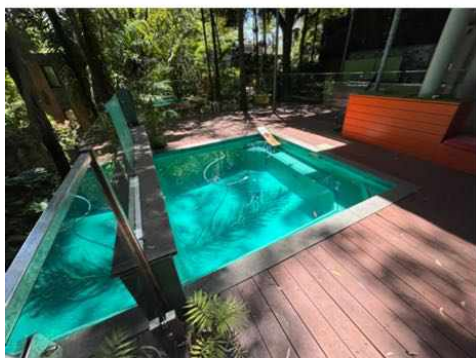
Building:	Main Building
Location:	Pool Area
Finding:	FYI - Pool Area
Information:	This inspection explicitly excludes any assessment of the pool, spa, associated pool equipment, and the surrounding areas. As a standard building inspection does not encompass these elements, it is crucial for the client to understand that no evaluation has been conducted regarding the condition, functionality, or safety compliance of the pool or its associated systems. This includes, but is not limited to, pumps, filters, heating equipment, and structural integrity of the pool or spa surrounds.

To gain a comprehensive understanding of the condition and compliance of these components, it is highly recommended that the client engages a specialist pool inspector. A pool inspection will evaluate the structural condition of the pool, ensure

the functionality of all associated equipment, and assess whether the pool and its surroundings meet current safety regulations. In particular, pool safety requirements, including fencing and access controls, are subject to stringent regulatory standards, which must be verified separately by a qualified pool inspector.

It is important to note that a pool safety inspection, which is crucial to ensure compliance with legal safety standards, is not part of a standard building inspection and must be commissioned separately. Engaging a licensed pool inspector ensures that any potential safety hazards or functional defects are identified and addressed in a timely manner, safeguarding the well-being of the occupants and ensuring compliance with relevant legislation.

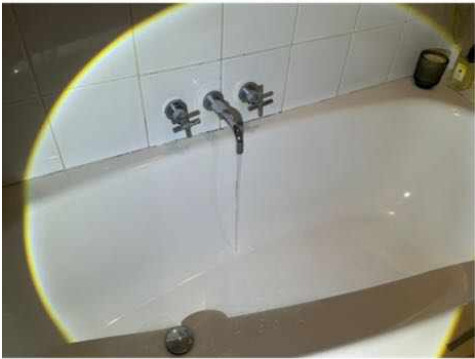
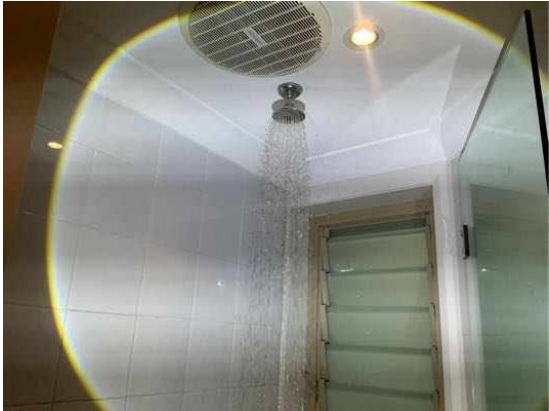
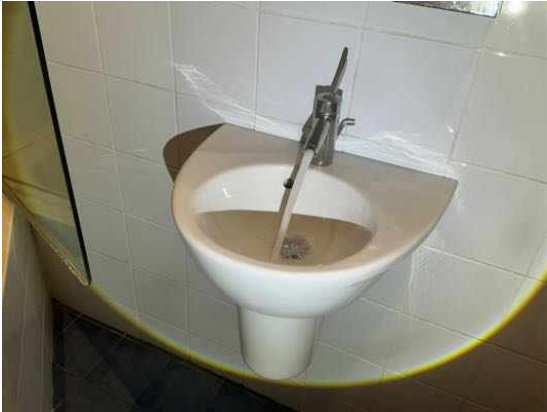
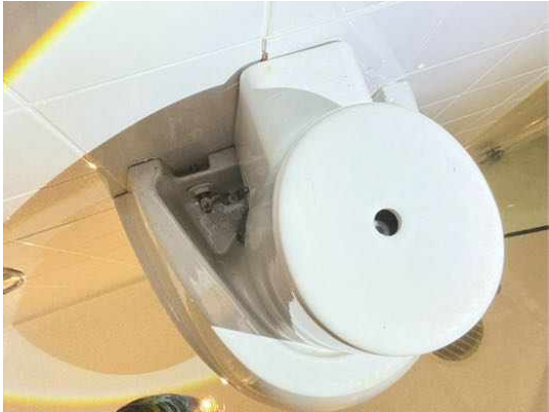
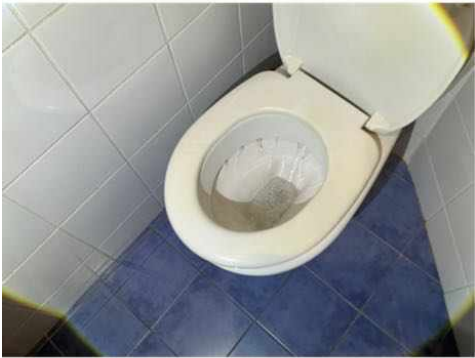
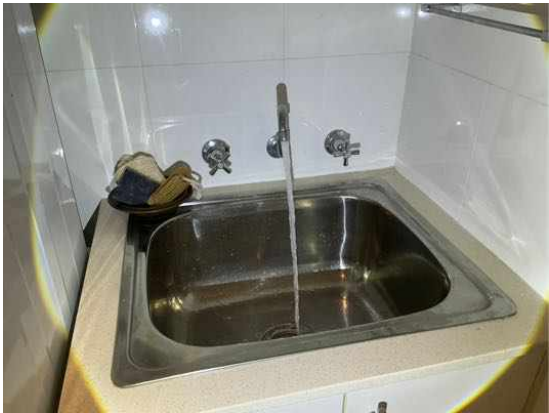
Building:	Main Building
Location:	All Areas
Finding:	FYI - Taps, Drainage & Toilets Tested and Cabinetry Obstructions
Information:	During the inspection, all accessible taps, drainage systems, and toilets were tested for water flow and drainage efficiency, and checked for any visible signs of leakage. At the time of the inspection, no issues were noted in these areas. Unless highlighted in a separate defect statement, no immediate remedial work appears necessary. Supporting images may be found in the additional photos section for reference.

It is important to note that while a visual inspection of cupboards and cabinetry beneath sinks and vanities was undertaken, stored personal items and fixtures presented obstructions that limited full visibility of the internal areas. As per standard inspection practices, inspectors are not permitted to move or disturb personal belongings during the inspection process. Therefore, only visible and accessible sections were inspected, and concealed water damage or plumbing defects may not have been detected.

Given this, a re-inspection is recommended after all obstructions have been cleared to allow for a comprehensive assessment of these areas. Regular maintenance and monitoring of plumbing and drainage systems is also advised to ensure ongoing functionality and early detection of potential issues.

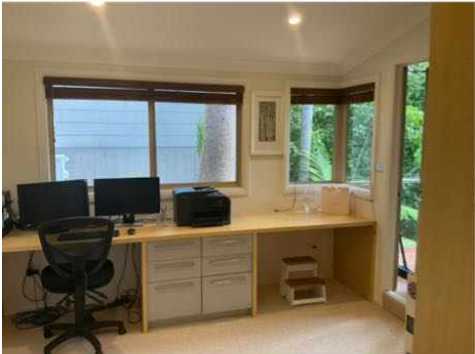
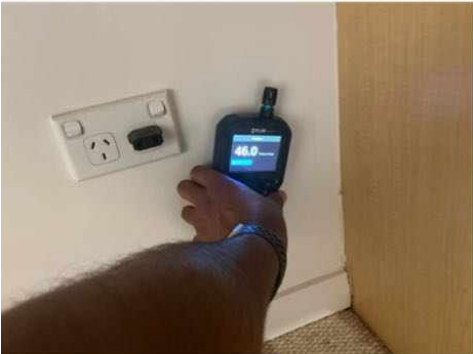
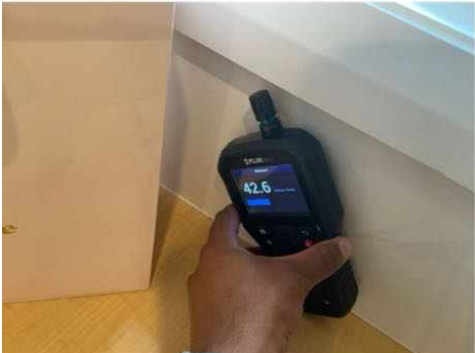
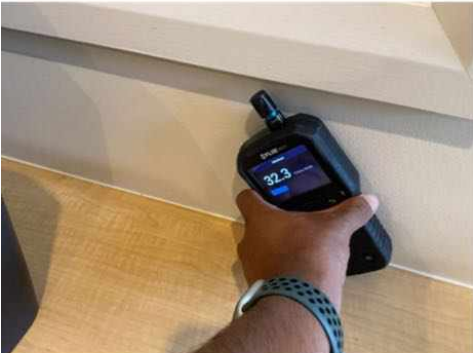
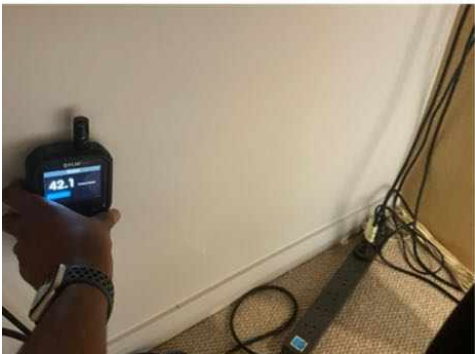
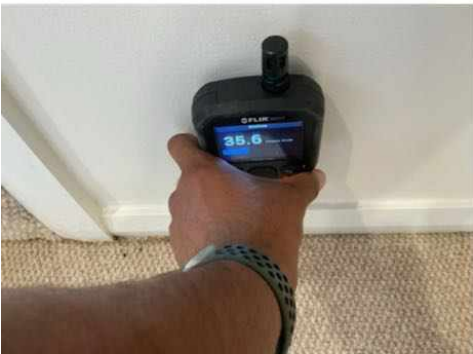
Building:	Main Building
Location:	All Areas
Finding:	Additional Photos - Moisture Meter Readings
Information:	Additional moisture meter reading photos have been provided for the property to offer further clarity on areas tested during the inspection. These photos are intended to give a visual reference for the specific locations where moisture levels were measured. These readings were taken at the time of the inspection to assess any potential moisture-related issues within the property. Any defects related to moisture that were identified during the inspection have been separately mentioned in the defect statements within the report.

It is important for the client to understand that moisture levels can fluctuate over time due to various factors, including changes in weather, humidity, and environmental conditions. While the readings reflect the property's moisture levels during the inspection, they may not represent future conditions, and increased moisture could lead to issues such as dampness, mould growth, or deterioration of building materials if left unmonitored.

For further clarification or additional information regarding the moisture readings, the client is encouraged to contact the building inspector directly. Regular monitoring of moisture-prone areas is recommended to ensure any emerging concerns are addressed promptly, particularly during wetter seasons or in high-humidity conditions.

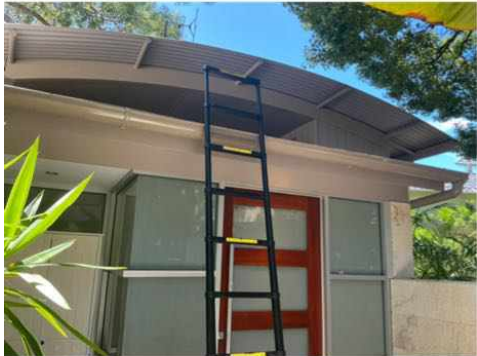
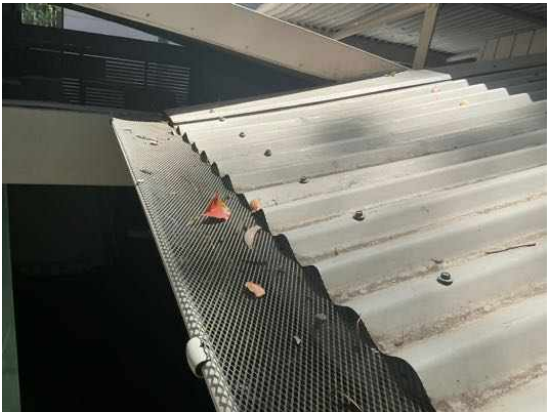
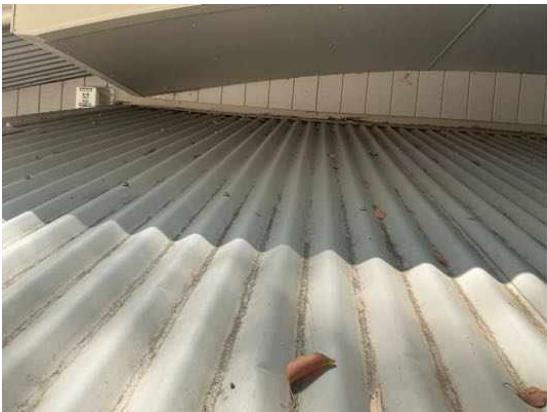
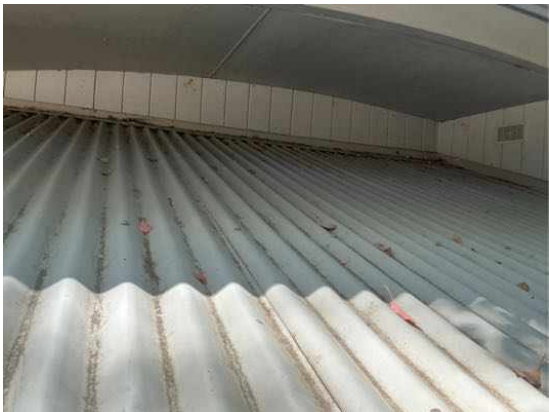
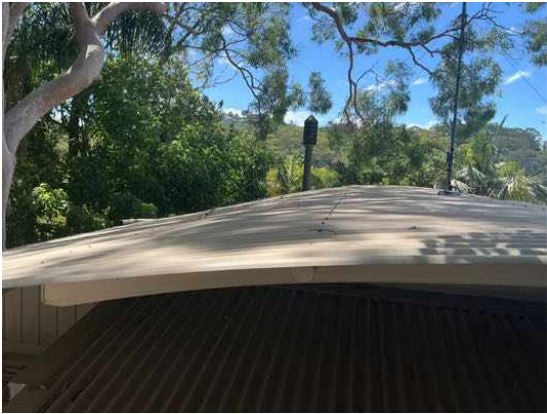
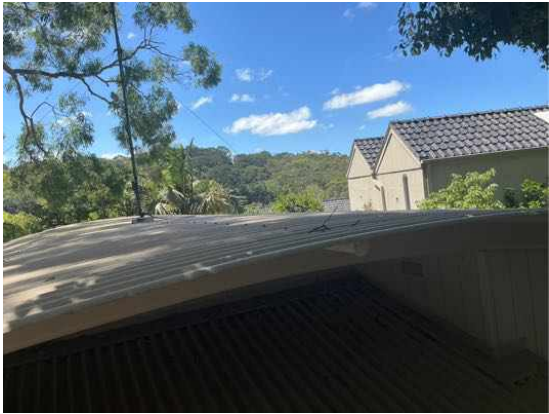
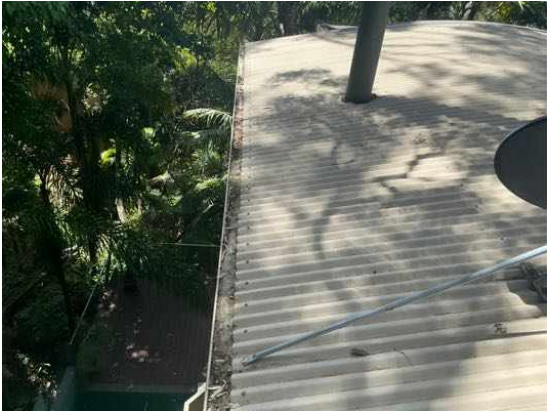
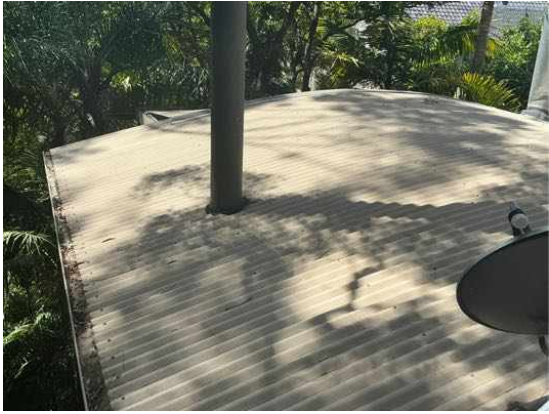
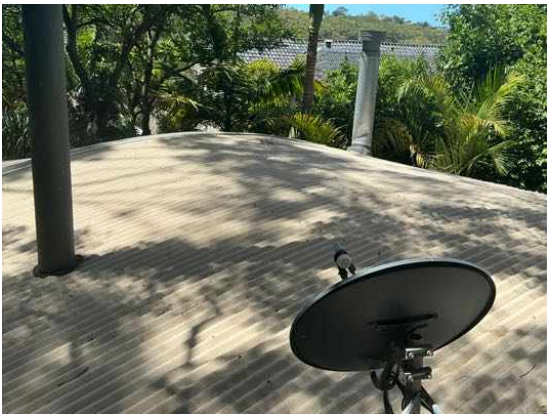
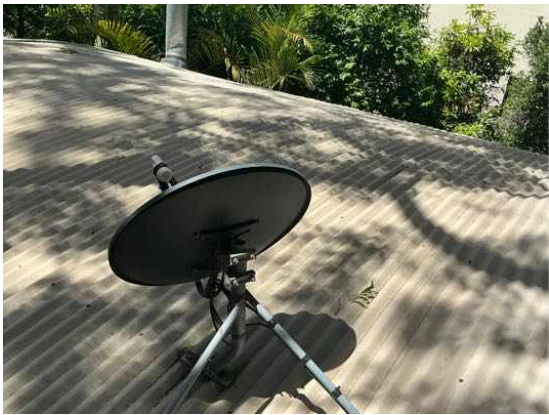
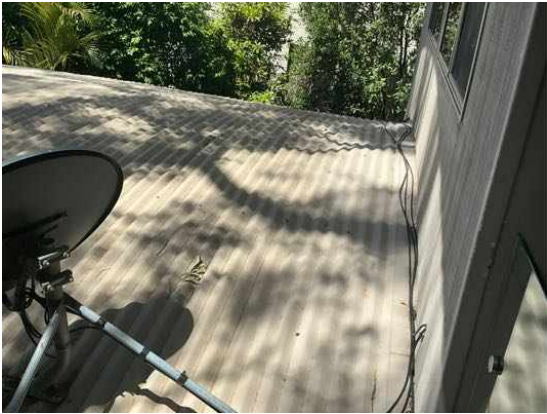
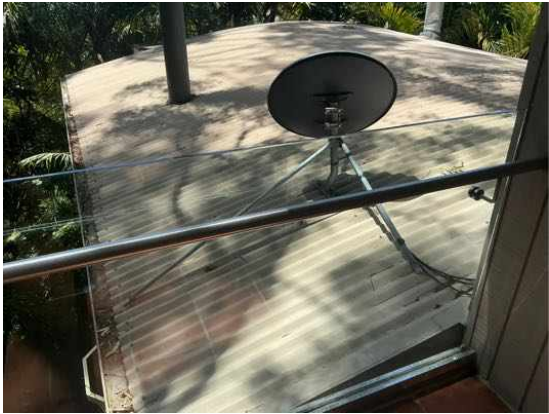
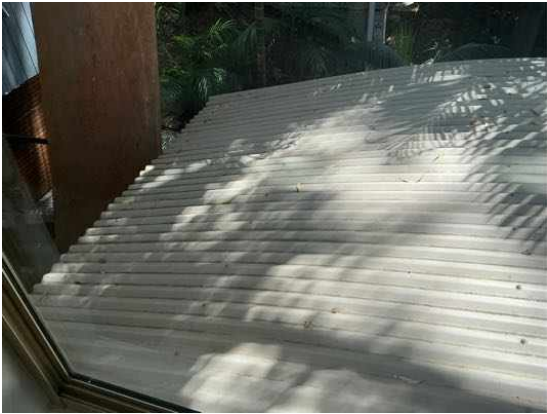
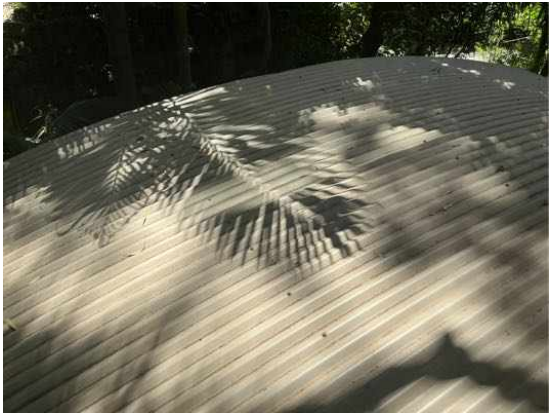
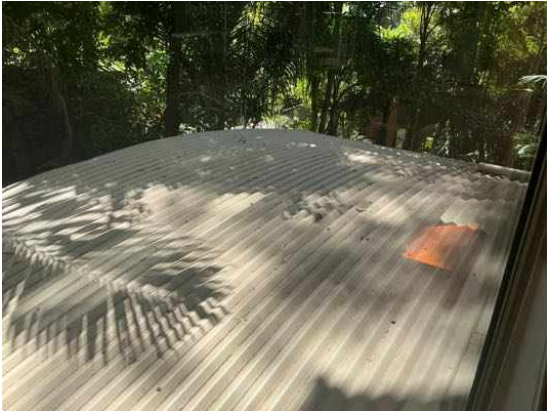
Building: Main Building
Location: Roof Exterior
Finding: Additional Roof Photos

Information: As part of the information provided, please note that the attached roof photos represent the condition of the roof at the time of inspection. These photos are for visual reference only and do not constitute a detailed roofing assessment. Any defects or issues identified with the roof are mentioned separately in the defect statements. It is strongly recommended that the client engage a qualified roofer to conduct a thorough inspection of the roof, ensuring that any potential issues, such as leaks, structural integrity, or wear and tear, are properly identified and addressed.

Additionally, the condition of the roof may change over time due to weather, natural wear, or other unforeseen factors. Regular maintenance and inspections by a licensed professional are advised to ensure the roof remains in good condition and to avoid costly repairs in the future. The information provided in these photos should be considered a snapshot of the roof's condition during the time of inspection and not a guarantee of its future performance.

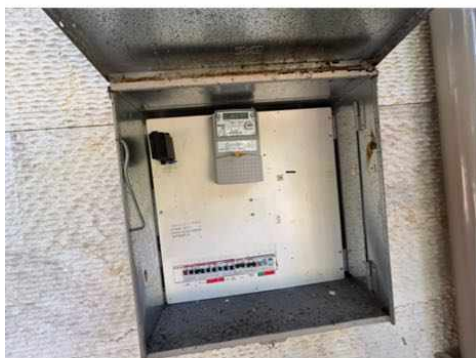
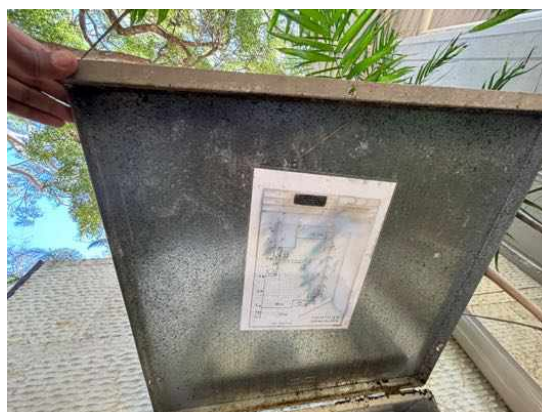
Building:	Main Building
Location:	Meter Box
Finding:	Termite Management Recommendation – No Evidence of Chemical Installation
Information:	At the time of inspection, there was no visible evidence of a chemical termite management system installed around the property. Chemical barriers are a key component of termite protection and are particularly important in preventing concealed termite entry into timber elements of the structure.

In accordance with standard requirements, a durable notice should be located within the electrical switchboard to detail any termite protection systems applied, including chemical treatments. No such notice was observed during the inspection.

It is recommended that the client engage a licensed pest controller to assess the suitability of installing a chemical barrier, and to provide advice on associated costs and procedures. This should be considered a short-term priority, particularly if the property has any history of termite activity or is located in a high-risk area.

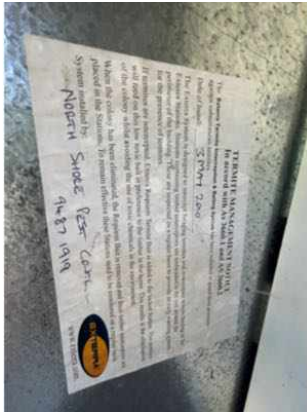
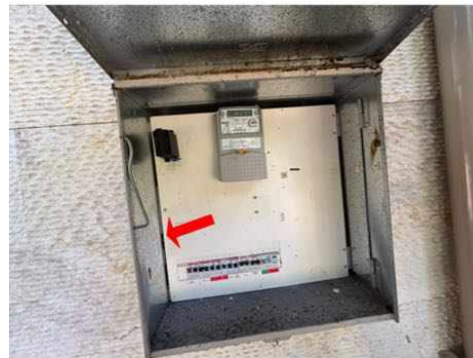
The following items were noted as - Evidence of a previous termite management program

Where a Termite Management System has been identified you should refer to the type of barrier date of installation warranty conditions and any documentation provided by a builder or past owner. Consult the company who installed the barrier to confirm whether the system is still under warranty.

Most chemical termite management systems expire and require replenishment and all physical systems are primarily designed to prevent concealed entry.
