Building and Timber Pest Inspection Report

Inspection Date: Wed, 8 Apr 2026

Property Address: 189 Slopes Road, North Richmond NSW
2754

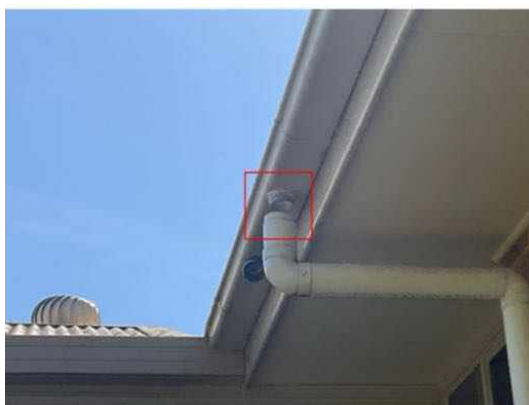
Building: Main Building
 Location: Rear Elevation
 Finding: Minor Defect – Roof Plumbing (Downpipes / Stormwater Connection).
 Information: Observation:

At the time of inspection, sections of the roof plumbing system were observed to be inadequately connected to the stormwater drainage system. In particular, downpipes were not properly sealed at their connection points, with visible gaps, damage and/or incomplete junctions noted. The condition of these connections suggests that stormwater discharge may not be effectively captured or directed into the drainage system.

Unsealed or poorly connected downpipes can result in water leakage or overflow during periods of rainfall, particularly where surface drains are obstructed or inadequately maintained. This may lead to water pooling at the base of the structure and adjacent areas. Prolonged exposure to excess moisture in these locations can contribute to subfloor dampness, increased risk of timber decay, and conditions conducive to pest activity. In addition, ongoing moisture exposure may lead to deterioration of masonry elements, including brickwork and mortar joints. While considered a minor defect at the time of inspection, failure to address this issue may result in more significant moisture-related problems over time.

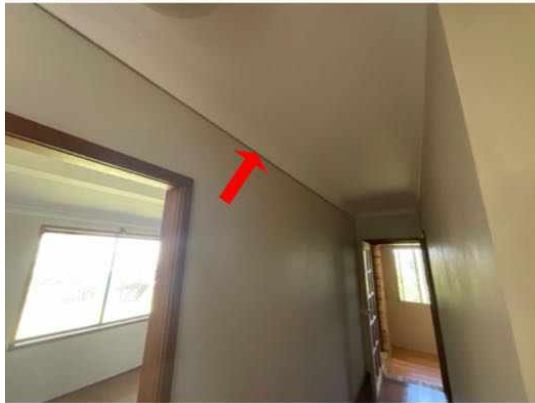
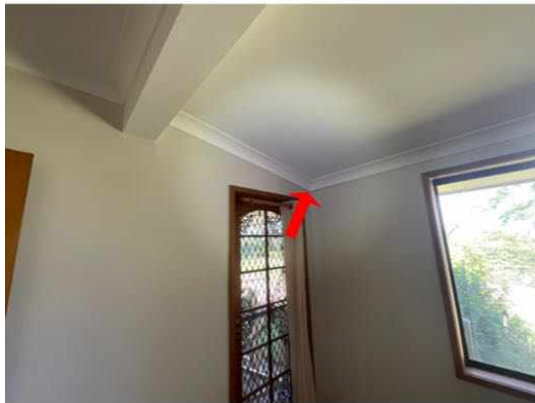
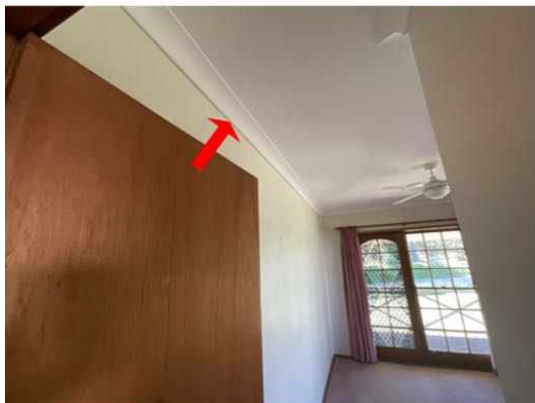
Finding 3.02

Building:	Main Building
Location:	Hallway & Bedrooms
Finding:	Minor Defect – Cornice Cracking / Detachment.
Information:	Observation:

Repairs are recommended to re-secure and reinstate affected cornice sections, which may include re-gluing, fastening, and patching as required. These works are generally considered minor maintenance and can be undertaken by a qualified plasterer or relevant tradesperson.

Prompt attention is advised to prevent further movement or damage and to maintain the overall presentation and integrity of the internal finishes. Regular monitoring of the affected areas is also recommended as part of ongoing maintenance.

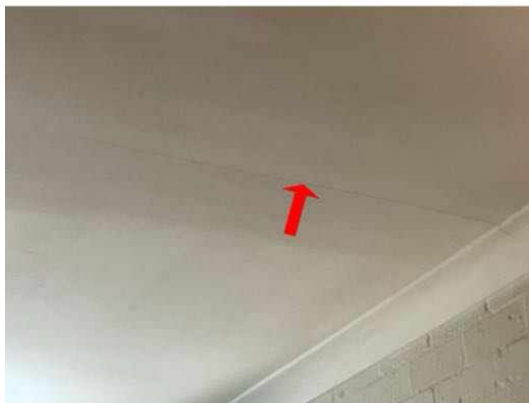
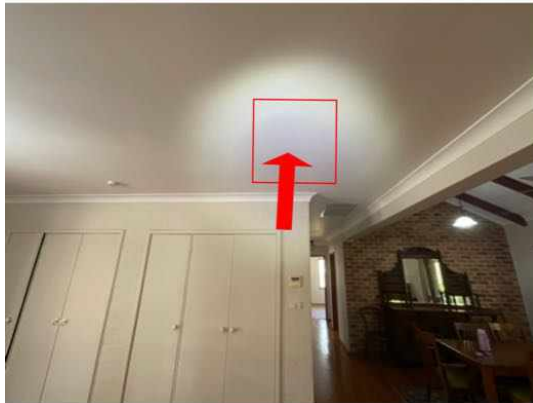
Finding 3.07

Building:	Main Building
Location:	Living Rooms
Finding:	Minor Defect – Popped Nails to Internal Ceiling.
Information:	Observation:

Prompt attention is advised to maintain the stability and integrity of the ceiling linings

and to prevent further deterioration. Ongoing monitoring is also recommended as part of routine property maintenance.

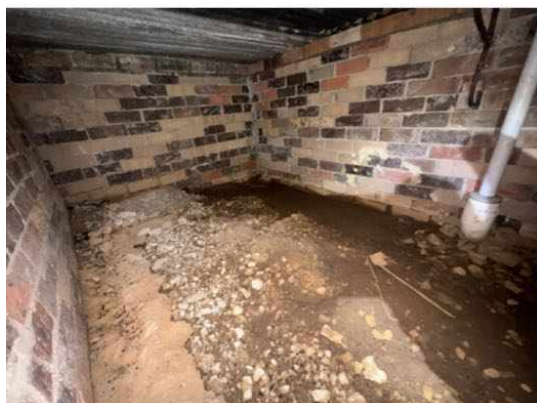
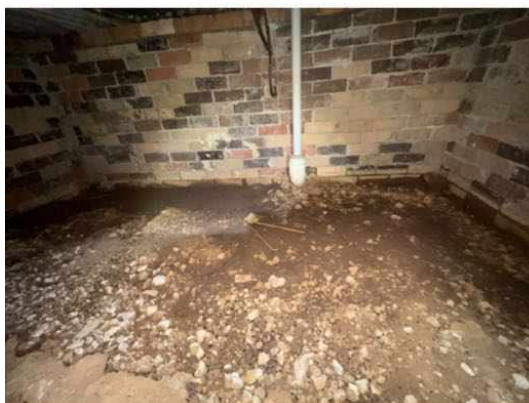
High – Conducive to concealed termite activity and fungal growth.

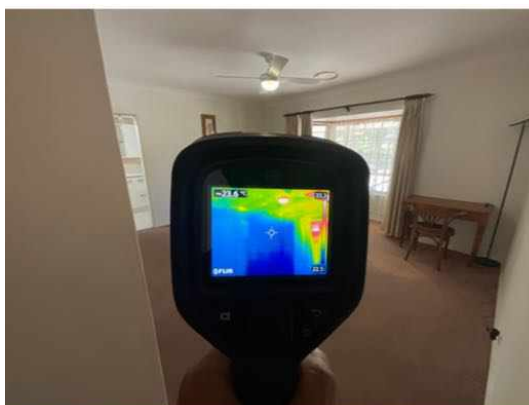
At the time of the inspection, no abnormalities indicating live termite activity were observed. However, it's important to note that various factors—such as obstructions, ambient temperature, and wall material/thickness—can impact the accuracy of thermal readings. In cases where surfaces are visually restricted or obstructed, a comprehensive thermal scan may not always be feasible.

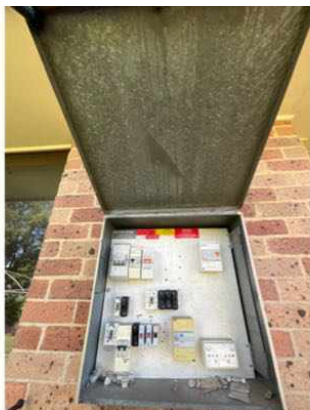
Noted Item

Building: Main Building
Location: All Areas
Finding: Termite Management System - Missing Durable Notice..
Information: Observation: Missing Durable Notice for Termite Management System

Proper maintenance and documentation are essential to ensure continued protection. Without a visible durable notice, there is no clear indication of what system (if any) is in place, which may limit the effectiveness of future termite inspections and hinder warranty claims.

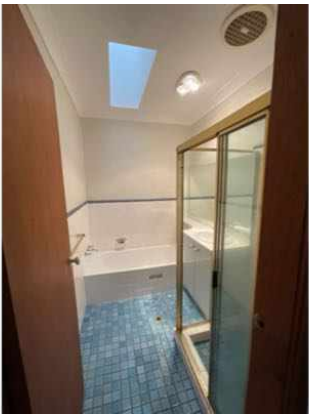
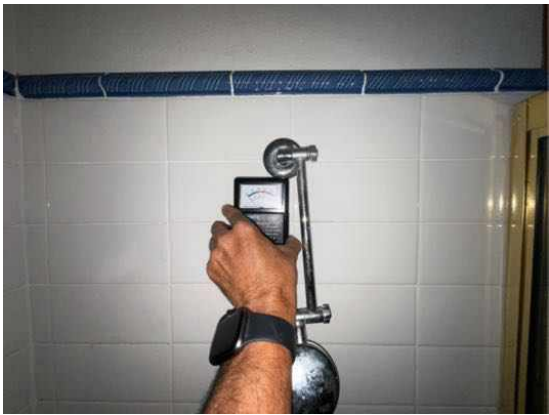
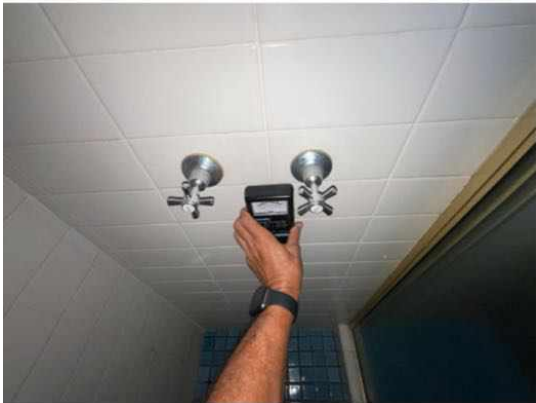
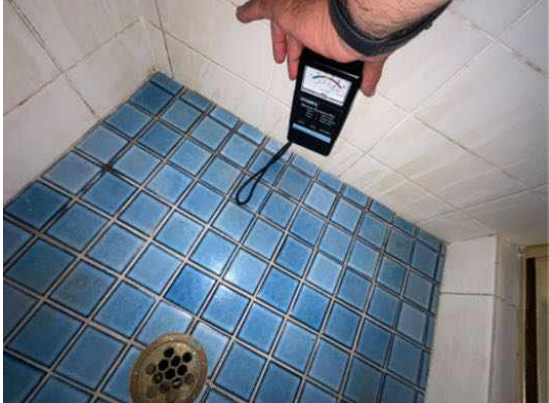
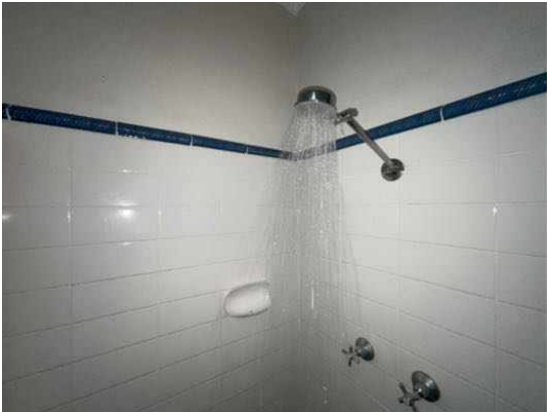
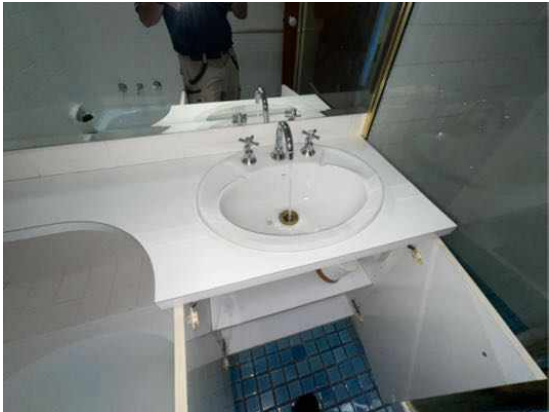
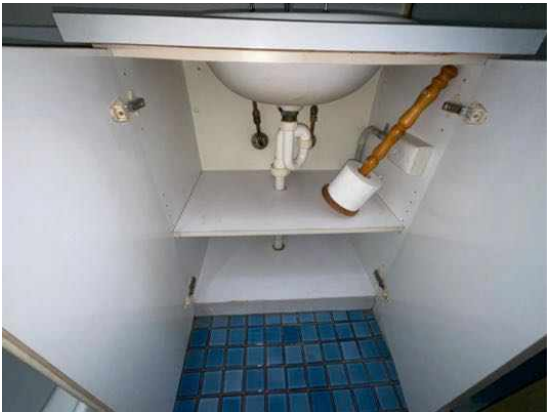
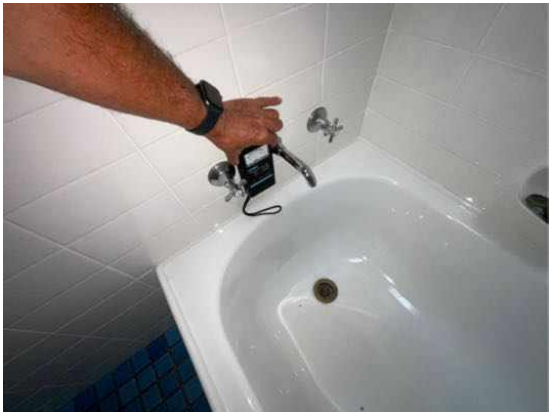
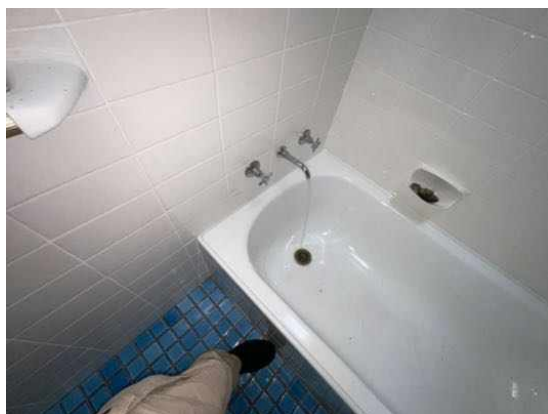
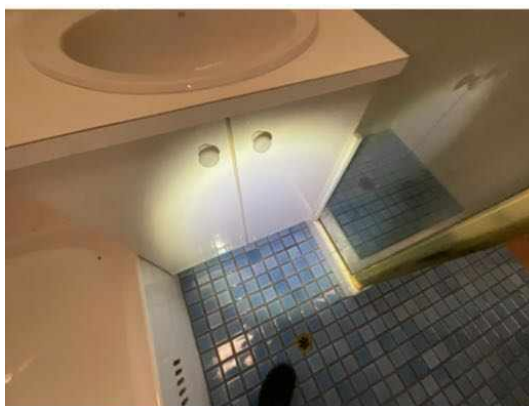
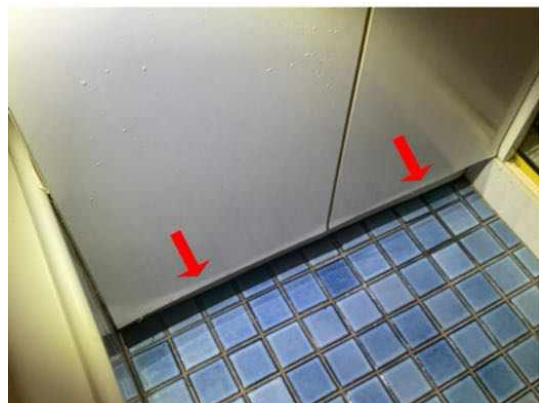
Building: Main Building
 Location: Ensuite
 Finding: Wet Areas - Bathroom(s) - Overall Condition & Recommendations.
 Information: Overall Condition & Recommendations

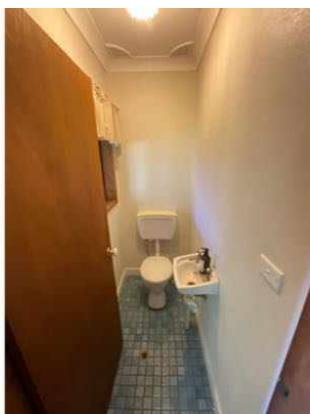
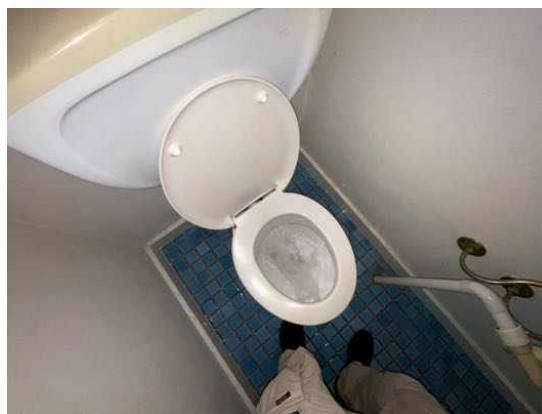
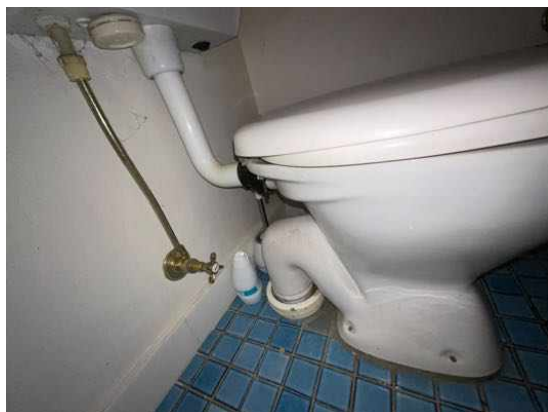
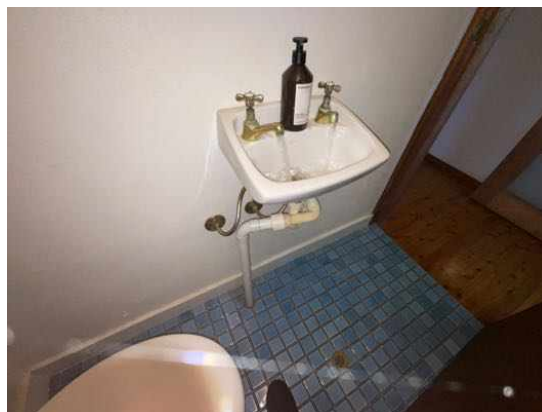
Building: Main Building
 Location: Toilet (WC)
 Finding: Overall Condition: Toilet & Basin.
 Information: TOILET & BASIN ASSESSMENT

- No leaks were observed during the flushing process.
- The toilet operated normally with no signs of malfunction or abnormal water flow.
- The toilet pan was securely fixed to the floor at the time of inspection.

- Basin(s) were water tested and inspected, with no evidence of leaks or blockages identified in the plumbing or drainage systems at the time of inspection.
- Water flow and drainage appeared satisfactory under limited-use testing conditions.
- It is recommended that flexible, mould-resistant sealant be applied or replaced where missing or degraded to prevent future water ingress.
- Regular maintenance of sealant and grouting in wet areas is essential to prolong the life of surrounding materials and reduce the risk of water damage.

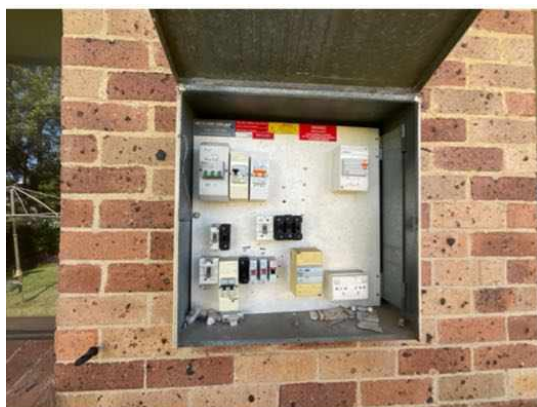
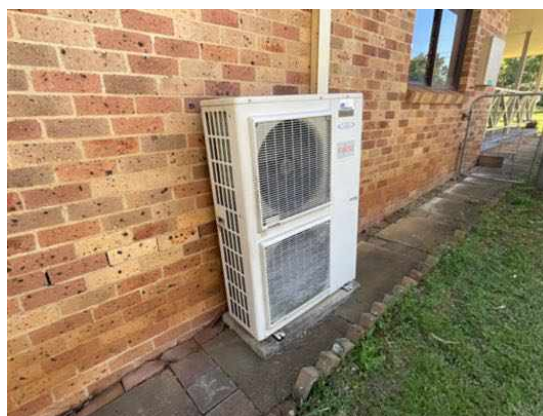
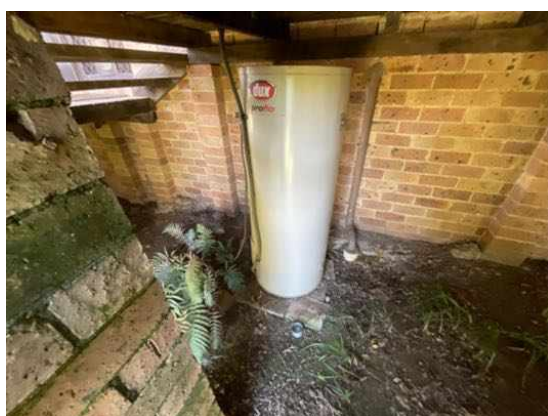
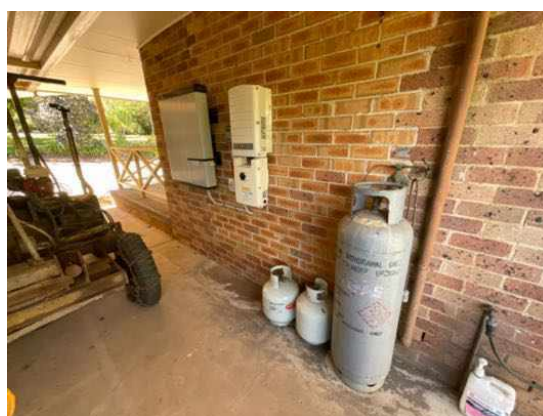
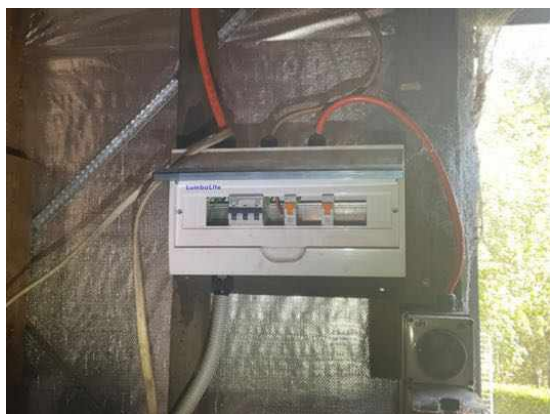
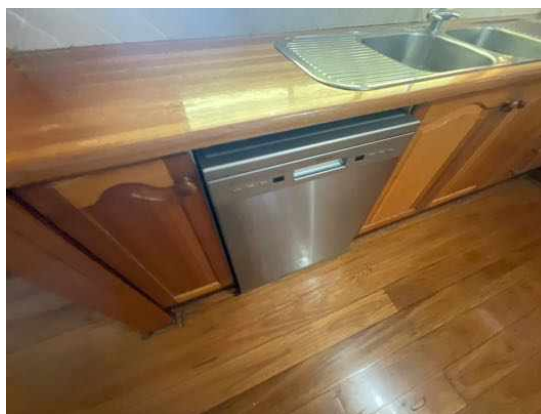
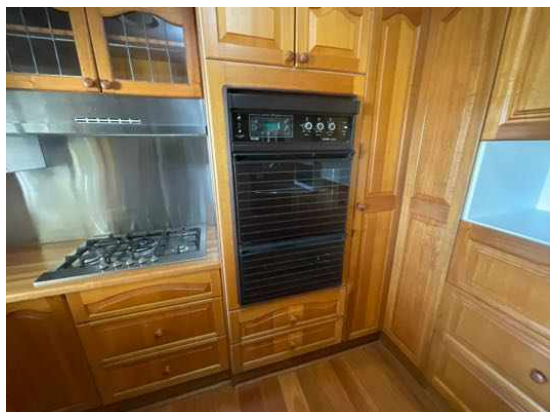
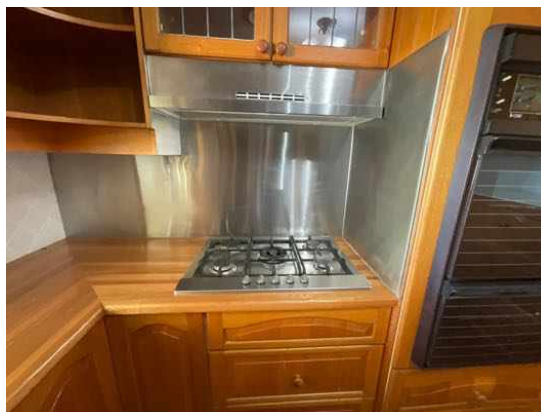
Building: Main Building
 Location: All Areas
 Finding: Plumbing, Electrical & Gas Installations – Scope and Recommendations.

Additional photos have been supplied with this report for your general reference.

- Any gas appliances (if applicable) must be inspected by a licensed gas plumber to confirm they are operating safely and efficiently.
- We also recommend that all other plumbing and electrical installations be thoroughly checked by qualified professionals to ensure they are functioning correctly and meet current safety and compliance standards.
