# Building and Timber Pest Inspection Report

Inspection Date: Wed, 01 Apr 2026

Property Address: 24 Flinders St, Matraville NSW 2036,  
Australia

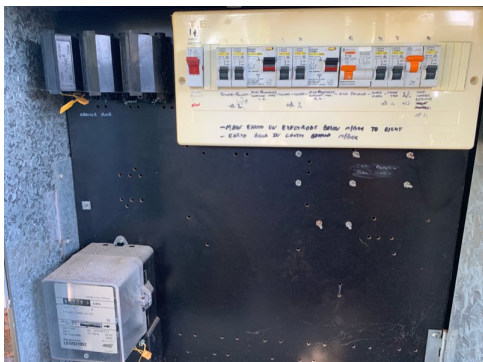
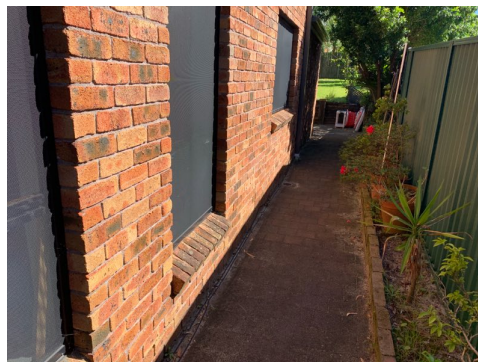
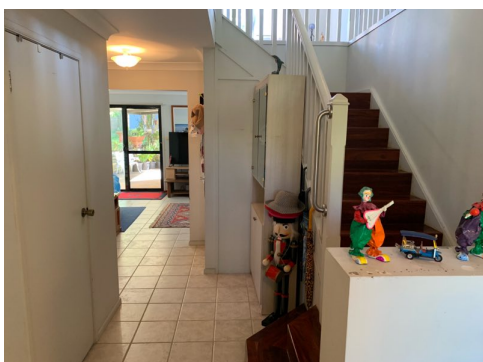
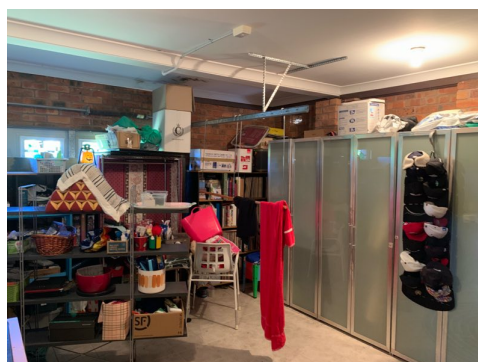
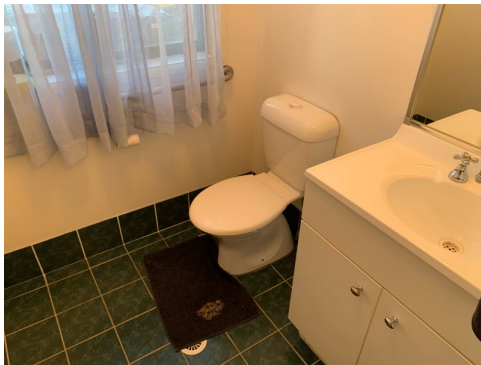
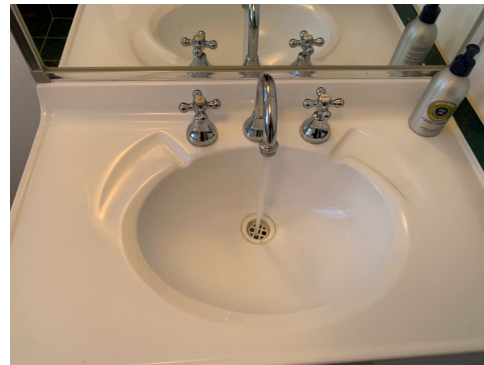
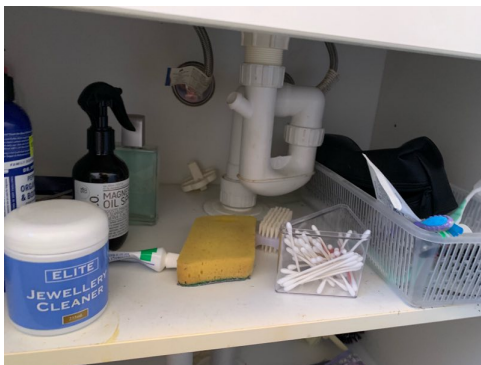
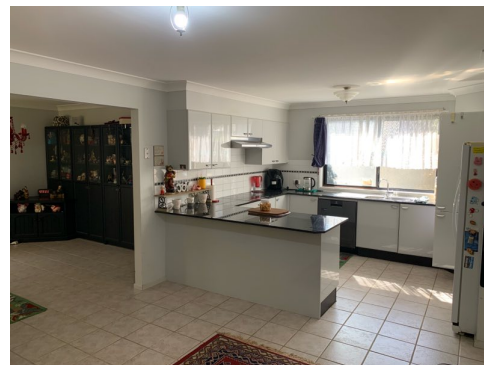
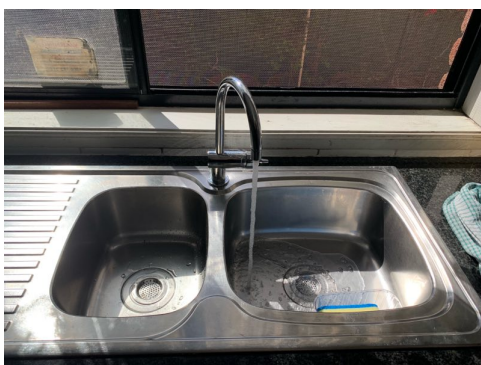
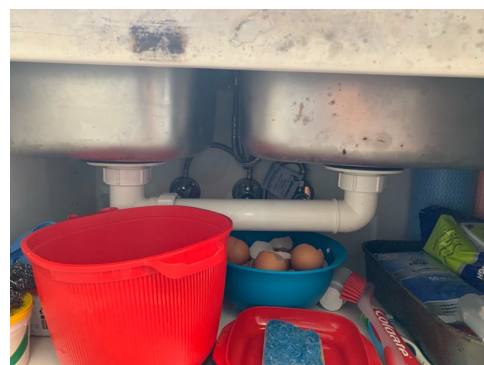
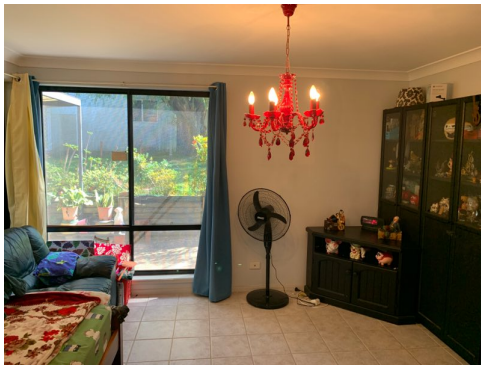
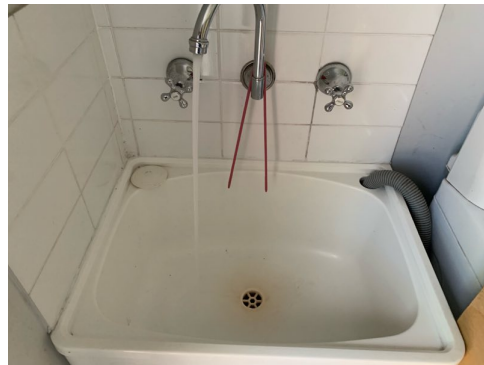
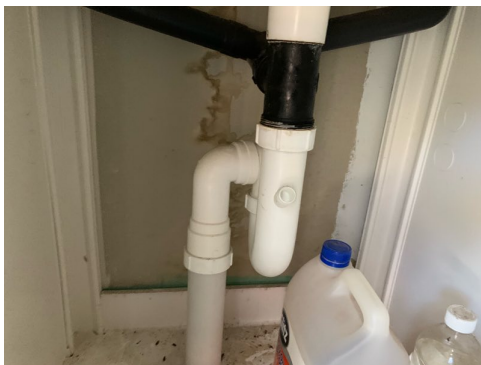
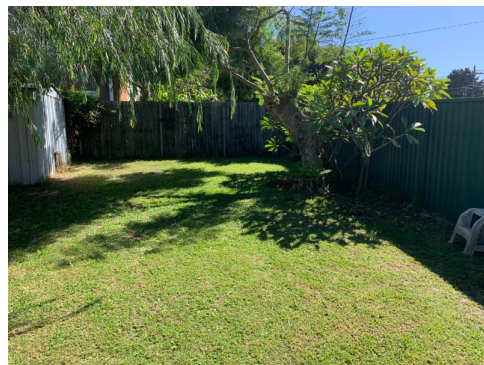
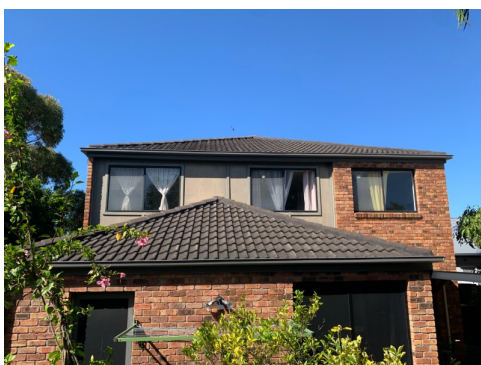
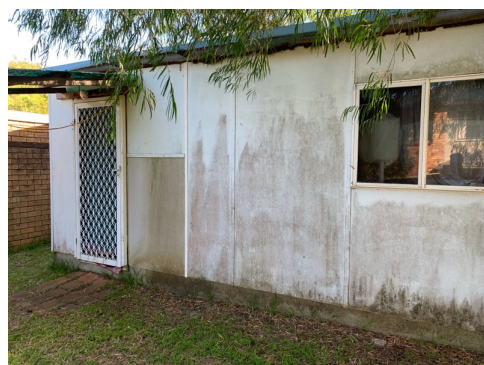
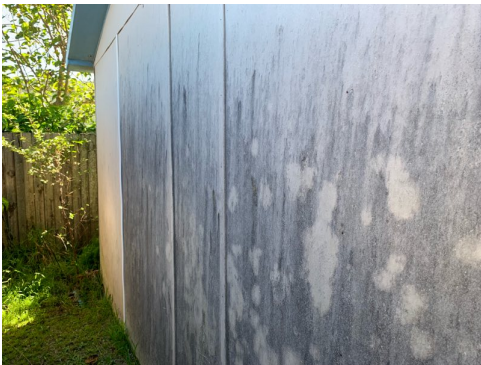
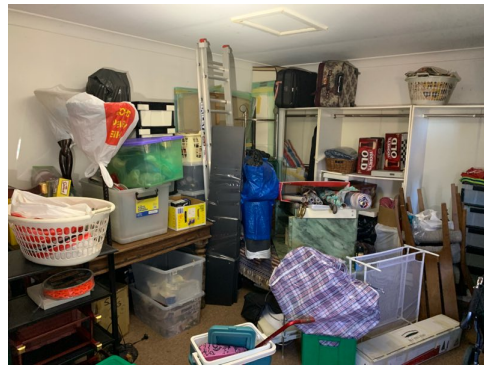
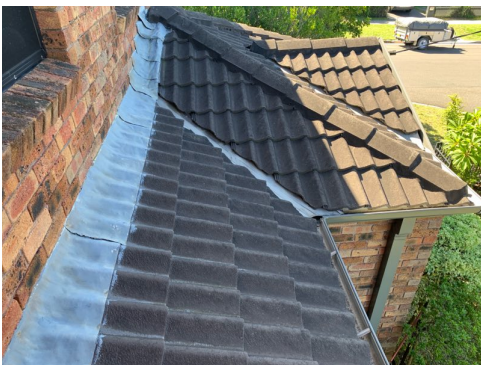
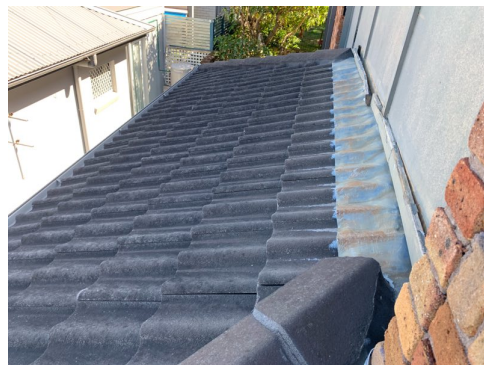
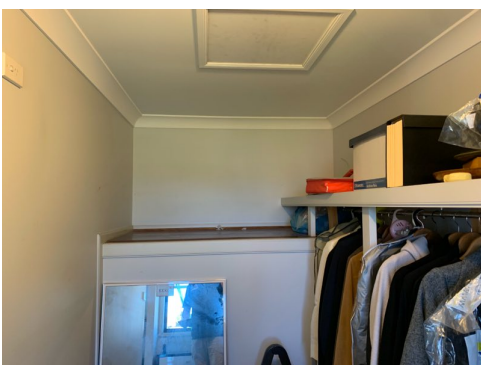
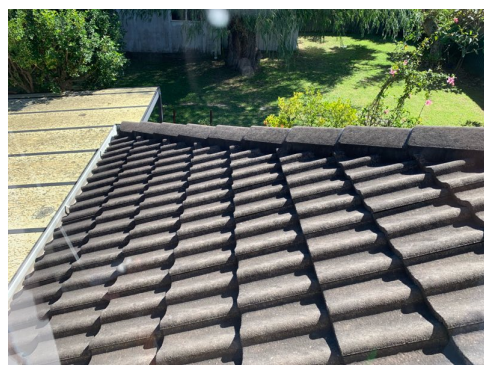
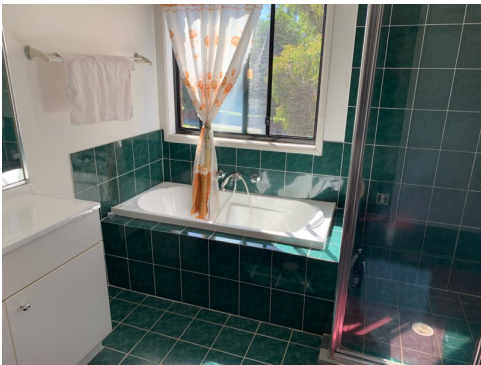
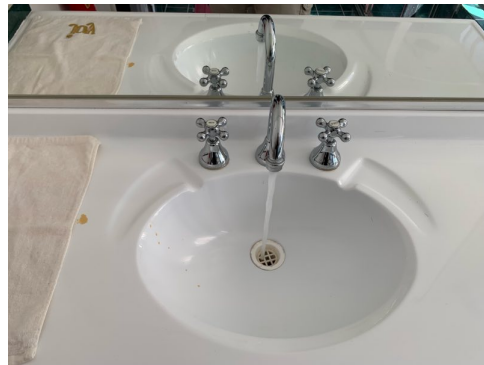
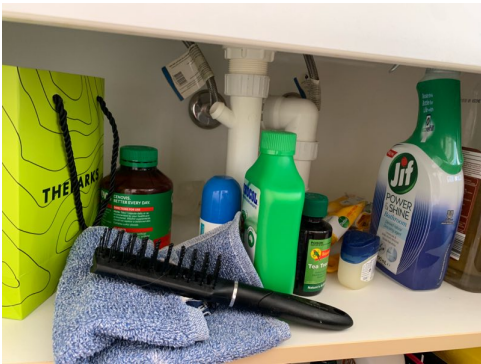
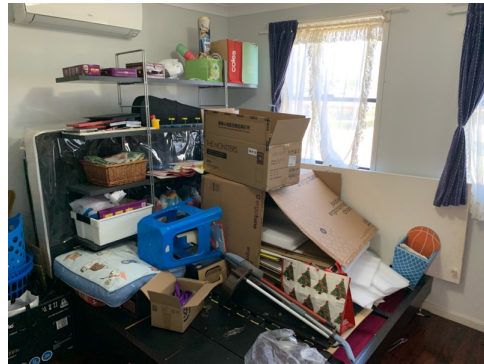
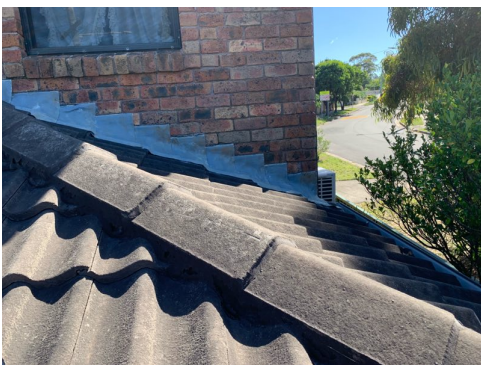
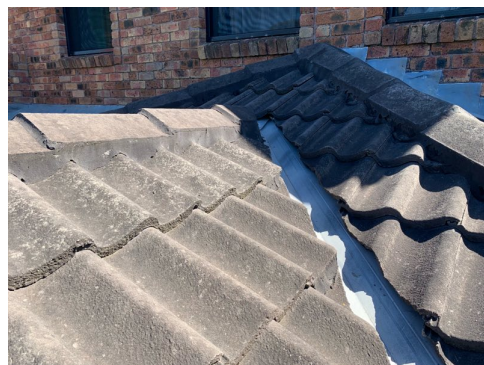
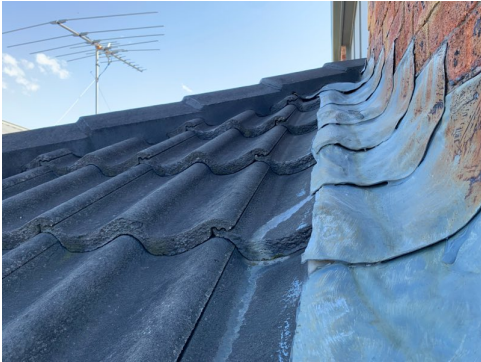
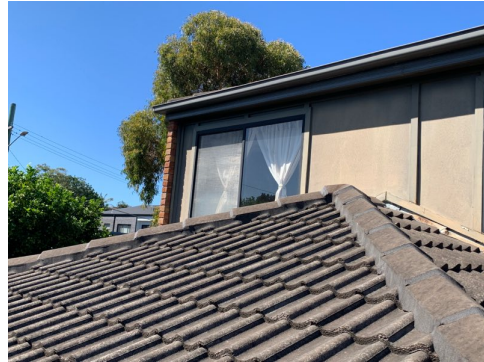
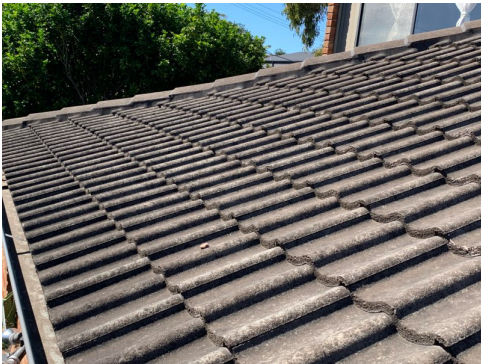
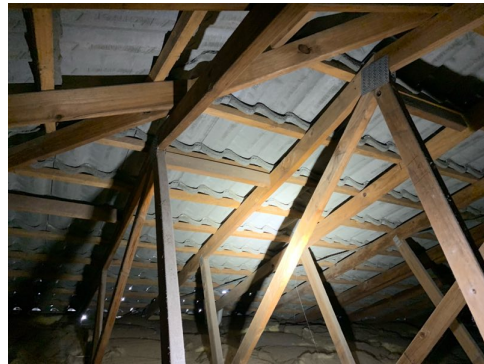
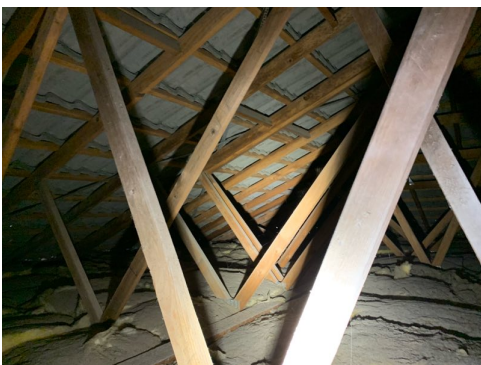
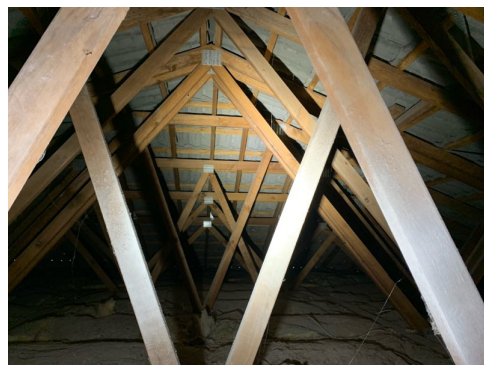
These photographs are an indication of the obstructions and limitations which impeded full inspection of the property at the time of inspection. These obstructions can hide an array of defects and should be removed to allow full inspection to be carried out.
