Building and Timber Pest Inspection Report

Inspection Date: Wed, 7 Jan 2026

Property Address: 91A Prince Edward Ave, Culburra Beach
NSW 2540, Australia

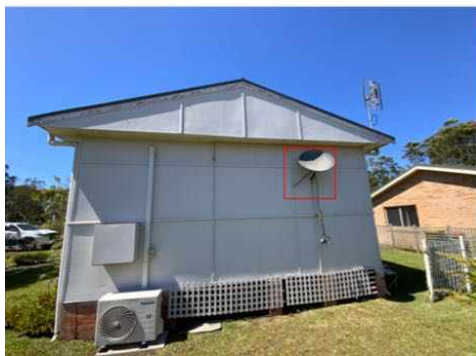
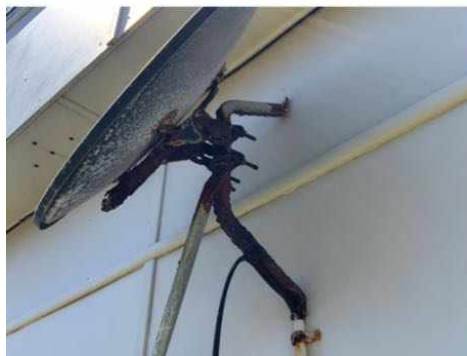
Finding 1.02

Building:	Main Building
Location:	Exterior walls - right side
Finding:	Building element - Rusted or corroded (Dish bracket)
Information:	This building element shows evidence of rusting and corrosion, which is likely to have developed as a result of excessive exposure to moisture and or inadequate coatings.

As surface rust provides no protection to the underlying iron, the deteriorating condition is likely to worsen if not addressed in the short-term future.

Where possible, the use of galvanized (treated) metals or aluminium coated metals aid in rust prevention, as does regular general maintenance. Rust formation can be controlled with coatings, such as paint, that isolate the iron from the environment.

Rusting and corrosion should be managed by ideally removing or limiting the affected surface from exposure to moisture. A registered builder may be appointed to replace any building elements that have been severely affected by rust or water damage.

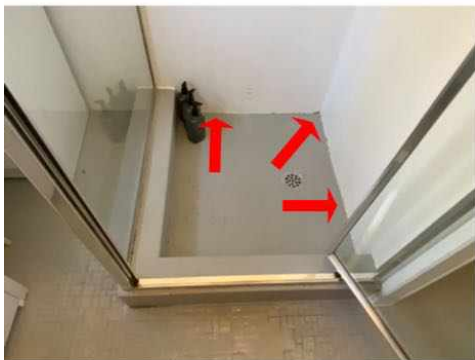
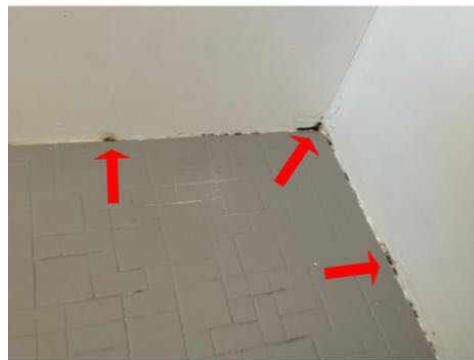
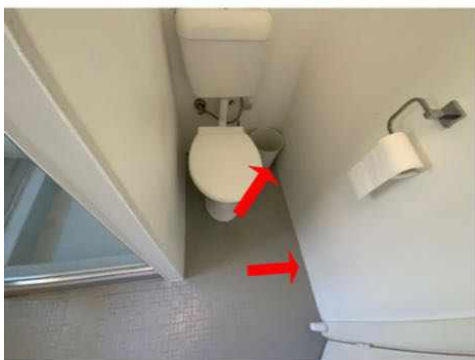
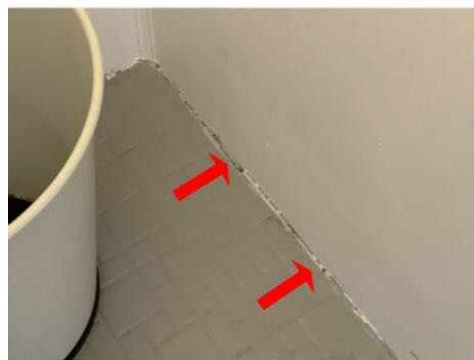
Building: Main Building
 Location: All Wet Areas
 Finding: Sealant or Grout - Deteriorated, Missing or substandard installation
 Information: Sealant appears to be inadequate to these tiled areas. The different materials and floor areas move at different rates therefore cracking the grout at this point. A flexible sealant is required to allow for this expansion & contraction while keeping the joint water tight and without holes for long term care of all building materials.

Apply a flexible sealant to match the grout that is best suited to the purpose as per product specifications. Regular maintenance &/or replacement of damage or missing sealant is highly recommended to the kitchen benches/splashbacks, vanity top to wall/splashback, laundry tub edge/splashback, wet areas floor edges and the shower floor & wall corners for the long term care of your property.

As a main priority remove damaged grout where applicable and thoroughly clean the area from old sealant, grout and soap scum. (Mouldy sealant is usually caused by dirt

Cut sealant nozzle end to approximately 5mm hole diameter and Squeeze in. Push in and wipe off excess silicone with your finger (lightly first to even out sealant and to push into gaps then push in harder the 2nd time), carefully peel off the masking tape, spray area with spray & wipe (or similar to avoid sealant smearing up the wall) then finally run your finger over the sealant to give a smooth final finish.

Regular maintenance &/or replacement of damage or missing sealant is highly recommended for the long term care of your property.

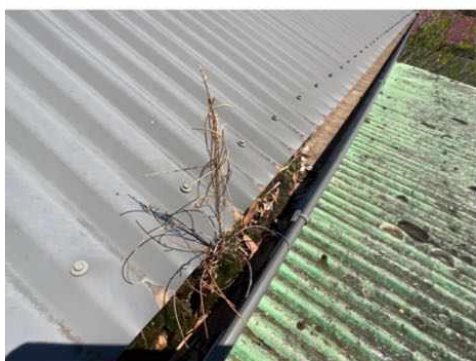
Finding 3.02

Building:	Main Building
Location:	Roof Exterior
Finding:	Gutters - Blocked
Information:	Roof plumbing structures, such as guttering and downpipes, should be free of all debris to prevent blockages. Blockages of the guttering and downpipes will lead to pooling and accumulated water overflows, which is likely to subsequently flood eaves and exterior walls.

Blocked gutters are likely to lead to high levels of moisture in the affected areas. Such moisture will not only cause rust and decay of the associated building materials, but can also provide conditions that are conducive to termite and timber pest activity. Blockages in gutters should therefore be removed immediately to ensure dry conditions are maintained.

Consult a Licensed Plumber for further specific advice on remedial works that may be required. In the interim, it is highly advised that blocked gutters be removed by the homeowner or a general handyperson as a matter of urgency.

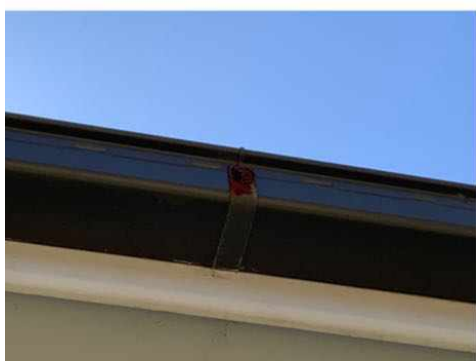
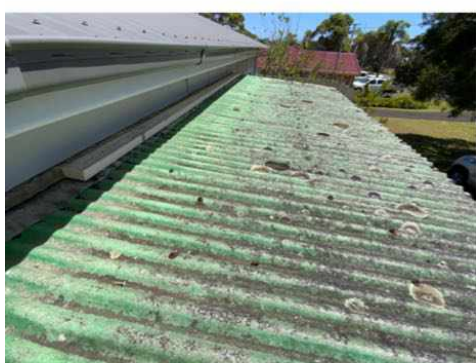
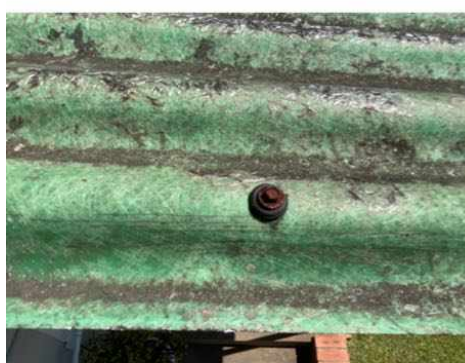
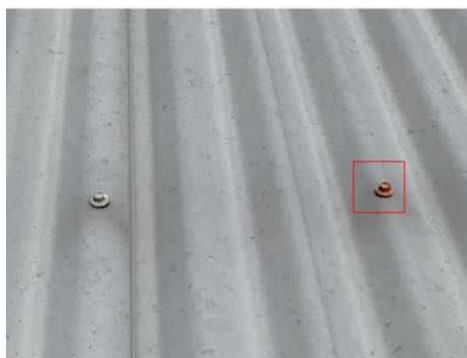
Finding 3.03

Building:	Main Building
Location:	Roof Exterior
Finding:	Building element - Rusted or corroded (gutter brackets and roofing screws to some areas)
Information:	This building element shows evidence of rusting and corrosion, which is likely to have developed as a result of excessive exposure to moisture and or inadequate coatings.

As surface rust provides no protection to the underlying iron, the deteriorating condition is likely to worsen if not addressed in the short-term future.

Where possible, the use of galvanized (treated) metals or aluminium coated metals aid in rust prevention, as does regular general maintenance. Rust formation can be controlled with coatings, such as paint, that isolate the iron from the environment.

Rusting and corrosion should be managed by ideally removing or limiting the affected surface from exposure to moisture. A registered builder may be appointed to replace any building elements that have been severely affected by rust or water damage.

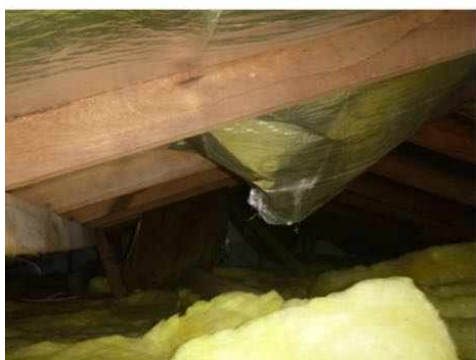
Finding 3.04

Building:	Main Building
Location:	Roof Void
Finding:	Sarking - Damaged
Information:	Sarking, a laminated aluminium foil applied to the interior of the roof covering, assists in insulating the property and acting as a vapour-barrier to the roof void and, subsequently, to the household.

Where sarking is damaged, both insulation and moisture protection of the property are inhibited. This creates a loss of energy and thus negatively impacts the energy efficiency of the property, allowing potential for moisture ingress from condensation or leaking roof tiles.

It is important to repair any holes or damaged sections of sarking to ensure that the building material is fully functional. A registered builder or qualified carpenter should be consulted to provide further advice on this defect and to perform rectification works at client discretion.

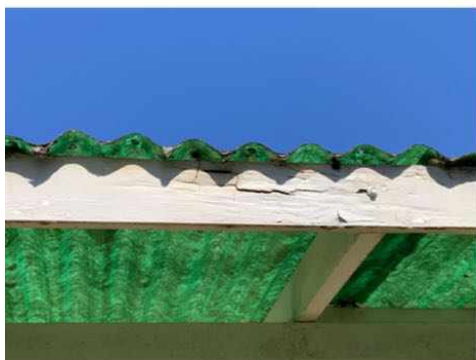
Finding 3.05

Building:	Main Building
Location:	All Areas

Finding: External paint to timbers - deteriorated
Information: Much of the external paintwork including but not limited to external timbers and trims have been neglected and require attention to prepare and re-paint.

Whilst incomplete or missing paint finish is generally an appearance defect, it can also lead to the development of secondary building defects over time. Incomplete areas of paint finish expose the area to moisture, potentially accelerating the deterioration of underlying building materials.

Degraded paint finishes should be sanded back, filled, leveled and painted, as applicable. Where inadequate or missing paint protection has led to the deterioration of the associated building element, repair and/or replacement of this building element may be required.

A painting contractor should be appointed as soon as possible to perform necessary works to aid the appearance of the affected area and to ensure the area is protected against further deterioration. Alternatively, the homeowner following manufacturer instructions may perform these works.

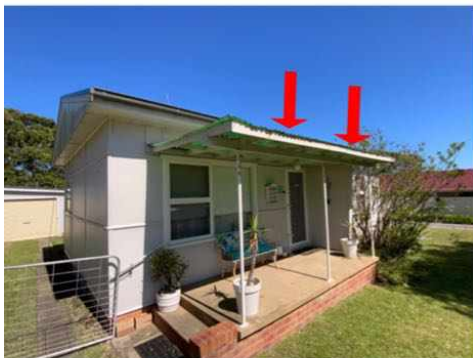
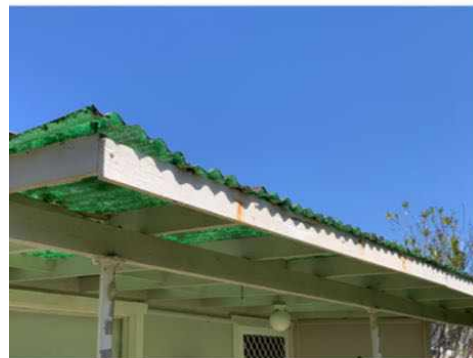
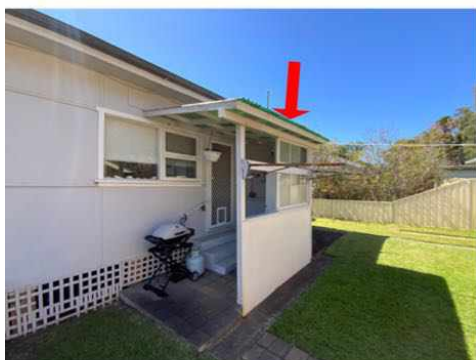
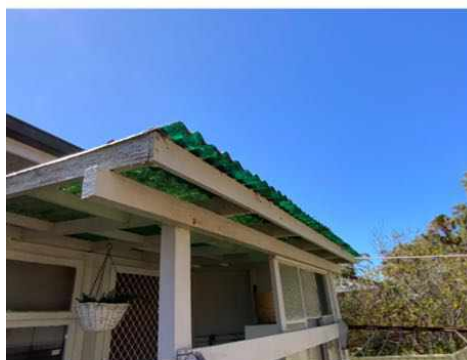
Finding 3.06

Excessive moisture creates an environment which accelerates the deterioration of building elements in the area, as well as being conducive to termite and pest infestation. Such an environment is likely to necessitate repair and/or replacement of building elements, which are prone to sustaining wood rot, rust or corrosion.

A roofing plumber should be appointed as soon as possible to install relevant roof plumbing materials. Depending on the extent of the damage, repair and/or replacement of damaged building elements may be required.

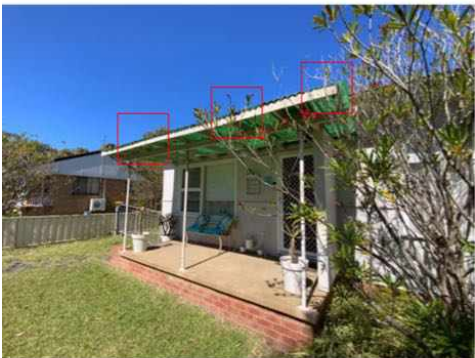
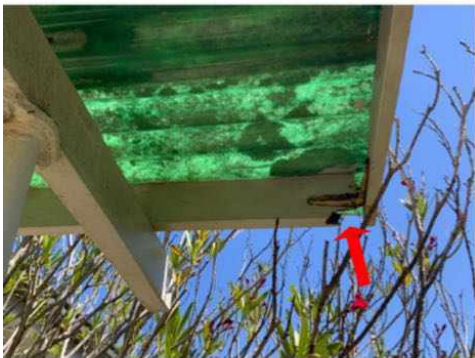
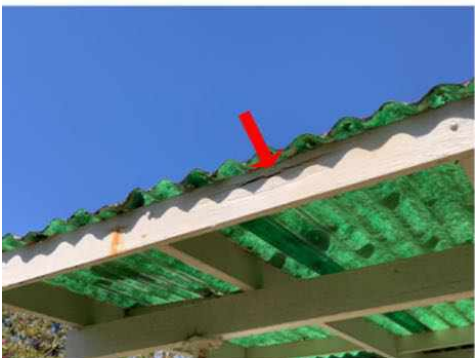
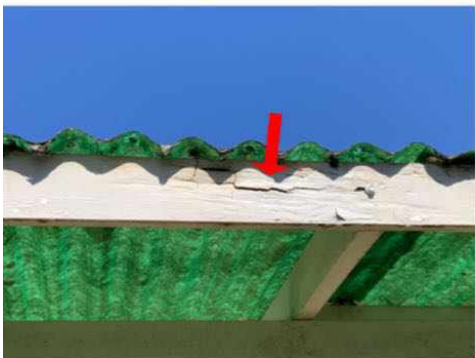
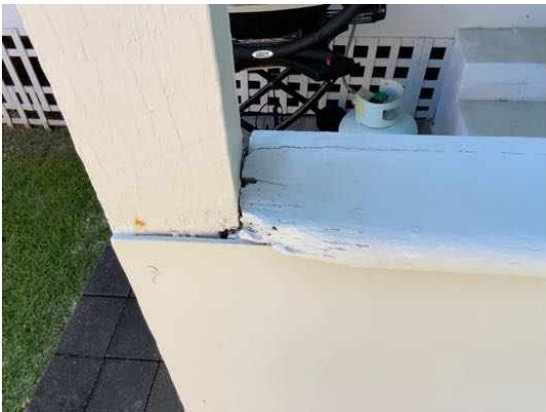
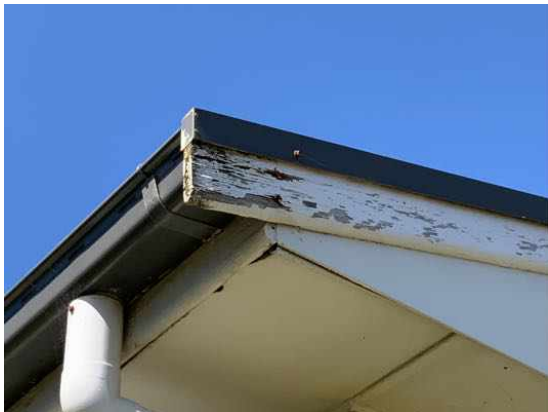
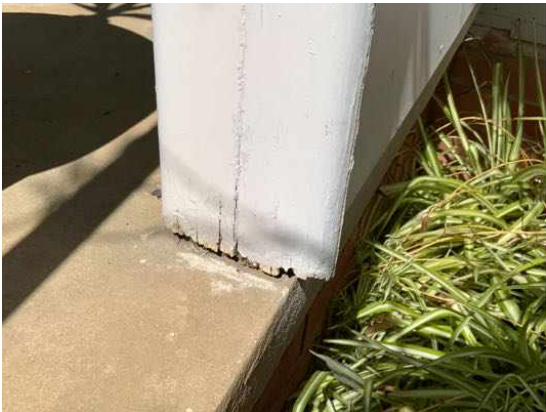
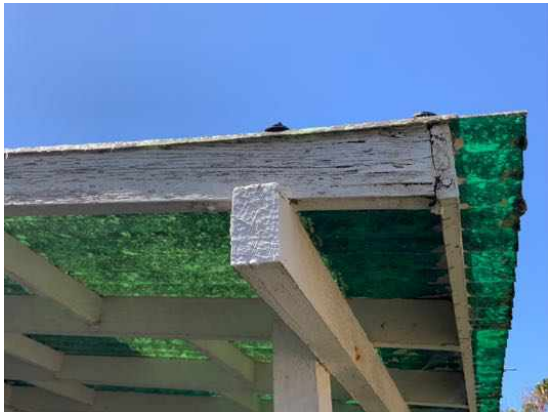
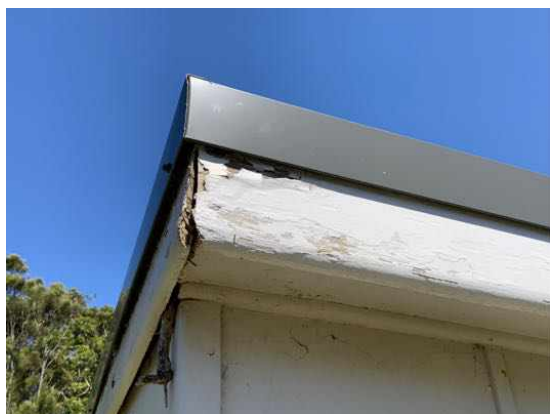
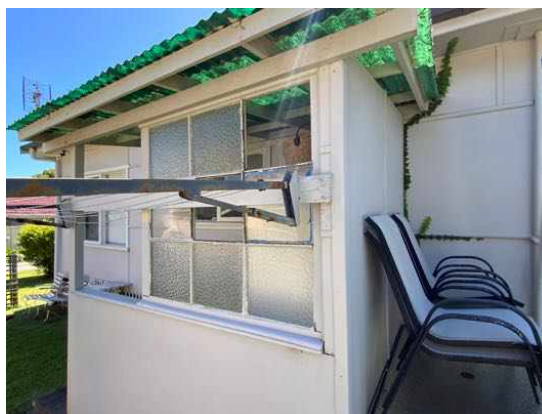
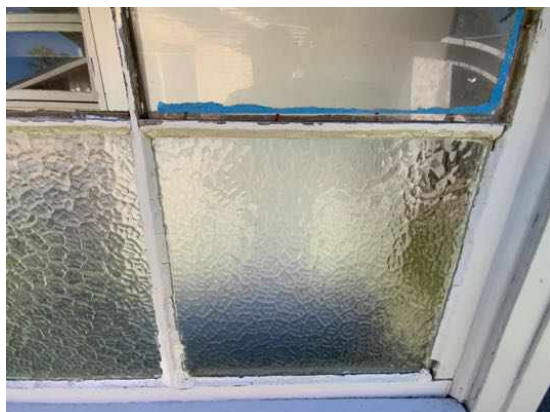
Finding 3.07

Building:	Main Building
Location:	Pergolas, Fascias and external Timbers
Finding:	Wood rot to some external timbers
Information:	This building element shows evidence of wood rot. Wood rot, also known as Fungal Decay, occurs when timbers and other cellulose building materials are exposed to damp conditions on an ongoing basis. This could be the result of exposure to weathering over a prolonged period of time, or the attraction of excessive moisture from other abutting building materials. Contributing factors also include poor air ventilation in the area.

Early intervention and regular maintenance, particularly of exterior timbers, will prolong the useful life of these building elements. Prior to any works being performed, the cause of the moisture that has created the visible wood rot should be identified and addressed in a suitable manner. Replacement of affected timbers may then be a necessary step in protecting surrounding building elements from such deterioration.

A qualified plumber may be appointed to assess the cause of excessive moisture and to provide advice on any remedial works as required. A qualified carpenter or registered builder may also be required to replace affected building materials.

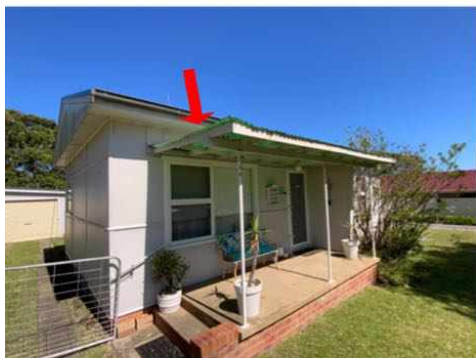
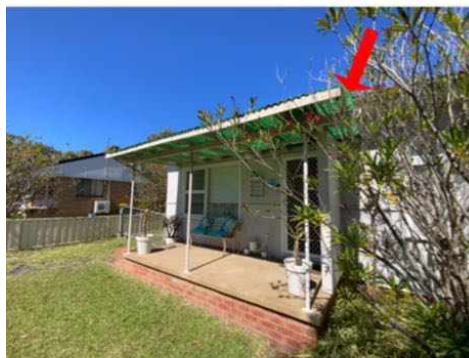
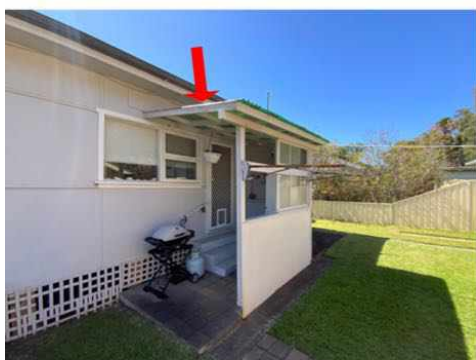
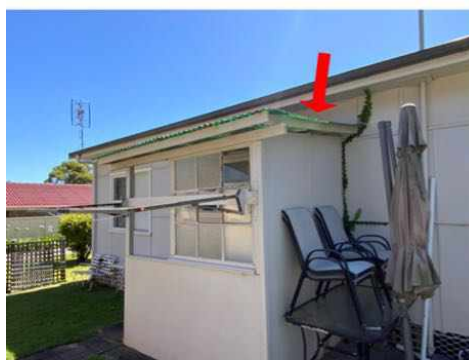
Finding 3.08

Building:	Main Building
Location:	Pergola
Finding:	Barge Flashings missing
Information:	The ends of the pergola roof are missing barge flashings. Flashings are metal and other materials which are applied to seals and intersections between roof coverings and building elements. They are designed to aid in weatherproofing of roof joins and avoid the roof sheeting from coming loose. Flashings that are not installed adequately or are missing are likely to result in water penetration to the interior of the building elements. Premature ageing and secondary building defects are imminent where roof plumbing is missing or inadequately installed. A roofing plumber should be appointed as soon as possible to install relevant roof plumbing materials, ensuring that no further damage is sustained.

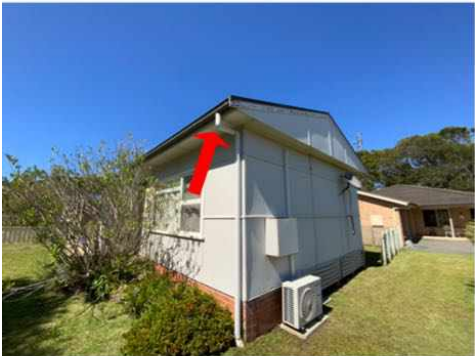
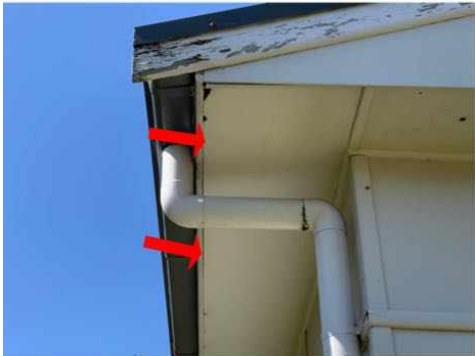
Finding 3.09

Building:	Main Building
Location:	Exterior walls - front
Finding:	Building element - Damaged (Loose eaves lining)
Information:	Breakage occurs generally when the building materials have either aged and decayed, or as a result of damage (accidental or deliberate).

Repair and/or replacement of broken elements is advised to ensure that additional secondary defects do not arise as a consequence. Such works are necessary, as all building elements play a key role in the operation and function of the overall structure and its performance.

A relevant tradesperson should be appointed to repair or replace the affected building element prior to any subsequent damage being caused.

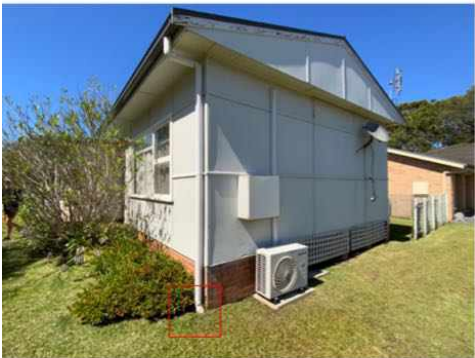
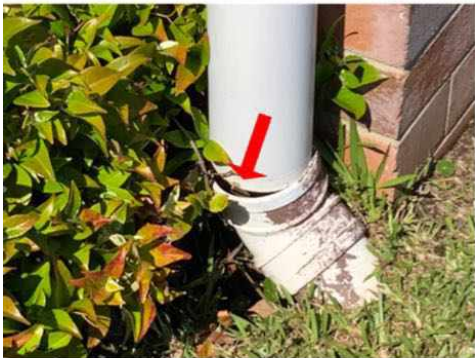
Finding 3.10

Building: Main Building
Location: Exterior walls - front
Finding: Building element - Damaged (Downpipe fitting loose or not connected)
Information: Breakage occurs generally when the building materials have either aged and decayed, or as a result of damage (accidental or deliberate).

Repair and/or replacement of broken elements is advised to ensure that additional secondary defects do not arise as a consequence. Such works are necessary, as all building elements play a key role in the operation and function of the overall structure and its performance.

A relevant tradesperson should be appointed to repair or replace the affected building element prior to any subsequent damage being caused.

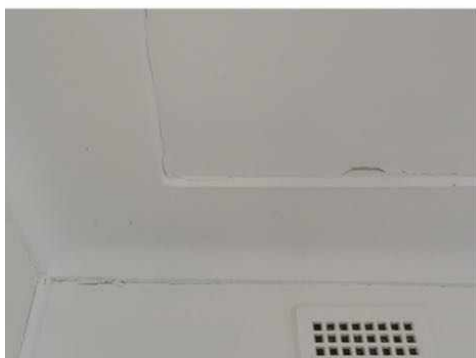
Finding 3.18

Building:	Main Building
Location:	All Areas
Finding:	Ceiling - Sagging
Information:	Sections of the ceiling were found to be sagging at the time of inspection. Sagging to

the fixed ceiling structure generally indicates that the building materials have swollen, due to contact with water, or that fixings (e.g. nails or glue) have become loose and require reattachment.

In some cases, sagging ceiling linings may also indicate that there are structural issues, causing surfaces to warp, twist or sag. Where sagging appears to be major, appointment of a structural engineer is advised to further inspect the property and identify the source and rectification works required.

Where minor sagging is evident, comparatively minor works, such as re-gluing of ceiling sheets, may be required. Such works may be performed by relevant tradespeople, such as plasterers and painters. Where excessive moisture has caused the roofing structure to swell and sag, the source of the water leak should primarily be identified prior to any remedial works being performed.

The appropriate action should be taken by the client as soon as possible to ensure that any potential further damage is limited.

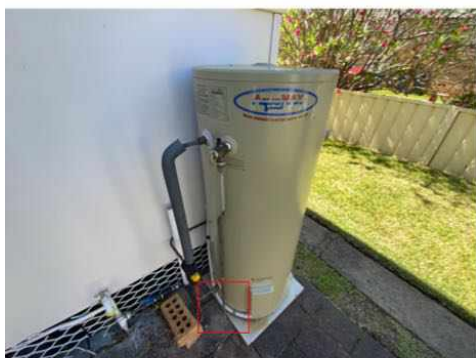
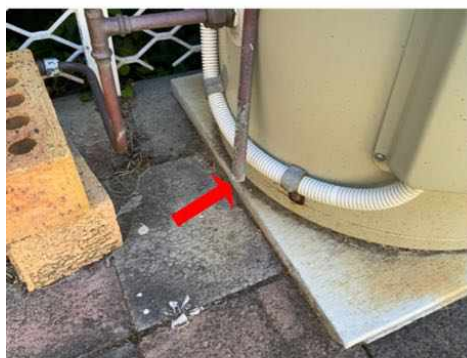
Finding 6.04

Building:	Main Building
Location:	All Areas
Finding:	Timber in ground contact
Information:	To reduce the risk of timber pest attack it is essential that timber used in a hazardous environment (e.g. in direct contact with the ground or frequently exposed to damp conditions) is of sufficient durability and/or is adequately preservative treated.

Untreated timbers in direct contact with the ground are likely to develop severe wood rot and/or fungal decay if left unattended creating attraction for subterranean termites to infest the timbers from surrounding areas.

If untreated or non-durable timbers are found to be in a hazardous environment it is highly advised that replacement of these building elements be performed as soon as possible to aid the protection of the property against termite / timber pest attack.

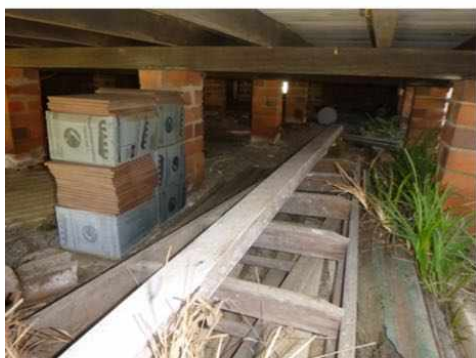
Finding 6.05

Building:	Main Building
Location:	All Areas
Finding:	Evidence of excessive moisture was present at the time of inspection (Guttering missing & Holes in down pipe)

Information: Excessive moisture can attract termites and produce conditions that promote termite attack fungal growth and wood decay.

Excessive moisture is generally caused by deteriorated inadequate or missing roof drainage, leaking plumbing pipes or fixtures, poorly plumbed HWS overflows or condenser units and poor site drainage.

It is highly recommended that all plumbing and drainage fixtures and fittings be maintained regularly in order to prevent excessive moisture being present in the external / internal property.

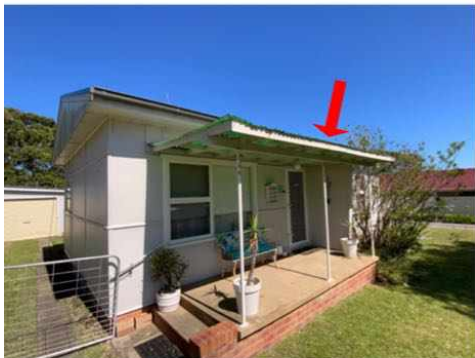
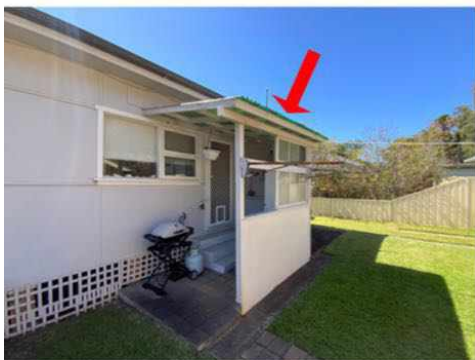
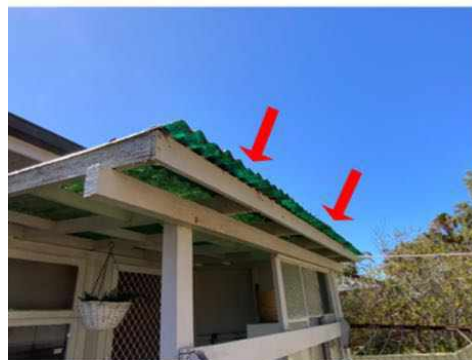
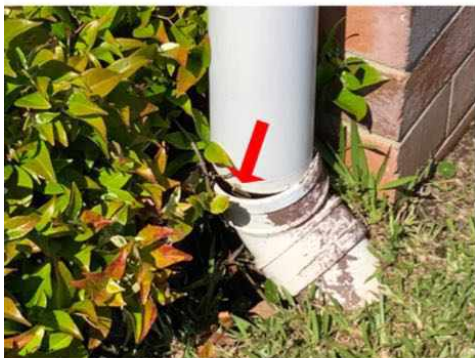
Finding 6.06

Building: Main Building
 Location: Exterior walls
 Finding: Bridging - Vegetation
 Information: Where vegetation obstructs inspection of building elements, also known as bridging as it provides a bridging point for the access of termites, full inspection can not be achieved. Consequently moisture or dampness may be present and the areas becomes conducive to termite activity. Plants against or very close to buildings provide cover, shade and can provide an environment that is attractive to termite infestation.

The removal and replanting of species that do not provide "cover" or cutting back of existing vegetation will assist greatly in preventing Bridging from occurring.

The removal of any such materials that may be conducive to termite activity should be carried out as soon as possible and arrange re inspection to minimize the risk of termite attack.

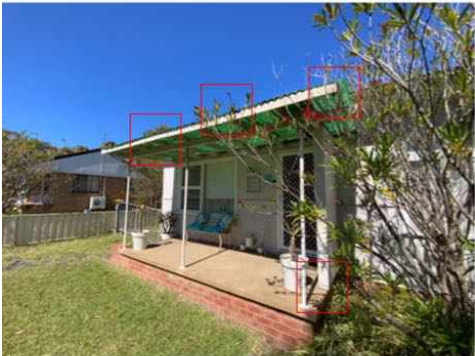
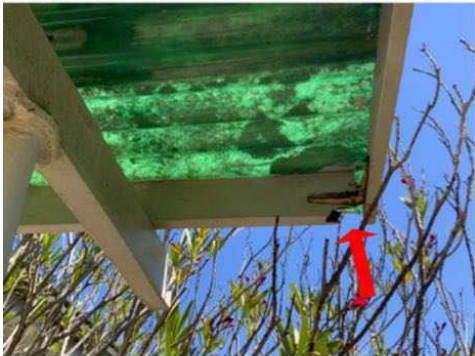
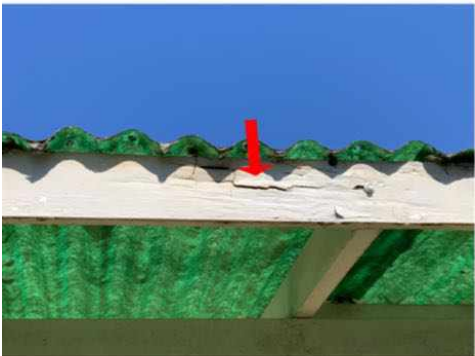
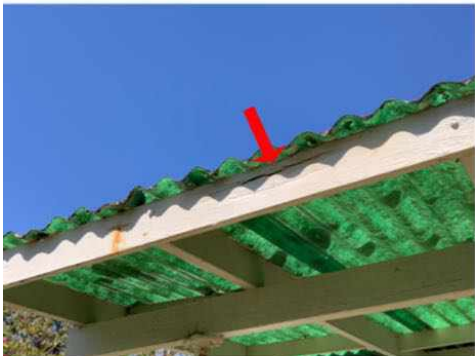
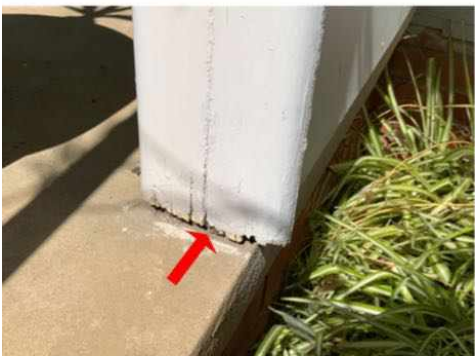
Finding 7.01

Building:	Main Building
Location:	All Areas
Finding:	Fungal decay - present (localised)
Information:	Fungal decay also known as wood decay or wood rot generally refers to the deterioration of timber elements when in contact with excessive levels of moisture for a prolonged period of time.

The development of fungal decay is accelerated by temperatures in the range of 5degreeC to 40degreeC as well as the presence of oxygen. Generally fungal decay develops on timber elements that are in use in an external environment which are exposed to rain penetration.

In this case although the affected timber element is in a decaying state the extent of any visible damage appears to be localised to a specific area and is yet to spread to other parts of the building element or affect adjoining structures. The fungal decay is therefore likely to be of a relatively superficial nature with minimal impact on the structural integrity or tensile strength of the timber element.

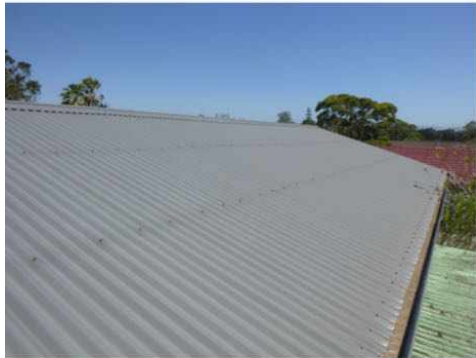
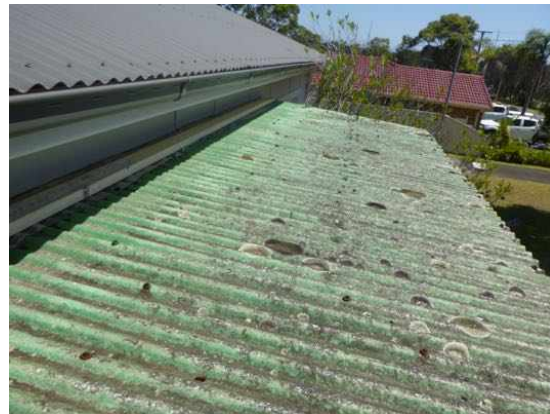
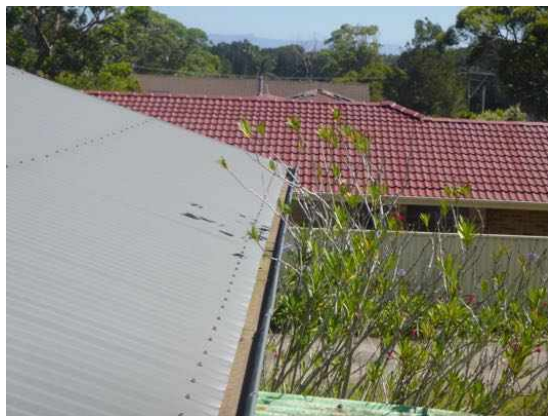
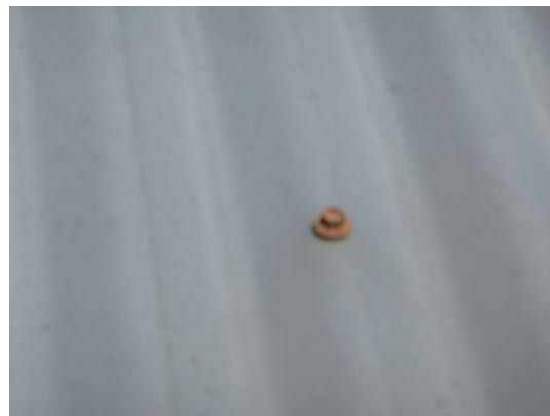
Noted Item

Building: Main Building
 Location: Roof Exterior
 Finding: Additional Photos - Obstructions and Limitations
 Information: These photographs are an indication of the obstructions and limitations which impeded full inspection of the property at the time of inspection. These obstructions can hide an array of defects and should be removed to allow full inspection to be carried out. A re-inspection is recommended once the areas are made accessible.

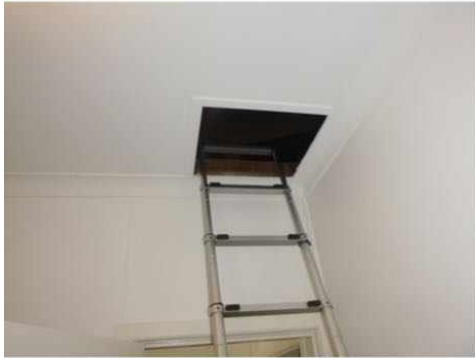
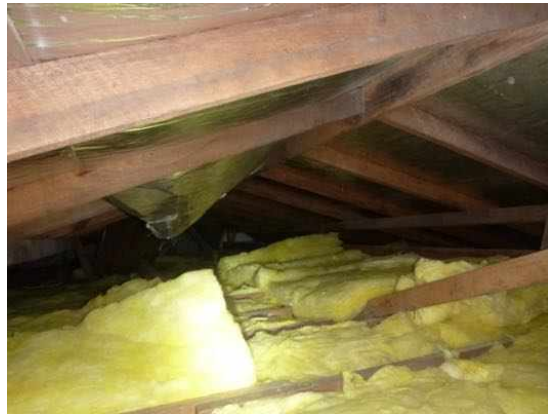
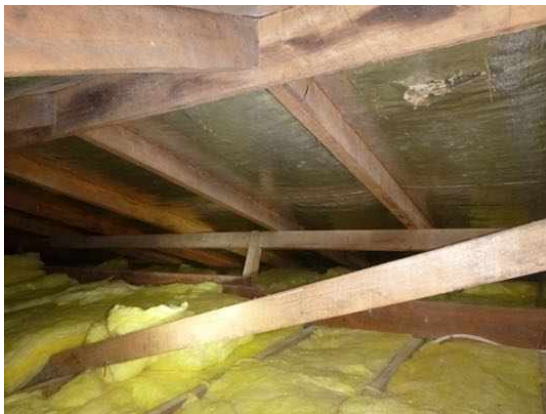
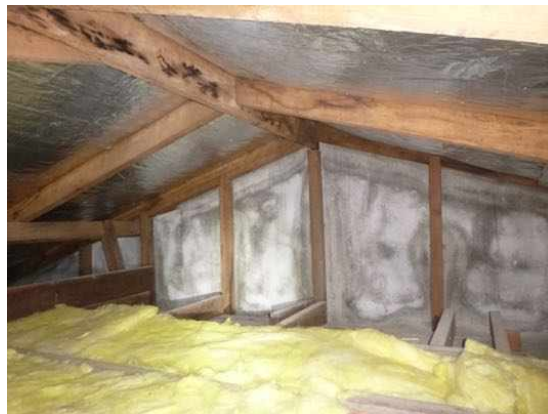
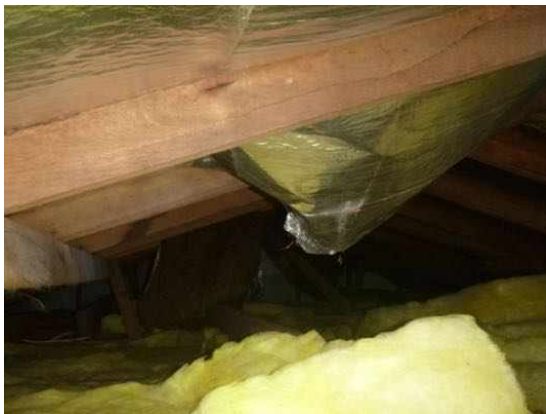
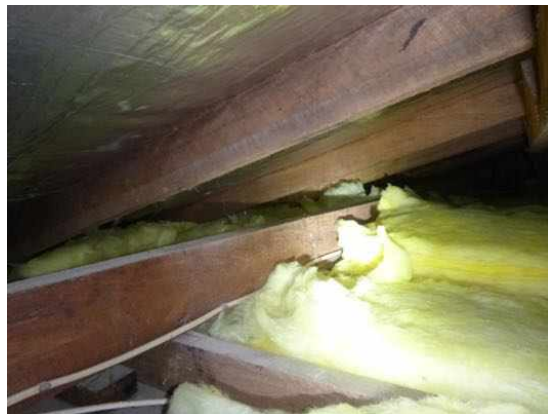
Noted Item

Building: Main Building
 Location: Roof Void
 Finding: Additional Photos - Obstructions and Limitations
 Information: These photographs are an indication of the obstructions and limitations which impeded full inspection of the property at the time of inspection. These obstructions can hide an array of defects and should be removed to allow full inspection to be

carried out. A re-inspection is recommended once the areas are made accessible.

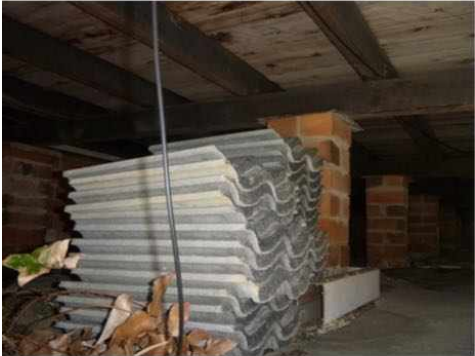
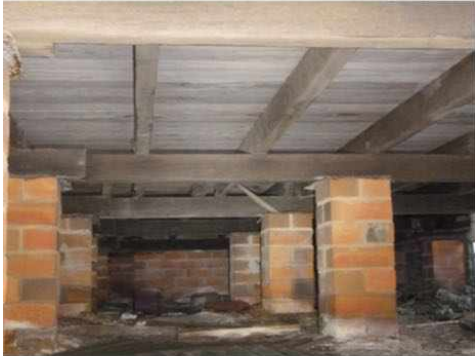
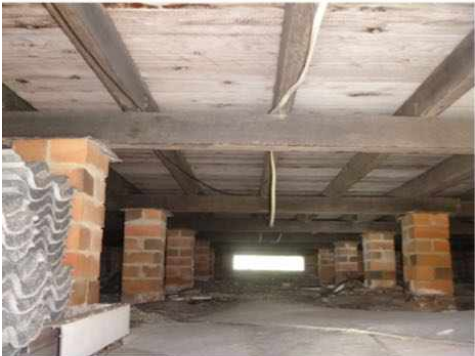
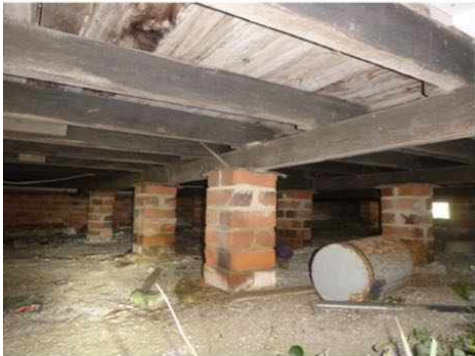
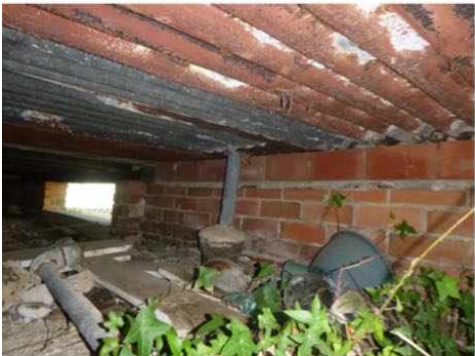
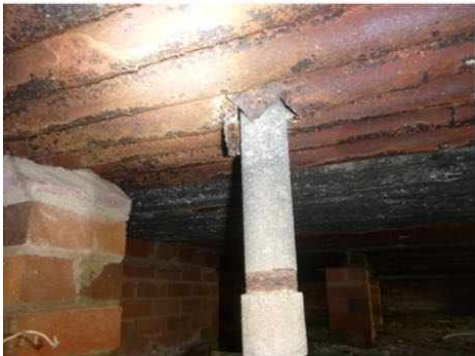
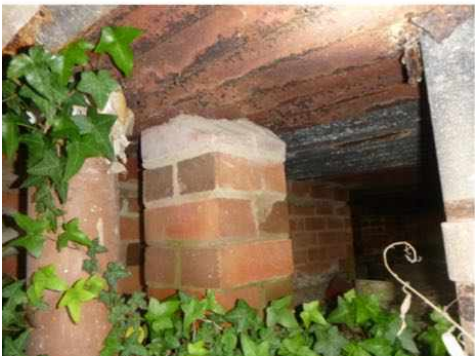
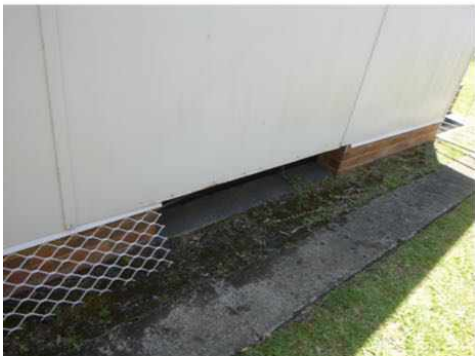
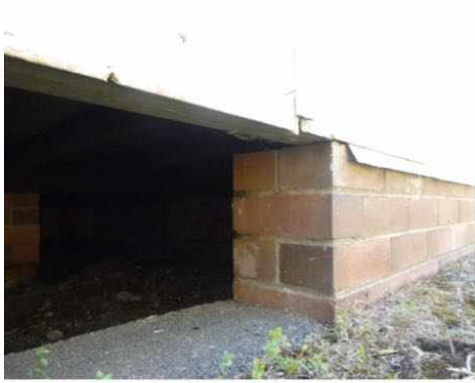
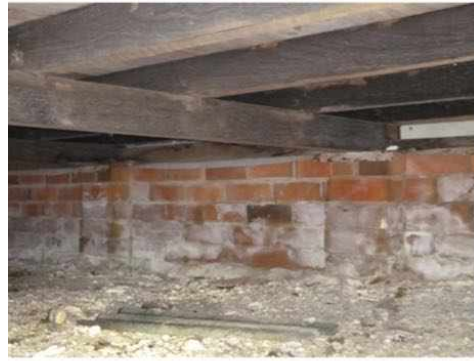
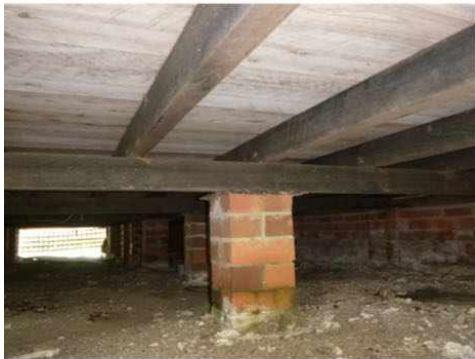
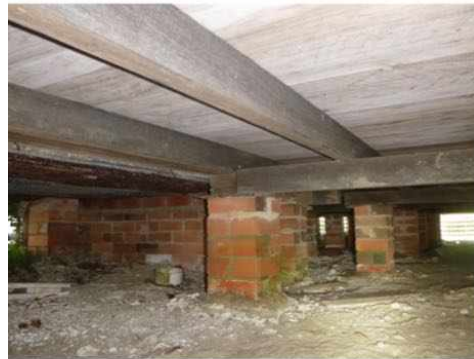
Noted Item

Building:	Main Building
Location:	Subfloor
Finding:	Additional Photos - Obstructions and Limitations
Information:	These photographs are an indication of the obstructions and limitations which impeded full inspection of the property at the time of inspection. These obstructions can hide an array of defects and should be removed to allow full inspection to be carried out. A re-inspection is recommended once the areas are made accessible.

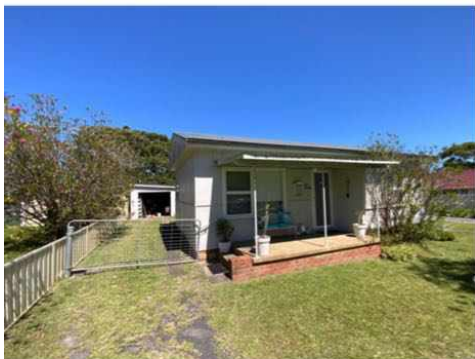
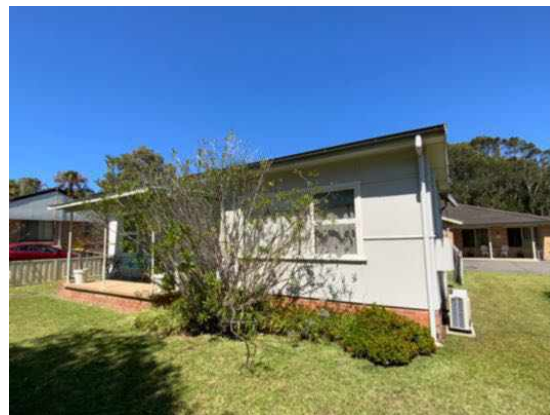
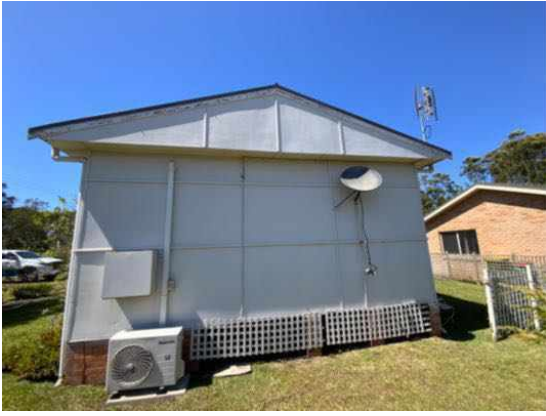
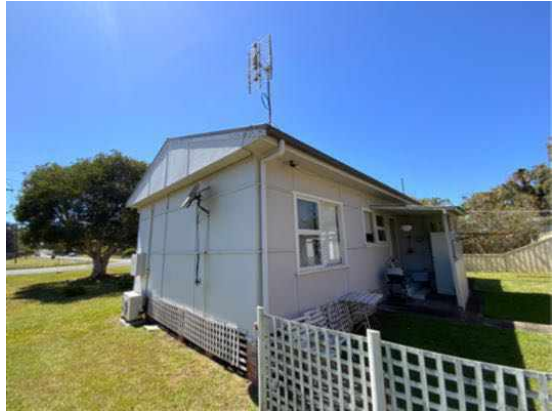
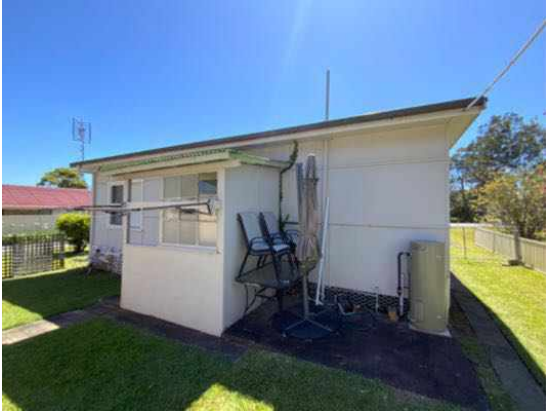
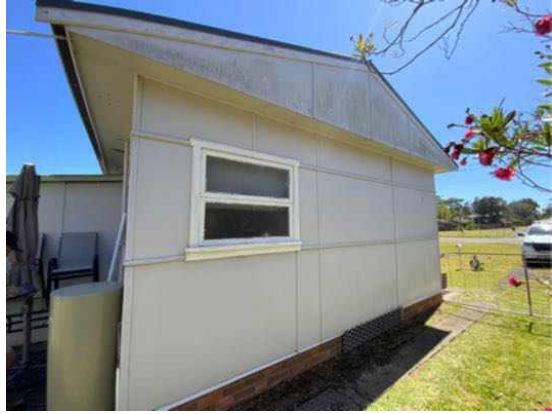
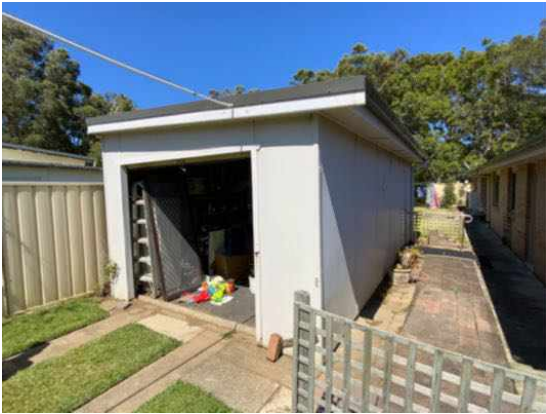
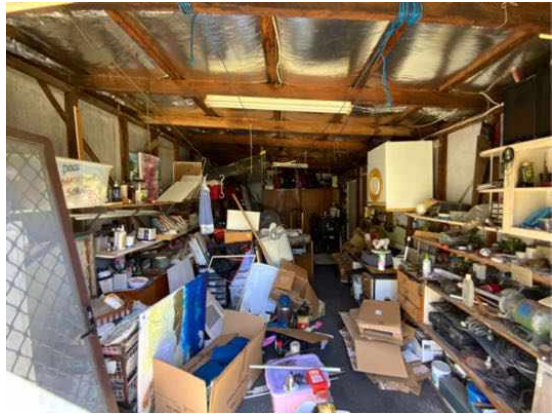
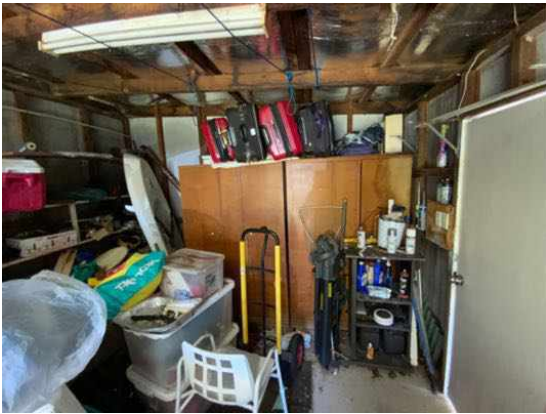
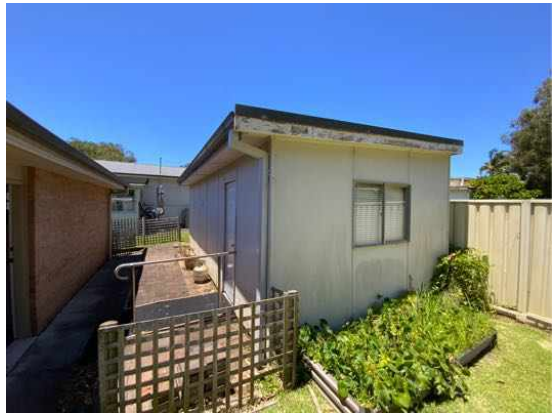
Noted Item

Building:	Main Building
Location:	All Areas
Finding:	Additional Photos - Obstructions and Limitations
Information:	These photographs are an indication of the obstructions and limitations which impeded full inspection of the property at the time of inspection. These obstructions can hide an array of defects and should be removed to allow full inspection to be carried out. A re-inspection is recommended once the areas are made accessible.

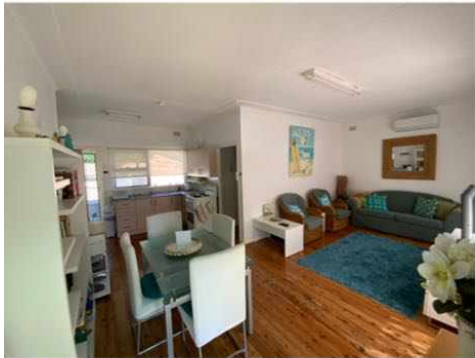
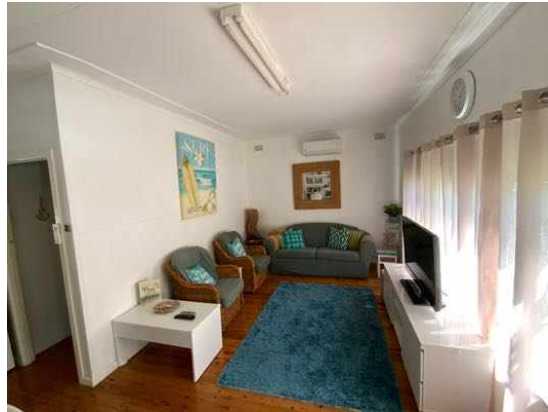
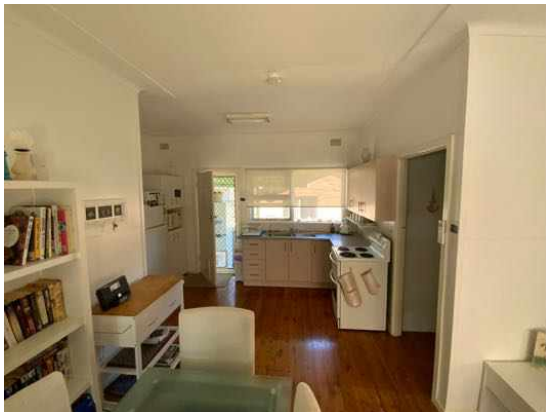
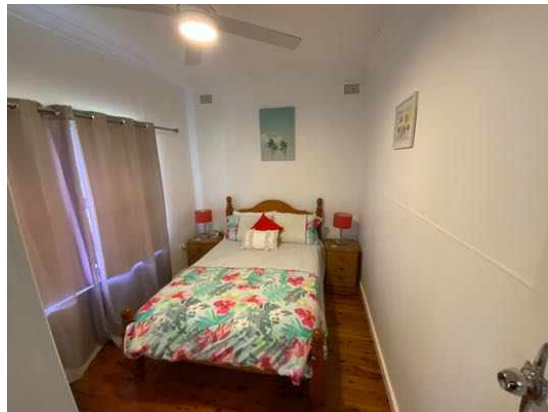
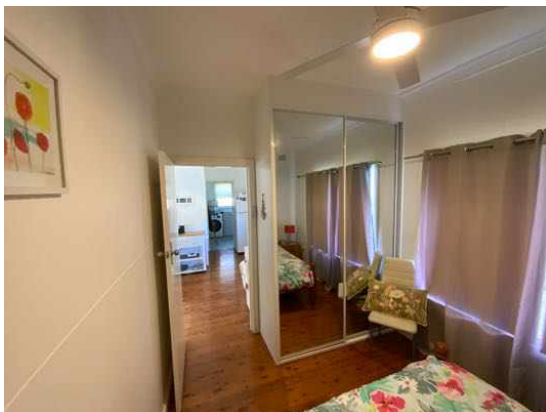
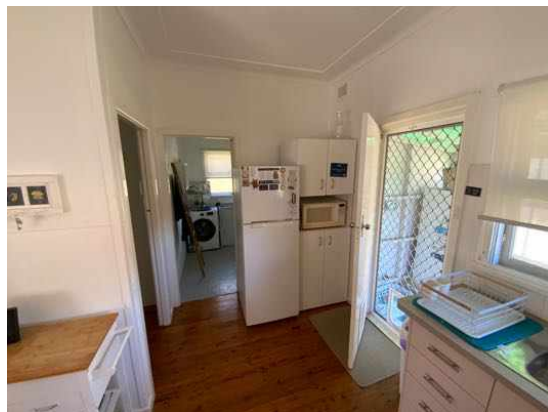
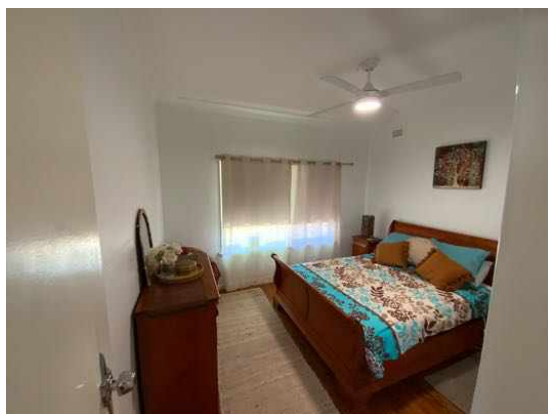
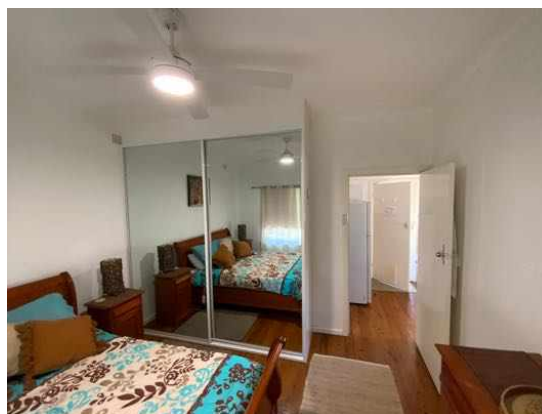
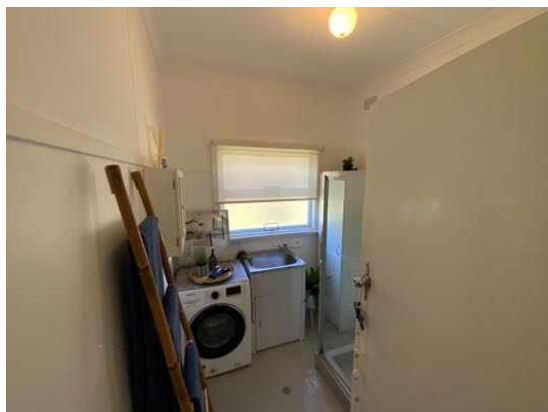
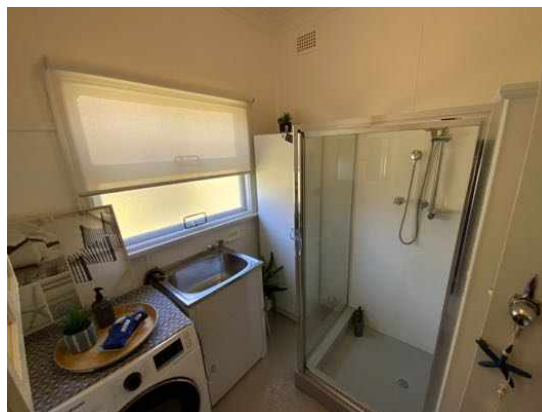
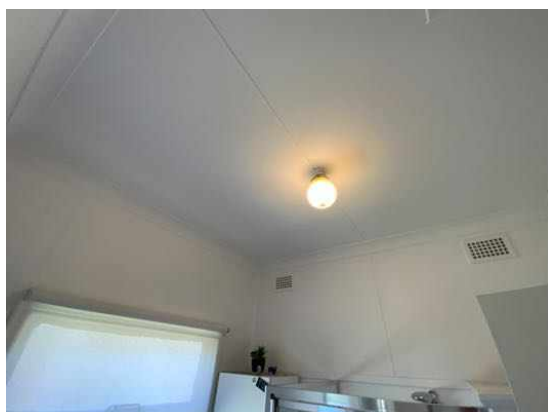
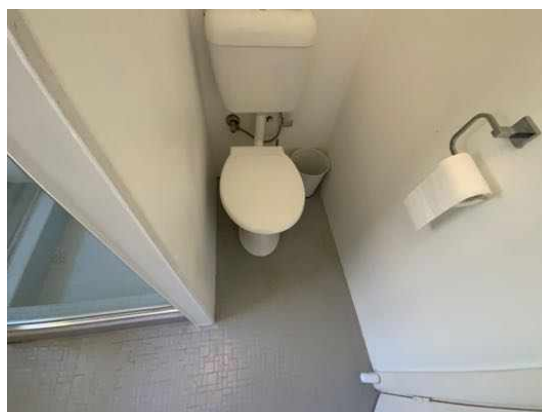
Building: Main Building
Location: All Areas
Finding: Additional Photos - Obstructions and Limitations
Information: These photographs are an indication of the obstructions and limitations which impeded full inspection of the property at the time of inspection. These obstructions can hide an array of defects and should be removed to allow full inspection to be carried out. A re-inspection is recommended once the areas are made accessible.
