Building and Timber Pest Inspection Report

Inspection Date: Wed, 7 Jan 2026

Property Address: 91A Prince Edward Ave, Culburra Beach
NSW 2540, Australia

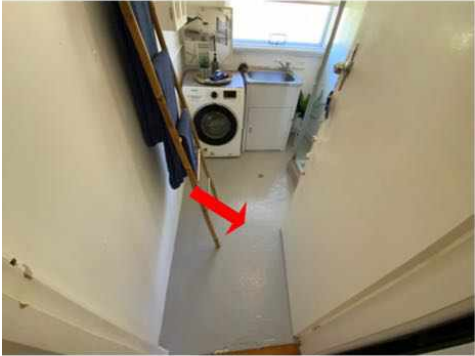
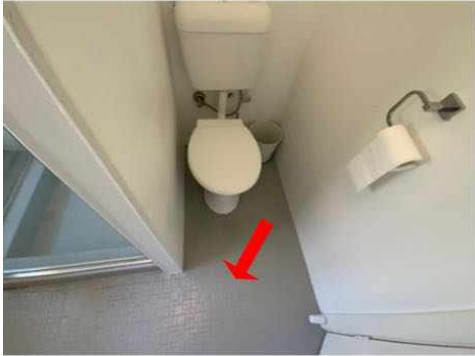
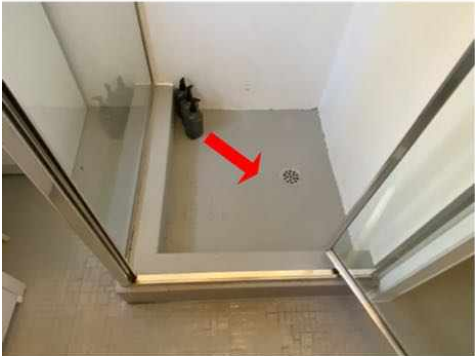
Building: Main Building
 Location: All Wet Areas
 Finding: Water Proofing Membranes - Information Only
 Information: Internal Water Proofing Membranes, are crucial in preventing water ingress into the property is important to know that the Membrane System used is to Australian Standards and has been installed correctly.

With older property's where this information is unavailable all wet areas should be monitored. Generally waterproofing certificates are only valid for approximately 7-8yrs. If any leaks, water staining, peeling or bubbling of the paint become evident to any adjacent walls or ceilings below a licensed builder or waterproofing specialist is recommended to investigate further.

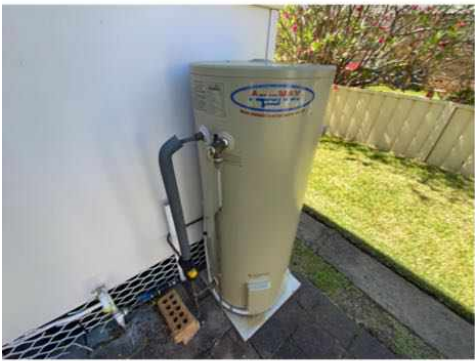
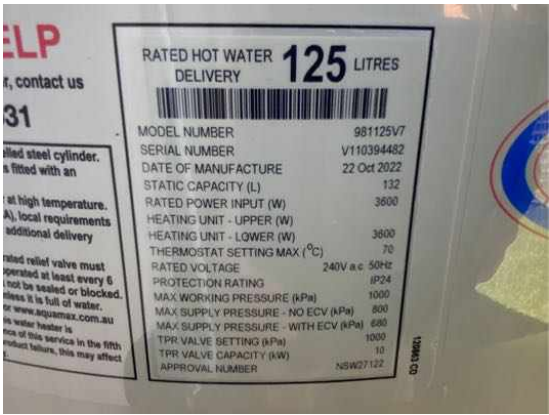
Building: Main Building
Location: All Areas
Finding: Additional Photos
Information:

Additional photos are provided for your general reference. Arrows have been included to highlight areas of importance. Please discuss these photos with your building consultant for clarification.

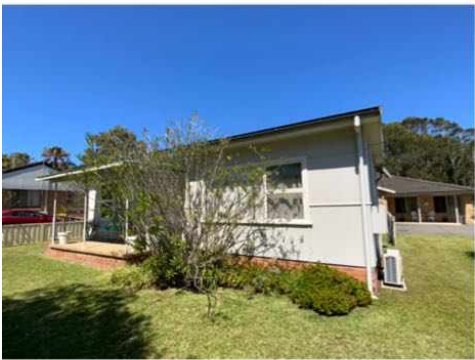
Building: Main Building
 Location: All Areas
 Finding: Asbestos - Suspected ACM Identified on Site
 Information: Reporting on Asbestos is outside the Scope of this Report. This suspected defect is highlighted as a caution only. We suspect, based on our experience in the building industry, that there is a higher risk of the identified building element containing asbestos.

As Asbestos Reporting is outside the scope of this report, we advise that you consider a separate Asbestos Inspection and Condition Audit, which can include the taking of samples for definitive confirmation of the presence of Asbestos.

In the interim, the client is advised to act with caution, especially when considering any damage to building materials general wear and tear renovations extensions demolition and general maintenance activities due to the suspected presence of Asbestos.
