# Building and Timber Pest Inspection Report

Inspection Date: Wed, 25 Feb 2026

Property Address: 21 Fallows Way, Cherrybrook NSW 2126,  
Australia

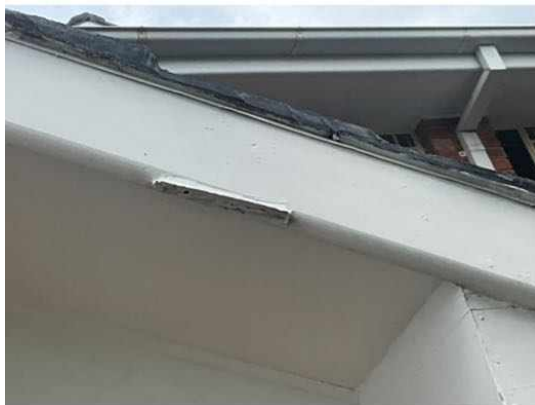
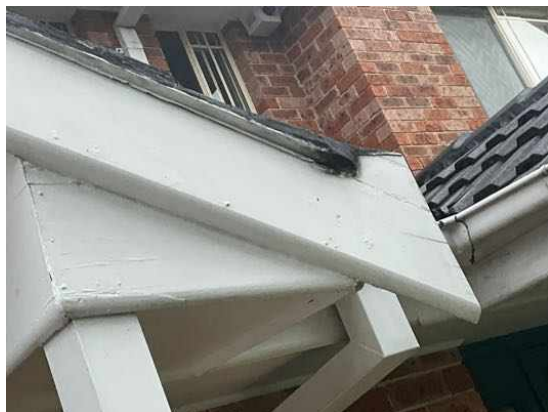
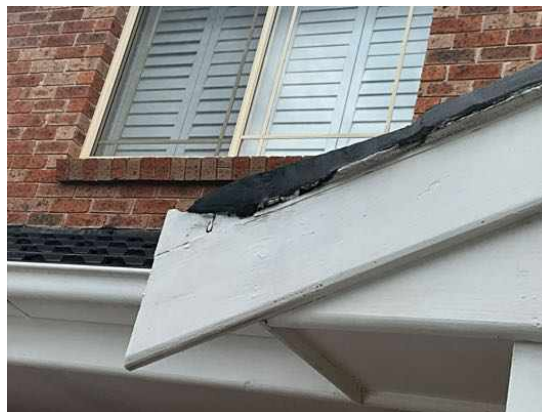
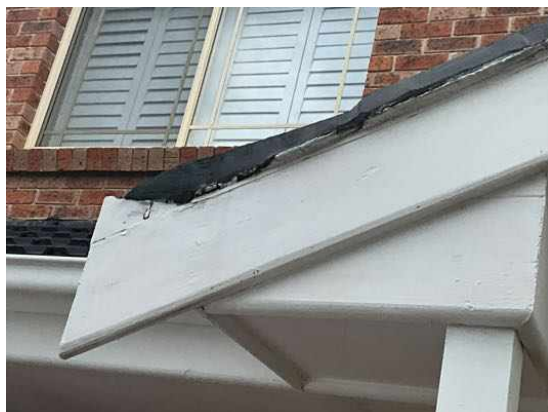
### Finding 3.02

Information: External timbers that are frequently exposed to harsh weather conditions require adequate protection in order to maintain their condition. Where timbers have not been painted or treated adequately, general deterioration is likely to occur at an accelerated rate.

If left unattended, replacement of these timbers is likely to be necessary in the short-term future. Adequate treatment of these timbers is required as soon as possible by a painting contractor or general handyman.

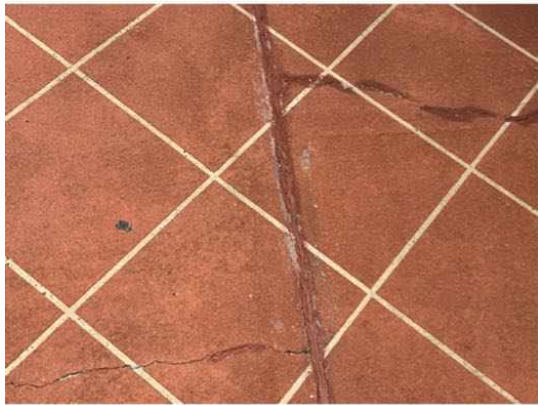
### Finding 3.03

Finding: Crack in concrete slab - Category 0

Information: A crack coded as Category 0 was identified in the slab. A Category 0 crack is described as a hairline crack, representing insignificant movement of slab from level.

The approximate width of the crack to be considered Category 0 is 0.3mm, or change in offset of less than 8mm when a 3m straight edge is placed over the defect.

No rectification is required at this time. However, all cracking should be monitored over a 12 month period to identify any further damage in the area.

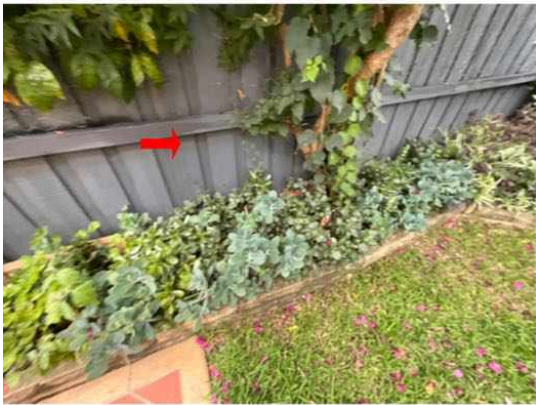
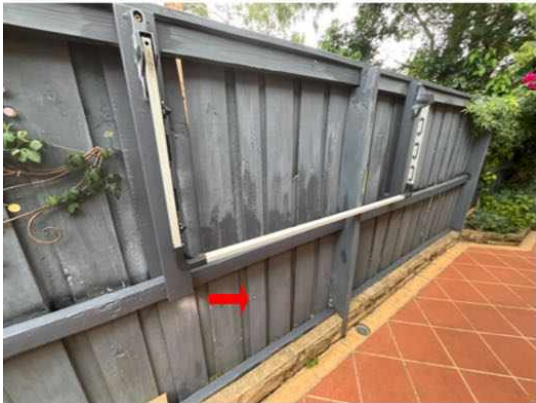
Finding 3.04

Building:	Main Building
Location:	All Areas
Finding:	Deteriorated fence
Information:	The fence along the property boundary has deteriorated significantly, showing signs of rot, rust, and structural weakness. Several sections are leaning or have become detached, compromising the integrity of the fence and its ability to perform its intended function.

The deteriorated fence poses multiple risks:

1. **Safety Hazard:** The unstable fence may collapse, posing a risk of injury to residents, visitors, and passersby.
2. **Security Concern:** The compromised fence may allow unauthorized access to the property, increasing the risk of theft, vandalism, or trespassing.
3. **Property Damage:** Falling sections of the fence could damage nearby structures, plants, or other property features.

- **Licensed Fencing Contractor:** A professional fencing contractor should be hired to assess the extent of the damage and either repair or replace the deteriorated sections.
- **Handyman Services:** For minor repairs, a qualified handyman could be engaged to reinforce or repair specific sections of the fence.
- **Landscaper (if the fence is part of a larger garden feature):** If the fence is integrated into the landscape design, a landscaper with experience in fencing could be involved in the repair or replacement process.

It's important to ensure that whoever is hired is experienced and qualified to ensure the fence is restored to a safe and functional condition, compliant with local regulations.

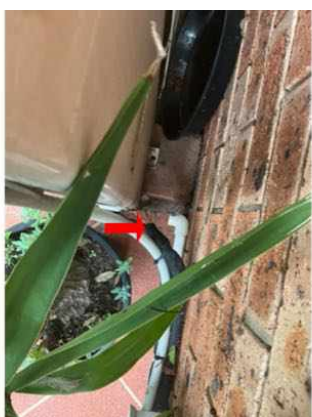
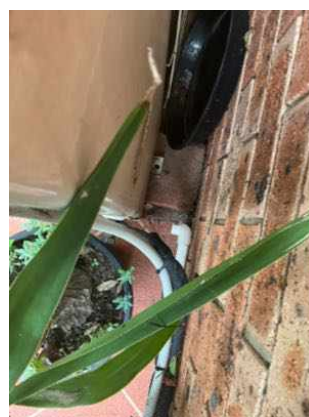
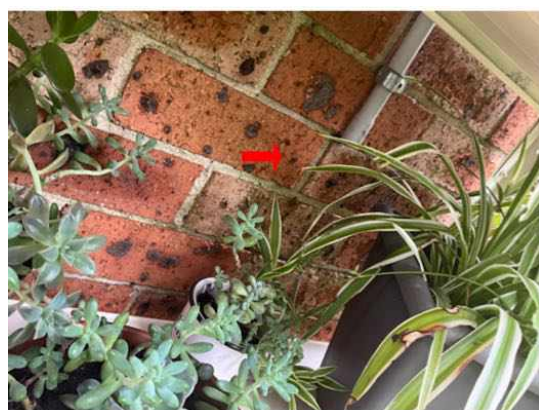
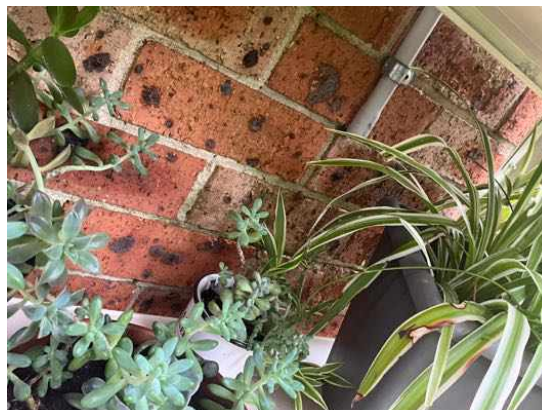
Finding 3.05

Building: Main Building  
 Location: All Areas  
 Finding: Air conditioner - Disconnected overflow  
 Information: The Air Conditioner (A/C) overflow was found to be disconnected from storm water drainage and is creating excessive moisture in the surrounding area.

Such leaking creates an environment which is conducive to an array of defects, including water damage to associated building elements and the attraction of termite or timber pest infestation.

It is highly recommended that a licensed plumber be appointed to connect the A/C overflow in order to prevent such an environment from being created. These minor works should be carried out as soon as possible.

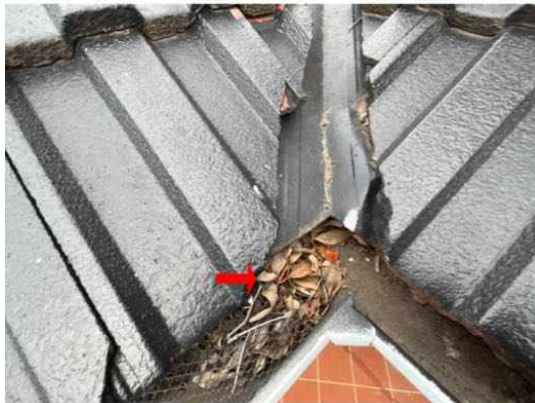
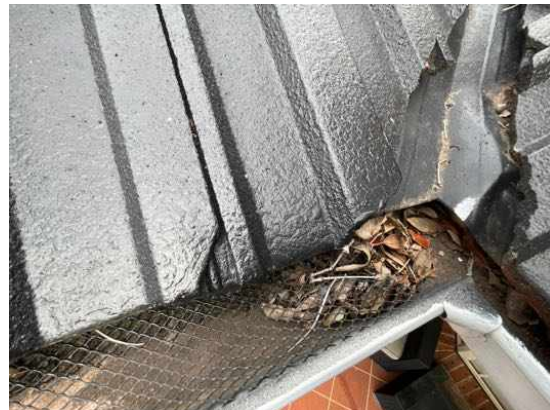
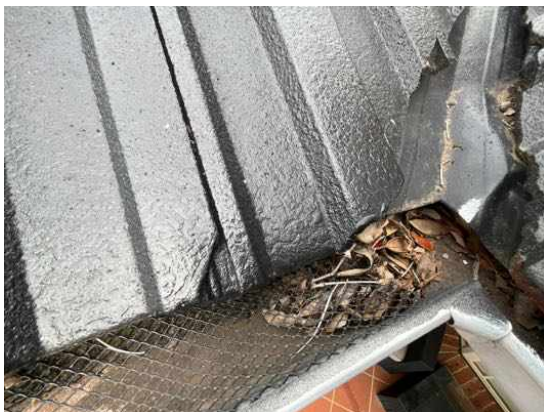
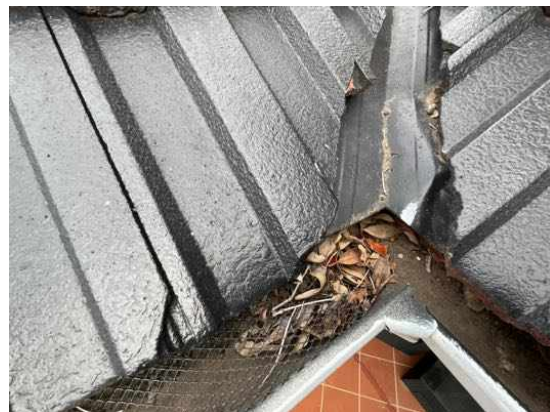
### Finding 3.06

Building: Main Building  
 Location: All Areas  
 Finding: Blocked gutters - organic debris  
 Information: The roof gutter system was observed to be blocked with organic debris and moss growth, as evident in the provided images.

- Water ingress into the eaves or walls,
- Timber rot or deterioration of fascia and soffits,
- Accelerated moss and algae growth, promoting further blockages,
- Potential foundation issues if water pools near the base of the structure.

A licensed roofing contractor or qualified gutter cleaning service should be engaged to remove the debris and inspect the system for any further issues.

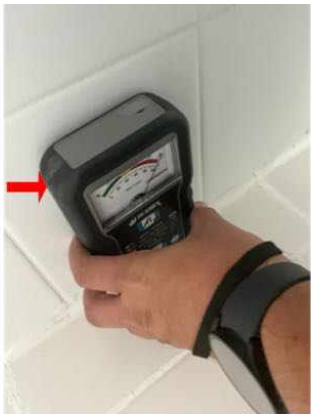
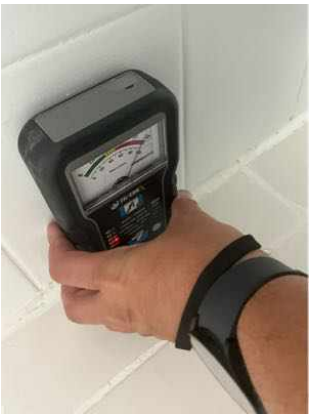
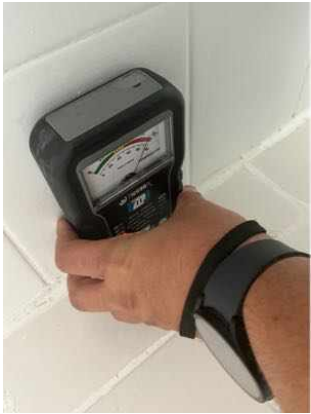
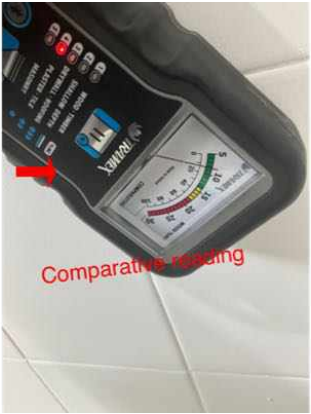
### Finding 3.07

Building:	Main Building
Location:	Bathroom
Finding:	Shower - Damp
Information:	Damp is evident to the lower 300mm of wall to the shower alcove. This defect is quite common, and is suspected to have been caused by moisture permeating through the grouting in this area, which shows evidence of deterioration. Leaking pipes within the adjoining wall is also a possible cause.

Damp (or structural damp) refers to the presence of unwanted moisture in the structure of a building, either as the result of intrusion from outside, or condensation from within the structure. In the shower area, internal water leaks or other sources of excessive moisture are generally the cause of damp.

Unmanaged damp in the shower recess is likely to facilitate the formation and development of mould and fungi growth, decaying associated building materials and compromising their structural integrity. It is important to address damp conditions, as the World Health Organisation notes that excess moisture leads - on almost all indoor materials - to growth of microbes such as moulds, fungi and bacteria, which subsequently emit spores and other matter into the indoor air. Exposure to these contaminants is associated with a wide range of respiratory and other health-related problems.

Consultation with a qualified plumber or bathroom specialist is advised immediately to identify the cause of damp and to perform remedial works as required. Where excessive mould growth is present, further inspection by a specialist environmental health inspector should also be considered.

Always ensure that sealant and grout is in good condition to prevent any moisture issues occurring in the future.

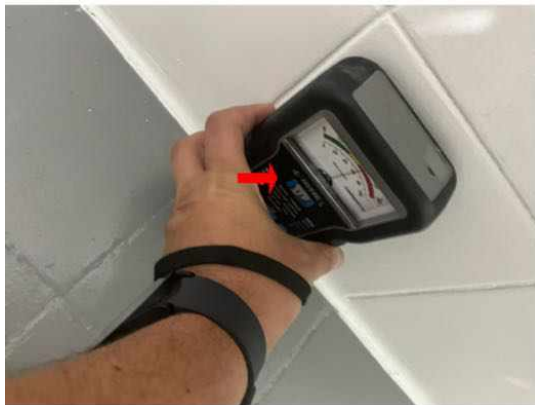
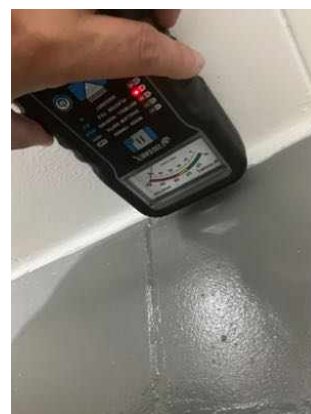
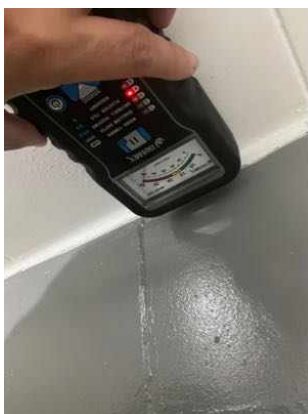
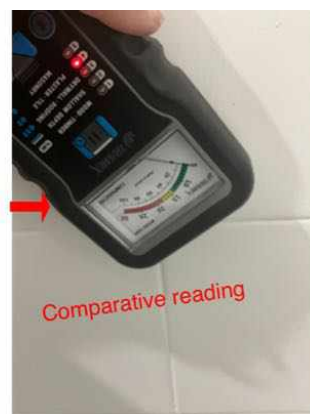
**Finding 3.08**

Building: Main Building  
Location: Ensuite  
Finding: Shower - Damp

Information: Damp is evident to the lower 300mm of wall to the shower alcove. This defect is quite common, and is suspected to have been caused by moisture permeating through the grouting in this area, which shows evidence of deterioration. Leaking pipes within the adjoining wall is also a possible cause.

Damp (or structural damp) refers to the presence of unwanted moisture in the structure of a building, either as the result of intrusion from outside, or condensation from within the structure. In the shower area, internal water leaks or other sources of

excessive moisture are generally the cause of damp.

Unmanaged damp in the shower recess is likely to facilitate the formation and development of mould and fungi growth, decaying associated building materials and compromising their structural integrity. It is important to address damp conditions, as the World Health Organisation notes that excess moisture leads - on almost all indoor materials - to growth of microbes such as moulds, fungi and bacteria, which subsequently emit spores and other matter into the indoor air. Exposure to these contaminants is associated with a wide range of respiratory and other health-related problems.

Consultation with a qualified plumber or bathroom specialist is advised immediately to identify the cause of damp and to perform remedial works as required. Where excessive mould growth is present, further inspection by a specialist environmental health inspector should also be considered.

Always ensure that sealant and grout is in good condition to prevent any moisture issues occurring in the future.

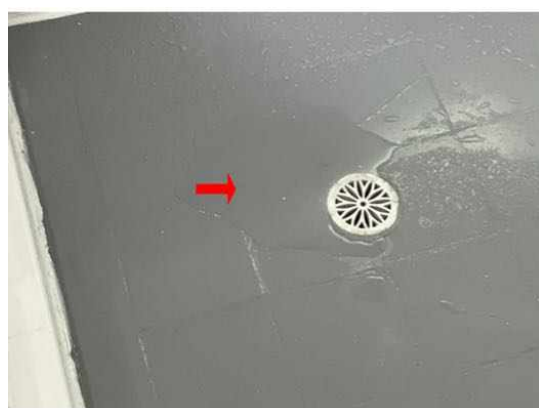
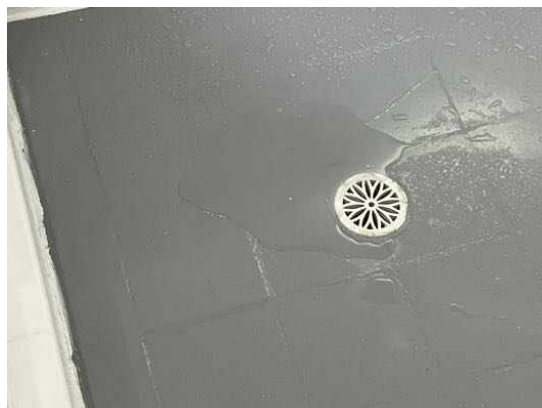
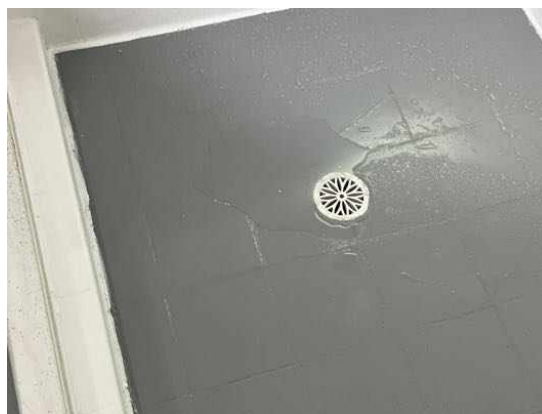
### Finding 3.09

Building:	Main Building
Location:	Ensuite
Finding:	Shower base - Water pooling
Information:	Evidence of water pooling around the floor waste in the shower recess was noticed at the time of inspection. It is suspected that this excessive moisture is attributed to insufficient fall in the shower floor tiles.

This pooling is minor overall but is still considered unsatisfactory, as standard tiling practices would not permit this situation to occur. Pooling water around floor wastes can create a slip hazard in extreme cases and create conditions that are conducive to mould growth over time. Where left unmanaged, the degradation of sealant and grouting is also likely to occur, possibly necessitating further repair works.

Remedial works may involve some sections of tiling and flooring repair and replacement. A tiling contractor or bathroom specialist should be appointed to provide further advice on reparation options and to perform works as necessary.

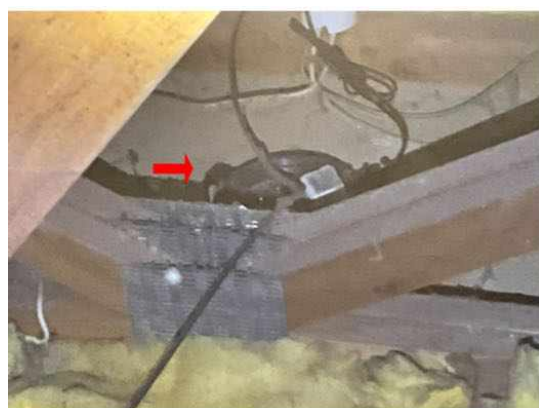
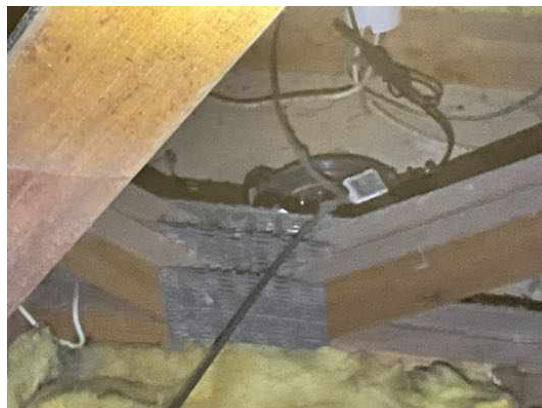
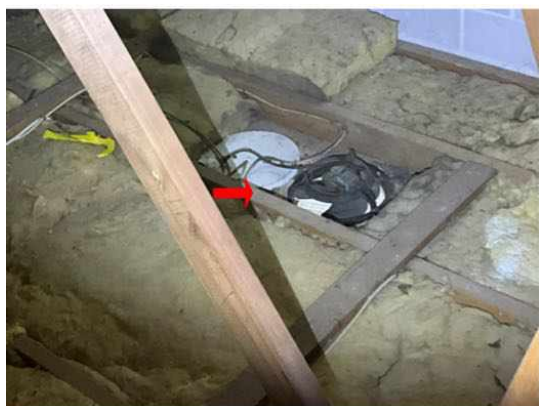
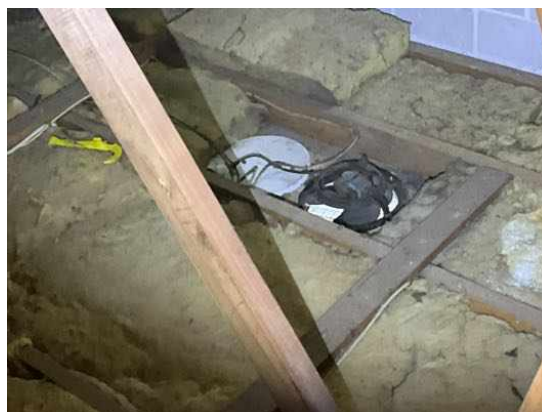
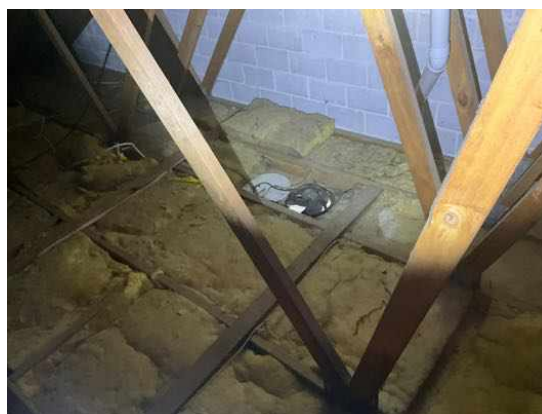
### Finding 3.10

Building:	Main Building
Location:	Roof Void
Finding:	Exhaust fan not vented out
Information:	The exhaust fan located within the roof void is not appropriately ducted to the external atmosphere and is currently discharging moist air directly into the roof space. This is considered a defect under AS 4349.1, as it does not meet the minimum standard of residential building performance expected under normal residential building practices.

This condition may lead to excessive condensation within the roof void, increasing the risk of mould growth, deterioration of insulation, timber decay, and overall reduced durability of building elements. It may also result in poor indoor air quality, potentially affecting occupant health.

It is recommended that the exhaust fan be modified by a licensed HVAC contractor or qualified builder, ensuring it is properly ducted to discharge externally in accordance with manufacturer specifications, the National Construction Code (NCC), and applicable Australian Standards.

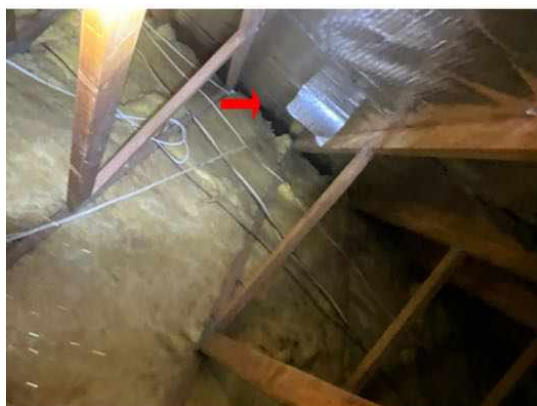
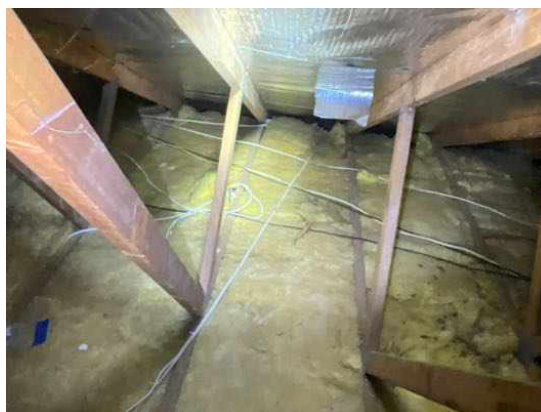
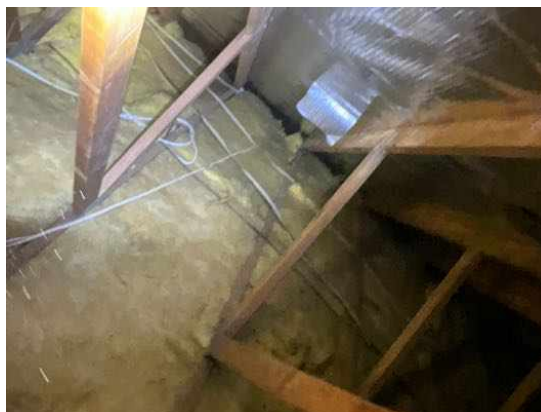
### Finding 3.11

Building:	Main Building
Location:	Roof Void
Finding:	Sarking - Damaged
Information:	Sarking, a laminated aluminium foil applied to the interior of the roof covering, assists in insulating the property and acting as a vapour-barrier to the roof void and, subsequently, to the household.

Where sarking is damaged, both insulation and moisture protection of the property are inhibited. This creates a loss of energy and thus negatively impacts the energy efficiency of the property, allowing potential for moisture ingress from condensation or leaking roof tiles.

It is important to repair any holes or damaged sections of sarking to ensure that the building material is fully functional. A registered builder or qualified carpenter should be consulted to provide further advice on this defect and to perform rectification works at client discretion.

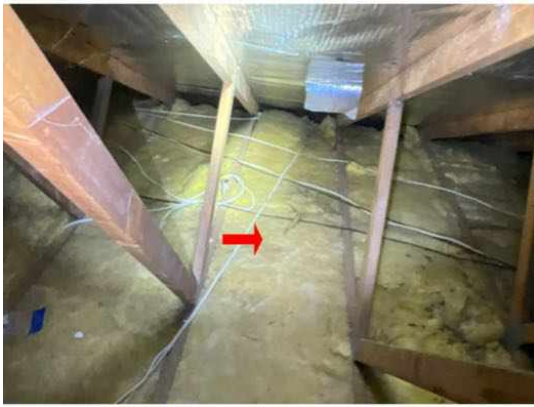
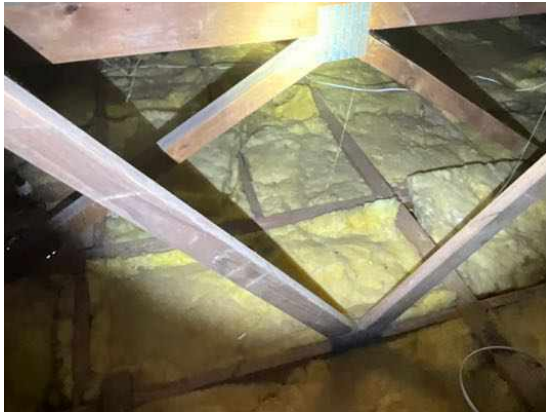
Building:	Main Building
Location:	Roof Void
Finding:	Insulation - Covering downlights
Information:	Sections of insulation in the roof void have been poorly installed or moved from their original position and are covering down light fittings. While the down lights have been fitted with appropriate protective covers, the presence of this insulation creates a potential fire hazard.

Any insulation within the vicinity of down light fixtures should be moved and re-applied to more appropriate sections of the roof void, thus ensuring the area is fire-safe. An insulation contractor should be appointed as soon as possible to perform any necessary works as required.

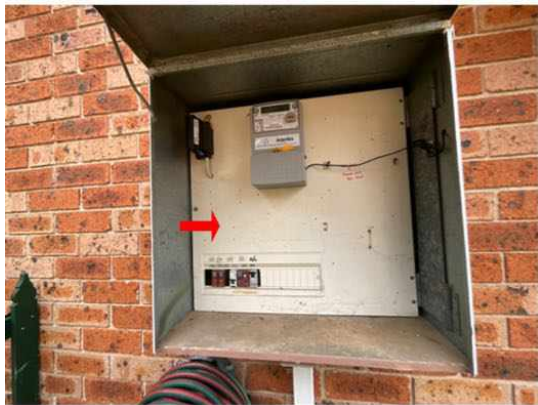
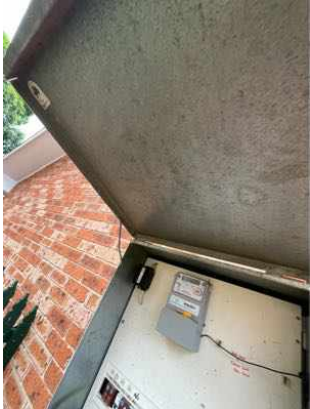
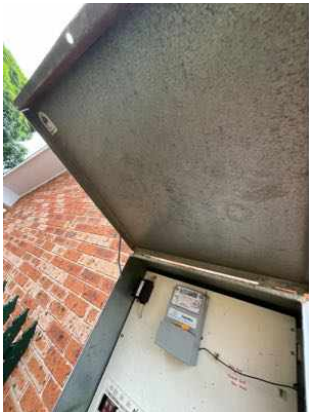
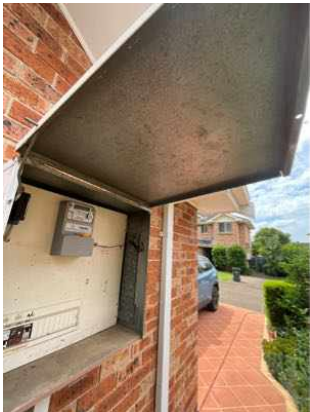
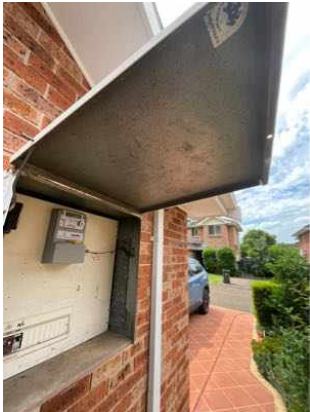
Building: Main Building  
Location: Exterior walls - left side  
Finding: No Evidence of Termite Management System - Durable notice / Legible Sticker  
Information: The application of a pre & post-construction chemical termite barrier is highly recommended for all properties. Such barriers are highly effective in preventing termite attack on any timber building elements throughout the property.

A durable notice was not placed in the switchboard unit to indicate current termite barriers is legible at the time of inspection.

Client must seek further information from the vendor or real estate agent if the conditions of termite management systems were maintained.

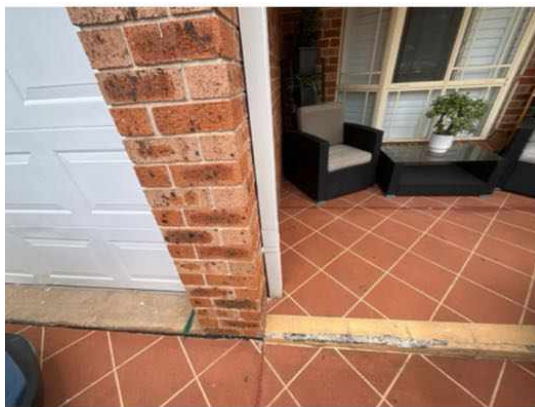
## Finding 6.02

If the slab edge is not properly exposed there is a high risk of termite attack. Sometimes, in order to determine the type of slab, a suitably qualified person such as an architect or builder may be required to consult the construction plans.

Where the slab edge cannot be properly inspected, it is highly recommended that termite or timber pest inspections be carried out every 6-12 months to aid protection of the property against infestation.

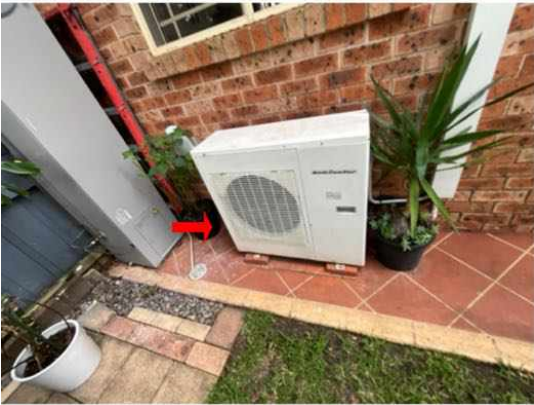
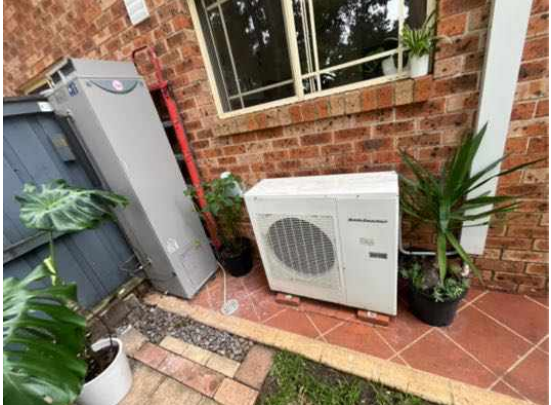
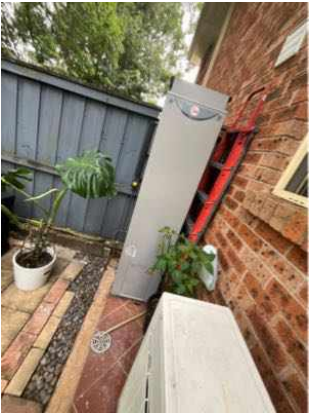
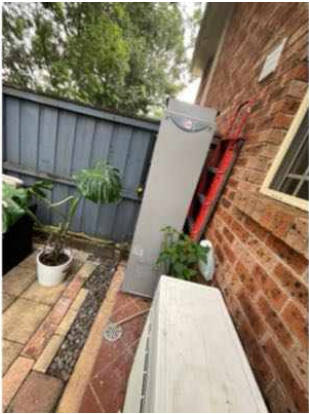
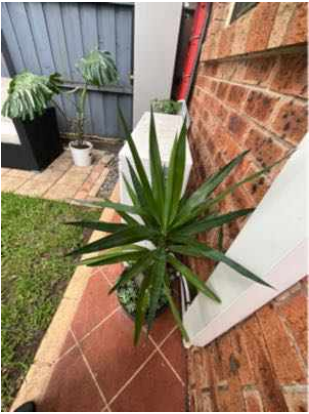
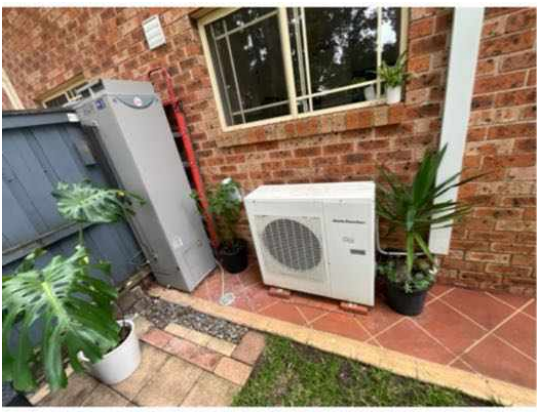
Where bridging has occurred full inspection is prevented and termites may enter a property in a concealed or undetected manner.

Recommended moving obstructions away from the external walls for further and future inspections.

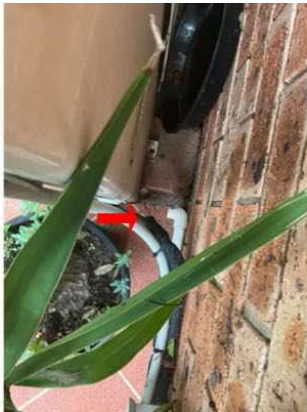
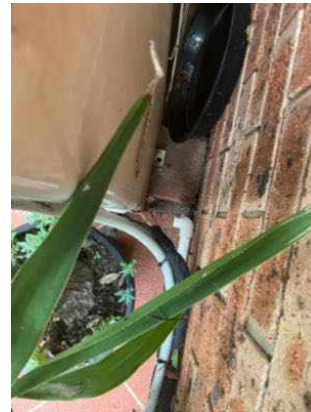
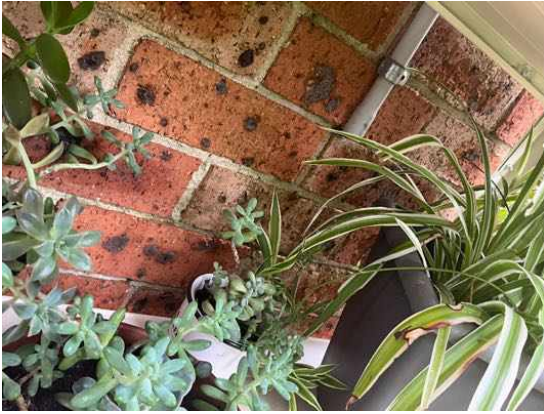
### Finding 6.06

Building:	Main Building
Location:	All Areas
Finding:	Aircon - Excessive moisture conducive condition near Air-conditioner
Information:	Excessive moisture near an air conditioner can indeed create conducive conditions for termites. Termites are attracted to damp and decaying wood, which can be found in areas with high moisture levels. To fix this issue: <ul style="list-style-type: none"> <li>1. Fix Leaks: Check for any leaks or condensation around your air conditioning unit. Repair any damaged pipes, drains, or insulation that may be causing moisture buildup.</li> </ul>

2. Proper Drainage: Ensure that your air conditioner has proper drainage. Make sure the condensate drain line is clear and directed

away from your home's foundation.

3. Ventilation: Improve ventilation around the unit. Ensure that the area is well-ventilated to reduce humidity levels.

4. Regular Maintenance: Schedule regular maintenance for your air conditioning system. This can help prevent leaks and ensure

it's working efficiently, reducing the chance of moisture.

5. Please consult a HVAC Technician: HVAC (Heating, Ventilation, and Air Conditioning) technicians are trained to diagnose and

repair a wide range of air conditioning problems. They can handle issues with the cooling system, refrigerant, electrical components, and more.

6. Consult an appropriate and Qualified Professional: For severe moisture issues or persistent termite problems, consult with a

pest control professional who can provide targeted solutions.

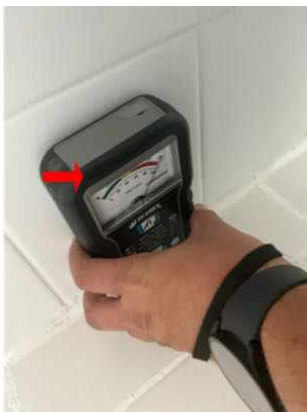
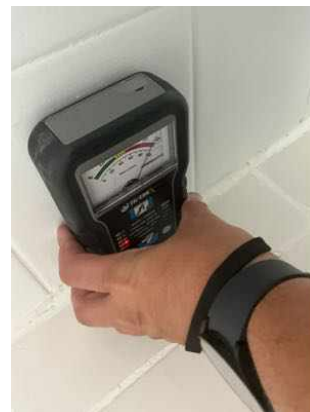
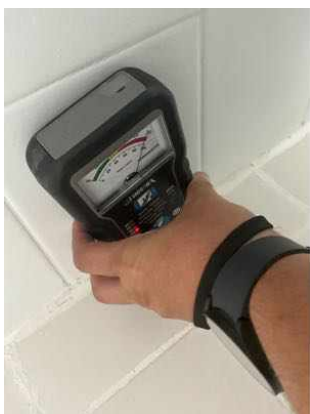
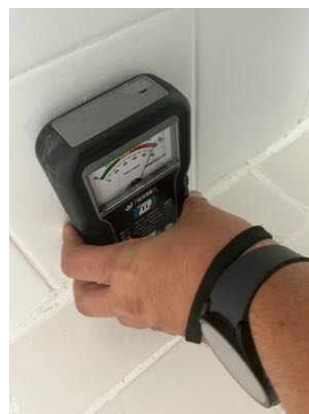
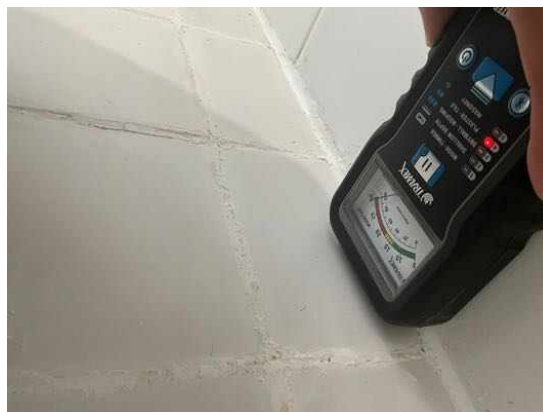
### Finding 6.07

Building:	Main Building
Location:	Bathroom
Finding:	Excessive moisture - Conducive to Timber pest
Information:	Excessive moisture can attract termites and produce conditions that promote fungal growth and wood decay.

Excessive moisture is generally caused by deteriorated inadequate or missing roof drainage leaking plumbing pipes or fixtures poorly plumbed HWS overflows or condenser units and poor site drainage.

Prior to any remedial works being performed a qualified plumber should be appointed to further inspect the property and to identify the cause of the excessive moisture. Works to remove affected building elements may then be necessary and should be performed by an appropriate tradesperson.

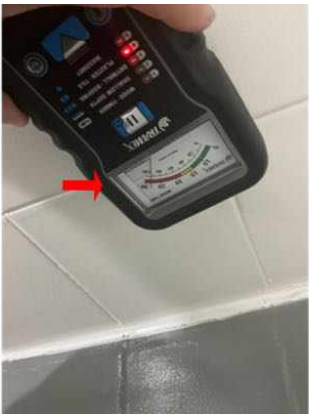
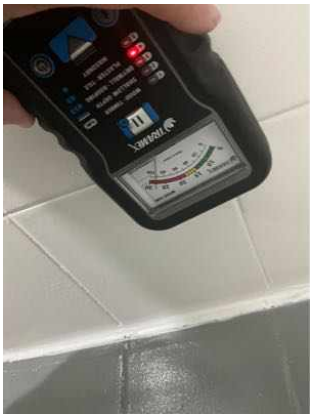
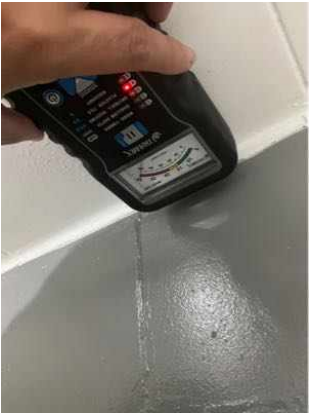
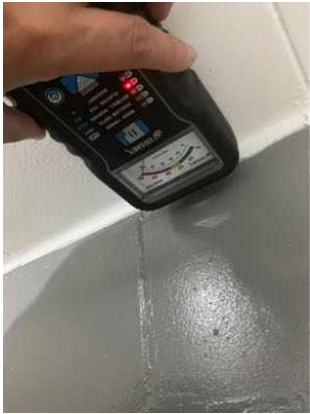
### Finding 6.08

Building:	Main Building
Location:	Ensuite
Finding:	Excessive moisture - Conducive to Timber pest
Information:	Excessive moisture can attract termites and produce conditions that promote fungal growth and wood decay.

Excessive moisture is generally caused by deteriorated inadequate or missing roof drainage leaking plumbing pipes or fixtures poorly plumbed HWS overflows or condenser units and poor site drainage.

Prior to any remedial works being performed a qualified plumber should be appointed to further inspect the property and to identify the cause of the excessive moisture. Works to remove affected building elements may then be necessary and should be performed by an appropriate tradesperson.

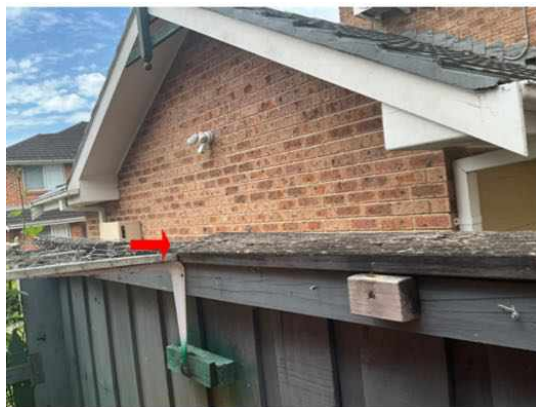
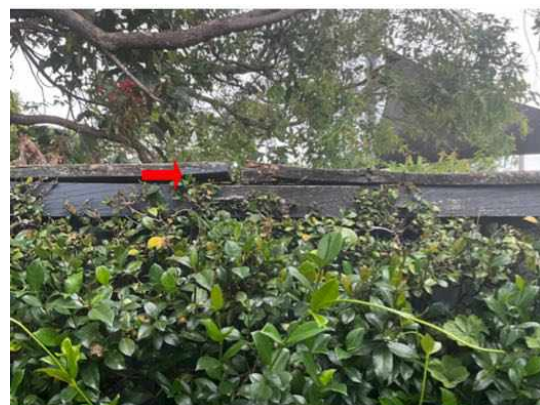
**Finding 7.01**

Building: Main Building  
Location: All Areas  
Finding: Wood rot  
Information: This building element shows evidence of wood rot. Wood rot, also known as Fungal Decay, occurs when timbers and other cellulose building materials are exposed to damp conditions on an ongoing basis. This could be the result of exposure to weathering over a prolonged period of time, or the attraction of excessive moisture

Wood rot is often associated with general damp problems and is evidenced by a 'musty' smell or mould and mildew occurring on surfaces. If left unmanaged, damp conditions can lead to further health problems and the decay of timbers will continue.

Early intervention and regular maintenance, particularly of exterior timbers, will prolong the useful life of these building elements. Prior to any works being performed, the cause of the moisture that has created the visible wood rot should be identified and addressed in a suitable manner. Replacement of affected timbers may then be a necessary step in protecting surrounding building elements from such deterioration.

A qualified plumber may be appointed to assess the cause of excessive moisture and to provide advice on any remedial works as required. A qualified carpenter or registered builder may also be required to replace affected building materials.

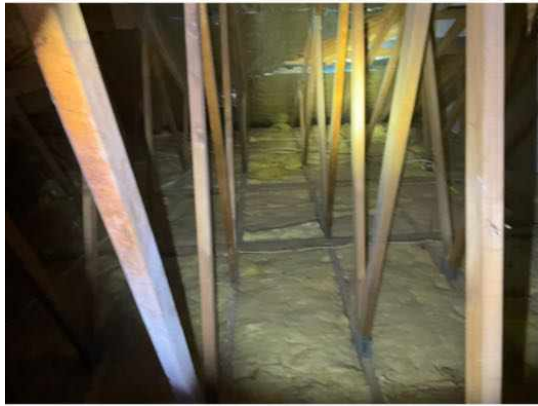
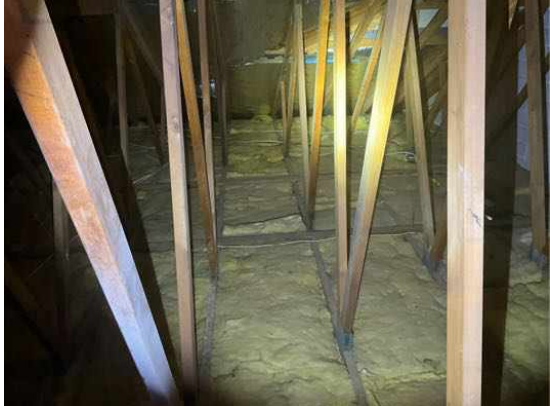
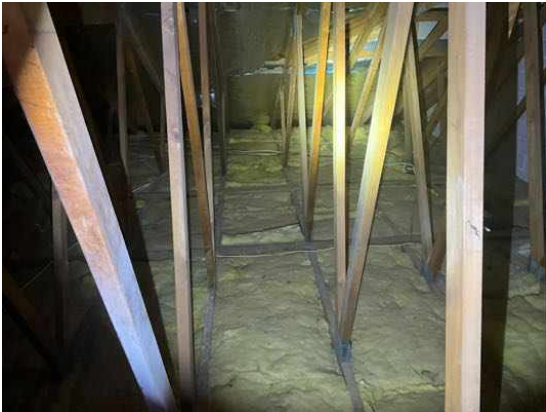
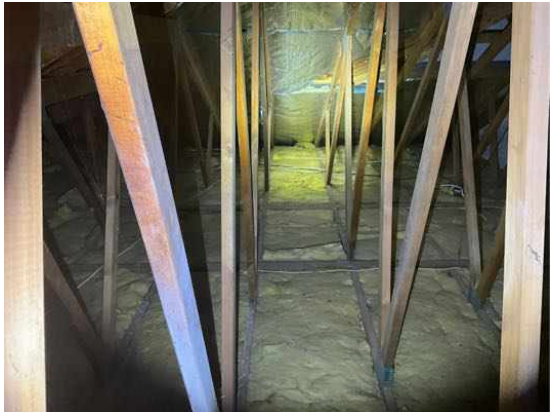
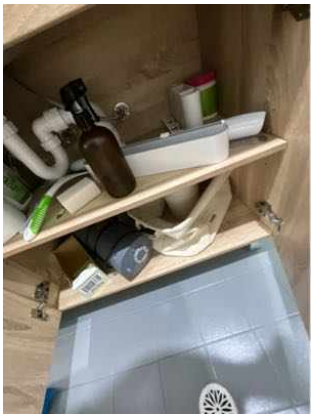
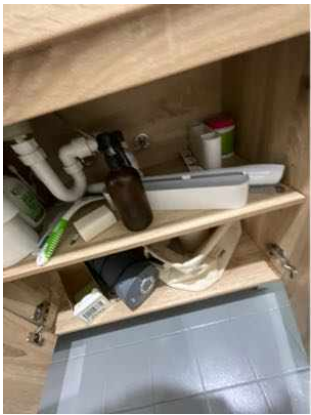
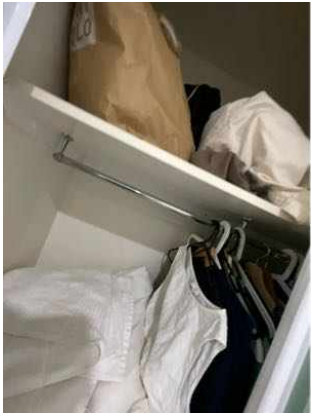
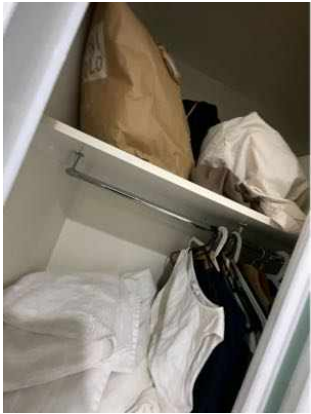
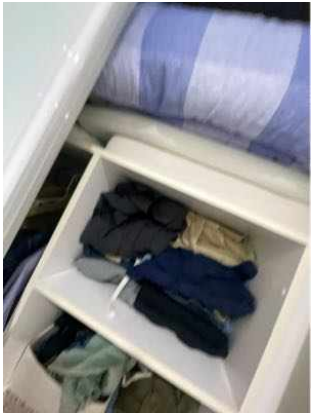
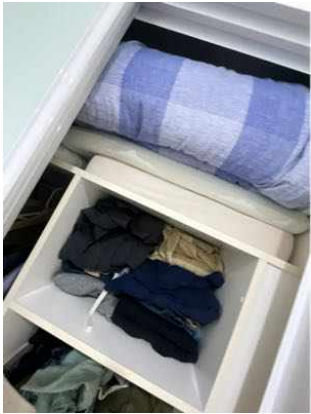
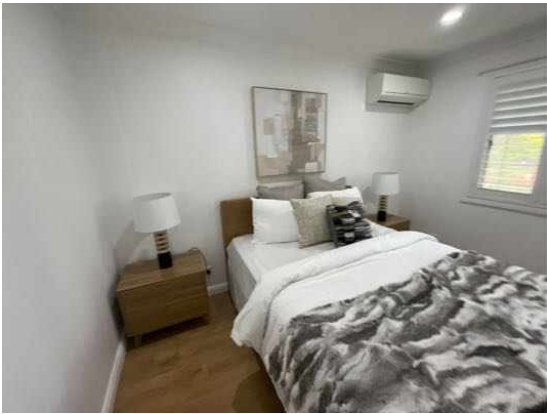
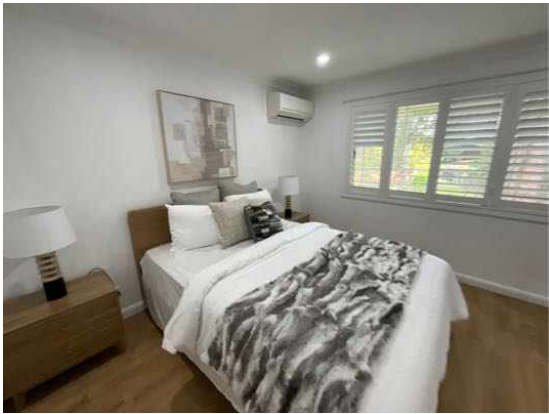
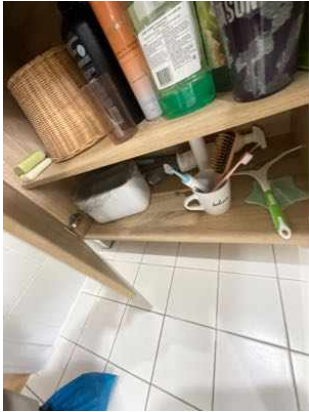
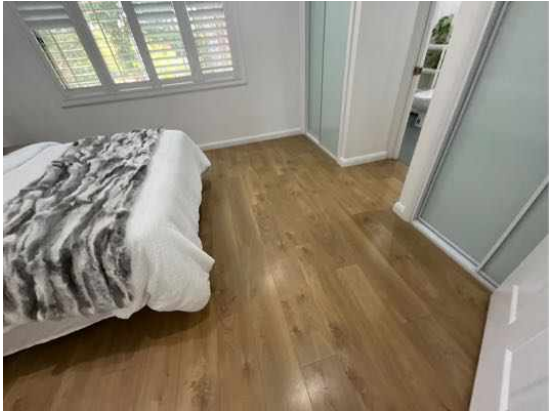
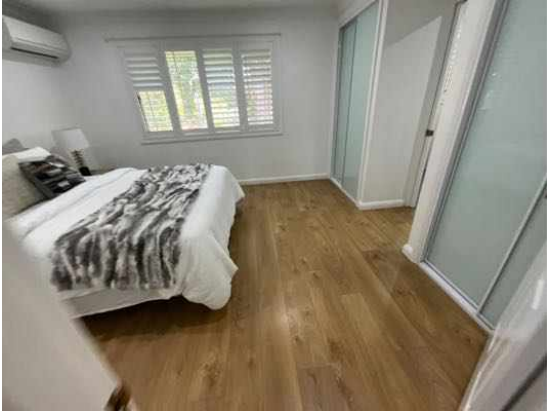
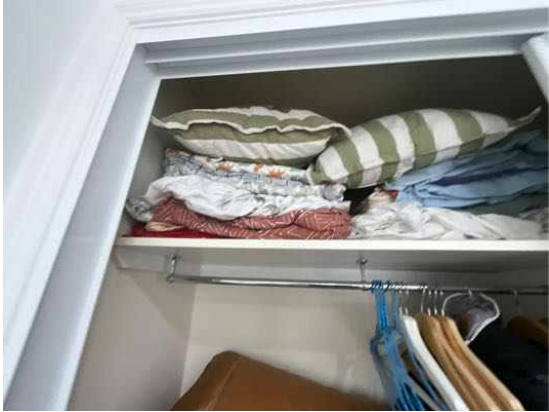
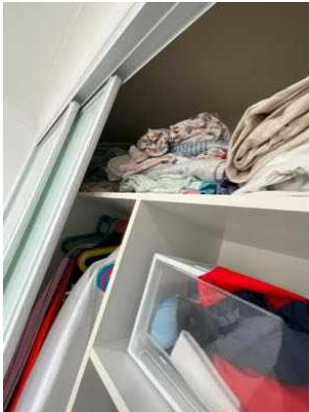
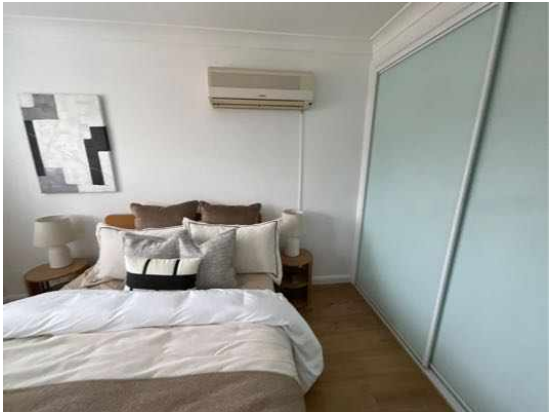
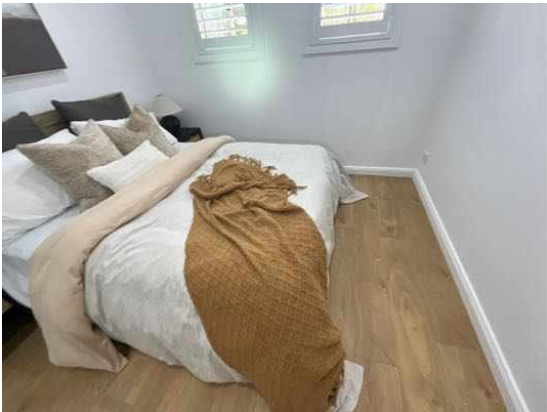
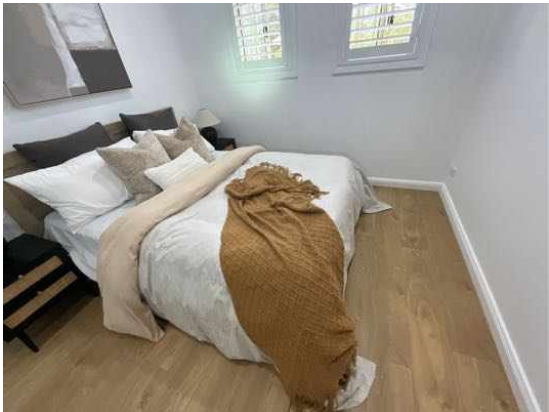
### Noted Item

Building: Main Building  
Location: All Areas  
Finding: Additional Photos - Obstructions and Limitations  
Information: These photographs are an indication of the obstructions and limitations which impeded full inspection of the property at the time of inspection. These obstructions can hide an array of defects and should be removed to allow full inspection to be carried out. A re-inspection is recommended once the areas are made accessible.
