# Building and Timber Pest Inspection Report

Inspection Date: Wed, 25 Feb 2026

Property Address: 21 Fallows Way, Cherrybrook NSW 2126,  
Australia

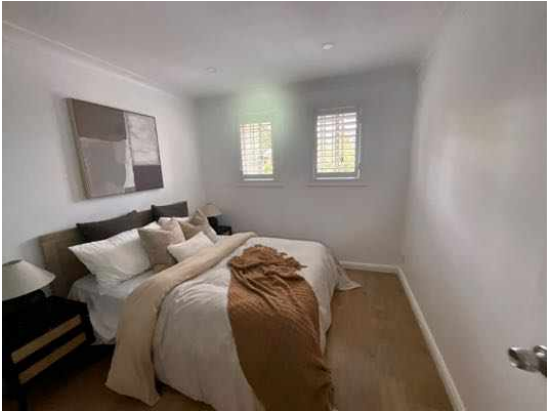
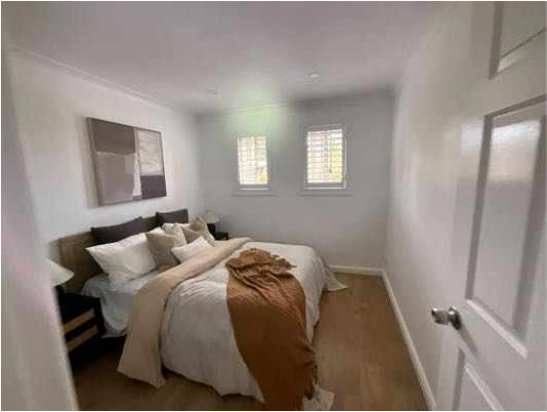
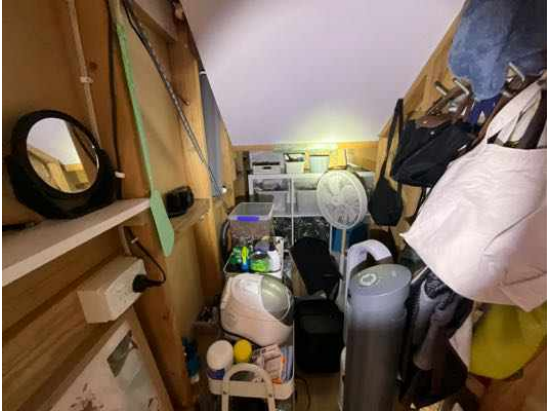
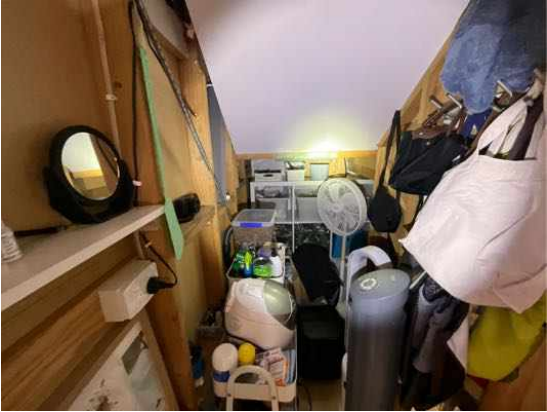
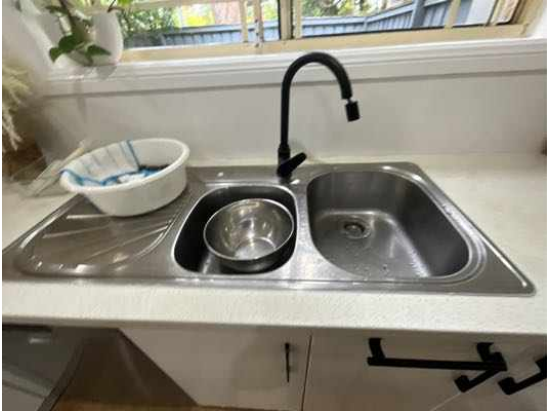
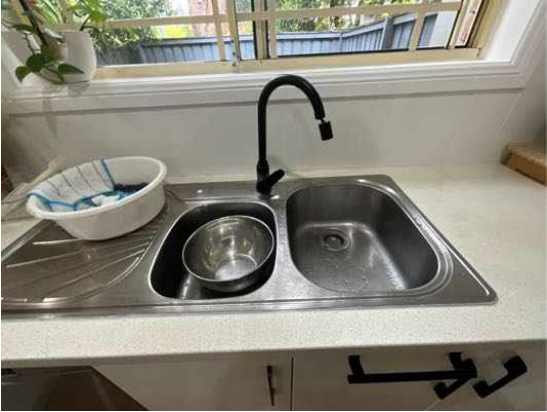
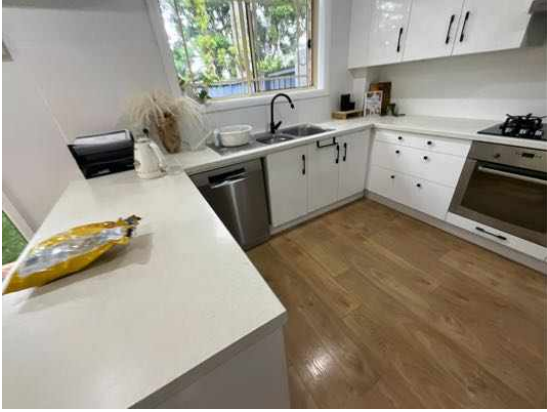
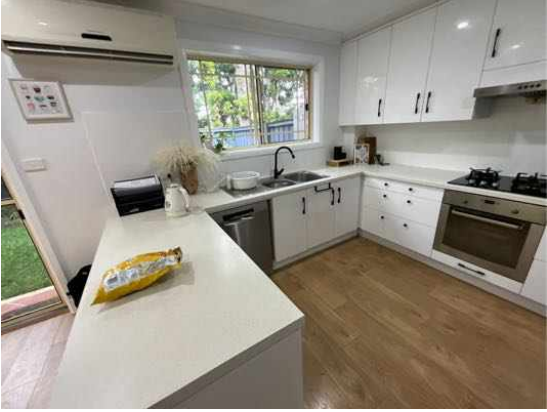
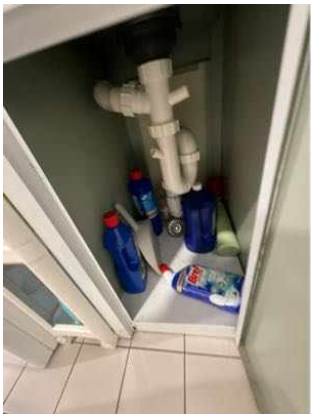
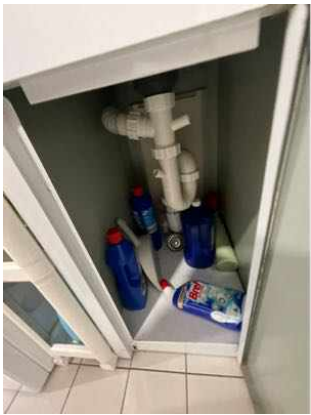
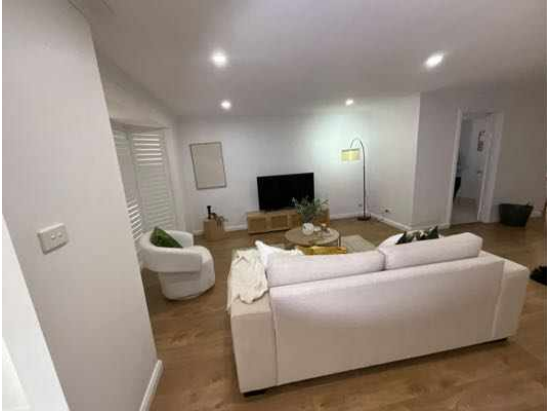
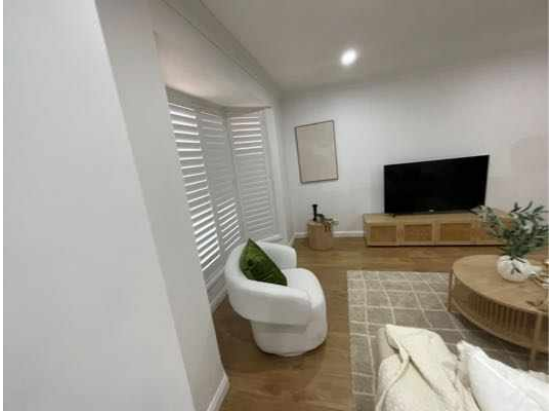
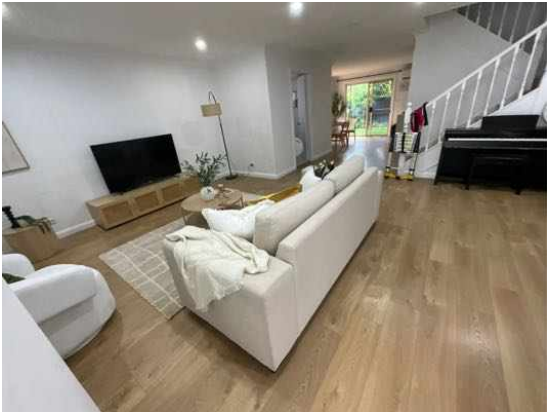
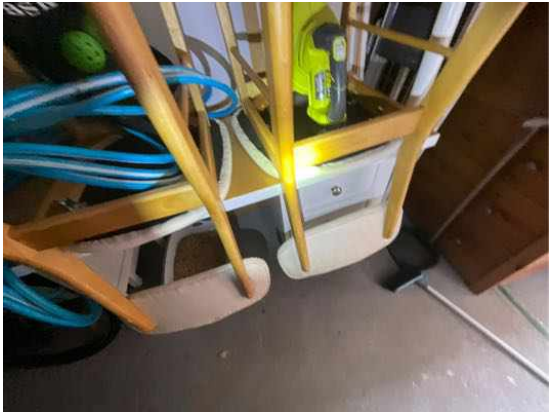
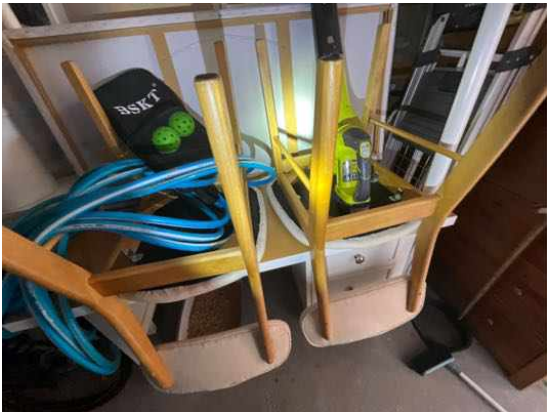
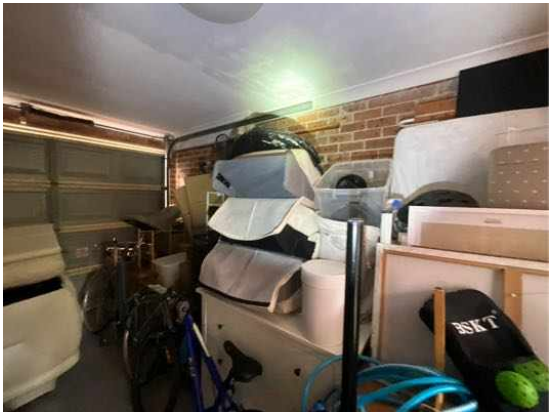
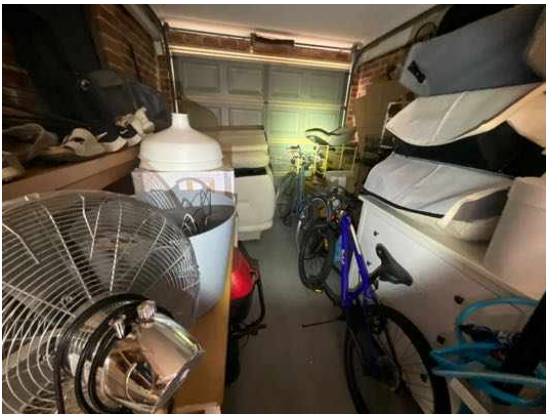
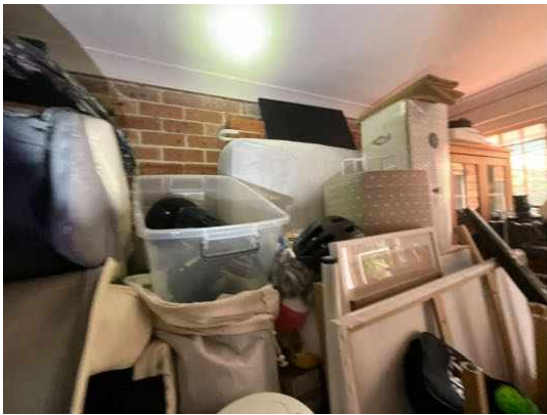
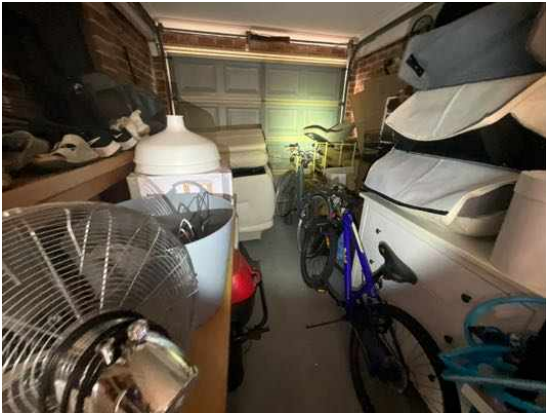
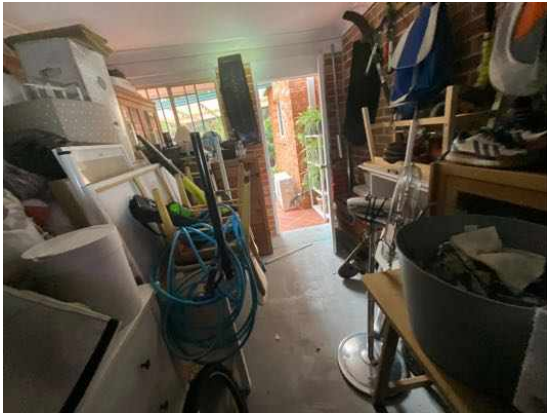
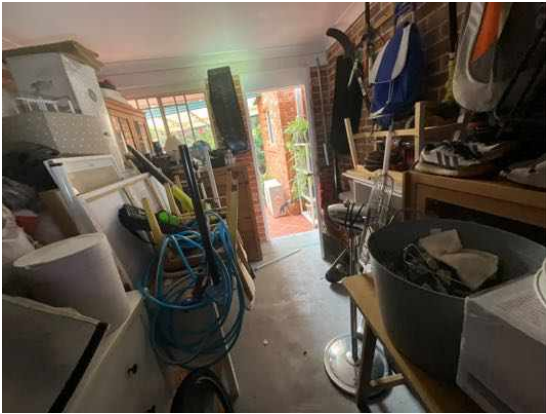
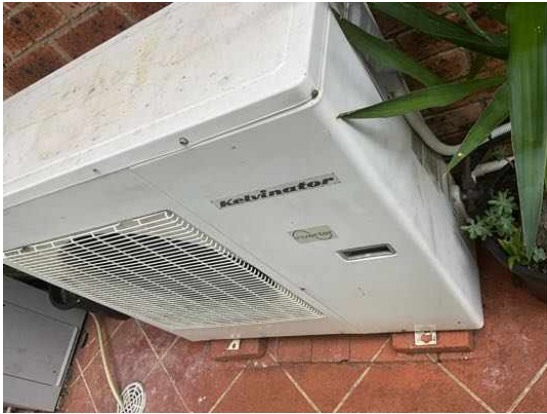
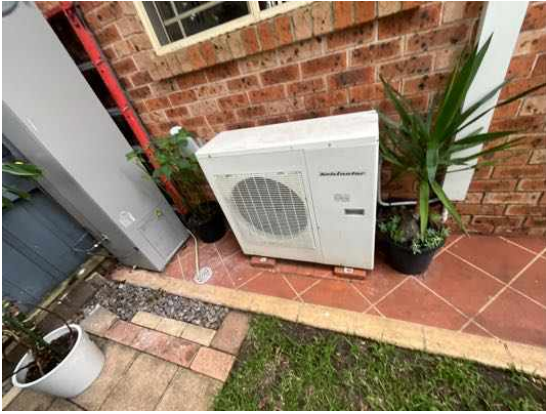
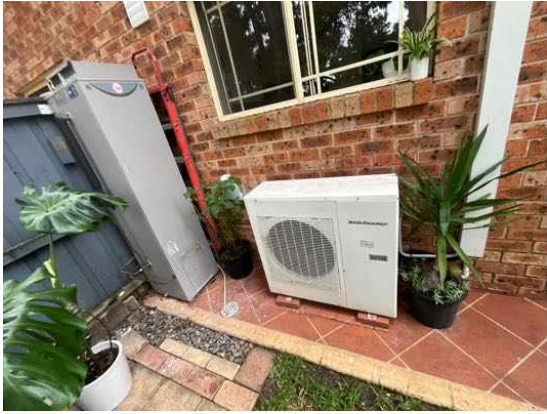
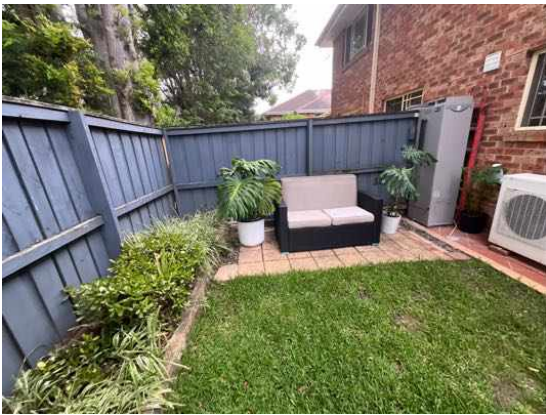
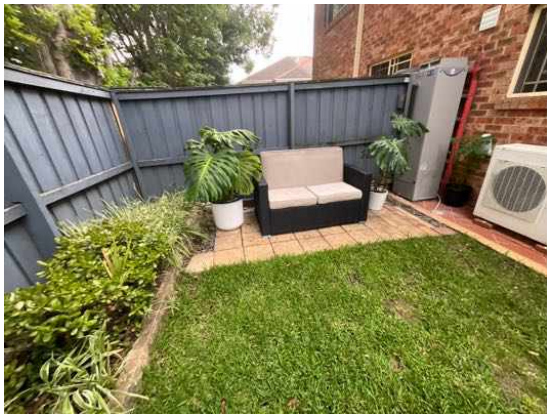
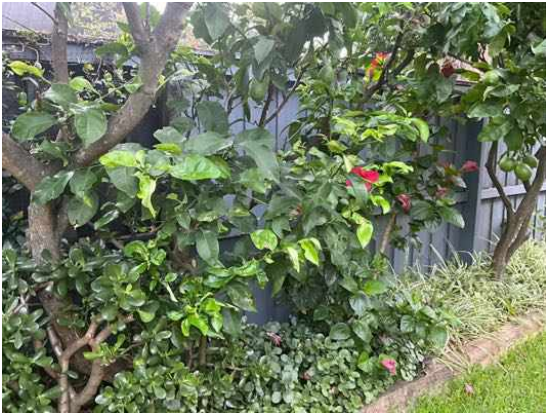
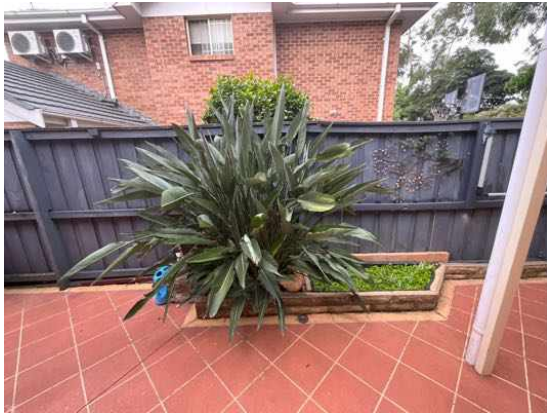
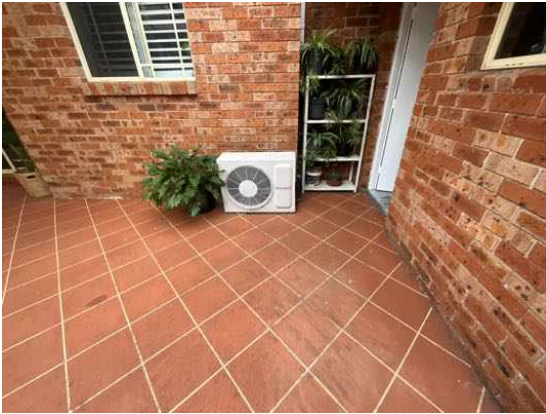
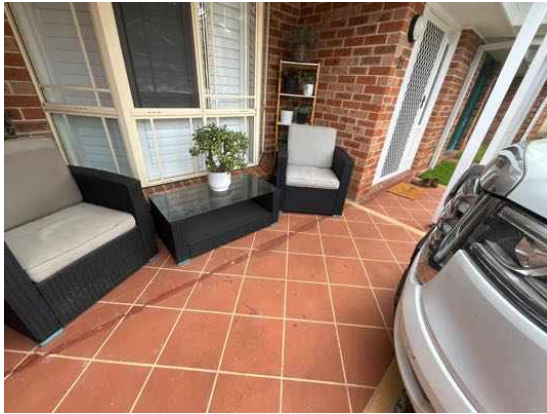
Building: Main Building  
Location: All Areas  
Finding: Additional Photos - Obstructions and Limitations  
Information: These photographs are an indication of the obstructions and limitations which impeded full inspection of the property at the time of inspection. These obstructions can hide an array of defects and should be removed to allow full inspection to be carried out. A re-inspection is recommended once the areas are made accessible.

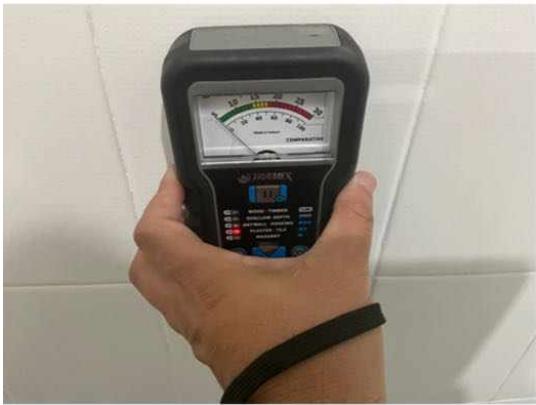
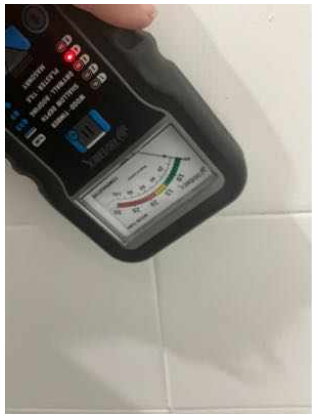
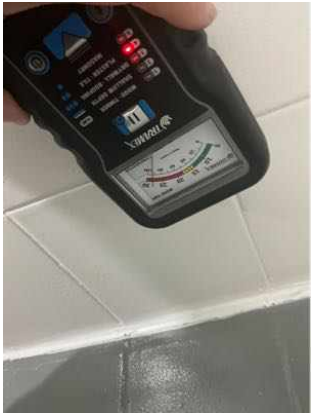
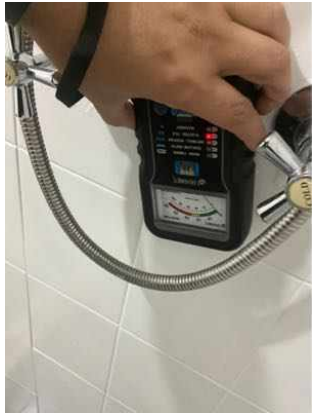
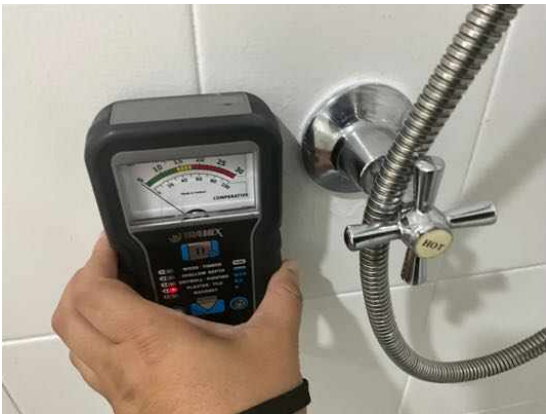
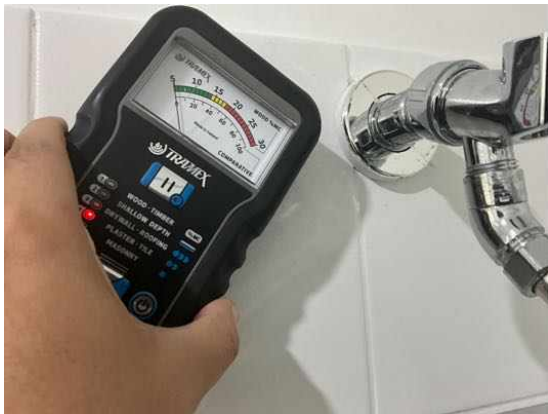
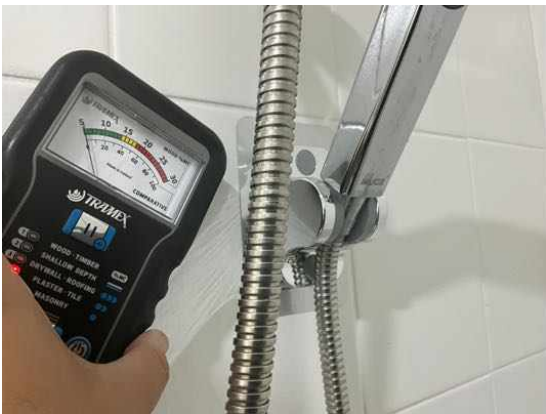
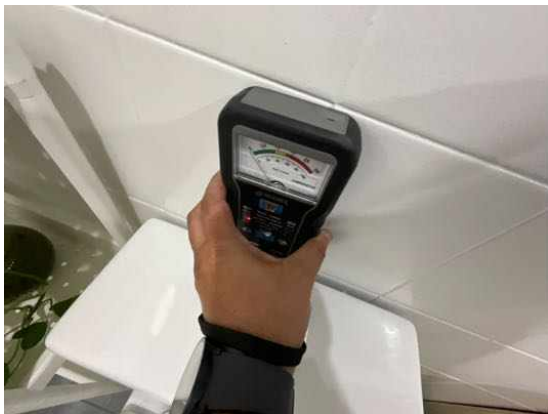
Building: Main Building  
Location: All Areas  
Finding: Additional Photos  
Information: Additional photos are provided for your general reference
