Building and Timber Pest Inspection Report

Inspection Date: Wed, 8 Apr 2026

Property Address: 75 Boronia Dr, Voyager Point NSW 2172,
Australia

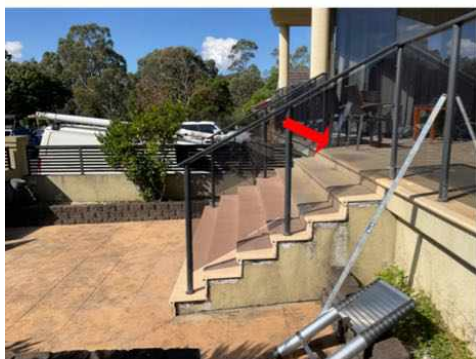
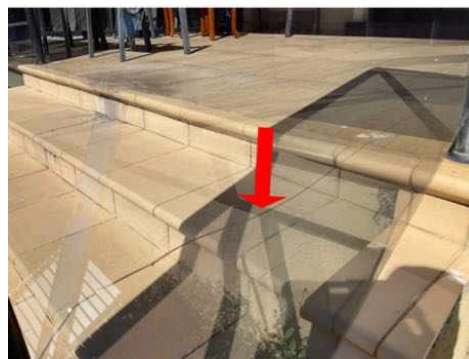
Building:	Building 1
Location:	Entry stairs
Finding:	Balustrade - Cracked
Information:	Cracks were identified in the stairs balustrade in this front area. Cracking in glass is generally the result of impact damage, and is likely to develop further when left unmanaged. The likelihood of this pane further cracking and shattering is increased exponentially, providing a safety hazard in the area.

A qualified glazier is required to repair the glass as soon as possible. Depending on the extent of the cracking, replacement of the glass may be required. Please be advised that any persons coming into contact with the cracked glass should do so with due caution to avoid any personal injury that may ensue.

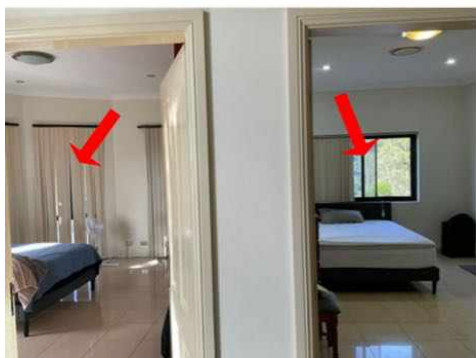
Finding 1.02

Building:	Building 1
Location:	Many upstairs windows
Finding:	Window opening restrictors missing.
Information:	Many upper windows are missing window restrictors. The Building Code of Australia rules require all openable windows (where the internal floor is more than 2m above the ground outside) in residential rooms to be fitted with a suitable screen or restrictor. Windows located 1.7m above the floor level do not require protection.

Window restrictors are required where people who are vulnerable to the risk of falling have access to windows. This means all windows above ground level which do not have another fall prevention safety measure in place, such as a balcony or balustrade should have a restrictor.

These need to be added urgently for the safety of all persons.

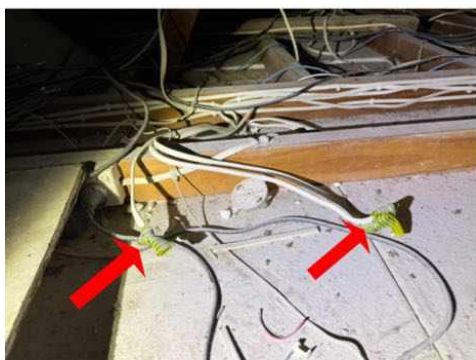
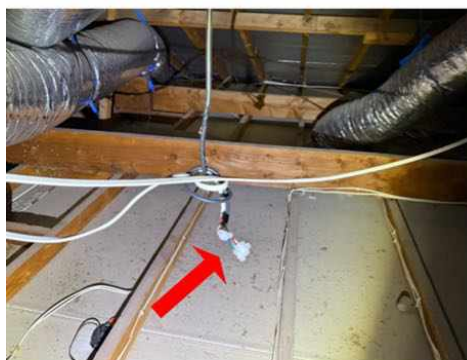
Finding 1.03

Building:	Building 1
Location:	Roof Cavity
Finding:	Electrical cables missing a junction box
Information:	The electrical fittings in the left and rear middle roof areas were found to be missing a junction boxes at the time of inspection.

This missing fittings and loose cables does expose electrical works, and may create a safety hazard if there is potential contact with persons in the area.

A Licensed electrician should be appointed to rectify these areas immediately.

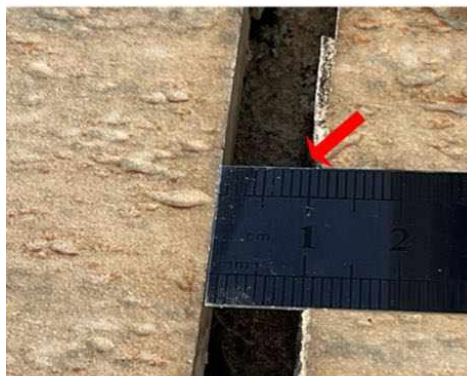
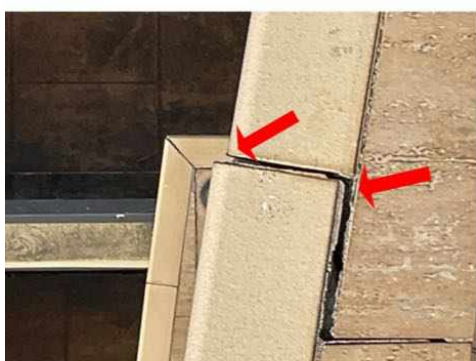
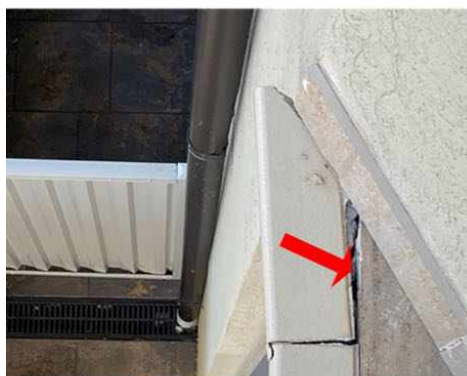
Building:	Building 1
Location:	Exterior walls & balconies
Finding:	Cracks in mortar beds and tile movement
Information:	Cracks and tile movement were identified in the upper verandah north east corner and other verandah areas.

All top floor damaged tile areas require rectification (tile removal, sealing and relaying) to stop moisture ingress causing tiles to dislodge and possible injury and potential concrete cancer to the verandah slabs.

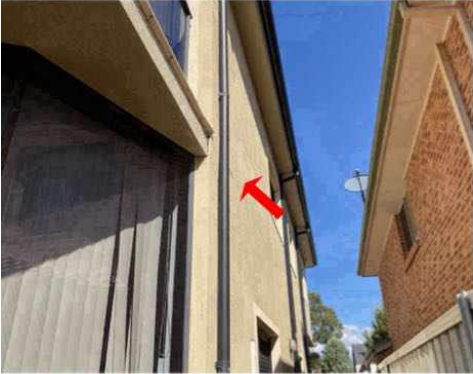
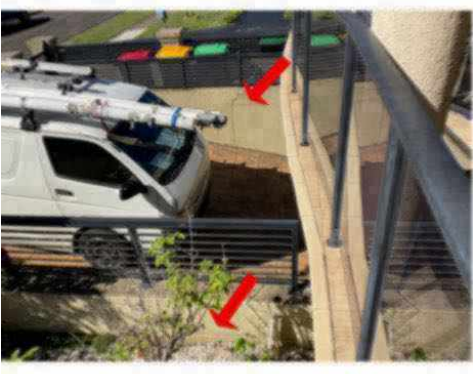
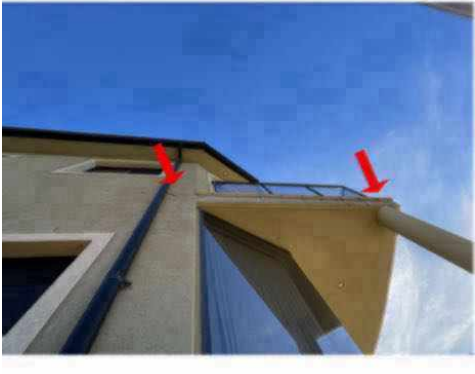
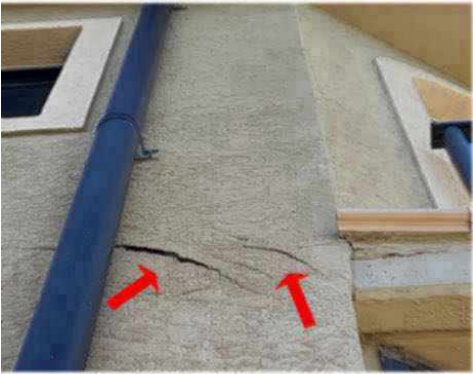
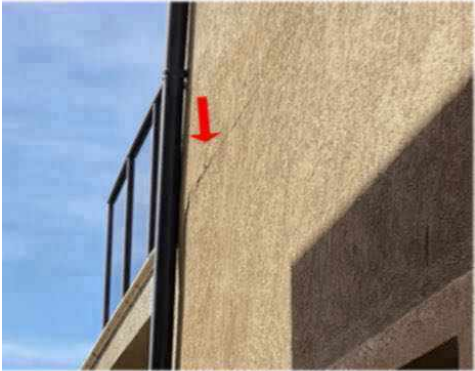
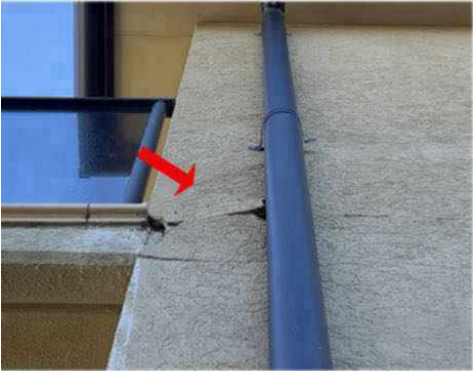
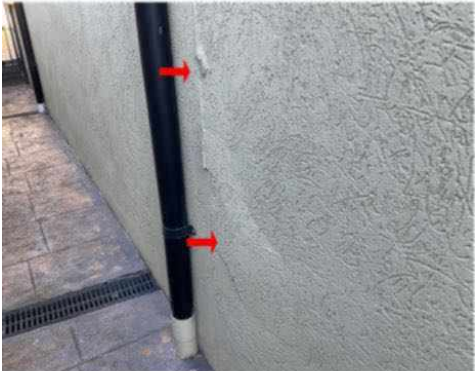
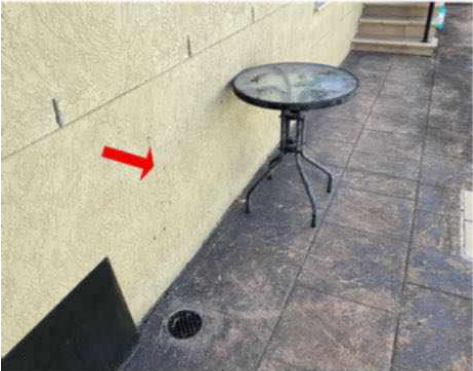
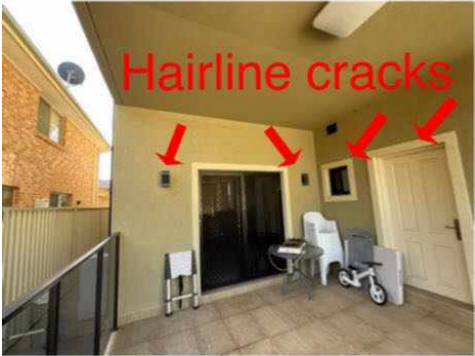
Finding 3.02

Building:	Building 1
Location:	Pictured front areas
Finding:	Render (external) cracking.
Information:	Cracking was observed to the external rendered wall finishes on the front right and three areas of the left elevations of the dwelling and other small areas. The cracks appear to be approximately up to 10 mm in width in places. Some of this render will fall off the walls in the near future. These cracked areas were inaccessible by ladder to measure. Based on visual inspection, the cracking appears consistent with movement and/or inadequate control joints within the render system. Cracks of this size may allow moisture ingress, potentially leading to deterioration of the render, loss of adhesion, and possible damage to the underlying substrate if left unrectified.

□ Further assessment by a qualified builder or renderer is recommended to determine the cause of movement and to carry out appropriate repairs. Repairs may include crack rectification, reinstatement of control joints where required, and re-rendering and repainting to restore weatherproofing and appearance.

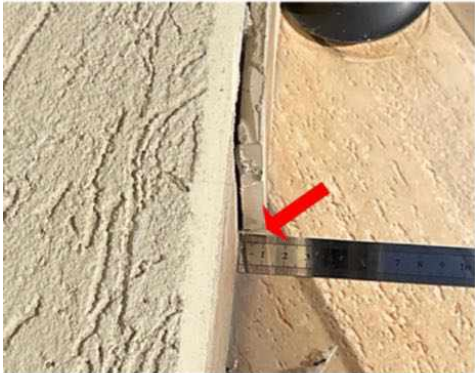
Finding 3.03

Building: Building 1
Location: Pictured areas
Finding: Render (external) cracking (continued)
Information:

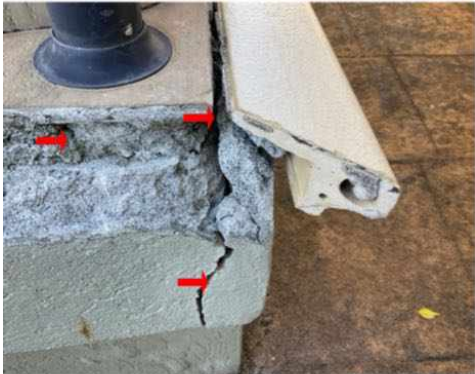
Finding 3.04

Building: Building 1
Location: Pictured front areas
Finding: Concrete spalling
Information: These right side verandahs has suffered Concrete Spalling. This is the breakdown of concrete via natural weathering and/or chemical reaction that results in sections of concrete chipping off the main body – often resulting in fractured, compromised concrete. Spalling looks like pitted acne scarring and breaks off in flecks which can expose rebar. It appears rainwater is getting into the areas of the missing and damaged grout on the verandahs.

A concreting contractor can provide advice on repairs of this damaged concrete when convenient.

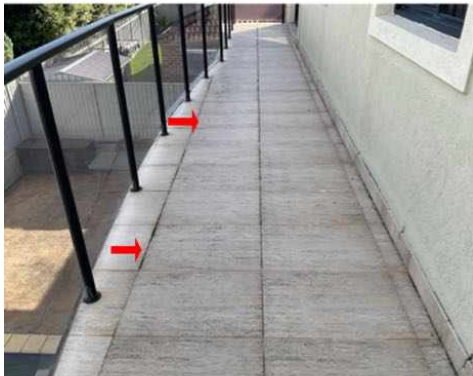
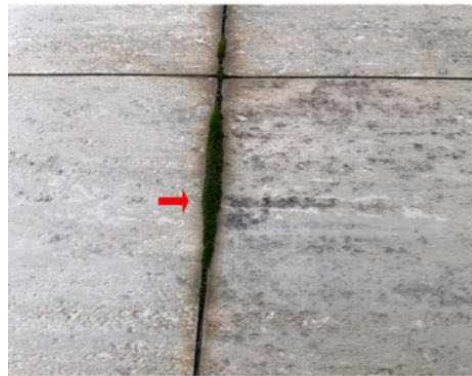
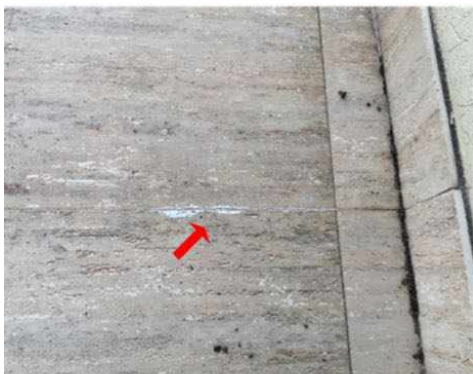
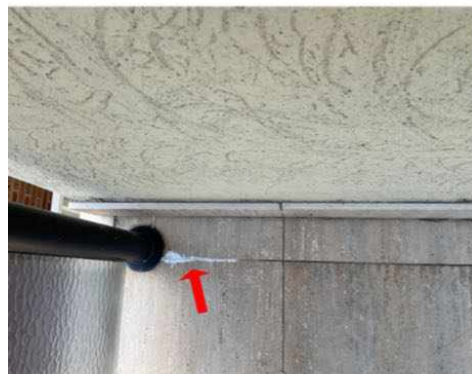
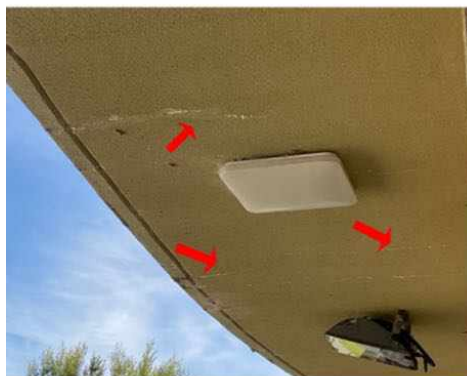
Building:	Building 1
Location:	Rear balcony
Finding:	Waterproofing of balconies
Information:	On inspection of the front and rear balconies, it is suspected no waterproofing membrane has been installed. There is a high risk of concrete cancer developing where the metal reinforcing in the concrete starts to rust, then expand and break apart the concrete. This is listed as a minor defect in this report as it is highly likely that it will lead to further damage over time if not repaired. If an invasive inspection by removing tiles shows concrete cancer, this defect may be upgraded to a major defect in this report.

Due to the amount of damaged sealant and grout, there are many areas rainwater can ingress the tiled surfaces and potentially damage the verandah slabs.

All elevated balconies, stairs and landings need urgent attention to stop further damage and very costly concrete and other repair work.

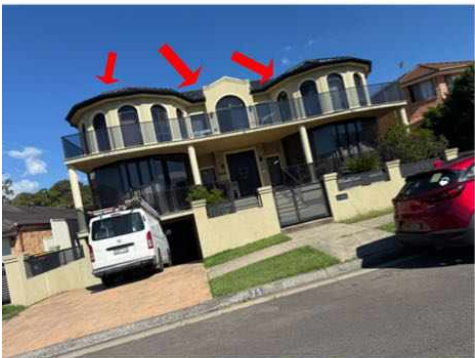
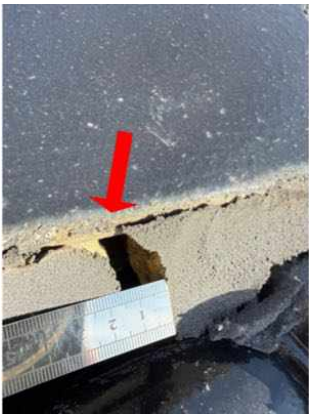
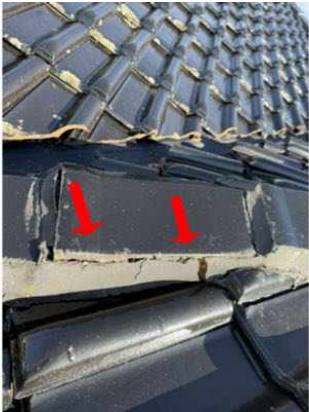
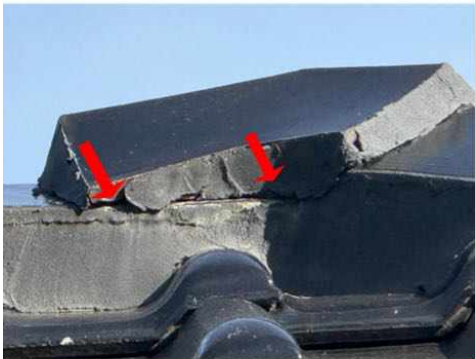
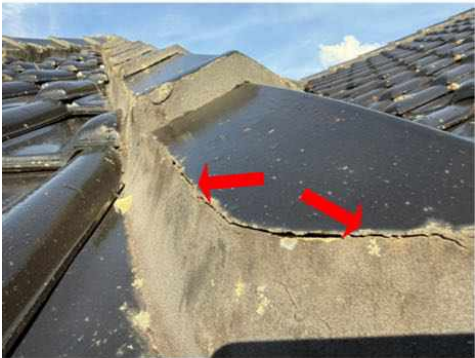
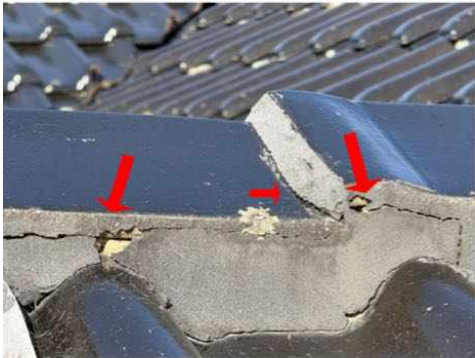
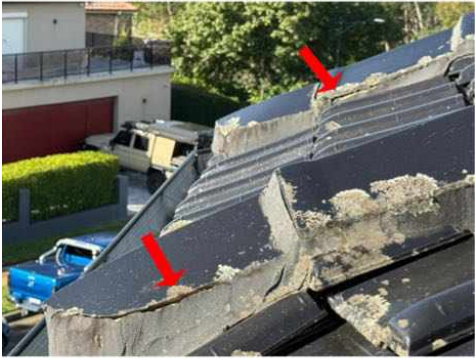
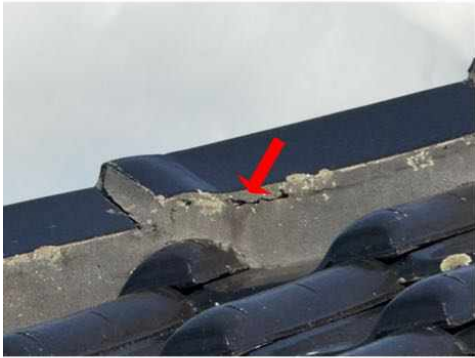
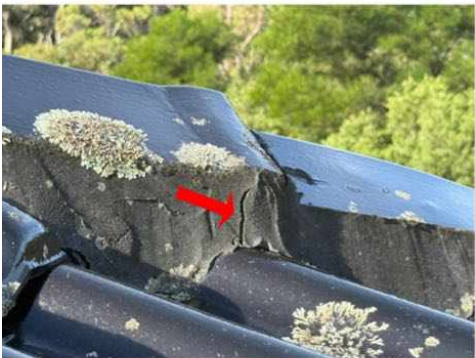
Finding 3.07

Building:	Building 1
Location:	Roof Exterior
Finding:	Roof tiles - Weathered
Information:	Upon inspection of the exterior roofing, the majority of visible roof tiles were considered to be in a good condition with the visible mortar in fair condition overall.

Isolated areas of mortar show cracking present. Re-pointing and re-sealing the may be considered as an interim solution by the client to help preserve and extend the life span of the tiles.

Where left unmanaged, deteriorating roof tiles are likely to lead to a number of secondary defects, including minor water leaks and weather exposure to internal roofing structures.

Consultation with a roofing contractor is highly advised to gain advice on cost of remedial works that may be required in the short to medium term. Remedial works are likely to increase the longevity of the exterior roofing structure.

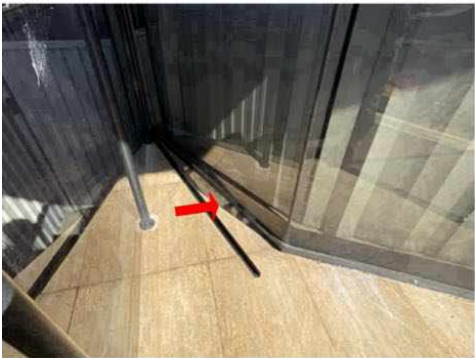
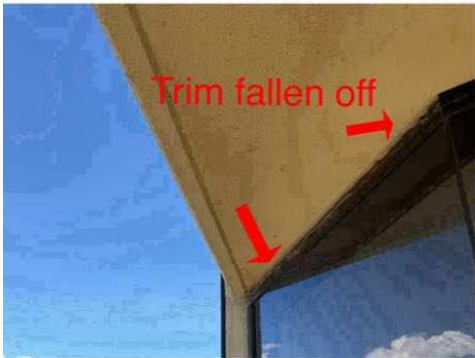
Finding 3.08

Building: Building 1
Location: Exterior walls & balconies
Finding: Sealant (external) - missing
Information: It was noted on inspection that numerous areas of external sealant was missing to many wall and balcony areas.

Flexible sealants should be applied to these affected areas to prevent any subsequent water damage that is occurring.

A sealant specialist or tiling contractor should be appointed to complete these works as soon as possible. Note - every area of render and concrete cracking is allowing rainwater ingress to damage these areas and all require sealing.

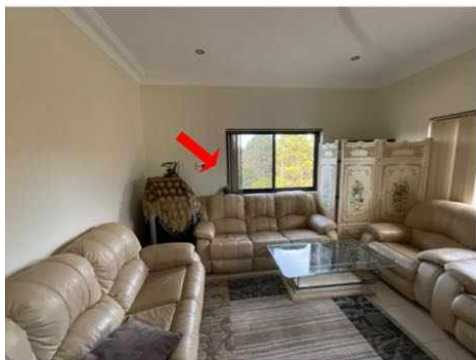
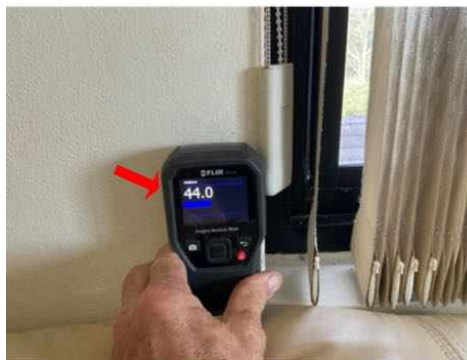
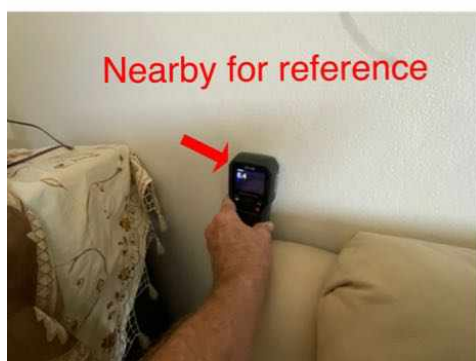
Finding 3.09

Building: Building 1
Location: Two bathrooms and rear left room
Finding: Excessive moisture and damaged wall elements
Information: Two bathroom door frames shows signs of excessive moisture and the main bathroom frame has progressed to wood rot. The rear left room also shows moisture evident.

Excessive moisture can damage walls as well as lead to the formation of mould and wood rot (see next defect).

Works to reseal or waterproofing the bathrooms may be required. A waterproofing expert should be consulted prior to purchase.

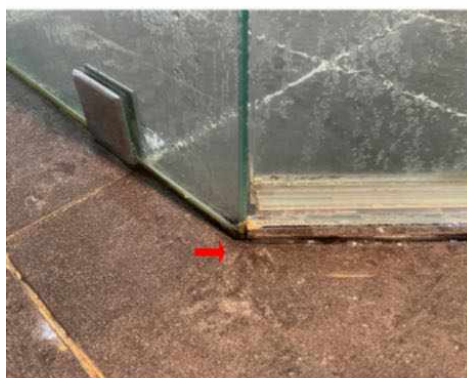
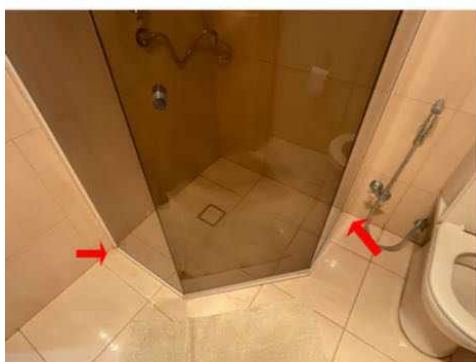
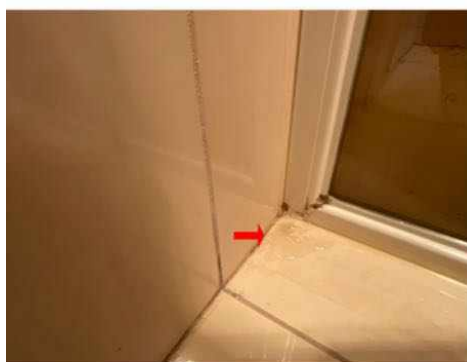
Finding 3.10

Building:	Building 1
Location:	Bathrooms
Finding:	Shower screens - Leaking
Information:	<p>Leaking was evident to two shower screens (one up and one downstairs) at the time of inspection. It is suspected that the leaking has occurred as a result missing sealant. Leaking from the showers , where left unattended, is likely to lead to water damage to adjoining flooring and walls. Such damage can lead to water damage and necessitate extensive remedial works being required. Active water leaks may also create an environment that is susceptible to the formation and development of mould.</p> <p>Appointment of a sealant expert is required to repair or replace this missing sealant. Such works should be performed as soon as possible to ensure that no further damage occurs. (see also areas of wood rot)</p>

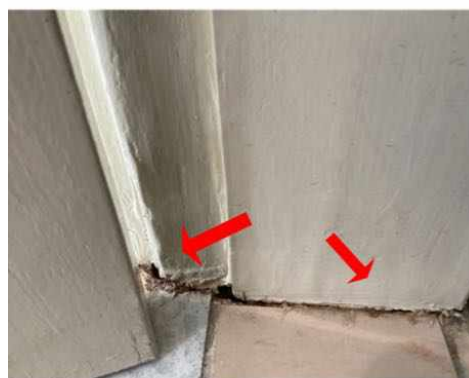
Finding 3.11

Building:	Building 1
Location:	Bathroom
Finding:	Efflorescence or calcification - Bathroom tiling
Information:	Efflorescence, characterised by white salt deposits visible at grout joints and tile surfaces, has been observed emerging from this bathroom tile bed. This condition typically indicates moisture migration through the tile system, drawing mineral salts from the underlying screed or adhesive bed to the surface.

The presence of efflorescence suggests the presence of excessive moisture beneath the tiles, potentially caused by:

A breach or failure of the waterproofing membrane,

Inadequate drainage to floor waste, resulting in water pooling.

Ongoing moisture below the tile bed can lead to the deterioration of adhesive bonds, tile debonding, and secondary water damage to the substrate or adjoining building elements.

Constant cleaning of the efflorescence will be required, if after a considerable amount of time and several cleaning attempts the efflorescence keeps returning a more intrusive inspection by a remedial builder is recommended.

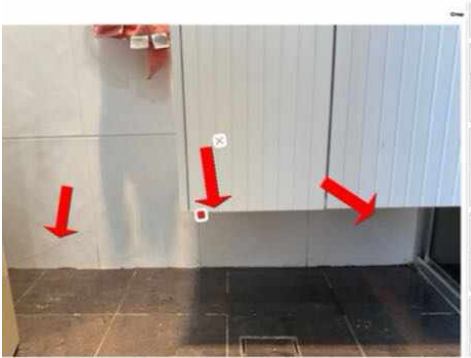
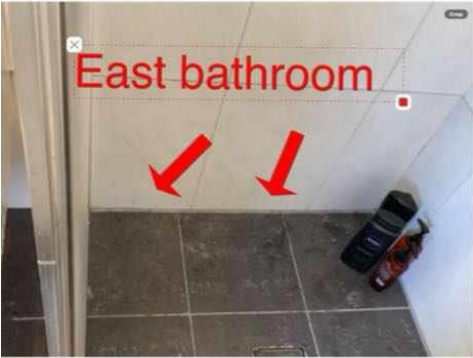
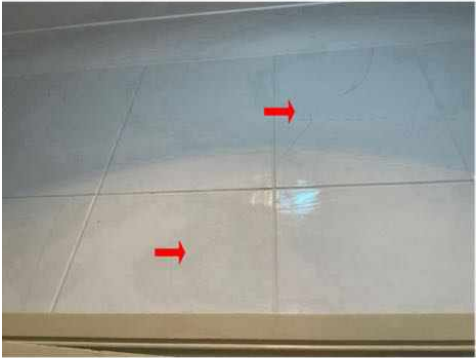
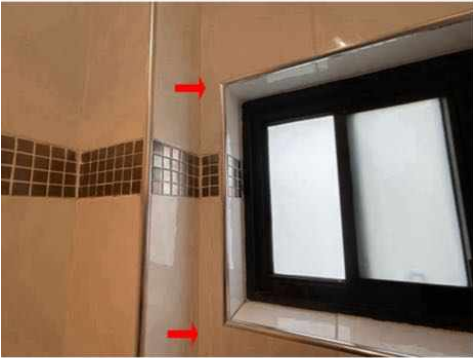
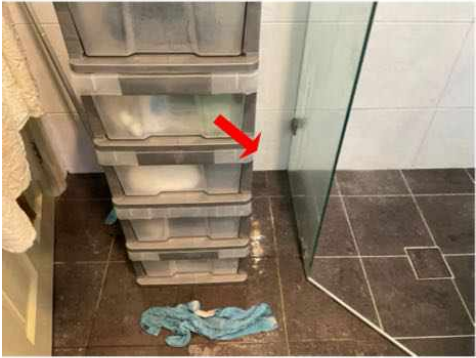
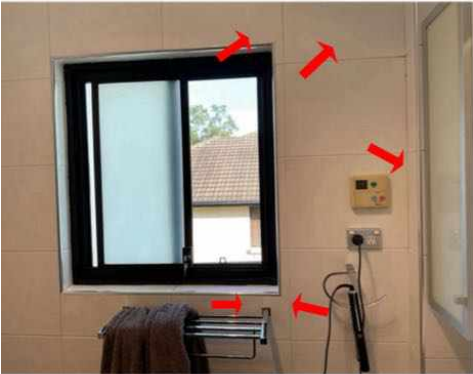
Building: Building 1
 Location: Bathrooms
 Finding: Tiles - Cracked or damaged
 Information: Cracking was evident to dozens of tiles in the wet areas at the time of inspection. These areas are frequently exposed to water, allowing potential for water penetration into adjoining sections of walls or flooring.

damage, which is likely necessitate repair work to affected building elements.

A tiling contractor should be appointed to ensure that no further water damage occurs. The re-application of silicone and grouting throughout remaining tile work is also advised, to further protect the area against water penetration.

Where water penetration has led to water damage, appointment of a relevant tradesperson may be required to repair damaged building elements.

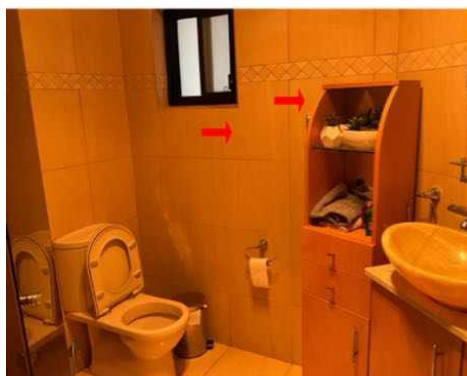
Finding 3.15

Building:	Building 1
Location:	Approx 6 areas of the property
Finding:	Tiles - Drummy
Information:	Drummy tiled areas were identified at the time of inspection. The term 'drummy' refers to tiles that have become detached from their fixing, despite otherwise being in relatively good condition. Such defects are generally caused by physical or moisture damage to the area. Drummy tiled areas may also be a direct result of poor workmanship during the construction process.

Tiled areas may swell and shrink with changes in air humidity if the area has sustained moisture damage. Any exposure to moisture is capable of causing tiled areas to become drummy and/or cracked over a prolonged period of time. Drummy tiled areas generally require removal and replacement of affected tiles, with adequate sealant and grouting.

Specialist trades are available for these types of services. A registered builder may be required to undertake works if damage is extensive or if secondary building defects have resulted. Otherwise, it is advised that a tiling contractor be appointed to perform works as necessary. Immediate action is recommended to ensure that no further damage is sustained in the affected area.

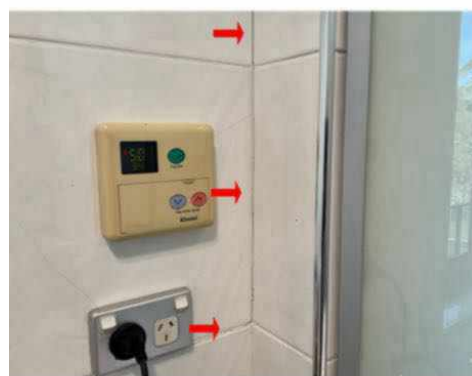
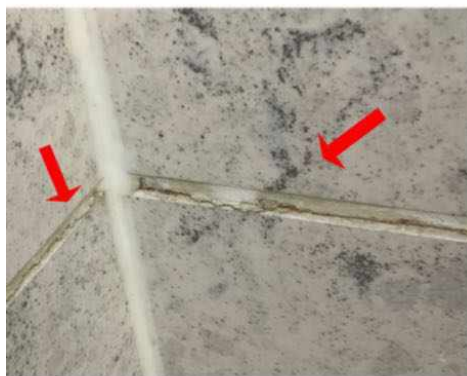
Finding 3.19

Building:	Building 1
Location:	Pictured areas
Finding:	Building elements - Damaged
Information:	Evidence of minor missing or damaged areas was identified at the time of the inspection. These include -

1. The main bathroom shower diverter does not work.
2. Many bathroom towel rails and shelves are loose or missing.
3. The front left bedroom shows a moisture damaged internal lower wall but no excessive moisture at the time of the inspection.

This is likely caused by the external damaged render.

A plumber and renderer would be the trades responsible for rectification of these areas when convenient.

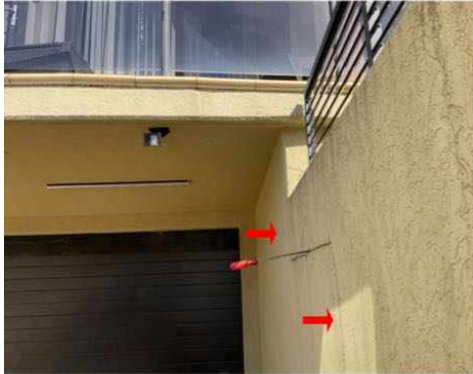
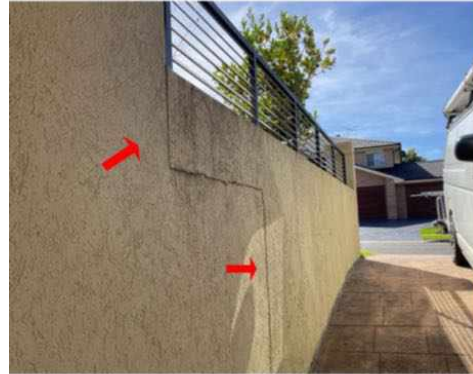
Finding 3.21

Building: Building 1
Location: Exterior driveway walls
Finding: Step cracking to brickwork (minor)
Information: Step cracking was identified to the brickwork in this area at the time of inspection. Step cracking, which is similar to other forms of cracking, has a variety of possible causes. However, the most common is the subsidence of adjacent footings.

Step cracking is a relatively common defect, and is most likely to occur adjacent to windows, doors and other openings. Mortar failure in the gaps between affected bricks indicates the stresses and tensions affecting the wall.

Where step cracking is extensive or severe, the client is advised to consult a structural engineer. This minor step cracking can be used as a warning sign to address factors causing stress to the wall, which can include the effect of surrounding trees, water leaks, soil erosion, or even the presence of reactive soils in the surrounding area.

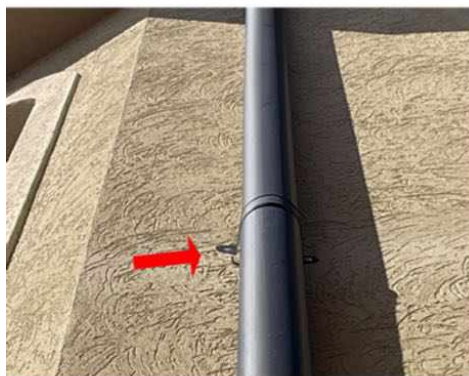
Finding 3.22

Building:	Building 1
Location:	Exterior walls - both sides
Finding:	Additional fixings to downpipe
Information:	Evidence of insufficient fixings were evident to most down pipe. This downpipes need additional fixings to affix to the adjoining wall ensure its longevity.

A carpenter, plumber or handy person should add additional fixings to this area as soon as possible to limit potential damage.

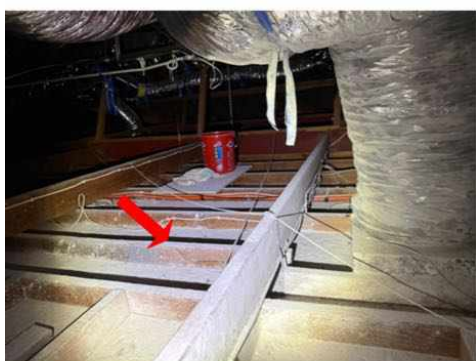
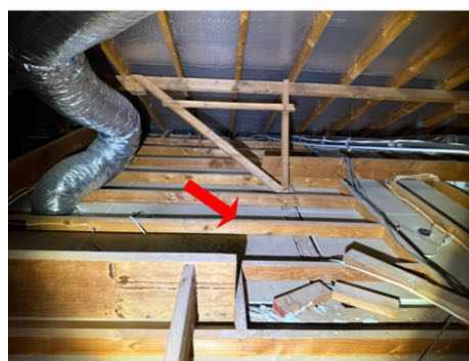
Building: Building 1
 Location: All Roof cavity areas
 Finding: Insulation - Missing
 Information: Upon inspection of the roof void it was noted that insulation is not present.

Insufficient insulation will result in a comparatively higher cost to heat and cool a property as there is a lack of Insulation (or uneven coverage of insulation) which works as a barrier to heat transfer. This helps to keep out unwanted heat in summer and preserves warmth inside your home in winter. It can also help soundproof your home from unwanted airborne noise transfer.

Where insulation is absent, the area does not meet current Australian Standards. Installation of adequate insulation is required and should be conducted as soon as possible.

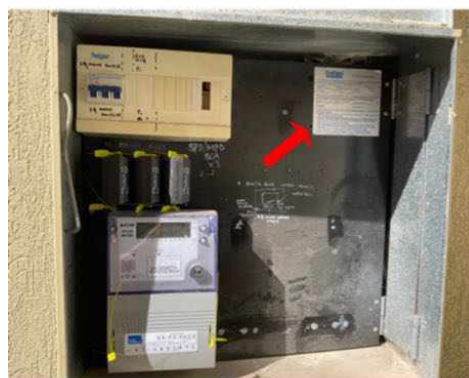
Building: Building 1
 Location: Meter Box
 Finding: Termite Management System - no evidence of a chemical installation
 Information: The application of a post-construction chemical termite barrier is highly recommended for all properties. Such barriers are highly effective in preventing termite attack on any timber building elements throughout the property.

A durable notice should be placed in the switchboard unit to indicate current termite barriers. At the time of inspection, the durable notice was evident and it appeared as though a physical but no chemical termite management system has been installed, with no evidence to suggest preventative works taking place since the property was built.

The client may consider gaining further advice from a pest controller as to the costs and procedures involved with a 'chemical' application. It is recommended that obtaining such advice be a short-term priority.

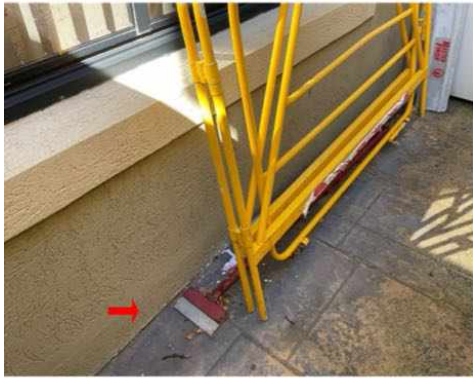
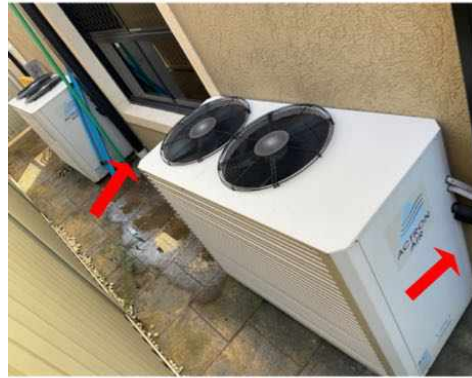
Finding 6.02

Building:	Building 1
Location:	Exterior walls - right side
Finding:	Bridging or breaching of termite barrier
Information:	The concrete around the property appears to bridge the termite barrier. The AC units also block inspection of the barrier.

Bridging is the spanning of a termite barrier or inspection zone so that subterranean termites are provided with passage over or around that barrier.

Breaching is the making of a hole or gap in a termite barrier so that termites are provided with a passage through that barrier.

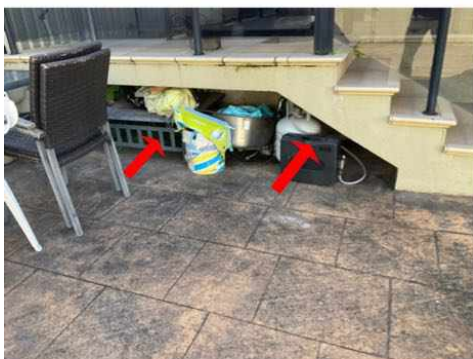
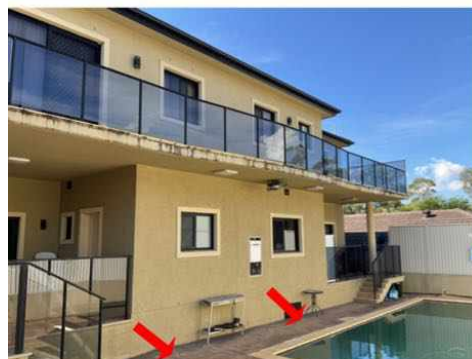
Finding 6.03

Building:	Building 1
Location:	Exterior walls
Finding:	Slab Edge - Exposure
Information:	An inspection zone of at least 75mm in relation to the exposed slab edge, between the bottom brick and the perimeter pavement, is required. This inspection zone should be maintained in order to force termites into the open where they can be detected more readily during regular inspections. The slab edge should not be concealed by anything that may prevent inspection of the area, including render, landscaping, soil, turf, paving, concrete cladding or other structures.

If the slab edge is not properly exposed there is a high risk of termite attack. Sometimes, in order to determine the type of slab, a suitably qualified person such as an architect or builder may be required to consult the construction plans.

Where the slab edge cannot be properly inspected, it is highly recommended that termite or timber pest inspections be carried out every 6-12 months to aid protection of the property against infestation.

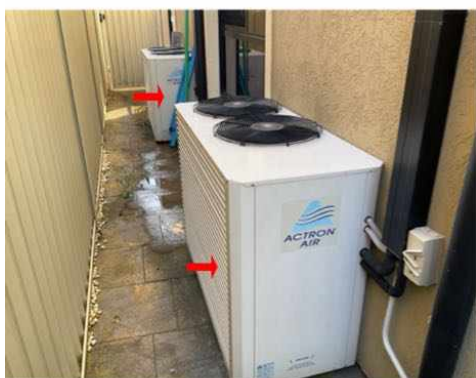
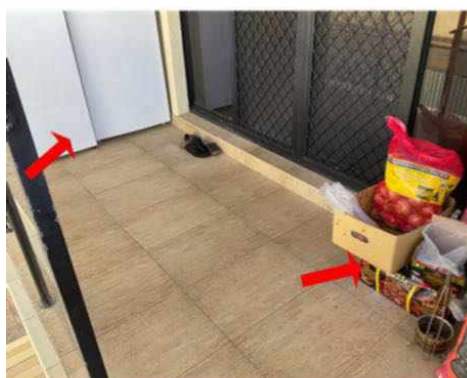
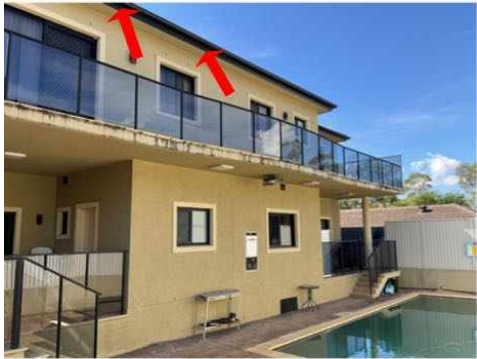
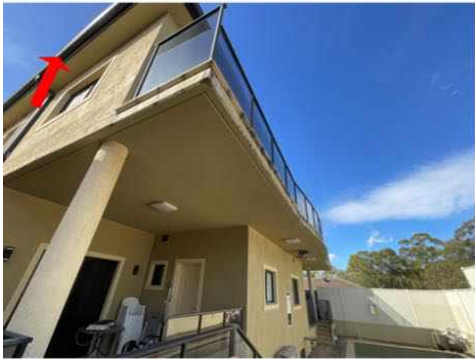
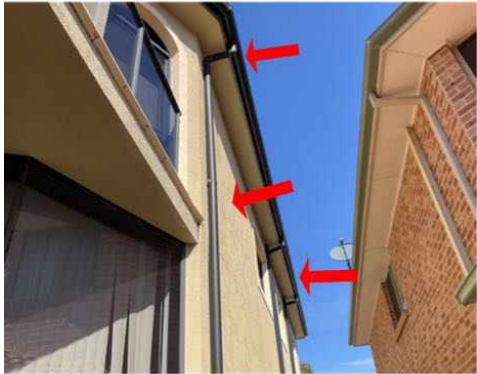
Building: Building 1
 Location: All External Areas
 Finding: Additional Photos - Obstructions and Limitations of EXTERNAL AREAS
 Information: These photographs are an indication of the obstructions and limitations which impeded full inspection of external areas at the time of inspection. These obstructions can hide an array of defects and should be removed to allow full inspection to be carried out. A re-inspection is recommended once the areas are made accessible.

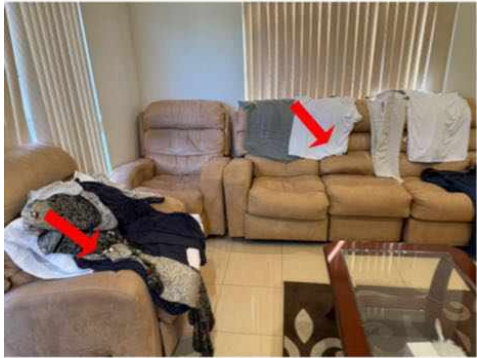
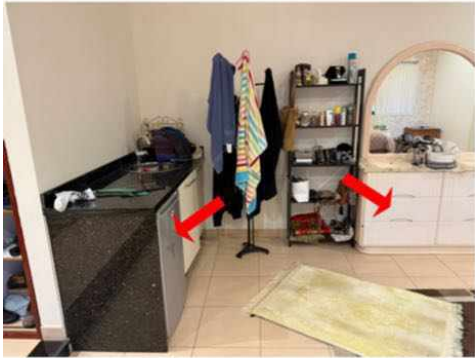
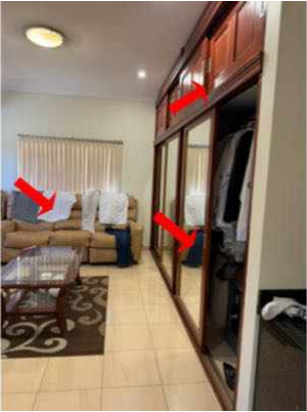
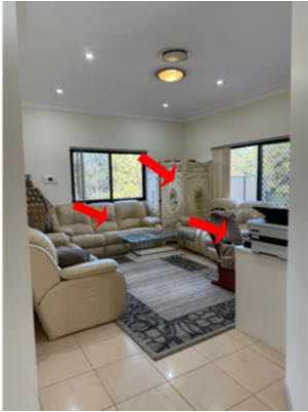
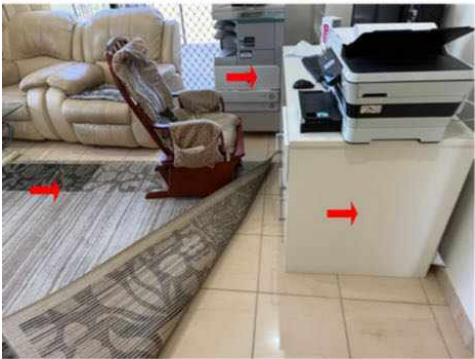
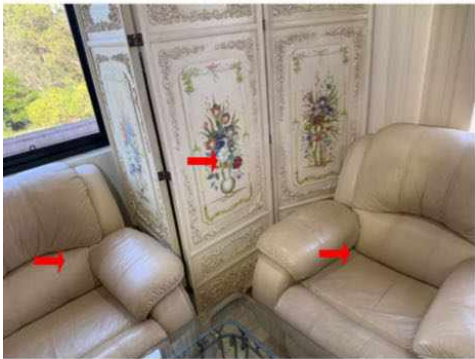
Building: Building 1
Location: All Internal Areas
Finding: Additional Photos - Obstructions and Limitations of INTERNAL AREAS
Information: These photographs are an indication of the obstructions and limitations which impeded full inspection of Internal areas at the time of inspection. These obstructions can hide an array of defects and should be removed to allow full inspection to be carried out. A re-inspection is recommended once the areas are made accessible.

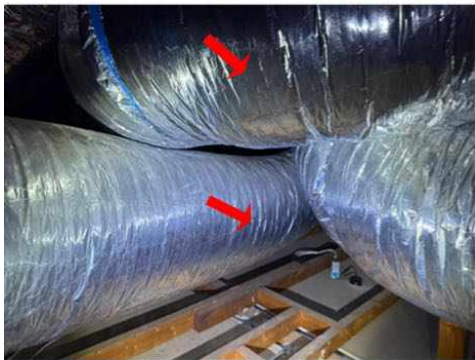
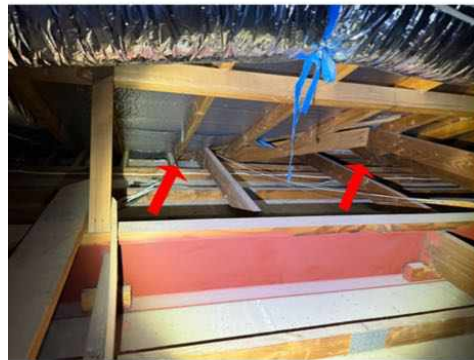
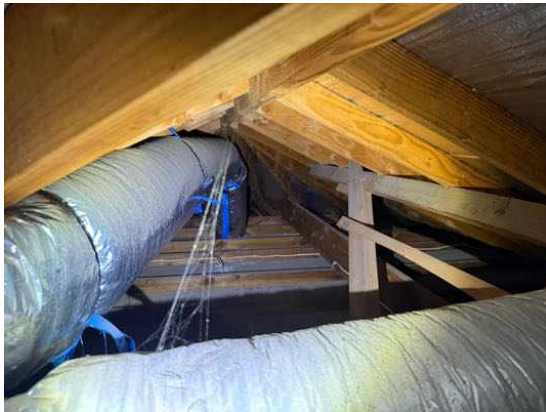
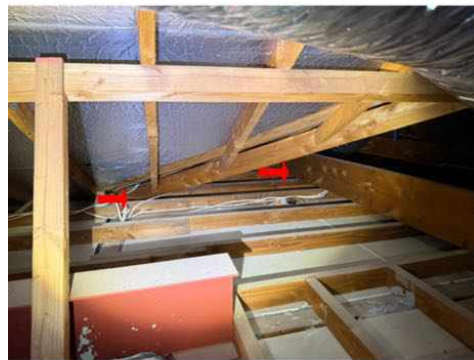
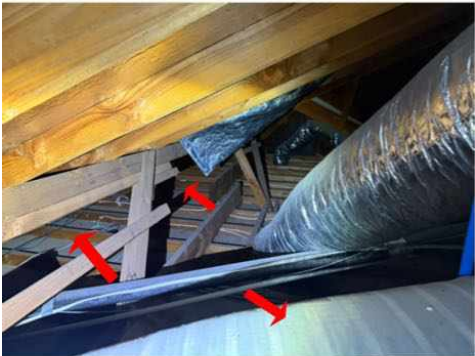
Building: Building 1
Location: All Roof cavity areas
Finding: Additional Photos - Obstructions and Limitations of the ROOF CAVITY
Information: These photographs are an indication of the obstructions and limitations which impeded full inspection of roof cavity areas at the time of inspection. These obstructions can hide an array of defects and should be removed to allow full inspection to be carried out if applicable. A re-inspection is recommended once the areas are made accessible.

The inspection was also limited to areas with an allowable crawl space of 600mm x 600mm, in particular towards the external walls where the roof line diminishes, these areas were not accessible.

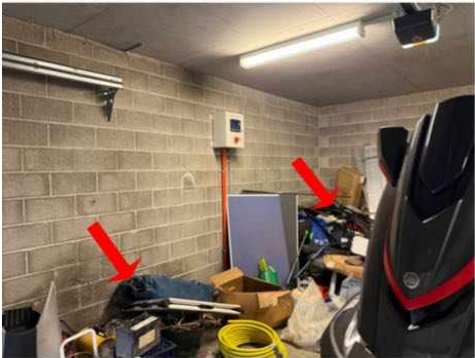
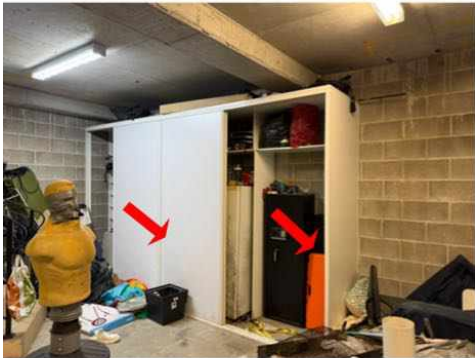
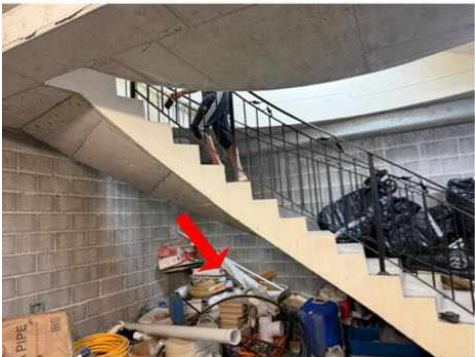
Building: Building 1
Location: All Subfloor Areas
Finding: Additional Photos - Obstructions and Limitations of GARAGE AREAS
Information: These photographs are an indication of the obstructions and limitations which impeded full inspection of subfloor areas at the time of inspection. These obstructions can hide an array of defects and should be removed to allow full inspection to be carried out. A re-inspection is recommended once the areas are made accessible.

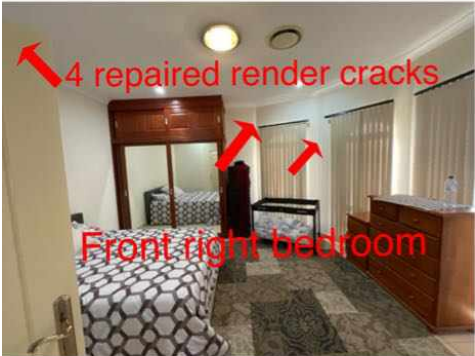
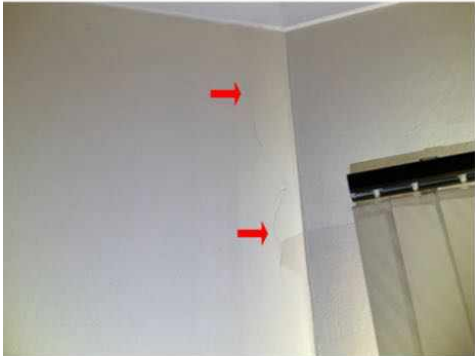
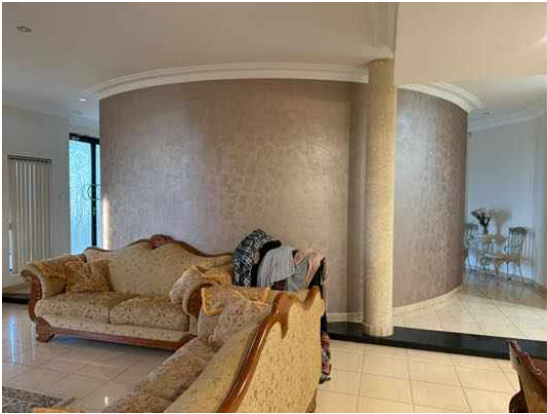
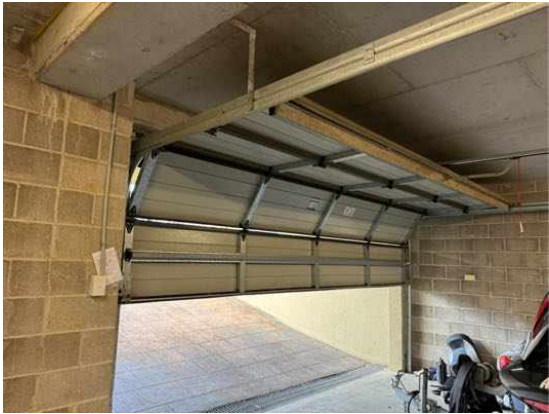
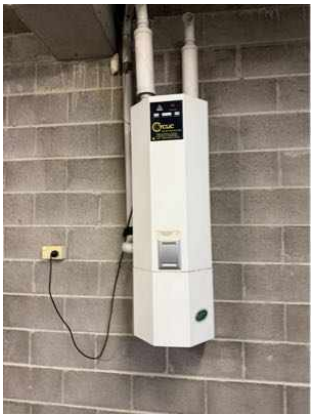
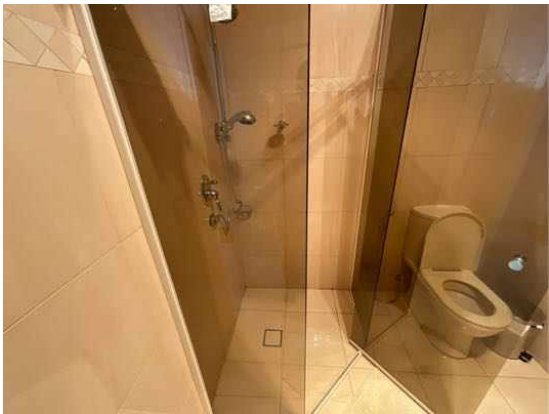
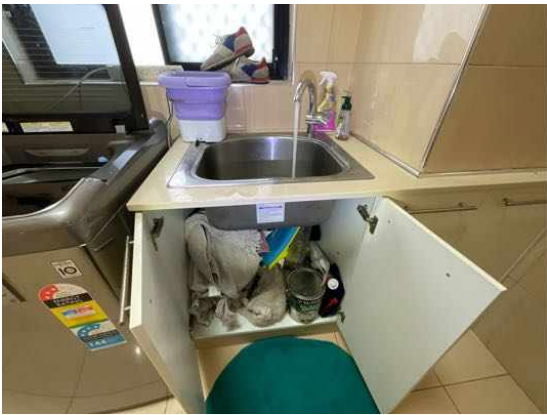
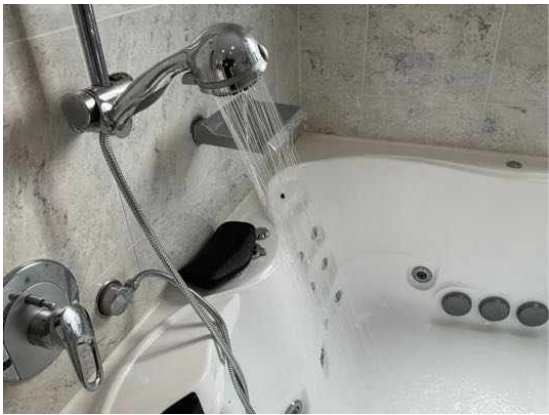
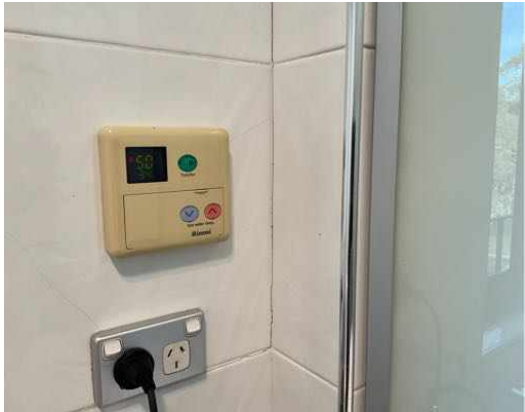
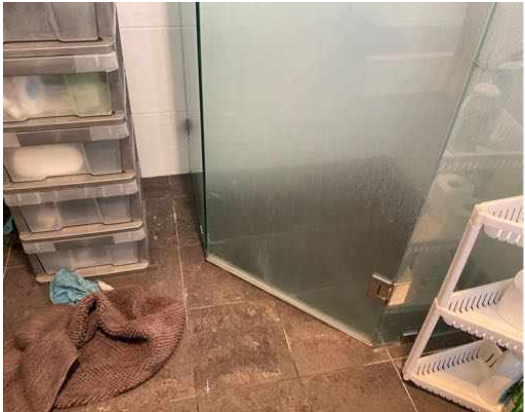
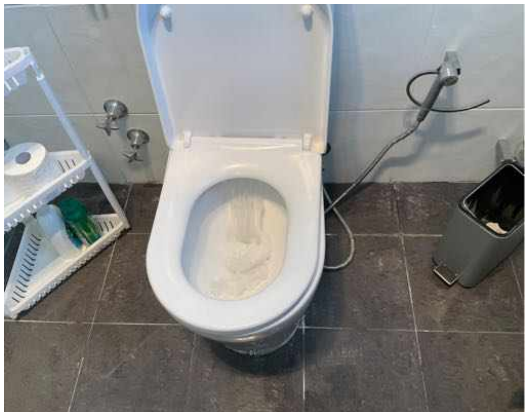
Building: Building 1
Location: All Internal Areas
Finding: Additional Photos
Information: Additional photos are provided for your general reference
