Building and Timber Pest Inspection Report

Inspection Date: Wed, 8 Apr 2026

Property Address: 75 Boronia Dr, Voyager Point NSW 2172,
Australia

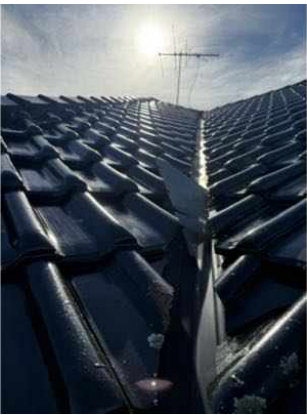
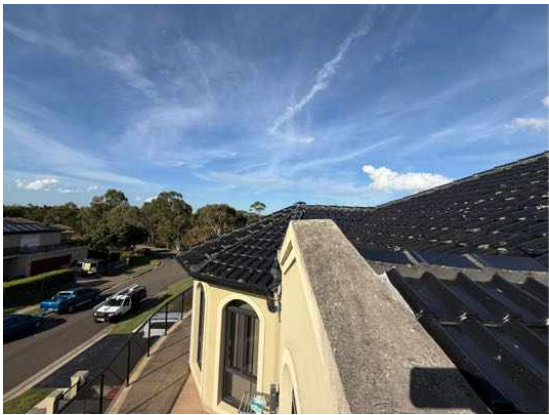
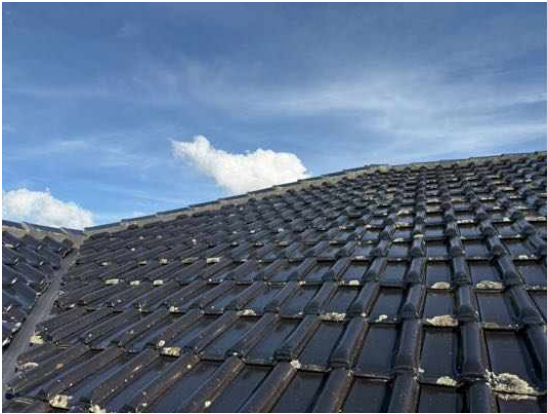
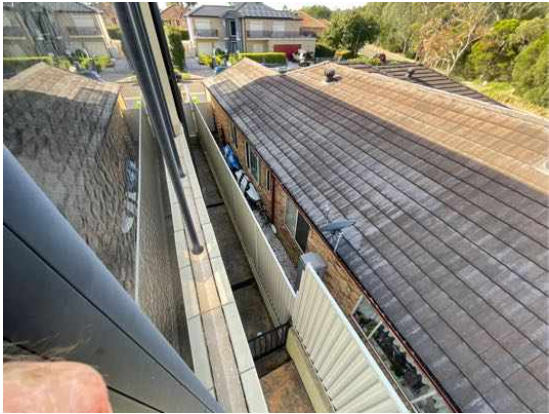
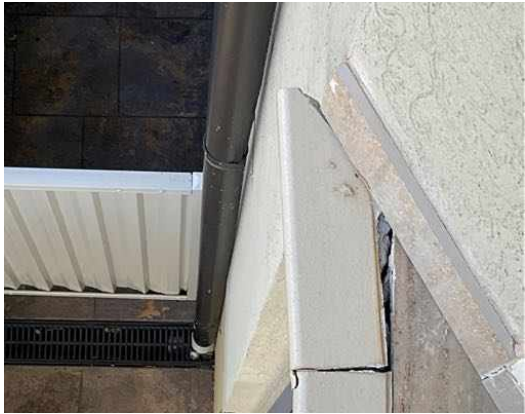
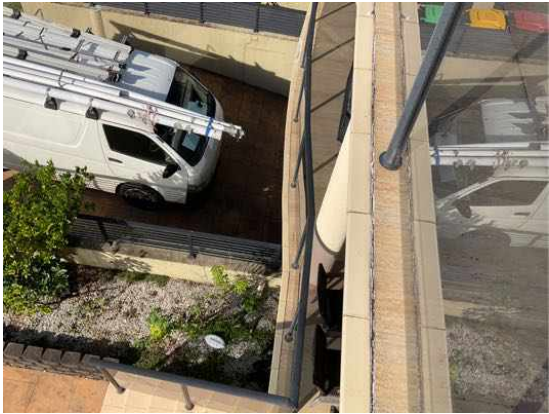
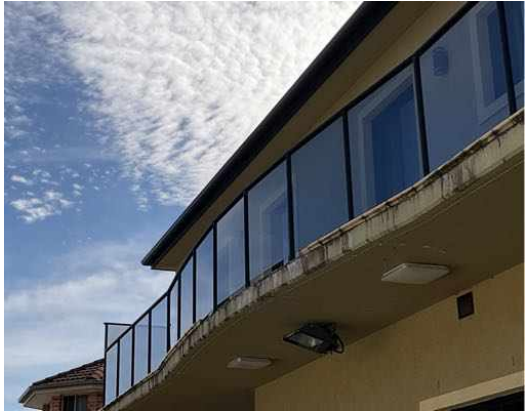
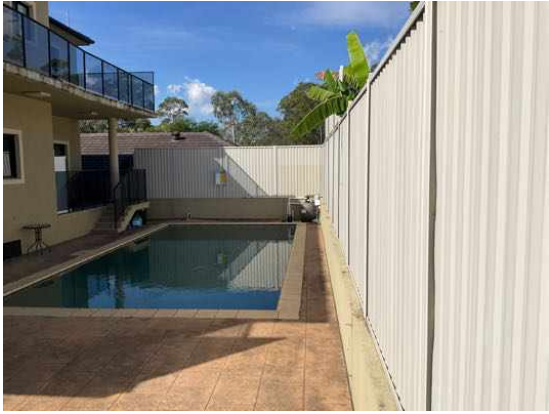
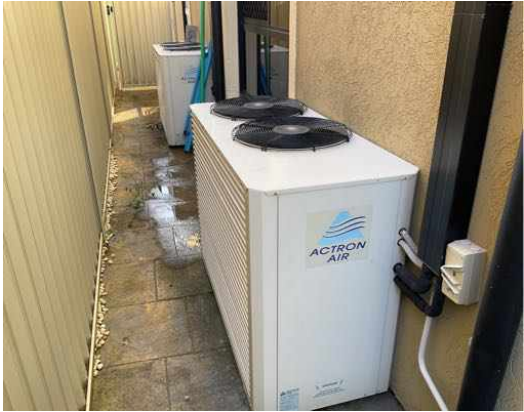
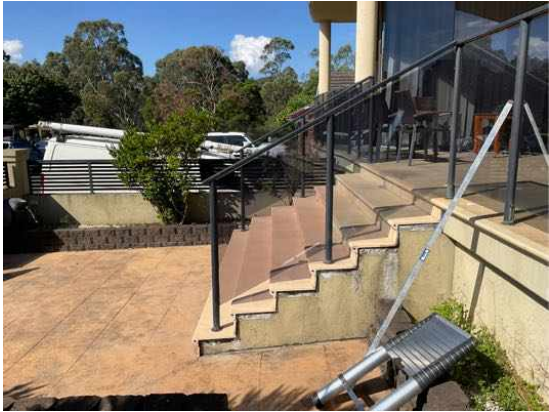
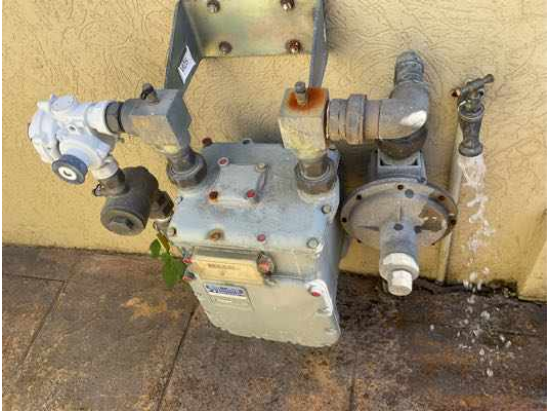
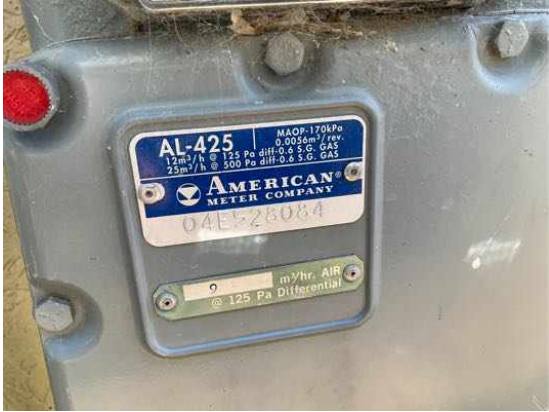
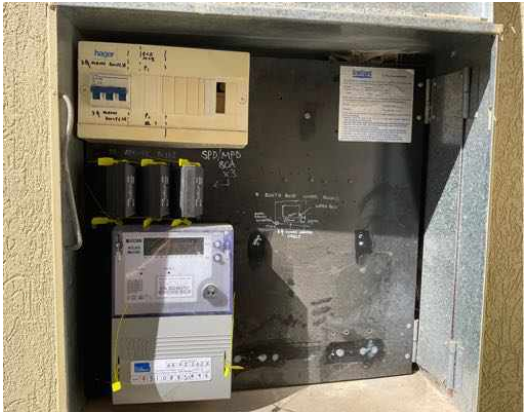
Building: Building 1
Location: All External Areas
Finding: Additional Photos
Information: Additional photos are provided for your general reference
