Building Inspection Report

Inspection Date: Mon, 16 Mar 2026

Property Address: Unit 60, 151-153 Mudjimba Beach Rd,
Mudjimba QLD 4564, Australia

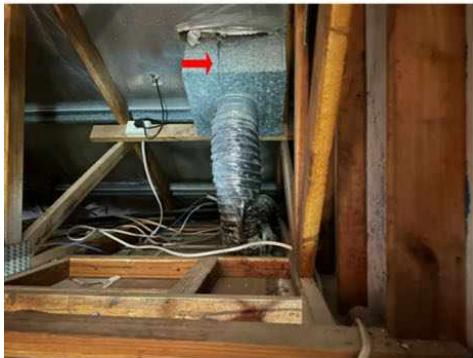
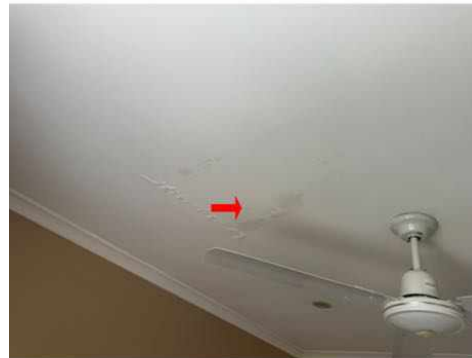
Defects 2.01

Building: Main Building
Location: Upstairs Bedroom
Finding: Ceiling - Water damaged
Information: Water damage to the ceiling lining is generally an indication of excessive moisture being present in the roof void, usually via a leak to the roof covering.

Where water damage is evident to the ceiling, the primary requirement is to identify and rectify the source of the leak. A roofing contractor should be appointed as soon as possible to identify the leak and perform rectification works as necessary, ensuring the water damage is restricted.

Once the leak is repaired, consultation with relevant tradespeople, including plasterers and painters, is advised. Rectification works may include replacement of ceiling lining or minor repainting, depending on the extent of the damage.

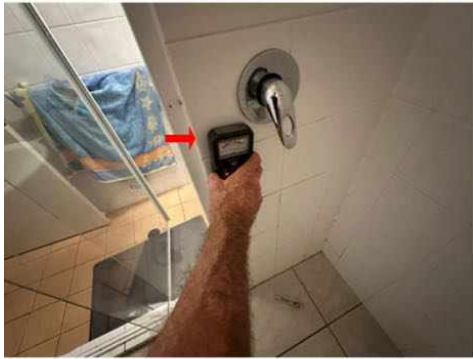
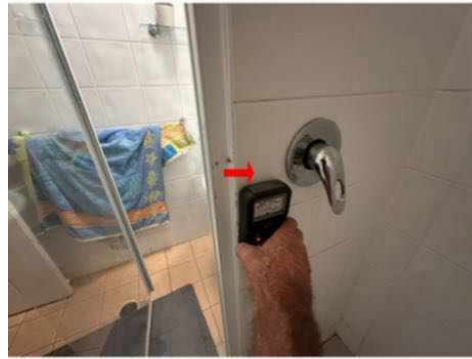
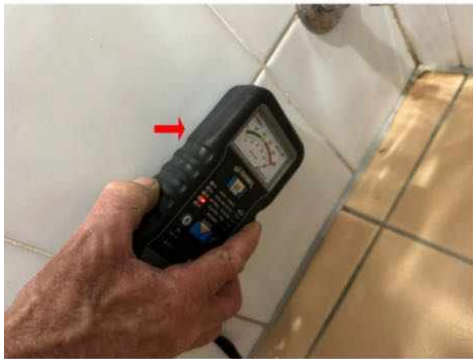
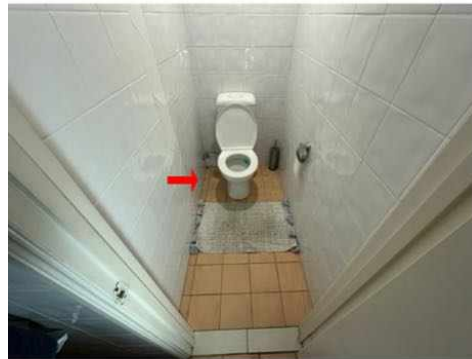
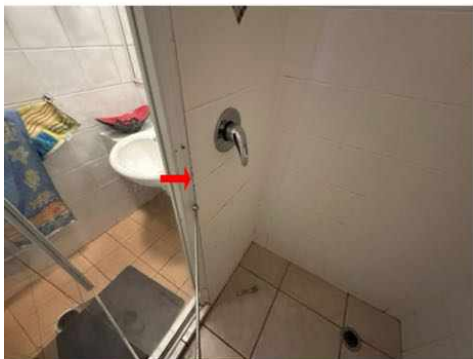
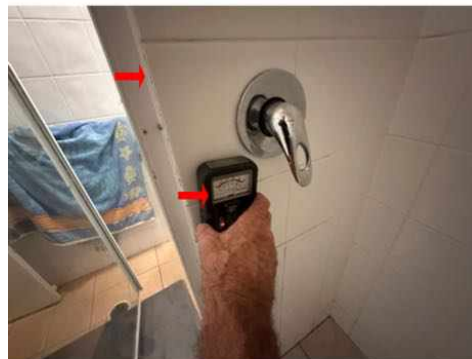
Defects 2.02

Building:	Main Building
Location:	Downstairs Bathroom
Finding:	Evidence of excessive moisture was present at the time of inspection
Information:	Excessive moisture is generally caused by deteriorated inadequate or leaking plumbing pipes, Deteriorated silicone and grout or failing water proofing membrane to wet areas.

There was high moisture to all areas of the downstairs shower recess, including around the mixer both adjacent walls including the lower section of the toilet wall.

It is highly recommended that all plumbing and drainage fixtures and fittings, Silicone and grouts be maintained regularly in order to prevent excessive moisture being present in the internal areas of the property.

Recommend a plumber be engaged to check shower recess mixer for leaking and also recommend a builder or be engaged to further investigate

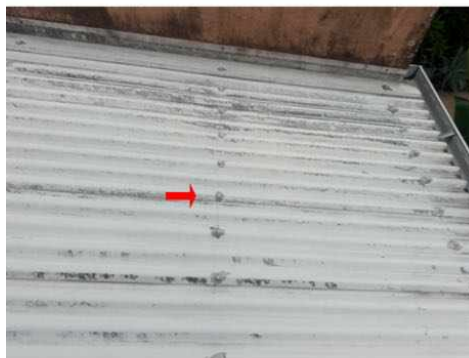
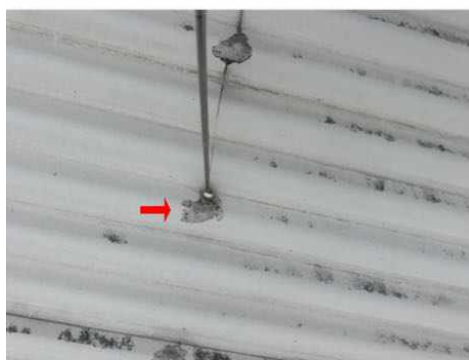
Defects 2.03

Building: Main Building
Location: Roof Exterior
Finding: Roof screws - Excessive silicone work
Information: The silicone repair work performed to the roofing screws is excessive and should not be necessary if the roof screws were correctly installed.

Recommend a roofing contractor be engaged to further investigate .

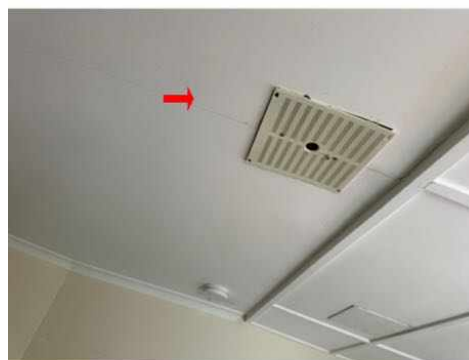
Defects 3.01

Building:	Main Building
Location:	Downstairs Living Room
Finding:	Cracking - Damage Category 1 - Fine (up to 1mm)
Information:	Although fine cracks are quite noticeable, they are often only considered to be an appearance defect, and usually do not indicate any structural damage. Generally, the cause of a fine crack is indicative of a separation between building materials and finishes (e.g. paint, plaster, etc.) along joints.

Cracking of this nature can generally be repaired with minor sanding, filling and/or repainting. Such works should be performed by a qualified painter or a general handyman.

Monitoring of all cracking should be conducted frequently. Always contact a building inspector should cracks widen, lengthen, or become more numerous.

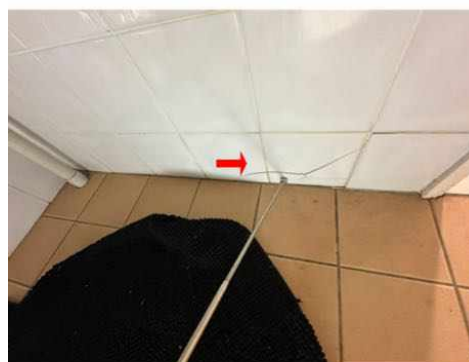
Defects 3.02

Building:	Main Building
Location:	Downstairs Bathroom
Finding:	Tiles - Cracked
Information:	Cracking was evident to the tiling in this bathroom at the time of inspection. While the cracking appears to be minor, this area is frequently exposed to water, allowing potential for water penetration into adjoining sections of walls or flooring.

If left unmanaged, water penetration to these areas may lead to subsequent water damage, which is likely necessitate repair work to affected building elements.

A tiling contractor should be appointed to ensure that no further water damage occurs. The re-application of silicone and grouting throughout remaining tile work is also advised, to further protect the area against water penetration.

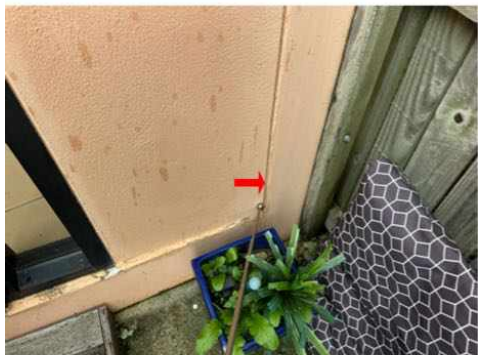
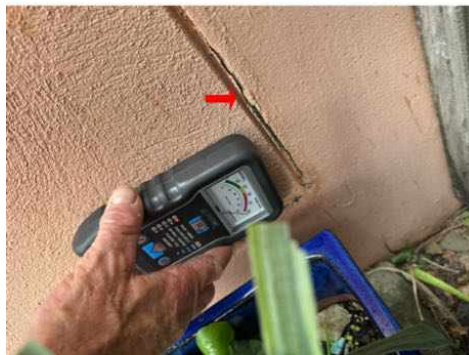
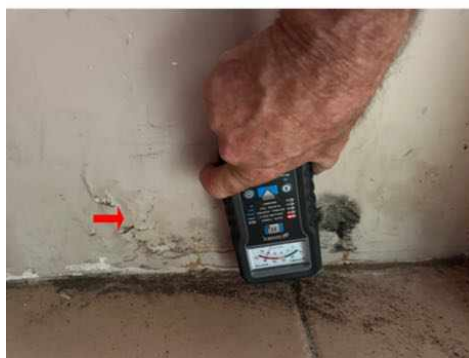
Defects 3.03

Building:	Main Building
Location:	Storage area wall under Stairs
Finding:	Evidence of excessive moisture and mould was present at the time of inspection
Information:	There was excessive moisture and mould to the external wall under the stair landing cupboard, there is also evidence of cracking between the block work and render in

this area to the external wall.

Recommend a carpenter or experienced handyman be engaged to reseal this joint between the external render and block work to this wall.

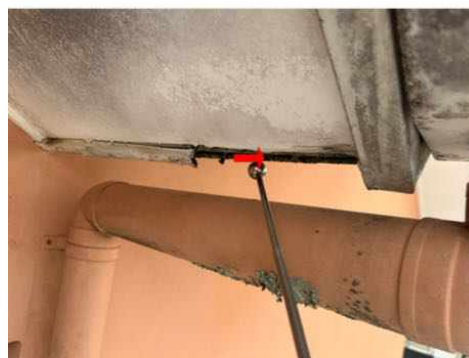
Defects 3.04

Finding: Wood Rot

Information: These timber eaves mouldings shows evidence of wood rot. Wood rot, also known as Fungal Decay, occurs when timbers and other cellulose building materials are exposed to damp conditions on an ongoing basis. This will be the result of exposure to weathering over a prolonged period of time. Early intervention and regular maintenance, particularly of exterior timbers, will prolong the useful life of these mouldings . A qualified carpenter or handyman may also be required to replace affected eave mouldings at owners discretion

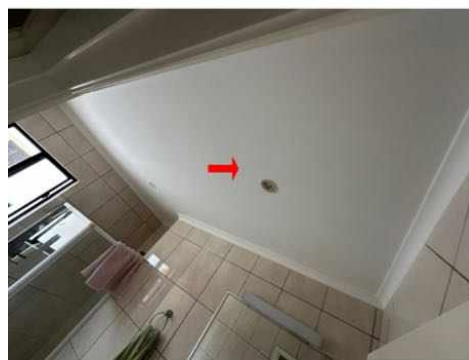
Defects 3.05

Building:	Main Building
Location:	Upstairs Bathroom
Finding:	Exhaust fan - Missing
Information:	An exhaust fan has not been installed in this bathroom . Missing exhaust fans may lead to the development of more significant defects such as moisture damage to surrounding ceilings and walls from inadequate ventilation. Inadequate ventilation in internal areas creates an environment that is conducive to the formation and development of mould and other respiratory hazards. It is highly advised that a licensed electrician be appointed to retrospectively install an exhaust fan. Failure to perform works to aid the ventilation of the area may lead to the development of these secondary defects.

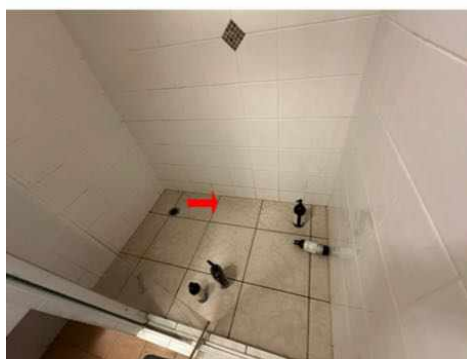
Defects 3.06

Building:	Main Building
Location:	Downstairs Bathroom
Finding:	Silicone and grout - mouldy
Information:	Silicone and grout is mouldy in this shower recess . Silicone and grout is used to protect gaps and crevices in building materials to ensure that they are water-tight and prevent water penetration to the associated structures.

Where silicone and grout is mouldy , a tiling contractor should be appointed immediately to re-apply any silicone and grout where necessary. Failure to do so is likely to lead to water damage to the surrounding area.

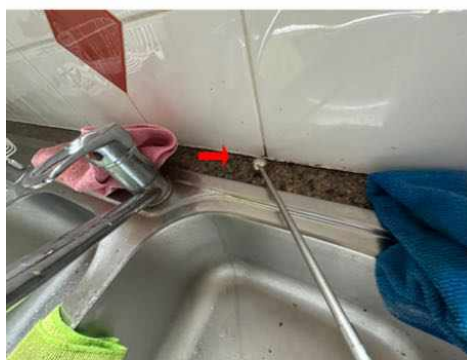
Defects 3.07

Building: Main Building
 Location: Downstairs Kitchen
 Finding: Silicone - missing
 Information: Silicone is missing in this kitchen splash back . Silicone is used to protect gaps and crevices in building materials to ensure that they are water-tight and prevent water penetration to the associated walls.

Where silicone is missing , a tiling contractor should be appointed immediately to re-apply any silicone where necessary. Failure to do so is likely to lead to water damage to the surrounding area.

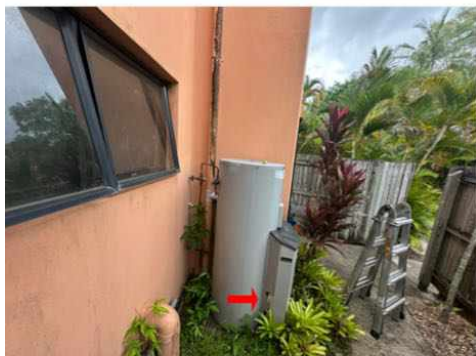
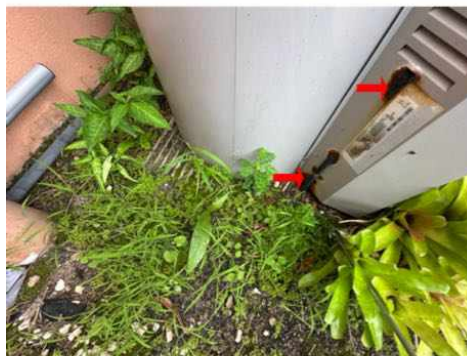
Defects 3.08

Building: Main Building
 Location: Exterior walls - left side
 Finding: Hot water unit - Rusted
 Information: The external hot water unit shows evidence of rust and general deterioration. This rust

is likely to have developed due to minor leaks in the unit. Such damage is expected of a building element of this age and with this level of exposure to excessive moisture.

While the hot water unit is still fully operational, any leaks should be identified and rectified by a licensed plumber as soon as possible. Prevention of further deterioration will delay the need for replacement of the unit in the near future.

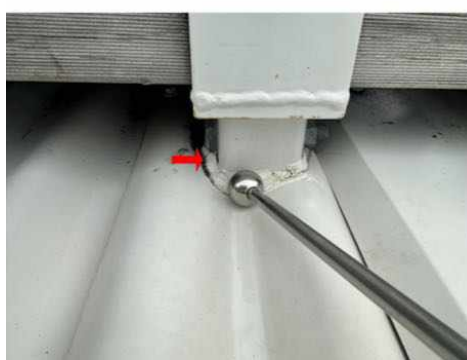
Defects 3.09

Building:	Main Building
Location:	Roof Exterior
Finding:	Deck tites missing
Information:	There were no deck tites on the steel posts holding up the deck above the lower downstairs roof, these posts were relying on silicon to seal between the post and the roof sheets, there is evidence of deterioration and cracking of the silicon which can allow water to enter the lower roof void, recommend a roofing contractor being engaged to fit deck tites around these steel posts.

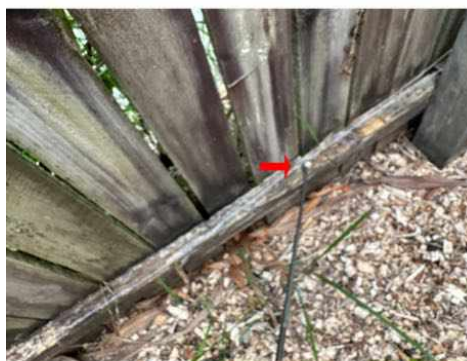
Defects 3.10

Building:	Yard
Location:	Yard - Side
Finding:	Fencing - Deteriorated

Information: It was noted at the time of inspection that sections of the fencing throughout the property have deteriorated. Typically fencing deteriorates due to age and rot which is generally expected for a structure of this age, due to prolonged exposure to weather conditions. Sometimes inadequate installation or maintenance can be to blame.

If left unattended, it is likely that further damage will occur. It is suspected that repair of several elements of the fencing may be required however replacement may be a consideration of the client also.

A licensed fencing contractor should be appointed to provide further advice and perform rectification works as necessary.

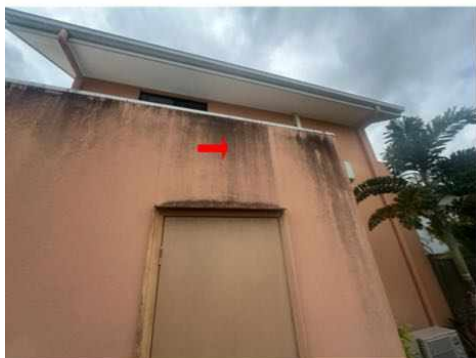
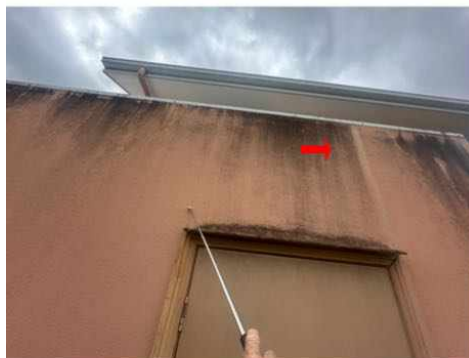
Defects 3.11

Information: Generally, the client is advised to ensure that the general environment is free of moisture to aid in the prevention of mould formation and development. Any mould found during the inspection should be cleaned immediately by a cleaning contractor or the homeowner as applicable.

Please note that severely affected building elements may require replacement by a registered builder or qualified carpenter.

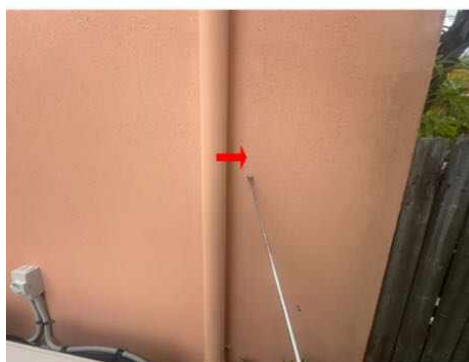
Defects 3.12

Building:	Main Building
Location:	Exterior walls - front and back
Finding:	Cracks to external render
Information:	It has been observed that cracking to internal rendered surfaces has occurred. The degree of damage falls within Category 2, described as noticeable cracks which are easily filled. Cracking of this size are generally less than 5mm in width.

Category 2 damage is required to be monitored for a period of 12 months. After the monitoring period, a crack rated at Category 2 or above is considered a defect requiring rectification.

Always contact your building inspector should cracks widen, lengthen, or become more numerous.

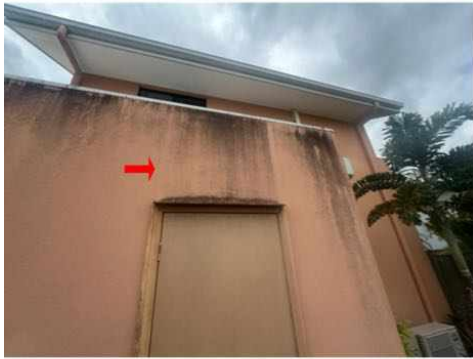
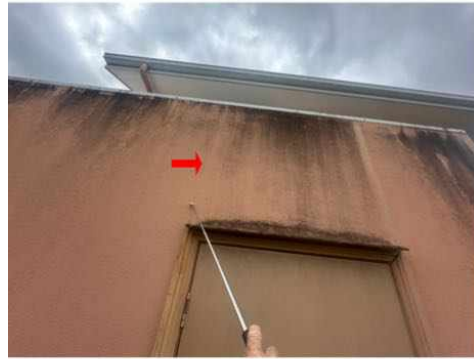
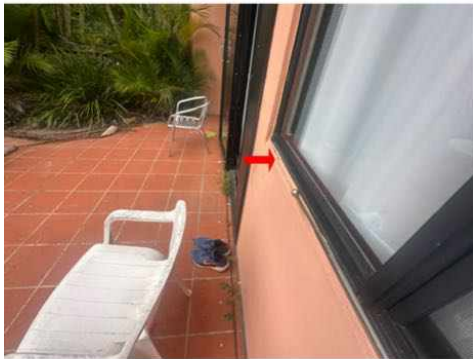
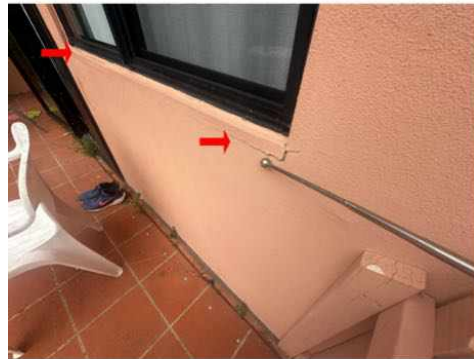
Defects 3.13

Building:	Main Building
Location:	Eaves
Finding:	Eaves - damaged and evidence of wood rot to timber framing
Information:	There was a large hole to the eve sheets below the box gutter to the front of the unit, there is also evidence of wood rot to the timber framing inside this area, recommend a carpenter being engaged to repair any Woodrow and replace this eve sheet, then recommend a painter be engaged to repaint the area

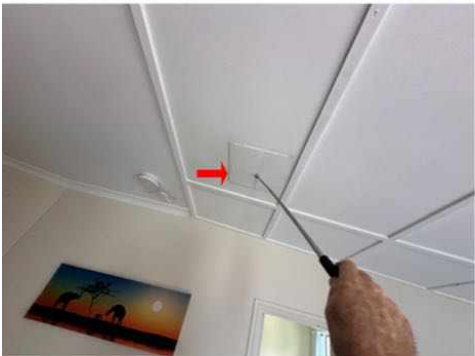
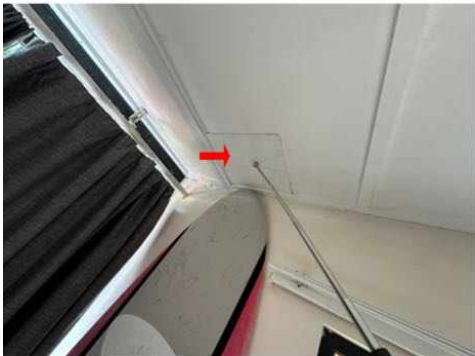
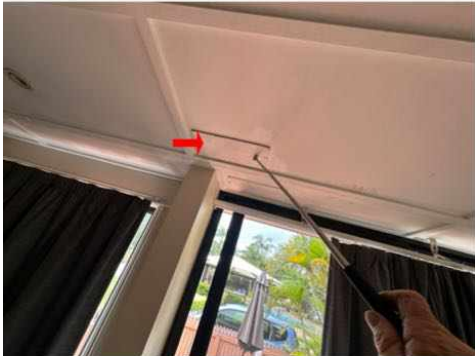
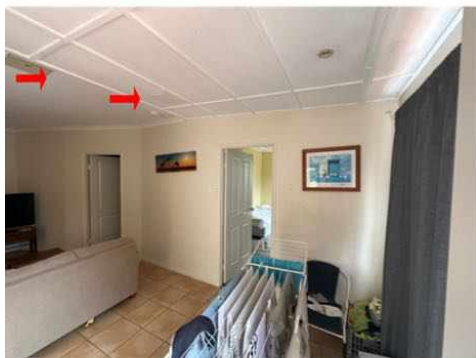
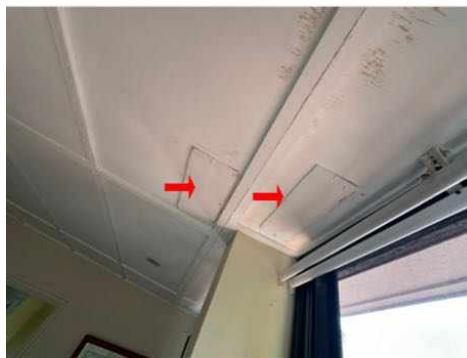
Noted Item

Building: Main Building
Location: Downstairs Living Room
Finding: Ceilings - inspection holes and vents
Information: There were evidence of several areas in the downstairs ceiling living area where they have been inspection outlets cut in the ceilings , this would indicate that there have been leaks in this ceiling in the past.

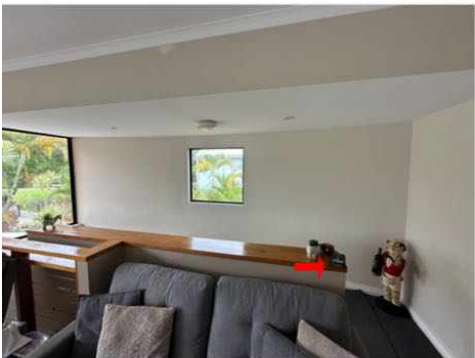
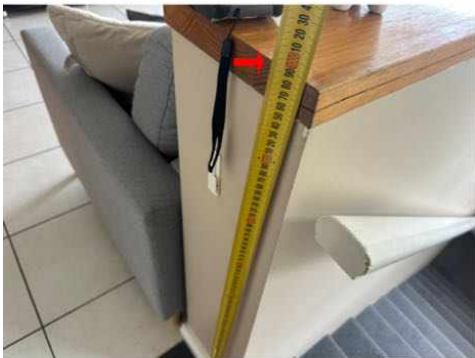
Noted Item

Building:	Main Building
Location:	Stair Landing
Finding:	Balustrade - Suspected Non-Compliance
Information:	The top rail to this stair landing balustrade is less than the regulated height of 1 meter of the floor .

This defect creates a potential safety hazard and should be rectified as soon as possible to ensure the safety of the area and to meet present building standards and regulations.

A registered builder should be contacted to discuss possible rectification solutions.

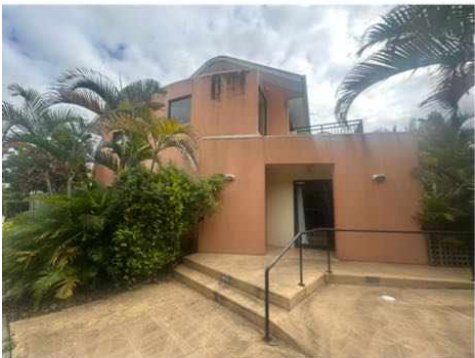
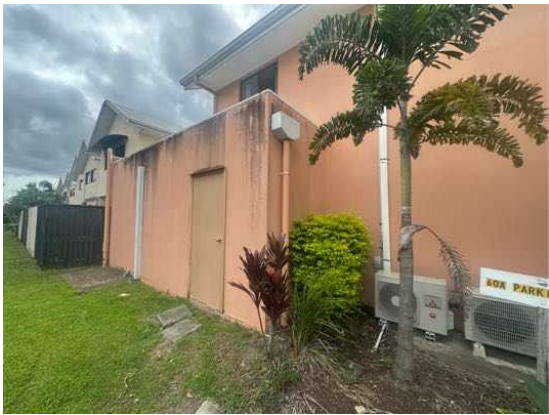
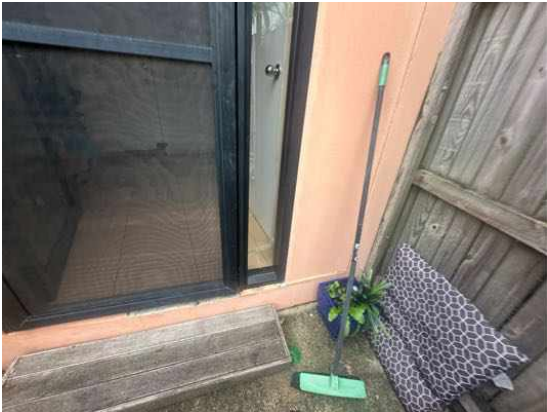
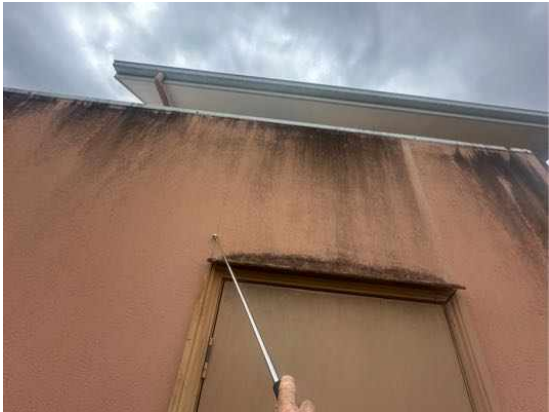
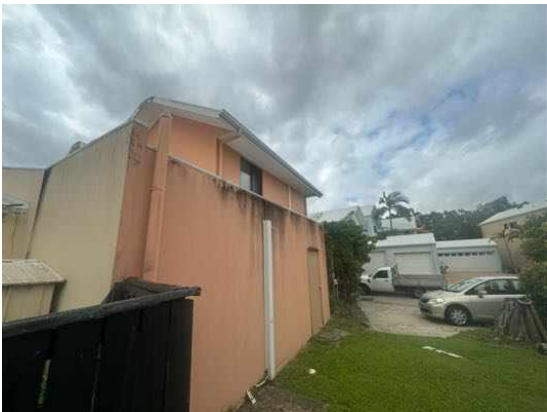
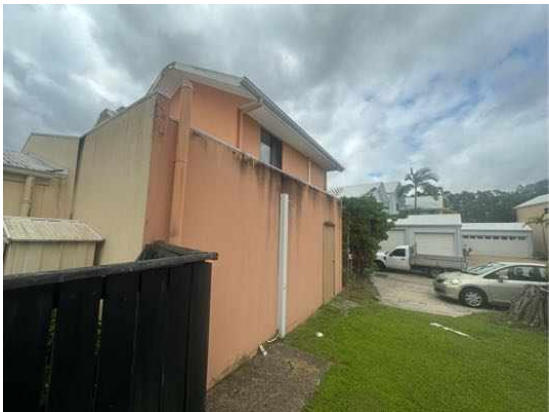
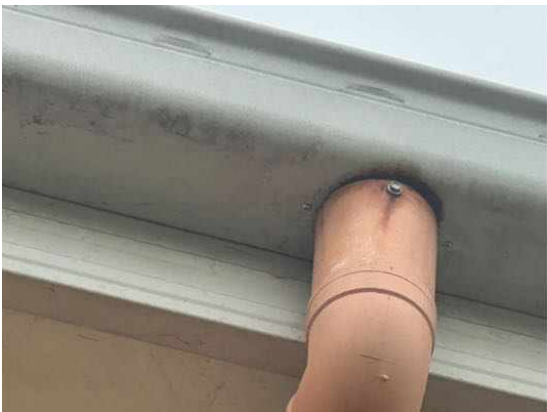
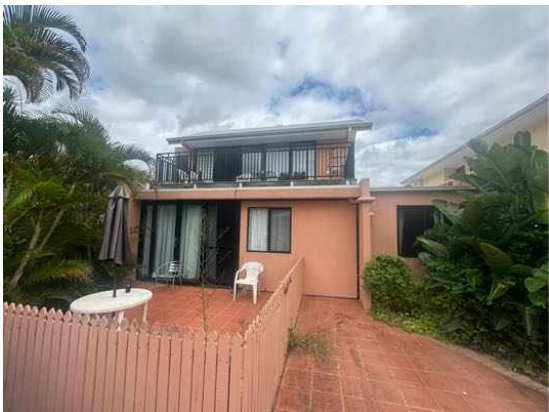
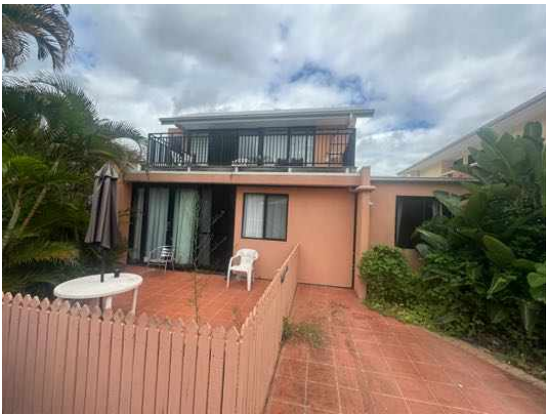
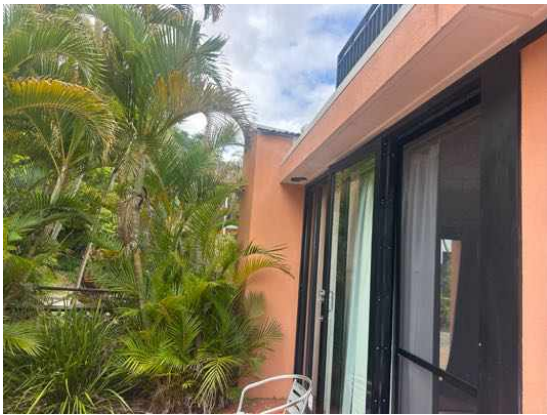
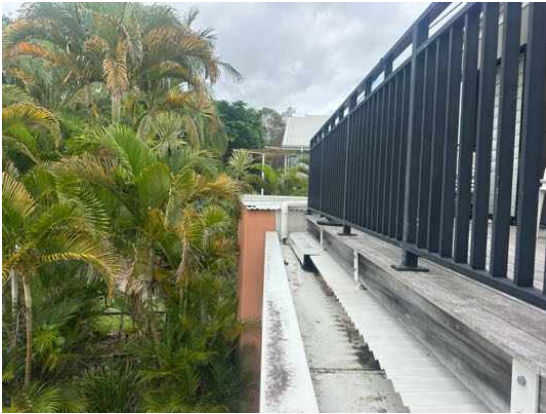
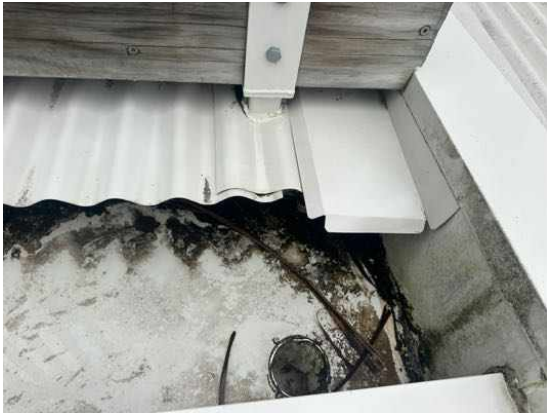
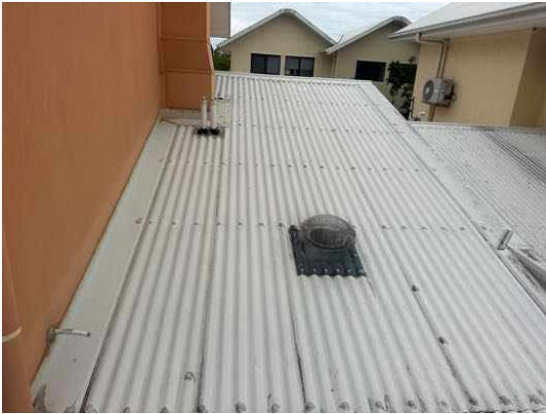
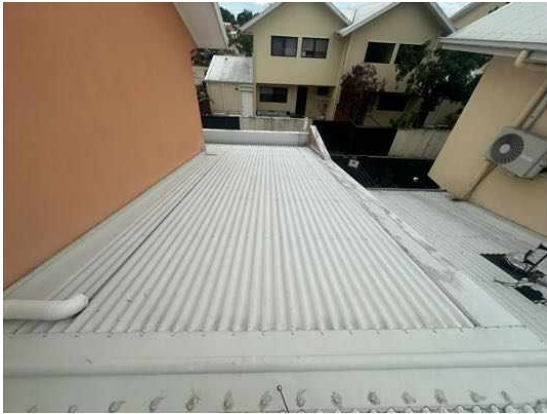
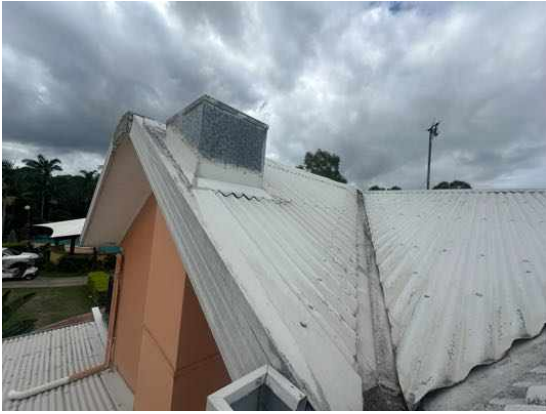
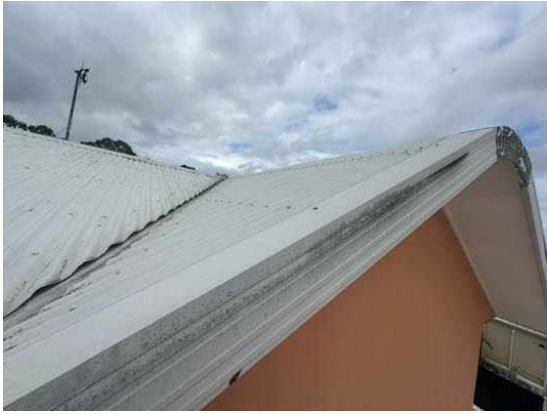
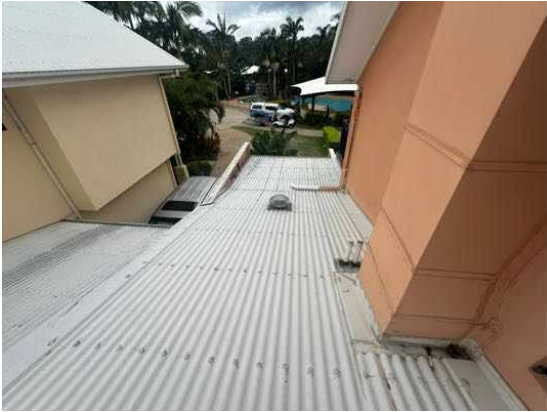
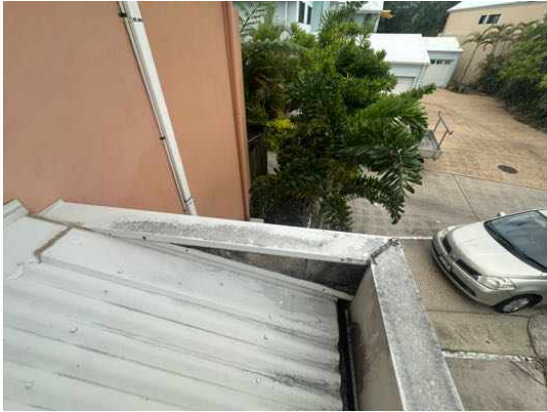
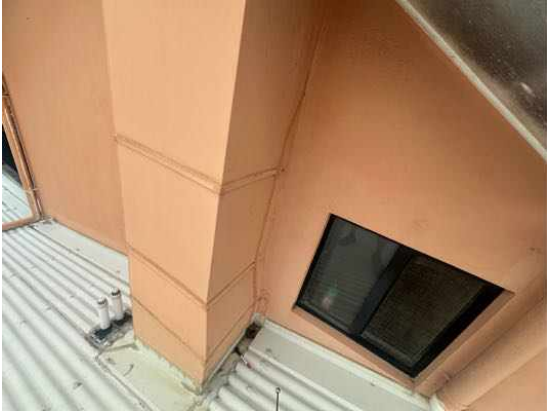
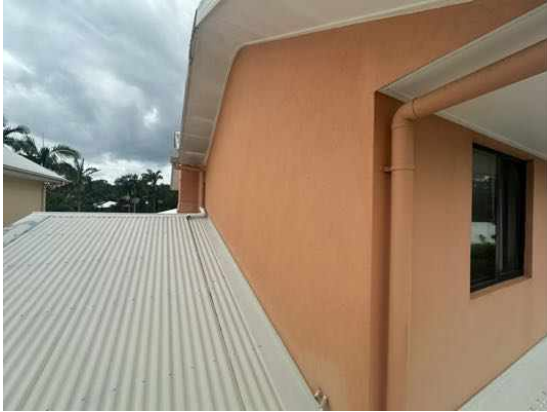
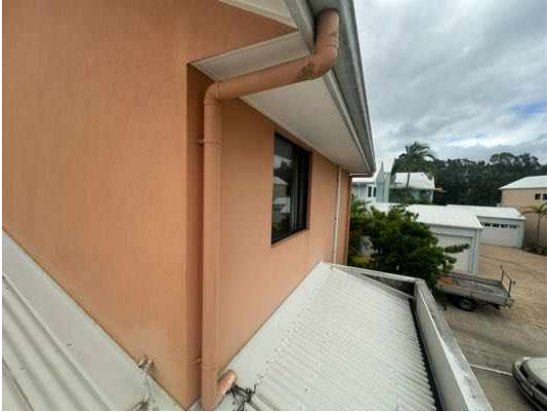
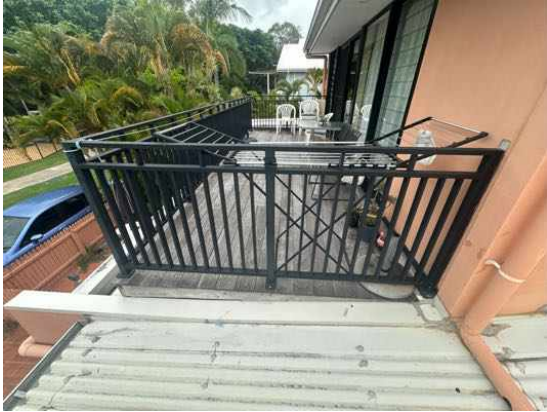
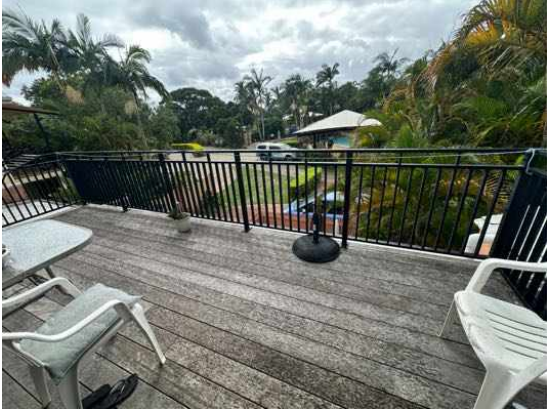
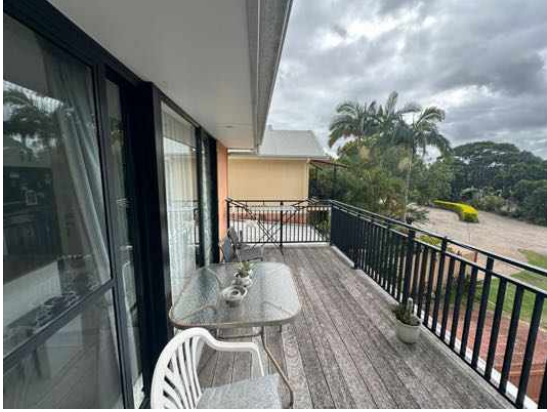
Noted Item

Building: Main Building
Location: External Areas
Finding: Additional Photos
Information: Additional photos are provided for your general reference.

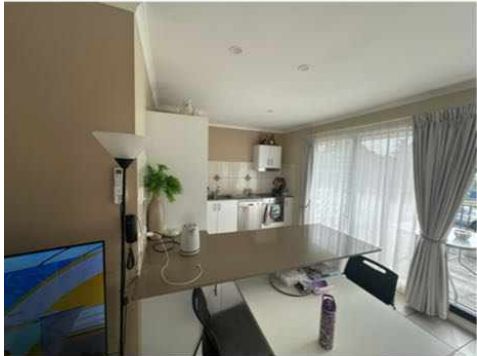
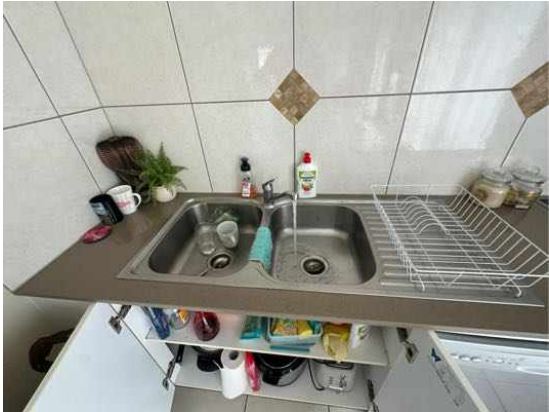
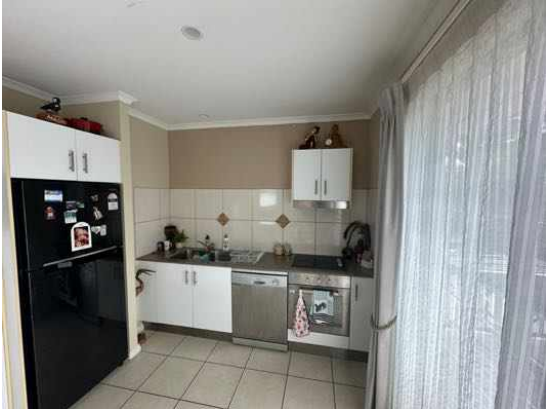
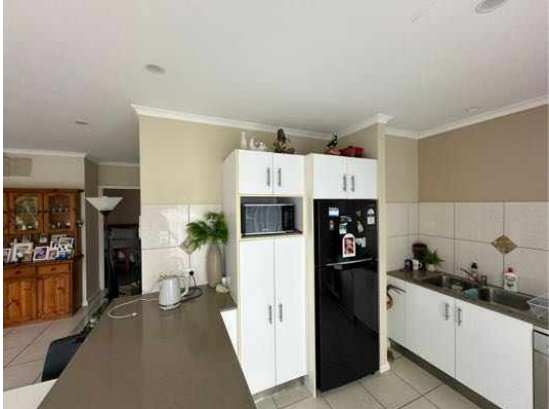
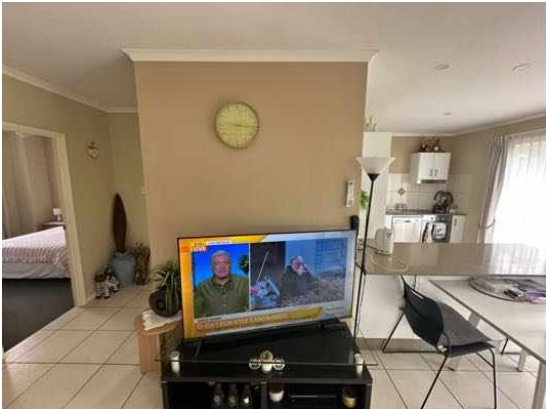
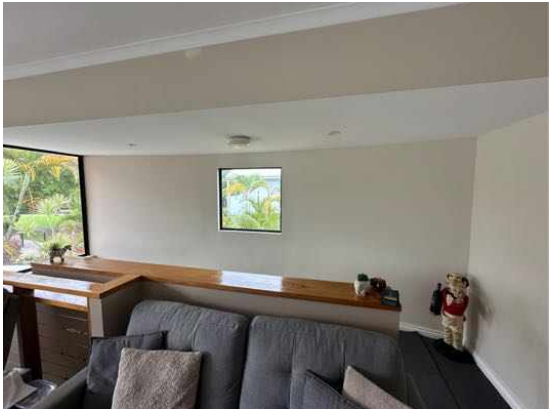
Noted Item

Building: Main Building
Location: Internal Areas
Finding: Additional Photos
Information: Additional photos are provided for your general reference. Please discuss these photos with your building consultant for clarification.

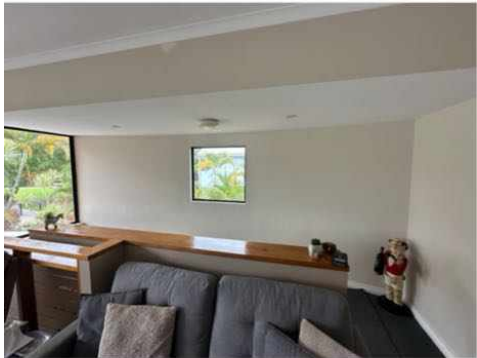
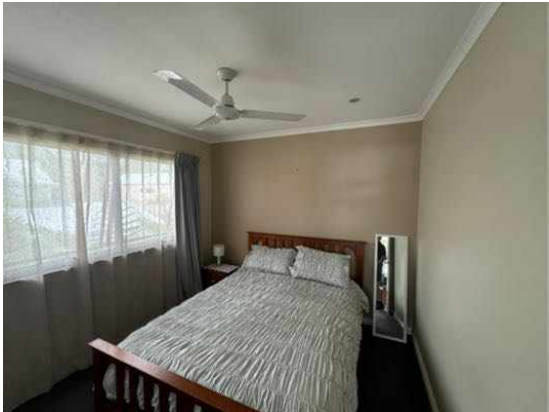
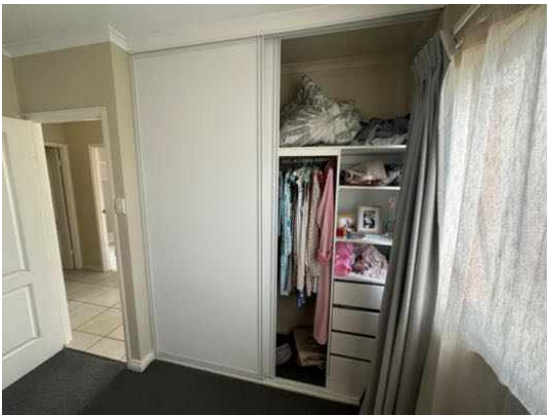
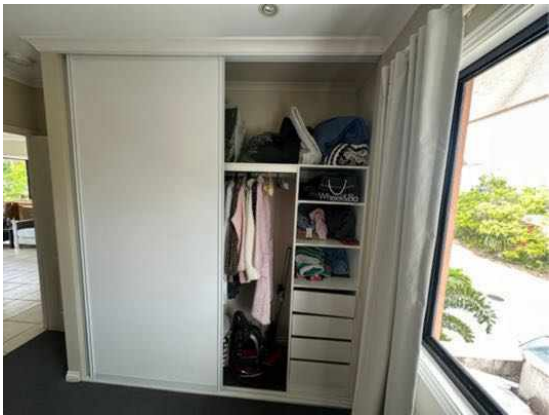
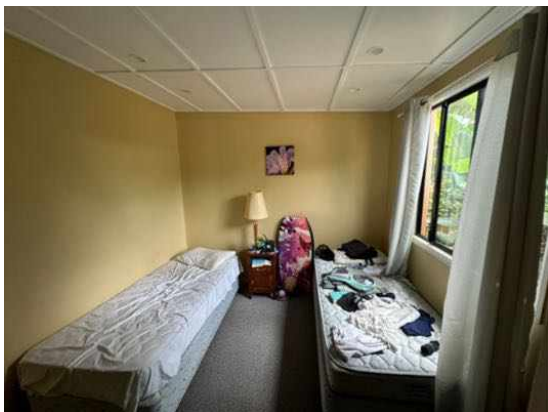
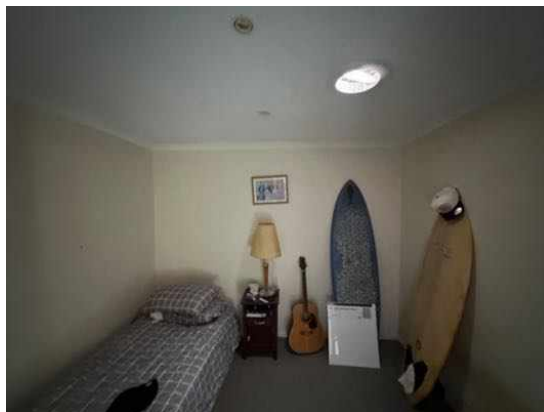
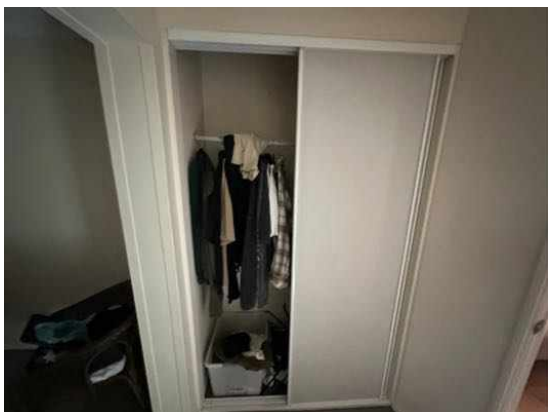
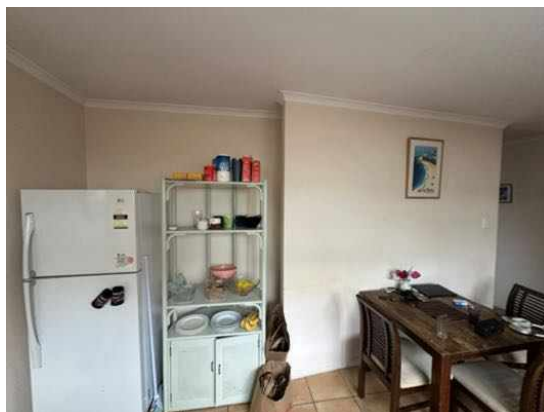
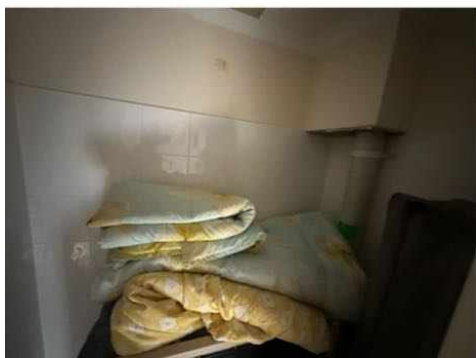
Finding: Additional Photos - Obstructions and Limitations

Information: These photographs are an indication of the obstructions and limitations which impeded full inspection of the property at the time of inspection. These obstructions can hide an array of defects and should be removed to allow full inspection to be carried out.
