Building and Timber Pest Inspection Report

Inspection Date: Wed, 4 Mar 2026

Property Address: 45 Mahoney Dr, Campbelltown NSW 2560,
Australia

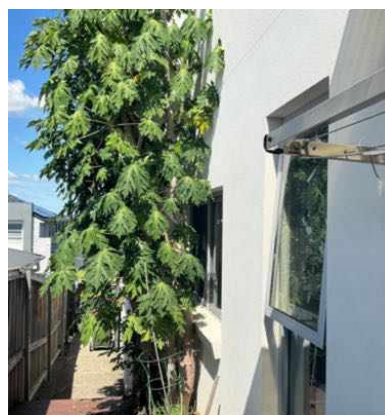
Finding 1.01

Building:	Main Building
Location:	All External Areas - Right
Finding:	Observation – Vegetation/Tree Proximity to Dwelling
Information:	A large tree is located immediately adjacent to the dwelling wall, with the trunk leaning toward the structure; this proximity poses risks including potential damage to footings and underground services from root activity, increased moisture retention conducive to timber pest activity, and ongoing maintenance issues from falling fronds and debris. While the lean of the tree may also present a future safety risk if it becomes unstable, and further assessment by an arborist is recommended to determine stability and potential impacts, with consideration for trimming, monitoring, or removal if necessary.

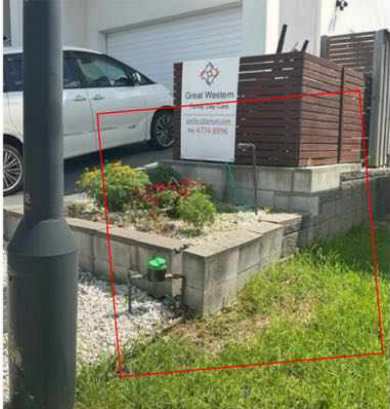
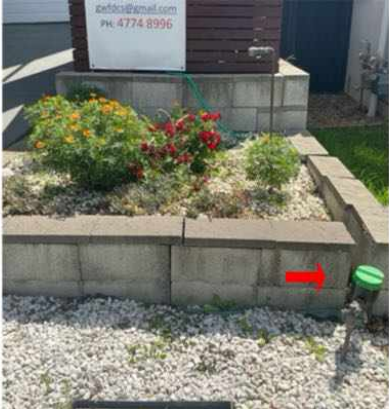
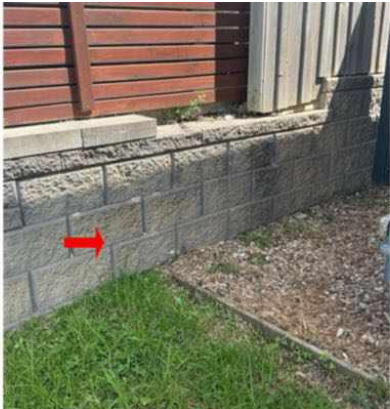
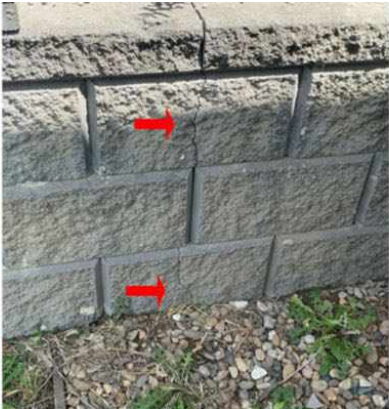
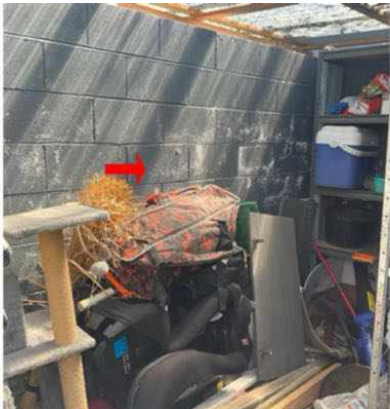
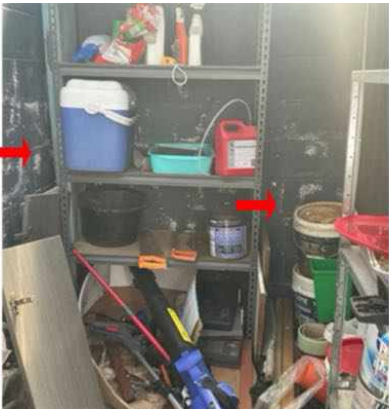
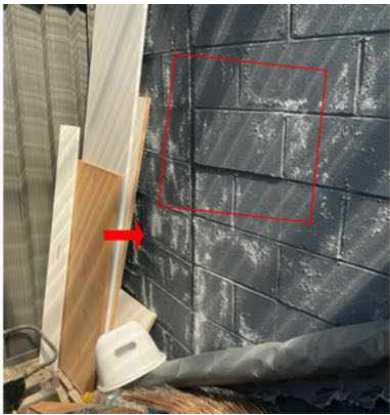
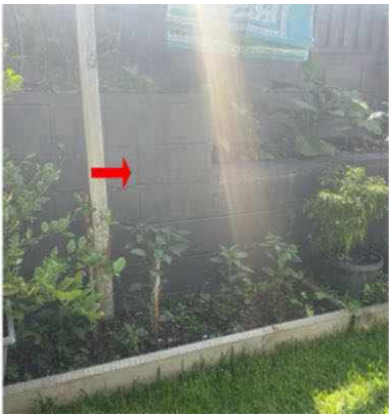
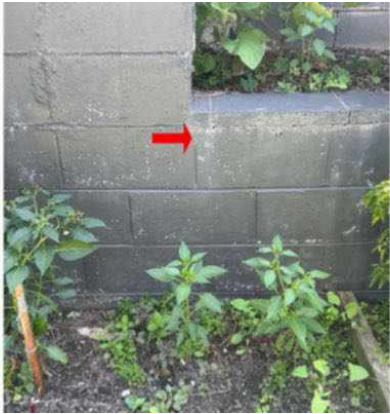
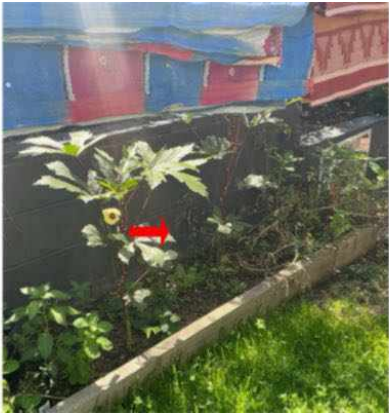
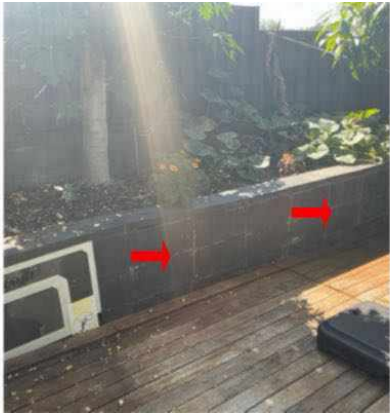
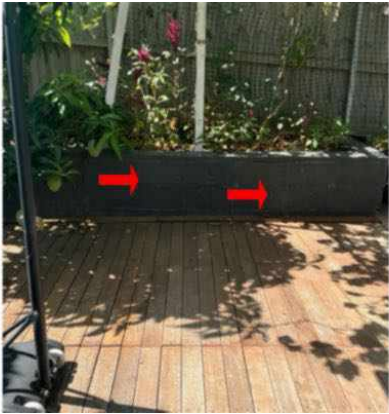
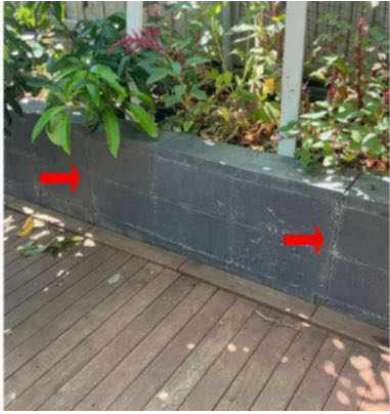
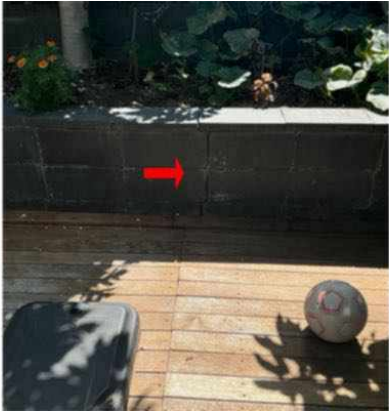
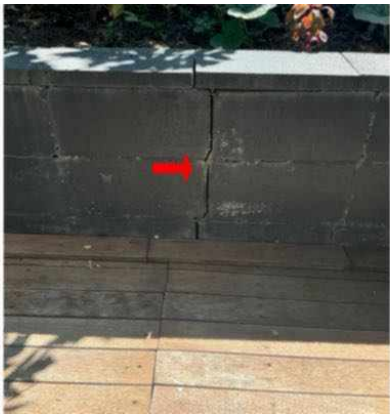
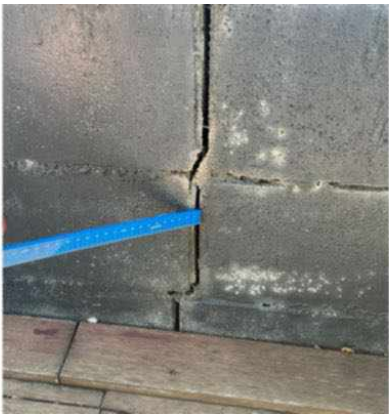
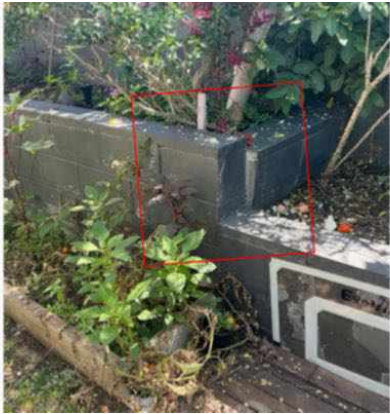
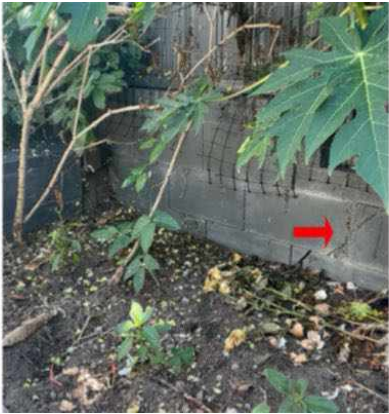
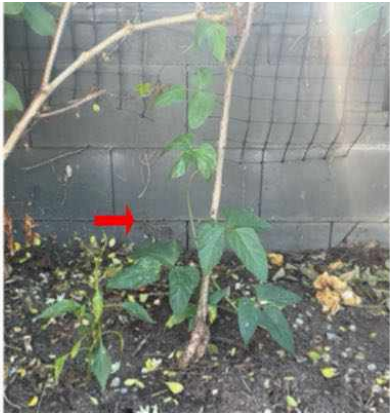
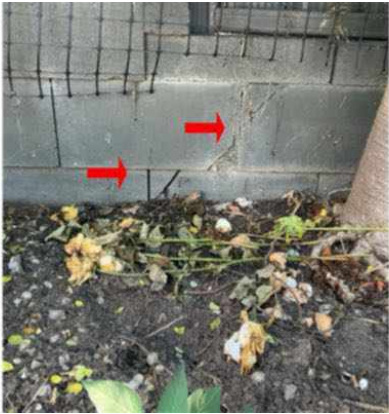
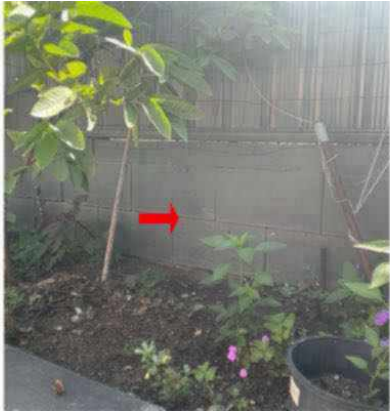
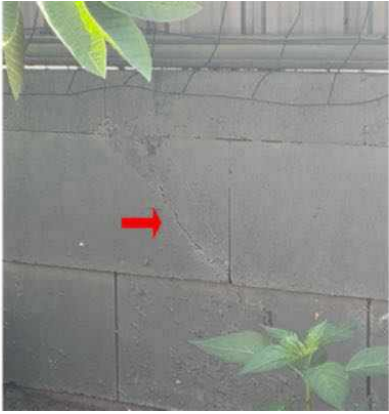
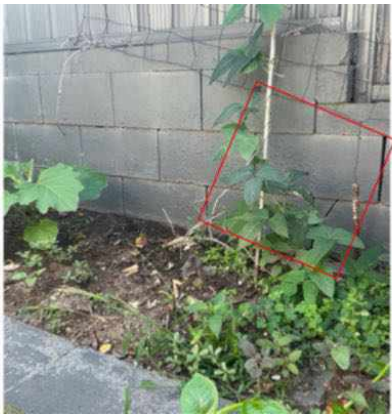
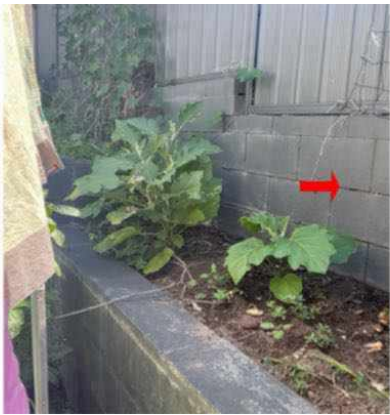
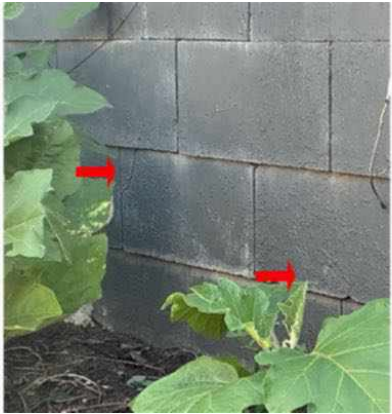
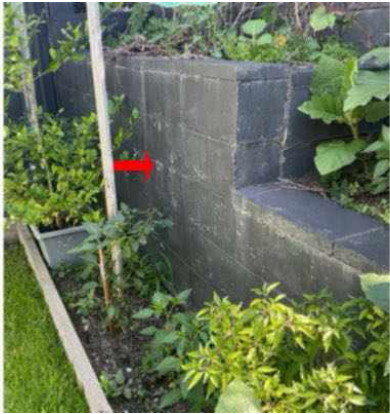
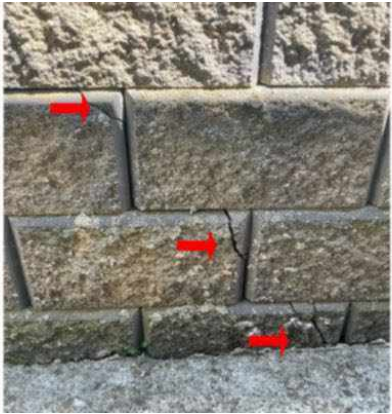
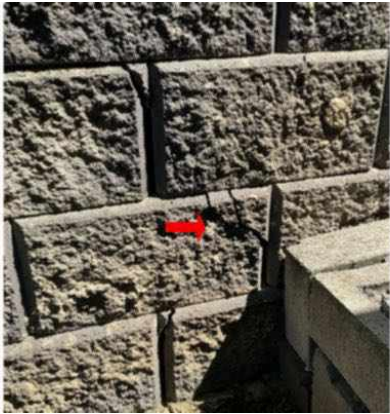
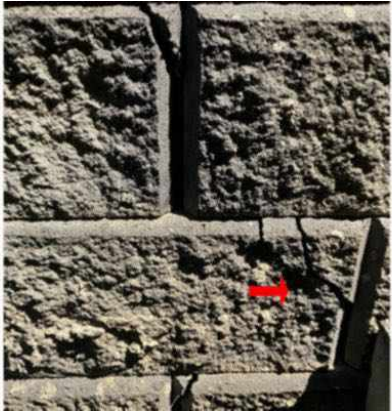
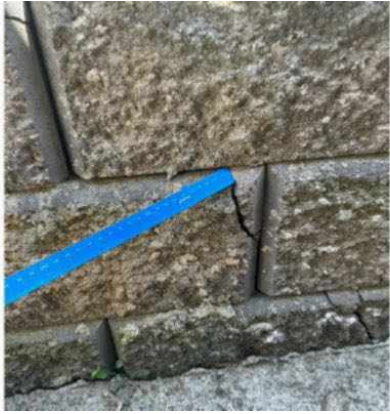
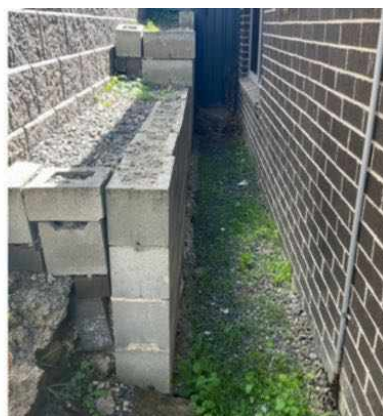
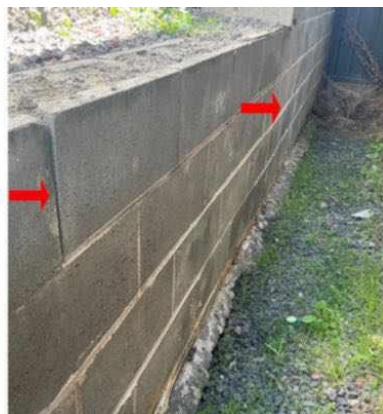
Finding 2.01

If left unmanaged, the retaining wall may become a safety hazard if it continues to destabilise. Where retaining walls further rot and decay, an environment is created that is conducive to termite and pest infestation.

Significant repair and replacement should be expected. Where retaining walls are considered structural walls, a structural engineer / surveyor should be consulted regarding required remedial works. Otherwise, a landscaper or retaining wall installer may be appointed to repair or replace the wall, at the discretion of the client.

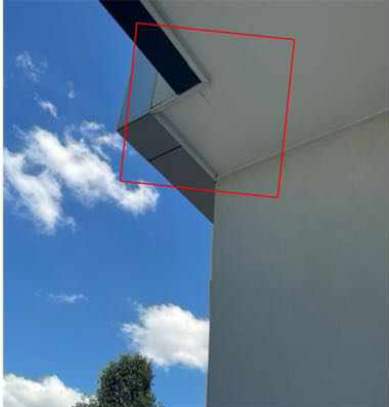
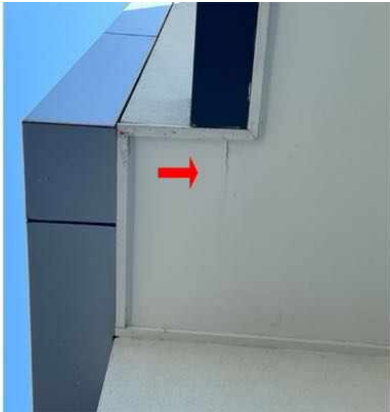
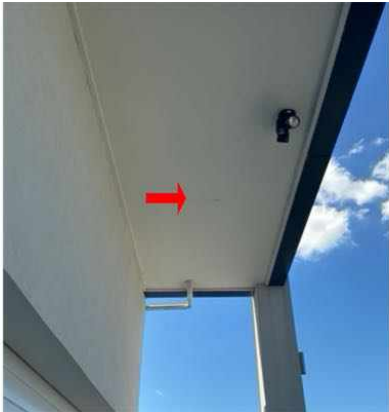
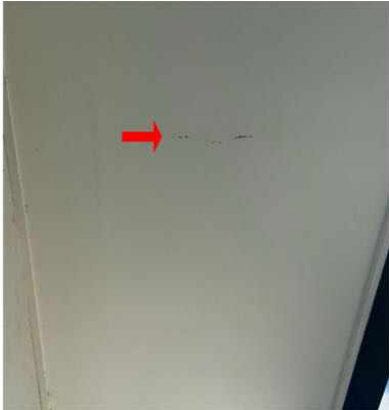
Finding 2.02

Building:	Main Building
Location:	All Internal Areas - Front balcony soffit and above balcony and garage
Finding:	Water staining/Paint bubbling - Further investigation required (Also refer to defect 3.1)
Information:	Water staining was evident in this area at the time of inspection. Water staining indicates that surfaces have been exposed to excessive moisture over time. The minerals and other elements in the water lead to staining, which may graduate to corrosion and deterioration if left unmanaged.

The exact source of water ingress could not be confirmed at the time of inspection.

Further investigation by a licensed plumber and/or licensed roofing/waterproofing contractor is recommended to determine the cause. Failure to rectify could result in significant works in the future.

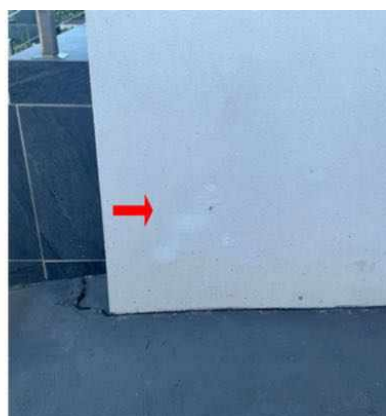
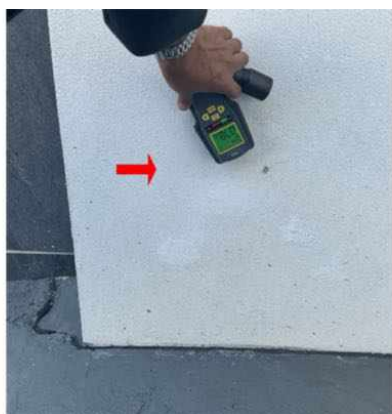
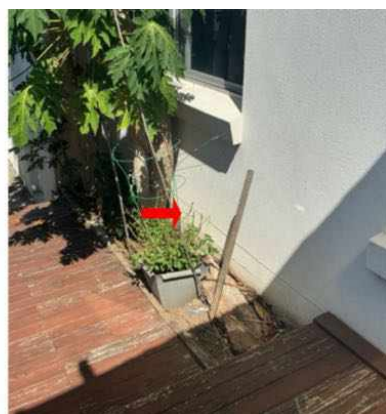
Building: Main Building
Location: All External Areas
Finding: Damp
Information: Damp (or structural damp) refers to the presence of unwanted moisture in the structure of a building, either as the result of intrusion from outside, or condensation from within the structure. Generally, structural damp is caused by rain penetration, rising damp, and leaks from plumbing pipes.

Unmanaged damp facilitates the formation and development of mould, fungi growth and wood rot, decaying associated building materials and compromising their structural integrity. Damage to finishes is also likely to occur, including lifting, bubbling, peeling and staining of paint, plaster and wallpaper.

It is important to address damp conditions, as the World Health Organisation notes that excess moisture leads - on almost all indoor materials - to growth of microbes such as moulds, fungi and bacteria, which subsequently emit spores and other matter into the indoor air. Exposure to these contaminants is associated with a wide range of respiratory and other health-related problems. Additionally, the development of damp in timber building elements also provides an environment that is conducive to termite / timber pest attack.

The first step in addressing damp is to diagnose the cause. The identified cause should be addressed first prior to repairing the appearance and other defects which have resulted from the rising damp. If the original cause is not resolved, further cases of damp are likely to ensue, resulting in secondary defects.

Consultation with a qualified plumber is advised immediately to identify the cause of damp and perform remedial works as required. Where excessive mould growth is present, further inspection by a specialist environmental health inspector should also be considered.

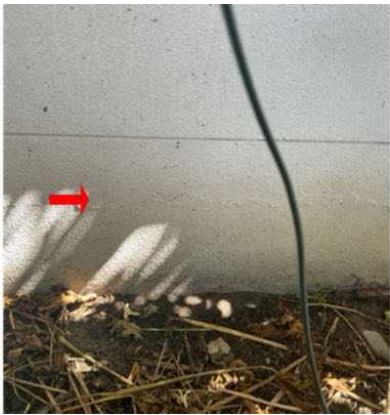
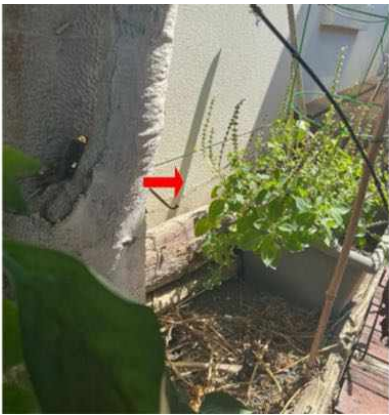
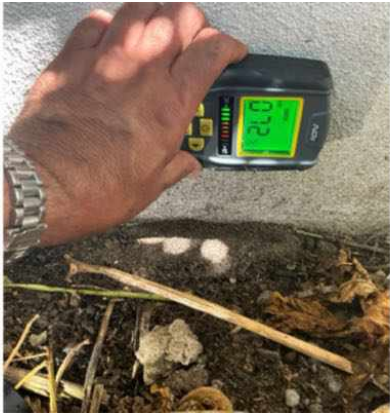
Finding 3.03

Building: Main Building
Location: All External Areas
Finding: Render Finish Covering Damp Membrane
Information: During the inspection, it was noted that the applied render finish is covering the damp-proof membrane. This is affecting the membrane’s ability to prevent moisture movement above it, leading to moisture-related issues over time. It is recommended to consult a qualified builder to ensure the damp-proof membrane is properly exposed, maintaining its effectiveness in preventing moisture ingress.

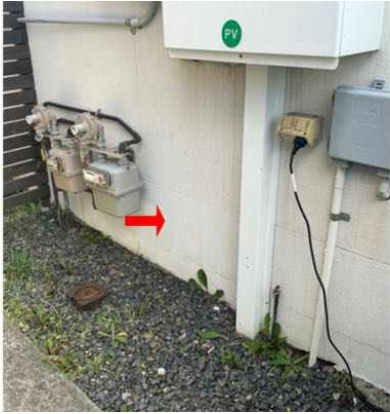
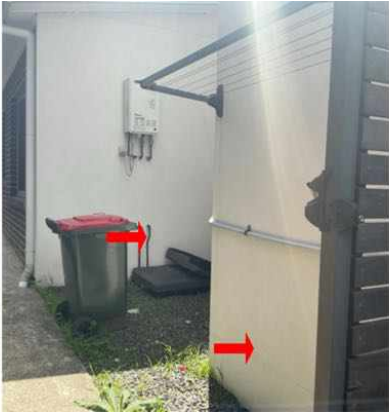
Finding 3.04

Building:	Main Building
Location:	All External Areas
Finding:	Weep Holes
Information:	No weep holes were visible along the lower brick course to the external wall in the area inspected. The base of the wall is finished with render and gravel landscaping, which may obscure or cover the weep hole openings. Weep holes are typically provided above the damp-proof course (DPC) to allow moisture within the wall cavity to drain and to promote ventilation of the cavity. The absence of visible weep holes may increase the risk of moisture retention within the wall system if they are blocked, covered, or not installed. Further confirmation is recommended to ensure weep holes are present and not obstructed.

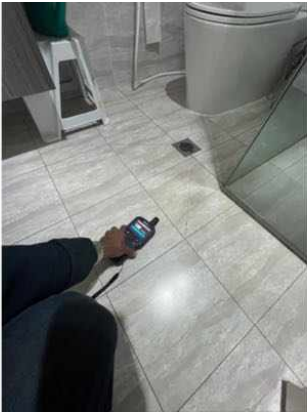
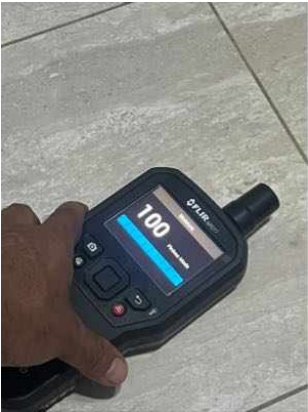
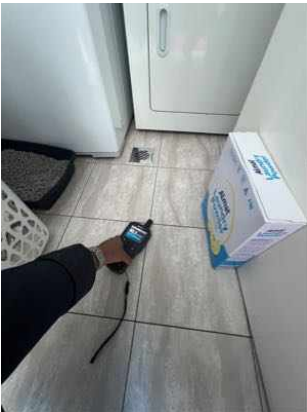
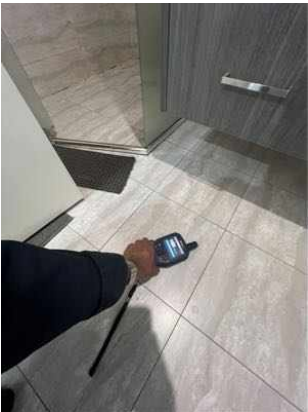
Building:	Main Building
Location:	Bathrooms, laundry
Finding:	Elevated Moisture Bathroom (No visible deterioration noted)
Information:	<p>Elevated moisture levels were detected to tiled surfaces in bathroom/shower areas. Persistent moisture ingress can lead to concealed damage, including timber rot and mould growth.</p> <p>Elevated moisture readings in tiled wet areas can occur from normal shower use, age/deterioration of waterproofing membranes, plumbing leaks or moisture absorption through grout lines. While no damage was visible, elevated readings may indicate moisture retention behind tiles, which can be a conducive condition for future</p>

deterioration if not monitored.

No immediate action required. Monitor the area over time for signs of drumming, efflorescence, tile movement, or grout deterioration. If concerns arise, a licensed waterproofing specialist can perform further investigation (e.g., pressure testing, membrane assessment).

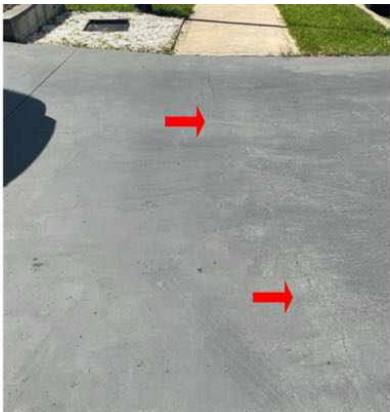
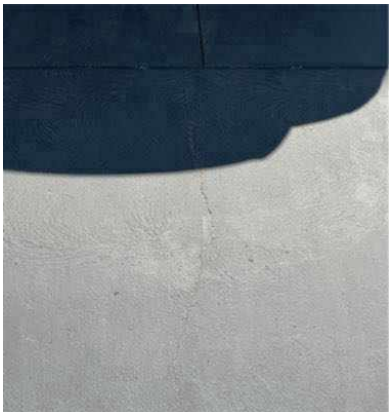
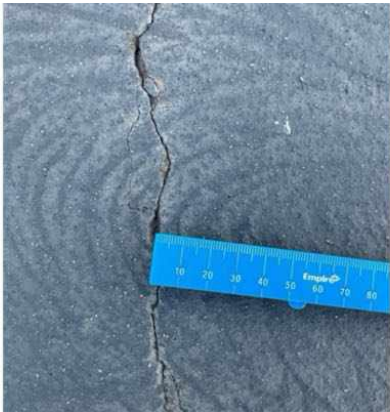
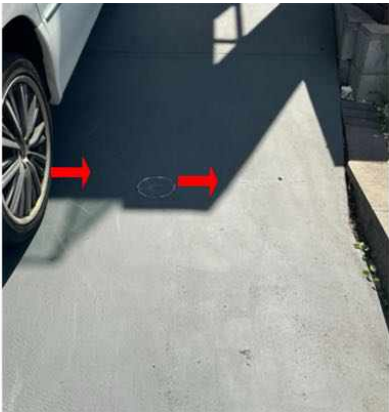
Finding 3.08

Building: Main Building
Location: All External Areas
Finding: Cracking - External Concrete Paving Damage Category 3 - Wide Cracks (2mm - 4mm)

Wide cracks were identified in external concrete paving Wide cracks are significant and are likely to lead to the development of safety hazards and secondary defects if left unmanaged.

General age and expected deterioration of the paved areas is a common cause of this type of cracking. However, expansion and contraction of the slab may also have occurred due to environmental factors. Such factors include variable moisture and weather conditions, the presence of trees and their roots having a settling or lifting affect on the soil, or the effect of load bearing, e.g. heavy vehicles over a sustained period of time.

Cracking to this degree may also be due to poor original installation of the concrete. Factors such as poor compaction of the sub surface and/or inadequate reinforcing of the slab may create cracking and other secondary defects. Wide cracks may also have a more significant structural cause, such as subsidence of soils.

Where the crack is located adjacent to structural elements of the building, the advice of a Structural Engineer is advisable before undertaking repairs. Significant repair and likely replacement of the concrete paving is probable.

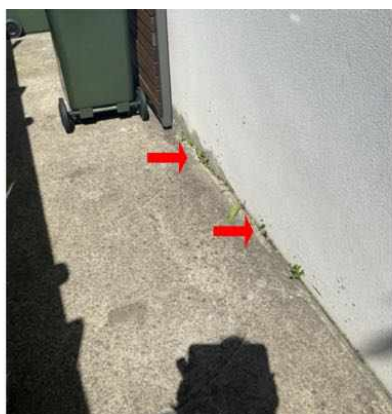
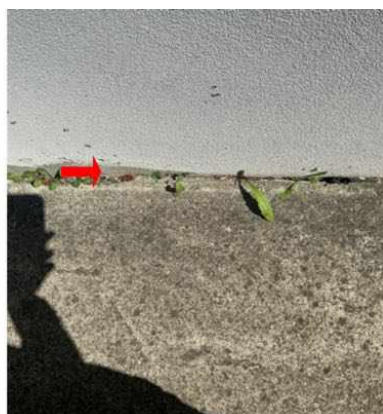
Finding 3.12

Building:	Main Building
Location:	All External Areas
Finding:	Gap Between Concrete and External Wall - to some areas
Information:	Visible gaps were observed between the external masonry wall and adjacent concrete slab at the pathway.

This separation may permit water ingress and contribute to concealed moisture-related damage, pest ingress, or slab movement if left unsealed.

The defect appears consistent with common differential settlement or poor sealant detailing at the slab-to-wall junction. Recommend a licensed contractor seal the gap with an appropriate flexible, UV-stable exterior-grade sealant to prevent moisture entry and pest intrusion.

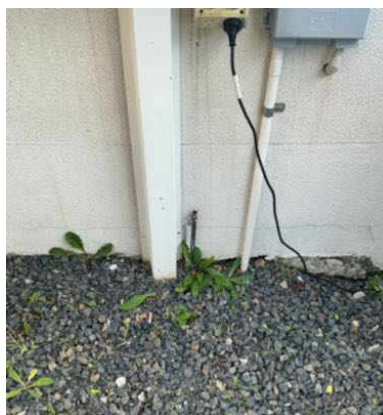
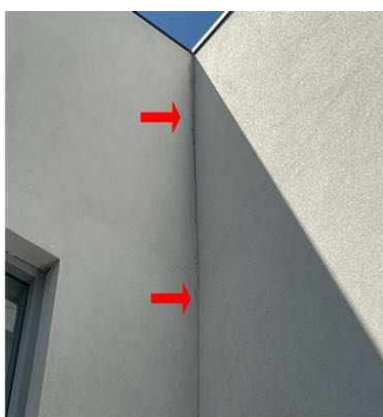
Finding 3.13

Building:	Main Building
Location:	All External Areas
Finding:	Cracks to render - Category 1
Information:	It has been observed that cracking to rendered surfaces has occurred. The degree of damage falls within Category 1, described as fine cracks that do not need repair and

which are less than 1.0mm in width limit.

Damage of this category is not considered a defect for rectification. Always contact your building inspector should cracks widen, lengthen, or become more numerous.

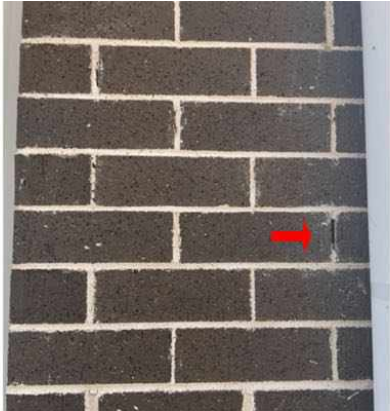
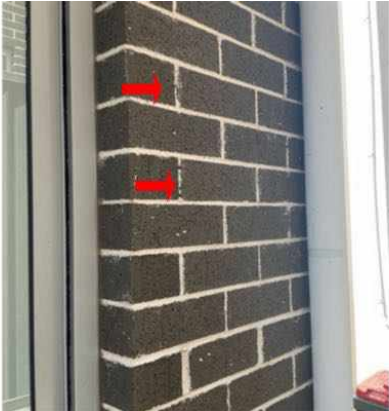
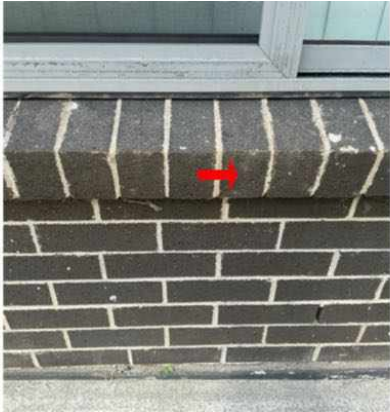
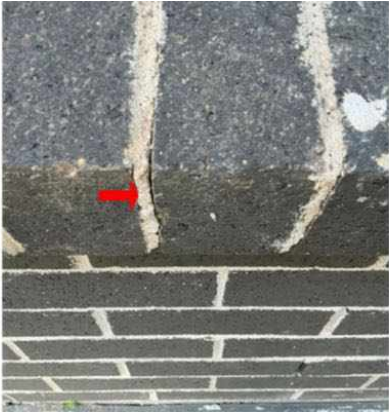
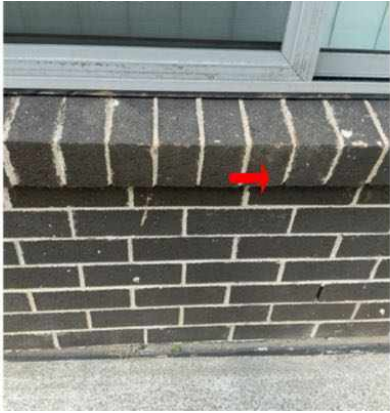
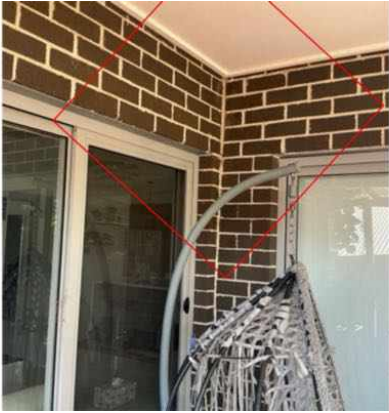
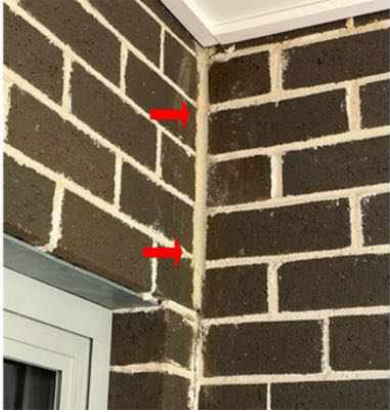
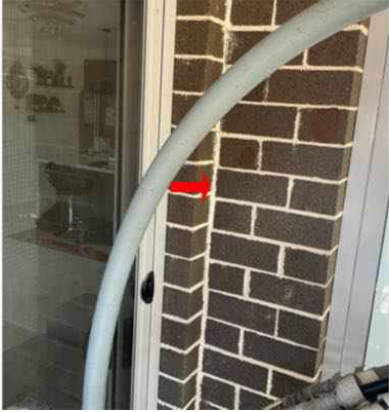
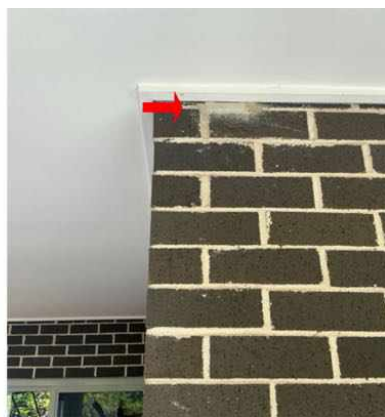
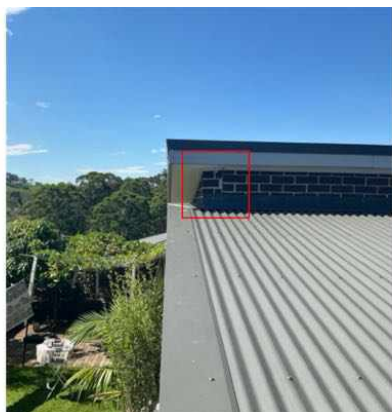
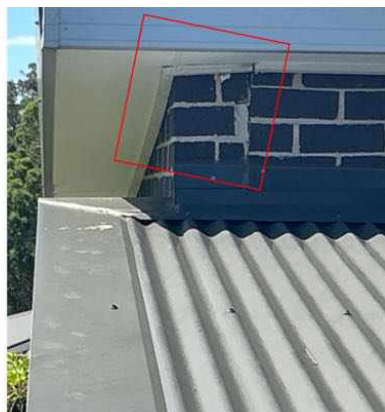
Finding 3.14

Building:	Main Building
Location:	All External Areas
Finding:	Brickwork - Deteriorated mortar to some areas
Information:	Mortar, or 'bedding', is the material which fills joins and intersections between bricks in masonry walls and structures. Sections of mortar in this brickwork were identified as having deteriorated, which is generally expected for a property of this age and condition.

Mortar may deteriorate as a result of age of building materials, minor movement of bricks, or frequent exposure to weathering. Mortar should be replaced to ensure that bricks remain in their intended location and to prevent gaps, which would allow water or moisture ingress and secondary damage as a result.

Mortar deterioration can be addressed by a bricklayer where areas of deterioration are localised and easily accessible. Alternatively, appointment of a registered builder is advised, to repoint large areas of decaying mortar. Where secondary structural defects have become evident, consultation with a structural engineer may be required.

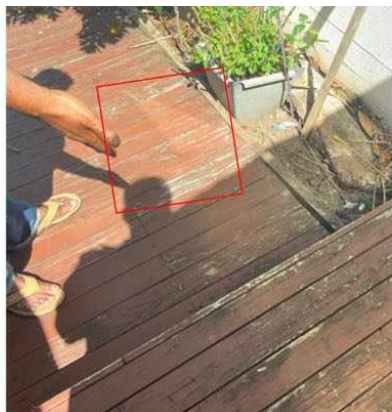
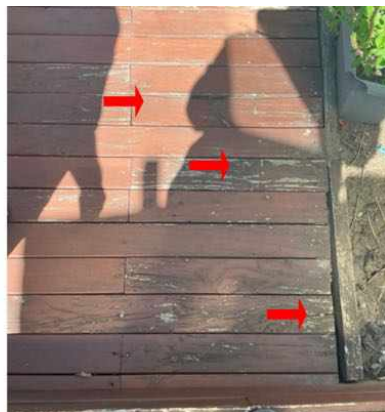
Finding 3.15

Building:	Main Building
Location:	All External Areas
Finding:	Building element - Damaged - timber damaged , weathered and some areas showing early signs of decay
Information:	Breakage occurs generally when the building materials have either aged and decayed, or as a result of damage (accidental or deliberate).

Repair and/or replacement of broken elements is advised to ensure that additional secondary defects do not arise as a consequence. Such works are necessary, as all building elements play a key role in the operation and function of the overall structure and its performance.

A relevant tradesperson should be appointed to repair or replace the affected building element prior to any subsequent damage being caused.

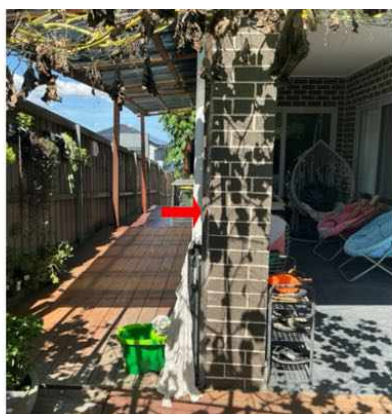
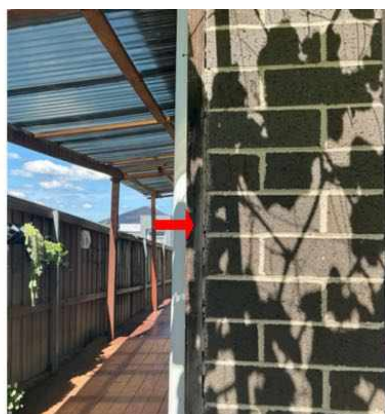
Finding 3.16

Building:	Main Building
Location:	All External Areas
Finding:	Incomplete or substandard works - Timber loose
Information:	The works to this area appear to be incomplete or have been completed to a substandard level.

Works that have not been completed to a satisfactory level create potential for the development of building defects and may impede on the safety and integrity of the overall structure.

It is highly recommended that the relevant trades be appointed to complete these works and ensure the safety of the area and the longevity of all associated building elements.

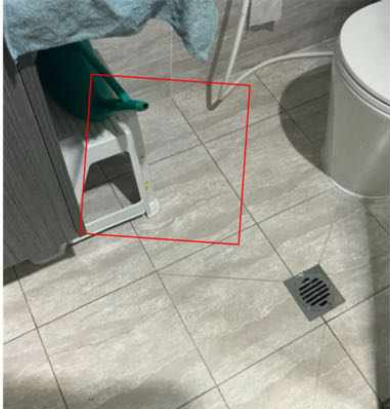
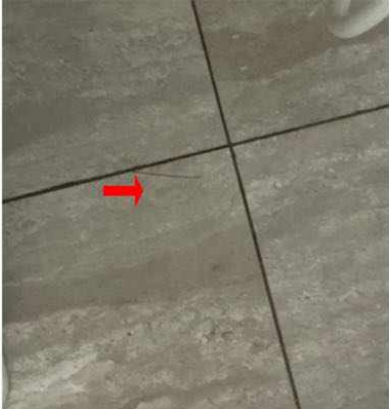
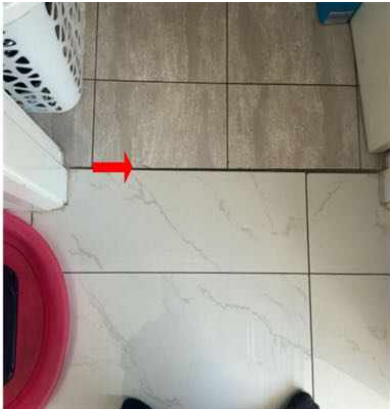
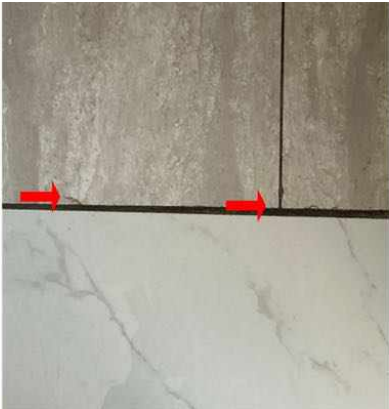
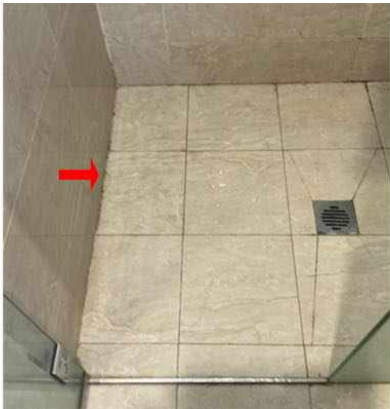
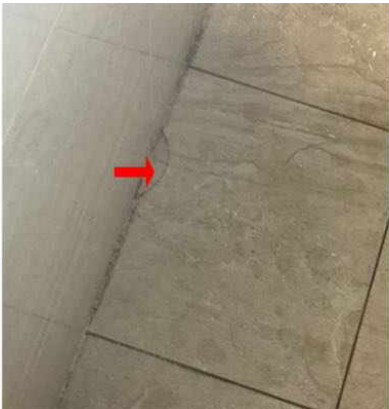
Finding 3.17

Building:	Main Building
Location:	All Internal Areas - Bathroom , laundry, ensuite
Finding:	Tiles Cracked
Information:	Hairline cracking was observed to wall tiles in the bathroom, extending vertically and branching in a tension-related pattern. These defects are considered minor at present,

but are likely caused by substrate movement, water-induced expansion, or installation stresses. While structural impact appears limited, failure to address this may compromise waterproofing integrity. Prompt rectification by a qualified tiler is recommended to prevent further damage and potential water ingress behind the tiled surface.

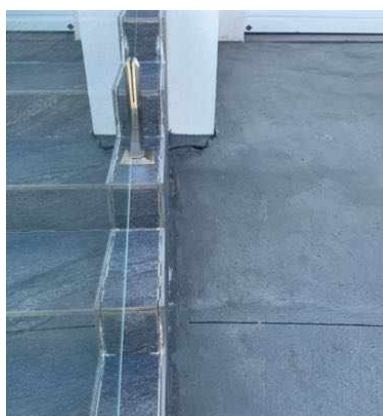
Finding 3.18

Building: Main Building
Location: All Internal Areas
Finding: Tiles - Drummy
Information: Drummy tiled areas were identified at the time of inspection. The term 'drummy' refers

to tiles that have become detached from their fixing, despite otherwise being in relatively good condition. Such defects are generally caused by physical or moisture damage to the area. Drummy tiled areas may also be a direct result of poor workmanship during the construction process.

Tiled areas may swell and shrink with changes in air humidity if the area has sustained moisture damage. Any exposure to moisture is capable of causing tiled areas to become drummy and/or cracked over a prolonged period of time. Drummy tiled areas generally require removal and replacement of affected tiles, with adequate sealant and grouting.

Specialist trades are available for these types of services. A registered builder may be required to undertake works if damage is extensive or if secondary building defects have resulted. Otherwise, it is advised that a tiling contractor be appointed to perform works as necessary. Immediate action is recommended to ensure that no further damage is sustained in the affected area.

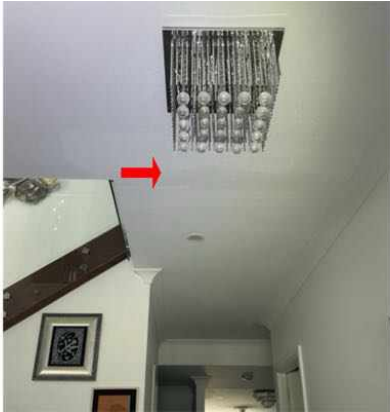
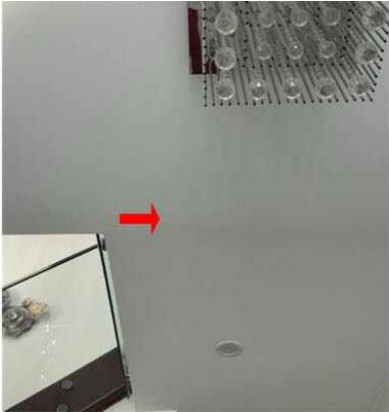
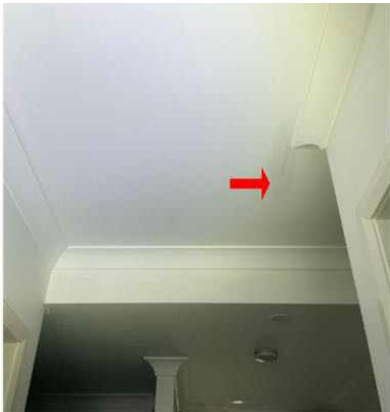
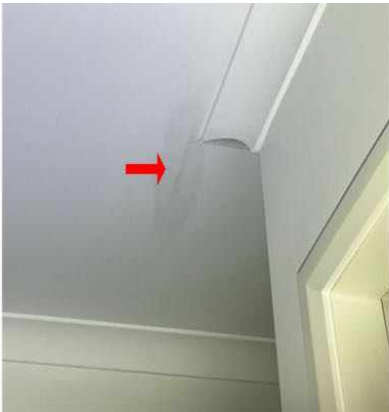
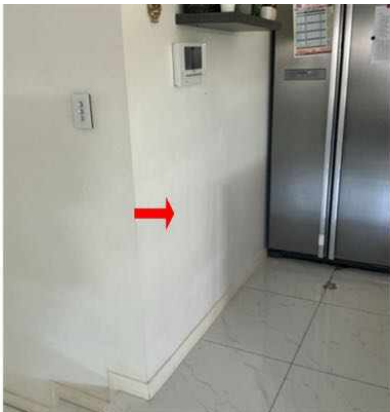
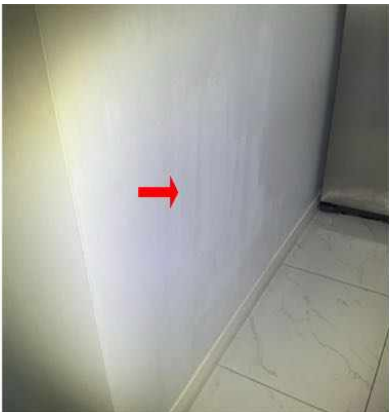
Finding 3.19

Building:	Main Building
Location:	All Internal Areas
Finding:	Paint Finish & Hairline Cracking - To some areas
Information:	The paint finish in this area was identified as being incomplete or substandard at the time of inspection including some hairline minor cracking/separation. Monitoring is recommended where cracking and separation is evident.

Whilst incomplete or missing paint finish is generally an appearance defect, it can also lead to the development of secondary building defects over time. Incomplete areas of paint finish expose the area to moisture, potentially accelerating the deterioration of underlying building materials.

Incomplete paint finishes should be sanded back, filled, leveled and painted, as applicable. Where inadequate or missing paint protection has led to the deterioration of the associated building element, repair and/or replacement of this building element may be required.

A painting contractor should be appointed as soon as possible to perform necessary works to aid the appearance of the affected area and to ensure the area is protected against further deterioration. Alternatively, the homeowner following manufacturer instructions may perform these works.

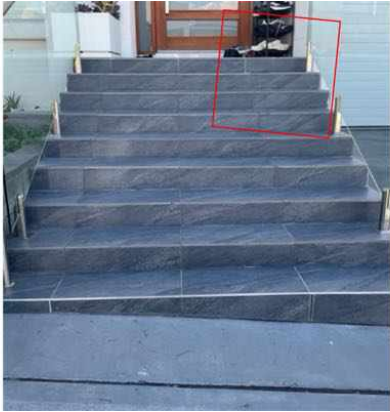
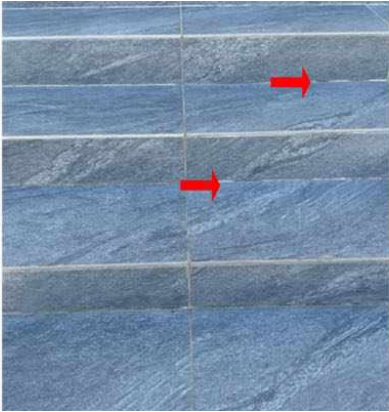
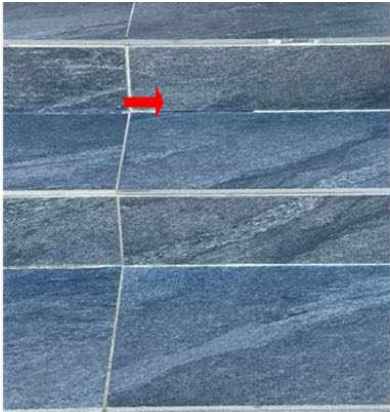
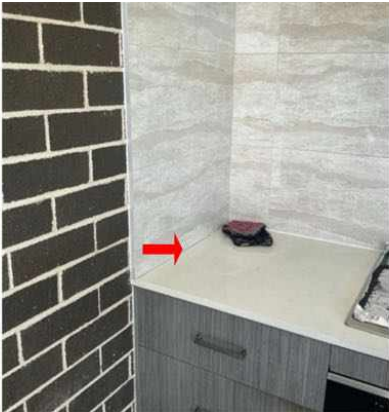
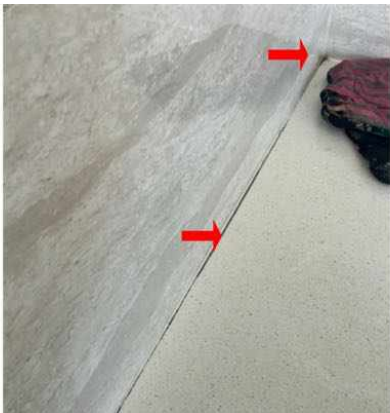
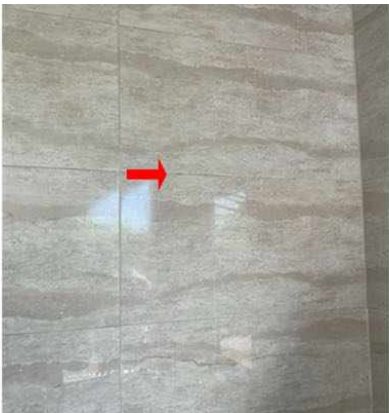
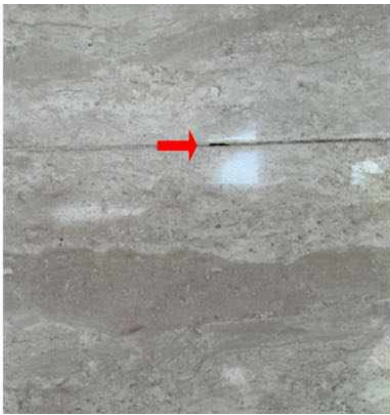
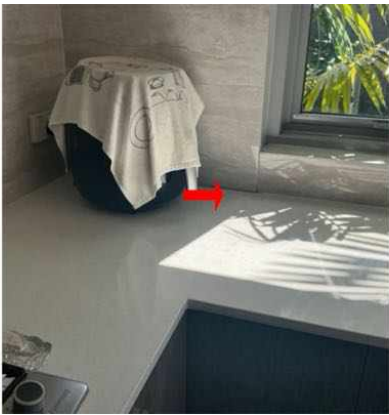
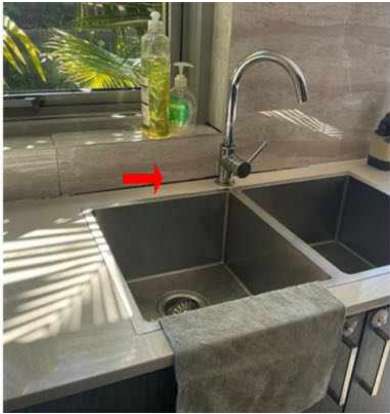
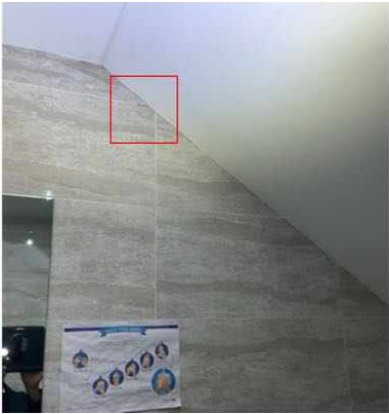
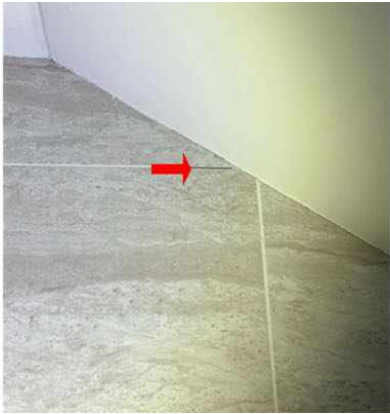
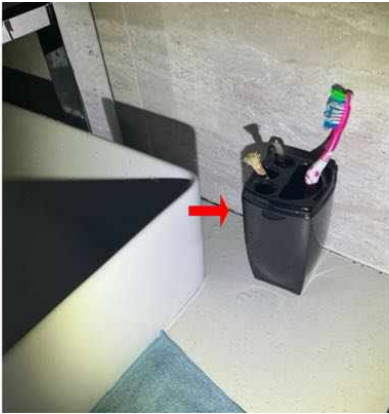
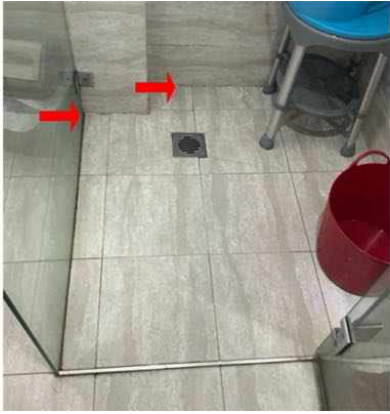
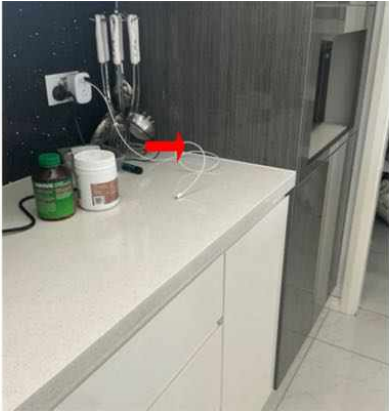
Finding 3.20

Building:	Main Building
Location:	All Internal Areas & balcony
Finding:	Sealant and grouting - Missing or degraded to some areas
Information:	It was noted on inspection that sealant or grout is degraded.

Different materials and floor areas move at different rates, generally causing cracking to grout or sealant at this point. A flexible sealant is required to allow for expected expansion and contraction, while keeping the joint water tight and protective of all associated building materials.

Excessive mould to the sealant and grout may require scraping out and replacement.

Flexible and mould resistant materials should be applied to affected areas to prevent any subsequent water damage that is likely to occur. Regular maintenance and replacement of damage or missing or damaged sealant and grout is highly recommended to the wet areas, as this is a regular wear and tear defect. Sealant and grouting in areas that come into regular contact with water should be maintained for the long term care of your property.

A sealant specialist or tiling contractor should be appointed to complete these works as soon as possible

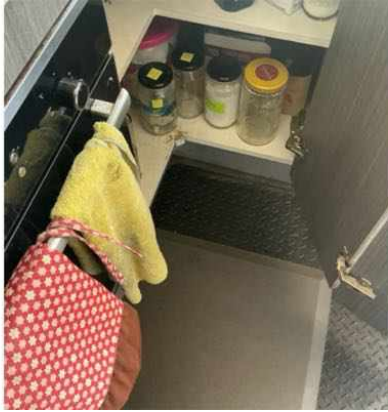
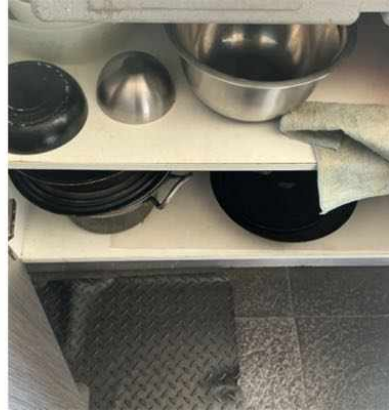
Building:	Main Building
Location:	All Internal Areas
Finding:	Building element - Damaged , external kitchen cabinets moisture damage
Information:	Breakage occurs generally when the building materials have either aged and decayed, or as a result of damage (accidental or deliberate).

Repair and/or replacement of broken elements is advised to ensure that additional

secondary defects do not arise as a consequence. Such works are necessary, as all building elements play a key role in the operation and function of the overall structure and its performance.

A relevant tradesperson should be appointed to repair or replace the affected building element prior to any subsequent damage being caused.

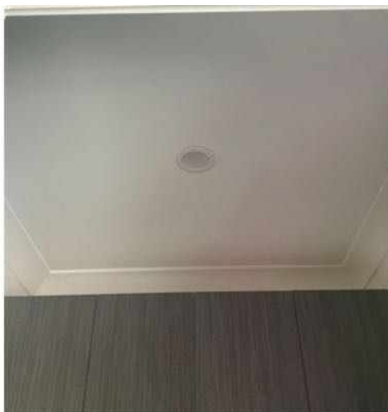
Finding 3.23

Building: Main Building

Finding: Building element - Missing - No ventilation

Replacement of any missing building element should be conducted as soon as possible to ensure that no damage or functional issues occur to associated building materials.

The appropriate tradesperson should be appointed as soon as possible to replace the missing building element.

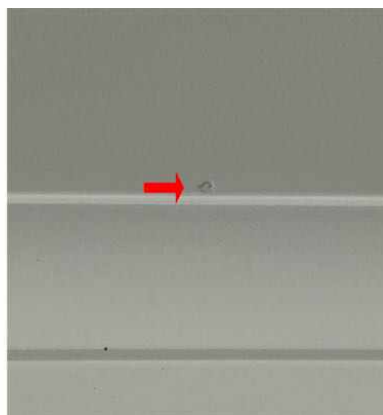
Finding 3.24

Building:	Main Building
Location:	All Internal Areas
Finding:	Ceiling nails - Popping To some areas
Information:	Numerous popped nails were identified in the internal ceiling at the time of inspection. Nails and screws hold simply by the friction between them and the surface they are applied to. Over time, the nails and screws can back out, which is often a result of general ageing and deterioration of the building structure.

If left unmanaged, the ceiling sheets may become loose and unstable, increasing the rate of deterioration of the internal ceiling and creating potential for the development of secondary defects.

Re-fastening of popped nails will help to maintain the stability of the internal ceiling and associated building elements. Such minor works will also help to improve the appearance of the affected area and secure the ceiling sheets, so as to prevent the onset of ceiling sagging. These works should be performed by a qualified carpenter or plasterer at client discretion.

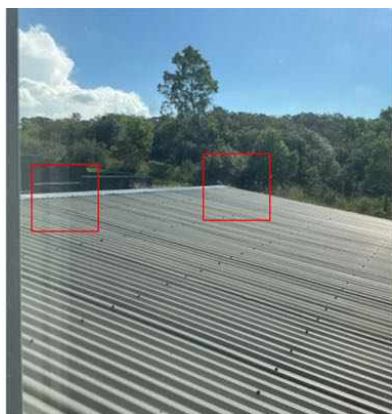
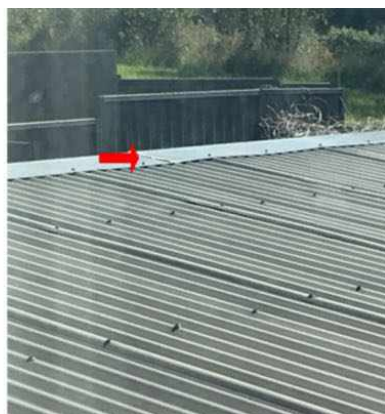
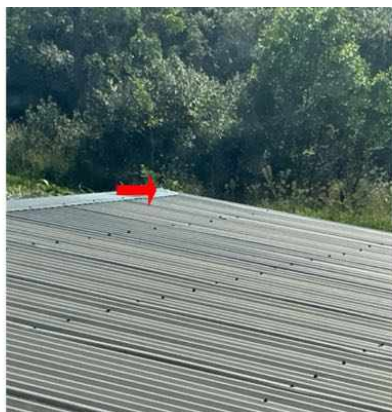
Finding 3.25

Building:	Main Building
Location:	Roof Exterior
Finding:	Flashing defective -poor installation (excessive silicone usage)
Information:	The metal flashing at the wall junction appears inadequately installed, with visible gaps and lifting and reliance on surface sealant rather than a properly chased and continuous detail. The junction does not appear fully weather-tight, increasing the risk of moisture ingress into the wall cavity or roof structure over time. Defective flashing installation can lead to concealed deterioration if not addressed. Recommend assessment and rectification by a qualified roofing contractor to ensure compliant and effective weatherproofing.

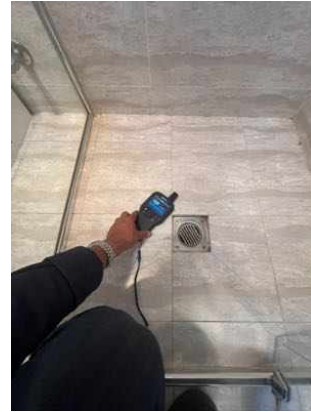
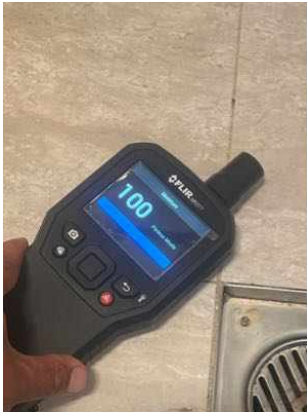
Finding 3.26

Building:	Granny-Flat
Location:	All Internal Areas - Granny
Finding:	Elevated Moisture Bathroom (No visible deterioration noted)
Information:	Elevated moisture levels were detected to tiled surfaces in bathroom/shower areas. Persistent moisture ingress can lead to concealed damage, including timber rot and mould growth.

Elevated moisture readings in tiled wet areas can occur from normal shower use, age/deterioration of waterproofing membranes, plumbing leaks or moisture absorption through grout lines. While no damage was visible, elevated readings may indicate moisture retention behind tiles, which can be a conducive condition for future deterioration if not monitored.

Monitor the area over time for signs of drumming, efflorescence, tile movement, or grout deterioration. Recommend a licensed waterproofing specialist to perform further investigations on cause of elevated moisture (e.g., pressure testing, membrane assessment).
