Building and Timber Pest Inspection Report

Inspection Date: Wed, 4 Mar 2026

Property Address: 45 Mahoney Dr, Campbelltown NSW 2560,
Australia

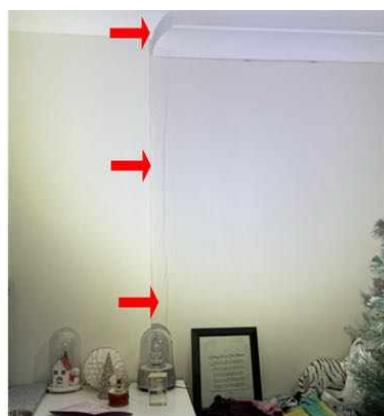
Building: Granny-Flat
 Location: All Internal Areas - Granny
 Finding: Painted surface - Bubbling
 Information: Sections of paint in this area was found to have bubbled and deteriorated. Paint bubbling is generally an indication of excessive moisture in the area, that is currently hidden by the painted surface.

The presence of excessive moisture can have major implications on associated building elements if left unattended. While only seemingly minor at this stage, the damage cannot be determined due to the paint obstructing any further inspection of the damage.

It is highly advised that the affected paint be cleaned to allow a further, more invasive inspection by a licensed plumber. Failure to act on this defect may necessitate major works in the future.

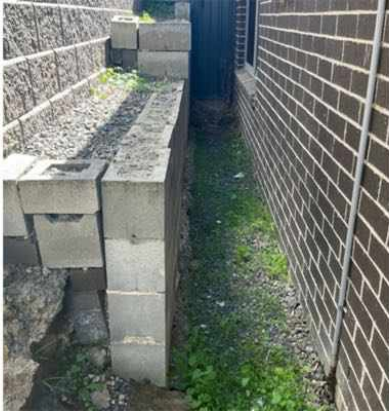
Finding 3.29

Building: Granny-Flat
 Location: All Internal Areas - Granny
 Finding: Surface Drainage - Gravel

Information: The setback is finished with loose aggregate. While gravel can assist with surface dispersion of water, it is not a controlled drainage system. The adequacy of falls and stormwater connection could not be confirmed at the time of inspection. Monitoring during rainfall is recommended to ensure no ponding or water discharge occurs toward the slab edge. Further inspection by a licensed plumber is recommended.

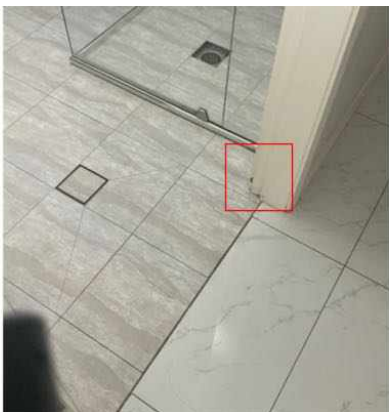
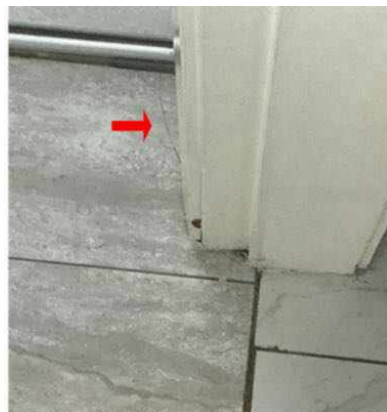
Finding 3.30

Building: Granny-Flat
Location: All Internal Areas - Granny
Finding: Tiles Cracked to some areas
Information: Hairline cracking was observed to wall tiles in the bathroom, extending vertically and branching in a tension-related pattern. These defects are considered minor at present, but are likely caused by substrate movement, water-induced expansion, or installation stresses. While structural impact appears limited, failure to address this may compromise waterproofing integrity. Prompt rectification by a qualified tiler is recommended to prevent further damage and potential water ingress behind the tiled surface.

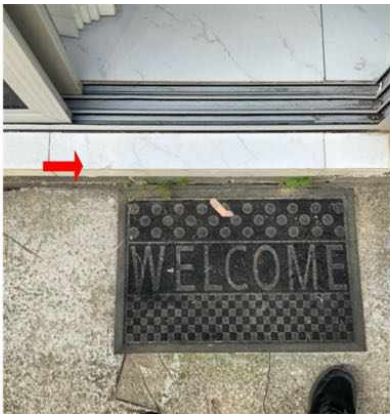
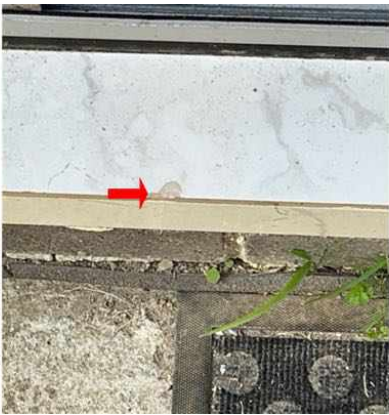
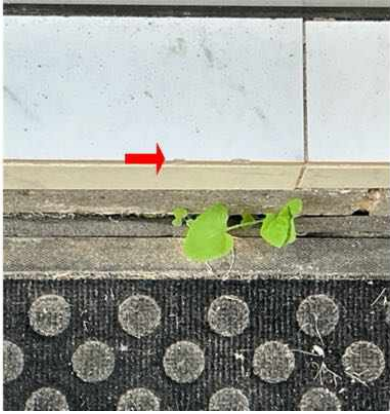
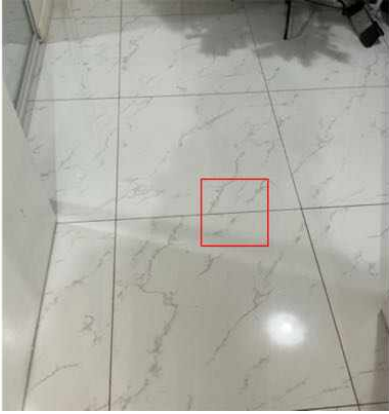
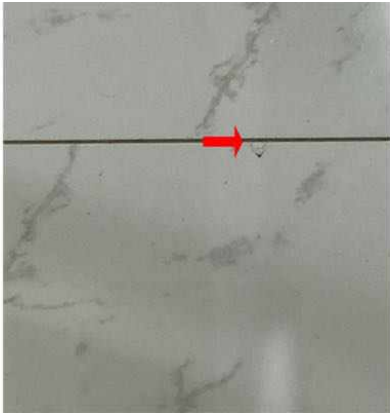
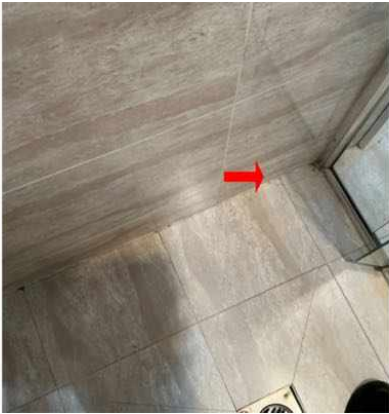
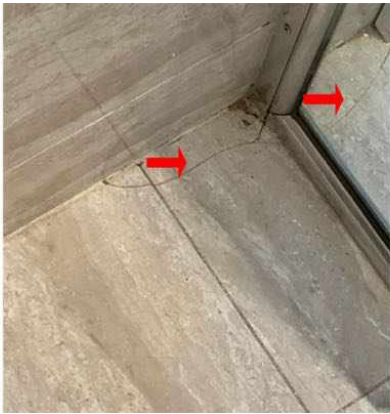
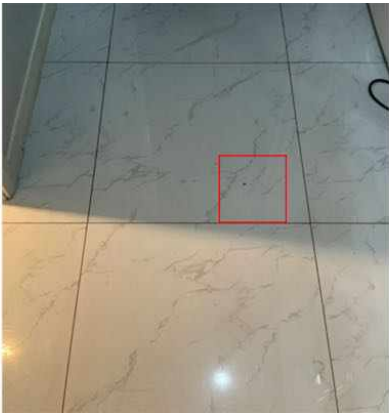
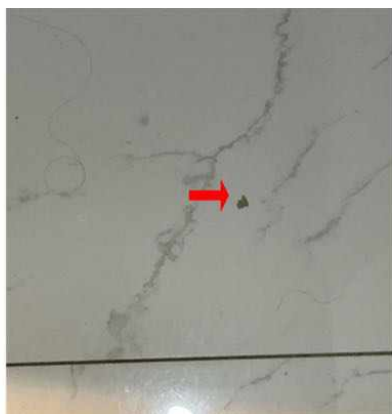
Building:	Granny-Flat
Location:	All Internal Areas - Granny
Finding:	Paint Finish & Hairline Cracking to some areas
Information:	The paint finish in this area was identified as being incomplete or substandard at the time of inspection including some hairline minor cracking/separation. Monitoring is recommended where cracking and separation is evident.

Whilst incomplete or missing paint finish is generally an appearance defect, it can also lead to the development of secondary building defects over time. Incomplete areas of paint finish expose the area to moisture, potentially accelerating the deterioration of underlying building materials.

Incomplete paint finishes should be sanded back, filled, leveled and painted, as applicable. Where inadequate or missing paint protection has led to the deterioration of the associated building element, repair and/or replacement of this building element may be required.

A painting contractor should be appointed as soon as possible to perform necessary works to aid the appearance of the affected area and to ensure the area is protected against further deterioration. Alternatively, the homeowner following manufacturer instructions may perform these works.

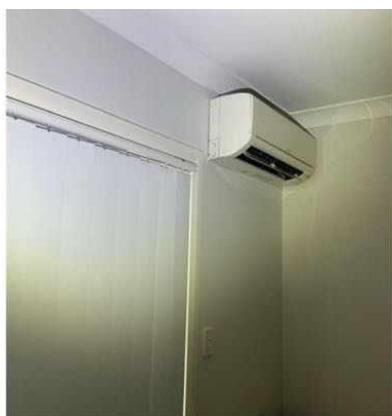
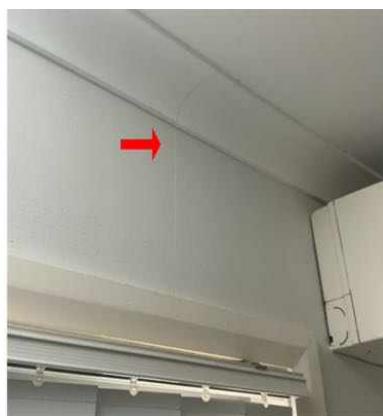
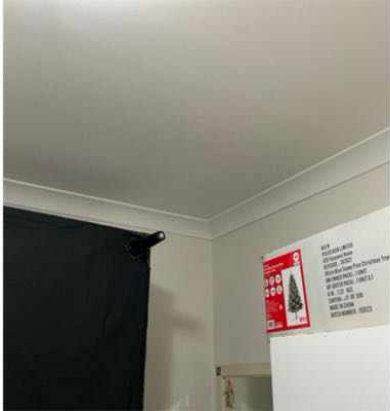
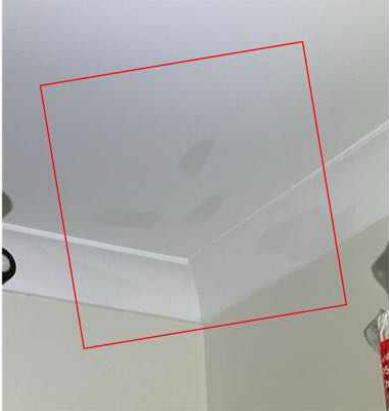
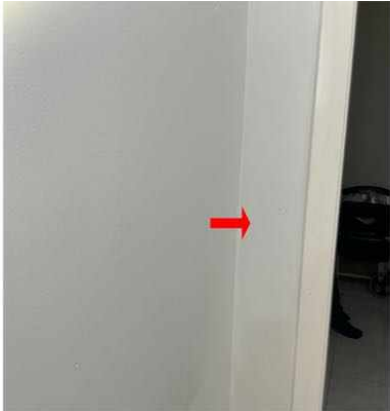
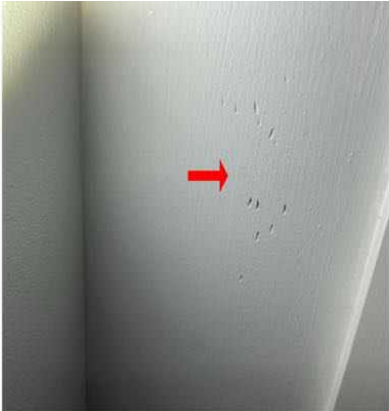
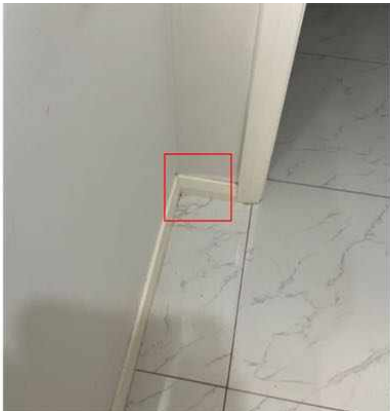
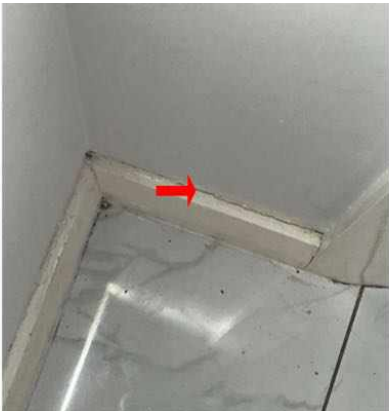
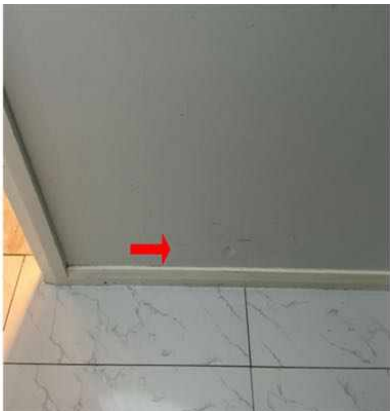
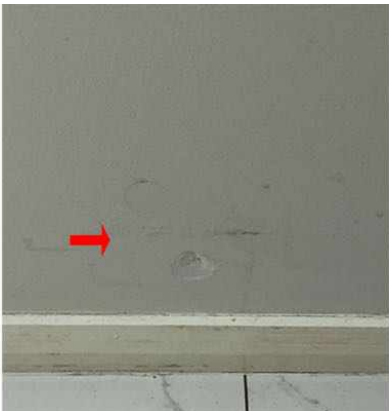
Building:	Granny-Flat
Location:	All Internal Areas - Granny
Finding:	Sealant and grouting - Missing or degraded to some areas
Information:	It was noted on inspection that sealant or grout is degraded.

Different materials and floor areas move at different rates, generally causing cracking to grout or sealant at this point. A flexible sealant is required to allow for expected expansion and contraction, while keeping the joint water tight and protective of all associated building materials.

scraping out and replacement.

Flexible and mould resistant materials should be applied to affected areas to prevent any subsequent water damage that is likely to occur. Regular maintenance and replacement of damage or missing or damaged sealant and grout is highly recommended to the wet areas, as this is a regular wear and tear defect. Sealant and grouting in areas that come into regular contact with water should be maintained for the long term care of your property.

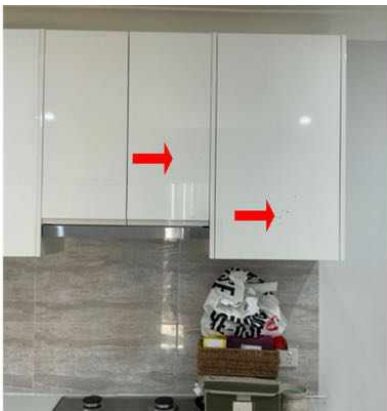
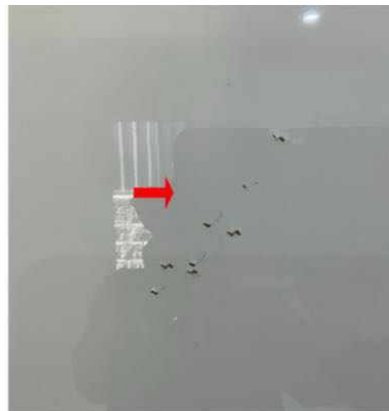
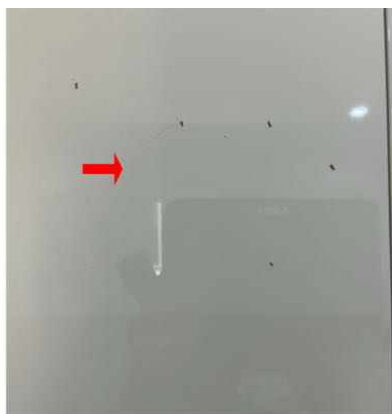
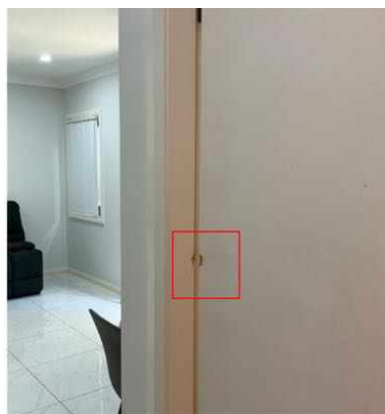
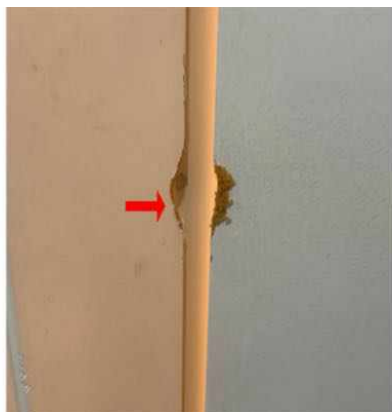
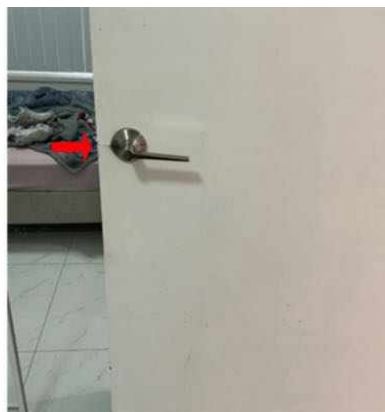
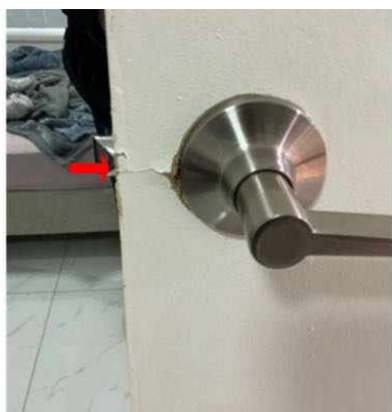
Finding 3.33

Building:	Granny-Flat
Location:	All Internal Areas - Granny
Finding:	Building element - Damaged - Cabinet chipped kitchen , bathroom/bedroom door damaged
Information:	Breakage occurs generally when the building materials have either aged and decayed, or as a result of damage (accidental or deliberate).

Repair and/or replacement of broken elements is advised to ensure that additional secondary defects do not arise as a consequence. Such works are necessary, as all building elements play a key role in the operation and function of the overall structure and its performance.

A relevant tradesperson should be appointed to repair or replace the affected building element prior to any subsequent damage being caused.

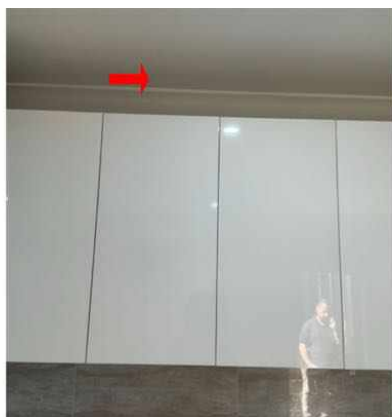
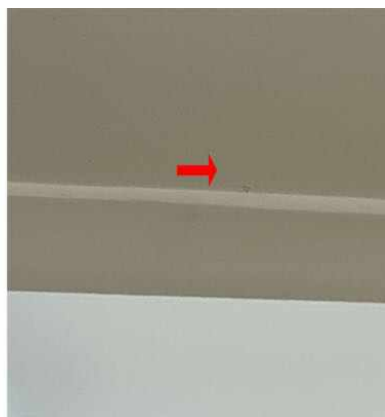
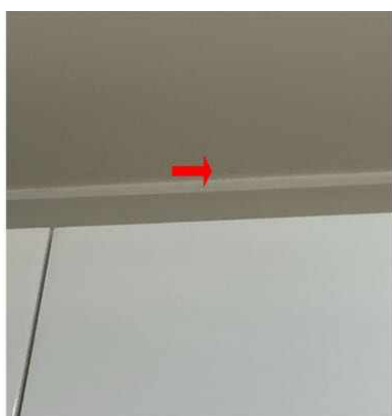
Finding 3.34

Building:	Granny-Flat
Location:	All Internal Areas - Granny
Finding:	Ceiling nails - Popping to some areas
Information:	Numerous popped nails were identified in the internal ceiling at the time of inspection. Nails and screws hold simply by the friction between them and the surface they are applied to. Over time, the nails and screws can back out, which is often a result of general ageing and deterioration of the building structure.

If left unmanaged, the ceiling sheets may become loose and unstable, increasing the rate of deterioration of the internal ceiling and creating potential for the development of secondary defects.

Re-fastening of popped nails will help to maintain the stability of the internal ceiling and associated building elements. Such minor works will also help to improve the appearance of the affected area and secure the ceiling sheets, so as to prevent the onset of ceiling sagging. These works should be performed by a qualified carpenter or plasterer at client discretion.

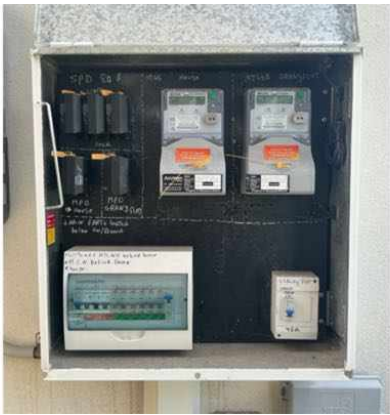
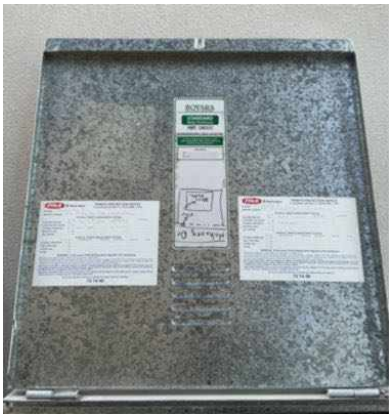
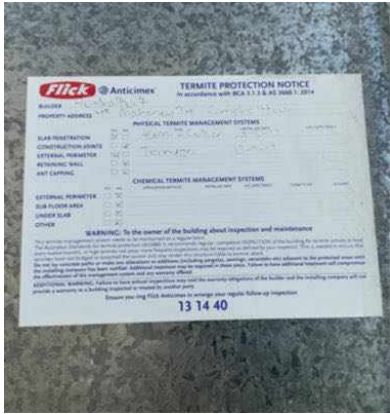
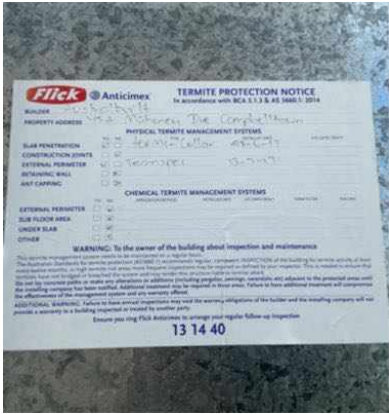
Building:	Main Building
Location:	All External Areas & Granny
Finding:	Termite Management System - no evidence of a chemical installation
Information:	The application of a post-construction chemical termite barrier is highly recommended for all properties, particularly if live termite activity has been found on the site previously. Such barriers are highly effective in preventing termite attack on any timber building elements throughout the property.

A durable notice should be placed in the switchboard unit to indicate current termite barriers. At the time of inspection, it appeared as though no termite management system has been installed, with no evidence to suggest preventative works taking place.

The client may consider gaining further advice from a pest controller as to the costs and procedures involved with this application. It is recommended that obtaining such advice be a short-term priority.

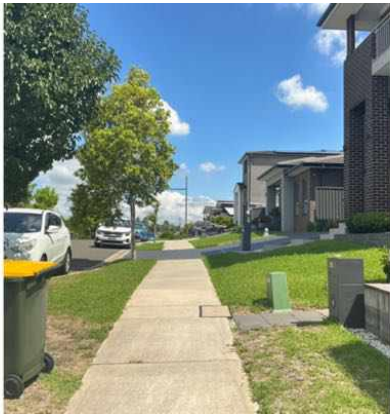
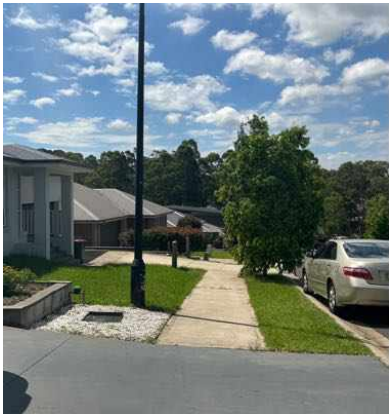
Finding 6.02

Building: Main Building
 Location: All External Areas & Granny
 Finding: Trees within 50m
 Information: Trees within 50m of the property can be conducive to termite activity. It is recommended an invasive inspection of all trees with 50m to the property be carried out by a qualified pest control expert.

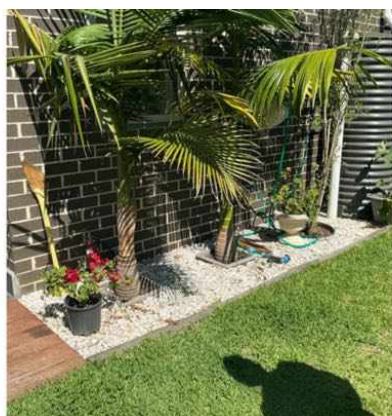
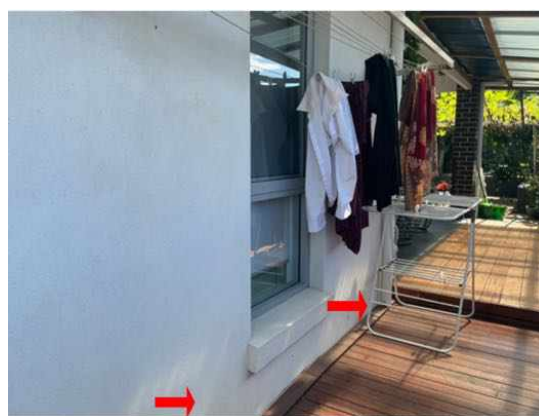
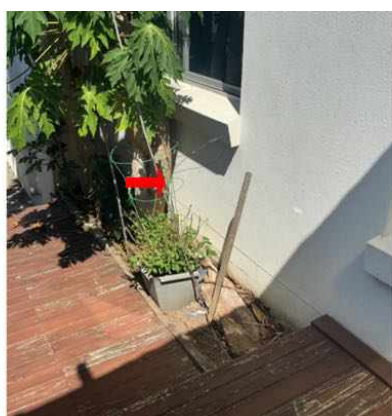
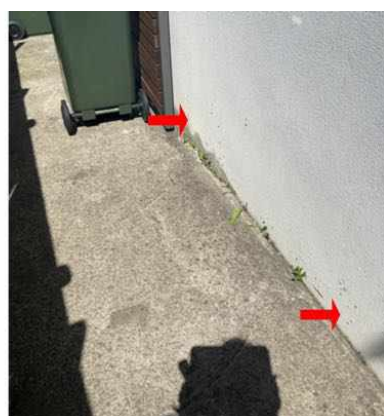
Finding 6.03

Building: Main Building

If the slab edge is not properly exposed there is a high risk of termite attack. Sometimes, in order to determine the type of slab, a suitably qualified person such as an architect or builder may be required to consult the construction plans.

Where the slab edge cannot be properly inspected, it is highly recommended that termite or timber pest inspections be carried out every 6-12 months to aid protection of the property against infestation.

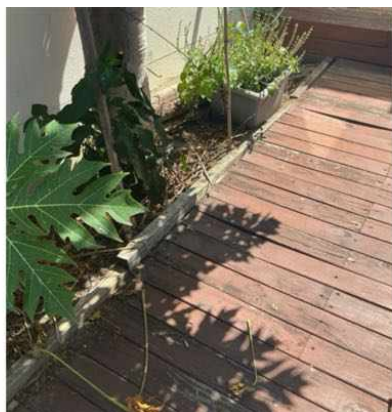
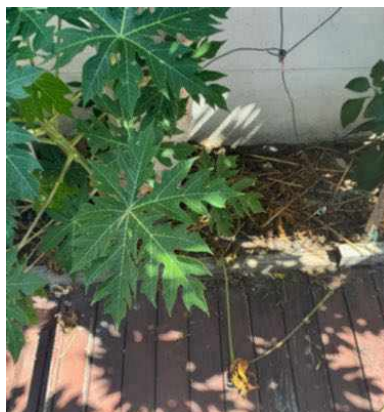
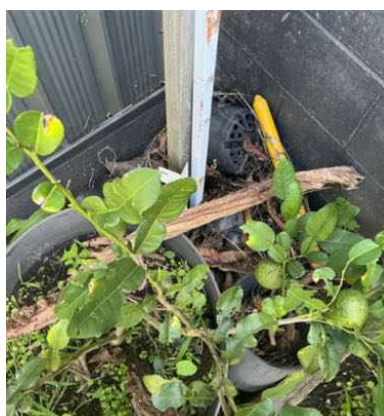
Finding 6.04

Building: Main Building
 Location: All External Areas
 Finding: In ground contact - Timber
 Information: Any timbers in direct ground contact provide opportunity for concealed termite entry

and are likely to be subject to premature rot and decay as the soil retains moisture or damp conditions against the timbers.

Remove untreated timber that is in direct contact with external grounds. Consider replacement with more durable materials i.e. treated timber or non timber elements. Frequent pest inspections are advised to readily identify any termite activity in these areas.

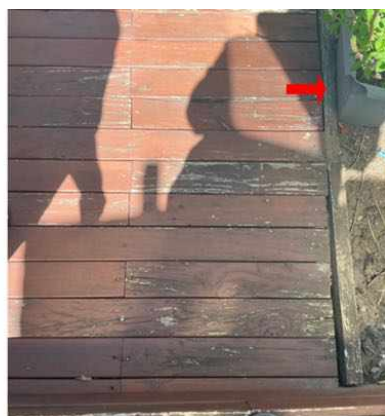
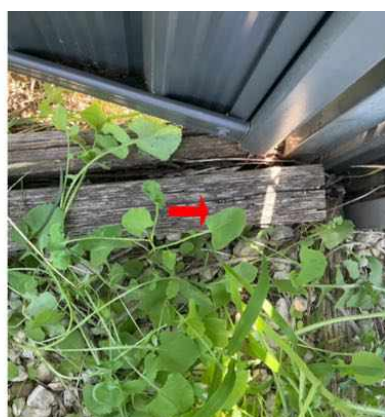
Building:	Main Building
Location:	All External Areas
Finding:	Fungal decay - present
Information:	Fungal decay also known as wood decay or wood rot generally refers to the deterioration of timber elements when in contact with excessive levels of moisture for a prolonged period of time.

The development of fungal decay is accelerated by temperatures in the range of 5degreeC to 40degreeC as well as the presence of oxygen. Generally fungal decay develops on timber elements that are in use in an external environment which are exposed to rain penetration.

In this case although the affected timber element is in a decaying state the extent of any visible damage appears to be localised to a specific area and is yet to spread to other parts of the building element or affect adjoining structures. The fungal decay is therefore likely to be of a relatively superficial nature with minimal impact on the structural integrity or tensile strength of the timber element.

A further invasive inspection by a licensed timber pest technician is highly recommended to check for concealed activity.

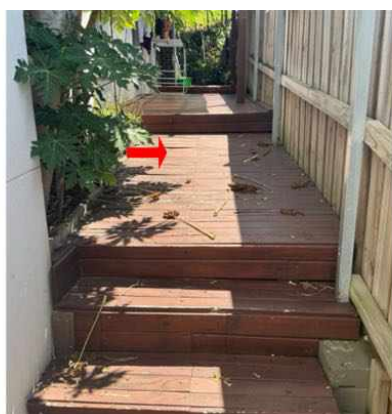
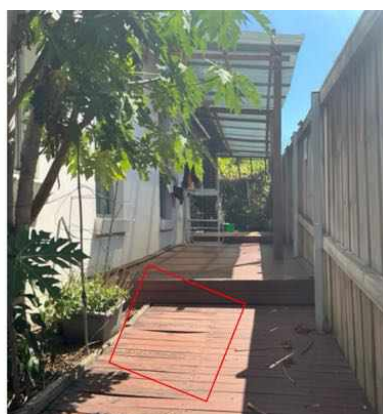
External timber structures are also constantly exposed to weather elements and can deteriorate in an accelerated manner, ongoing assessments are required.

It is highly recommended that a Structural Engineer further assess the external timber balcony or deck to inform the client of its load capacity. Regular maintenance inspections by competent practitioners is needed.

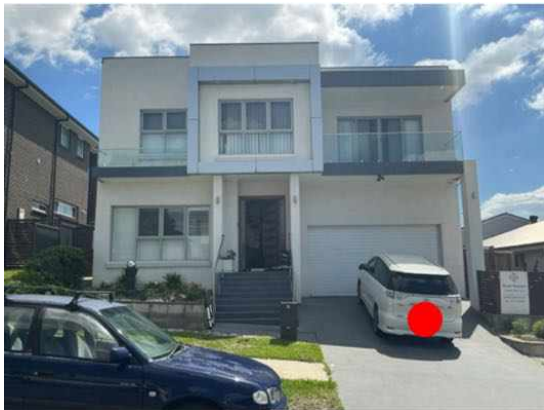
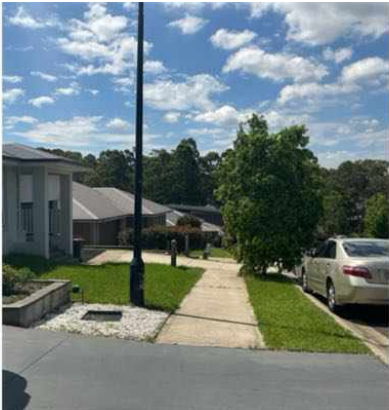
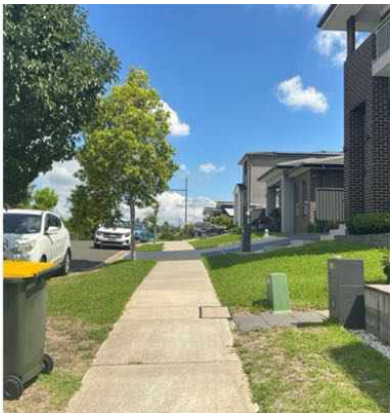
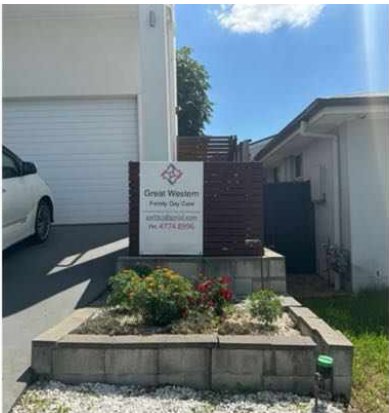
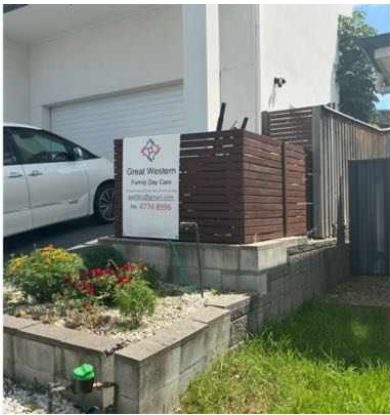
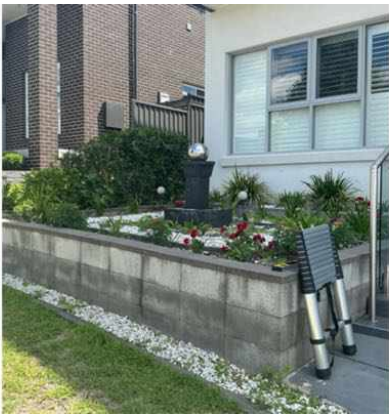
Noted Item

Building: Main Building
 Location: All External Areas
 Finding: Additional Photos - Obstructions and Limitations
 Information: These photographs are an indication of the obstructions and limitations which impeded full inspection of the property at the time of inspection. These obstructions can hide an array of defects and should be removed to allow full inspection to be carried out. A re-inspection is recommended once the areas are made accessible.

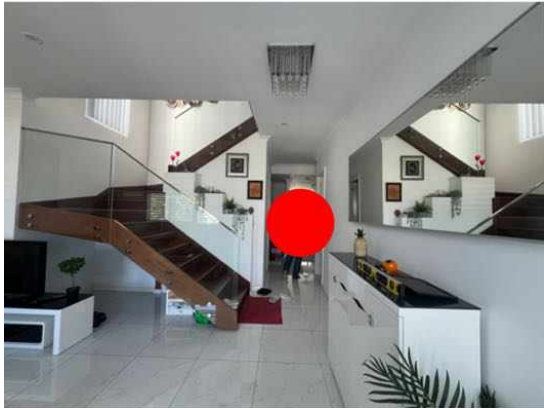
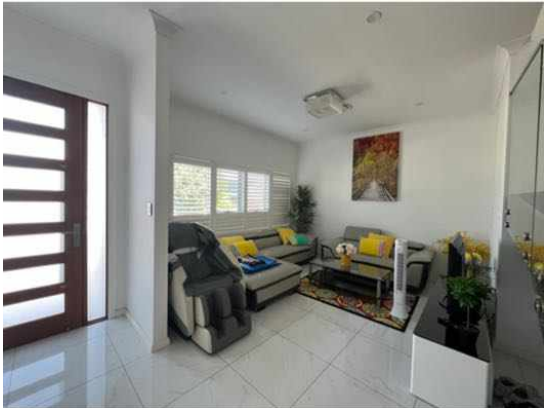
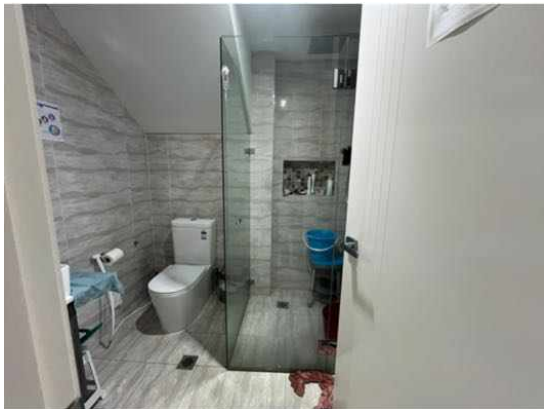
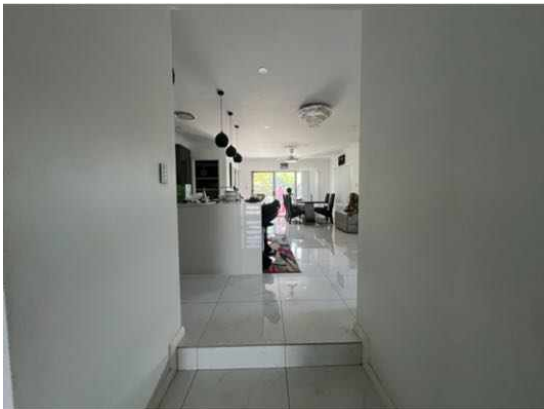
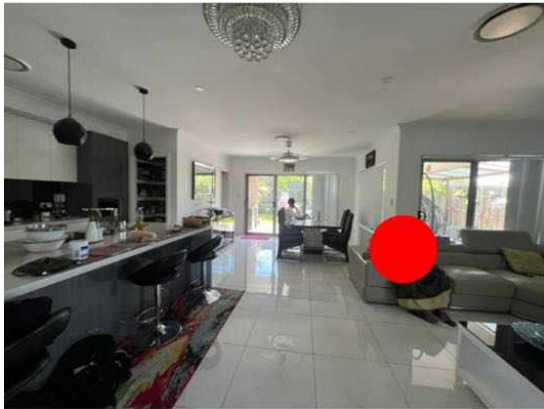
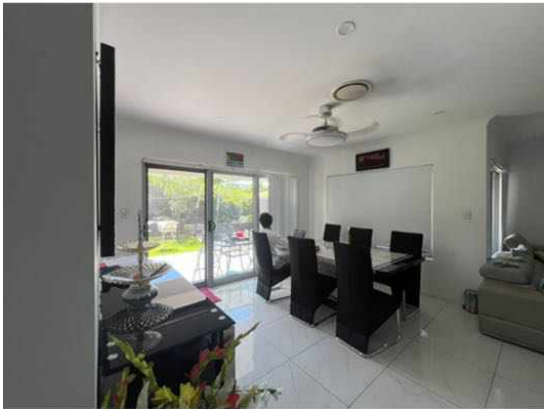
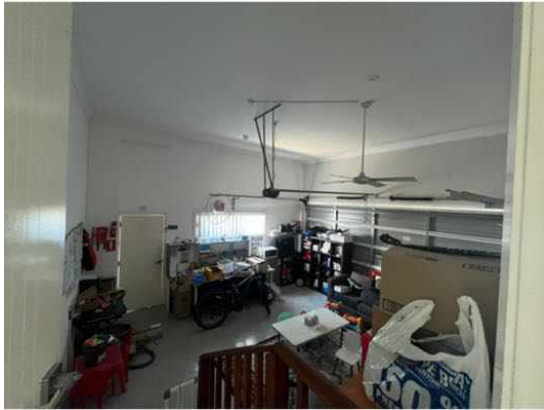
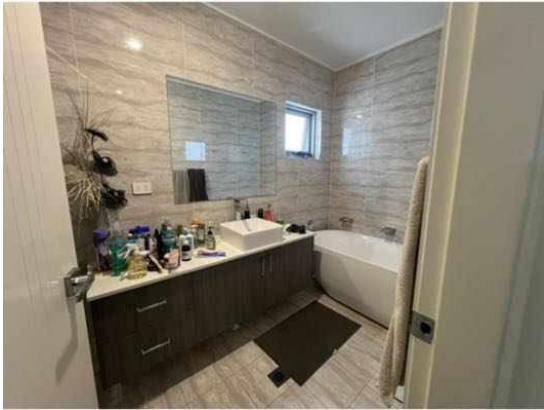
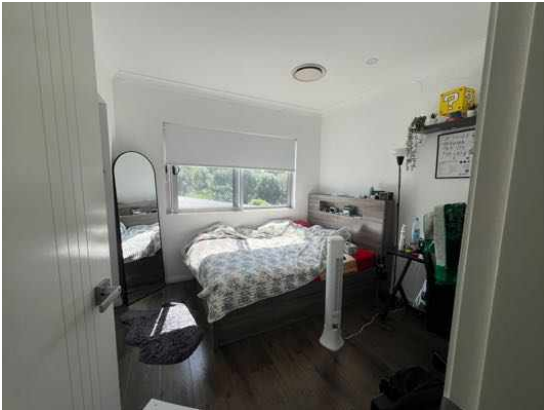
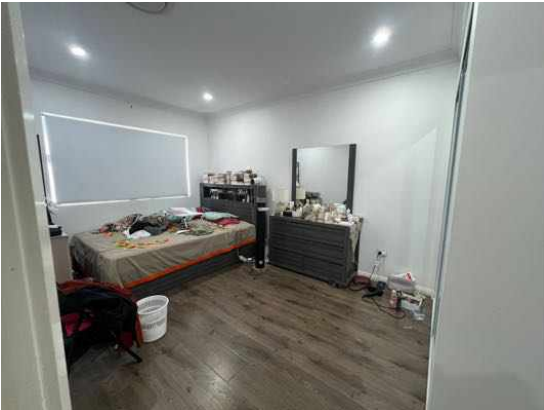
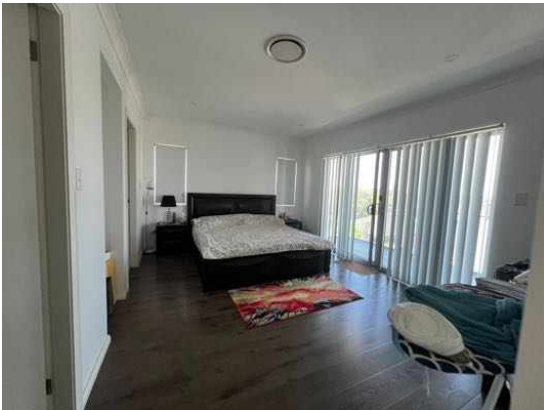
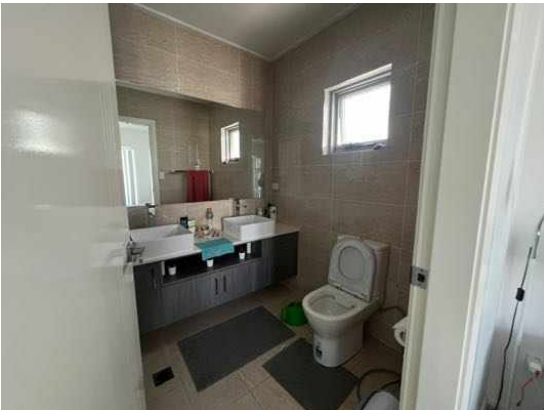
Building: Main Building
Location: All Internal Areas
Finding: Additional Photos - Obstructions and Limitations
Information: These photographs are an indication of the obstructions and limitations which impeded full inspection of the property at the time of inspection. These obstructions can hide an array of defects and should be removed to allow full inspection to be carried out. A re-inspection is recommended once the areas are made accessible.

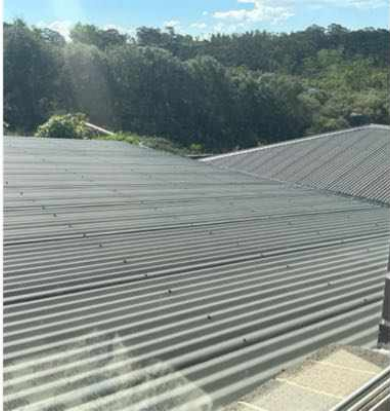
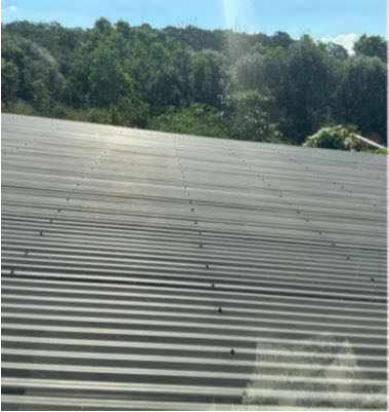
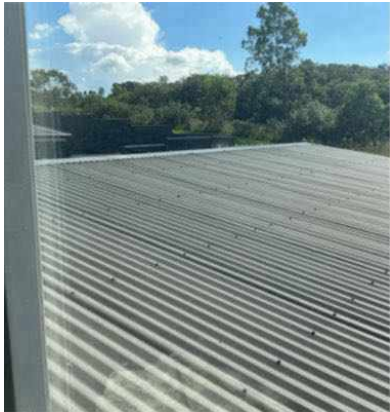
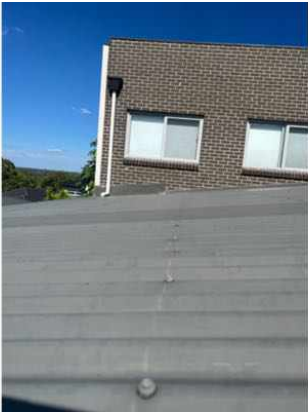
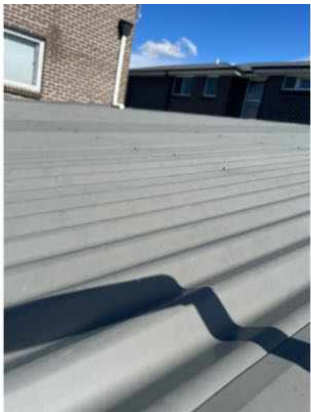
Building: Main Building
Location: Roof Exterior
Finding: Additional Photos - Obstructions and Limitations
Information: These photographs are an indication of the obstructions and limitations which impeded full inspection of the property at the time of inspection. These obstructions can hide an array of defects and should be removed to allow full inspection to be carried out. A re-inspection is recommended once the areas are made accessible.

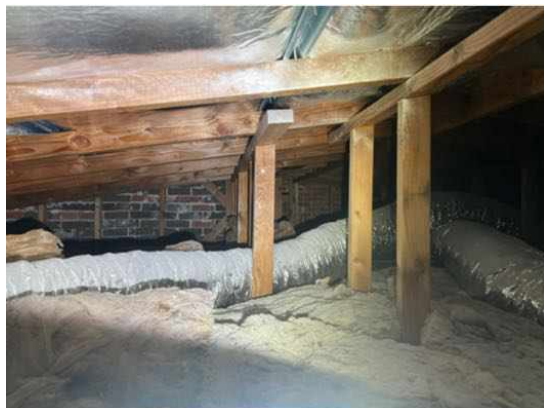
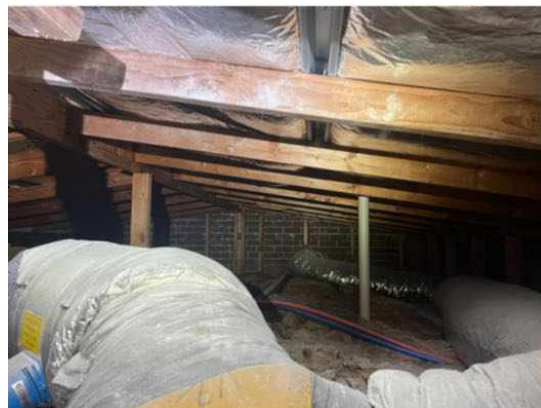
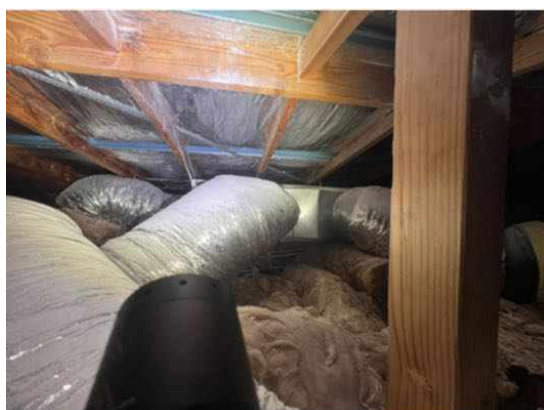
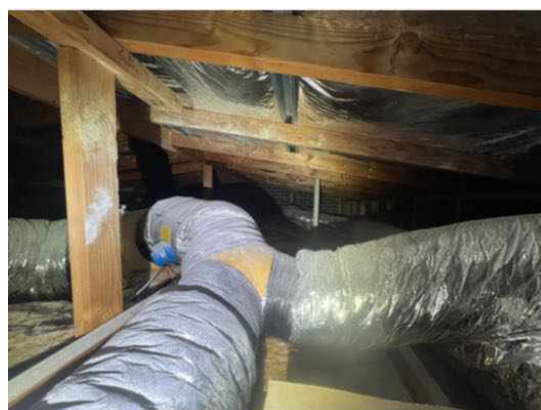
Building: Main Building
Location: Roof Void

Finding: Additional Photos - Obstructions and Limitations
 Information: These photographs are an indication of the obstructions and limitations which impeded full inspection of the property at the time of inspection. These obstructions can hide an array of defects and should be removed to allow full inspection to be carried out. A re-inspection is recommended once the areas are made accessible.

It is recommended to install a second manhole at a suitable location to allow for full inspection of the roof space.

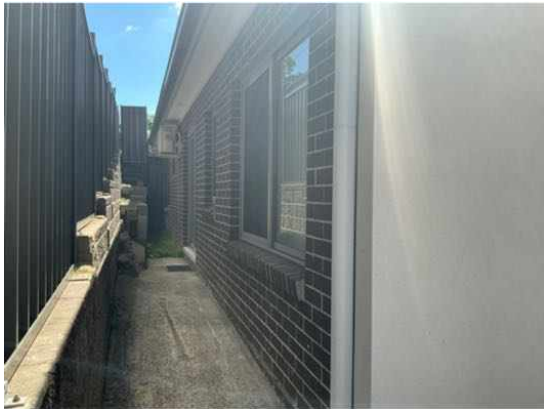
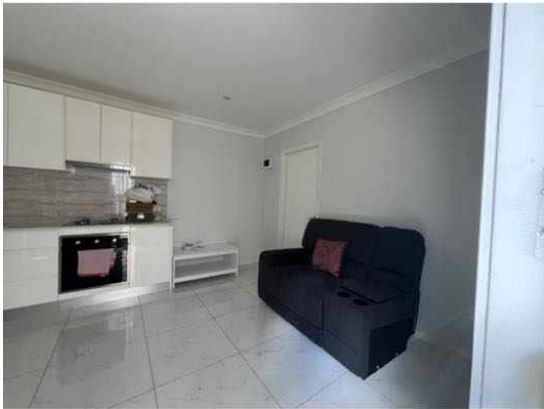
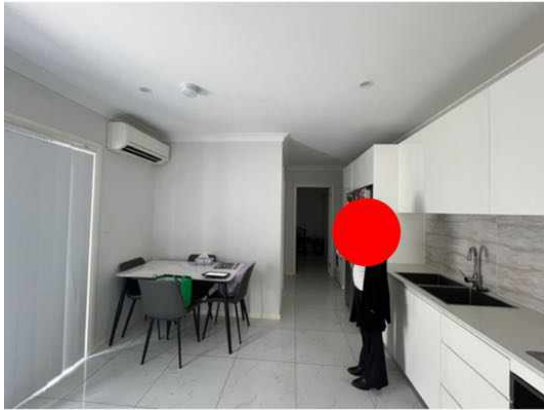
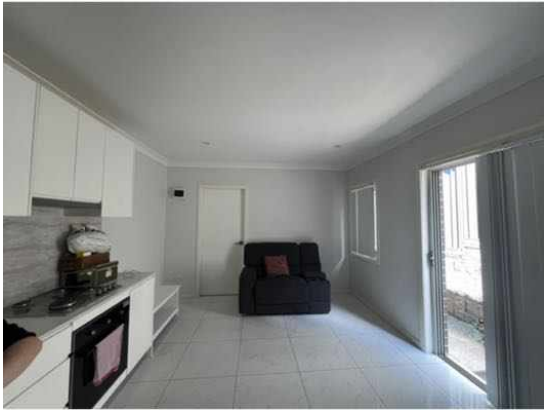
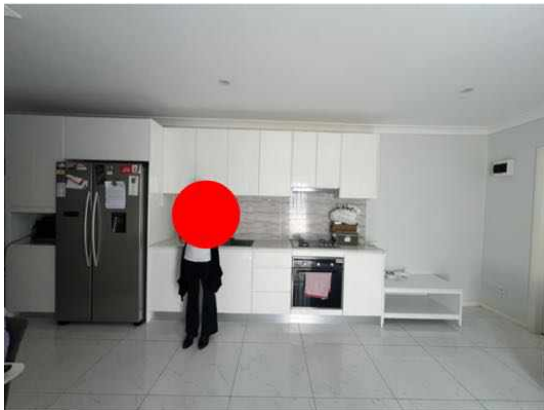
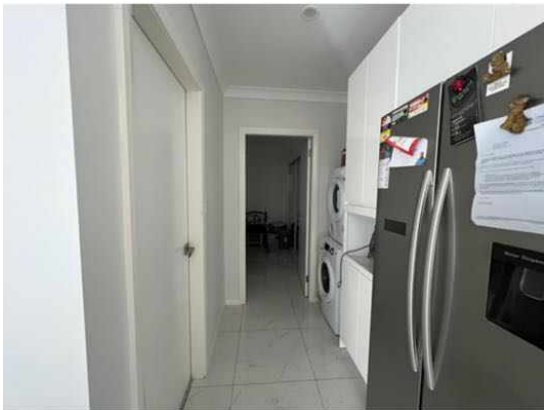
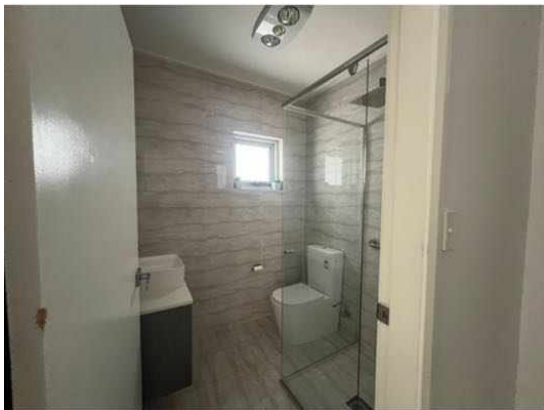
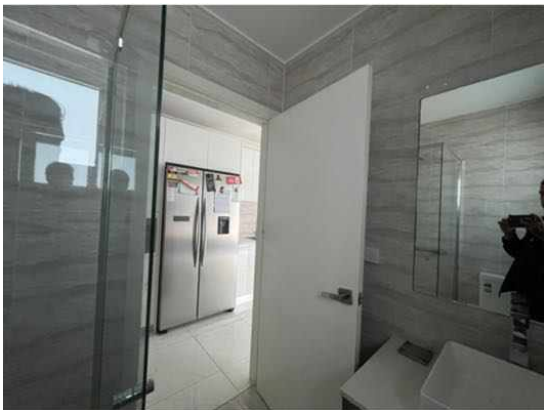
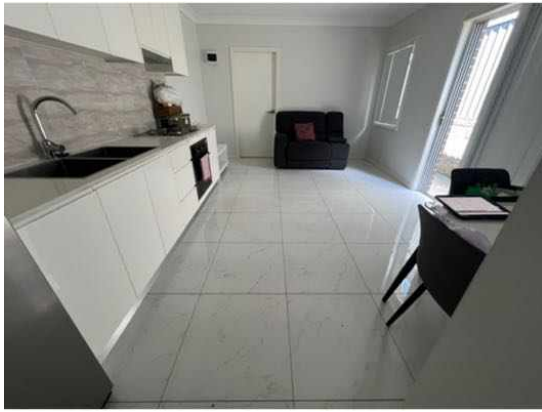
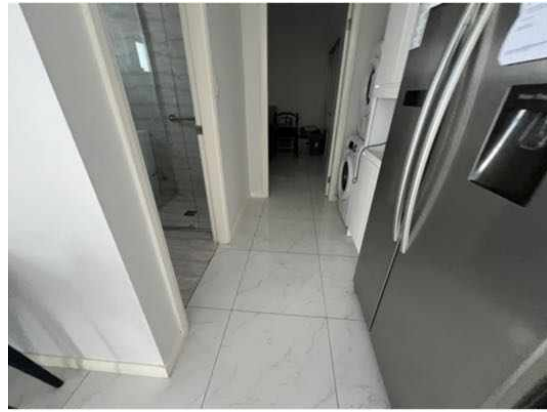
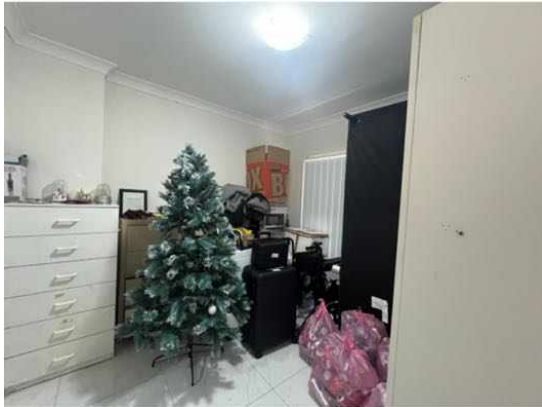
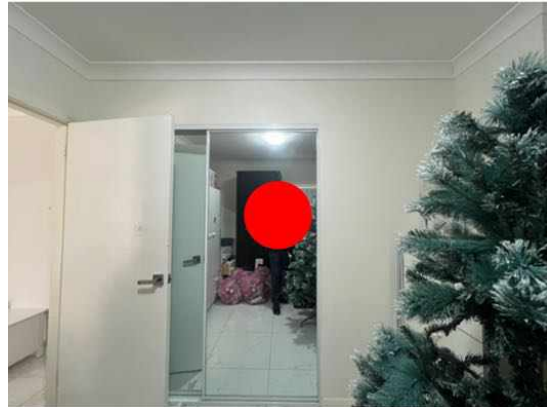
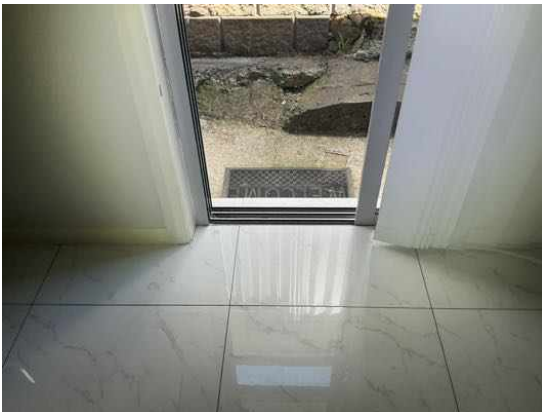
Building: Granny-Flat
 Location: All Internal Areas - Granny
 Finding: Additional Photos - Obstructions and Limitations
 Information: These photographs are an indication of the obstructions and limitations which impeded full inspection of the property at the time of inspection. These obstructions can hide an array of defects and should be removed to allow full inspection to be carried out. A re-inspection is recommended once the areas are made accessible.

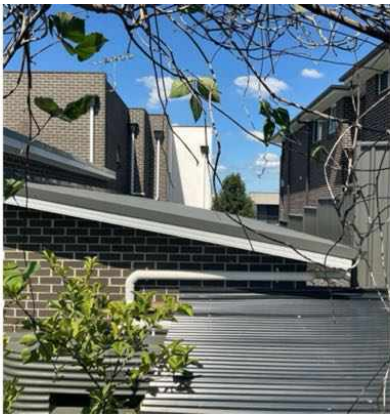
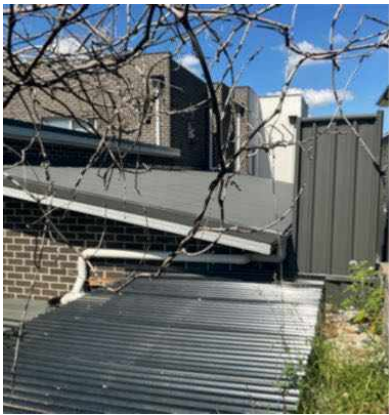
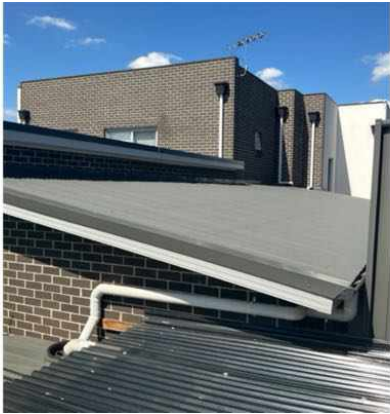
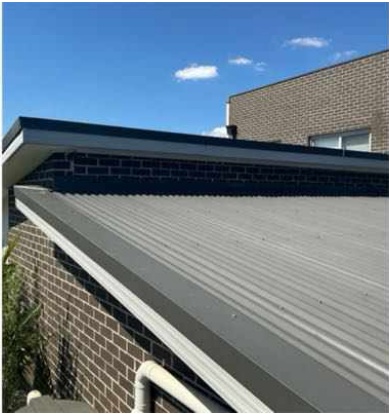
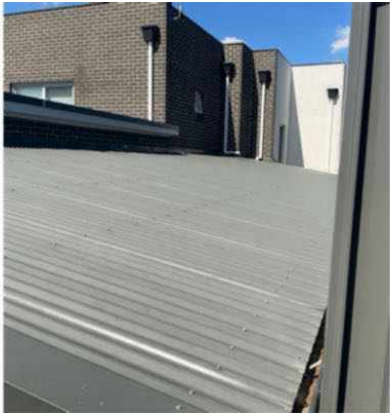
Building: Granny-Flat
 Location: Roof Exterior - Granny
 Finding: Additional Photos - Obstructions and Limitations
 Information: These photographs are an indication of the obstructions and limitations which impeded full inspection of the property at the time of inspection. These obstructions can hide an array of defects and should be removed to allow full inspection to be carried out. A re-inspection is recommended once the areas are made accessible.

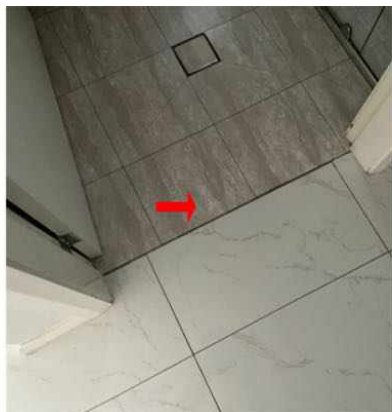
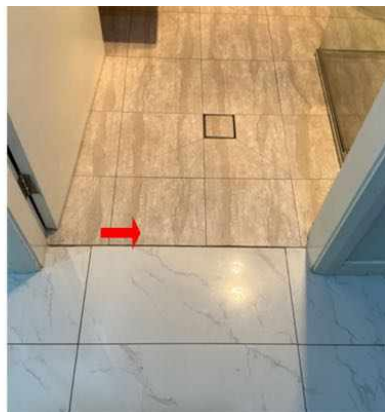
Noted Item

Building: Granny-Flat
Location: All Internal Areas - Granny
Finding: Bathroom & external floor threshold
Information: The bathroom floor is at the same level as the adjoining timber flooring. This configuration is typical in modern apartments and is permitted where compliant waterproofing and floor falls are provided. No evidence of moisture damage was observed at the time of inspection; however, waterproofing performance cannot be confirmed without invasive inspection.

Care should be taken to avoid excessive water migration beyond the bathroom during use.

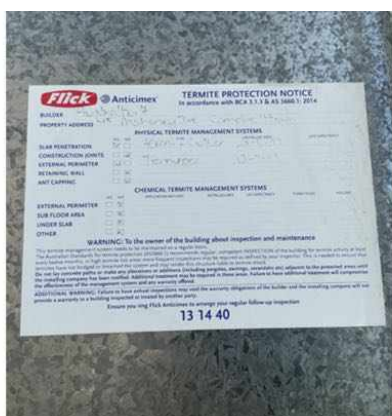
Noted Item

The following items were noted as - Evidence of a previous termite management program

Where a Termite Management System has been identified you should refer to the type of barrier date of installation warranty conditions and any documentation provided by a builder or past owner. Consult the company who installed the barrier to confirm whether the system is still under warranty.

Most chemical termite management systems expire and require replenishment and all physical systems are primarily designed to prevent concealed entry.
