# Building and Timber Pest Inspection Report

Inspection Date: Mon, 30 Mar 2026

Property Address: 26 Sydney Ave, Callala Bay NSW 2540,  
Australia

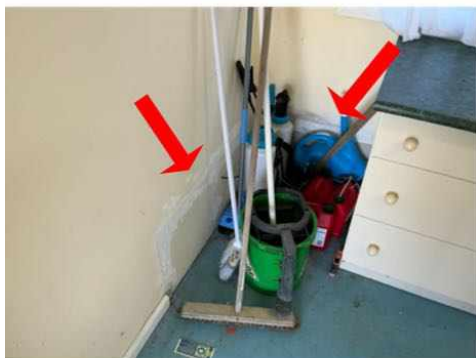
## Finding 2.02

Building: Main Building

Finding: Water Damage.

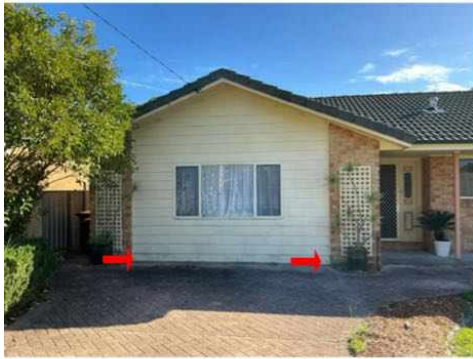
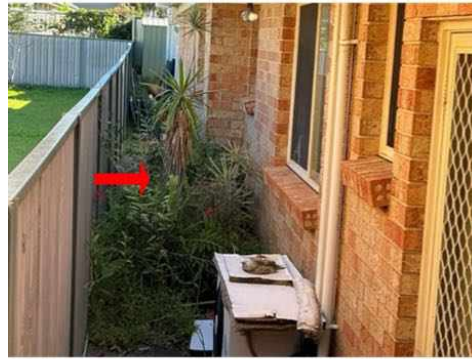
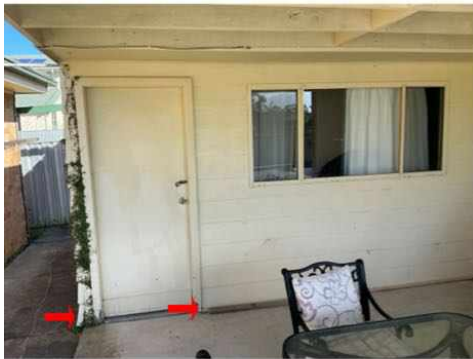
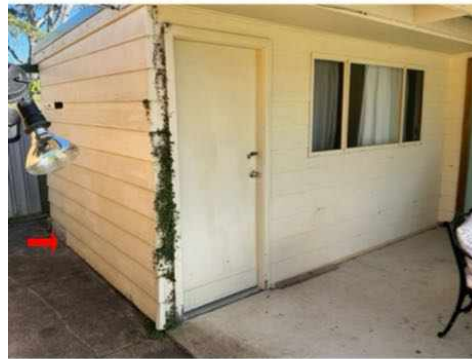
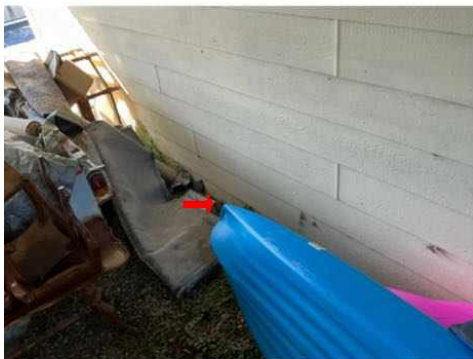
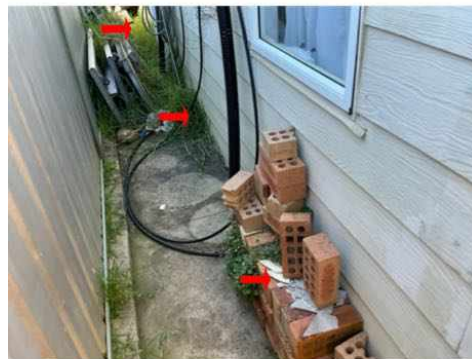
Generally this takes the form of finished ground levels external paving, concrete, fencing posts, gardens, vegetation, plumbing, stored items etc being retrospectively installed above the ant cap level or weep and ventilation holes.

Where bridging of the termite management system has occurred full inspection is prevented and termites may enter a property in a concealed or undetectable manner.
