Building and Timber Pest Inspection Report

Inspection Date: Fri, 13 Mar 2026

Property Address: 92A Sixth Ave, Altona North VIC 3025,
Australia

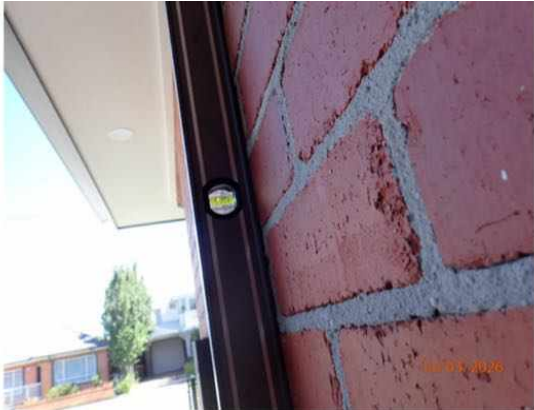
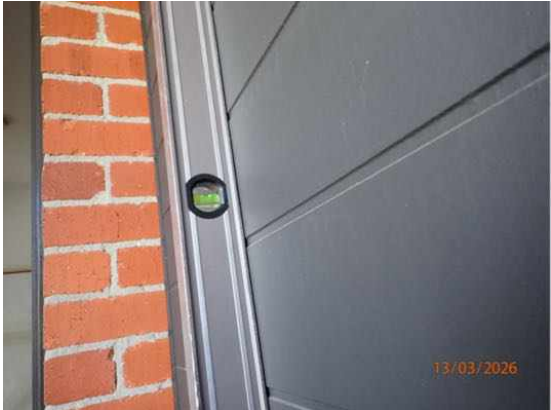
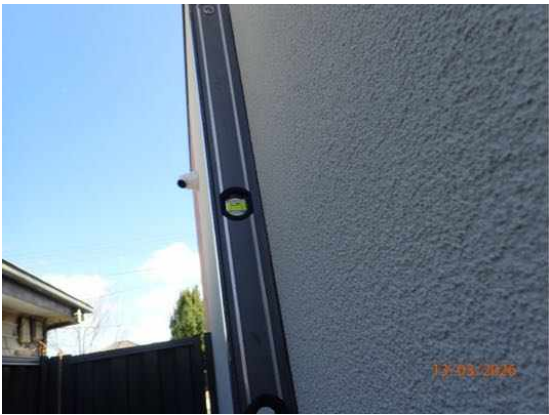
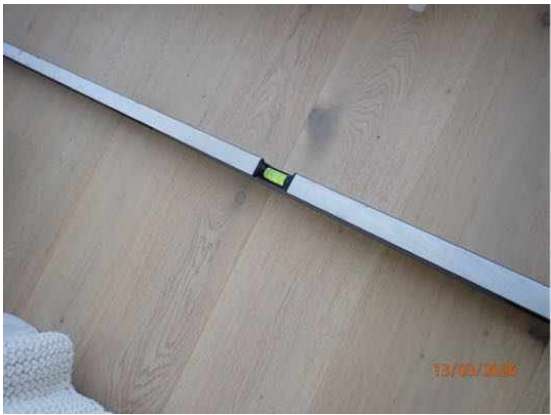
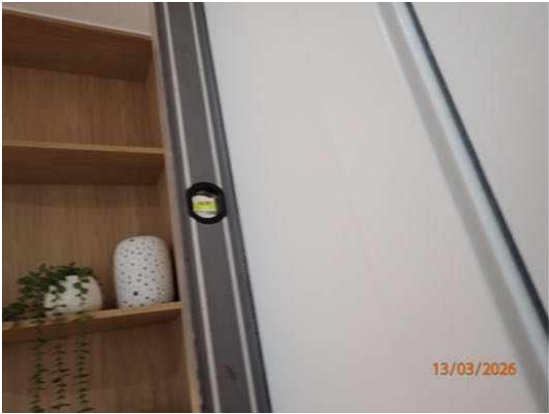
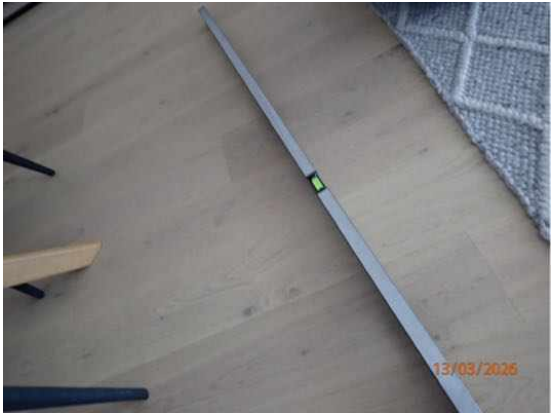
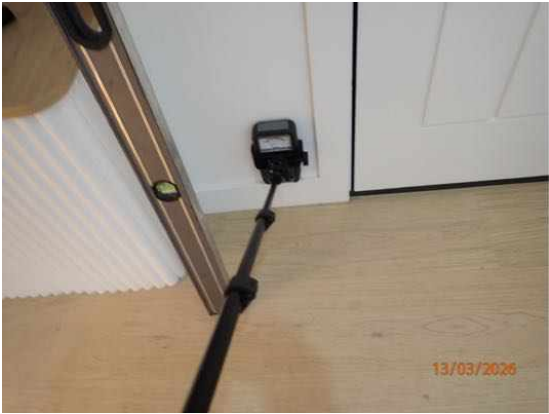
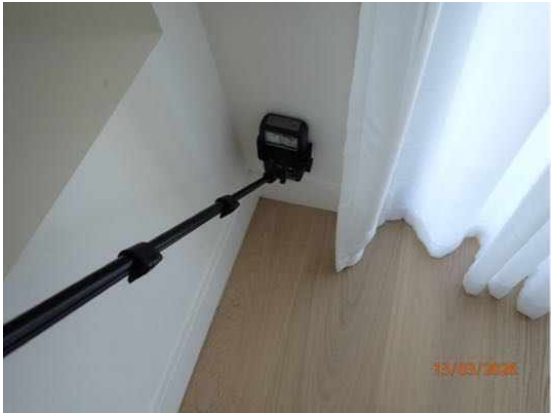
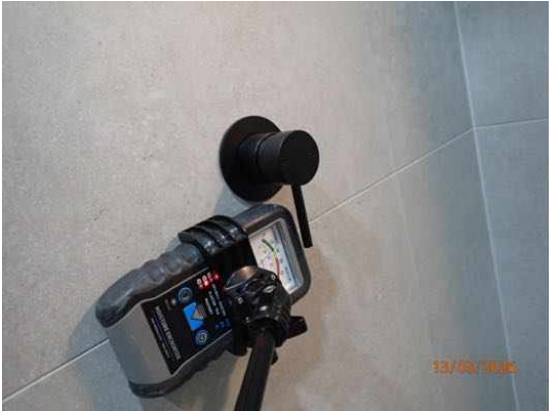
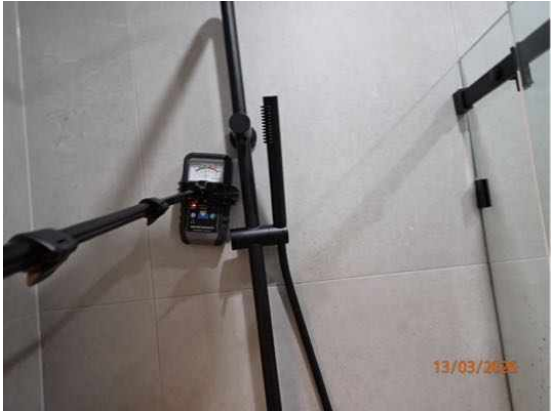
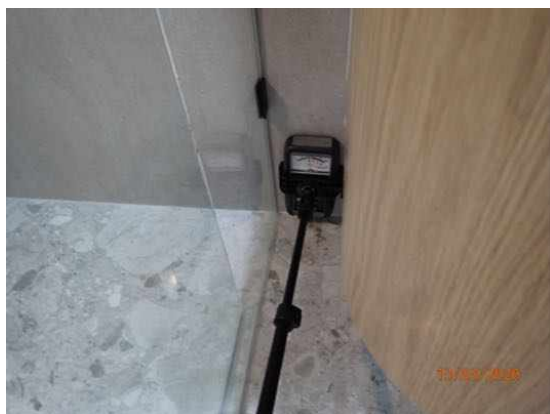
Building: Main Building
Location: All Areas
Finding: Additional Photos
Information: Additional photos are provided for your general reference

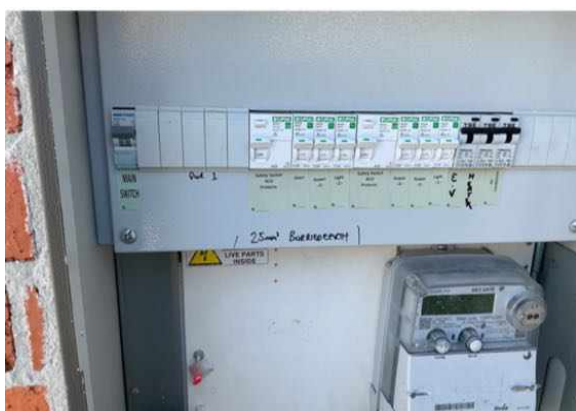
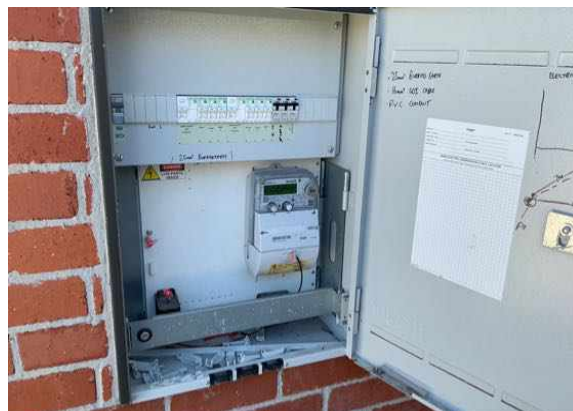
Building: Main Building
 Location: Meter Box
 Finding: Electrical Switch Box
 Information: All electric wiring, meter boxes and appliances need to be checked by a licensed Electrician ensuring any work completed as part of a renovation or extension has been issued with a Certificate of electrical Safety (CES). The checking of any electrical items is out side the scope of this inspection.

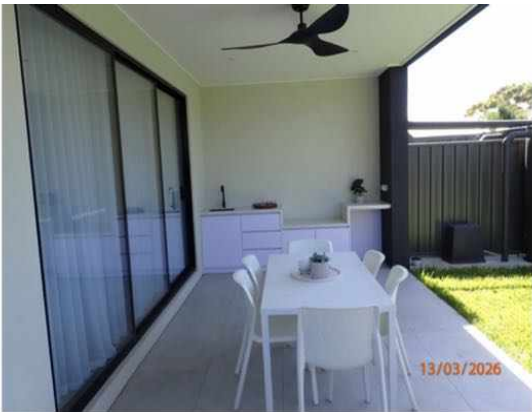
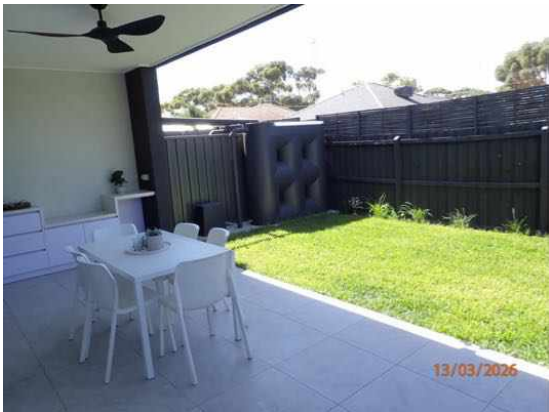
Building: Main Building
 Location: All External Areas
 Finding: Additional Photos - Obstructions and Limitations External Areas
 Information: These photographs are an indication of the obstructions and limitations which impeded full inspection of the External areas of the property at the time of inspection. These obstructions can hide an array of defects and should be removed to allow full inspection to be carried out. A re-inspection is recommended once the areas are made accessible.

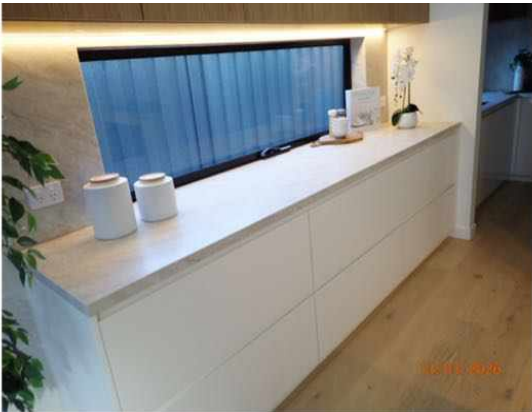
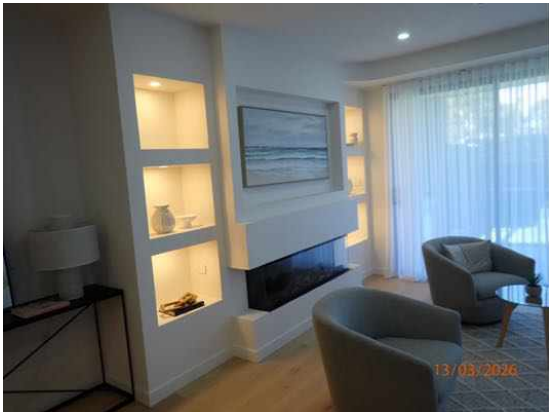
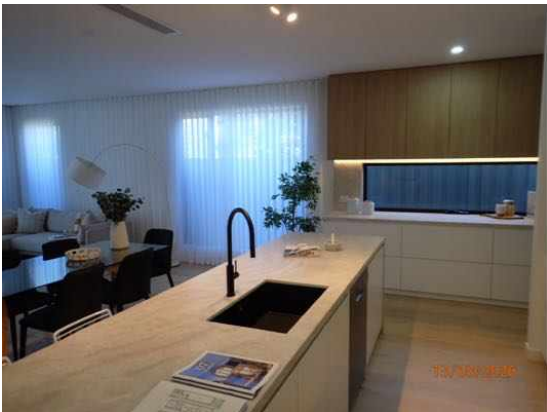
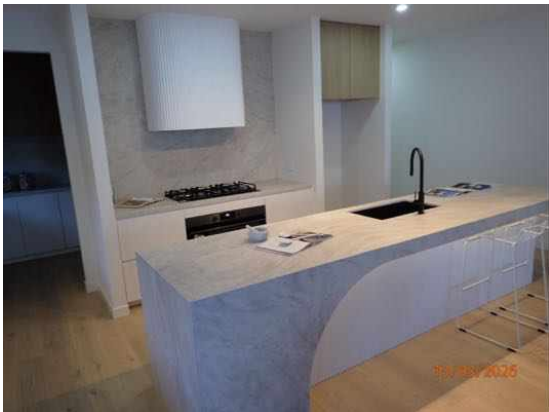
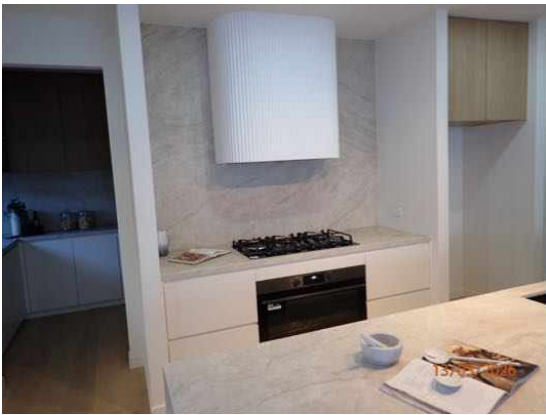
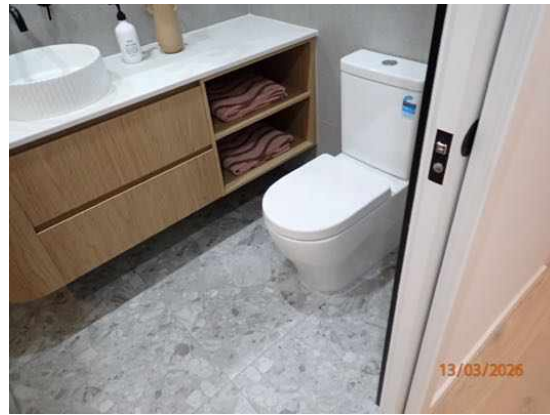
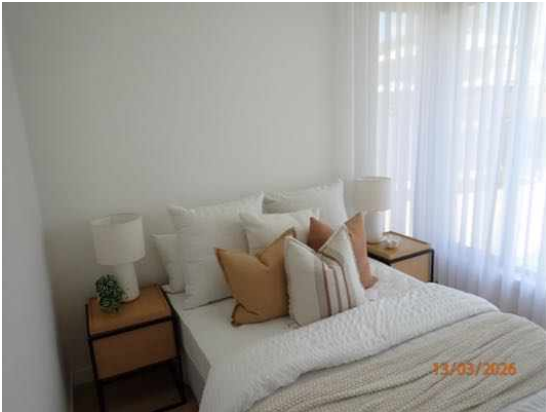
Building: Main Building
Location: All Internal Areas
Finding: Additional Photos - Obstructions and Limitations internal Areas
Information: These photographs are an indication of the obstructions and limitations which impeded full inspection of the internal areas of the property at the time of inspection. These obstructions can hide an array of defects and should be removed to allow full inspection to be carried out. A re-inspection is recommended once the areas are made accessible.

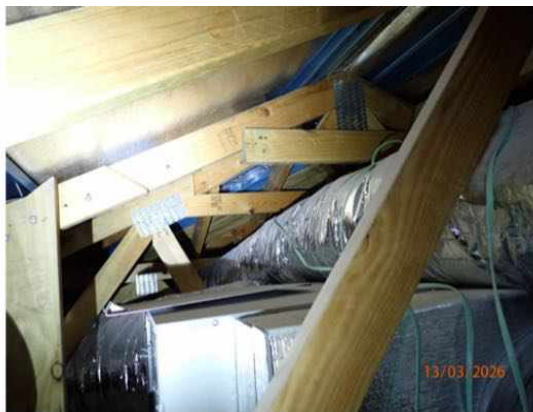
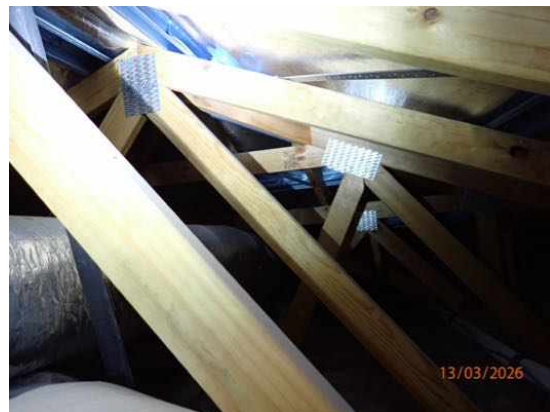
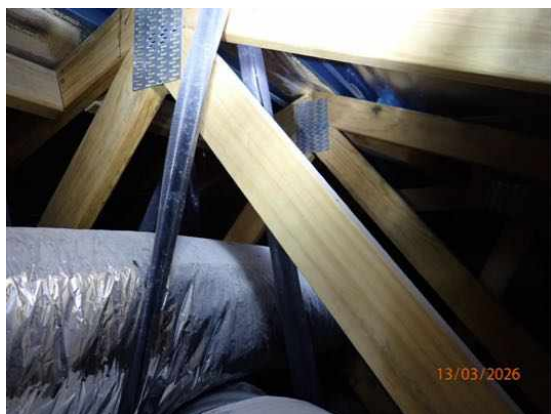
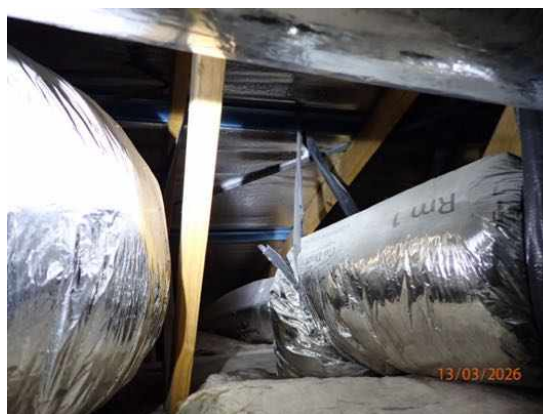
Building: Main Building
Location: Roof Void
Finding: Additional Photos - Obstructions and Limitations Roof Void
Information: These photographs are an indication of the obstructions and limitations which impeded full inspection of the Roof Void of the property at the time of inspection. These obstructions can hide an array of defects and should be removed to allow full inspection to be carried out. A re-inspection is recommended once the areas are made accessible.
