Building Inspection Report

Inspection Date: Mon, 16 Mar 2026

Property Address: 26 Pyingerra Cres, Cheltenham VIC 3192,
Australia

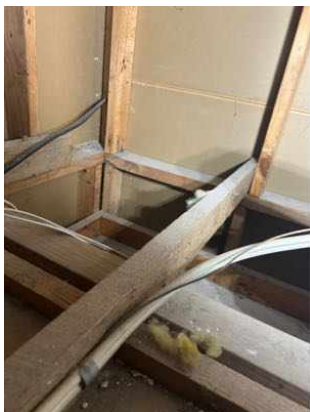
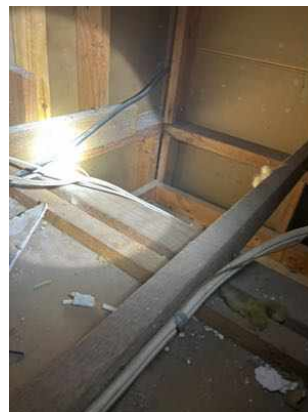
Defects 3.12

Building:	Main Building
Location:	All Areas
Finding:	Unconventional handyman work
Information:	This handyman work appears to have been completed to a substandard level and does not comply with regular building practices. Where handyman work is not completed satisfactorily, accelerated deterioration of the associated building elements is likely to occur and secondary defects to surrounding structures may develop.

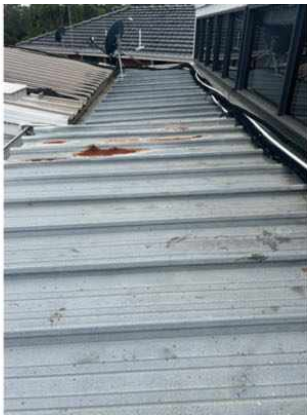
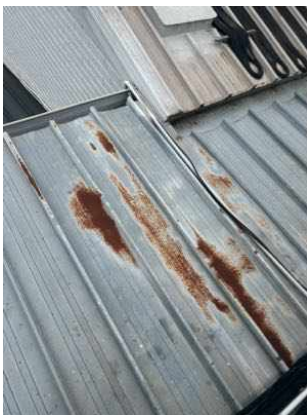
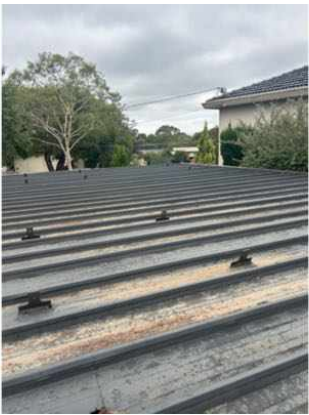
Upon inspection of the exterior roofing structure, evidence of rust to these sections was identified. If left unmanaged, these degrading joints can allow water ingress to the internal roofing structures, potentially leading to secondary damage of building elements. Accelerated deterioration of the roofing sheets and any associated building elements is also likely to occur.

A roofing contractor should be appointed immediately to assess the damage to the roofing sheets and to perform remedial works as necessary. Works may include replacement of severely affected roofing sheets or minor works such as the application of rust-retardant surface protectors.

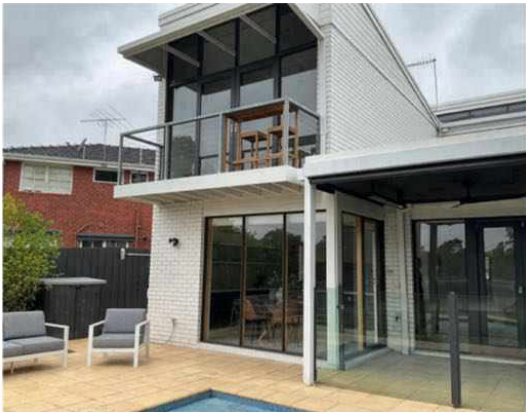
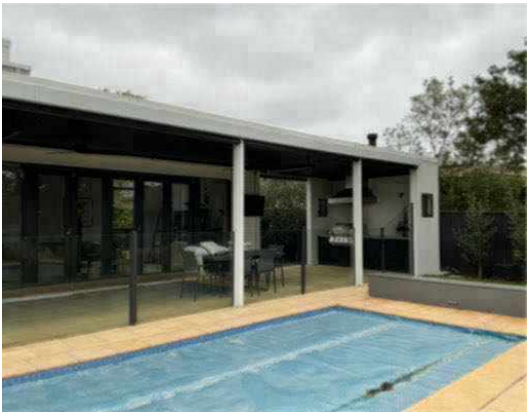
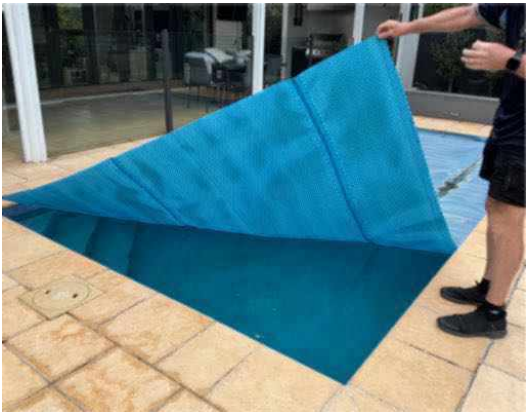
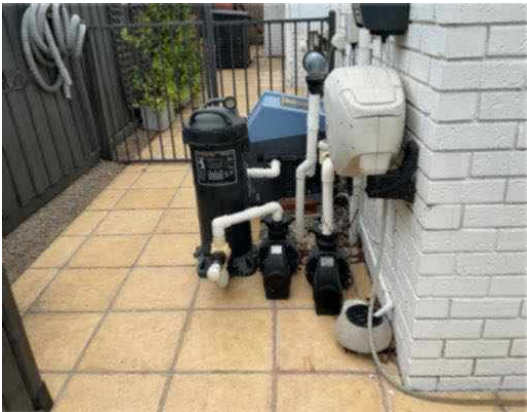
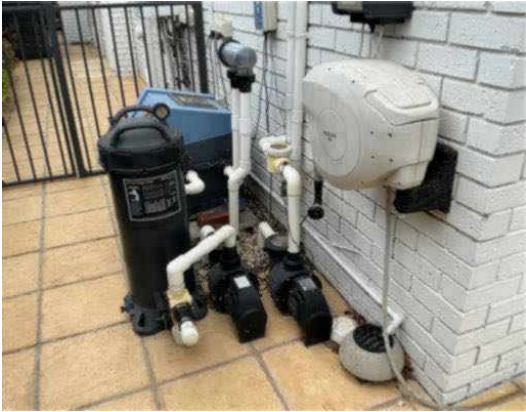
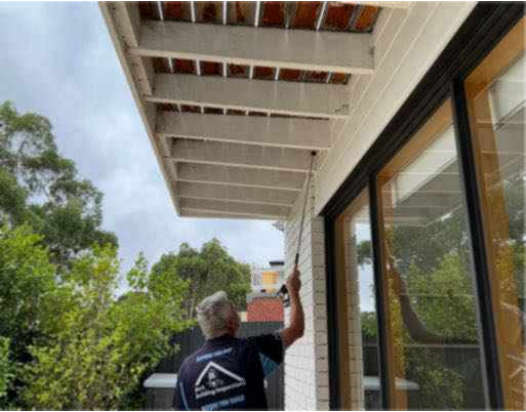
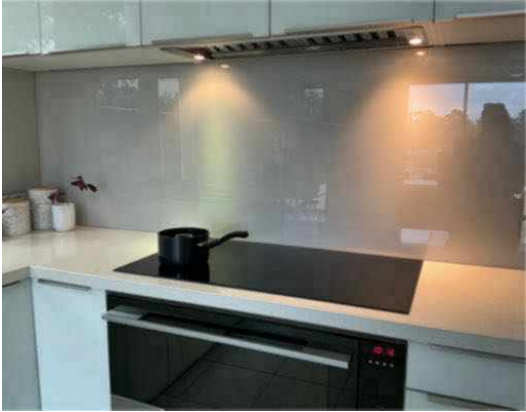
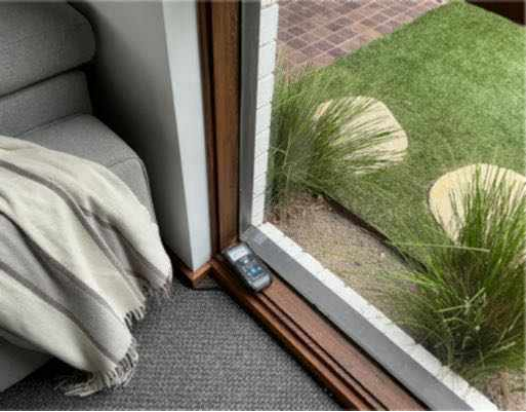
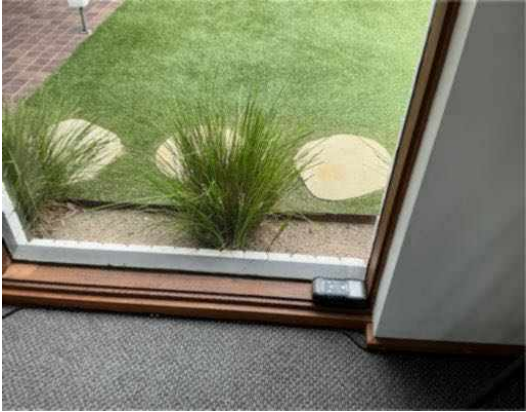
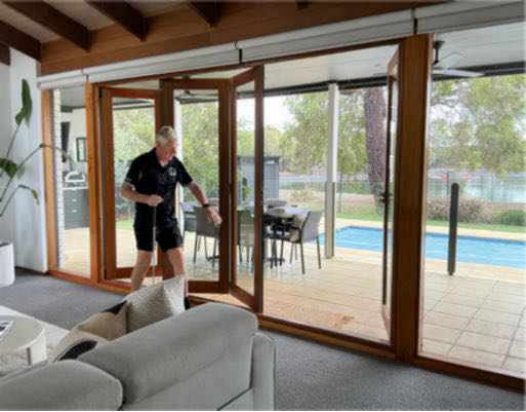
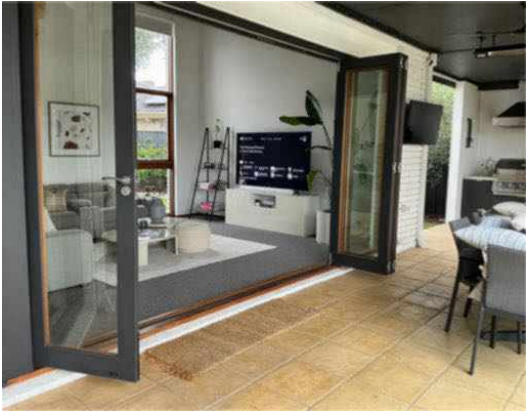
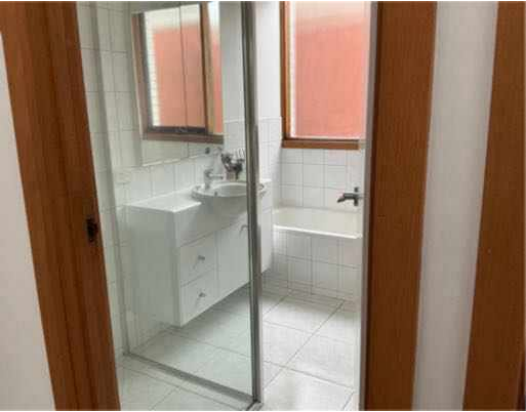
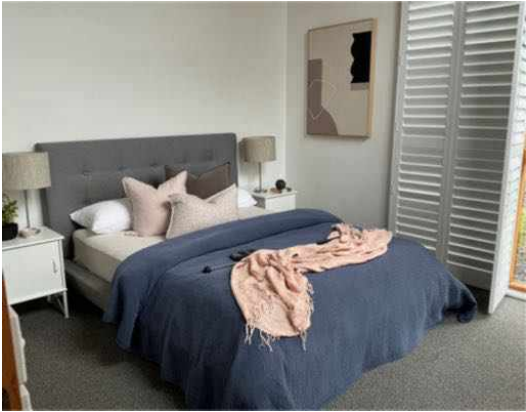
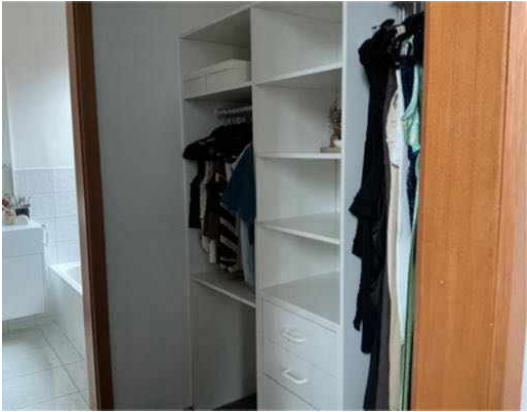
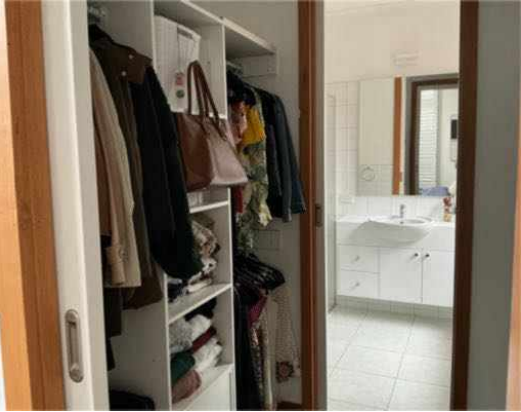
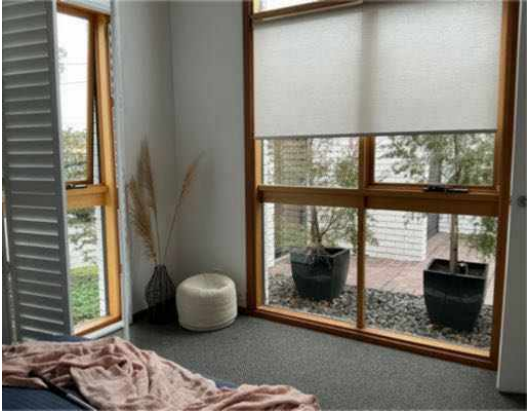
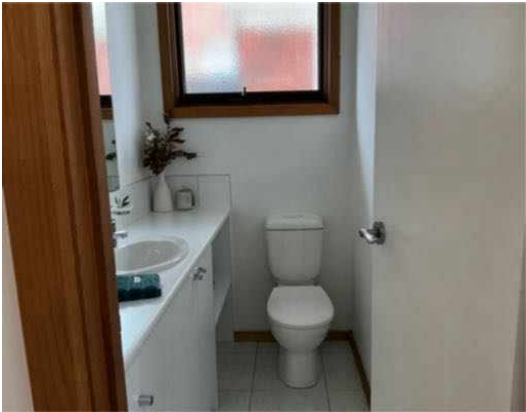
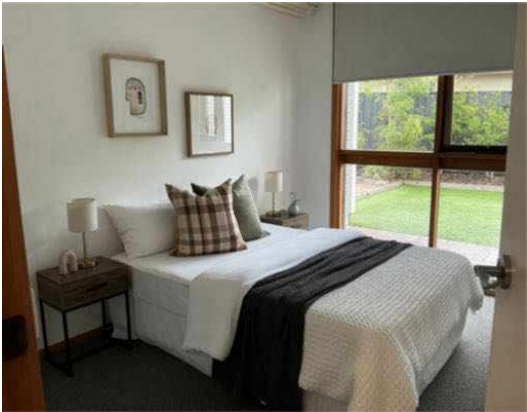
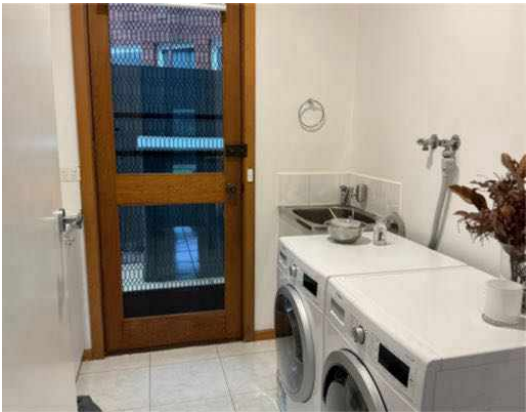
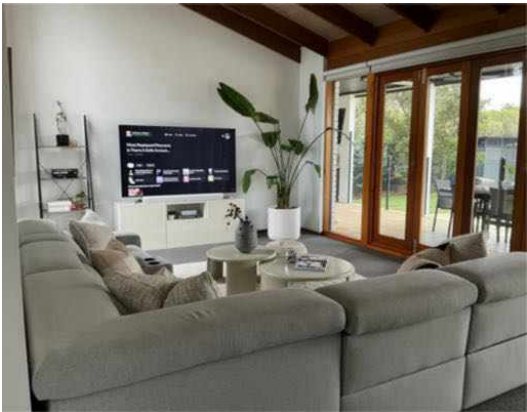
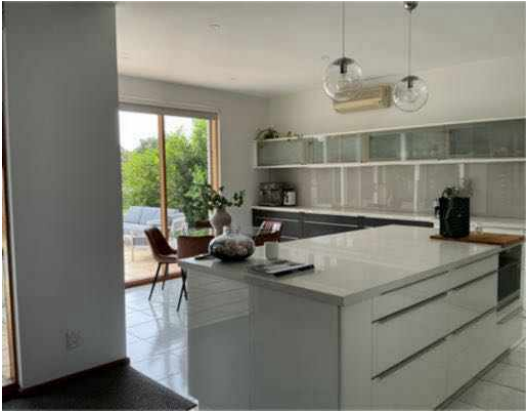
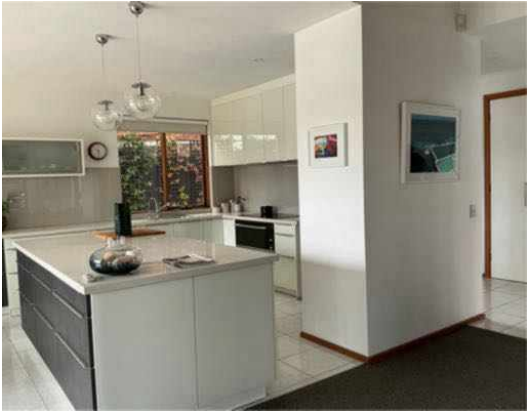
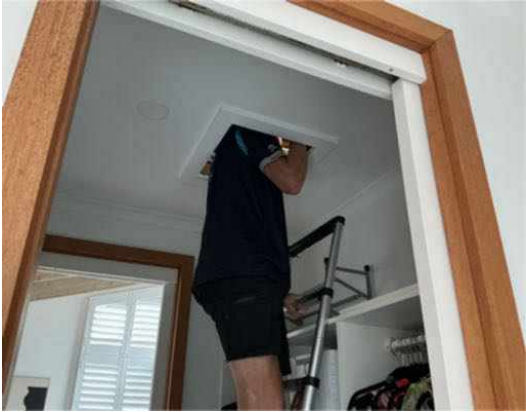
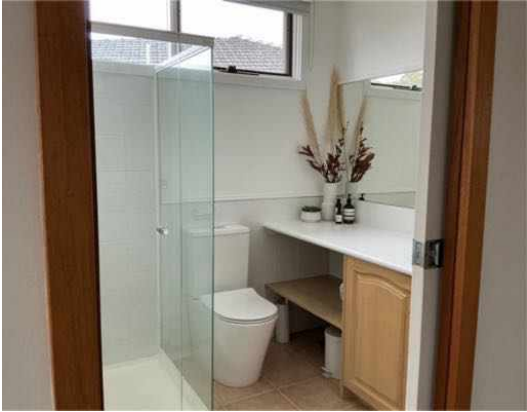
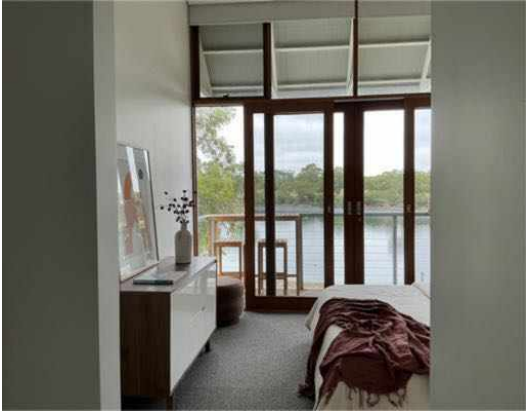
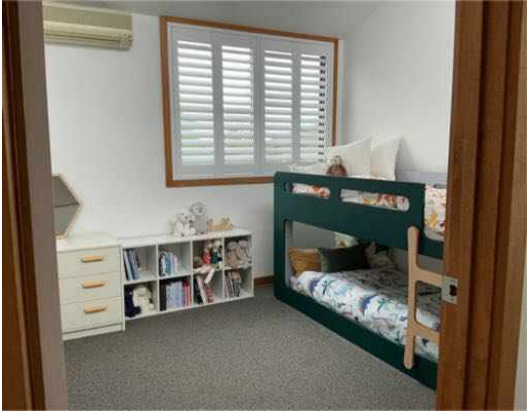
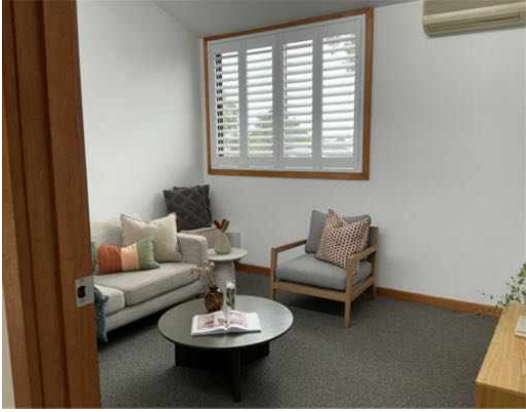
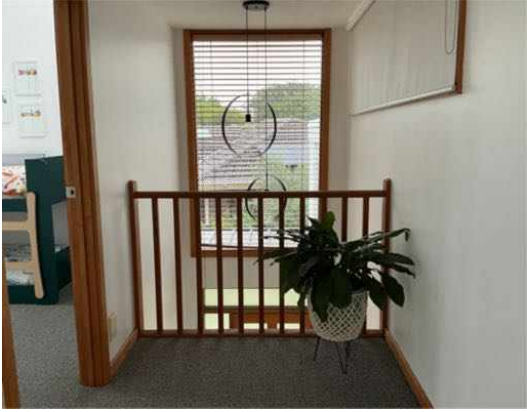
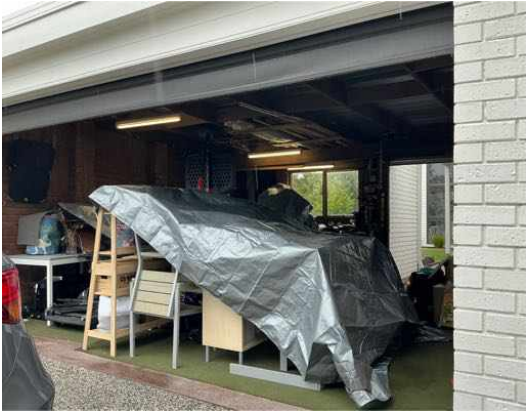
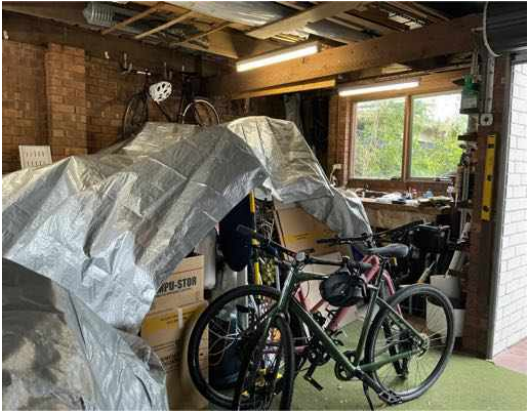
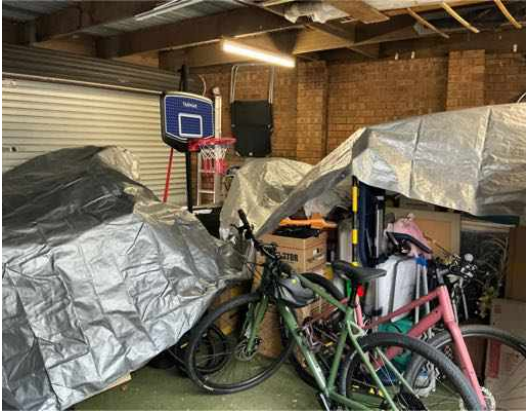
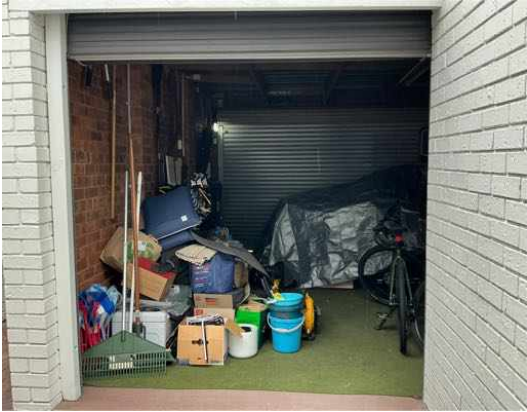
Noted Item

Building: Main Building
Location: All Areas
Finding: Additional Photos and Obstructions and Limitations
Information: These are additional photographs and photographs of the obstructions and limitations inside and outside (furniture, landscaping etc) which may impede full inspection of the property at the time of inspection. These obstructions can hide an array of defects and may be removed to allow full inspection to be carried out. A re-inspection may be made if clients require once the areas are made accessible.

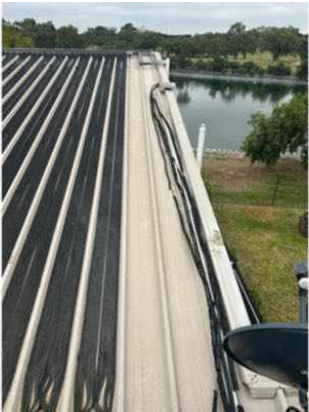
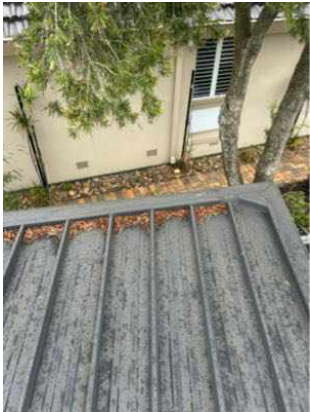
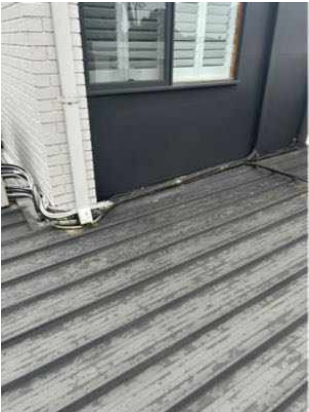
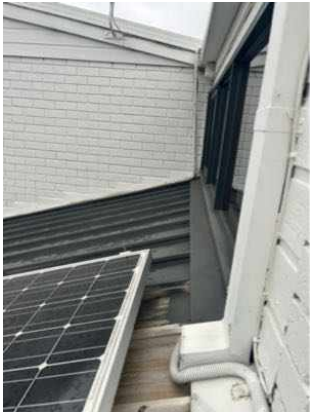
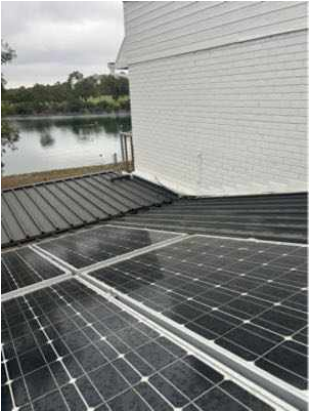
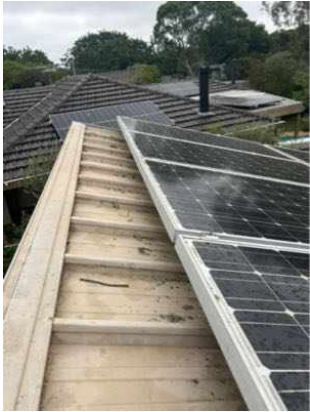
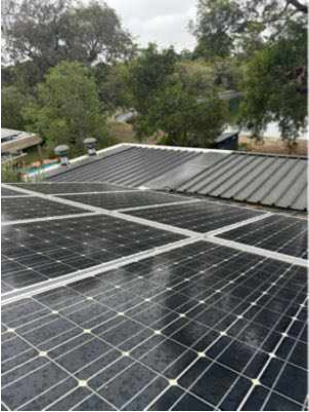
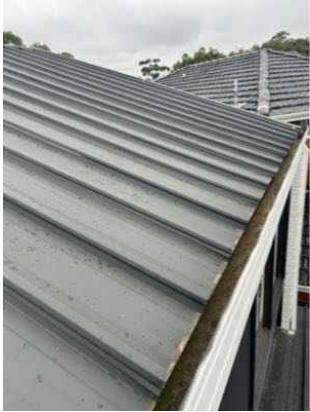
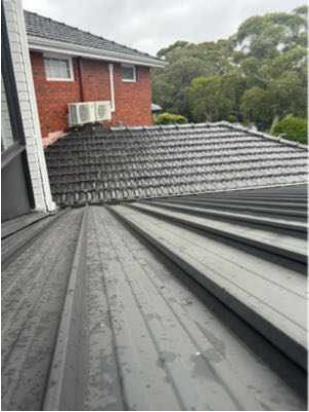
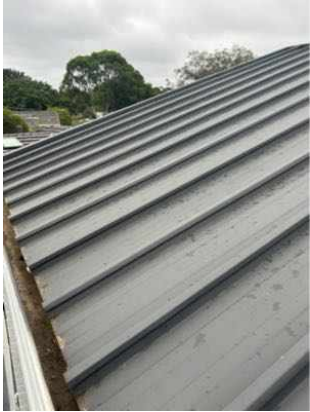
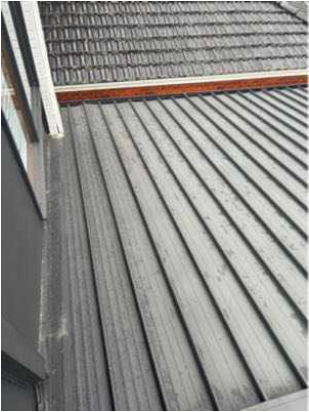
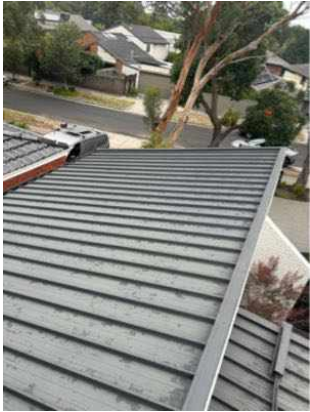
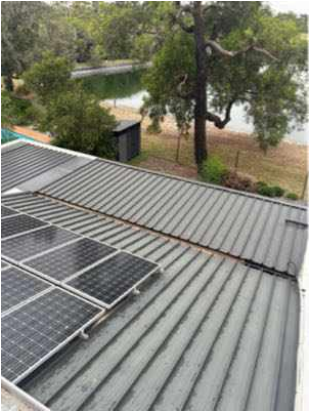
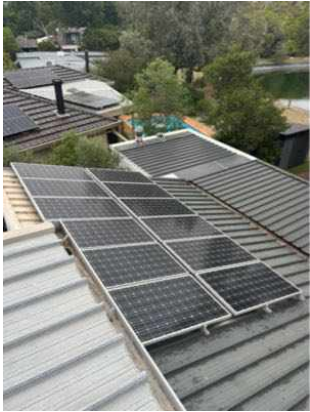
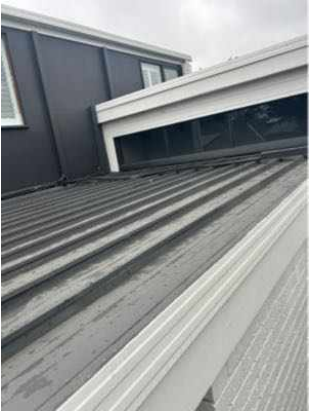
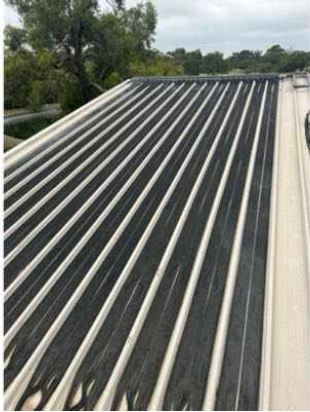
Building: Main Building
Location: All Areas
Finding: Additional Photos
Information: Additional photos are provided for your general reference
