# Building and Timber Pest Inspection Report

Inspection Date: Thu, 26 Mar 2026

Property Address: 805 Merrylands Rd, GREYSTANES, NSW,  
2145, Australia

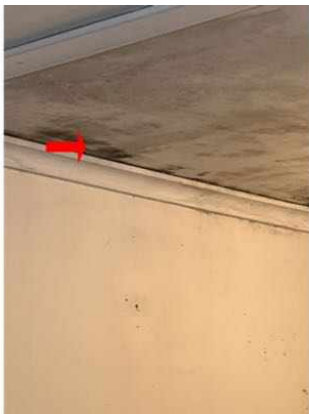
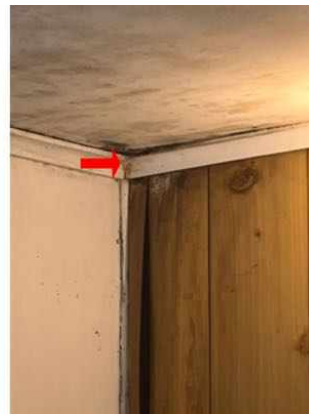
Building:	Main Building
Location:	Garage Converted to a Entertainment Area
Finding:	Mould - Present
Information:	Mould growth is evident to the ceiling linings and wall junctions within the converted garage/entertainment area. The affected areas display widespread discolouration, dark spotting, and patchy staining, particularly concentrated along ceiling corners and perimeter junctions. Localised areas also show heavier fungal growth consistent with prolonged damp conditions. The ceiling lining panels exhibit visible moisture staining, and the adjoining wall linings—particularly the timber panelling—show signs of moisture absorption and surface deterioration.

The pattern and extent of mould growth indicate that this is not a superficial or isolated issue, but rather the result of ongoing elevated moisture levels within the space. Contributing factors are likely to include a combination of roof leakage (as supported by visible ceiling staining), inadequate insulation, and poor ventilation—conditions commonly associated with garage-to-living-area conversions that may not meet current building or moisture control standards.

The presence of mould in this location raises potential environmental and health concerns, particularly where spores may become airborne in an enclosed area used for occupancy. In addition, prolonged moisture exposure may result in concealed deterioration to structural timbers and lining materials.

Overall, the condition is considered significant, with clear evidence of prolonged moisture ingress and inadequate environmental control within the converted garage space. Prompt remediation is required to address both the cause and the resulting damage.

A specialist inspection by a suitably qualified environmental health or mould remediation professional is recommended where the extent of growth is significant or where indoor air quality concerns exist. Immediate action should be taken to address the underlying moisture source—this includes engaging a licensed roofing plumber to investigate and rectify any roof leaks or defective flashings contributing to water ingress.

Following rectification of the moisture source, all affected surfaces should be cleaned and treated using appropriate mould remediation methods by a qualified contractor or competent person. Severely affected materials, including ceiling linings and possibly sections of wall lining, may require removal and replacement by a licensed builder or qualified carpenter.

It is also recommended that the space be improved in terms of ventilation and moisture control. This may include the installation of adequate ventilation openings or mechanical ventilation, ensuring proper insulation is in place, and maintaining the area in a dry condition to prevent recurrence.

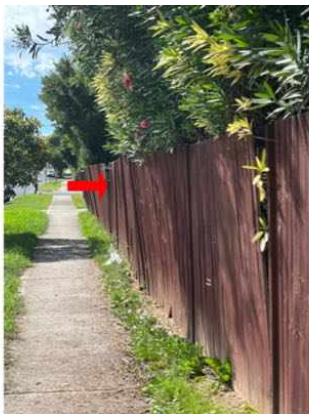
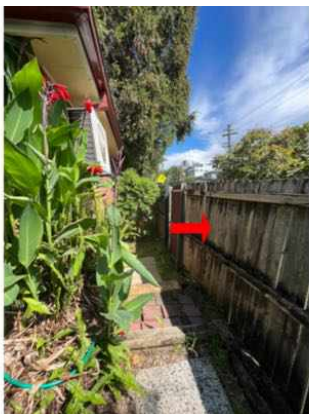
Finding: Fencing - Noticeably Deteriorated

Information: It was noted at the time of inspection that sections of the fencing throughout the property have noticeably deteriorated. Typically fencing deteriorates due to age and or wear, rot and or rust which is generally expected for a structure of this age, due to prolonged exposure to weather conditions. Sometimes inadequate installation or maintenance can be to blame.

If left unattended, it is likely that further damage will occur. It is suspected that repair of several elements of the fencing may be required however replacement may be a consideration of the client also.

A licensed fencing contractor should be appointed to provide further advice and perform rectification works as necessary.

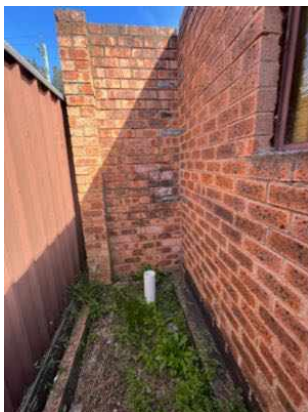
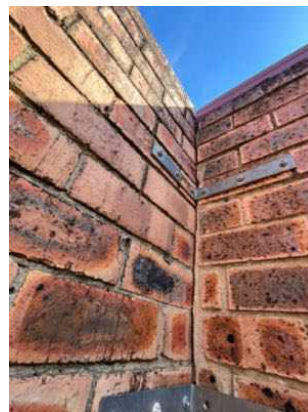
### Finding 3.02

Finding: Deteriorated Brick Fence

The brick boundary fence located adjacent to the dwelling was observed to be in a deteriorated condition, with visible signs of long-term movement and environmental exposure. The masonry shows evidence of displacement at the junction with the main structure, where separation and cracking have developed along the vertical joint, indicating differential movement between the fence footing and the dwelling. The installation of metal restraint brackets at multiple **نقاط** suggests that previous attempts have been made to stabilise the wall, which is consistent with ongoing movement rather than a one-off defect.

The brickwork itself exhibits weathering and surface deterioration, including mortar joint erosion and localised cracking, particularly at the upper courses and corner sections. Minor misalignment and loss of plumb are also evident, which may be associated with inadequate footing support, soil movement, or prolonged moisture exposure in this confined side passage. The presence of vegetation, accumulated organic debris, and poor drainage conditions at the base of the wall are considered contributing factors, as they promote moisture retention and reduce the long-term durability of both the mortar and the footing.

Overall, the fence is considered to be structurally compromised but currently in a restrained condition due to the installed brackets. While immediate collapse was not observed at the time of inspection, the wall should be regarded as unstable in the long term. Remedial works are recommended, which may include partial or full reconstruction with appropriate footings, improved drainage, and removal of vegetation to prevent further movement and deterioration.

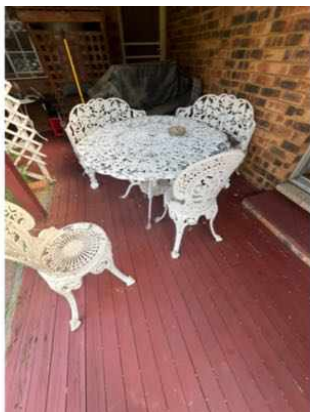
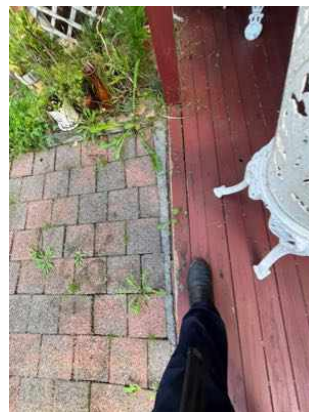
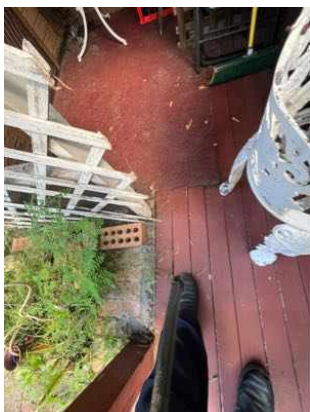
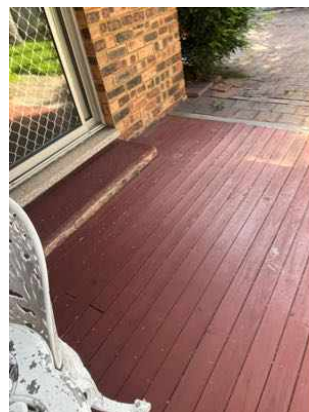
### Finding 3.03

Building:	Main Building
Location:	Deck
Finding:	Deck - Loose and Bouncy
Information:	The external timber decking to the rear patio area was found to be in a deteriorated and locally compromised condition at the time of inspection. When traversed under normal foot traffic, sections of the decking exhibited a noticeable deflection and springing movement, commonly described as a “bouncy” feel underfoot. This condition is indicative of reduced structural stiffness within the decking system and suggests that either the decking boards themselves have deteriorated, or more critically, that the supporting substructure—including joists, bearers, or fixings—may be inadequately secured, undersized, or affected by deterioration.

Visual assessment of the surface indicates areas of wear to the coating, minor splitting to boards, and possible loosening of fixings, all of which can contribute to movement. In addition, the interface between the decking and adjacent paved surfaces shows irregular levels, which may reflect minor settlement or movement over time. Given the age and exposure of the structure, moisture ingress and weathering are considered likely contributing factors, which may have led to softening or decay within concealed timber elements. Where decking is installed close to ground level and adjacent garden beds, there is also an increased risk of subfloor moisture retention, further accelerating deterioration.

While the decking remains in serviceable condition for light use at the time of inspection, the observed movement indicates that the structural integrity of the affected areas is no longer performing as intended. This condition may worsen if left unaddressed and could present a safety concern, particularly in areas of frequent use. It is recommended that the affected sections be further assessed and repaired, which may include re-securing or replacing loose boards, and if required, strengthening or replacing underlying joists and supports. Maintenance should also include sealing and ongoing protection of the timber to improve durability and performance.

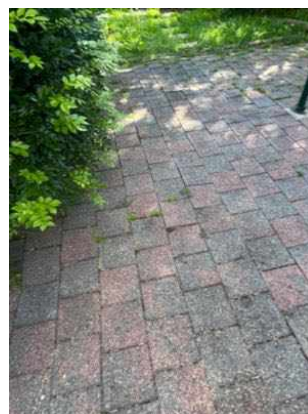
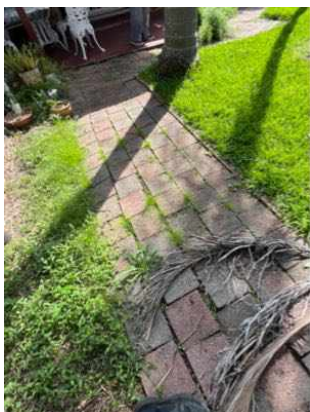
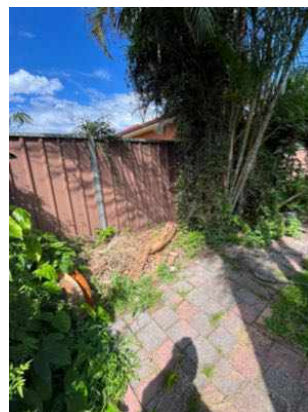
### Finding 3.04

Building:	Main Building
Location:	All Areas
Finding:	Pavements - Uneven
Information:	<p>Inspection of the side pathway and adjoining areas revealed sections of brick paving that are uneven, with notable height variations and displacement of individual pavers. In some locations, the brick surface has lifted or subsided, which may present a potential trip hazard. Additionally, sections of the adjoining retaining brickwork display vertical cracking, which appears consistent with minor movement of the structure over time.</p>

If left unattended, further movement could increase the extent of the defect and potentially compromise the safe use of the area.

While the movement appears localised, it is recommended that these areas be monitored for any progression. Rectification may involve re-levelling the pavers and addressing any underlying soil movement or drainage issues contributing to the unevenness. The cracks in the retaining wall should be repointed or repaired to prevent further deterioration and maintain structural integrity.

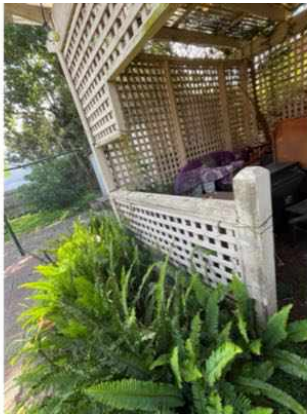
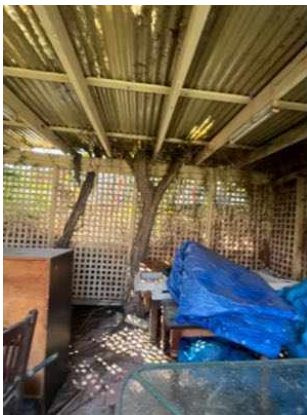
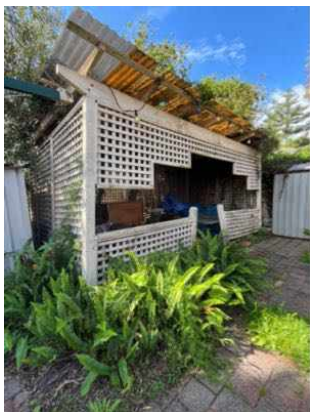
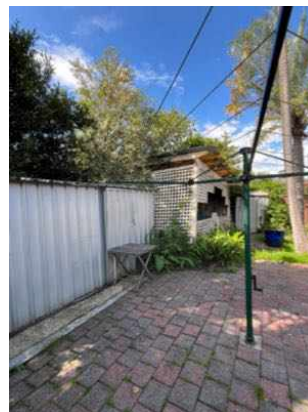
### Finding 3.05

Building:	Main Building
Location:	Yard - Back
Finding:	Deteriorated Entertaining Area
Information:	The detached rear entertaining structure was found to be in a significantly deteriorated condition at the time of inspection, with multiple elements exhibiting advanced weathering, structural fatigue, and lack of ongoing maintenance. The structure appears to be of lightweight timber construction with lattice screening and a corrugated roof covering, and overall it has reached the latter stage of its serviceable life.

The roof sheeting shows visible ageing and corrosion, with sections allowing light penetration, indicating deterioration and potential water ingress during rainfall events. Supporting timber members, including beams and rafters, exhibit surface weathering, discolouration, and early signs of decay consistent with prolonged exposure to moisture and inadequate protective coatings. The presence of vegetation growth and vine intrusion through the structure further contributes to moisture retention and accelerates timber deterioration.

The lattice wall panels and perimeter balustrade are notably degraded, with warping, splitting, and loosening of fixings observed. Sections of the framing appear misaligned, and the overall rigidity of the structure is reduced. The front railing and posts show signs of movement and are no longer providing adequate lateral support. The paved

Internally, the structure is cluttered, which limited full inspection of all surfaces; however, visible areas indicate poor ventilation, organic debris accumulation, and conditions conducive to timber decay and potential pest activity. The combination of moisture exposure, vegetation encroachment, and ageing materials suggests that concealed structural elements may be further compromised.

In its current condition, the structure is considered to be beyond economical repair for long-term use. While minor patch repairs may provide short-term usability, the extent of deterioration indicates that substantial rectification or complete replacement would be the more appropriate course of action. Immediate attention is recommended if the structure is to remain in use, particularly to address potential safety concerns associated with weakened structural components.

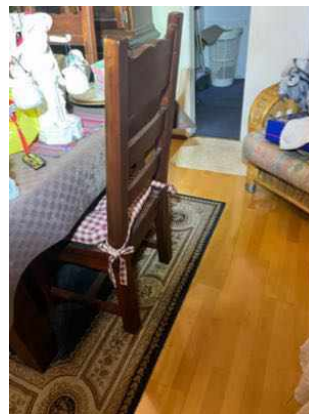
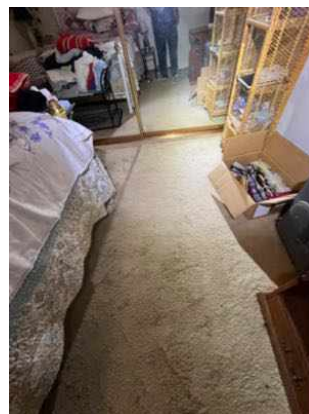
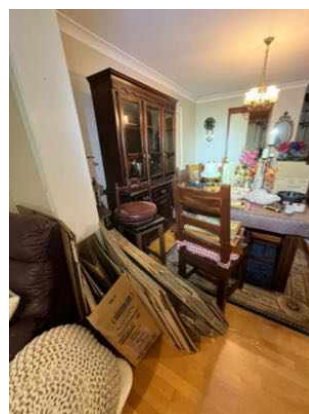
### Finding 3.06

Building:	Main Building
Location:	All Areas
Finding:	Floorboards - Noticeably Uneven
Information:	The internal flooring in this area was observed to be uneven and produced squeaking under foot traffic. Uneven flooring and floor squeaking may indicate minor defects such as normal foundation movement, slight movement of floor framing members, or potential subsidence or settlement of the subfloor stumps. Such conditions are relatively common in homes constructed on pier and stump foundations, where timber floor structures can move slightly over time due to changes in moisture levels, natural settlement, or wear of fixings.

It is recommended that the flooring condition be monitored over time to identify whether further movement or deterioration occurs. If the floor level and squeaking remain relatively stable over the coming months, the condition is likely associated with typical settlement and aging of the structure.

However, if the unevenness or squeaking becomes more pronounced, a more detailed inspection of the subfloor structure, including stumps, bearers, joists and associated fixings, will be required to determine whether structural movement or deterioration is present. Should this occur, rectification works such as re-leveling or re-stumping may be required, and such works should be undertaken by a registered builder experienced in subfloor structural repairs.

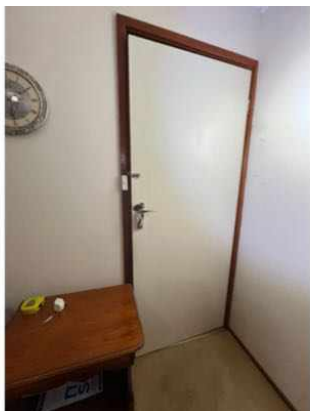
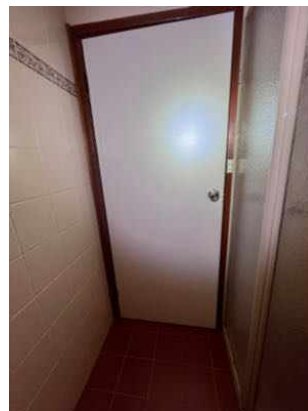
### Finding 3.07

Building: Main Building  
 Location: All Areas  
 Finding: Door Binding or Jamming  
 Information: It appears that there is a problem with this door as it is binding or jamming during normal operation. This defect not only affects the functionality of the door but also poses a risk for other building elements such as damage to the floor covering.

There could be various reasons behind the binding of the door, ranging from minor issues like poor installation or damaged hinges to major structural problems such as damage to the subfloor.

In some cases, the binding of the door may be caused by termite activities. In such instances, it is recommended to monitor the situation closely or conduct an invasive inspection to identify the root cause of the problem.

For minor issues, it is recommended to hire a qualified carpenter or handyman to carry out the necessary repairs as per the client's discretion.

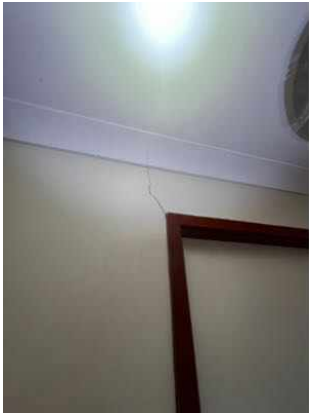
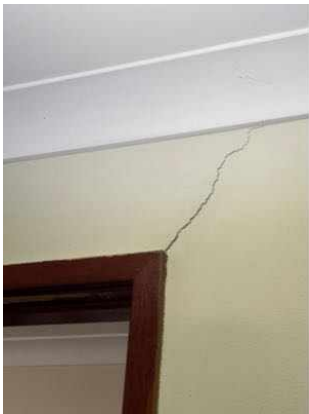
### Finding 3.08

Finding: Minor Cracks

Information: The interior cracks at wall corners or wall junctures with ceilings may have developed due to the separation of building materials caused by differential moisture levels or wood shrinkage during the framing drying process. Additionally, the cracks around openings, doors, and windows appear to be the result of inadequate installation of timber studs during the construction stage.

While these cracks may be noticeable, they are typically considered to be cosmetic issues and do not usually indicate any structural damage. Repairing such cracks can generally be done through minor sanding, filling, and repainting. It is important to have these repair works carried out by a qualified painter or a licensed handyman.

Regular monitoring of all cracks is recommended. If cracks widen, lengthen, or increase in number, it is advisable to contact a building inspector for further assessment.

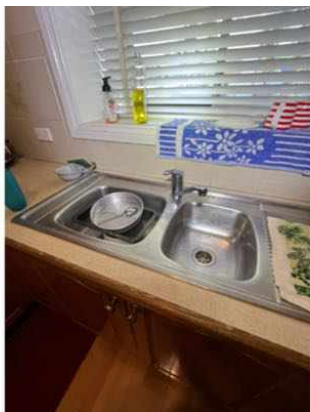
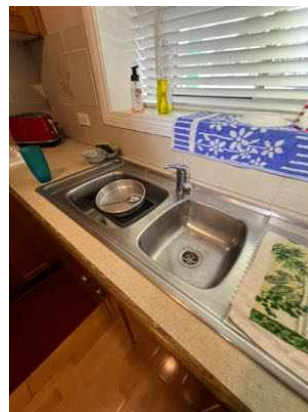
### Finding 3.09

Building:	Main Building
Location:	Kitchen
Finding:	Tap - Water hammer
Information:	This tap shows evidence of water hammer being present. Water hammer, a pressure surge resulting when a fluid is forced to suddenly change direction, is a common defect in plumbing fittings, particularly those that are aged and not frequently maintained. Water hammer is generally caused by factors that create high water pressure in the affected plumbing fixture, usually evidenced by a faint banging noise during operation of the affected tap.

Although water hammer is generally considered to be a minor defect, subsequent

damage such as erosion of tap hardware and/or water damage to associated building elements is likely to occur if left unmanaged.

A licensed plumber should be appointed as soon as possible to replace any affected tap hardware and perform any remedial works as necessary. Please be advised that the appointment of a cabinet maker or qualified carpenter may be necessary if water damage to associated building elements has occurred.

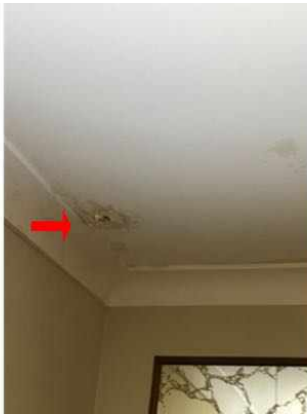
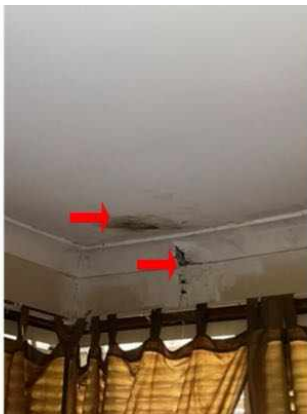
### Finding 3.10

Building:	Main Building
Location:	Lounge Room
Finding:	Ceiling - Water damaged
Information:	Water damage is evident to the ceiling linings in multiple locations within the dwelling, particularly adjacent to external wall junctions and window areas. The damage is characterised by widespread staining, discolouration, bubbling and deterioration of paint finishes, as well as localised cracking and delamination of the plasterboard. In more advanced areas, the ceiling lining shows signs of softening and breakdown, with visible deformation and splitting to the cornice and adjoining surfaces.

The pattern and concentration of staining—particularly at ceiling corners and along the wall/ceiling junction—are consistent with moisture ingress originating from above, most likely associated with defects to the roof covering, flashings, or roof plumbing components. The extent of staining and material deterioration indicates that this is not a recent or isolated event, but rather a prolonged or recurring moisture issue. In some sections, the level of damage suggests that water has penetrated beyond the surface finish and may have affected the underlying ceiling substrate and potentially adjacent framing.

There is also evidence of patch repairs and repainting in some areas, indicating previous attempts to address the symptoms without fully resolving the underlying cause. The presence of darkened staining and possible organic growth further suggests that the affected areas have remained damp for extended periods, creating conditions conducive to mould development and material degradation.

Overall, the condition is considered to be moderate to severe, with a high likelihood of ongoing moisture ingress if not addressed promptly. Immediate action is recommended to prevent further deterioration and potential concealed damage within the roof structure.

The primary requirement is to identify and rectify the source of moisture ingress. A licensed roofing plumber should be engaged as a matter of priority to carry out a thorough inspection of the roof covering, flashings, valleys, penetrations, and associated drainage systems, and to undertake all necessary repairs to eliminate water entry.

Following confirmation that the leak has been effectively rectified, internal remediation works should be undertaken. This may include removal and replacement of damaged ceiling linings where deterioration is advanced, treatment of any affected framing if required, and reinstatement of finishes by a qualified plasterer and painter. Any mould-affected materials should be appropriately treated or replaced in accordance with health and safety guidelines.

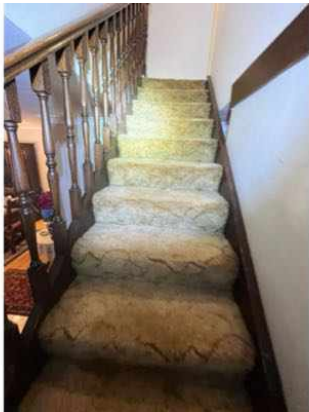
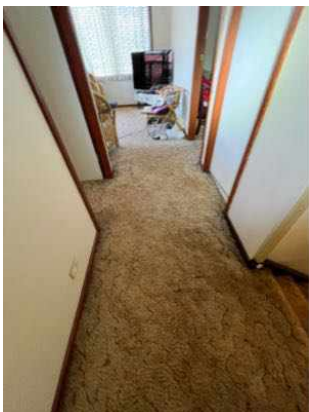
### Finding 3.11

Building:	Main Building
Location:	All Areas > Upstairs
Finding:	Squeaking Floor
Information:	During the inspection, creaking floors were noted in this area. This often occurs when the timbers are loose, causing friction between the edges of the boards when walked upon. It is recommended that the client consult a handyman or Registered Builder if the creaking intensifies or if the floor becomes excessively bouncy for further assessment and necessary action.

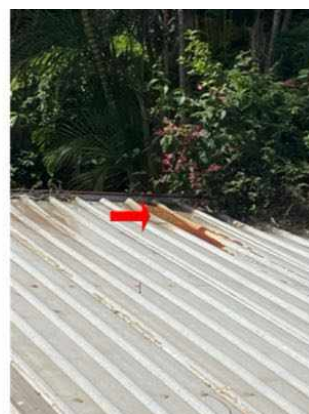
### Finding 3.12

Building:	Main Building
Location:	Roof Exterior
Finding:	Roof sheets - Rusted
Information:	Metal roofs generally comprise numerous individual sheets, which join and overlap. These intersections are particularly prone to lift at the edge and consequently rust at these points.

Upon inspection of the exterior roofing structure, evidence of rust to these sections was identified. If left unmanaged, these degrading joins can allow water ingress to the internal roofing structures, potentially leading to secondary damage of building elements. Accelerated deterioration of the roofing sheets and any associated building elements is also likely to occur.

A roofing contractor should be appointed immediately to assess the damage to the roofing sheets and to perform remedial works as necessary. Works may include replacement of severely affected roofing sheets or minor works such as the application of rust-retardant surface protectors.

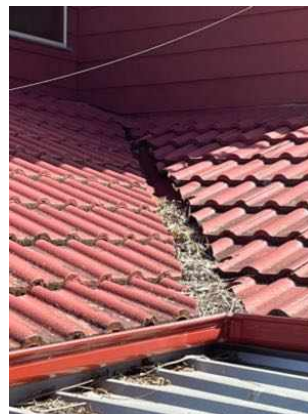
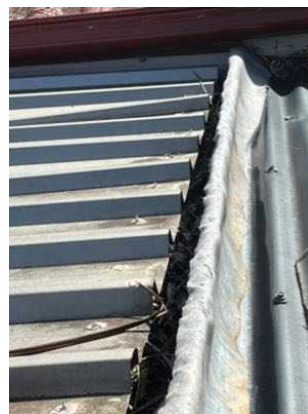
### Finding 3.13

Building:	Main Building
Location:	Roof Exterior
Finding:	Gutters - Blocked
Information:	Roof plumbing structures, such as guttering and downpipes, should be free of all debris to prevent blockages. Blockages of the guttering and downpipes will lead to pooling and accumulated water overflows, which is likely to subsequently flood eaves and exterior walls.

Blocked gutters are likely to lead to high levels of moisture in the affected areas. Such moisture will not only cause rust and decay of the associated building materials, but can also provide conditions that are conducive to termite and timber pest activity.

Blockages in gutters should therefore be removed immediately to ensure dry conditions are maintained.

Consult a Licensed Plumber for further specific advice on remedial works that may be required. In the interim, it is highly advised that blocked gutters be removed by the homeowner or a general handyperson as a matter of urgency.

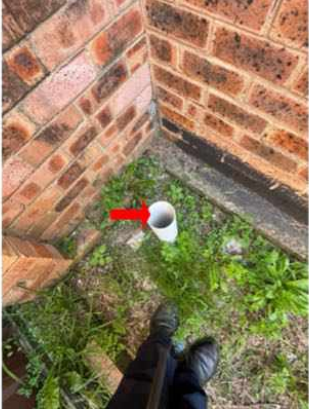
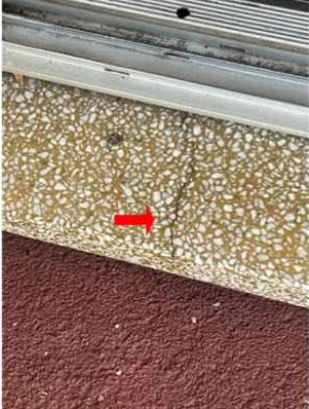
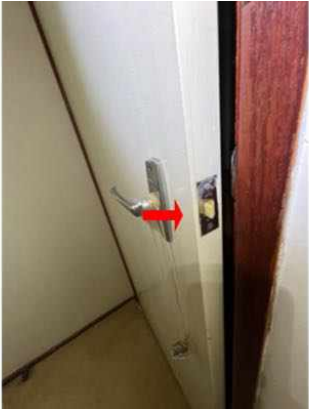
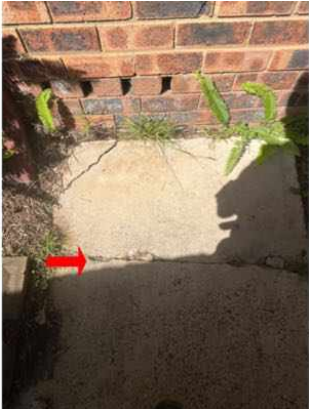
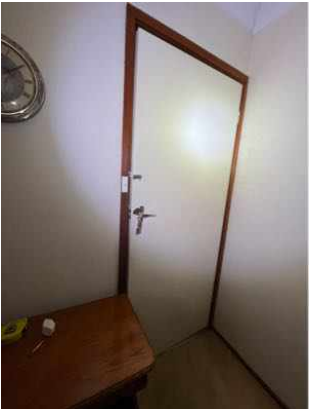
### Finding 3.14

Building:	Main Building
Location:	All Areas
Finding:	Deterioration due to fair wear and tears
Information:	Certain forms of deterioration commonly associated with fair wear and tear may not be specifically identified or itemised within this report. Minor cracking to brickwork, mortar joints, render, concrete paving, tiles, plaster linings, and timber beading, along with isolated areas of mortar loss, stiff or tight-operating windows, and similar age-related conditions, are typical of buildings over time and do not necessarily indicate defective workmanship or structural failure.

Some of minor defects other than in the report due to fair and wear and tears are ; cracked concrete paving and tile, opened drainage or inspection point, not latching door handle and minor rattling door due to misaligned strike plate.

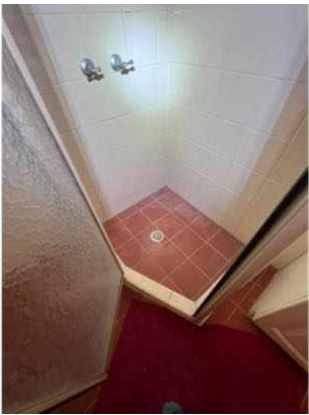
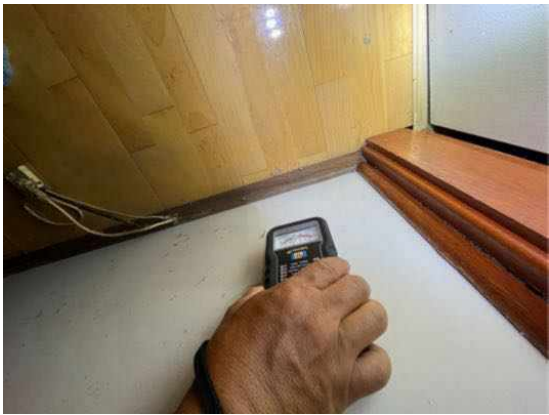
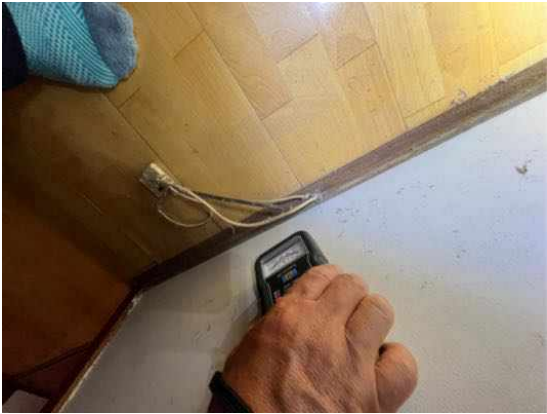
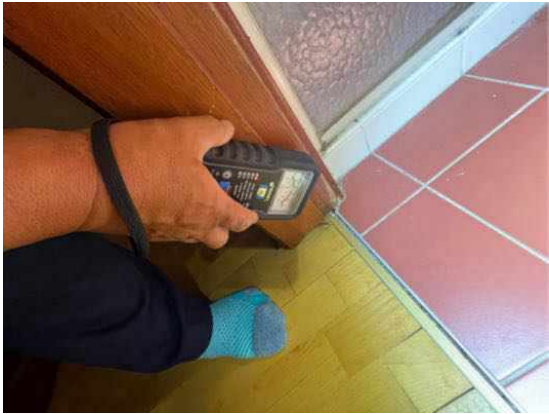
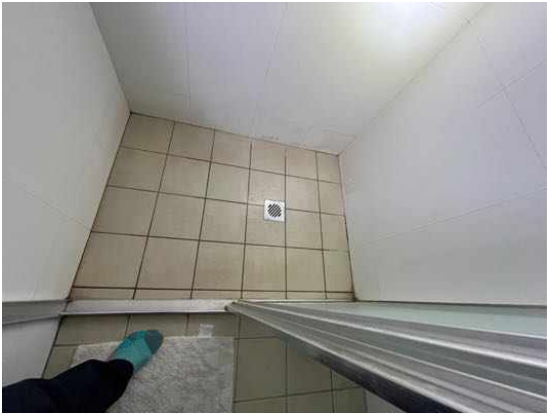
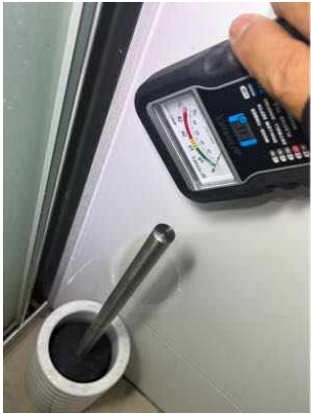
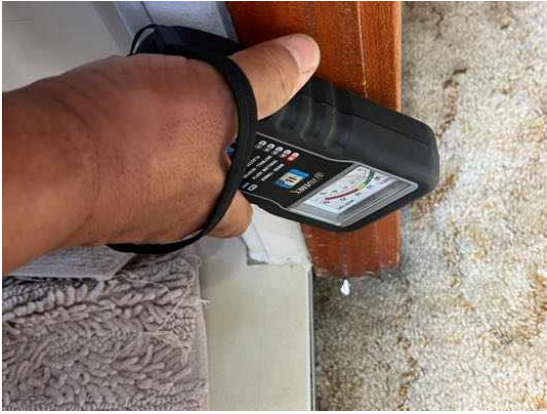
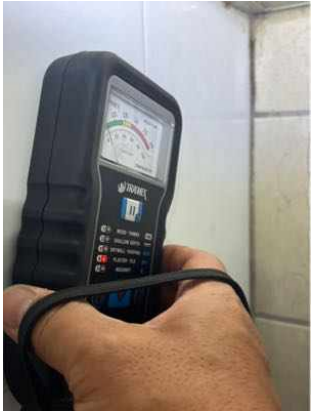
Building: Main Building  
Location: Bathroom  
Finding: Minimum Moisture Readings Detected  
Information: After assessing the shower recess, the moisture content of the walls within and surrounding the wet area was examined. The readings showed no significant variation between the walls behind the shower and other internal walls, and there were no visible signs of recent moisture-related damage on the surrounding accessible wall surfaces. Based on these findings, the waterproofing system appears to be performing adequately at the time of inspection, with no current evidence of active leakage.

However, it must be acknowledged that if the shower has not been used recently, moisture meter readings may not provide an accurate indication of the waterproofing condition. A lack of elevated readings under these circumstances does not conclusively confirm that the shower is free from leaks.

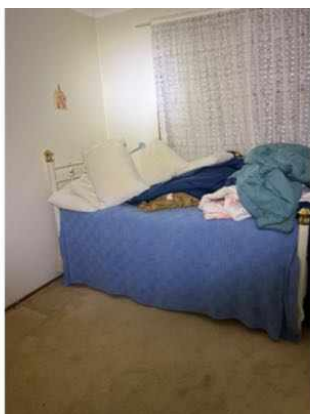
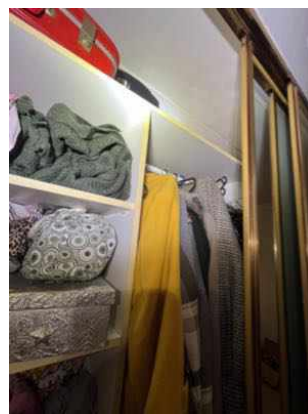
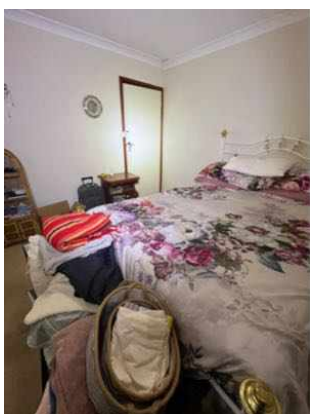
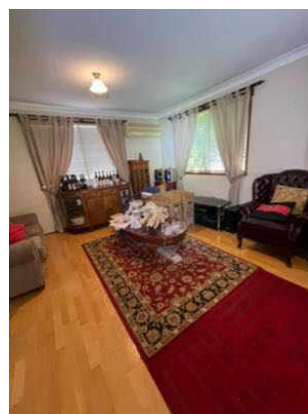
Building: Main Building  
 Location: All Areas  
 Finding: Note Regarding Mould and Staining  
 Information: It should be noted that the presence of furniture or stored items within the dwelling may restrict airflow and ventilation, particularly behind such items, creating conditions conducive to condensation and subsequent mould or staining.

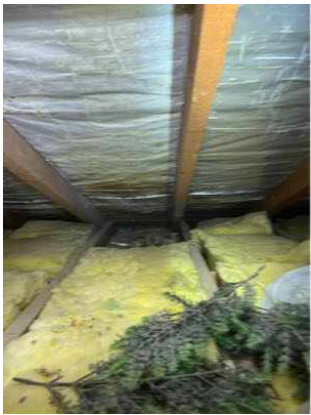
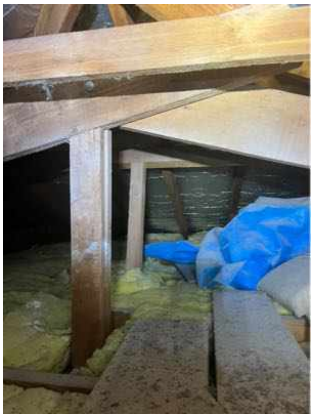
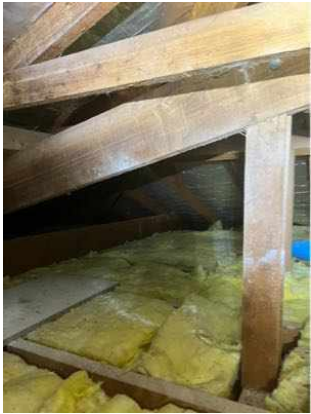
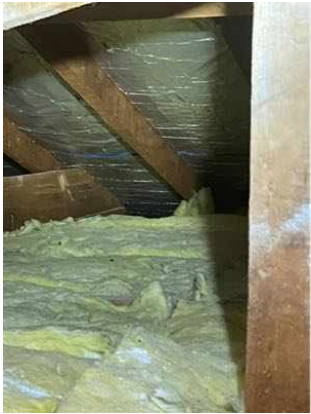
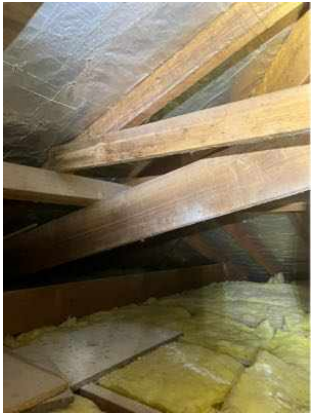
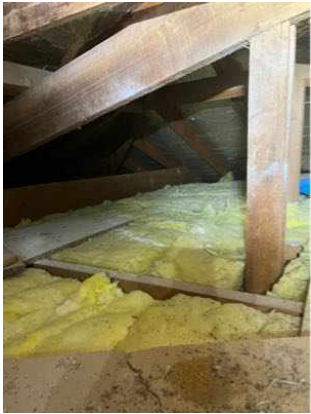
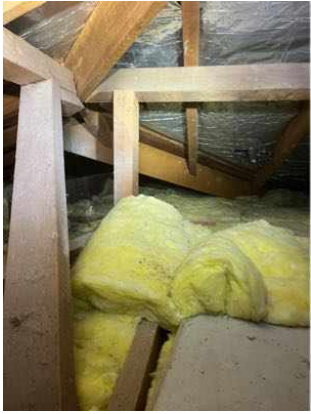
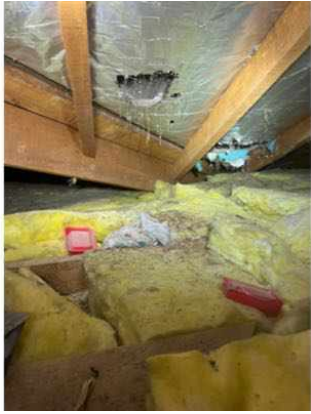
Building: Main Building  
 Location: Roof Void  
 Finding: Condition of Building Elements in the Roof Void  
 Information: The accessible roof void was inspected and found to be in a generally serviceable but poorly maintained condition, with several defects and risk factors noted. The timber

roof framing, including rafters, purlins, and struts, appears to be largely intact with no immediate evidence of significant structural failure; however, there are localised areas of moisture staining and discolouration to some members, which are consistent with past or ongoing water ingress. While no advanced decay or termite damage was clearly identified at the time of inspection, the presence of moisture-affected timbers increases the risk of future deterioration if not addressed.

The sarking/foil insulation beneath the roof covering is torn and deteriorated in multiple locations, with visible openings and sagging sections. In some areas, staining and residue to the sarking indicate previous water penetration. This compromised condition reduces the effectiveness of the moisture barrier and may allow wind-driven rain or condensation to enter the roof space. The bulk insulation (fibreglass batts) is poorly installed, displaced, and contaminated with debris, including organic matter and dust. Sections of insulation appear compressed or disturbed, which significantly reduces its thermal performance. Evidence of rodent activity is also present, including droppings and disturbed insulation, indicating that the roof void has been accessed by pests.

Storage of miscellaneous materials, including loose boards and plastic sheeting, has been noted within the roof void. This not only restricts access for inspection and maintenance but may also contribute to uneven loading on ceiling linings and create additional fire load. Walk boards are present but are inconsistently laid and not securely fixed in all areas, posing a potential safety risk during access.

Overall, the roof void condition is considered fair to poor, with evidence of moisture ingress, insulation disturbance, and pest activity. It is recommended that a licensed roofing contractor investigate and rectify any sources of water ingress, including roof coverings, flashings, and penetrations. Damaged sarking should be repaired or replaced where accessible. Insulation should be reinstalled or replaced to achieve adequate and consistent coverage, and contaminated materials should be removed. Pest control measures are also recommended to prevent further infestation. Regular maintenance and improved housekeeping within the roof space will assist in preserving the condition of the building elements.

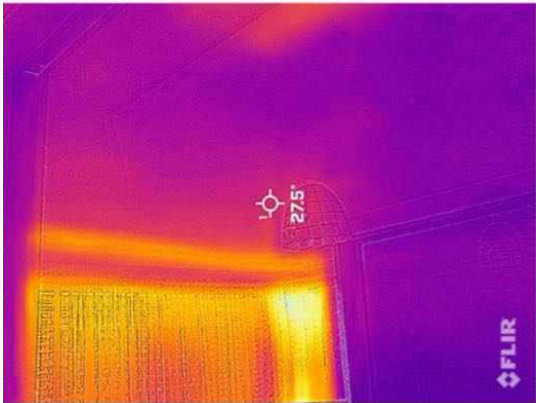
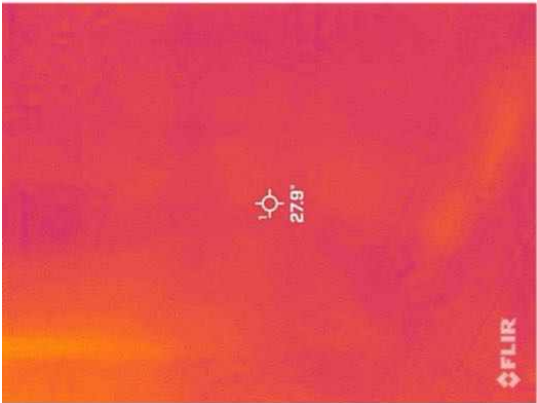
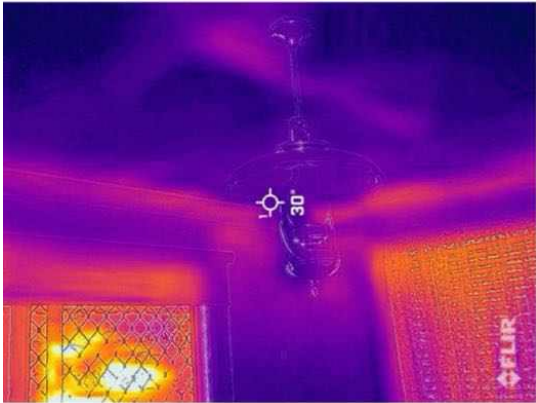
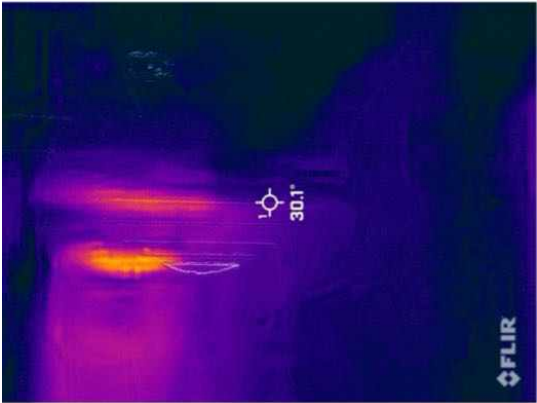
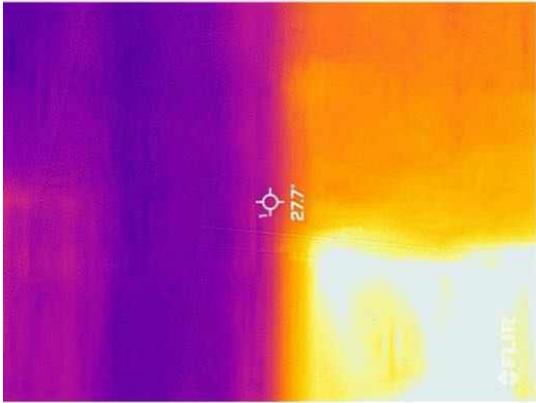
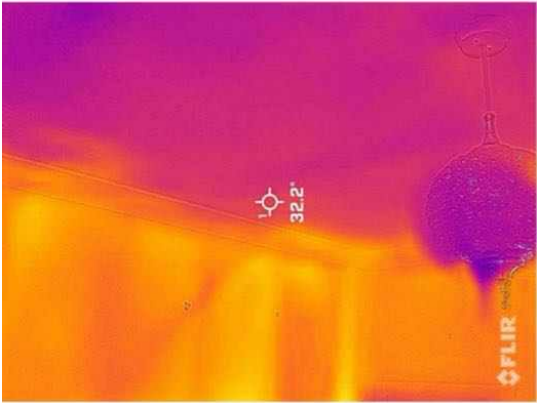
Building: Main Building  
Location: All Areas  
Finding: Additional Photos  
Information: Thermal imaging camera was used to detect any active water leaks or/ and termite activities in the property. No water leaks or termite activities were found from inspection by thermal imaging camera. Additional photos are attached for general reference.
