Building Inspection Report

Inspection Date: Wed, 4 Mar 2026

Property Address: 12 Grand Rd, Munno Para SA 5115,
Australia

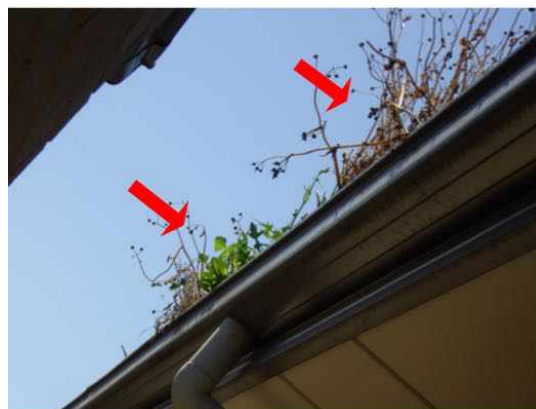
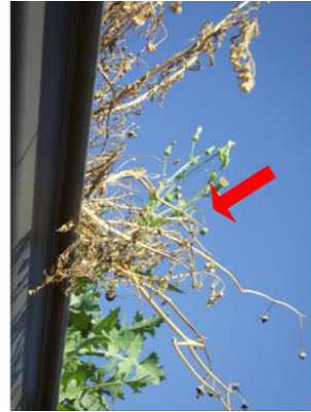
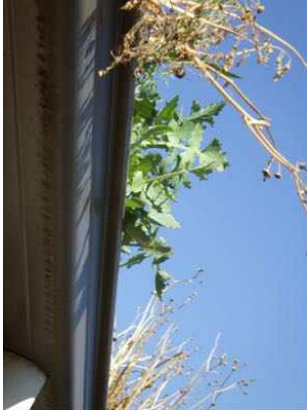
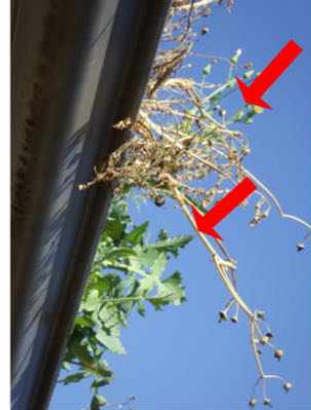
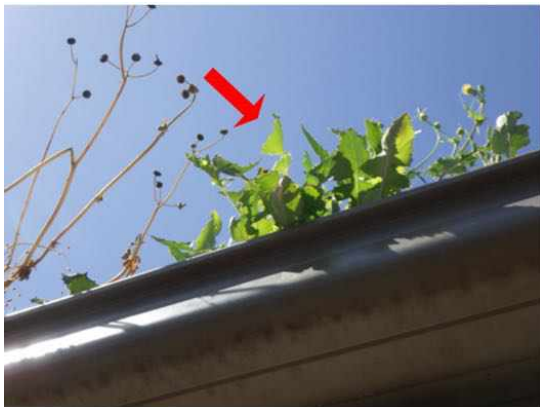
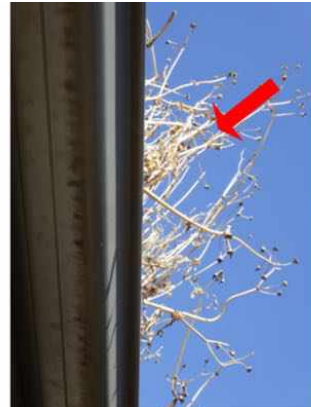
Defects 2.01

Blocked gutters are likely to lead to high levels of moisture in the affected areas. Such moisture will not only cause rust and decay of the associated building materials, but can also provide conditions that are conducive to termite and timber pest activity. Blockages in gutters should therefore be removed immediately to ensure dry conditions are maintained.

Consult a Licensed Plumber for further specific advice on remedial works that may be required. In the interim, it is highly advised that blocked gutters be removed by the homeowner or a general handyperson as a matter of urgency.

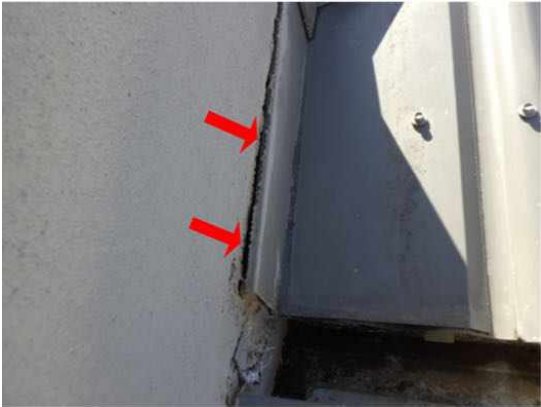
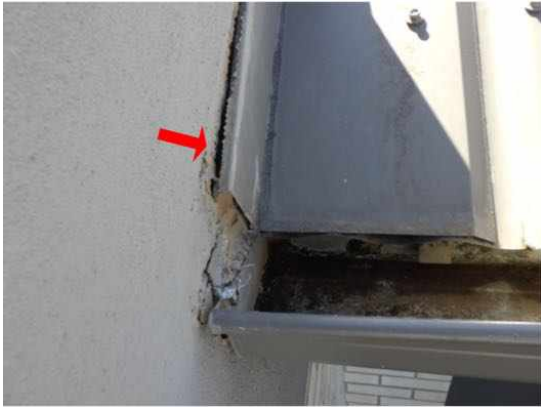
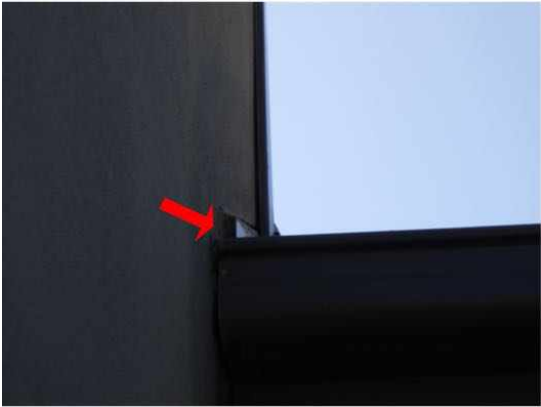
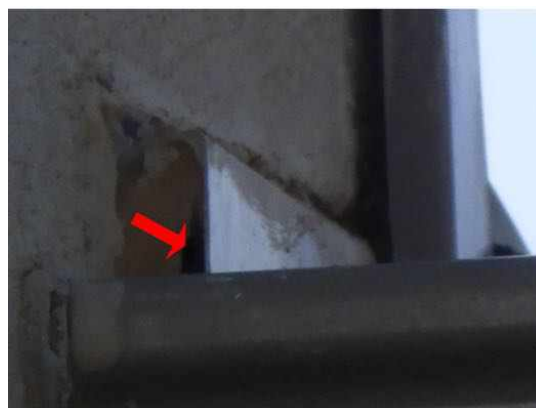
Defects 2.02

Building:	Building 1
Location:	All External Areas
Finding:	Roof plumbing - Flashing inadequate
Information:	At the time of inspection it was noticed that some sections of the roof flashing are inadequate / loose from its original fixing in this entry area.

Flashings that are not installed adequately or are missing are likely to result in water

penetration to the interior of the property, as well as creating excessively damp conditions against the exterior surfaces and around the base perimeter of the building.

Premature ageing and secondary building defects are imminent where roof plumbing is missing or inadequately installed. Additionally, water pooling also creates an environment that is susceptible to termite and pest infestation.

A roofing plumber should be appointed as soon as possible to install relevant roof plumbing materials, ensuring that no further damage is sustained.

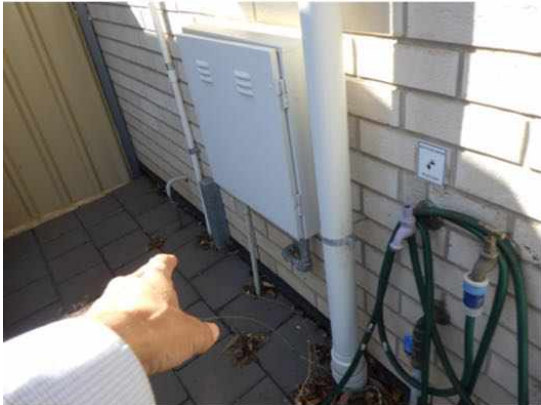
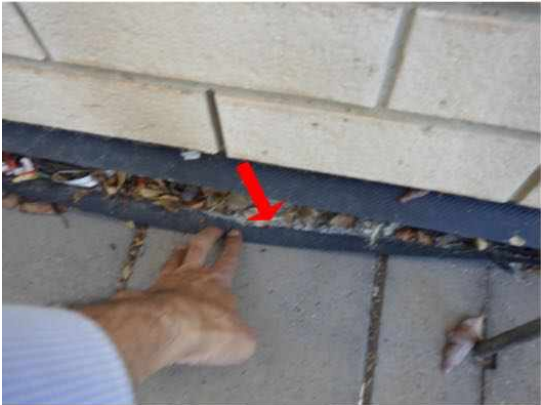
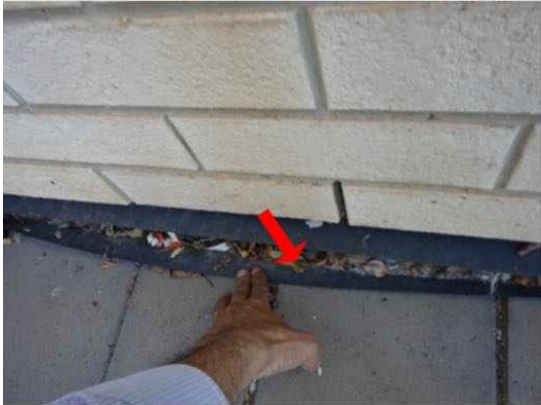
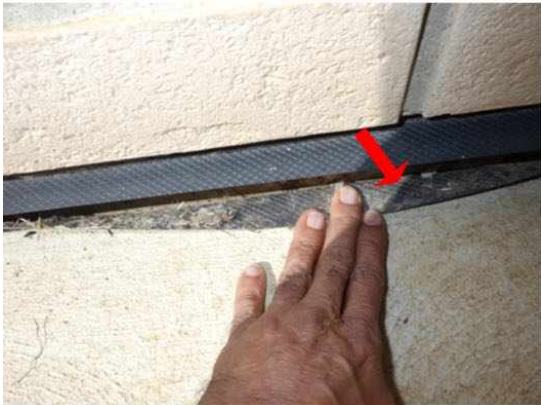
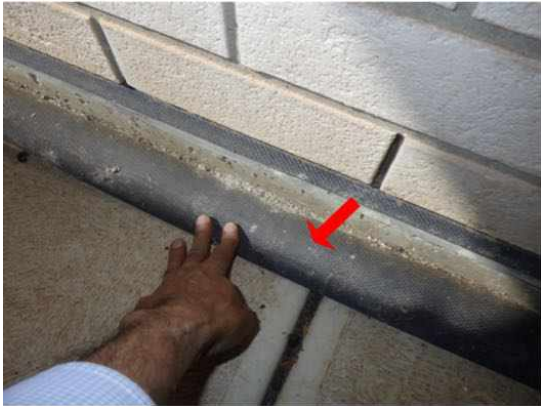
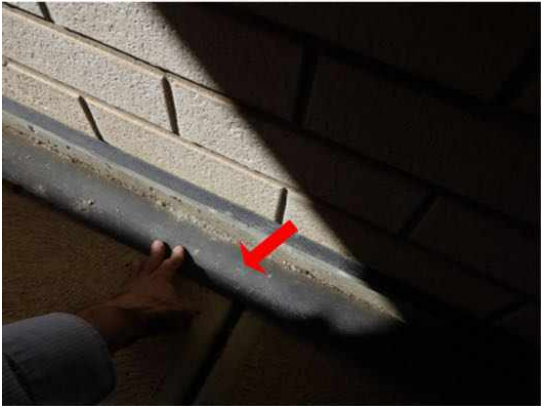
Defects 3.01

If the slab edge is not properly exposed there is a high risk of termite attack. Sometimes, in order to determine the type of slab, a suitably qualified person such as an architect or builder may be required to consult the construction plans.

Where the slab edge cannot be properly inspected, it is highly recommended that termite or timber pest inspections be carried out every 6-12 months to aid protection of the property against infestation.

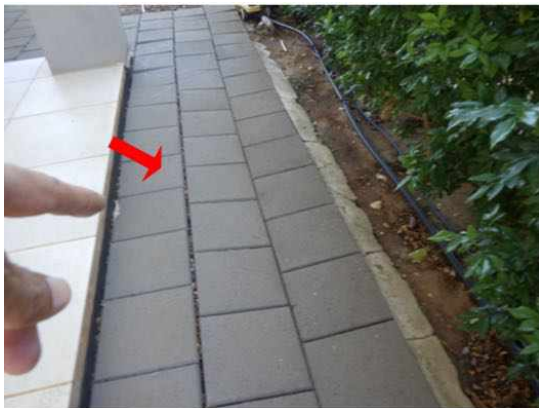
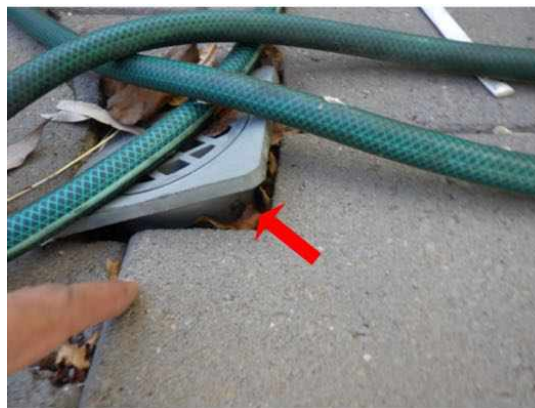
Defects 3.02

Information: Sections of the external paved area are uneven, creating a potential trip hazard. It appears as though the area has been subject to rough installation, or that paving sections have lifted due to movements in the foundation of the property.

Where paving creates a trip hazard, personal injury may ensue if due caution is not taken by all persons within this area.

Re-paving of the area is required as soon as possible to remedy this situation. Further consultation with a specialist concreter is advised.

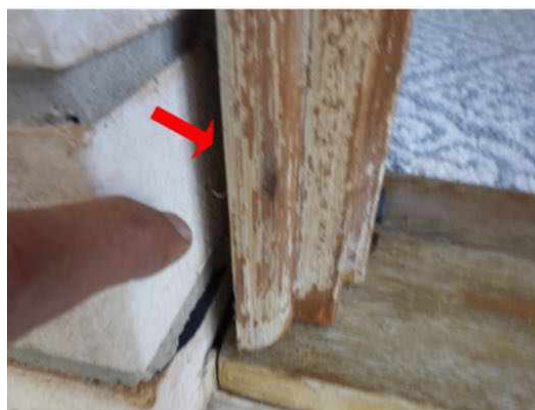
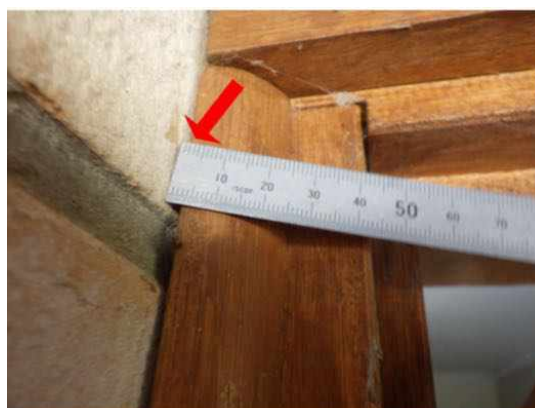
Defects 3.03

Building:	Building 1
Location:	All External Areas
Finding:	External Walls & Entry Door Frame Assembly - Significant Gaps Observed
Information:	At the time of inspection, it was noted that significant gaps are present between the external walls and entry door frame assembly. These gaps indicate poor detailing, movement, deterioration of materials, or inadequate installation and sealing.

Such conditions may arise due to age-related degradation, environmental exposure, or physical damage. If left unrectified, these gaps may allow water and air ingress, potentially leading to secondary defects, including moisture damage, deterioration of adjacent building elements, and reduced thermal and weatherproof performance.

Repair and/or replacement of the affected components is recommended to reinstate the integrity and performance of the building envelope. All building elements play an essential role in the operation and overall performance of the structure, and defects of this nature may adversely impact durability and habitability.

It is advised that a suitably qualified and licensed tradesperson be engaged to assess and rectify the affected areas to prevent further deterioration or consequential damage.

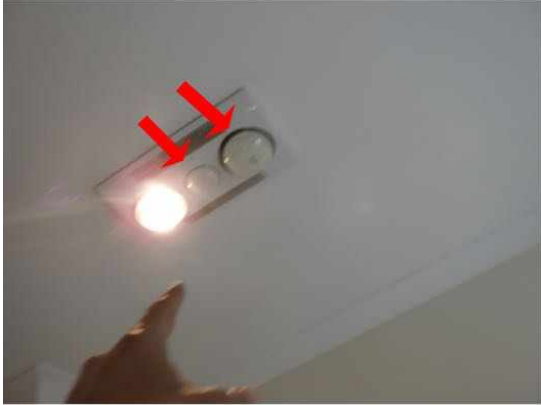
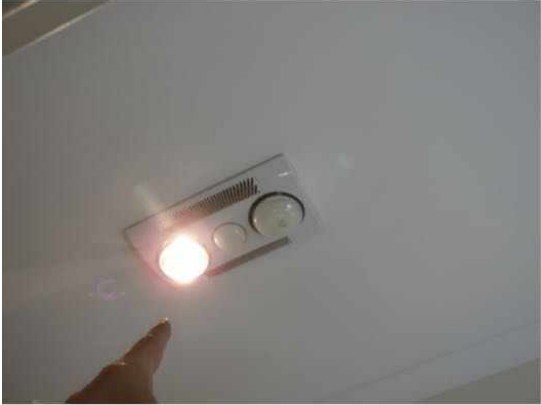
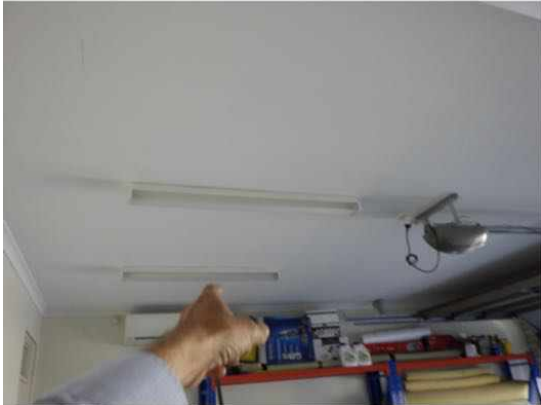
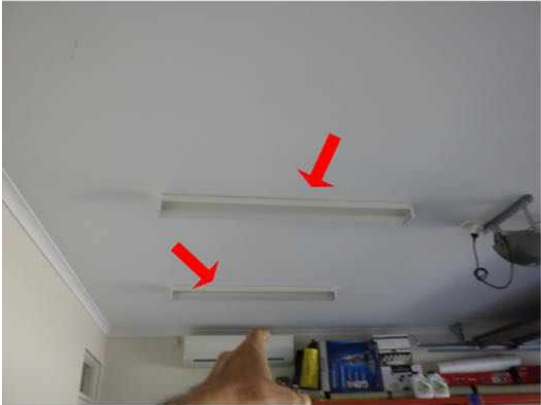
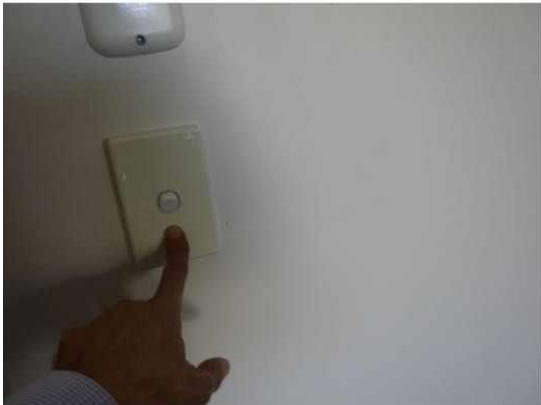
Defects 3.04

Building: Building 1
 Location: Garage
 Finding: Electrical fittings - Not operating
 Information: At the time of inspection it was noticed that electrical fittings in this garage & bathroom -ensuite area were not operational.

Non-operational items should be addressed to ensure that the full function of the building structure is available. Where some building elements are not operating as intended, it is possible that secondary building defects could arise due to their non-operation.

Repair and/or replacement of the faulty building element is recommended. It is highly recommended that the relevant tradesperson be engaged to perform any necessary works.

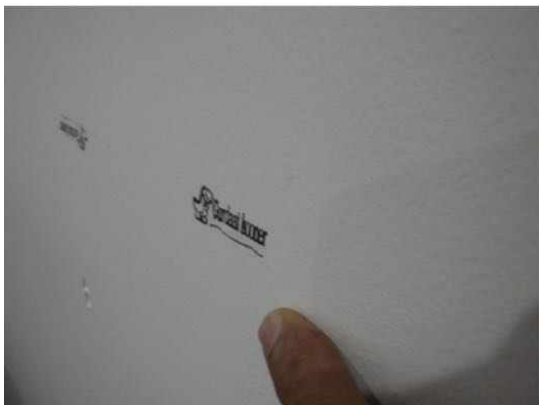
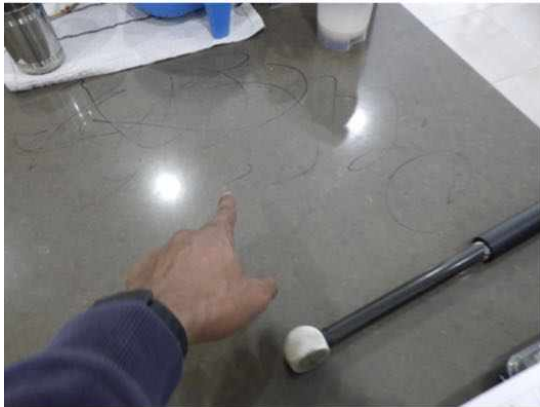
Defects 3.05

Building: Building 1
Location: All Internal Areas
Finding: Internal Walls - Scuffed

Scuffed surfaces, while detracting from the overall appearance of the affected building element, do not indicate any operational or structural damage. This degree of surface damage is consistent with general wear and tear and minor impact damage, normally accumulated over a number of years.

Marked surfaces may be left as is at the discretion of the client; no repairs or replacement are necessarily required, as this is an appearance defect. However, the client may wish to seek quotations for the cost to refurbish or replace the identified building element.

A general handyman or plasterer may be appointed to rectify marked surfaces if considered necessary by the client.

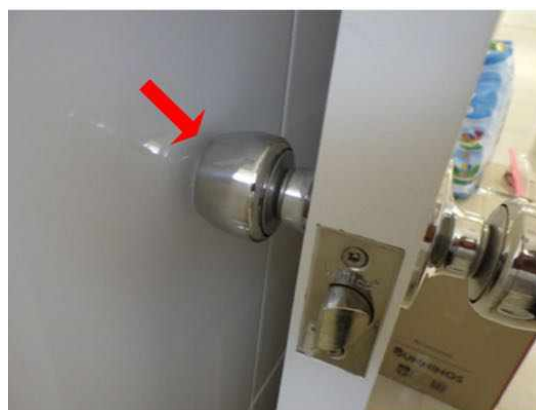
Defects 3.07

Building:	Building 1
Location:	All Internal Areas
Finding:	Door stop - Missing
Information:	At the time of inspection it was noticed that the toilet door stop is missing or is inadequate to stop the door handle from damaging the wall. Although some building elements may seem irrelevant or unnecessary, all building elements play a key role in the operation and function of the overall structure and its performance.

Re-installation or replacement of the door stop is advised as soon as possible to prevent any subsequent damage to the door or associated structures. A general handyman may be appointed to perform these works at client discretion.

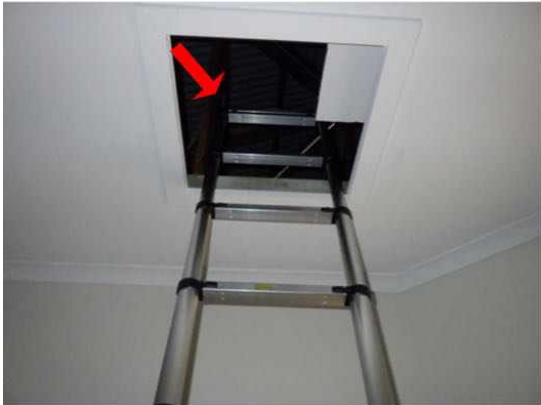
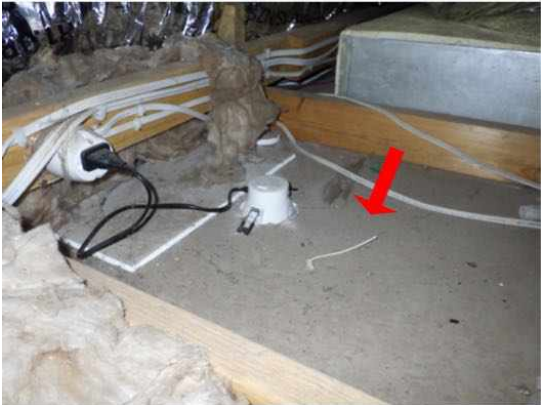
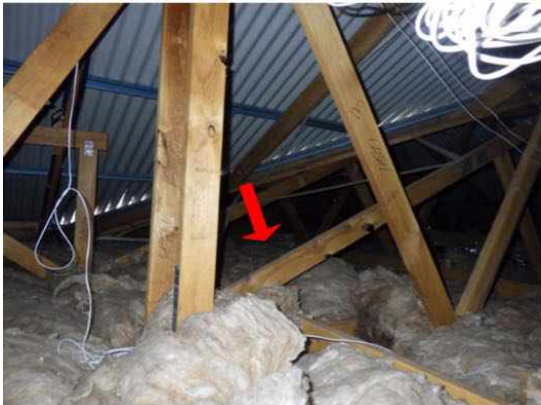
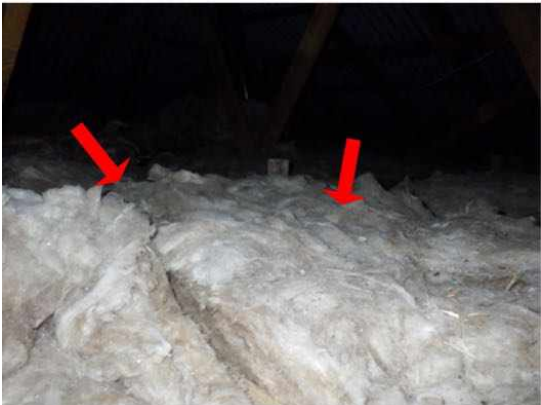
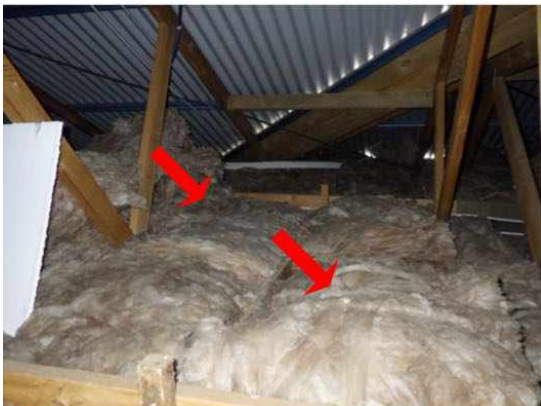
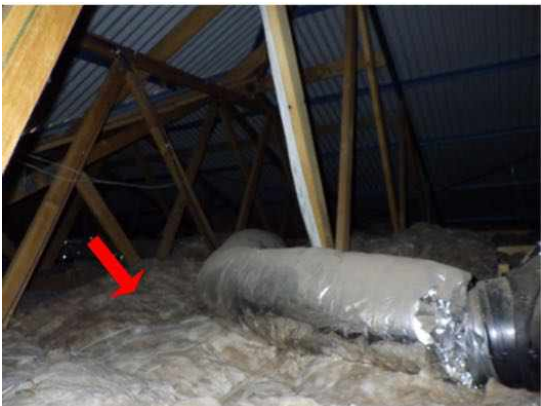
Defects 3.08

Building:	Building 1
Location:	All Internal Areas
Finding:	Insulation - Missing
Information:	Upon inspection of the roof void it was noted that insulation is not present in few sections in this roof space area. Apart from that at the time of inspection it was also noticed that insulation was present in most sections in this roof space area.

Insufficient insulation will result in a comparatively higher cost to heat and cool a property as there is a lack of Insulation (or uneven coverage of insulation) which works as a barrier to heat transfer. This helps to keep out unwanted heat in summer and preserves warmth inside your home in winter. It can also help soundproof your home from unwanted airborne noise transfer.

Where insulation is absent, the area does not meet current Australian Standards. Installation of adequate insulation is required and should be conducted as soon as possible.

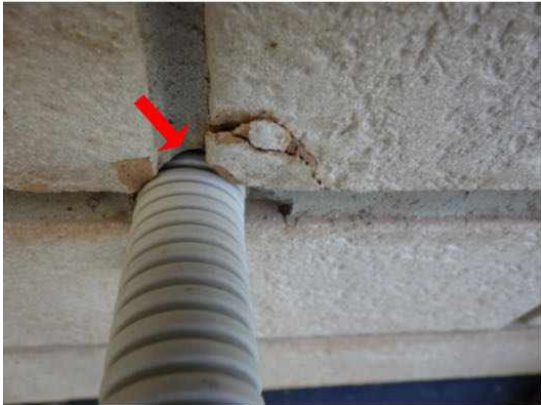
Defects 3.09

Gaps and holes around pipework makes the area susceptible to insect and vermin ingress, as well as allowing water penetration to the cavity wall. As such, associated building elements are likely to deteriorate at an accelerated rate, and major implications are expected if holes around the pipework are left unmanaged.

All excessive holes, gaps or cracks should be adequately filled by a suitable sealant or trimmings as soon as possible to prevent any further damage. Such works may be conducted by a general handyperson or licensed plumber.

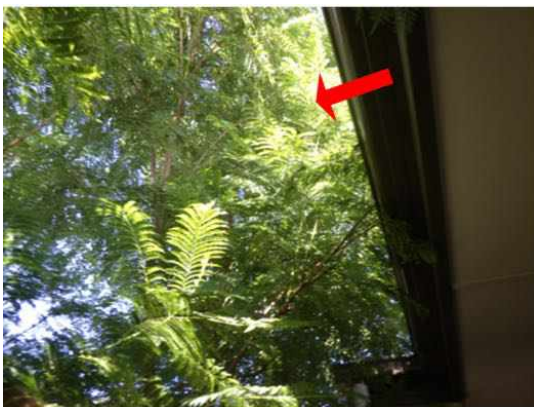
Gutters are a critical part of the building's management of storm water and rain. It is therefore important that they be kept clear to prevent secondary damage to associated building elements, including exterior and interior walls, ceiling linings and

any adjoining building elements. Where gutters are blocked, pooling of rainwater is likely to occur, fast-tracking rust and corrosion of the roof plumbing elements.

It is highly advised that all overhanging tree branches be removed as soon as possible to prevent any further damage. Repair and/or replacement of sections of damaged guttering may also be required where the extent of the damage necessitates.

Such works should be performed by the homeowner; however, appointment of a landscape contractor or an arborist may be required. Consultation with a licensed roof plumber is required where guttering has been damaged.

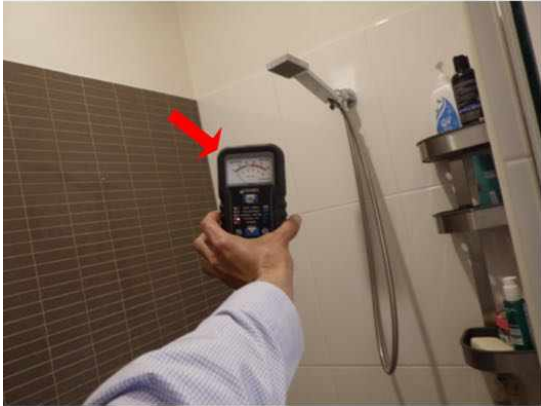
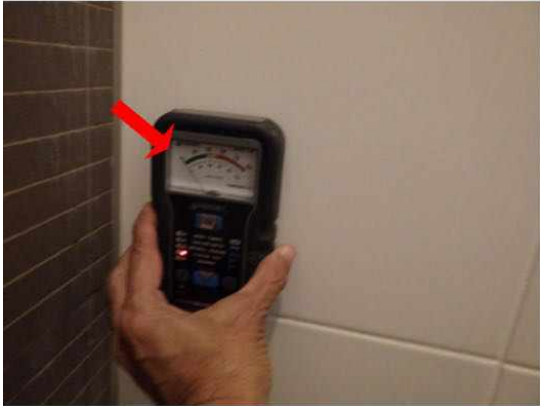
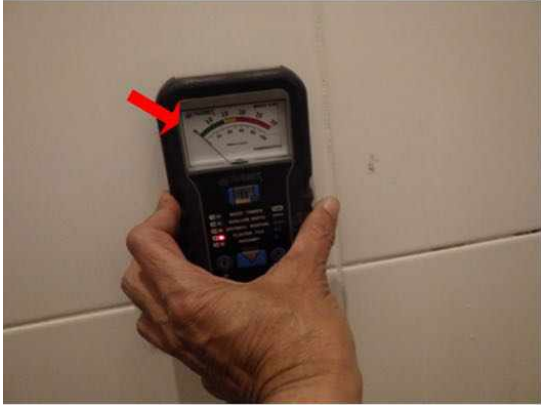
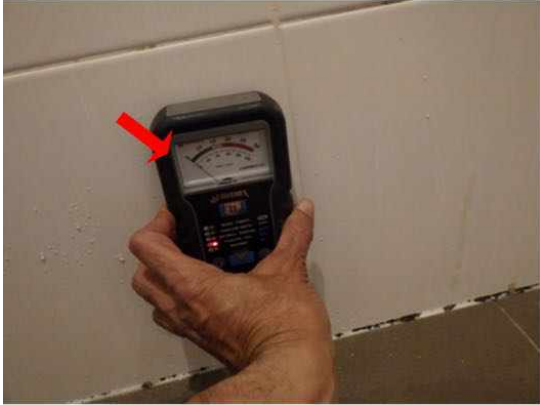
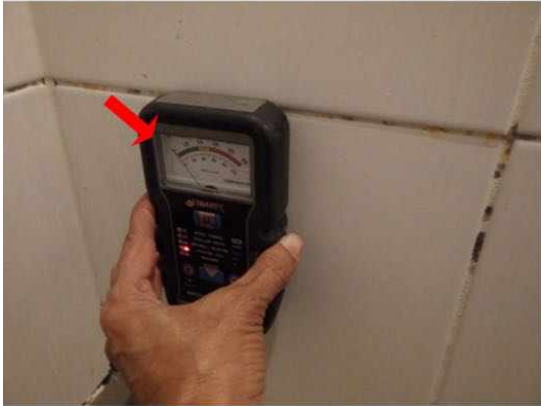
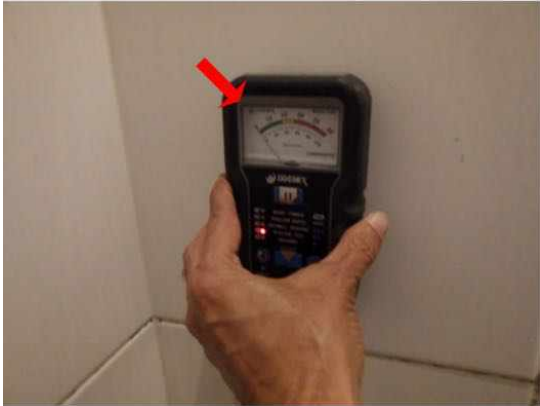
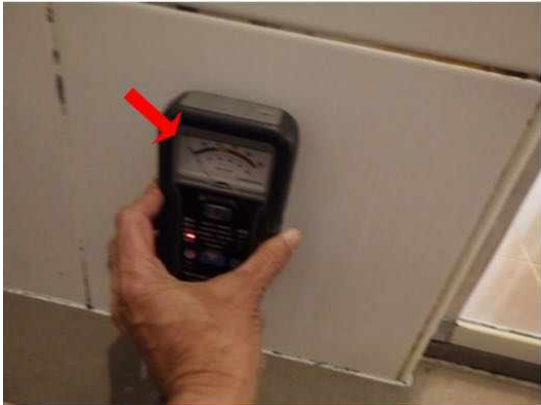
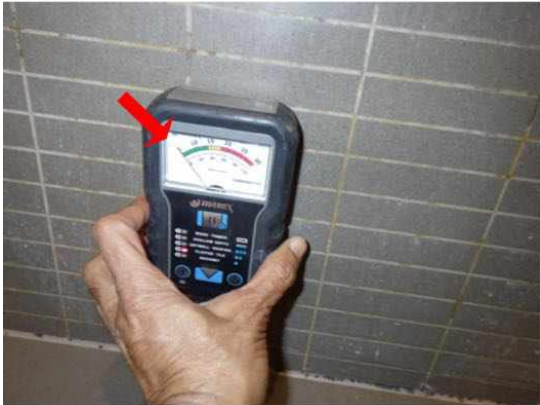
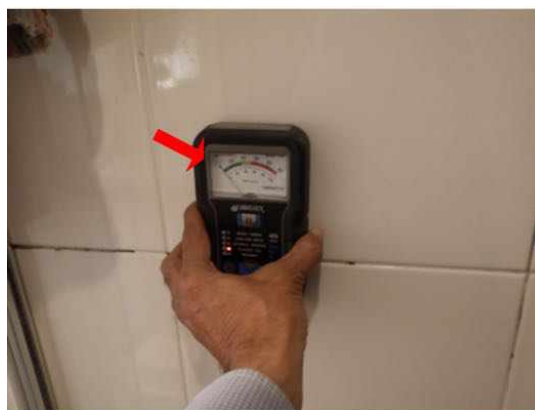
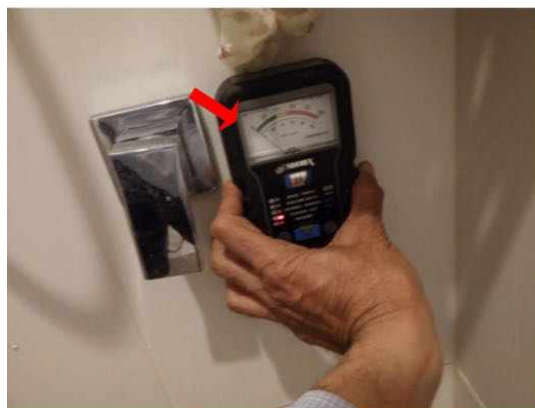
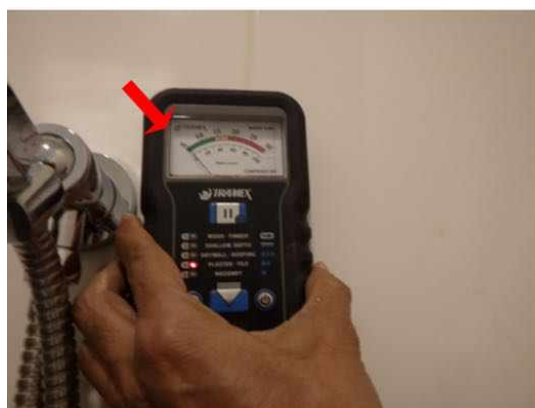
Damp (or structural damp) refers to the presence of unwanted moisture in the structure of a building, either as the result of intrusion from outside, or condensation from within the structure. In the shower area, internal water leaks or other sources of excessive moisture are generally the cause of damp.

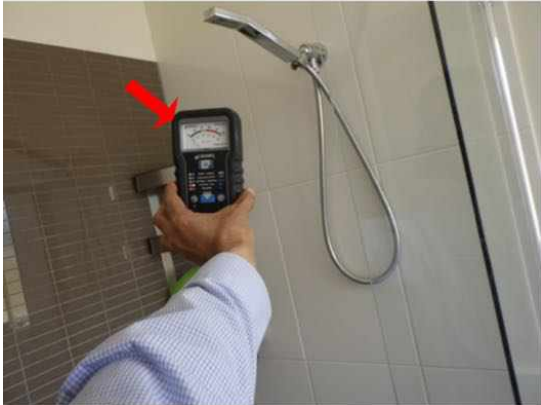
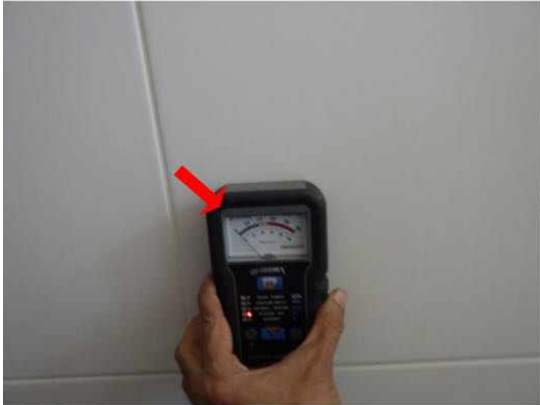
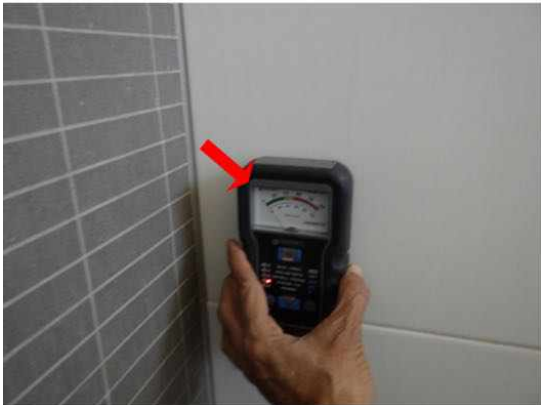
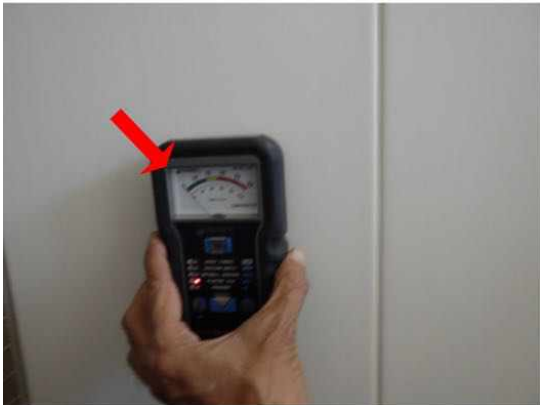
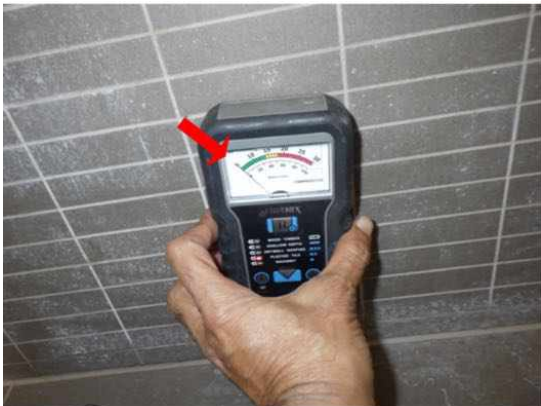
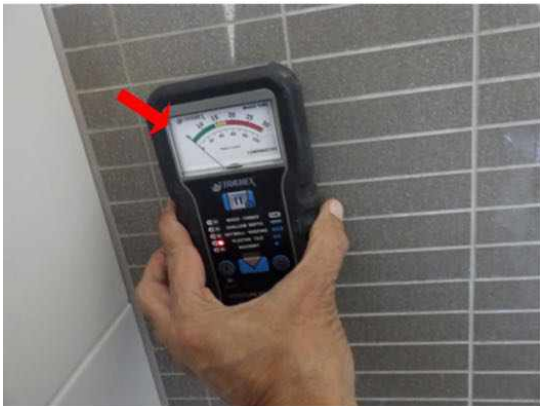
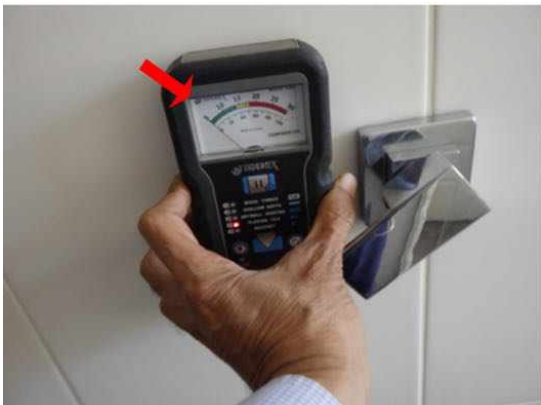
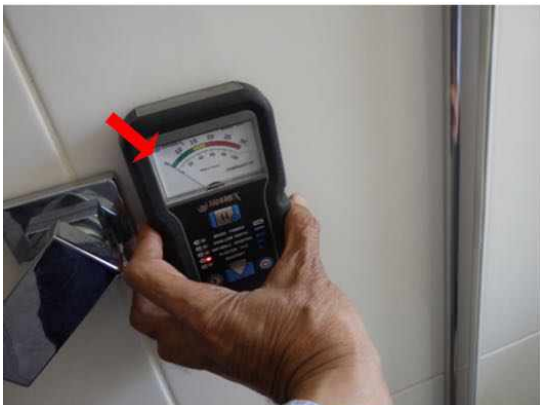
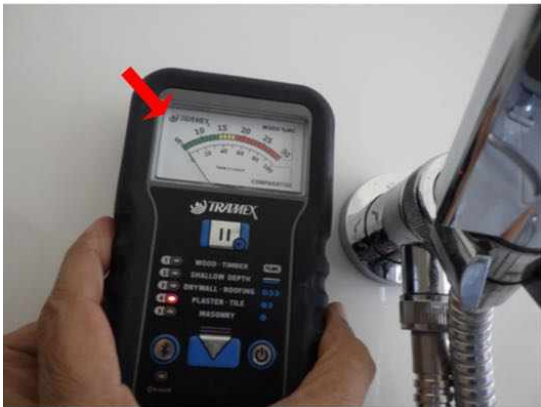
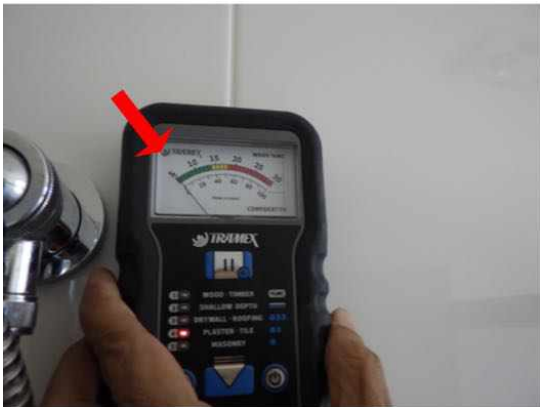
Building: Building 1
 Location: Bathroom 2
 Finding: Shower Alcove - No Damp
 Information: At the time of inspection it was noticed that damp is not evident to the shower alcove.

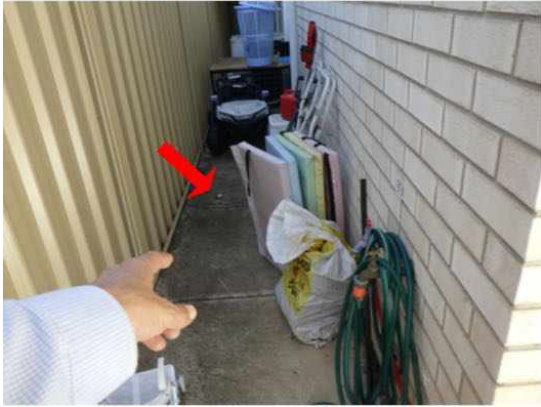
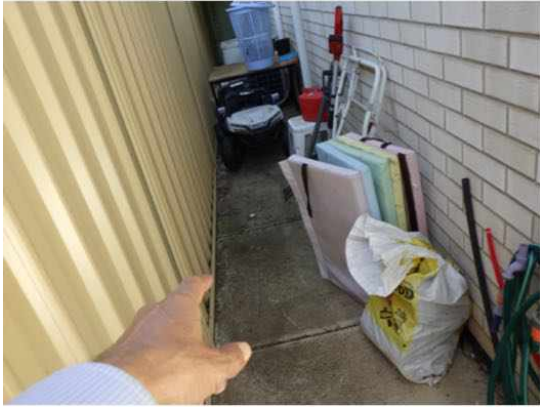
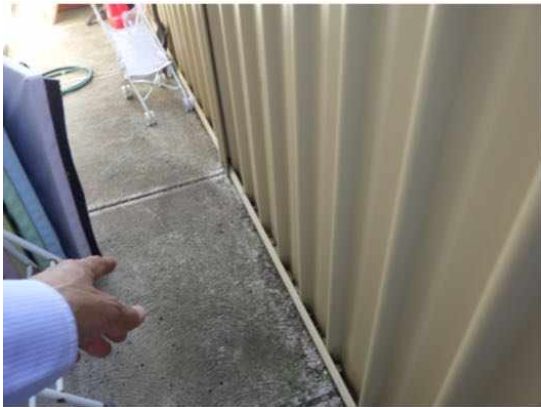
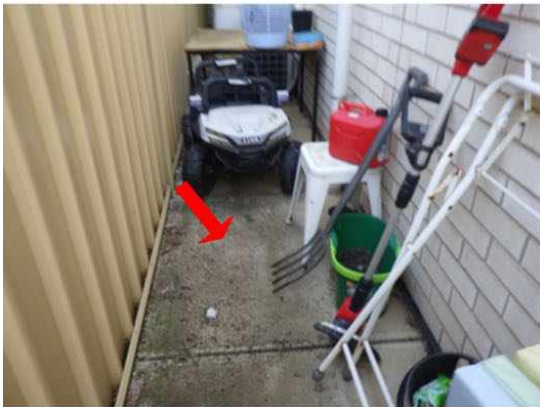
Building: Building 1
 Location: All External Areas
 Finding: Water pooling - against property
 Information: Water appears to be pooling against the house. It is suspected that this is a result of poor site drainage but may also be due to excessive moisture from an unidentified source.

Where water is pooling against the house water damage to the external wall cladding is imminent.

Such water pooling also increases the risk of termite activity and the development of fungal decay in the area.

Consult a Licensed Plumber regarding the cost of potential site drainage rectification works.

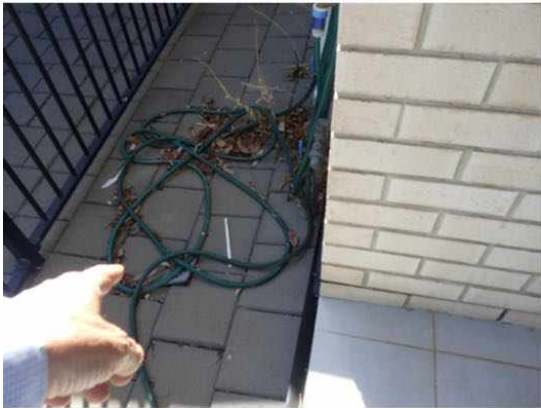
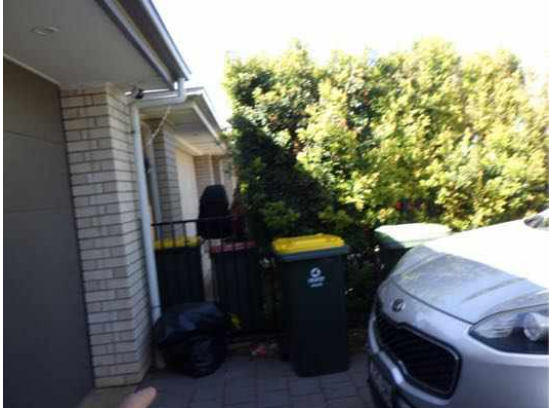
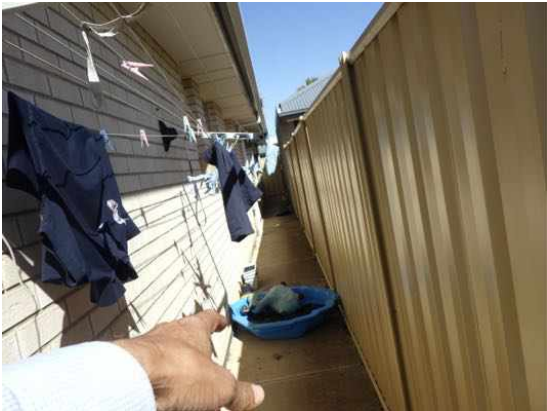
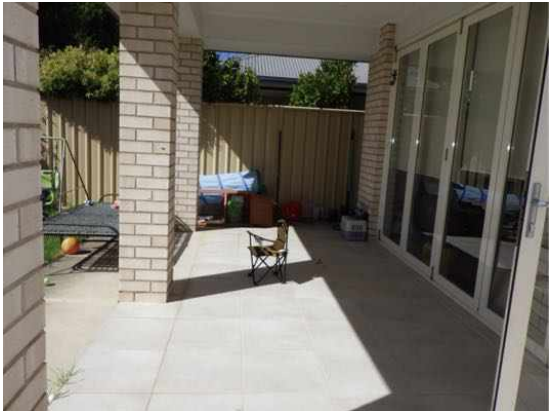
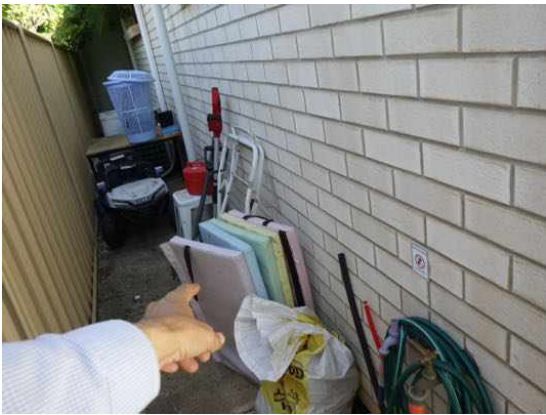
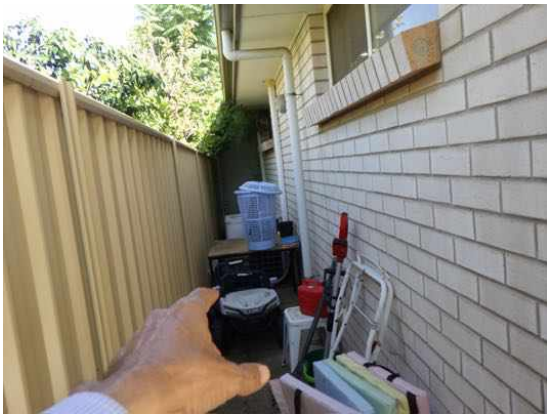
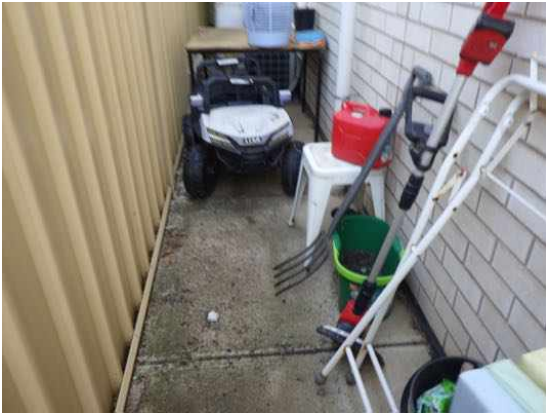
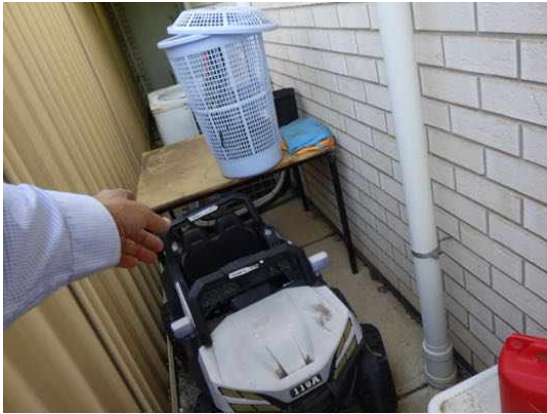
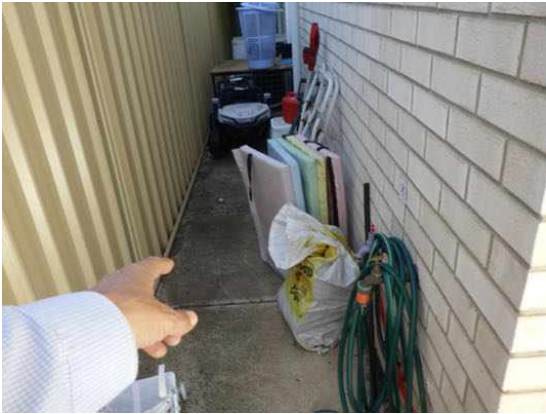
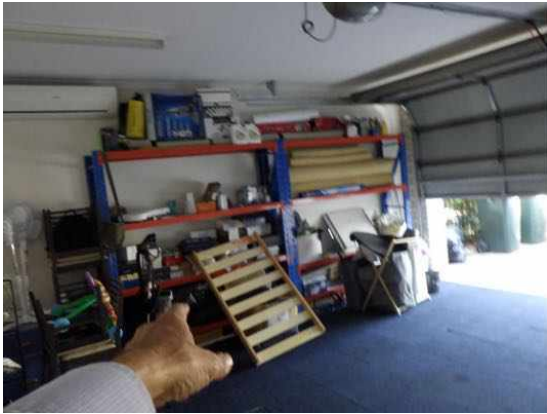
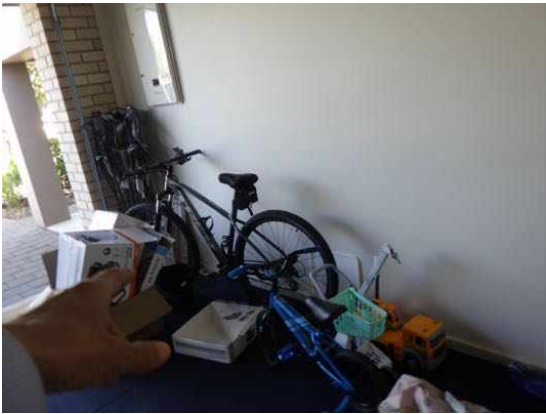
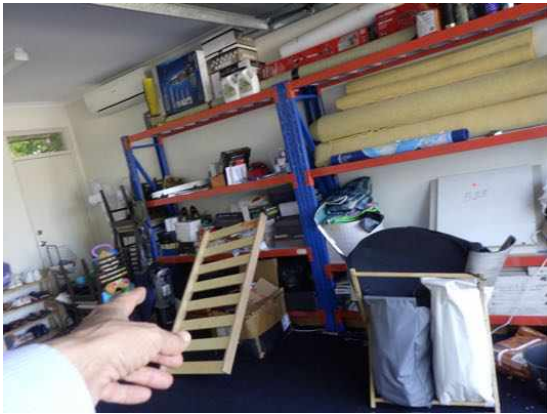
Building: Building 1
 Location: All Areas
 Finding: Additional Photos - Obstructions and Limitations
 Information: These photographs are an indication of the obstructions and limitations which impeded full inspection of the property at the time of inspection. These obstructions can hide an array of defects and should be removed to allow full inspection to be carried out. A re-inspection is recommended once the areas are made accessible.
