Building Inspection Report

Inspection Date: Wed, 4 Mar 2026

Property Address: 12 Grand Rd, Munno Para SA 5115,
Australia

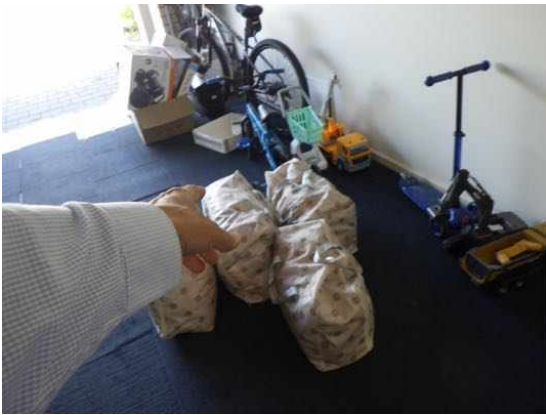
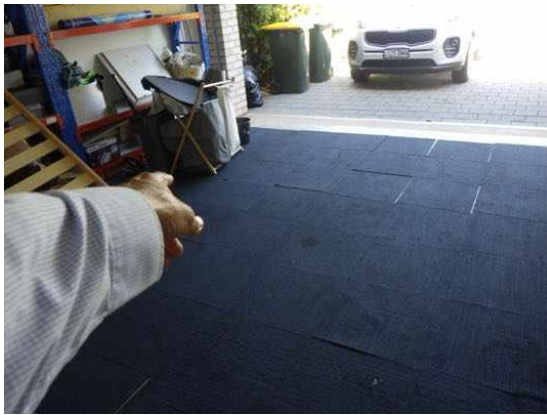
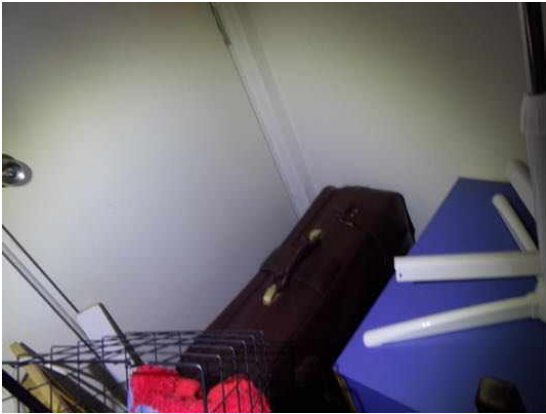
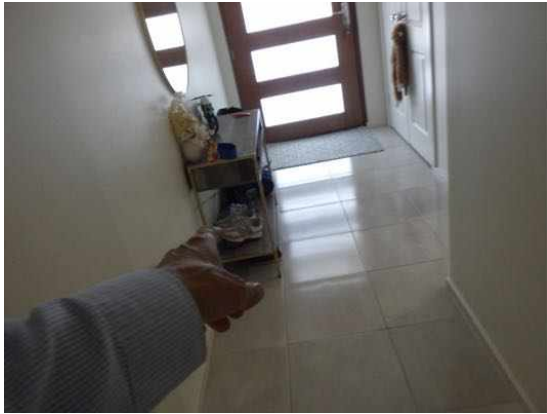
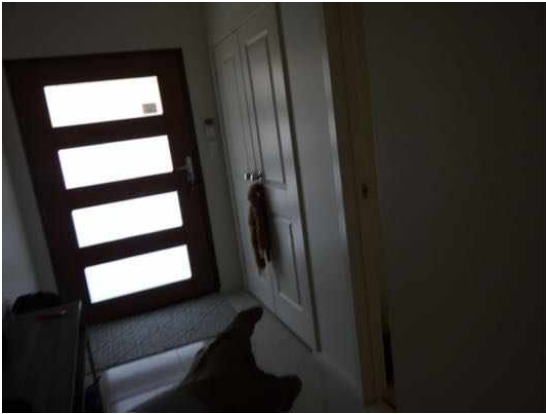
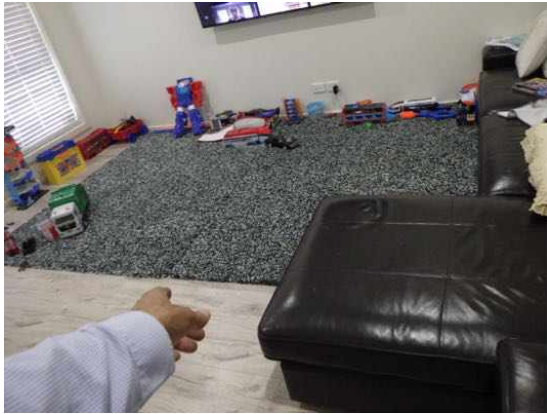
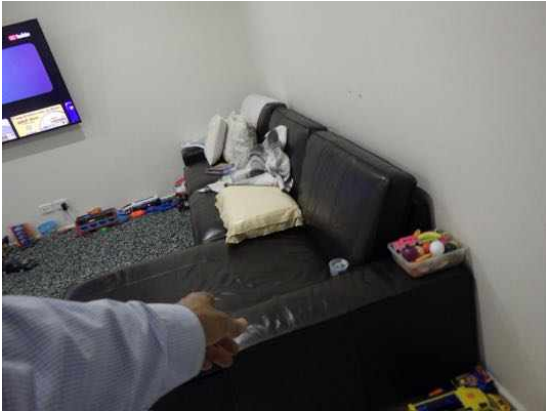
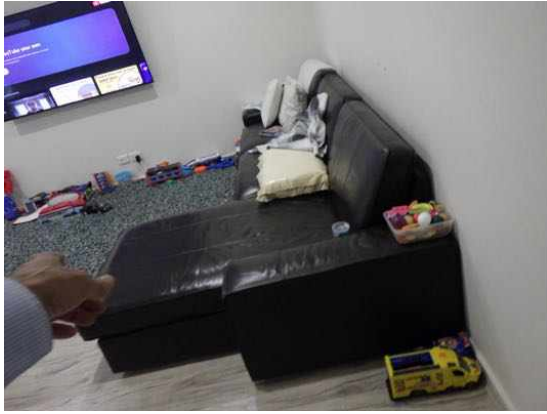
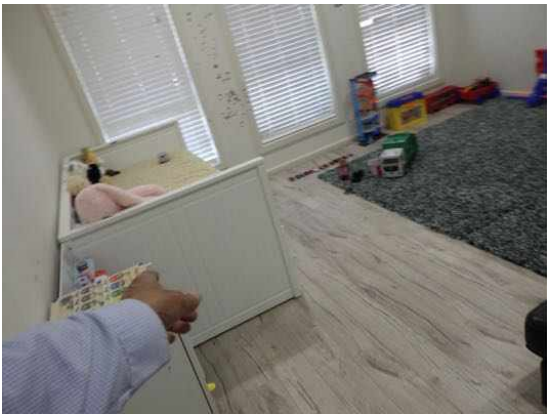
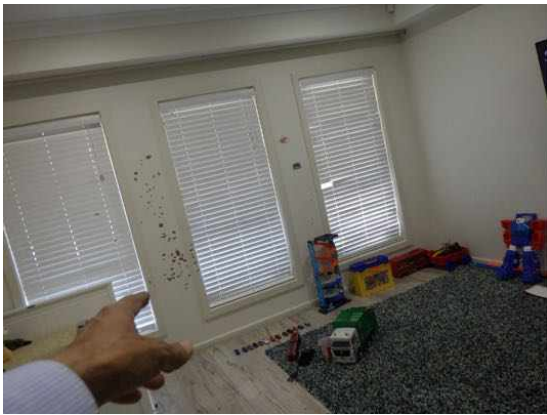
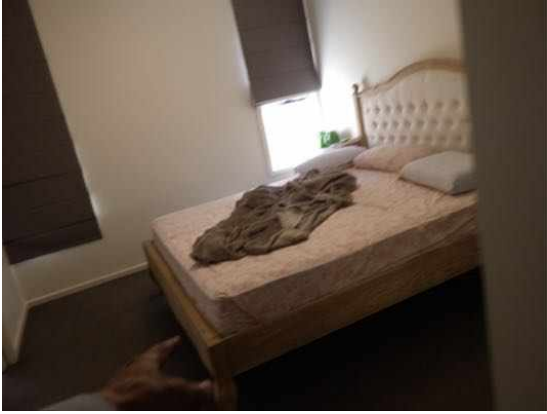
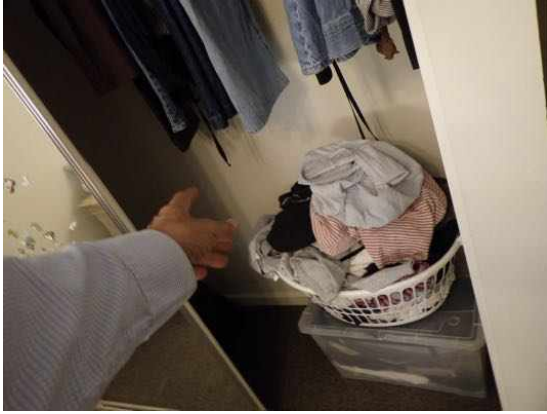
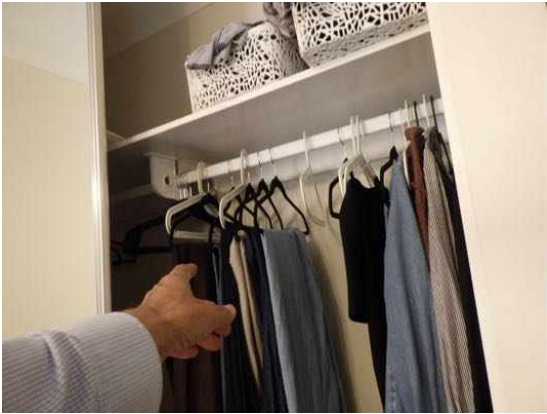
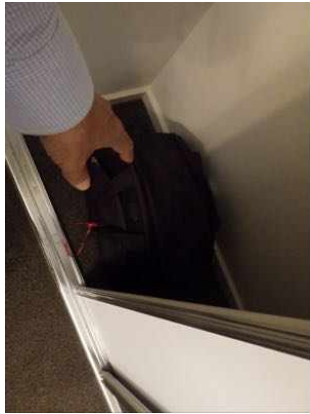
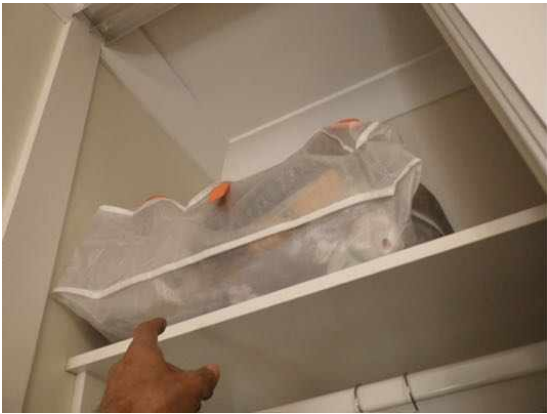
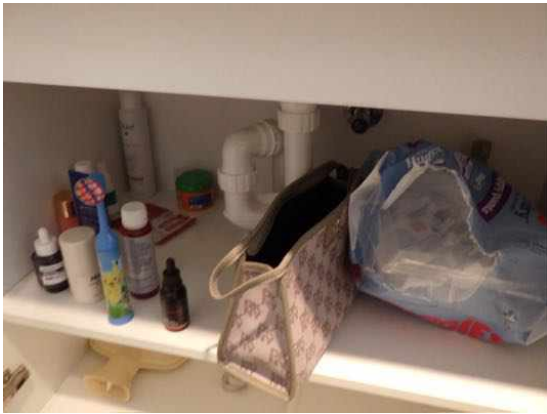
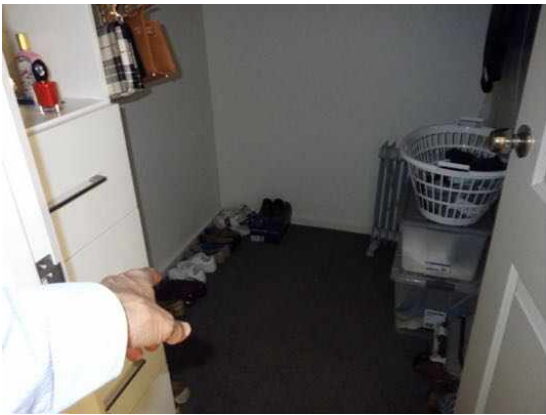
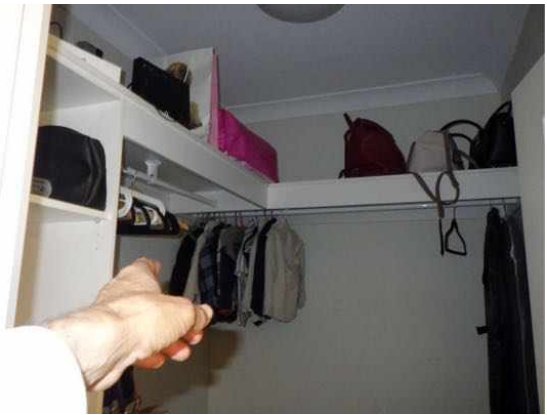
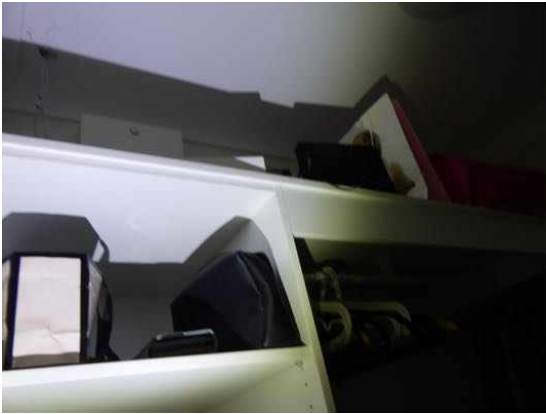
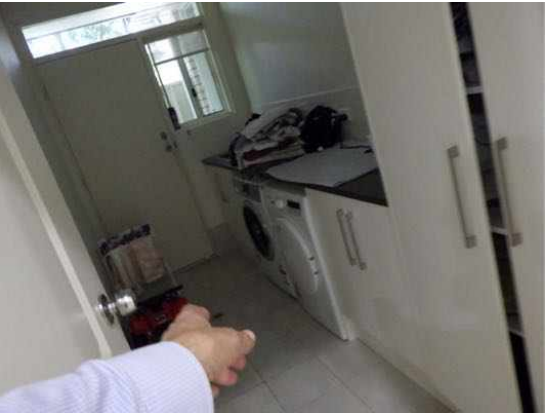
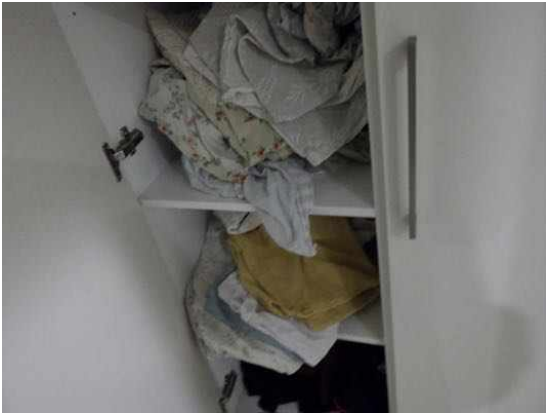
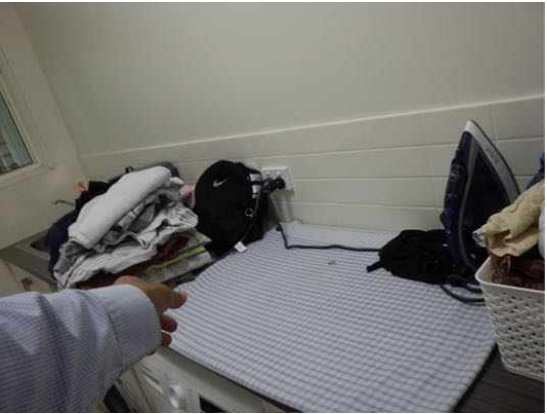
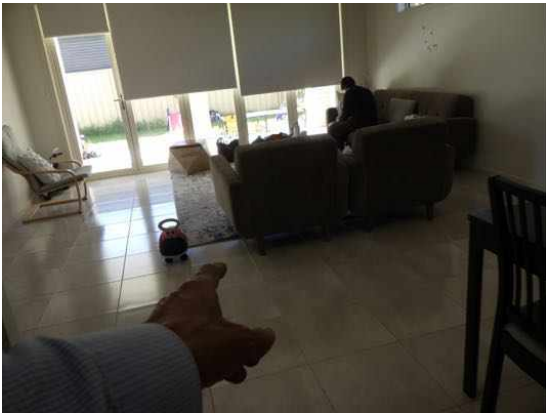
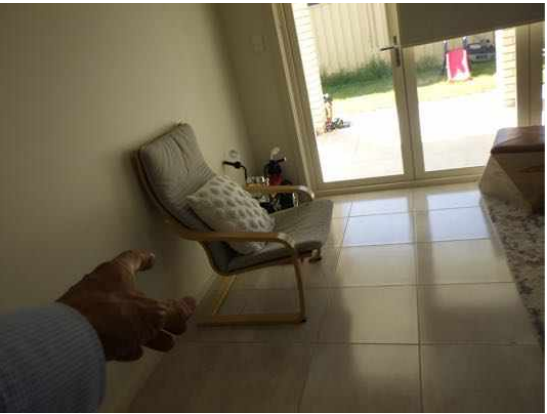
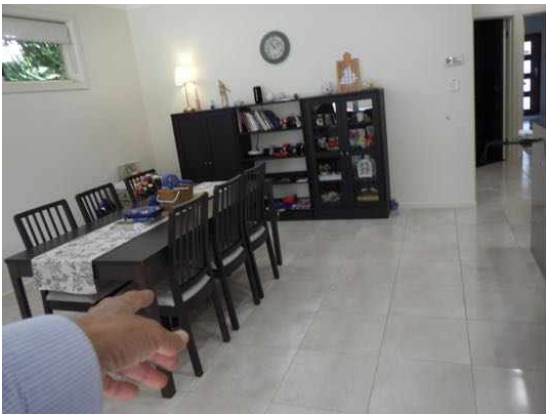
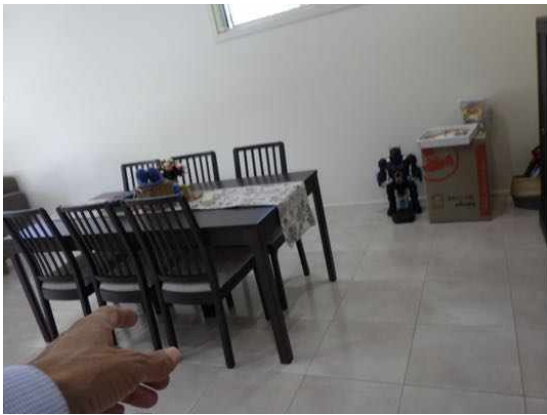
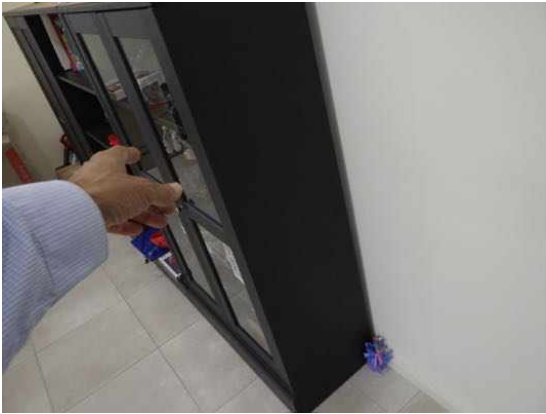
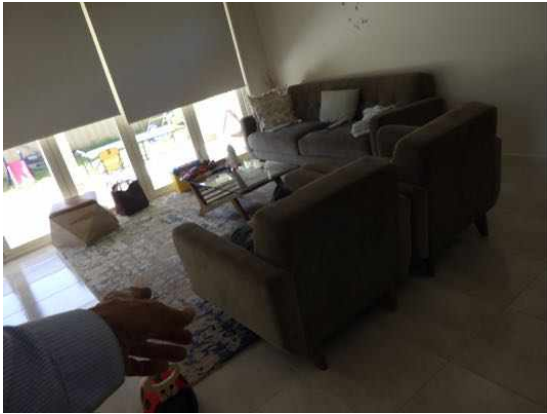
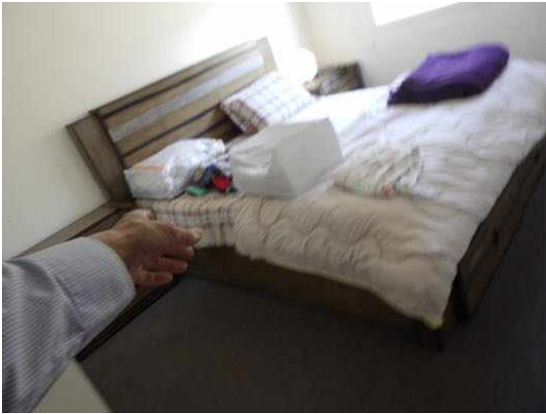
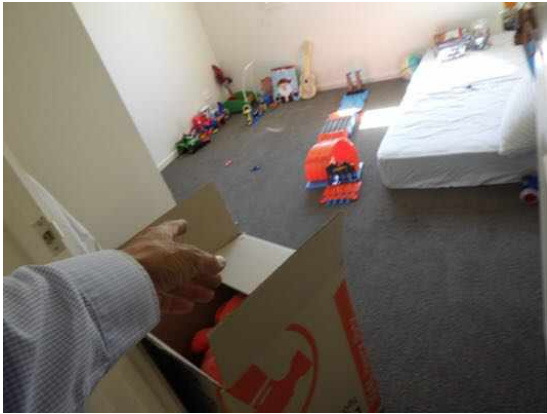
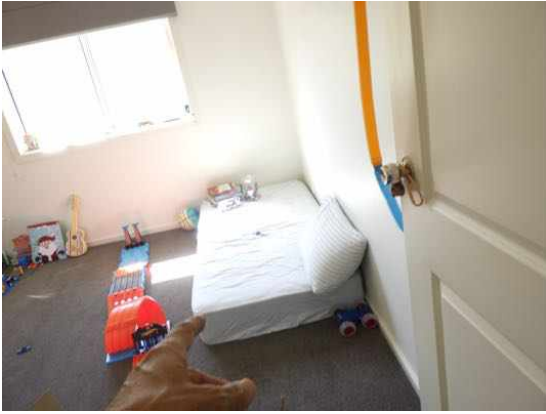
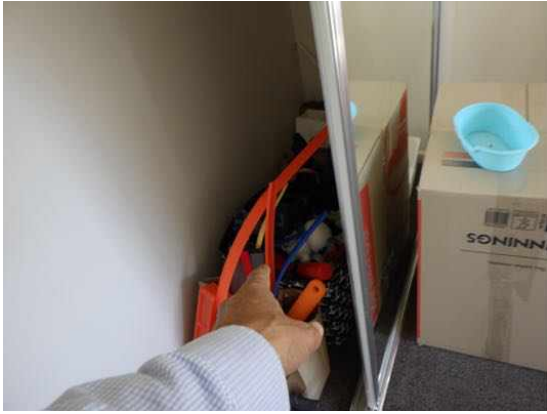
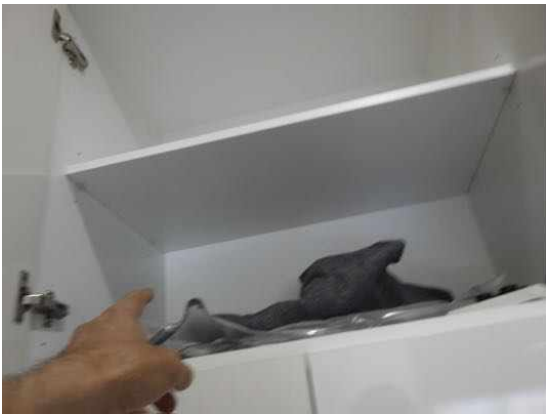
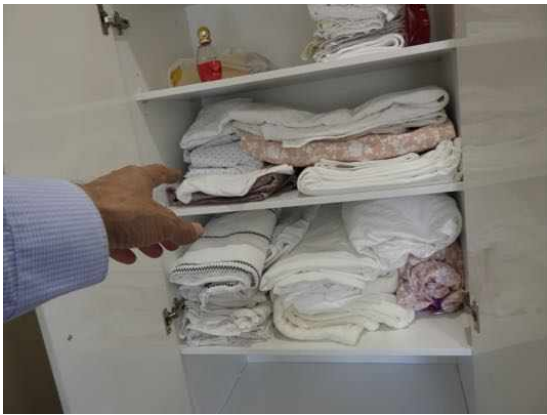
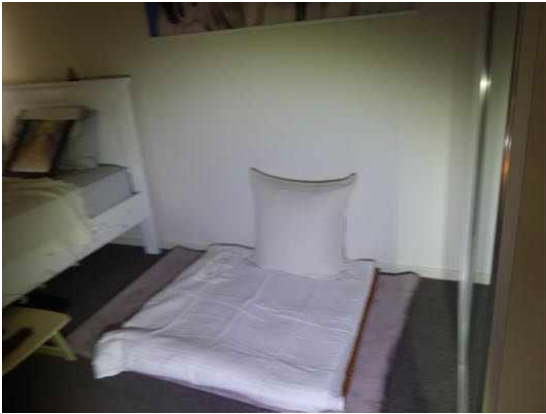
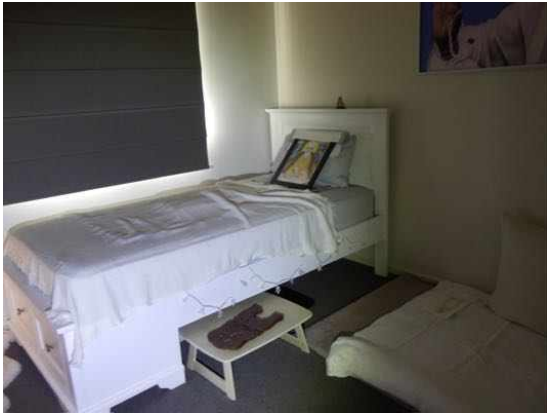
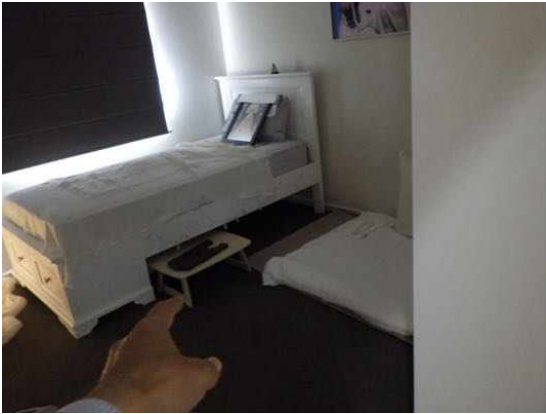
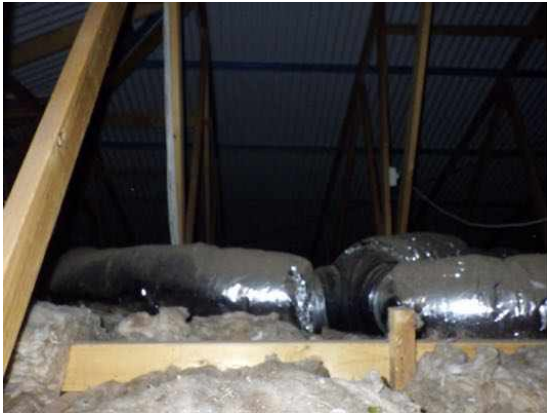
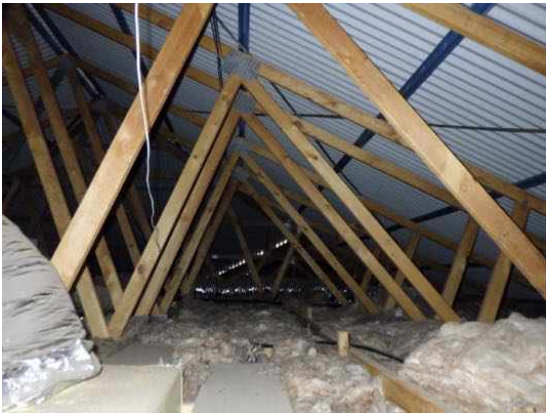
Noted Item

Building: Building 1
 Location: All Areas
 Finding: Additional Photos - Obstructions and Limitations
 Information: These photographs are an indication of the obstructions and limitations which impeded full inspection of the property at the time of inspection. These obstructions can hide an array of defects and should be removed to allow full inspection to be carried out. A re-inspection is recommended once the areas are made accessible.
