Building and Timber Pest Inspection Report

Inspection Date: Wed, 14 Jan 2026

Property Address: 17 Loch Avenue, Glenmore Park NSW
2745

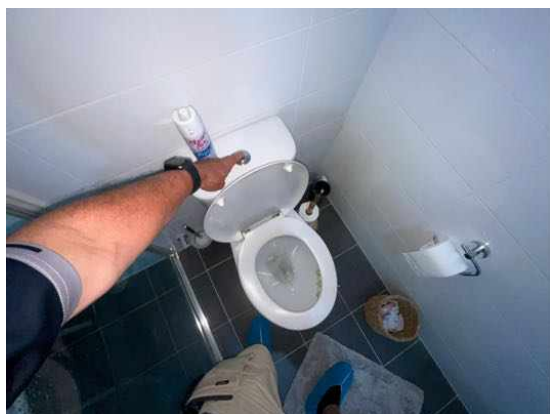
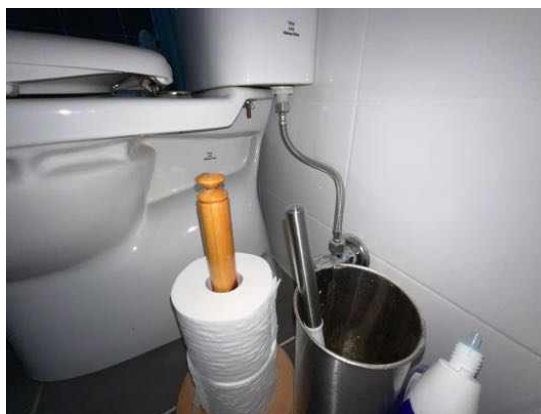
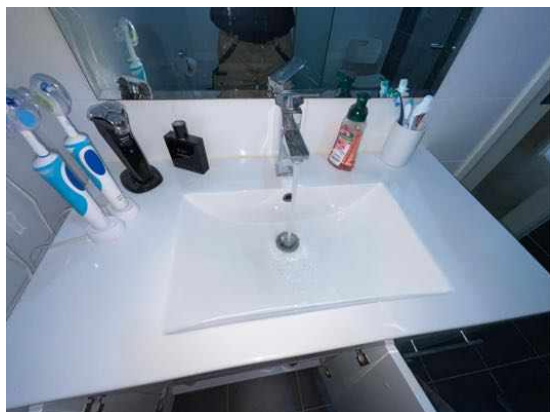
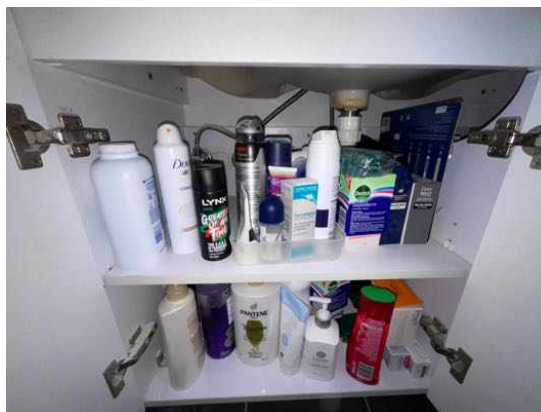
Building: Main Building
 Location: Bathroom
 Finding: Wet Areas - Bathroom(s) - Overall Condition & Recommendations.
 Information: Overall Condition & Recommendations

It is not possible under the visual inspection criteria of a standard pre-purchase report to categorically determine if leaks are present. If a more detailed or accurate assessment is required, a special-purpose inspection should be undertaken.

Alternatively, the assumption should be made that leakage may occur, particularly where historical or environmental conditions are conducive. The visual nature of this inspection cannot detect issues concealed behind wall/floor linings or cabinetry, and invasive investigation may be necessary to confirm the true condition of adjacent or hidden structures.

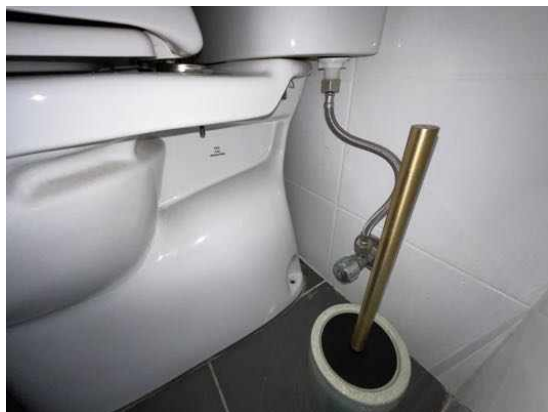
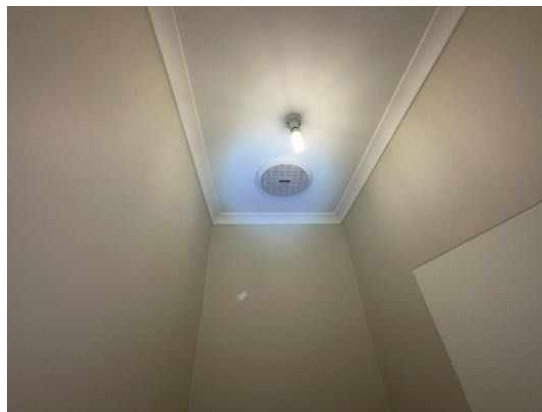
Building: Main Building
 Location: All Areas
 Finding: Water Pressure – Observation Only.
 Information: During the inspection, water pressure appeared to be within a normal operating range based on a basic functional check. However, this observation was made without the use of pressure testing equipment and does not constitute an assessment by a licensed plumber.
