Building and Timber Pest Inspection Report

Inspection Date: Mon, 2 Feb 2026

Property Address: 157 Riverview Rd, Earlwood NSW 2206,
Australia

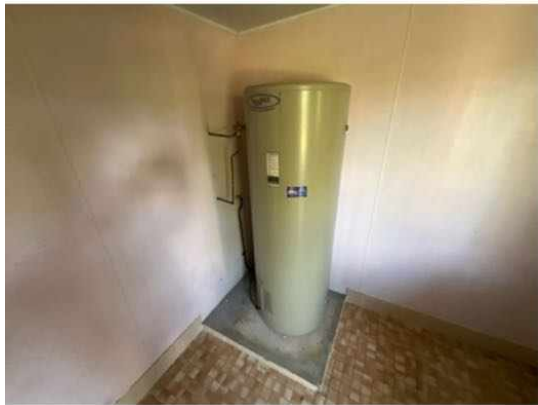
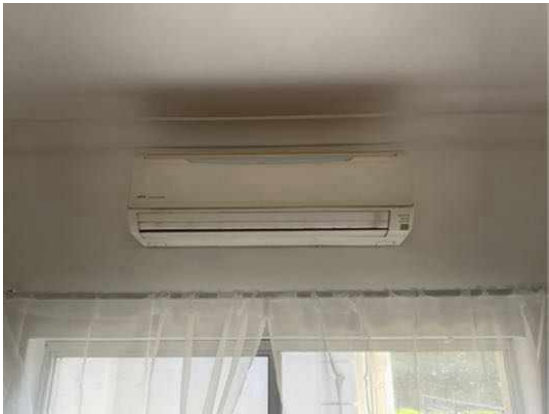
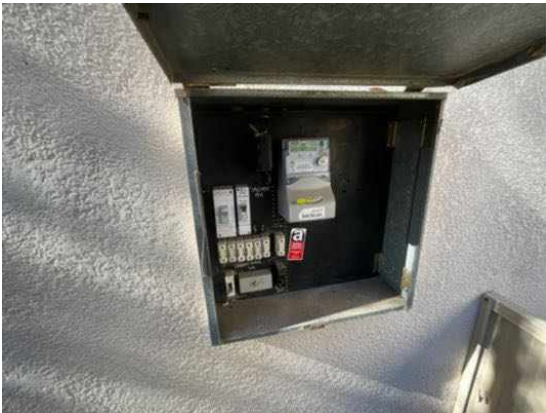
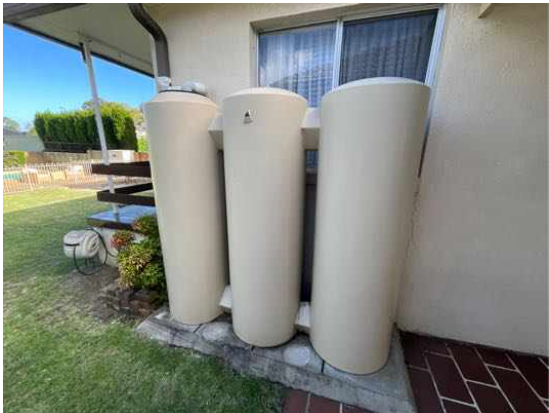
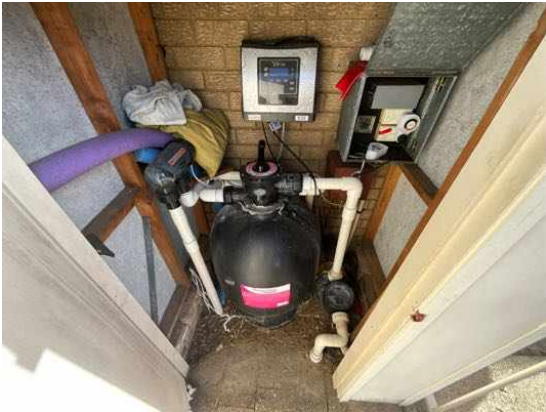
Building: Main Building
Location: All Areas
Finding: Photos Added
Information: Additional photos are provided for your general reference.

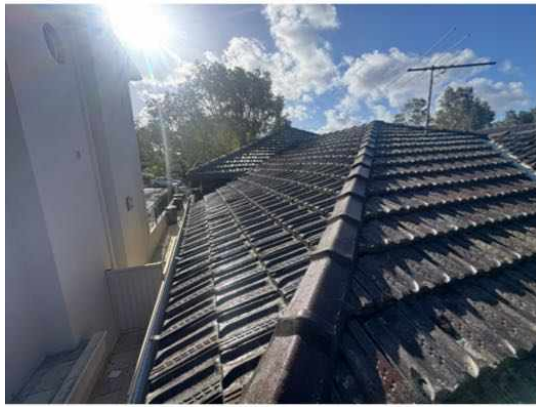
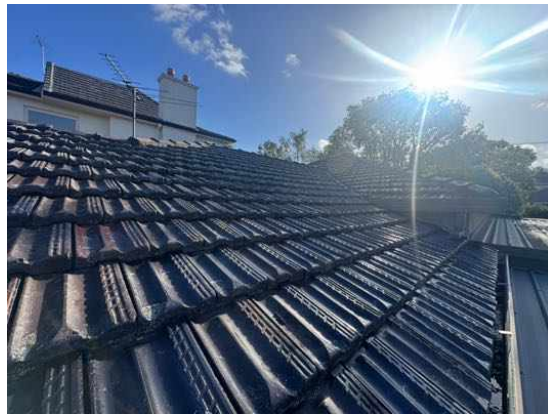
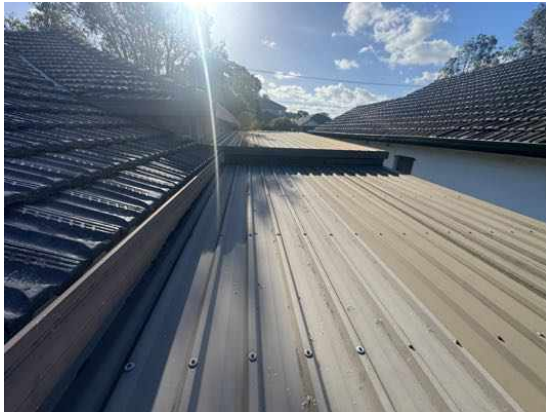
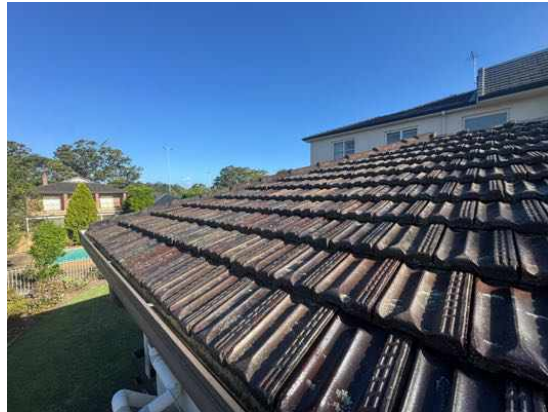
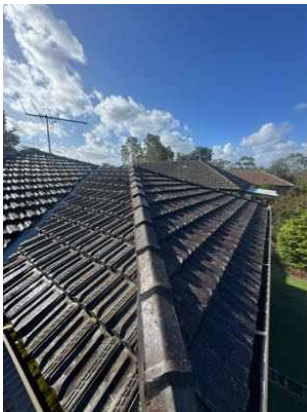
Building:	Main Building
Location:	Roof Exterior
Finding:	Photos Added
Information:	Additional photos are provided for your general reference.

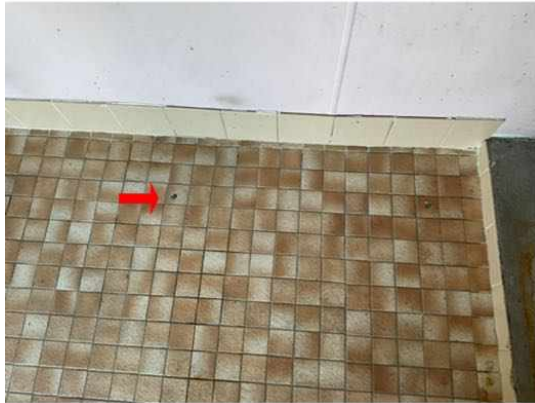
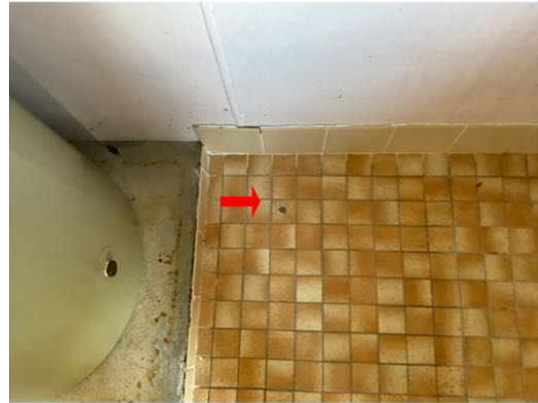
The following items were noted as - Evidence of a previous termite management program

Where a Termite Management System has been identified you should refer to the type of barrier date of installation warranty conditions and any documentation provided by a builder or past owner. Consult the company who installed the barrier to confirm whether the system is still under warranty.

Most chemical termite management systems expire and require replenishment and all physical systems are primarily designed to prevent concealed entry.
