Building and Timber Pest Inspection Report

Inspection Date: Wed, 11 Feb 2026

Property Address: 36/31-35 chamberlain street Campbelltown

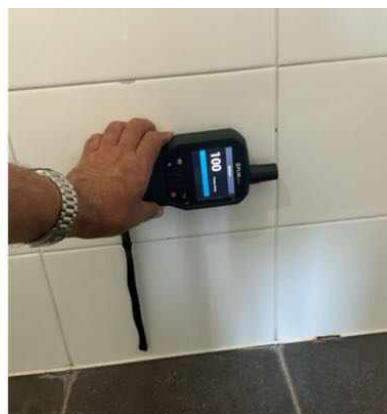
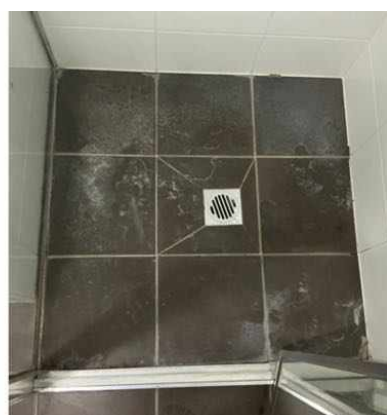
Finding: Elevated Moisture Bathroom and efflorescence

Information: Elevated moisture levels were detected to tiled surfaces in bathroom/shower areas. This may be due to porous or missing grout, cracked tiles or recent use, however the possibility of waterproofing membrane failure or plumbing leaks cannot be excluded.

Persistent moisture ingress can lead to concealed damage, including timber rot and mould growth. Further investigation by a licensed plumber and/or waterproofing contractor is recommended as soon as possible.

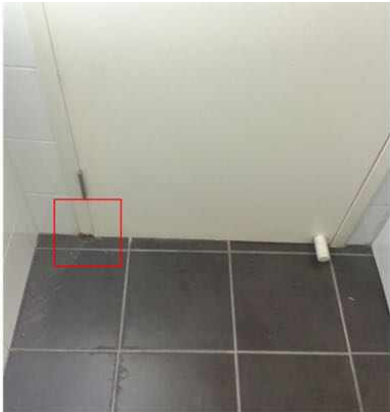
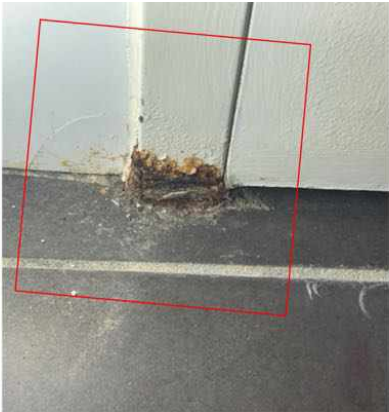
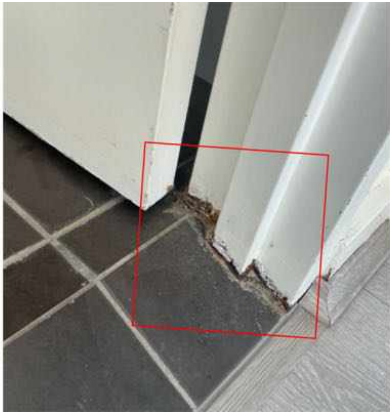
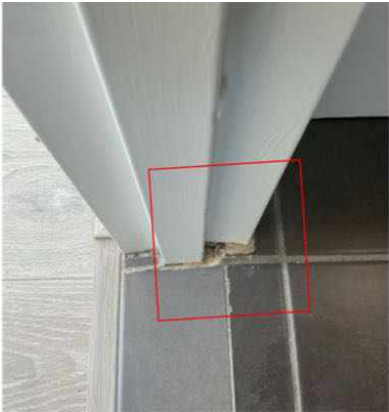
Finding 2.02

Building: Main Building
Location: Bathroom
Finding: Wet-Area Door Jambs – Moisture Staining / Decay
Information: moisture staining and deterioration were observed at the base of the wet-area door jamb and architraves. This is commonly due to water splashing or moisture tracking from the bathroom floor into adjacent joinery or inadequate waterproof transition at the bathroom threshold.

Further inspection by a licensed waterproofing contractor is recommended to verify exact cause and remedial measures

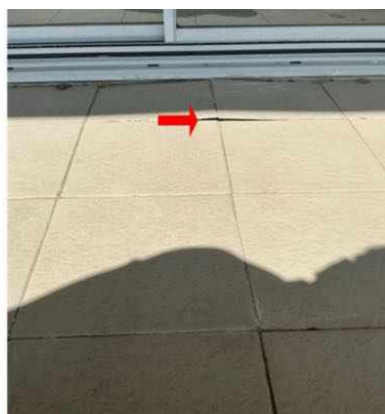
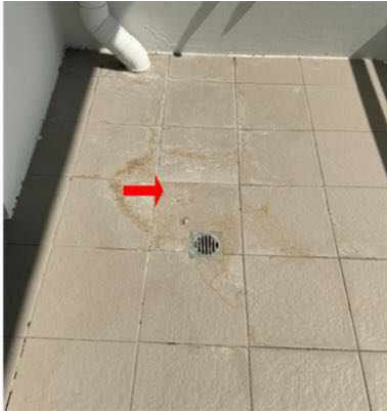
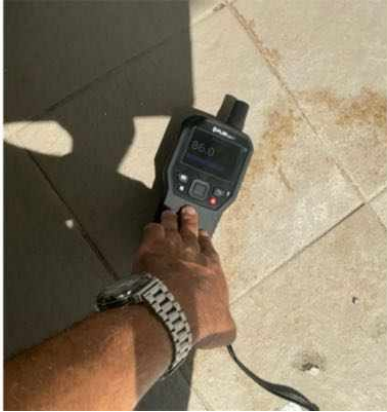
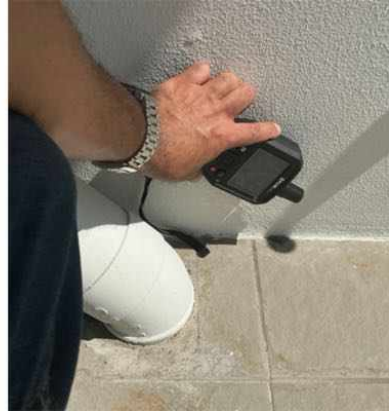
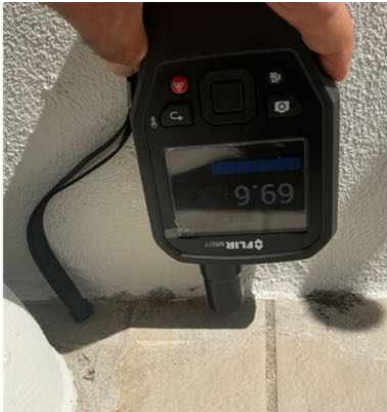
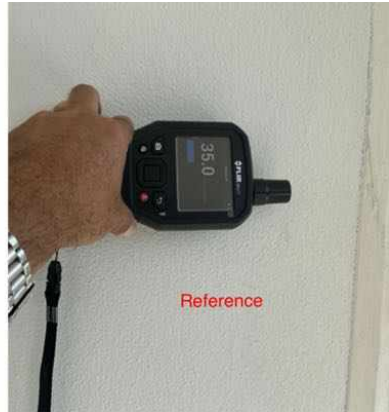
Finding 2.03

Building:	Main Building
Location:	Balcony - Lounge
Finding:	Balcony – Elevated Moisture , Efflorescence, Tiles lifting
Information:	Elevated moisture readings were detected to the tiled balcony floor with lifting tiles , visible efflorescence and discolouration to grout lines indicating prolonged or recurring moisture presence beneath the tile finish. This condition is commonly associated with failed grout or sealant joints, insufficient surface drainage and/or inadequate waterproofing allowing moisture to become trapped within the balcony substrate.

While no internal water ingress was evident at the time of inspection .It has potential to escalate if moisture migration continues, and assessment by a suitably qualified strata appointed waterproofing specialist is recommended.

Depending on the strata plan, this area may form part of the common property, in which case remedial responsibility may rest with the owners corporation (strata). Purchasers should seek clarification from the strata manager and legal adviser prior to purchase.

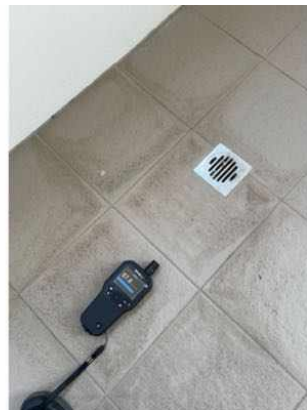
Finding 3.01

Building:	Main Building
Location:	Balcony 2
Finding:	Balcony Elevated Moisture - Strata
Information:	Elevated moisture was recorded at the base of the balcony wall and tiles, with associated staining consistent with water exposure. While no internal damage was visible at the time of inspection, balconies in multi-unit dwellings are high-risk areas for waterproofing failure, which can lead to leaks into adjoining units and significant

rectification costs. Further investigation by a licensed waterproofing contractor is strongly recommended.

Depending on the strata plan, this area may form part of the common property, in which case remedial responsibility may rest with the owners corporation (strata). Purchasers should seek clarification from the strata manager and legal adviser prior to purchase.

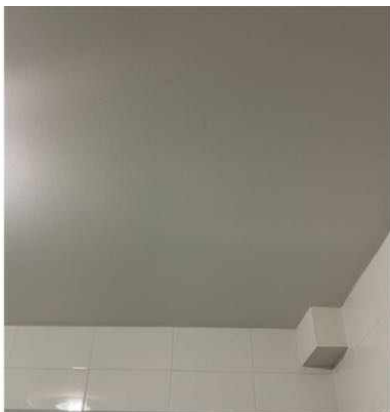
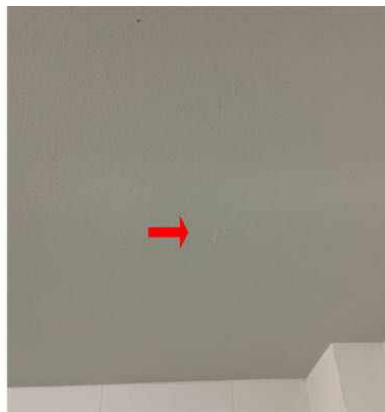
Finding 3.02

Building:	Main Building
Location:	Bathroom
Finding:	Water Staining - Humidity or Ventilation
Information:	The ceiling surface in the images shows faint darkened spotting or shadowing, commonly consistent with surface mould or humidity-related staining, often found in bathroom or wet area ceilings with insufficient ventilation. While there is no visible sagging or major water damage, the pattern suggests prolonged moisture exposure, possibly due to steam accumulation or minor condensation issues. According to AS 4349.1-2007 (Appendix C), this would be classified as a minor defect unless further deterioration or active leaks are found. Recommend improving mechanical or natural ventilation, cleaning the surface with mould treatment, and monitoring for recurrence.

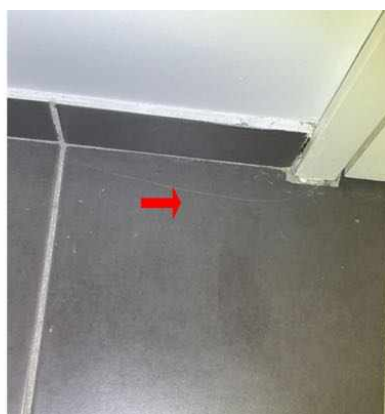
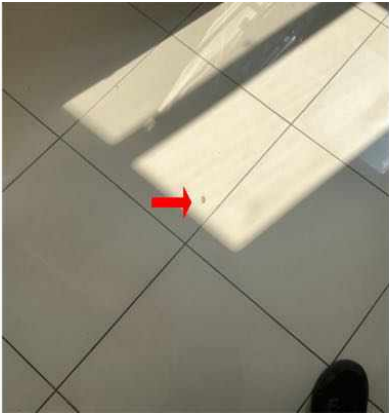
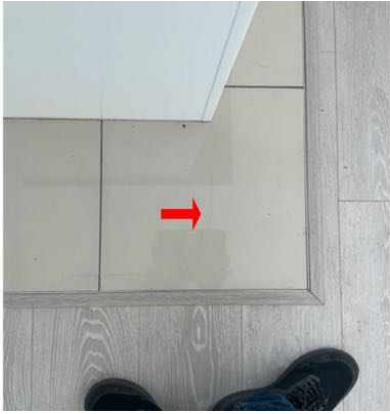
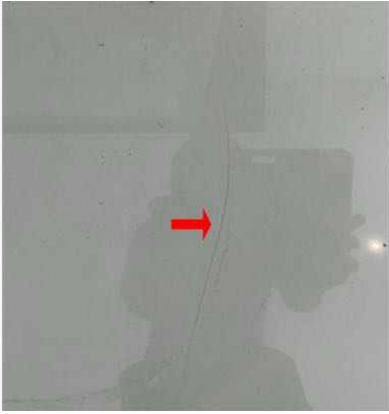
Finding 3.03

Building:	Main Building
Location:	All Internal Areas - Laundry, bathroom, kitchen
Finding:	Tiles - Cracked or damaged to some areas
Information:	Cracking was evident to the tiling in this area at the time of inspection. While the cracking appears to be minor, this area is frequently exposed to water, allowing potential for water penetration into adjoining sections of walls or flooring.

If left unmanaged, water penetration to these areas may lead to subsequent water damage, which is likely necessitate repair work to affected building elements.

A tiling contractor should be appointed to ensure that no further water damage occurs. The re-application of silicone and grouting throughout remaining tile work is also advised, to further protect the area against water penetration.

Where water penetration has led to water damage, appointment of a relevant tradesperson may be required to repair damaged building elements.

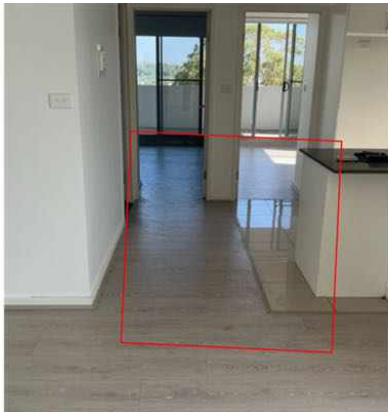
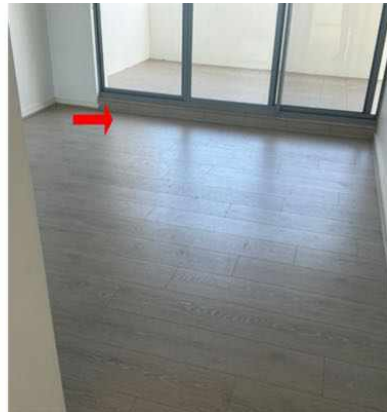
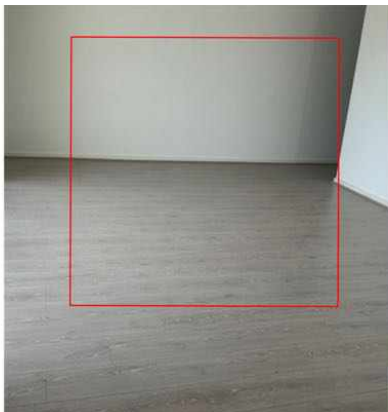
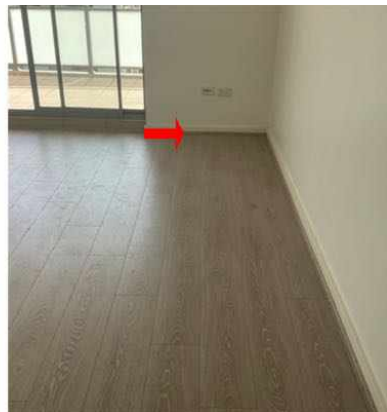
Finding 3.04

Building: Main Building
Location: All Internal Areas
Finding: Uneven Laminate Floor
Information: unevenness was observed to sections of the laminate flooring. This condition is typically associated with installation tolerances, minor subfloor irregularities, or natural movement of a floating floor system. While not considered a major defect, the unevenness may present a minor trip hazard and lead to accelerated wear of the flooring if left unrectified. Monitoring and, if required, localised rectification by a flooring contractor is recommended.

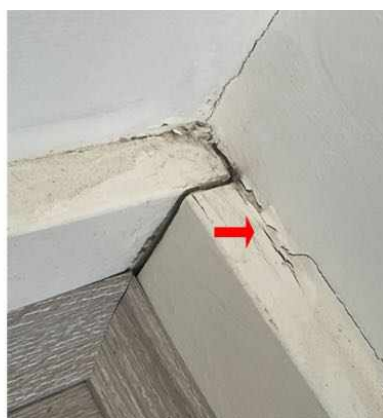
Finding 3.05

Building:	Main Building
Location:	Bedroom 2
Finding:	Building element - Damaged - Skirting possible moisture damage
Information:	Breakage occurs generally when the building materials have either aged and decayed, or as a result of damage (accidental or deliberate).

Repair and/or replacement of broken elements is advised to ensure that additional secondary defects do not arise as a consequence. Such works are necessary, as all building elements play a key role in the operation and function of the overall structure and its performance.

A relevant tradesperson should be appointed to further investigate ,repair or replace the affected building element prior to any subsequent damage being caused.

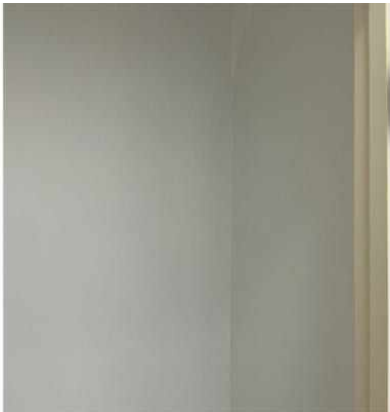
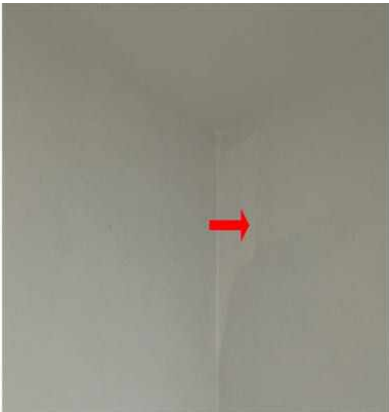
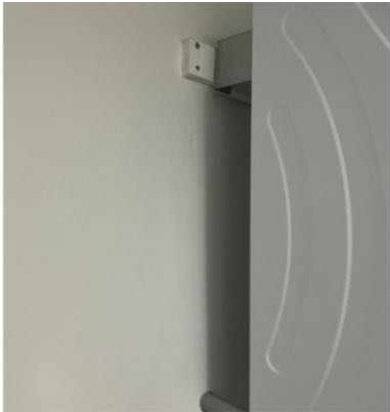
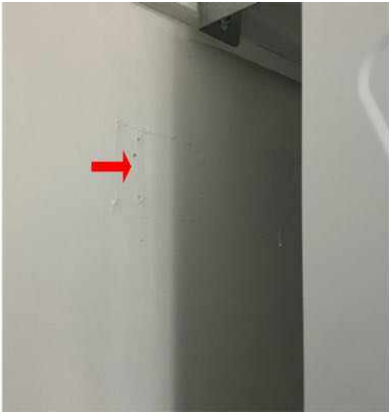
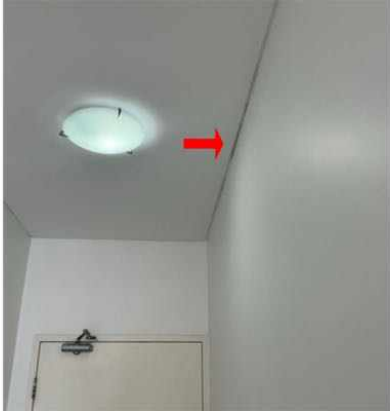
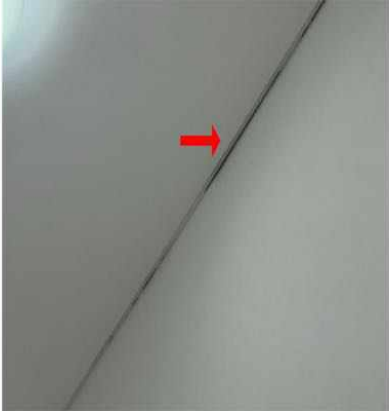
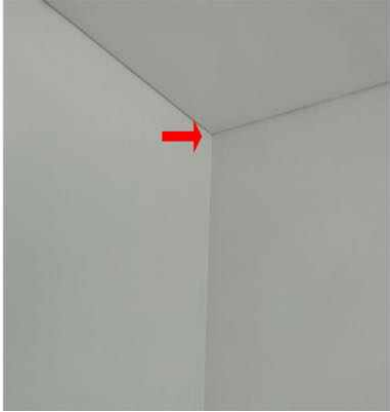
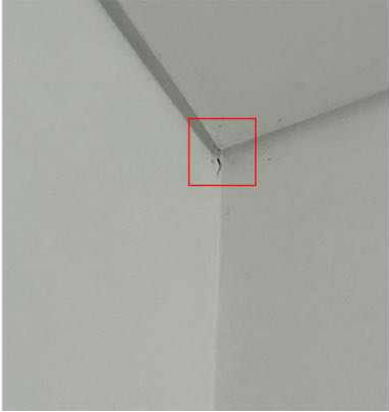
Finding 3.06

Building:	Main Building
Location:	All Internal Areas
Finding:	Paint finish and hairline cracking to some areas
Information:	The paint finish in this area was identified as being incomplete at the time of inspection including some hairline minor cracking.

Whilst incomplete or missing paint finish is generally an appearance defect, it can also lead to the development of secondary building defects over time. Incomplete areas of paint finish expose the area to moisture, potentially accelerating the deterioration of underlying building materials.

Incomplete paint finishes should be sanded back, filled, leveled and painted, as applicable. Where inadequate or missing paint protection has led to the deterioration of the associated building element, repair and/or replacement of this building element may be required.

A painting contractor should be appointed as soon as possible to perform necessary works to aid the appearance of the affected area and to ensure the area is protected against further deterioration. Alternatively, the homeowner following manufacturer

instructions may perform these works.

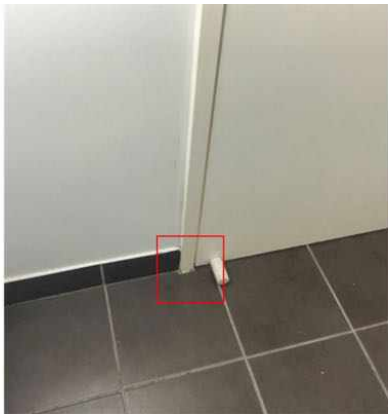
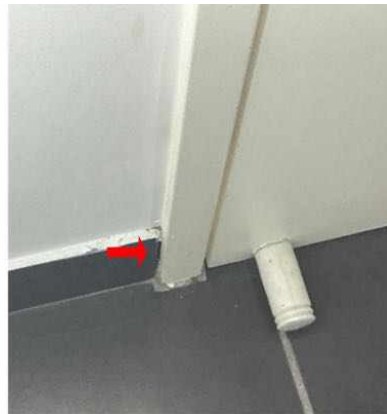
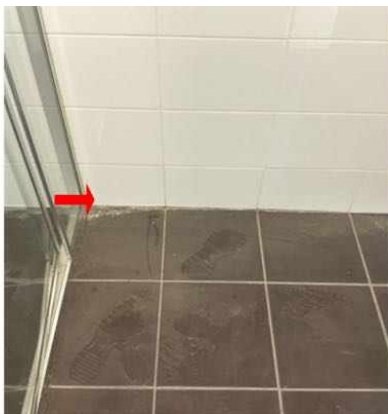
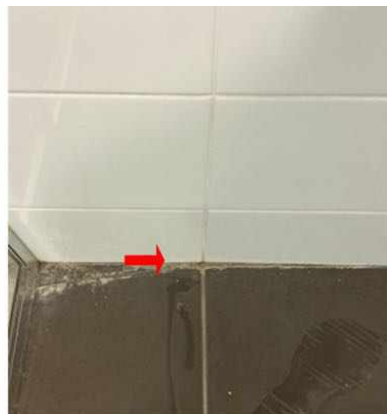
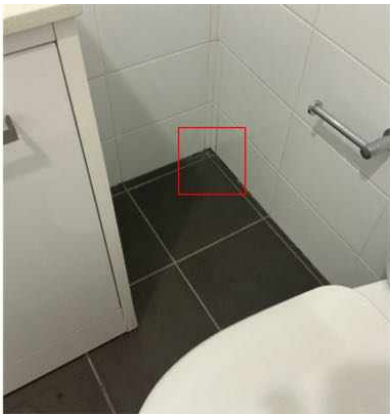
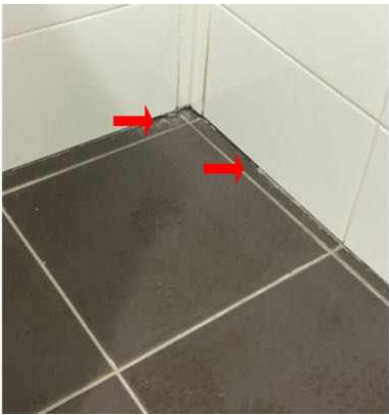
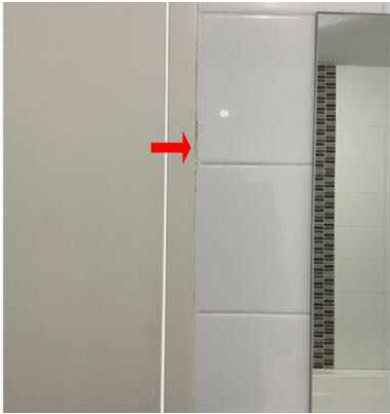
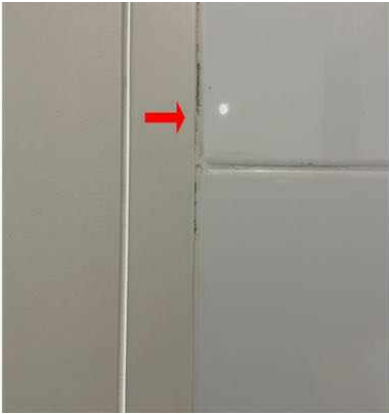
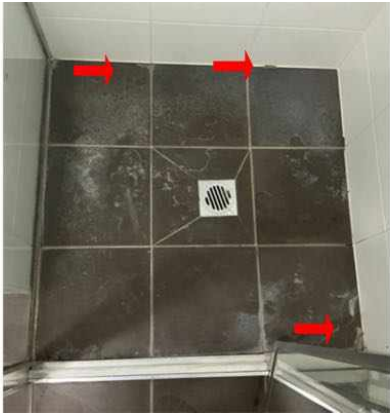
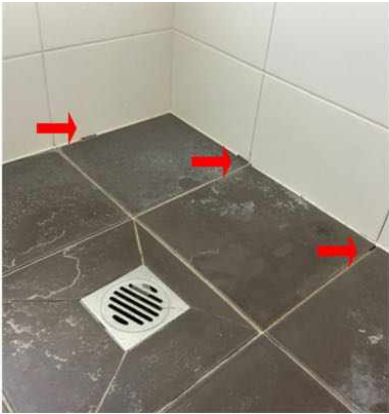
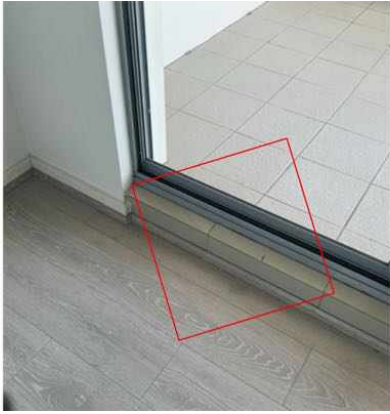
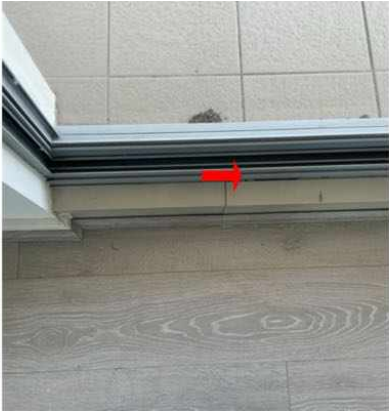
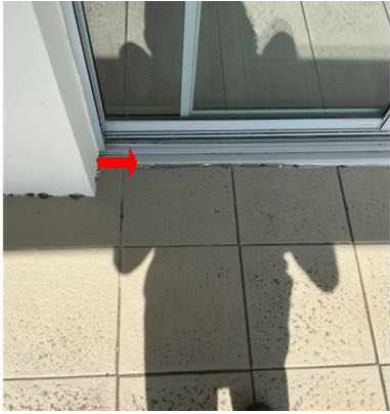
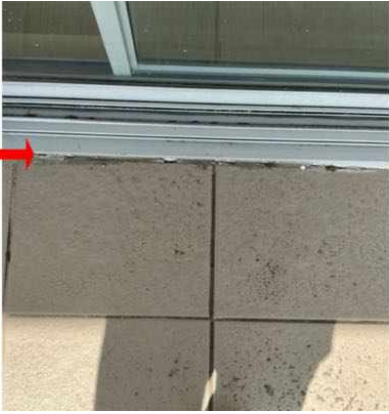
Finding 3.07

Building:	Main Building
Location:	All Internal Areas
Finding:	Sealant and grouting - Missing or degraded to some areas
Information:	It was noted on inspection that sealant or grout is degraded. There is also evidence of poor workmanship and excessive use of sealant. Silicone should never be used as a first line of defence against waterproofing. Further inspection by a licensed waterproofing contractor is highly recommend

Different materials and floor areas move at different rates, generally causing cracking to grout or sealant at this point. A flexible sealant is required to allow for expected expansion and contraction, while keeping the joint water tight and protective of all

There appears to be excessive mould to the sealant and grout which will likely require scraping out and replacement.

Flexible and mould resistant materials should be applied to affected areas to prevent any subsequent water damage that is likely to occur. Regular maintenance and replacement of damage or missing or damaged sealant and grout is highly recommended to the wet areas, as this is a regular wear and tear defect. Sealant and grouting in areas that come into regular contact with water should be maintained for the long term care of your property.

A sealant specialist or tiling contractor should be appointed to complete these works as soon as possible

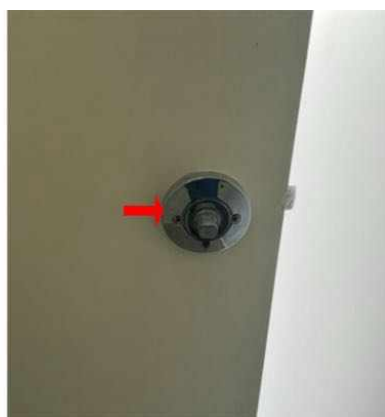
Finding 3.08

Building:	Main Building
Location:	All Internal Areas
Finding:	Building element - Damaged - Door handle broken hallway , Flyscreens not installed
Information:	Breakage occurs generally when the building materials have either aged and decayed, or as a result of damage (accidental or deliberate).

Repair and/or replacement of broken elements is advised to ensure that additional secondary defects do not arise as a consequence. Such works are necessary, as all building elements play a key role in the operation and function of the overall structure and its performance.

A relevant tradesperson should be appointed to repair or replace the affected building element prior to any subsequent damage being caused.

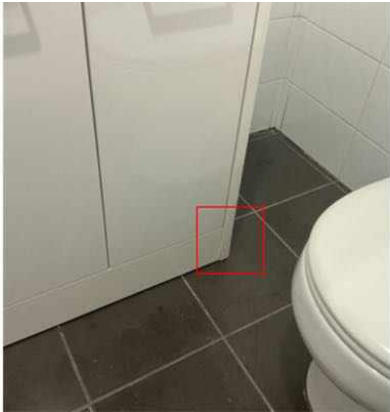
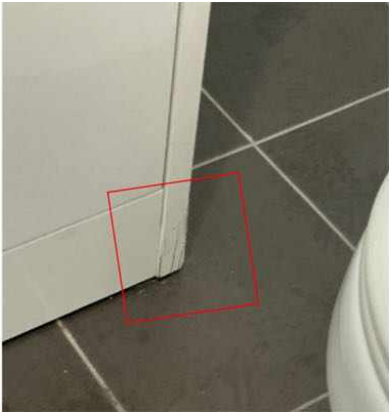
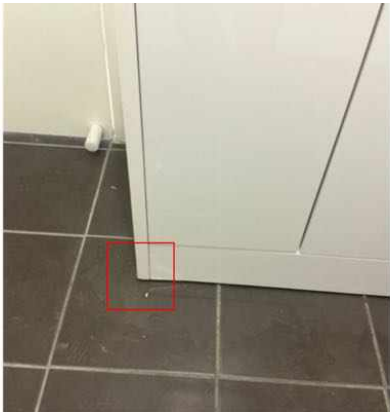
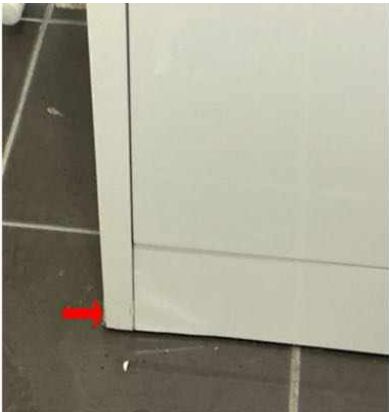
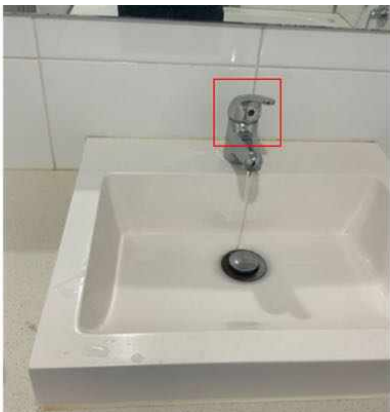
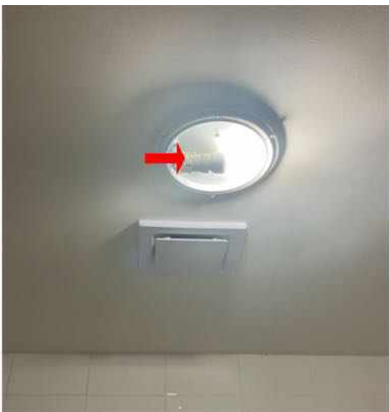
Finding 3.09

Building:	Main Building
Location:	Bathroom , kitchen
Finding:	Building element - Damaged - vanity moisture damaged , basin tap handle loose , light cover missing bathroom , kitchen holes not sealed , benchtop chipped
Information:	Breakage occurs generally when the building materials have either aged and decayed, or as a result of damage (accidental or deliberate).

Repair and/or replacement of broken elements is advised to ensure that additional secondary defects do not arise as a consequence. Such works are necessary, as all building elements play a key role in the operation and function of the overall structure and its performance.

A relevant tradesperson should be appointed to repair or replace the affected building element prior to any subsequent damage being caused.

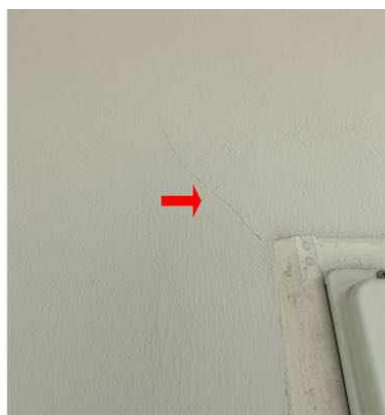
Building:	Main Building
Location:	Balcony - Lounge
Finding:	Cracks to render - Category 1 to some areas
Information:	It has been observed that cracking to rendered surfaces has occurred. The degree of damage falls within Category 1, described as fine cracks that do not need repair and which are less than 1.0mm in width limit.

Damage of this category is not considered a defect for rectification. Always contact your building inspector should cracks widen, lengthen, or become more numerous.

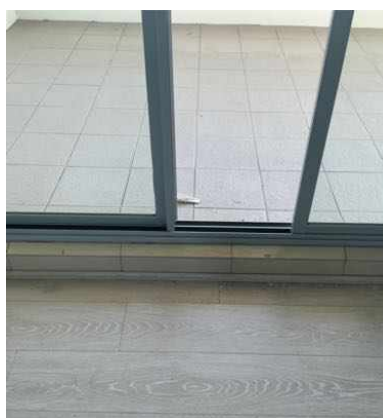
Building:	Main Building
Location:	Balcony
Finding:	Balcony Floor Level Differential
Information:	The balcony finished surface appears to be close to, higher or at the same level as, the internal floor. Standard construction practice requires a step-down of approximately 50 mm unless a fully engineered threshold drainage system is provided. No such drainage features were visible during inspection. This configuration increases the risk of water ingress, and confirmation of the balcony waterproofing detail through strata/building management is recommended.

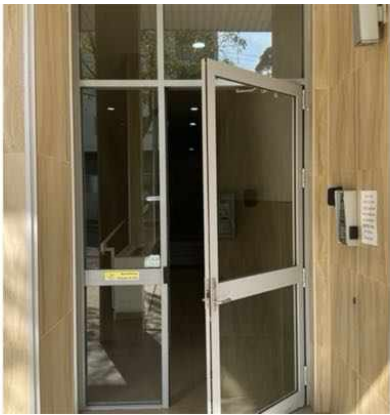
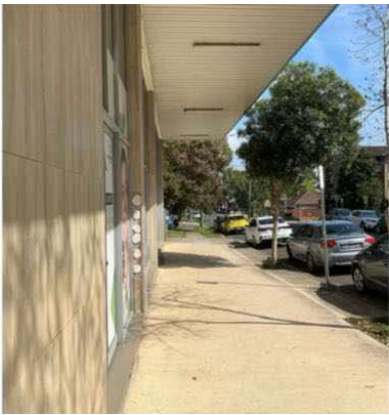
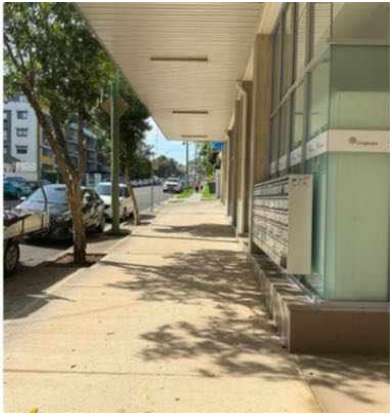
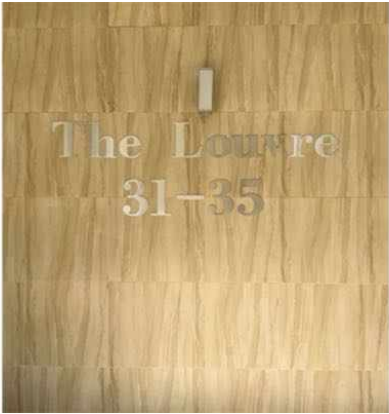
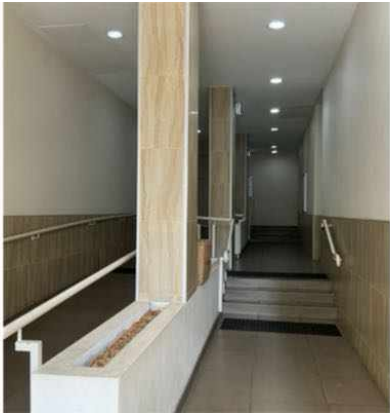
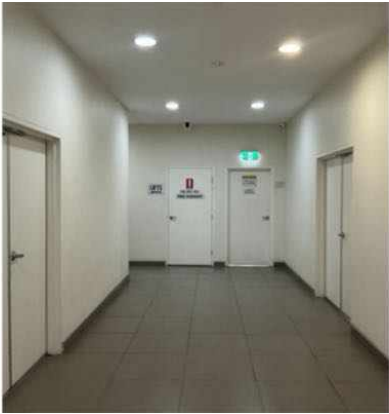
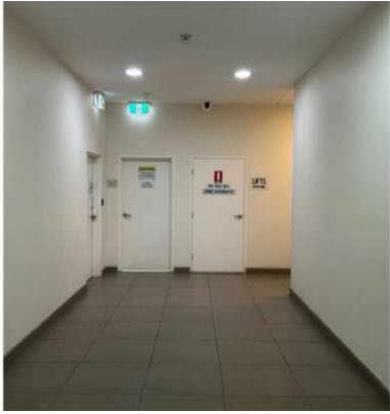
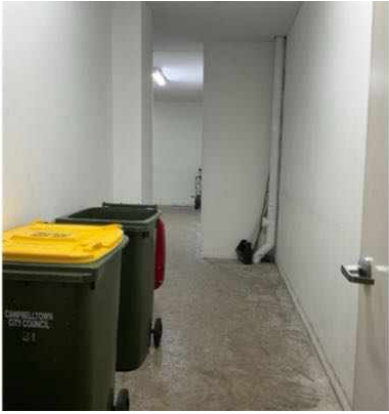
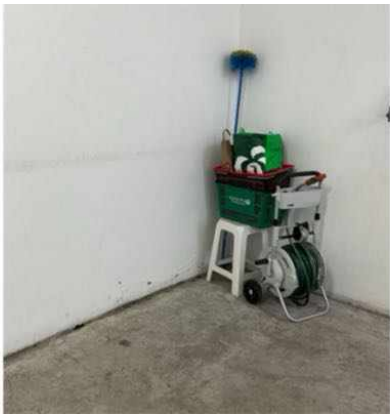
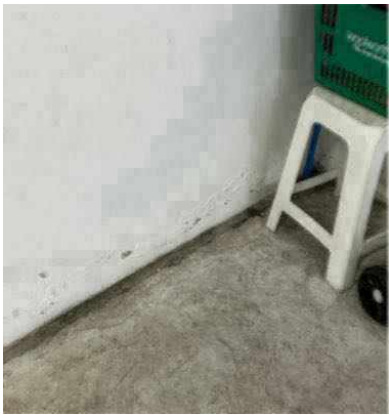
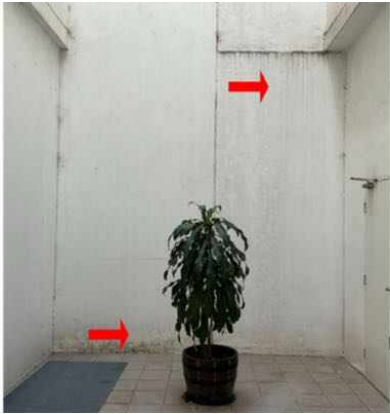
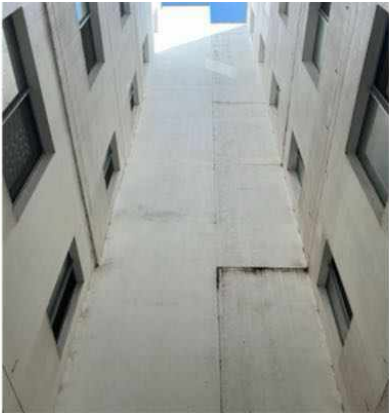
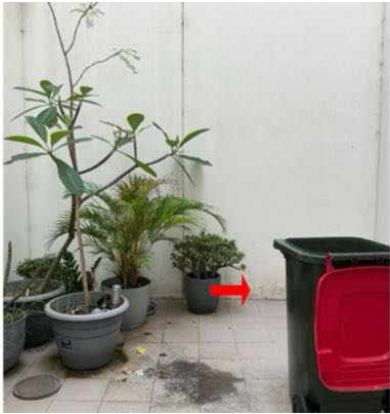
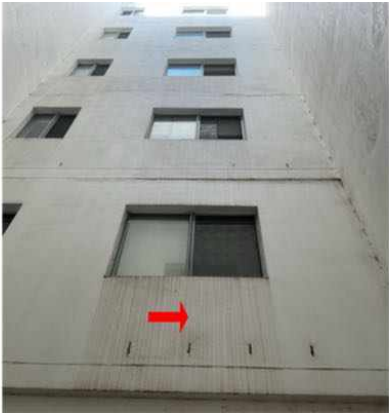
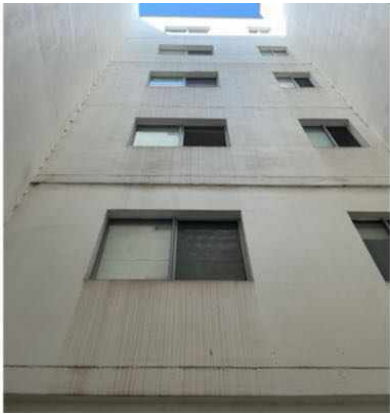
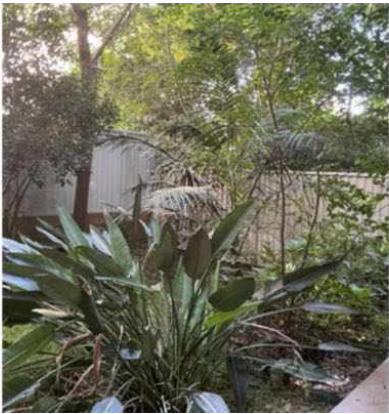
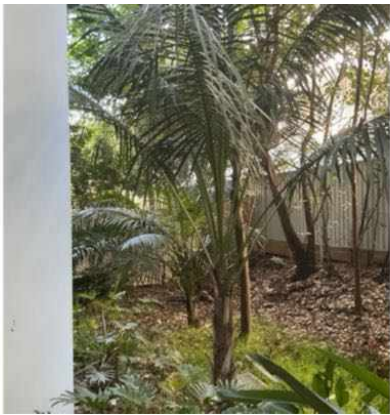
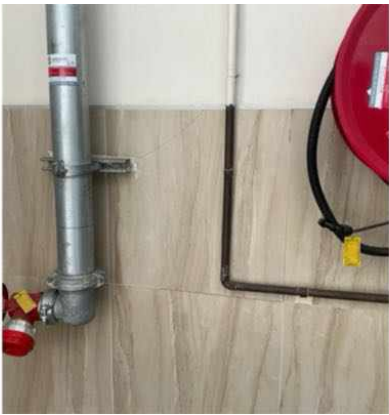
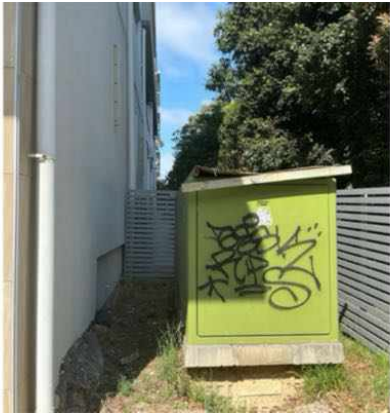
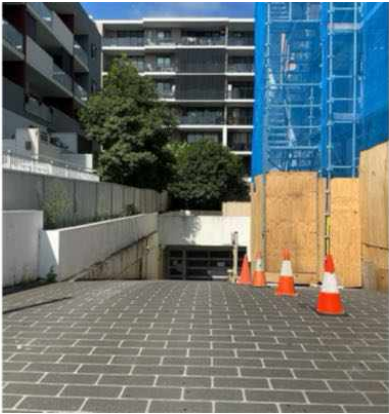
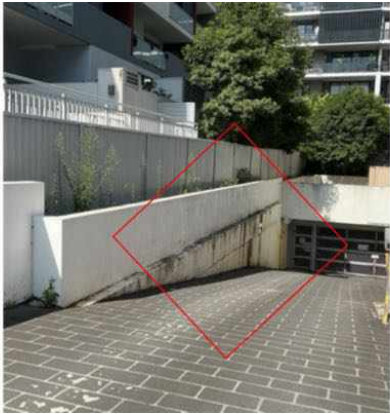
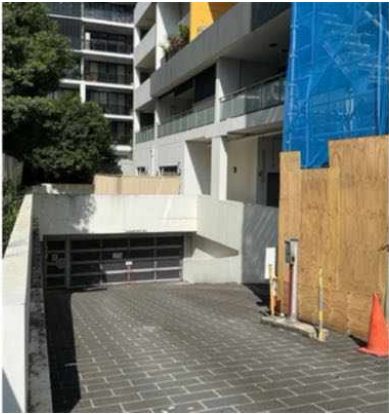
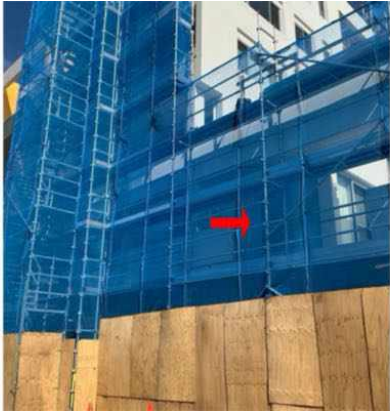
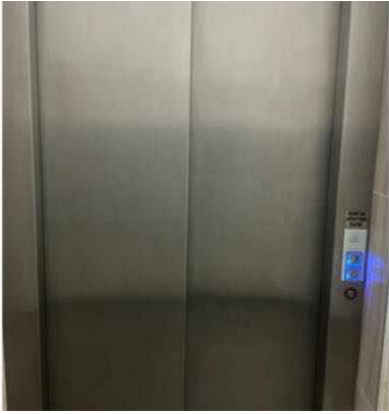
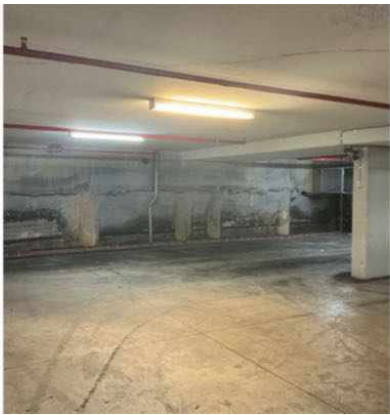
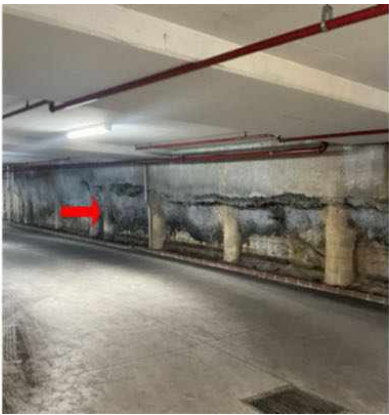
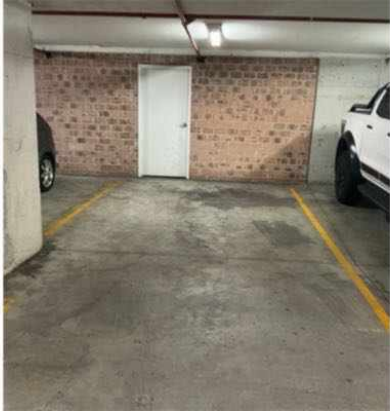
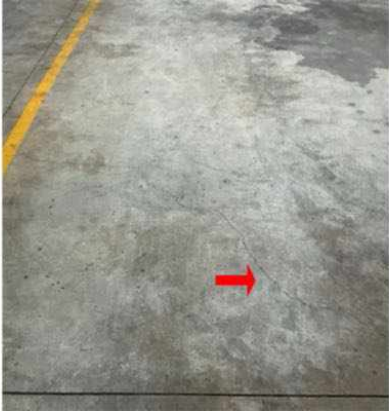
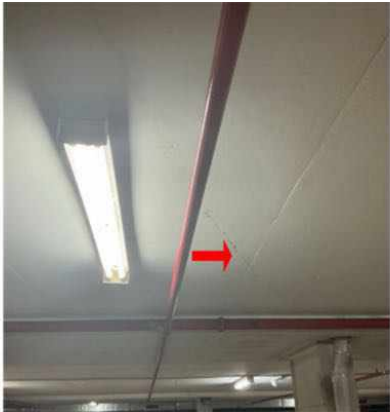
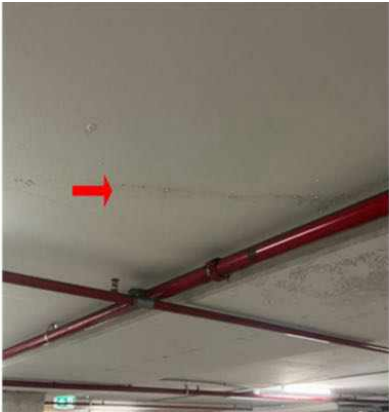
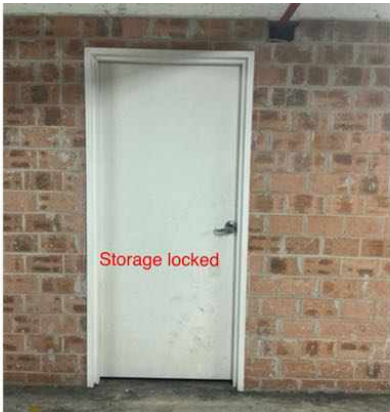
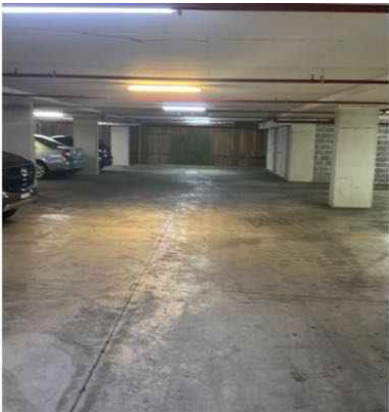
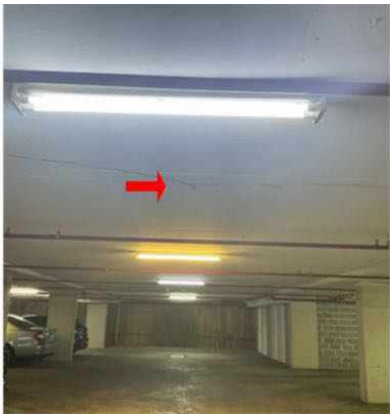
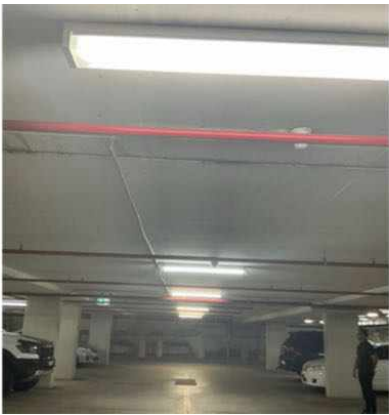
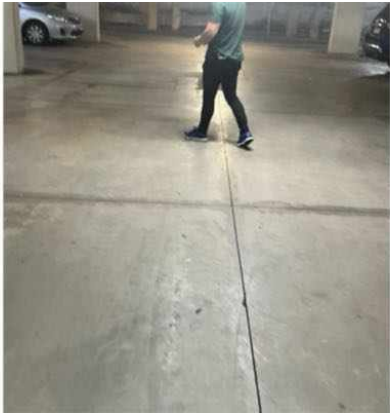
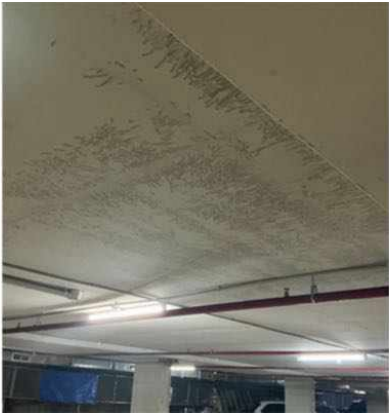
Building:	Main Building
Location:	All External Areas
Finding:	Additional Photos - Obstructions and Limitations
Information:	These photographs are an indication of the obstructions and limitations which impeded full inspection of the property at the time of inspection. These obstructions can hide an array of defects and should be removed to allow full inspection to be carried out. A re-inspection is recommended once the areas are made accessible.

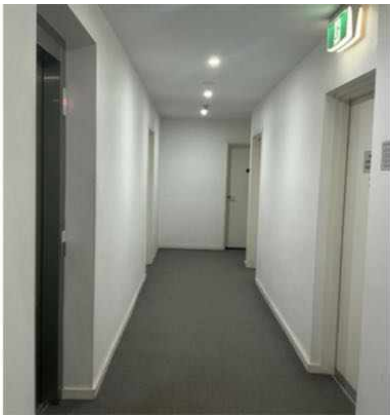
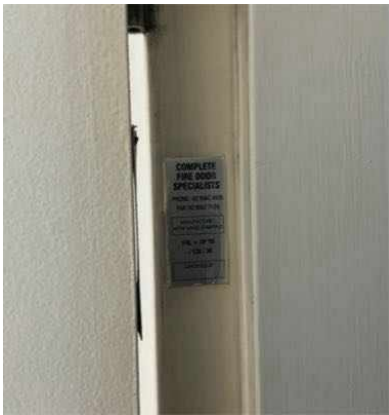
Building: Main Building
Location: All Internal Areas
Finding: Additional Photos - Obstructions and Limitations
Information: These photographs are an indication of the obstructions and limitations which impeded full inspection of the property at the time of inspection. These obstructions can hide an array of defects and should be removed to allow full inspection to be carried out. A re-inspection is recommended once the areas are made accessible.
